**Assessment of Water Supply Service Provision Limitations
and Its Effects in Case of Masha Town, SNNPR, Ethiopia**

Thesis on the Degree of Master of Science in Civil and Environmental Engineering
(Major in Water Supply and Environmental Engineering)

BY: KUMLACHEW DAKITO GUCHETO

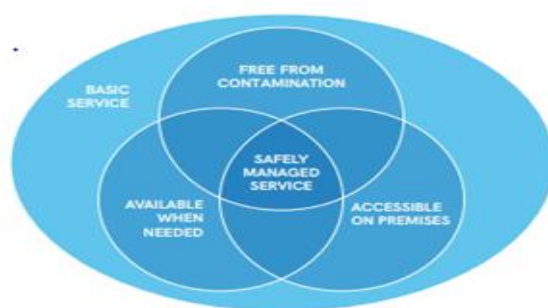
- it should be accessible on premises,
- water should be available when needed, and
- the water supplied should be free from contamination.

Figure 2-2-1: diagram describing criteria for safely managed service (JMP, 2017)

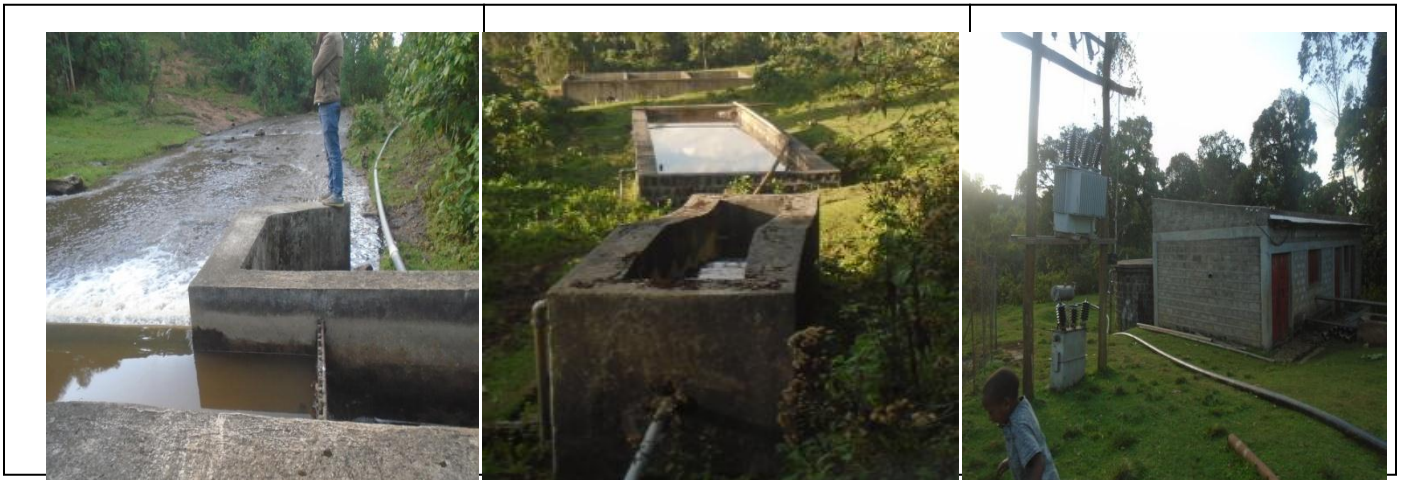
Wonani river treatment plant comprises different treatment components. Sequentially treatment components are cascade aerator, plane sedimentation tank, horizontal roughening filter, slow sand filter, balancing chamber and clear water tank (wet well) from initial to final treatment stages. The image of existing water supply system is as shown in figure below.

Figure 3-2: Image of existing Masha town water treatment plant, intake and wet well

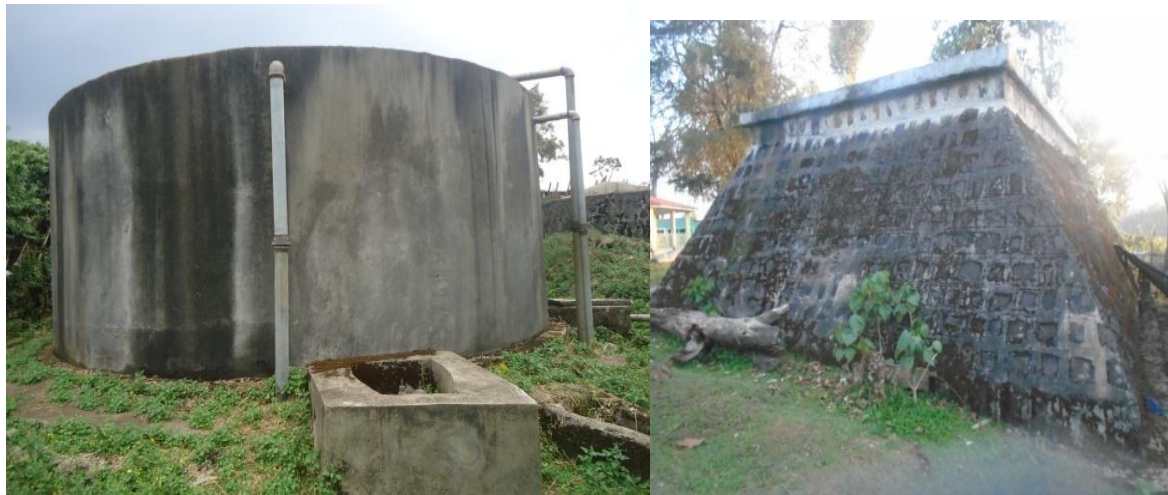
Currently the town has three reservoirs with total capacity of 175m³ in service that are found two at town center 25m³ Sandwich masonry and 100m³ reinforce concrete reservoirs and also at premises of St. Mary church 50m³ sandwich trapezoidal masonry reservoirs. The 25m³ sandwich masonry reservoir situated at center of town is not functional this time.

Figure 3-3: Picture of Reservoirs of the Town

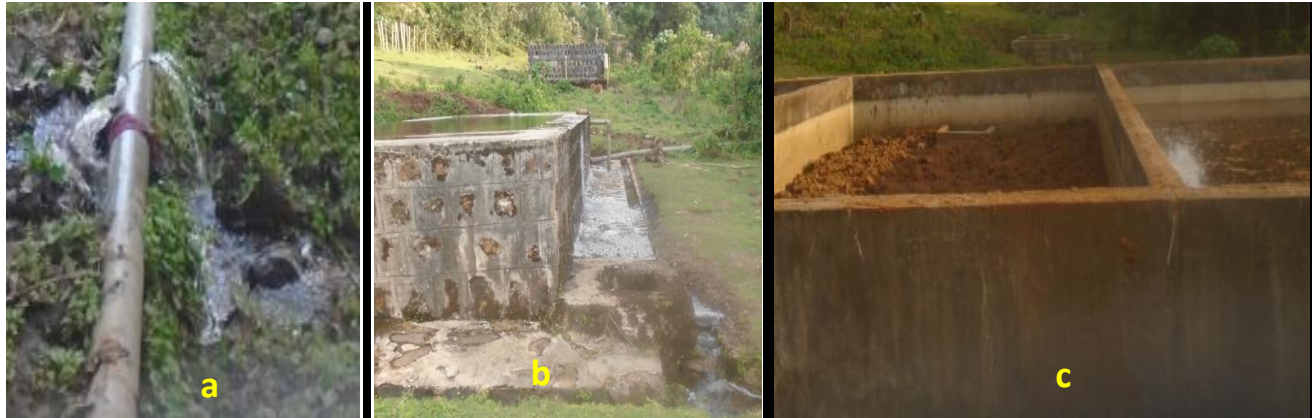
As visited in different system components of water supply, existing weir intake was filled with silt and not properly maintained. In addition, water is passing downstream by eroding left bank of the river at weir site. Conveyance pipe line seriously leaked due to pipe damage as it was lied on surface where there was road in which humans and animals use Seen in figure4-3(a) below. Water from Horizontal roughening filter unit was overtopping and significant amount of conveyed water was lost as shown in figure 4-3(b). As visited in the site, sand filter media was not cleaned and water also lost through overflow due to reduced filtration rate as shown in figure 4-3(c). Generally, part of water diverted to treatment plant was significantly lost due to poor operation and maintenance of the components. These clearly confirm that there is poor operation and maintenance of treatment plan that result in reduced water production and risk of damage of structure.

Figure 4-1: Picture showing water losses in conveyance and treatment units

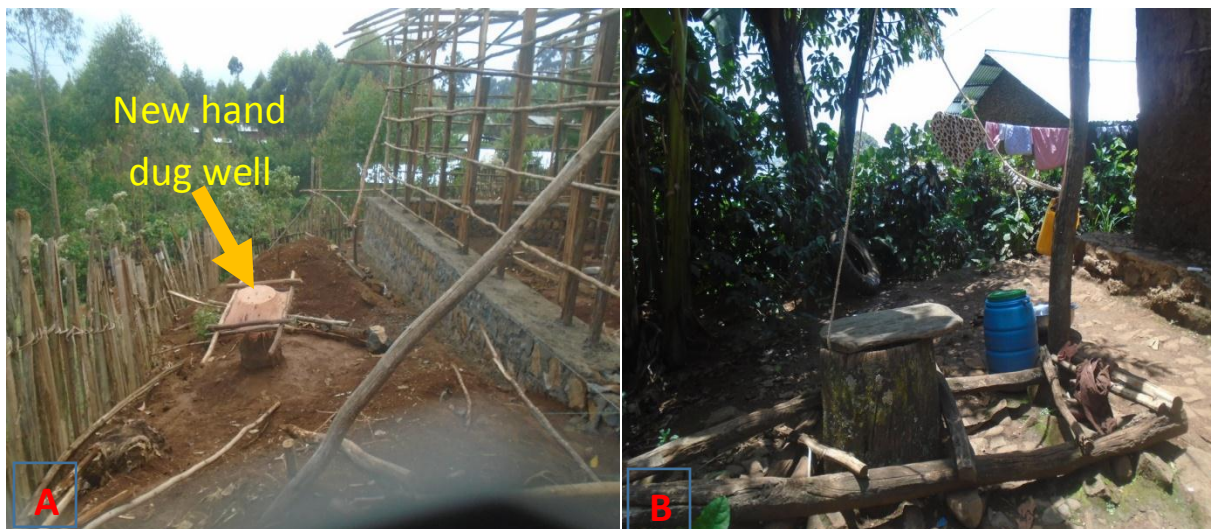
As site visit in Masha town showed hand dug well was common source of domestic water for entire areas of the town except limited areas of the town where construction of wells were impossible due to hard geologic formation. Depth of these wells varies from place to place based on topography of the location and ground water could be reached even at 4 meters depth in some places. In Masha town, most of the time, hand dug well was constructed during house construction as shown in picture below as it needs plenty of water spatially during dry season. Then after it will continue serving as water source for domestic activities. Surprisingly there were water wells aged above 40 years and still serving as water source. The head of these water wells were constructed traditionally from hollow wood as shown in fig 'B' below and not well protected.

Figure 4-5: Image showing appearance of hand dug newly constructed (A) older wells (B)

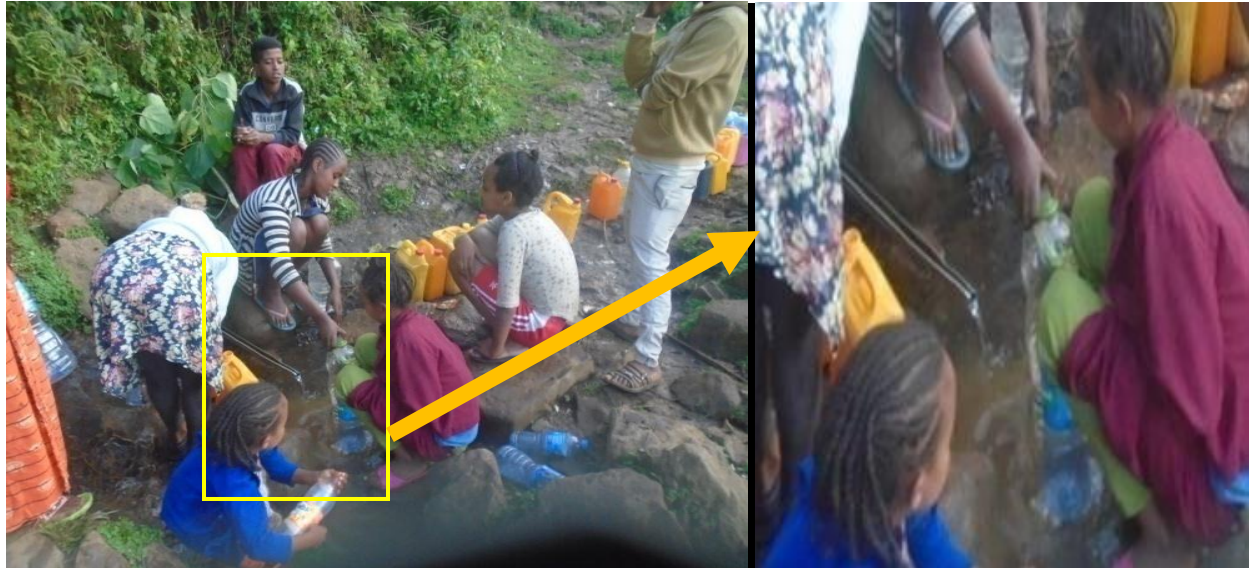
from this unprotected source. As spring water users indicated that they were waiting for long time to fetch the water because of low flow of springs. Most of water users fetch water in the morning or evening since it was not school time. As shown in the figure the fetch water in small jerry can and their reason was long distance from their home and using only for drinking purpose. In the town people were going distant water sources even though they have nearby pipe water sources.

Figure 4-6: Image showing people fetching water from spring and situation of the spring in the town

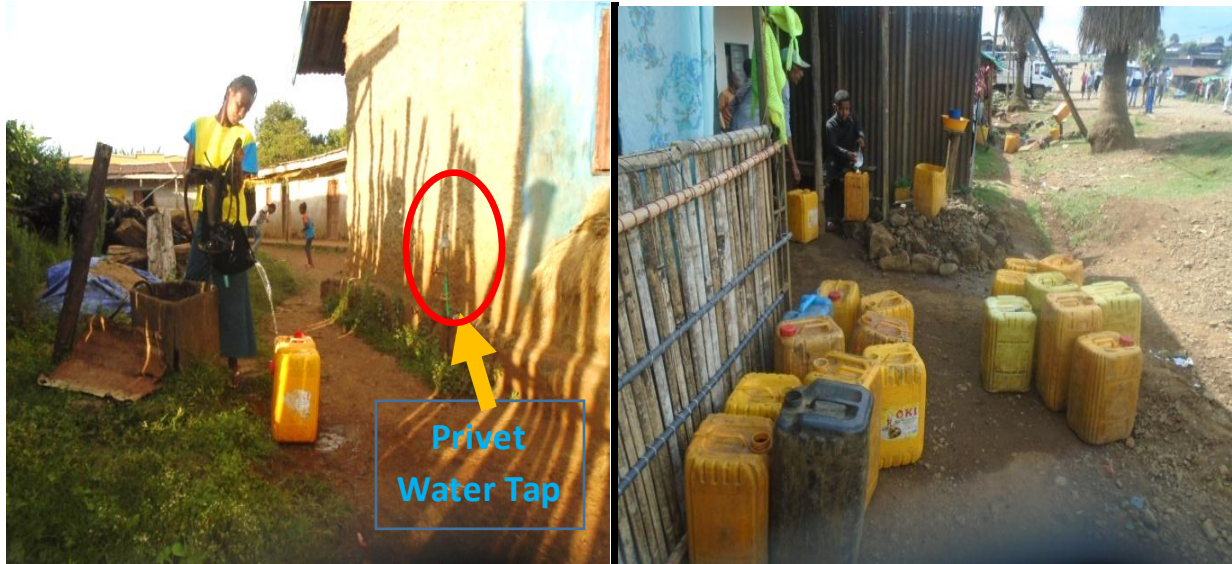
The study result shows that almost all of resonant about 93.75 (those without emergency tankers) were forced to use unprotected water sources or water from vendors in the town.

Figure 4-9: Woman fetching water from Hund dug well while private tap was dry and boy selling piped water for people of the same town

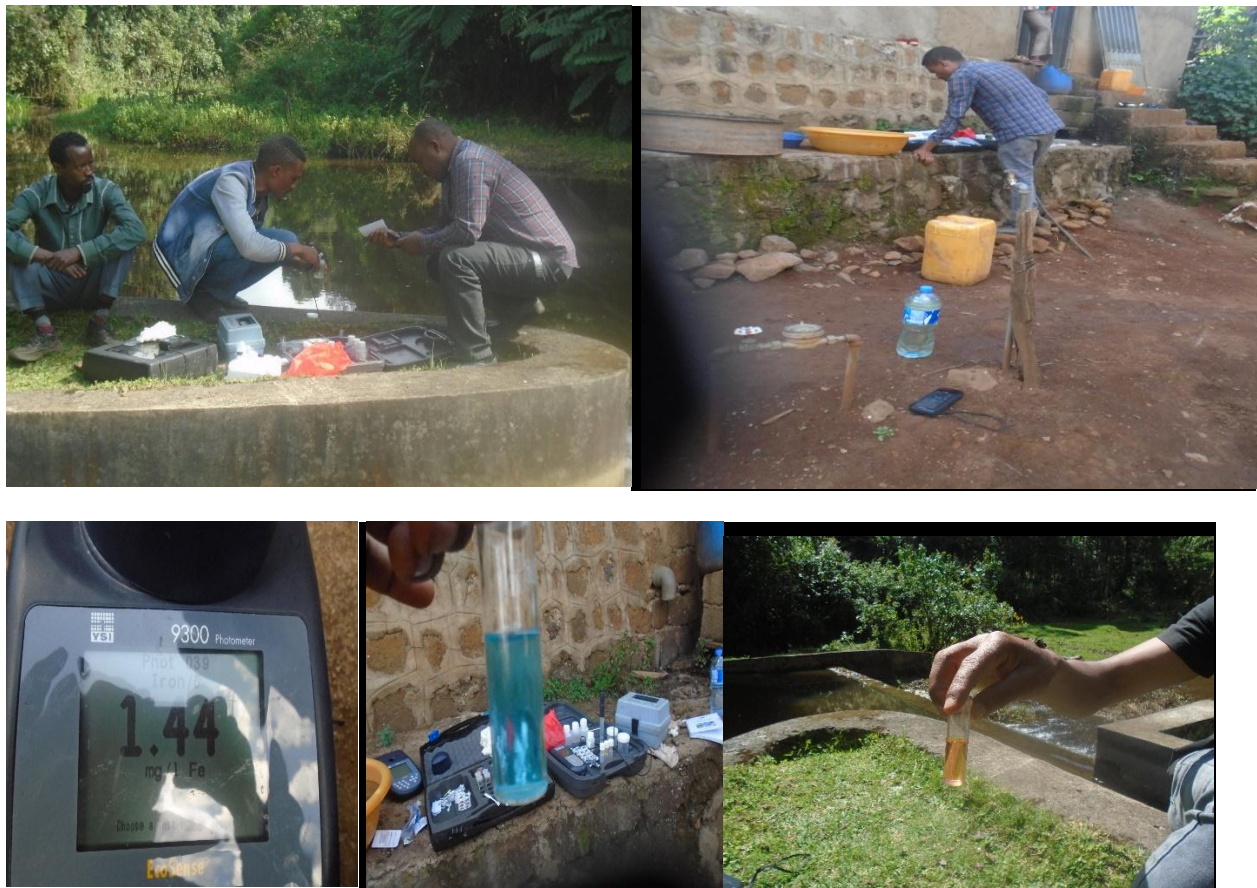
Figure 4-14: picture showing water quality testing in the site (Intake Point) at Private Tap

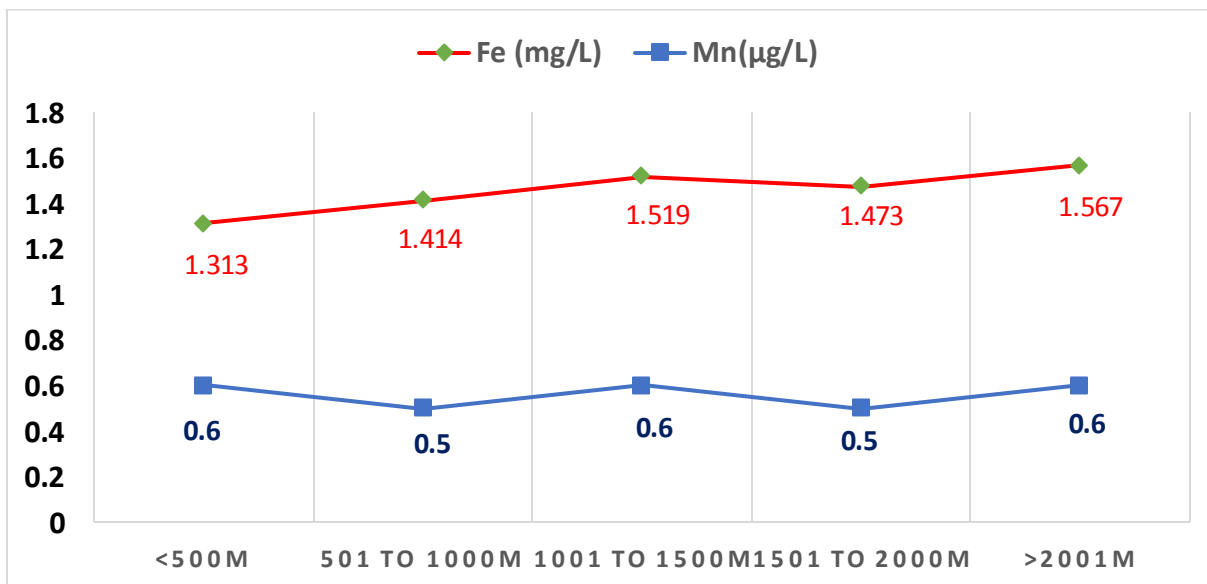
Figure 4-15: Graph showing variation of average Fe& Mn contents in the distribution system with distance from central reservoir

As the result in graph clearly shows that average concentration of Fe increased as sample site gets far from storage reservoir. Average concentration of manganese has no unique trend and it shows fluctuation throughout length of distribution system. The average concentration of iron has declined in distance from 1501 to 2000 meters and this was due to factors affecting concentrations like water pressure. As the result indicates that water users far from reservoir are more affected by high concentration of Iron. Most of newly developed parts of the town were more affected as the end users of water from the system. The increase in iron concentration was

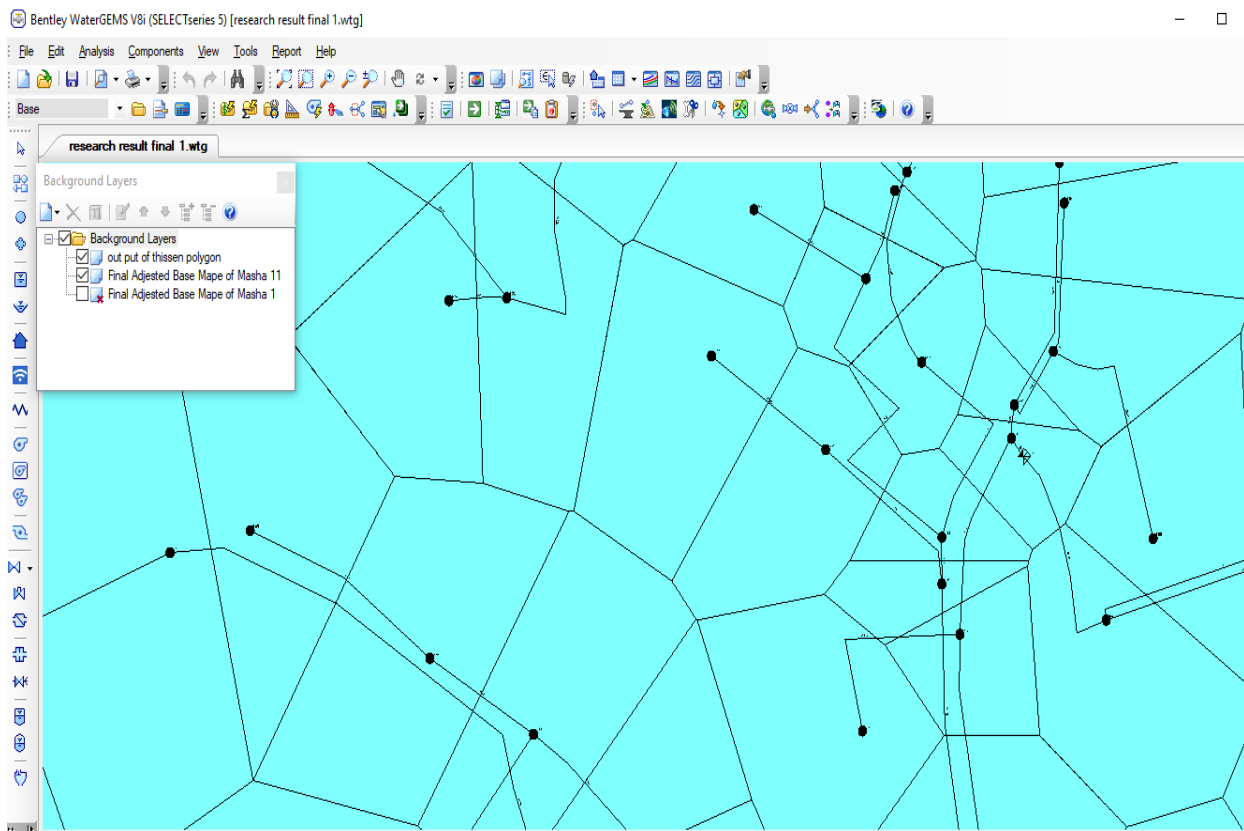
Based on housing density classification mash town existing settlement was evaluated and total number of housing units in town was found to be 4616.39. Based on this the average number of people in a house was 4.33 which is not far from number of people in a household as surveyed in the study by questioner which was 4.2. Based on global mapper software the catchment of demand area of each junction were analyzed by overlaying Thissen polygon and structural map of the town.

Figure 4-16: Image showing Thissen polygon for Junctions

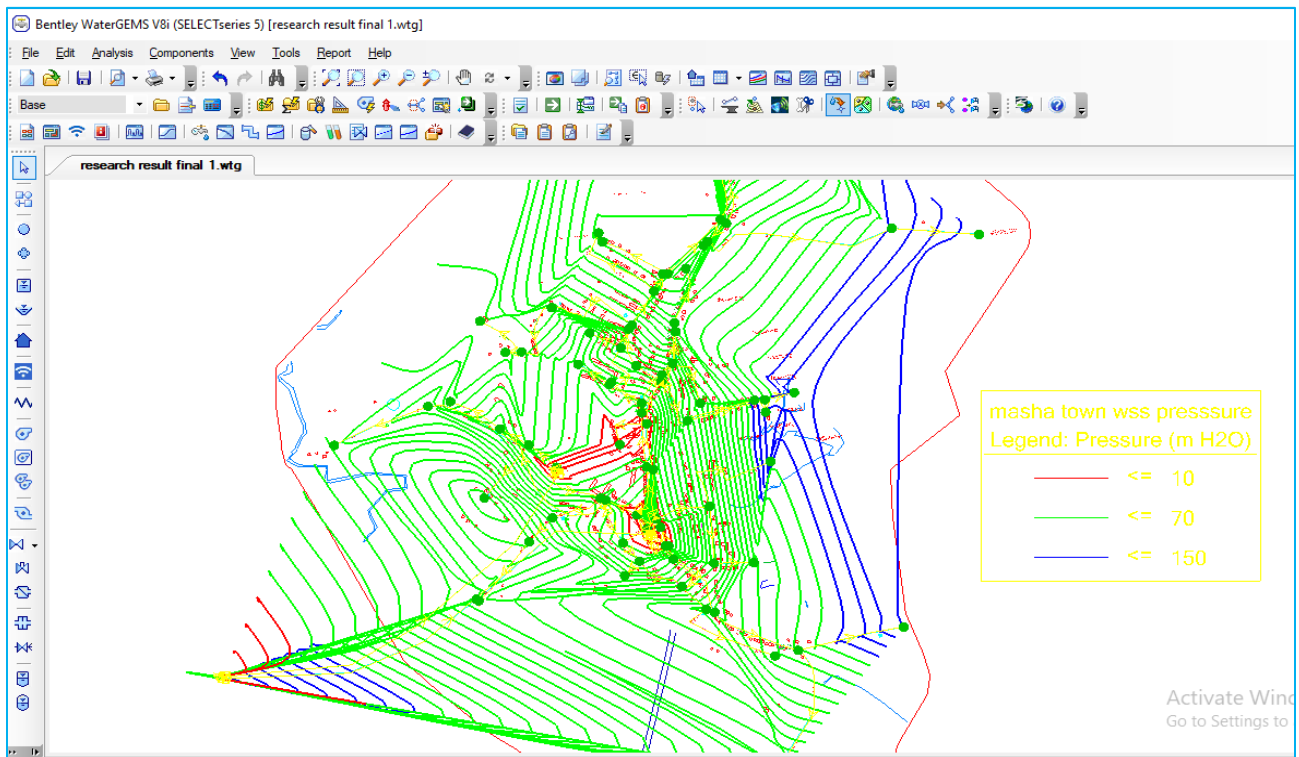
After modeling the existing situation of Masha town water supply distribution system and calibration, out put pressure contour map was reported as shown in figure below. The existing flow rate was below minimum flow that was 2.2 l/s and the velocity of flow were further reduced to nill to some points in the distribution system. As the contour shows that in some parts of the town like in center of the town where the reservoir was situated the system supplies water in low pressure. In central area of the town where high story buildings were under construction water pressure were not adequate to supply houses. Therefor the distribution system cannot deliver sufficient water with adequate pressure for these areas. In some areas of the town pressure was found to be above recommended value as shown in the analysis result. Based on the pressure contour the low pressure junctions were concentrated within limited area and this has opportunity to supply water by zoning this area with special consideration. The analysis result of the model for each junction was annexed in the research report.

Figure 4-20: Figure showing pressure contour of Masha town based on recommended values

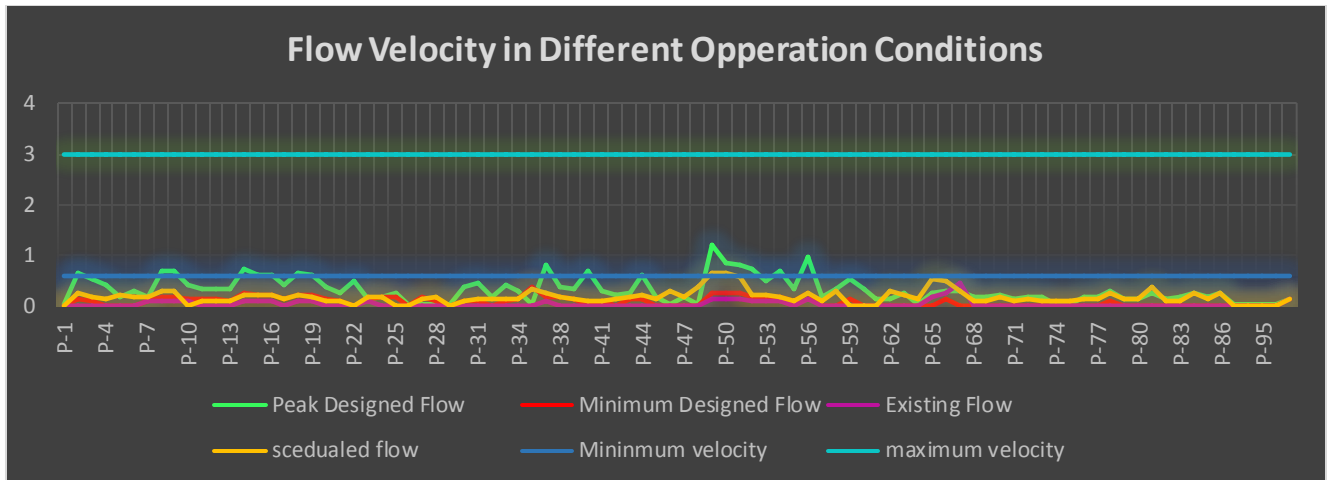
In all case the flow velocity were almost below recommended values (0.6m/s) and in case of peak time operation velocity of flow in the pipe were nearer to recommended values. Flow velocity were very low (<1 m/s) for existing water operation condition and minimum flow time of designed capacity. In scheduled operation condition the velocity has recovered in some extent. Further it can be improved by improved by scheduling based on once in a three day time but by itself affects the water use trend of the town. In general reduced flow rate due to limited treatment and capacity were affecting the distribution efficiency and water equity in the system. Tabular value for model results were as attached in the annex-6.

Figure 4-25: Figure showing Velocity variation different system capacity flow condition

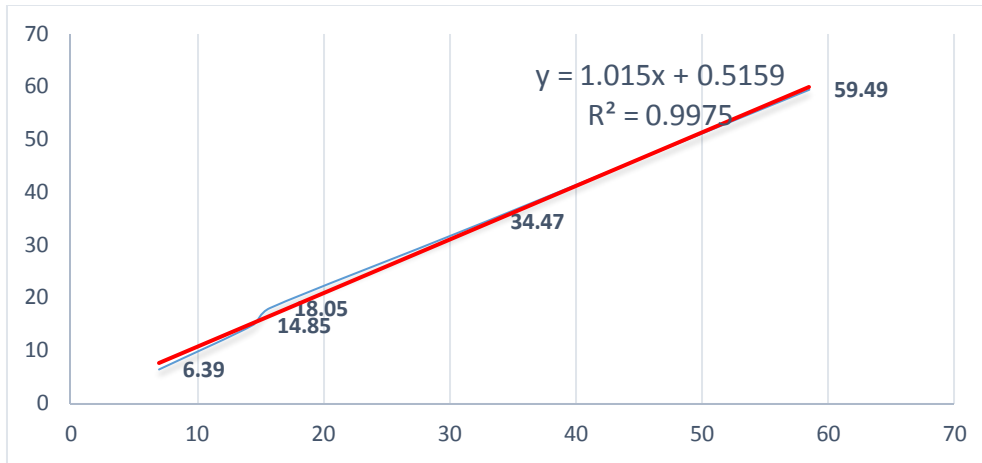
Figure 4-26: Graph of actual versus simulated pressure values for calibration

Even though the pressure calibrated was not within the recommended value, as shown in graph, there was acceptable correlation of observed pressure and simulated pressure that was above 99.95%. This can improve model representation of real system of Masha town water supply.
