STUDY ON BLACKOUTS OF ETHIOPIAN ELECTRIC POWER NETWORK AND IDENTIFICATION OF SYSTEM VULNERABILITIES

*A thesis submitted to Addis Ababa Institute of Technology, School of Graduate Studies,
Addis Ababa University in partial fulfilment of the requirements for the **Degree of Master
of Science in Electrical Power Engineering***

Addis Ababa, October 2017

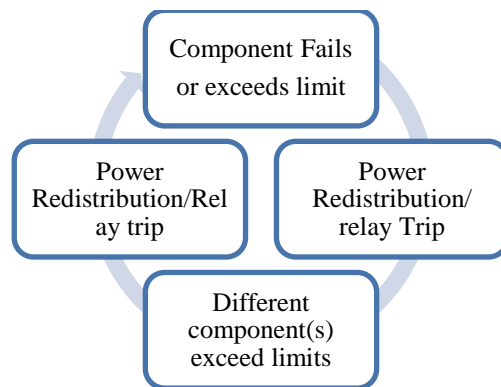
Figure 1-2 Cycle of cascading failure [12]

As was explored by Dobson et al [10] occurrence of large blackouts usually results from series of cascading failures. In some cases, a single failure in the system can trigger other failures across the network, pushing beyond operational limits. The protection layer in the power system is designed to prevent these kinds of events, while preventing permanent damage to expensive equipment. However, sometimes the indiscriminate actions of protection schemes remove components out of service that make the system even weaker. Figure 1-2 shows the cycle of cascading failures. Due to overloading, faults, or other circumstances, a particular component is taken out of service. In doing so, power is redistributed based on circuit laws. As a result, other components might get overloaded causing them to be taken out of service by the protection relay signals. The cycle repeats, usually in quick sequence, that operators are not able to manage the situation [10, 12].

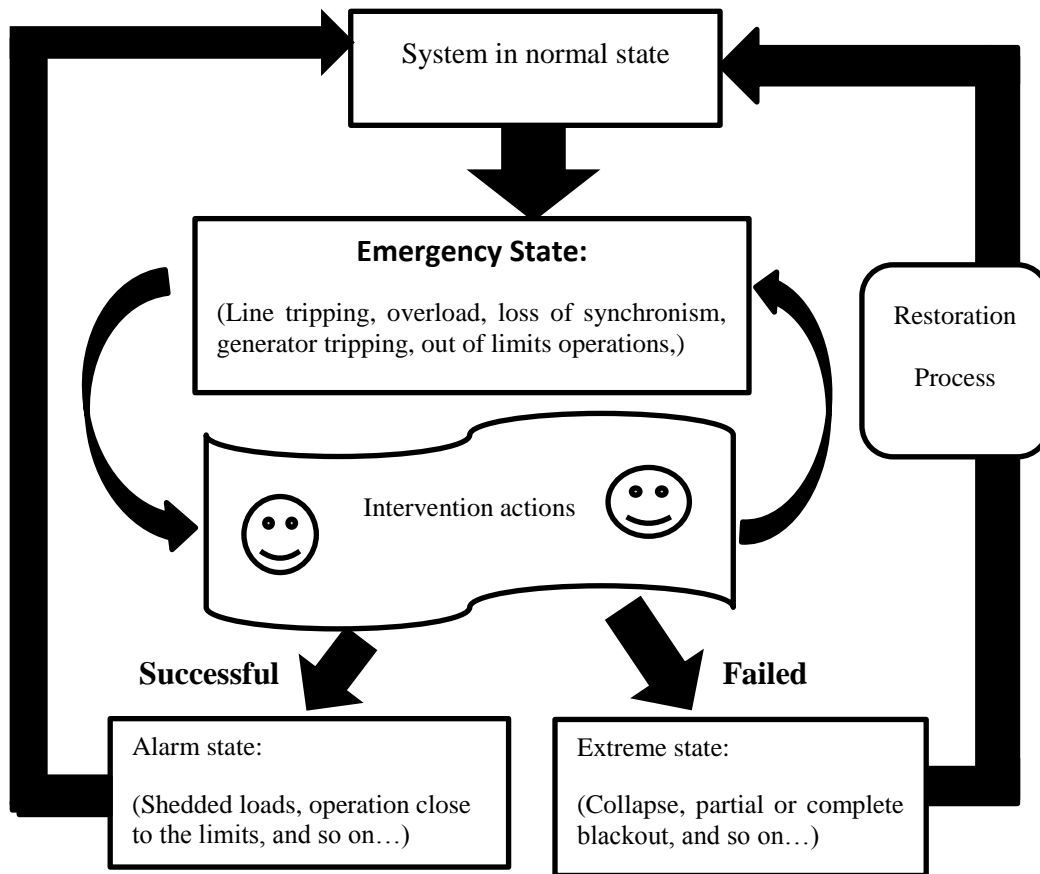
Figure 2-1 Operating states of the power system [23]

actions of the operator are able to bring back the variables in the limits, the system will be preserved and goes to the alarm state. The system is in alarm state when the constraint of providing electricity to customers is not entirely satisfied (a part of the customers is not supplied). The system is in extreme state if both types of constraints are violated.

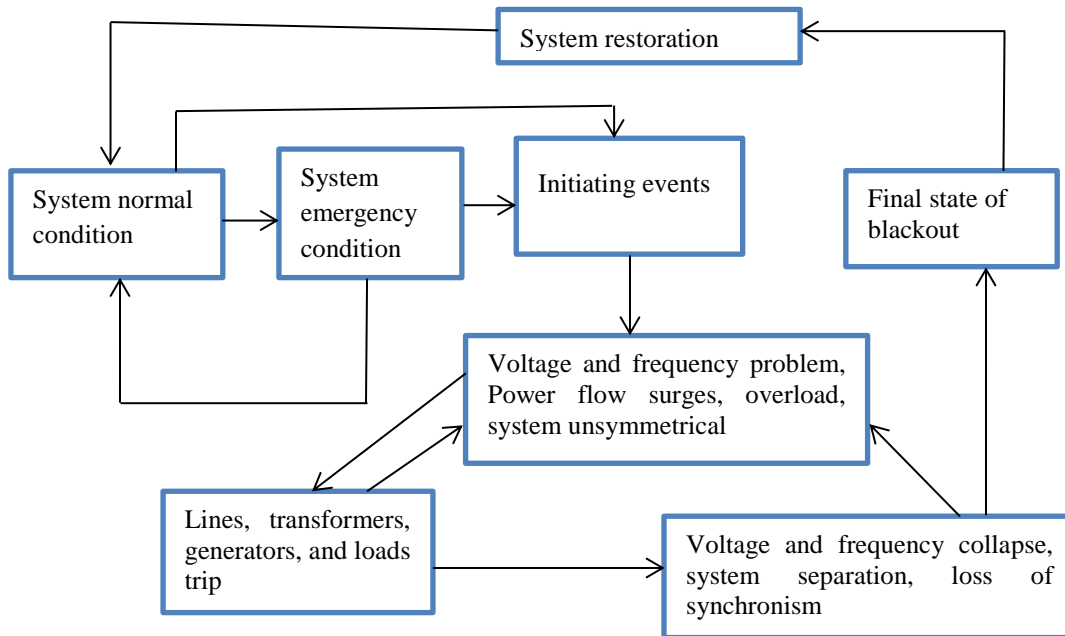
Figure 2-2 Mechanism of blackouts [22]

Veropai et al [24] described the mechanism of blackouts in Figure 2-2. According to this analysis, there are five types of faults that cause blackouts: voltage collapse, frequency collapse, cascading overload, system separation, and loss of synchronism.

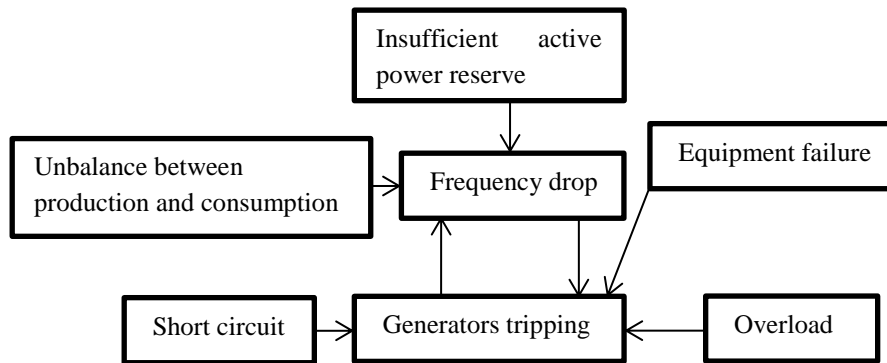
Figure 2-4 The mechanism of frequency collapse [25]

- b) **Frequency collapse** - unbalance between production and consumption appears, insufficient active power reserve in the system and generator tripping cause the frequency collapse. Facing these events, the power system uses the primary active reserve to keep the frequency in the limited operating range. If there is not enough primary reserve, the frequency can go out of the limits. The underfrequency protections of generators provoke their cascade tripping and, consequently, the acceleration of the frequency collapses. It happens in some seconds and can be stopped by underfrequency load shedding (Figure 2-4).

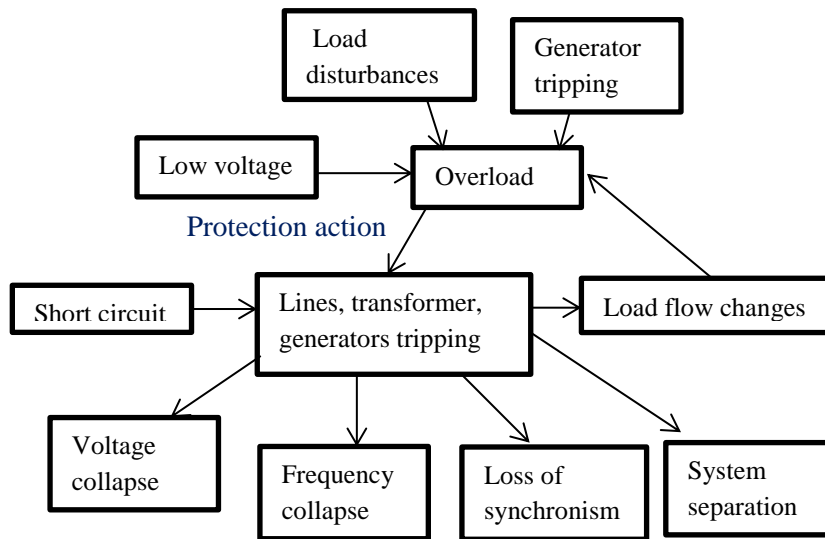
Figure 2-5 The mechanism of cascading overload [22]

A line can also be tripped by its overload protection. The power transfer on the other lines may cause them to be overloaded and also tripped by their protection devices and the cascade begins. The system enters into voltage collapse, frequency collapse then loss of synchronism or system separation and finally, the blackout happens. The duration of the cascading overload is from some minutes to some hours. A way to avoid the cascading overload is to use FACTSs, which can change the load flows and relieve the power flows in some critical lines. Load shedding can also help relieve the stress of the system and stop the cascade (Figure 2-5).

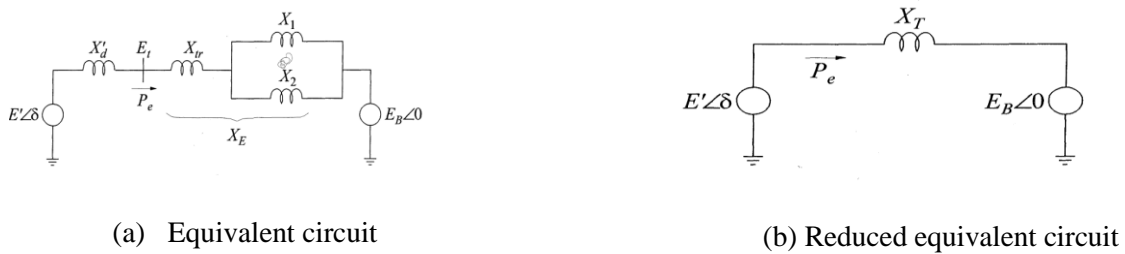
Figure 2-10 Corresponding system representation [11]

The corresponding system representation is shown in Figure 2-10 (a). X_E is the equivalent reactance of the transformer and the transmission lines. The voltage behind the transient reactance (X'_d) is denoted by E' . The rotor angle δ represents the rotor angle by which E' leads E_B . When the system is perturbed, the magnitude of E' remains constant at its pre-disturbance value and δ changes as the generator rotor speed deviates from synchronous speed ω_0 .

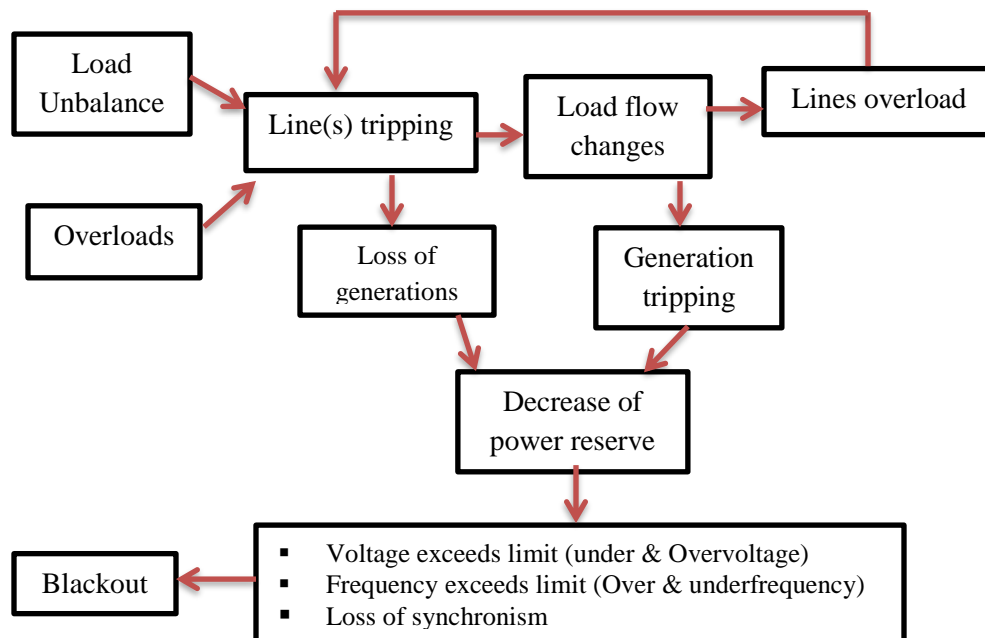
Figure 3-1 The mechanism of the November 5, 2014 blackout

In the November 5, 2015 blackout, we can clearly see the period of the steady state progression and the period of the high speed cascade. The triggering events tripped G/Gibe II- Sebeta II 400kV line, Sekoru_G/Gibe II 400kV line, G/Gibe I- Sekoru 230kV line I &II, and Ghedo- G/Gibe I 230kV line. The time of the cascade progression was around 40 minutes. The blackout mechanism of the November 5, 2014 blackout is shown in Figure 3-1.

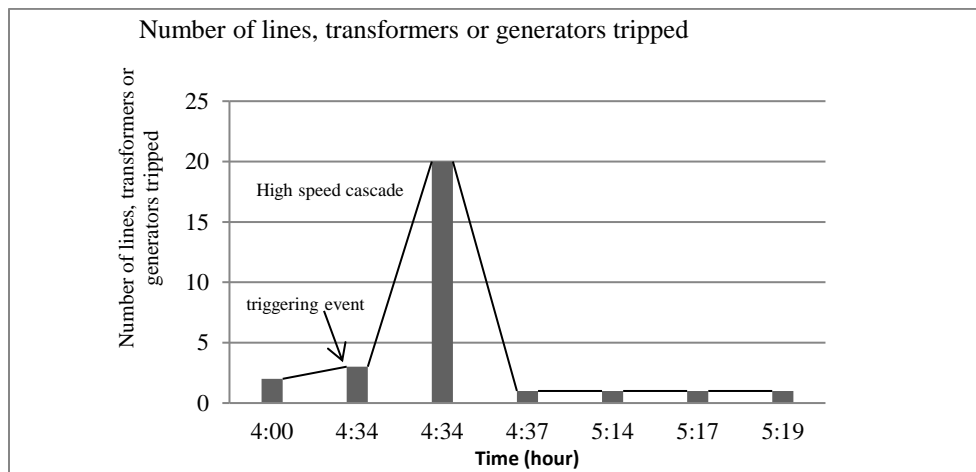
Figure 3-3 Accumulated line, transformers and generators tripping during the cascade in EEP grid on December 25, 2015 blackout

Immediately after the initiating events, B/Dar II – Gondar II 230 kV line was tripped by overvoltage protection and this had initiated a remedial action scheme that disconnected 19 generators. All the four units of Fincha HPP were overloaded and finally tripped by under frequency protection at 4:35 hrs. This further aggravated the system condition and as a result, the system voltage degraded drastically. G/Gibe I and G/Gibe III HPPs were unable to feed the required reactive power and hence, they tripped by overcurrent and under voltage protections. The power flow changed its route to other lines and power plants. These lines and power plants became overloaded and were unable to supply the power demanded by the load. Within 2 minutes' interval, more than 80% of the transmission lines and generators tripped. Generally, the December 25, 2015 blackout constituted only by a high-speed cascade, which led to the collapse of the entire system.

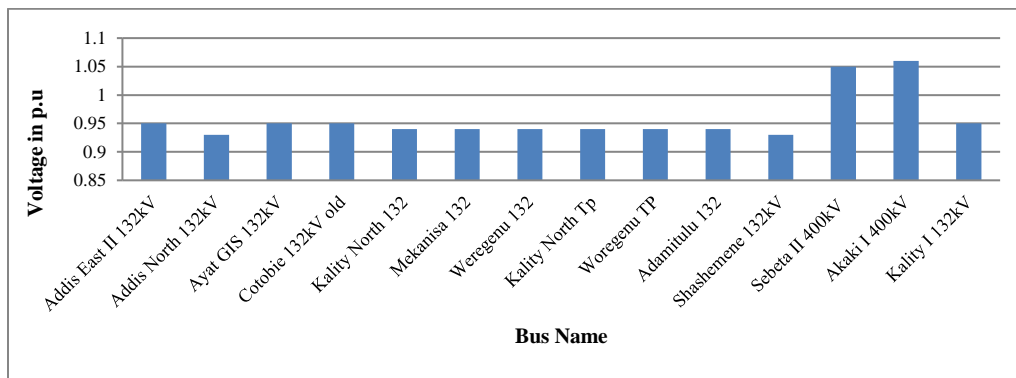
Figure 4-10 Voltage profiles of buses whose voltages deviate from 1 pu by ± 5% or more.

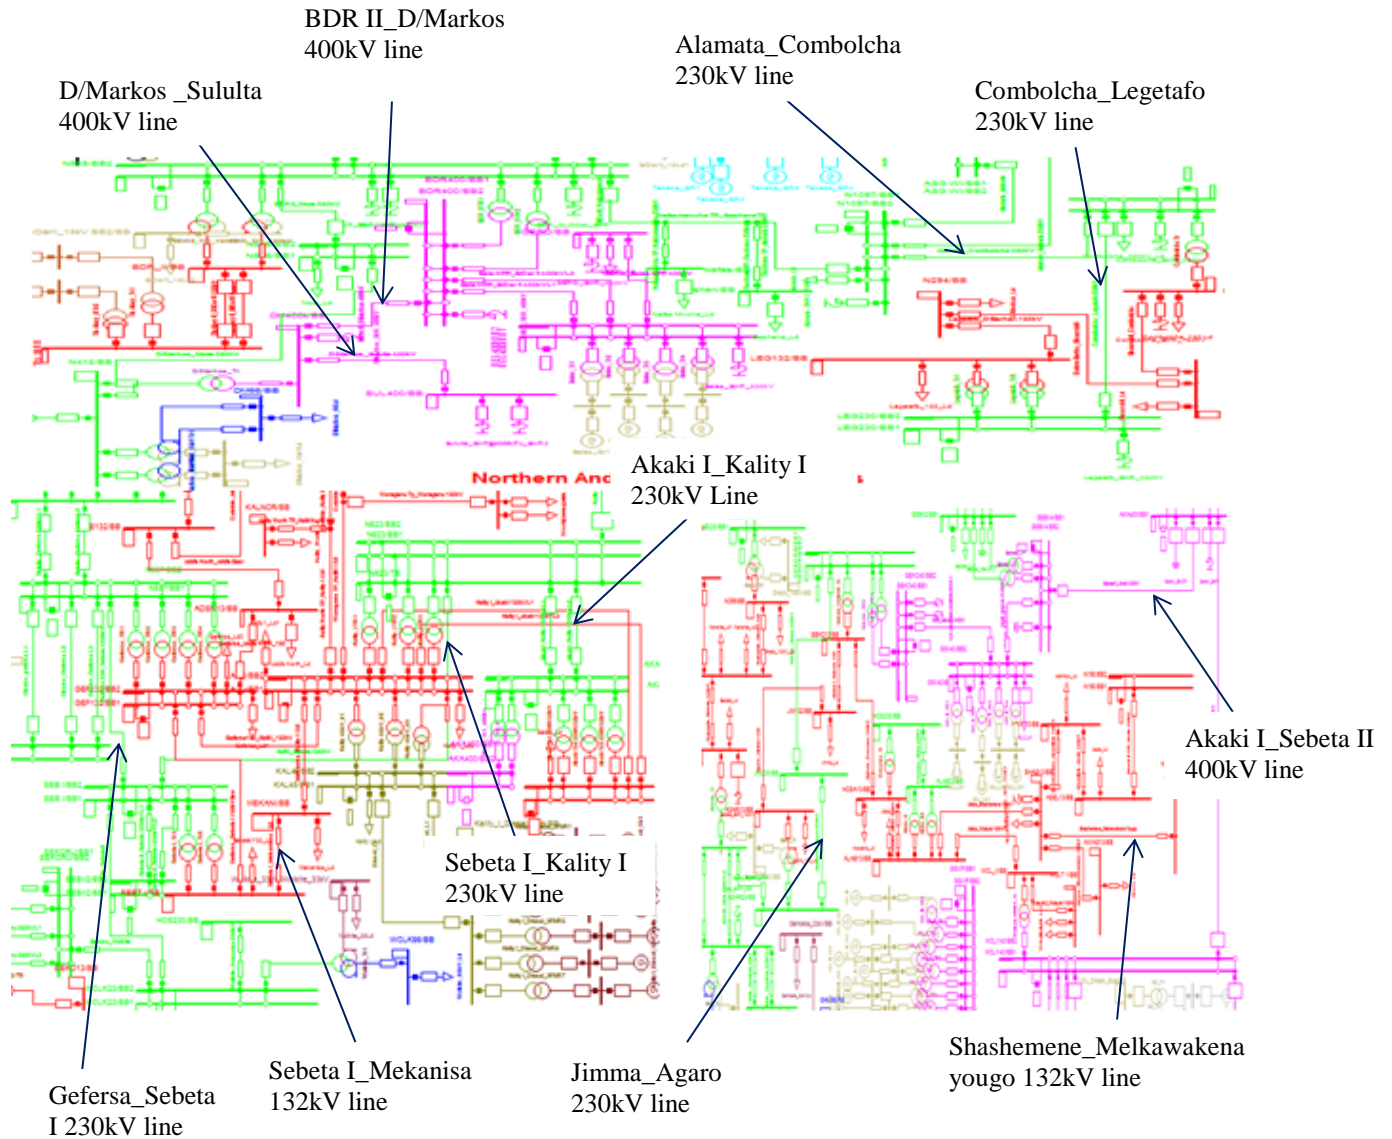
Figure 5-4 Portion of the EEP grid showing points of interest
