**Prospect of Architectural Heritage Conservation in Addis Alem St. Mary Church
and its surroundings, Western Oromia Region, Ethiopia**

A Thesis Submitted to the School of post graduate Studies, Addis Ababa University
School of Built Environment

For the Degree of Master of Science in Conservation of Urban and Architectural Heritage

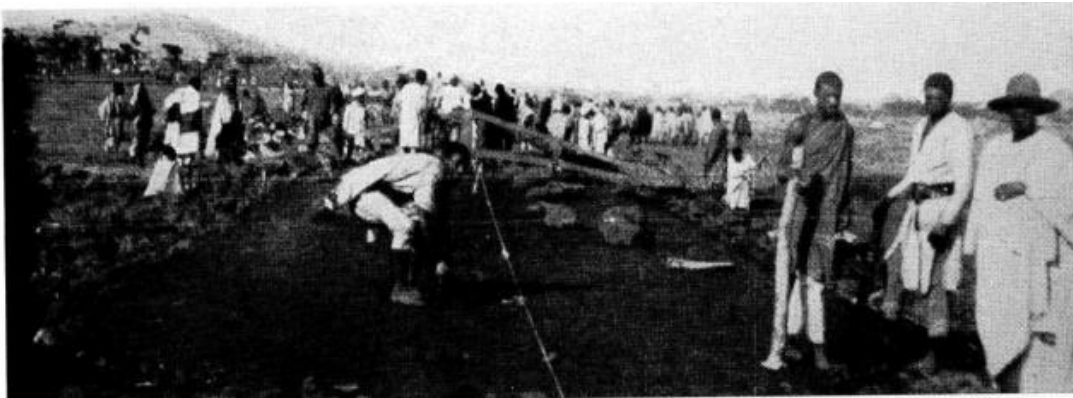
Figure 5 Road construction from Addis Ababa to Addis Alem

According to *Sergew Hable Selassie*, in 1903, immediately after the rainy season of 1902 ended, the emperor ordered the construction of a road from Addis Alem to the capital city of Addis Ababa. The road starts from west of Arada market to Addis Alem. The main purpose of constructing this road was to transport wood for the construction of houses in Addis Ababa (Milena and Gian, 2004).

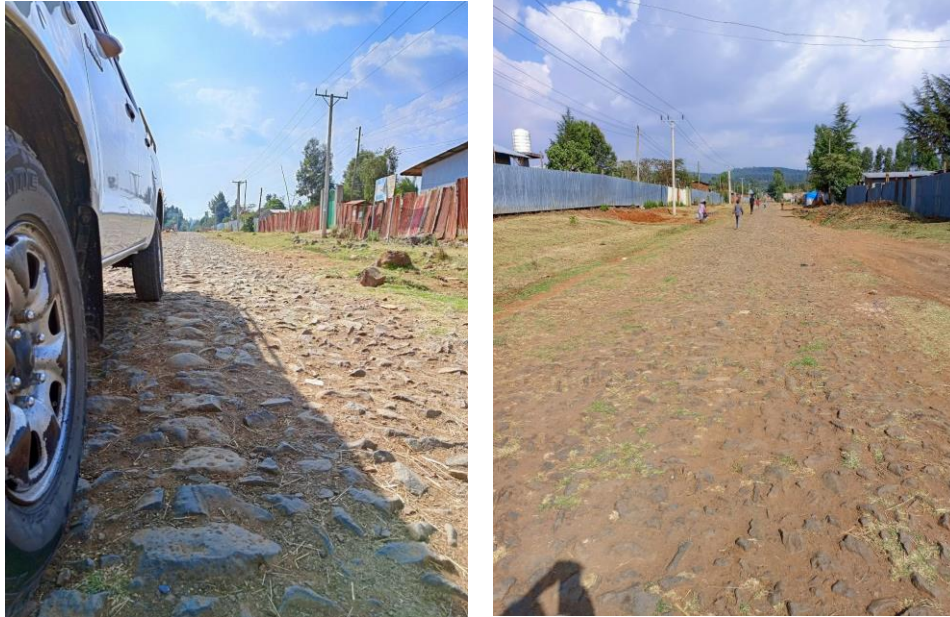
Figure 6 Current view of the old road

The researcher identified that the road which was constructed during the Emperor Menelik's reign is with a single lane a two-way road built with Crashed stone on a well-defined median (Author. 2023)

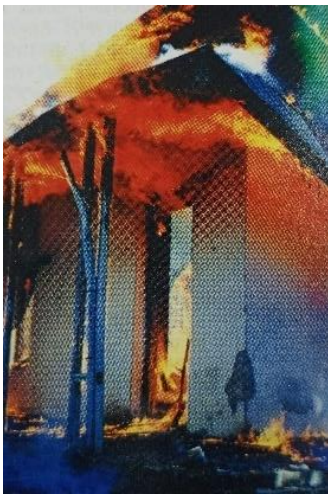
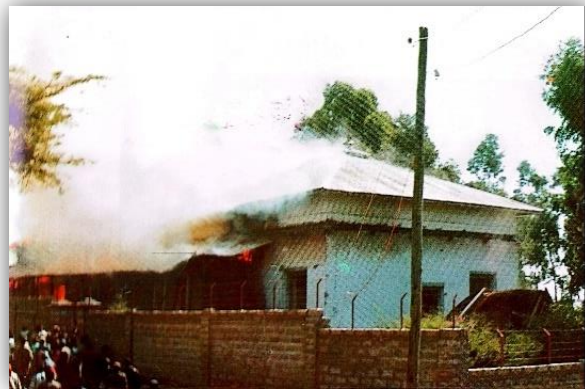
Figure 17 Palace building during fire damage in 1996

In 1989 E.C., the palace was damaged due to a fire caused by the negligent handling of candles. On the same day, the community quickly gathered to save the artifacts from destruction, ensuring that no artifacts were damaged. According to the inventory list by the Development Committee of Addis Alem(2007), the fire primary damaged the museum room, including the roof and some parts of openings (EHA Archive, 2000).

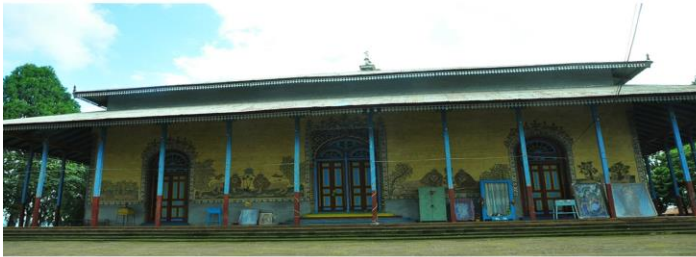
Dagmawit Ztsion Addis Alem church building

St. Mary church Addis Alem is the largest building in the study Area. It has a rectangular shape with an open veranda. However, most ancient Ethiopian St. Mary

churches are circular in shape .The veranda has forty-eight decorative wooden posts that support the roof. The roof is made of corrugated iron sheet with Gabel step roof and finials. Additionally, there is an ornamented wooden architrave. The church has well-decorated arched doors and windows on all sides of the wall. Besides, the internal and external walls were decorated with paintings (Field observation,2023).

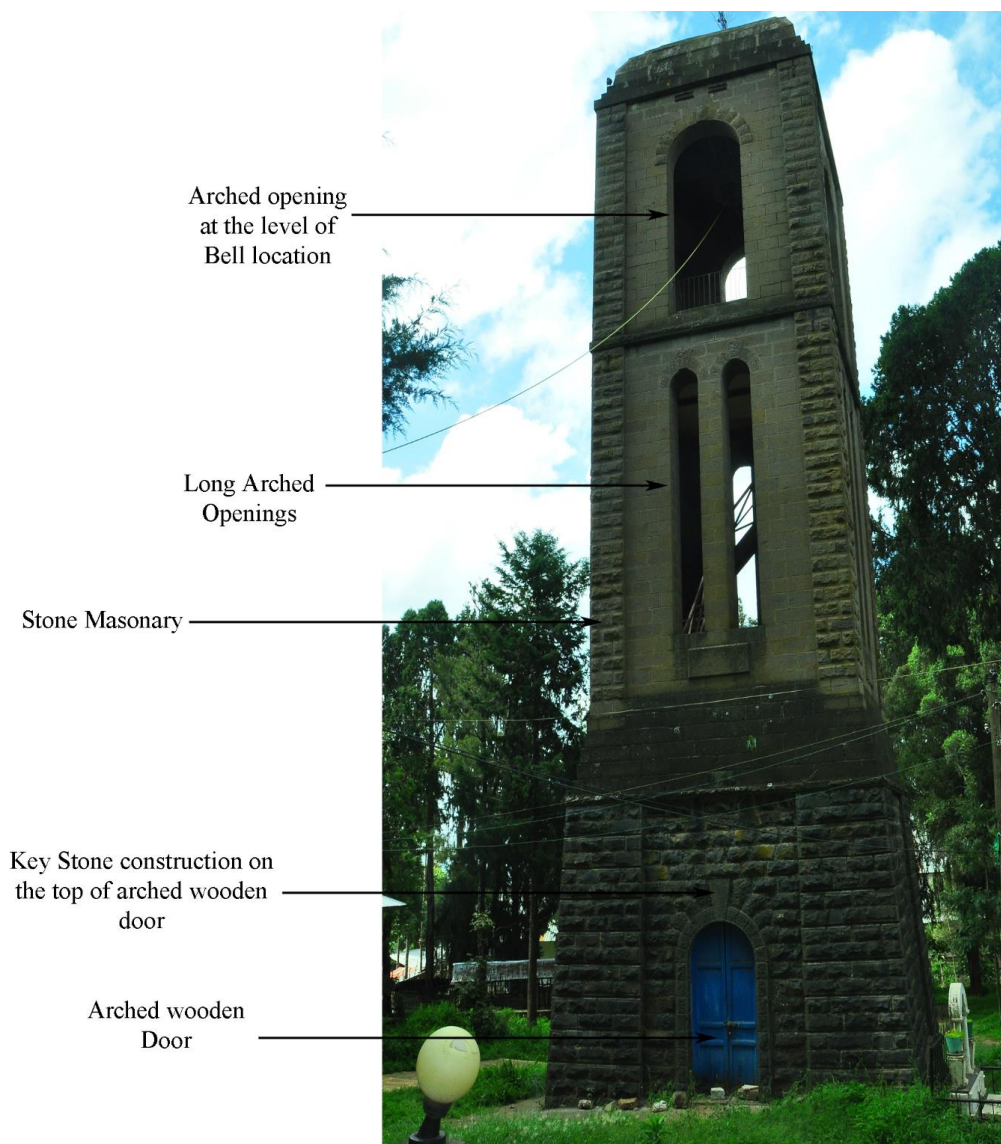
Figure 31 The architectural Analysis of the church Bell Tower

The bell tower is a distinctive structure with interesting high masonry construction. It has a rectangular shape with well-decorated arched opening, But it does not have a wing. Additionally, it has a wooden arched door that provides access to wooden stair way leading from the ground to the bell of the tower (Observation, 2023). According to video Archive of EHA, this structure began construction during Emperor Menelik period but was halted for a long period due to various reasons. The construction resumed and was completed in 1926 with the help of Etege Menene.

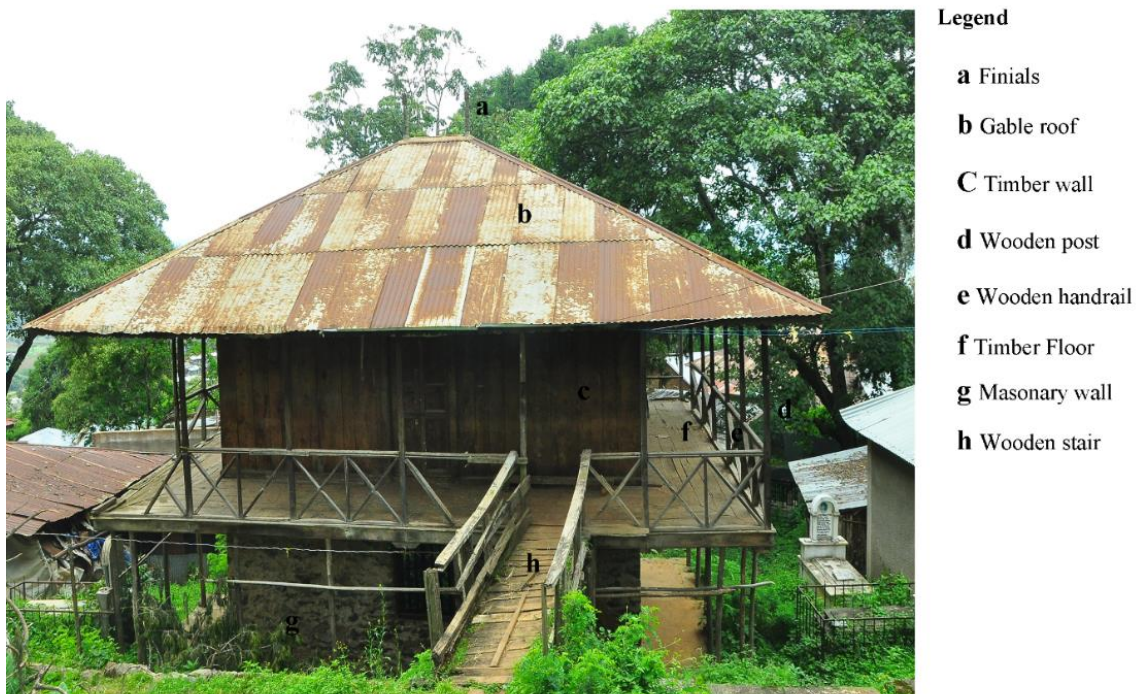
Figure 32 The Architectural analysis of the Nebir'ed residence

This structure is a significant rectangular shape one-story building constructed by preserving the natural landscape. The ground floor is a mud masonry building that can be accessed from the natural landscape whereas the upper floor is a timber structures accessed by using a street flight wooden stair connected with ground level of natural landscape. The building has a rectangular wooden and latter addition steel frame with glass window and doors. Additionally, it has an interesting well-decorated wooden balustrade and post that helps to support the roof (Observation, 2023).

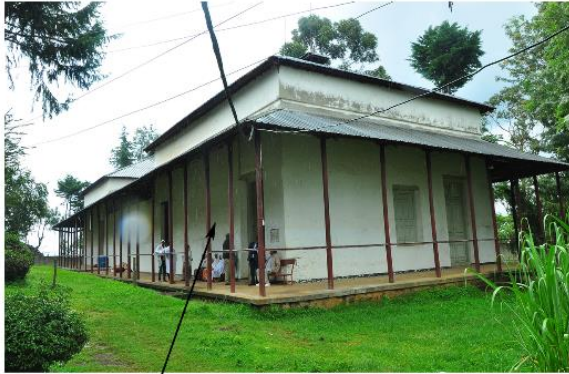
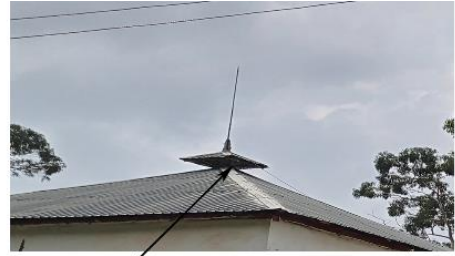
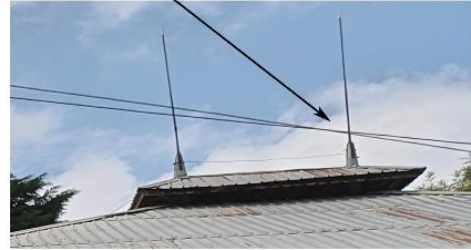
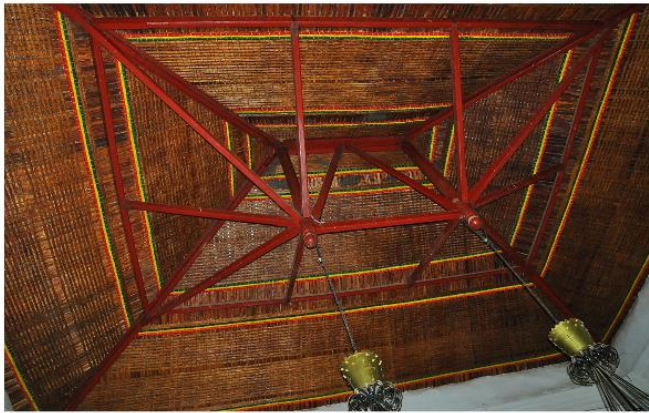
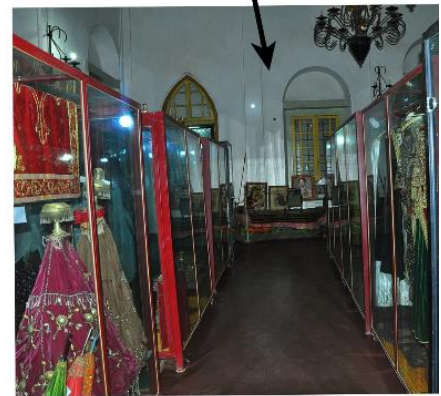
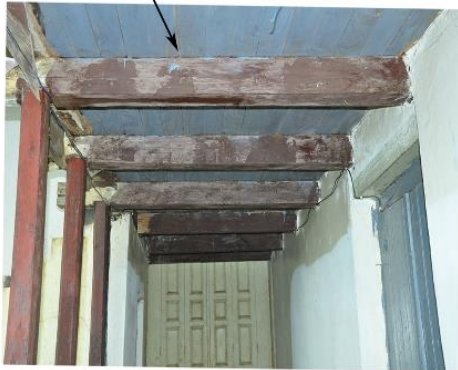
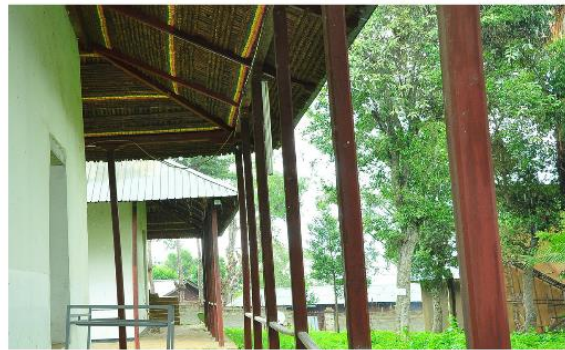
Figure 35 Architectural analysis of Emperor Menelik palace

This palace was formerly used as a palace of Emperor Menelik, but now it serving as a museum and residence. The researcher observed that: It is a one-story building with two square blocks dominated the view and is connecting by covered veranda. In addition, the verandah has an ornamented quadrilateral wooden post. The structure has a rectangular, pointed, and arched window (in the internal parts) and doors. The ceiling has an interesting traditional unique technique (Observation, 2023).

Finials at the roof top parts

Traditional internal ceiling at the palace interior part

The Beam serving as a ceiling and structural bearing at the external corridor parts

Decorated wooden post serving as roof structural bearing external verendah

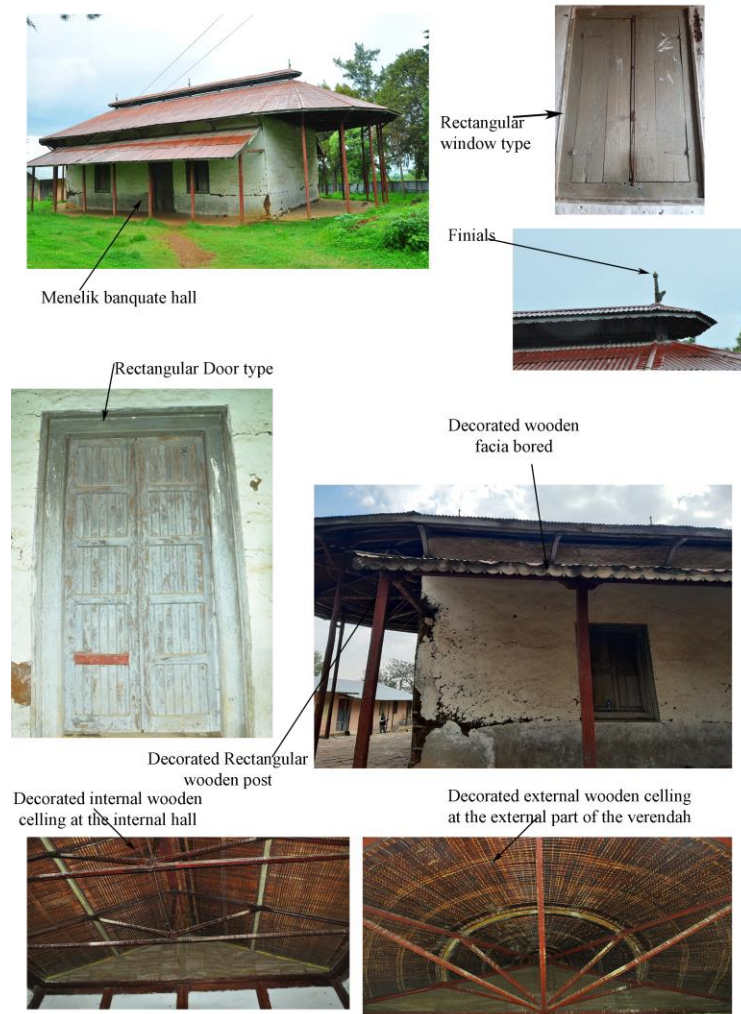
Figure 36 Architectural analysis of banquet hall of Emperor Menelik

The researcher observed that the building is fascinating by, the elliptical roof design of this dining hall, which features a finials and rectangular pillars, in addition only the roof and the circular along the veranda edge are designed in an oval form. The building wall has a rectangular shape, which also reflects in its openings. The ceiling has an interesting look built in traditional technique. The ceiling has an intriguingly patterned rope made out of plant that is used to link the roof truss and ceiling. The surrounding veranda has 44 wooden posts with decorative fascia boards (field observation, 2023)

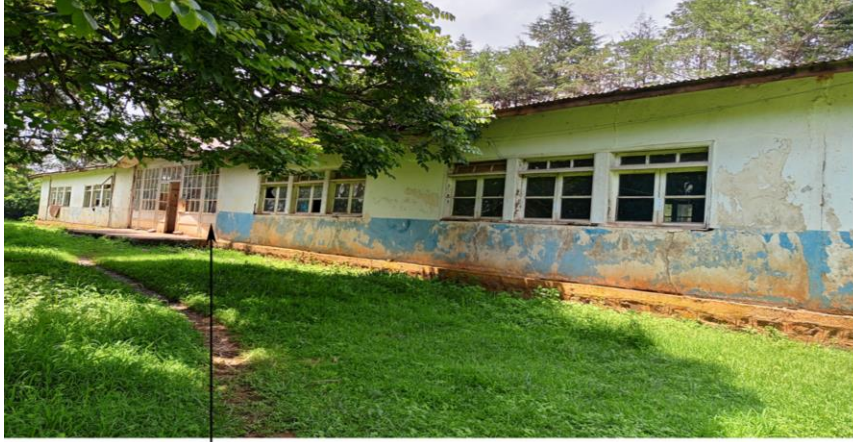
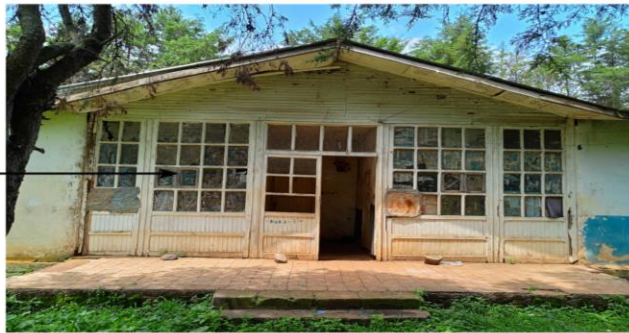
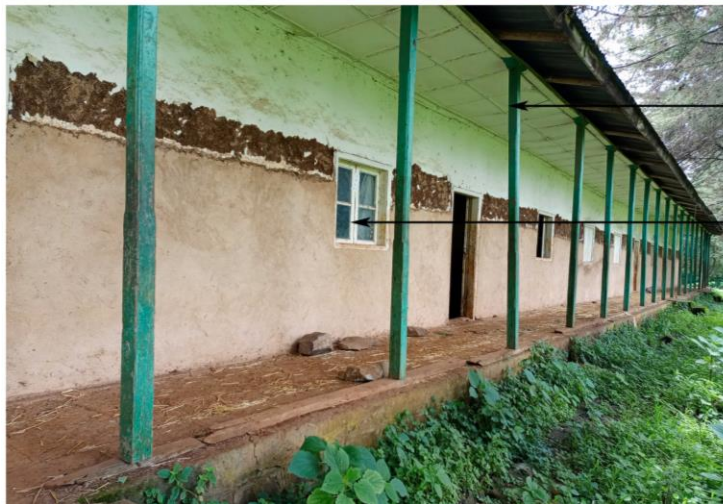
This school block has a linear form with square shaped window and wooden gate that emphasized in the middle of the plan. In the front façade, there are twelve square shaped windows with top window and opened wings. In the middle, there is a wide curtain opening. On the other hand, at the rear side there are six square-shaped window and four doors that helps to access the classroom. In addition, there is a rectangular wooden post at the rear side of the entrance door. The school was constructed using mud, stone, wood, and corrugate iron sheet (Field observation,2023)

school front entrance
designed with glass and
wood

Rectangular wooden post at
the school verendah

Square Wooden
and glass window

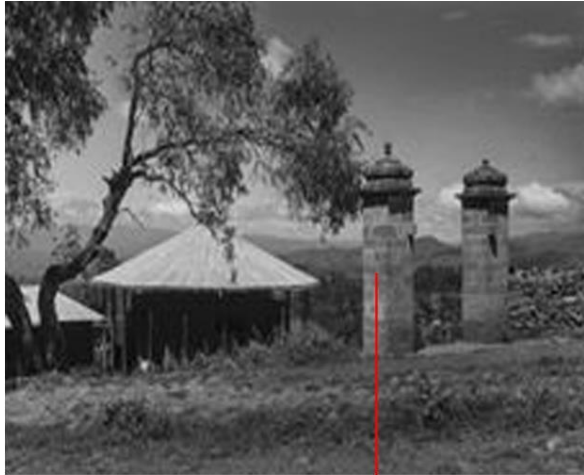
The landscape is found with an interesting slope starting from the main road to the church. The church building surrounding is found to be well preserved except there is a change in entrance that was replaced with modern entrance fence. The former entrance was built with a masonry fence wall with an interesting entrance column that was destroyed. Only trace of a column is found standing at the courtyard of the church. There is also a new design and an integration of modern materials.

1930's image shows the historical masonry entrance of the church

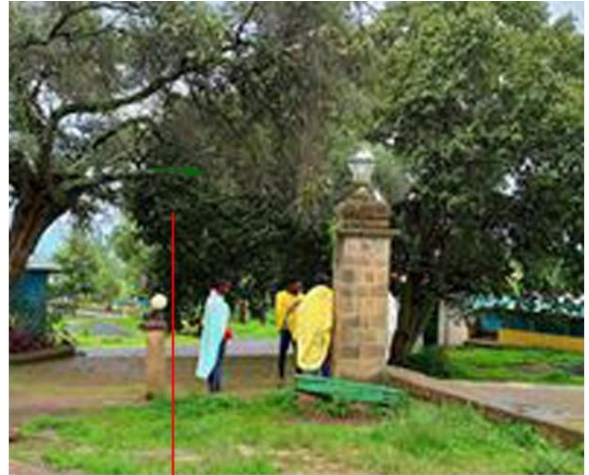
Image captured in 2015 E.c shows the demolished historical entrance pillar

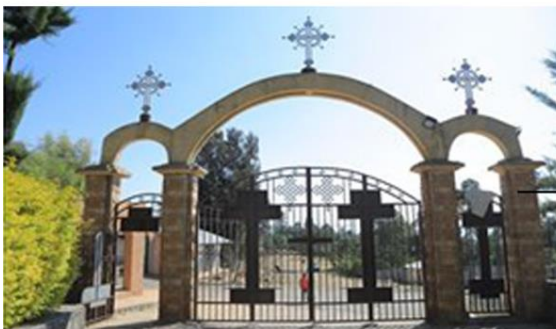
The current modern gate

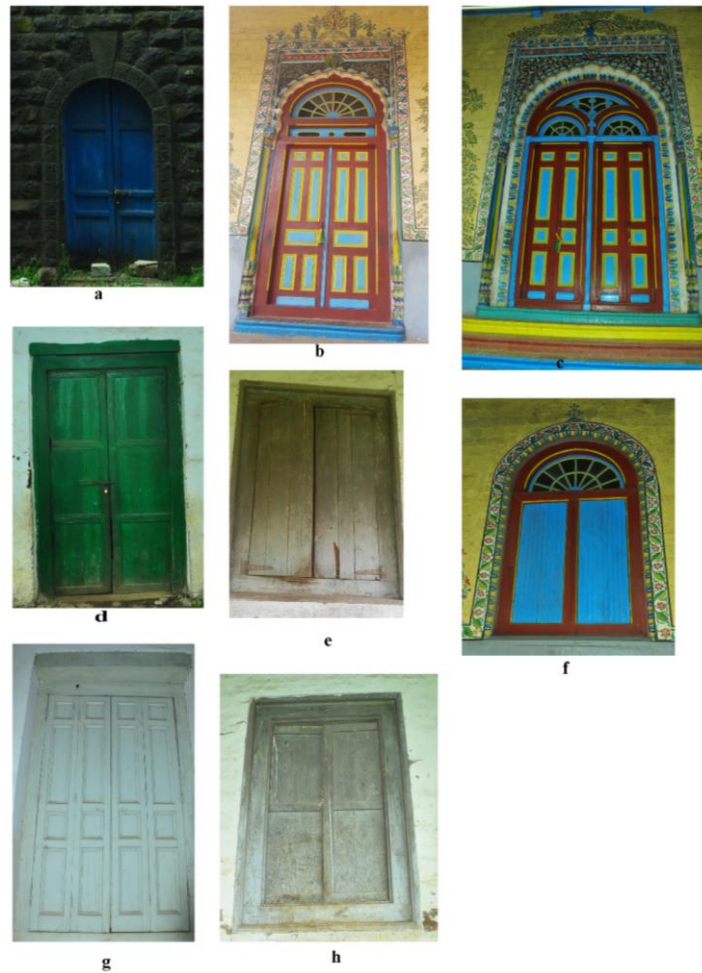
Figure 49 Types of door (a,b,c,d) and window (e,f,g,h)

In addition to the general architectural features, the study area exhibits a variety of opening typologies, each with distinct characteristics. Most of these openings are highly decorated, reflecting strong influences from traditional Indian architecture, such as intricate carvings, ornamental frames, and culturally symbolic motifs. Among the observed types, two forms are predominant: rectangular and arched openings. Rectangular openings tend to be simpler in shape but often embellished with decorative elements, while arched openings are more elaborate, frequently showcasing curved profiles and detailed ornamentation that enhance the aesthetic appeal of the structures. These openings not only serve functional purposes but also contribute significantly to the cultural and visual identity of the built environment. (Field visit,2023).

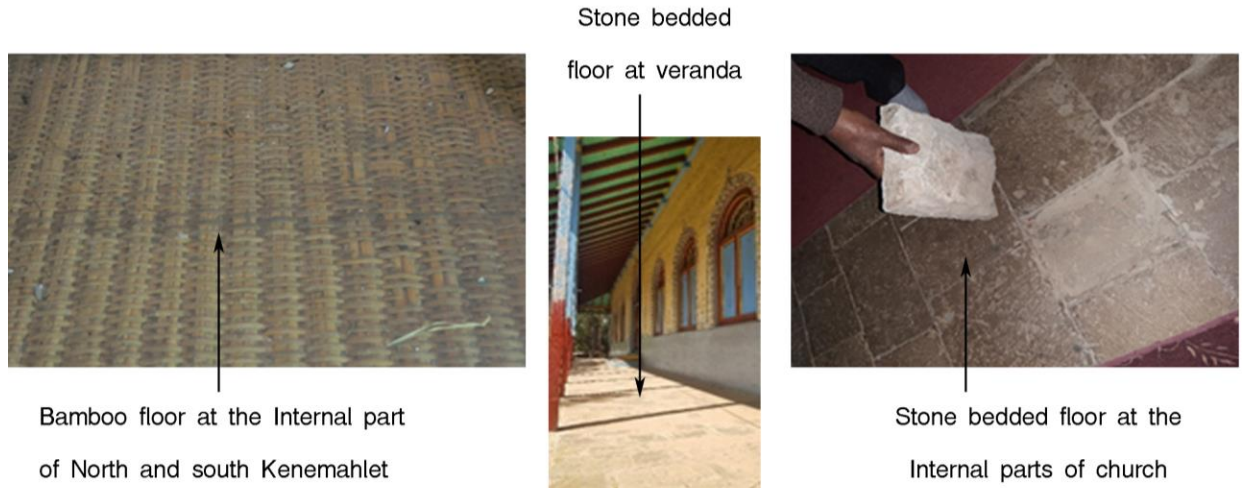
Figure 50 Condition of the church floor

The church has two type of floor: stone bed floor and bamboo floor. It is found in a good state of condition. The stone-bedded floor and Bamboo floor is found in the internal parts of the St. Mary church. During the church service the church administrator, cover the floor with carpets (Observation, 2023).

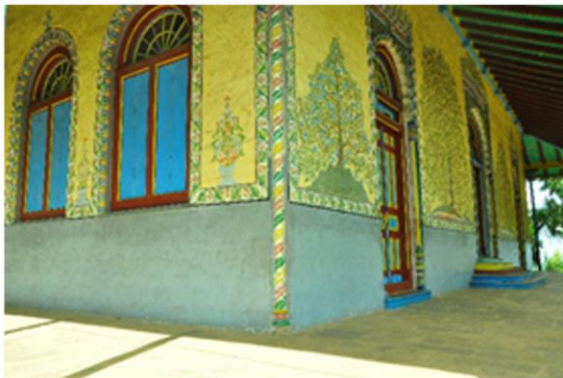
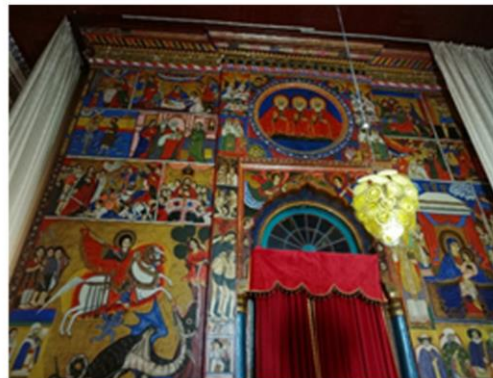
Figure 51 Condition of wall paintings

The masonry walls are in a good state of preservation. However, aside from the painting, there is dust on the external walls and surrounding areas of the church. Additionally, cracks less than 1 mm in width are observed on both the internal and external parts of the walls (Observation, 2023).

External parts of th church wall have painting at the four side of the wall

Internal parts of the church /outer parts of *Mekedes*/ the four sides Covered with paintings

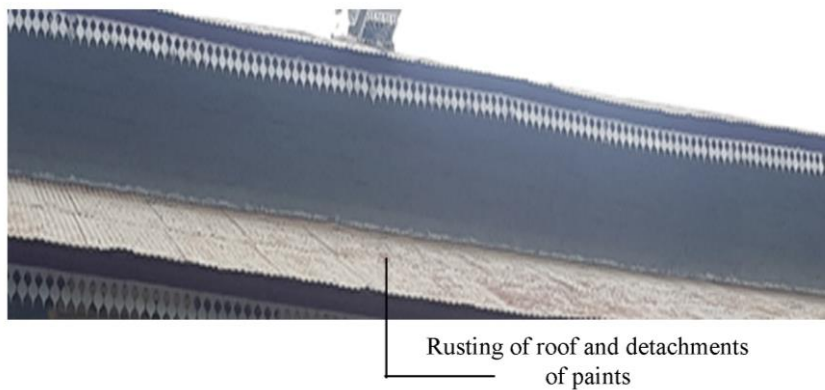
Figure 54 Current condition of the church roof

The researcher observed that, the roof of the church has rust due to weathering and lack of periodic maintenance. In addition, the detachments of paintings have occurred due to peeling of paints from the surface of the sheet due to improper surface preparation (Observation, 2023).

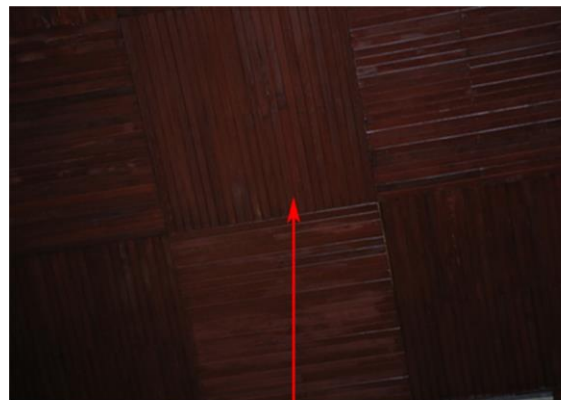
Figure 55 Current condition of church ceiling

The internal ceiling is constructed from wood and mesh wire and remains in a good state of preservation. However, there is noticeable accumulation of dust, likely brought in from outside by foot traffic. In contrast, the external ceiling of the veranda also made of wood shows signs of deterioration. The damage is primarily due to peeling paint, prolonged exposure to moisture, aging materials, and fluctuations in temperature (Observation, 2023).

Wooden ceiling at the kedest of the church

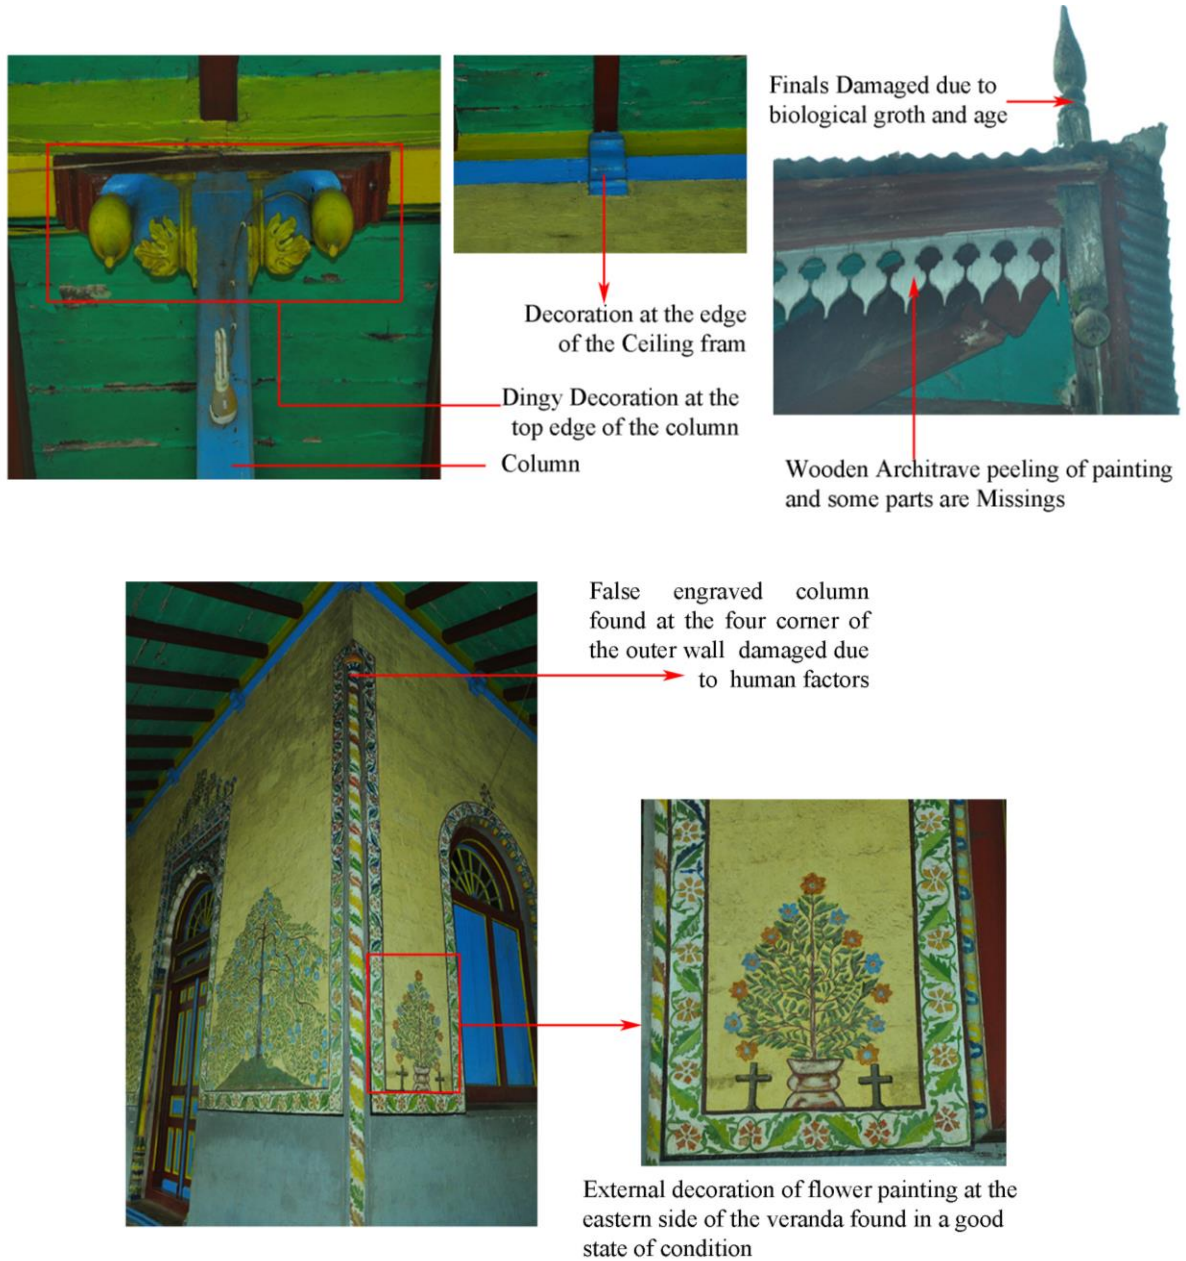
Figure 56 Current condition of the church decorative details

The decorative details are highly deteriorated due to moisture. There is also a missing of some decorative details around the verandah .In addition; there is wooden deterioration of antenna deteriorated due to age and weather conditions (Observation, 2023).

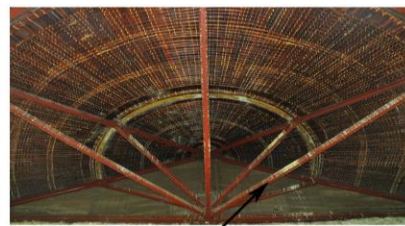
External parts of the hall ceiling damaged due to bird droppings

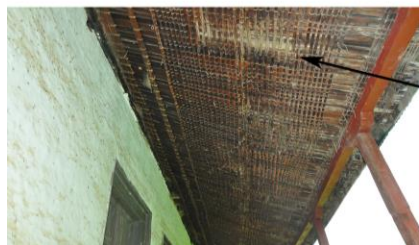
Figure 57 Current condition of ceiling banquet hall

External parts of the hall corridor ceiling damaged due to dampness comes from the roof

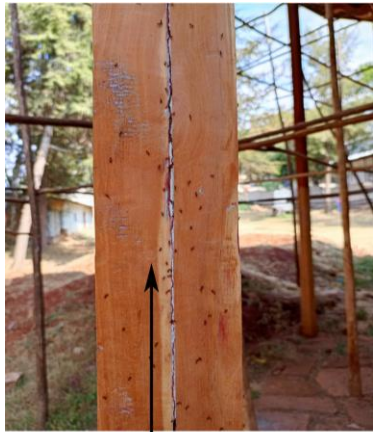
The banquet hall has a wooden pillar in the surrounding veranda with decorative details. They are damaged by termite, insects and Some of them are damaged due to rising damp and moisture (Field Visit, 2023).

Damaged by insect

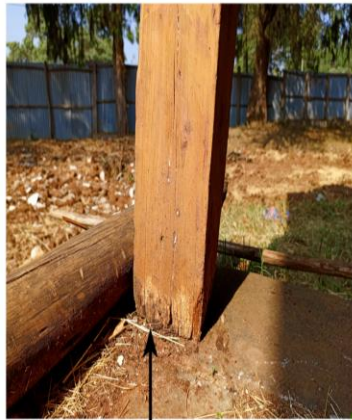
Damaged by rising damp

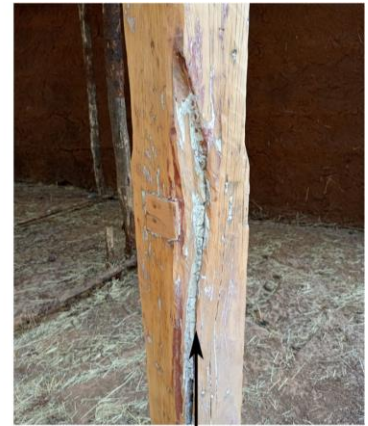
Consolidation using incompatible material

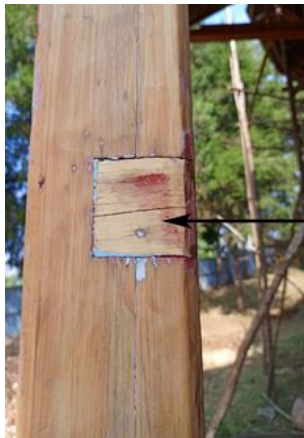
consolidation by using wood

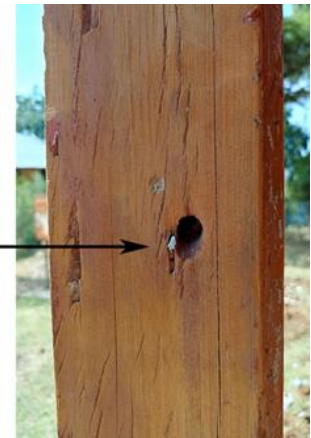
Damaged by borehole

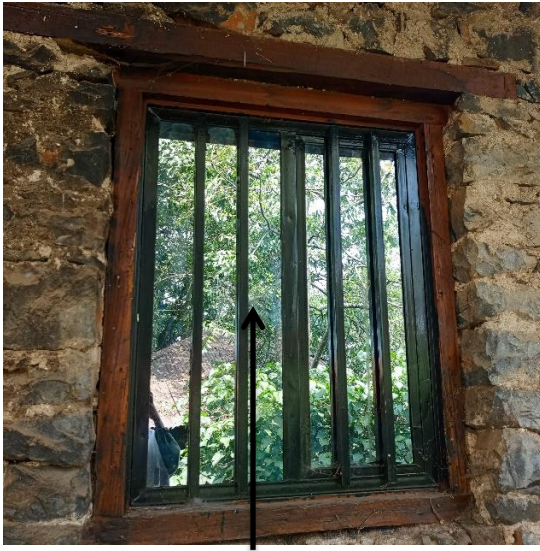
Wood window change into glass and steel

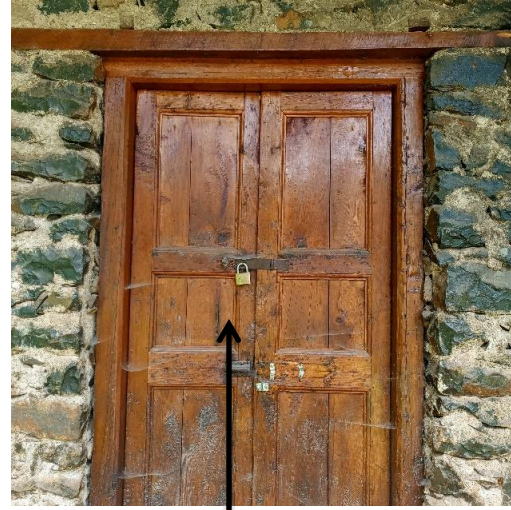
The door lock has changed

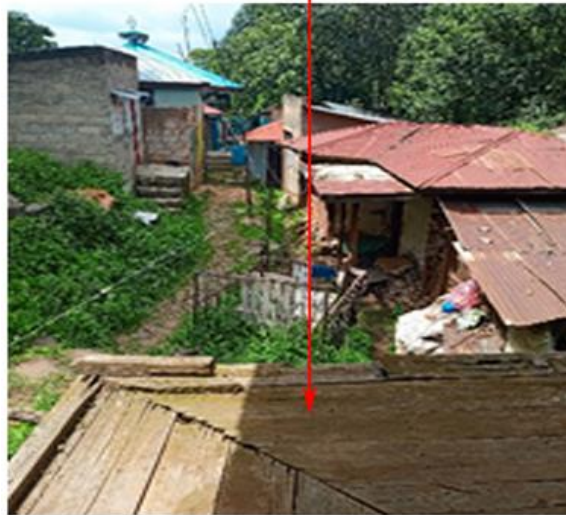
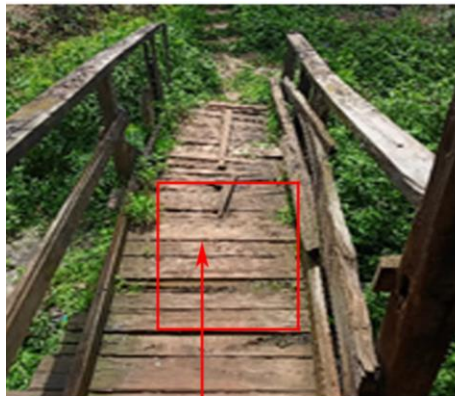
Deteriorated floor of the ramp due to rain and age

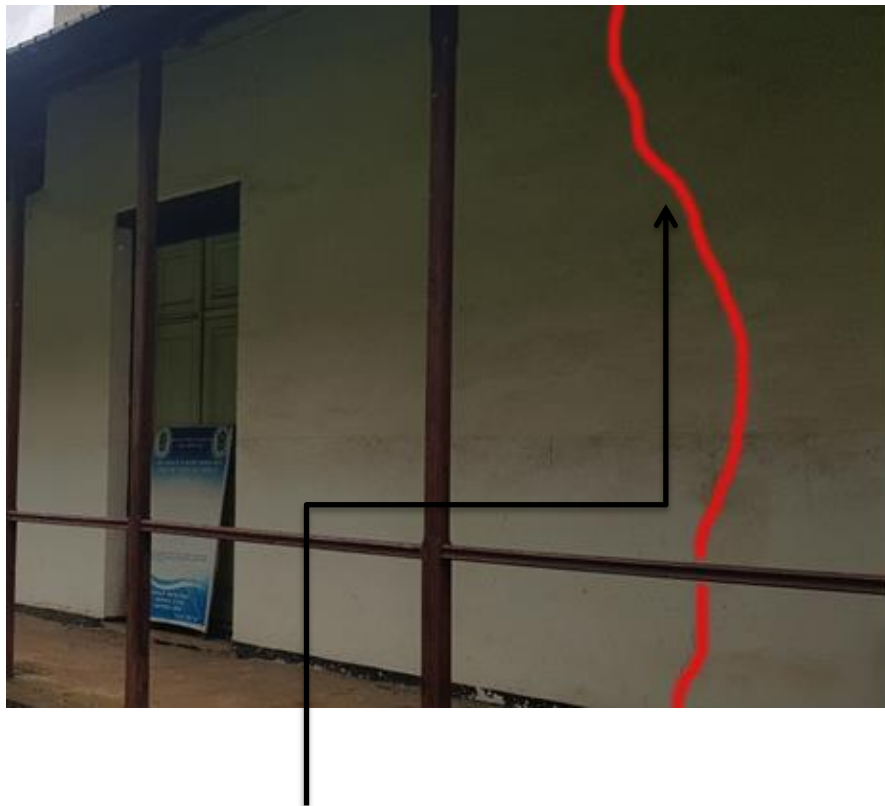
Plaster crack observed the front side of the wall
