Pavement Distress on Addis Ababa Ring Road Assessment of Causes and Evaluation of Rehabilitation Measures

A Thesis
Submitted to
School of Graduate Studies
Addis Ababa University

In Partial Fulfillment of the Requirement for the
Degree of Masteres of Science in
Engineering Geology

PAVEMENT DISTRESS ON ADDIS ABABA RING ROAD
– ASSESSMENT OF CAUSES AND EVALUATION OF
REHABILITATION MEASURES

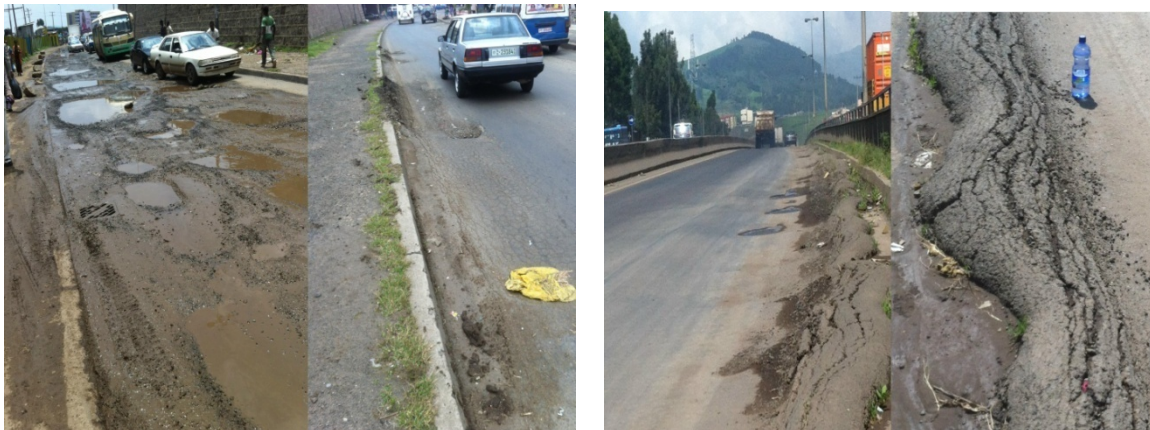
Plate 1.1 Pavement distress in the study area around Bole Brass and on way Kality to Hana Mariham, respectively

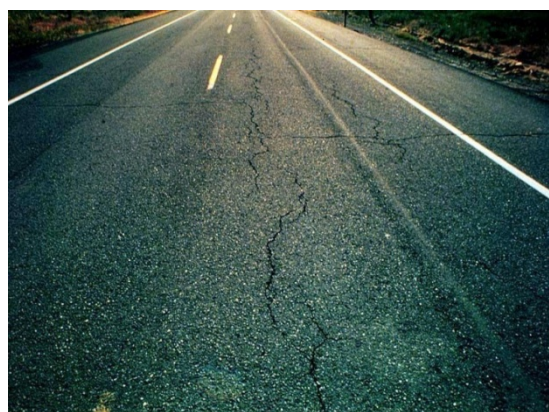
Plate 2.3 Longitudinal Cracking

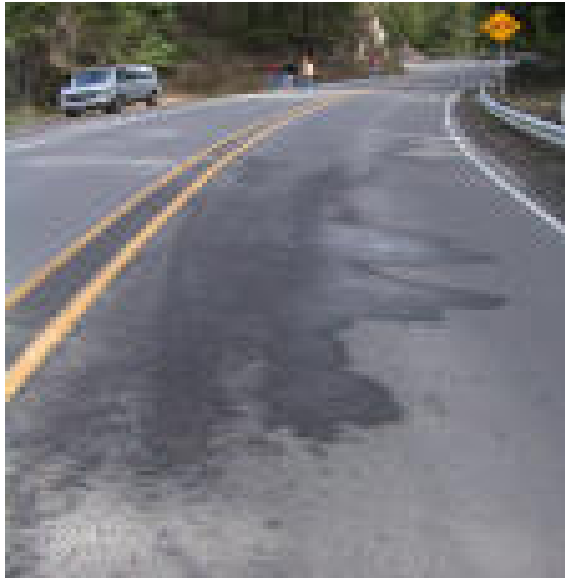
Bleeding is a film of bituminous material on the pavement surface that creates a shiny, reflective surface. Bleeding is caused by excess asphalt cement in the mix and/or low air void content. During hot weather the asphalt fills the voids of the mix and then expands out onto the surface of the pavement. The process is not reversible during cold weather, thus asphalt binder will accumulate on the surface ([NCDT, 2010](#)).

Plate 2.5 Bleeding on the road surface

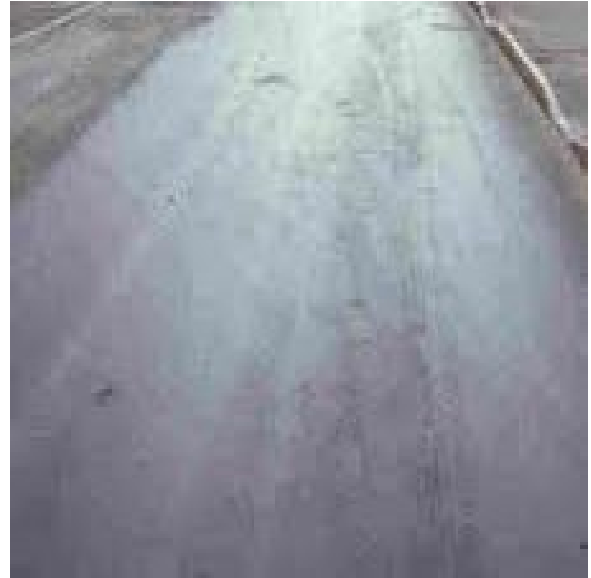
Plate 2.6 Fattening-up of the road surface

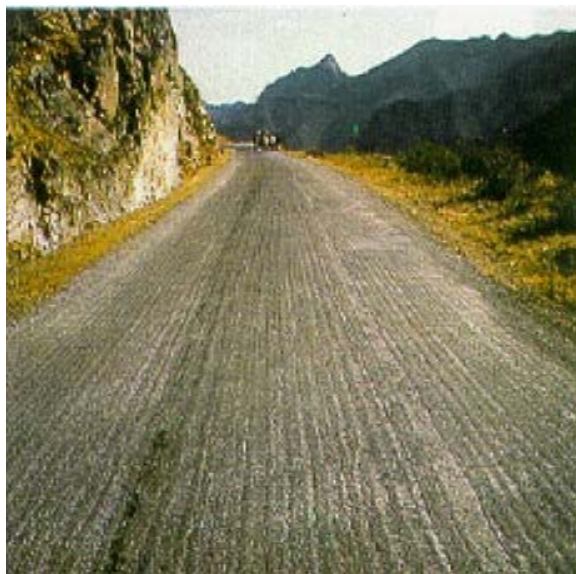
Fretting is the progressive loss of fine aggregate from the road surface and occurs when the small movements of individual particles, under the action of traffic, exceeds the breaking strain of the bitumen (Plate 2.7). It tends to occur later in the life of the surfacing after the bitumen itself deteriorates with age and usually begins in areas of high traffic stress such as sharp bends.

Plate 2.7 Fretting of aggregates

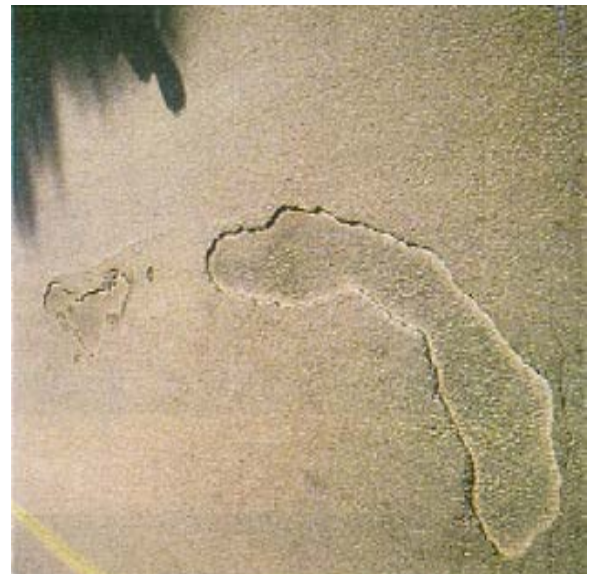
Plate 2.8 Stripping in Asphalt

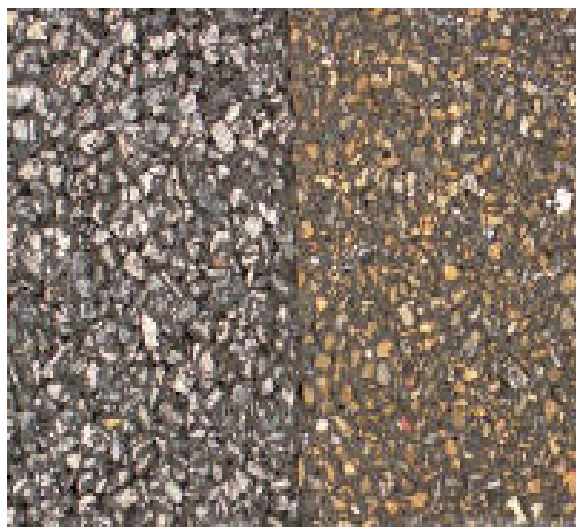
Plate 2.9 Polished Aggregates

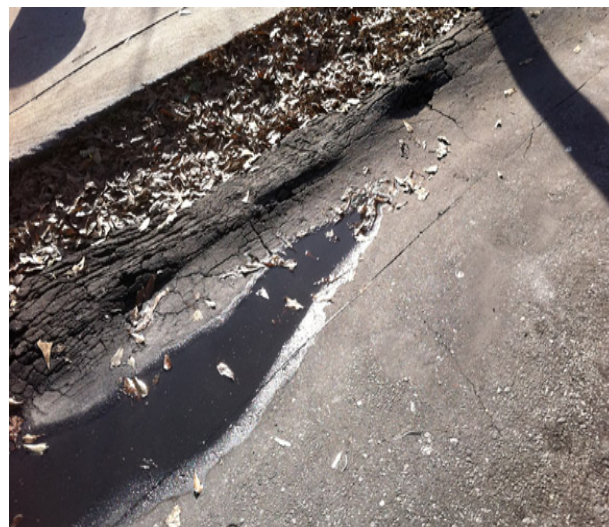
Plate 2.10 Rutting on the Wheel-path

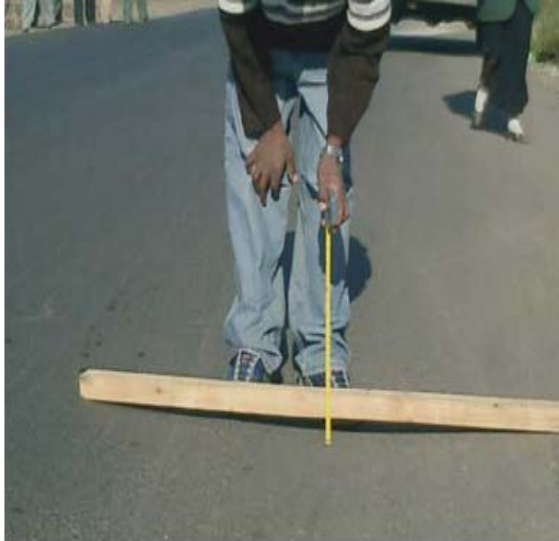
Plate 2.11 Depression

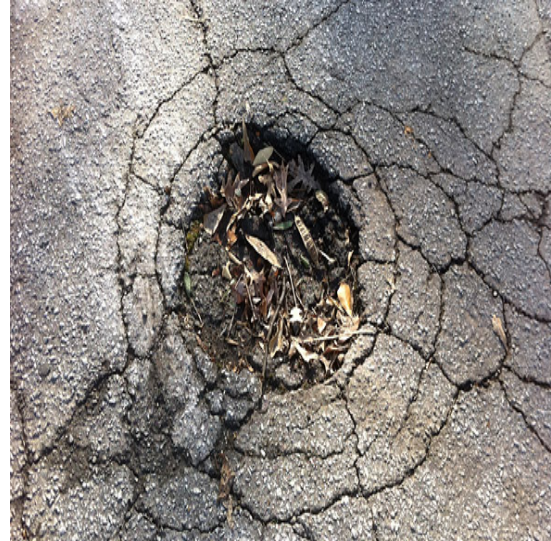
Potholes are usually caused by a localized weakness in the pavement resulting from a combination of such factors as too little asphalt, thin surface thickness, too many fines, too few fines, or poor drainage (Plate 2.12). Unless repaired promptly, their growth will be accelerated by traffic and moisture collected in the pothole.

Plate 2.12 Potholes with alligator crack

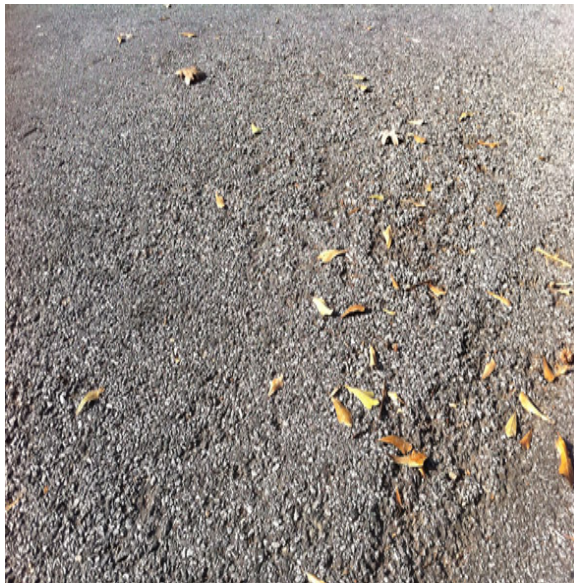
Raveling is the on-going separation of aggregate particles in a pavement from the surface downward or from the edges inward (Plate 2.13). Usually, the fine aggregate wears away first and then leaves little "pock marks" on the pavement surface. As the erosion continues, larger and larger particles are broken free and the pavement soon has the rough and jagged appearance typical of surface erosion. There are many reasons why raveling can occur, however one common cause is placing asphalt too late in the season. This is because the mixture usually lacks warm weather traffic which reduces pavement surface voids, further densification, and kneading of the asphalt mat. For this reason raveling is more common in the cold climates (Snow Belt) (http://www.pavemanpro.com/article/identifying_asphalt_pavement_defects/).

Plate 2.13 Raveling

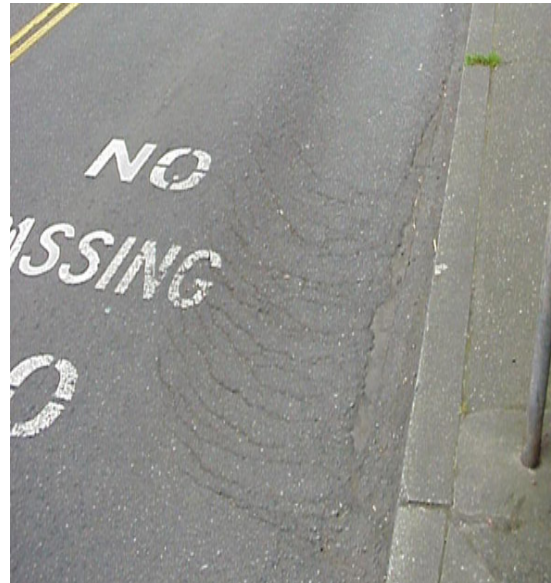
Plate 2.14 Slippage crack

Slippage cracks are crescent-shaped cracks or tears in the surface layer(s) of asphalt where the new material has slipped over the underlying course (Plate 2.14). This problem is caused because of lack of bonding between layers. This is often because a tack coat was not used to develop a bond between the asphalt layers or because a prime coat was not used to bond the asphalt to the underlying stone base course. The lack of bond can be also caused by dirt, oil, or other contaminants preventing adhesion between the layers (http://www.pavemanpro.com/article/identifying_asphalt_pavement_defects).

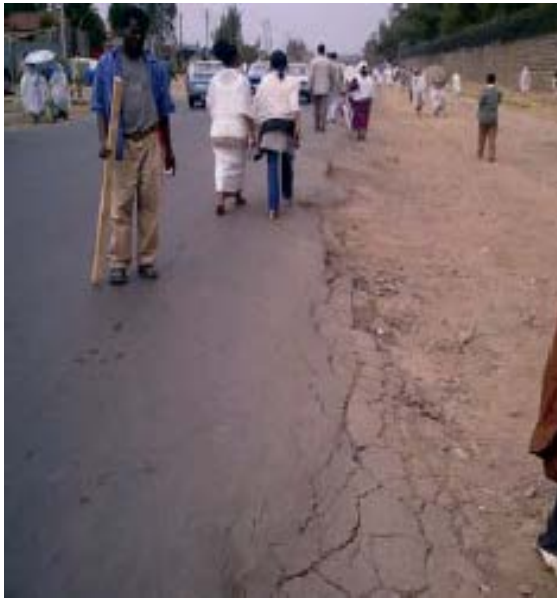
Plate 2.15 Edge Cracks

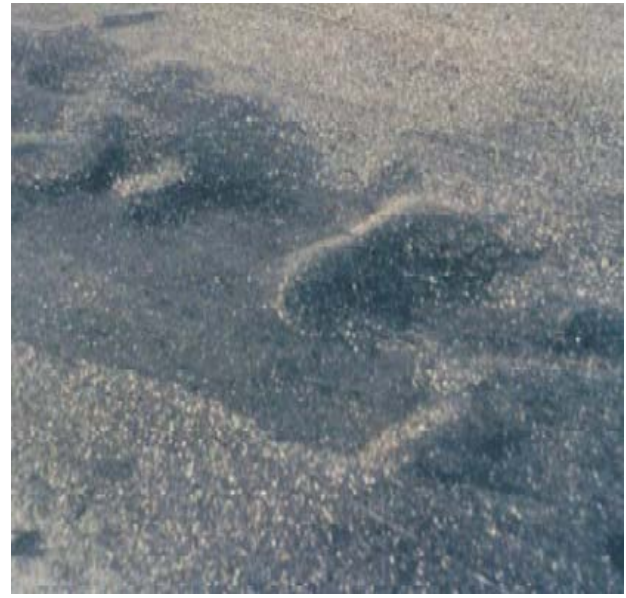
Plate 2.16 Shoving

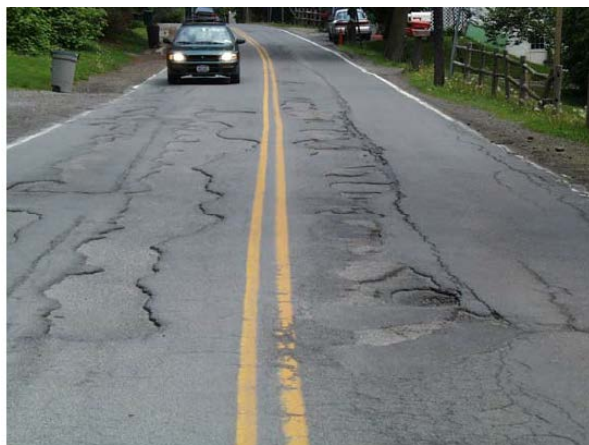
Cleaning the old surface and applying a light asphalt emulsion tack coat will go a long way toward alleviating this problem. A tack coat is especially helpful when the overlay thickness is two inches or less. (T. Hall et al, 2002)

Plate 2.17 Delamination

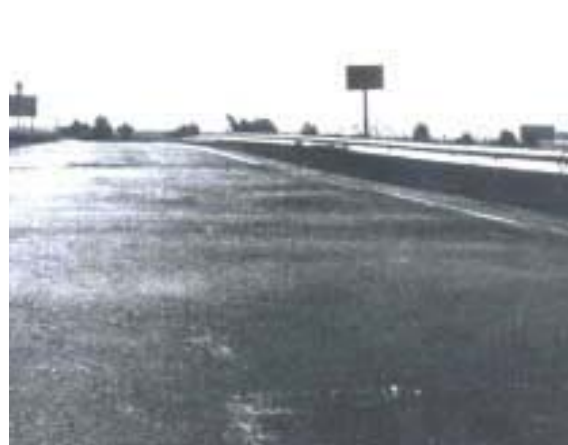
Plate 2.18 Corrugation

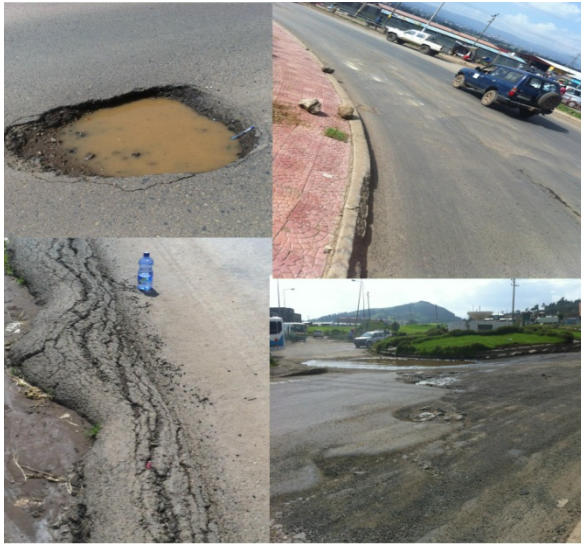
Plate 2.19 Pothole, Shoving, Rutting and Raveling distress types

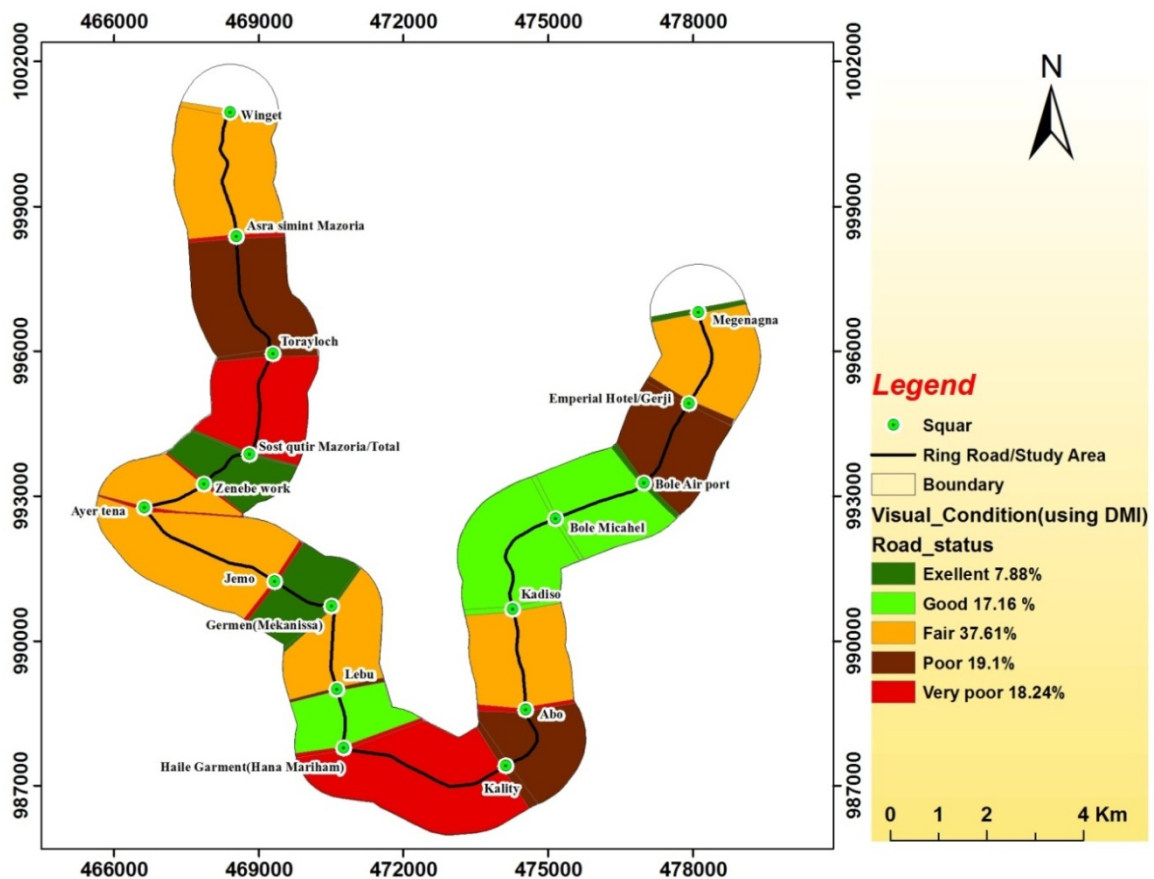
Fig 4.2- Visual inspection (Inventory) Map (Using DDM)

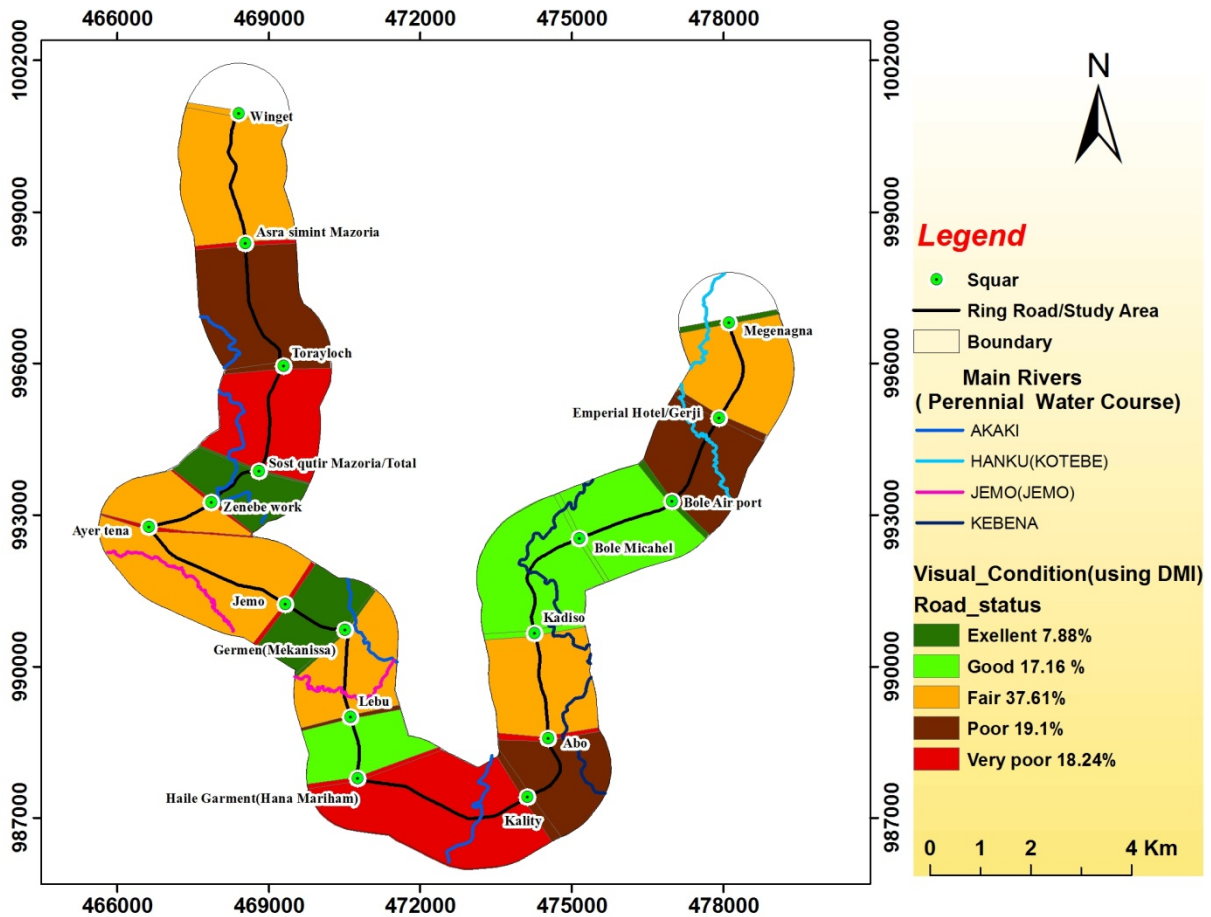
Fig 5.4 Major streams overlaid on pavement condition status map

Thus, the results obtained from the overlay analysis of surface drainage with pavement condition clearly shows a good relation of poor pavement condition with perennial streams. It is reasonable and logical to have this type of corelation as perennial streams may influence the pavement through out the year. It is also known that the soil properties considerable changes when it is saturated. Also, the analysis has shown that seasonal streams are less associated with pavement condition. Further, a good corelation between pavement condition and the surface drainage can be observed in graph (Fig. 5.6). In case of Perennial streams as the pavement condition improves from poor to excellent the percentage coverage of perennial streams decreases. Similarly, seasonal streams show reverse trend as the pavement condition improves from poor to excellent percentage coverage of seasonal streams increases.

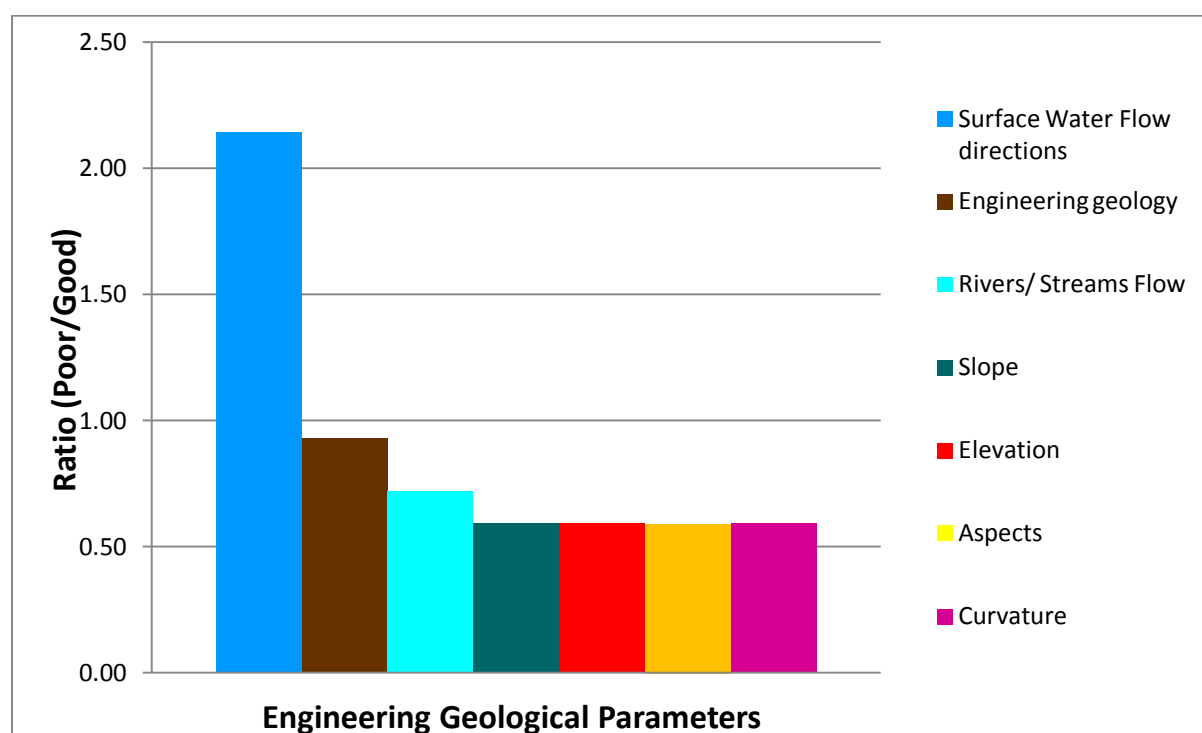
**Fig 5.22** - The order of influencing geotechnical parameters on the road status
