ADDIS ABABA UNIVERSITY
ADDIS ABABA INSTITUTE OF TECHNOLOGY
SCHOOL OF CIVIL AND ENVIRONMENTAL ENGINEERING

**A Thesis in Analysis and Remedial Measures for Slope Instability
Related Problems of Selected Sections of LOT II: Belta (KM60+000)
– Otolo (KM 87+000) Asphalt Road Project, Southern Part of
Ethiopia.**

FEBRUARY 2016, ADDIS ABABA

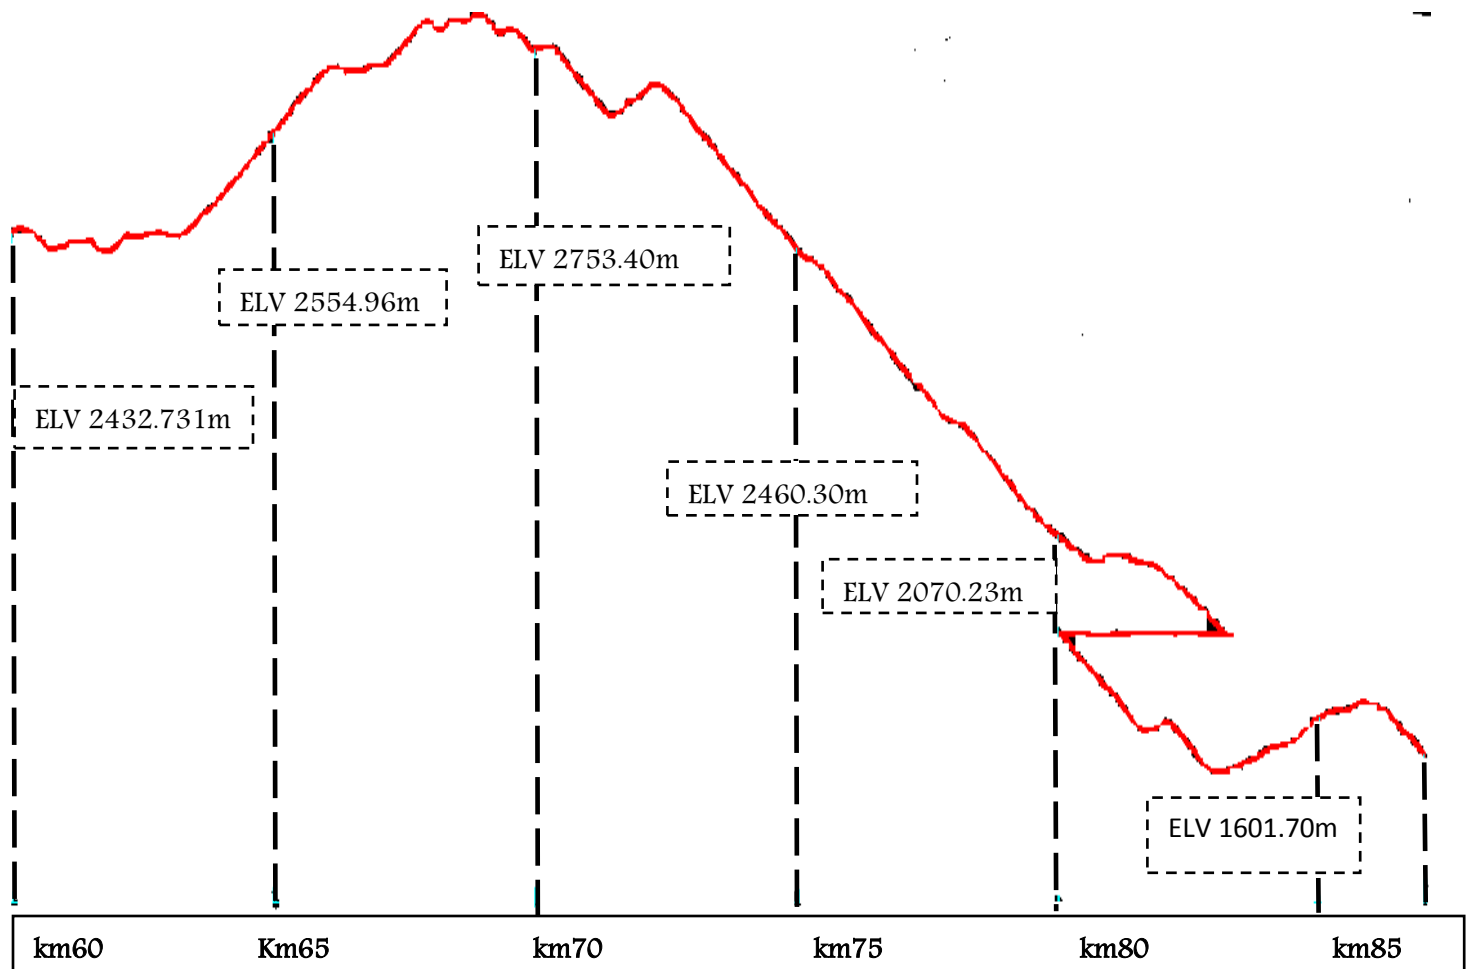
Figure 3.3: Vertical profile of designed road alignment

The terrain of the road alignment can be generally described as escarpment/mountainous over the large portion of the road with some sections characterized by rolling and flat physiographic features. From the terrain classification road, the stretches from Sta.67+000 to Sta.67+060 and from Sta.68+020AHD to 69+140BCK are classed as escarpment(transverse terrain slope in excess of 50%) while the stretch Sta.72+740 to 72+790LHS is classed as mountainous(transverse terrain slope from 25% to 50%) topography as depicted in Figures 3.3 and 3.4 below.

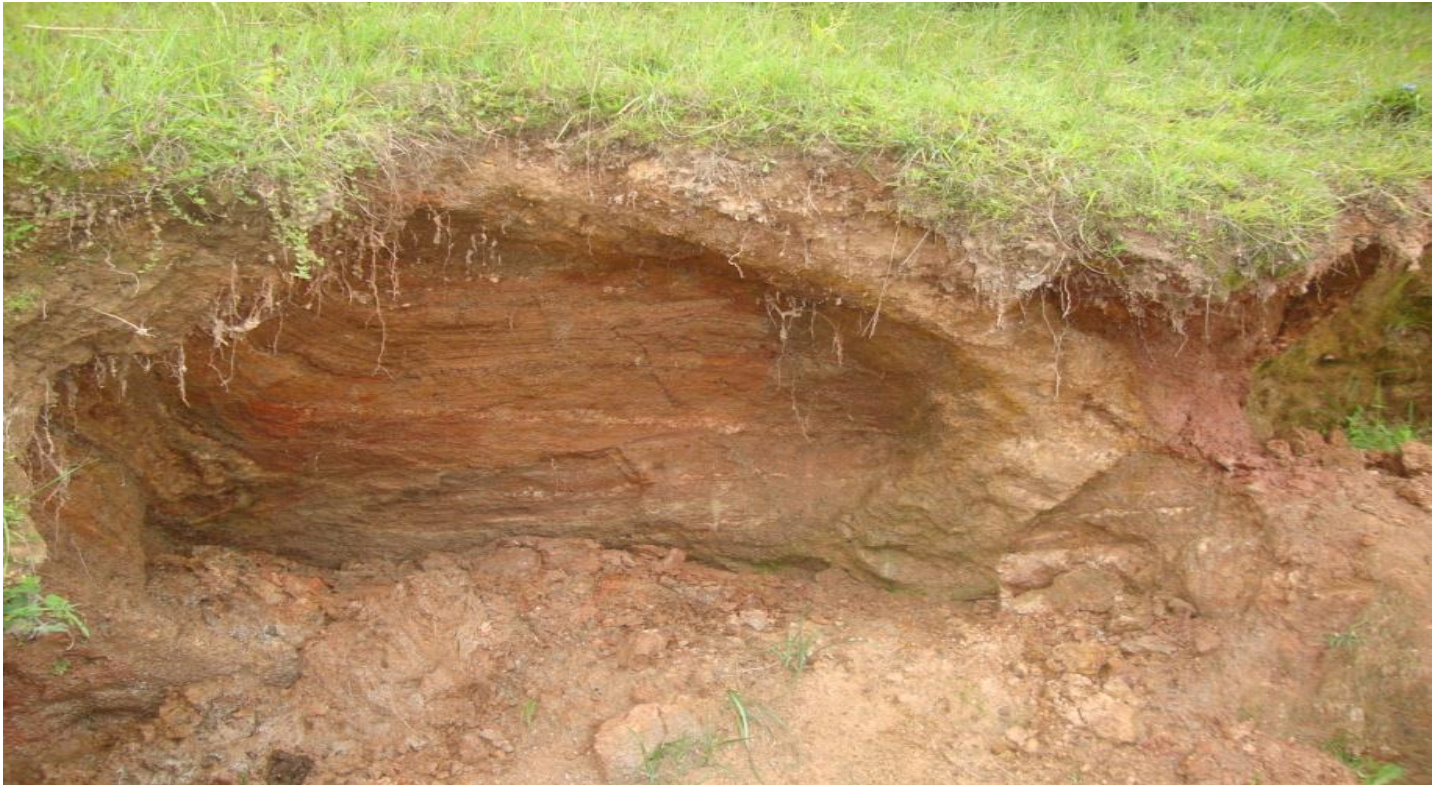
Figure 3.6: Well foliated and banded biotite bearing stratum of quartzo-feldspathic gneiss exposed at Km60+200

The two major dominant litho logical groups observed in the project road are: first, the high grade metamorphic rock composed of biotite bearing quartzo–feldspathic gneiss which is mainly observed at the start of the project and all the way up to 62+000km. As far as it is the oldest formation of the region it occupies low topography and is characterized by light grey color, well foliated and banded with alternating colors of light and dark grey minerals, completely weathered and highly decomposed, easily dozeable. Similar rock exposure is also exposed in the valleys between Kemba town and Korza River.

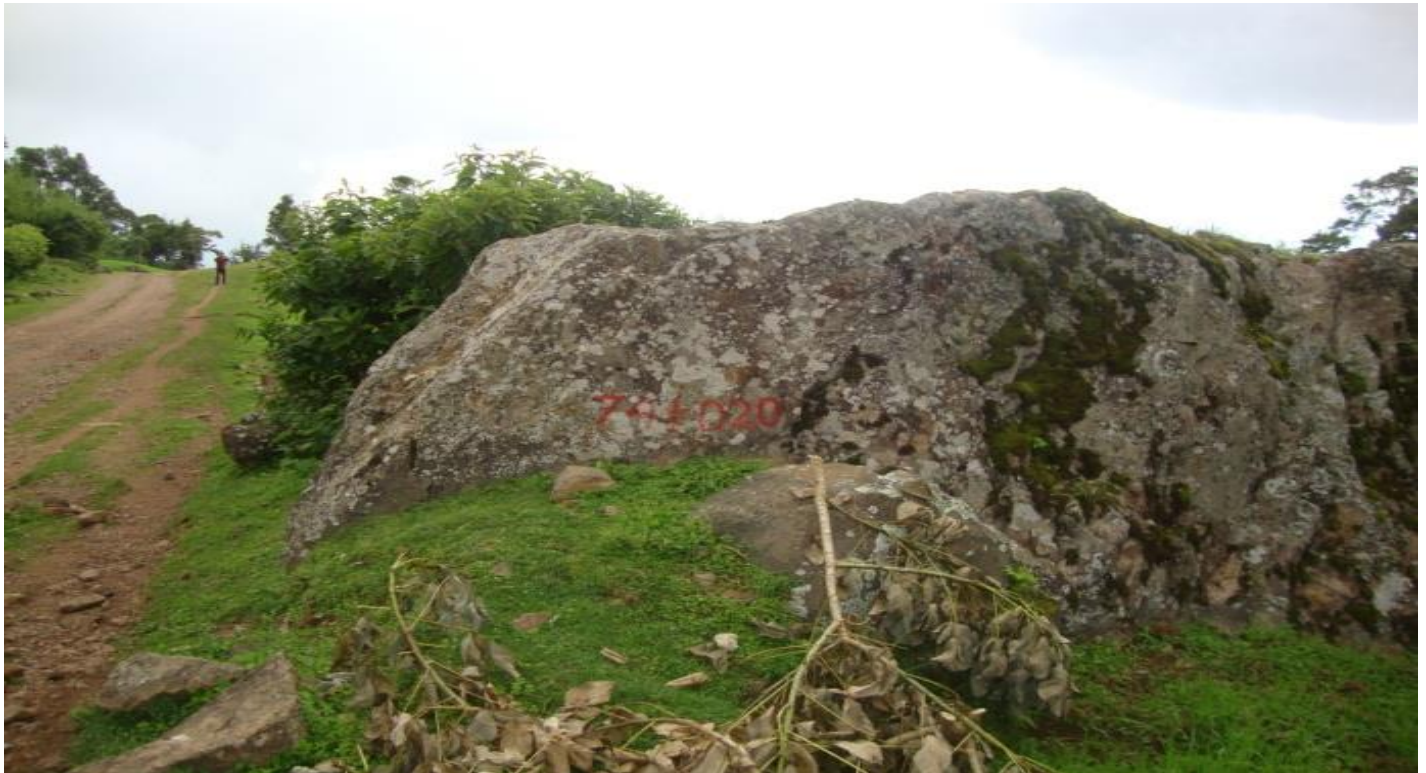
Figure 3.7: Isolated rock boulder at the foot of mountain chain of Dolja, resulted from rock fall

The second dominant lithologic unit exposed overlying the basement rocks is volcanic rocks of Jima group which are mainly forming the high topography, sharp ridge, mountainous and plateaus, but locally exposed as slope deposits composed of angular rock fragments of rhyolite, and lithic trachyte, tuffs and associated ash mostly exposed at the foot of slopes, especially as an isolated boulders and blocks at the foot of Dolja mountain slopes.

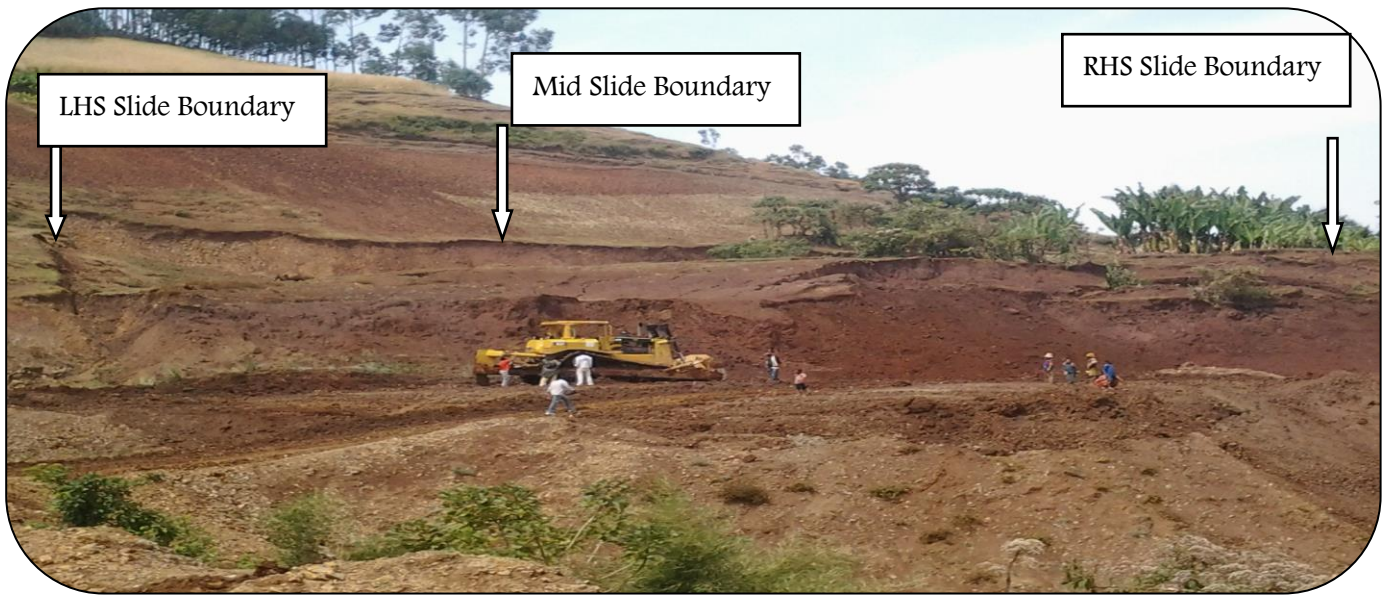
Figure 4.2: Front view of the cut slide manifestation

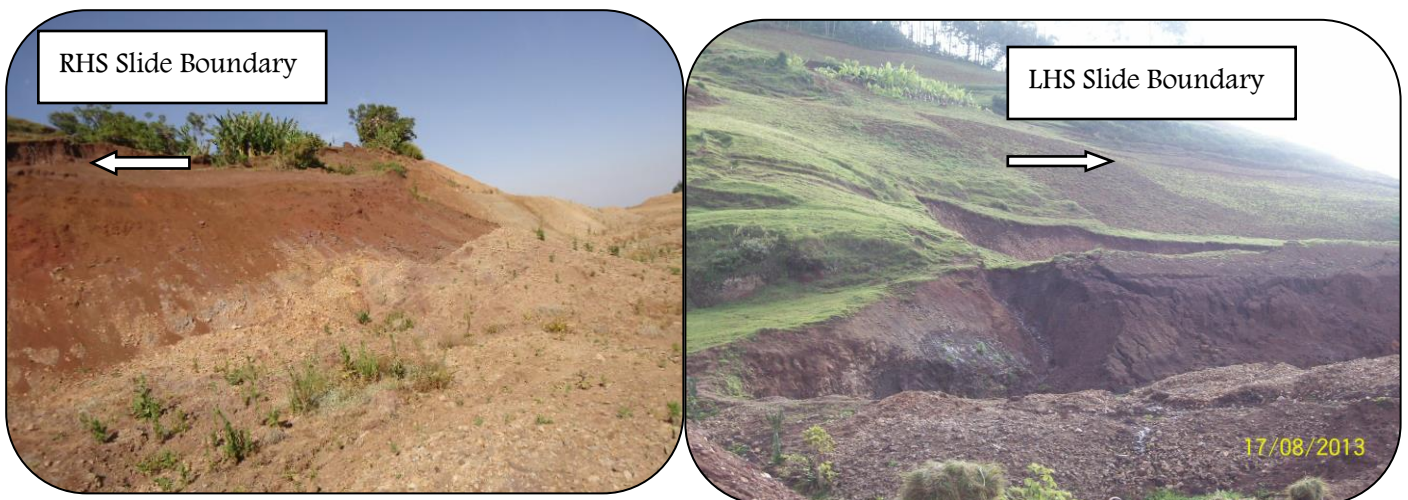
Figure 4.4: View of the failed cut slope RHS and LHS boundary

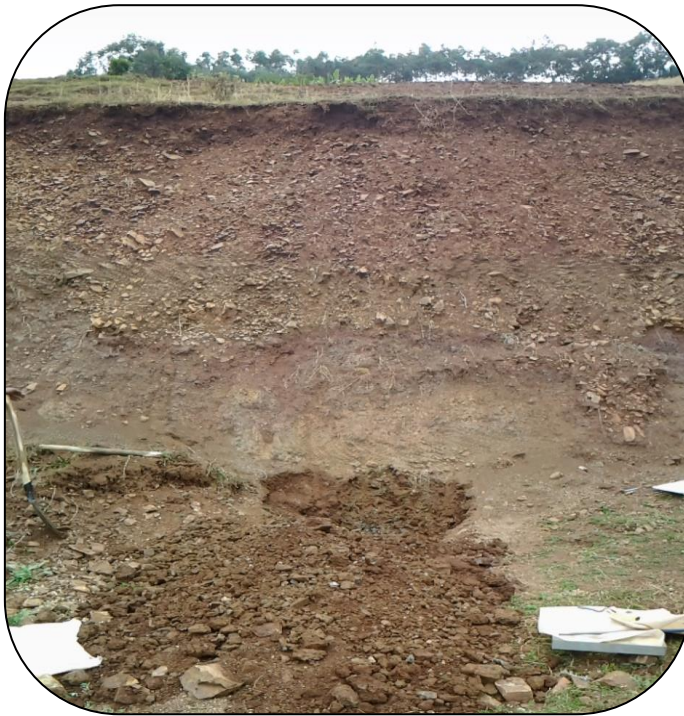
- The material on the slide plane ranges from gravel with considerable amount of fines(top exposed part) and gravely silt soil(at the toe /interface of the slide plane) while the displaced or failed cut slope material ranges from clayey to sandy silt soil. From the foregoing it can be stated that, the material on the slide plane and the failed or displaced material are distinct.
- The overall slope material is heterogeneous, and the slide plane is approximated by composite failure surface and;
- Relatively the same material extends below the toe of the slope as the exposed slide plane material as depicted in the slope profile and index tests conducted;

Figure 4.8: Granular exposed part of the slide plane material

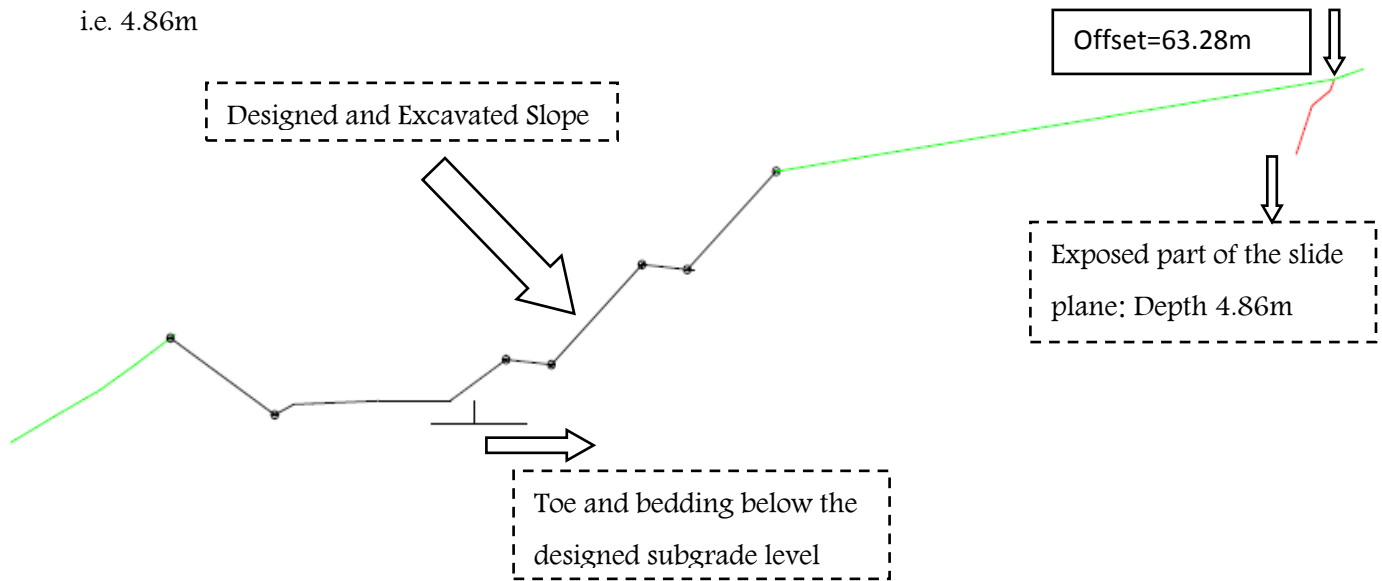
- Toe location and the depth of the Slip Surface (bedding) i.e. 1.4m and 2.3m below the designed sub grade level
- The outer Crown of the slide surface i.e. at 63.28m offset from the centerline.
- The top exposed part of the slide plane, head scarp i.e. from the Crown to the Top of the displaced soil mass i.e. 4.86m

Figure 4.10: Approximated toe and crown of the Slide Surface Location

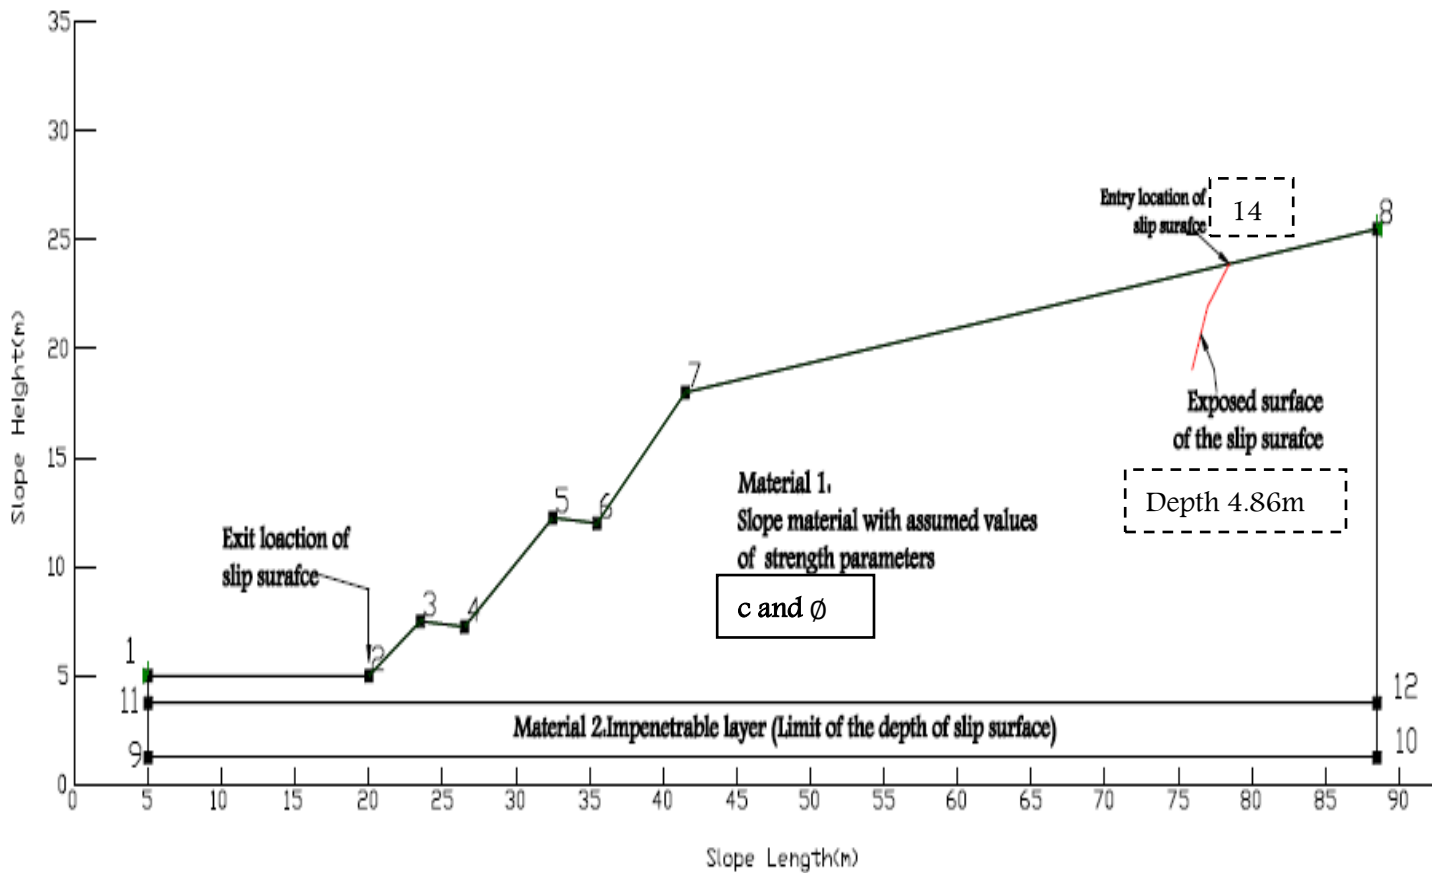
- ii. Create the slope geometry in Geo studio 2004 SLOPE/W Software as shown on Figure 4.11 using data from the designed slope and slide plane as depicted in figures 4.5, 4.6 and 4.10 above.

Figure 4.11: Slope Geometry in Geo Slope/W 2004

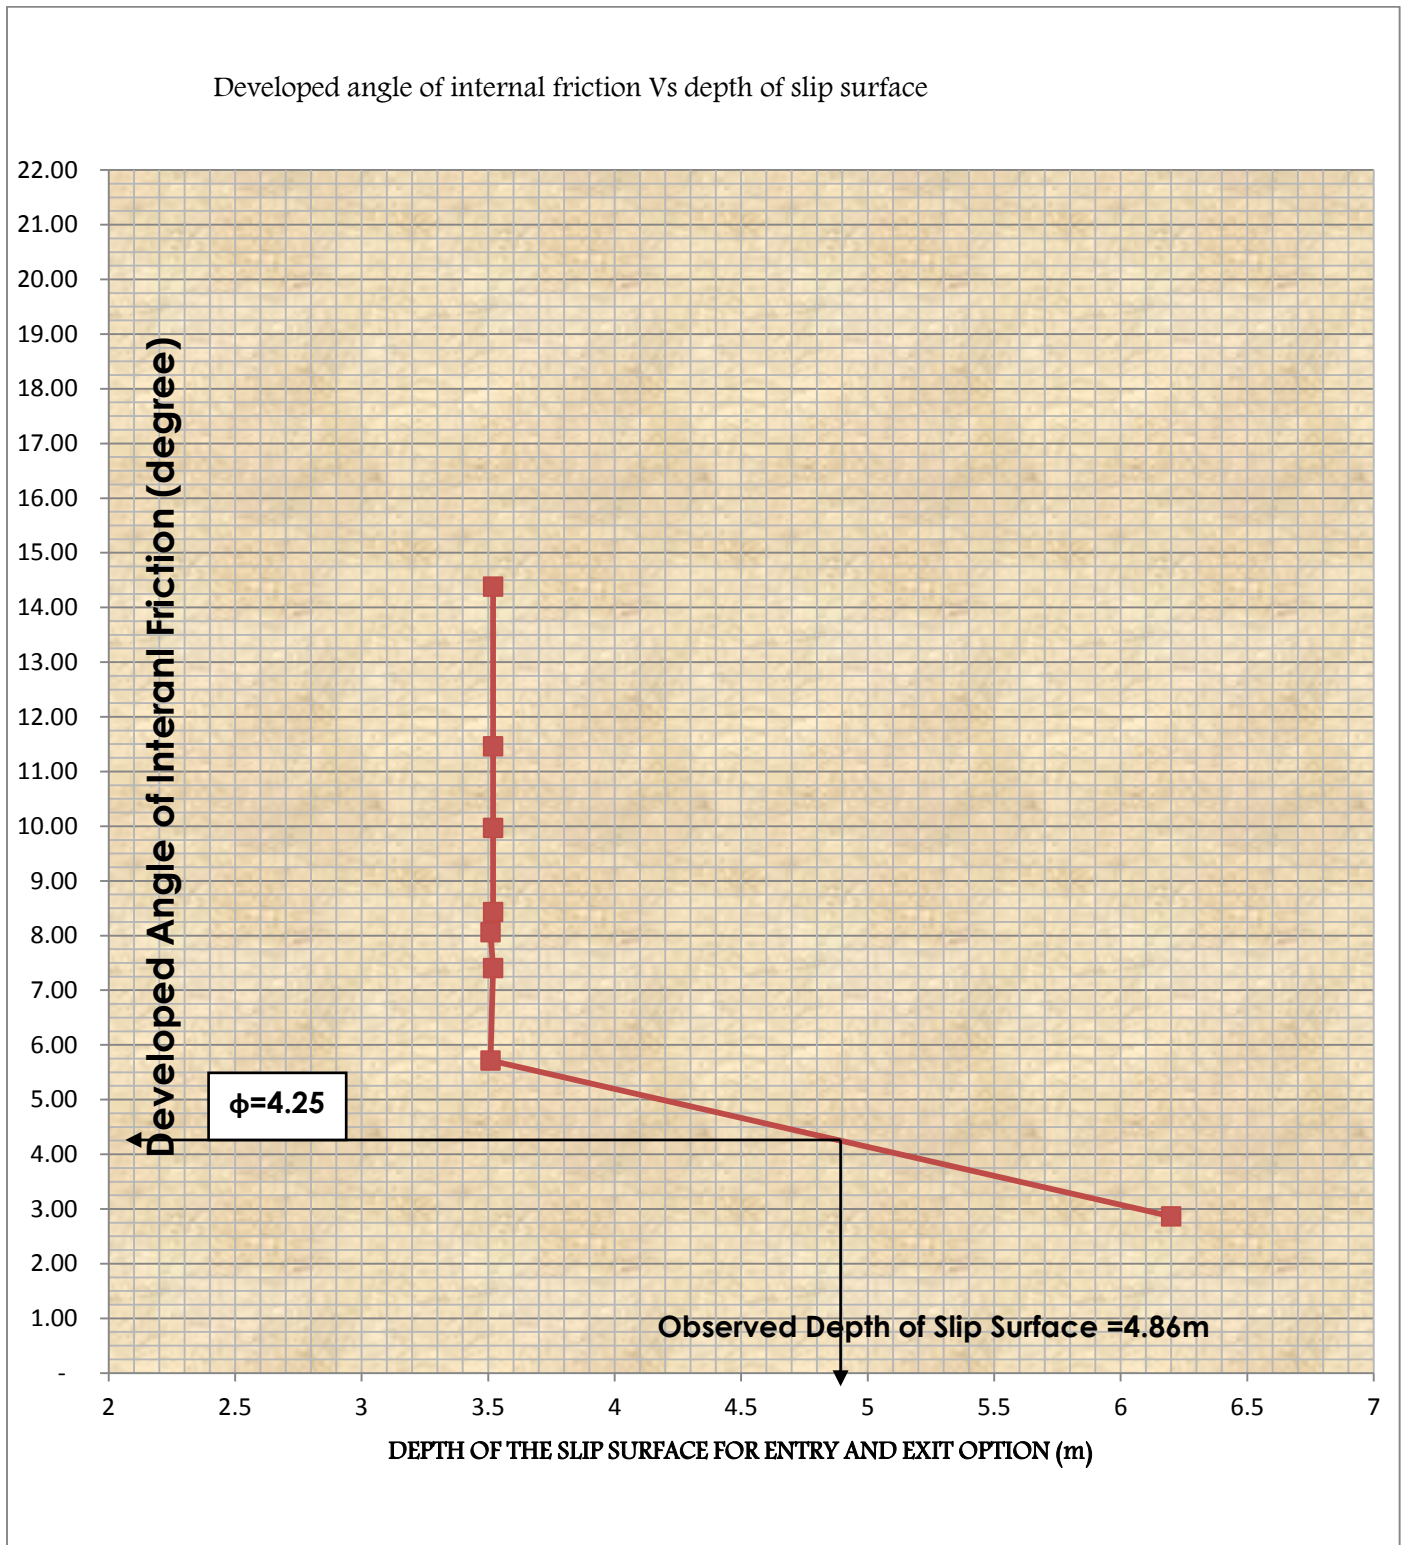
- vii. Next, prepare a plot of the developed strength parameters (c_d and ϕ_d) corresponding to a Factor of Safety, FS=1 and the depth of the slip surface measured in (v) above from analysis results.
- viii. Finally, calculate from the plot prepared in (vii) above the corresponding back analysis strength values (c and ϕ) corresponding to the actual depth of slip surface i.e. 4.86m, reference is made to figures from 4.1 to 4.8 as indicated in appendix C.
- ix. Accordingly, from the use of back analysis method, the results of the developed internal friction angle and cohesion are 4.25° and 20kPa respectively as indicated in Figures 4.12 and 4.13 below.

Figure 4.12: Back calculated friction angle Vs depth of critical slip surface

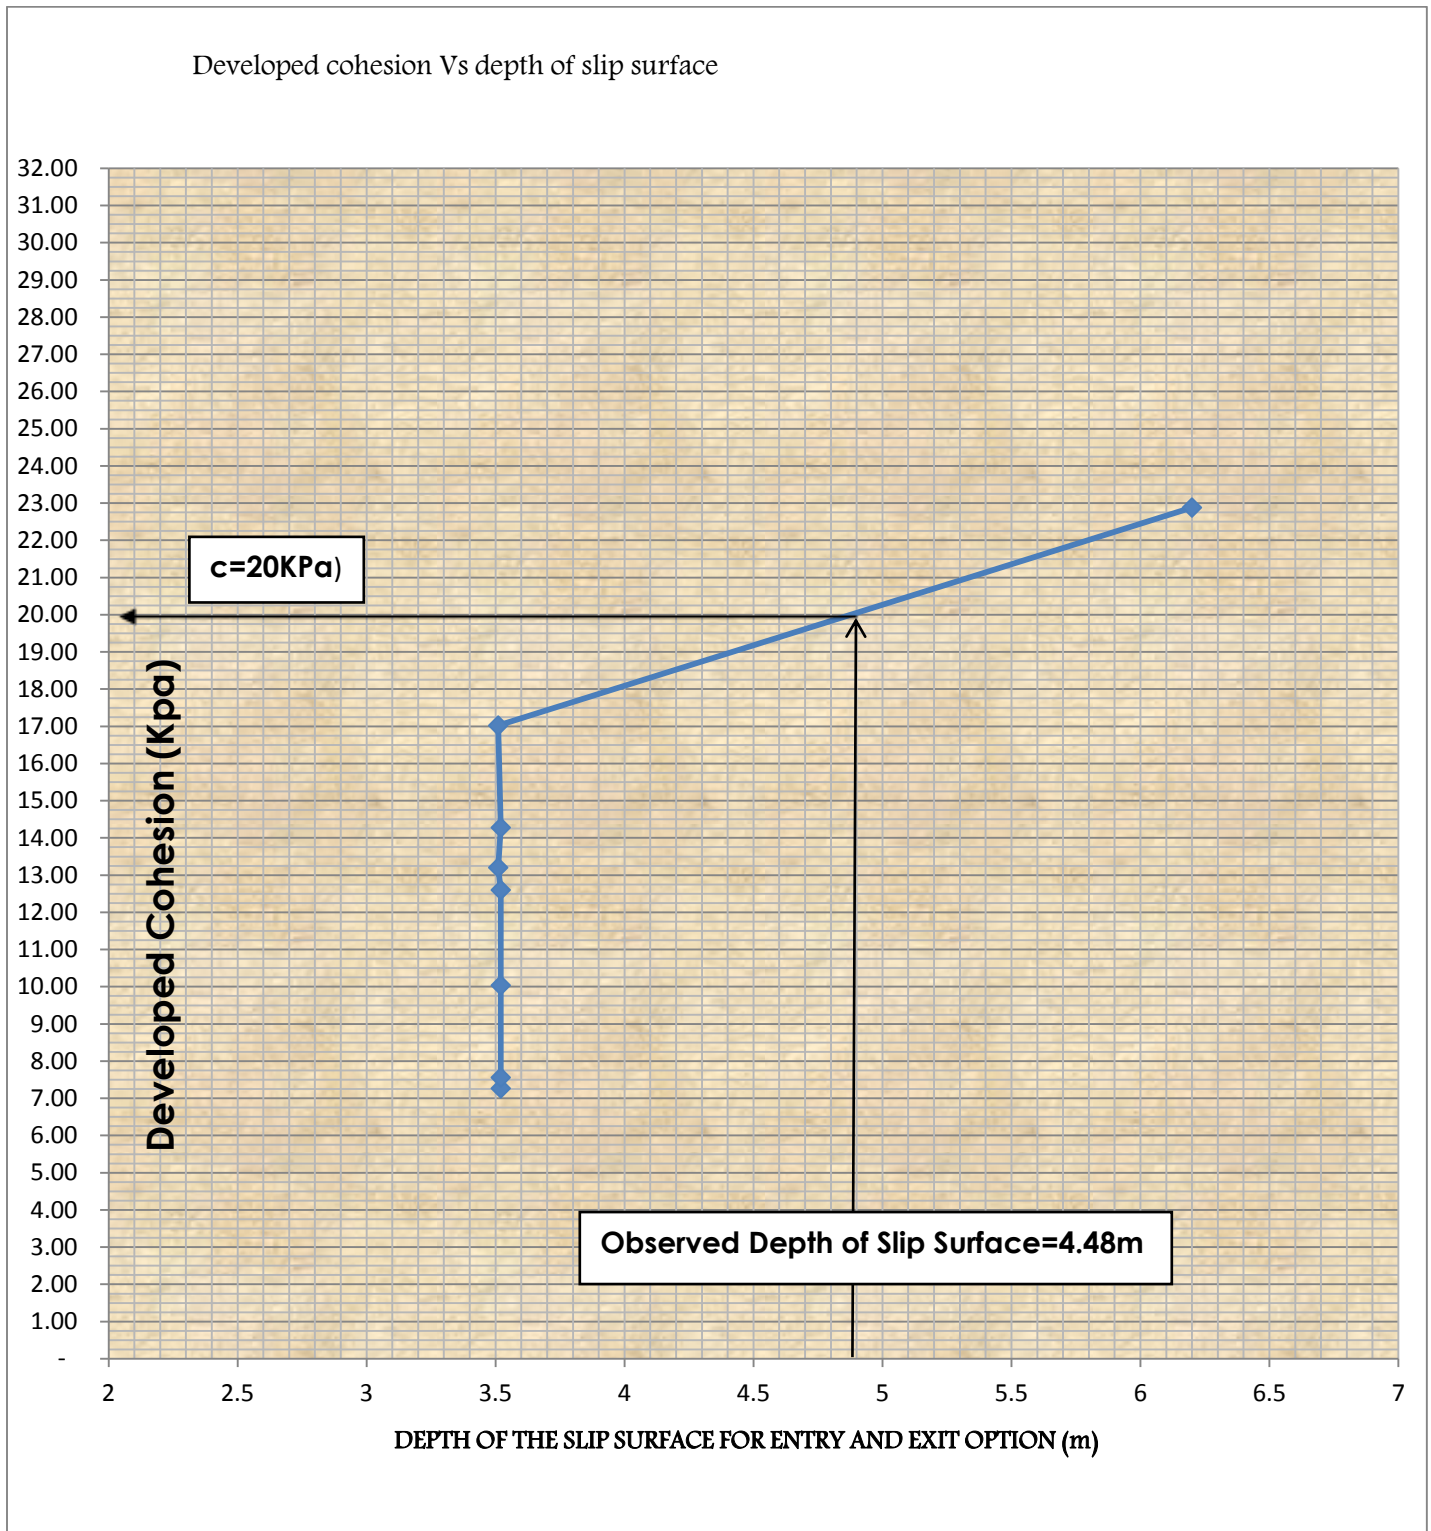
Figure 4.13: Back calculated cohesion Vs depth of critical slip surface

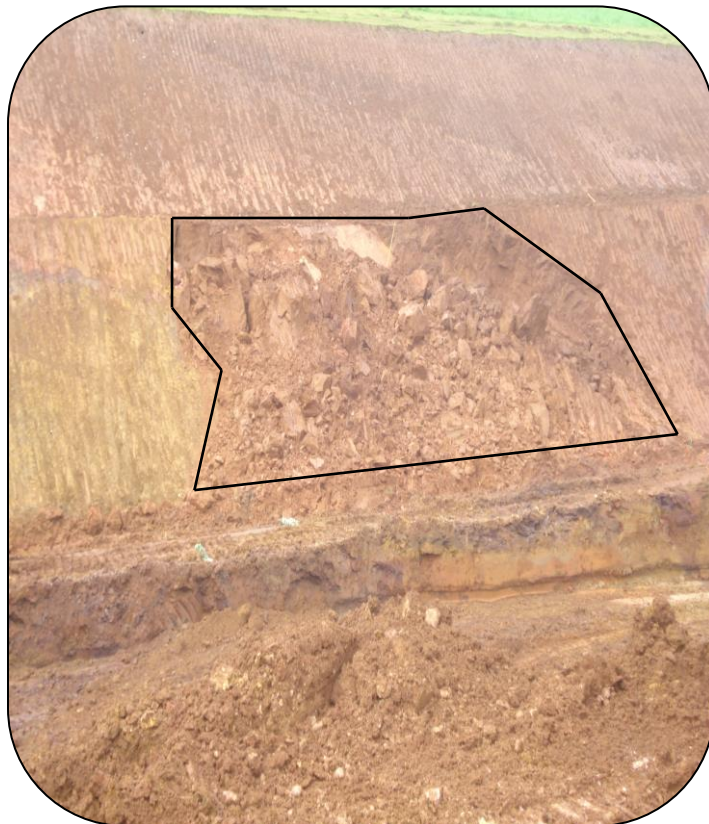
The total plan area, surface area and perimeter covered by the sliding mass are 7488.46m², 9300.84m² and 337.01m respectively. According to the classification of landslides this slide is categorized as medium landslide (Slope Failure). [2] During field investigation, no seepage or ground water flow was observed on the slope or failed mass.

Figure 4.14: Initial Wedge Slide day lighting on the slope during progress of excavation work

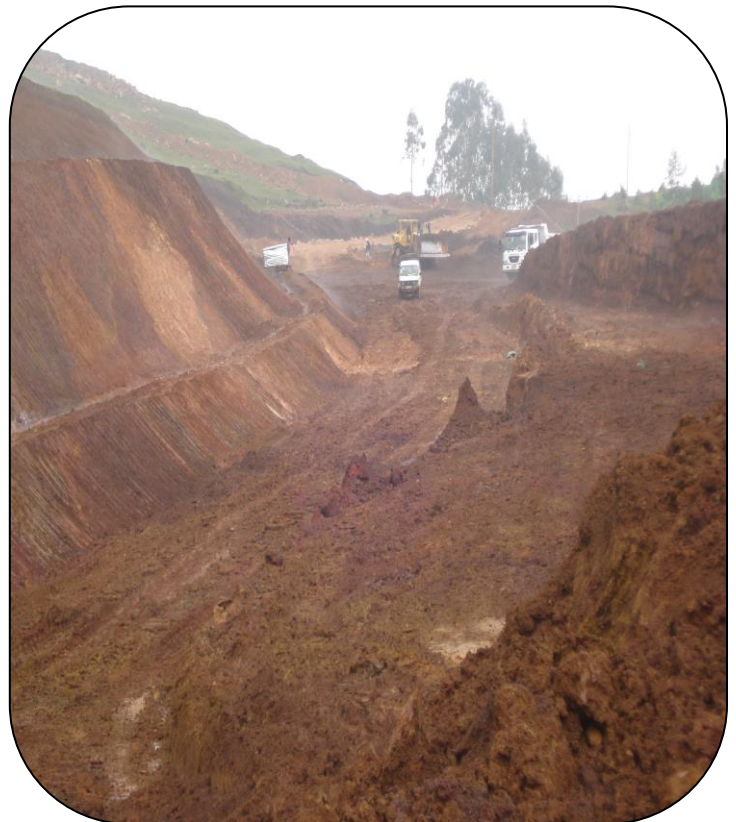
Figure 4.15: Common Excavation work on progress

The land slide (cut triggered slope failure) occurred after the excavation within the section was finalized to the depth of sub grade level in box cut section except on some width of LHS side of the road cross section which was left for traffic accommodation. A rotational type of slide through the base toe of the excavated slope with a downward (from top of the slope) and outward (from the slip surface) movement of the soil mass peculiar to rotational type of slide has been observed. Initially, during the progress of the common excavation works, wedge type of slope failure day lighting on the cut slope was observed on the slope as shown on Figure 4.14 and progressed to a distance about 80.4m from the center of the road to a stable position as per the typical slide cross section made at Sta.68+080 RHS, Figure 4.16.

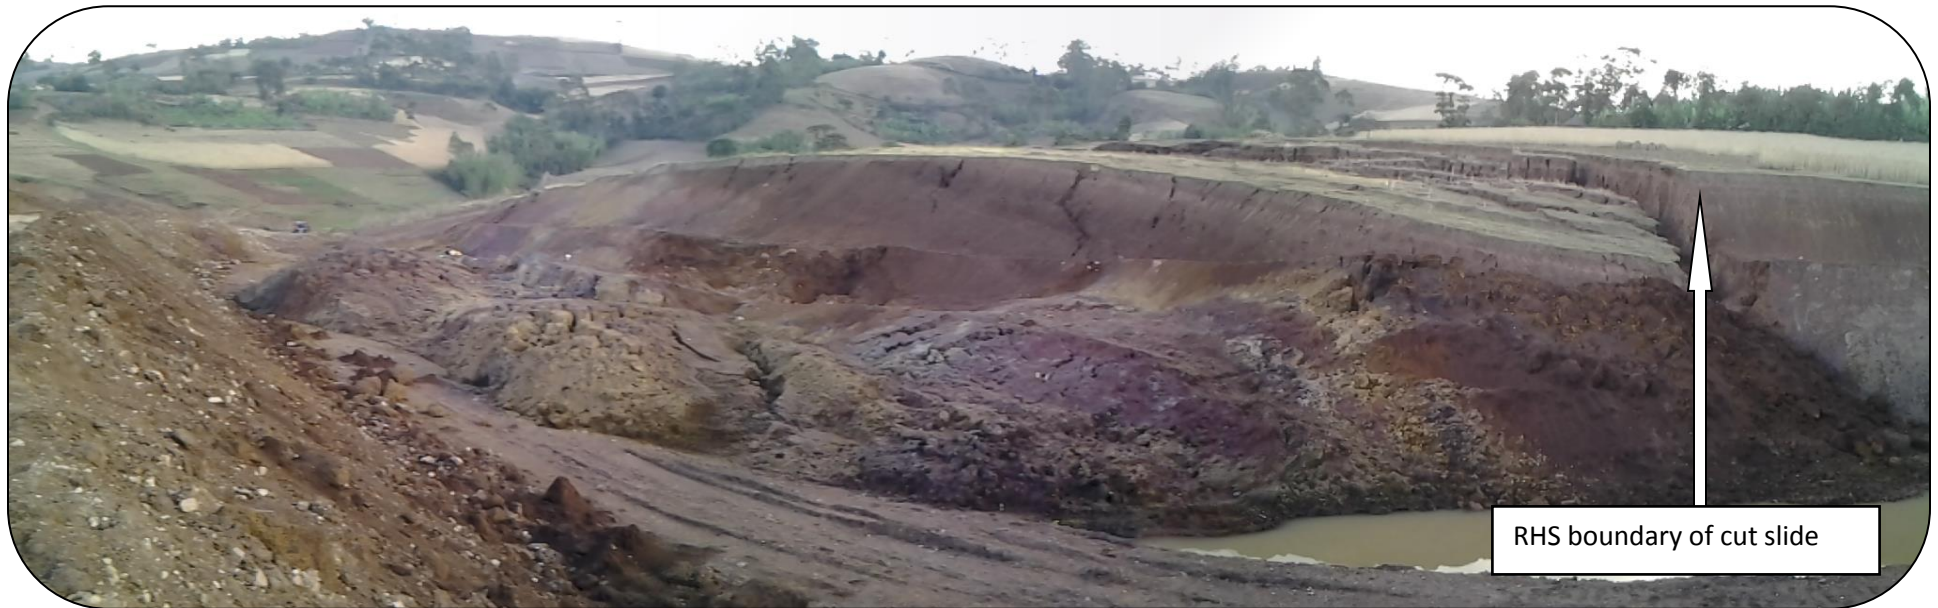
Figure 4.19: Slide at Start of Sta.68+020(Ahead)

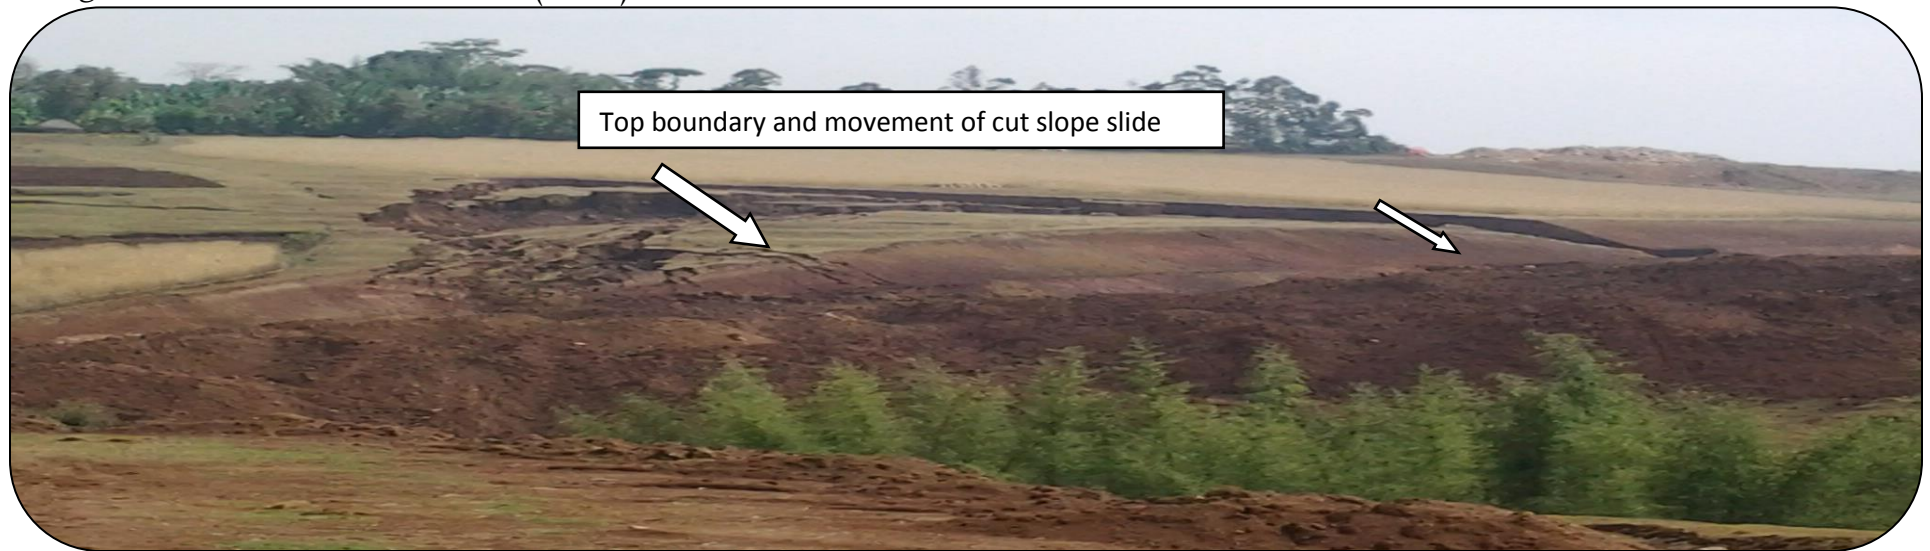
Figure 4.20: Slide manifestation from 68+020(Ahead) to 68+140(Back) RHS

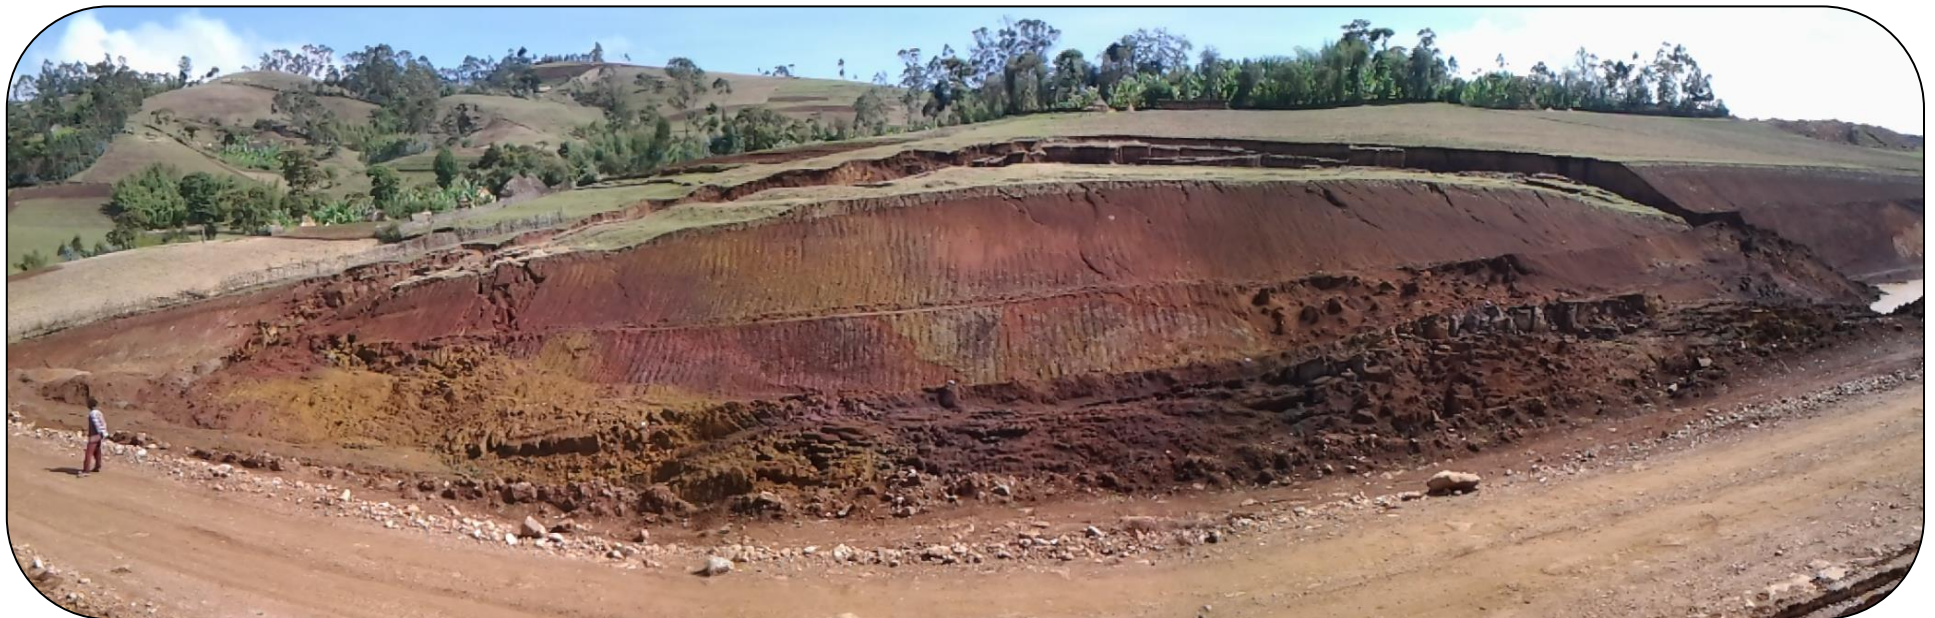
Figure 4.22: Front view of the slide and block movement of the slide mass

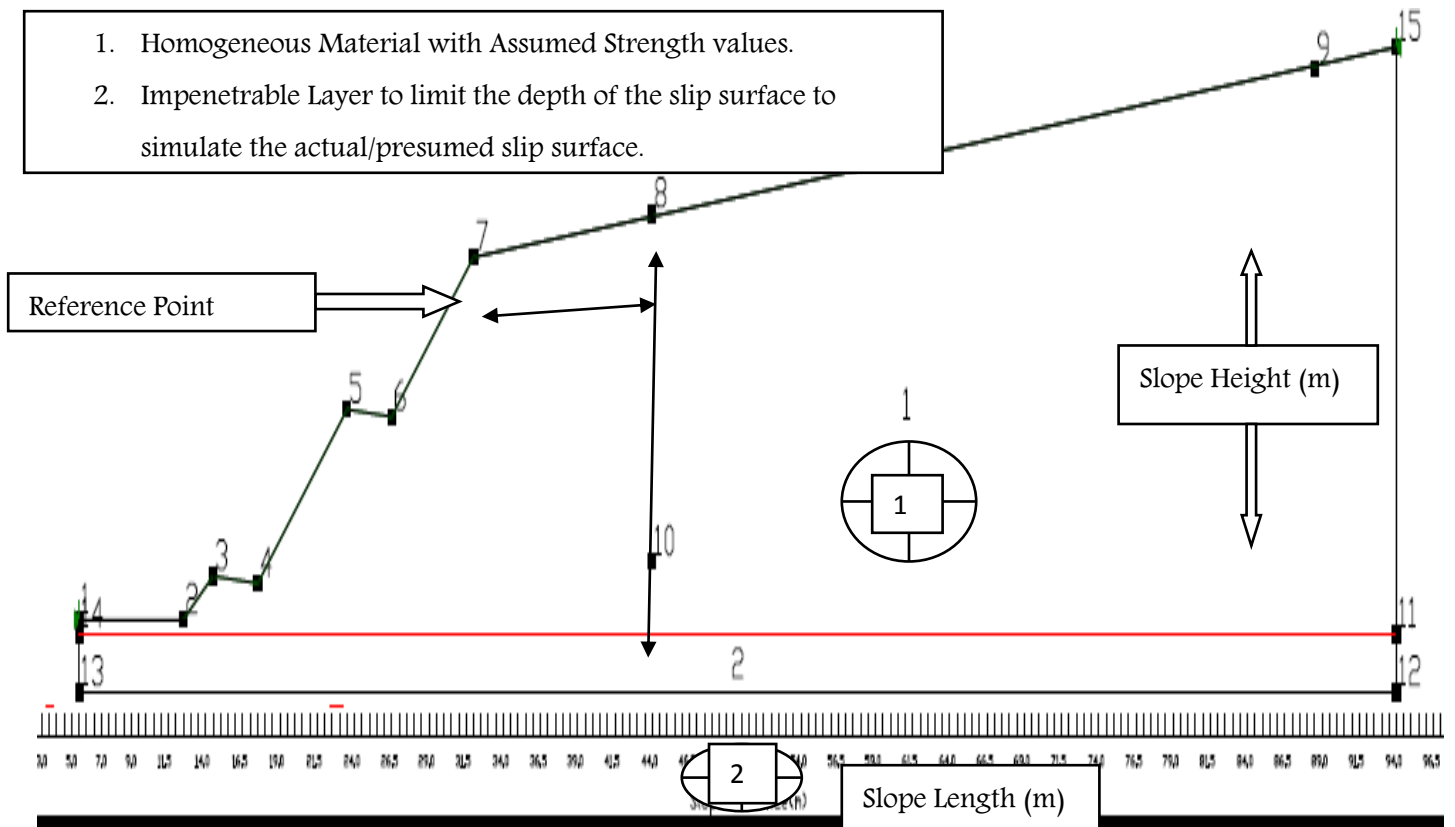
- ii. Create the slope geometry in Geo studio 2004 SLOPE/W Software as shown on Figure 4.23 below using data from the designed slope and slide plane as depicted in figures 4.16 and 4.17 above ;

Figure 4.23: Slope Geometry in Geo Slope/W 2004

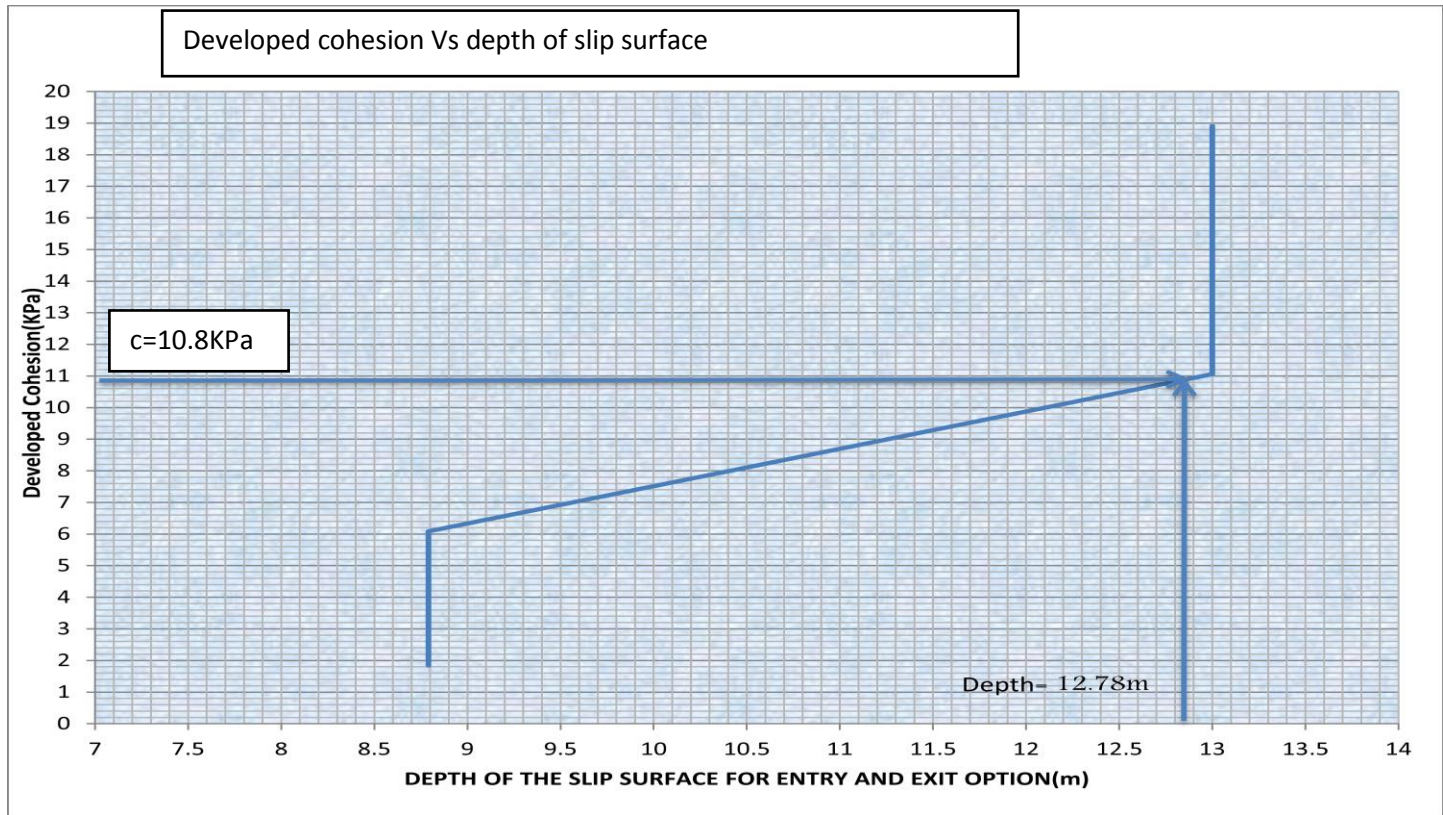
- viii. Finally, from the use of back analysis, the results of the developed internal friction angle and cohesion are 4.8° and 10.8KPa respectively.

Figure 4.24: Calculated (developed) cohesion for a FS of 1 and depth of slip surface

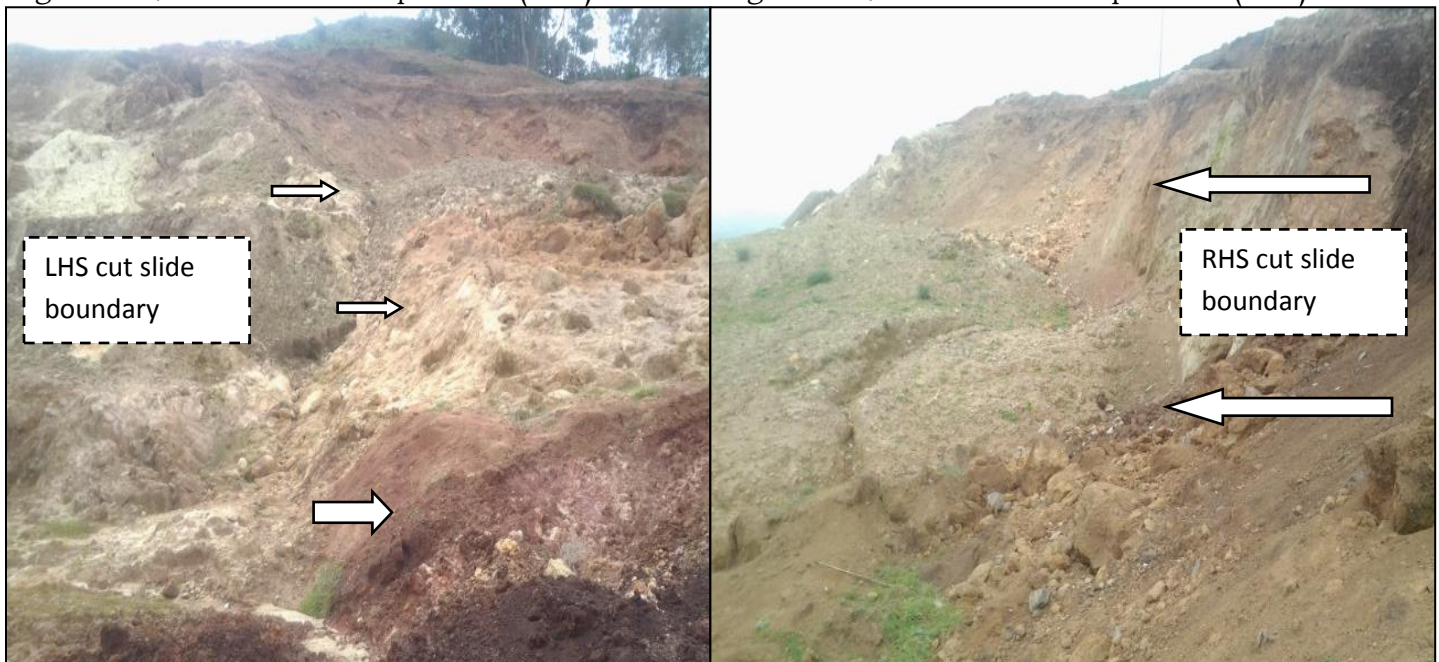
Figure 4.31: Front side of the slide from sta.72+740 to sta.72+790LHS

- The outer crest of the slide surface measured at the offset of 80.37m from the centerline of the road.
- Depth of failure surface: The depth of the failure surface below the crest of the slope is usually equal to the distance from the crest of the slope back to the furthest shear crack as depicted under figure 4.31 below and Figure 2.5 above.[1]

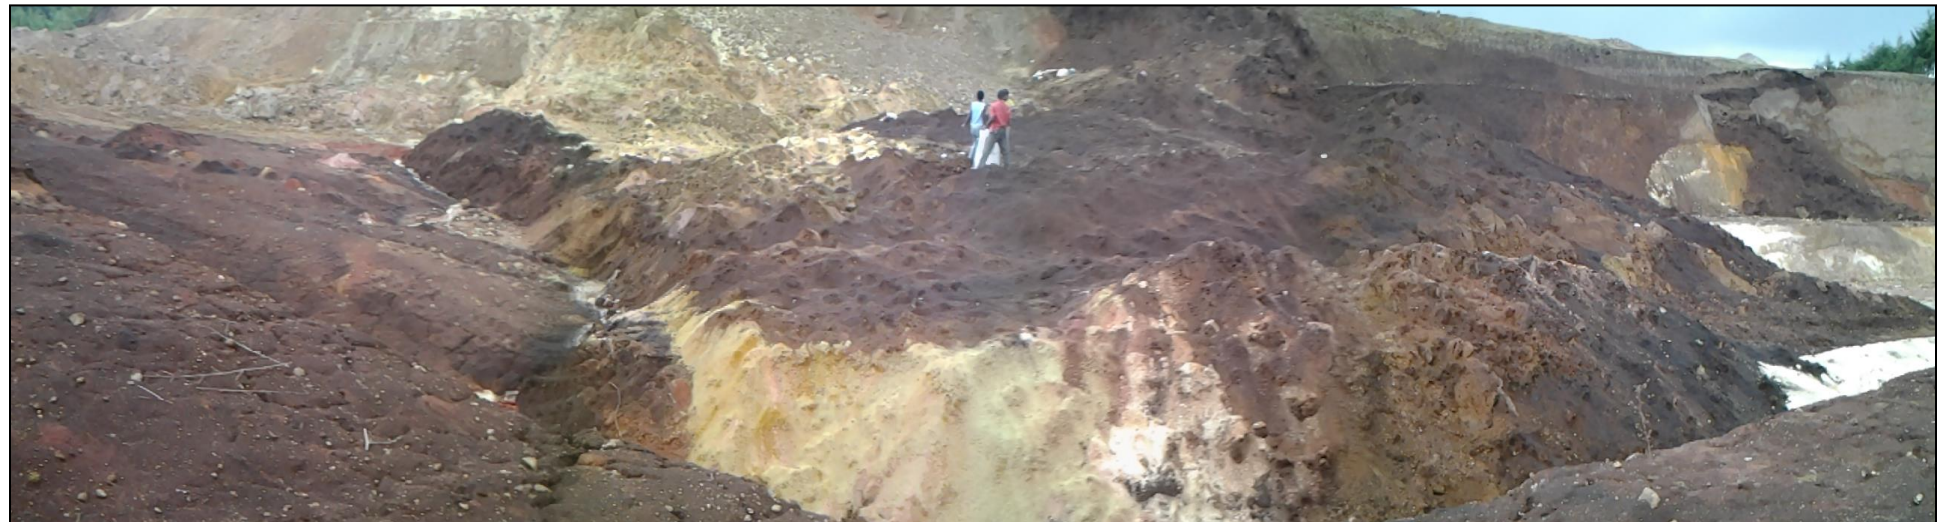
Figure 4.32: Displaced material at foot of the cut slope slide from Sta. 72+740 to Sta.72+790 LHS: front view
