ADDIS ABABA UNIVERSITY
ADDIS ABABA INSTITUTE OF TECHNOLOGY
SCHOOL OF CIVIL AND ENVIRONMENTAL ENGINEERING

**A Thesis in Analysis and Remedial Measures for Slope Instability
Related Problems of Selected Sections of LOT II: Belta (KM60+000)
– Otolo (KM 87+000) Asphalt Road Project, Southern Part of
Ethiopia.**

FEBRUARY 2016, ADDIS ABABA

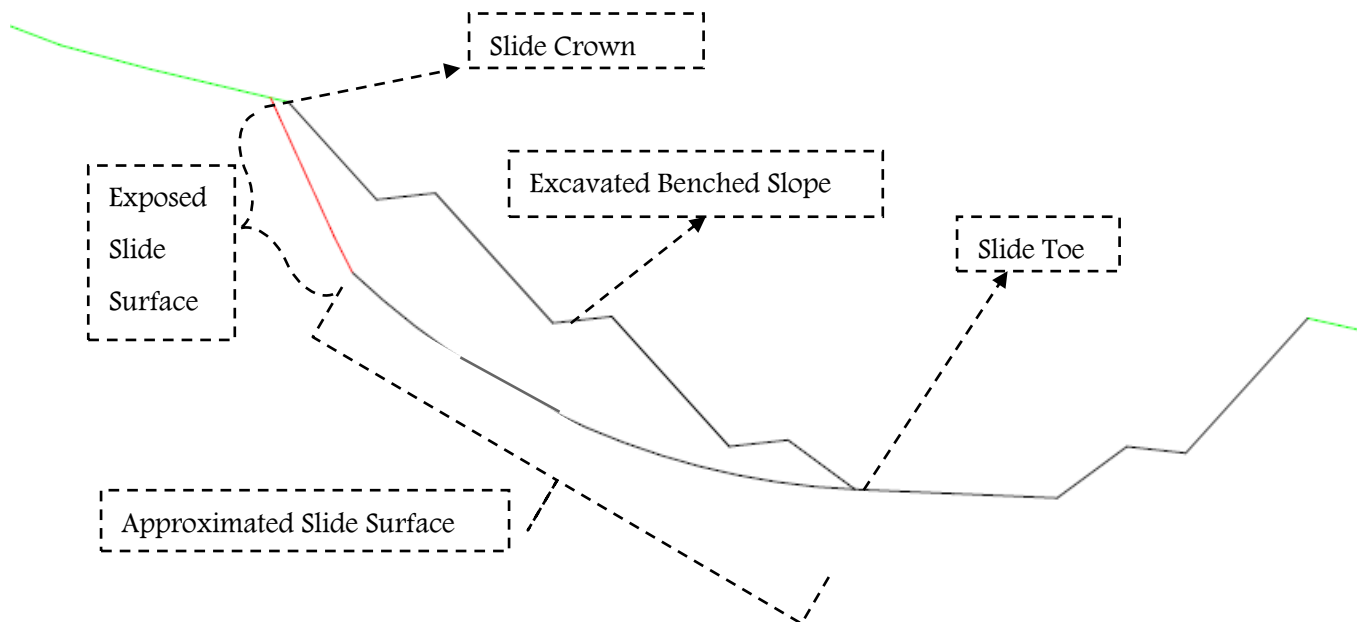
- The top exposed part of the slide plane i.e. from the crown to the top of the displaced soil mass i.e. the depth from Pt.No. 12 to Pt.No. 13 as referred from figure 4.34 below.

Figure 4.33: Approximated slip surface location

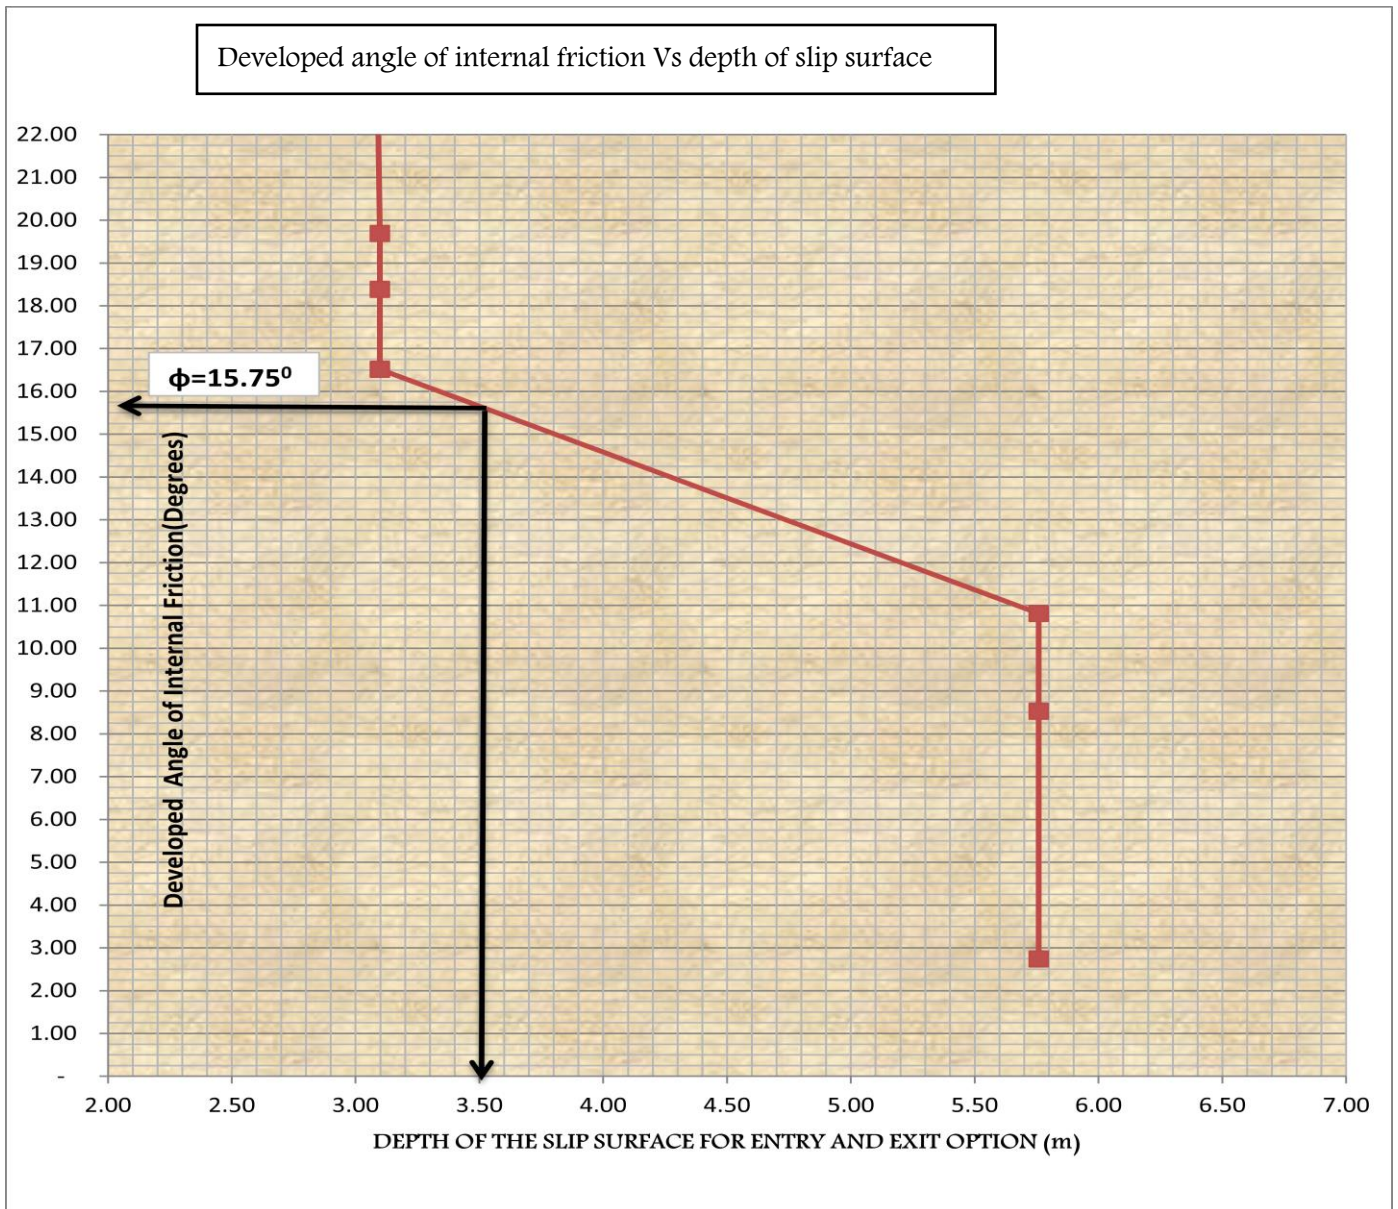
Figure 4.36: Back analysis values of developed angle of internal friction for a Factor of Safety of 1.0

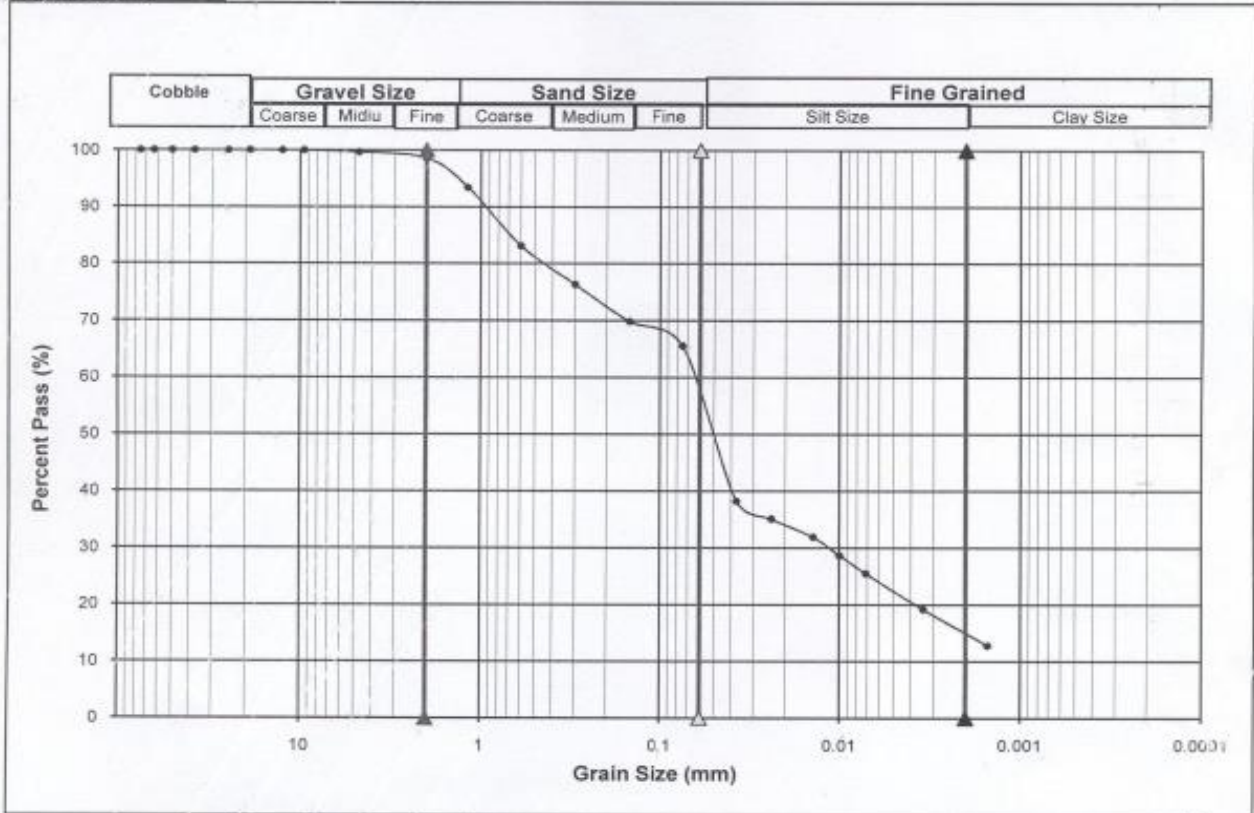
Station :- 68+080
 Sliding material at center line

Specific gravity 2.62

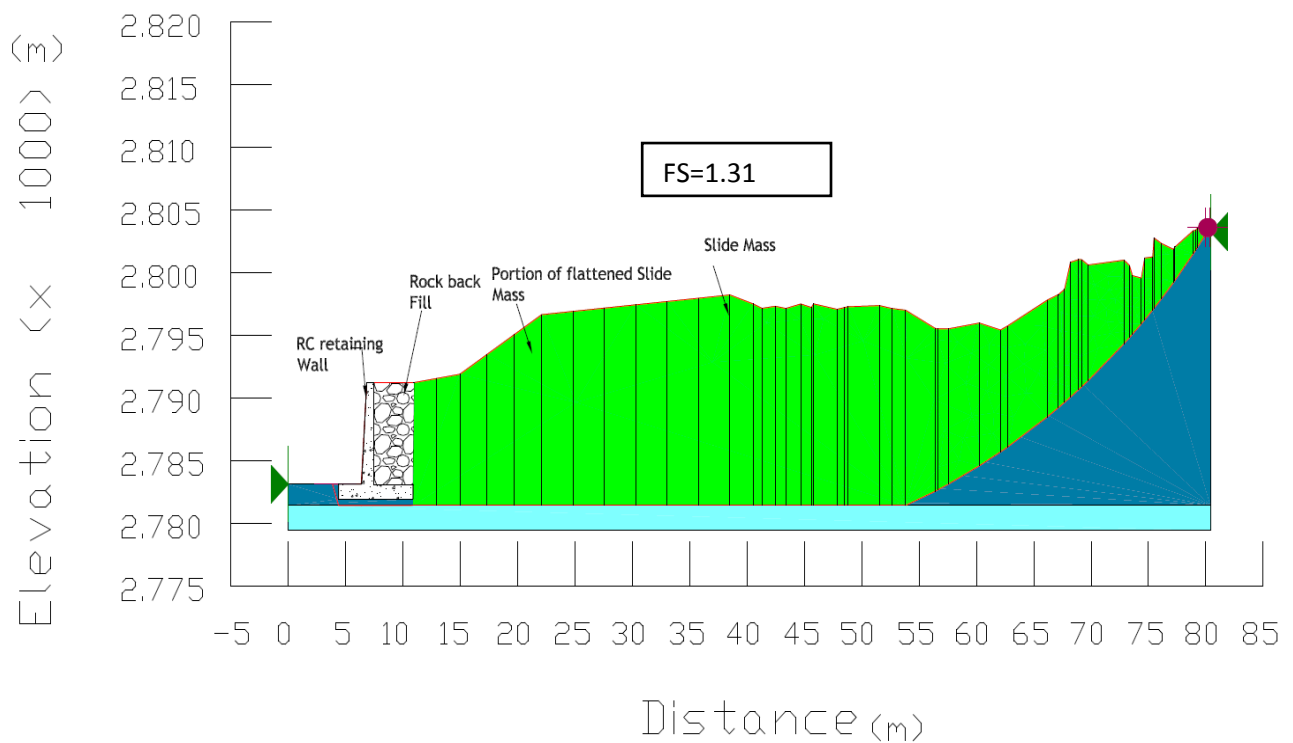
Figure B.13 (a): Designed remedial structure and slide mass FOS; static stability
