**Environmental Impact Assessment of Quarrying Activity and Aggregate
Production in Dire Dawa Administration, Eastern Ethiopia**

**Environmental Impact Assessment of Quarrying Activity and
Aggregate production in Dire Dawa Administration, Eastern
Ethiopia**

Studies as Partial Fulfillment of Master of Science in Geological Engineering

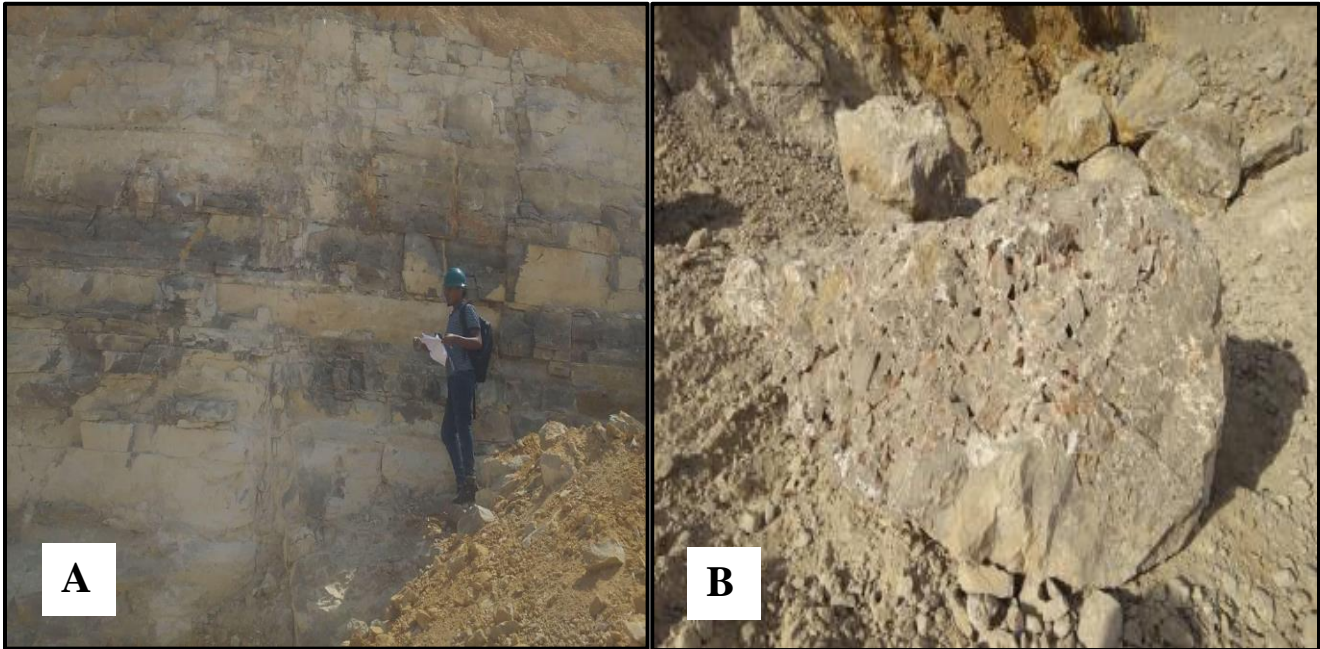
Figure 6. A) Photo plate showing massive limestone in quarry site (study area) B) Photo Plate showing brecciated limestone boulder

The limestone of the area is light to dark grey and sometimes black with inter-beds of light brown limestone. The surface of the limestone is commonly sculpted into hollows by weathering but no true karst type form exists. The limestone of the area is massive, fine-grained, hard, and compact (Fig 6). The limestone is also seen brecciated at places in quarry sites as well as boreholes drilled in the area.

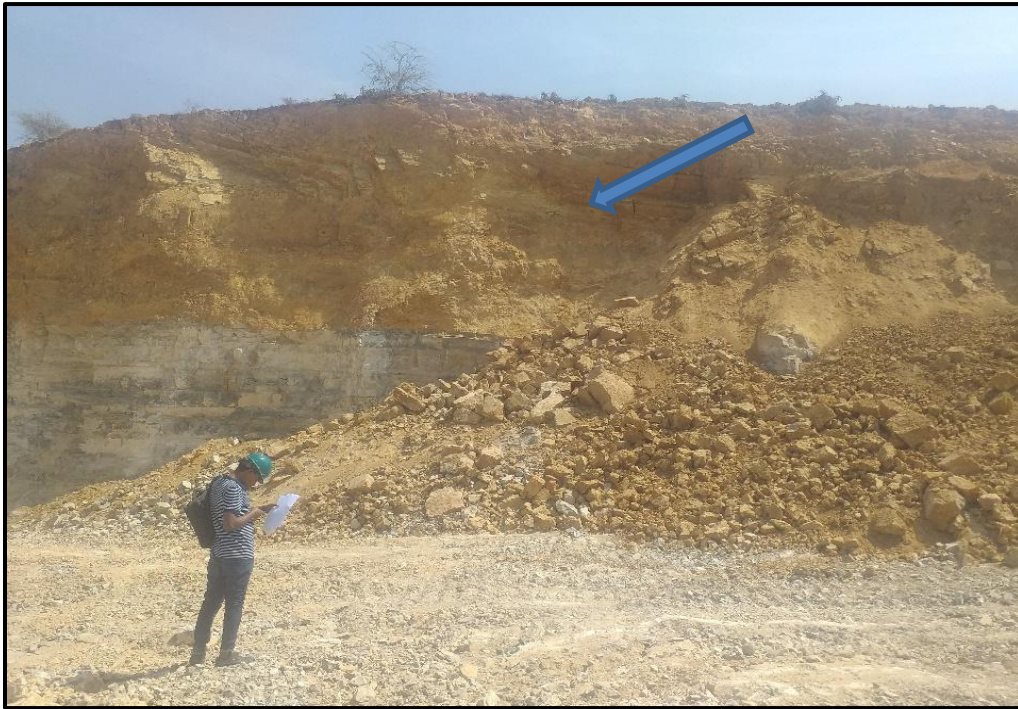
Figure 7. Photo plate showing Sandstone in quarry site (study area)

The limestone of the quarry area is overlain by Upper Cretaceous sandstone. The sandstone is exposed in a limited area towards the southwest corner of the quarry area. In general, the sandstone is massive, fine to medium-grained, red to brown, and ferruginous (Fig 7).

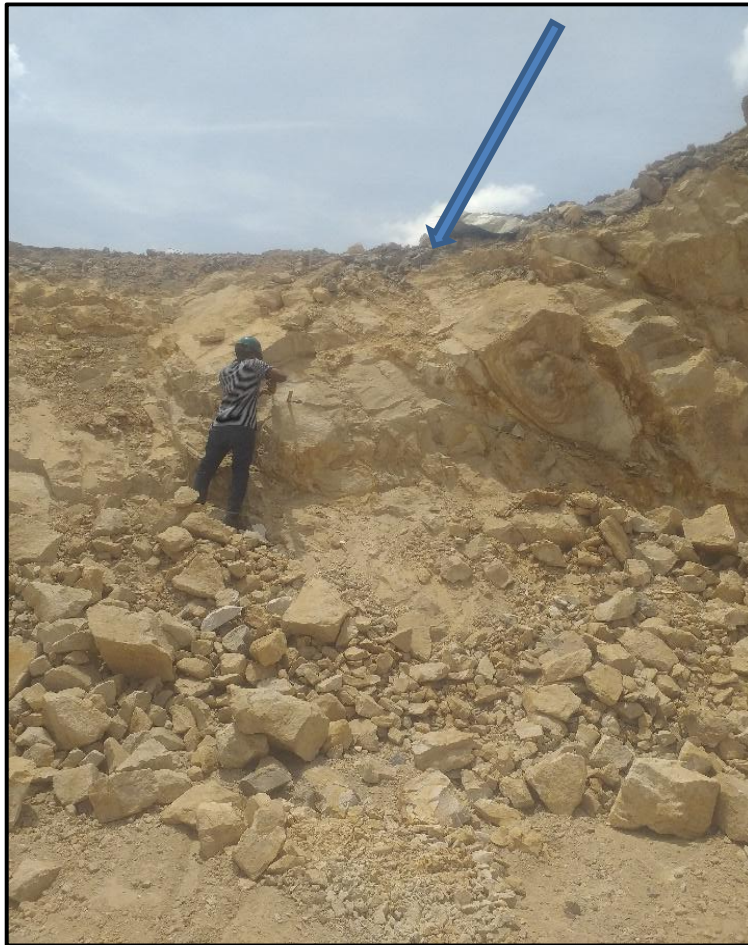
Figure 8. Photo plate showing Rhyolite in quarry site (study area)

The rhyolite (Fig 8) and basalt are yellowish-grey to grey and sometimes brown, weathered, and fine-grained.

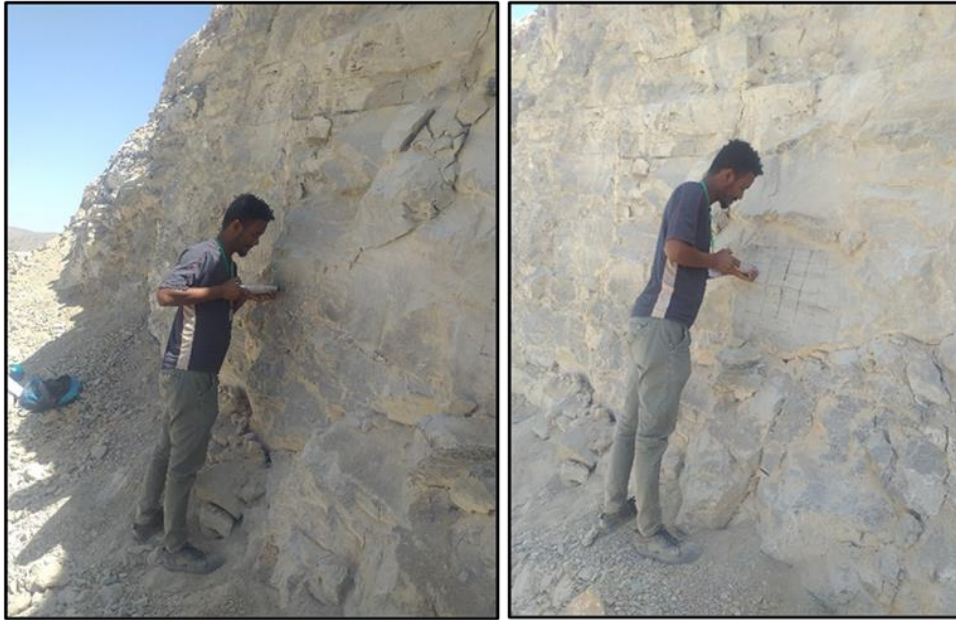
Figure 9.Schmidt hammer in the field for compressive strength determination

Field study is done to document the present condition of the study area and based on reconnaissance surveys different sampling sites were selected to rock mass characterization of the quarry sites. Discontinuities, their frequency, dip, dip direction, and strike were measured. In addition, the Schmidt hammer was used to determine the uniaxial compressive strength of the rock mass.

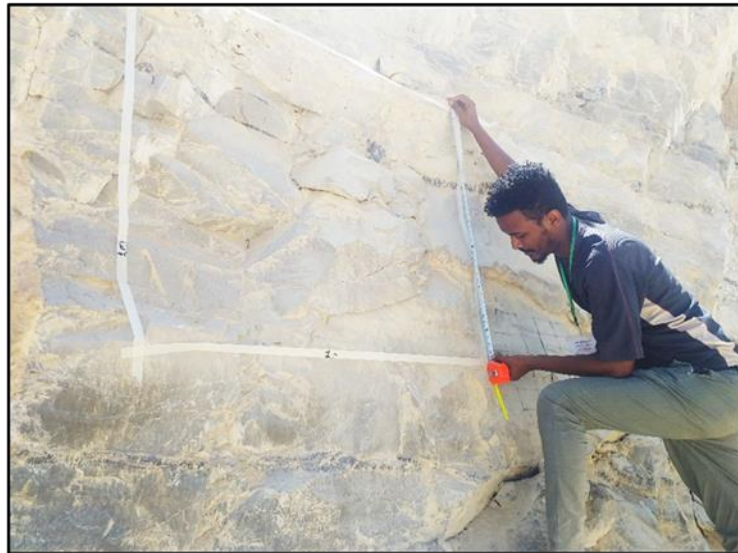
Figure 10.1 1m Volumetric count of an exposed rock face in the study area.

$$\mathbf{RQD = 115 - 3.3 J_v}$$

The measuring tape was utilized to measure the volumetric count of rock quality designation (Bieniawski, 1989). In the quarry sites, a geotechnical investigation was carried out. Different representative sites were selected based on systematic and judgmental descriptions according to the characteristics of the rock mass visual description. Techniques of geomechanics classification (rock mass rating system) by (Bieniawski, 1989) were applied to collect measurement data from the field. Because this technique is very simple to use and the classification parameters are simply obtained through measurement. In addition, the method is appropriate and adaptable to many different situations including, coal mining, hard rock mining, slope stability, foundation stability, and tunneling (Nicholson *et al.*, 1986). To determine the rock mass rating (RMR) the following six parameters were measured.

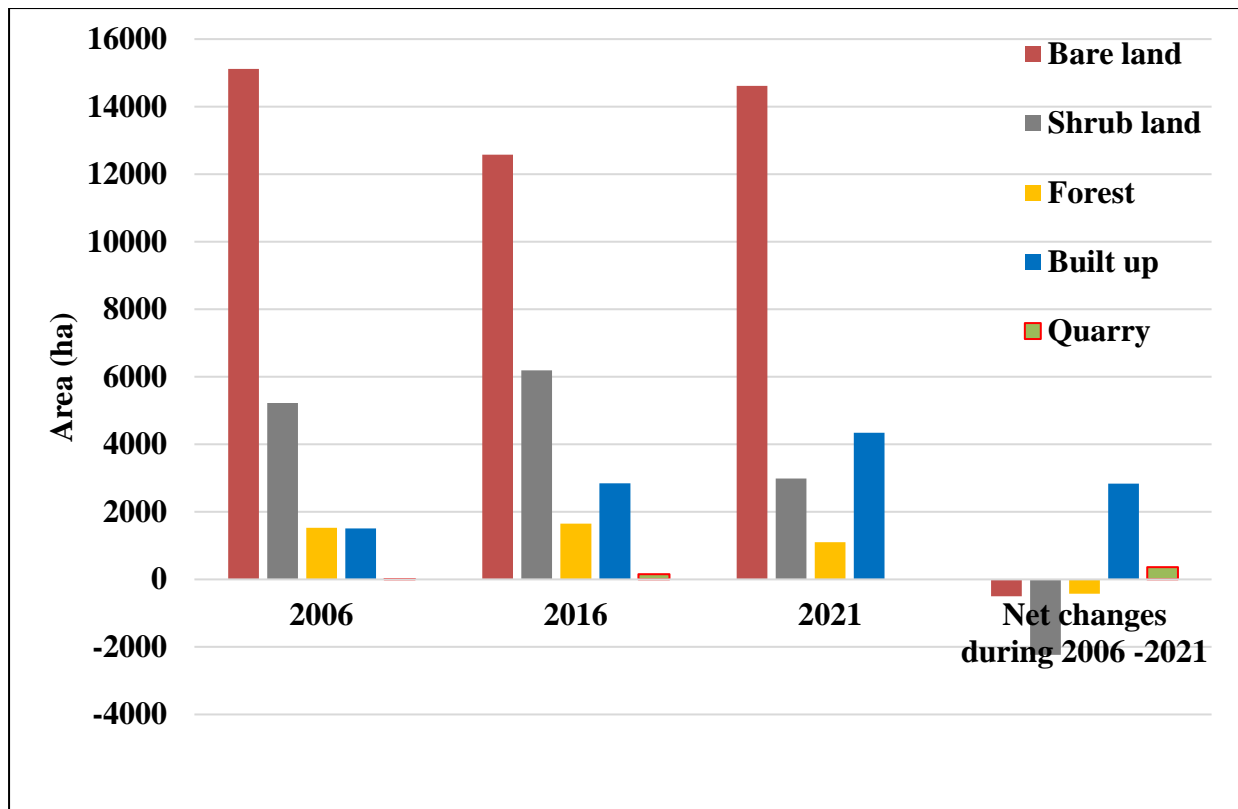
Figure 14. A chart showing the LU/LC changes in the study area

The LU/LC change tendencies of the study area revealed that quarry and built-up have increased by quarry 2,834.08 ha and 360.37ha, respectively. Other classes showed increasing and fluctuating area coverage. As shown in graph (Fig 14).

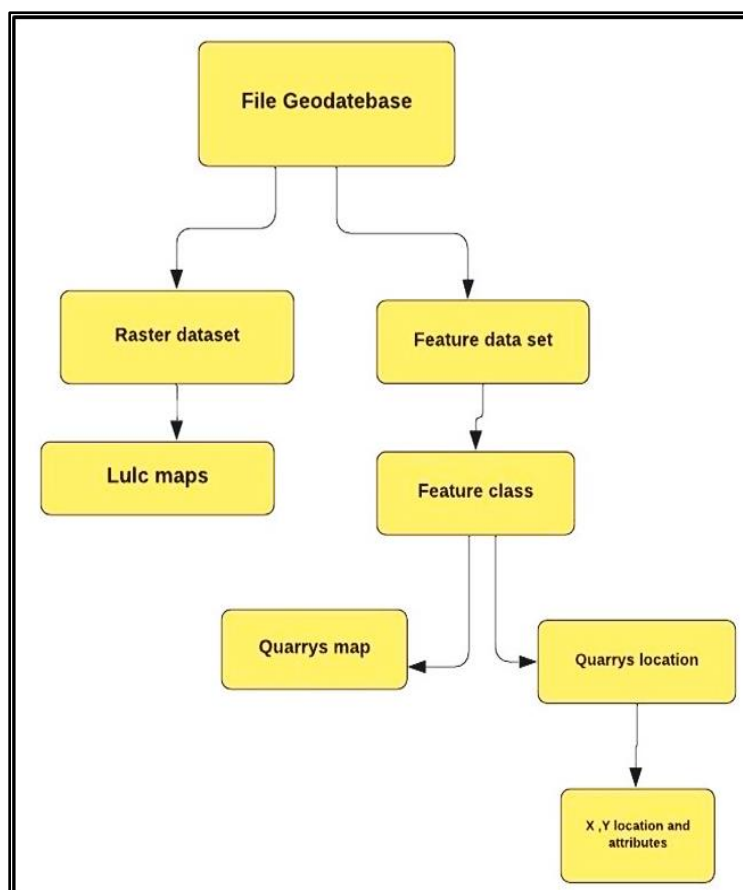
Figure 16. Flow chart of geo-database components

Geodatabase of quarries in Dire Dawa is prepared. It contains data on location (x, y coordinate, and elevation), name of the quarry, purpose of the quarry, starting time of the quarry, lithology, proximity to rivers, and institutions such as schools, hospitals. A geodatabase file was created containing feature classes, raster datasets, and feature datasets. File geodatabases feature class contains different classes which are quarry maps and quarry location and their attributes. Fig 16 shows the information about the quarry name, the starting time, the elevation, the lithology of the quarry, and the closeness of the quarry to institutions.

All the data that were organized in the geodatabase give services for managing and accessing the quarry site by offices that are responsible for managing and licensing (Fig 17). The absence of any geodatabase for quarries operating in Dire Dawa made their management difficult. Therefore, designing and developing this geodatabase can make a difference in facilitating the management of quarrying activity in the research area. Moreover, the possibility of easily visualizing the information contained in the geodatabase using specific thematic maps will help the communication of the planning decisions to the stakeholders, thus ensuring participatory decision processes (Mondini 2016).

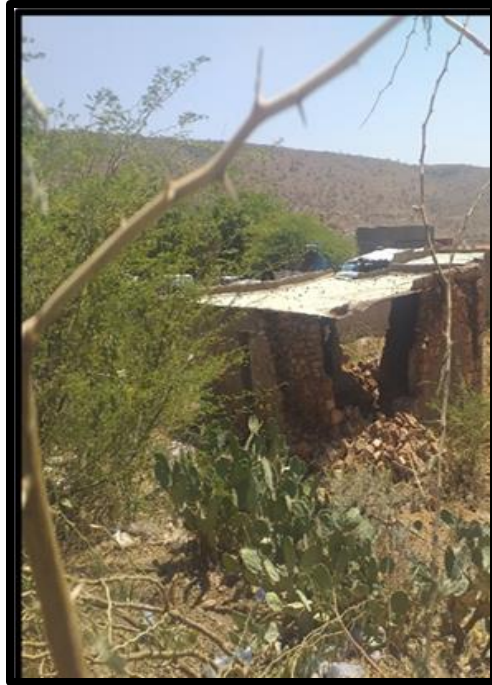
Figure 19. Series of cracks and collapse in buildings

They also responded on the open-ended questionnaire that the vibration, especially the blasting negatively affects their hearing ability. The blasting problem extends to death where a person was dead according to the evidence recorded by the police administration office. The presence of flying rocks emanated primarily from the blasting of rock products using powerful explosives like dynamite. Flying rocks had caused various degrees of damages. A mother from the community said flying rock harmed her son on his head and nobody was accounted for. As shown in Fig 19 cracked house walls and floors were in the area due to the blasting. Additionally, the blast led to constant damage in the pit toilets where equipment fell from tables and became damaged. According to the data obtained from the community leader, some of the electric poles scattered and fell on the ground in the area.

Further to this, residents in the blasting area are unable to lead their day-to-day activities because of the vibration and noise of the quarry. For instance, students can't study properly, patients are unable to recover at home. Besides, house roofs were damaged due to the flying rocks from the

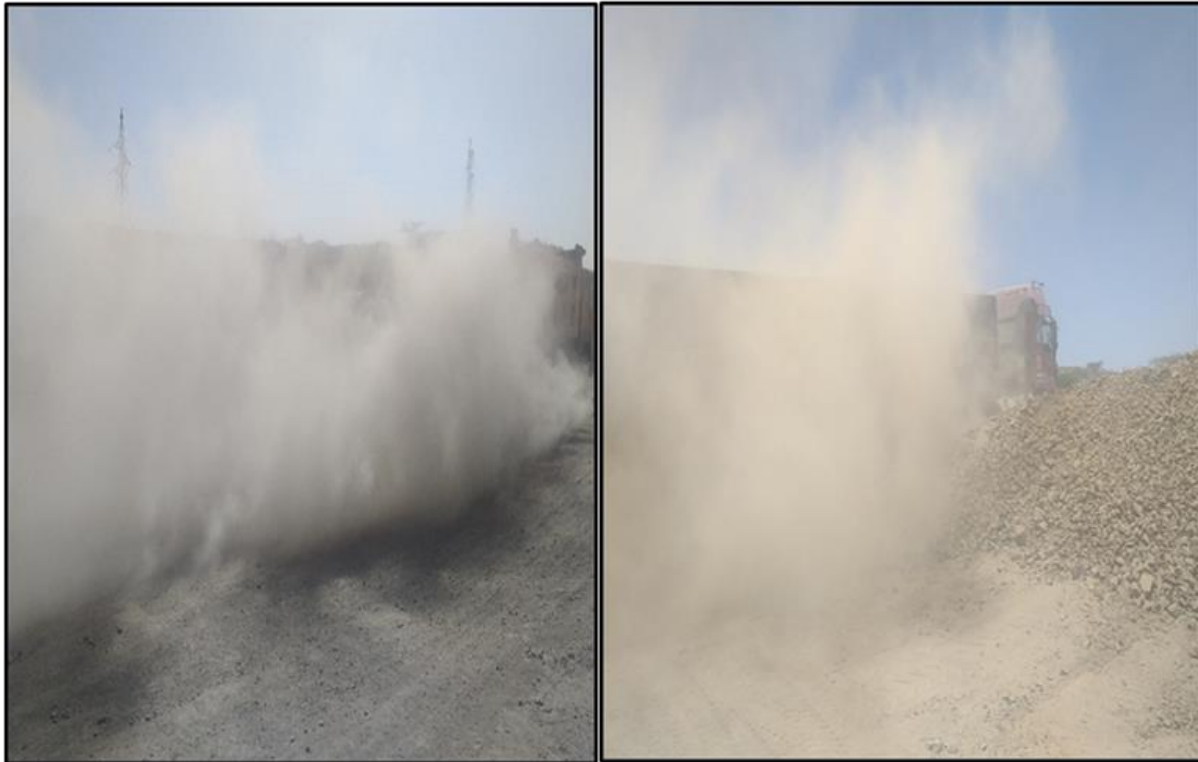
Figure 24. A photo of dust accumulation.

from the observations made during the field survey of quarrying sites, the negative excessive emission of dust into the atmosphere was evident (Fig 24).

The dust tends to affect local air quality. Dust emission into the atmosphere was primarily caused by excavation, drilling, blasting, and the crushing of rock products into their respective aggregate sizes (Howard and Cameron, 1998). The dust particle in effect does not only affect the quality of local air but results in serious respiratory disorders like cancer, tuberculosis, and silicosis in the nearby community (Fig 25). In terms of dust emissions, the workers at the quarrying sites were the most vulnerable since they had no protective clothing like a nose mask to reduce the inhalation of these dust particles. It was also reported that the degree of proximity to the quarries has a direct linkage to the extremes of effect on victims (Howard and Cameron, 1998).

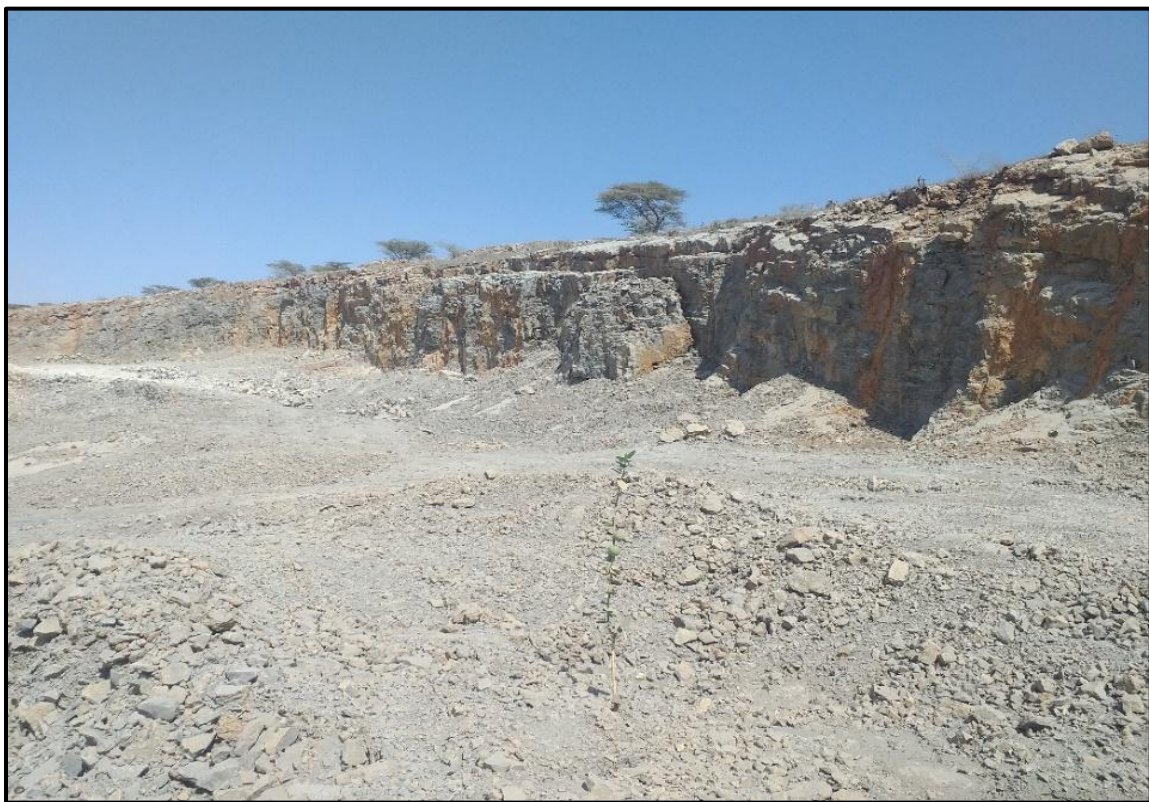
Figure 28. Photo plate shows degraded land

human-induced processes acting upon the land (Johnson, 1991). Quarrying activity plays a negative role in land degradation and the loss of top soils (Ata-Era, 2016). In this study, it was observed that quarrying has a negative environmental consequence on the natural environment by way of forest degradation and loss of fertile topsoil. There was an indication of deep large pits, trenches, and deep gullies, resulting from the excavation activities. These big pits had been created due to the continuous extraction of rock products. It was revealed from the field survey that no measures have been put in place by the quarrying companies to reclaim the degraded lands as a result of their activities (Fig 28).

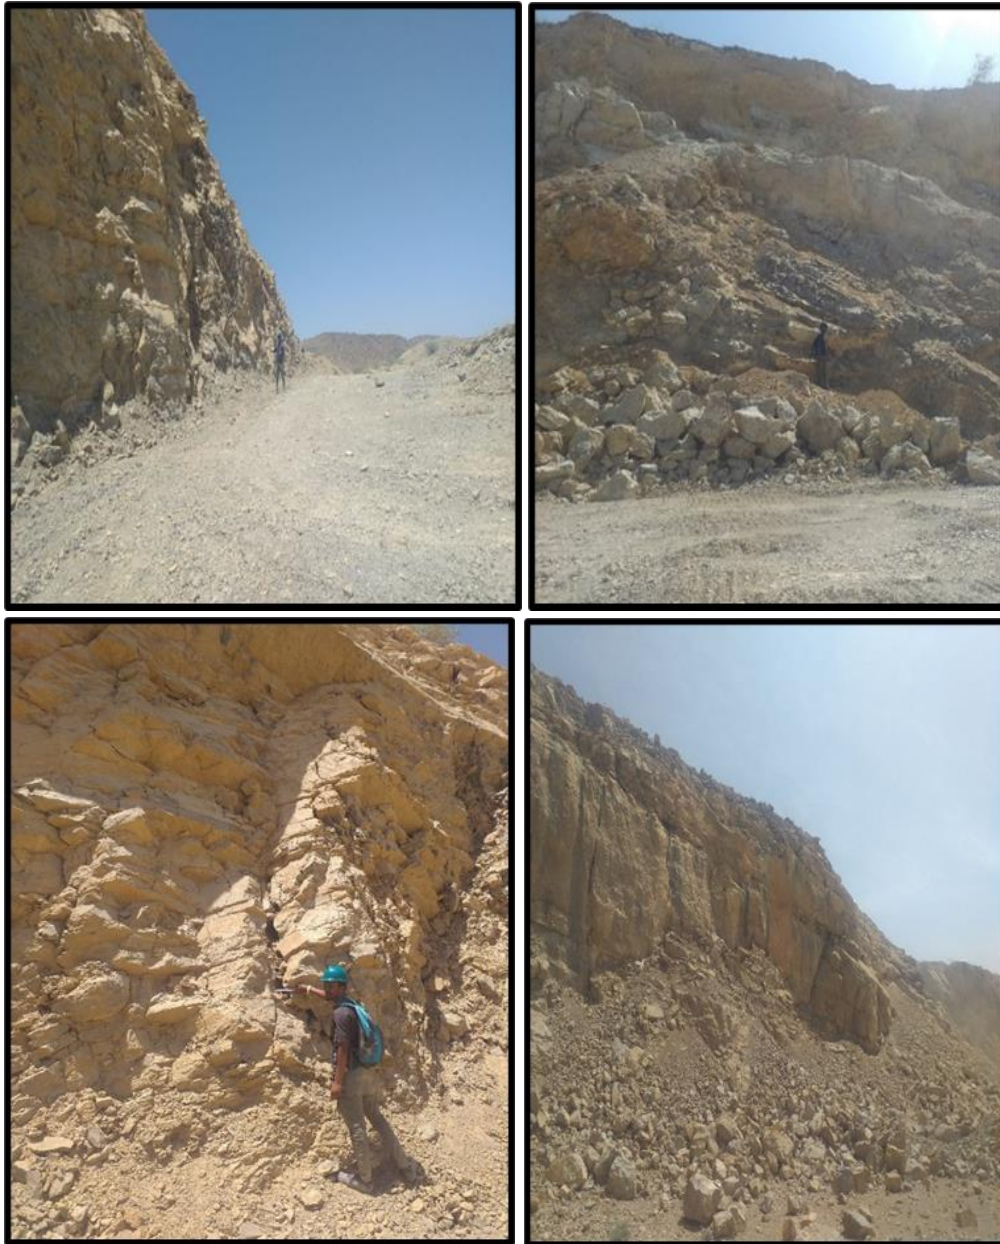
Figure 30. photo plate of limestone exposure in the study area

As observed in the field the limestone exposure has a slightly too recently weathered appearance. as Fig 30 shows the area has lost its natural slope as a result of rock extraction, and a shift in landscape has been noted. The joint openings are filled with silt to clay material, and the joint spacing is about 3 to 26 cm. Rock block failures have occurred as a result of slopes cut at steep angles ($> 70^{\circ}$). At the bottom of the rock slopes, rock blocks of various sizes are accumulating.
