**ADDIS ABABA UNIVERSITY
SCHOOL OF GRADUATE STUDIES
ADDIS ABABA INSTITUTE OF TECHNOLOGY
SCHOOL OF CIVIL AND ENVIRONMENTAL ENGINEERING
CONSTRUCTION TECHNOLOGY AND MANAGEMENT STREAM**

**DEVELOPMENT OF MAINTENANCE
PRIORITIZATION GUIDELINE FOR HISTORICAL
PUBLIC INSTITUTION BUILDINGS IN ADDIS ABABA**

**A Thesis submitted to School of Graduate Studies of Addis Ababa University
in partial fulfillment of the requirements of the Degree of Master of Science
in Civil Engineering (Construction Technology and Management)**

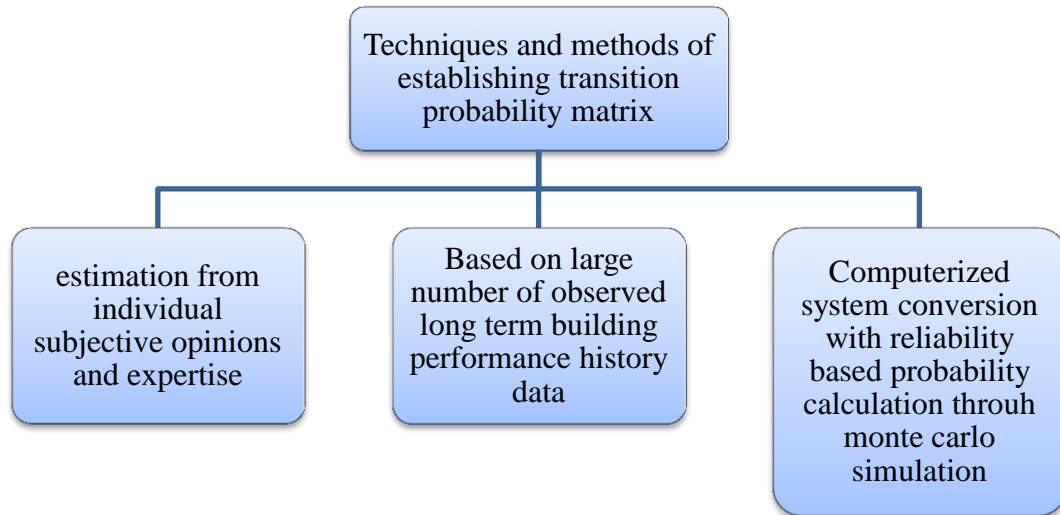
There are different methods of determining the probability of transition to the next poorest condition of a building component. The transition probability due to natural environmental factors can be estimated based on various procedures as discussed in the literature review part. Figure 3.2 presents methods to establish deterioration probability matrix.

Figure 3.2: Techniques and methods of establishing transition probability matrix (Mohseni, 2012)

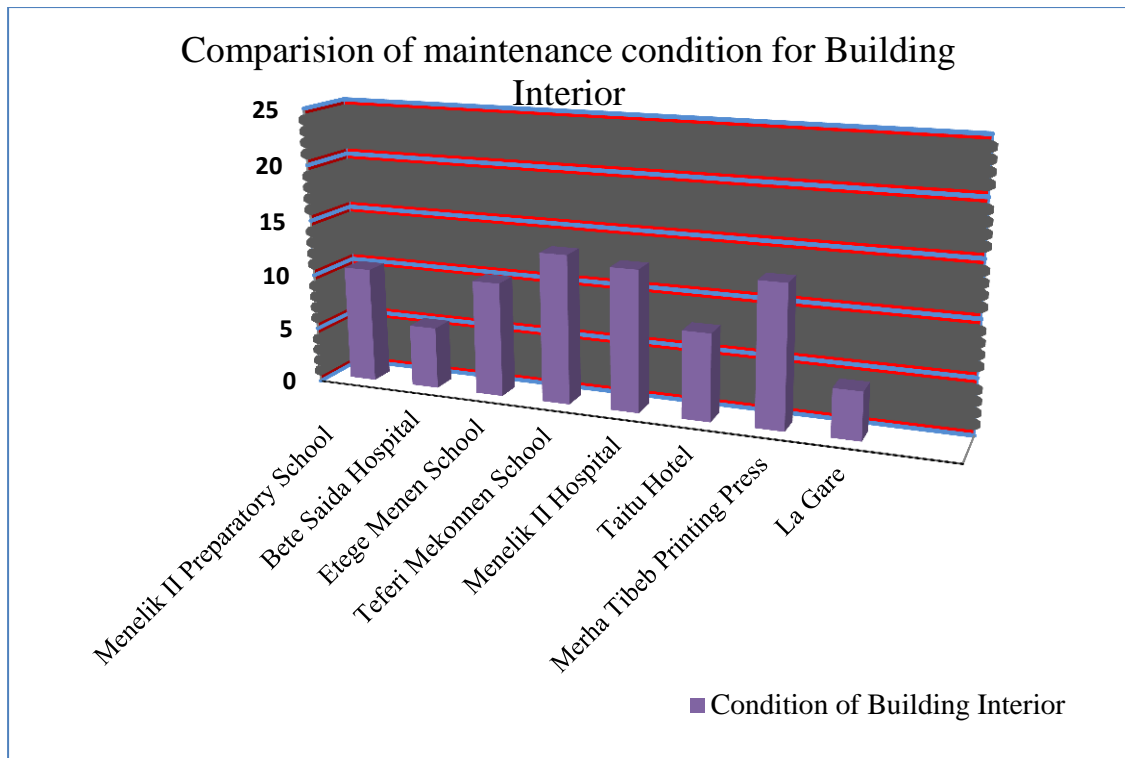
S/n	Name of Heritage Building	Condition of Building Interior						
		Condition Matrix			Interior Condition summary			
		Internal Wall	Floor	Ceiling	Defect No.	condition matrix	Score	Condition
1	Menelik II Preparatory School	14.95	54.61	34.57	10.00	104.12	10.41	Moderate
2	Bete Saida Hospital	5.71	16.14	6.07	5.00	27.93	5.59	Good
3	3. Etege Menen School	15.83	10.80	25.00	5.00	51.64	10.33	Moderate
4	Tafari Mekonnen School	-	56.67	23.93	6.00	80.60	13.43	Moderate
5	Menelik II Hospital	5.71	12.50	32.69	4.00	50.91	12.73	Moderate
6	Taitu Hotel	14.95	34.71	20.88	9.00	70.53	7.84	Good
7	Merha Tibebe Printing Press	30.26	28.50	30.71	7.00	89.47	12.78	Moderate
8	La Gare	4.00	8.93	0.00	3.00	12.93	4.31	Excellent

Figure 4-17: Interior condition for buildings under the study

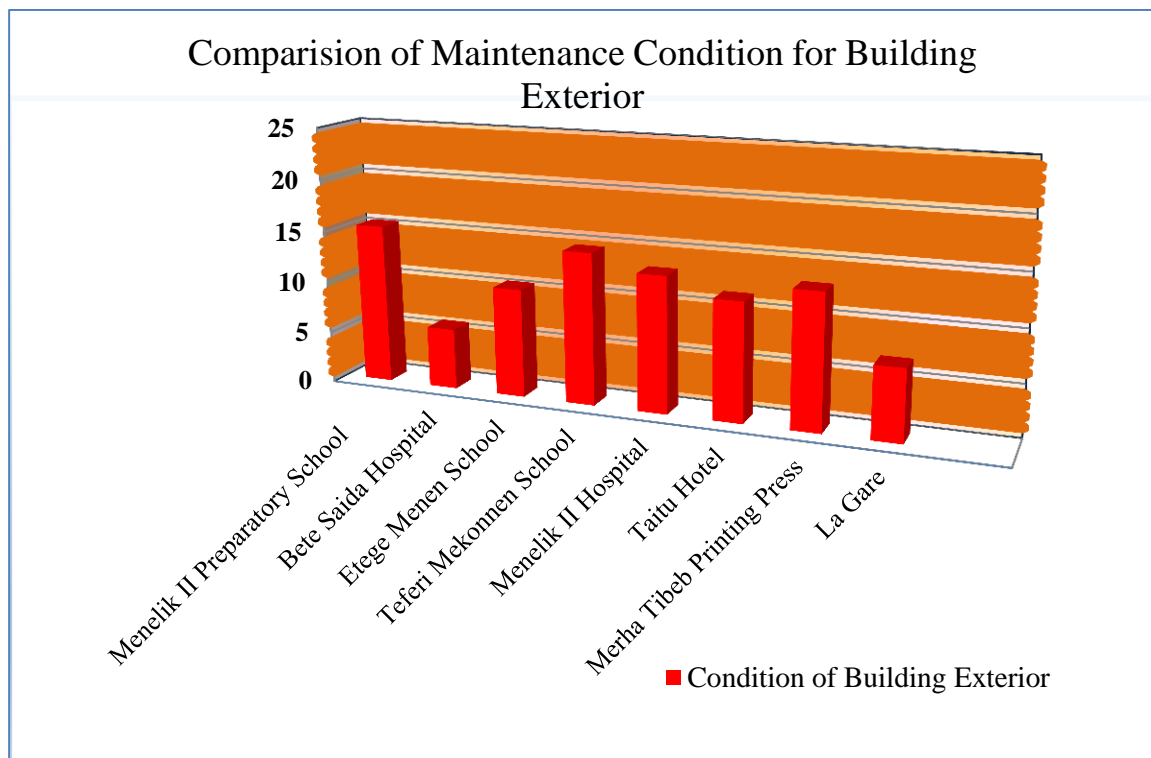
S/n	Name of Heritage Building	Condition of Building Exterior									
		Condition Matrix						Exterior Condition summary			
		External Wall	Doors	Windows	Roof	Balcony/porches	External stair	Defect No.	condition matrix	Score	Condition
1	Menelik II Preparatory School	63.78	86.36	80.68	13.3	7.69	25.87	18.00	277.72	15.43	Poor
2.	Bete Saida Hospital	13.23	6.43	0.00	9.2	0.00	24.00	9.00	52.89	5.88	Good
3	Etege Menen School	25.37	24.61	37.94	18.2	9.23	0.00	11.00	115.34	10.49	moderate
4	Teferi Mekonnen School	48.57	37.14	52.86	43.8	7.50	0.00	13.00	189.88	14.61	Moderate
5	Menelik II Hospital	48.09	43.18	55.68	31.5	0.00	18.21	15.00	196.72	13.11	Moderate
6	Taitu Hotel	14.95	27.41	18.46	0.00	42.08	0.00	9.00	102.90	11.43	Moderate
7	Merha Tibebe Printing Press	26.56	35.06	55.68	21.7	0.00	43.00	14.00	182.04	13.00	Moderate
8	La Gare	15.28	0.00	24.61	5.7	9.71	0.00	8.00	55.32	6.92	Good

Figure 4.18: Exterior conditions for selected historic buildings

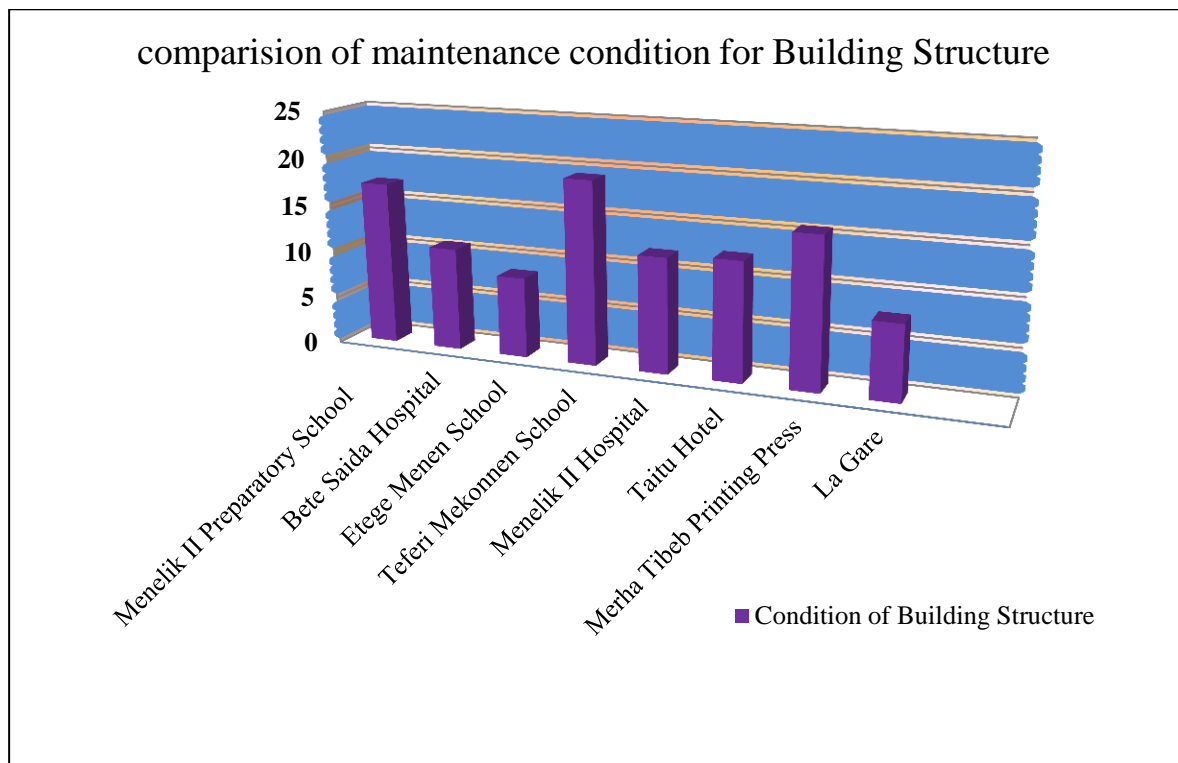
S/n	Name of Heritage Building	Condition of Building Structure					
		Condition Matrix		Exterior Condition summary			
		Roof structural Element	Foundation and Structural Wall	Defect No.	condition matrix	Score	Condition
1	Menelik II Preparatory School	13.3	38.3	3.0	51.7	17.2	Poor
2	Bete Saida Hospital	-	21.7	2.0	21.7	10.9	Moderate
3	Etege Menen School	21.73	20.7	5.0	42.4	8.5	Good
4	Teferi Mekonnen School	-	38.6	2.0	38.6	19.3	Poor
5	Menelik II Hospital	19.7	40.756	5.0	60.5	12.1	Moderate
6	Taitu Hotel	27.4	22.6	4.0	50.0	12.5	Moderate
7	Merha Tibeb Printing Press	-	31.5	2.0	31.5	15.8	Poor
8.	La Gare	12.5	19.1	4.0	31.6	7.9	Good

Figure 4.19: Condition of building structure for historical buildings

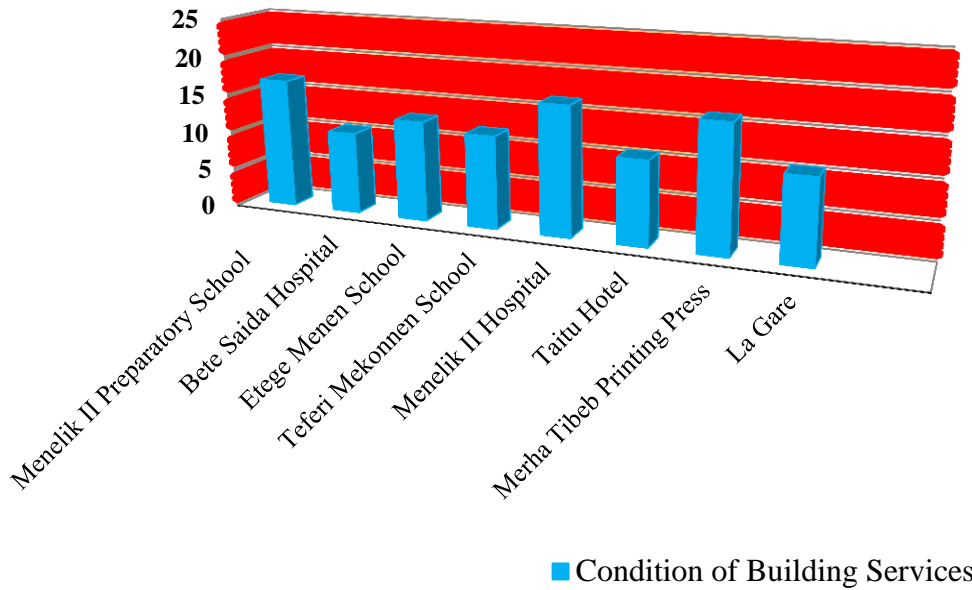
Figure 4.20: Condition of building services

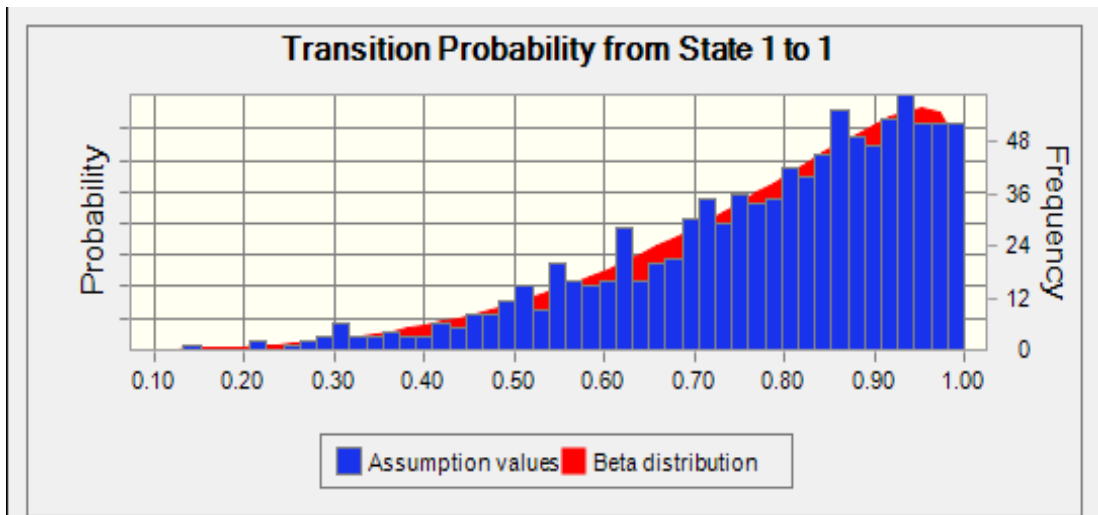
From crystal ball-Monte Carlo simulation, the probability of a state to stay in its condition is estimated from forecast charts generated for each state under ‘do-nothing’ and ‘preventive maintenance’ alternatives by assigning most likely values from the researcher’s personal judgment. Table 5.10 and table 5.11 summarized the transition probability matrix for ‘preventive maintenance’ and ‘do-nothing’ actions respectively.

Figure 5.1: Transition probability from state 1 to state 1 under preventive maintenance

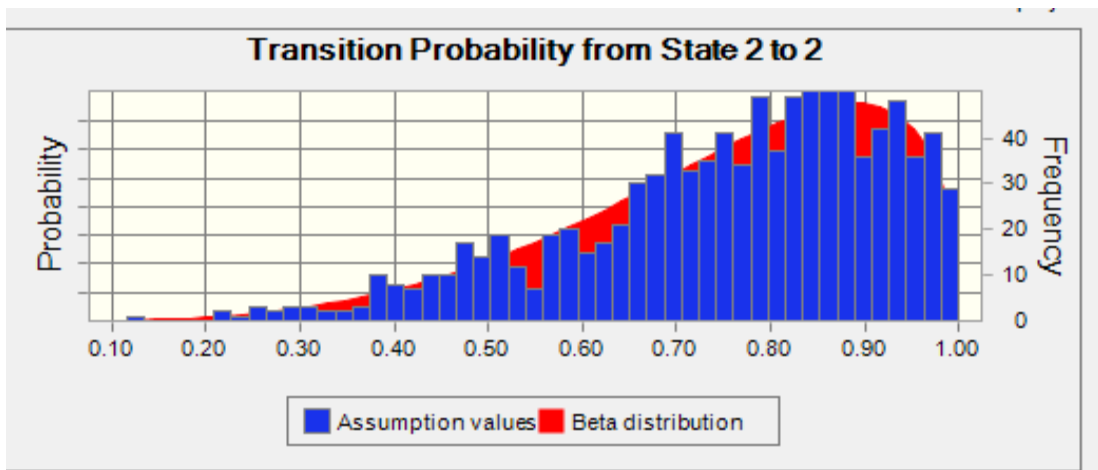
Figure 5.2: Transition probability from State 2 to state 2 under preventive maintenance

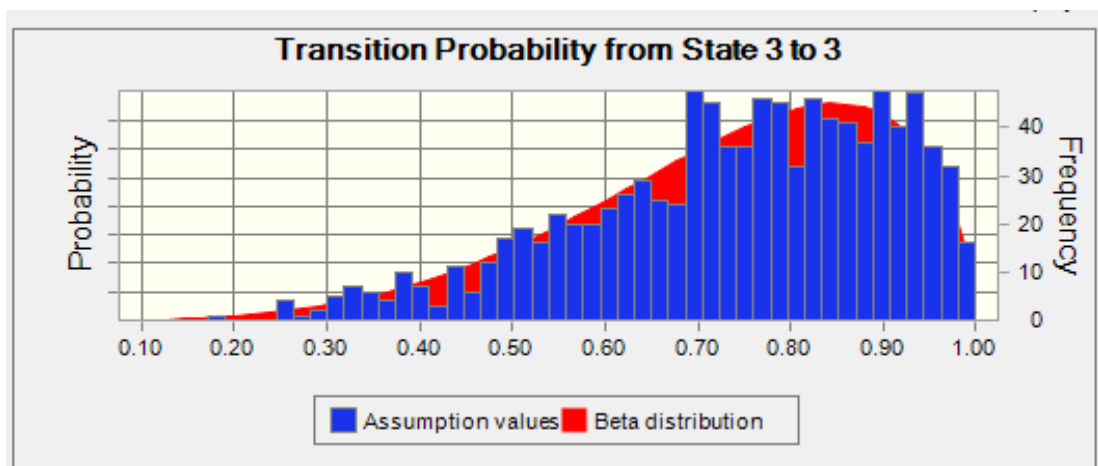
Figure 5.3: Transition probability from state 3 to state 3 under preventive maintenance

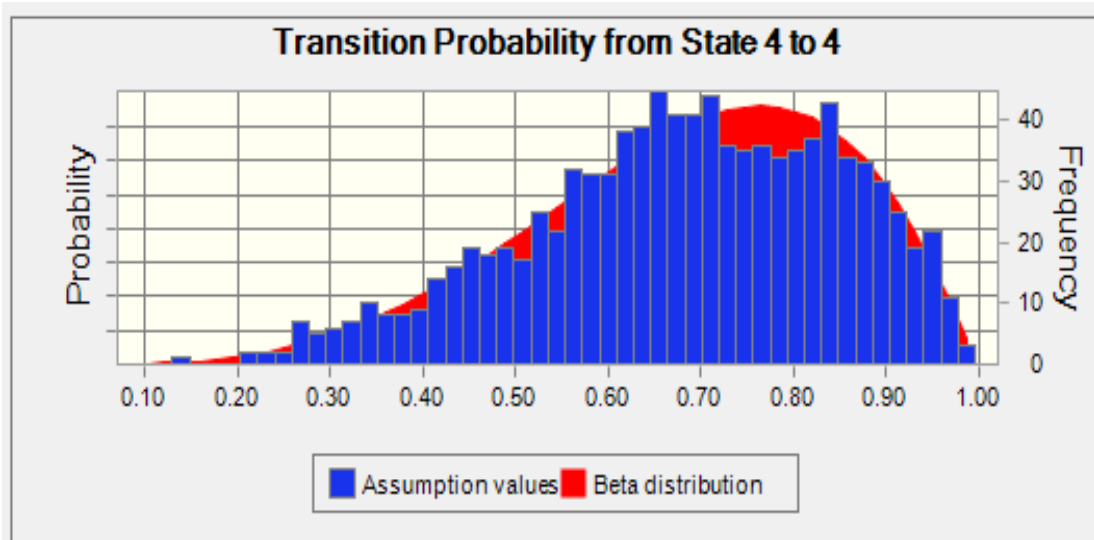
Figure 5.4: Transition probability from Sate 4 to state 4 under preventive maintenance

P_{ij} (preventive maintenance)	State	1	2	3	4	5
	1	0.92.	0.08	0	0	0
	2	0	0.88	0.12	0	0
	3	0	0	0.85	0.15	0
	4	0	0	0	0.78	0.22
	5	0	0	0	0	1

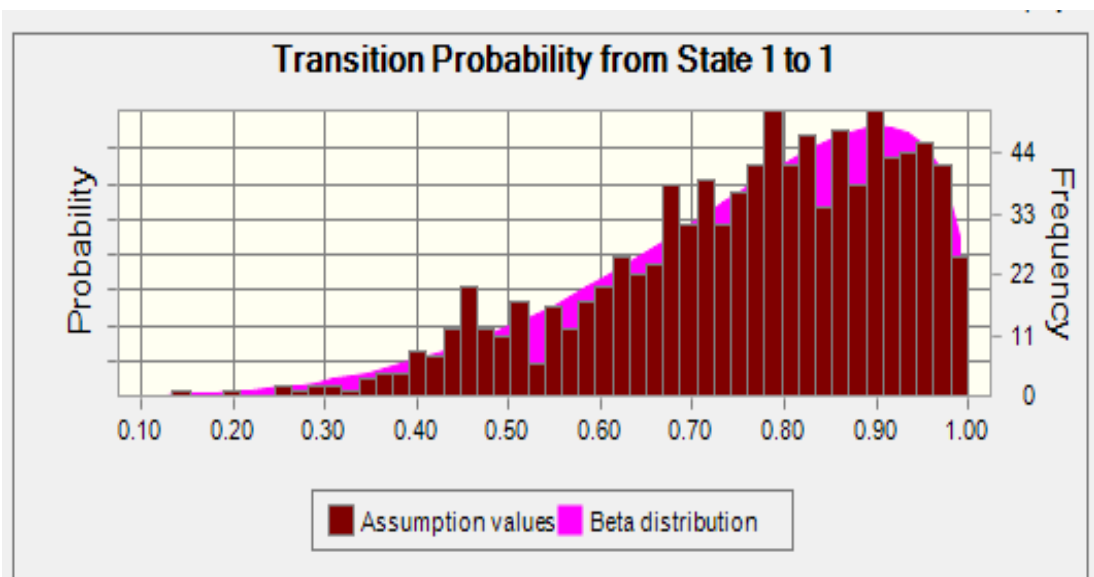
Figure 5.5: Transition probability from sate 1 to state 1 under Do-Nothing

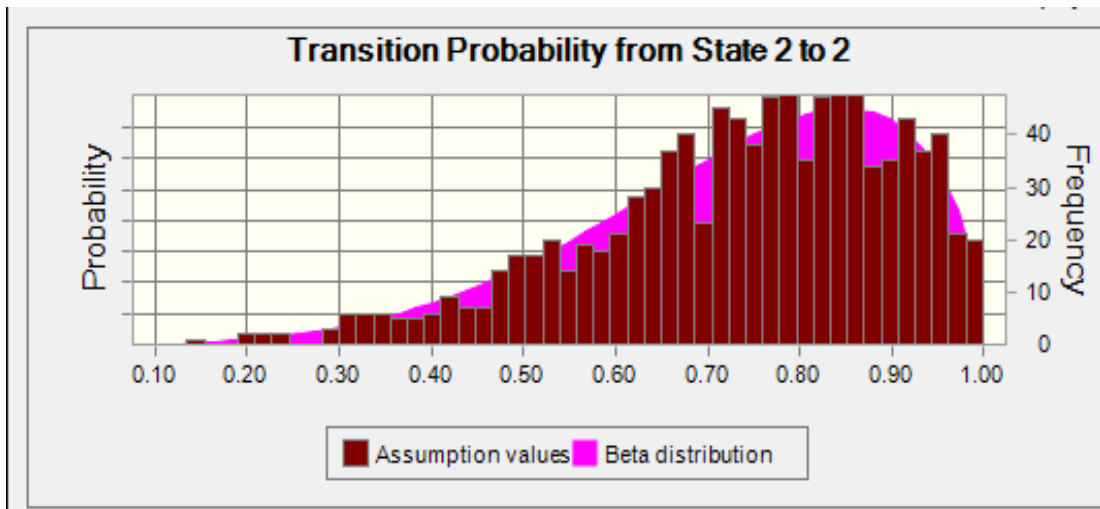
Figure 5.6: Transition probability from state 2 to state 2 under Do-Nothing

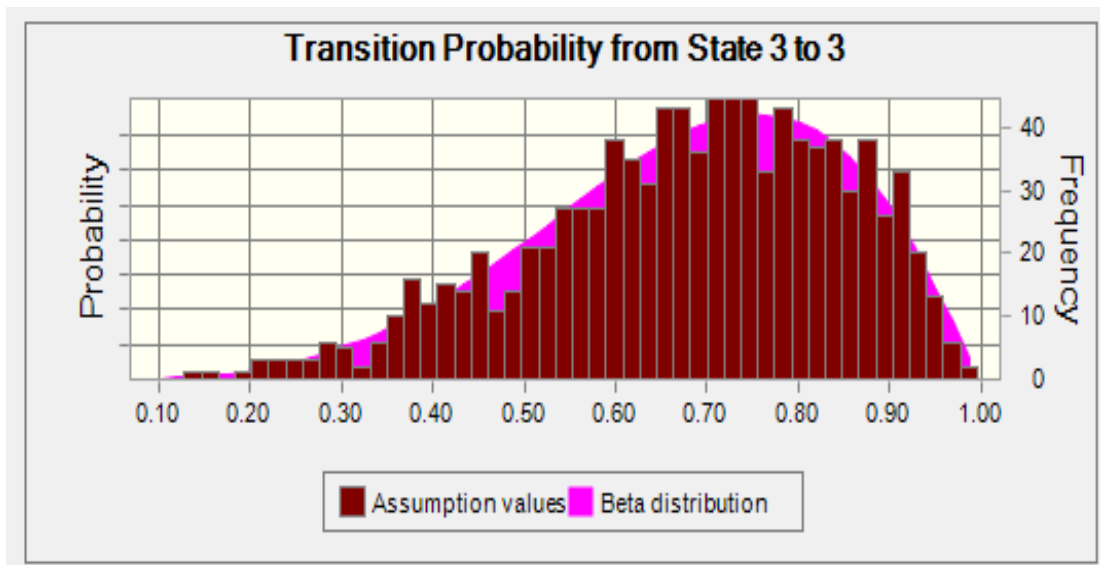
Figure 5.7: Transition probability from state 3 to state 3 under Do-Nothing

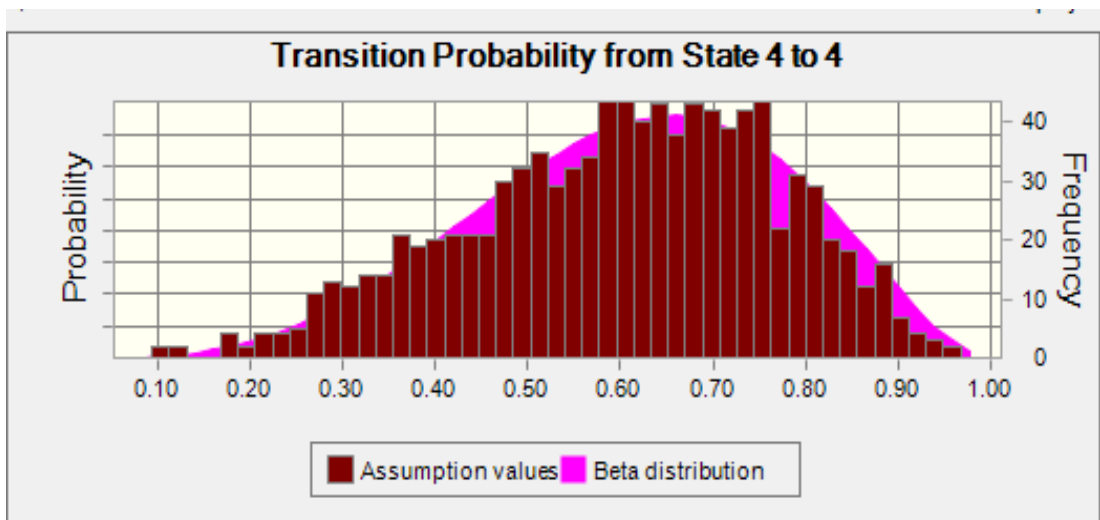
Figure 5.8: Transition probability from state 4 to state 4 under Do-Nothing
