ADDIS ABABA UNIVERSITY
ADDIS ABABA INSTITUTE OF TECHNOLOGY
SCHOOL OF CIVIL AND ENVIRONMENTAL
ENGINEERING

**The Role of Bond in Shear Transfer of Shear
Critical Reinforced Concrete Slender Beams**

A Thesis in structural engineering

By Weyneshet Getachew

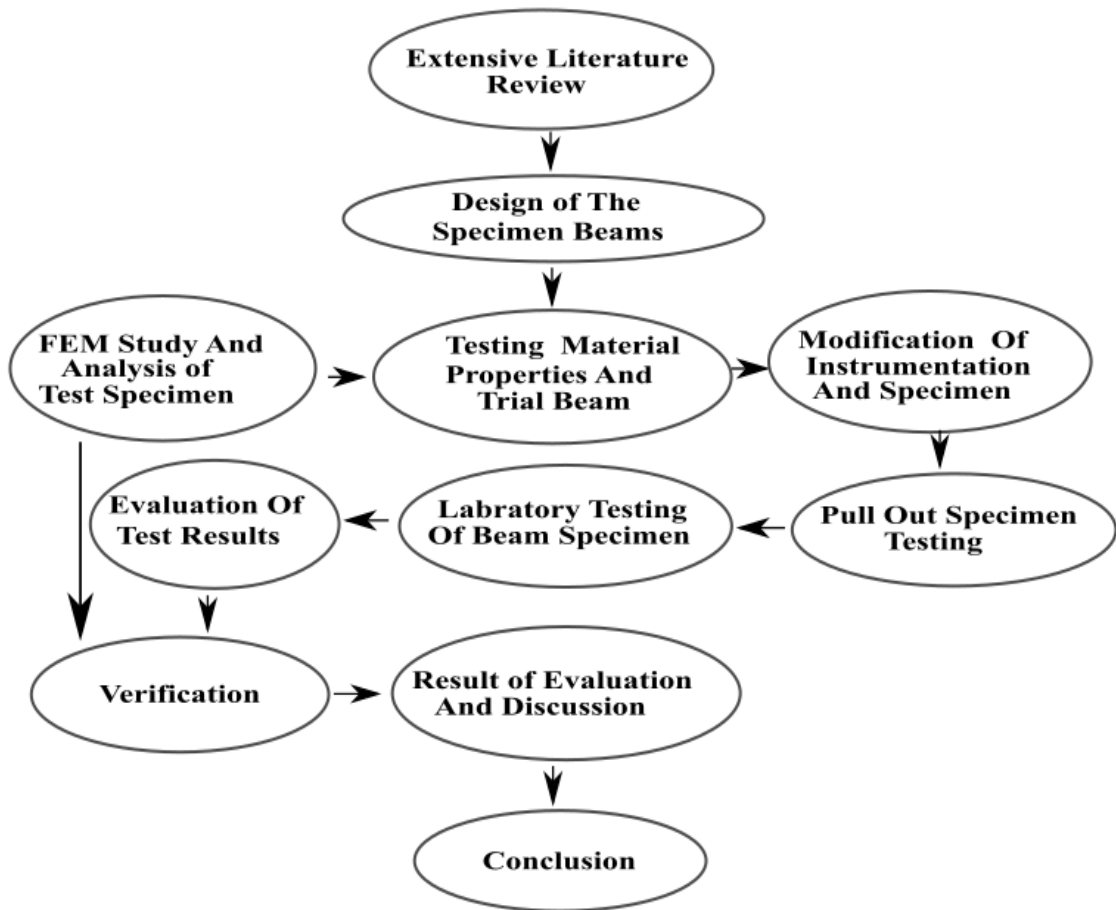
Figure 1-1 A flow chart of the methodology

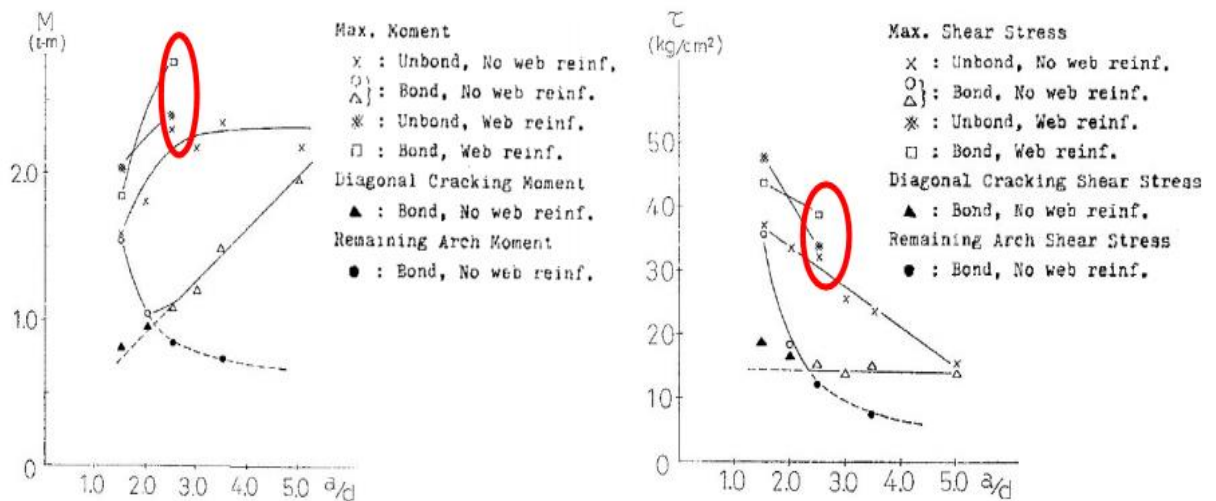
Figure 2-9 Moment and shear stress to shear span ratio relationships for Ikeda's test (Masukawa, 2012)

The next evolution came in 1980, when Ikeda experimented on 16 simply-supported beams (10cm x 20cm) with or without stirrups, changing the shear-span-to-depth ratio (a/d) from 1.5 to 5.0. The researcher eliminated bond for half of the specimen along the whole span between supports by covering the valleys between reinforcement ribs with wax, winding vinyl tape on them and coating the surface with grease before casting the concrete. Three D13 (1.267 cm²) bars were used for longitudinal reinforcement ($\rho = 2.1\%$) and plain 6 mm (0.3167 cm²) bars for web reinforcement.(Masukawa, 2012)

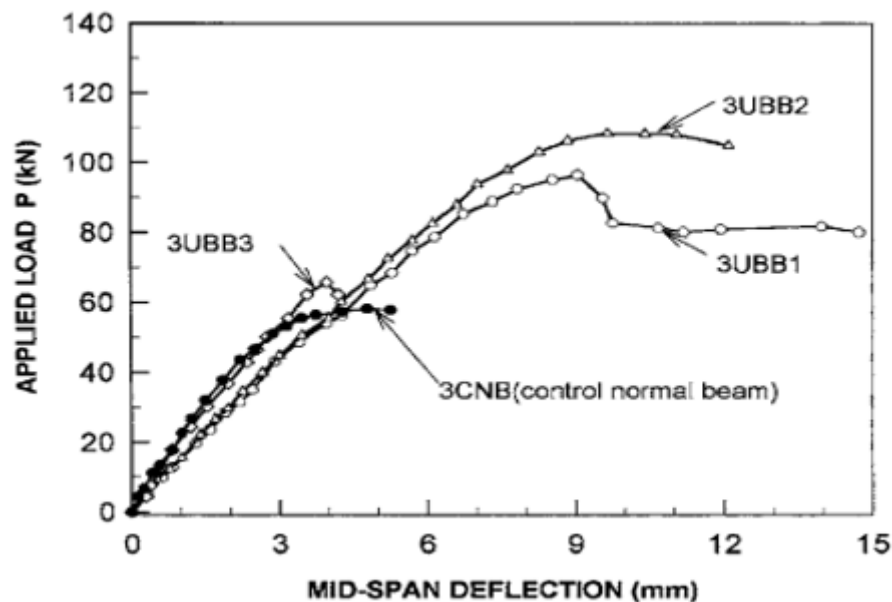
Figure 2-19 Load vs deflection of the UBB series(Kim & White, 1999)

Specimen	Concert strength (MPa)	Ultimate load (kN)	Flexural strength M_u/M_n
3CNB	30.1	58.7	0.54
4CNB	30.1	60.5	0.75
3UBB1	27.1	96.5	0.94
3UBB2	33.6	110.3	1.04
3UBB3	30.1	64.9	0.62
4UBB1	28.4	76.1	0.98

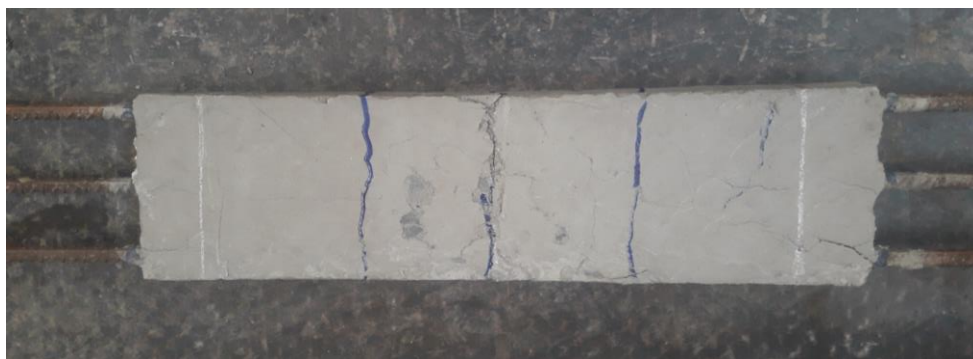
Figure 3-21 Cracks formed after trial damaged concrete section loading

The crack spacing for the beam with dimensions 25cm x 30cm and with the specifics of the specimens were found to be 138mm. The formation of crack at the position of the slits was made sure by loading trial damaged concrete sections. As it could be seen from figure 3-21 the cracks formed at locations the slits were placed after loading of the damaged concrete section.

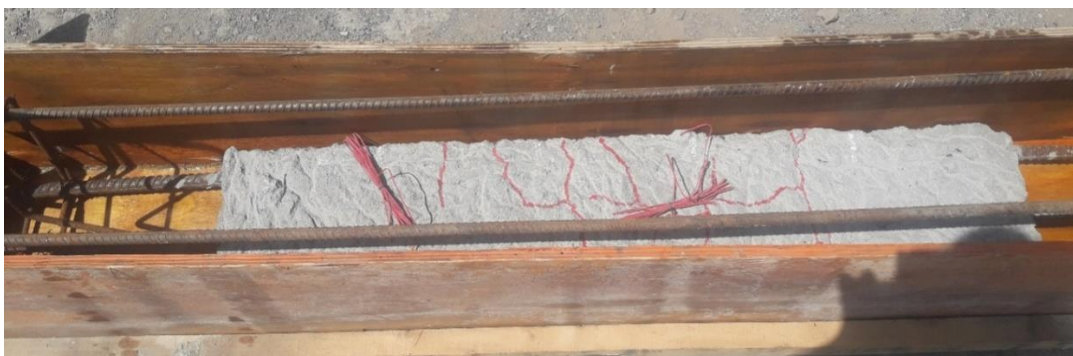
Figure 3-37 Placing of the damaged concrete section inside the trial beam formwork

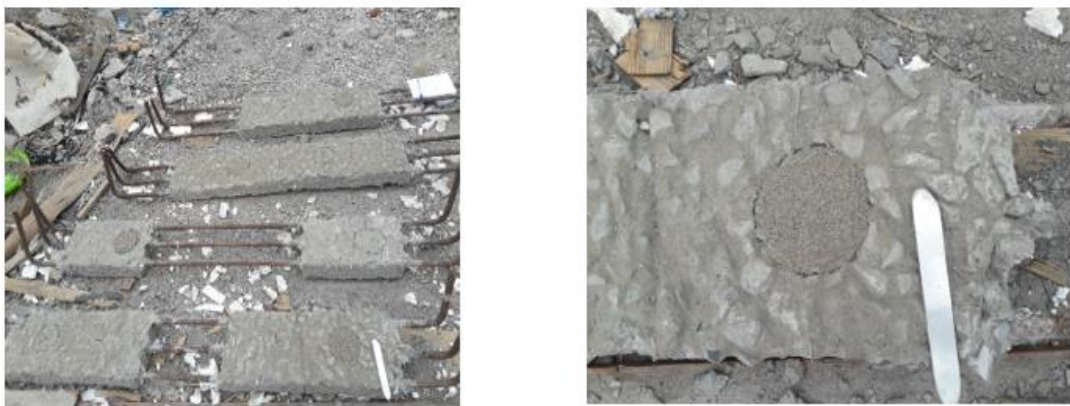
Figure 3-47 Patch selection of the sand patch test in damaged bond concrete sections

Surface Condition	Roughness Parameter (r)
Not Measurable(Very Smooth)	-
Smooth	<1.5mm
Rough	≥1.5mm
Very Rough	>3mm

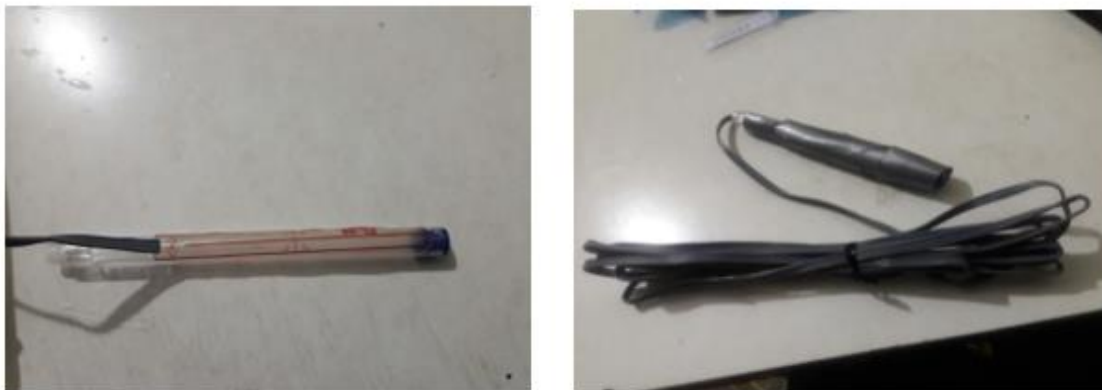
Figure 3-49 Fashioning of the mold strain gage

In this study, a similar device was created by attaching a concrete surface strain gage on a piece of mica and winding this prototype with water-proof tape to prevent damage and add water resistance. Another option was to use aluminum instead of mica, but this was ruled out due to noise in the measurement. To test the accuracy of the fabricated strain mold gauge, it was placed vertically in a cylindrical mold with diameter 10cm & height 20cm along the height at the center of the section. The cylinder specimen was casted, and after 3 days, the compressive strength of the specimen was tested while the strain gage reading was monitored.

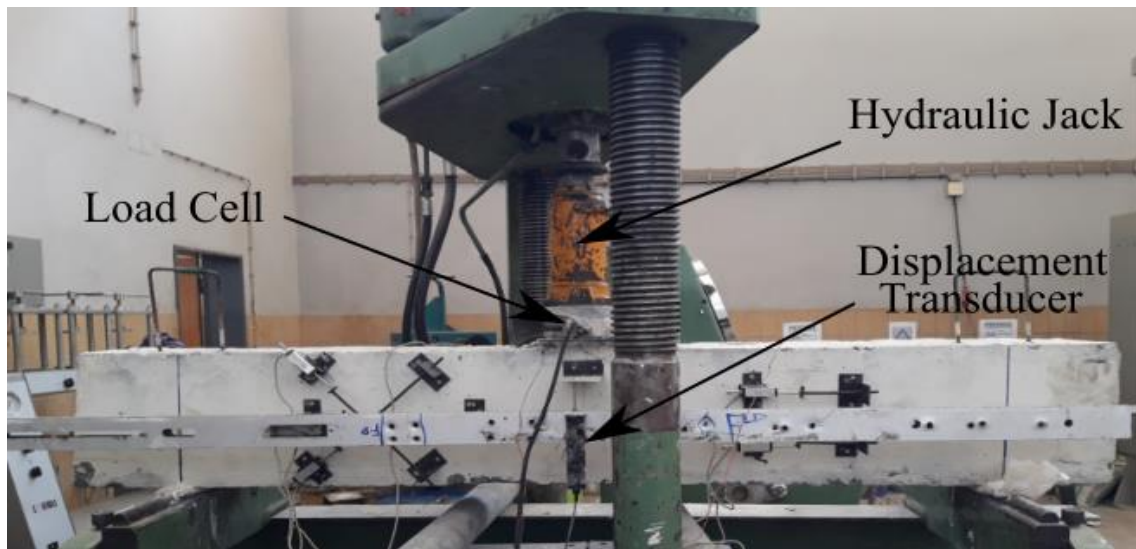
Figure 3-54 Test set up of the tests

The beams were placed on two steel rollers and one-point monotonic loading was applied to the center of the beam until failure. A hydraulic jack, a displacement transducer and a surface measurement were all part of the test setup. A 1.5m shear span was used. To distribute the load and avoid local concrete crushing, a thick metal plate with a width of 13 cm was placed beneath the load cell.

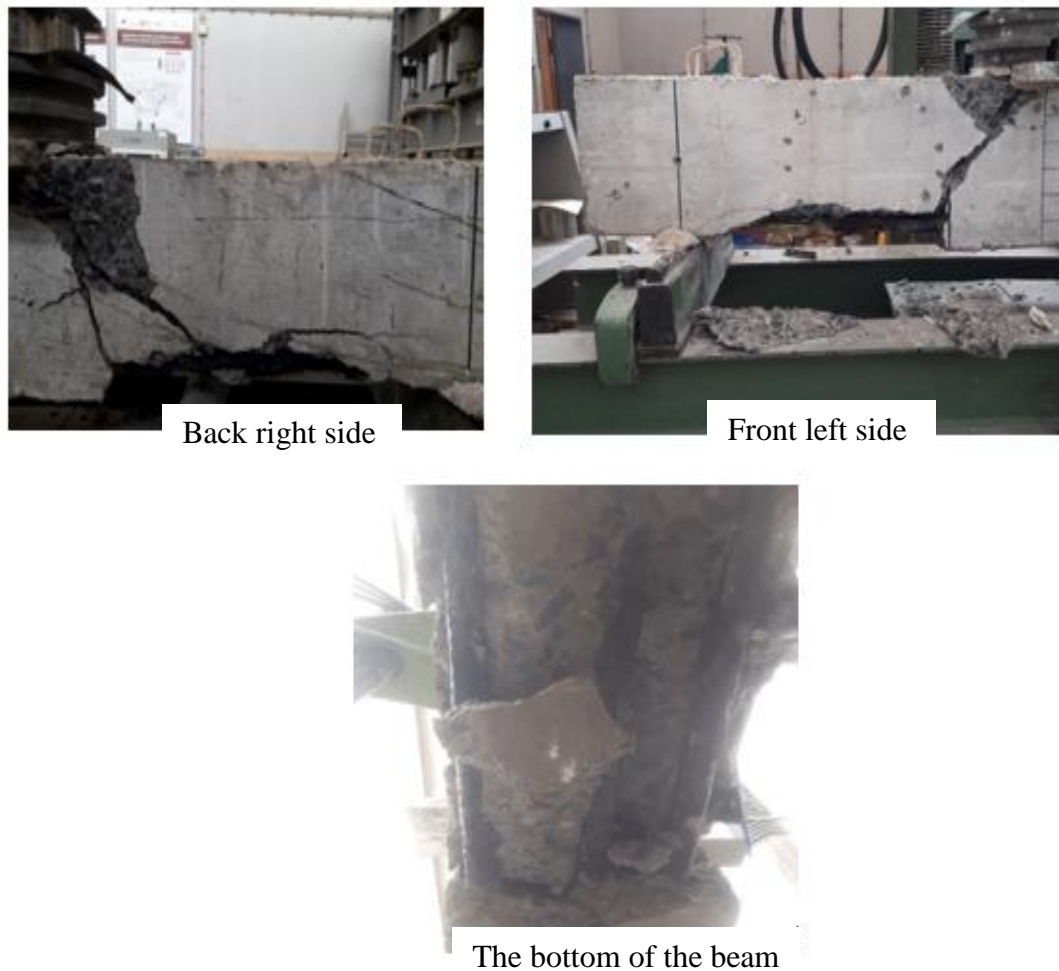
Figure 5-12 Close up on the cracks of beam 75BB2

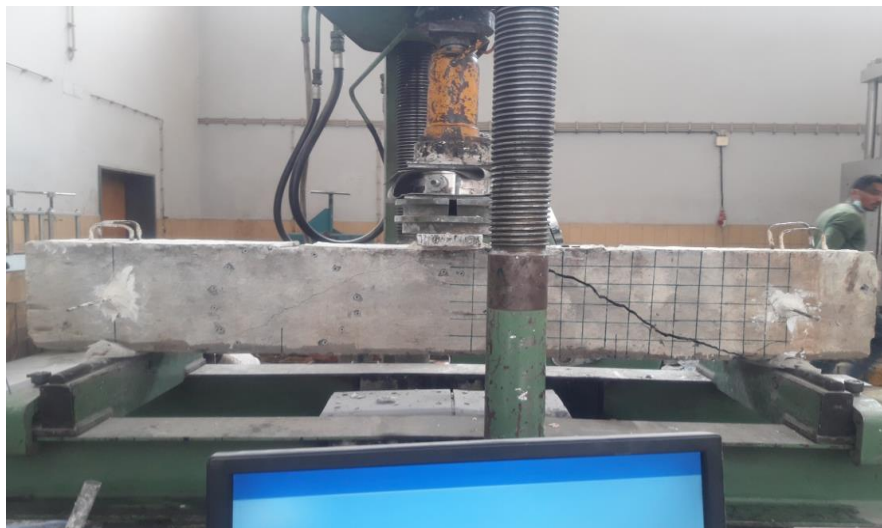
Figure 5-14 The beam 50DCB1 after failure

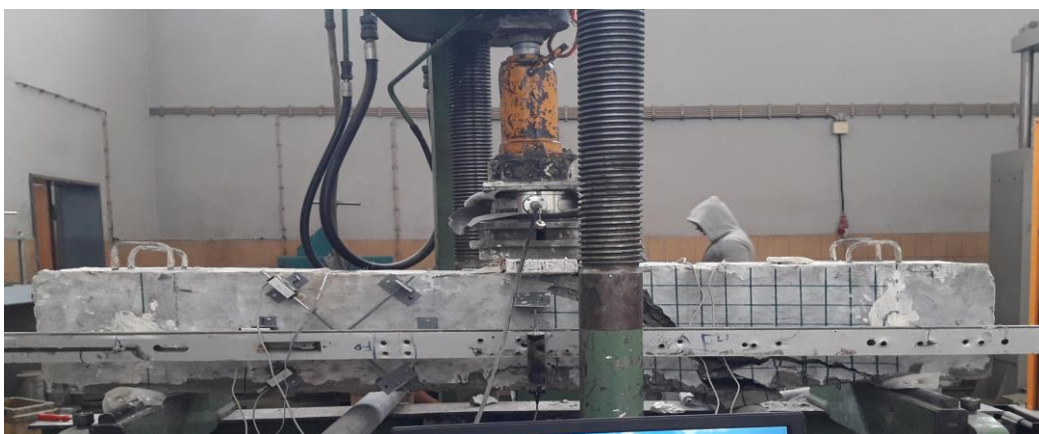
Figure 5-21 The beam 75DCB1 after failure

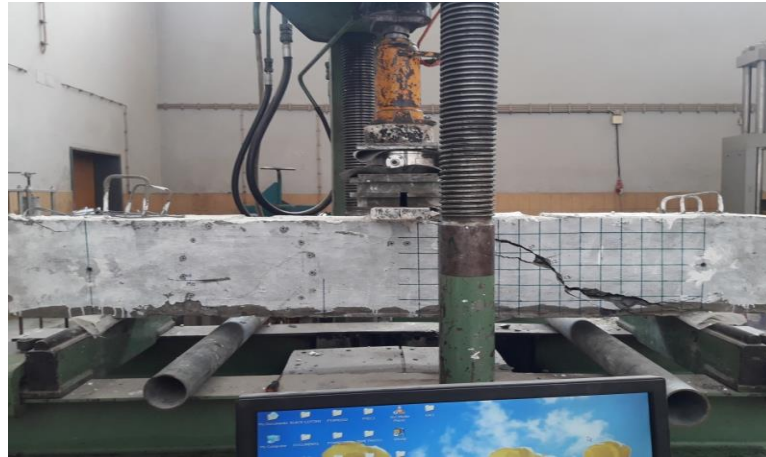
Figure 5-25 The beam 75DCB2 after failure

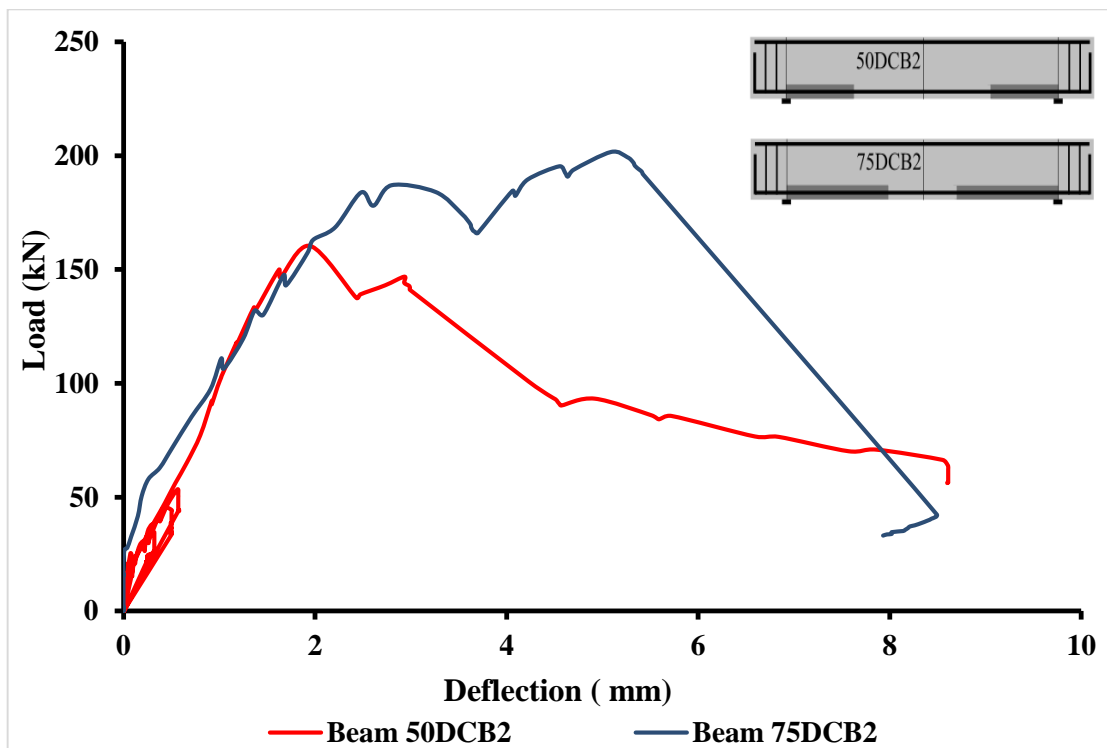
Figure 5-52 The load vs deflection of beams 50DCB2 and 75DCB2

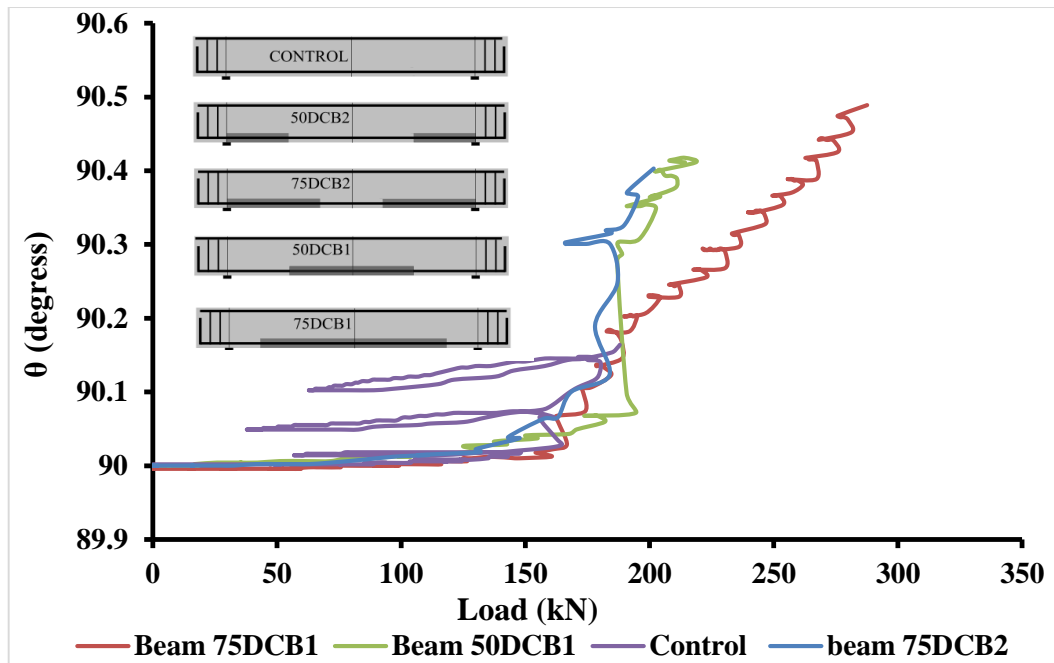
Figure 5-55 Angle θ for the DCB series
