# **Evaluation of Selected Addis Ababa Buildings with respect to the Green Building Features**

M.Sc. Thesis in Environmental Planning and Landscape Design

Ethiopian Institute of Architecture, Building Construction and  
City Development, EiABC, Addis Ababa University

June, 2015

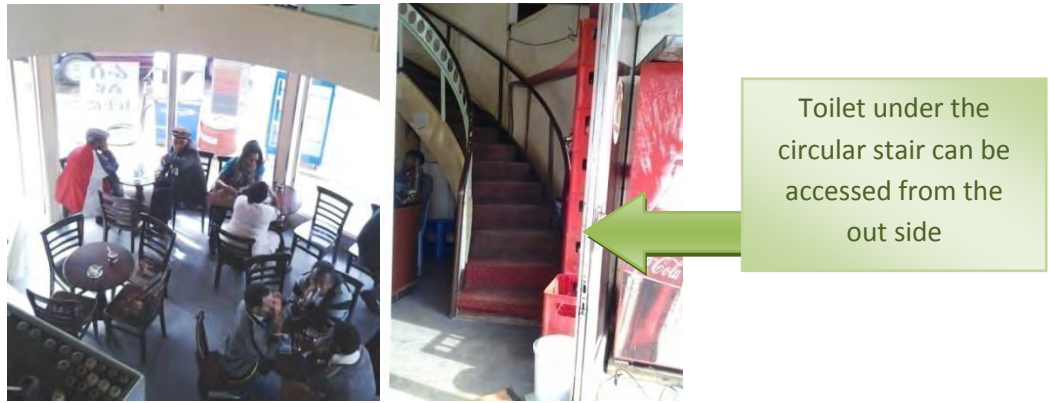
It was observed that the afternoon sun (harsh sun) enters the building through the rear side making that area a bit hot. Due to its huge round concrete roof the building is under its own shadow for the most part of the day except on late afternoons as stated repeatedly in the above paragraphs. The shadows of the building and harsh sun that mostly gets the rear of the building have their own impacts on the indoor environment. The quality of indoor environment is one of the main concerns of Green Buildings and here are the following facts that were gathered during assessment of this particular building.

Figure 3- 3 Photograph showing the afternoon sun entering through the entrance and shining on the stair and the toilet underneath.

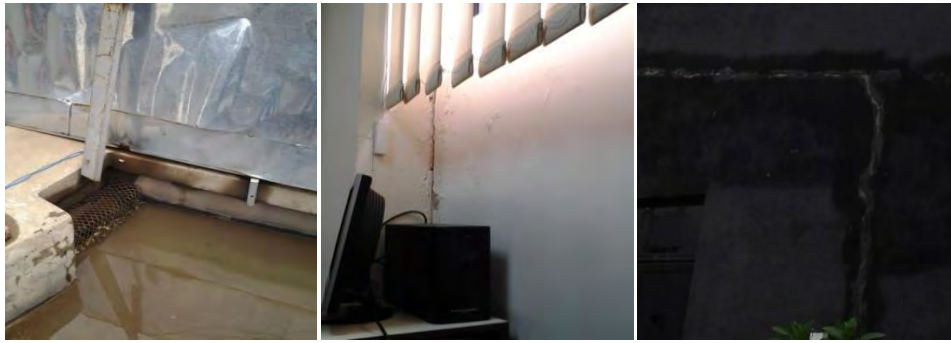
Though they were self conscious to show their toilet, they claimed to have relatively healthy and neat toilets, one for male and another for female. But one thing they wanted to reveal eagerly was fact that the accessible roof leaked causing dampness and microbial growth those occupants underneath it. They mostly occur during construction and when proper precaution is not taken to prevent leakage, the first victims are the structure itself and the occupants that may experience mild to series range of sickness.

Figure 3- 7 Leakage that has occurred on the roof and walls affect the interior equipments of the building

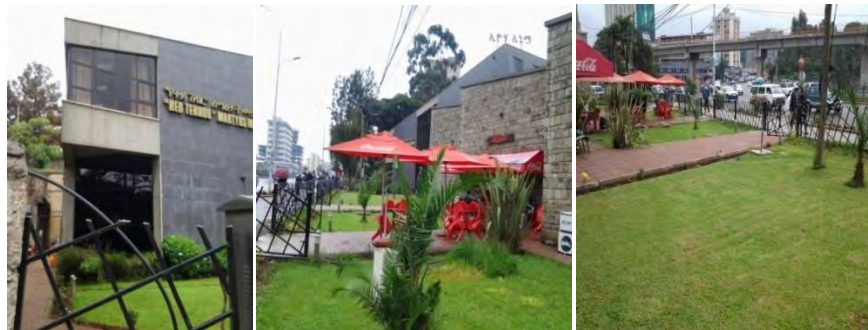
Figure 3- 8 Green infrastructure around the Museum

The building has a vast green area in front of it. This green area not only adds to its sustainability but also increases the building’s aesthetic value.

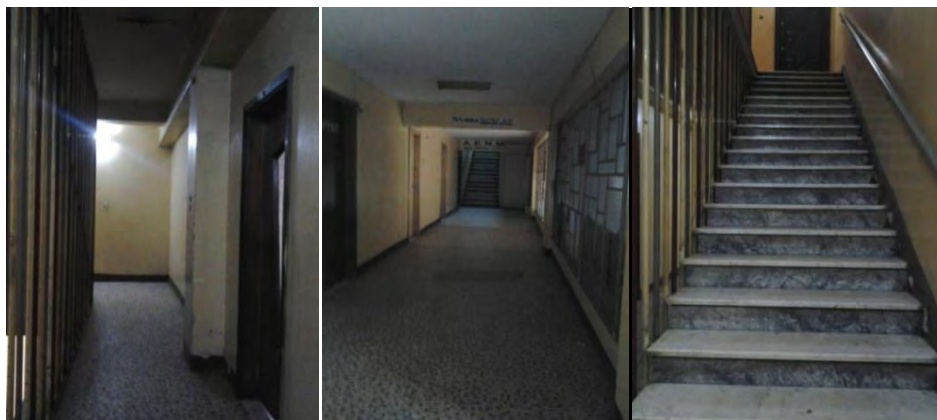
Figure 3- 12 Window and light in stairs and corridors

As stated in the section 3.3.1 the stairs and corridors of this building are ventilated and lighted mechanically.

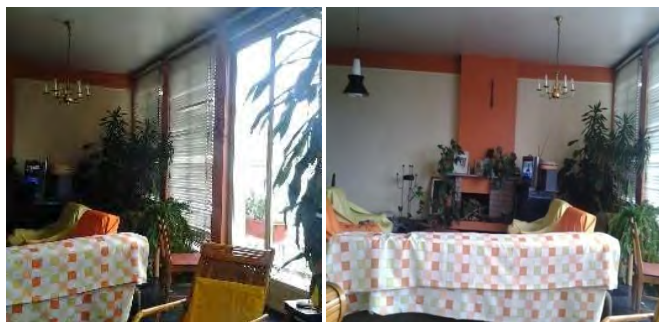
Figure 3- 13 Interior of apartments

Though the public spaces like corridors and stairs may lack natural light the most of the interior rooms of the apartments are rich in it. If we take a look for example the typical apartment

arrangement in apartment 3, here is what we will find out. But still some rooms lack windows and sun light.

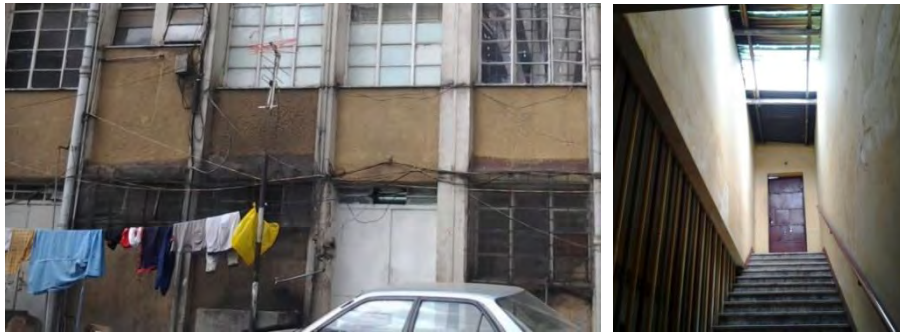
- Unattractive façade that were degraded in strength

Figure 3- 15 Unpleasant looking façade because of leakage and dampness and effects of dampness due to open roof (from left to right)

And also respondents were supportive enough to identify the causes of dampness in the building which are:

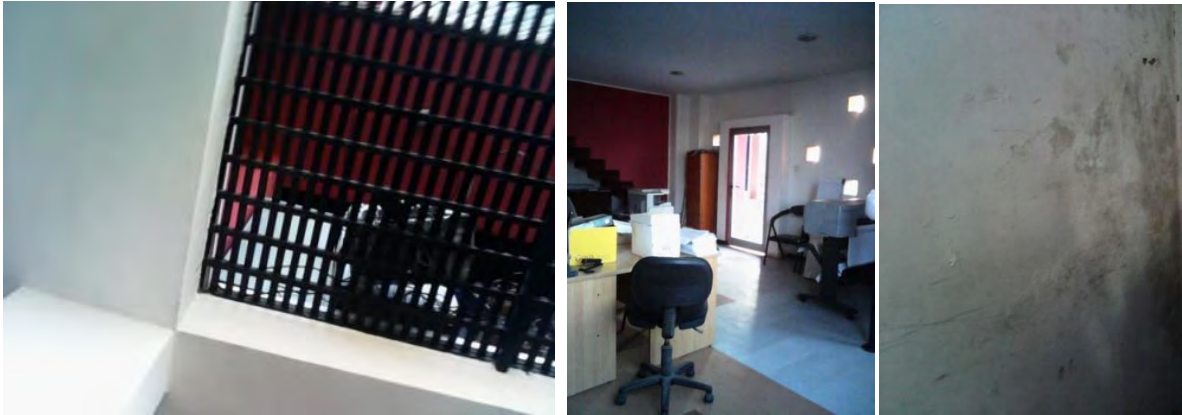
On the third floor, this temperature difference becomes visible. Due to the open up with in the third and fourth floor (done to increase interaction) has created a problem for the third floor space in trapping heat. One of the respondents Ato Kaleabe who works on the third floor has explained that during the winter times, the room gets unbearably cold.

Figure 3- 18 Interior space of the office

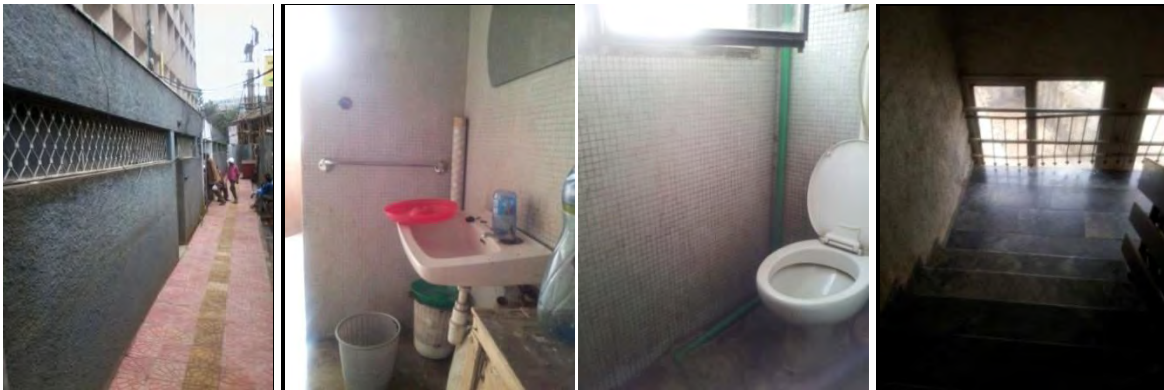
The ground floor is totally occupied by the Ethiopian Commercial Bank and its small tea room. The dark stair case and the stuffed odor from the tea room welcome one as he/she enters through the door. Then the first floor is occupied by an Architectural firm and a somewhat larger dining and cooking area for workers of the bank.

Figure 3- 20 Entrance and interior spaces of the building (sin, WC and stair case from left to right)

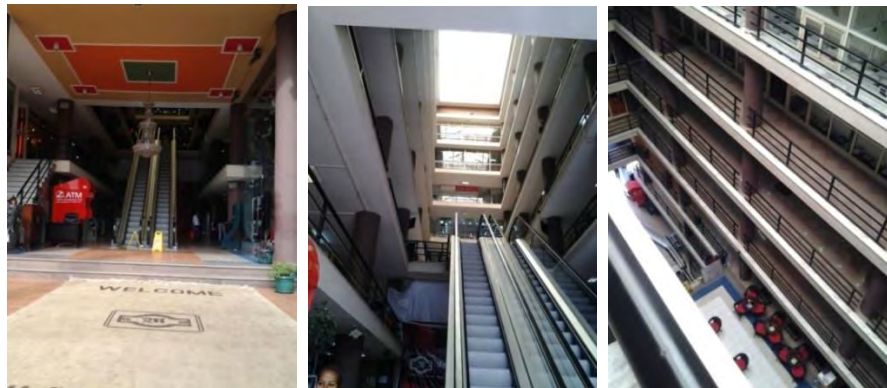
Figure 3- 22 Interior space of Mafi City Mall

With the middle part completely subtracted it is designed so that natural light diffuses all the way in. After walking in one is again mesmerized by the abundant light entering through the sky light that is all the way on the top floor showering in light to all of the lower floors.

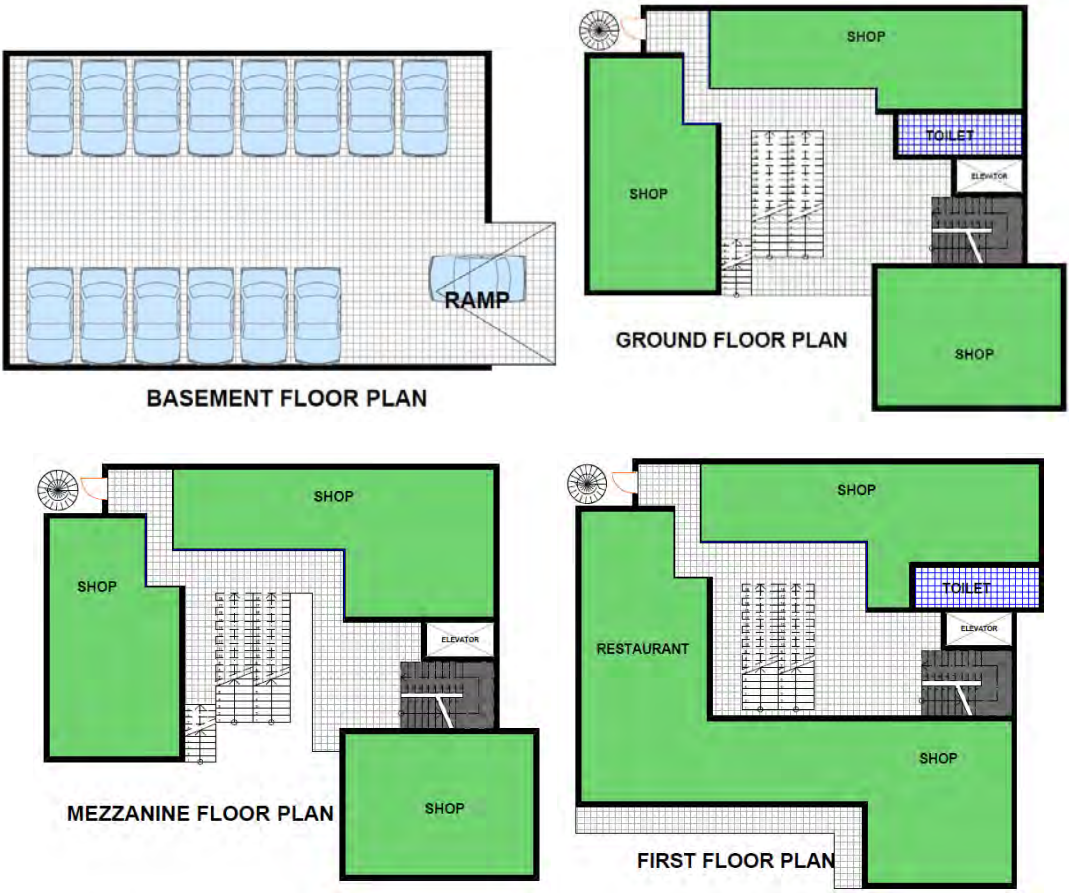
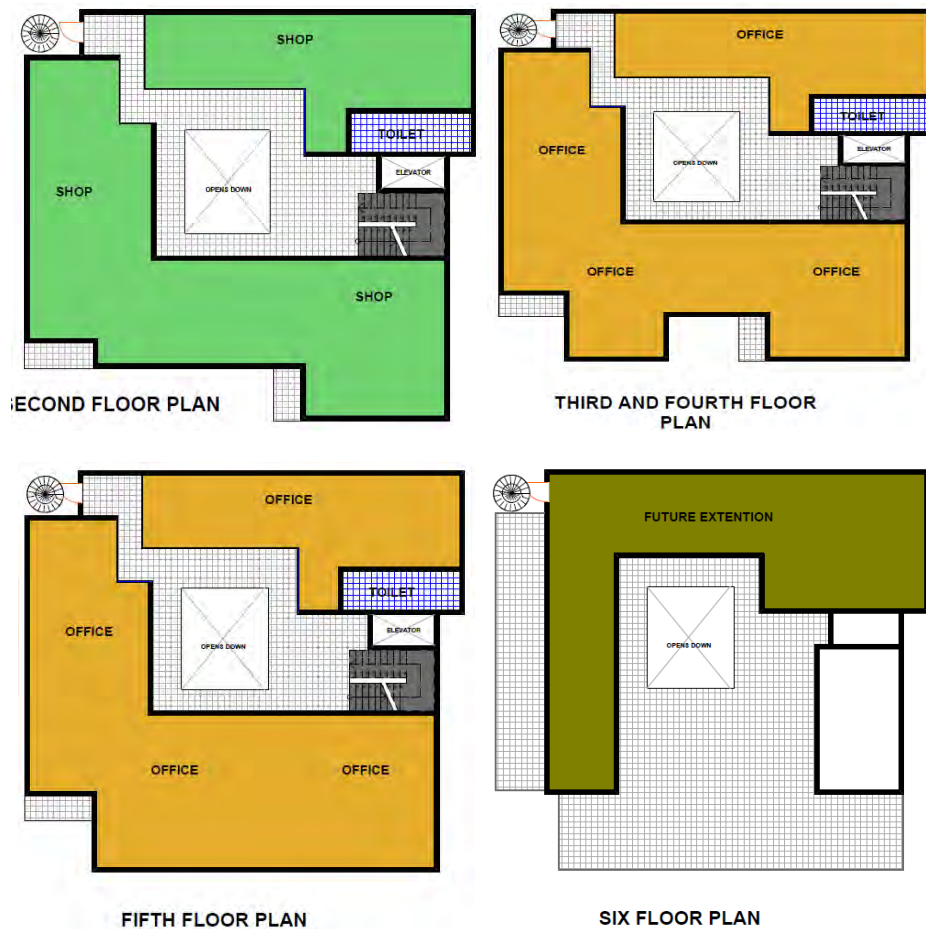
Figure 3- 23 Floor plan illustration of Mafi City Mall

Mafi City mall has two escalators that connect the ground floor to the first floor and a stair for regular circulation and a fire escape stair case in the case of emergency. Mafi has two elevators to aid in vertical circulation and also a very capable corridor for horizontal circulation. The building has a basement floor used for parking and ground floor, mezzanine floor, first floor, second floor, third floor used for shops and from fourth to six floors, it used for office purposes.

The building manager has kindly shared some vital information to aid in this research. According to him there are around 80 rented or rentable shops in the building till the third floor, and from three to four offices on each of the floors above. Each floor has four toilets for female and four toilets for male which fulfills more than the requirement.

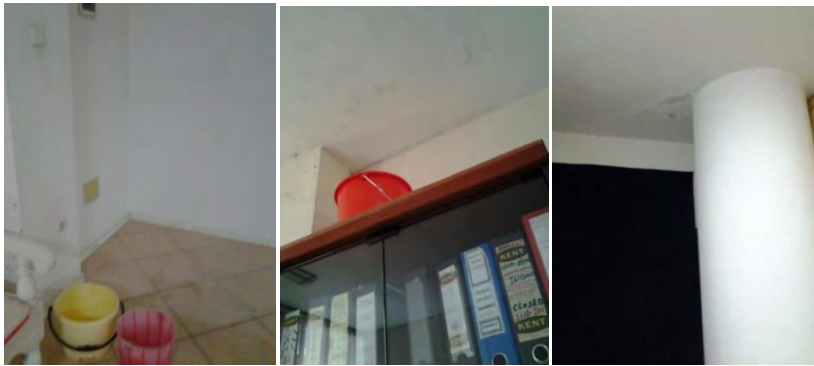
Due to the much exposed terrace on the sixth floor, leakage and seepage of water has occurred.

*Figure 3- 24 Leakage on roofs and terrace*

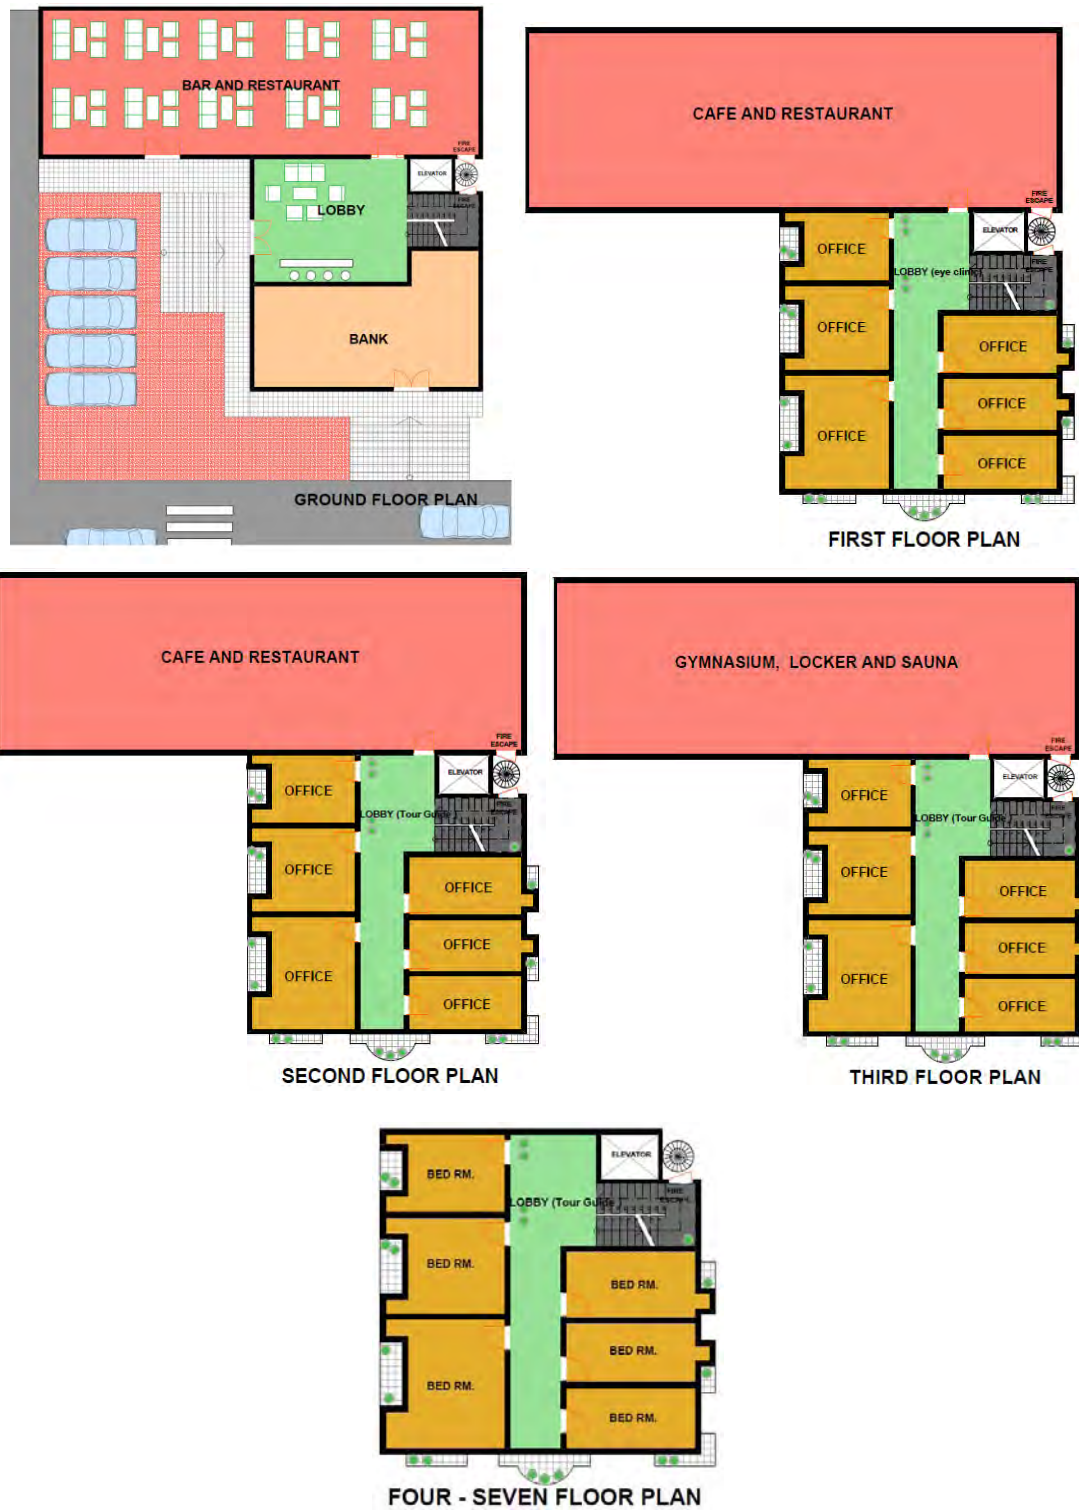
Figure 3- 27 Illustrations of floor plans of Haimi Hotel

The building has a bank and a bar and the Hotel’s lobby in between them on the ground. On the first and second floor eye clinic and tour guide is available respectively. And from the Third floor up, the building serves as very stylish and elegant Hotel. The building has one stair case and an elevator. The building also has a fire escape stair case which is a mark of good design.

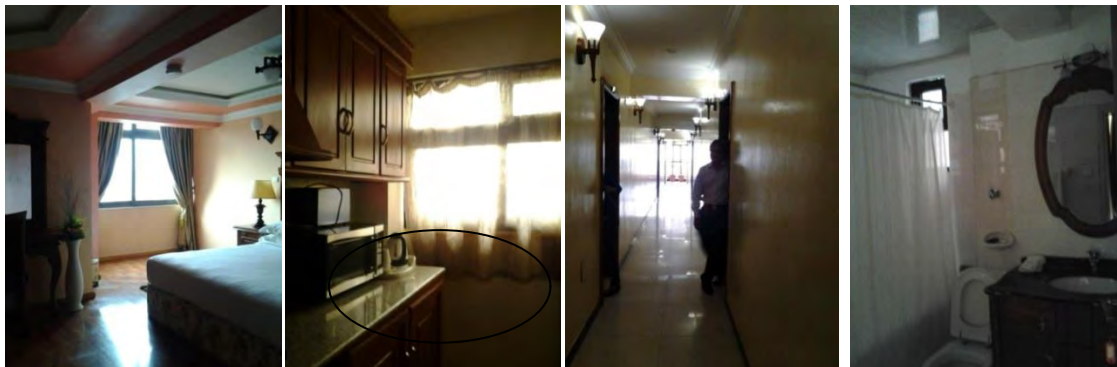
The building has enough light that enters through its medium sized windows. Though enough light enters every room, they still turn on artificial light. Below from left to right are pictures of the bed room area, the kitchen area and the collider of the building. As seen in the pictures, the building's interior is designed in away every room gets natural light. But still the use of artificial light is applied.

Figure 3- 29 Interior window location of the hotel and toilet free of microbial growth

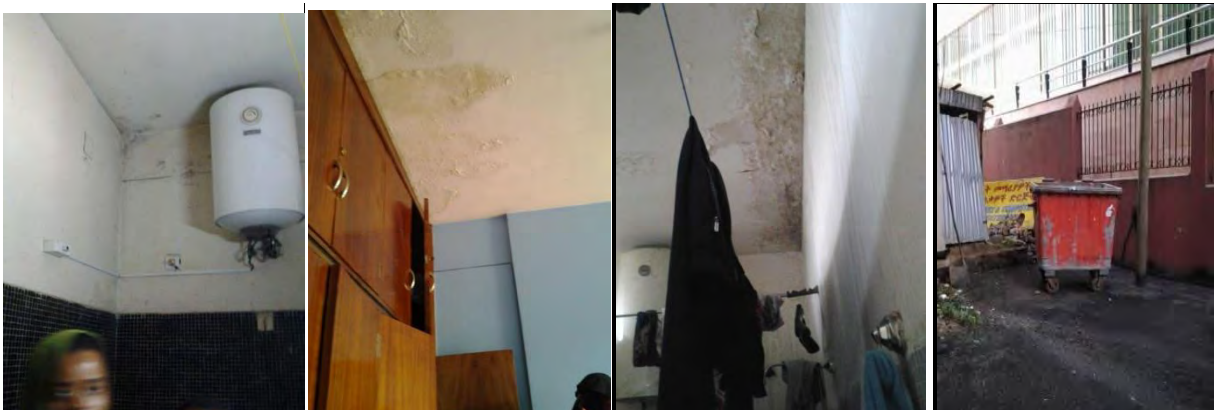
If the people in the building open their windows a stream of heated sun rays will enter their houses unblocked. Thus, they will not open the building due to this reason the inner rooms are stuffed and unventilated with unpleasant smell.

Figure 3- 32 Dampness caused by leakage and dampening of garbage near the play area

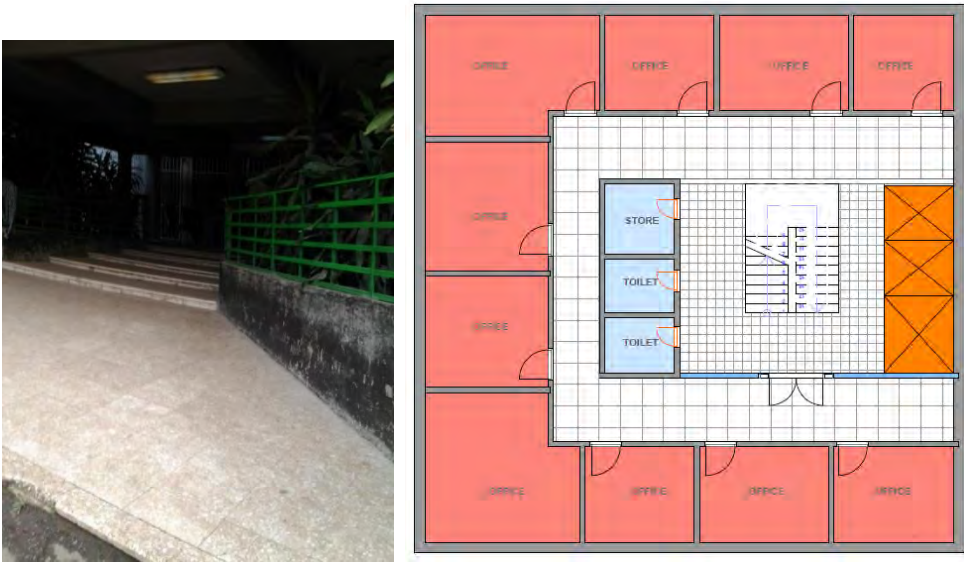
The first basement is accessed directly the right side ramp of the building. But it can also be accessed with internal stairs even though that is not suitable for disabled people. The function of this basement is for parking only. The lower second basement is used as a garbage disposal it is in unhealthy way this is disposed. On the ground the national bank of Ethiopia is located. As one move further in he/she finds three elevators & one stair case. And also its hard to pass without mentioning that the corridor & stair case both are artificially lighted & are not ventilated.

Figure 3- 34 Entrance of the building (left) and rough presentation of typical floor plans of Ministry of trade (right)

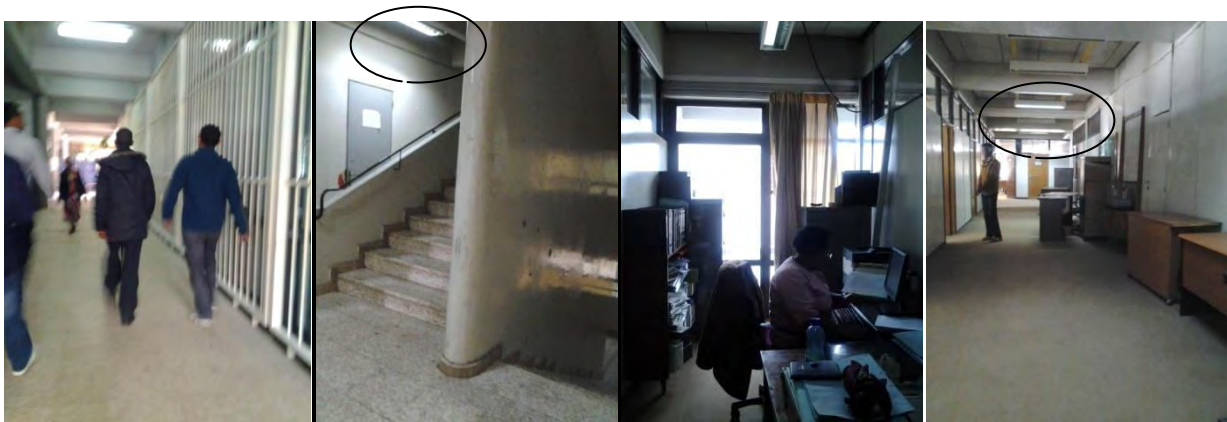
Stated in the above section that reviews the architectural, functional lay out, the stair & toilets do not have windows that can be used to light them up. Artificial lights are used. On the contrary the office spaces have large windows that let in enough light but can't protect users from the glare of the newly built buildings on the next site. Glare seems to be a problematic barrier in the building.

Figure 3- 35 The use of artificial light during day time

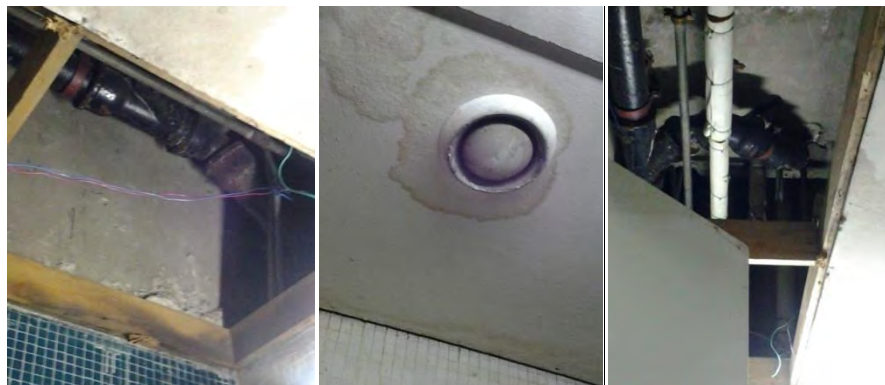
Since the toilet does not receives natural light due to the absence of windows it is suitable for microbial growth to occur on the wet surfaces of the toilet. Also leakage & faulty installation of pipes are witnessed. And the corridor as a whole has a damp smell to it.

Figure 3- 36 Microbial growth and dampness in the toilet

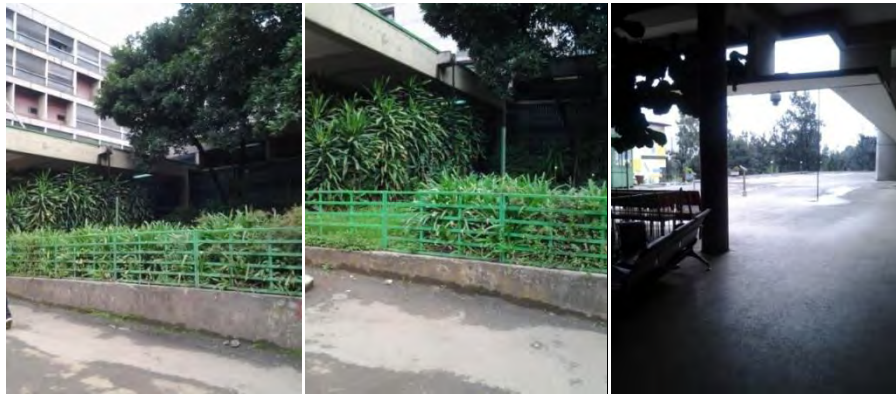
Figure 3- 37 Green infrastructure around the building

The building's greenery is one of the defining features of the area. The properly maintained and kept green area adds up to the beauty and the sustainability of the total location. The greenery includes *Zembaba*, lawn (grass) and more.

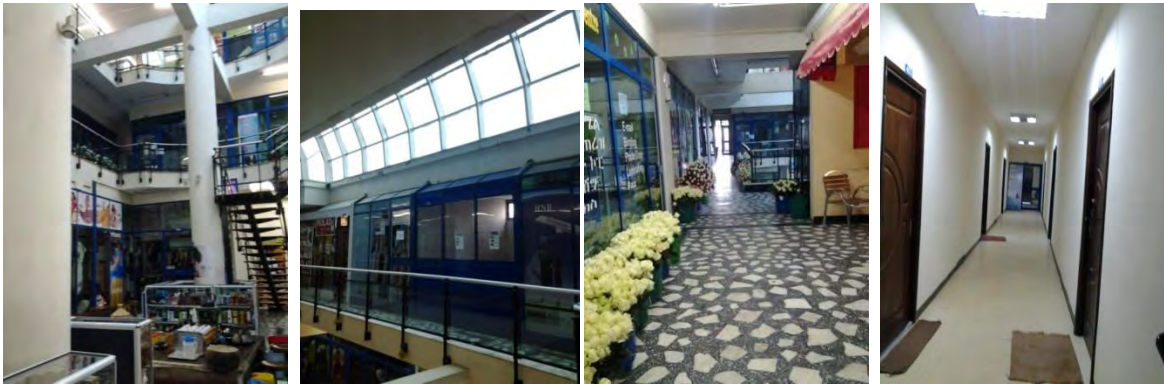
Figure 3- 39 Interior spaces of the Sheger House, open down, sky light, shop collider and office collider (from left to right)

After the fourth floor the building becomes an office building. Each floor has seven to eight offices (fig. 3.41). The building has one elevator and a regular stair. Also fire escape is available. There is a wooden stair that connects the ground floor to the first floor. As shown in the above pictures, this stair is located in the middle of the open down. The sky light is located on the roof of second floor. This brings light into the three floors down.

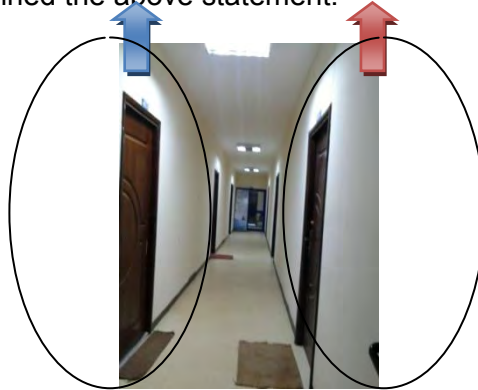
Respondents found in the left of the building claim to experience a cold and chill indoor environment due to the excessive use of curtain wall. And respondents in the right wing of the building have explained that they experience a bit warmer indoor air quality. This statement is designated in the below diagram that shows that the blue arrow is the side of the building that is cooler and the red one is the warmer side. The doors are those that show the entrance to those offices that have explained the above statement.

Figure 3- 40 Temperature difference of the building

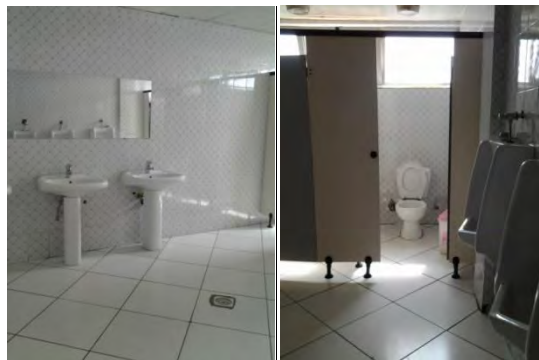
The regular unmaintained toilet we see in most of our city's building is not seen in this building. But still if not maintained well the result will be same the rest.

*Figure 3- 46 Microbial growth free toilet*

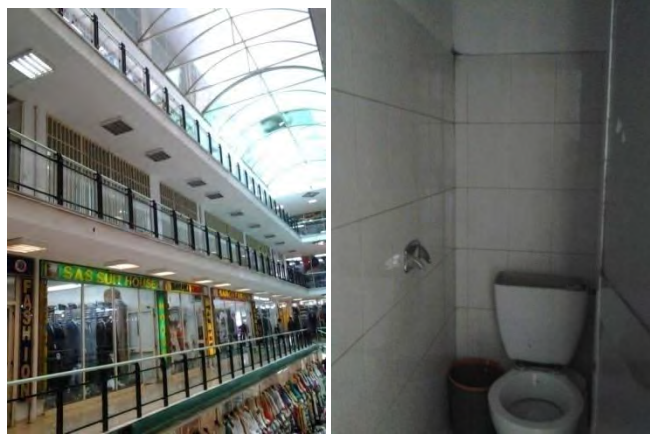
The building's toilets do not have the proper windows that could let in the natural light necessary for one see the function that takes place in the space. Also some of the inner shops do not have windows, thus they use artificial lights for the working hours of the day. In the above floors the right side toilet does not have enough light. These are also important because it is related with ventilation. But the sky light aided the lighting situation significantly. Though there is effect of glare due to the sky light, it has also helped in naturally lighting the lower spaces.

Figure 3- 49 Interior space of the building, sky light and toilet (from left to right)

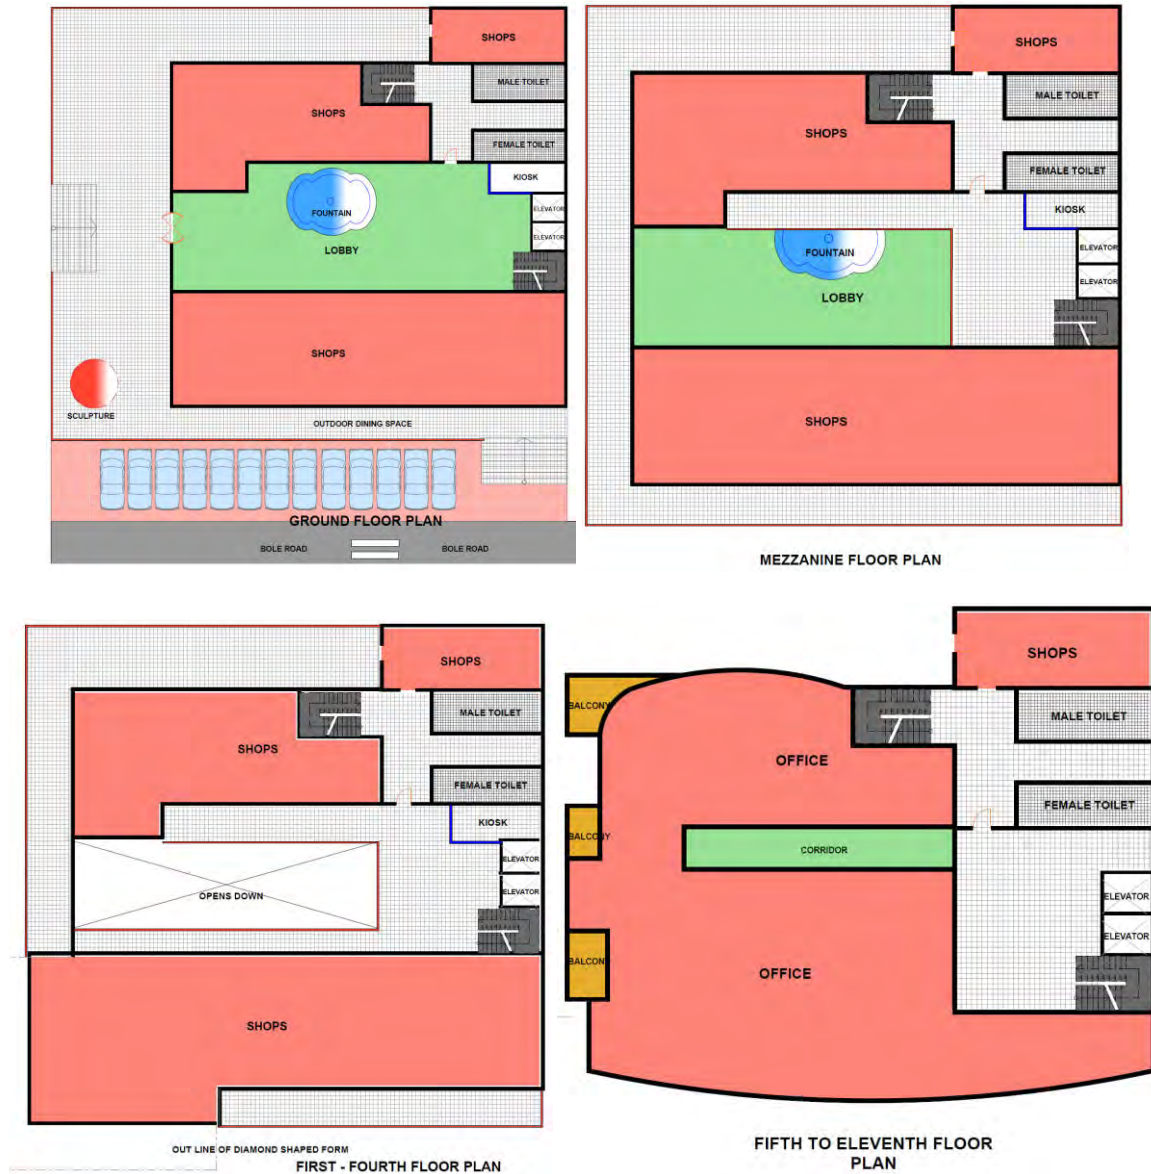
Figure 3- 52 Illustration of floor plans of Friendship City Center

As one enters the lobby the enormous fountain pool welcomes his/her eyes (fig 3.55). The ground has nine shops including *Kaldi's Coffee*. The mezzanine floor has seven shops. The first floor has ten shops that are rented. Balcones are integrated from the first floor to fourth floor. The second and third floors have twelve to fourteen rentable shops. The open down

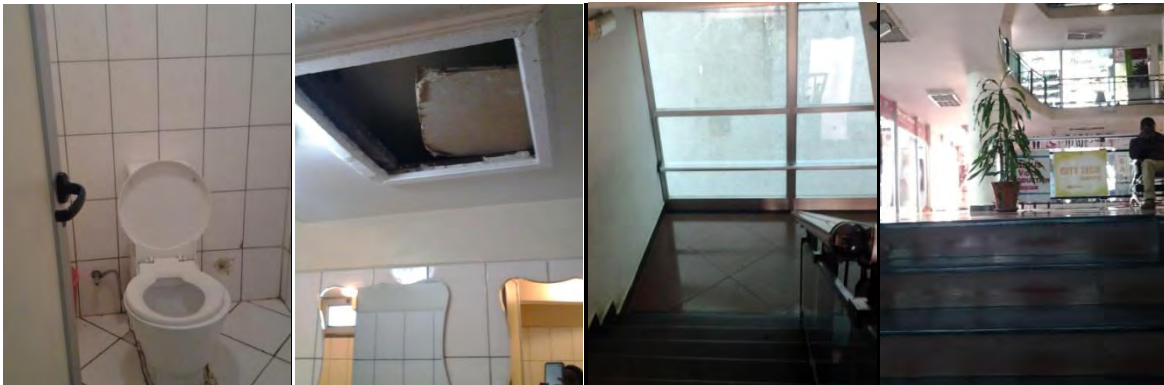
*Figure 3- 53 Toilets in the building stair case and open down windows*

The pictures seen above are the stair, the open down and lobby area respectively. It is clear that there is sufficient light that seem to reach every corner of the building.

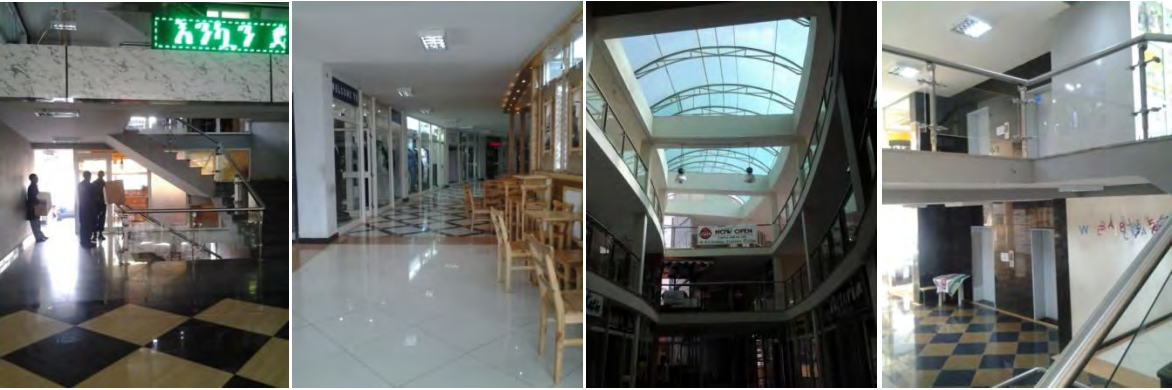
As we move in, the lobby is very wide and relatively darker. But the easily accessible lifts and stairs make it is simple to experience the whole building. The intricate spaces and plans are very complicated but without purpose. The building has many spaces and pockets that are simply unreadable and unfriendly. The basement access is, for instance, found not directly under the stair leading to the ground floor but after we step down a stair of 4 steps and then a pathway leading to the hallway to the basement.

Figure 3- 55 Lobby, sky light and basement access of Medhanialem mall

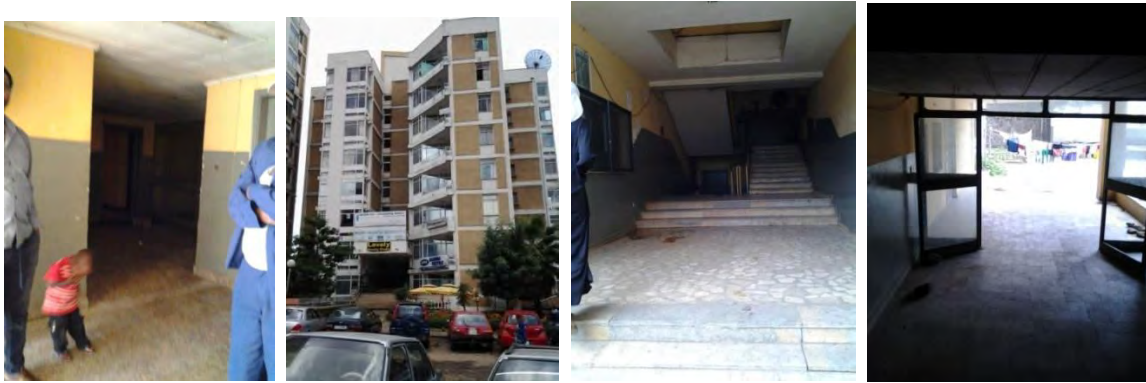
placement of sensitive items (objects) and the electricity sometimes causes contacts when children play with it.

Figure 3- 58 Some worn out facilities in the apartment and the entrance of the apartment

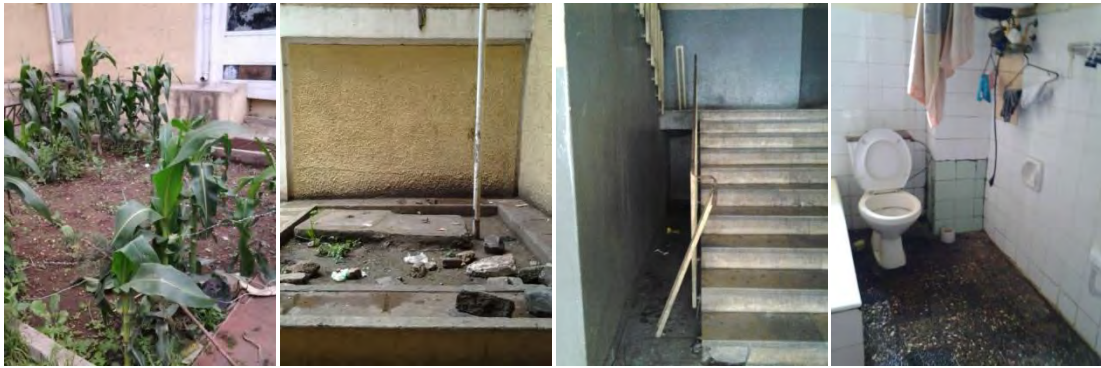
Figure 3- 59 Unmanaged green infrastructure microbial growth and dampness within the apartment

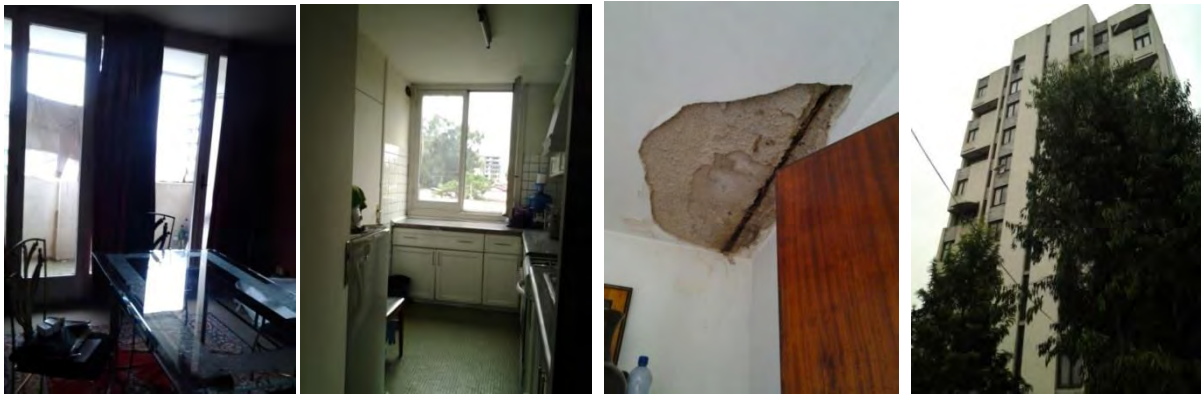
Figure 3- 65 Interior space of the apartment building

Every space has window that is suitable and sufficient for performance.

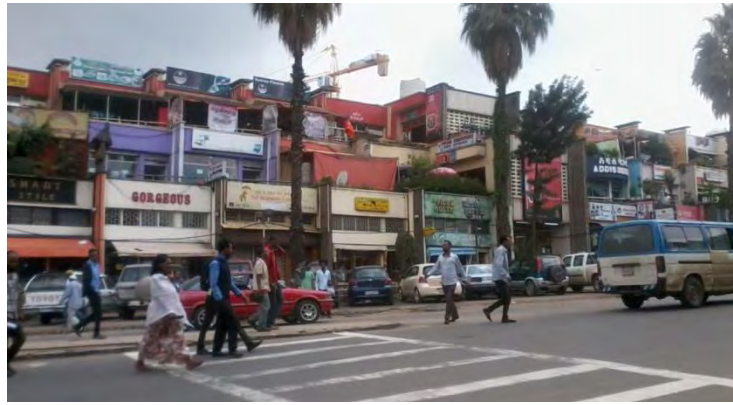
Figure 3- 67 Building slope

As we approach the building we notice that it is built on a sloppy ground. It is slopping both on the longest direction and shortest direction. The arrows show that there is a gentle slope upwards both as we move from the side that is close to Churchill road to the upper and also from back to the front.

This has a suggestion of split level design in which the sloppiness of the building is balanced by the addition of stairs and ramps. Though ramps are not seen on near the building entrances it has been noticeably tried to balance the level difference by addition and subtraction of stairs. The building has six entrances, to the bank, the main tower and the rest four entrances to the shopping sections

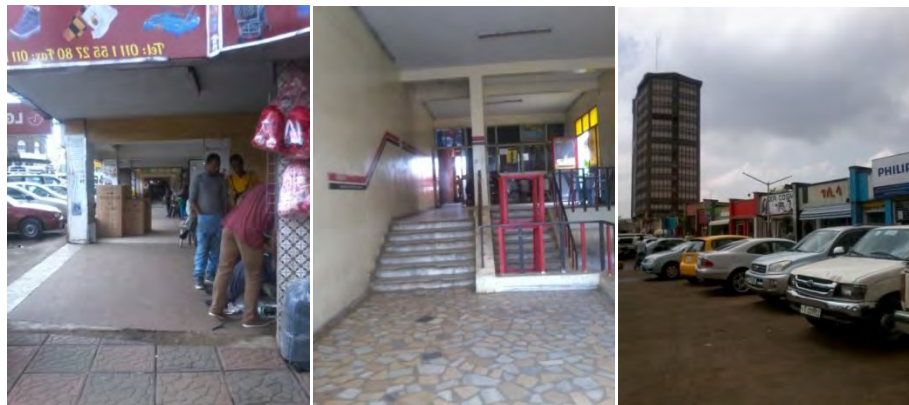
The four external stairs lead to the entrance to the shops. The basement is access able to one coming from Churchill Road and as he/she moves up ward the road lifts upward making the floor basement. And as we reach the opposite direction we notice there is a stair that could equalize the floor level to the road level.

Figure 3- 68 Access, stair and parking space of Arada building

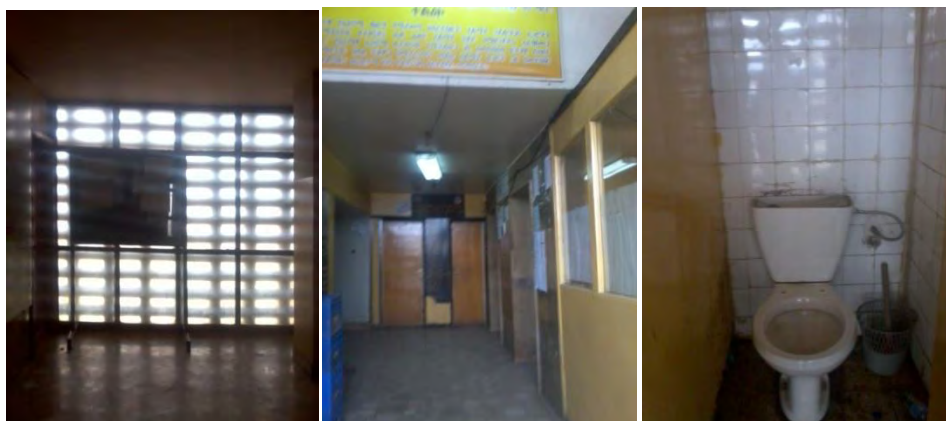
Though the building is considered to be built in the olden days, it is still an iconic structure in the way it's lay out is designed. Every office space in the tower is provided with windows that are functional. But due to habit the occupants of the building still turn on light during day time. Also some modifications the users of the building have done created pockets and gorges that are a bit difficult to light naturally.

Despite the careful lay out plan, the tower's toilet still lack windows that provide light.

Figure 3- 70 Windows of the interior space and unventilated toilet

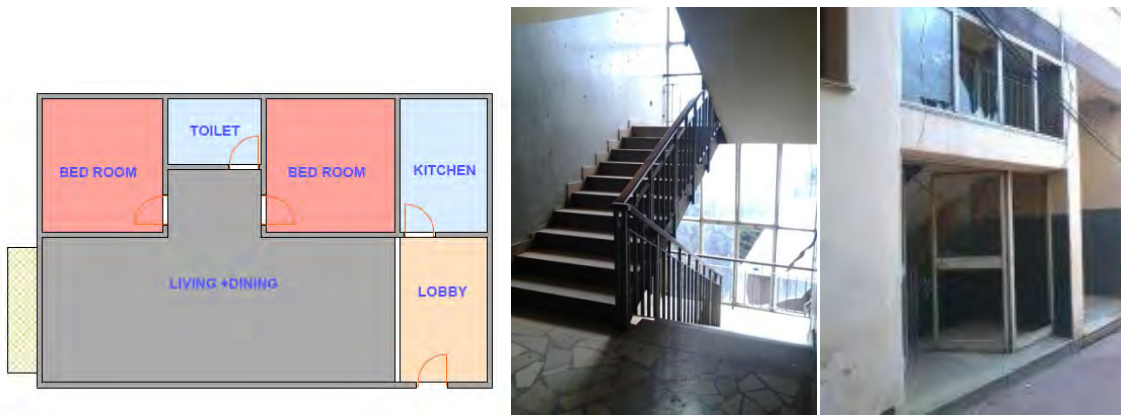
The building has shops, restaurants (café) and offices on the ground and first floor and apartments on its upper floors on its front side. And the apartment starts from the ground in the back side. There are four apartments on each floor that are of one bed room and two bedroom types.

Figure 3- 72 Illustration of floor plans, stair case and entrance to the building

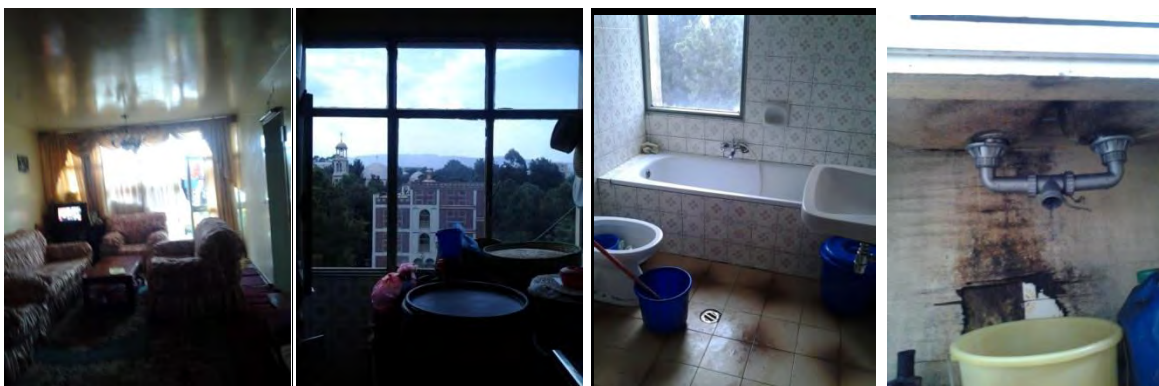
Figure 3- 73 Windows of the apartment and floor drainage causing dampness and kitchen fixture leakage causing damage

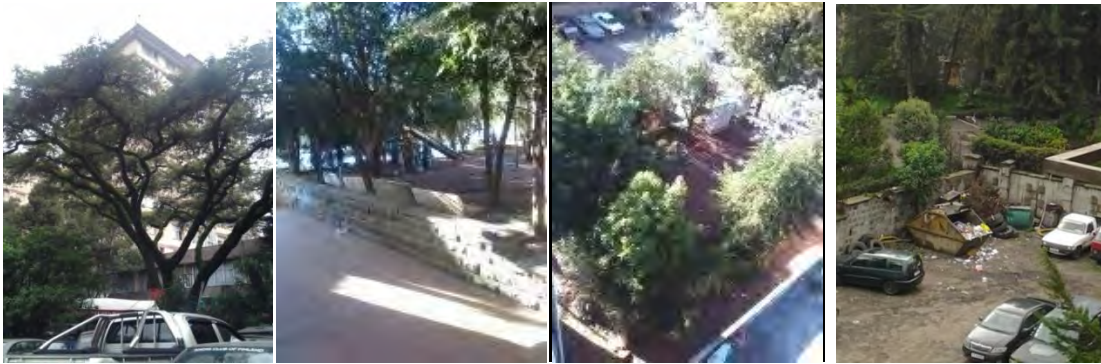
The site has enough green space composed of wide canopied trees. But those trees are not tall enough to shade the G +12 building from the glare windows have created.

Figure 3- 74 Green infrastructure around the building and garbage bin of the building

But the residents lack green infrastructure of their own other than the public space provided outside the building.

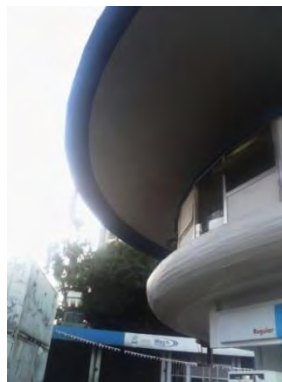
- ❖ Buildings like 'Ras Shell' are not faced with such problems because of the large over hand roof protecting them from glare. From the data collected about surveyed buildings, Adam's Pavilion could be the leading example of Glare Attacked building.

Figure 4- 2 Overhang of Ras Shell

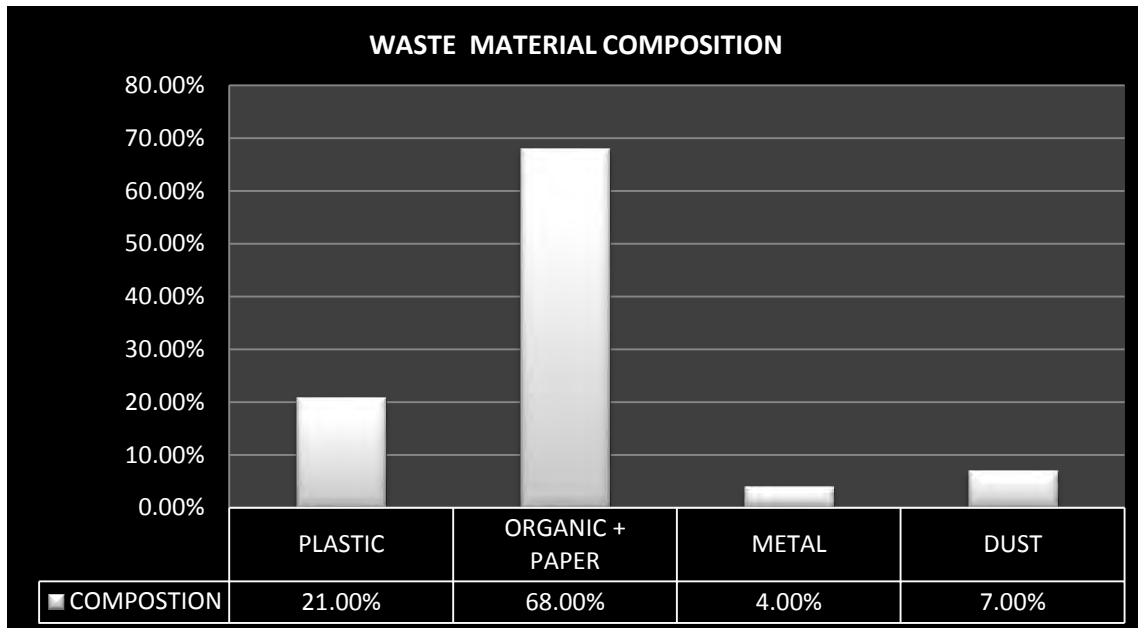
Figure 4- 12 Composition of waste material in offices

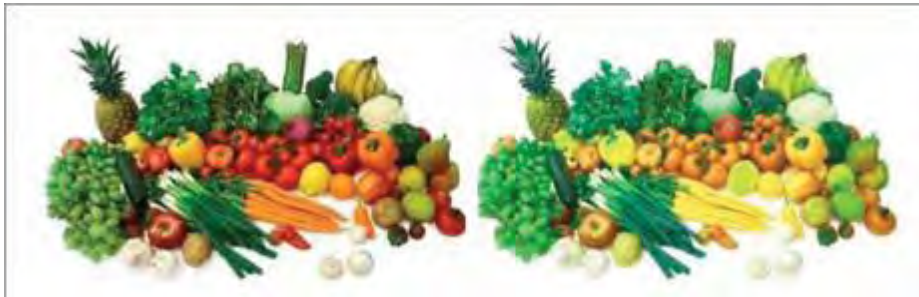
The vegetables on the left are in natural light and the ones in the right are under artificial lighting.

Figure 4- 18 The color rendering index rates the portrayal of color

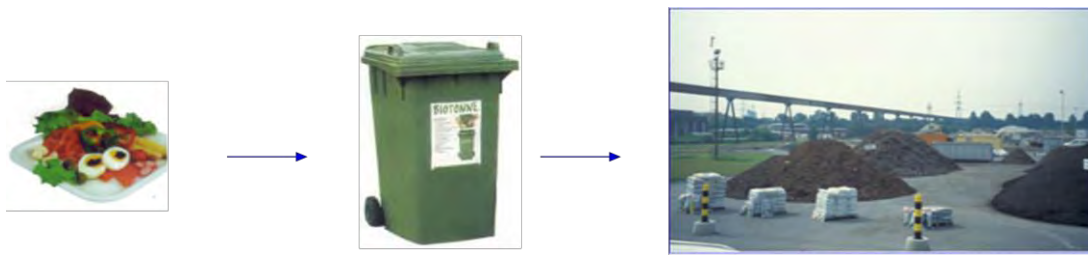
Biological degradation and transformation process for organic substances under aerobic conditions by a variety of microbes and may be other small organisms. It leads to the evolution of heat, the formation of carbon dioxide and water. Humus rich compost is generated as a product.

Figure 4- 23 Compost

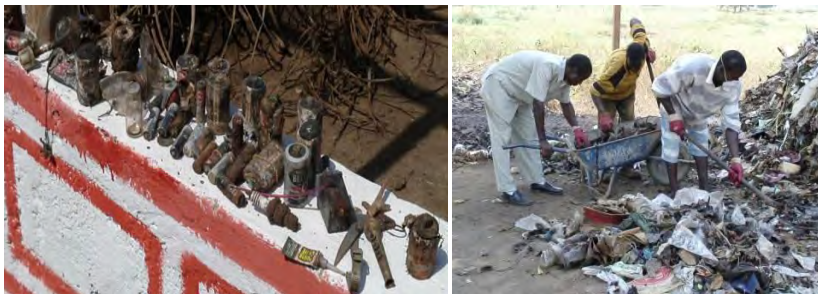
- Seasonal variations: this may have effects on quantities or composition.
- Origin: (mixed) household waste, market waste, hotels...
- Contaminants – Purity of input material => sorting process is necessary.
- Collection of input material

Figure 4- 24 Inputs for compost
