# **Evaluation of Selected Addis Ababa Buildings with respect to the Green Building Features**

M.Sc. Thesis in Environmental Planning and Landscape Design

Ethiopian Institute of Architecture, Building Construction and  
City Development, EiABC, Addis Ababa University

June, 2015

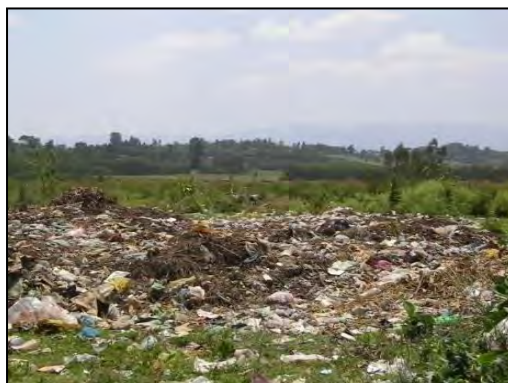
In physical social and economical findings it was stated that surveyed buildings do not generate income, do not promote socialization and also their interaction of the environment is very weak. One way a building interacts with its environment is through the amount of waste it produces. The Giant land fill site that lies around Ayer Tena is the judge of how much waste is produced in the study area. The area's frontal length stretches about a kilo meter long and the width about 300 meters. And the area is filled with mounds of waste composed of different substances. Plastic, paper, metal, glass, clothes, ashes, and so on.

Figure 4- 26 Landfill around Ayer Tena

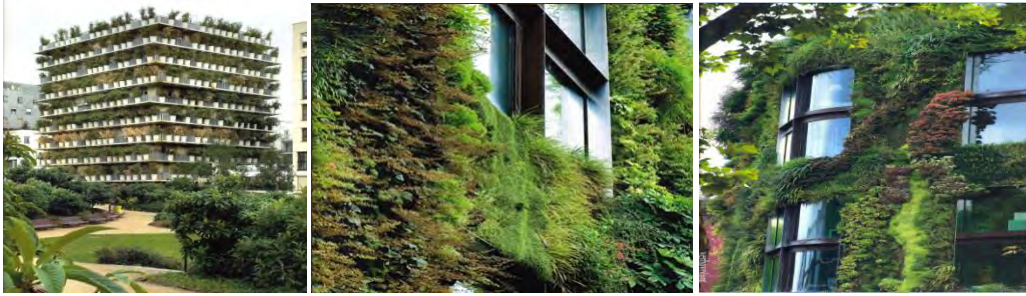
- Plants that is evergreen because if we use seasonal climbers, when they shade their leaves the resulting dirt will be hard to manage.

- While applying such techniques we should be considerate of the building's openings

Figure 5- 1 Consideration while applying vertical gardening

- In order to protect the buildings' walls from deteriorating it is better to use climbers first planted in pots and that later on will free fall to the ground without touching the wall or to guide the climbers with ropes or wires.
- While applying greeneries on roofs or walls we need to consider *Zeroscaping* which is the term used for plants that use small amount of water also we need to study the types of plants that are to be considered.

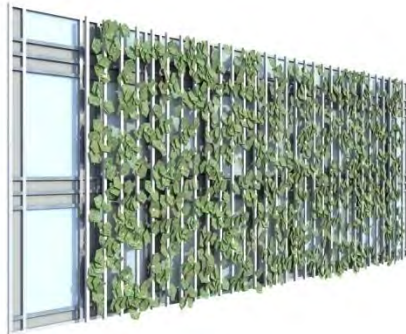
Figure 5- 2 Application of green on existing surveyed buildings for cooling purpose A simple additional frame that supports climbers in front of curtain wall façade that could shade the indoor space from the harsh sun

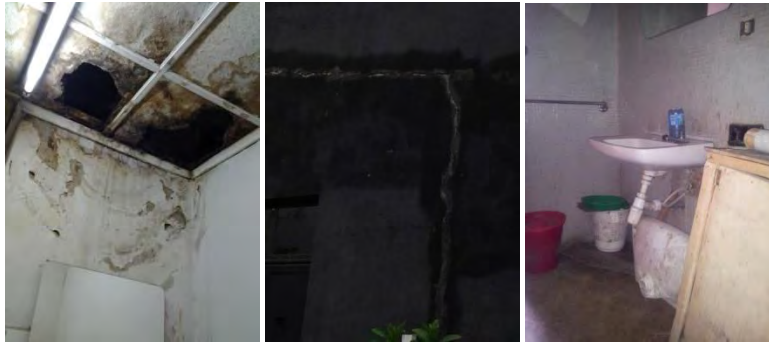
Figure 5- 3 Showing some of the problems in existing buildings caused by dampness and microbial growth

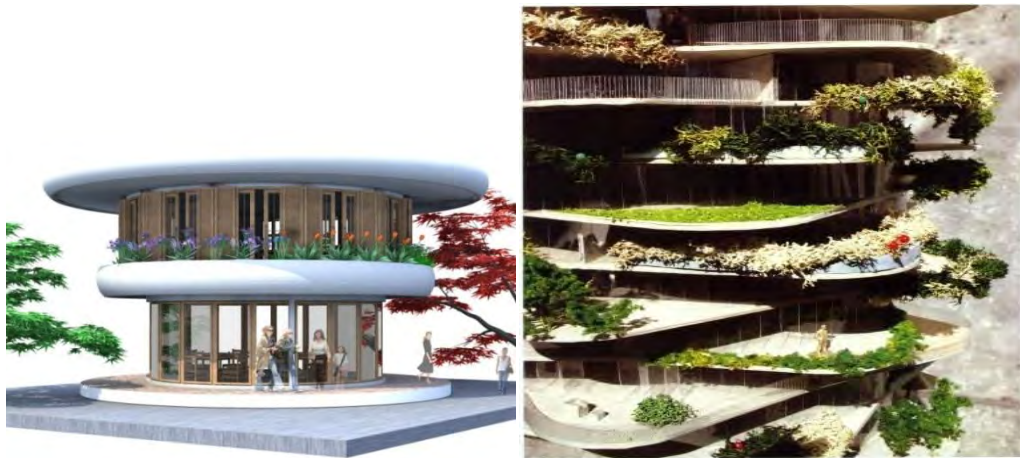
- Psycho-physiological value of cultivated area (the feeling of well being is positively influenced by the area of the greenery.) (Ernest Neufert, 1999)
- Adds to natural cycle of nutrients and resources of bio diversity that may have been hindered by urbanization.
- And most important to this section, cool and moister air due to high heat consuming plants. (Ernest Neufert, 1999)
  - ✓ Where a conventional flat roof temperature rises up to 80<sup>0</sup>
  - ✓ The green roofs falls to 35<sup>0</sup> due to transpiration of H<sub>2</sub>O

Figure 5- 5 Wall covered by Green Acts likes a shade and also helps reduce urban heat island effect

- *The best examples from the surveyed data where this technique could be applied are Adam's Pavilion and Dembel city center.*

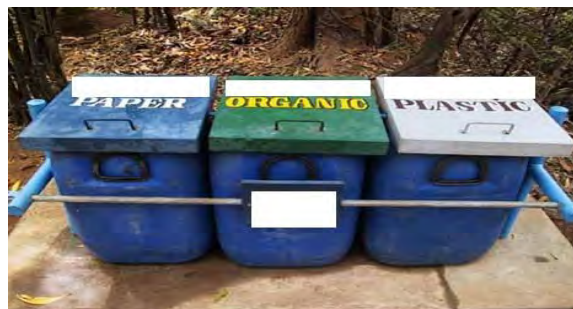
Second step is more or less related with waste management, i.e. sorting of garbage in such a way they are classified into plastic, paper and organic. Since a good building design and planning integrates the energy aspect as well as the plan and lay out a space should be provided for such activities. The separately accumulated wastes can be collected by waste collectors grouped as small and micro enterprises and the plastics and metals can also be sold for the 'Kurales'. Besides creating awareness for the residents, restricting by laws not to dump solid wastes into garbage in a careless manner is the further step that needs to be taken.

Figure 5- 8 Sorting of garbage
