ADDIS ABABA UNIVERSITY
ADDIS ABABA INSTITUTE OF TECHNOLOGY
SCHOOL OF CIVIL AND ENVIRONMENTAL ENGINEERING

**AN EXPERIMENTAL INVESTIGATION ON THE EFFECT AND
MECHANISM OF SIDE COVER SPALLING FOR SLENDER BEAMS
SUBJECTED TO SHEAR**

A Thesis in Structural Engineering

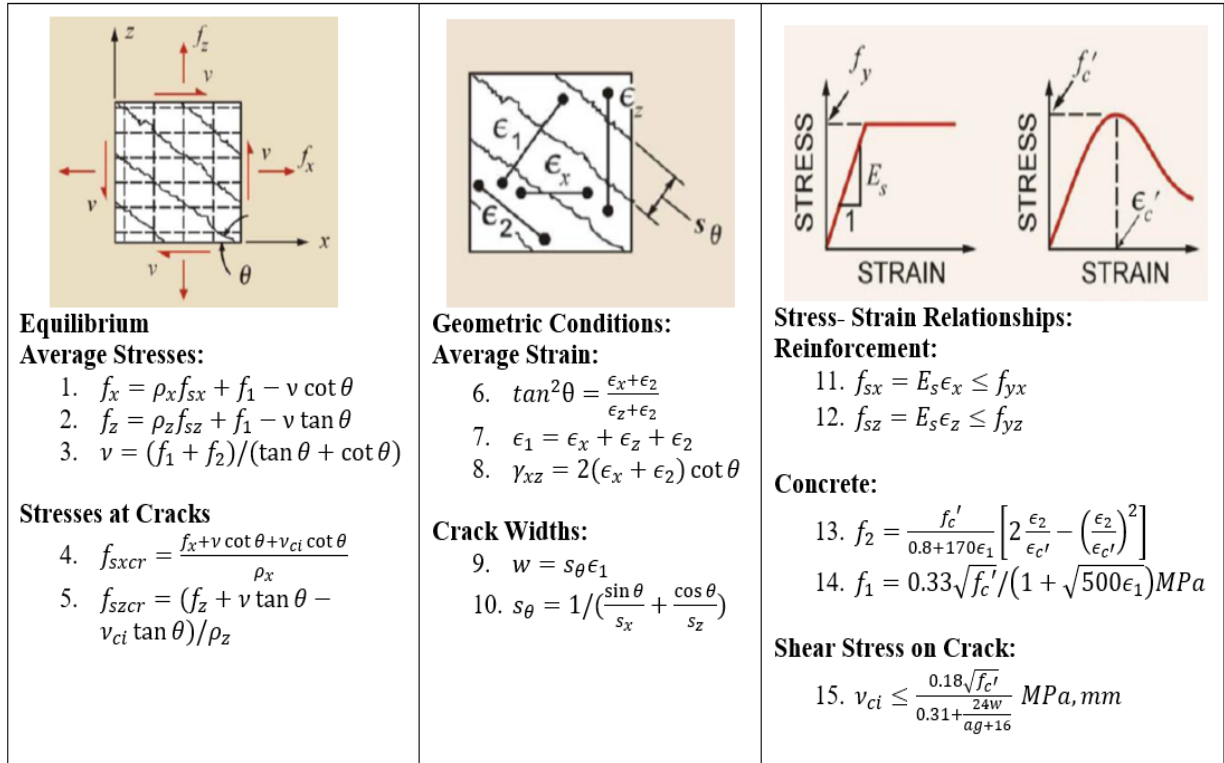
Figure 2-3:1986, Vecchio FJ and Collins MP. Modified Compression Field Theory (MCFT) Equations

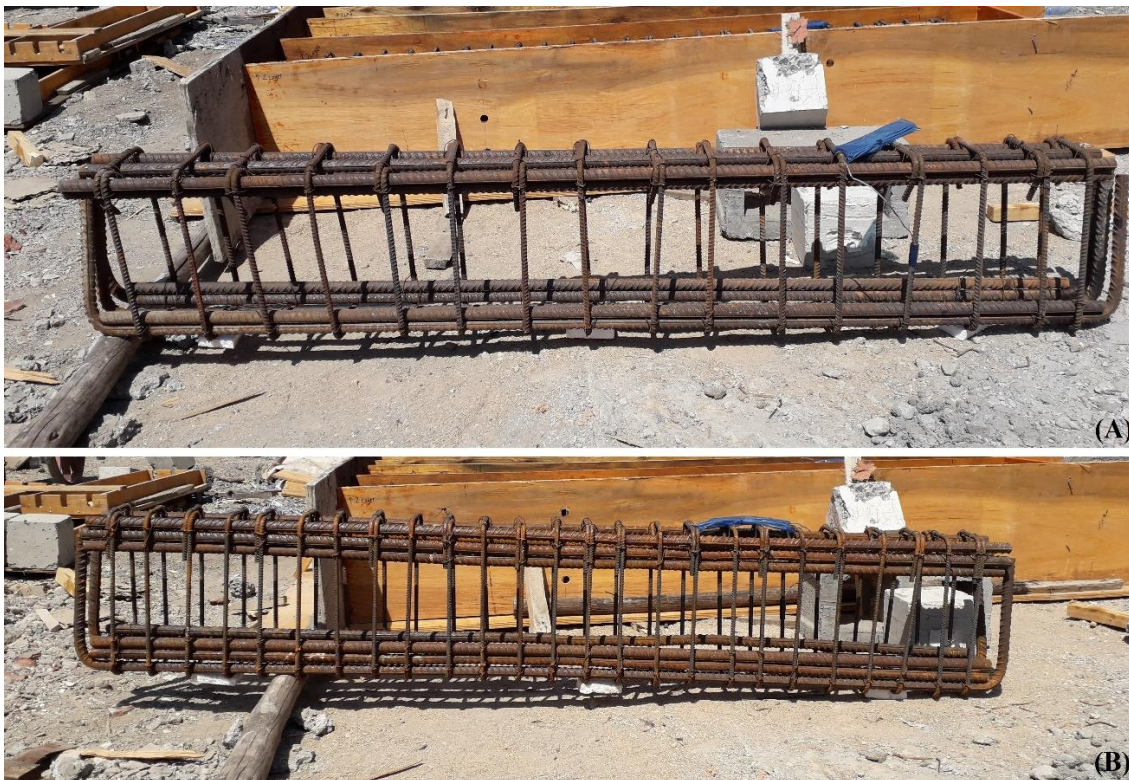
Figure 3-13: Reinforcement Cage for Main Specimens (A) SIII0-25 (B) SIII8-75

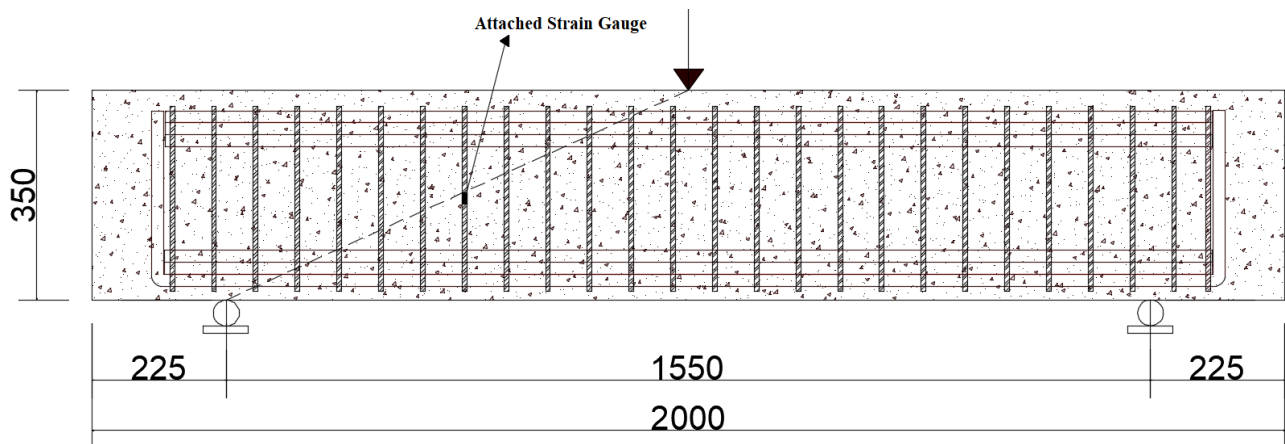
Figure 3-14: Location of Attached Strain Gauge

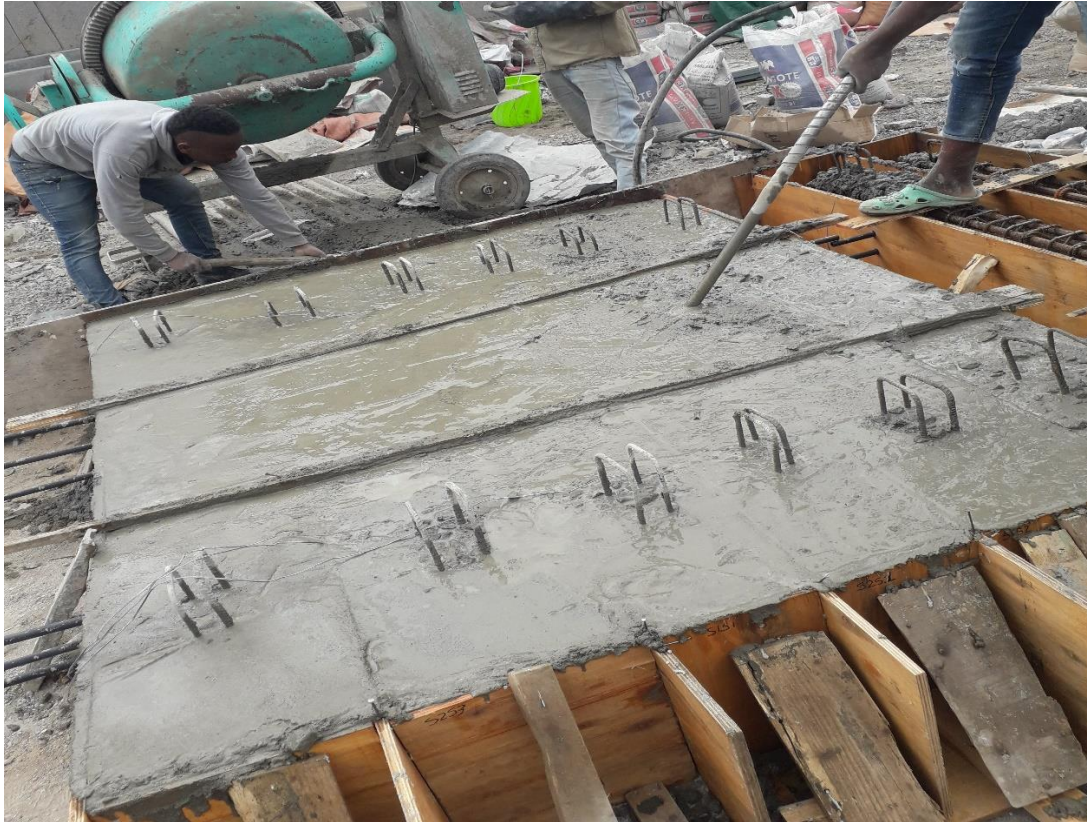
Figure 3-19: Concrete Casting of Main Specimens

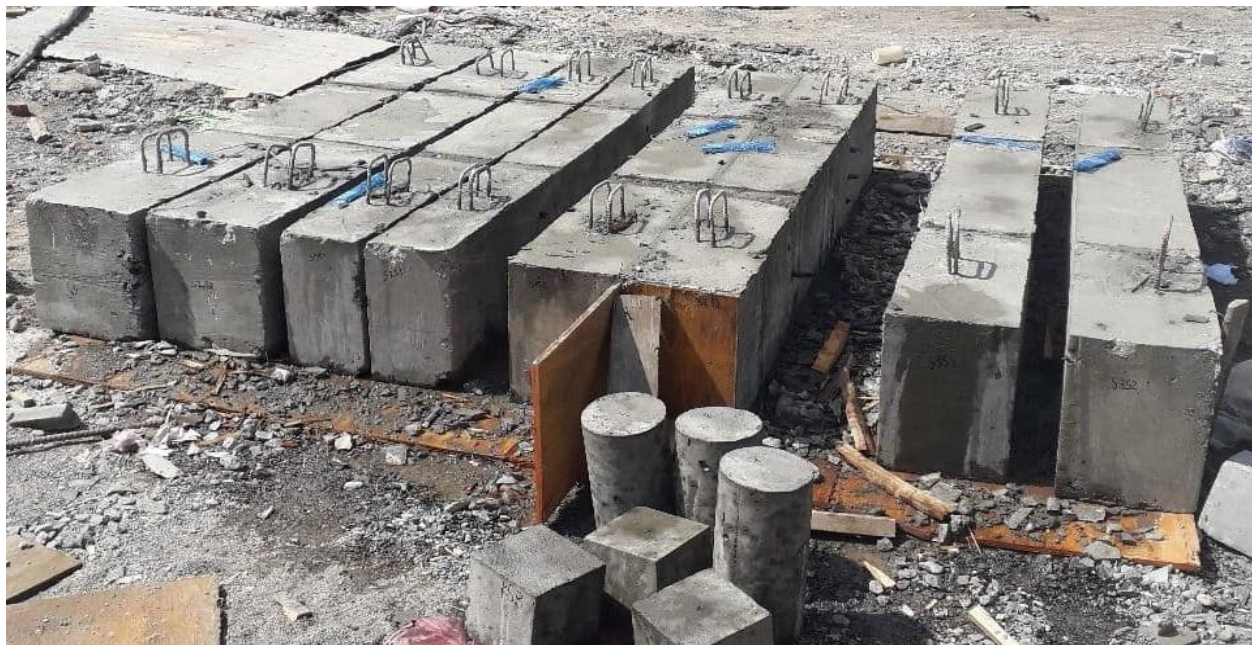
After casting, the formwork was removed after 48 hours and concrete was moist cured for 15 days by using a wet cotton cloth.

Figure 3-20: Formwork Removal of Main Specimens

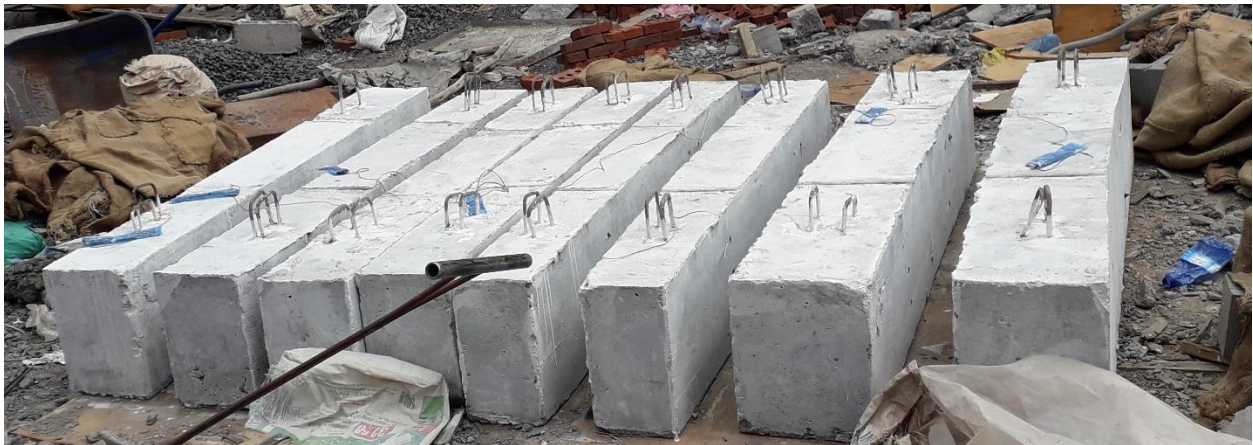
After the curing process the specimens were prepared to be tested. This preparation included cleaning the beam surfaces, cleaning the holes created and painting the specimens white for better visibility of cracks during testing.

Figure 3-22: Specimens Prepared for Testing

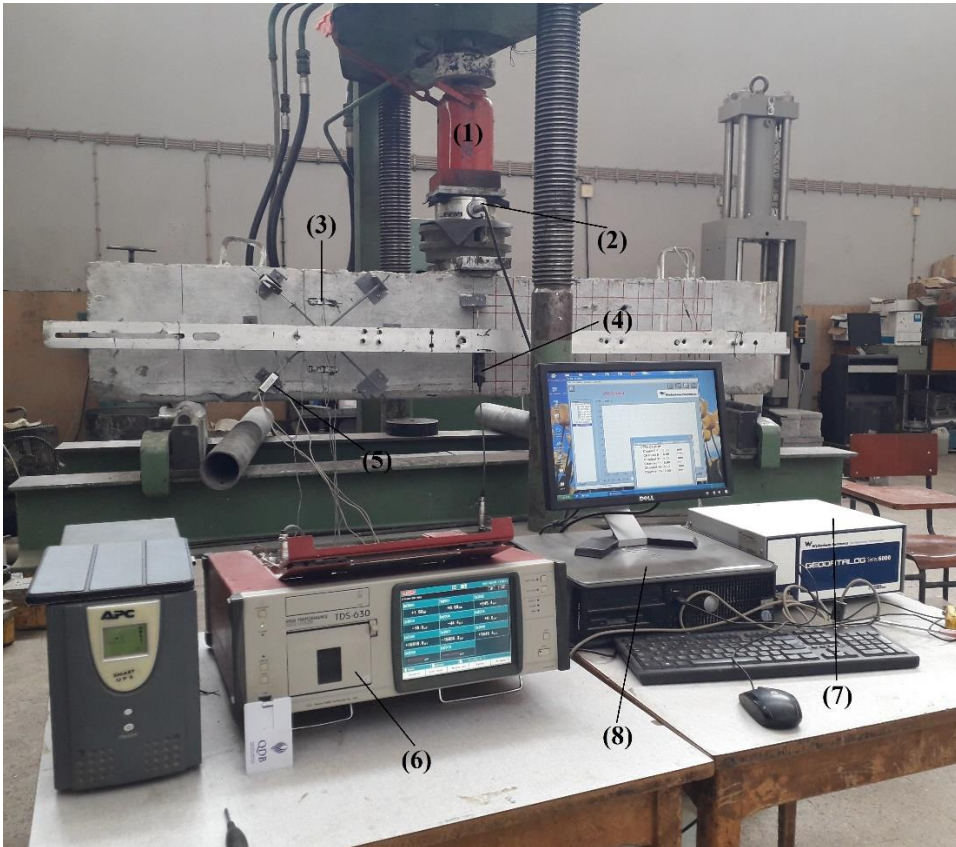
- LEGEND**
- (1) Hydraulic Jack
 - (2) Load Cell
 - (3) Strain Gauge attached on Aluminum Plate
 - (4) Displacement Transducer (For Mid-Span Deflection)
 - (5) Displacement Transducer (For Surface Displacement Measurements)
 - (6) TDS Data Logger
 - (7) Geodatalog
 - (8) Measurement Output Computer for Geodatalog

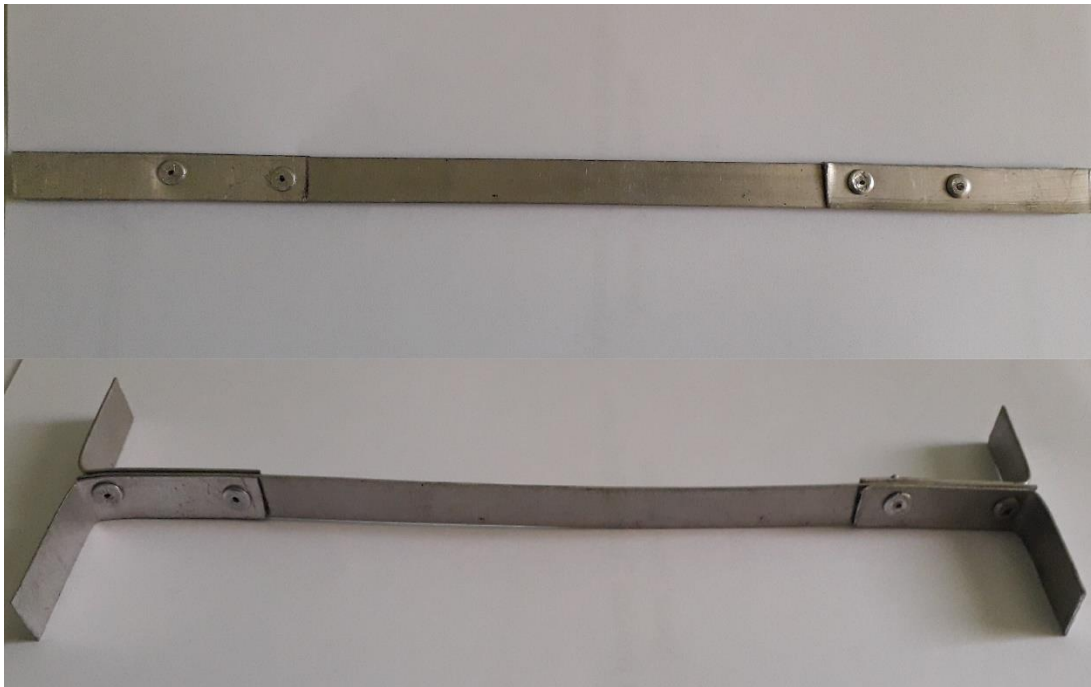
Inside the holes are 1 mm thick aluminum plate strips with an average 10mm width attached to two other strips on each side and were attach by an adhesive (Epoxy) to the outer surface of the beam.

Figure 3-34: Aluminum Strips used for Out of Plane Strain Measurement

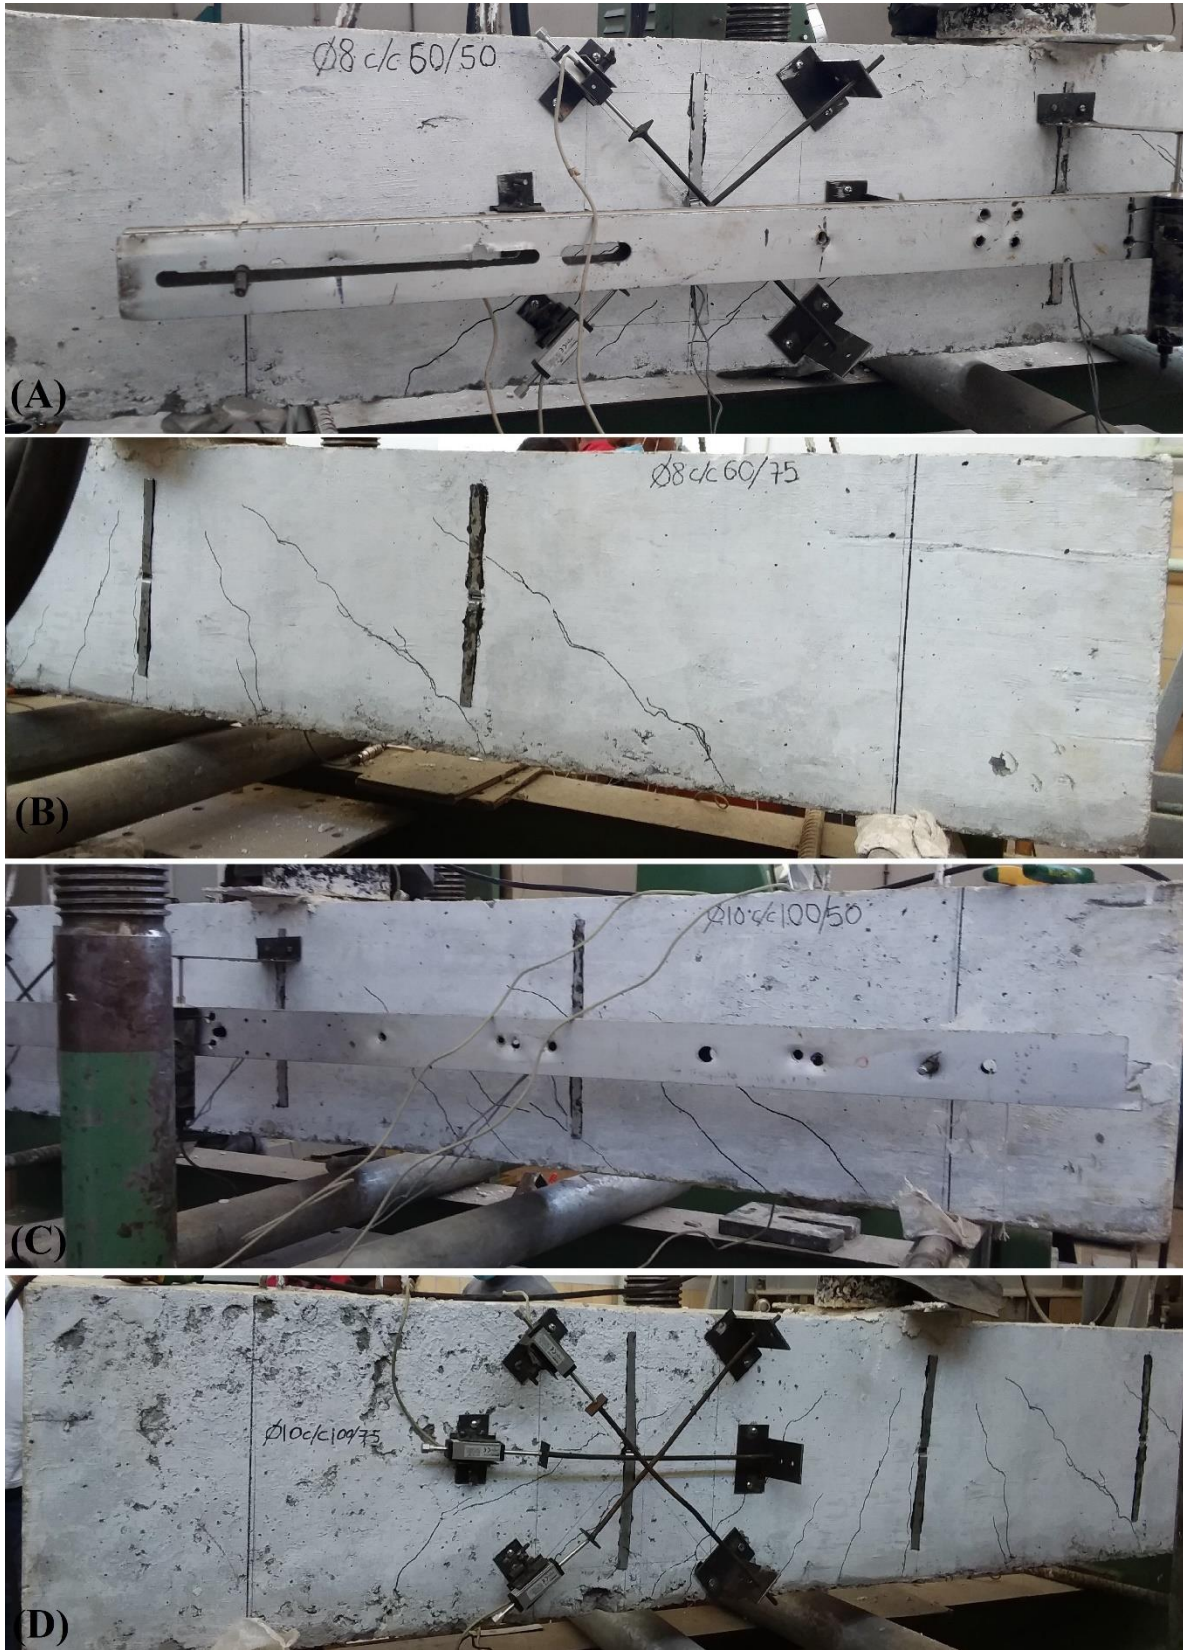
After the first 9 cycles flexural and diagonal cracks of width less than 0.8mm were observed on all four test regions and were marked with a black marker for better visibility. No significant damages had occurred to the physical surface of the beam.

Figure 4-2: Trial Specimen After the First 9 Cycles of Loading (A.TR 8-50 / B.TR 8-75 / C.TR 10-50 / D.TR 10-75)

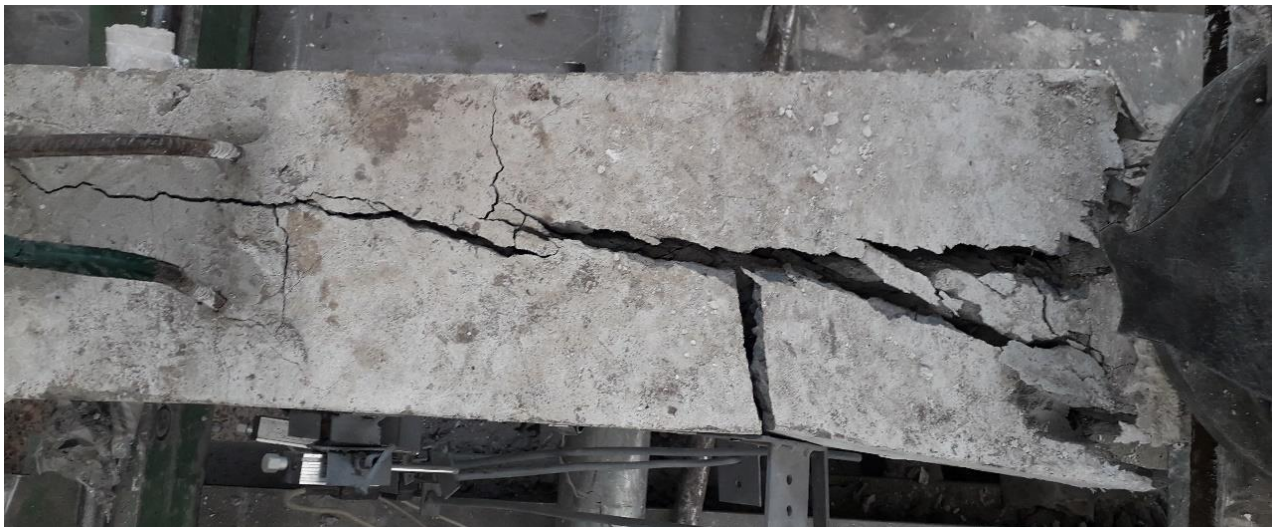
As the beam approached failure it was accompanied by multiple closely spaced diagonal cracks increasing in width and detaching from the concrete core. At failure the concrete cover was detached from the core at exactly where the diagonal compression cracks of failure had occurred. The top longitudinal crack also split outward creating an out of plane deformation.

Figure 4-3: Top Longitudinal Crack at Failure (TRIAL Beam (TR 8-50/75))

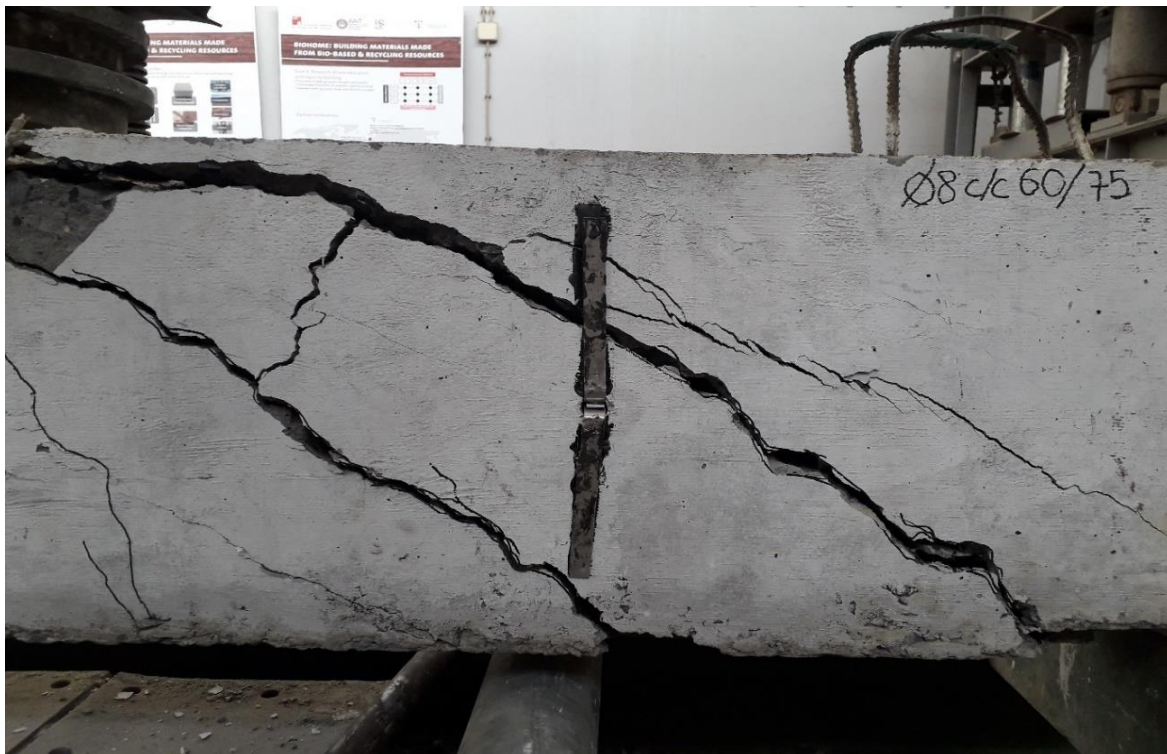
Figure 4-5: Diagonal Shear Cracks at Failure, 75mm Side Cover (TRIAL Beam (TR 8-75))

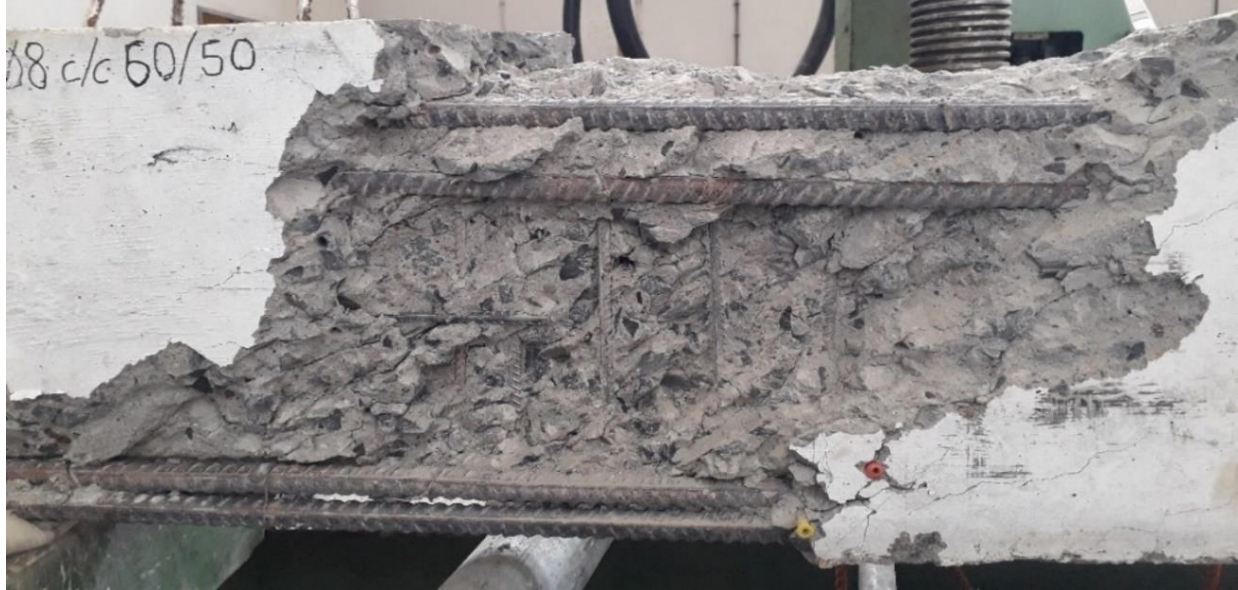
The side cover provided on each side had completely delaminated on the area of maximum shear following the diagonal compression cracks. After the surface measuring instruments were taken off the beam, the loose side cover detached from the core section was effortlessly removed by hand picking.

Figure 4-6: Side Cover Spalled ,50mm Side Cover (TRIAL Beam (TR 8-50))

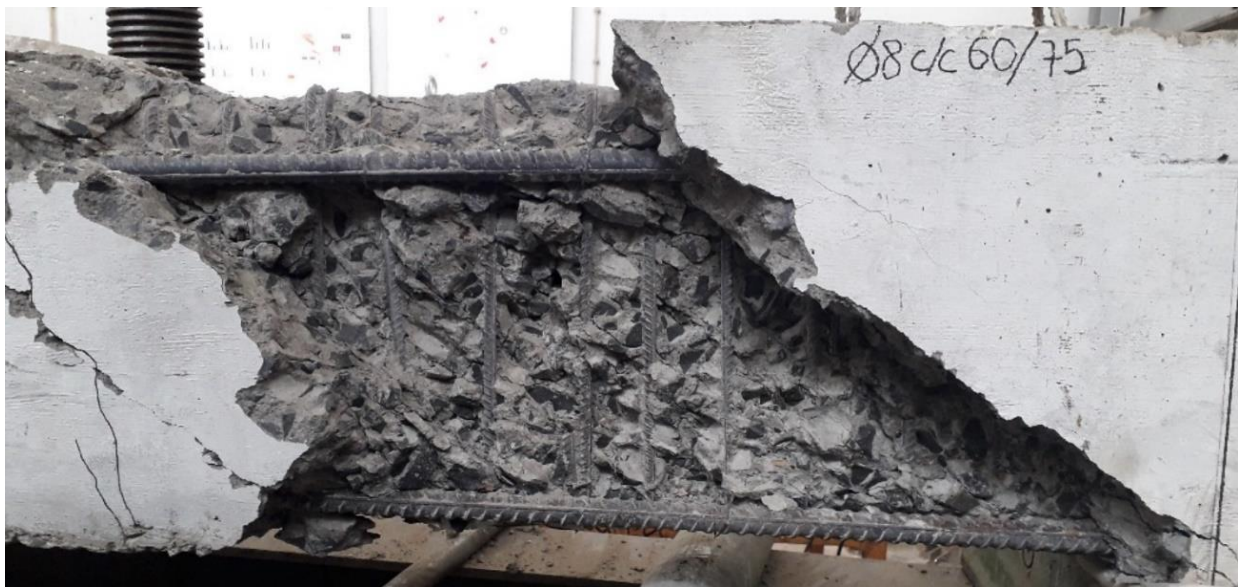
Figure 4-7: Side Cover Spalled, 75 mm Side Cover (TRIAL Beam (TR 8-75))

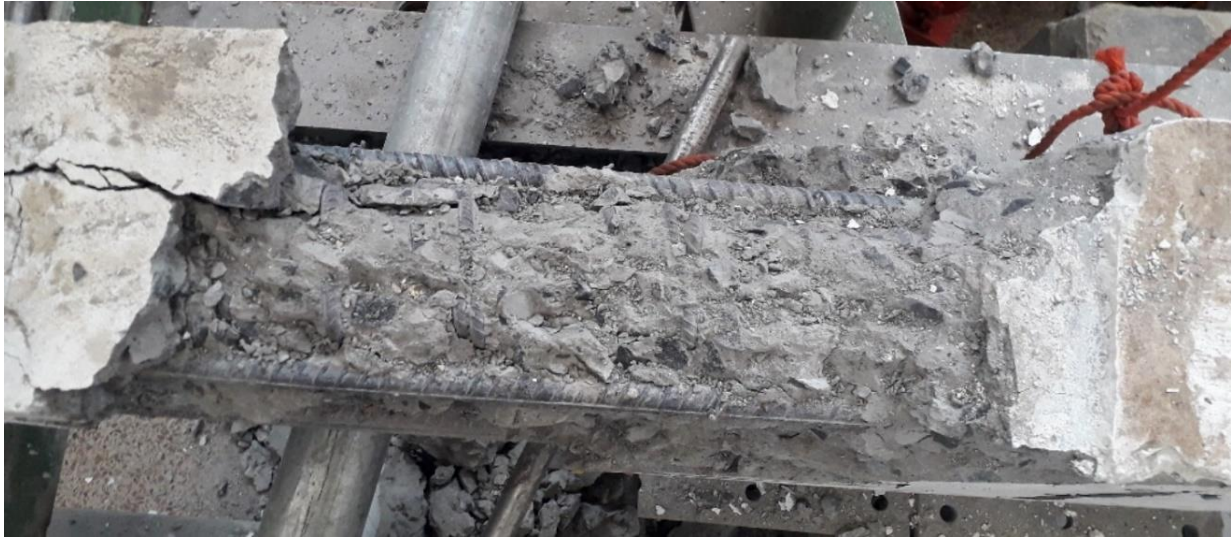
Figure 4-8: Side Cover Spalled, Top View (TRIAL Beam (TR 8-50/75))

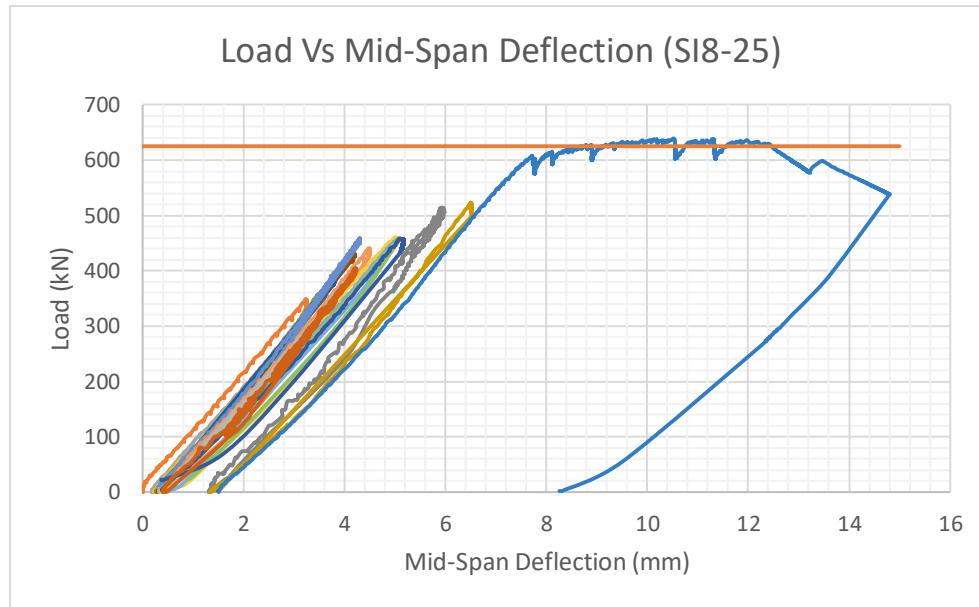
Figure 4-10: Load Vs. Mid-Span Deflection for SI8-25

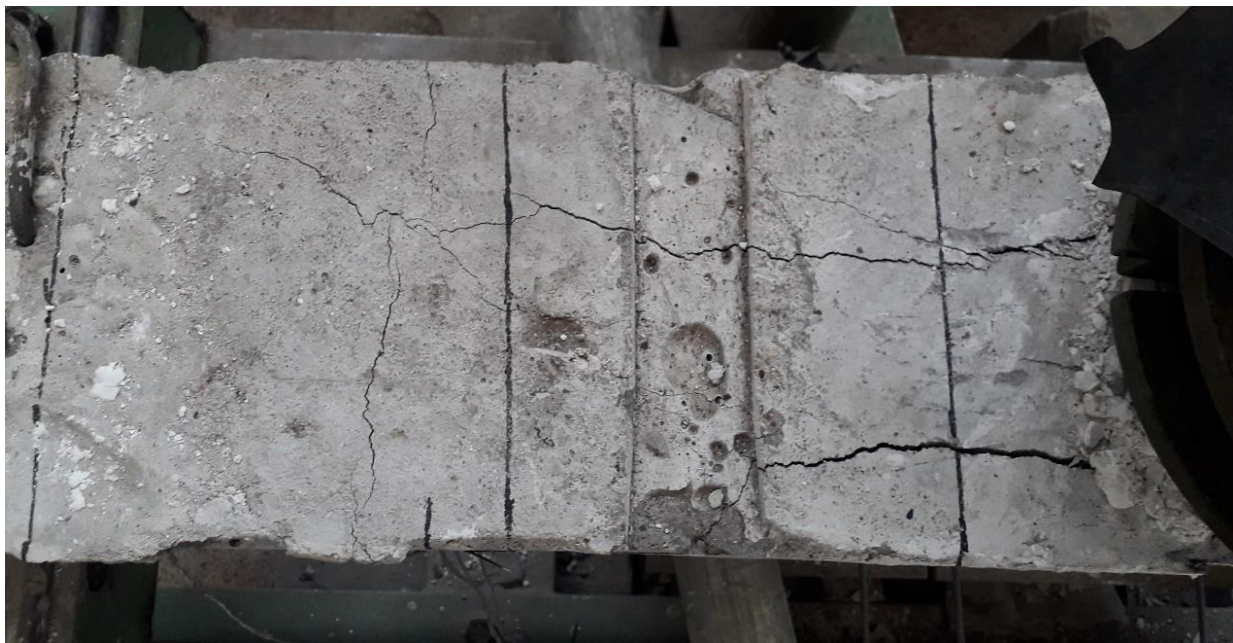
At earlier load stages diagonal shear cracks started forming following flexural cracks at the bottom of the beam. As loading progressed, the diagonal cracks on the left side (the side where failure had propagated) showed a greater increase in crack width as compared to the one on the right. Similar to the trial beam, top longitudinal crack originating from the loading point along the center was also observed in this specimen. In addition, top crack following the stirrup cage was observed but it was limited to a shorter length. However, at failure load this top crack did not widen as much as it did on the trial beam.

Figure 4-11: Top Longitudinal Crack (SI8-25)

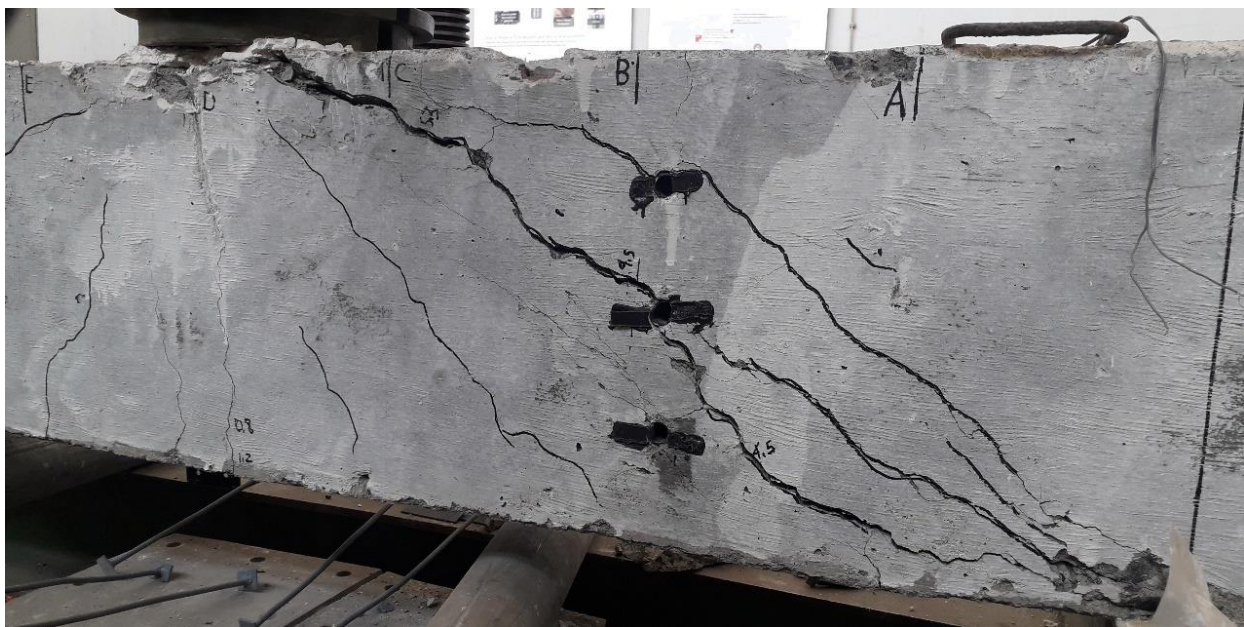
Similar behavior is reciprocated at the back of the beam as well. Although not accompanied by spalling, the top cover had detached from the concrete core.

Figure 4-13: Back Side Diagonal Compression Cracks at Failure (SI8-25)

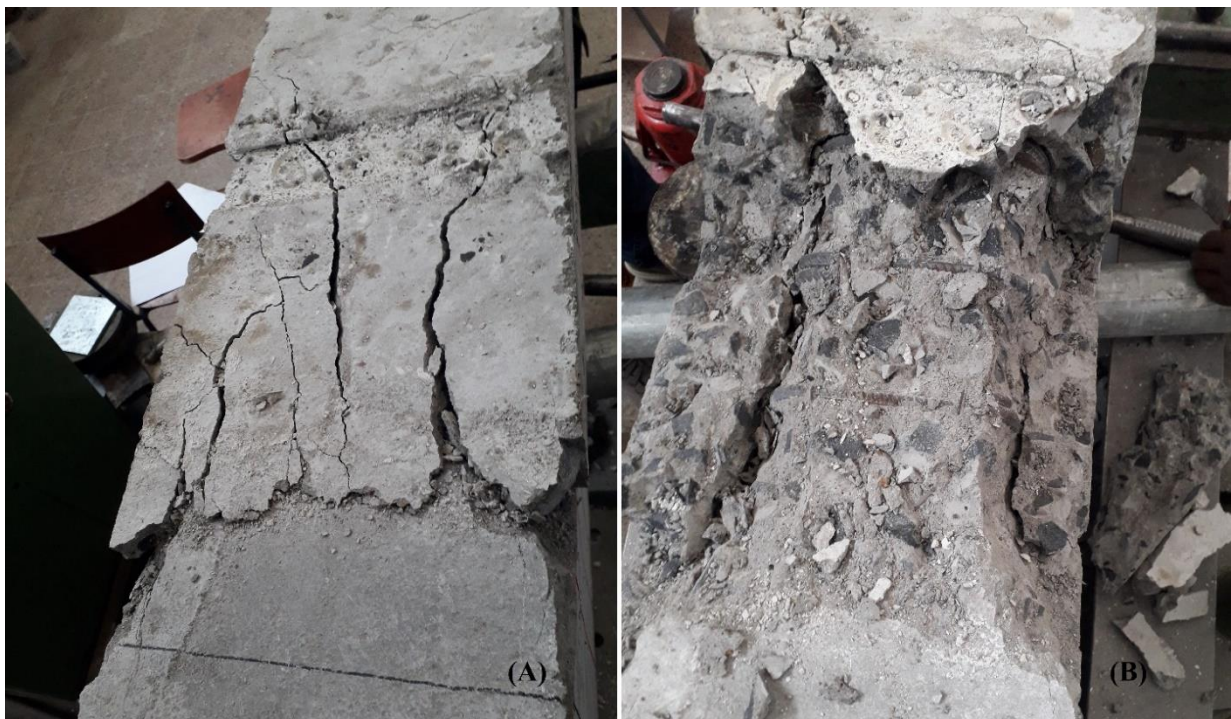
Top longitudinal cracks were observed following the edge of stirrup cage. The concrete side cover in both sides near the top had completely detached from the core and loose concrete was hand-picked after the test instruments were removed off the beam.

Figure 4-17: (A) Top Longitudinal Cracking (B) Spalled Section Top View (SI8-50)

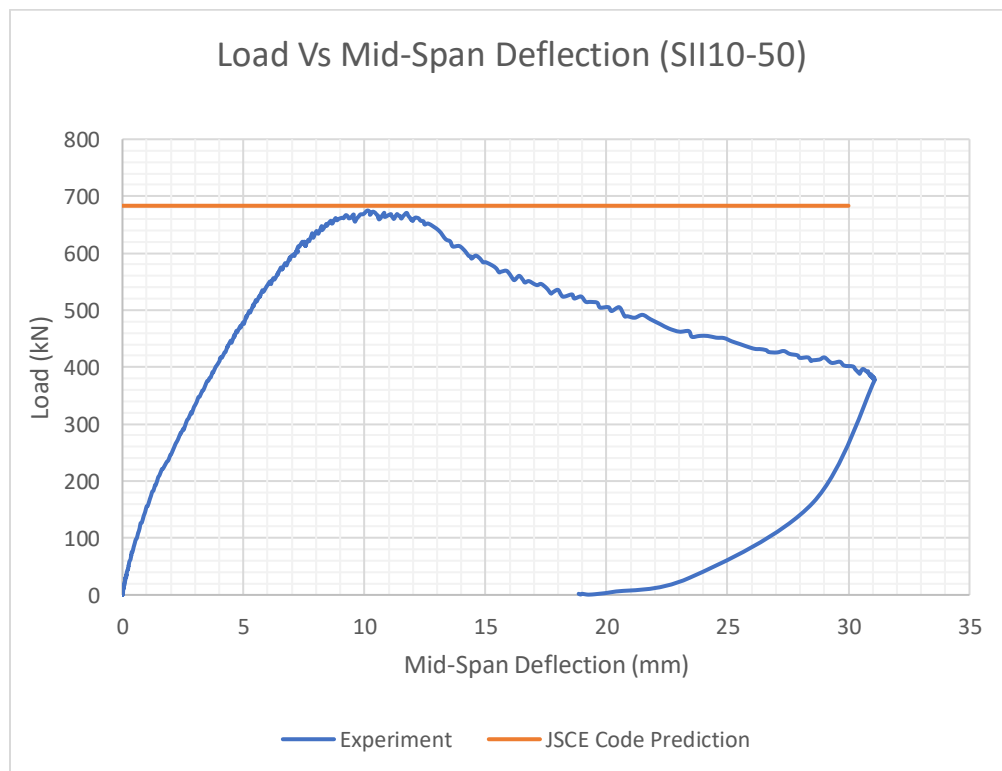
Specimen SII10-50 was designed with a side cover thickness of 50mm and a web reinforcement ratio of 0.57%, a stirrup $\phi 10$ c/c 110mm was used throughout the beam's length. This specimen is designed as replica of SI8-50 only differing in stirrup spacing. The beam had a flexure to shear over strength factor of 1.15. With a test day concrete compressive strength of 35.1MPa the specimen failed at 674kN.

Figure 4-21: Load Vs. Mid-Span Deflection for SII10-50

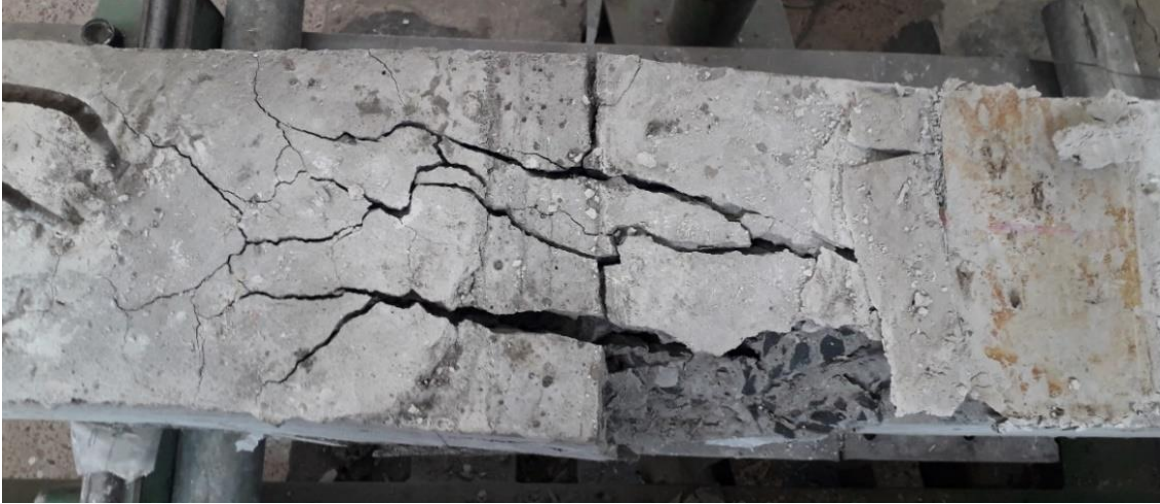
Figure 4-22: Top Longitudinal Cracking (SII10-50)

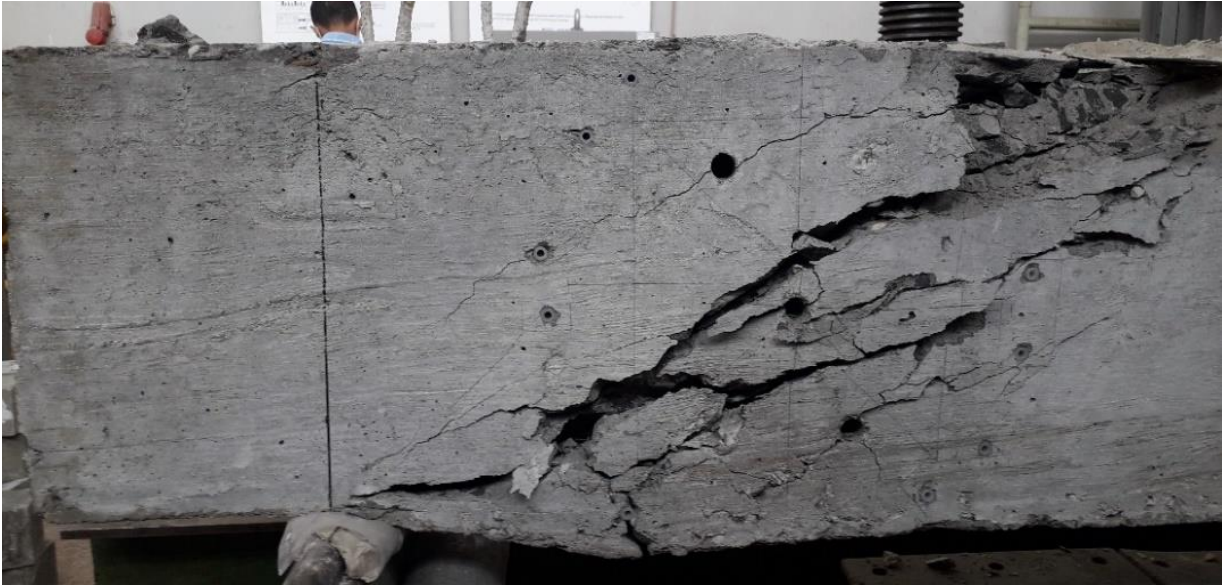
Figure 4-24: Diagonal Compression Crack and Top Spalling at Failure Back Side (SII10-50)

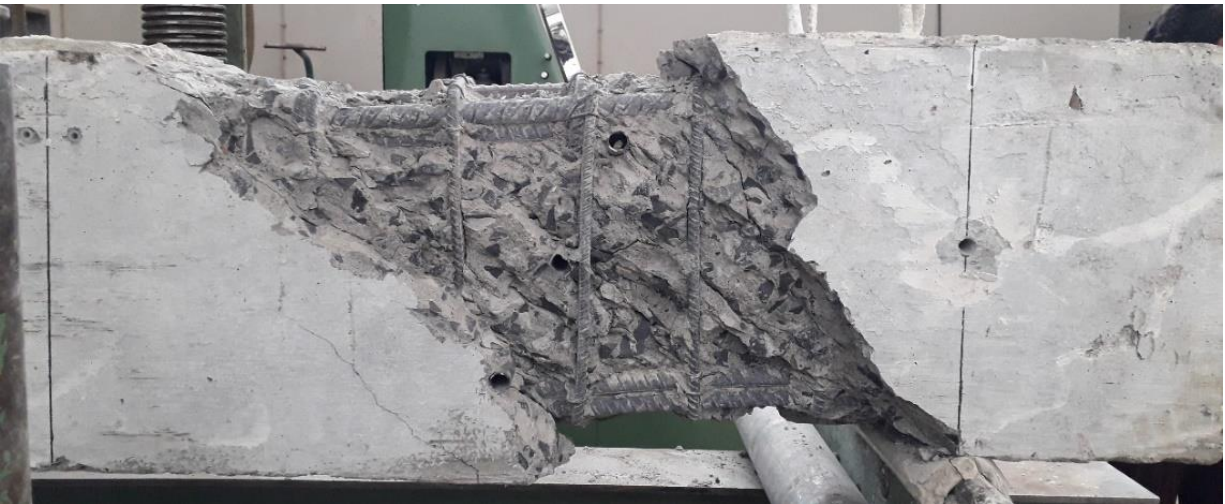
Concrete cover section in the entire diagonal compression region was detached from the core. The loose concrete cover was hand-picked as it was completely separated from the concrete core. Concrete covers (including top and bottom covers) were wholly spalled at the maximum shear stress area of the beam.

Figure 4-25: Spalled Section Front Side (SII10-50)

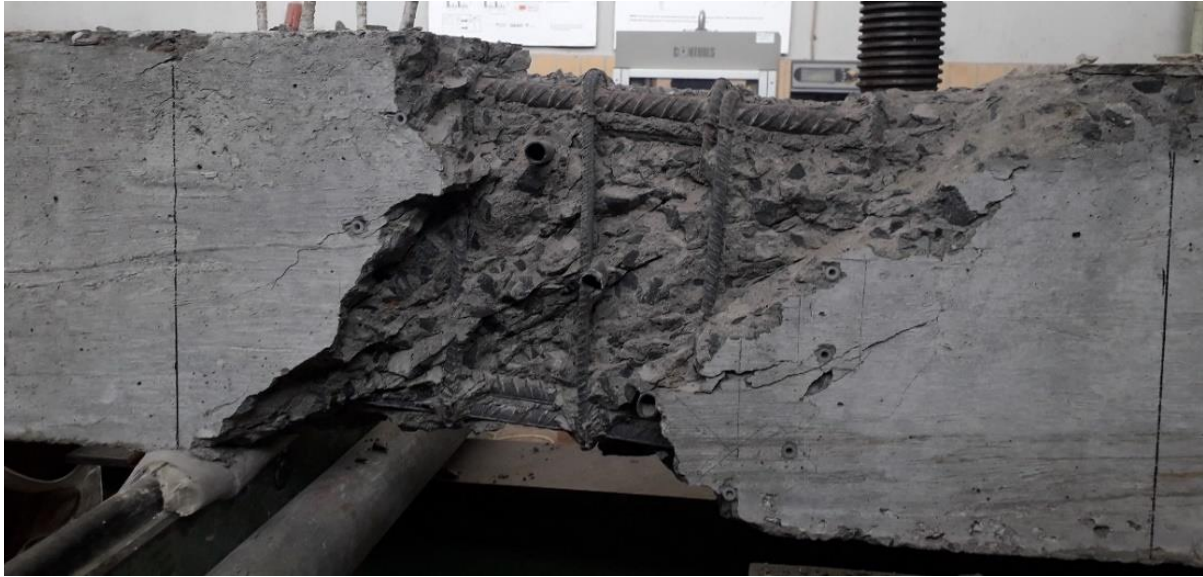
Figure 4-26: Spalled Section Back Side (SIII10-50)

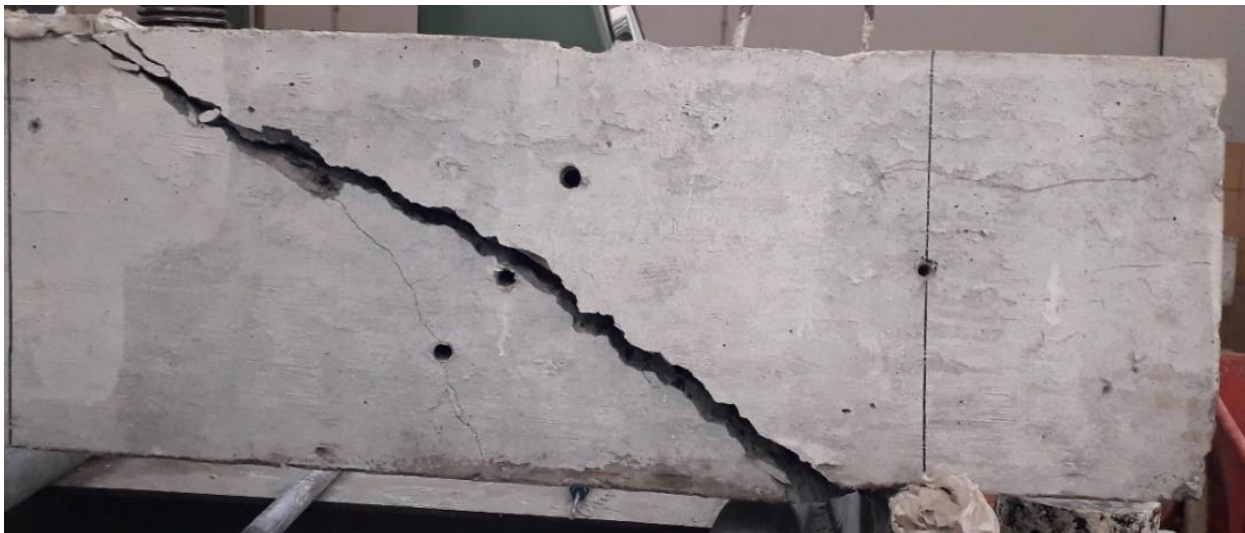
The diagonal compression crack that led to failure happened in the right side of the beam. Once the diagonal crack was created, its widening happened quickly. It had a width of 15mm.

Figure 4-29: Diagonal Compression Crack at Failure Front Side (SIII10-75)

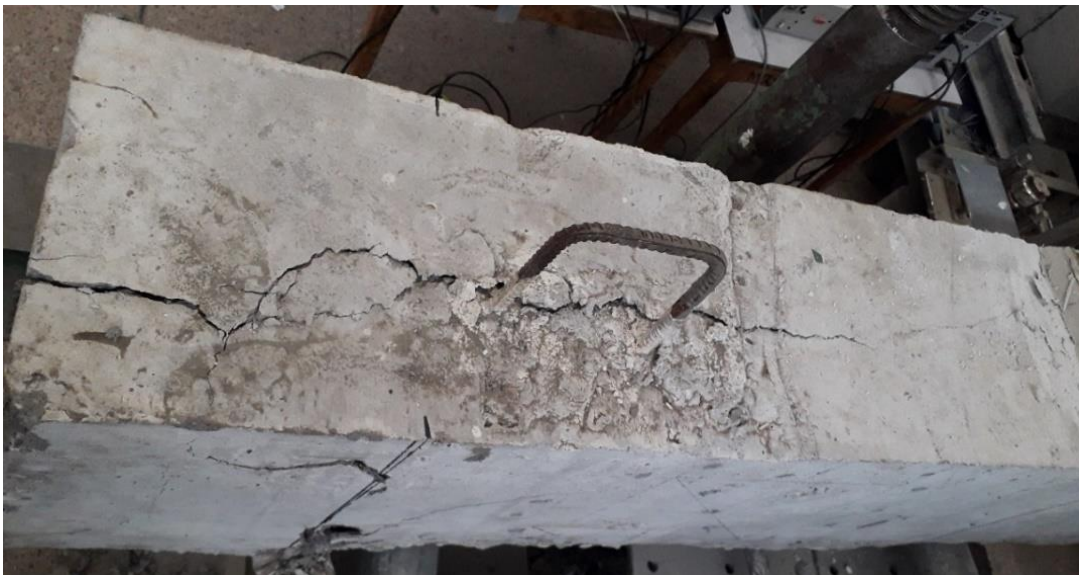
Cracks observed at the rear end cross section of the beam were continuation of the top longitudinal crack as shown below in Figure 4-31.

Figure 4-31: Top Longitudinal Crack (SIII10-75)

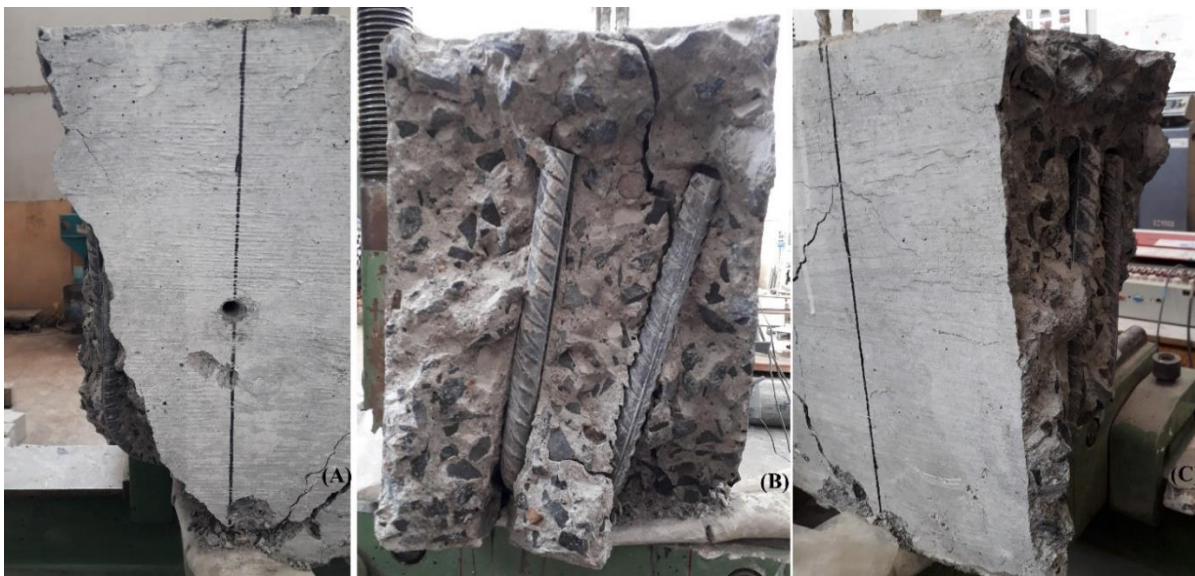
After reaching the peak load, the cover on the rear left side fell off. Failure started at the left support from the front side and propagated diagonally along the section, leading to a sudden detachment. This incident prevented post peak loading as the detached section created a loss of confinement near the support and the concrete directly above the support had crashed following the fall-off.

Figure 4-37: Concrete Cover Spalling at the Rear Left End (A) Front View (B) Sectional View (C) Back View (SIII8-75)

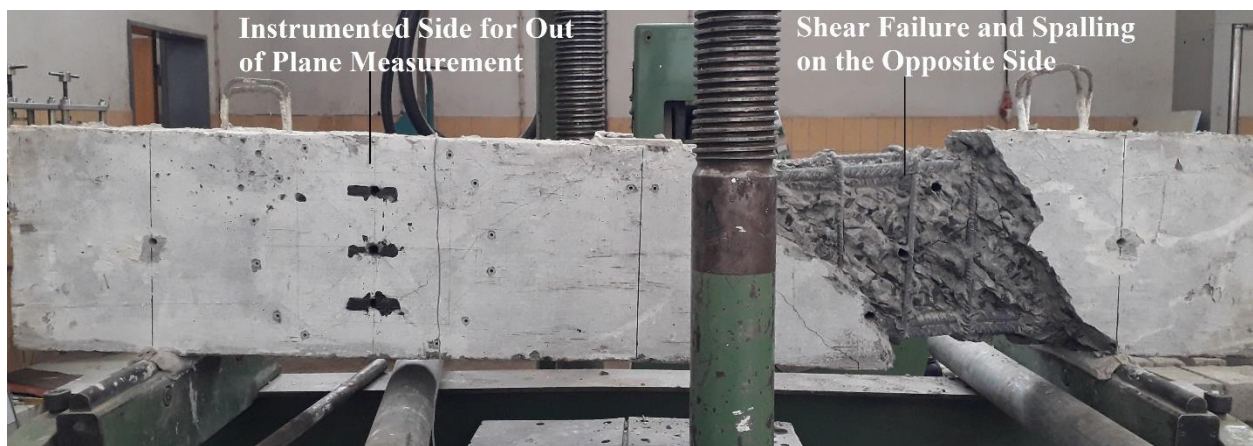
Figure 6-15: SII10-50's Failure Opposite to the Instrumented Side

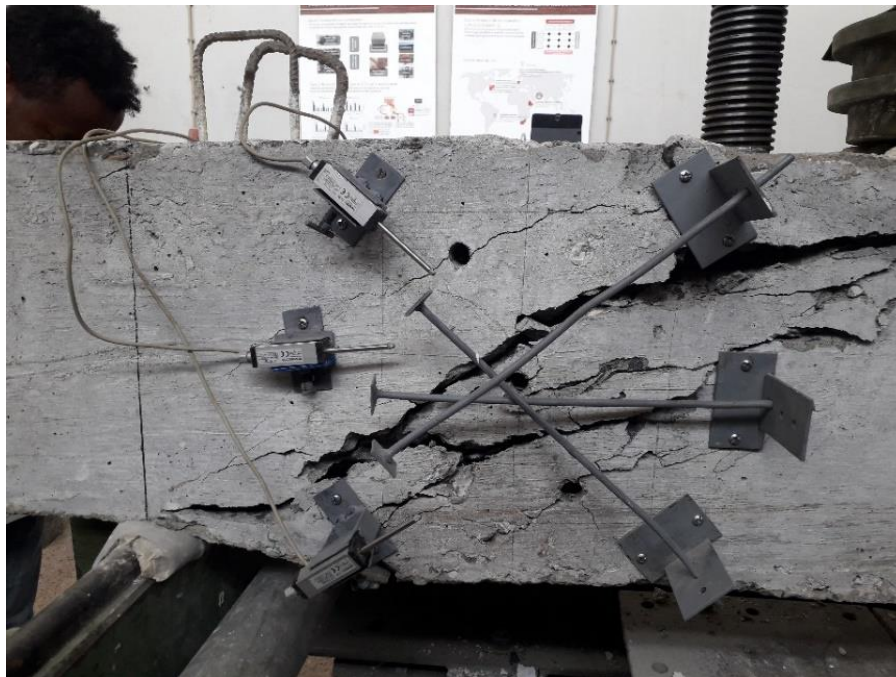
Figure 6-19: Out of Plane Deformation Disrupting Surface Displacement Measurements
