ADDIS ABABA UNIVERSITY
ADDIS ABABA INSTITUTE OF TECHNOLOGY
SCHOOL OF CIVIL AND ENVIRONMENTAL ENGINEERING

**AN EXPERIMENTAL INVESTIGATION ON THE EFFECT AND
MECHANISM OF SIDE COVER SPALLING FOR SLENDER BEAMS
SUBJECTED TO SHEAR**

A Thesis in Structural Engineering

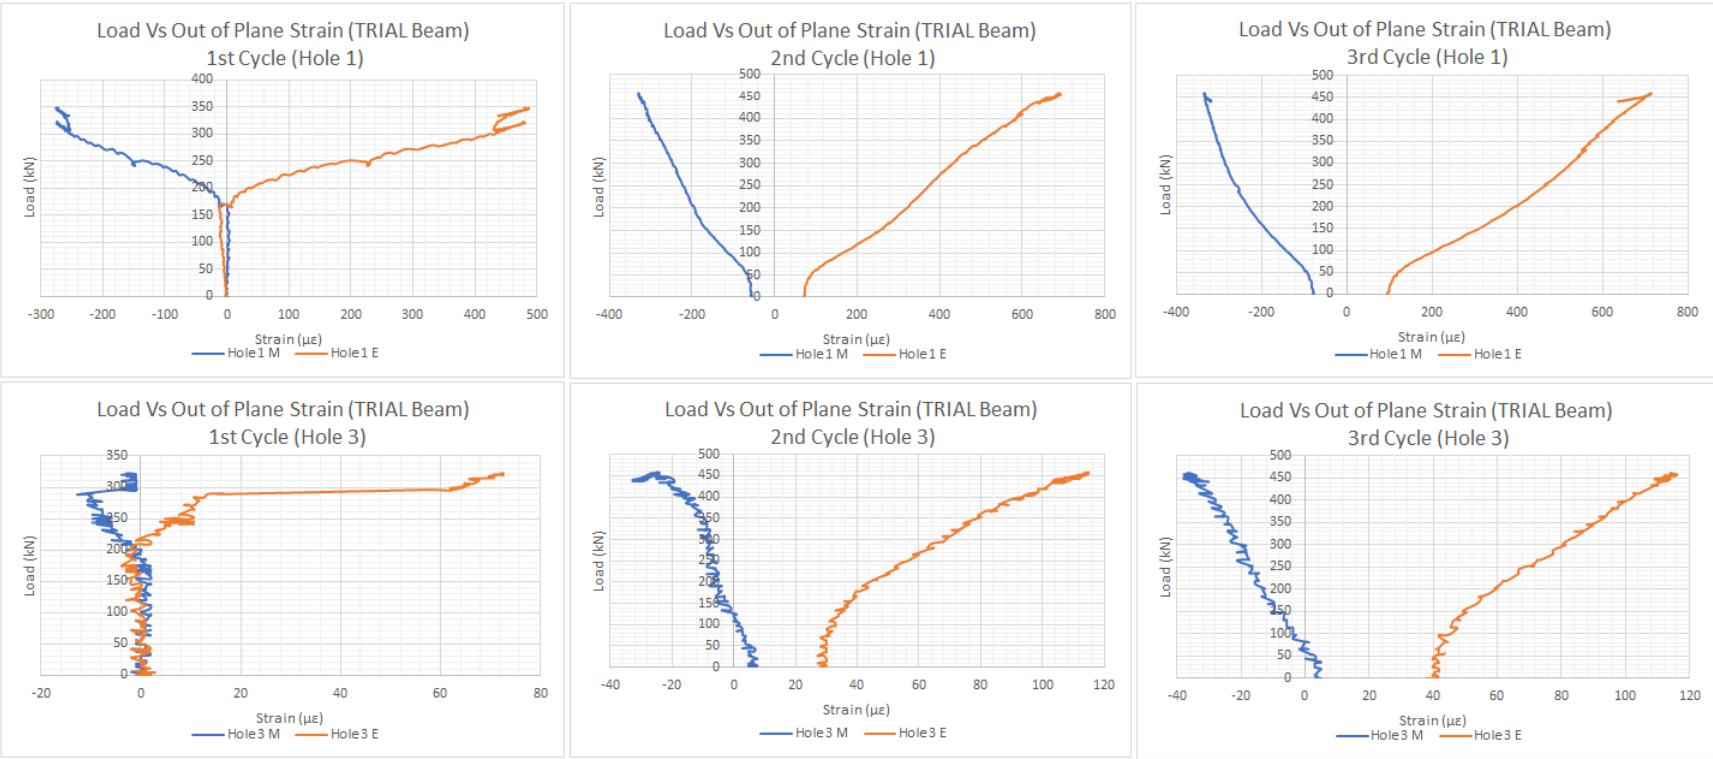
Figure 1: Load Vs Out of Plane Strain (TRIAL Beam 1st -3rd Cycle)
