Investigation of Cause of Failures of Highway Cross Drainage Structures

(Case Study on Raya River Bridge)

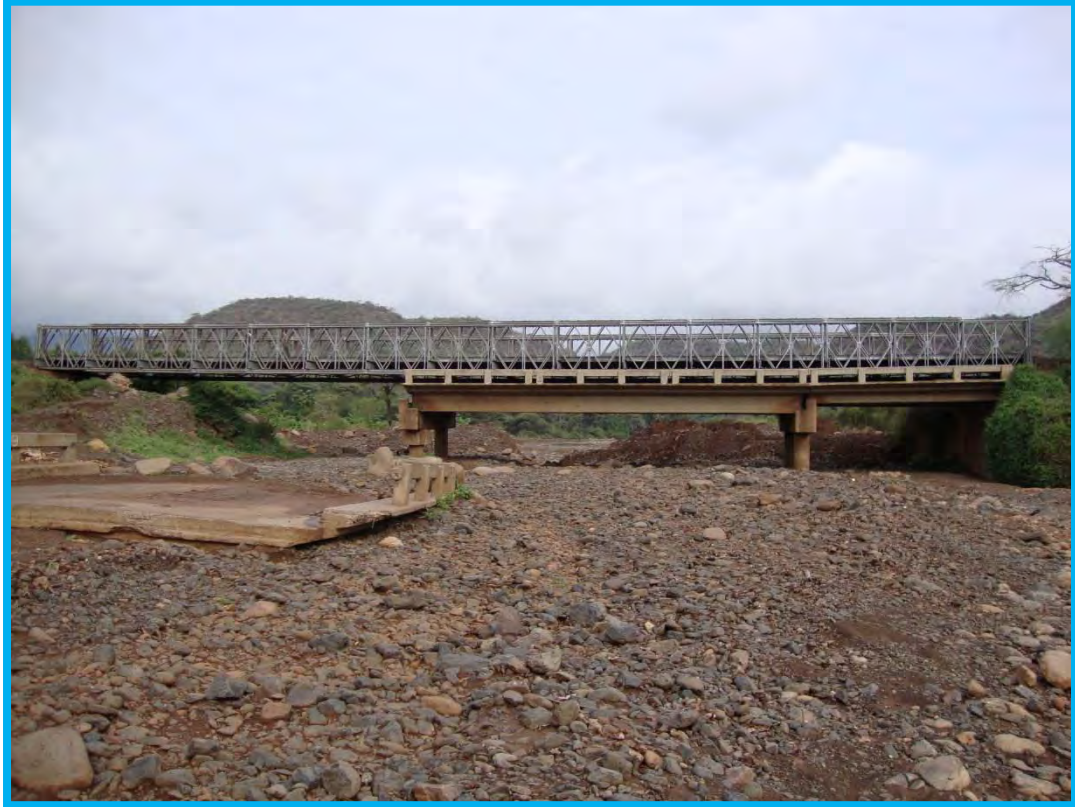
Photo 1: Raya River Bridge failure (Sep 2009)

- ✚ The failure of the existing multiple span (8m+18m+8m) span bridge along the Addis Ababa – Arbaminch main road. See photo # 1
- ✚ Cracks on the pier and abutment of the bridges. See photo # 2
- ✚ Aggradation or increasing of river bed elevation. See photo # 3
- ✚ Silted up weir or diversion structure at the upstream of the bridge. See photo # 4
- ✚ Flooding problems around bridge location.

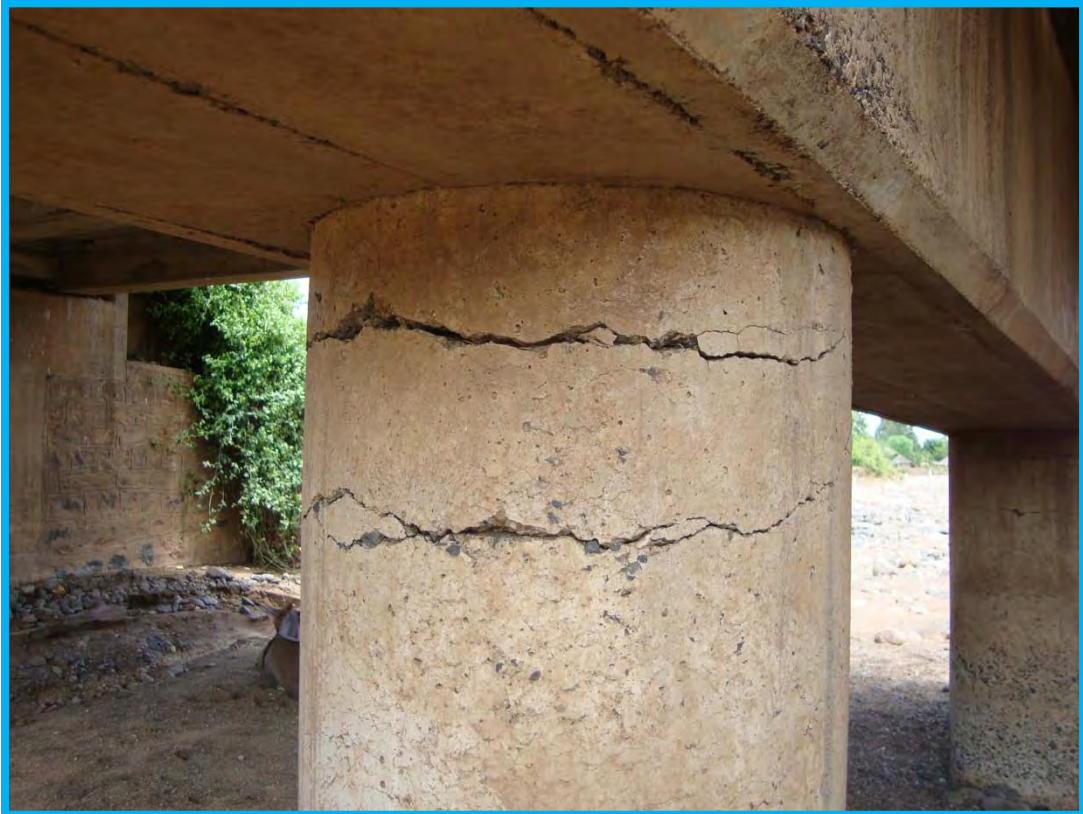
Photo 2: cracks on the pier (Sep 2009)

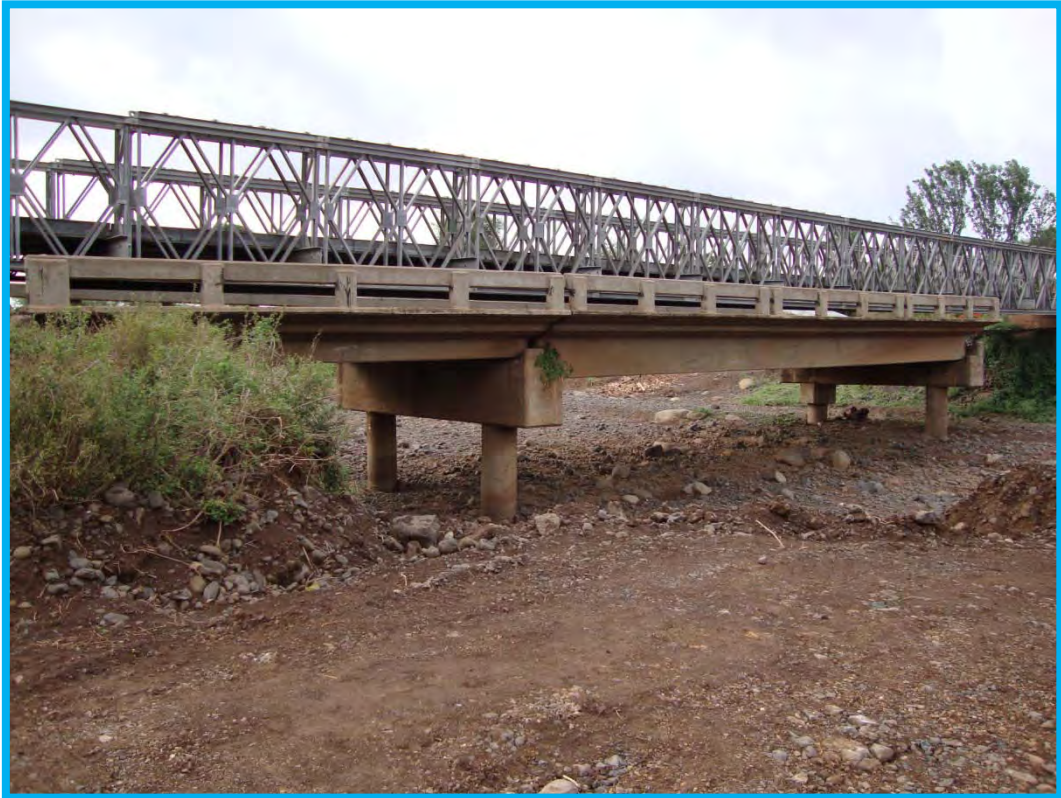
Photo 3: River bed level rise (Sep 2009)

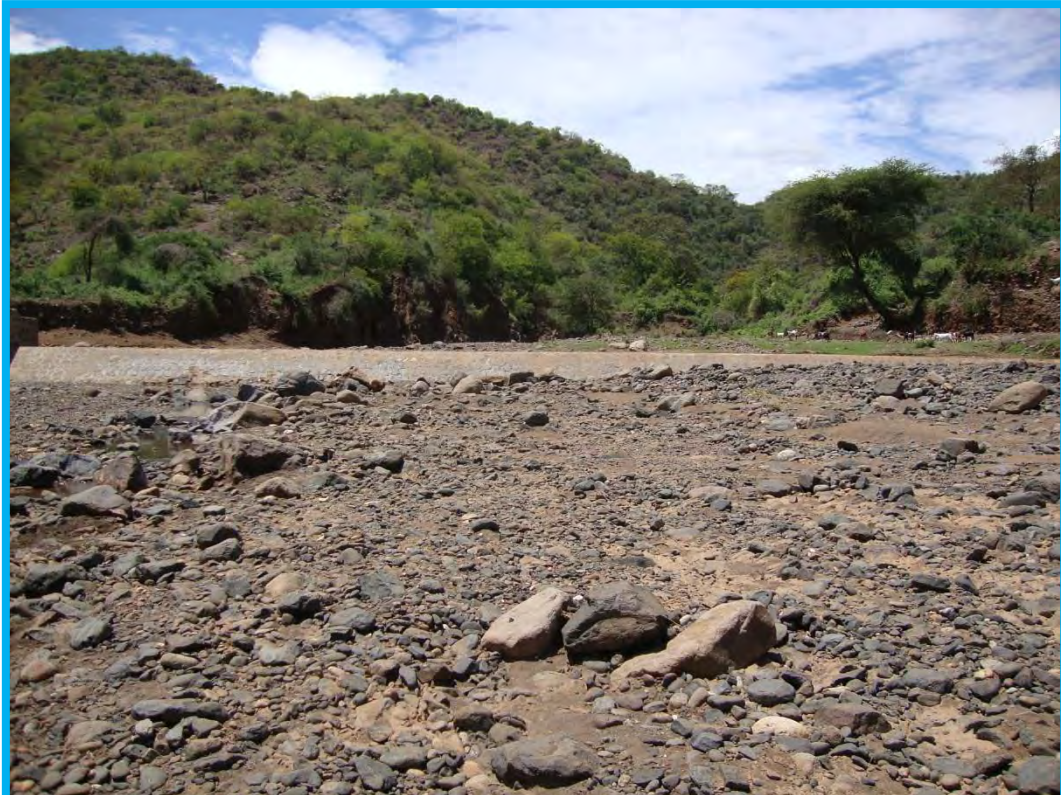
Photo 4: Silted up diversion structure (Sep 2009)

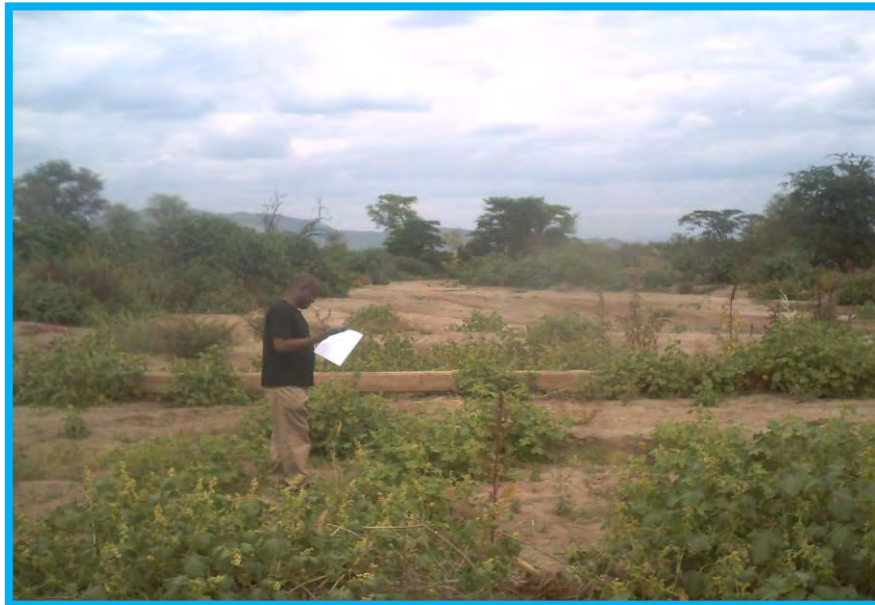
Photo 5: Segen River Bridge completely buried under sediment (Aug 2007)

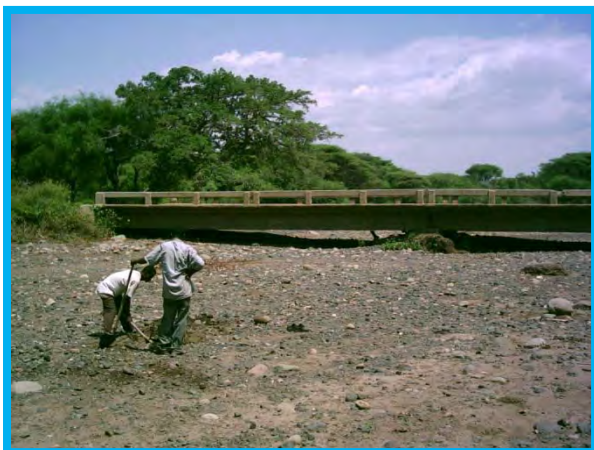
This mentioned bridges and other bridges which are located on Addis Arbaminch main road are vulnerable for completely failure due to the rise in their river bed level and reduction of clear opening height at the crossing locations. See photo # 6&7

Photo 6: Shefe River Bridge less than 0.9m clear opening height (Jun 2006)

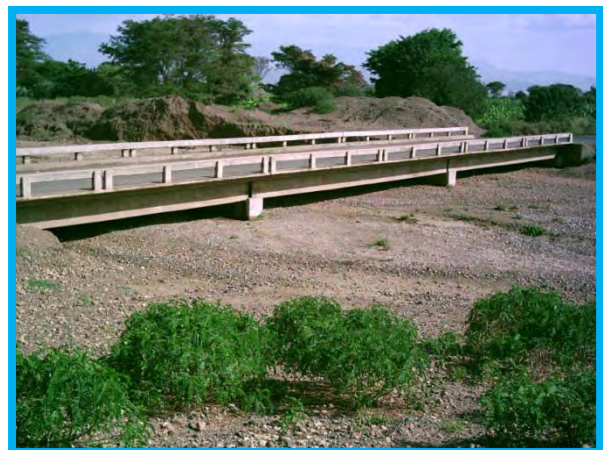
Photo 7: Baso River Bridge less than 0.7m clear opening height (Jun 2006)

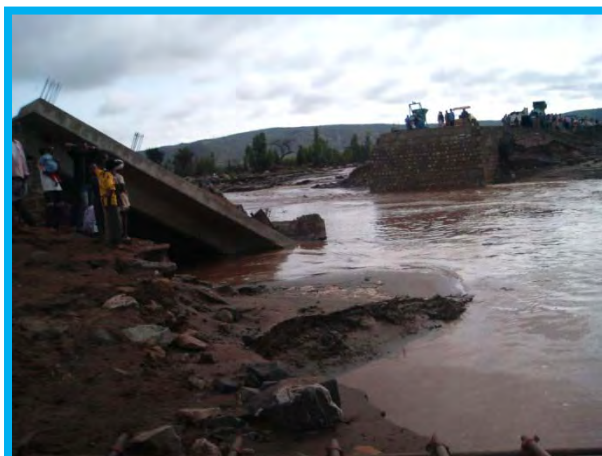
The Fafem River Bridge is located on Harar Jijiga road project at 68km from the tourist town Harar. The bridge is recently constructed in 2007 G.c and failed within a year in 2008G.c due to flooding. From the observed and collected data the bridge does not have sufficient opening size to accommodate the coming flood on the proposed bridge location.

Photo 8: Failed Fafem River Bridge (Jul 2008)

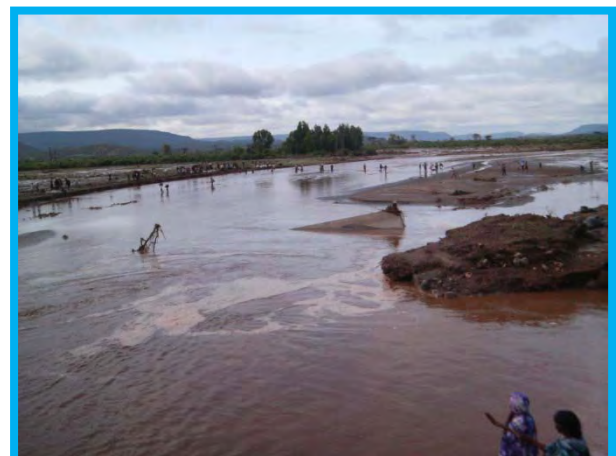
Photo 9: Fafem river flooding condition (Jul 2008)

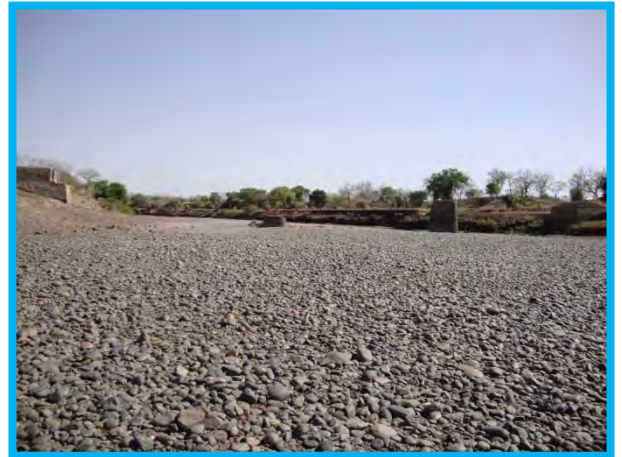
Guang River Bridge is located on Metema Abederafi gravel road section around 8km from Metema. The bridge is a triple span Girder bridge having span of 72m each 24m span were constructed by nongovernmental organization(NGO) and the bridge serves only for one rainy season and completely failed due to flooding. Based on the local peoples information given the bridge does not have sufficient opening size to accommodate the flood during rainy season.

Photo 10: Failed Guang River Bridge (Jun 2009)

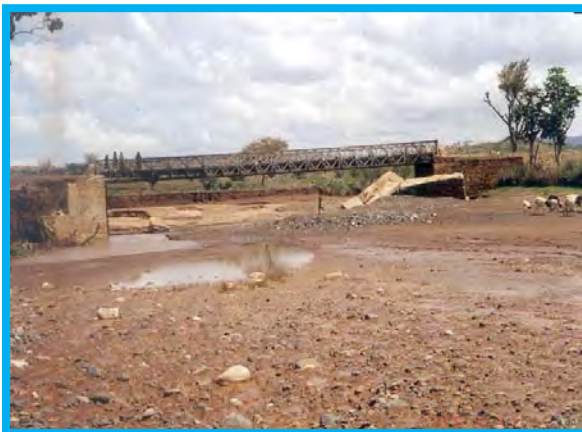
Photo 11: Delbena River Bridge (Aug 2006)

Delbena River Bridge located on the Arbaminch Konso road and it is failed due to flooding. In addition there are also other bridge failures observed on this road section.

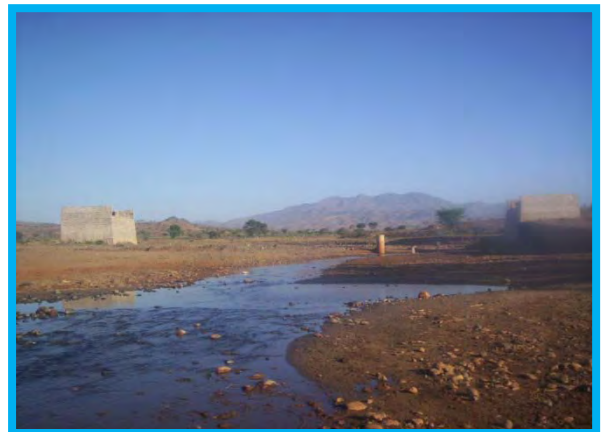
Photo 12: Failed Delbena Bridge (Aug 2006)

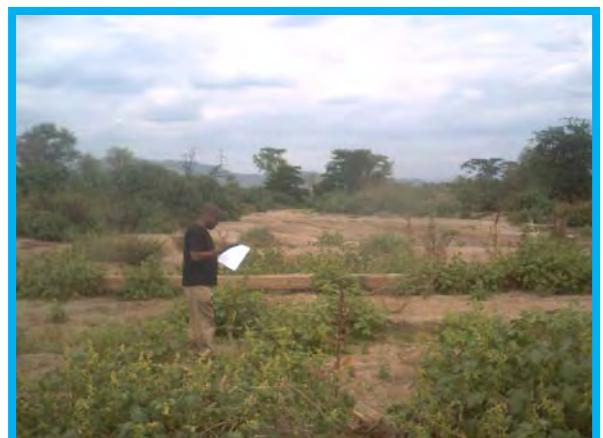
The Segen River Bridge is located on Fesehagenet Konso road around 16km from the tourist town Konso. This bridge is completely buried under sediment and at present it's not functional at all.

Photo 13: Completely buried Segen Bridge (Aug 2007)

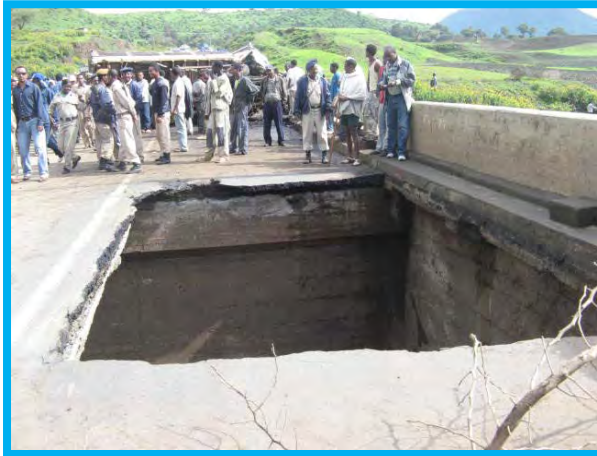
Garno River Bridge is located on Addis Ababa Gonder main road at 674km from Addis Ababa. This is 12m span Girder Bridge constructed in 1977G.c there is a scouring problem on one of the abutment and it causes failure of the approach slab.

Photo 14: Collapsed approach slab of Garno Bridge (Jul 2006)

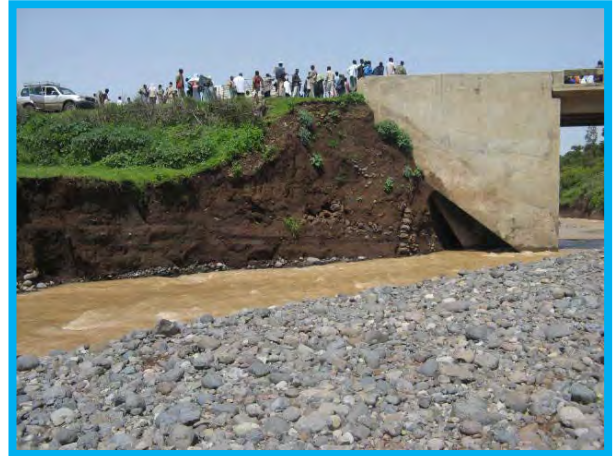
Photo 15: Scouring on the abutment of Garno Bridge (Jul 2006)

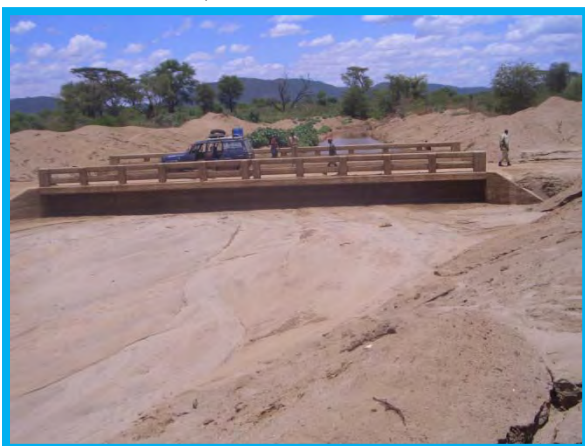
Photo 16: Aggradation on river Segen with inadequate opening (Aug 2007)

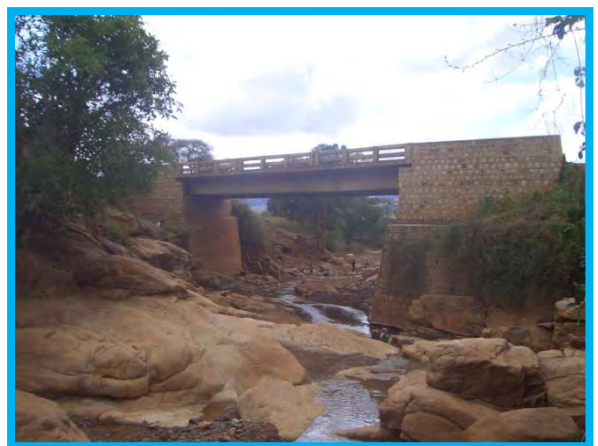
As illustrated in photo # 17 the highway crossing problems associated with degradation are the exposure of footings, the exposure of pile bents, and the erosion of the abutments. Degradation also undermines bank protection, results in instability of channel banks, and increases debris problems. Ultimately, the degradation can result in the loss of a bridge and in fact, is responsible for the loss of many bridges throughout the country.

Photo 17: Degradation on river Warda exposing the foundation of the abutment (Aug 2007)

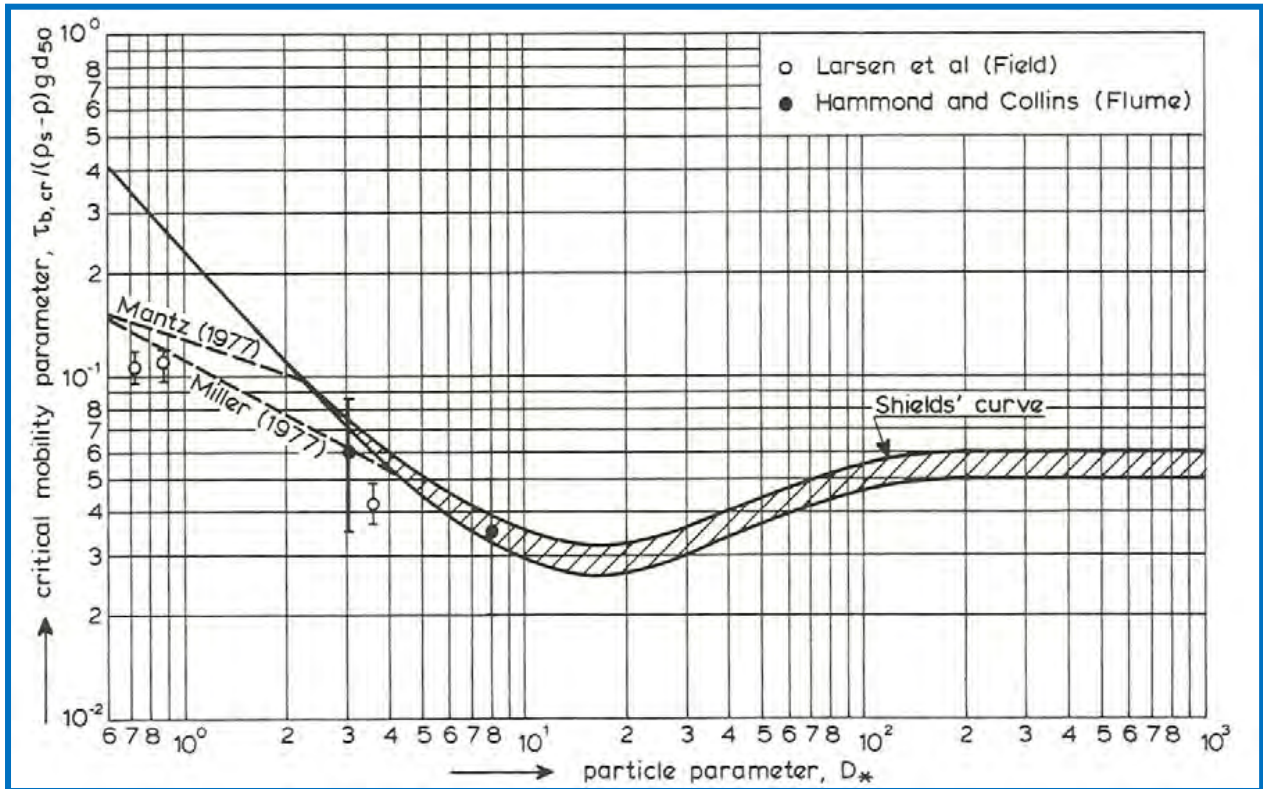
Figure 3: Critical bed shear stresses as a function of sediment particle diameter, shields (1936).

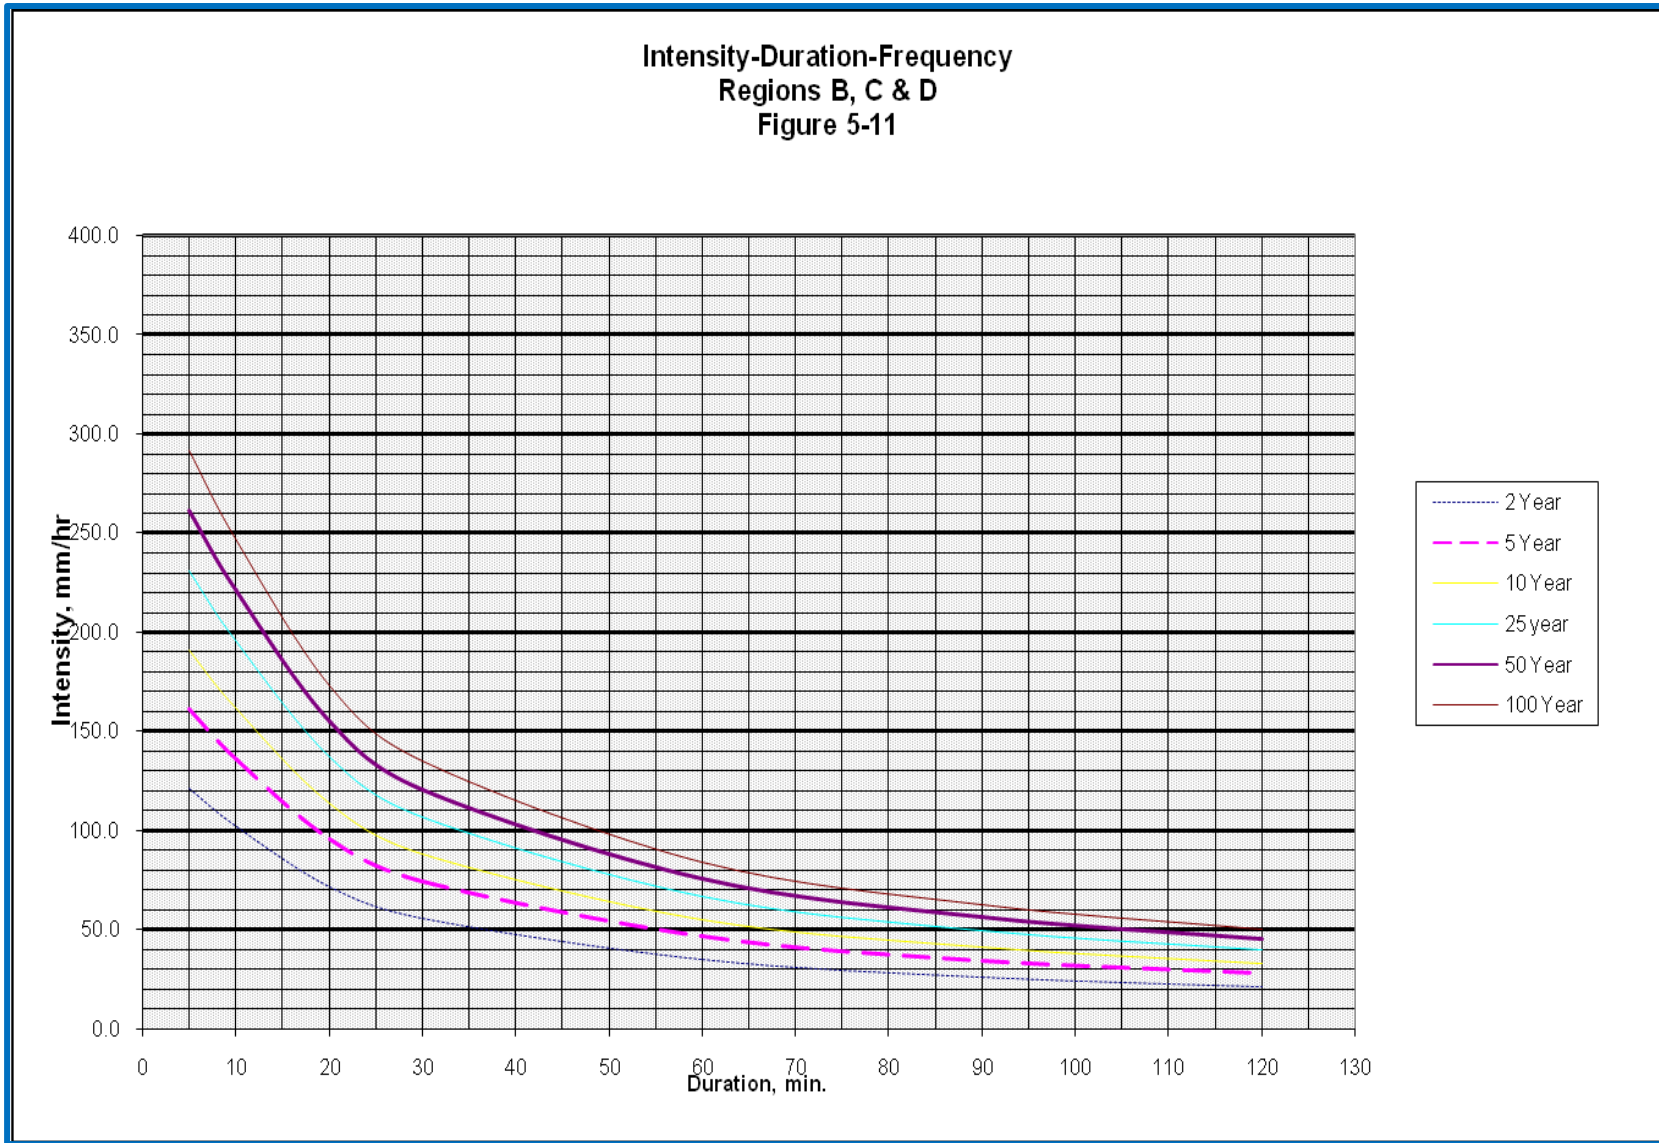
Figure 4: Intensity duration frequency curve for region B (ERA DDM 2002)

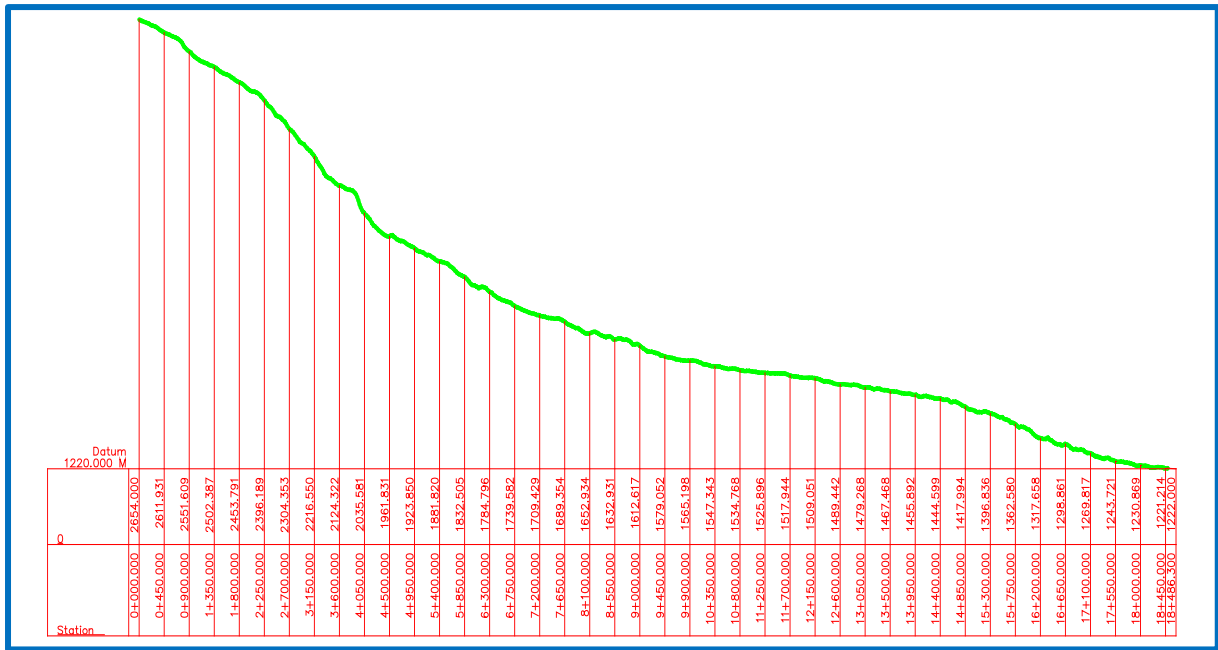
Figure 7: Raya River bed profile

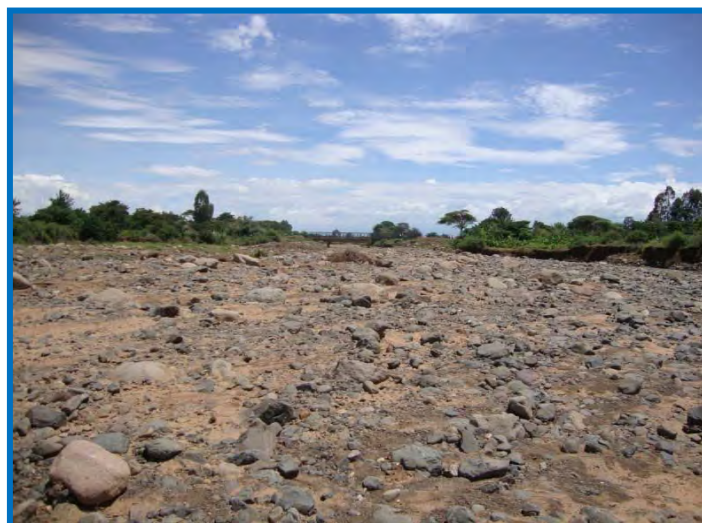
Photo 18: Raya River Bed Material (Sep 2009)

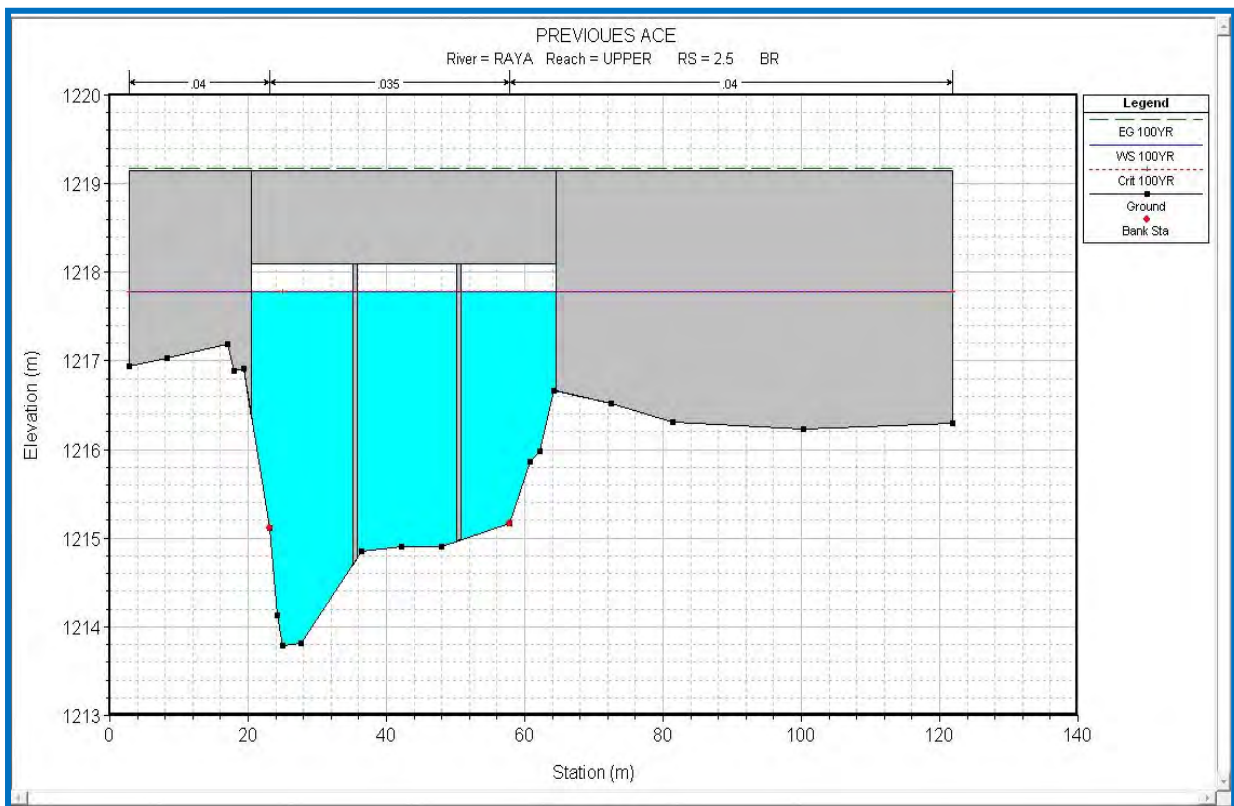
Figure 13: 100 yr peak flood profile for the new AEC 45m span bridge

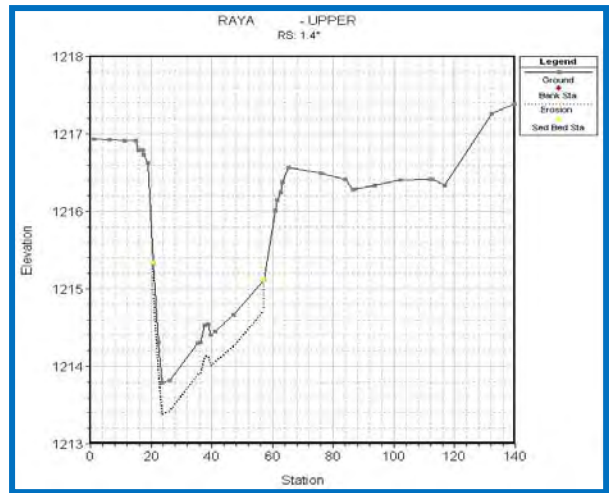
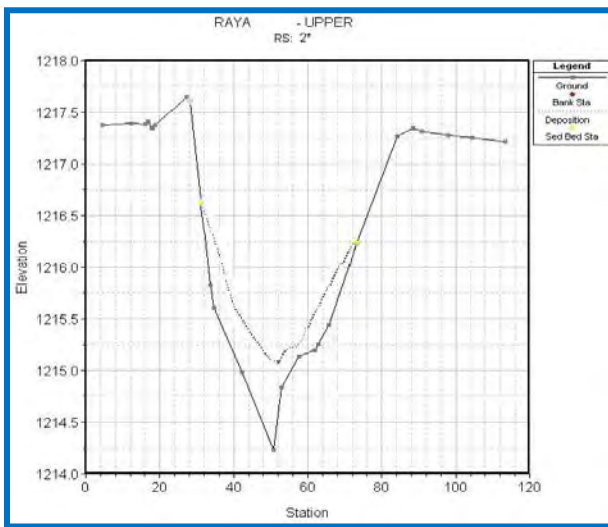
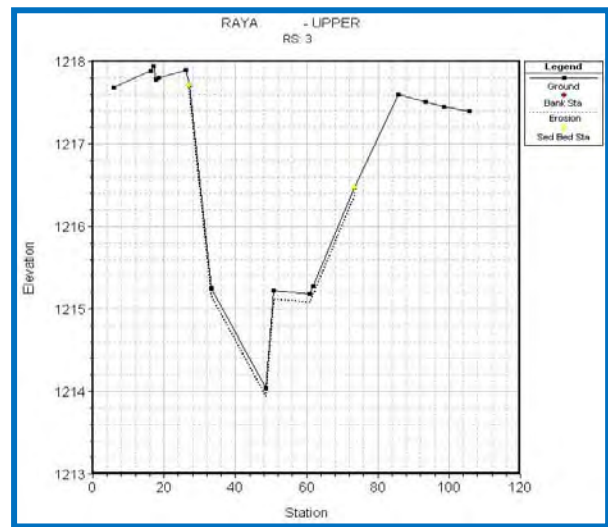
Figure 17: HEC-RAS sediment model result showing Scour and Deposition in Cross section

A) Downstream of bridge crossing location

B) At bridge crossing location

C) Upstream of bridge crossing location
