Landslide Inventory Mapping and Susceptibility Analysis for
the Jimma-Metu-Gore Transportation Route.

A Thesis in Geotechnical Engineering

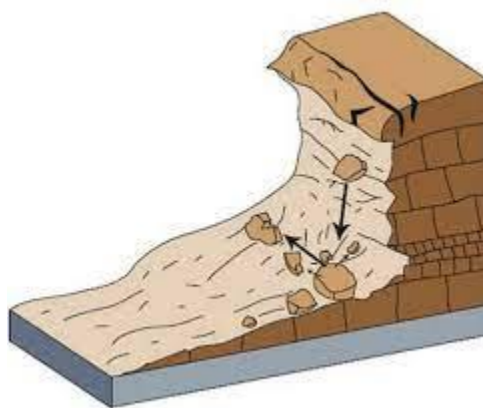
Figure 2-1: Rock Falls (USGS, 2004)

Rock falls involve sudden movements of large rocks or boulders detached from their parent rock. Typically occurring along steep slopes or cliffs, these falls result from separation along discontinuities like fractures, joints, and bedding planes as shown in Figure 2-1. The movements manifest through free-fall, bouncing, and rolling. Rock falls are highly triggered by mechanical weathering and entrance of water in the fracture of rock masses. The phenomenon is common in jointed, fractured and weathered bedrock and steep slopes (Wachal & Hundak, 2000).

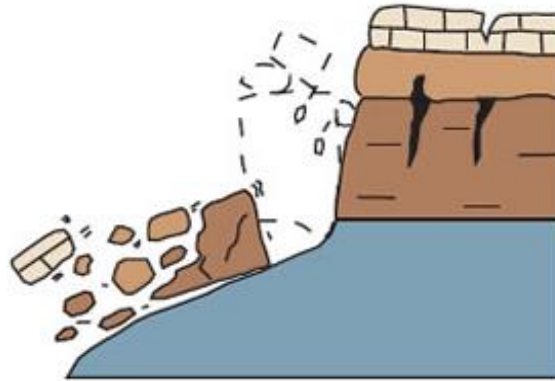
Figure 2-2: Topples (USGS, 2004)

Tumble refers to the forward rotation of a mass of slope materials such as huge masses of rock, debris and earth around a point or axis located below the center of gravity of the displaced mass (Varnes D. J., 1978). Unlike sliding, this form of failure occurs due to the overturning of blocks rather than simple sliding as shown in Figure 2-2. Cracks or fractures in bed rock are the main causes for this type of failure (Highland & Bobrowski, 2008)

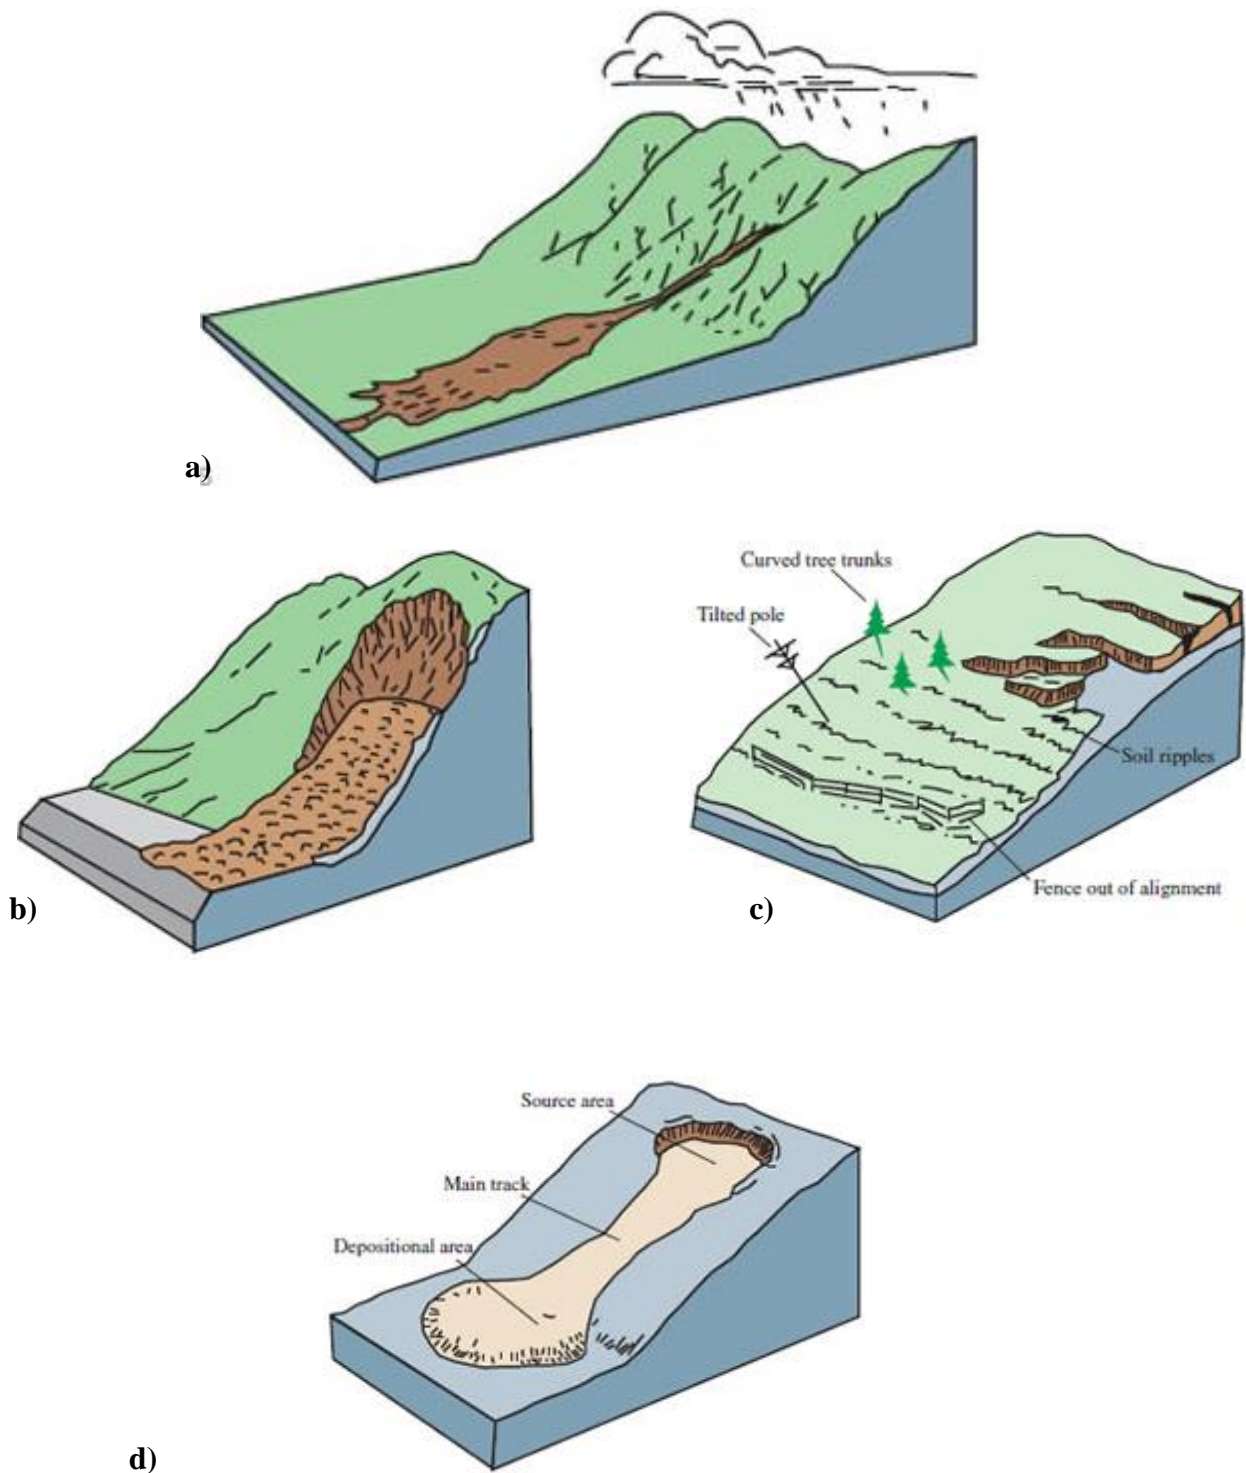
Figure 2-4: a) Debris Flow b) Debris Avalanche c) Creeps
 d) Earth Flow and Mudflow (USGS, 2004)

The first type, debris flow, involves rapid downhill movement of loose earth material which is accompanied by water as shown in *Figure 2-4 a*). It is characterized by rapid mass movement where the mix of loose soil, rock, organic matter, air, and water flowing as a slurry. Less than 50% fines are included in debris flow. They are usually triggered by intense surface-water flow, as a result of heavy rainfall or quick snowmelt that erodes and moves loose soil or rock on steep slopes. Their source areas are often linked with steep gullies, and their deposits are usually identified by the existence of debris fans at the mouths of gullies. The second type, debris avalanche, have similarities with debris flow but shows a more accelerated flow as shown in *Figure 2-4-b*. It varies from rapid to extremely rapid debris flow.

The third type, creep (shown in *Figure 2-4-c*), known by its slower nature, which usually is the cause of slight bends in electric poles and roads. It is the imperceptibly slow, steady, downward movement of slope-forming soil or rock. It is often triggered by heavy surface water flow, resulting from intense rainfall or rapid snowmelt, eroding and mobilizing loose soil or rock on mountainous areas which leads shear stress sufficient to produce permanent deformation, but too small to produce shear failure. It can also move large objects like houses downhill or fill structures with the rapid accumulation of organic matter or sediment, (Lynn & Peter , 2008). Creeps can be

The fourth type, earthflow, exhibits washed away finer earth material, leaving a depression bowl at the head as shown in Figure 2-4-d. The slope material liquefies and runs out, forming a depression at the head (top). Fine-grained materials or clay-bearing rocks on moderate slopes and under saturated conditions are more exposed to this phenomenon. Despite the fact that earth flow usually happens in wet conditions with fine grained material, dry flows of granular material are also possible. The last type, mudflow, made of saturated silt, sand, and clay materials, flowing rapidly. It is an earthflow made of material that is sufficiently saturated to flow rapidly and that have a minimum of 50 percent sand, silt, and clay-sized particles.

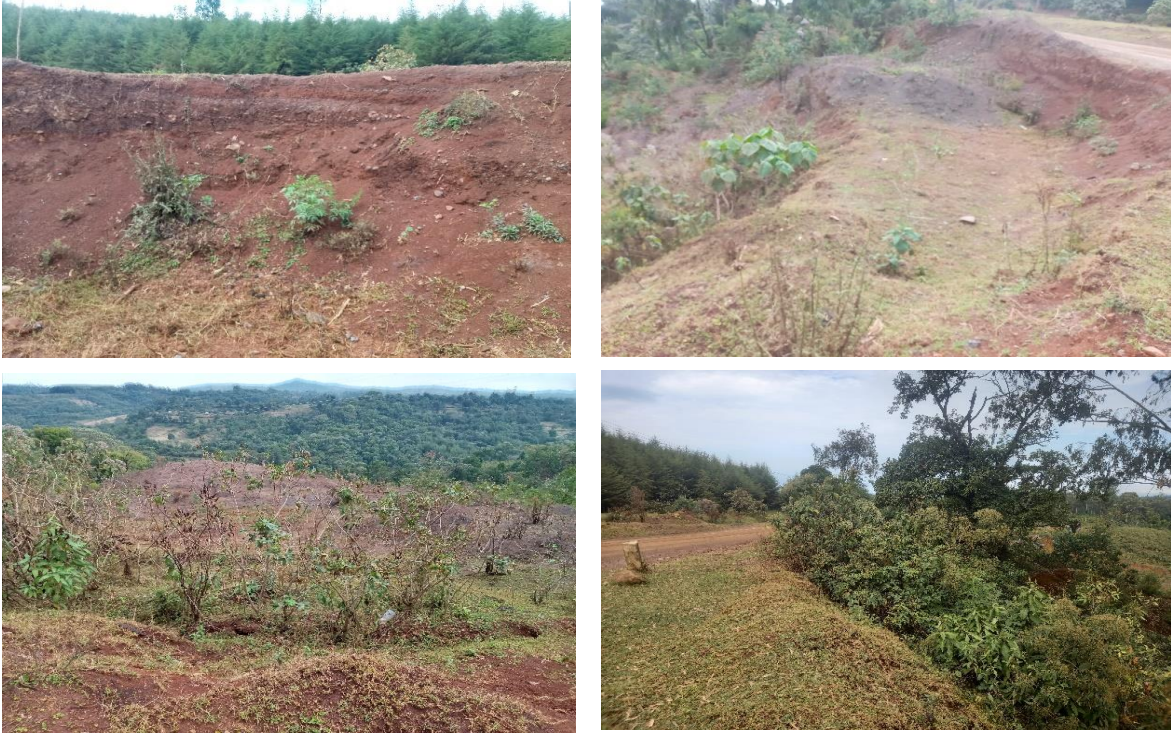
Figure 4-6: Land slide at 36+720 (Gechi)

The landslide at this location occurred near the Gechi area, which exhibits a moderately steep slope of 35 degrees. The failure developed across the road alignment, with the crown positioned on the edge of the road, and the road way is partially damaged as shown in Figure 4-6. The type of landslide is rotational landslide extending across an estimated 75 meters in length along the road.

Poor drainage and surface water accumulation are likely contributors to slope instability during wet seasons. The landslide exhibits a main scarp near the slope crest, with displaced materials moving downslope and minor scarps are also present.

A change of route with detour development was implemented to avoid the affected section as shown in Figure 4-7. While this measure temporarily solved the issue, the new path became completely out of service due to wet season. The old road way is currently giving service with twice a year maintenance at the landslide affected section.

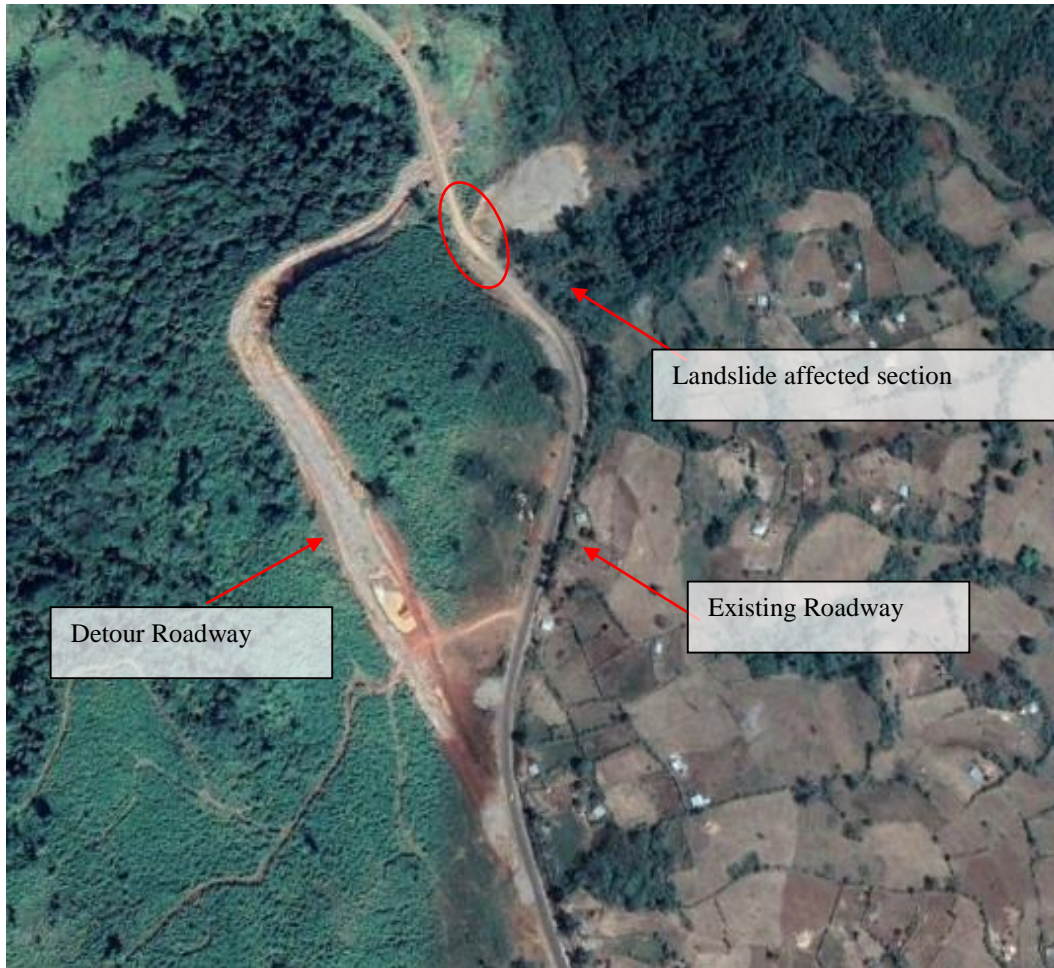
Figure 4-7: Existing and new detour roadways at 36+720 (Gechi) [Source – Satellite Image by Google Earth]

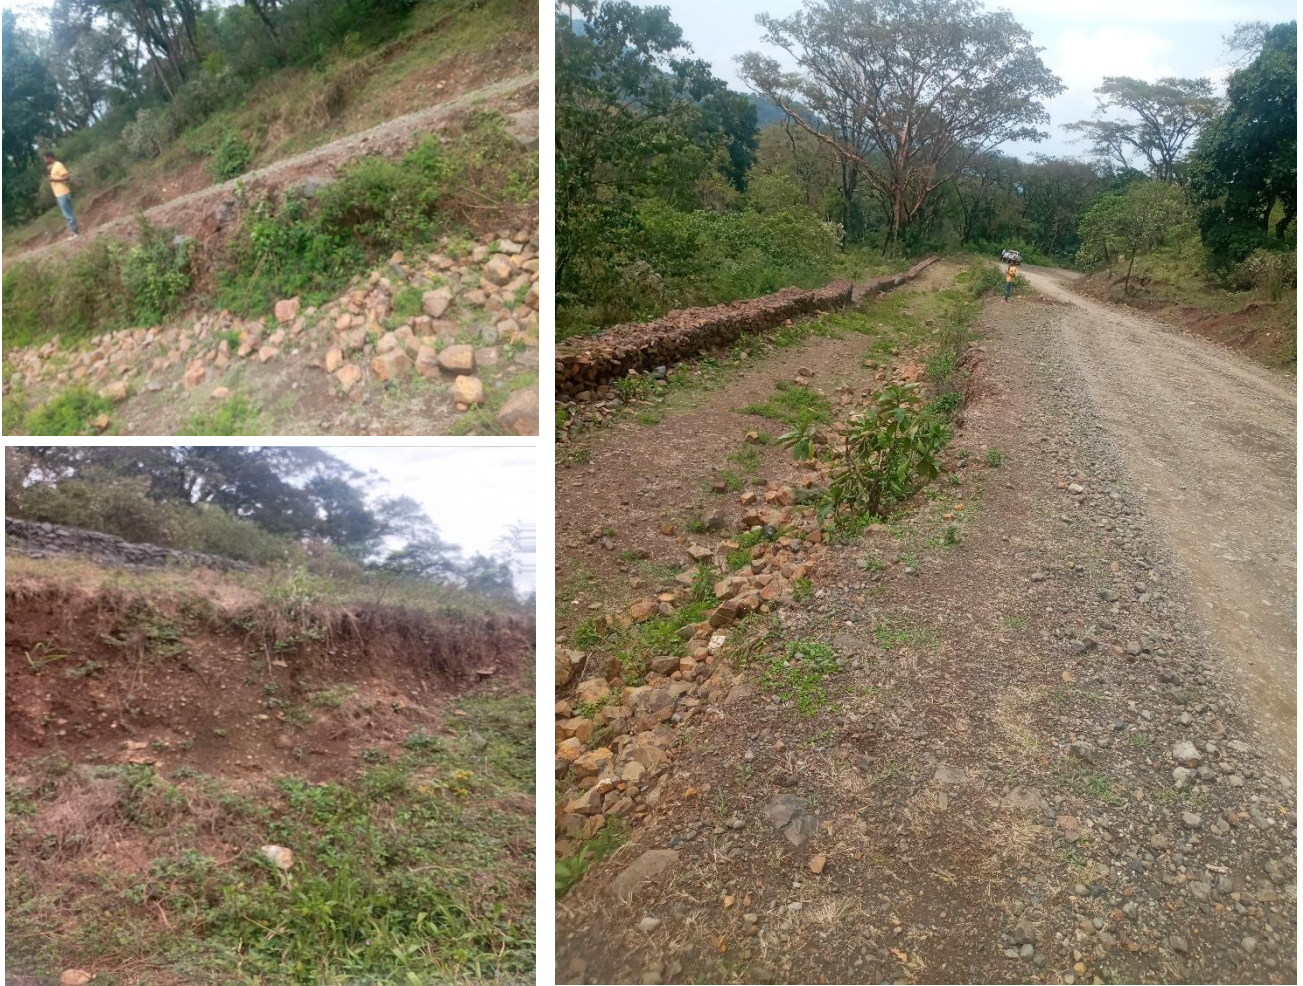
Figure 4-8: Land slide at 44+000 (inside "Yayo Forest")

The primary cause is uncontrolled surface water runoff during the rainy season. To address ongoing movement, a gabion retaining system was installed, but this by itself is moving downslope with the failure material as shown in Figure 4-8 and Figure 4-9. The area still demands twice yearly maintenance, indicating that the current intervention only reduces the extent of failure.

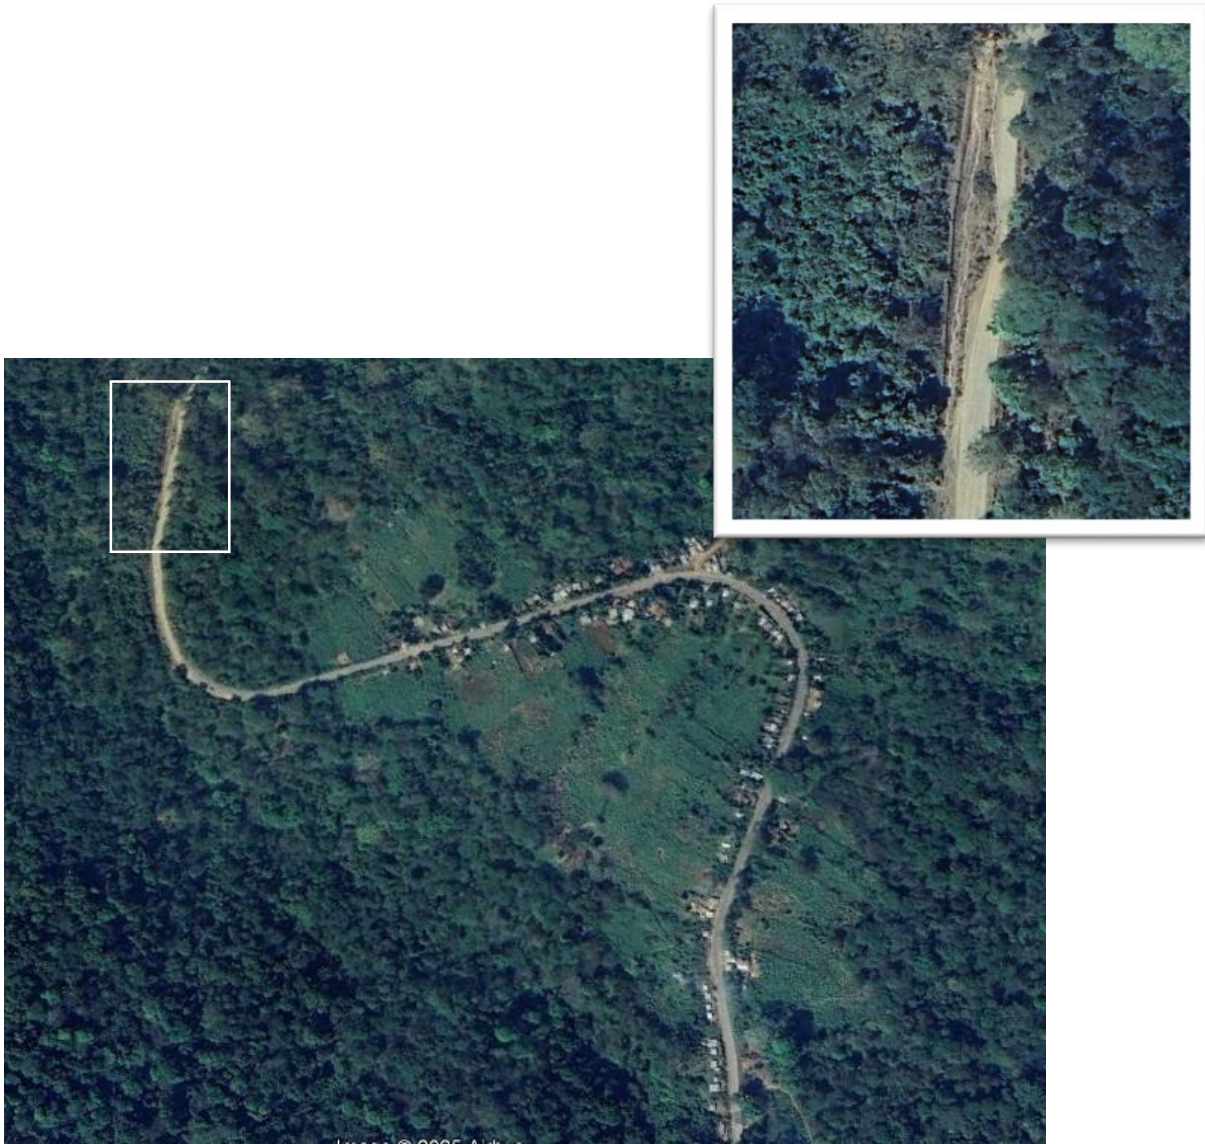
Figure 4-9: Landslide affected road section at 44+000 (inside "Yayo Forest") [Source – Satellite Image by Google Earth]

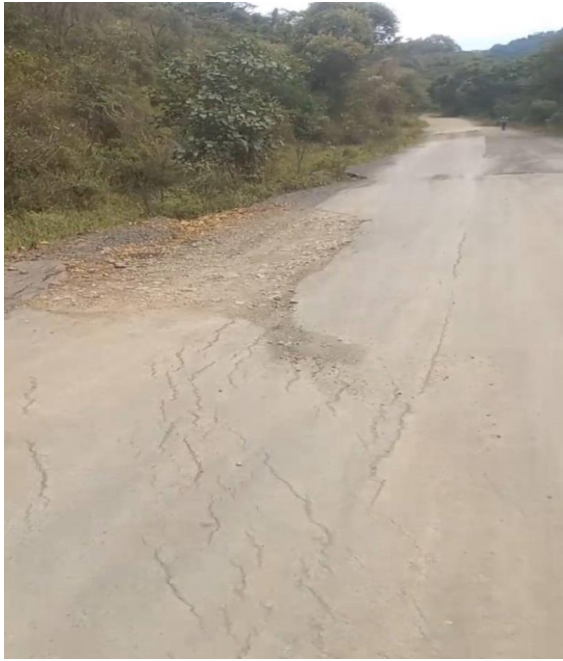
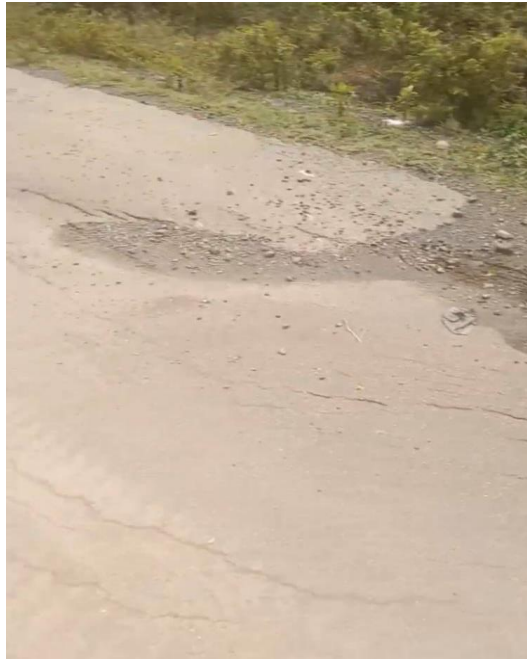
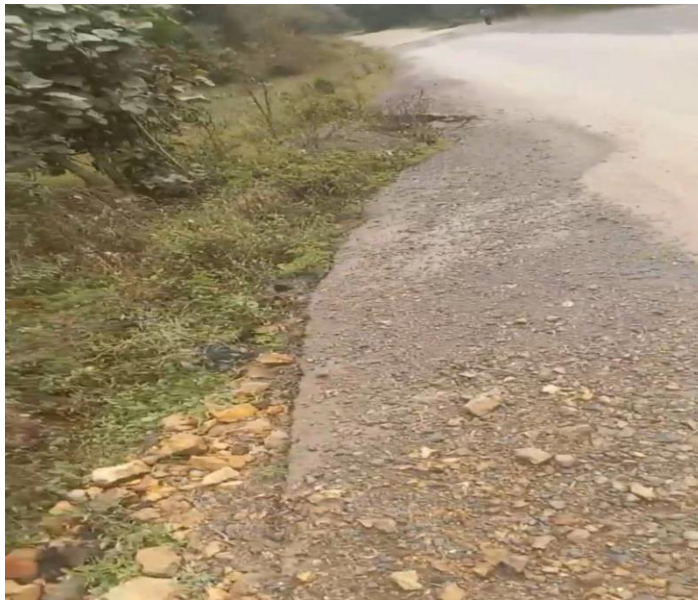
Figure 4-10: Land slide at 44+800 (Yembo)

The damaged area has been repeatedly refilled with selected material as a treatment as well as the pavement is reconstructed. But the failure is being encountered redundantly and the site requires once up to two times annual maintenance, showing the continuous occurrence of the failure and partial effectiveness of the remedial measure.

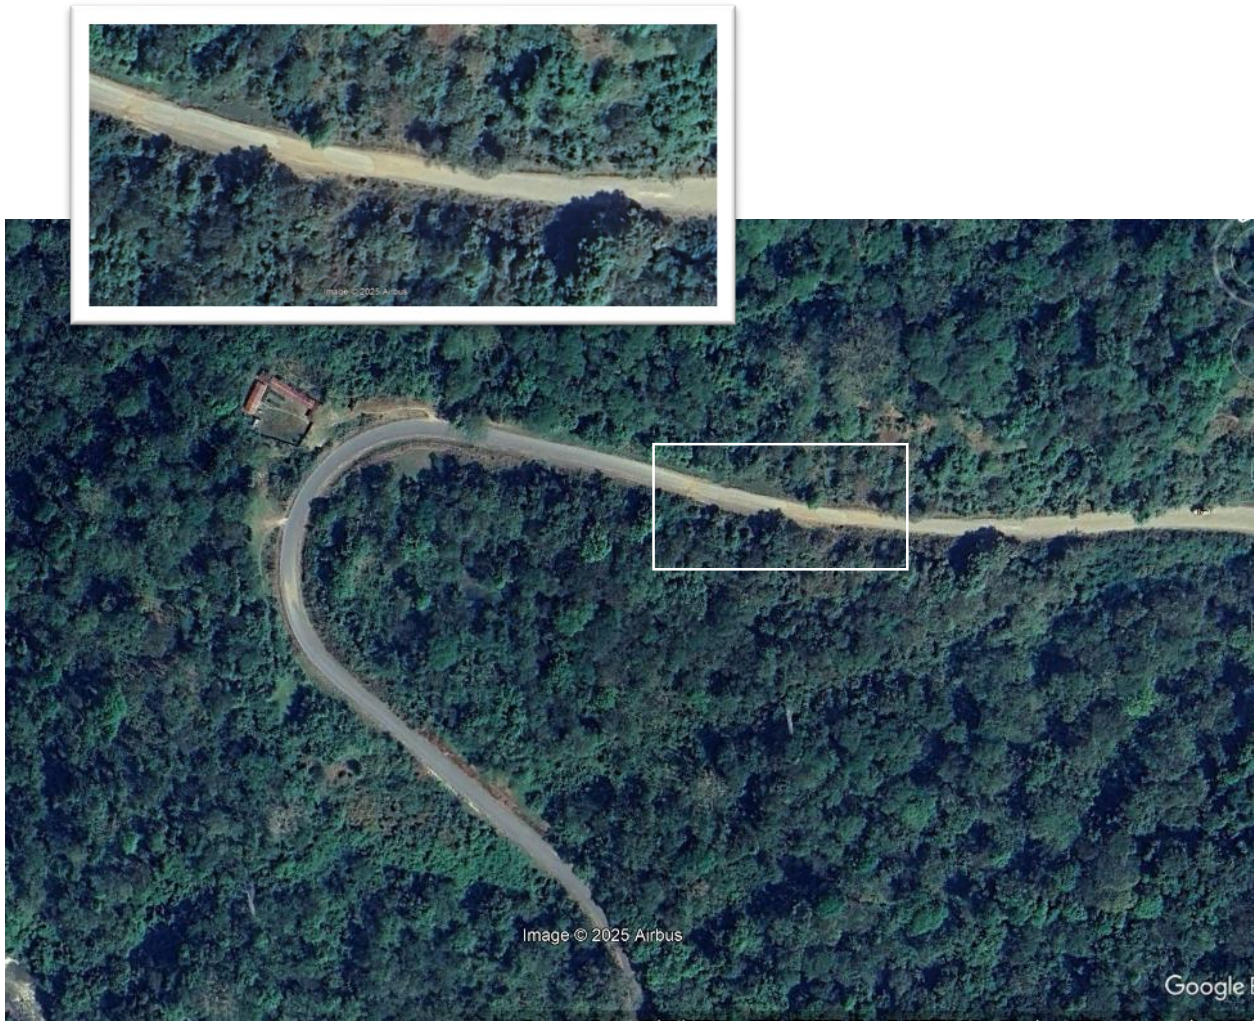
Figure 4-11: Landslide affected road section at 44+800 (Yembo) [Source – Satellite Image by Google Earth]

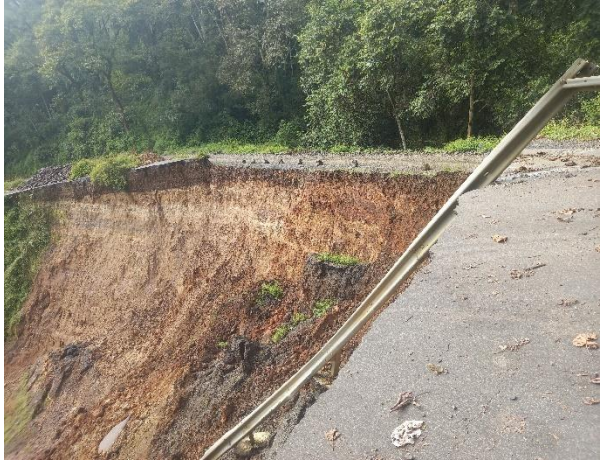
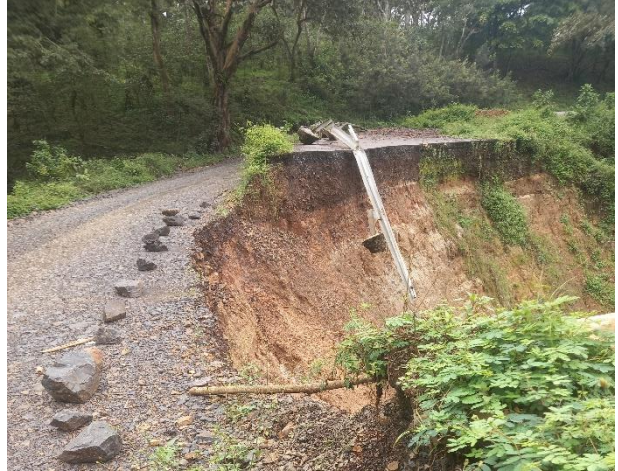
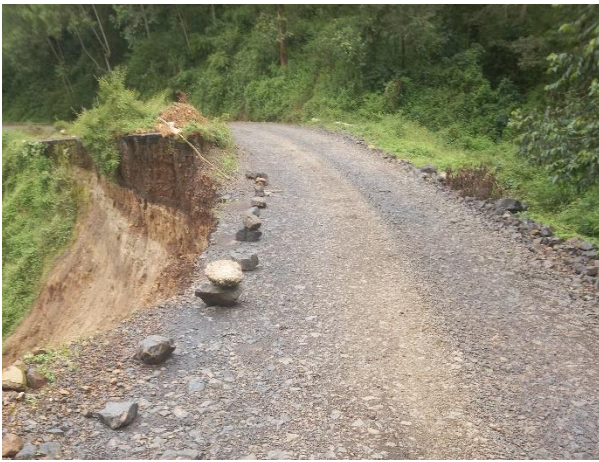
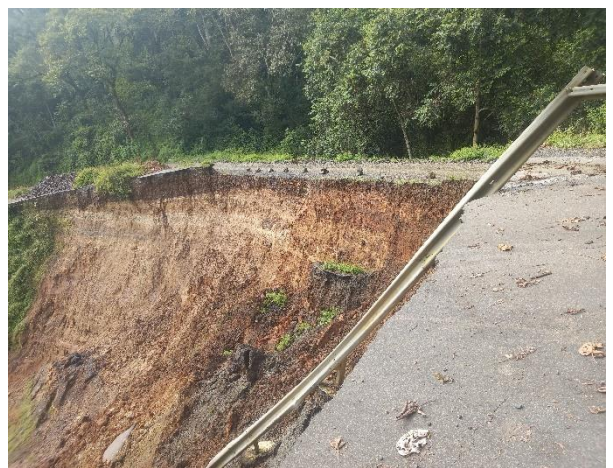
Figure 4-12: Land slide at 46+920 (Yembo) before any remedial measure taken [Source – historical pictures of onsite investigation by ERA engineers]

The landslide is very old and is still active. Even though the section has been treated repeatedly, the refilled material continues to fail bringing serious challenges to road safety and stability. To repair the damaged section of the road, various expensive remedial measures were taken. These are, large volume of selected fill material was applied at downstream side of the road as a construction of embankment to widen the passage way. The mountain above the roadway was also demolished to some extent for the same purpose as shown in Figure 4-13. Additionally, box culvert was built in order to give passage way for the upstream spring water. However, redundantly occurrence of the landslide indicates that the mitigation measures taken have only been partially effective, indicating that further investigation and improvement in stabilization techniques are still necessary.

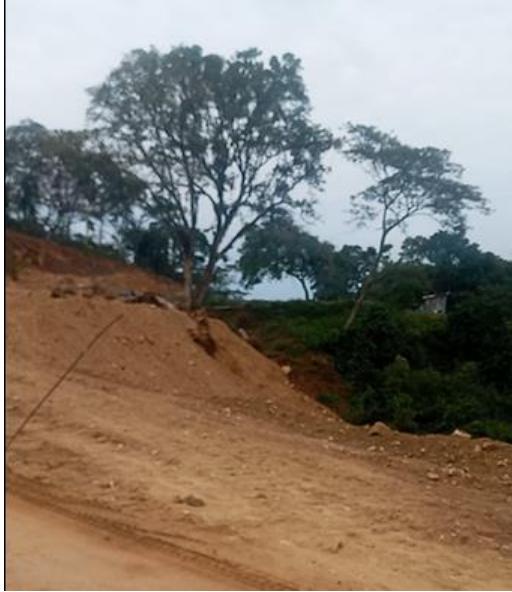
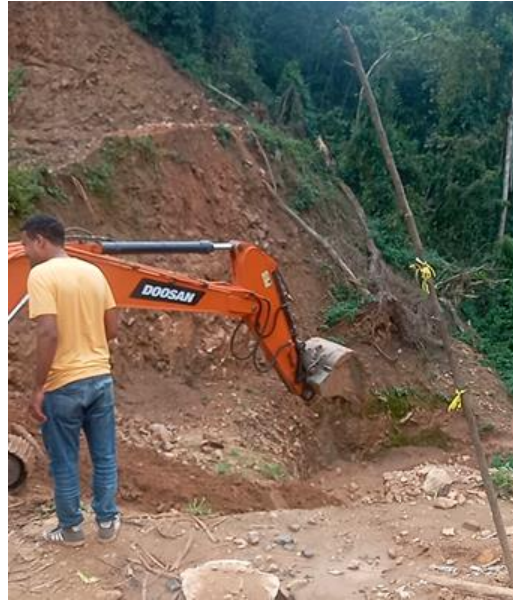
a) Large volume of selected fill material application downstream of the roadway

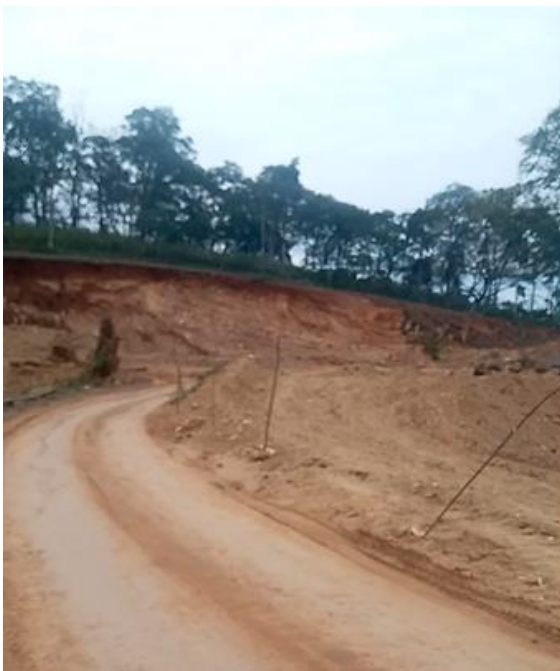
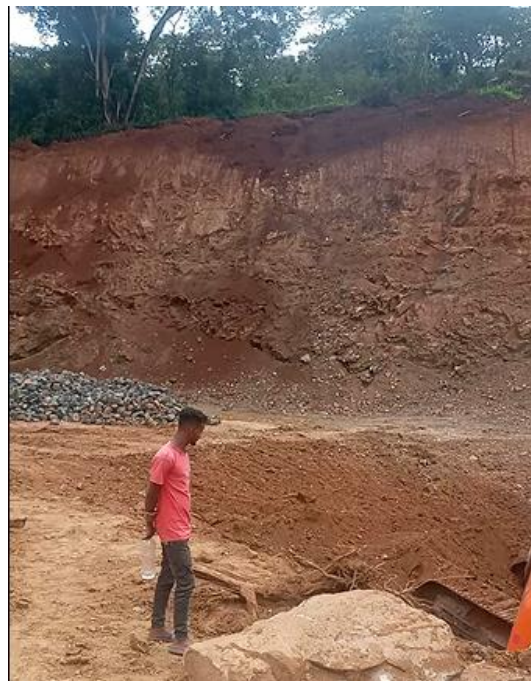
Figure 4-13: Land slide at 46+920 (Yembo)

b) The demolished mountain above the roadway to widen the passageway

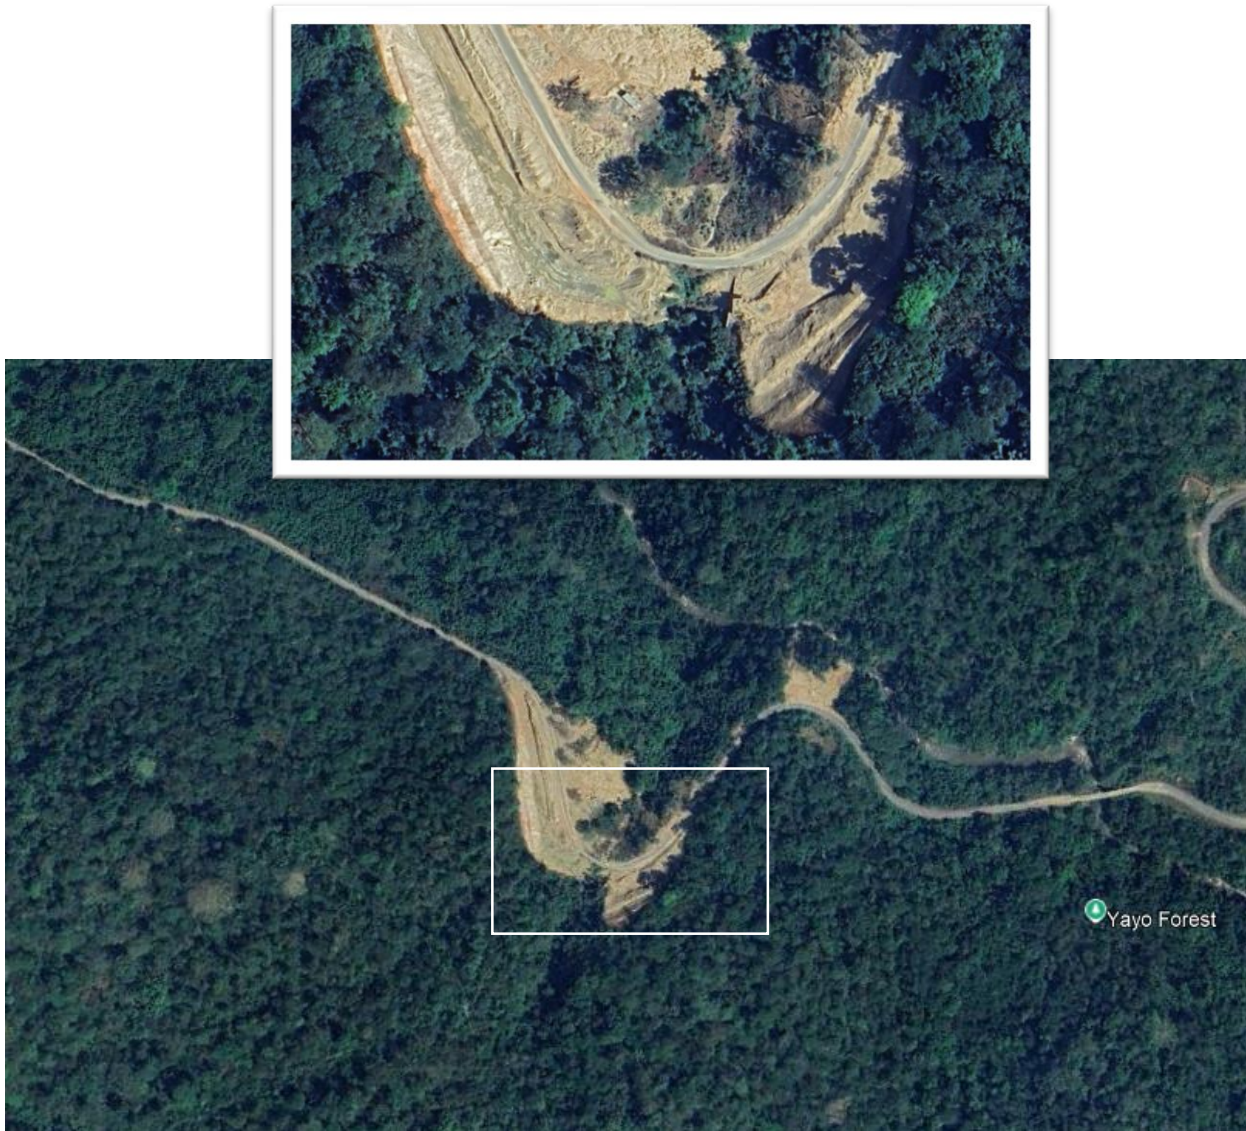
Figure 4-14: Landslide affected road section at 46+920 (Yembo) [Source – Satellite Image by Google Earth]

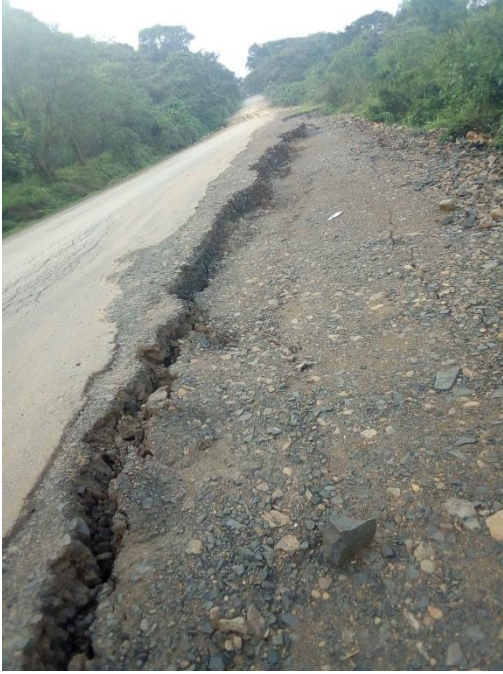
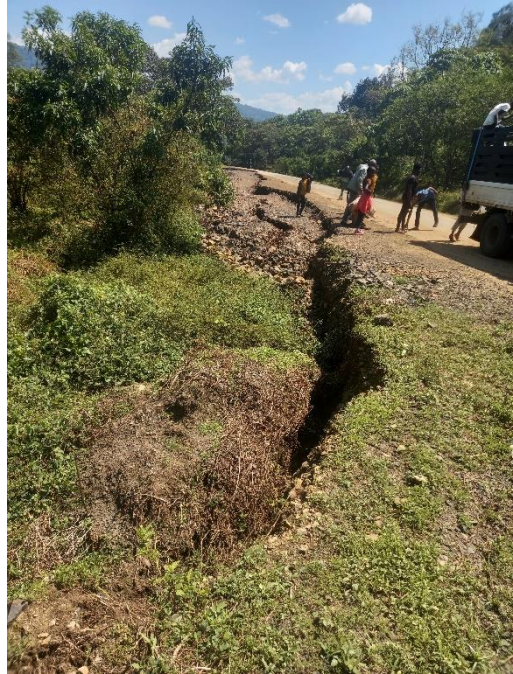
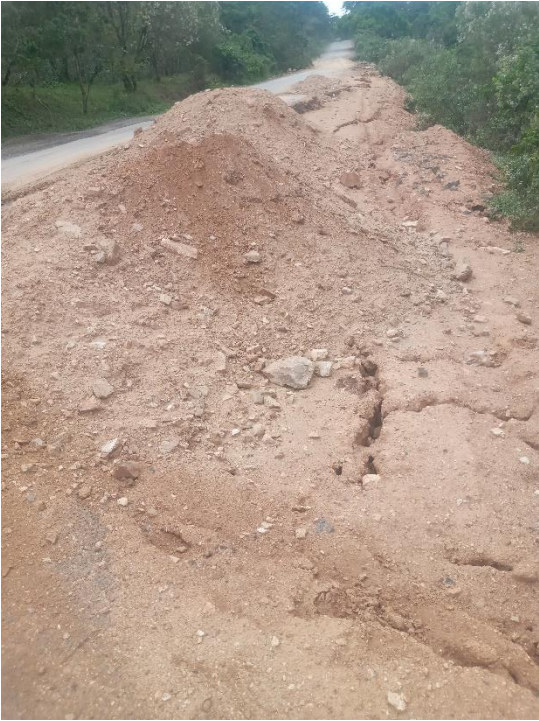
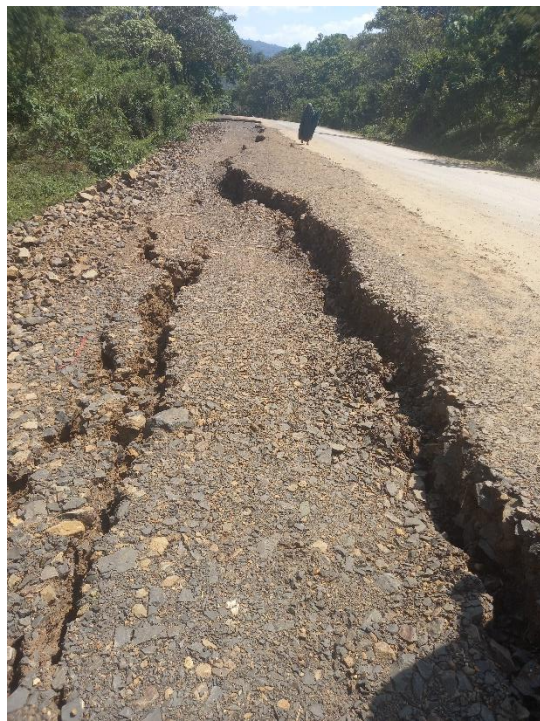
Figure 4-15: Land slide at 48+800 Achebo/Dawe

There are small streams on both sides of the failure zone which might indirectly contribute to continuous moisture infiltration elevating pore water pressure which maximize the opportunity of slope failure.

The only remedial measure taken so far has been localized treatment of the failed road section, which couldn't solve the redundantly occurring translational slide. The site has been investigated by a private geotechnical consulting firm and the solution provided was construction of pile foundation anchored to the bedrock. But the budgeting construction process is not started yet.

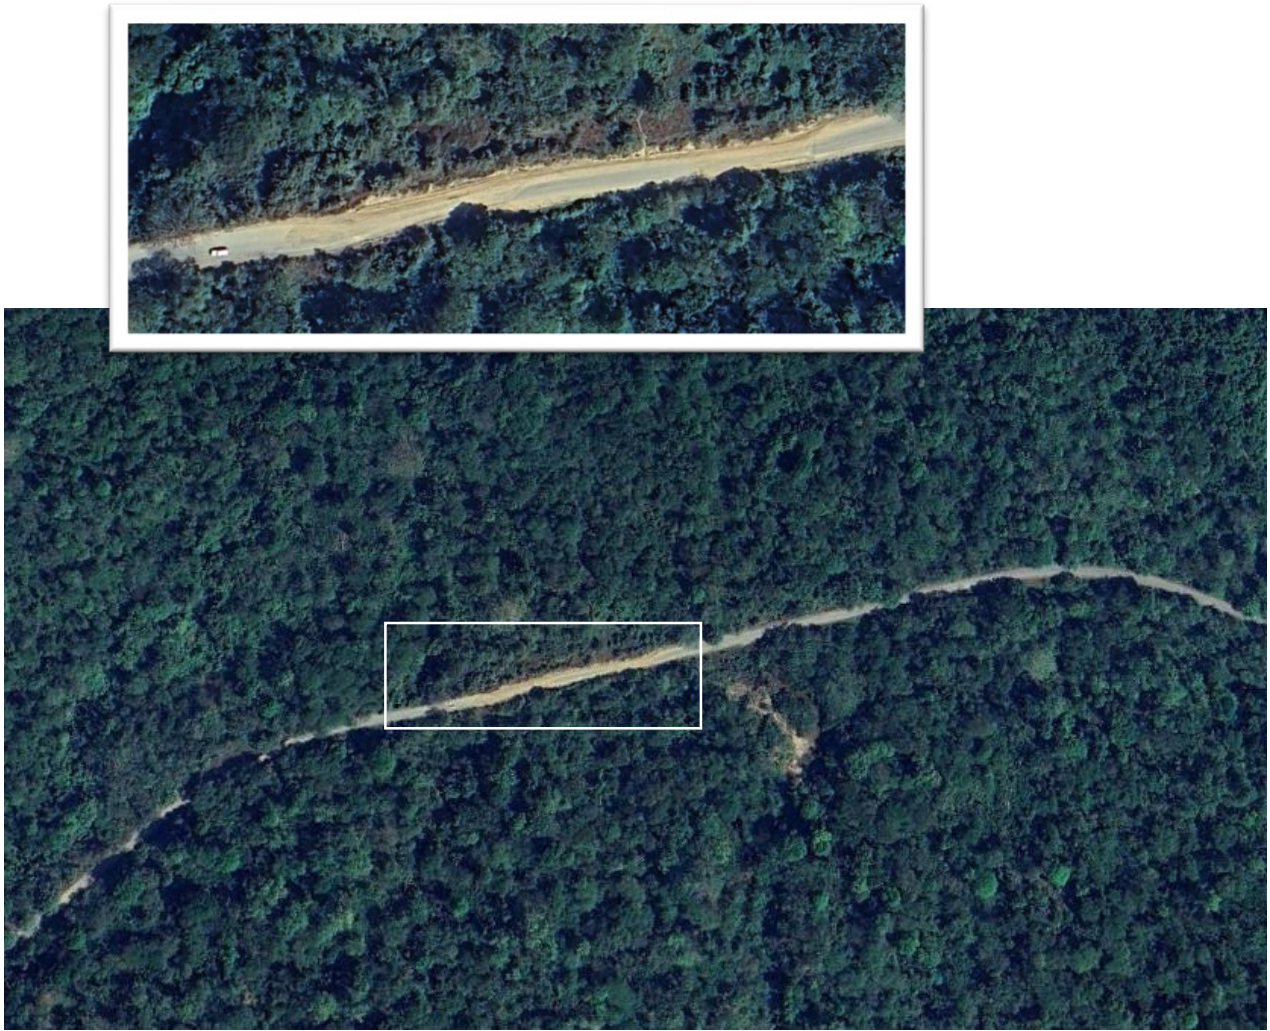
Figure 4-16: Landslide affected road section at 48+800 [Source – Satellite Image by Google Earth]

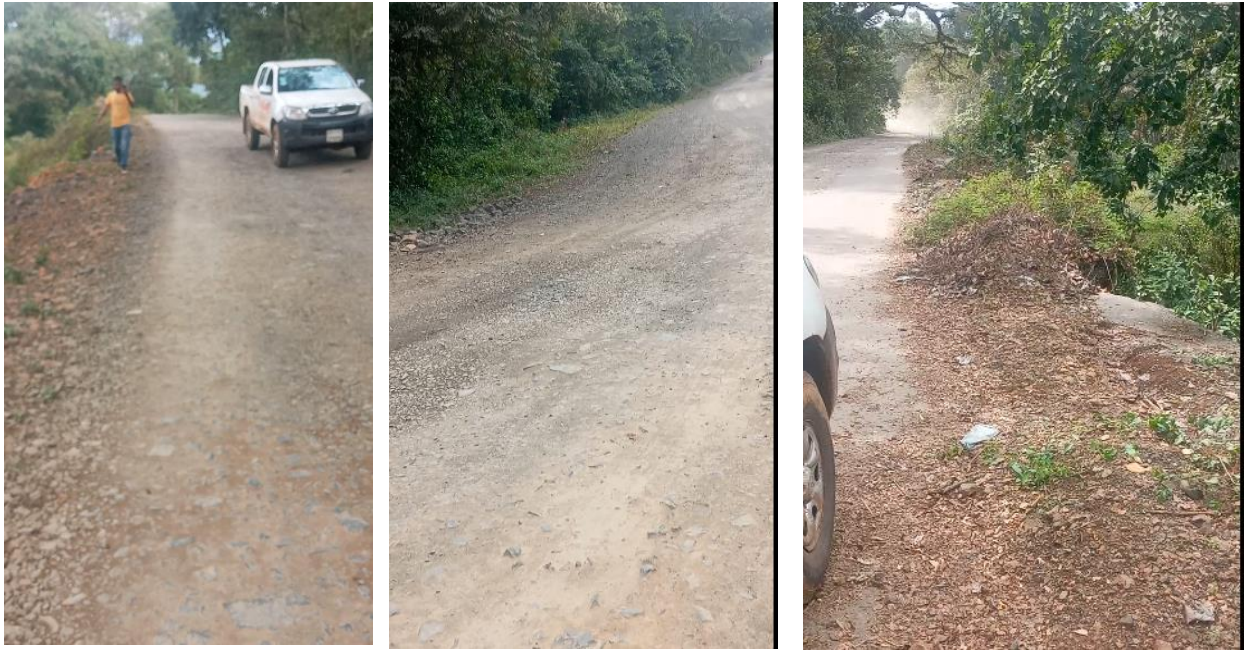
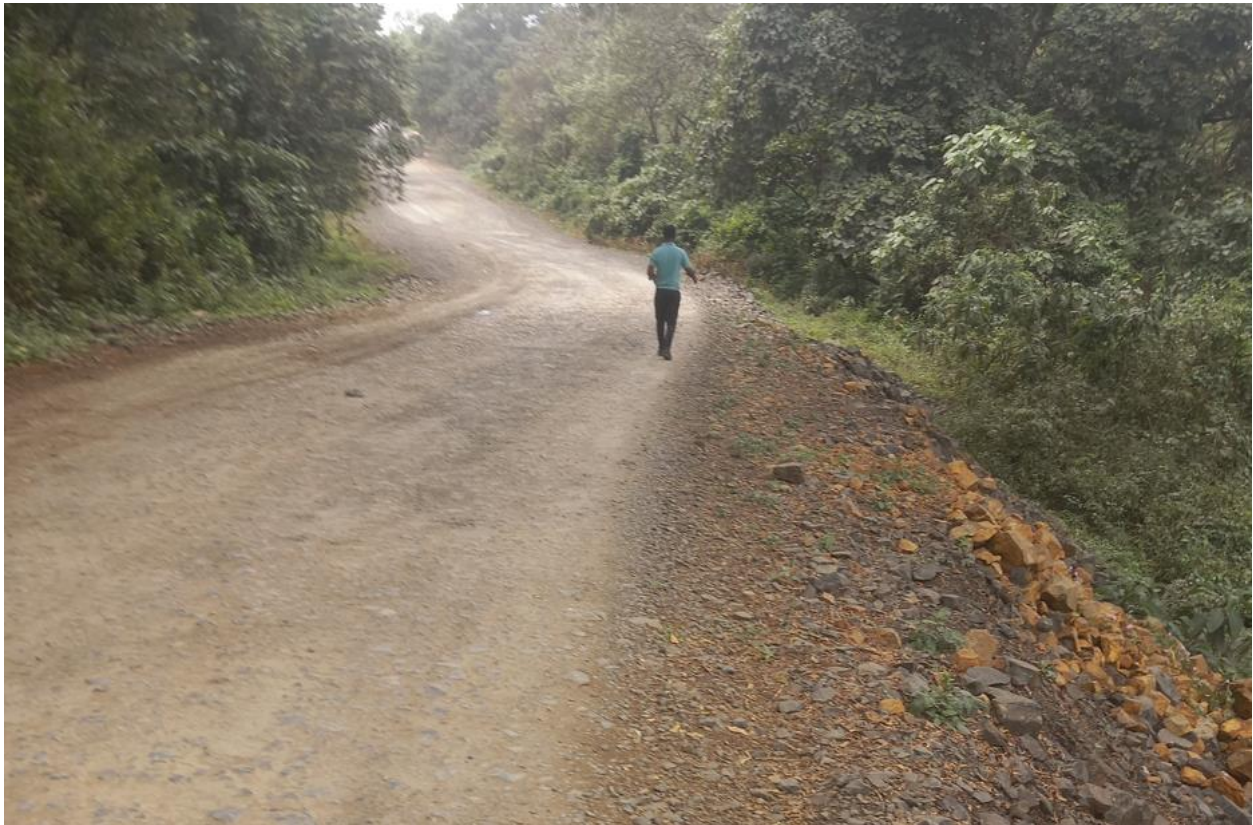
Figure 4-17: Land slide at 49+000 Achebo/Dawe

As a remedial measure, repeated pavement and roadbed reconstruction at the damaged section is executed. However, these efforts have not solved the core problem and the area continues to experience active failure proving that the need for a more permanent engineering intervention.

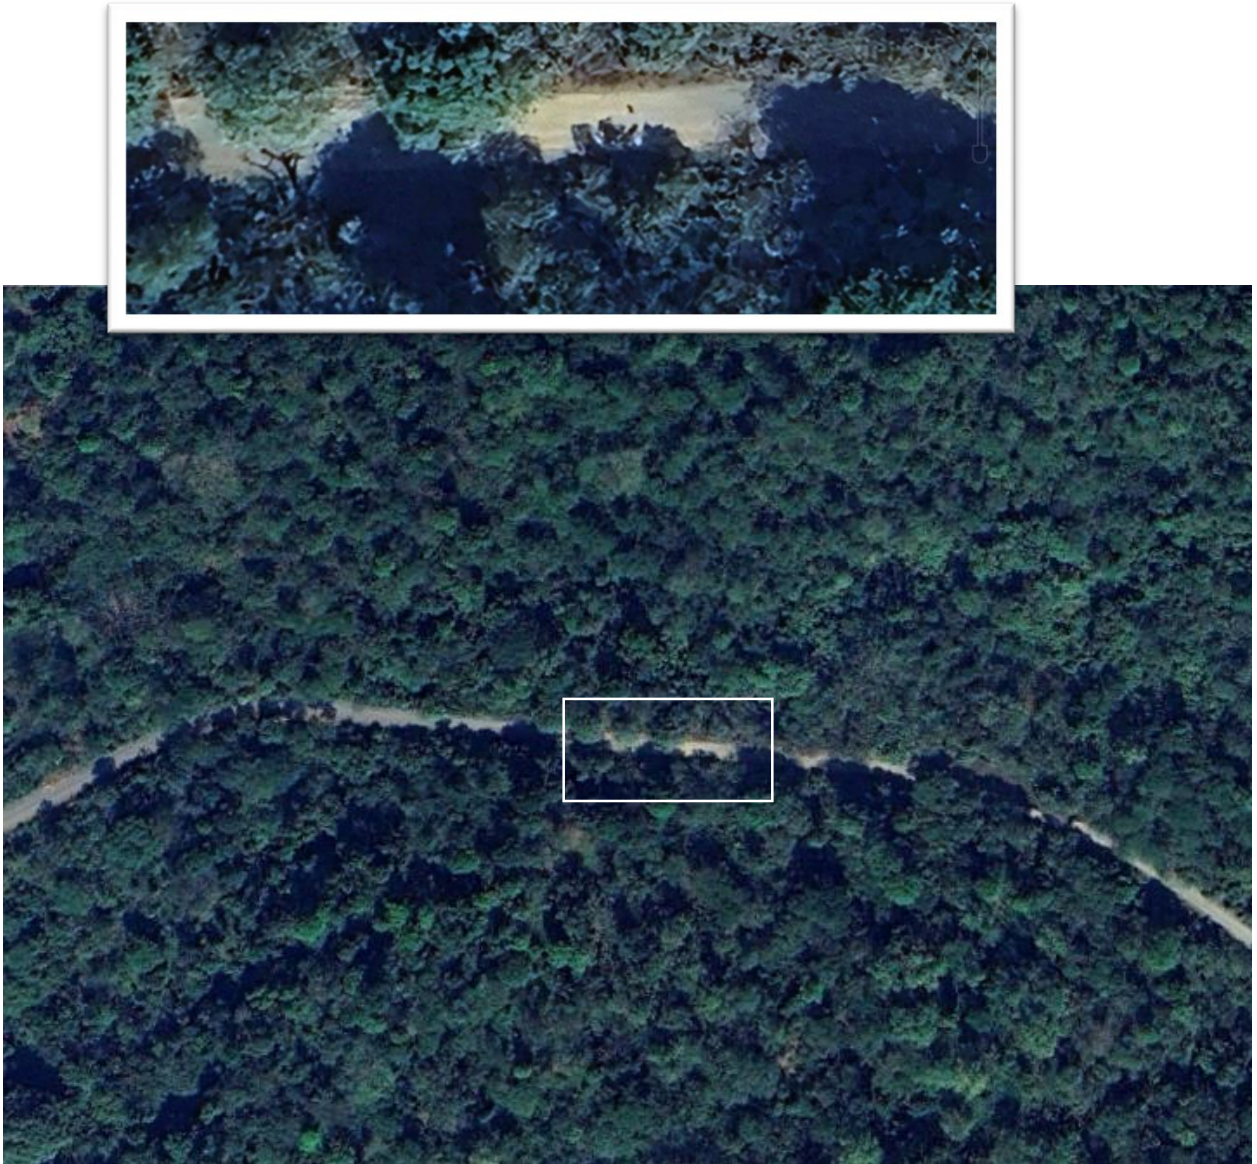
Figure 4-18: Landslide affected road section at 49+000 (Achebo/Dawe) [Source – Satellite Image by Google Earth]

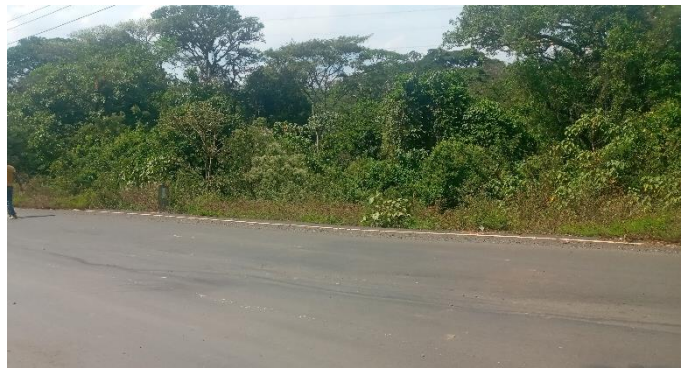
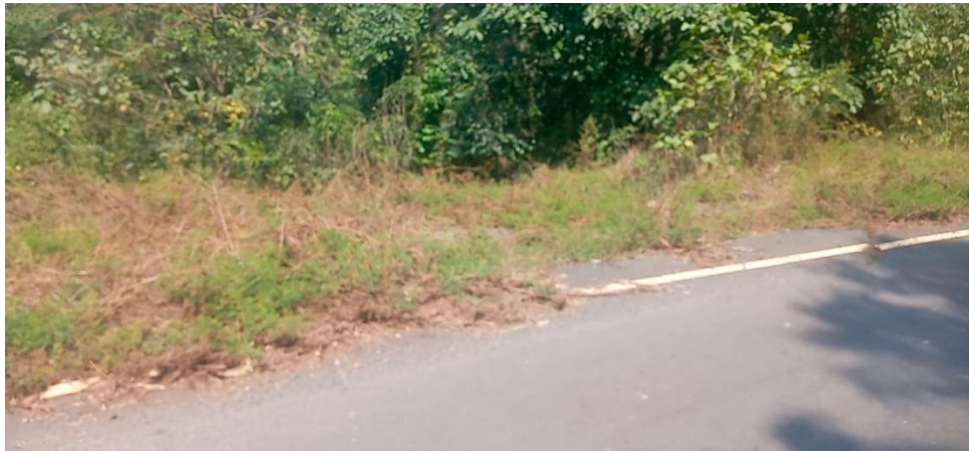
Figure 4-19: Land slide at 65+000 Witate

Remedial measures applied so far include construction of a gabion retaining wall and refilling of damaged sections. Additionally, the pavement gets renewed time to time. Even though the remedial measure gives temporary solution for the roadway functionality, there should be major mitigation project to permanently solve the recurrent failure problem.
