Landslide Inventory Mapping and Susceptibility Analysis for
the Jimma-Metu-Gore Transportation Route.

A Thesis in Geotechnical Engineering

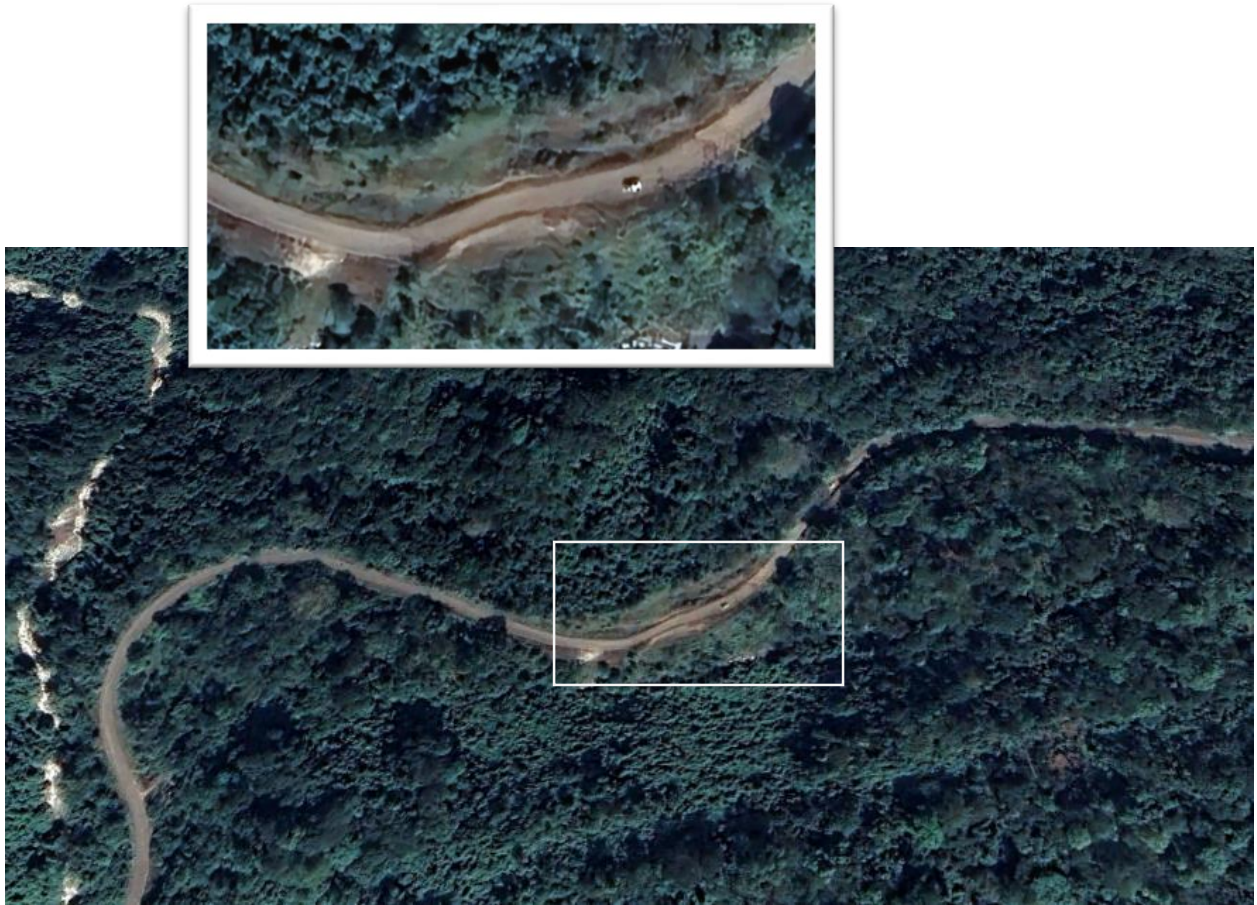
Figure 4-20: Landslide affected road section at 65+000 (Wutate) [Source – Satellite Image by Google Earth]

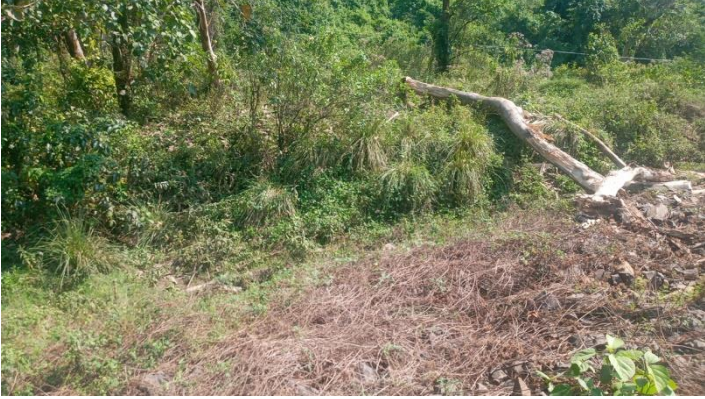
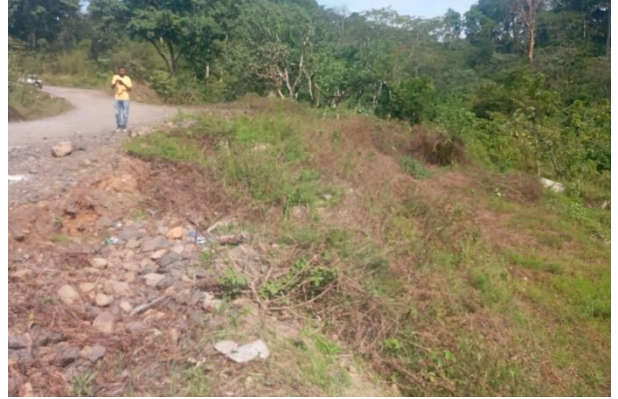
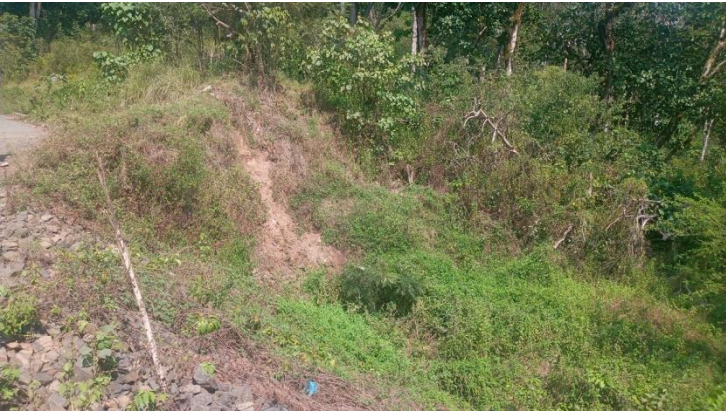
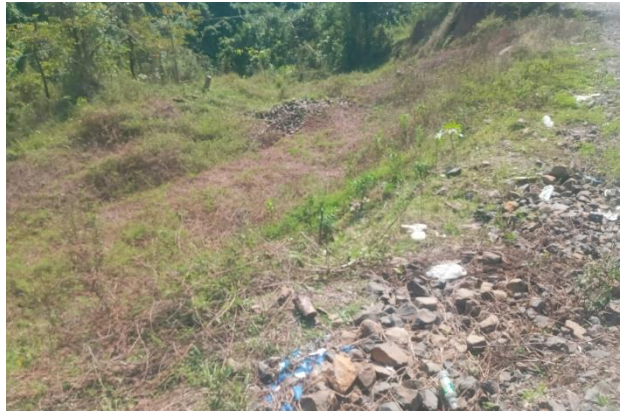
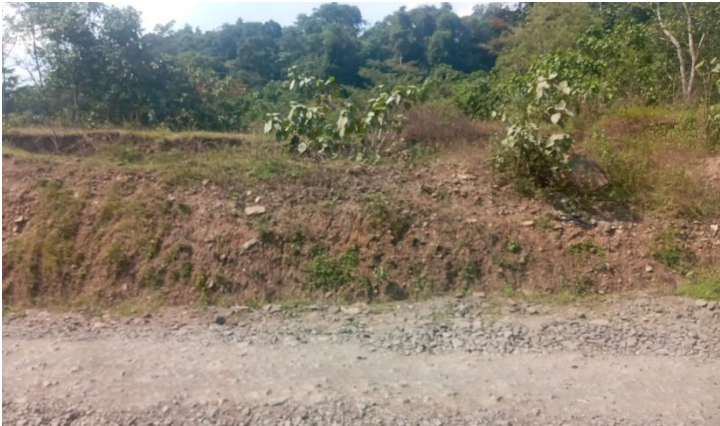
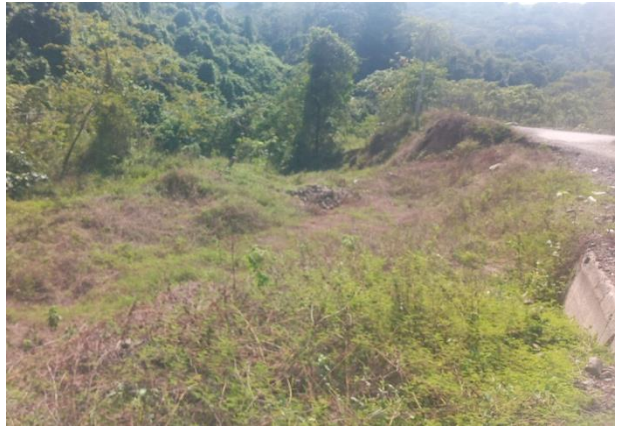
Figure 4-21: Land slide at 66+100 Witate

Previous remedial efforts included backfilling the failed region and repairing the pavement, but the failure keeps coming redundantly. The site reportedly requires maintenance more than four times annually showing that it's high recurrence rate and needs to be solved permanently with costly project.

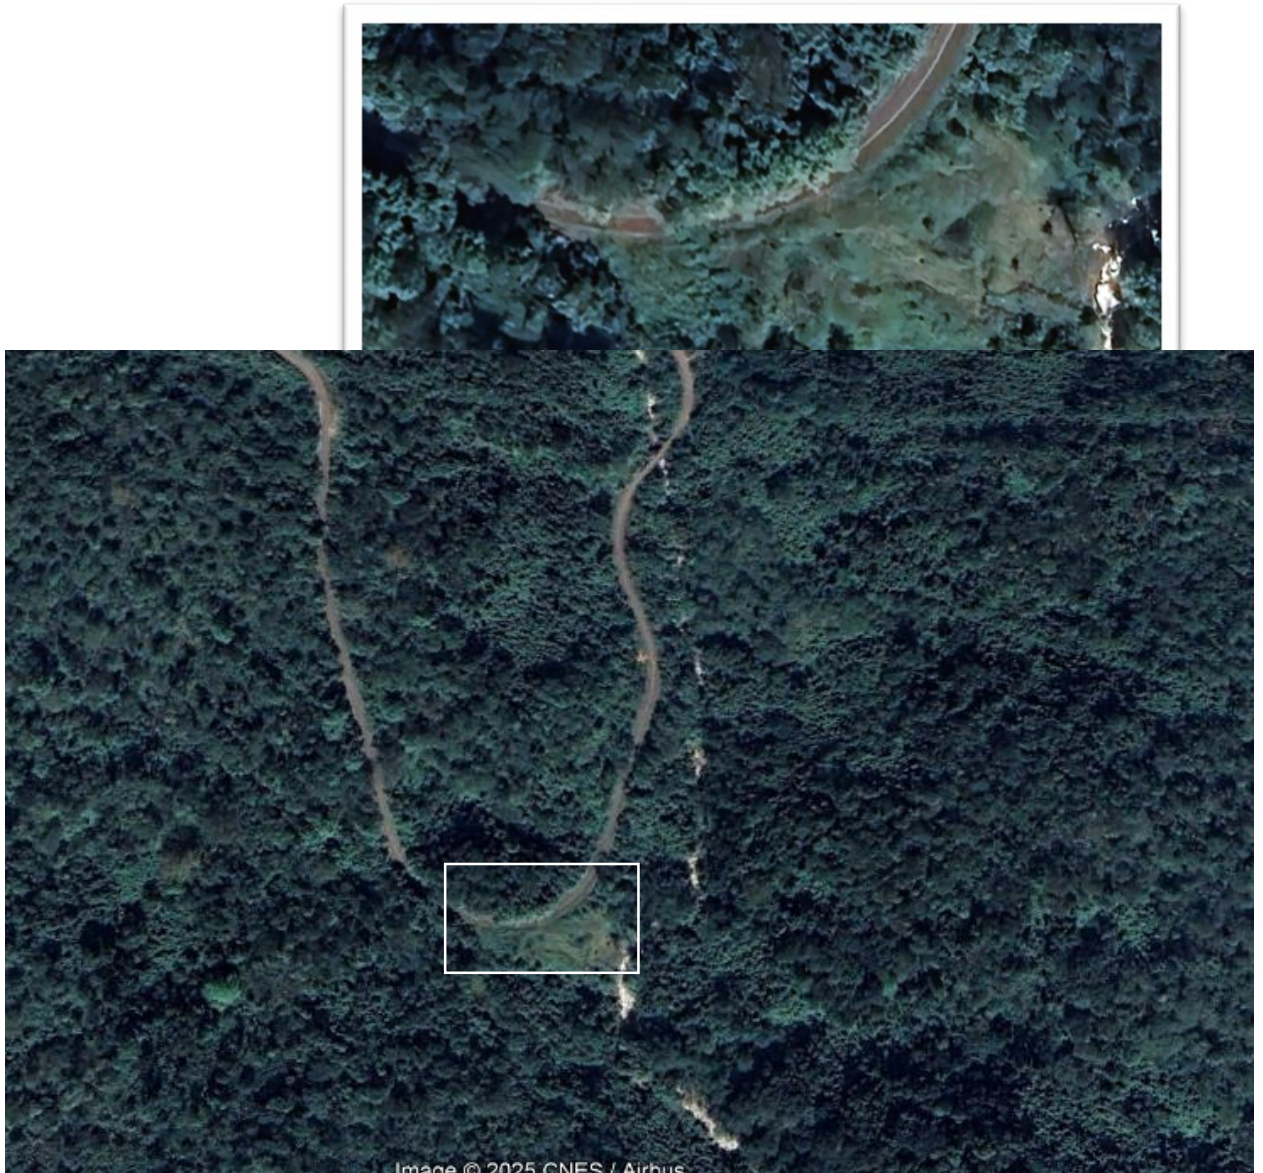
Figure 4-22: Landslide affected road section at 66+100 (Wutate) [Source – Satellite Image by Google Earth]

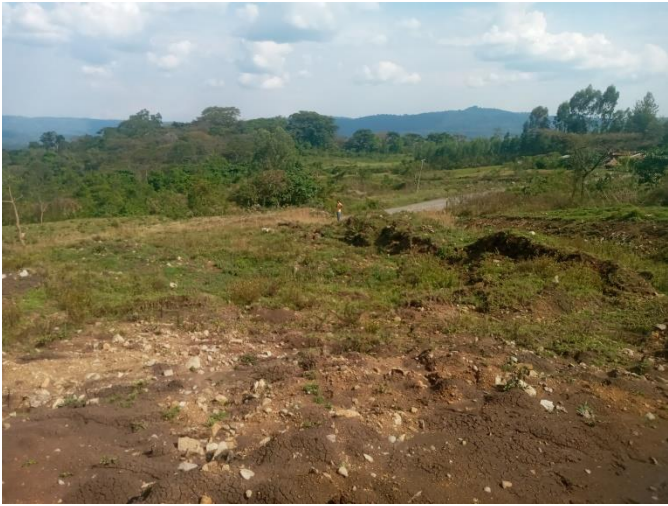
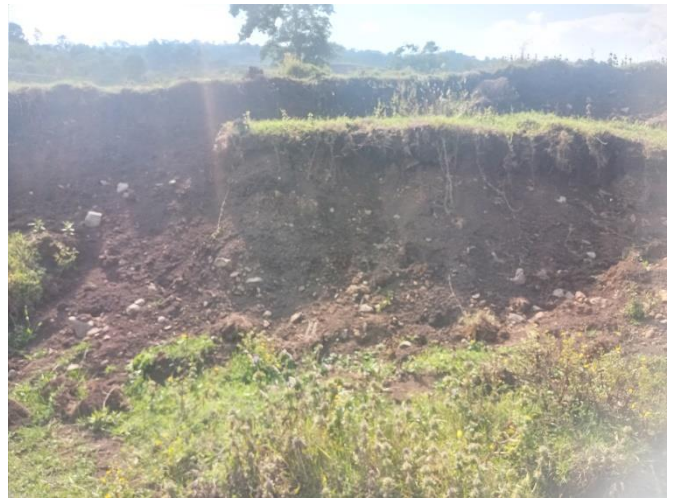
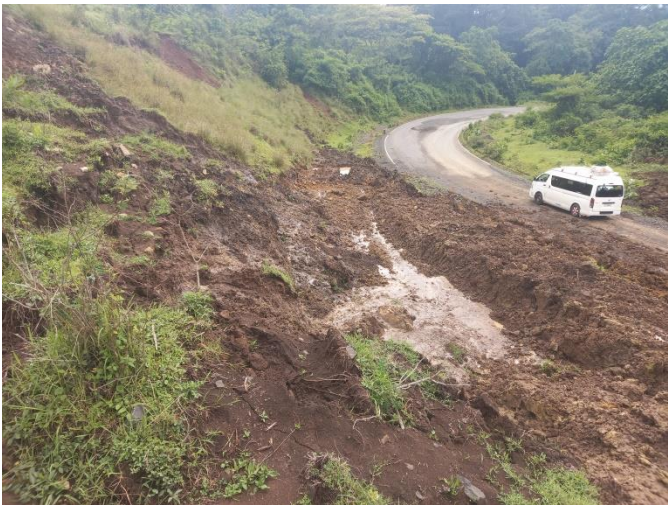
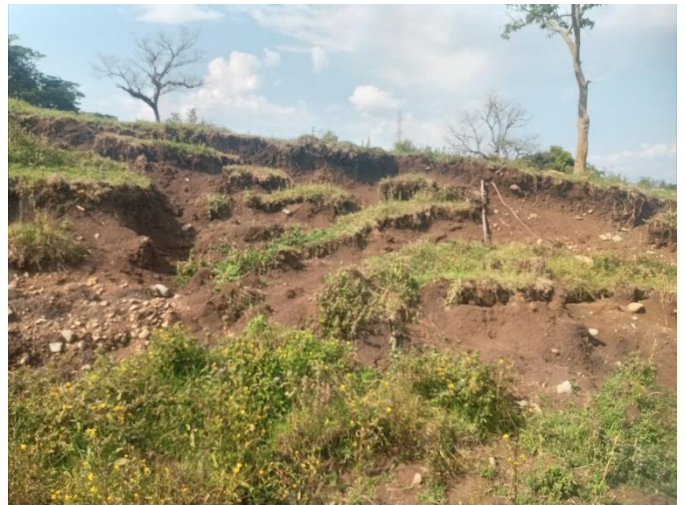
Figure 4-23: Land slide at 85+550 Hurumu/Gaba

Remedial measures previously applied include removal of the deposited slide material on the road and the construction of a retaining structure. However, the redundant occurrence of the failure suggests that these measures only partially address the causes and that more effective and permanent solutions should be considered.

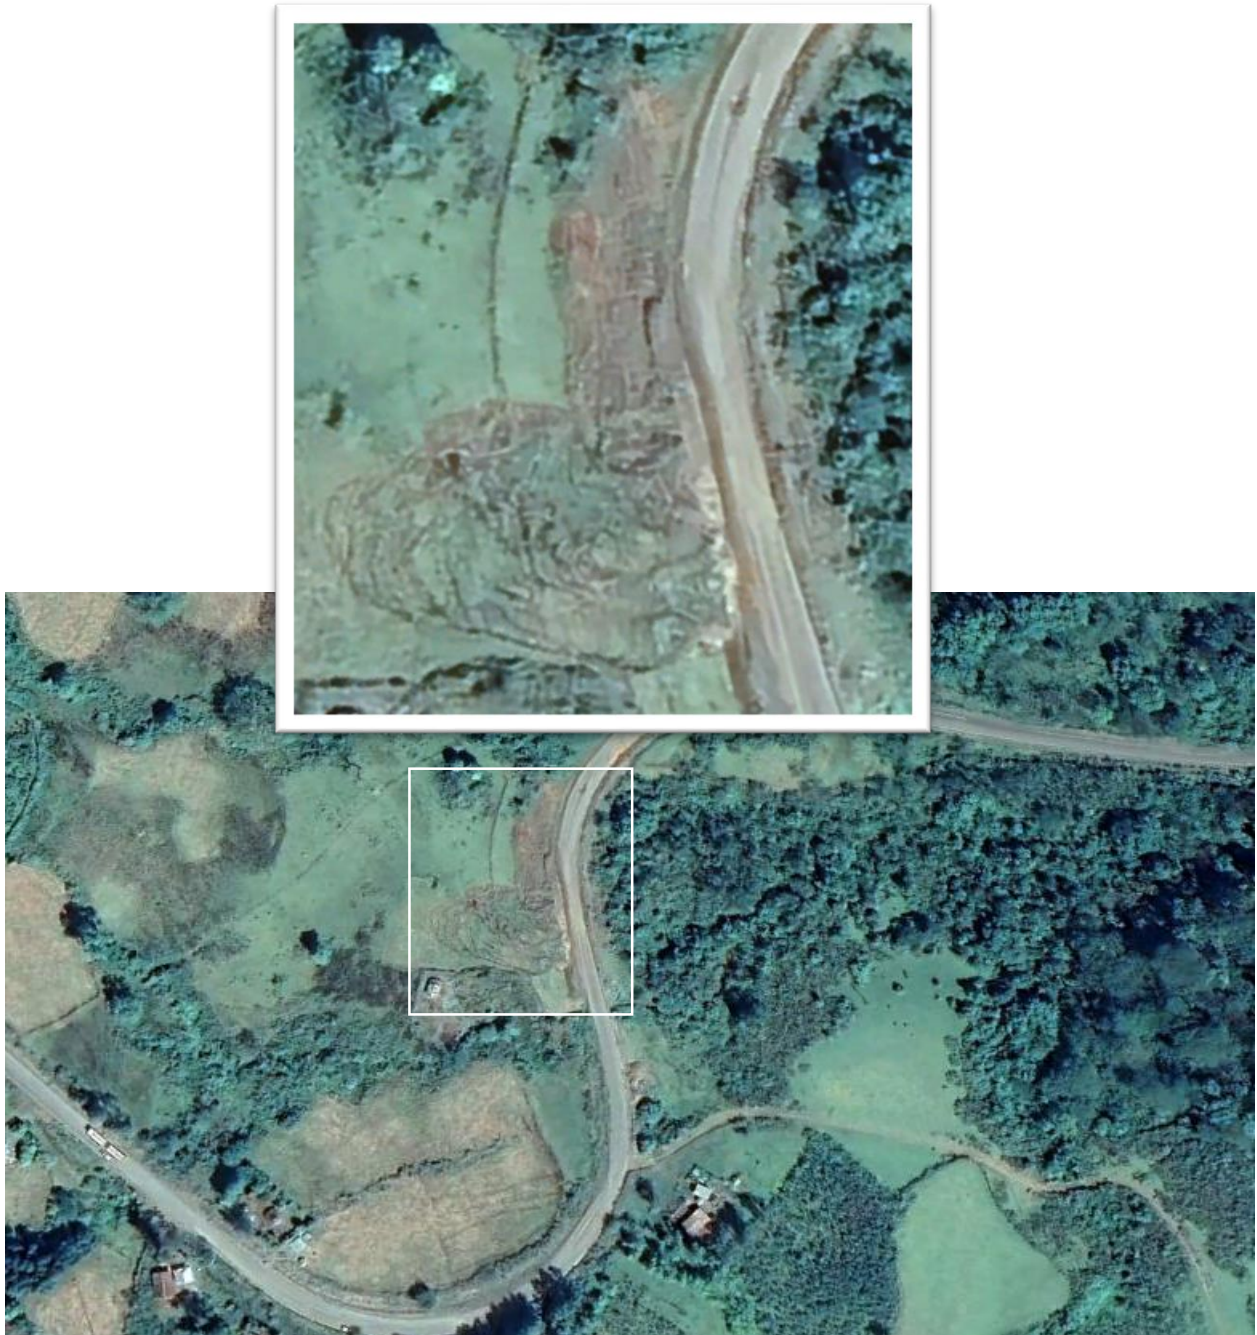
Figure 4-24: Landslide affected road section at 85+550 Hurumu/Gaba [Source – Satellite Image by Google Earth]

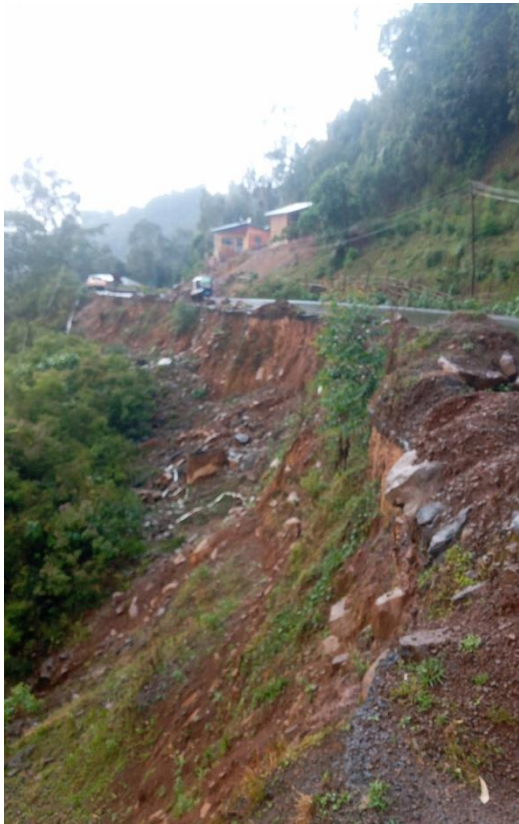
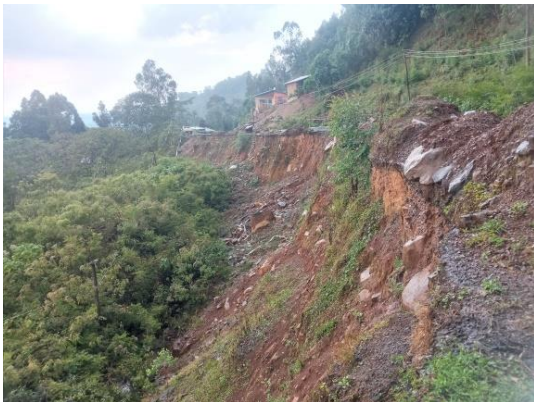
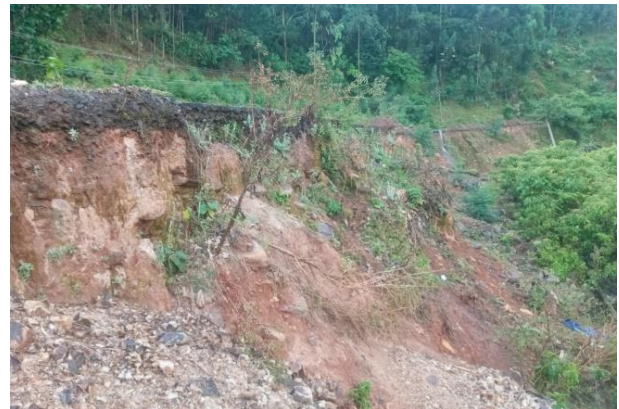
Figure 4-25: Land slide at 201+700 (Gore)

No formal remedial measures have been taken so far leaving the road vulnerable to further damage. Due to the hazardous nature of the slope material type, and presence of uncontrolled surface and subsurface water, this site requires significant engineering intervention and budget to ensure long term stability and road safety.

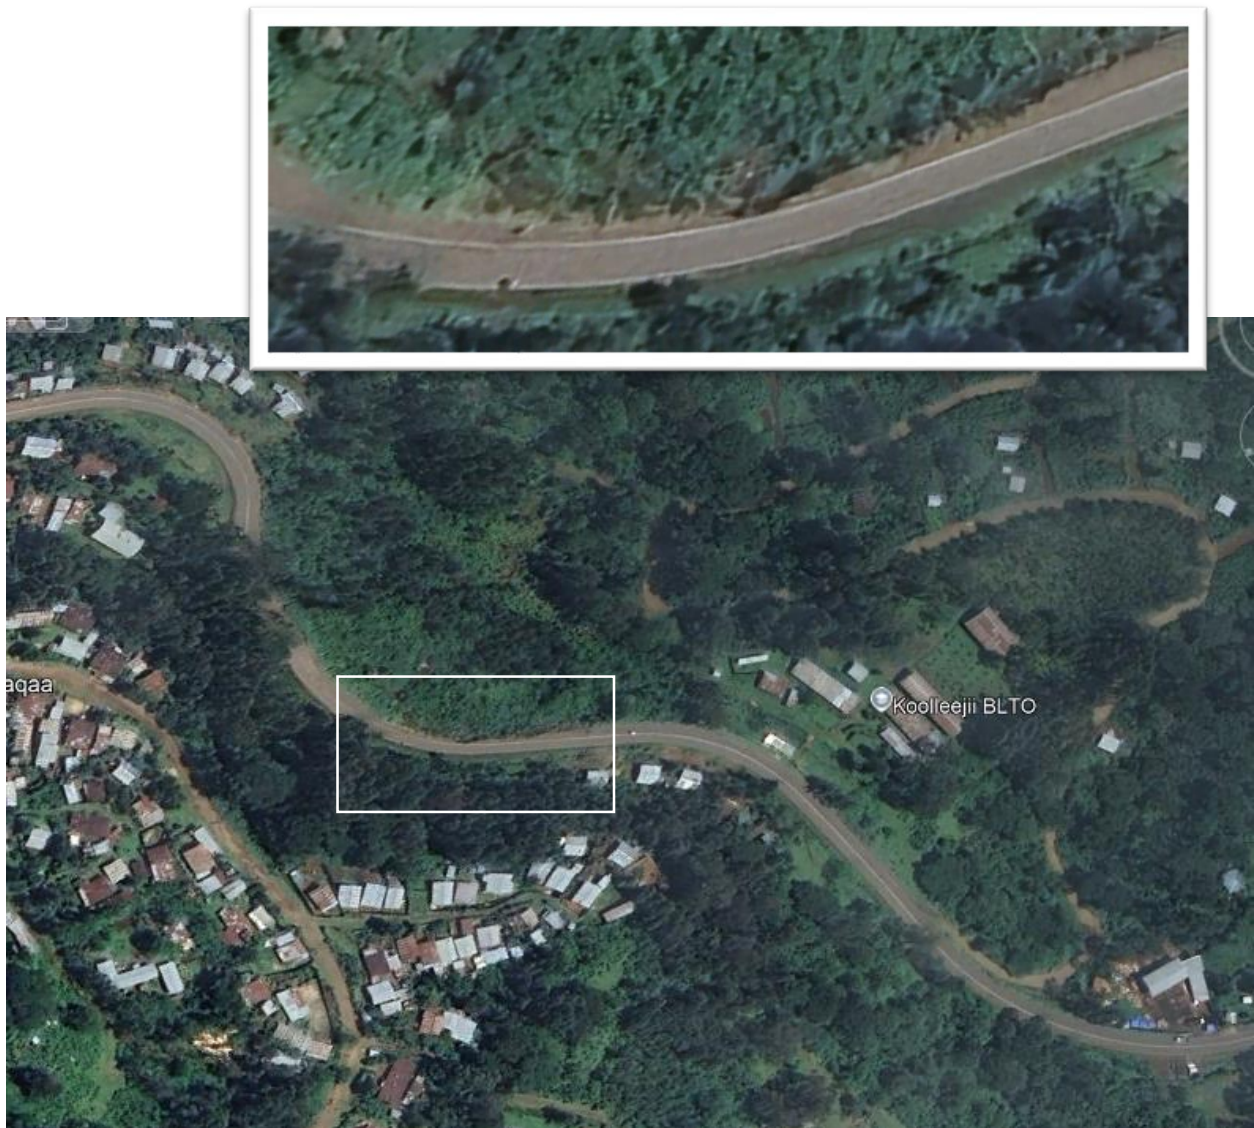
Figure 4-26: Landslide affected road section at 201+700 (Gore) [Source – Satellite Image by Google Earth]

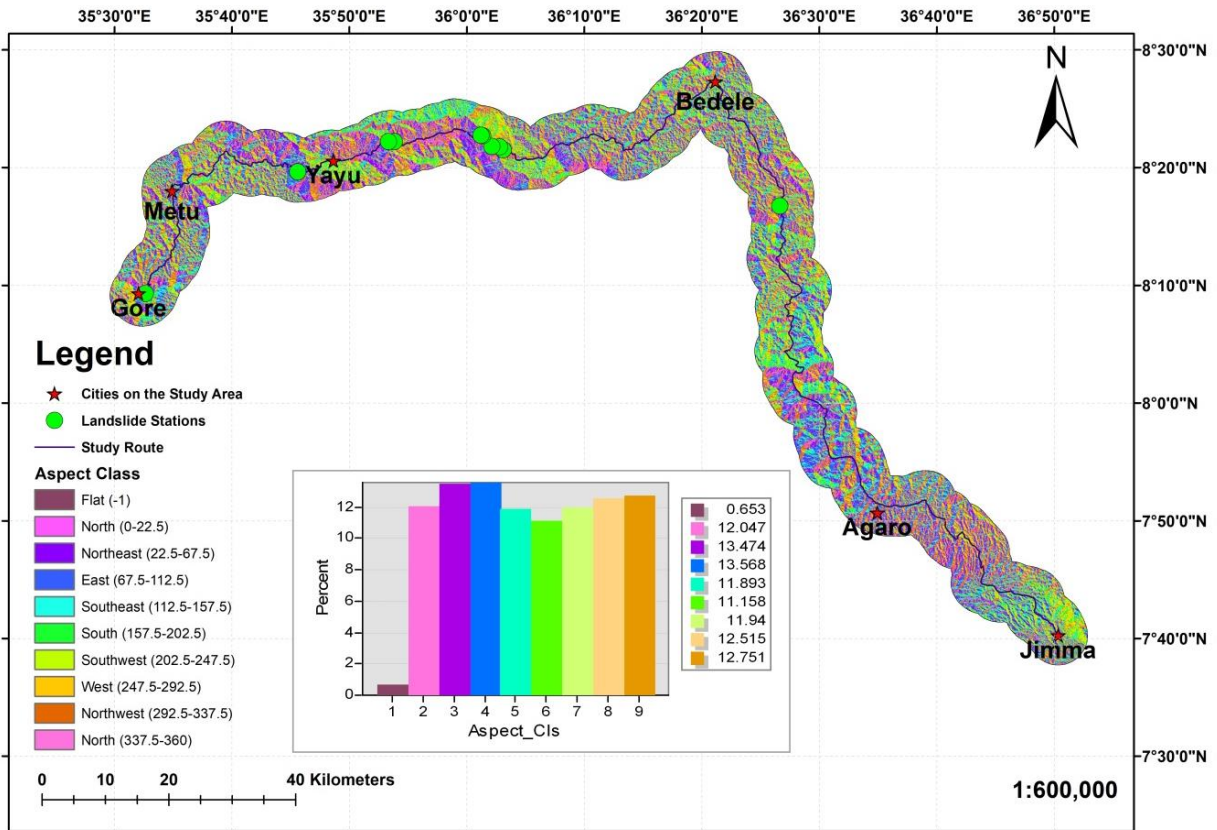
Figure 5-5: Slope aspect map

The derived slope aspect map as well as field observations along the Jimma-Metu-Gore corridor confirmed that most documented landslides occurred on north, northwest and northeast facing slopes. 60% of the landslides occurred in those classes whereas the remaining 40% occurred on the south and south west aspects as shown in Figure 5-6. This shows the importance of slope aspect in the susceptibility model.

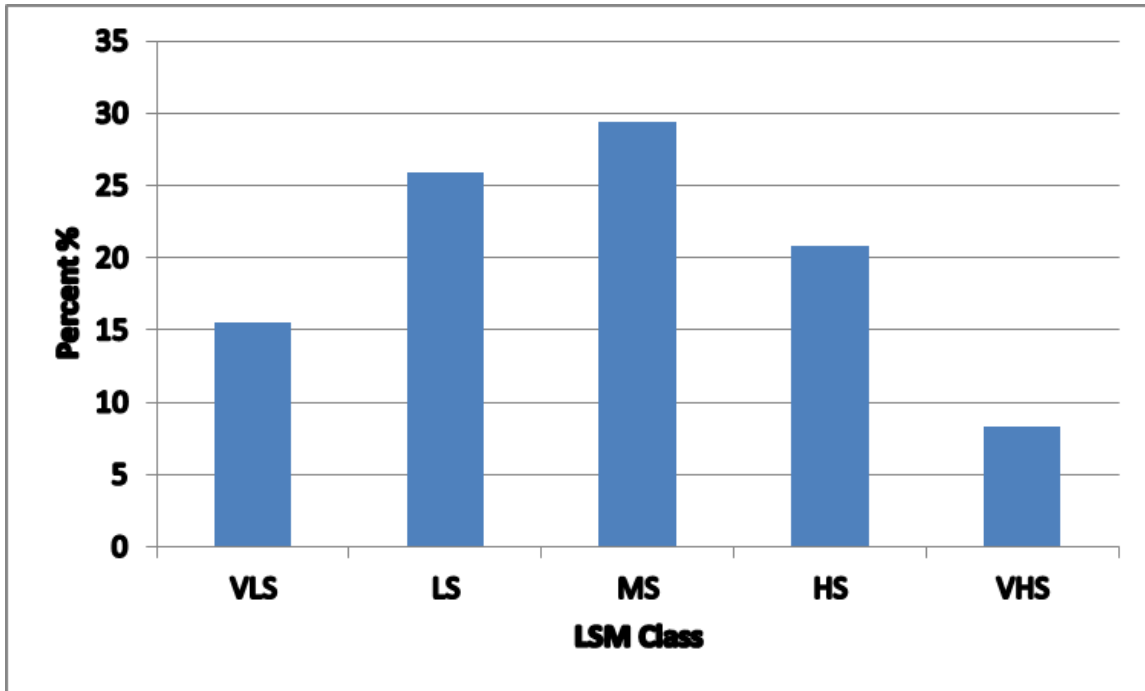
Figure 6-2: Landslide susceptibility classes' coverage in percent

The final Landslide Susceptibility Map (LSM) generated with the application of CRITIC method was categorized into five susceptibility classes that are Very Low Susceptibility (VLS), Low Susceptibility (LS), Moderate Susceptibility (MS), High Susceptibility (HS), and Very High Susceptibility (VHS). The spatial distribution of these classes shows a varying pattern of susceptibility across the study route.
