ENGINEERING GEOLOGICAL MAPPING AND LAND SLIDE  
ASSESSMENT OF DESSIE TOWN

June 2001

**A Thesis Presented to the School of Graduate Studies, Addis Ababa University  
In Partial Fulfillment of the Requirements for the  
Degree of Master of Science in Geology**

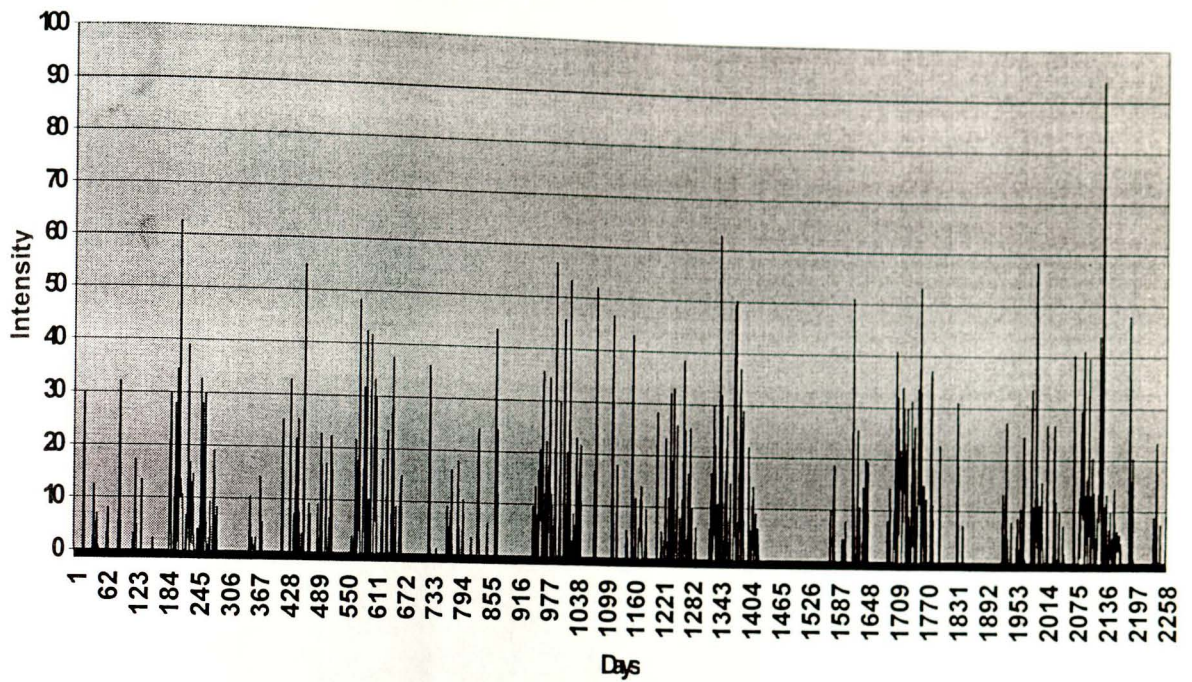
Figure 4.1 Daily rainfall intensity of dessie from 1990-1996

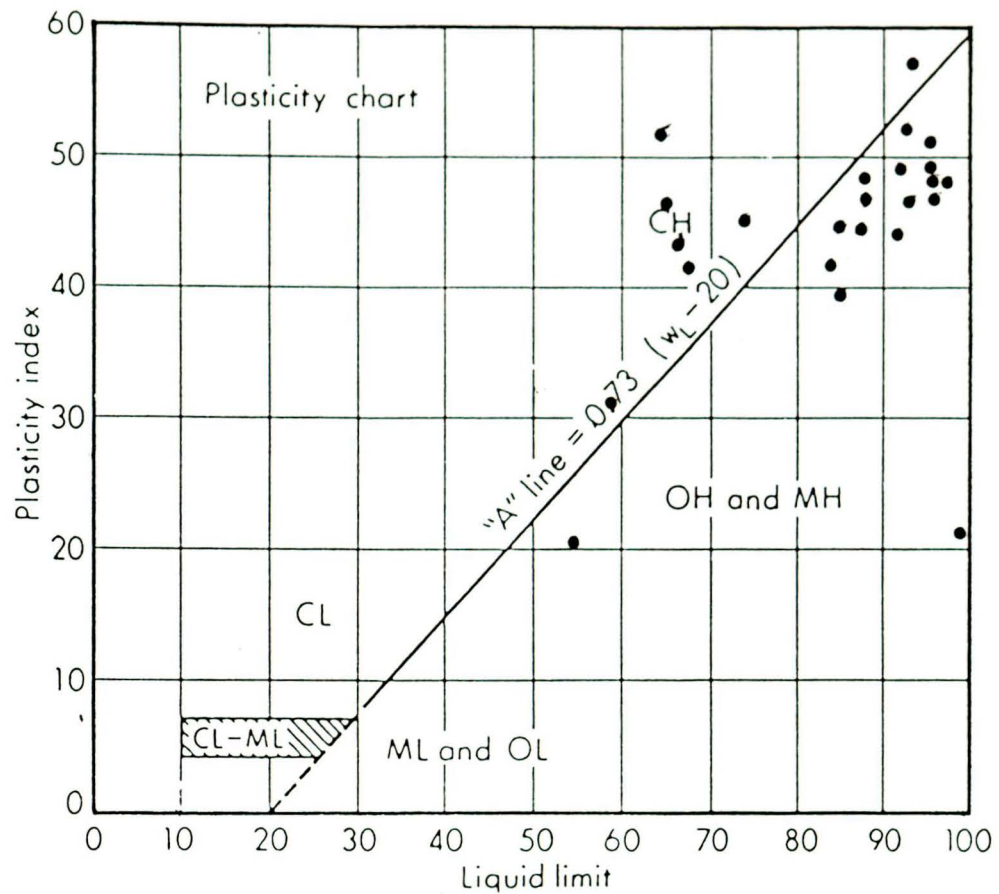
**Figure 6.2 plasticity chart**

CH=Inorganic clays high plasticity

Description of plasticity of fine soils in terms of their range of liquid limits given in plasticity chart. Comparison of the liquid limit of soils of the study area with their respective plastic index plotted on the plasticity chart enables to describe the soils as being of very high to extremely high clay for Kerra soils and high to very high plastic silty clay for other area clays.

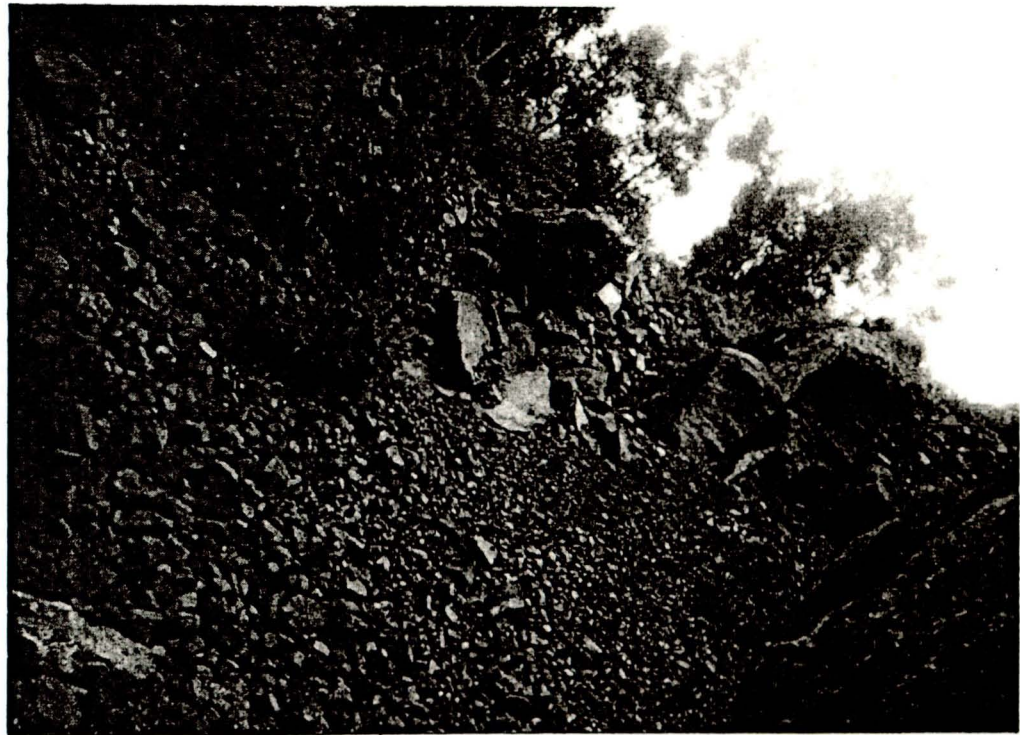
Figure 7.3 Creep and Rock full along Tossa Foot

The most risky area related to rock fall is concentrated around Teacher Training Institute north of "Sire Spring" and around land slide 11. Rock falls generally involved small blocks from 0.5m to 3m in diameter and further small creep, occur in some steep to gentle hill sides both process are related to periods of heavy rainfall. The more severe condition occurred around a residential house and a flourmill along the foot where a big block about 3m in diameter is blocked by an eucalyptus tree Figure 10.1. According to rock fall classification based on a volumetric nomenclature of rock falls around Dessie are Debris fall (less than  $10\text{m}^3$ ) boulder fall ( $10\text{-}100\text{m}^3$ ) usually only a few large blocks, and block falls greater than  $100\text{m}^3$  of a large block which is fragmented during travel in different localities. For the failure of the rocks, the form of the discontinuities are determinant. Joints along the fault scarp provide planar sheets, intersect to form wedge, yield stepped surface or boundary vertical joints. Repeated falls from the same wall, ultimately form a fan-shaped cone of fallen debris at the base of the slope. These are more pronounced in the previously quarry areas and these talus screes should be distinguished from its accumulation arising from a large fall, results in accumulation of debris of all sizes that can obstruct a valley upon erosion from the cliff. The distance covered by the rock fall along the foot of the Tossa scarp depends up on the orientation and angle of the slope facet, imparted, the size and shape of the block, the angle at which it strikes the slope, the state and deformation of the rock or ground, absorption of the shock by any covering vegetation.

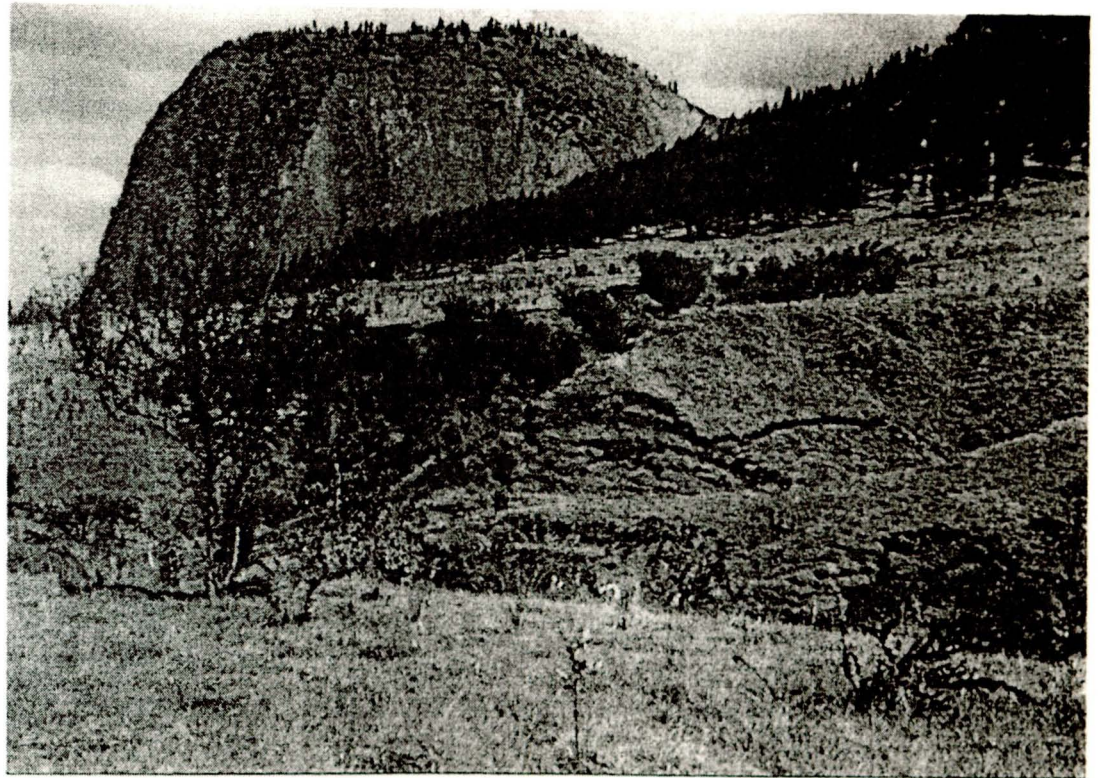
**Figure 7.5 Planar Slide at Doro mezlia, Slump at Kerra and protecting vegetations**

The rotational slips around Kerra area mostly have shallow depth and they are more clearly classified as a slump (Figure 7.5). It is induced by the removal of underlying material, that

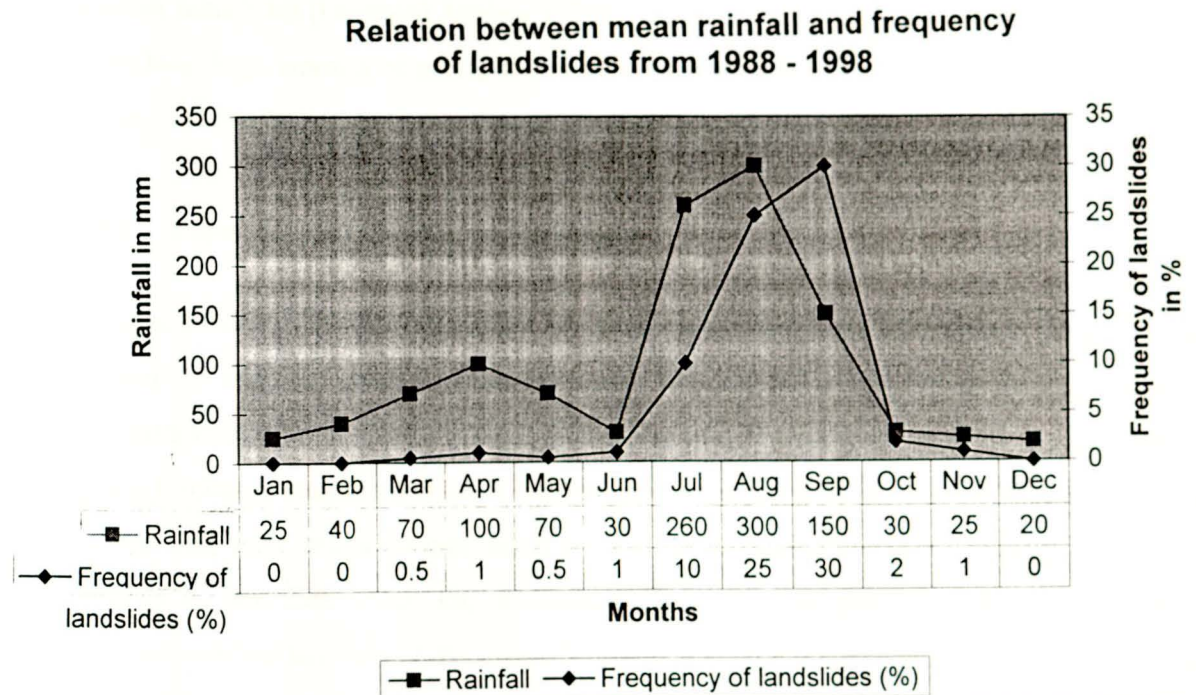
Figure 8.2 Effects of rainfall on landslide

Lulseged Ayalew 1999, selected three years of unusual high amount of precipitation (1993, 1994 and 1996). The high amount of precipitation in these three years was happened following some years of dry periods. To determine the influence of rainfall in

the occurrences of landslides in the study area and its surroundings, precipitation data of 10 years from 1988 - 1998 was taken and analyzed. A mean of precipitation was setup to compare it with the frequency of failure in the same span of time. The result is shown in Figure 8.2 from the result except some months, the relation of the amount of precipitation and frequency of slope failure is strongly correlated.

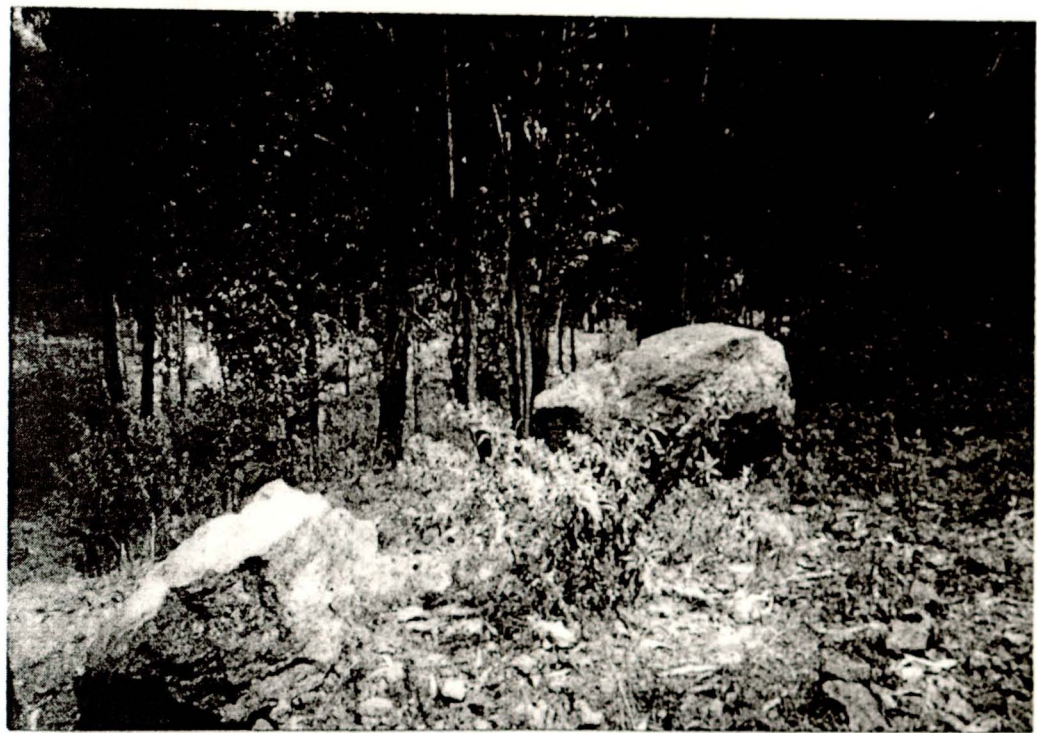
**Figure 10.1 Eucalyptus trees as a barrier for rock fall**

the inter twining of its roots, minimized seepage of runoff in to the soil by intercepting rainfall, and retards runoff velocity. Large diameter trees such as eucalyptus trees also act as a barrier during rock fall. The most remarkable example for this is occurred along the foot of Tossa ridge where a big block about 3m in diameter is blocked by eucalyptus tree that saves the nearby houses (residential and a flavor mill houses). (Figure 10.1)

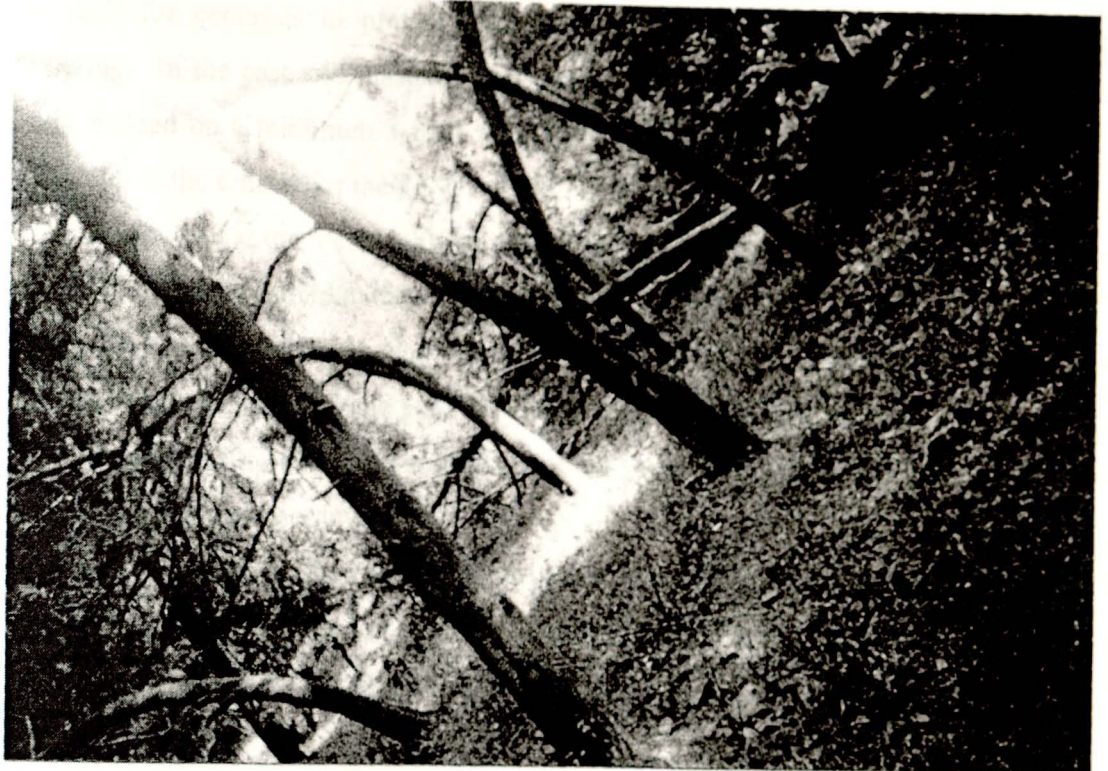
**Figure 10.4 Uprooted and tilted trees along the Tossa foot**

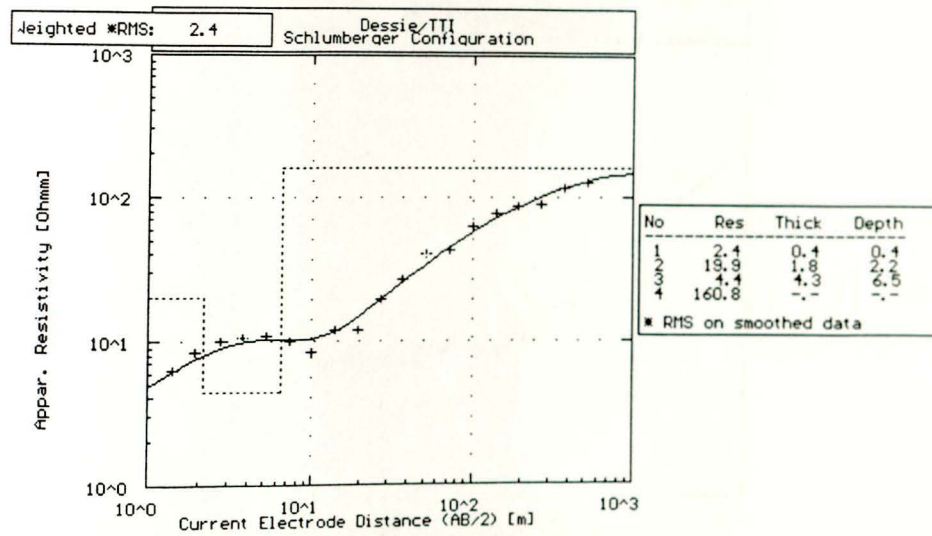
### VES Site \_ TTI/Dessie

Layer Number	Resistivity value (Ohm.m)	Thickness (m)	Depth (m)	Possible geologic units represented by the given resistivity value
1	2.4	0.4	0.4	Clayey top soil
2	19.9	1.8	2.2	Sand (with clays)
3	4.4	4.3	6.5	Clay
4	160.8	-	-	Sandy gravel
