Comparative Evaluation of Pavement Performance
A Case Study on Bus stop stations in Addis Ababa

*A thesis submitted to the School of Graduate Studies of
Addis Ababa University*

*In partial fulfilment of the requirements for the Degree of
Master of Science in Civil Engineering
(Road and Transport Engineering)*

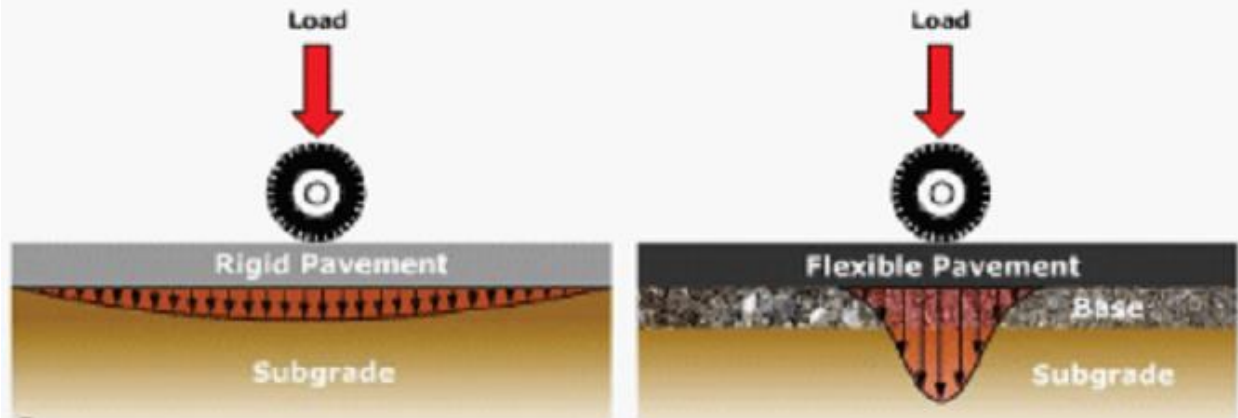
Figure 2: Rigid and flexible pavement load distribution

Each of these pavement types distributes load over the sub grade in a different fashion. Rigid pavement, because of concrete's high elastic modulus stiffness, tends to distribute the load over a relatively wide area of subgrade. The concrete slab itself supplies most of a rigid pavement's structural capacity. Flexible pavement uses more flexible surface course and distributes loads over a smaller area. It relies on a combination of layers for transmitting load to the subgrade. Figure 2 below indicates the variation in load transfer for the two pavements.

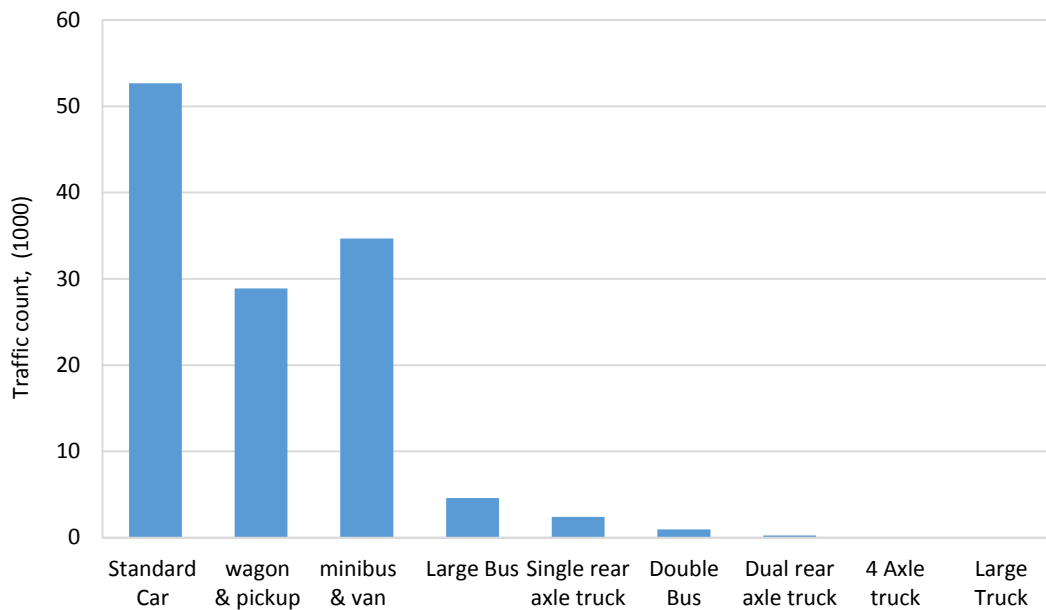
Figure 3: The traffic count data of AratKilo – Sheromeda

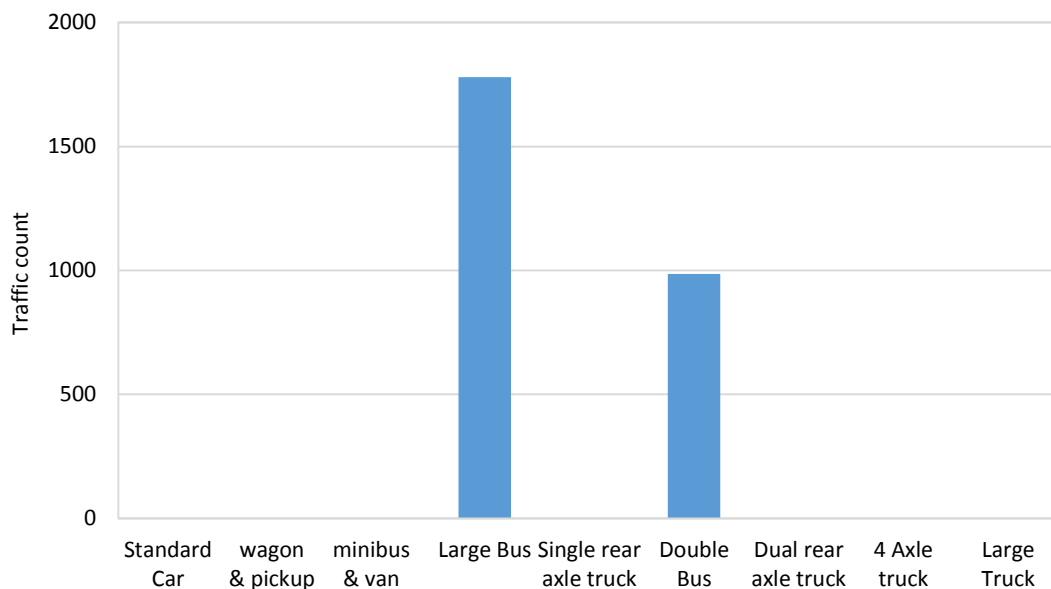
Figure 4: The traffic count data of Leghare Bus Depot

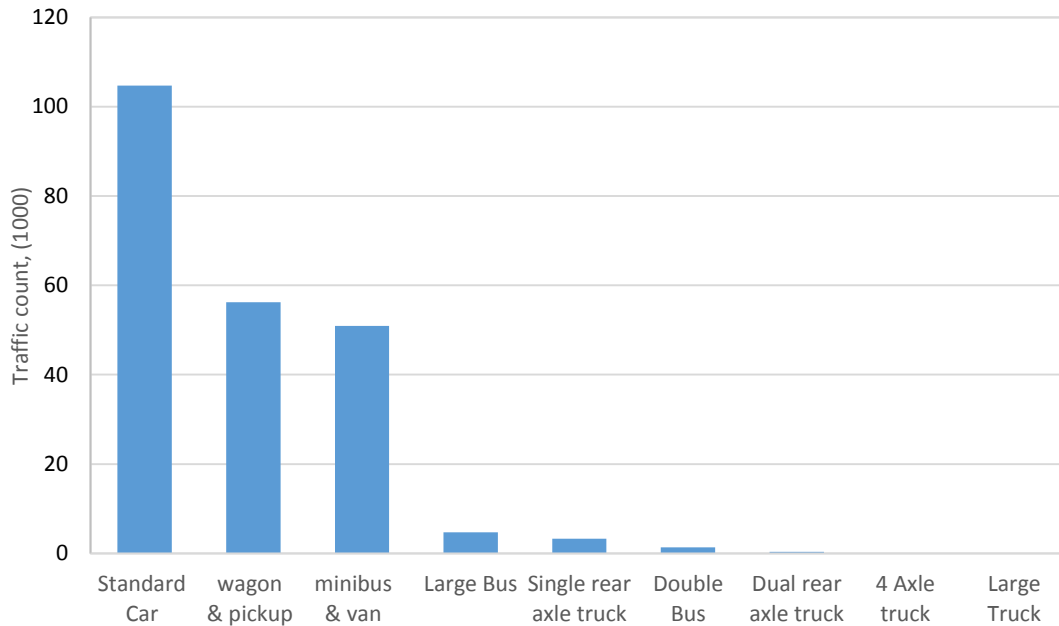
Figure 5: The traffic count data of Mexico - Piyassa

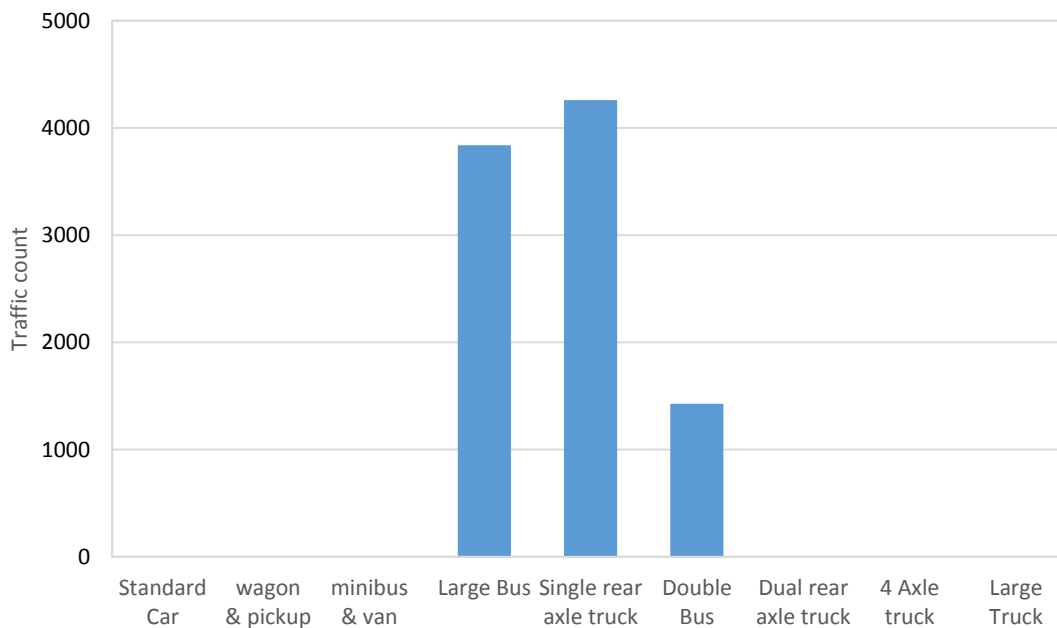
Figure 6: The traffic count data of Megenaga Bus Depot

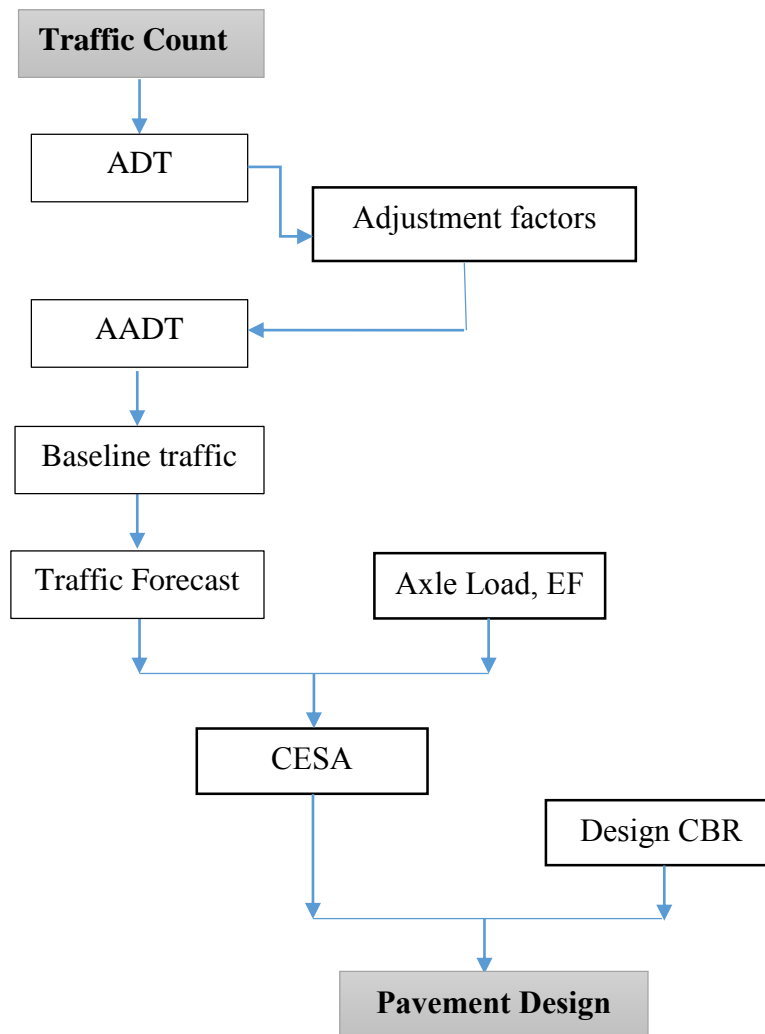
Figure 8: flow chart of pavement design

After conducting traffic count, determination of the daily traffic flow for each class of vehicle, ADT was carried out and adjusted to obtain the Annual Average Daily Traffic, AADT which used in traffic analysis. After finding of AADT, using traffic growth rate Base Line traffic determined. Then traffic projection for respective design year was carried out. Finally, the values of Equivalency Factor, EF, for each vehicle classes in conjunction with traffic forecasts used to determine the design traffic, Cumulative Equivalent Standard Axle, CESA. Figure 8 shows the flow chart of pavement design for this study.

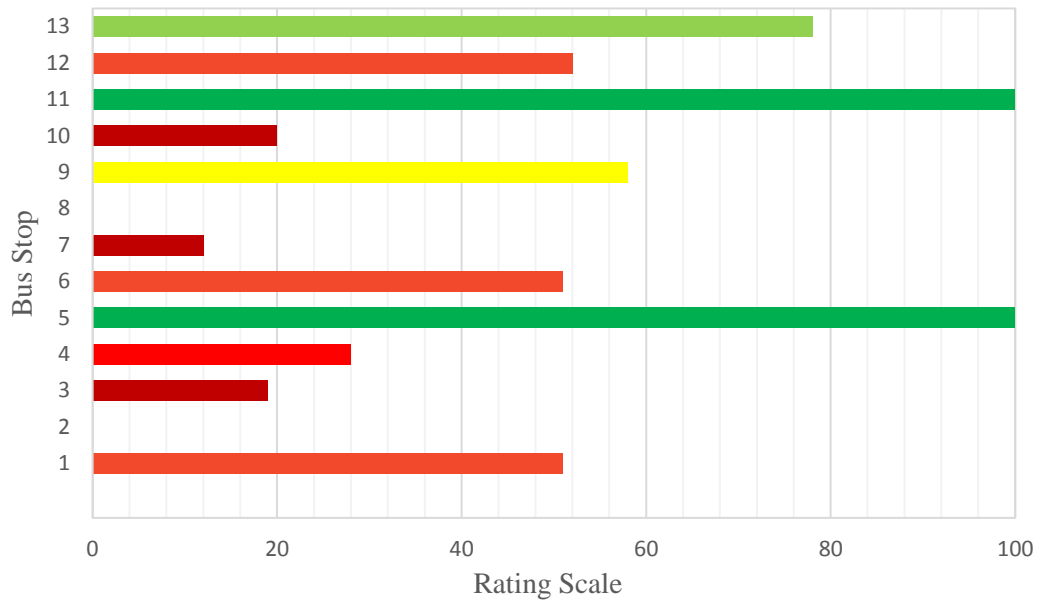
Figure 10: Summary of PCI for Aratkilo-Sheromeda.

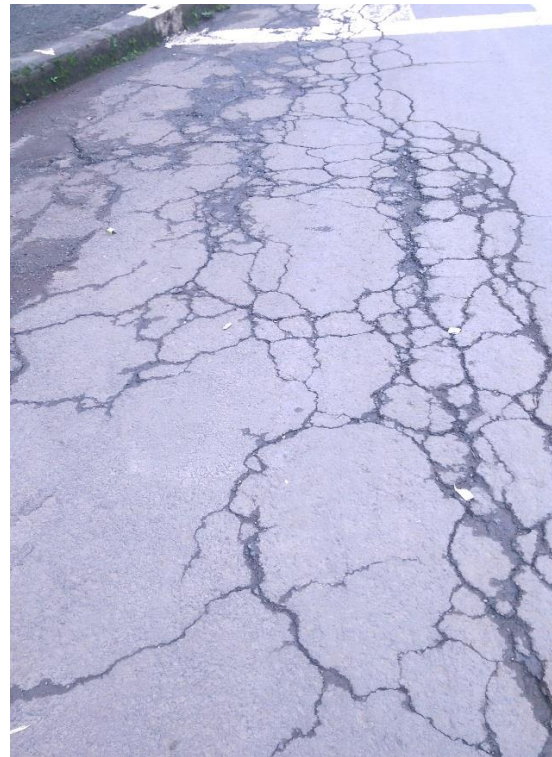
Figure 11: (a) Alligator Cracking and Potholes at bus stop 8, (b) Block Cracking at bus stop 7

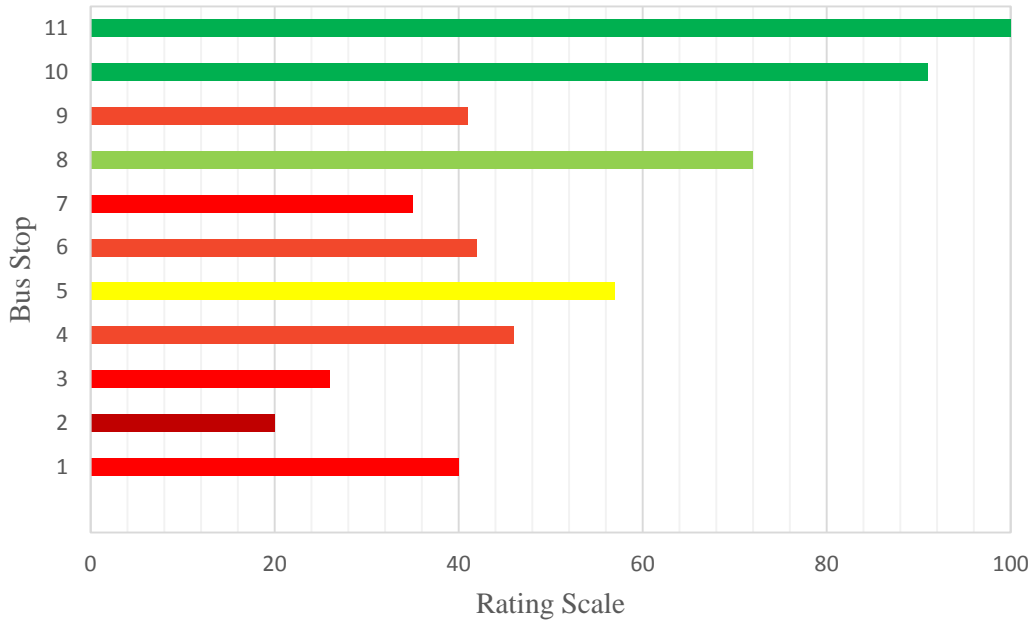
Figure 14: Summary of PCI values for Mexico to Piyassa Route

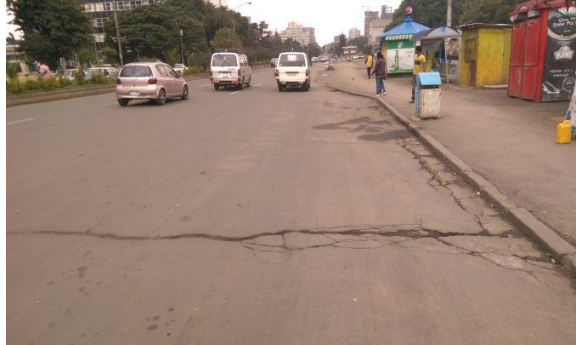
Figure 15: a) Potholes and Raveling at bus stop 4, b) Transversal and Edge Cracking at bus stop 6

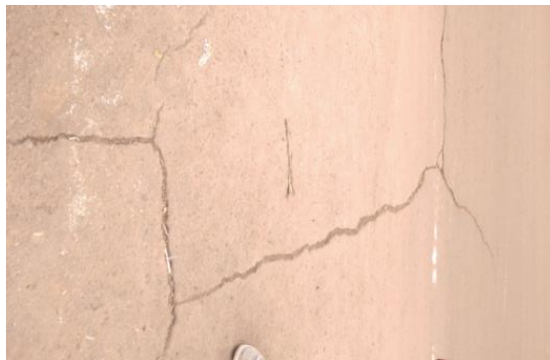
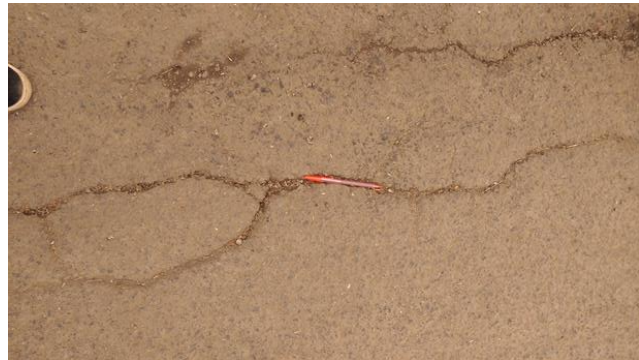
Figure 16: c) Transversal at bus stop 6, d) Longitudinal Cracking at bus stop 6

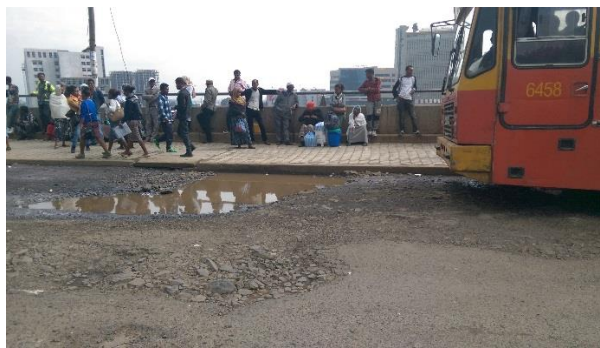
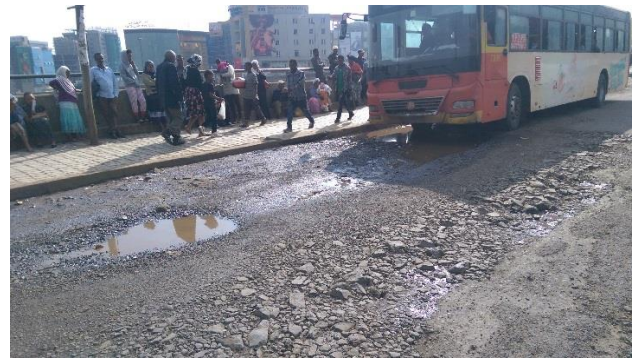
Figure 19: Potholes and Total failure of pavement

The interval of the pavement distresses found were too frequent and well exceeded the standard limits. Figure 19 and Figure 20 shows some of the photographs of taken on Megenaga bus-depot.

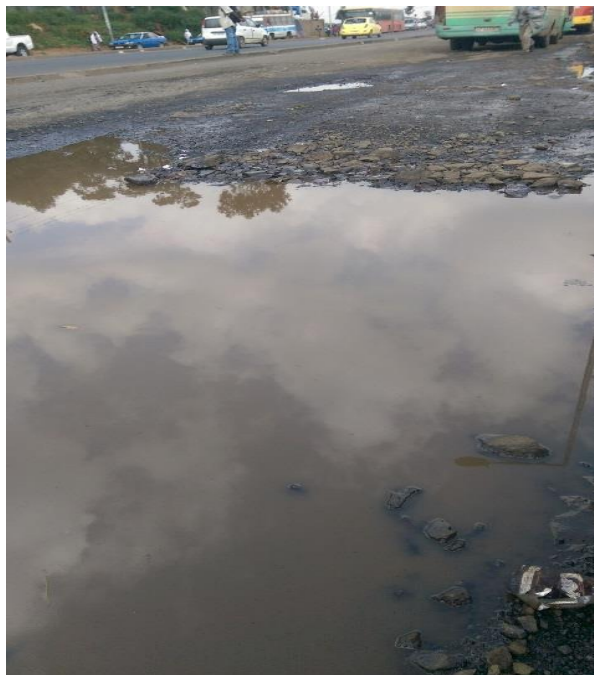
Figure 20: c) Total failure of pavement and d) Raveling

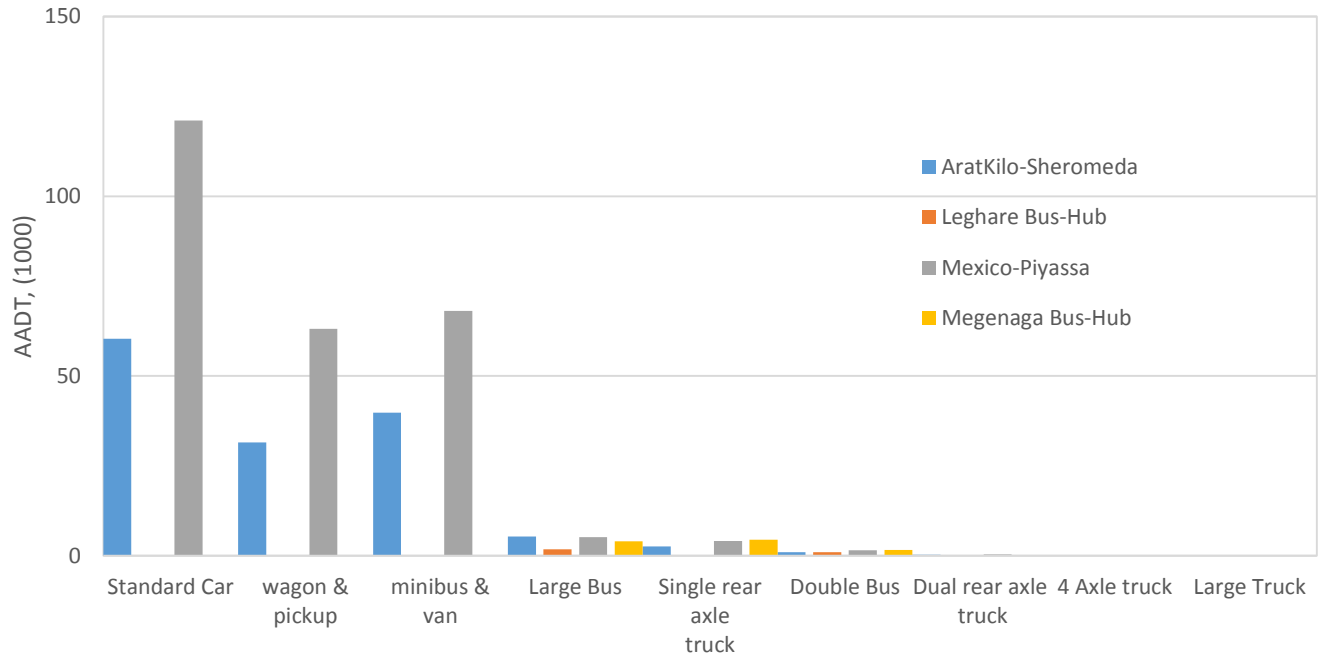
Figure 22: Annual Average Daily Traffic, AADT in Vehicle category for all study sections

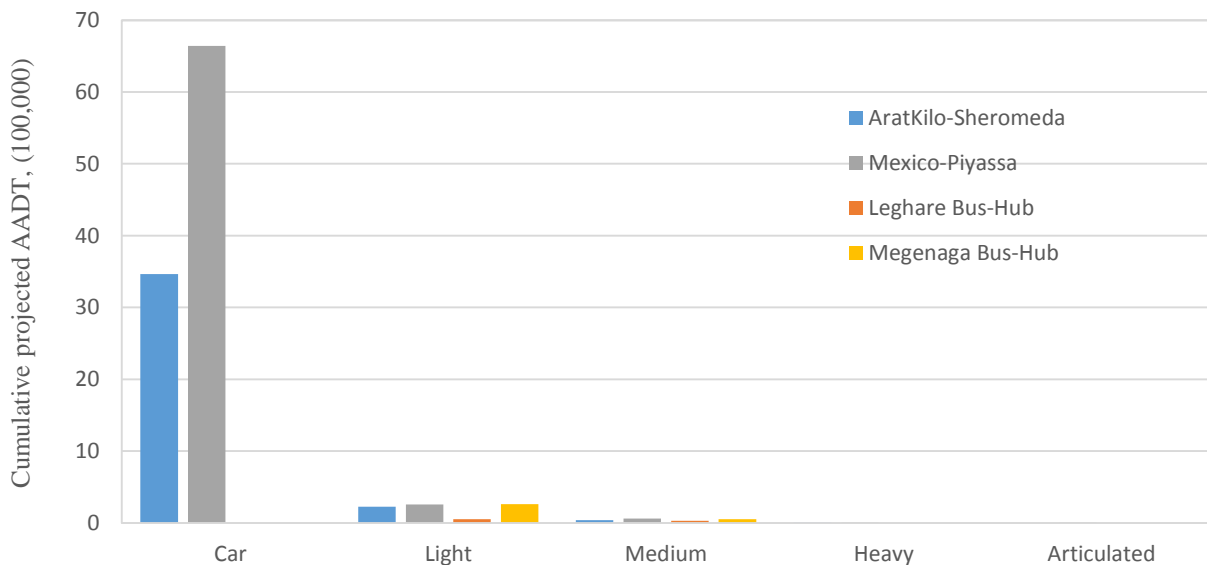
Figure 23: Cumulative projected AADT for 15 years design period

The Cumulative projected AADT are presented in the Figure 23 and Figure 24 shown in below for each design period and design section.

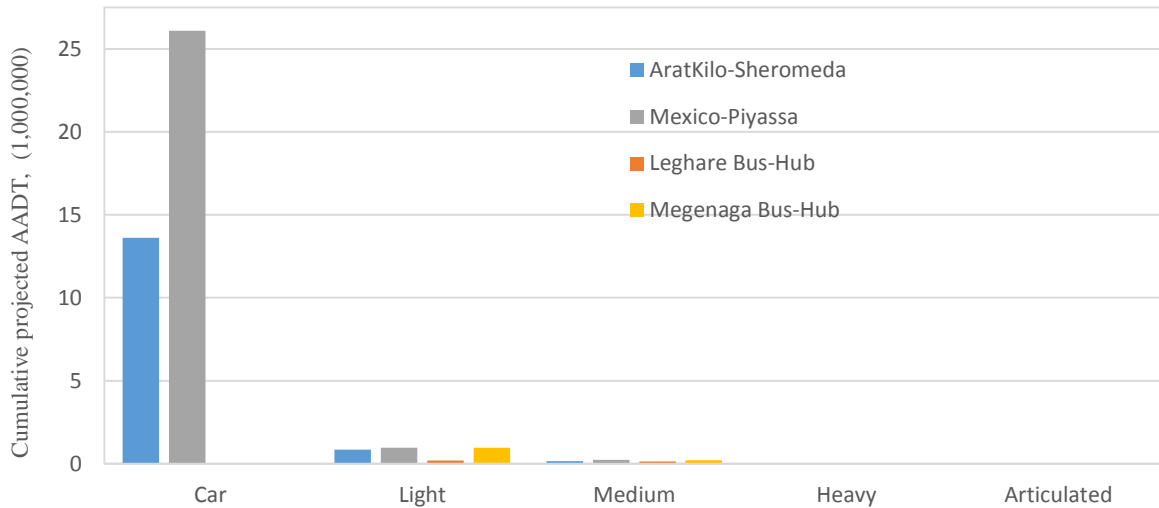
Figure 24: Cumulative projected AADT for 30 years design period

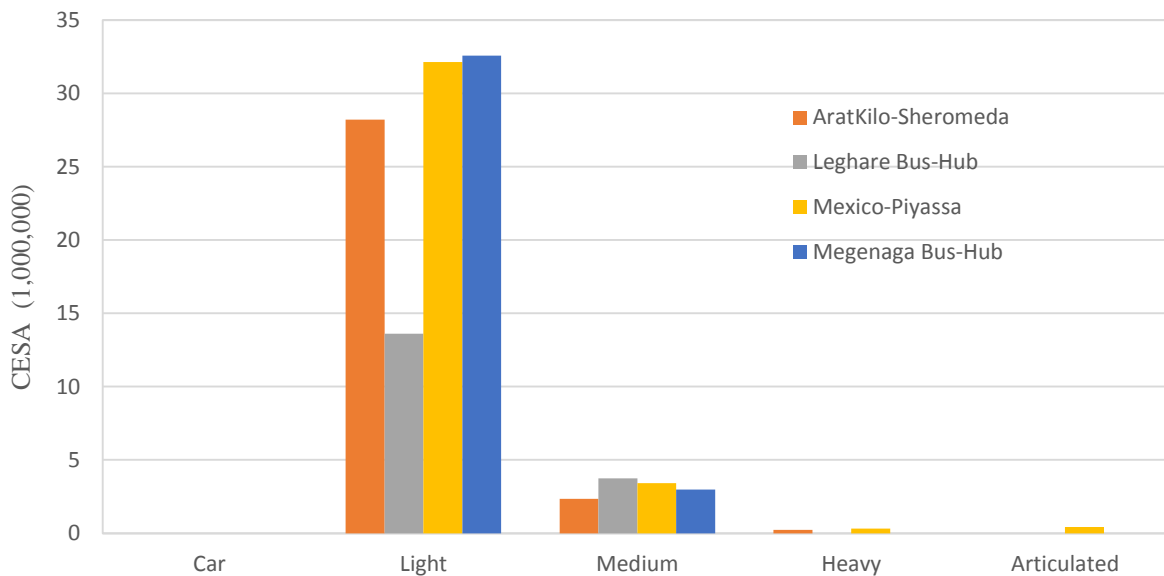
Figure 25: CESA in 10⁶ of each Vehicle Category for 15 years design period

The directional distribution factor 0.5 and lane distribution factor 0.8 were taken for all vehicle category except bus, for the bus lane distribution factor 1 was used for AratKilo-Sheromeda, Mexico-Piyassa and Megenaga bus-depot referring to the actual condition and AASHTO manual suggestion, but for Leghare-bus-depot both the directional distribution factor and lane distribution factor were taken 1. The Cumulative Equivalent Standard Axles (CESA) in the design lane are presented in the Figure 25 and Figure 26 below.

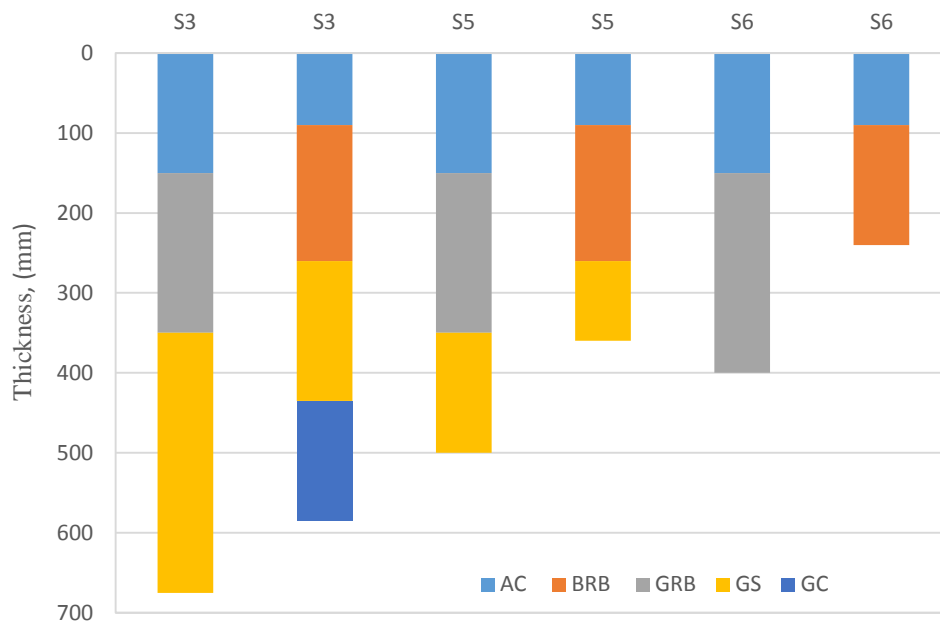
Figure 28: Designed Pavement Alternative Structure for Leghare Bus-Depot for T8

b) For Leghare bus-depot, for the traffic class T8, there are two alternative for each subgrade class in ERA 2013 pavement design manual structural catalogue, Chart C1 and Chart D1. Each design thickness shown in the Figure 28 below. To select economical pavement structure cost comparison analysis between alternative pavement structures was done.

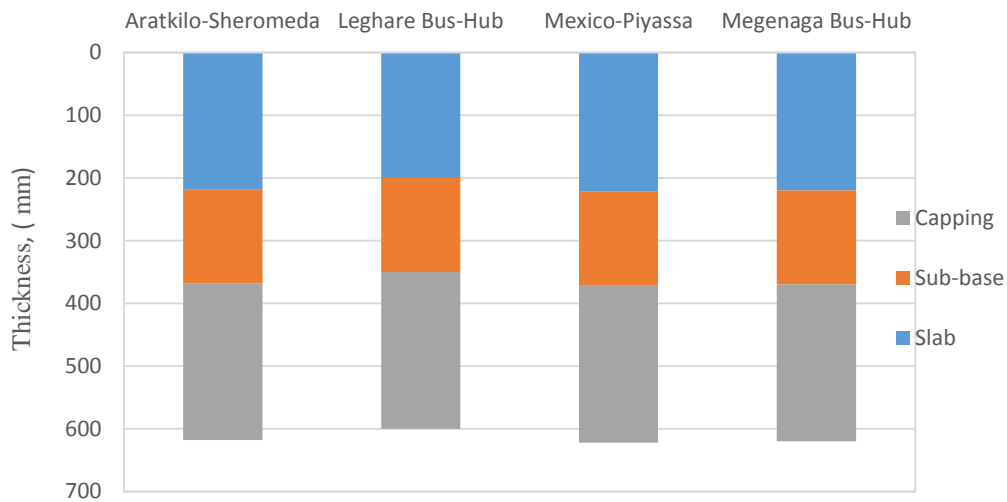
Figure 30: The selected Pavement Layer Thicknesses for subgrade class S3

The detail price comparison of rigid pavement structure is found in Appendix E. The cost comparison indicated that the pavement structure from CRCP was more economical. This due to JRCR has higher concrete slab thickness than CRCP. Therefore, the selected pavement structure is shown below in figure for each subgrade layer.

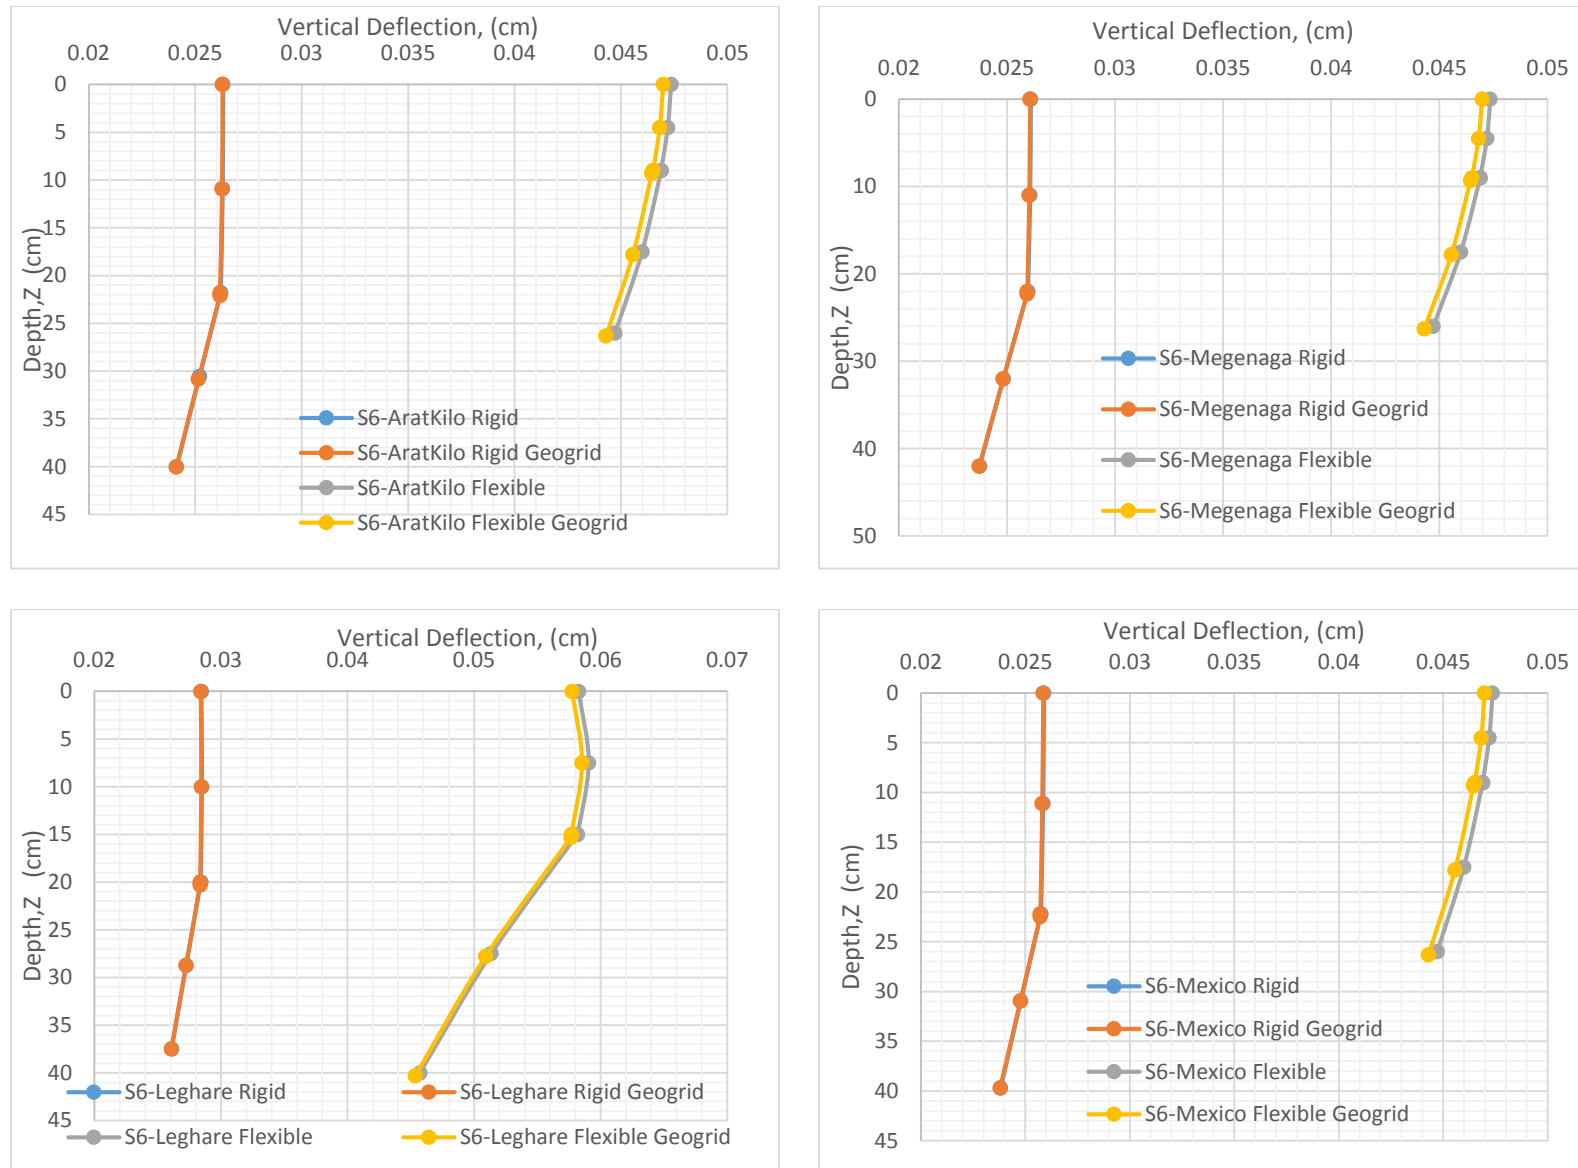
Figure 41: Variation of the vertical displacement against changes in vertical coordinate for S6

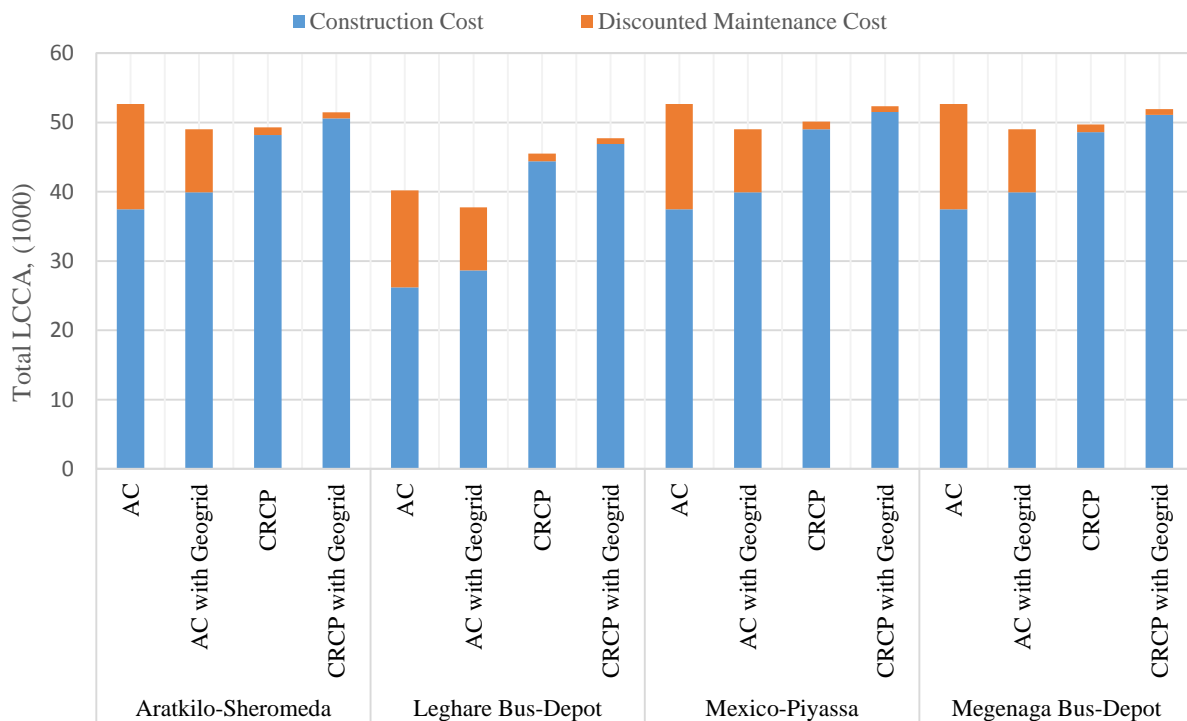
Figure 57: LCCA, When cost of Cement increased by 10% and cost of Bitumen decreased by 10% for S6

From Sensitivity analysis for LCCA over all I can say that, bitumen price fluctuations have significant effect on the initial cost of flexible pavements than cement price fluctuations on concrete pavement. Hence, bitumen is more sensitive and risky than cement as an alternative pavement construction material. Therefore, rigid pavements are more feasible, less responsive for price changes on cement as compared to the competing flexible pavement which is more sensitive to price changes on bitumen.
