**EVALUATION OF LAND DEGRADATION AND
LANDSLIDE USING INTEGRATED REMOTE
SENSING AND GIS APPROACH
AROUND WOLAYITA SODO-SHONE AREA,
SOUTHERN ETHIOPIA**

*A THESIS PRESENTED TO
THE SCHOOL OF GRADUATE STUDIES OF
ADDIS ABABA UNIVERSITY*

*In partial Fulfillment of the requirements for the Degree
Master of Science in Earth Sciences.*

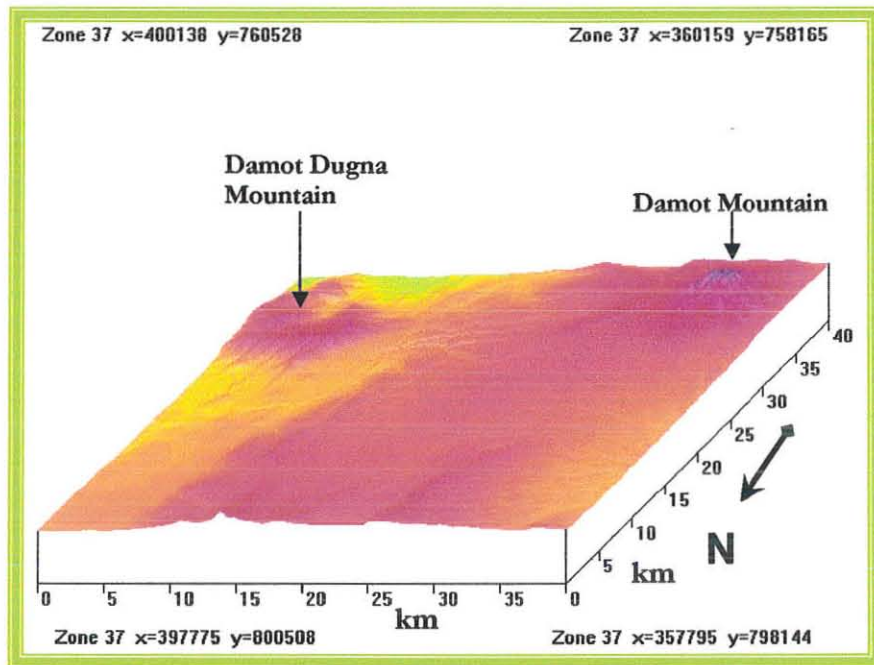
Figure 1. 2 3D-view of SRTM data at 90m resolution of the study area showing domes river cuts, tectonic structure ...etc.

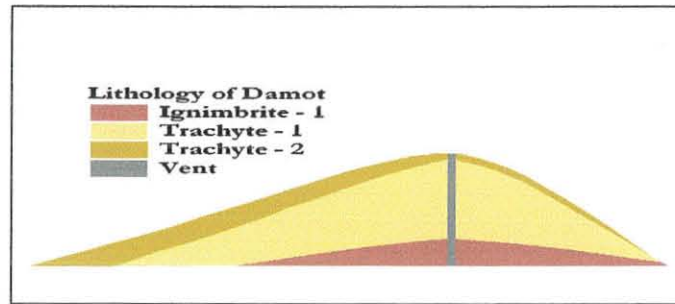
Figure 1.6 Damot Mountain before faulting and weathering

The trachytes which predominantly cover the volcanic dome in its northeastern, northern and western parts give the current asymmetrical shape of Damot (Figure 1.6).

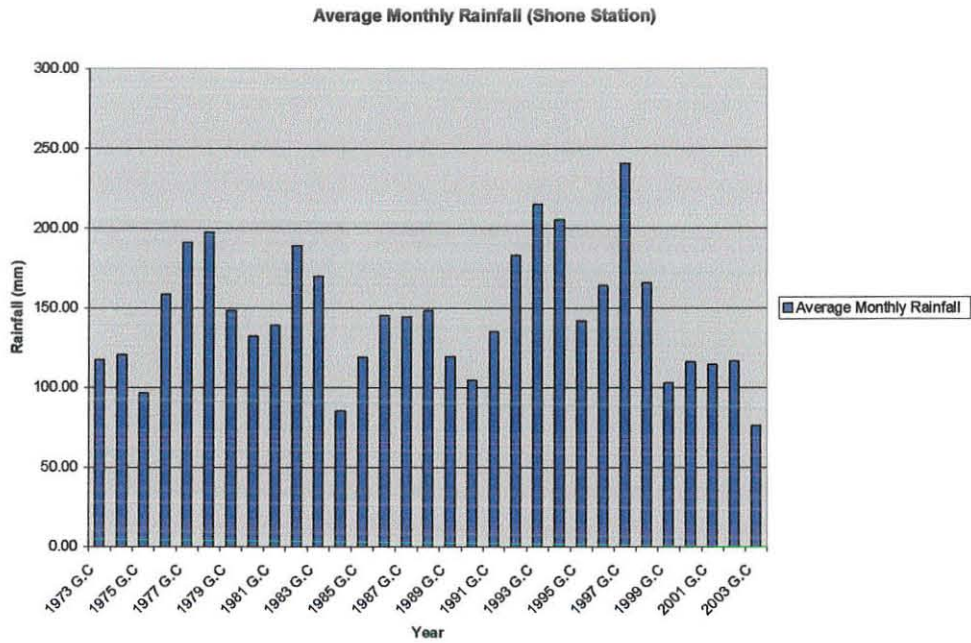
Figure 1.10 Average monthly rainfall of Shone area

The monthly mean rainfall data for 33 years and 30 years were analyzed for Wolayita Sodo and Shone area respectively. Monthly average rainfall in Wolayita Sodo and the surrounding areas ranges between 50mm-150mm (Figure 1.9) while in Shone and the surrounding areas it ranges from 80mm-200mm (Figure 1.10).

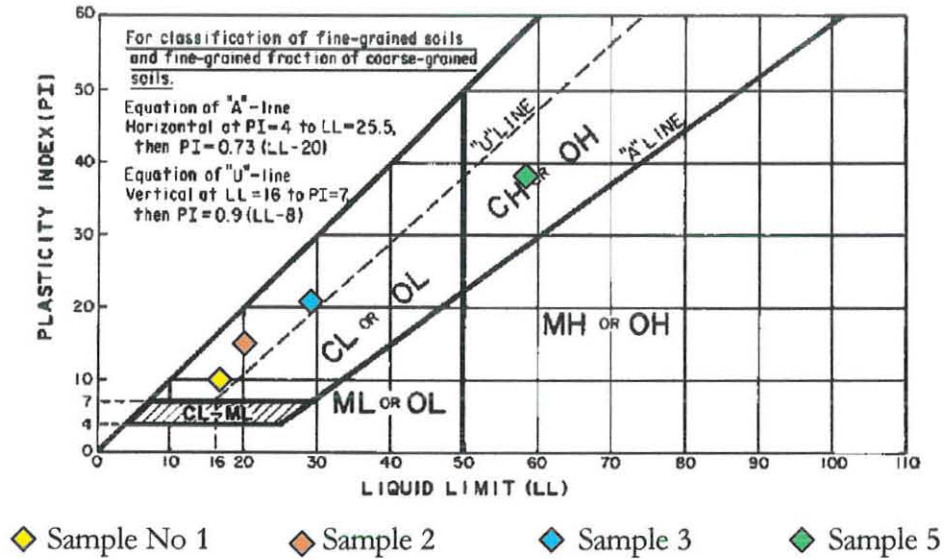
Figure 4.3 Samples plotted on the Plasticity chart

According to the Unified Soil Classification System (USCS), there are two major divisions namely fine grained soils in which more than half of material is smaller than No. 200 sieve and coarse-grained soils where more than half of material is coarser than No 200. Since all the soil samples percentage passing greater than 50% passing No. 200 sieve, the samples are classified as fine grained. Within this division the three samples (sample No 1, 2 and 3) have a liquid limit of less than 50% and their plasticity index ranges between 26.3-16.5, there for their typical class belongs to silty clays (CL). Whereas, sample No 4 and 5 have a liquid limit of 78.0 and 68.7 respectively. Their plasticity indexes are 69.1 and 9.84 respectively. Based on this fact they are classified as inorganic clays of high plasticity or fat clays.

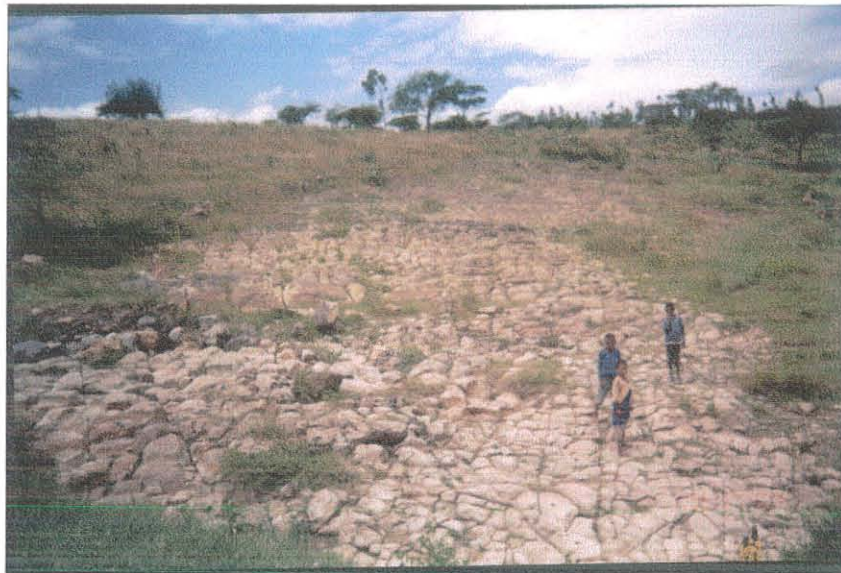
Figure 5.1 Bed rock exposed due to sheet erosion

Sheet erosion: Sheet erosion is the first stage of gully formation (figure 5.1). It occurs when the infiltration capacity of soil is exceeded by the amount of rain water resulting in surface flow, detaching fine particles from the upper loose soil. It involves the removal of a uniform thin layer of soil by raindrop splash or surface run off. This thin layer of topsoil often disappears little by little, making it difficult to monitor for the reason that the damage is not instantaneously traceable. This insidious process is often unnoticed until the subsoil is exposed. Most of the areas are characterized by removal of organic matter and vegetation cover is decreasing, aggregates are breaking down and in many parts crusts are formed which air and water can no longer penetrate.

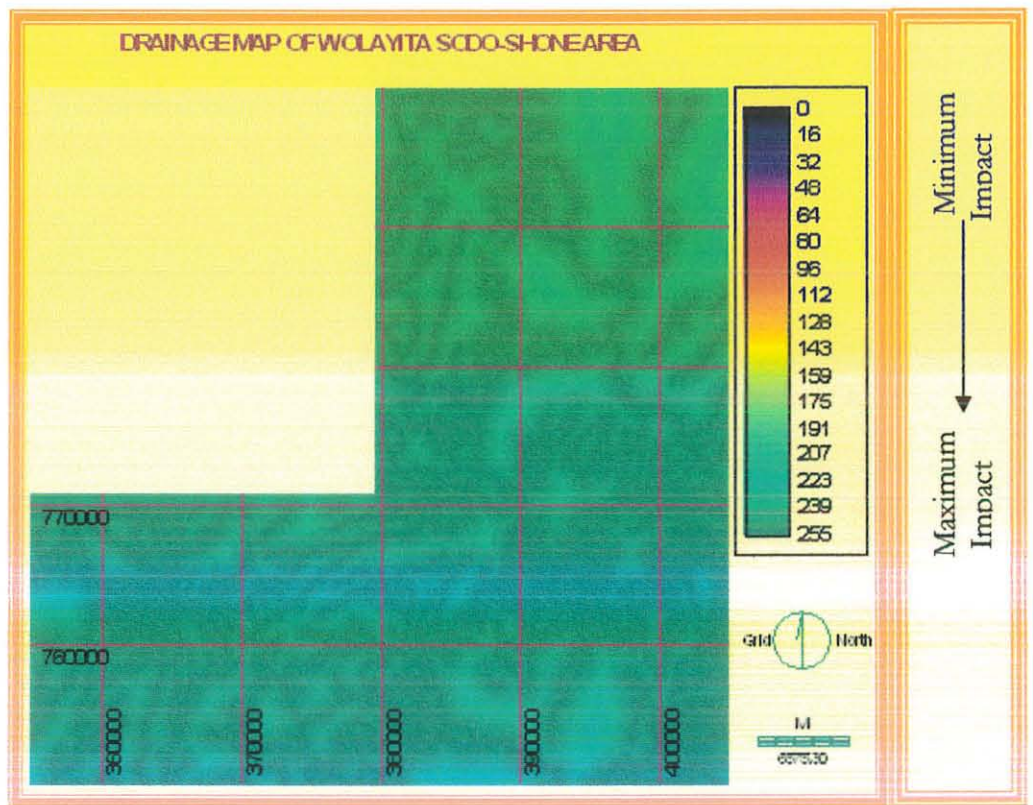
Figure 6.2 The Reclassified drainage map of the study area

scale is assigned to indicate a continuous increase from less degree of impact to high degree of impact Figure (6.2).

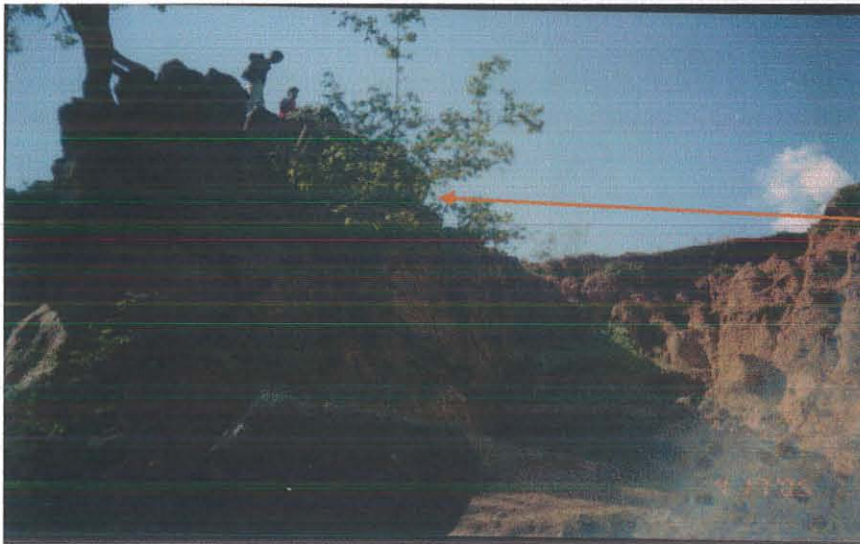
Figure 6.7 A thin basaltic flow that is relatively unaffected by land degradation

The lithologic units are other background factors that assist the degradation process together with the major and minor triggering factors. These units have varying level of fracturing and weathering that guide the way for further degradation process. The concentration of degradation mainly in the rift floor ignimbrite is strong evidence that the lithology has a significant impact on land degradation. From the picture below, we can see that there is a clear contact between a thin layer of basaltic flow and the rift floor ignimbrite. The part which is covered by the thin basaltic flow is relatively not affected by the degradation whereas the rift floor ignimbrite is highly eroded (Figure 6.7 & 6.8).

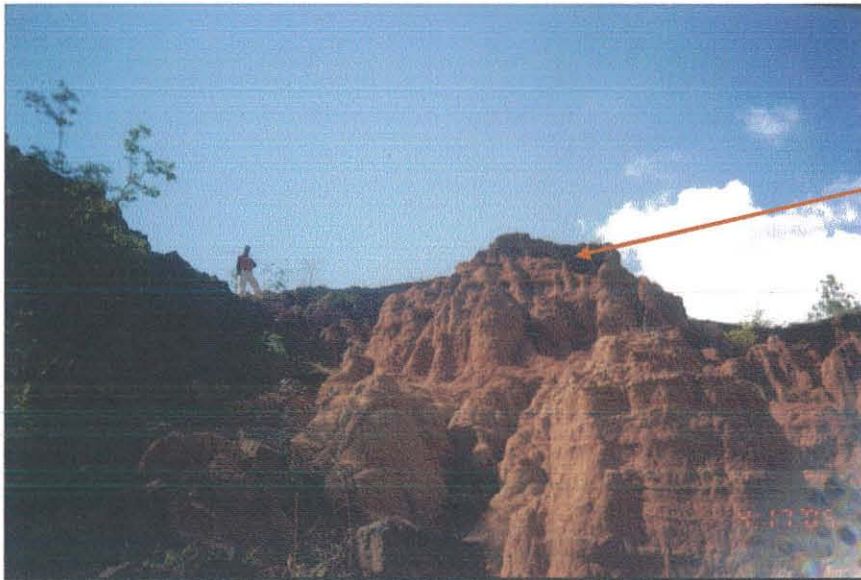
Figure 6.8 Rift floor ignimbrite affected by intensive degradation

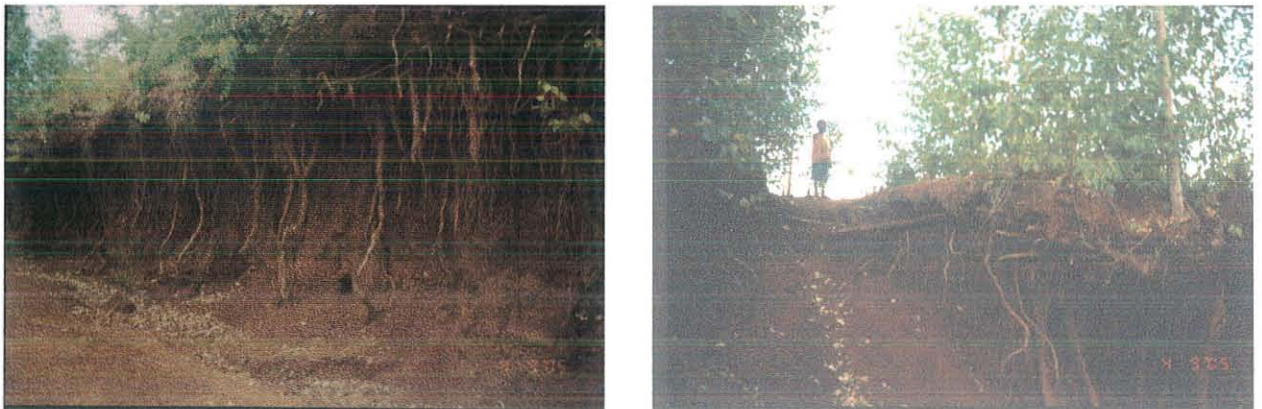
Figure 6.9 Land degradation aggravated by road cut

Intensity of soil erosion varies with different sort of landuse/land cover type. Crop lands are the most susceptible areas to erosion. Large amount of soil can be eroded and transported from farm lands especially after harvesting, where the tillage soil left bare for a certain period of time till the next cropping season comes. Generally, repeatedly cultivated soils, fallow soils or soils that are bare through overgrazing by stock animals are particularly vulnerable and have major impact for the on going processes. The eastern, north eastern and south western part of the study area is the most affected by degradation as they are dominated by annual crop and mixed annual intensive with lesser amount of perennial crops. Areas covered with perennial crops, natural vegetation and plantations have a minimum or negligible degradation. In addition to these landuse/landcover types, road cut also aggravate land degradation (figure 6.9).

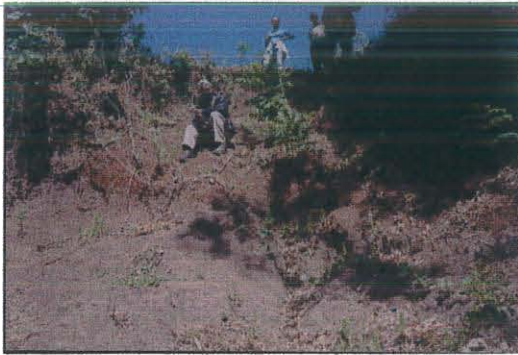
Figure 7.1 Mudflow that killed 11 people

Mud flow, rock fall and creeping are the most common mass movements in the study area. In Gurmu Wayide kebele, 11 people were killed by a mud flow that occurred on November 17 1993 (figure 7.1). According to the local people, the disastrous mud flow occurred at night following intensive rainfall that lasted for hours. The movement occurred only within 3 minuets period. The local people planted eucalyptus trees on the spot where the sliding occurred to prevent further sliding. But the trunks of the growing eucalyptus trees bend down slope (Figure 7.3) indicating soil creep, implying that the area is still active and prone to such events. Most of the

landslide scars present in the study area that cause such disasters are very small. The width of the scar that kills 11 people in Gurmu Wayide kebele is about 21 m while the depth after the flow is about 8 m. The slope angle measured on the spot of the sliding is about 21° .

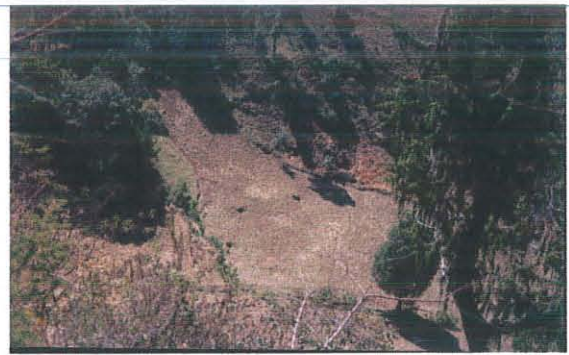
Figure 7.2 Landslide scar that damage property

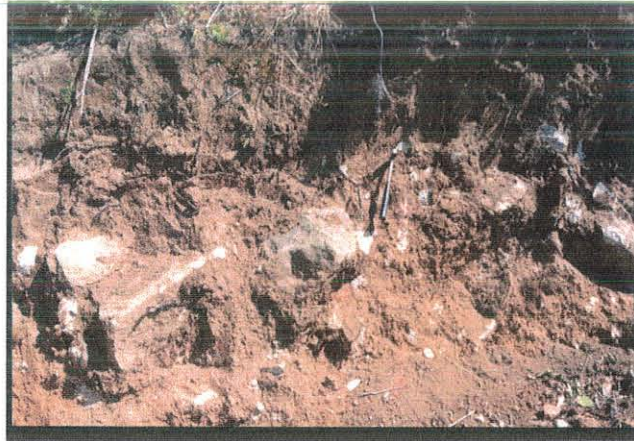
Figure 7.4 Transported materials as a result of mass movement

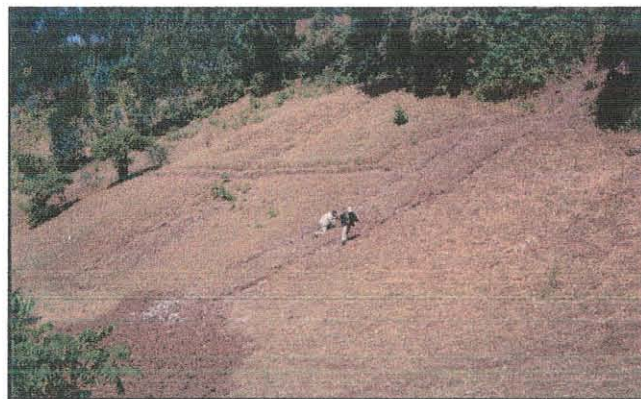
Figure 7.5 Mudflow that killed 5 people

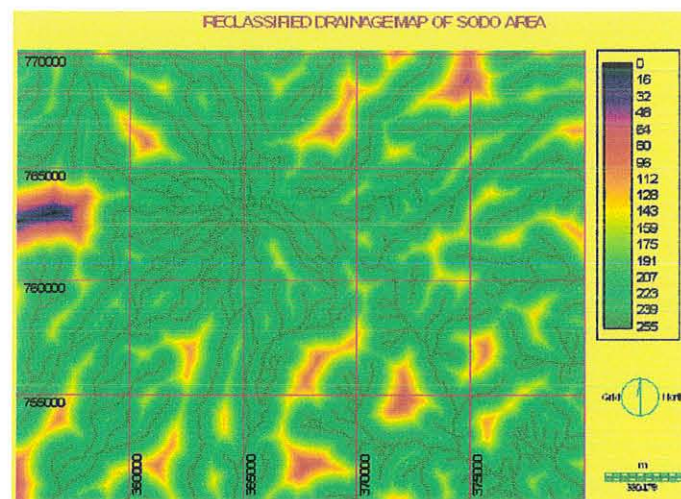
Figure 7.15 Reclassified Drainage map of Mount Damot

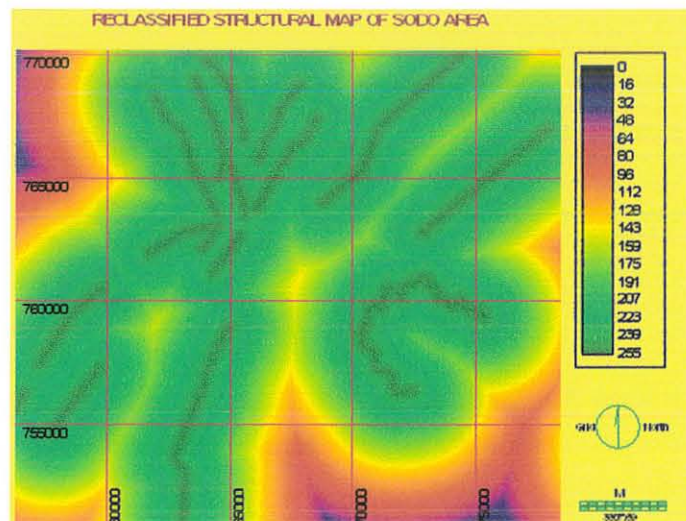
Figure 7.18 Reclassified Structural map of Mount Damot

(Figure 7.18). The impact of the structures usually decreases as the distance from the structures increases and vice versa. So monotonically decreasing type of fuzzy membership curve is chosen.

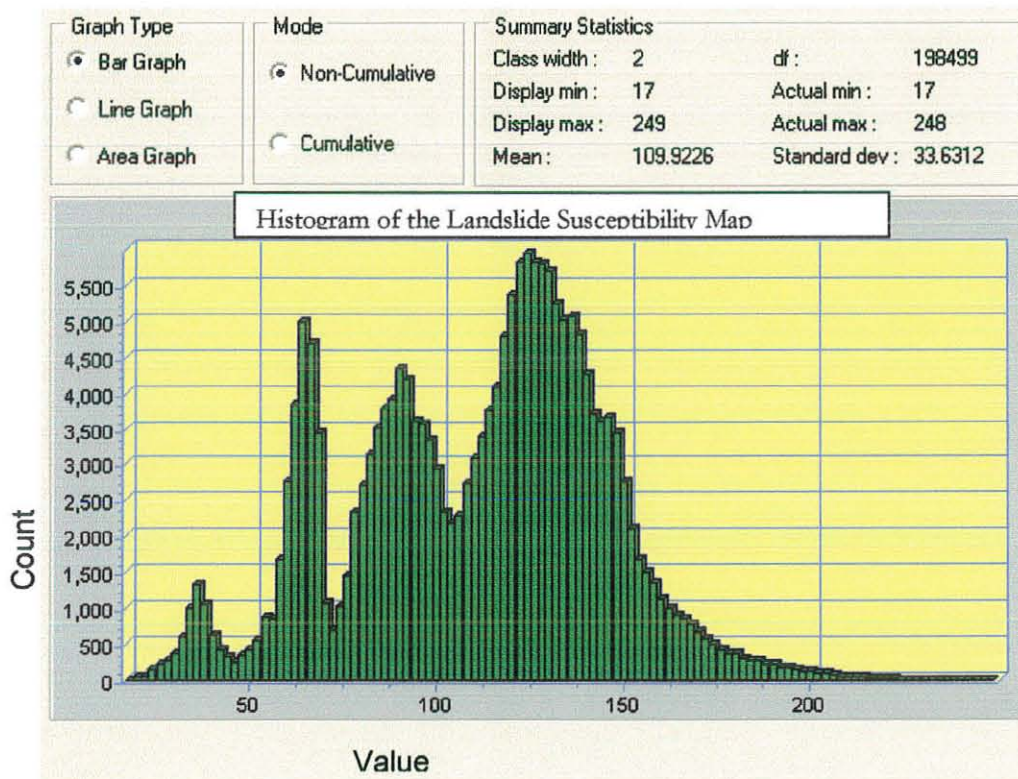
Figure 7.21 Histogram of the landslide susceptibility map around Wolayita Sodo area
