**GIS-BASED STATISTICAL ANALYSIS FOR EVALUATION OF LANDSLIDE
SUSCEPTIBILITY MAPPING: A CASE STUDY IN WACHA-MIZAN ROAD
SECTION, SOUTHWESTERN ETHIOPIA**

**A Thesis Submitted to School of Earth Sciences for Partial Fulfillment of the
Requirements for the Degree of Master of Science in Engineering Geology**

By: Wegderes Tena

June, 2024

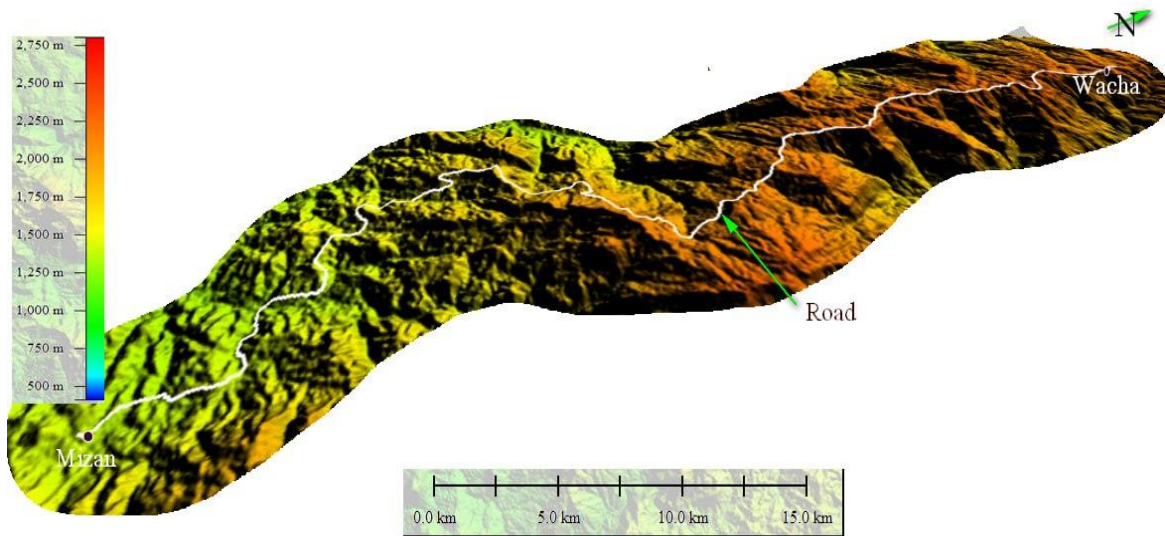
Figure 3: Physiographic map of Wacha-Mizan Road

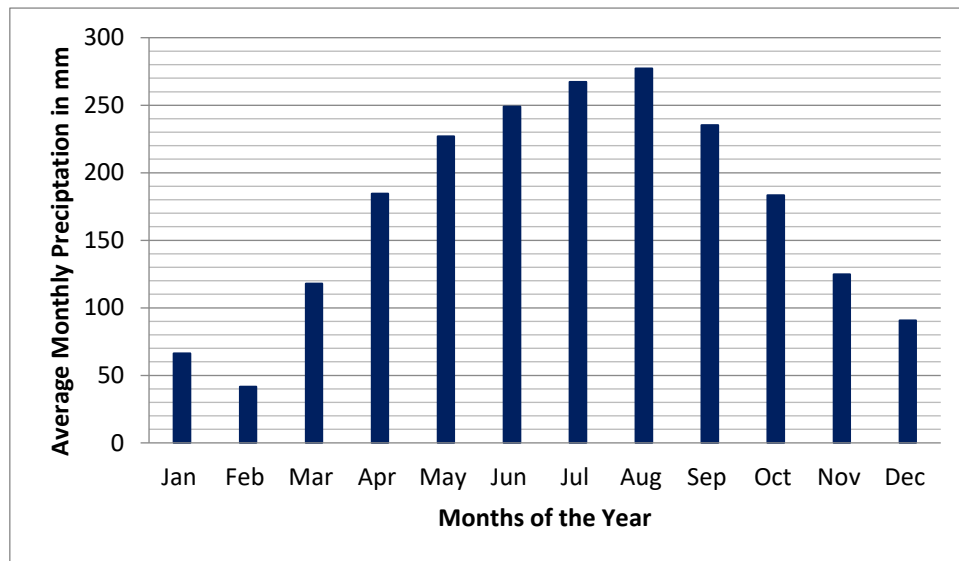
Figure 4: Average Monthly precipitations from 1990 to 2019 for Mizan Teferi station

The project area gets maximum rainfall during the months of April through September, and it gets minimum rainfall during the months of December through February. The mean annual rainfall of the project corridor is ranging from 1500 to 1800m. Therefore, this high amount of rainfall during the major rainy Ethiopian season is considered as one of the main triggering factors that can have an impact for the slope by facilitating erosion and landslide problem for the study area.

In general, the cumulative monthly and annual amount of precipitations in the wacha-mizan Teferi area was higher especially in the month of June to September. This indicates that rainfall plays a major role for triggering landslide activity in the study area through increasing groundwater level in the slope or storage capacity of the soil is exceeded which ultimately results in the erosion of colluvium and residual materials that are exposed in the slope surface.

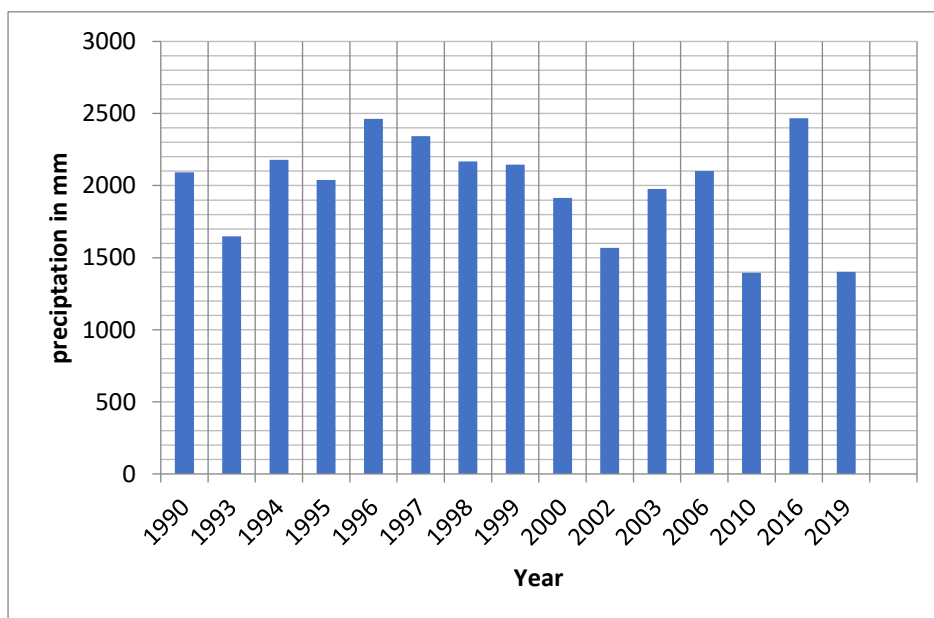
Figure 5: Annual precipitation from 1990 to 2019 for Mizan Teferi station

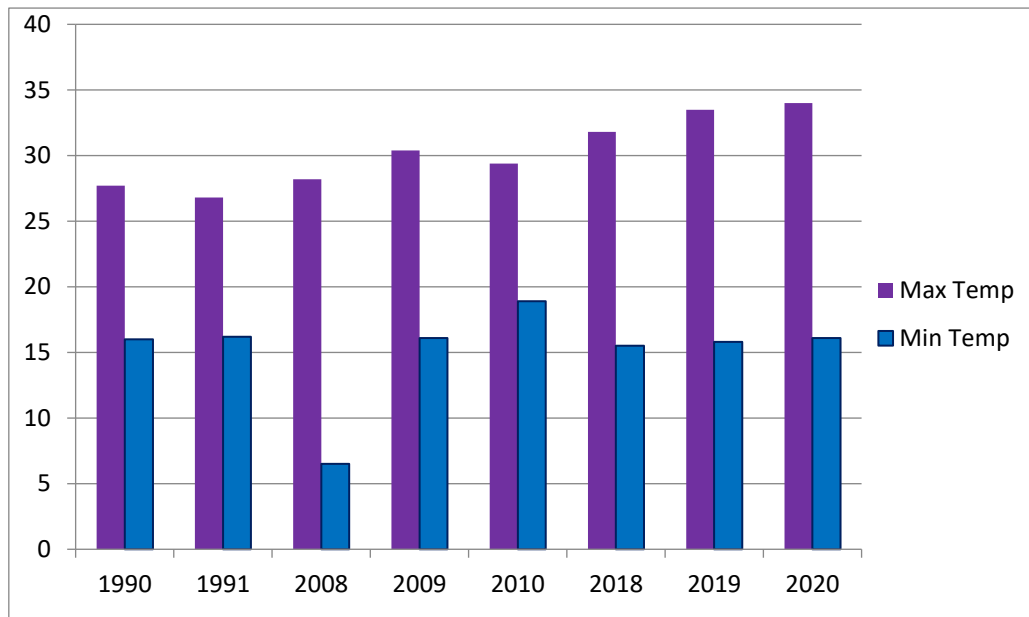
Figure 6: Annual maximum and minimum Temperatures of the study area

The climate of the project section is classified as cold climatic nature or low temperature zone, high rainfall and low Evapotranspiration. Minimum temperature is 4.5°C and maximum temperature is 41°C . There is a large variation in the minimum and maximum temperature as well as annual average temperature condition of the study area.

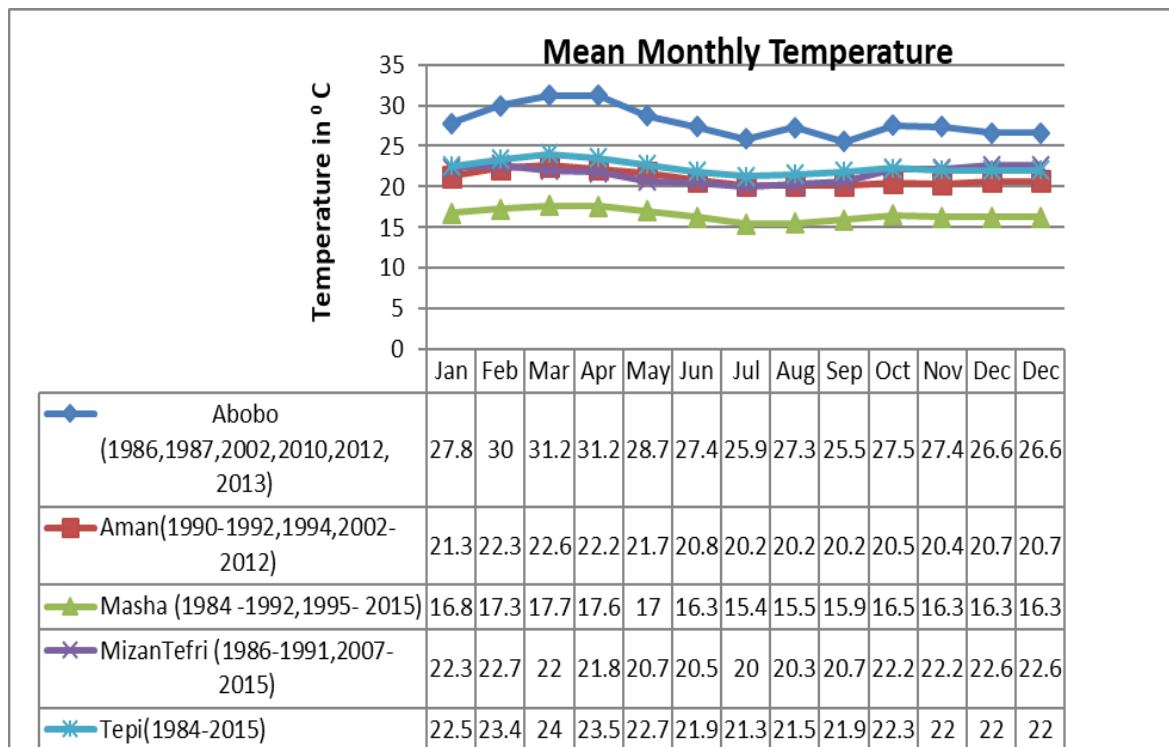
Figure 7:Min, average & max Temp for Gecha meteorological stations

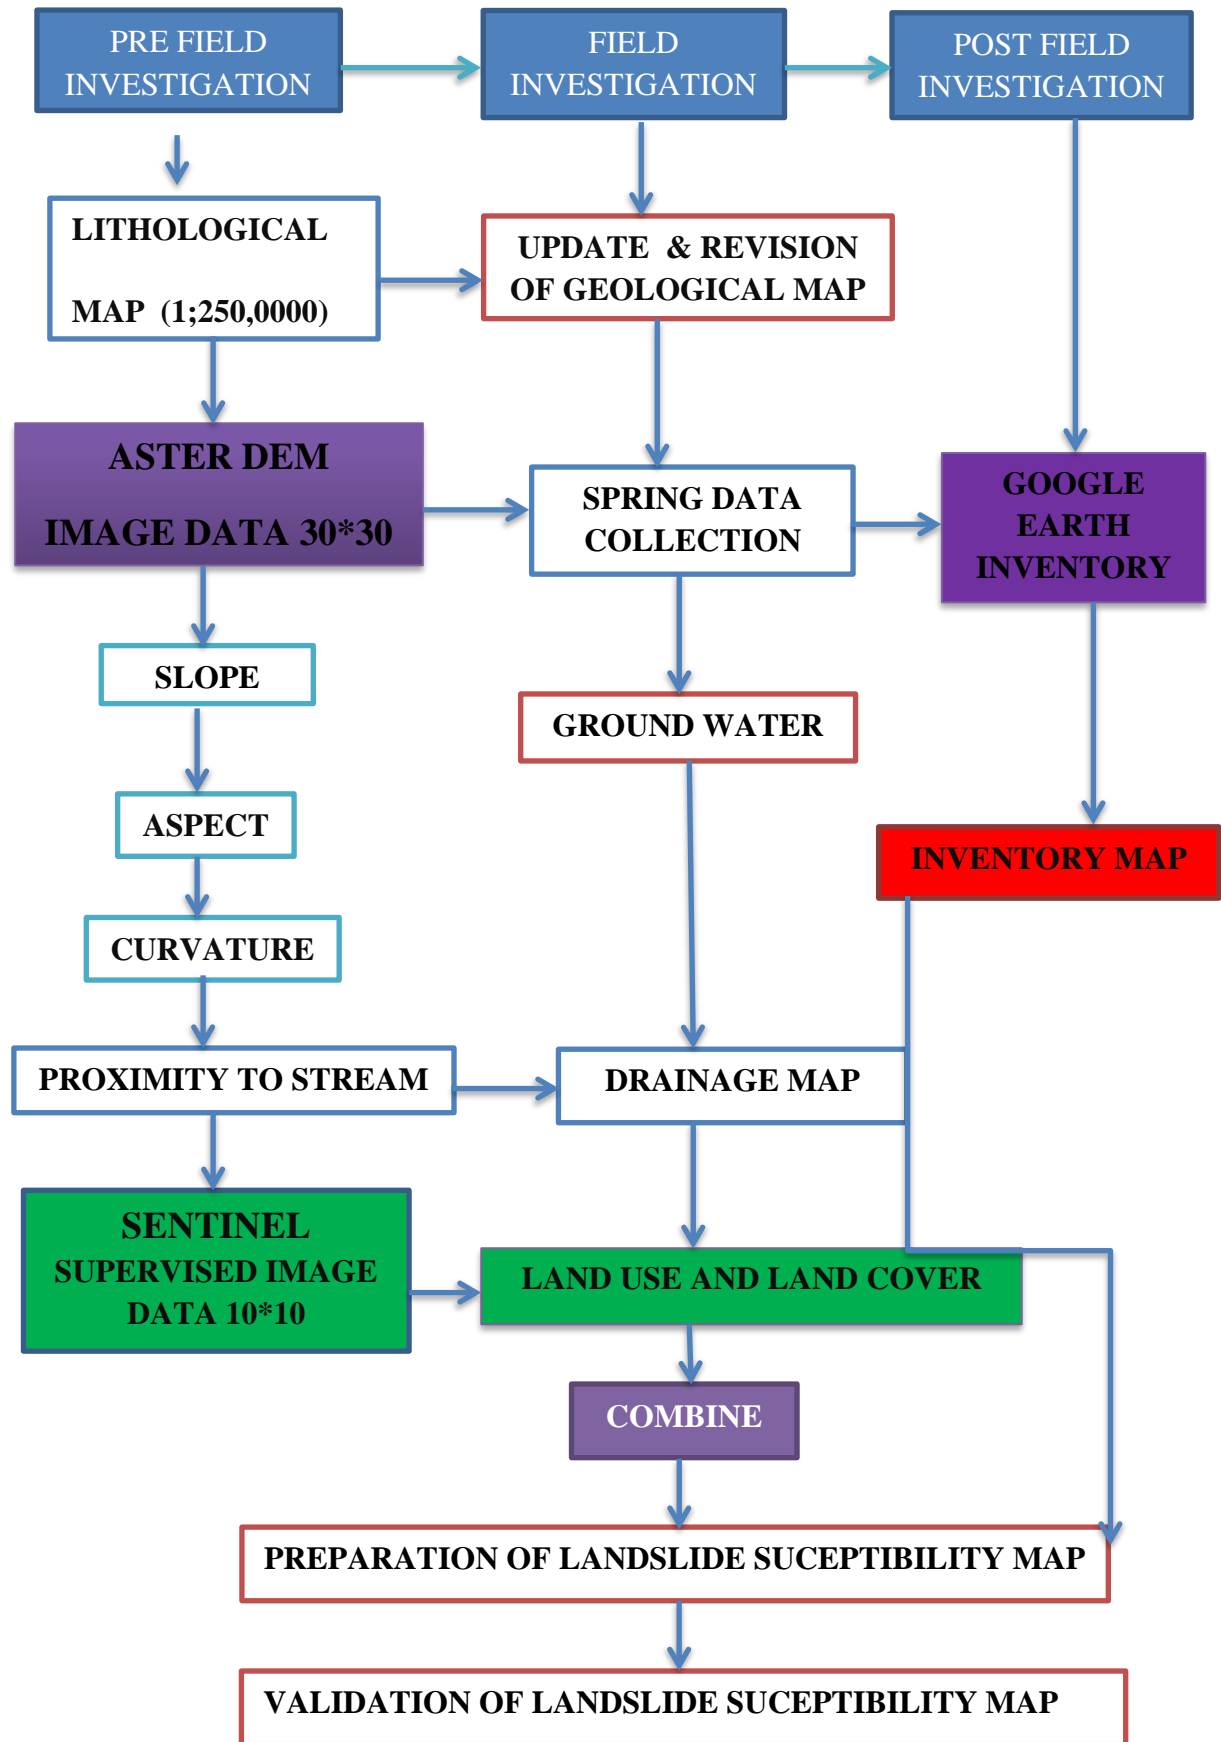
Figure 13: Flow chart of general methodology adopted for the study

To determine the weight of each class, the landslide map and the causal factor maps were combined. In the statistical modeling of landslides, the assumption is based on the rule "the past is the key to the future". For the present study six prominent causative factors are considered for the landslide hazard susceptibility. These causative factors are i) slope material, ii) slope, iii) land use and land cover iv) groundwater and v) aspect vi) curvature.

Pre-field works include secondary data collection related to previous field reports, topographical maps, satellite images, and Digital Elevation Model (DEM) data. The landslide hazard causative factors were processed using Arc-GIS built in software and ratings were given based on the contribution of each factor for the occurrence of mass movement of the slope and landslide hazard index of the study area were calculated.

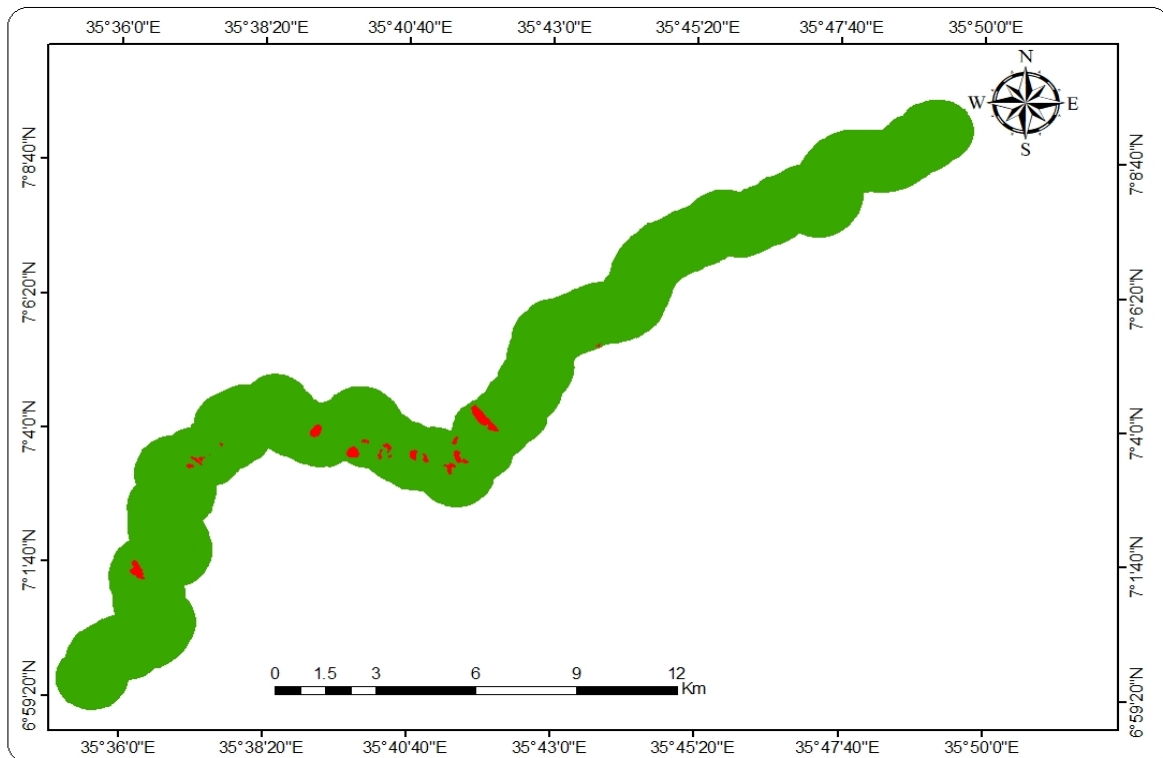
Figure 14 : landslide inventory mapping

- There are deep-seated rotational failures that are affecting the back slope, the roadbed, and the side slope. These landslides are active and intensifying that are results of either reactivated from old landslides due to modifications in the road slope geometry, or due to deep slope cuts within weak residual formation, or interface of soil mass with the underlying rock when saturated with surface and groundwater.
- There are also shallow earth slide translational failures that are caused by improper management of surface and subsurface water flow.

- The soils during rainfall season are prone to sliding by surface water flooding due to losing of grain to grain contact of their shear strength property found within the soil mass.

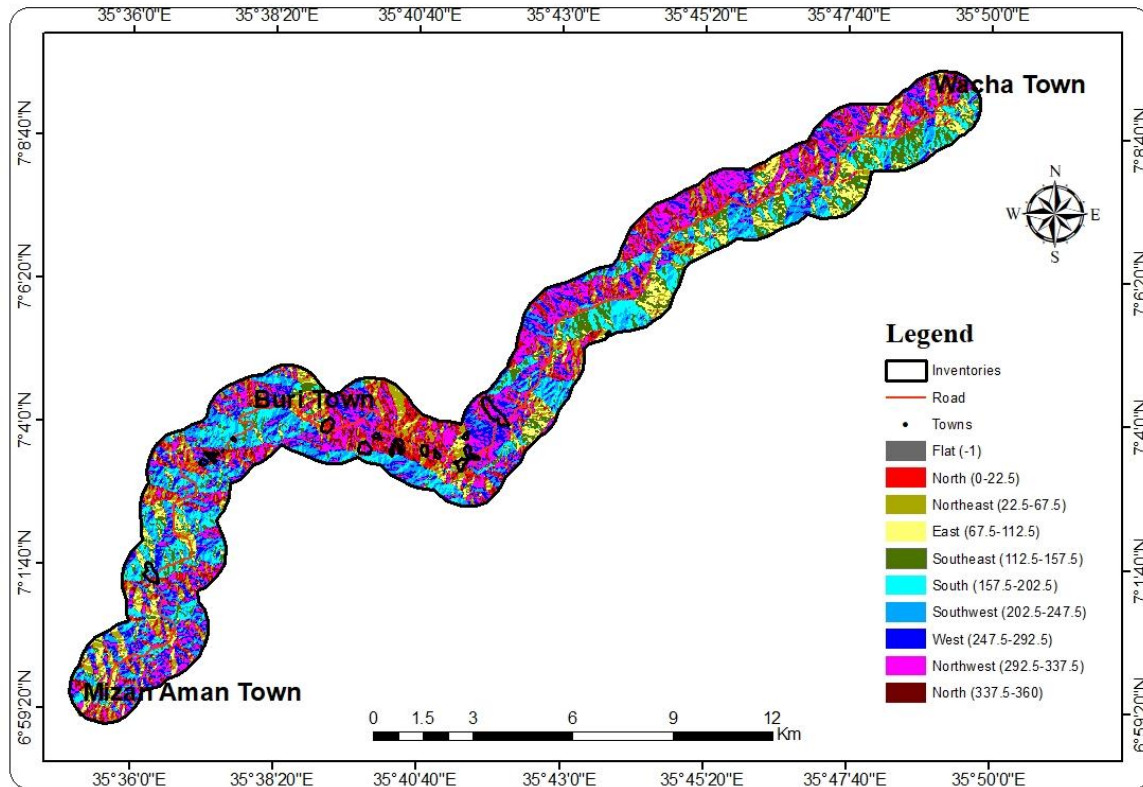
Figure 16: Aspect map of the study area

This could be due to the slope directions dipping towards north may receive more solar radiation and rainfall humidity. As a result the slopes facing towards north are more affected with weathering conditions which is responsible for the sliding activity.

In addition, from the aspect orientation it is possible to deduce that the south facing slopes are more covered with forest vegetation where as the north facing slopes have asparse vegetation cover with bare agricultural lands. As a result, the landslide activities are more concentrated towards north facing slopes due to the overlay analysis of slope aspect causative parameter.

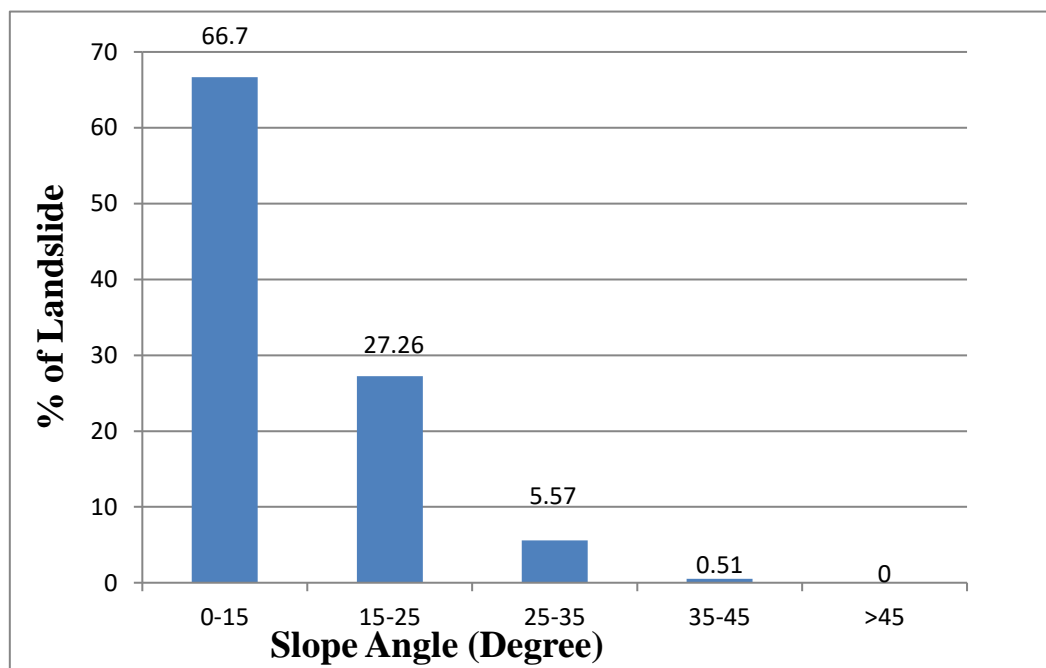
Figure 22: Relations b/n percentage of landslide distribution with Slope classes

The slope classes $15-25^{\circ}$ & $25-35^{\circ}$ have positive information values (IV) of 0.02 and 0.01, respectively, which shows those classes have a higher contribution to the probability of landslide occurrence. From the slope analysis result, it is possible to deduce that more landslides have the potential to occur in gentle to moderate slope terrain rather than on steep slopes, where the IV value is higher for the slope classes $15-25^{\circ}$ followed by $25-35^{\circ}$ degrees, respectively.

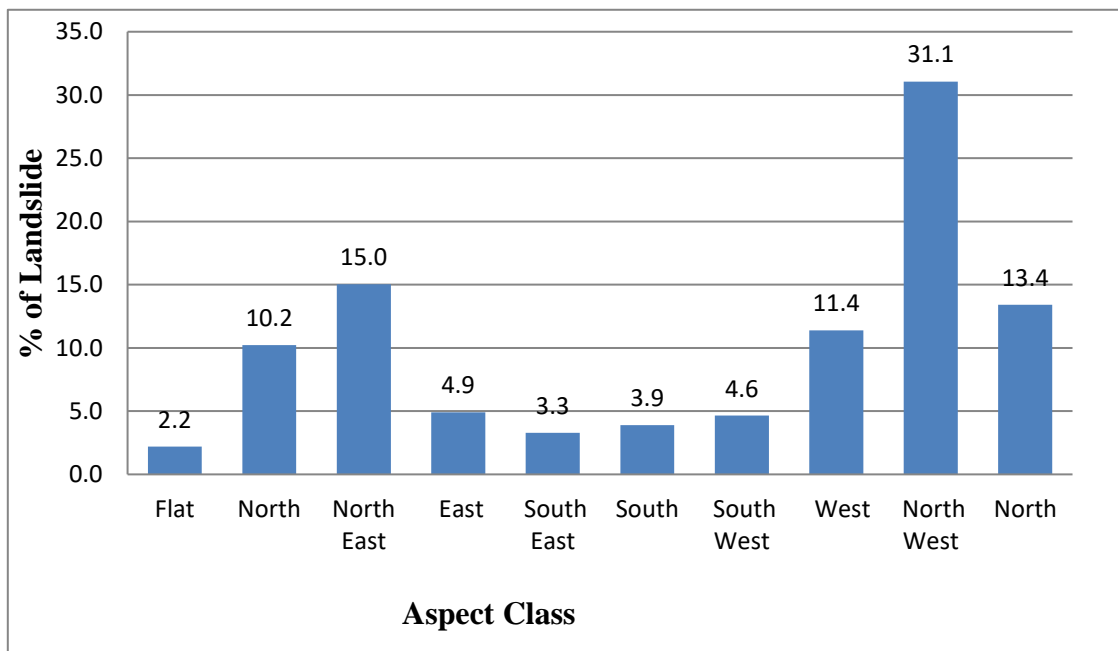
Figure 23: Relations b/n percentage of landslide distribution with Aspect classes

This may be due to the fact that the north-facing slopes can receive a high amount of solar radiation and rainfall. This favors land sliding due to the increased rate of saturation and weathering, particularly in loose disintegrated rock masses and colluvium soil materials. Further, the overlay analysis showed that 31.1% landslides occurred in slopes that are oriented towards North west, 15% occurred in slopes that are oriented towards northeast, 13.4% occurred in slopes that are oriented towards north, 11.4% occurred in slopes that are oriented towards west, 10.2% occurred in slopes that are oriented towards North direction and the remaining 9%, 4.9%, 4.6%, 3.9%, 3.3% and 2.2% landslides occur in slopes oriented towards East, south west, south, southeast and flat respectively (Table 6 and Fig 22).

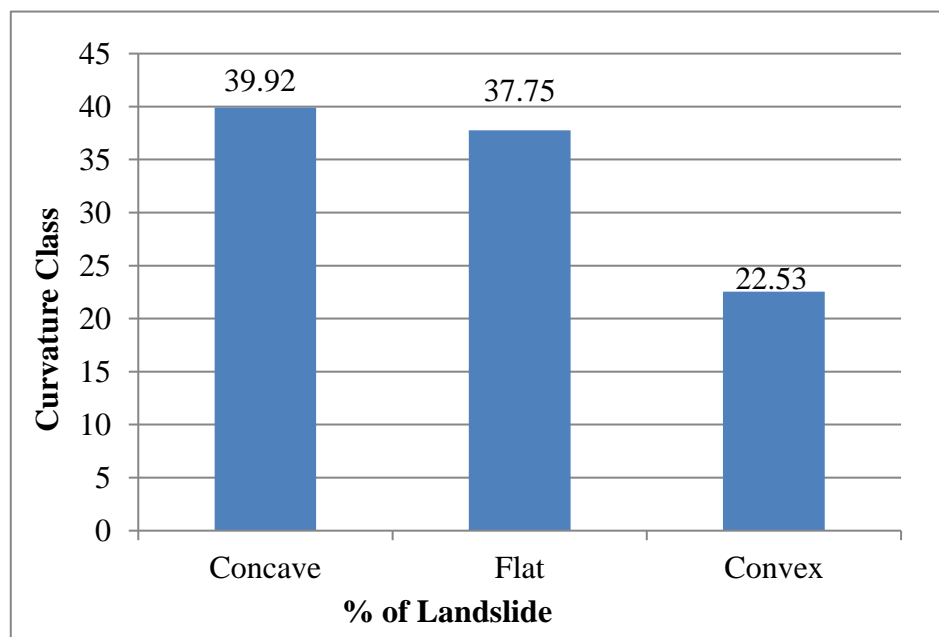
Figure 24: Relations b/n percentage of landslide distribution with Curvature classes

The reason the IV value is higher in the concave curvature class is due to surface runoff, which is responsible for the landslide activity. However, flat classes have a higher IV value, due to the gentle slope classes dominate in the study area indicating a higher probability of land slide occurrence next to the concave curvature class.

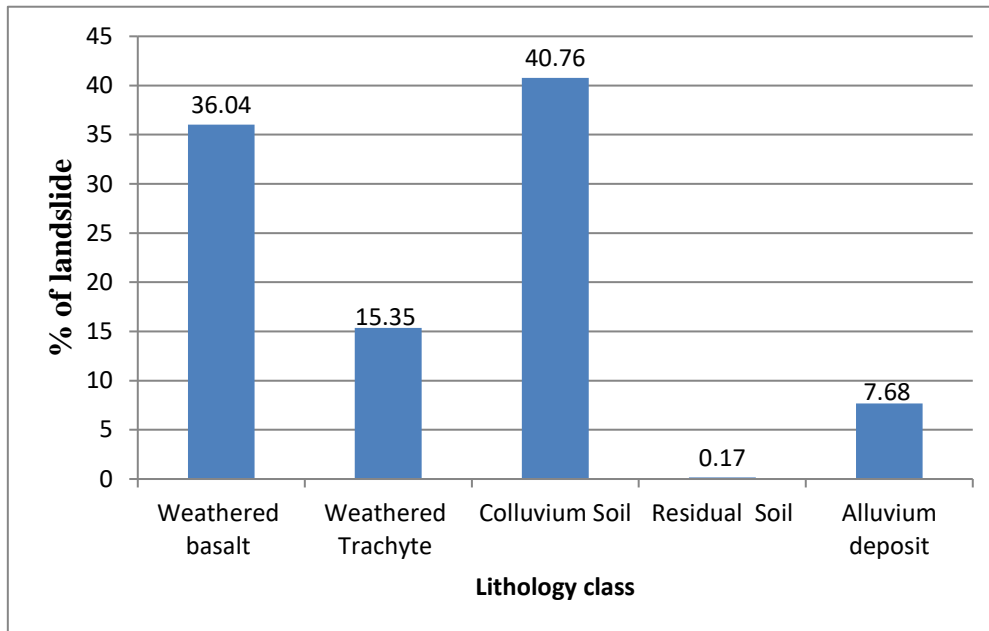
Figure 25: Relations b/n percentage of landslide distribution with Lithology classes

Alluvium deposits have a probability of occurrence of 7.68% due to the fact that this unit is found at the base of the stream which is affected by erosion hence the probability of landslide is also higher for this class.

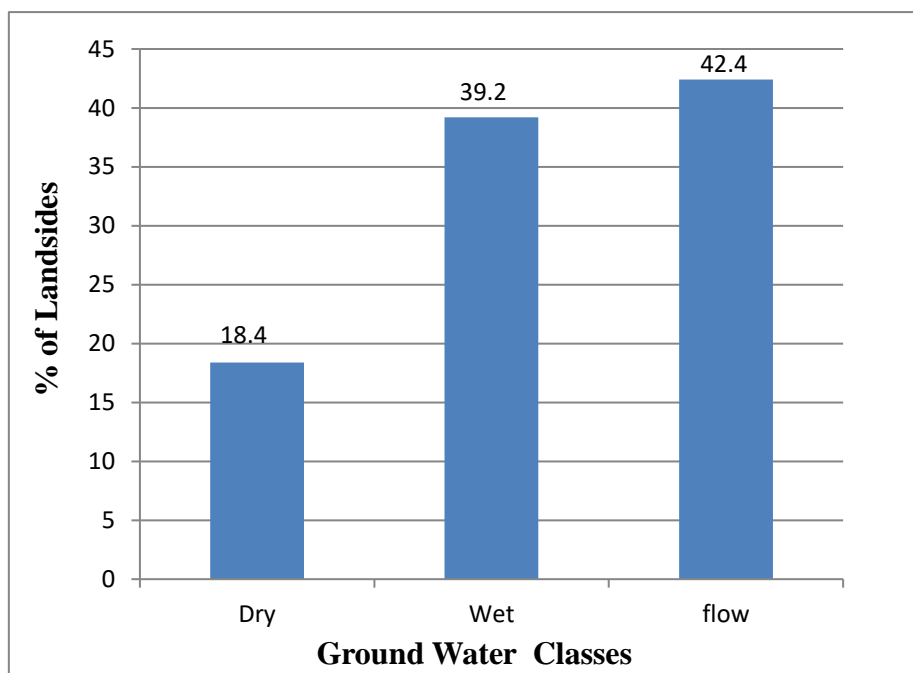
Figure 26: Relations b/n percentages of landslide distribution with Ground water classes

The IV value for dry class has a value of -1.15 indicates it have a low probability for landslide activity. The IV value for wet class has a value of 0.19 and for the flow class has a value of 0.49 indicates it has high probability for landslide occurrence. Further, the overlay analysis for the ground water classes shows that 42.4% of landslides occurred on flow, 39.2% fall into wet and 18.4% occur on dry classes.

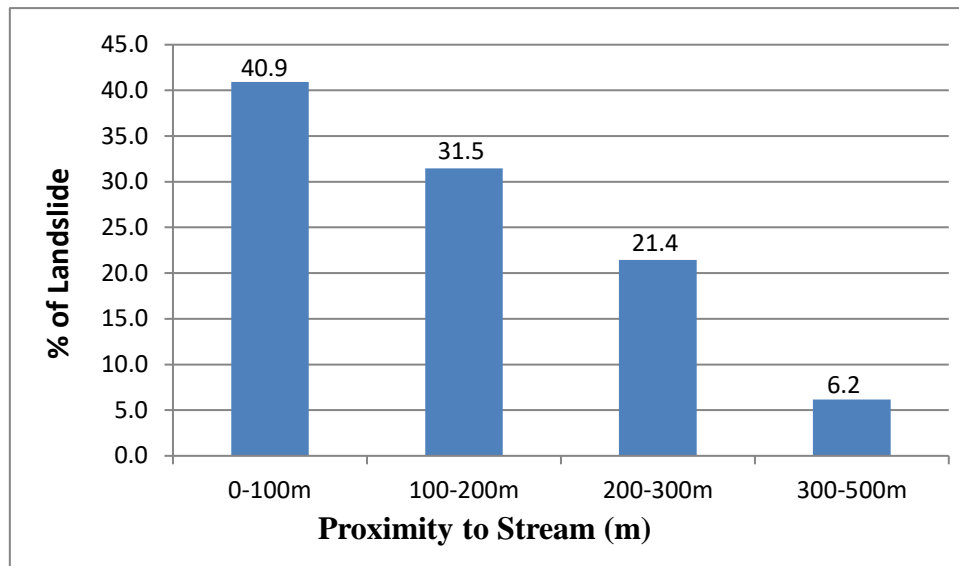
Figure 27: Relations b/n percentages of landslide distribution with Proximity to stream

The present study area is dissected by various perennial and intermittent seasonal streams. Thus, as the network density of the stream increases the slope is prone to erosion by surface water and the probability of landslide is much higher than the lower drainage density of the stream network area. The toe of the slope is eroded by streams the slope is devoid of support and prone to landslide failure. The percentage of landslides with the proximity to stream class of causative factor is presented in Figure 26.

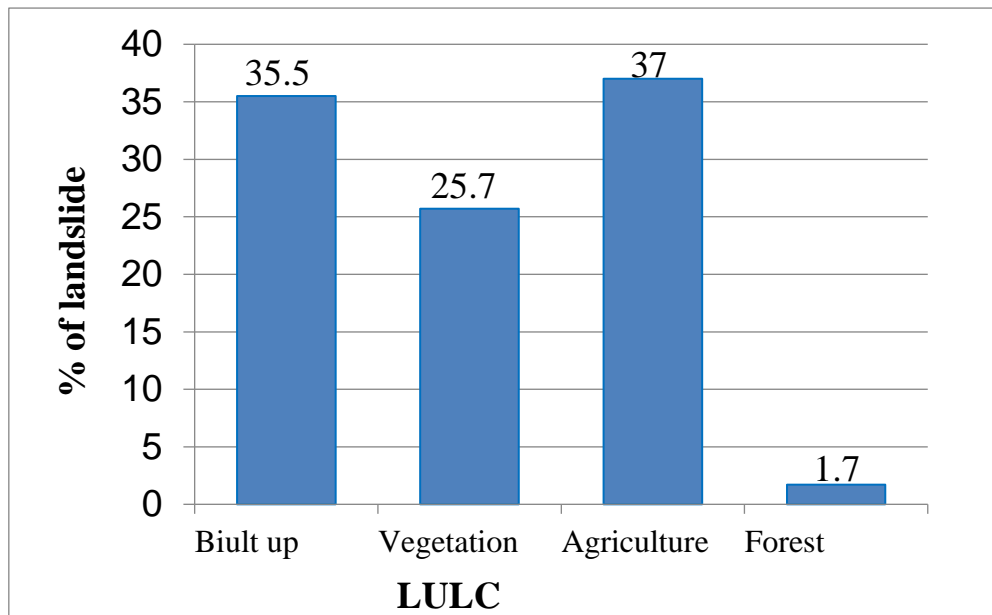
Figure 28: Relations b/n percentages of landslide distribution with LULC classes

Agricultural lands include ridge colluvium slopes, cultivated flat lands; Stream River bank slope surfaces have highest probability contribution for landslide occurrence. The statistical information value is negative in Forest and Vegetation indicates that they have lowest probability contribution for landslide occurrence (Table 6). Those four land-use land-cover classes and the percentage of landslide occurrence is presented as shown below (Figure 27).

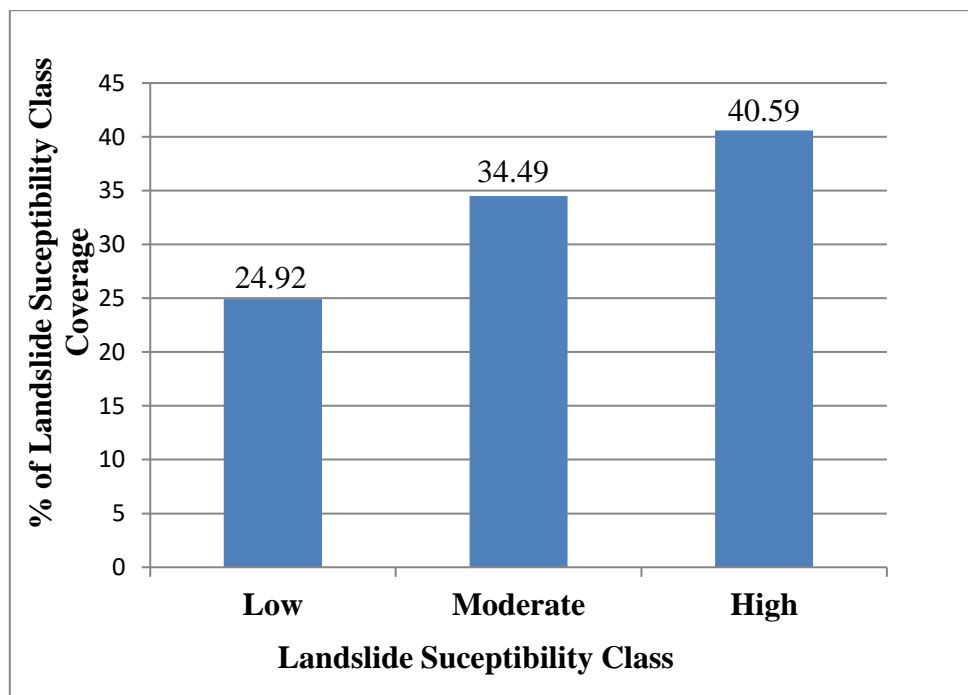
Figure 30: Distribution of landslide susceptibility classes

- The pixels of the landslide susceptibility values have been divided into three classes: low susceptible (LS), moderate susceptible (MS), high susceptible (HS) using the classification system's natural break approach. The landslide susceptibility map's results clearly demonstrate that 20.7 km² (24.92%) of the study area falls in low susceptible class, 28.7km² (34.49%) of the area falls in moderate susceptible (MS) class and 33.7km² (40.59%) of the study area falls in high susceptible (HS) class.
- Therefore, it can be safely concluded that the susceptible classes in the current study validates with the past landslide data. Finally, based on the causative factors considered and the results obtained from the model shows that it is applied for the safe infrastructure planning of the study area.
