**Pavement Distresses on Addis Ababa City Arterial  
Roads, Causes and Maintenance Options**

**A Thesis**

**In Partial Fulfillment of the Requirement of the  
Degree of Master of Science in Civil Engineering  
(Geo-techniques)**

**By  
Fiker Alebachew**

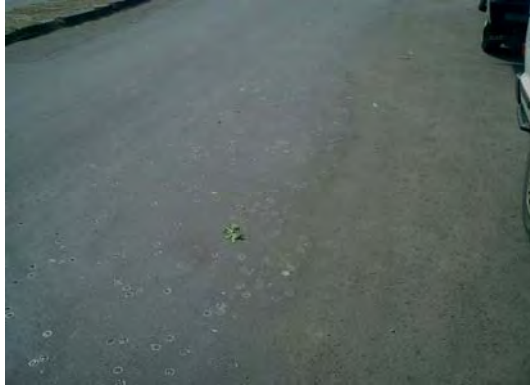
*Figure 2.4 Bleeding corks*

Bleeding is the upward movement of the binder material in the pavement creating a film of bituminous material on the surface (Figure 2.4). This condition usually occurs during hot weather and will cause an extremely slippery surface. The most common cause of bleeding is excess asphalt binder in one or more of the pavement courses. This can result from a rich mix, variations in aggregate blending, improperly constructed seal coat, or heavy prime or tack coat. Traffic volume, tire pressure, or load in excess of design quantities can cause over compaction of bituminous layers forcing the binder to the surface particularly in a mix of very low void.

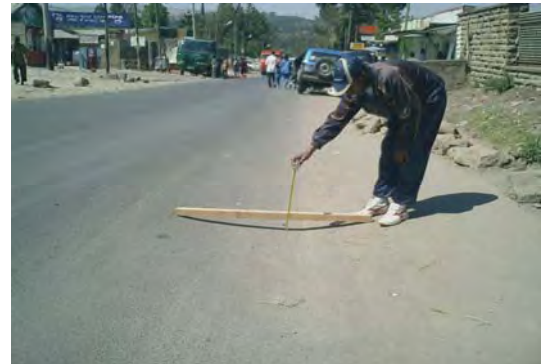
*Figure 2.6 Sag in asphalt*

Bumps and sags are small, localized, upward and downward displacements of the pavement surface (Figure 2.6). Bumps can be caused by differential heave or settlement over utilities, the buildup of material in a crack in combination with loading. Sags are caused by a localized failure of the underlying material resulting in subsidence.

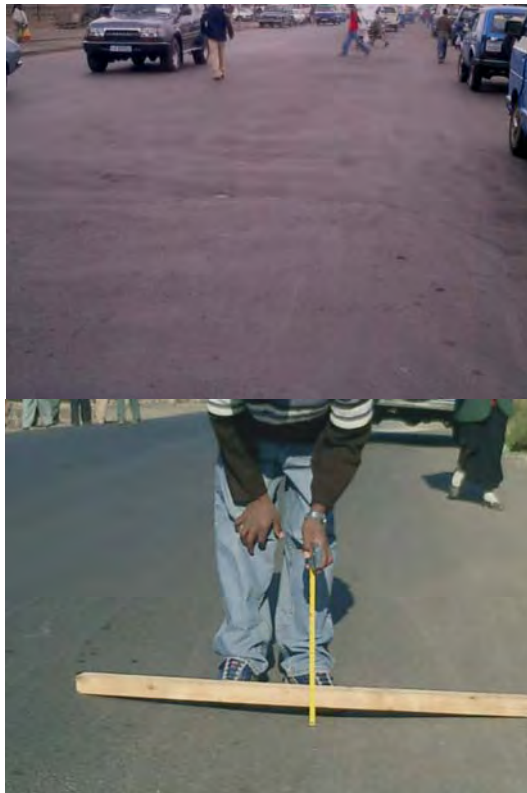
*Figure 2.7 Corrugation*

*Figure 2.8 Depression*

Corrugation is a form of plastic surface movement typified by ripples across the bituminous pavement surface (Figure 2.7). The cause of corrugations is usually lack of stability in the bituminous mix. Lack of stability can be caused by the mix being rich, the aggregate having excessive amounts of fines, rounded or smooth textured particles, poor bond between material layers, or the use of soft binder.

Depressions are localized low areas of limited size which may or may not be accompanied by cracking (Figure 2.8). Depressions dip below grade and water collects in them. Depressions may be caused by traffic heavier than that for which the pavement was designed, by settlement of the underlying pavement layers, or by poor construction methods.

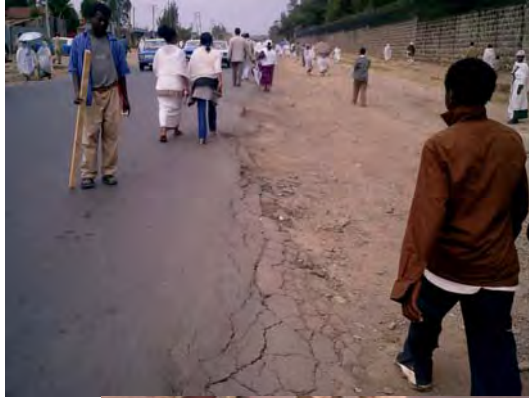
*Figure 2.9 Edge cracking drop-off*

Edge cracks are parallel to and usually within 30 to 60 cm of the edge of the pavement (Figure 2.9). This distress is accelerated by traffic loading and is caused by a weakened base or sub base at the pavement edge. Weakening of the base or sub base can normally be associated with a drainage problem causing water intrusion.

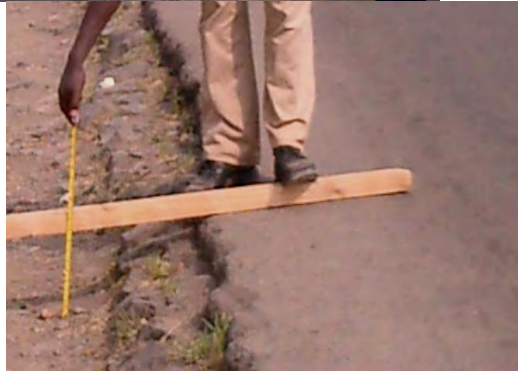
*Figure 2.10 Lane/shoulder drop-off*

Lane/shoulder drop-off is a difference in elevation between the pavement edge and the shoulder (Figure 2.10). This distress is caused by either shoulder erosion or settlement, or by building up the roadway (i.e., overlay) without correcting the shoulder height.

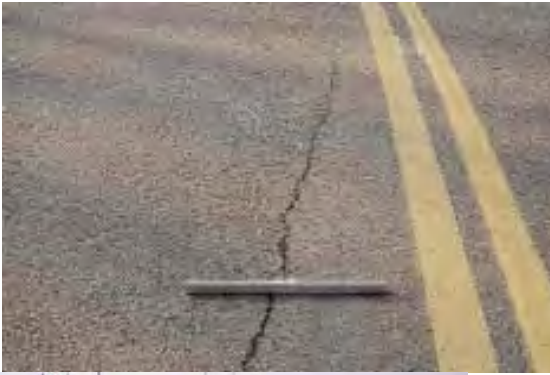
*Figure 2.11 Longitudinal crack patching*

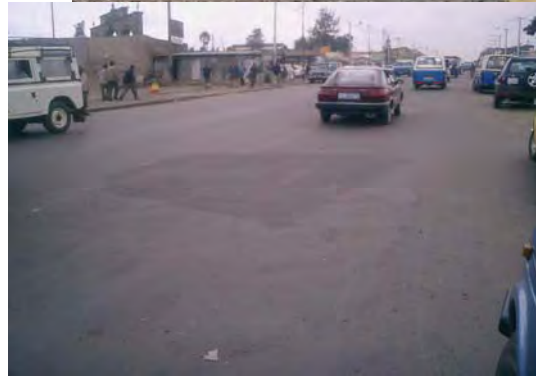
*Figure 2.12 Utility cut*

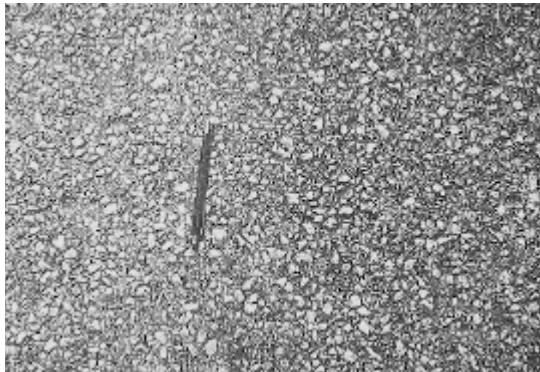
*Figure 2.13 Polished aggregate*

Polished aggregate is a term applied to asphalt pavements in which the surface aggregate has been worn smooth. Polished aggregate causes a reduction in skid resistance, especially when wet (Figure 2.13). This distress is caused by low quality aggregate and repeated traffic applications.

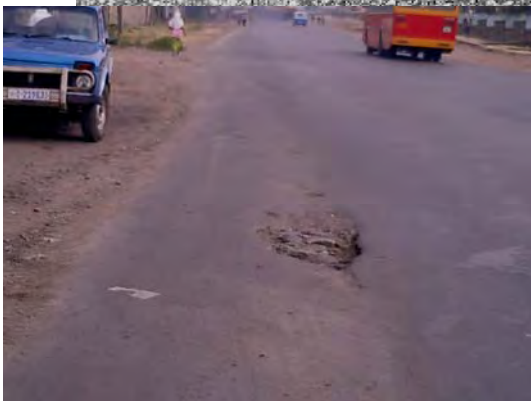
*Figure 2.14 Potholes*

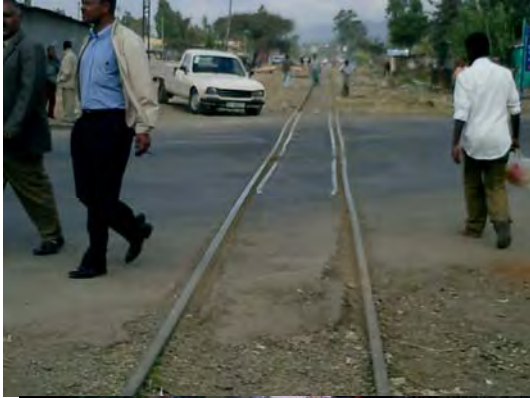
*Figure 2.15 Railroad crossing*

Railroad crossing distresses are depressions or bumps around and/or between the tracks (Figure 2.15).

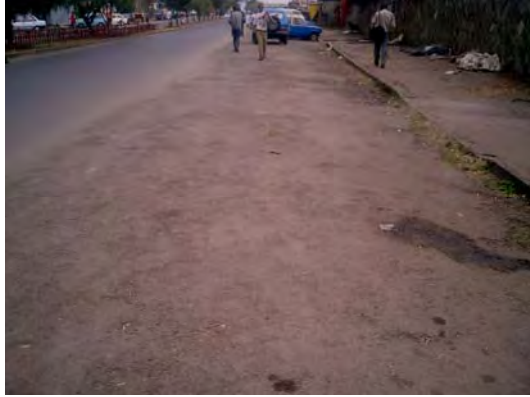
*Figure 2.16 Raveling*

Raveling is a progressive separation of the aggregate from the binder (Figure 2.16). Raveling is the failure of bond between the aggregate and the bituminous binder. Raveling may be caused by insufficient compaction during construction, construction during wet or cold weather, dirty or disintegrating aggregate, insufficient binder in mix, or over-heating of the surface mix.

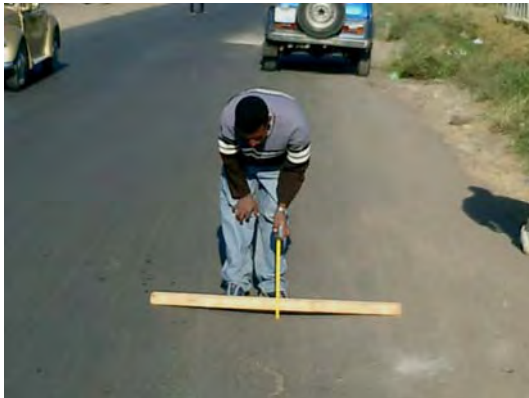
*Figure 2.17 Rutting*

Rutting is a depression in the wheel path (Figure 2.17). In extreme cases there may be uplift between the wheel paths in conjunction with the rutting. Rutting may be caused by a permanent deformation in the pavement layer or the sub grade due to traffic loads. Pavements constructed of low stability asphalt mix or unsatisfactory compacted asphalt mix is leading causes for the deformation in the pavement layers.

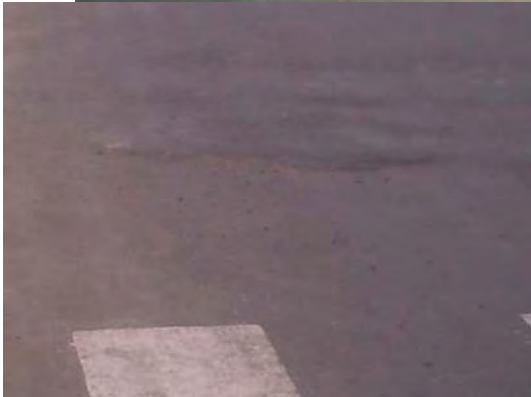
*Figure 2.18 Shoving*

Shoving is a localized plastic movement in the bituminous surface (Figure 2.18). Areas subjected to frequent vehicular braking action can exhibit shoving. The cause of shoving is usually lack of stability in the bituminous mix. Lack of stability can be caused by the mix being too rich, the aggregate having excessive amounts of fines or rounded or smooth textured particles, poor bond between material layers, or the use of a soft binder. Plastic flow in patching materials can also be caused by excessive moisture in the mix, contamination by oil spillage, or too much volatile material remaining when a cold-laid patch is placed.

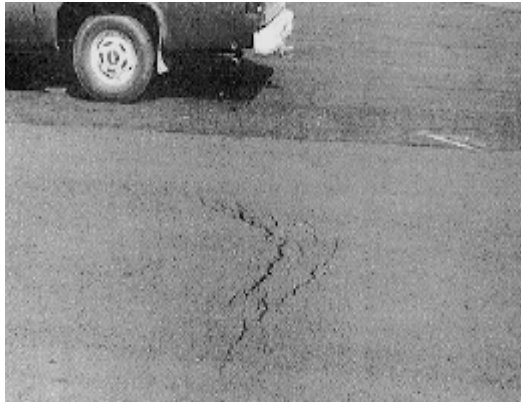
*Figure 2.19*Slippage cracks

Slippage cracks are usually crescent shaped cracks that normally point in the direction of the thrust of the wheels during braking (Figure 2.19). A low strength surface mix or a lack of bond between the surface layer and the course beneath causes this distress. This slippage or delaminating can cause failures on the pavement surface under traffic. The slippage can be caused by poor drainage, which could aggravate a stripping problem, or by construction.

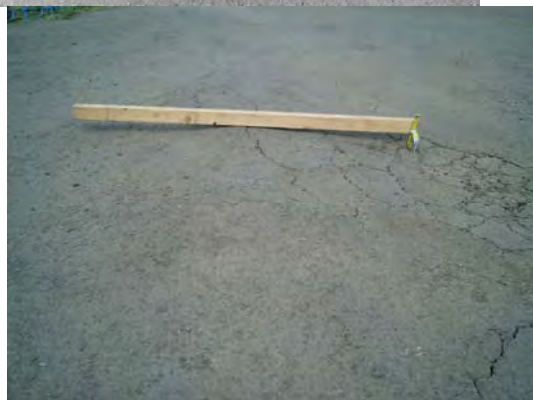
*Figure 2.20* Swelling

Swell is the localized upward displacement of a pavement due to the upheaval of the sub-grade or some portion of the pavement structure (Figure 2.20). Swell or heave is commonly caused by infiltration of moisture into an expansive-type soil.

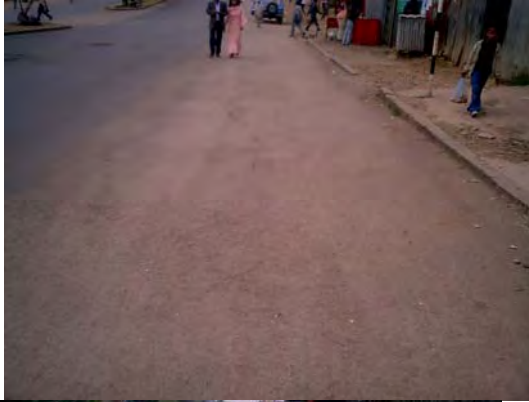
*Figure 2.21 Weathering spills*

Weathering is a process in which the more volatile parts of the asphalt are lost which results in the hardening or aging of the asphalt binder in a pavement (Figure 2.21). Defects such as cracks or holes in the pavement or low pavement density will allow more area of the pavement to be exposed to air and water and increase the weathering process. Raveling is often associated with weathering and is often a direct result of it. Weathering can be a problem in open-graded pavement surfaces due to the increased surface area exposed to weathering conditions.

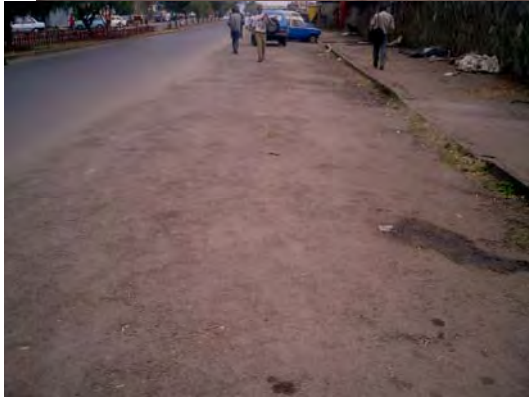
*Figure 2.22 Rave due to fuel*

Raveling from fuel spills is similar to the raveling described earlier (Figure 2.22). However, in this case the raveling is caused by fuel leaching away the asphalt binder. This distress will accelerate if more fuel is spilled on a surface

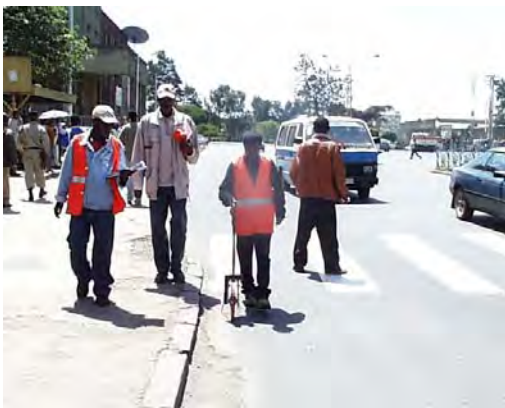
**Figure 3.1 Visual Surveys on Test  
Road N0-2**

The following pieces of equipment are utilized to carry out visual condition survey: measuring wheel, measuring tape and camera. Figure 3.1 shows the visual condition surveys on Test Road No-2.

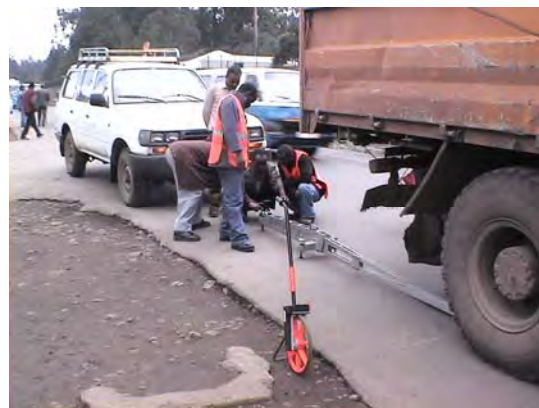
**Figure 3.2 Deflection  
Road N0-5**

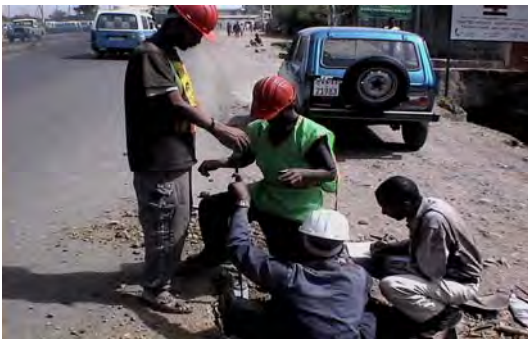
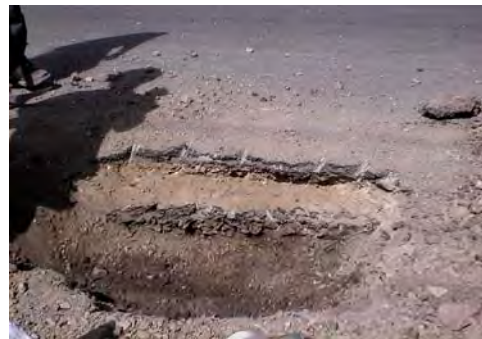
This investigation is employed to collect information about the in-situ pavement structure and sub grade CBR that eventually will help to observe any potential problem or cause of distress. Refer to Fig.3.4 & Fig. 3.5.

**Figure 3.4 DCP Surveys on Test Road No 1**

**Figure 3.5 Test pit excavation on Test Road No 1**

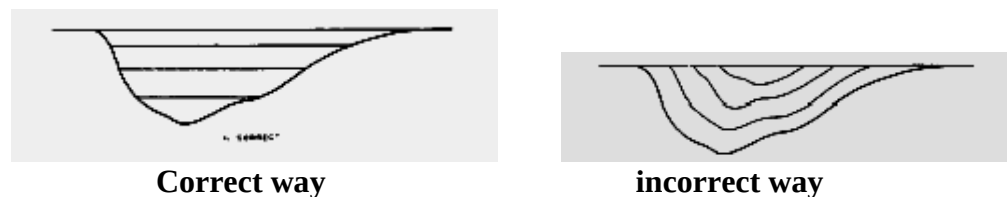
**Figure 5.1 Back fill in deep depression**

Two or more layers of asphalt are required in the repair of deep depression. Filling the area by following the contour of depression is mostly mistakenly done. The correct way to repair a deep depression is to begin in the deepest part of the depression and place a thin layer, the surface of which, when compacted, will be parallel to the original pavement surface. Successive layers can be placed in the same manner. Figure 5.1 shows the correct and incorrect way to place asphalt backfill in a deep depression.
