**Slope Stability Analysis on a Selected Slope Section  
along the Road Gohatsion – Dejen**

**A Thesis**

**In Partial Fulfillment of the Requirements for the Degree of  
Masters in Earth Sciences (Engineering Geology)**

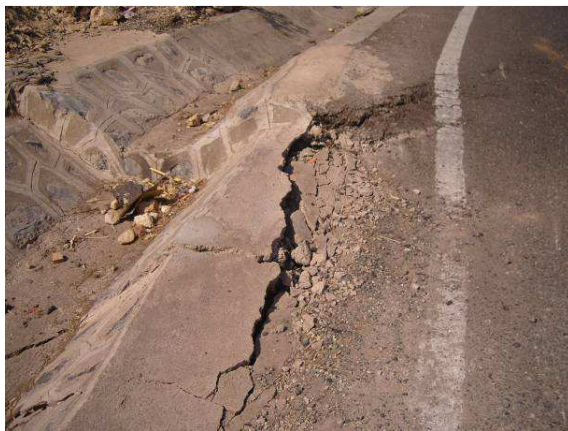
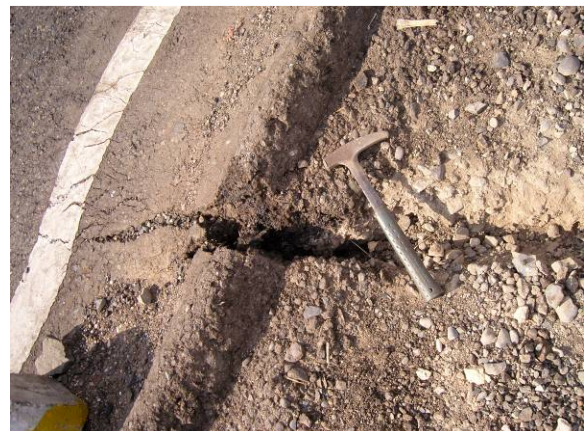
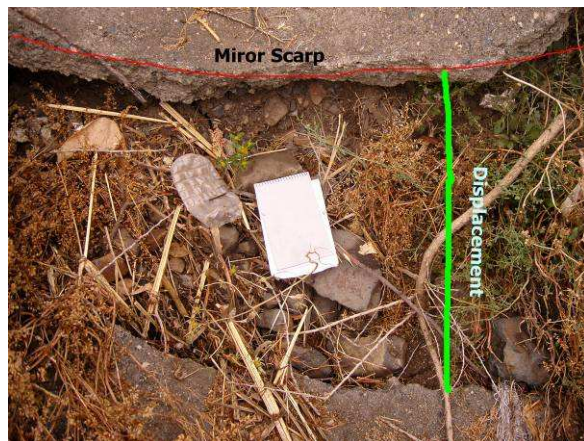
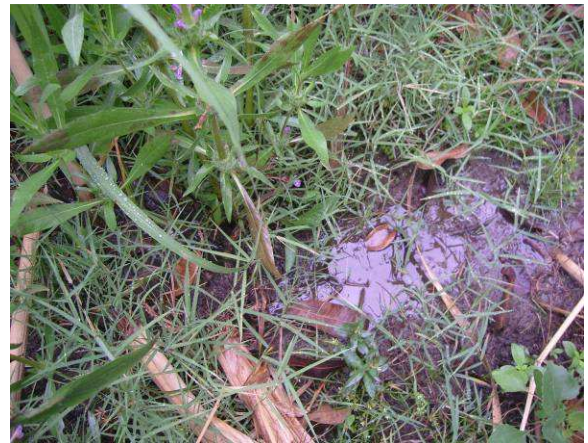
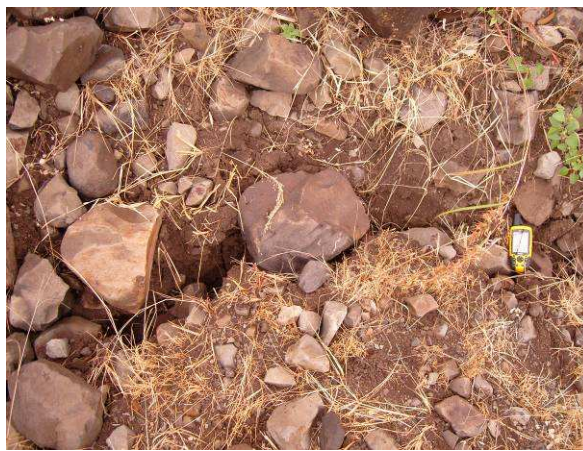
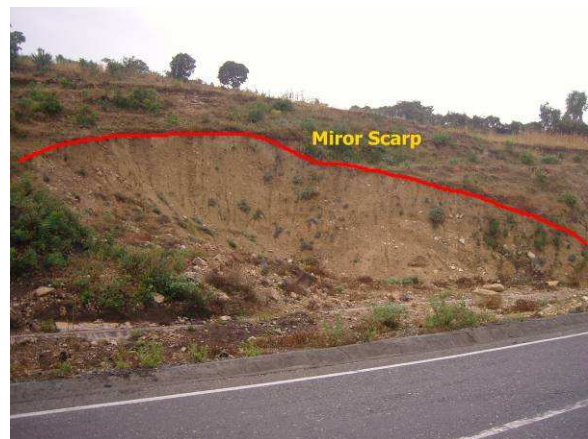
Damage on the road

Tension Crack on the road

Newly developed slide

Spring water

Colluvial material

Scarp face

**Fig. 3.1 Different instability manifestation features and causative factors present in the study area**

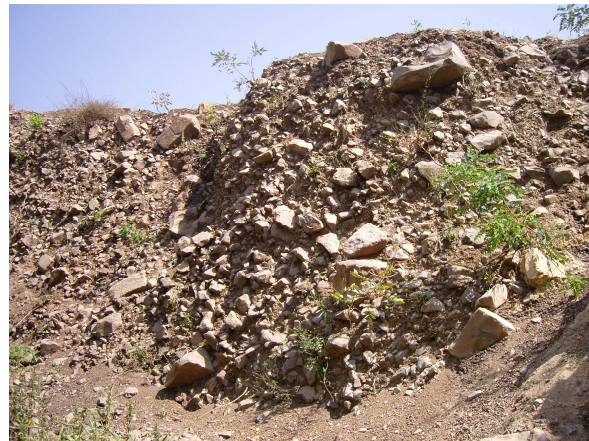
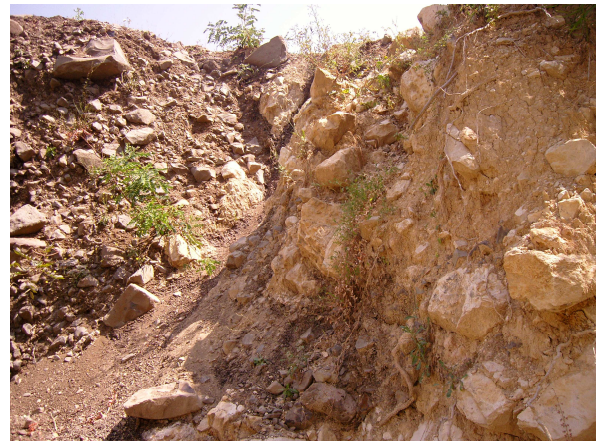
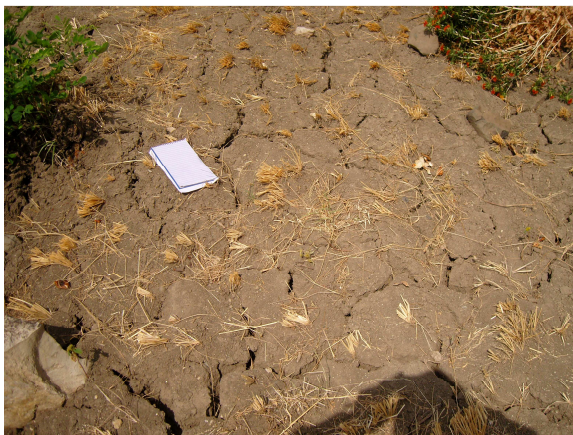
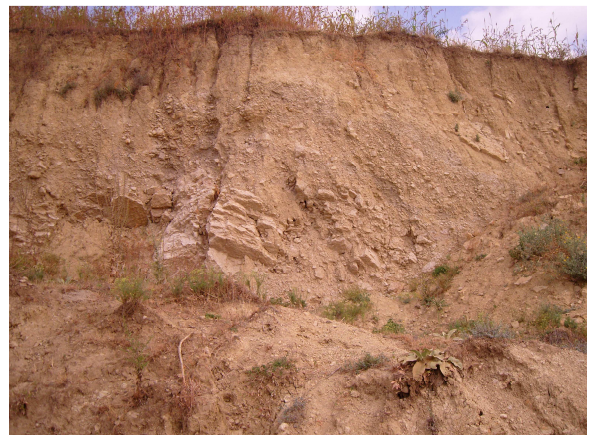
Colluvial material from basaltic source

Basaltic and Limestone source

Clay soil from basaltic source

Clay soil from limestone source

**Fig. 4.7 Colluvial material and soils in the study area**

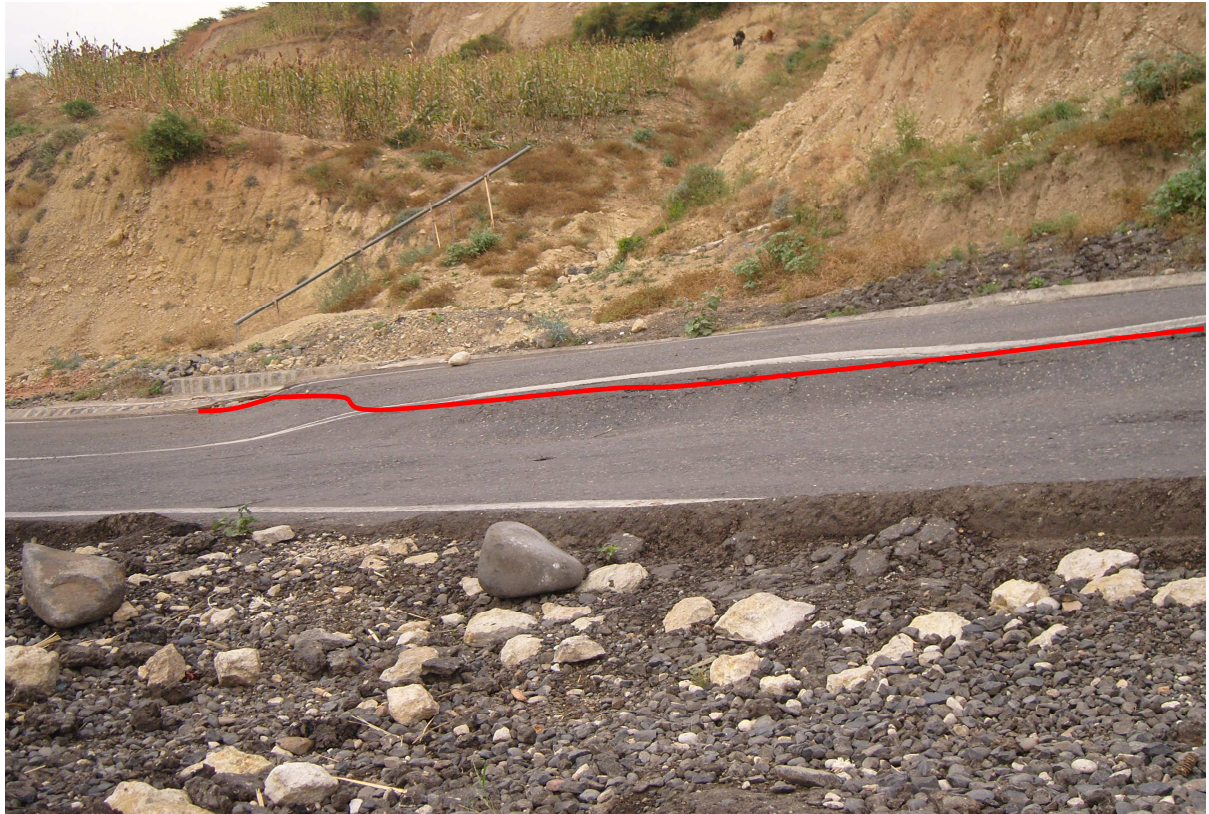
**Fig.4.9 Photo showing tension crack on the road**

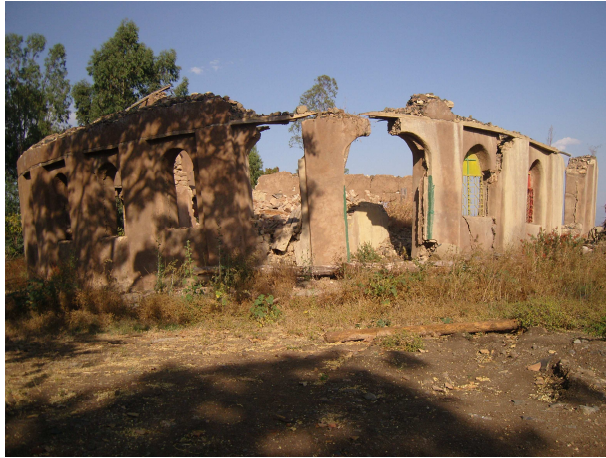
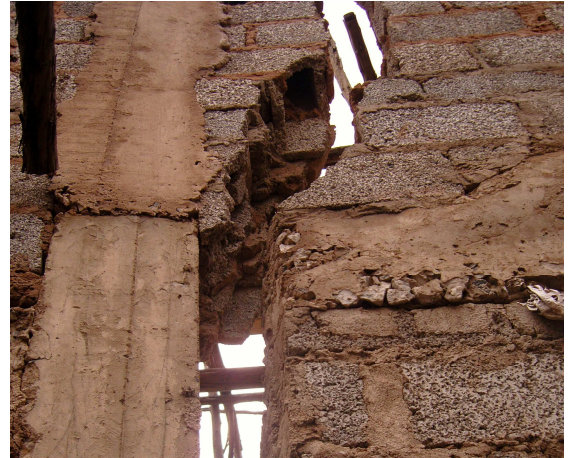
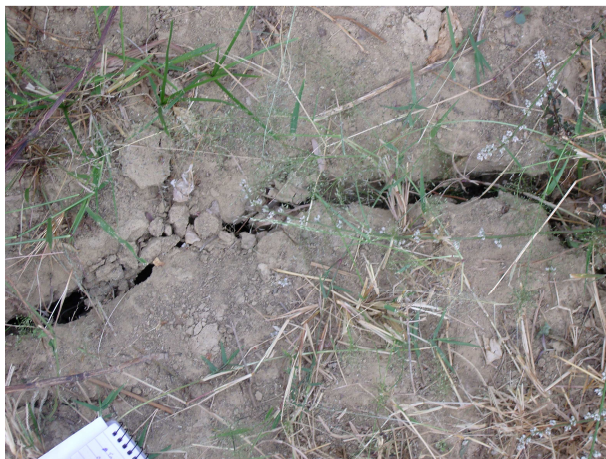
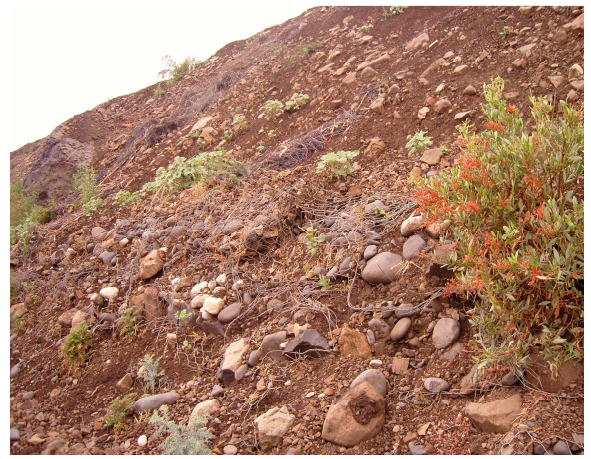
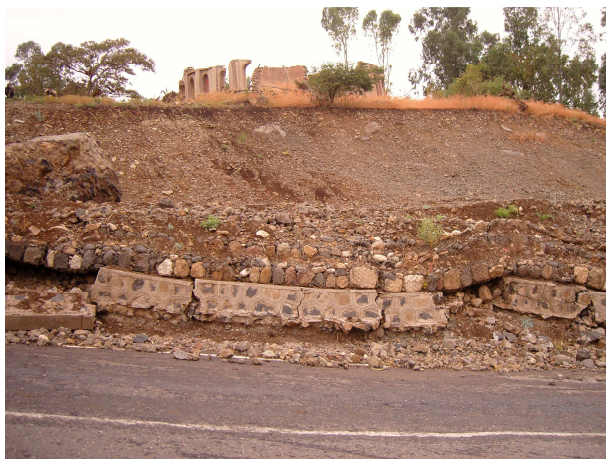
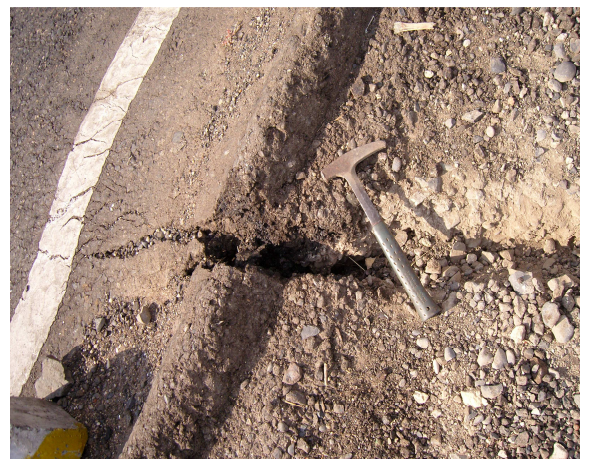
Damage on the old church

Damage on the church under construction

Tension crack on soil mass

Damage on Gabion wall

Massive slide on the road

Tension crack cutting the road

**Fig 4.10 Hazards caused by the landslide**

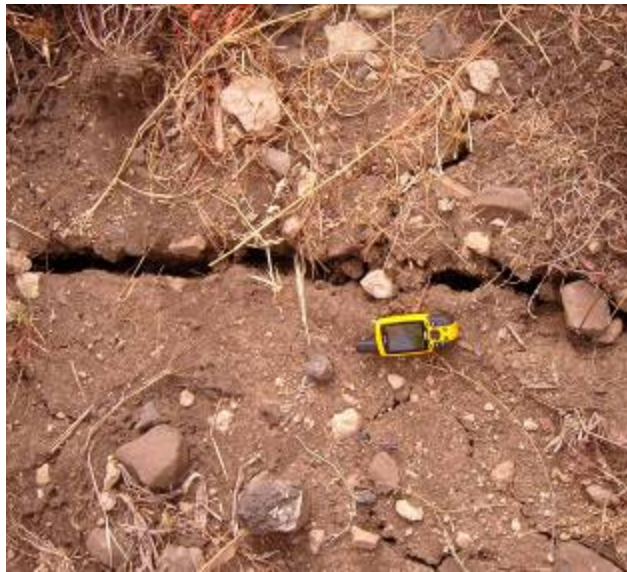
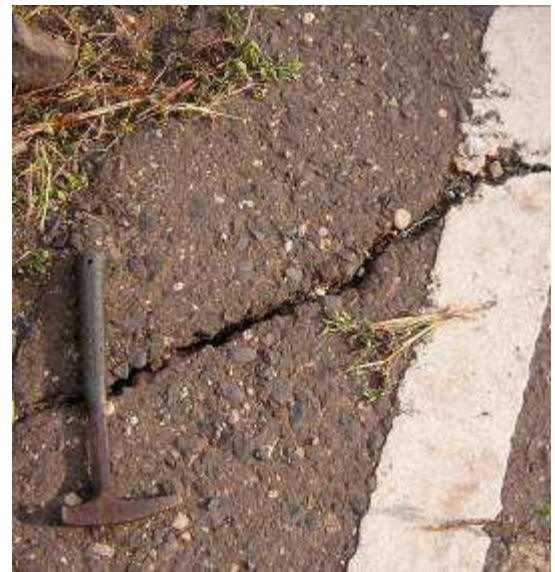
a. Tension crack on agricultural land

b. Tension crack developed on the road

**Fig. 5.2 Photograph showing tension cracks**

In the area many tension cracks being developed on the agricultural lands as well as on the main roads were observed and mapped (Fig. 5.2). Some of the Tension cracks extend for more than 50 - 70 meters. Some have wide openings about 5 – 10 cm. In some areas along such tension cracks traces of sliding movement can also be observed. During rainy season, water infiltrates into the ground and the water loosens the colluvial material to reduce the cohesion ([www.isprs.org/proceedings/XXIX/congress/part7/754\\_XXIX-part7.pdf](http://www.isprs.org/proceedings/XXIX/congress/part7/754_XXIX-part7.pdf)).

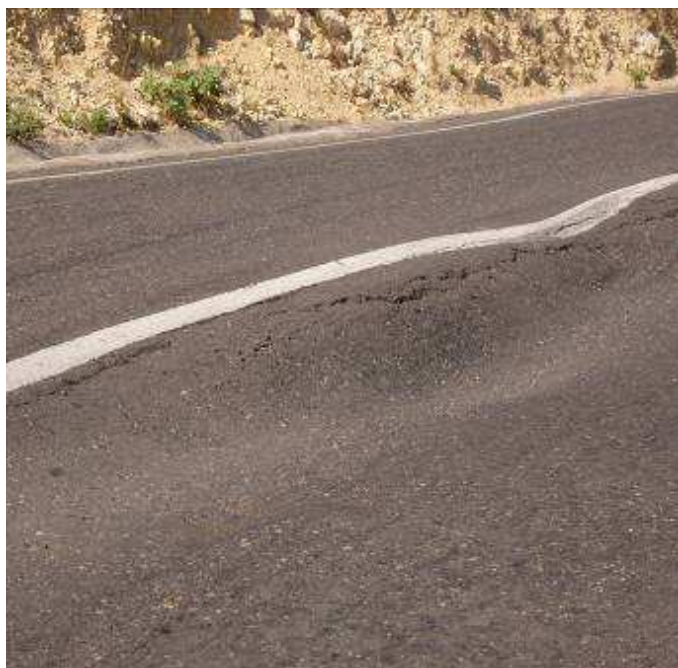
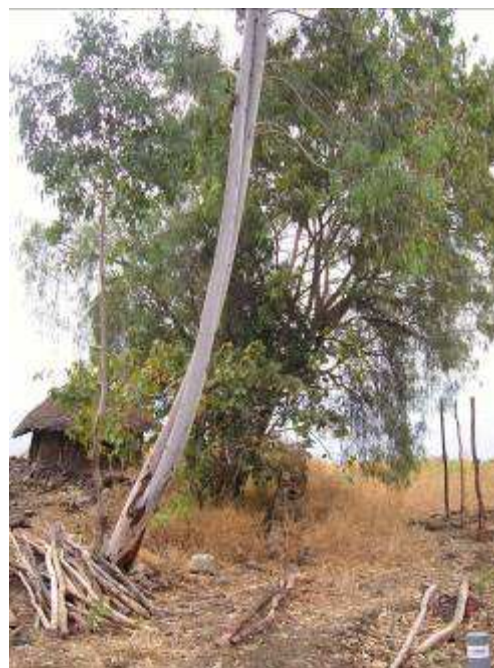
a. Damage on the main road

b. Tilted trees

**Fig. 5.3 Photograph showing damage on the road and tilted trees**

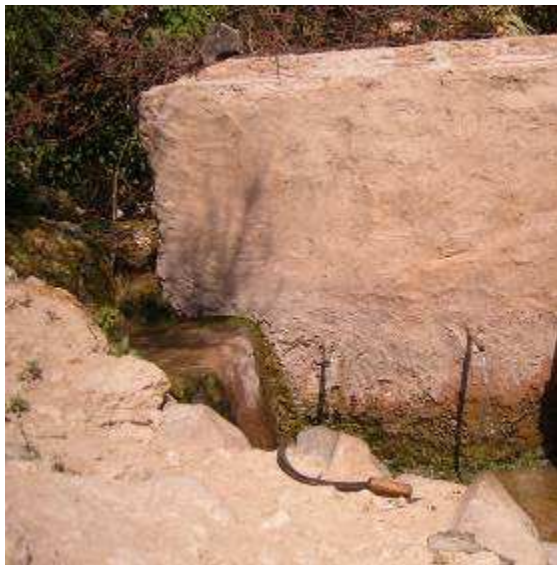
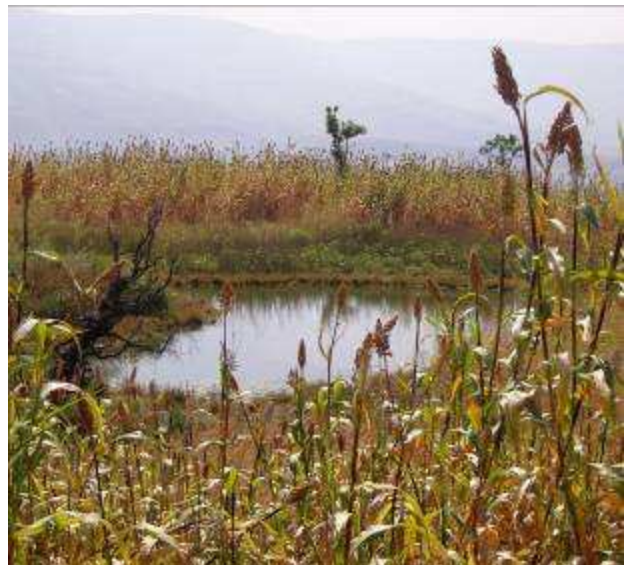
a. Developed spring water

b. Pond

**Fig. 5.4 Photograph showing spring water and pond in the study area**

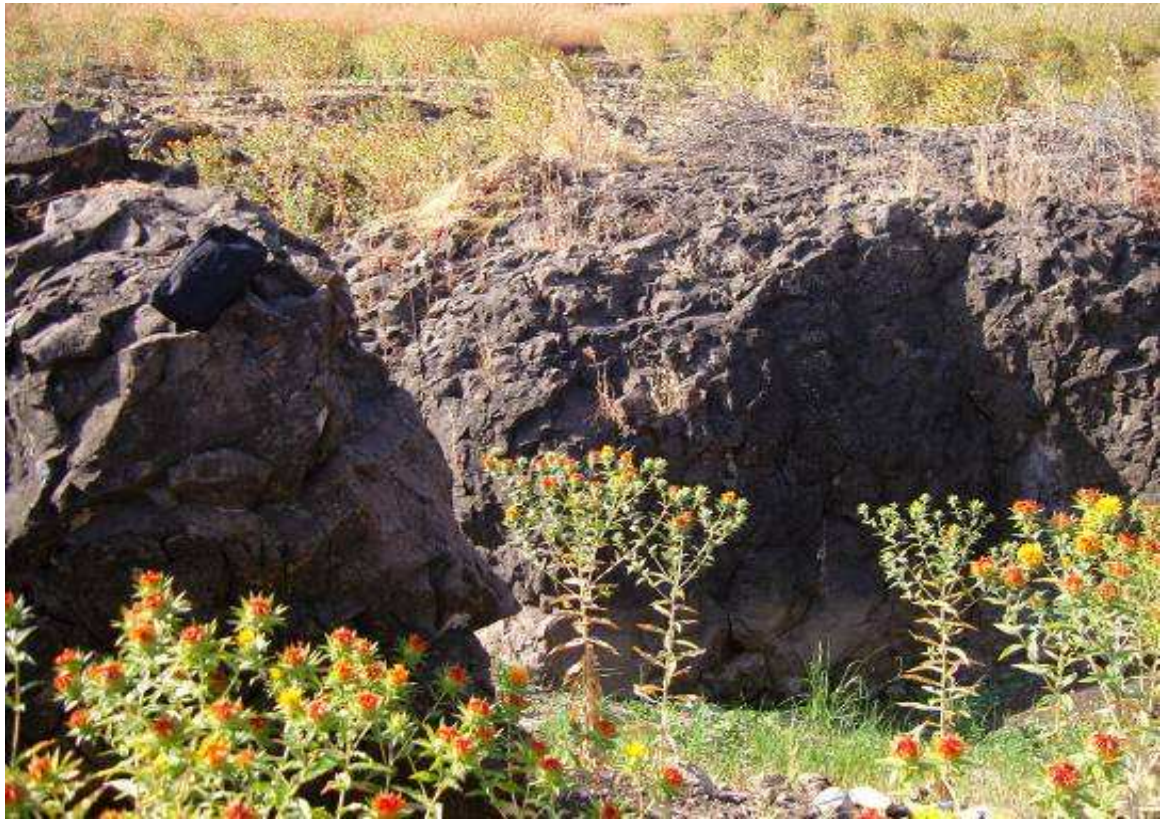
**Fig. 5.14 Photograph showing the big boulders in the colluvial soil**

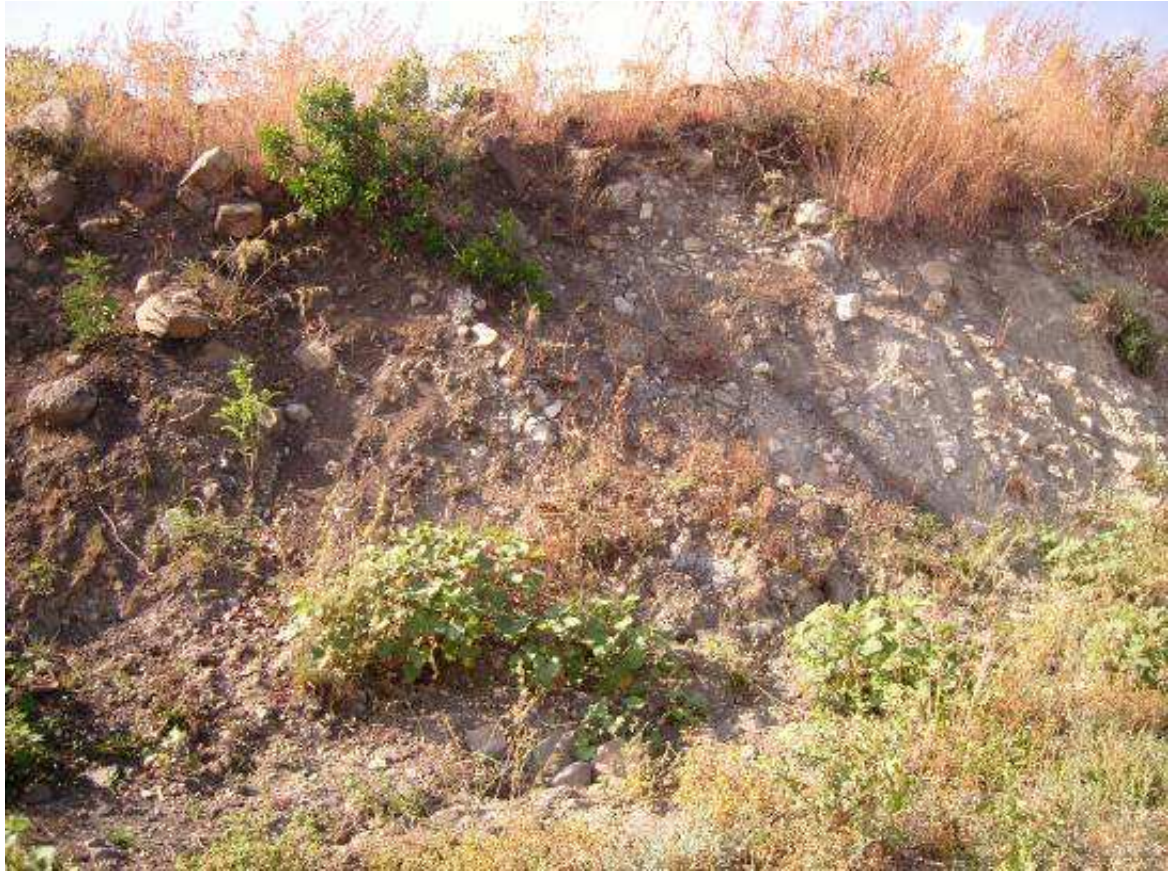
**Fig. 5.15 Photograph showing fine clay to gravel size materials**

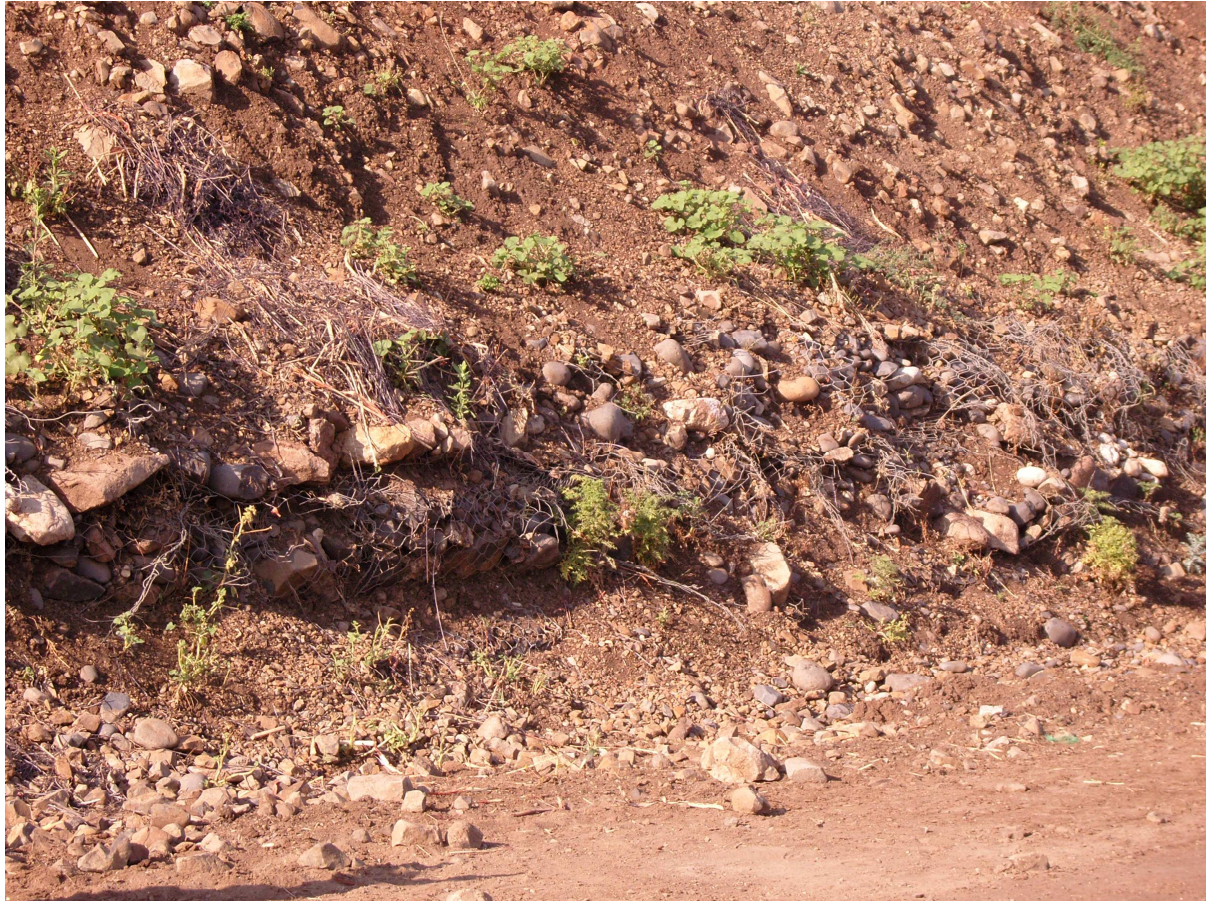
Fig. 6.4 Damage on the Gabion wall
