ADDIS ABABA UNIVERSITY
Addis Ababa Institute of Technology
School of Graduate Studies

Failure Analysis of Rocket Shell puncher Die

A thesis final draft submitted to school of Mechanical and Industrial Engineering for
the partial fulfillment of the requirements for the Degree of Masters of Science in
Mechanical Engineering
(Mechanical Design Stream)

This paper studied Failure analysis of Rocket Shell punching die manufactured in Homicho ammunition and engineering industry having the crack on the surface of the male punching die. Detailed investigations including macroscopic examination, metallographic observation, and mechanical properties analysis were carried out. The investigations reveal that the failure mechanism of the punching die is fast brittle fracture caused by high stress under the condition of material self-embrittlement. As it is observed on 39 pieces of the puncher the main crack originated from the lower tip that has a direct contact with the hot of the punching die. The serious impact toughness degeneration and presence of impurities at the internal section of the die resulted in the material embrittlement. The hardness test and the oxidation process formed insid

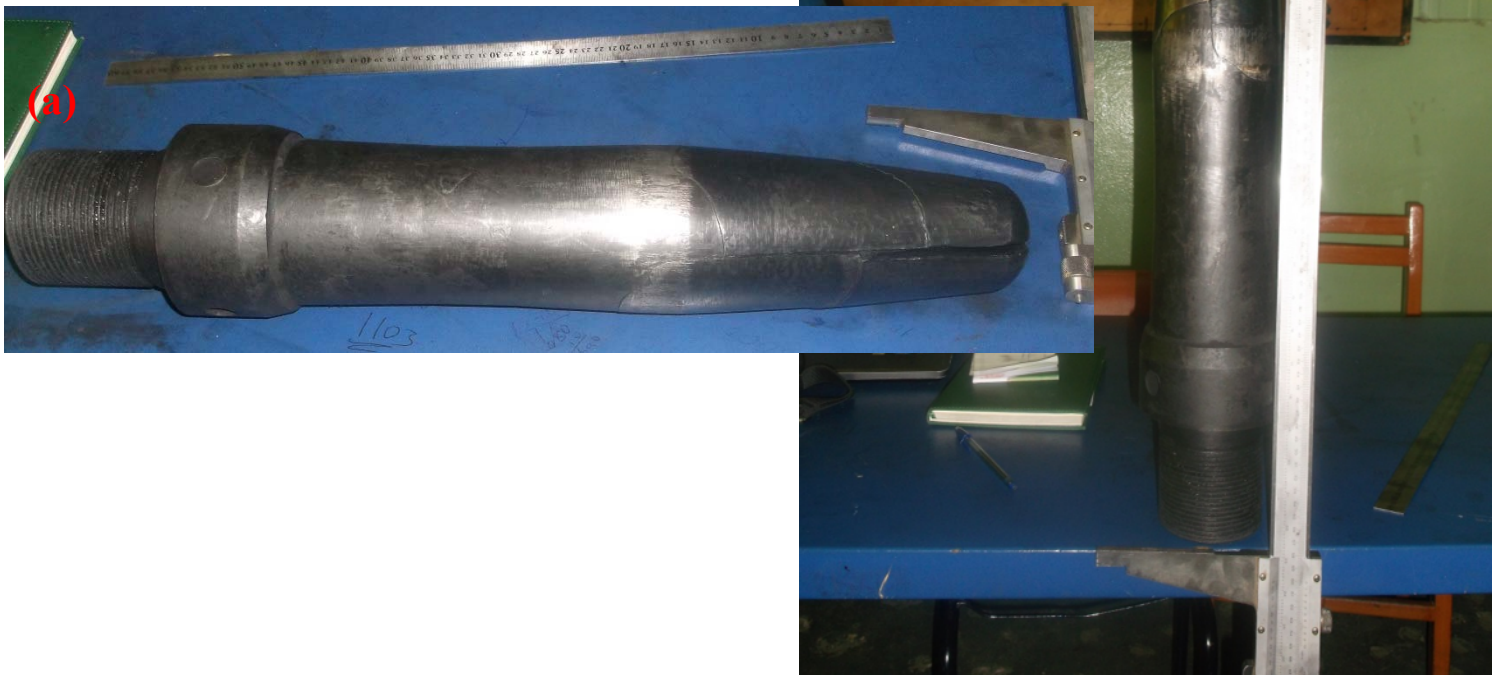
Figure 3-3: puncher profile manufactured in Homicho (a) in its horizontal position (b) in its vertical but opposite direction

Both has punchers manufactured in Korea and in Ethiopia (Homicho) has the same surface profile but they have different dimensions. In addition, both has the same three holes and has treaded features at the end. Those punchers have a tapered profile and the holes are for mounting purpose so that it will increase the turning effect for handle in fastening with the press machine. The Korean puncher have an overall dimension of 680mm as shown in Fig. 1 and that of Homicho has 600mm as shown on figure 3.

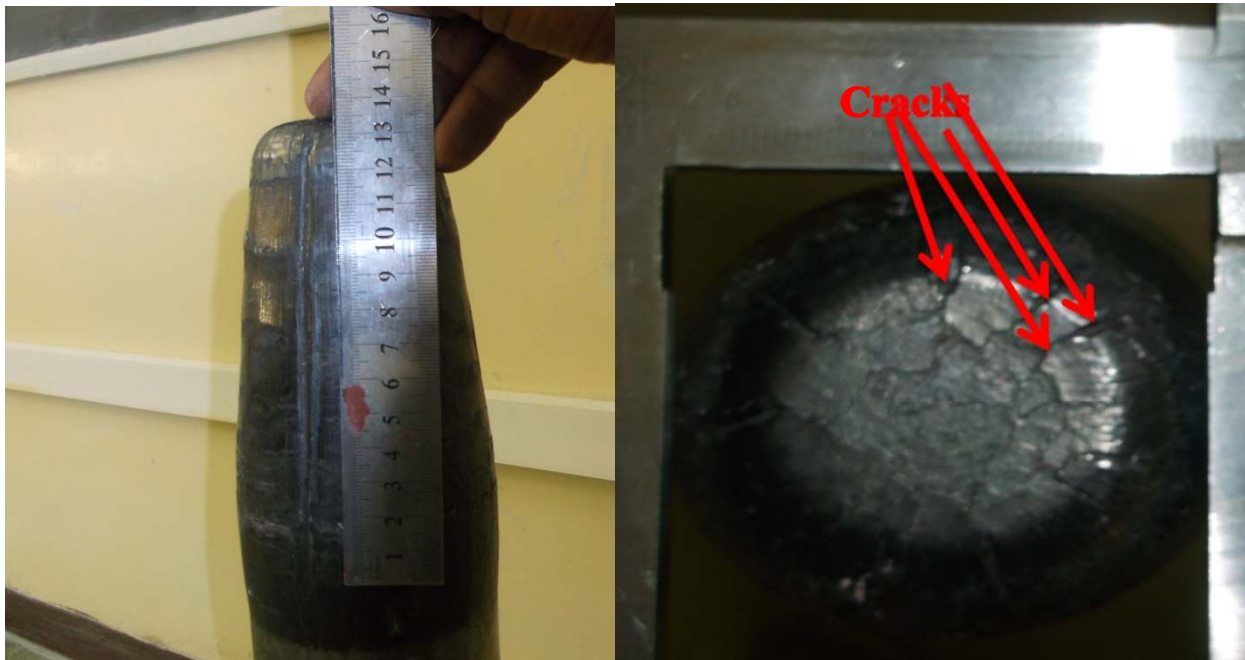
On the Korean puncher there are 3 main cracks which seems initiated from the bottom tips. These three cracks extended as long as 134-140mm in the inner cavity bottom and it penetrates the bottom and right side. This male die, which was made of **35CrMnSi** hot forging die steel by forging process, austenitized at 850°C for 15 hours, then quenched in the water for 30 minutes, after that cooled in the oil to room temperature. Finally, the punch was tempered at 620°C and 560°C in order.

Figure 3-4: Crack extension length a) crack on the surface profile b) crack on the tip profile

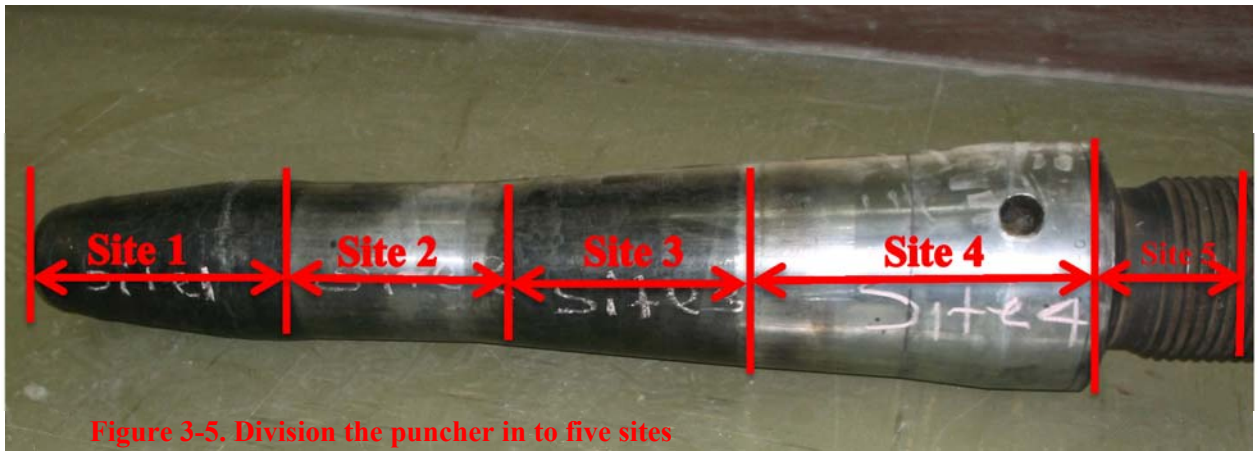
In order to study the fracture features, different specimens produced from sites numbered from site 1 to site 3 were cut off in order to analyze the fracture surface. Those different sections are shown on Fig 4. For failure identification purpose the puncher is divided in to five sites. Site 1 is the bottom part of the puncher to draw and it is tapered and also it is a thick dark and different cracks are originated. Site 2 is a part which has a dissolved and clean part. Site 3 is the second dark part and at this location different small cracks are located. Site 4 is the most clean and it is sites where there are almost no cracks. Site 5 is a place where there is a threaded part and a part that is joined with the pressing machine.

Site 1 is a location where the puncher starts to draw with 1400⁰c hot steel. Initially the whole puncher is preheated. As it seen on the figure, this site is much damaged part and most of the

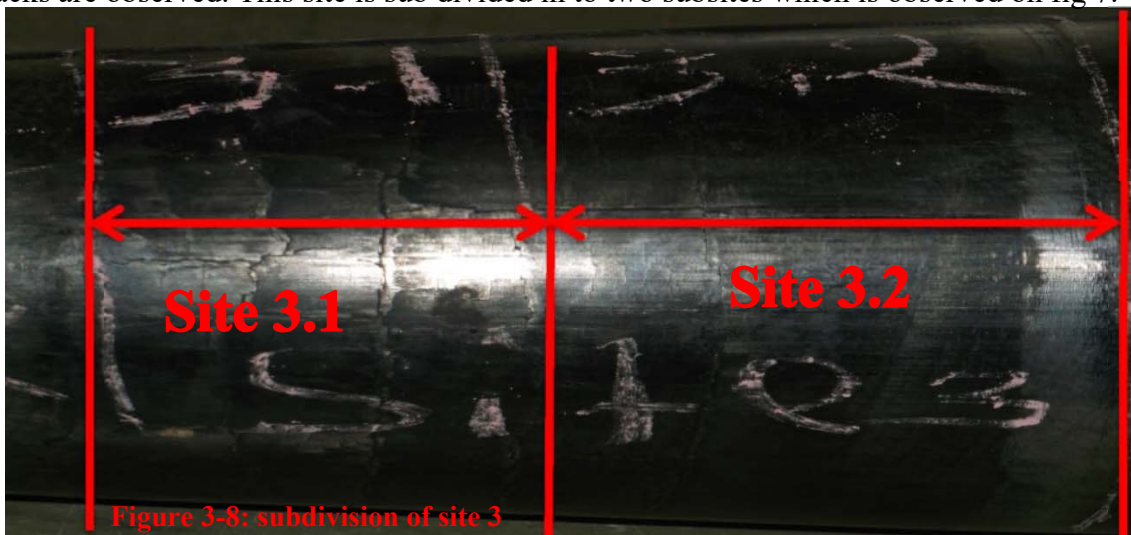
Site 3 is the second dark region next to site 1. It is also the second that a large amount of surface cracks are observed. This site is sub divided in to two subsites which is observed on fig 7.

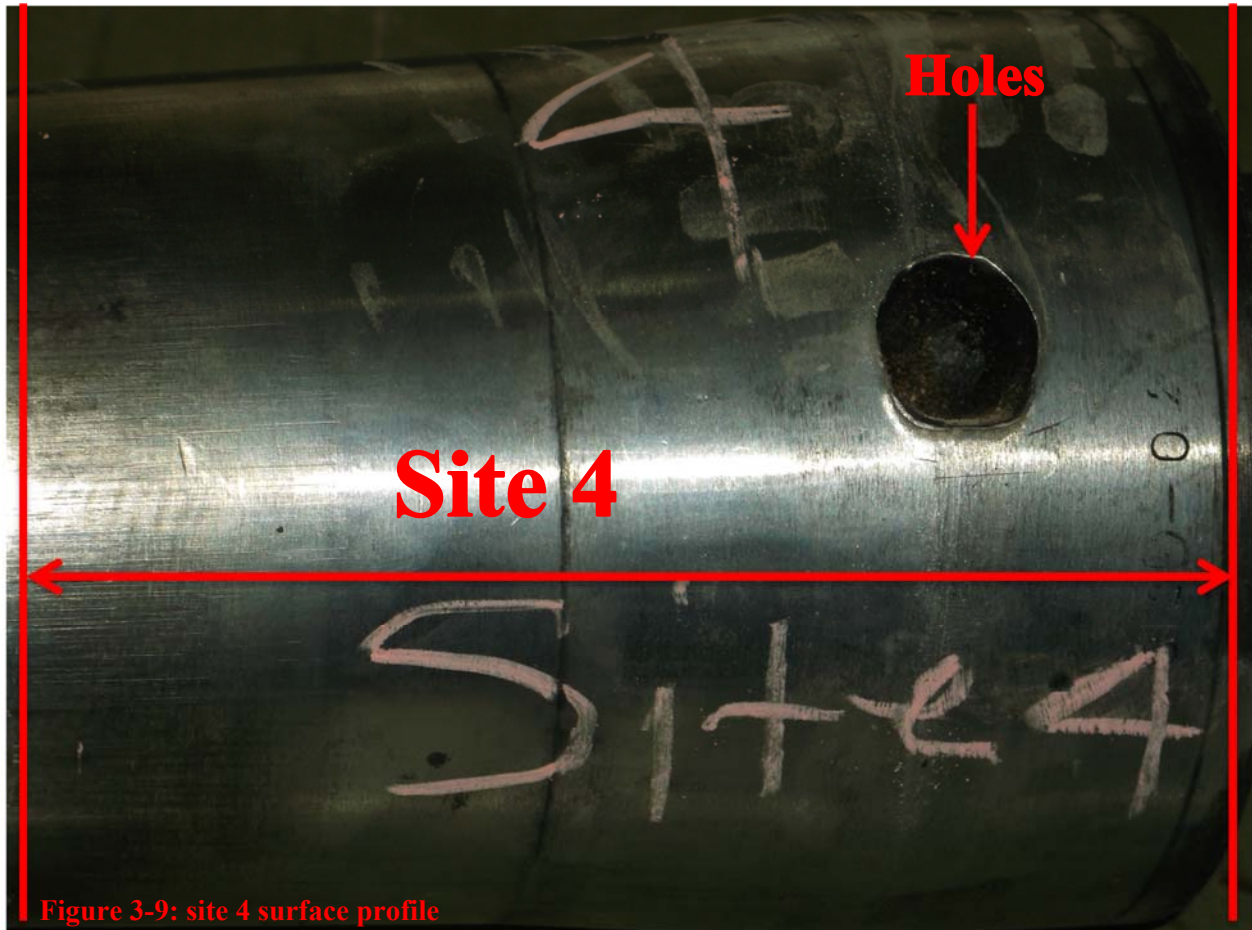
Figure 3-9: site 4 surface profile

Site 4 is a site where a clean and clear surface of the metal is observed. At this site, there are three holes having a depth of 29mm from the surface in which it is used for pin lock but one of the three holes is offsetted from the radial distance. This site has no visible cracks by our necked eyes on the surface. As it is seen on figure 8 the surface of the metal is very clean.

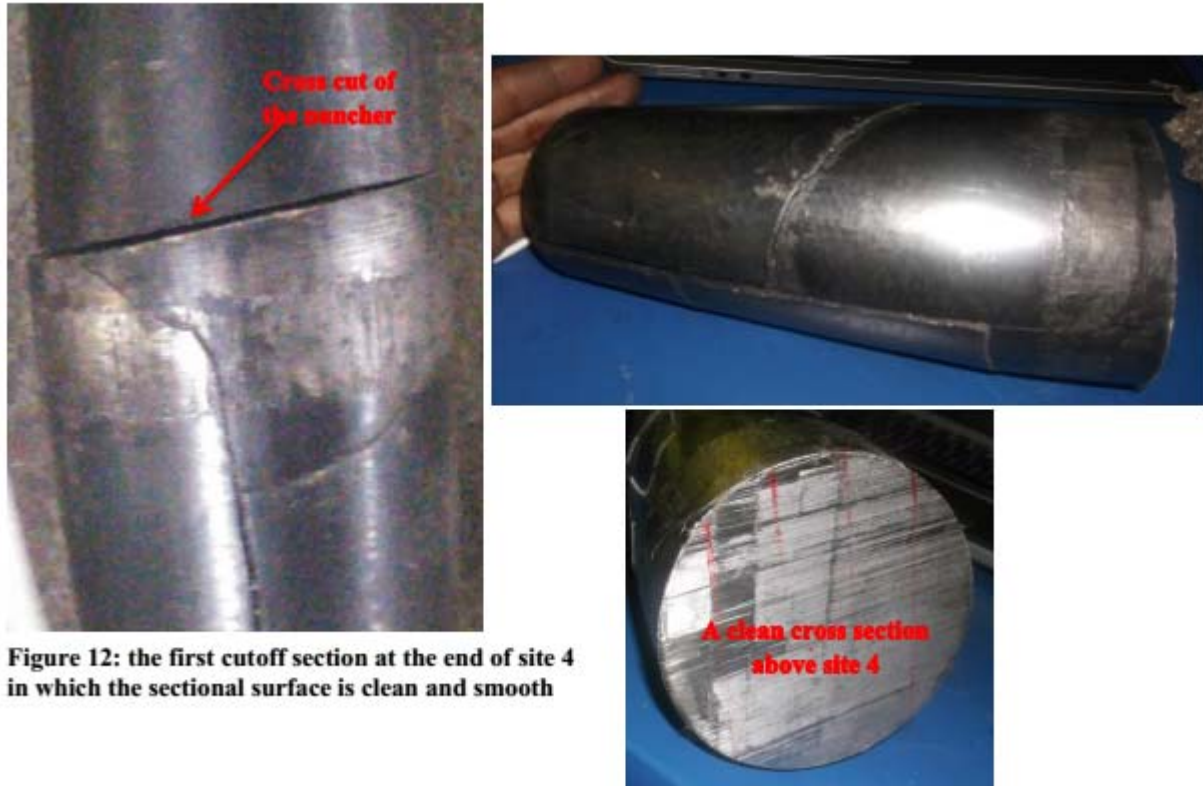
In this industry, different techniques were used and after taking 4 hours the pieces has successfully cross cut at section 4 after 2 blades each costs 3000EB are eroded and worn-out in the process. But the machining process has its own difficulties.

Figure 12: the first cutoff section at the end of site 4 in which the sectional surface is clean and smooth

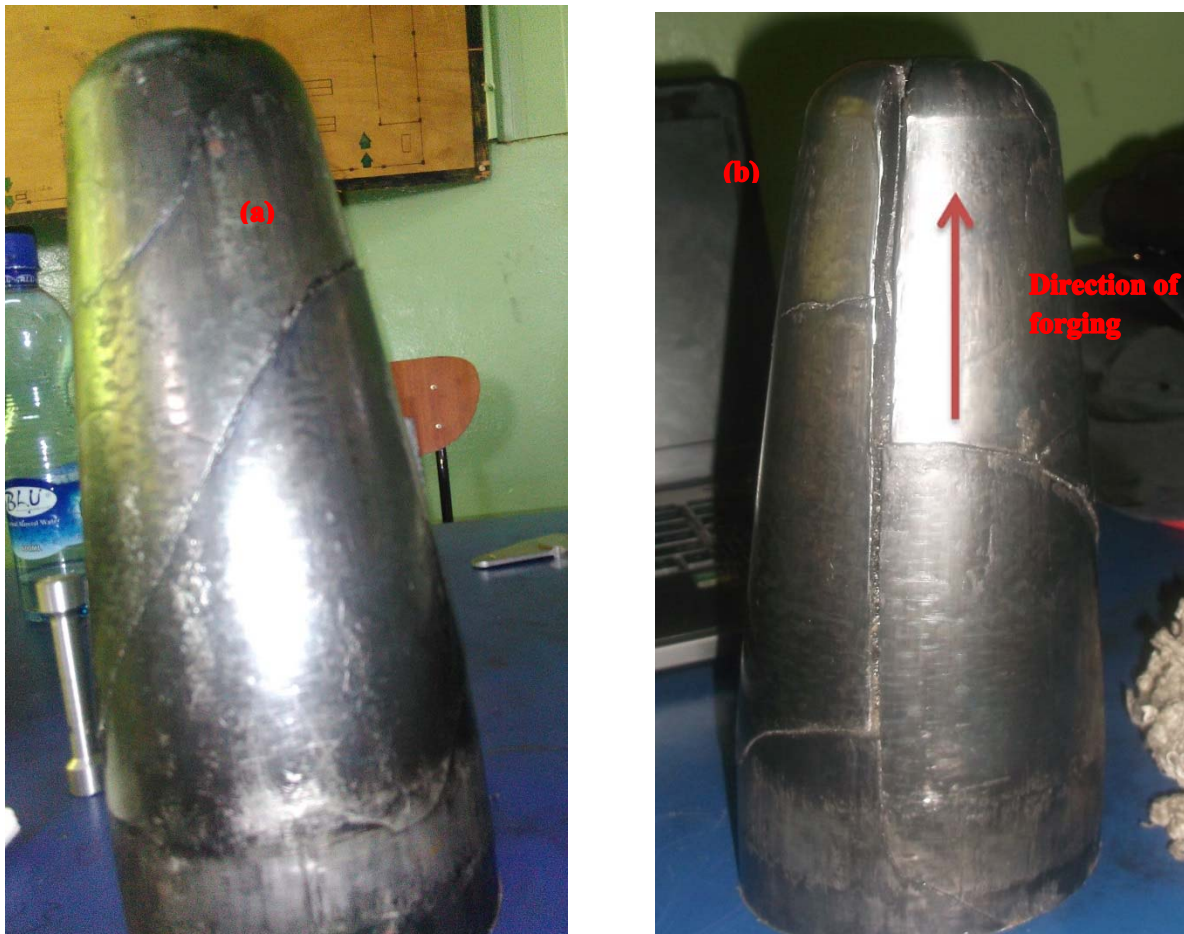
It can be seen on the figure that the cracks seem to originate from the tip of the puncher which is a part that has a first contact with an average high temperature of greater than 1350°C [24] billet. The brittleness occurs for a specific puncher is after it has manufactured 167 products. But while producing the last job that is 167th, a huge sound is heard. When the puncher has completed its last operation, those cracks are observed on the surface. From this the behavior of the crack is believed that it is fast and brittle fracture. On the surface of the puncher there are many cracks one crosses the other. At the back of the main crack, there are cracks that are interlocked and cause the puncher for a sudden broken in to pieces. Figure 17 has a more illustrations.

Figure 4-2: interlocked cracks at the back surface of the main cracks (a) back surface (b) main crack surface

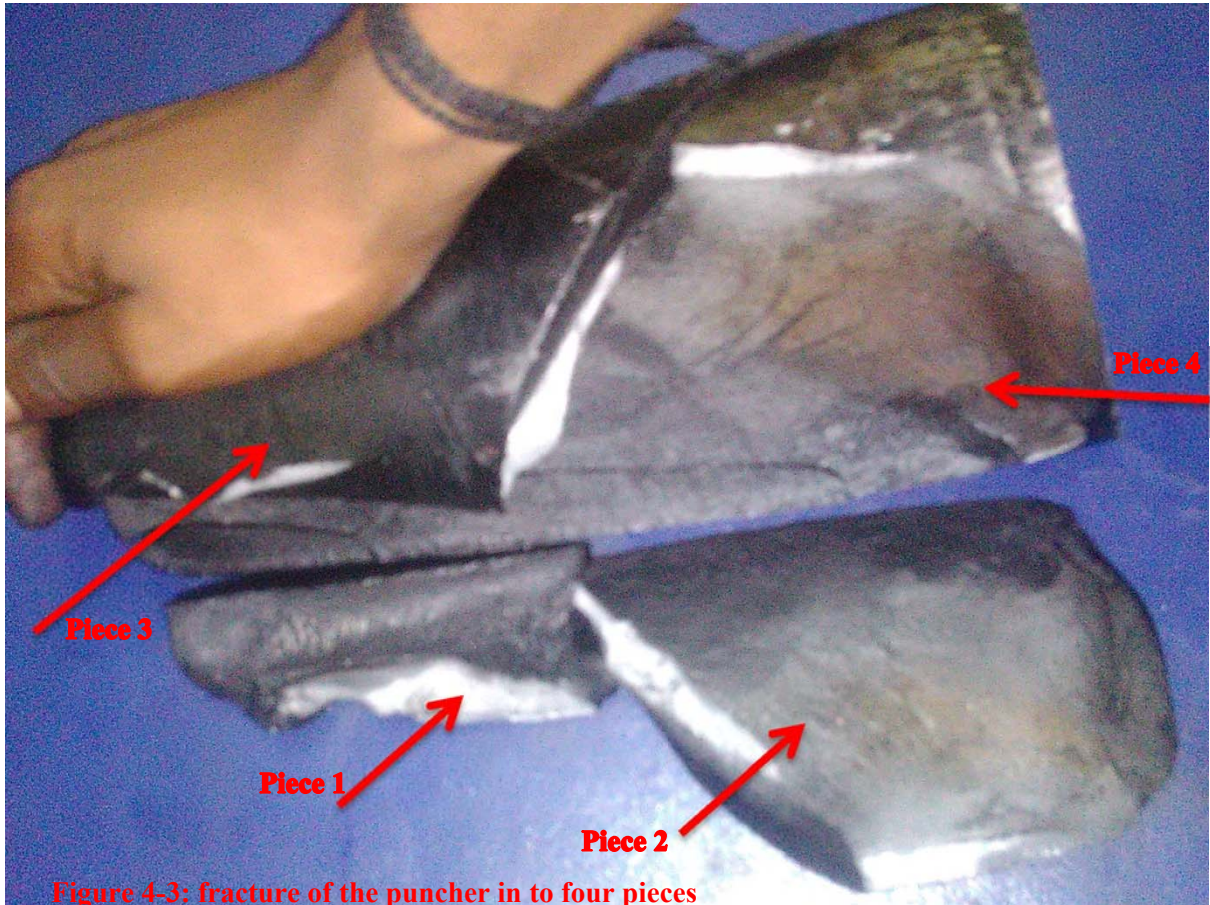
When the puncher is to be sectioned at the required sites, it has broken down in to four

Figure 4-3: fracture of the puncher in to four pieces

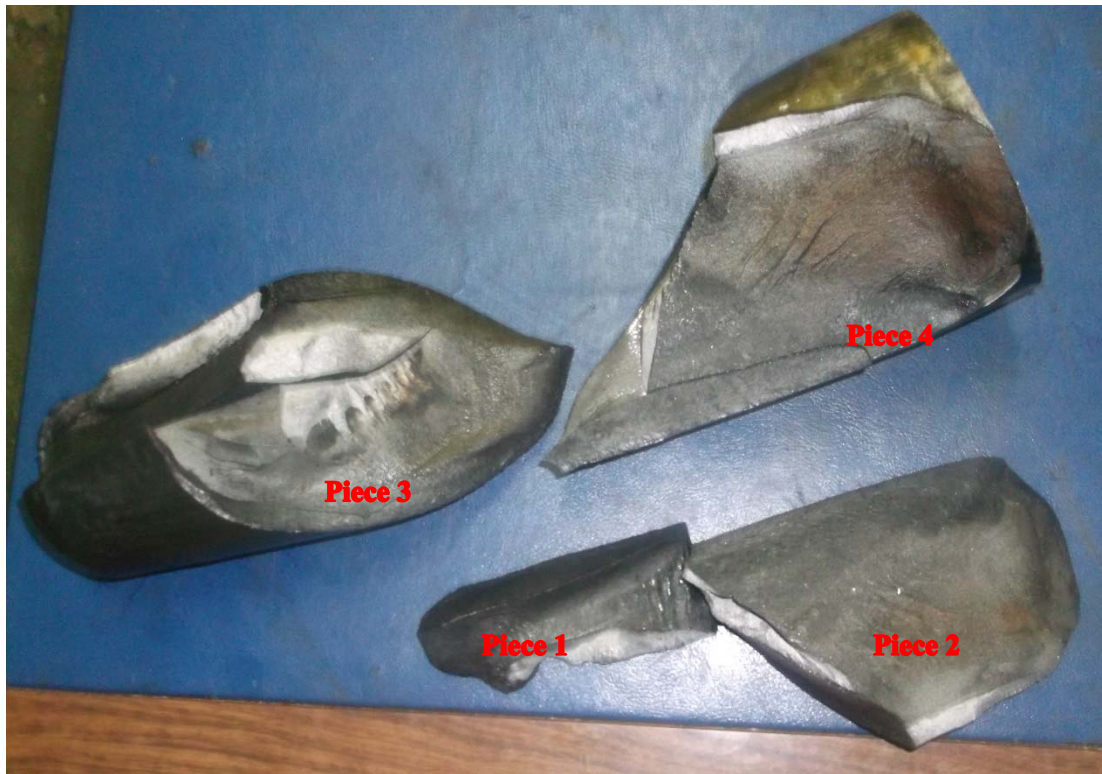
Figure 4-4: the four fractural pieces

pieces by itself as shown on figure 4.3 and fig 4.4. The reason is that due to the heat treatment the puncher become very hard so that its high hardness and high brittleness property generated [9] leads the material to broken up in to four pieces. Not only has that but, the cracks played an important role because the broken parts are broken exactly following the crack path. So that, the behavior of the propagation of the cracks starts from a surface which has a surface contact with the billets at high temperature. [1] [9]

Piece 1: As it is shown on Fig 20 bellow, this piece weighs 408g in which it is the most sever part of the puncher to fail. The reason is that it is with in site 1 and site 2 of the research that is the most responsible sites for forging after receiving that high temperature from the billet. This

Piece 3: It is a little massive part which is 3.25kg and it covers site 1, site 2 and site 3. This piece has the second interior layer as it is seen on figure 4.4. For layer observation this piece has very crucial information for the location of crack zone. In addition to that it is this part that oxidation and corrosion takes place. In order to see the interior section, this part should be further broken in to pieces. And so that it is then broken in to ten subdivisions as it is illustrated on figure 4.7. Again the subdivisions are cracking dependent so that it can be reassemble which is shown on figure 4.10.

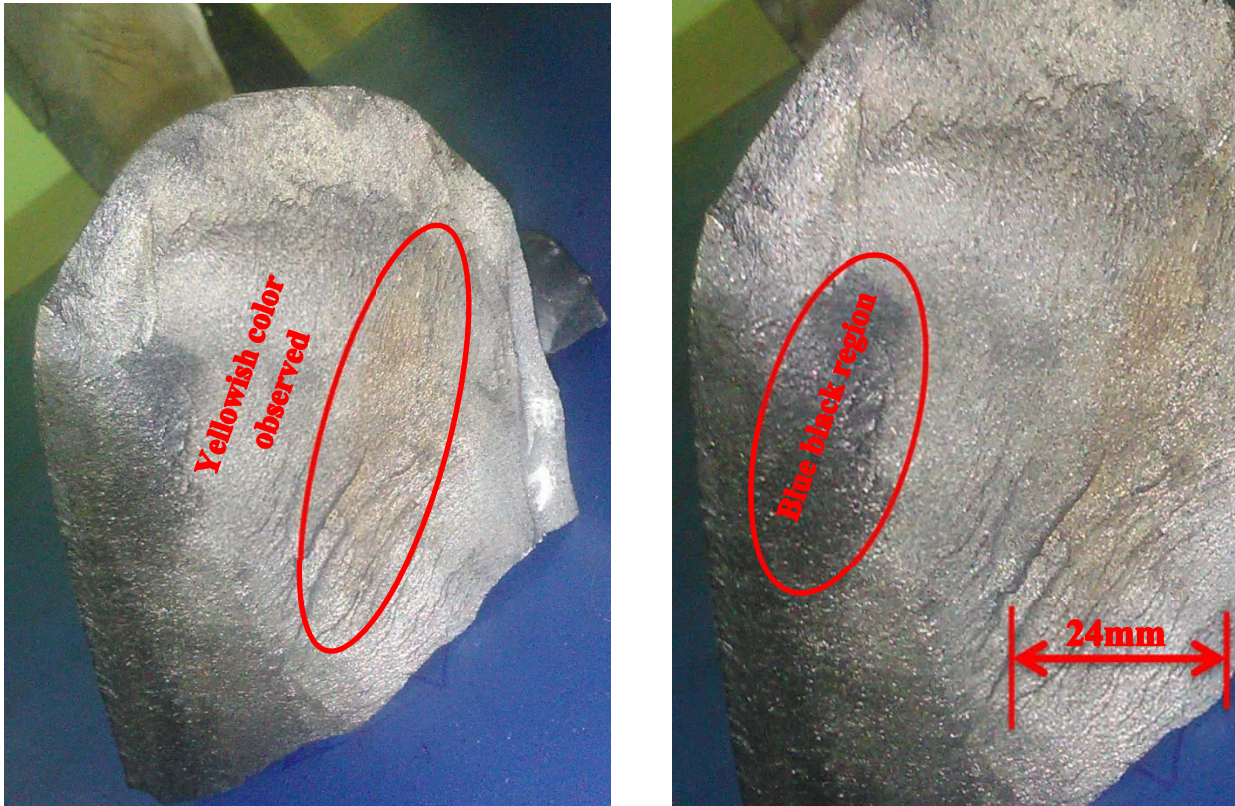
Figure 4-6: The broken image of piece 2

Piece 2: it consists of site 3 and site 4 of this research and that it is very thin but it is wide and curved. It weighs 819g. It has relatively smooth surface when it is compared.

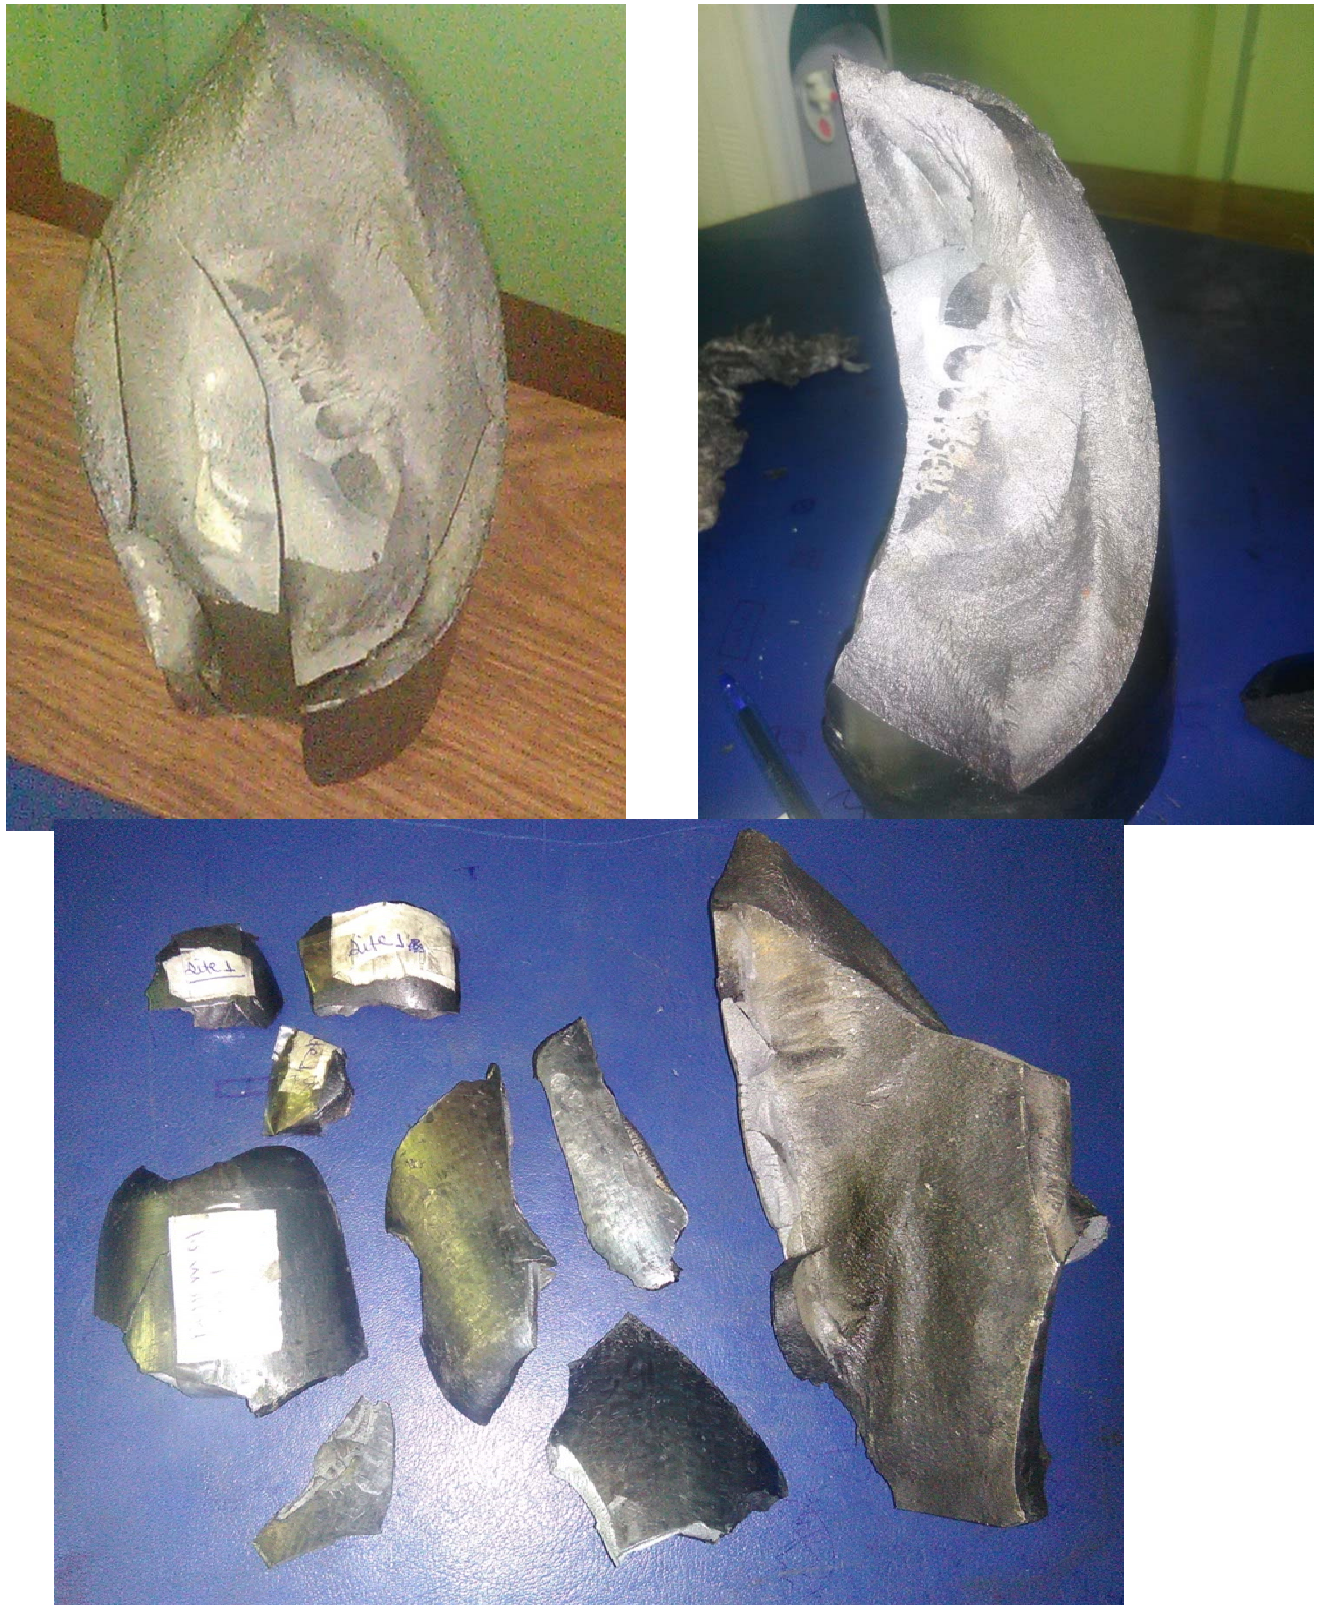
Figure 4-7: The subdivisions of piece 3 in to ten sub divisions (one of the ten is on machining for tensile testing samples)

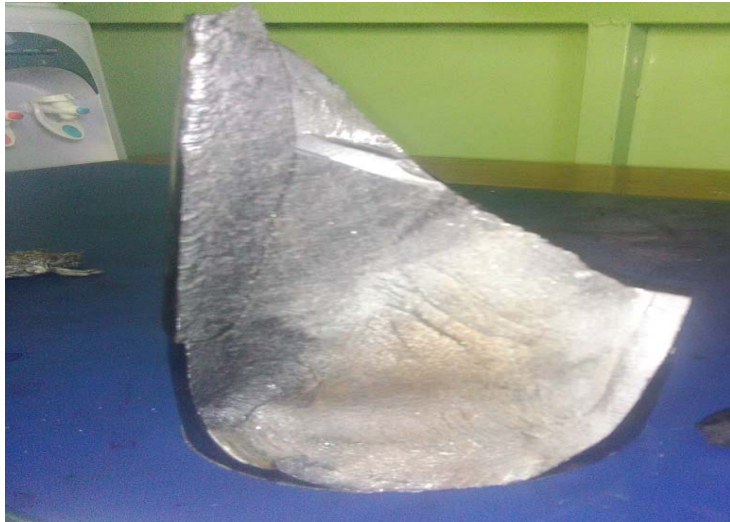
Figure 4-9: The broken image of piece 4

Piece 4: this piece is the upper part of the puncher and it weighs 3.0kg. This sectional part covered with an oxidation layer. And also the yellowish color is much observed on this site.

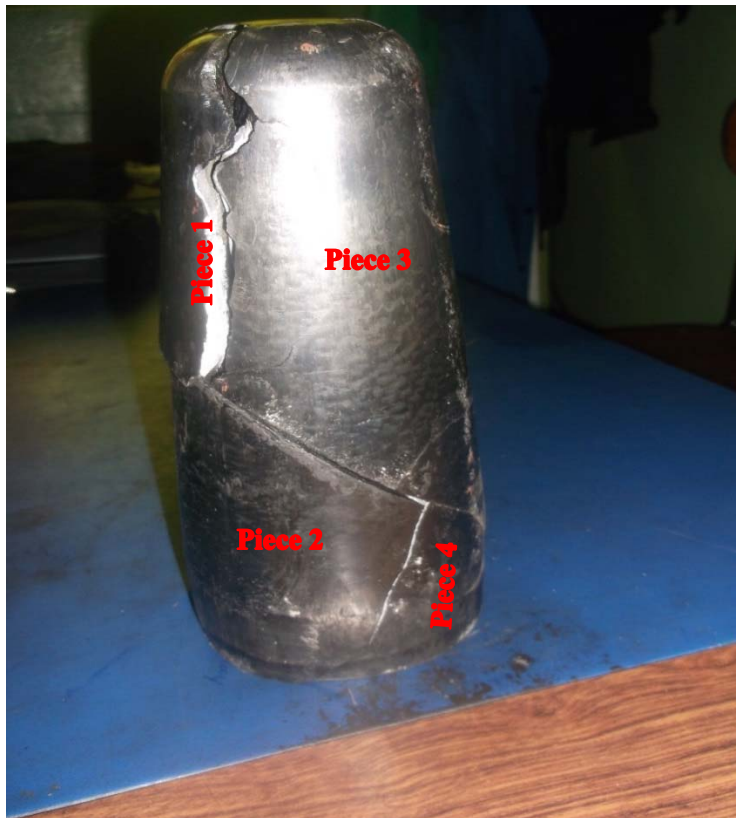
Figure 4-10: the assembly of the broken pieces

For convenience, the broken pieces are then assembled and all the pieces are perfectly aligned as it is shown on the figure 24 except one little missing scrap. And also, what everybody expect is that the width of the main and branched cracks is increased by 24 percent than before the material is broken in to pieces. A reader may compare and observe the difference of this with that of figure 4.9 with that of the original/before it is broken in to pieces/ material on figure 4.2.

The fracture surface shows yellow-blue-black feature [25], which implies that it has suffered high temperature and oxidation [25]. It is very important at which temperature this coloring will occur.

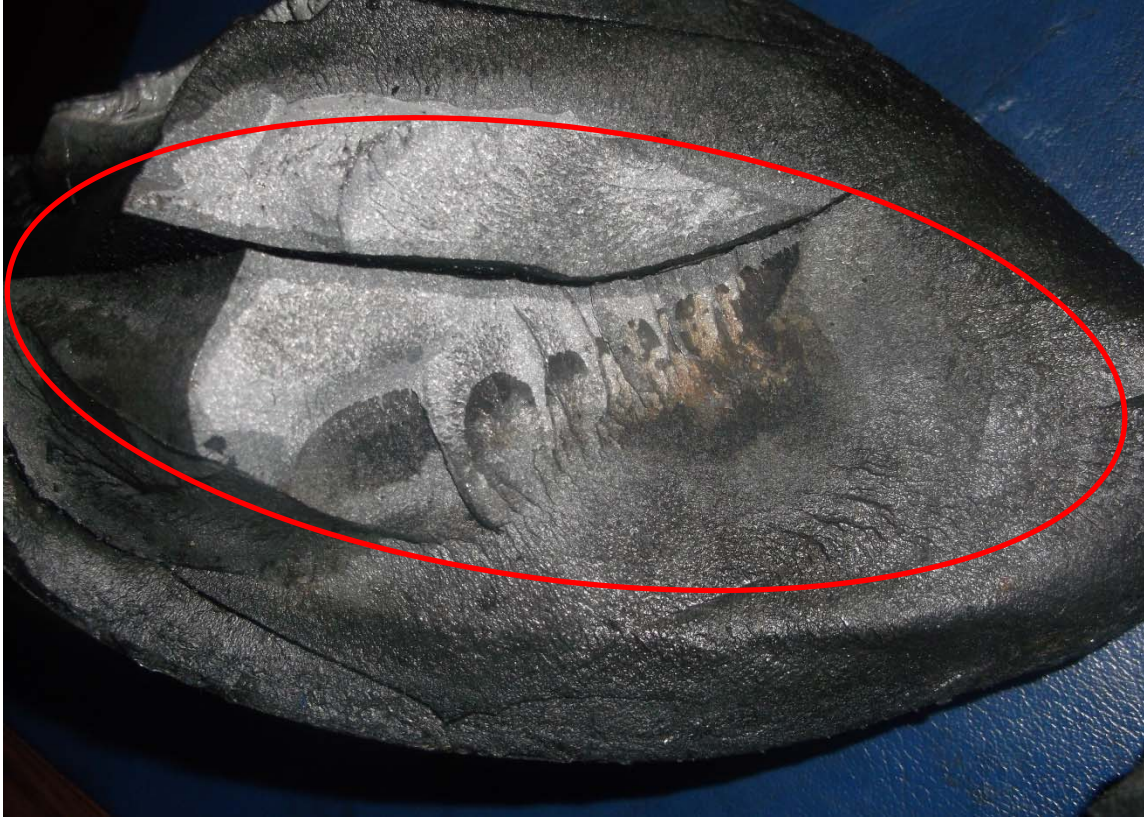
On this failure analysis the same kind of fatigue surface is observed having different layer formation. There are three layers that can be observed. If we look at the broken piece 3, the layers are highly visible as shown on the figure below.

Figure 4-12: observation of yellow -blue- black oxidation layer at ambient temperature

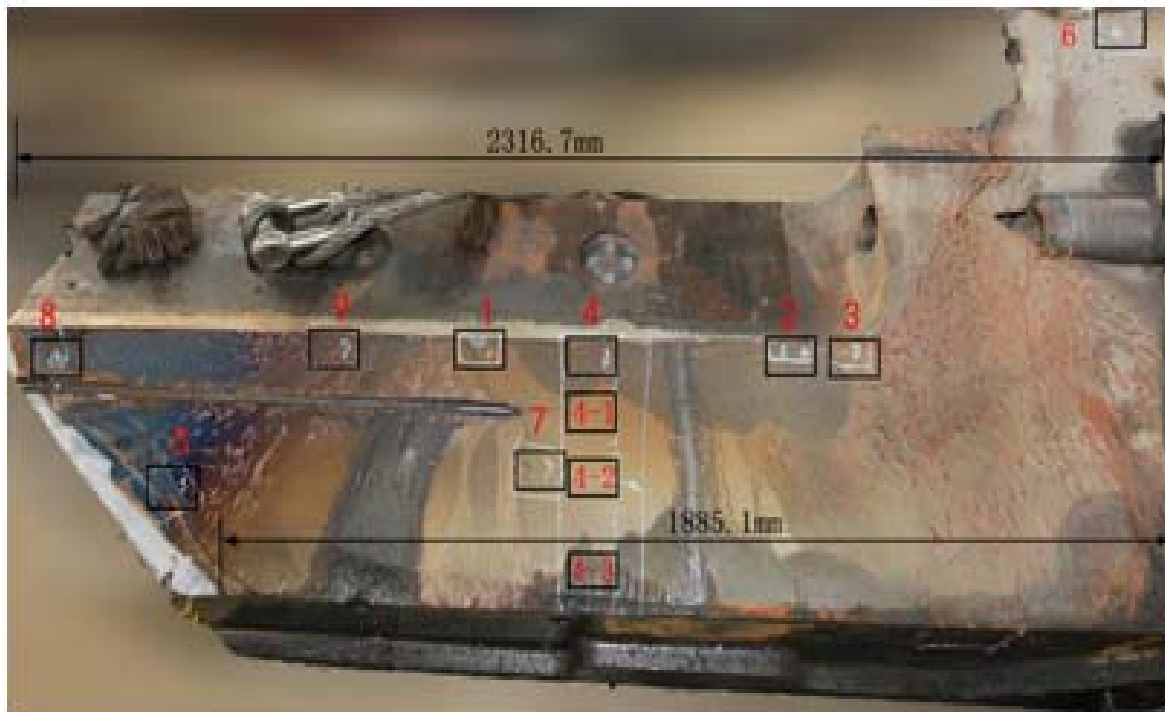
The other way that is used for the indication of the failure is that the type of colors observation on the surface of the material. Many literatures used this method of failure analysis like that of a research titled by Failure Analysis of large press die holder which is conducted by a collaborated writers named by Hongxun Wanga, Peng Jiang, Weifang Zhang, Yaozhong Zhang, Tong Song. The procedure that they have used was specimens were cut from the experimental site or a place where coloring effect was wanted is put for 40 minutes at different required temperature particularly at the temperature of 200°C, 250°C, 300°C, 350°C, 400°C and 450°C for 40 minutes from the die holder shown below.

Figure 4-13: The whole fracture appearance and specimen's number. (source: Engineering Failure Analysis: Failure Analysis of large press die holder named by Hongxun Wanga, Peng Jiang, Weifang Zhang, Yaozhong Zhang, Tong Song; 6 April 2015 china)

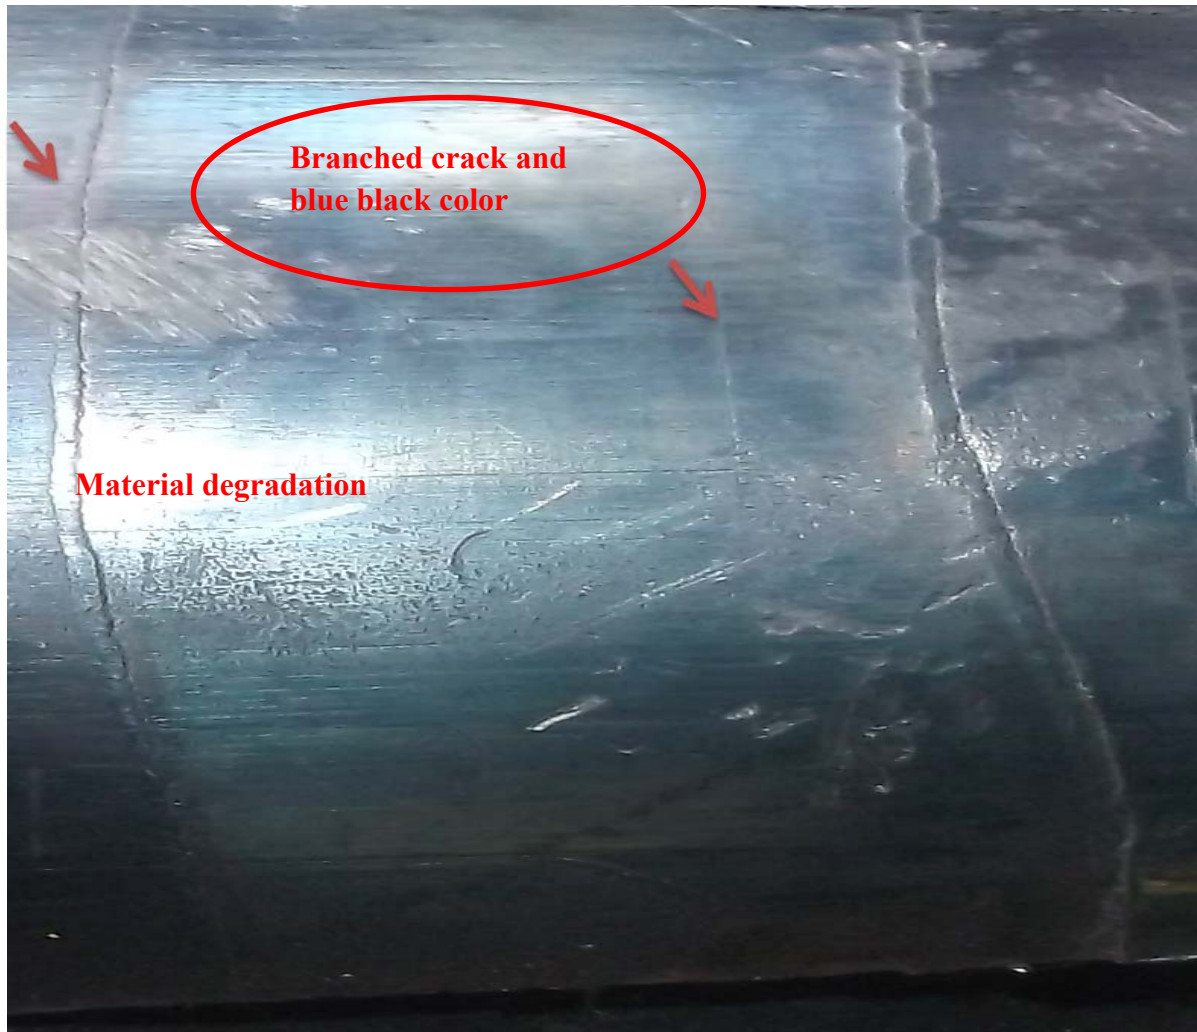
At room temperature or ambient temperature that is at about 34.43°C the surface of the metal is colorless at site 1, 2 and 3.1 or it doesn't show any color change. But at sites 3.2 and site 4 a small yellowish (interior cross section) and blue black colors are observed. The yellowish color indicates the oxidation layer formation inside the metal which is called Tribo-oxide layer. Not only that but also the blue black layer is because of another impurity scraps found inside the metal. Most literatures indicate this as it is phosphorus and sulfur.

Figure 4-15: blue black color on the surface of site 3.2 and site 4 at a temperature of 34.43°C.

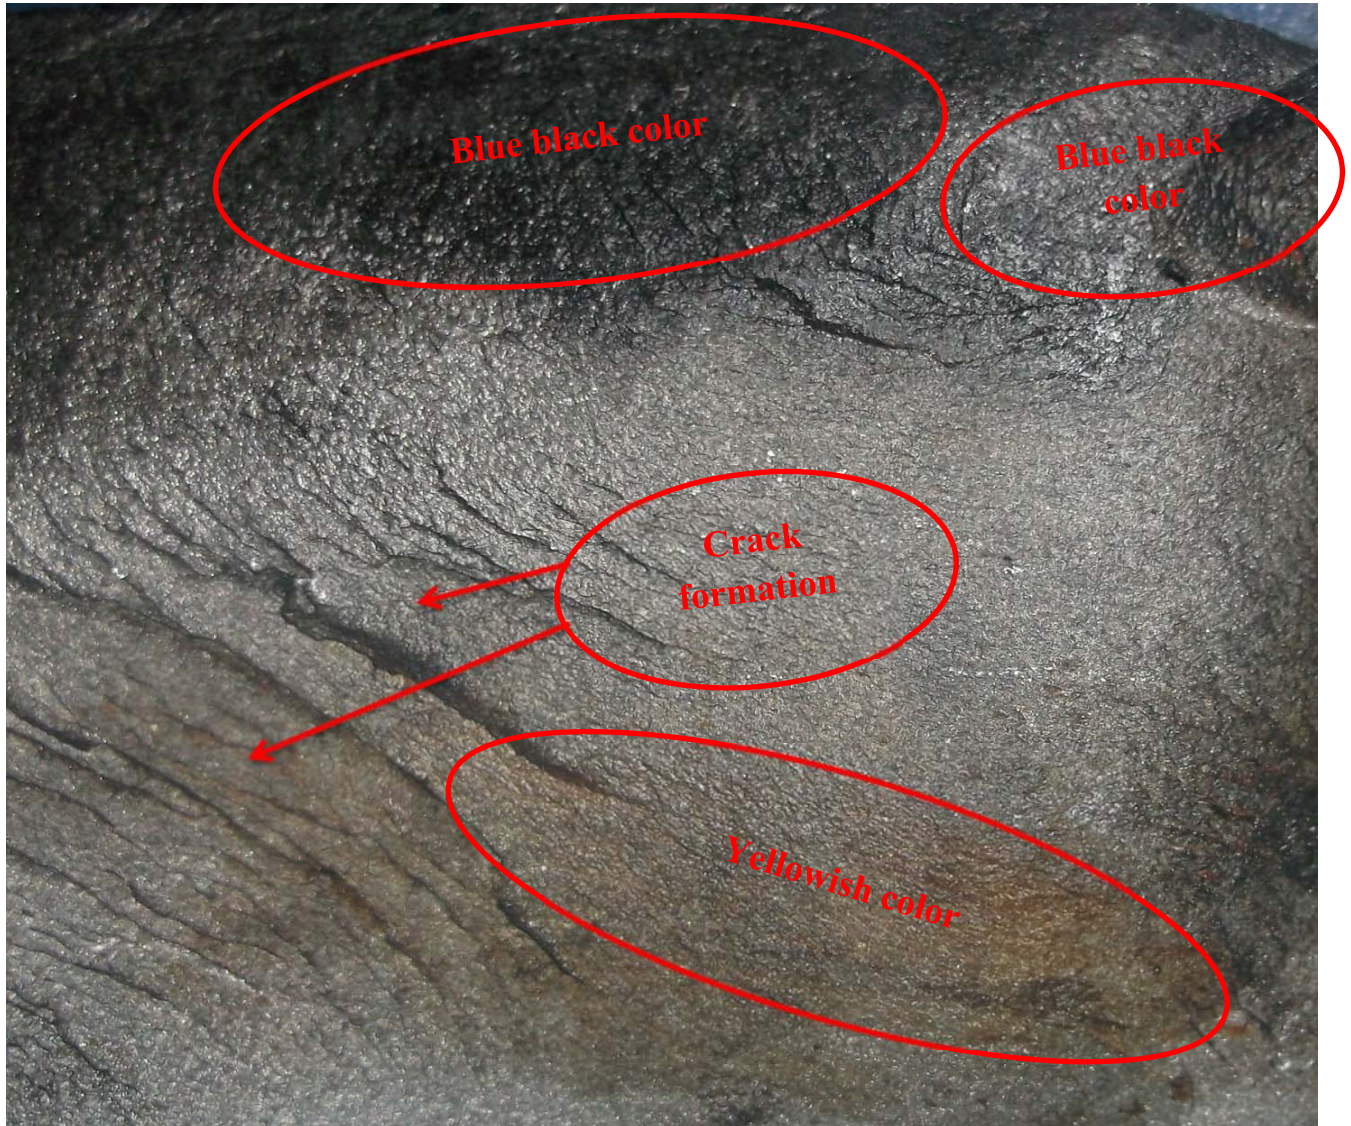
Figure 4-16: the yellowish color observed at site 4 of the puncher at a temperature of 34.43°C

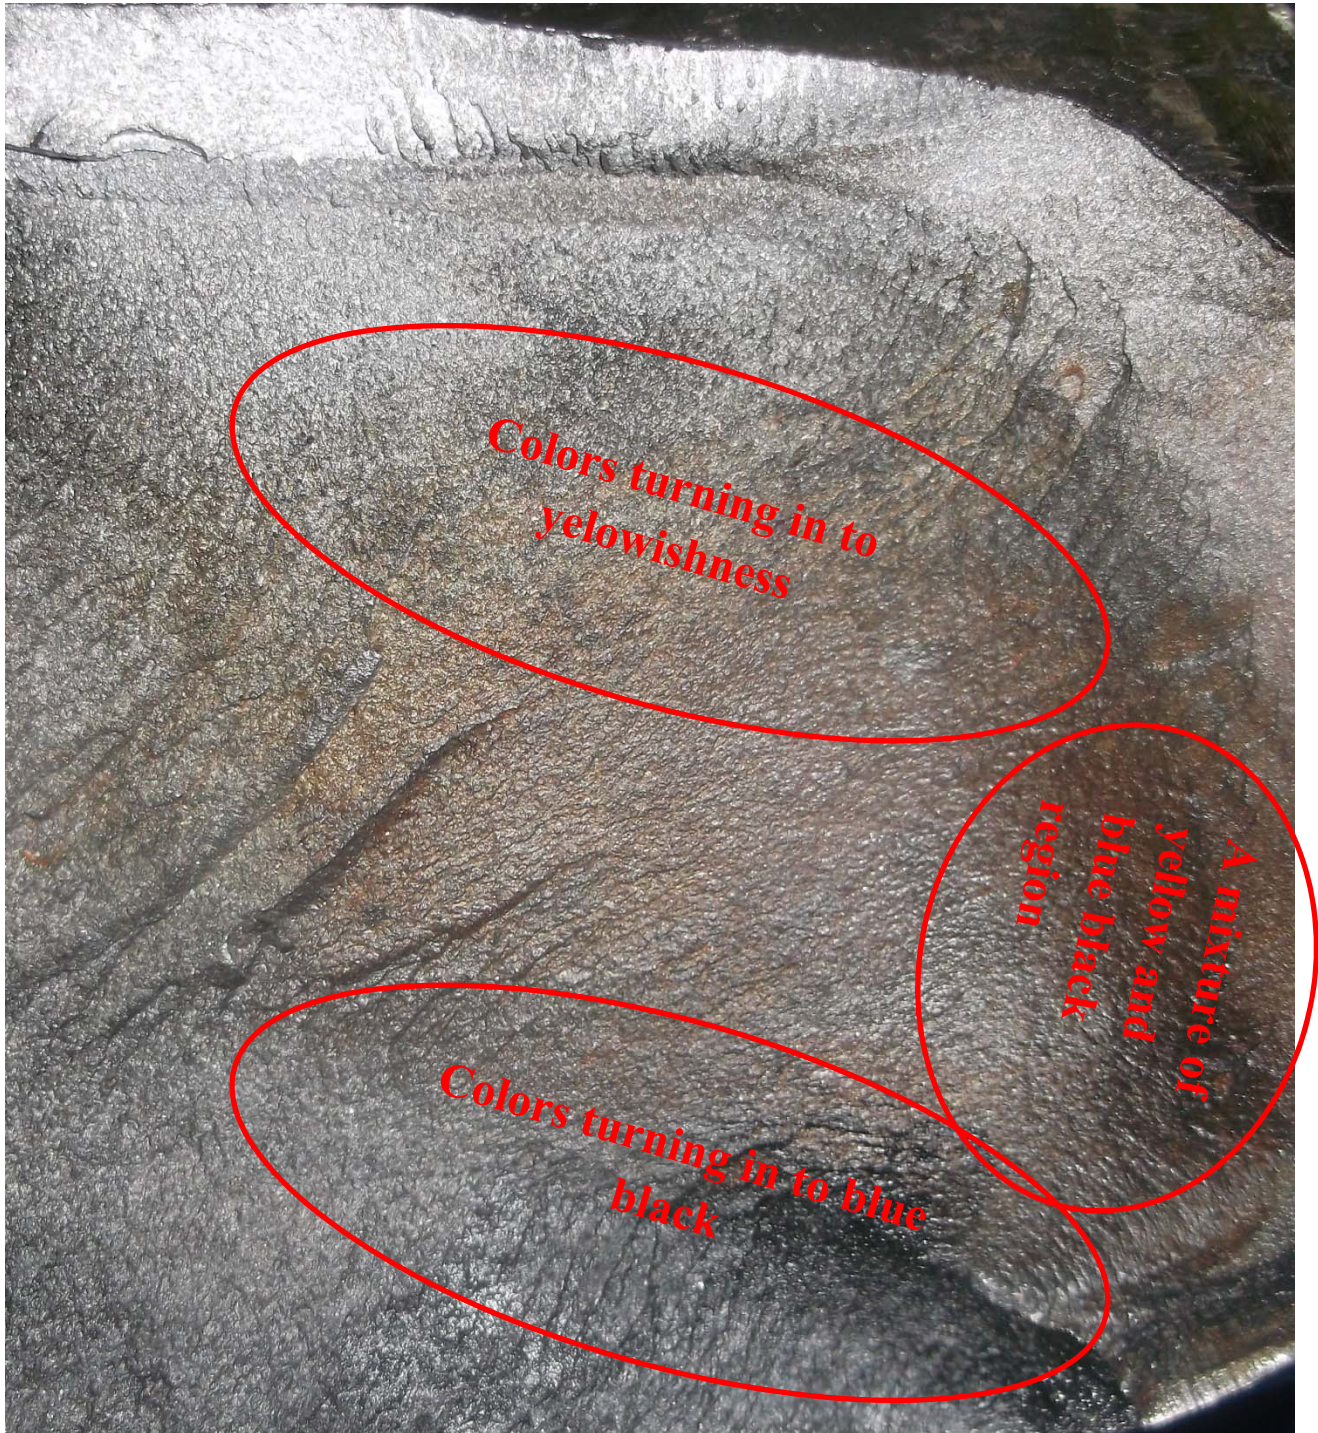
This is a temperature that the puncher receives in its process of forging a very hot billet that comes out of the Furnas. So that, the puncher may absorb this heat at this temperature and it shows some change of color on the interior surface. This condition is tried to be illustrated on the figure 30 shown below.

Figure 4-17: observation of oxidation layer on the puncher surfaces that is heated at a temperature of 100°C

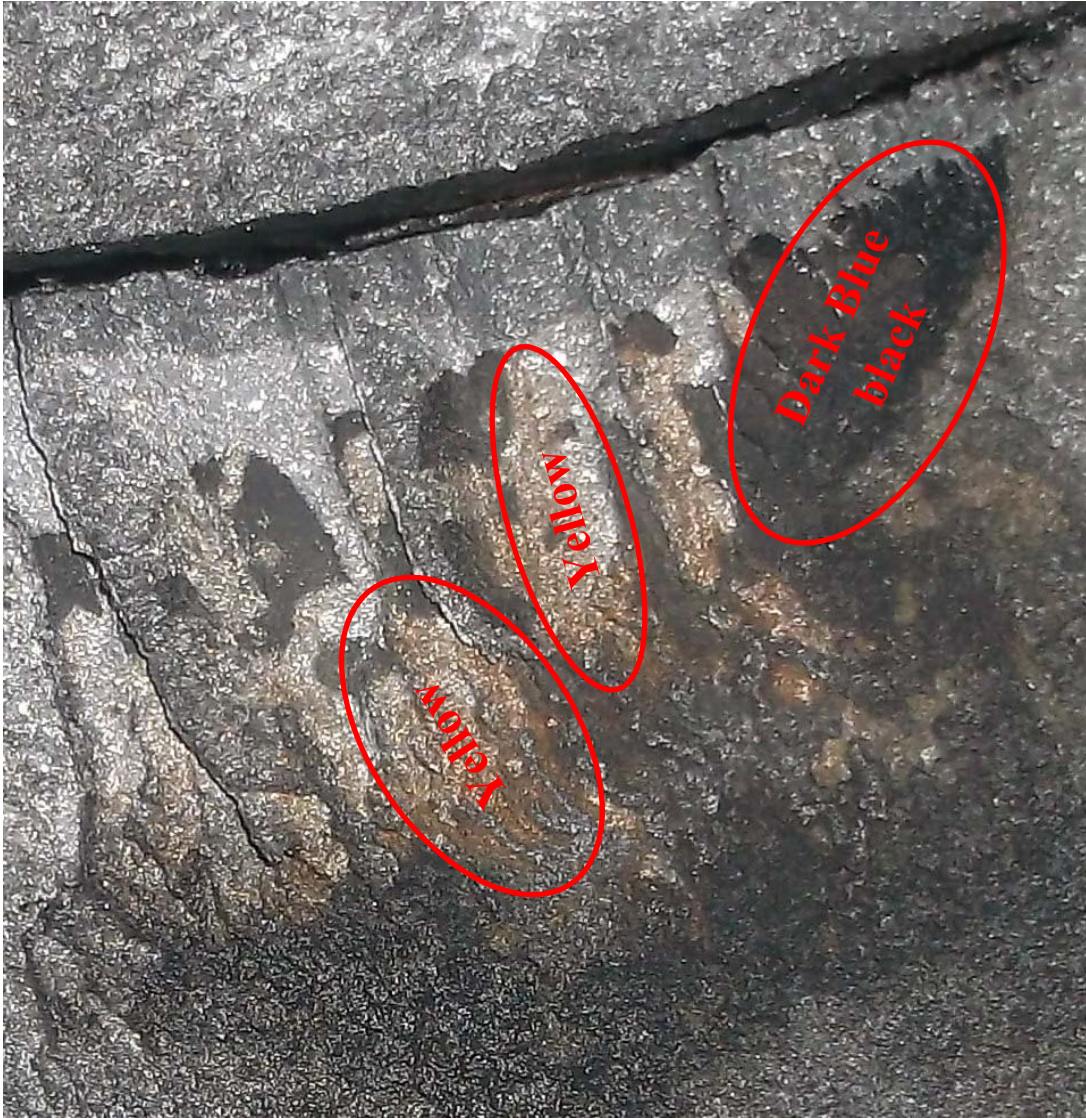
On the other broken pieces, in order to observe the formation of tribo oxide layer, a temperature is increased to 140°C. The result indicates that the oxidation layer will propagate on the surface and it gets dominating on that of the sulfur and the phosphorus layer. This means that the oxidation process is the first and the most dominating condition for the material degradation of the puncher.

Figure 4-18: observation of oxidation layer on the puncher surfaces that is heated at a temperature of 140°C
