ADDIS ABABA UNIVERSITY
Addis Ababa Institute of Technology
School of Graduate Studies

Failure Analysis of Rocket Shell puncher Die

A thesis final draft submitted to school of Mechanical and Industrial Engineering for
the partial fulfillment of the requirements for the Degree of Masters of Science in
Mechanical Engineering
(Mechanical Design Stream)

This paper studied Failure analysis of Rocket Shell punching die manufactured in Homicho ammunition and engineering industry having the crack on the surface of the male punching die. Detailed investigations including macroscopic examination, metallographic observation, and mechanical properties analysis were carried out. The investigations reveal that the failure mechanism of the punching die is fast brittle fracture caused by high stress under the condition of material self-embrittlement. As it is observed on 39 pieces of the puncher the main crack originated from the lower tip that has a direct contact with the hot of the punching die. The serious impact toughness degeneration and presence of impurities at the internal section of the die resulted in the material embrittlement. The hardness test and the oxidation process formed insid

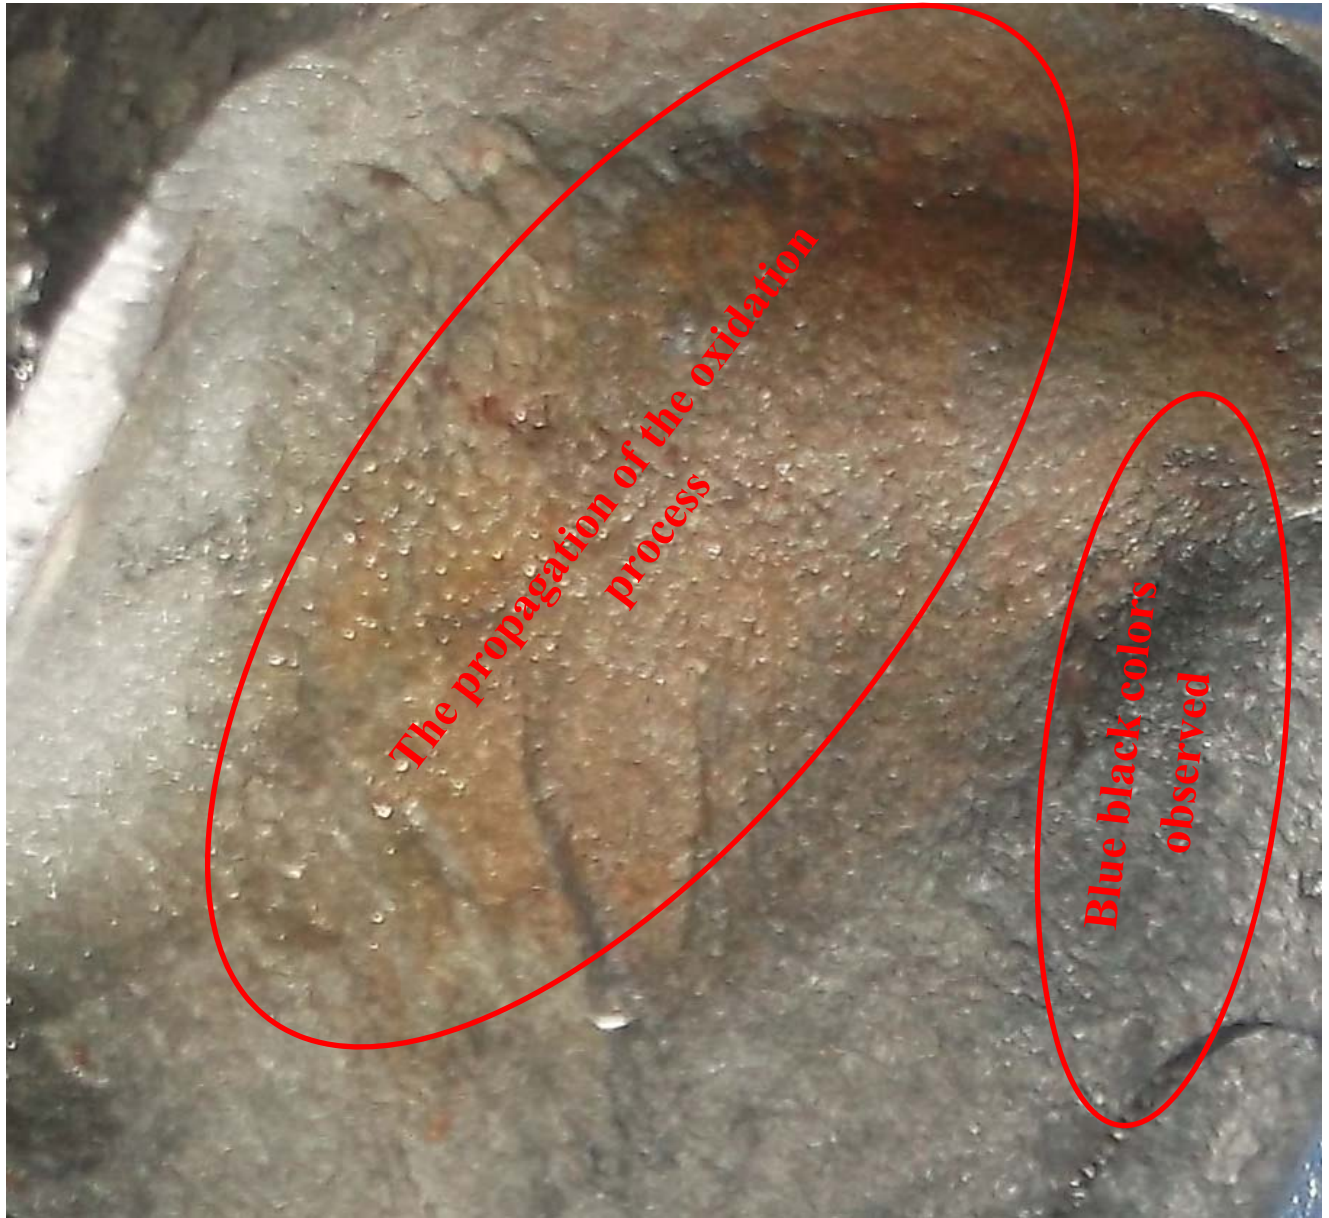
Here the puncher has nothing variable than that of colors observed at 140⁰C, but, propagation of the visibility of the oxidation process is observed. The tribo-oxide layer formation on the interior surface of steel die material should be studied further by other research.

Figure 4-19: observation of oxidation layer on the puncher surfaces that is heated at a temperature of 180⁰C

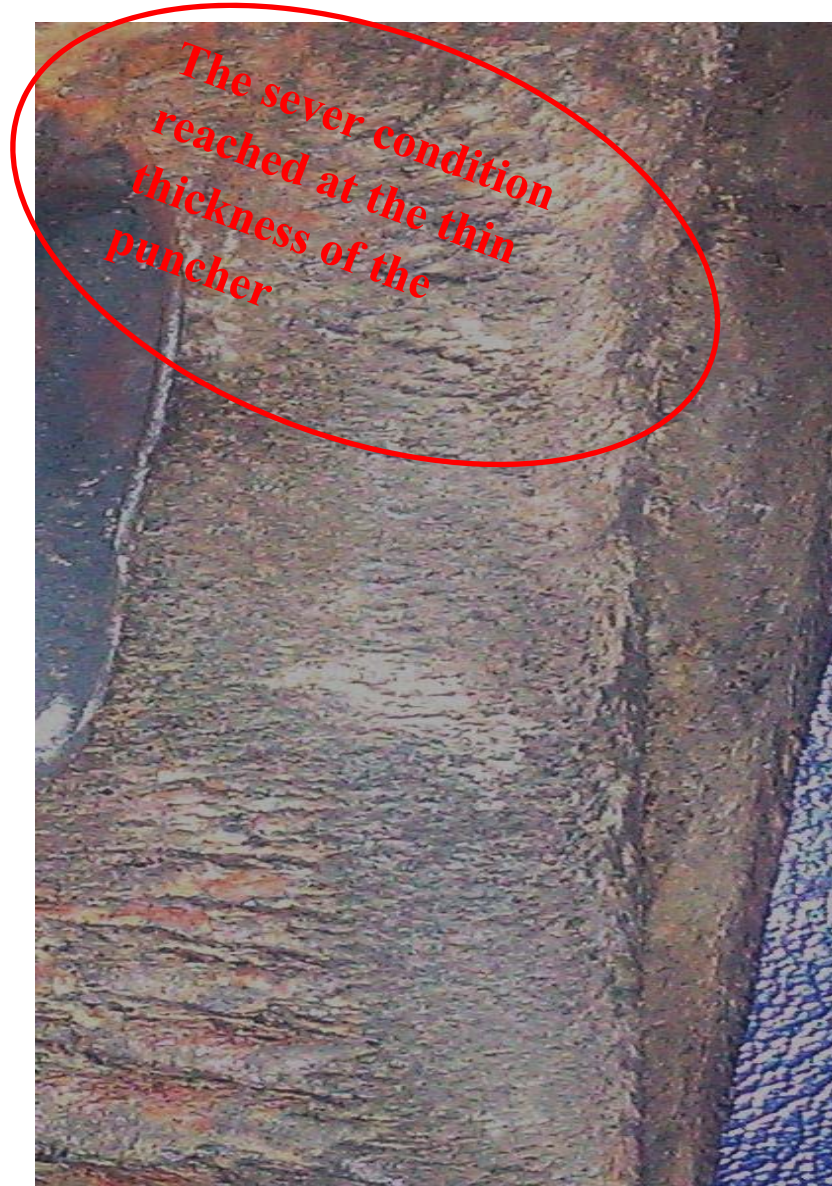
This temperature is required because the as it is stated on table 3 the maximum temperature recorded was 211⁰C in which the difference is only 9⁰C. At this temperature, at different corners and at sites that has a thin thickness and has a crack, the more oxidation process that is going to take place. This is observed on the figure 33 shown below.

Figure 4-20: observation of oxidation layer on the puncher surfaces that is heated at a temperature of 220⁰C

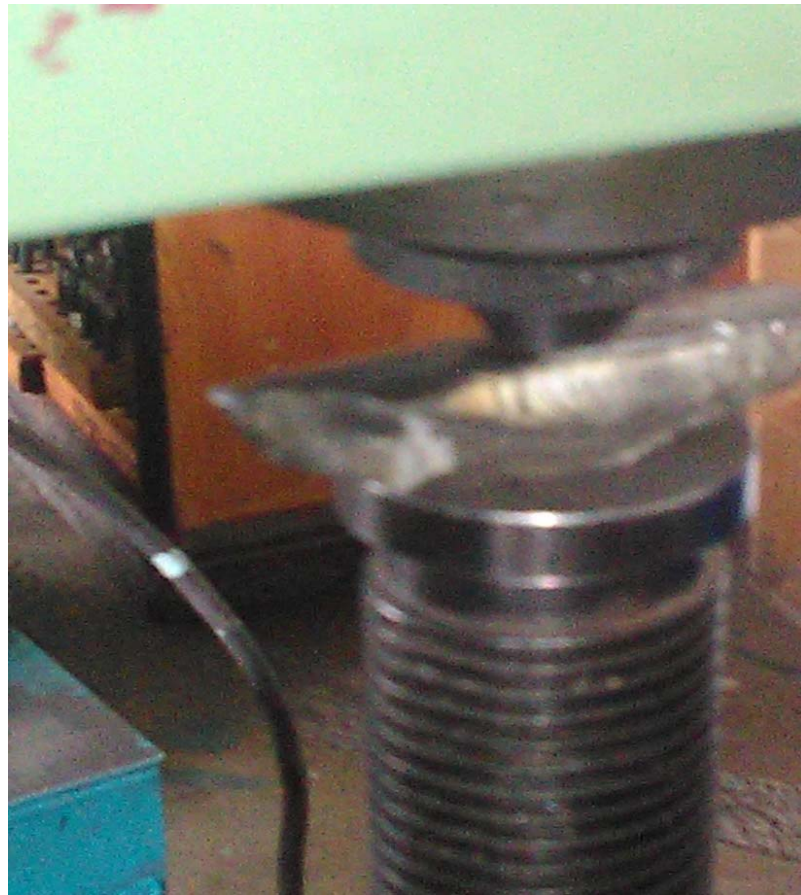
machine it and make its surface finish so perfect, some relatively smooth surface on each sites are tested by Rockwell Hardness Testing Machine as shown below on figure34.

Figure 4-21: Hardness testing by Rockwell Hardness Testing Machine

Even though the result will not be as satisfactory as that of the surface finished samples, but the test result of the hardness is tabulated on table 5 as shown below.

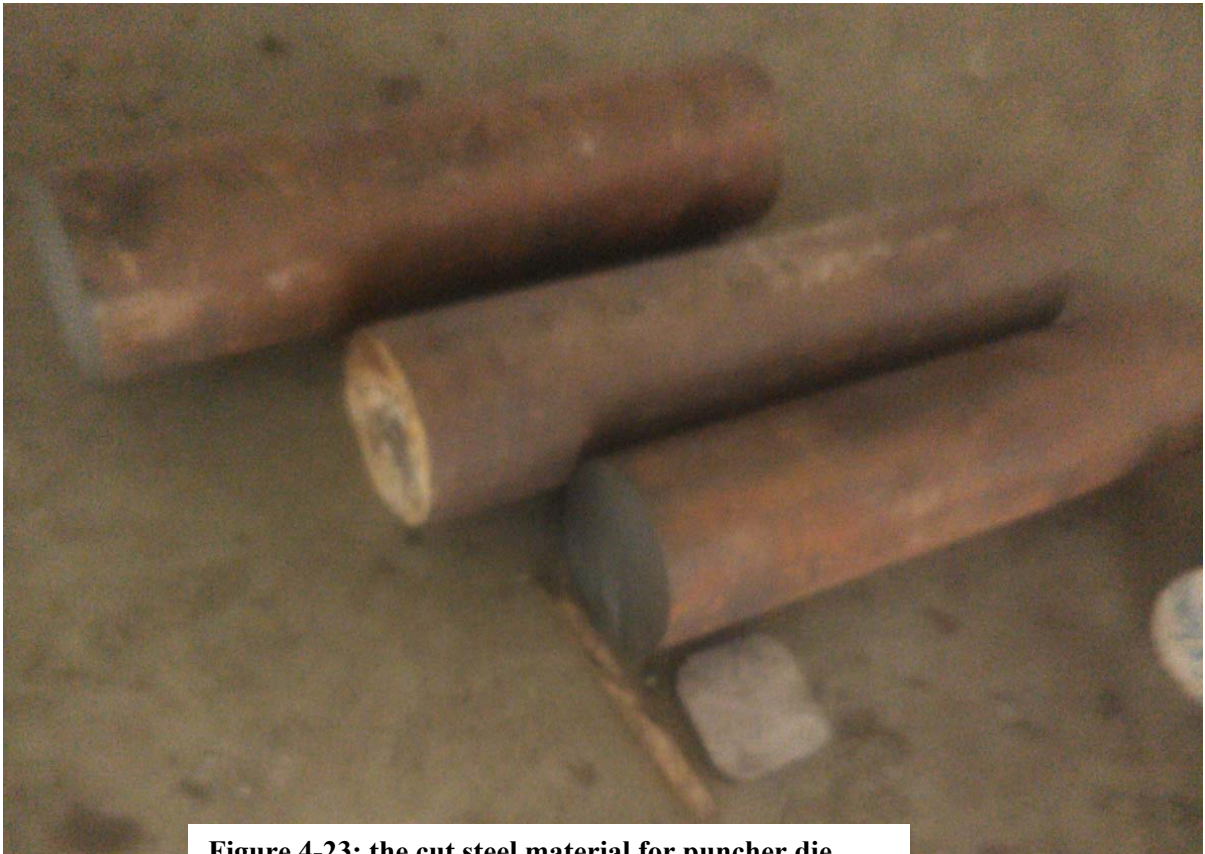
The investigation for the failure of the punching die with the time constraint has followed from the controlled die that has a mark of identification. This operation takes serious steps beginning from the cutting of the billet having a cross sectional area of 110mm by 115mm in to a dimension of 330mm length by using electrical power supplied hack saw machine. After it has followed a machining by CNC machine and has reached the designed dimensional accuracy it is then taken to heat treatment process to achieve a hardness of greater than 50HRC.

Figure 4-23: the cut steel material for puncher die

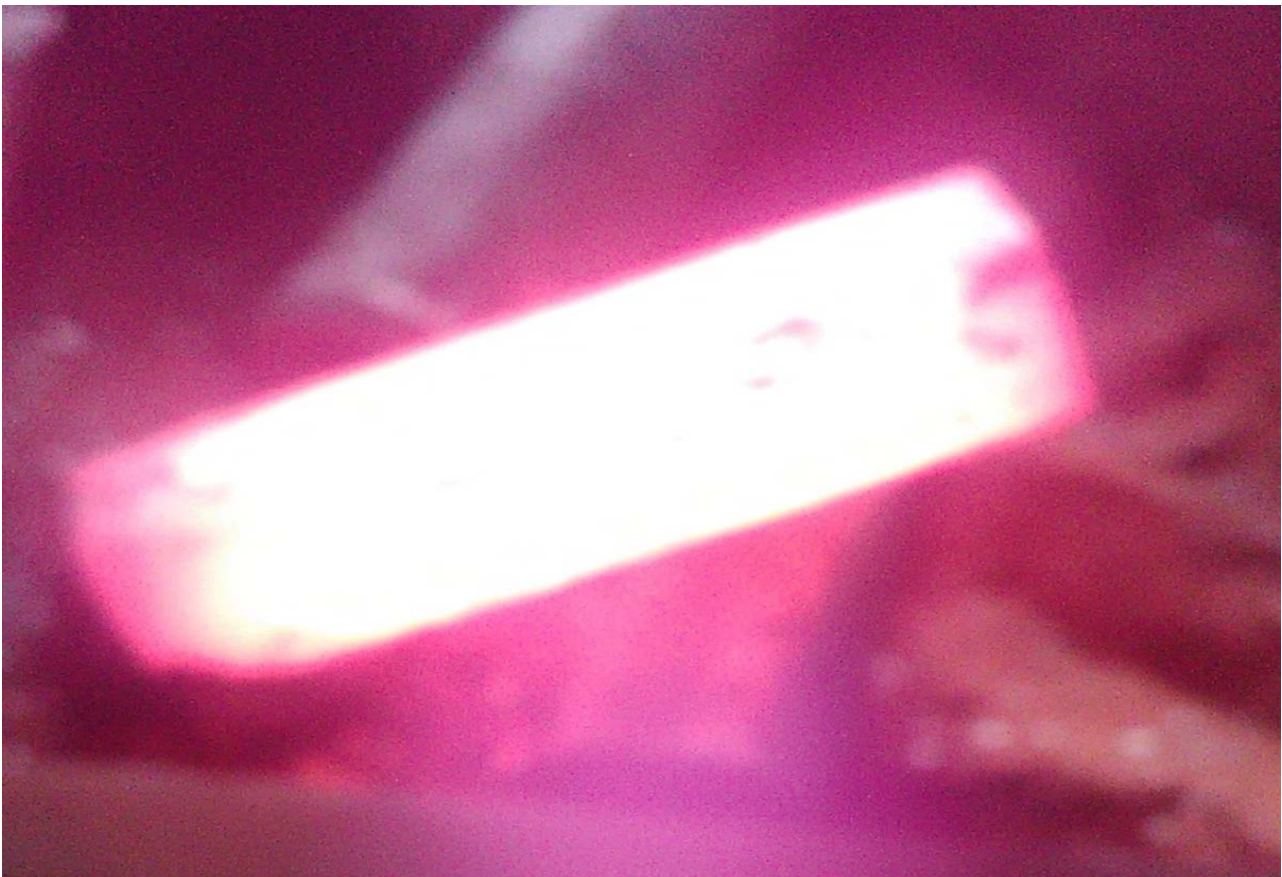
The billets that come out of the furnace are then taken out at the outlet of the furnace with the guidance of human labor until the robotic arm grips it firmly and then a robotic arm is what is going to take it to the pressing machine. After the robotic arm has taken it, it drags it out and rotates it in order to ease it to insert in the female die for drawing. This process takes about 3-4 minutes. Even though it is difficult to measure this temperature it is believed that the temperature of the billet is getting decreasing in some magnitude meaning that the hardness of the billet is getting higher and higher because it is a general truth that temperature and hardness of a material has a reverse relationship. With the increase of a temperature of a material, the hardness will be decreased. [1]

After the hot billet is inserted into the female die, the graphite is added on the upper surface of the billet for ease of penetration of the puncher just at the central portion of the billet. Then the pressing machine has first press down for positioning the billet and it makes the billet to stable with the female die at the bottom using a circular tube fixed next to the puncher. Then forging process using the puncher is followed. After completing a downward pressing, the puncher moves up.

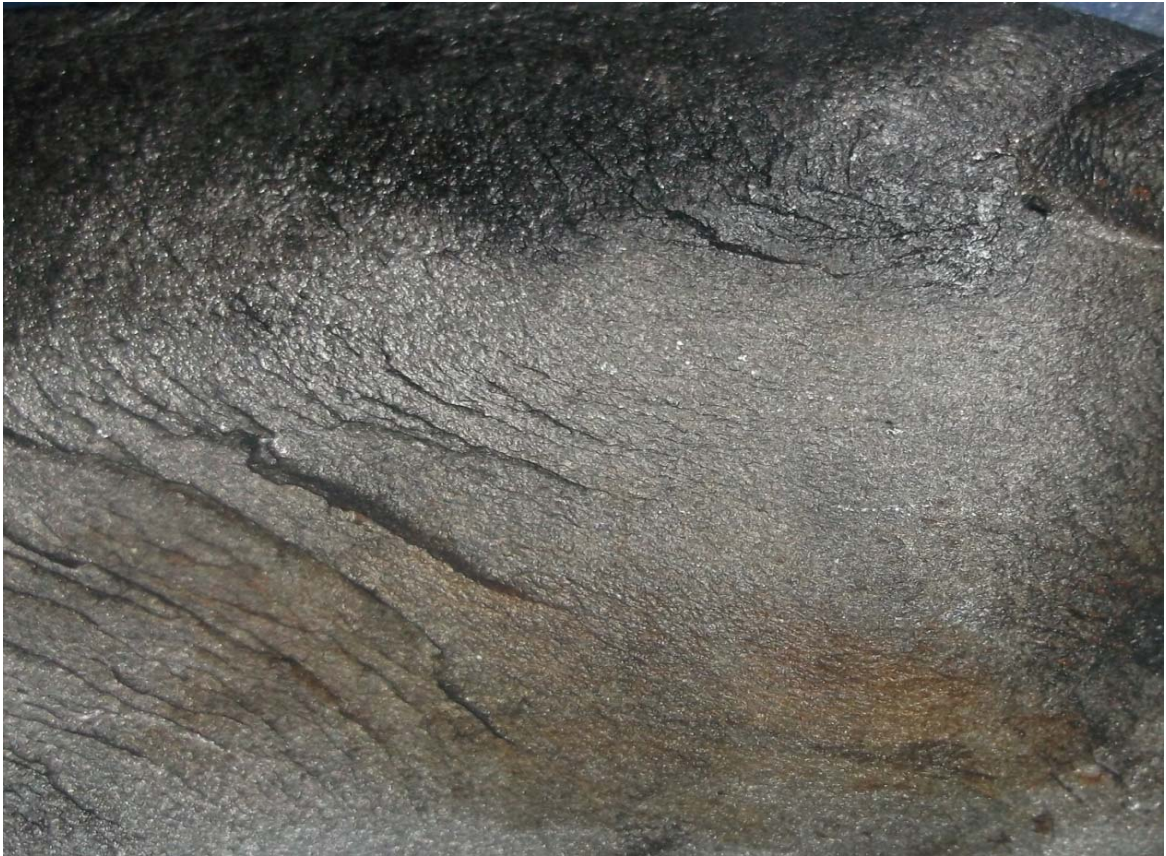
As the robotic arm has cleared the forged billet away from the pressing machine, the puncher is allowed to cooldown by water spray until it reaches its room temperature and keep stayed in cold water until the next operation is ready for punching process. This means that the material of the puncher is under tempering process and quenching process of the heat treatment. The maximum temperature of the puncher after completion of its operation is recorded on table 3 and 4, such that it would reach about 220⁰c. But taking some human error, environmental working condition

and errors with measuring device in a consideration, this temperature of the puncher may reach about 250⁰c.

Figure 4-25: martensitic morphology in comparison with figure 38.b

This process is cycling throughout the punching process until it is found broken and finally failed though cooling and heating in which it is under a tempering process. In heat treatment process, this temperature value is observed within the martensitic temperature in which the morphology of the structure of the metal is known to be martensite. It is known also that this martensite is a supersaturated solid solution of carbon in $\alpha - Fe$ possessing a high hardness but a poor toughness. [27] This heat treatment effect has been conducted by collaborated researchers on cast steel material for hot forging die having morphology of Martensite as shown on fig 38.b shown below. A clear observation indicates the figure on figure 4.26 is more likely similar with that of figure shown below.

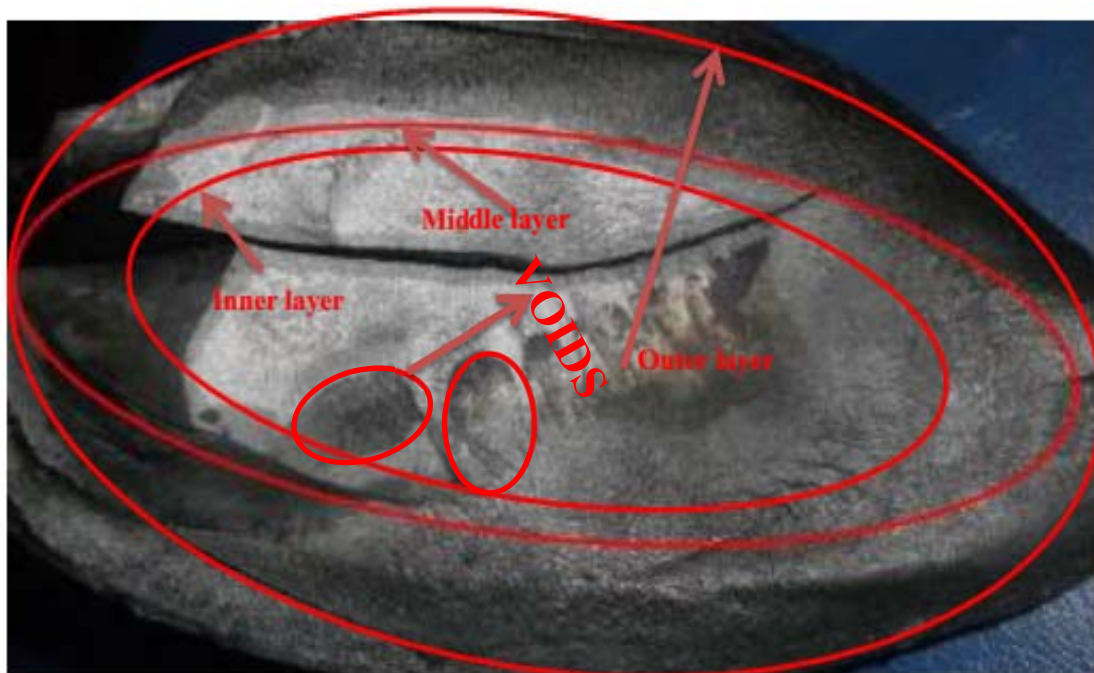
Figure 4-28: White elliptic shape occurred as a result of fatigue stress and different layer formation on the interior cross-section of the punching die.

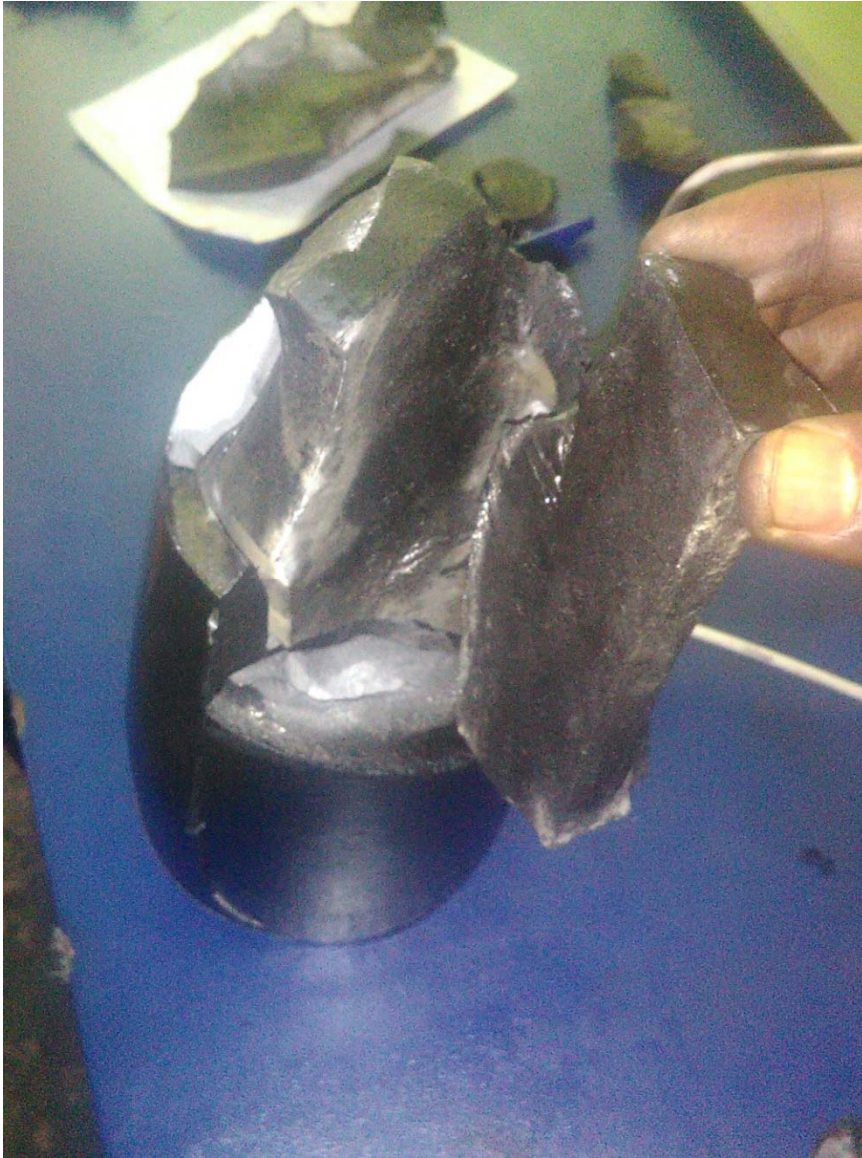
Figure 4-30: different sections of layered surface observed in a vertical position
