**MSC THESIS ON**  
**SMALL SCALE IRRIGATION PROJECT STRUCTURAL FAILURES AND**  
**THEIR MANAGEMENT PROBLEMS RELATED TO WATER LOSS in**  
**Ethiopia.**

**(the case of Jemjem small scale irrigation in upper Awash sub basin)**

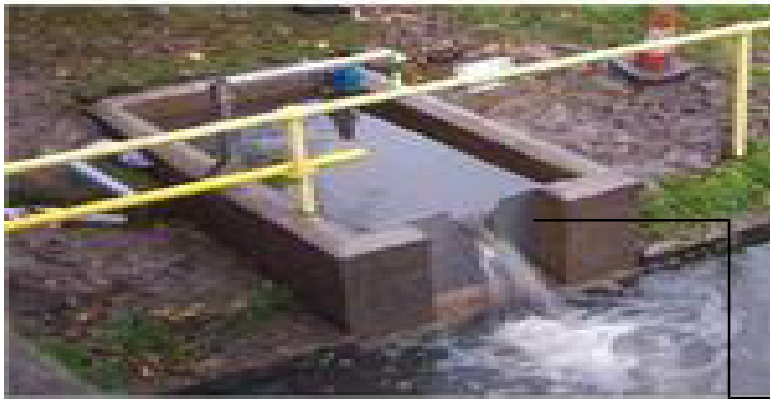
Fig 2.1 V-notch weir

The name for a v notch weir is very descriptive, as you can see in the picture and diagrams in the next couple of sections. A v notch weir is simply a 'v notch' in a plate that is placed so that it obstructs an open channel flow, causing the water to flow over the v notch. It is used to meter flow of water in the channel, by measuring the head of water over the v notch crest. The v notch weir is especially good for measuring a low flow rate, because the flow area decreases rapidly as the head over the v notch gets small. The upper edge of the section is always above the water level, so the channel is always triangular simplifying calculation of the cross-sectional area. Under laboratory conditions, V-notch weirs typically achieve accuracies of 2% to 5%, while field condition accuracies from 5% to 15% may be expected weir equations are discussed in the next two sections. The diagram at the left shows some parameters and terminology used with a sharp crested weir for open channel flow rate measurement.

The head over the weir is shown as H in the diagram; the height of the weir crest is shown as P; and the open channel flow rate or discharge is shown as Q.

The equation recommended by the Bureau of Reclamation in their *Water Measurement Manual*, for use with a fully contracted, 90°, v notch, sharp crested weir with free flow conditions and  $0.2 \text{ ft} \leq H \leq 1.25 \text{ ft}$ , is:

$Q = 2.49H^{2.48}$ , where Q is discharge in cfs and H is head over the weir in ft. The conditions for the v notch weir to be fully contracted are:  $P \geq 2H_{\text{max}}$ ,  $S \geq 2H_{\text{max}}$ . The diagram at the left shows the parameters H, P, θ and S for a v notch weir as used for open channel flow rate measurement.(see fig 2.3 above)

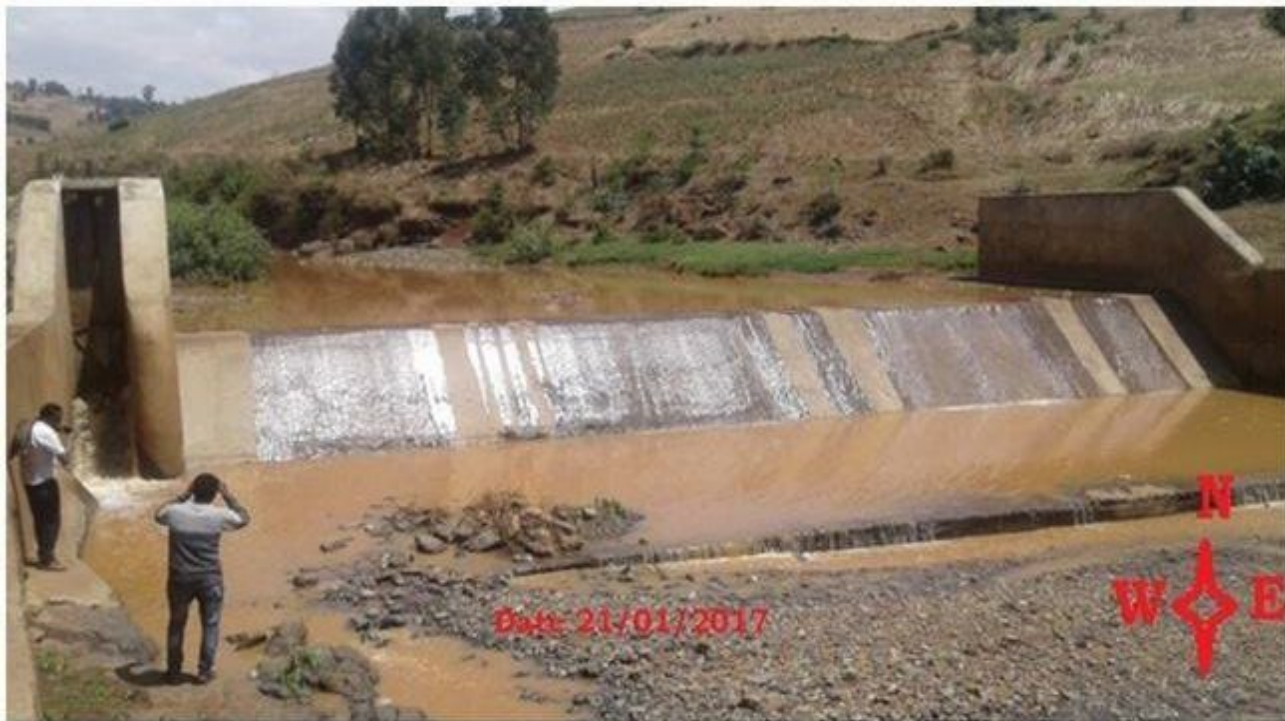
Fig 3.3 Jemjem SSIP weir view from down stream

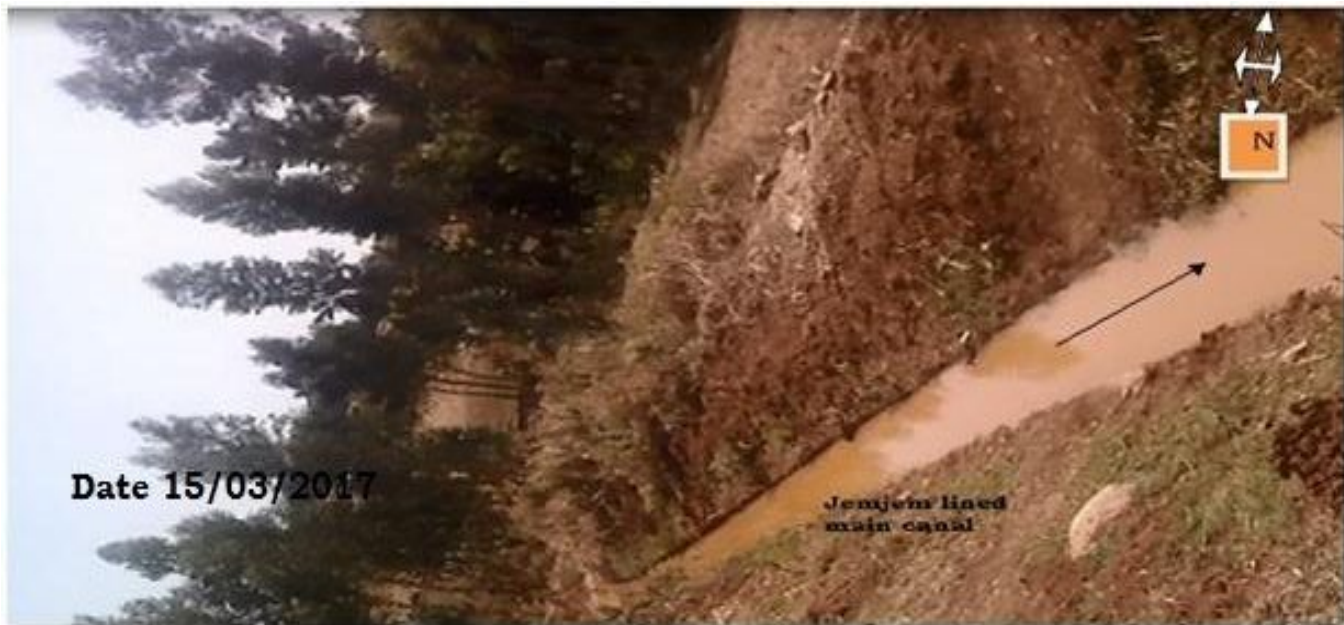
The overall efficiency of the main canal has found to be 34.9% as calculated in the table above. Similarly (**Adam T., 2013**), Hydraulic and Hydrologic Factors on Conveyance Efficiency: Case of Fentale and Tibila Irrigation Schemes was showed that efficiency calculated was 34.4% for Fentale and it was much lower than the standard value 95% taken during the design. But for Tibila case, 89% was obtained since geo-membrane and cement concrete were used on main canal where there was doughty to excessive seepage and as it was at good condition up to date of research.

Figure 4.2 Full canal flows as silt deposited in lined part of the MC

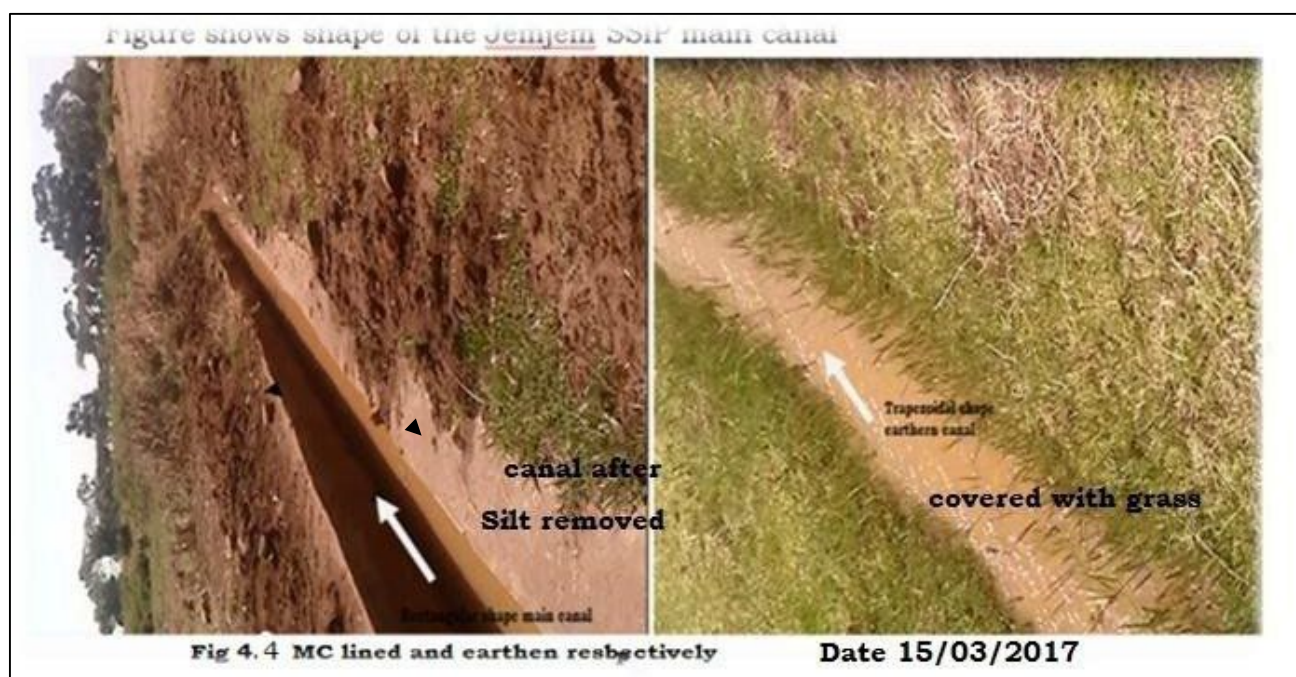
Unreliability of irrigation water supply due to the poorly functioning irrigation infrastructure and due to illegal water users (vandalism) was confirmed by 32.5 % of the irrigation scheme users. Unauthorized water users, seepage, canal over flow and herds of cattle drinking from the canals also contributed to water supply unreliability.

Figure 4.4 Desilted lined MC and earth canal covered with grass

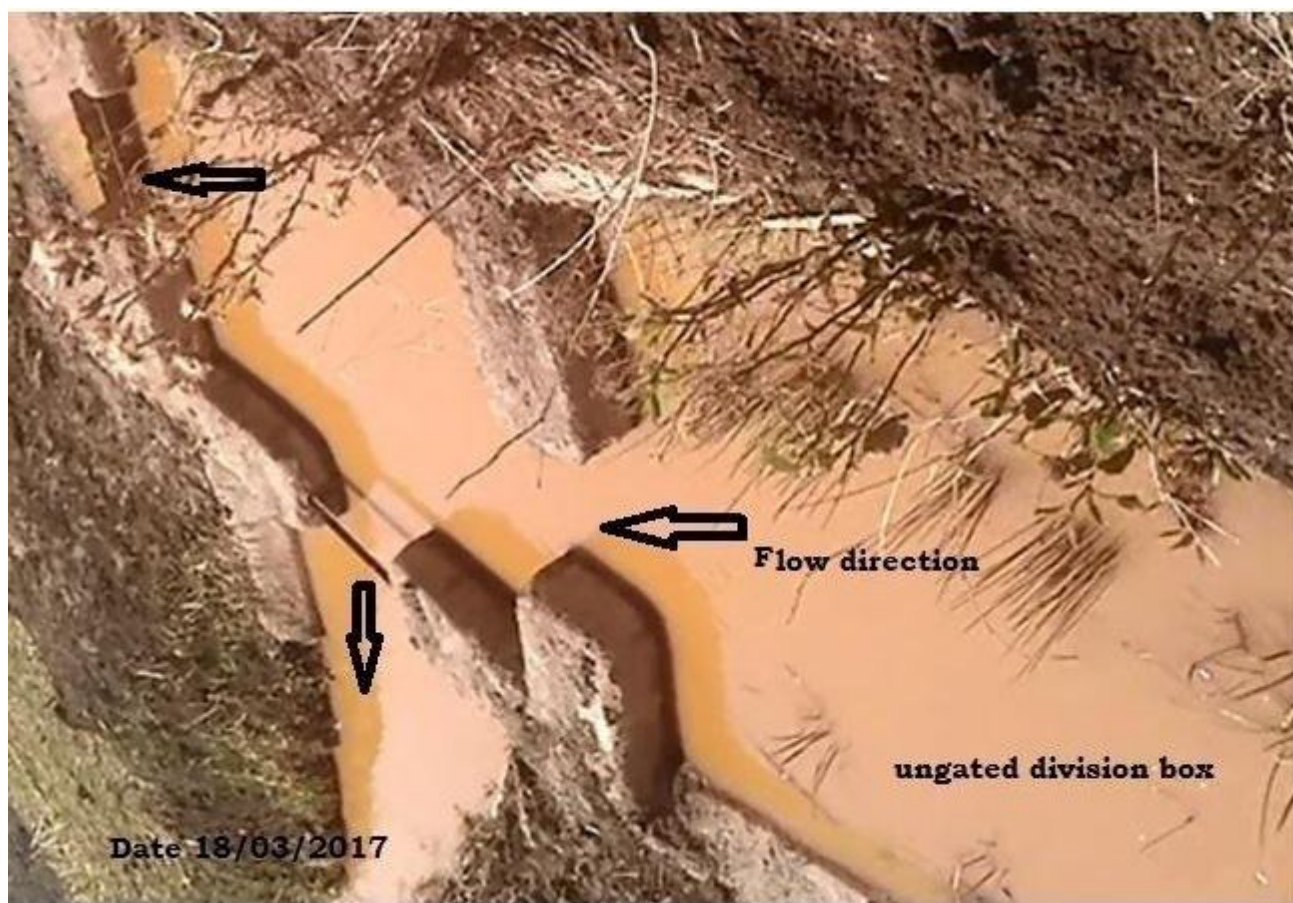
All division boxes and turn outs are without gates. Drops within the functional system were operating good except some cracks seen on some drops and those under nonfunctional system some were buried under the soil. Four aqueducts were constructed of which 2 are within the functional system and the remaining two are within nonfunctional system. One of the aqueducts of non functional part is totally destructed by violator. Generally, the scheme structural performance is found to be **57.07%** as the analysis observed in the table 4.1 above

Figure B-1 Division box without gate or uncontrolled water (Jemjem SSIP)

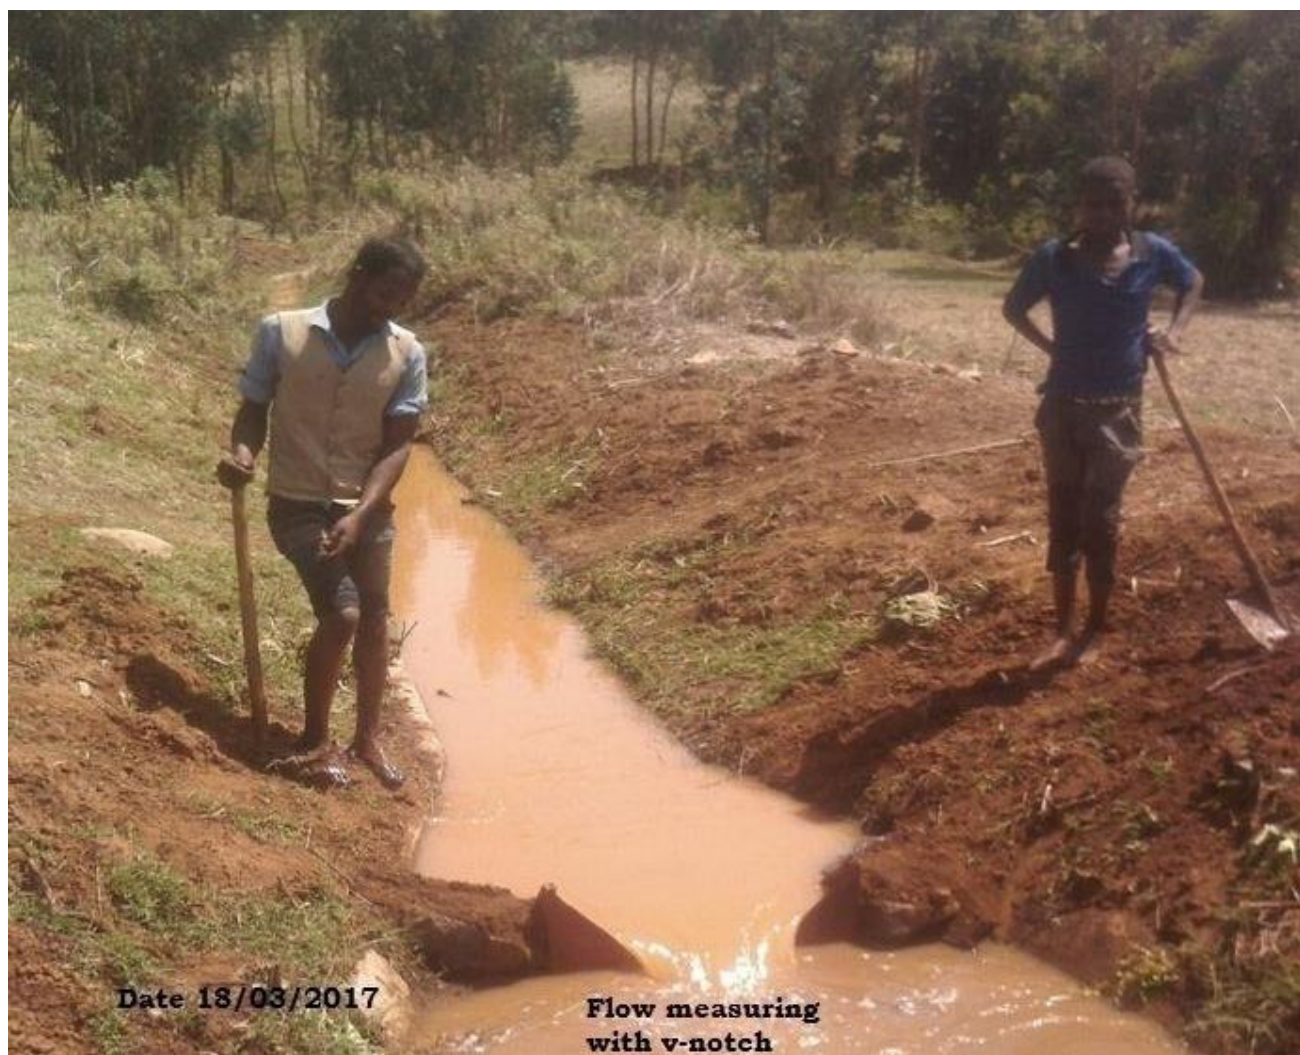
Figure B-2 Main canal discharge measurement of Jemjem SSI

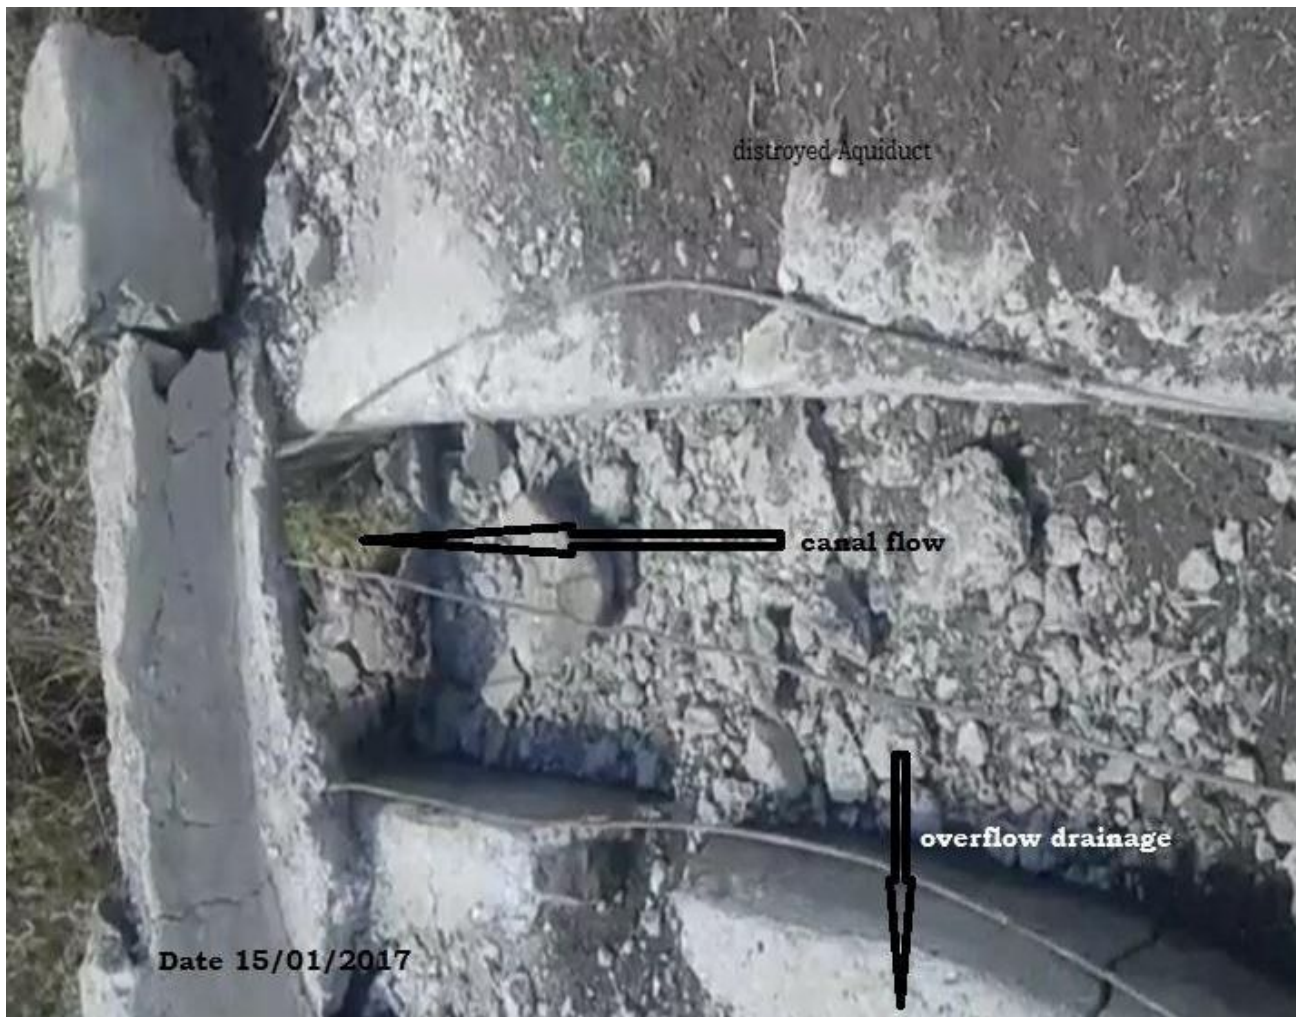
Figure B-4 Veiw of demolished aqueduct in nonfunctional Part of Jemjem SSIP seen during the study

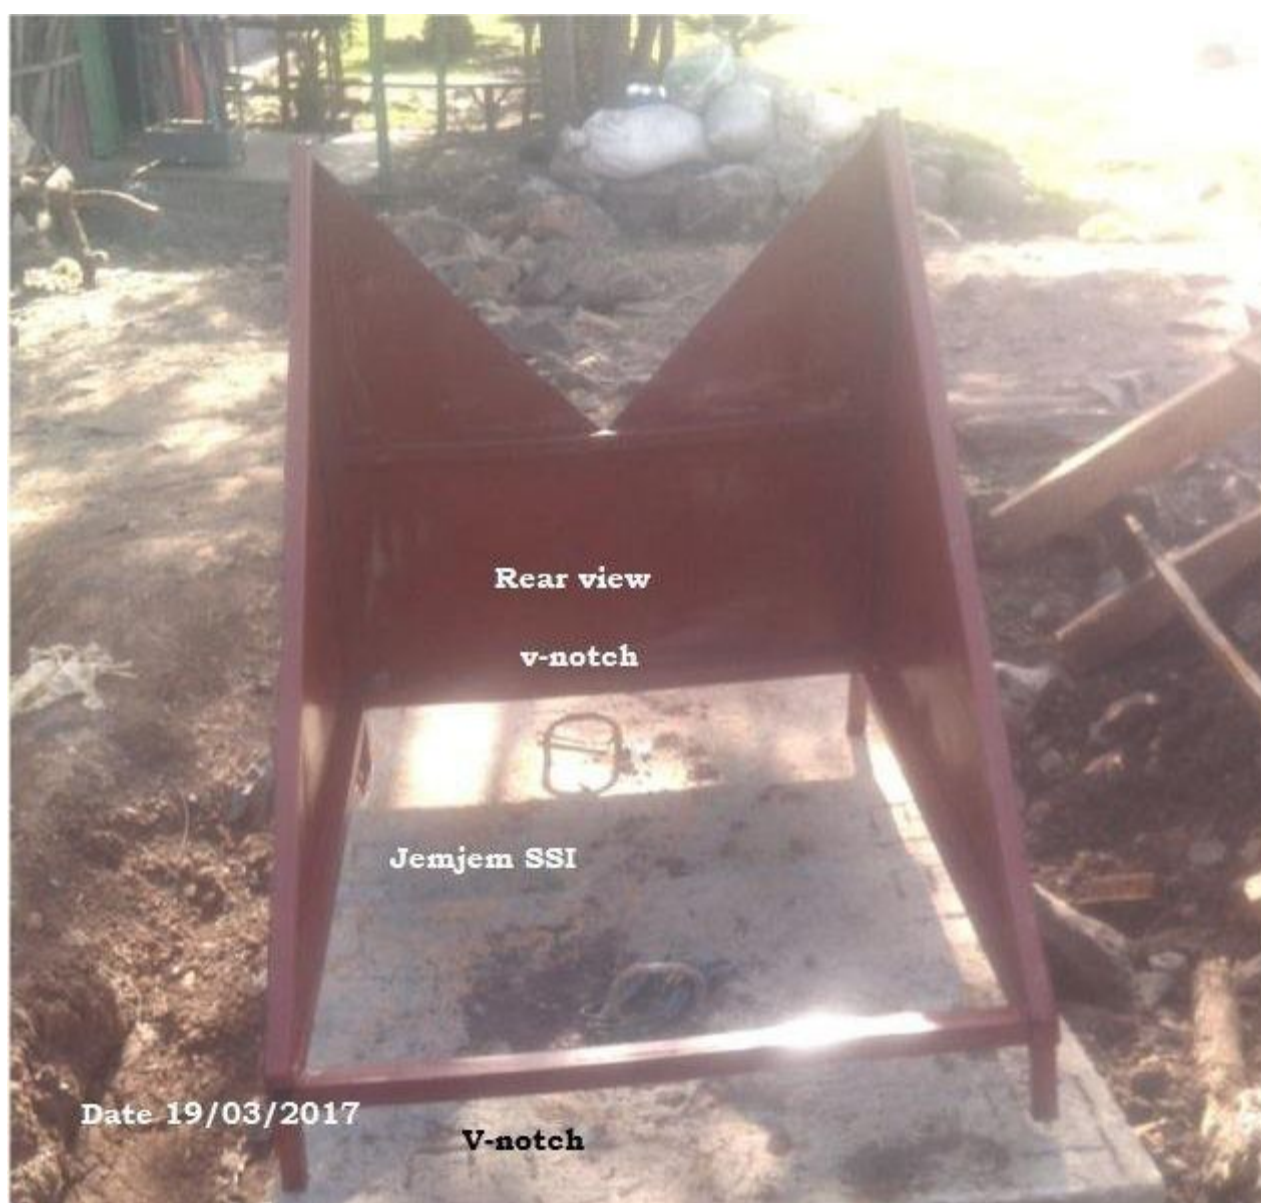
**Figure B-5 90 degree v- notch weir prepared for canal discharge measurement**

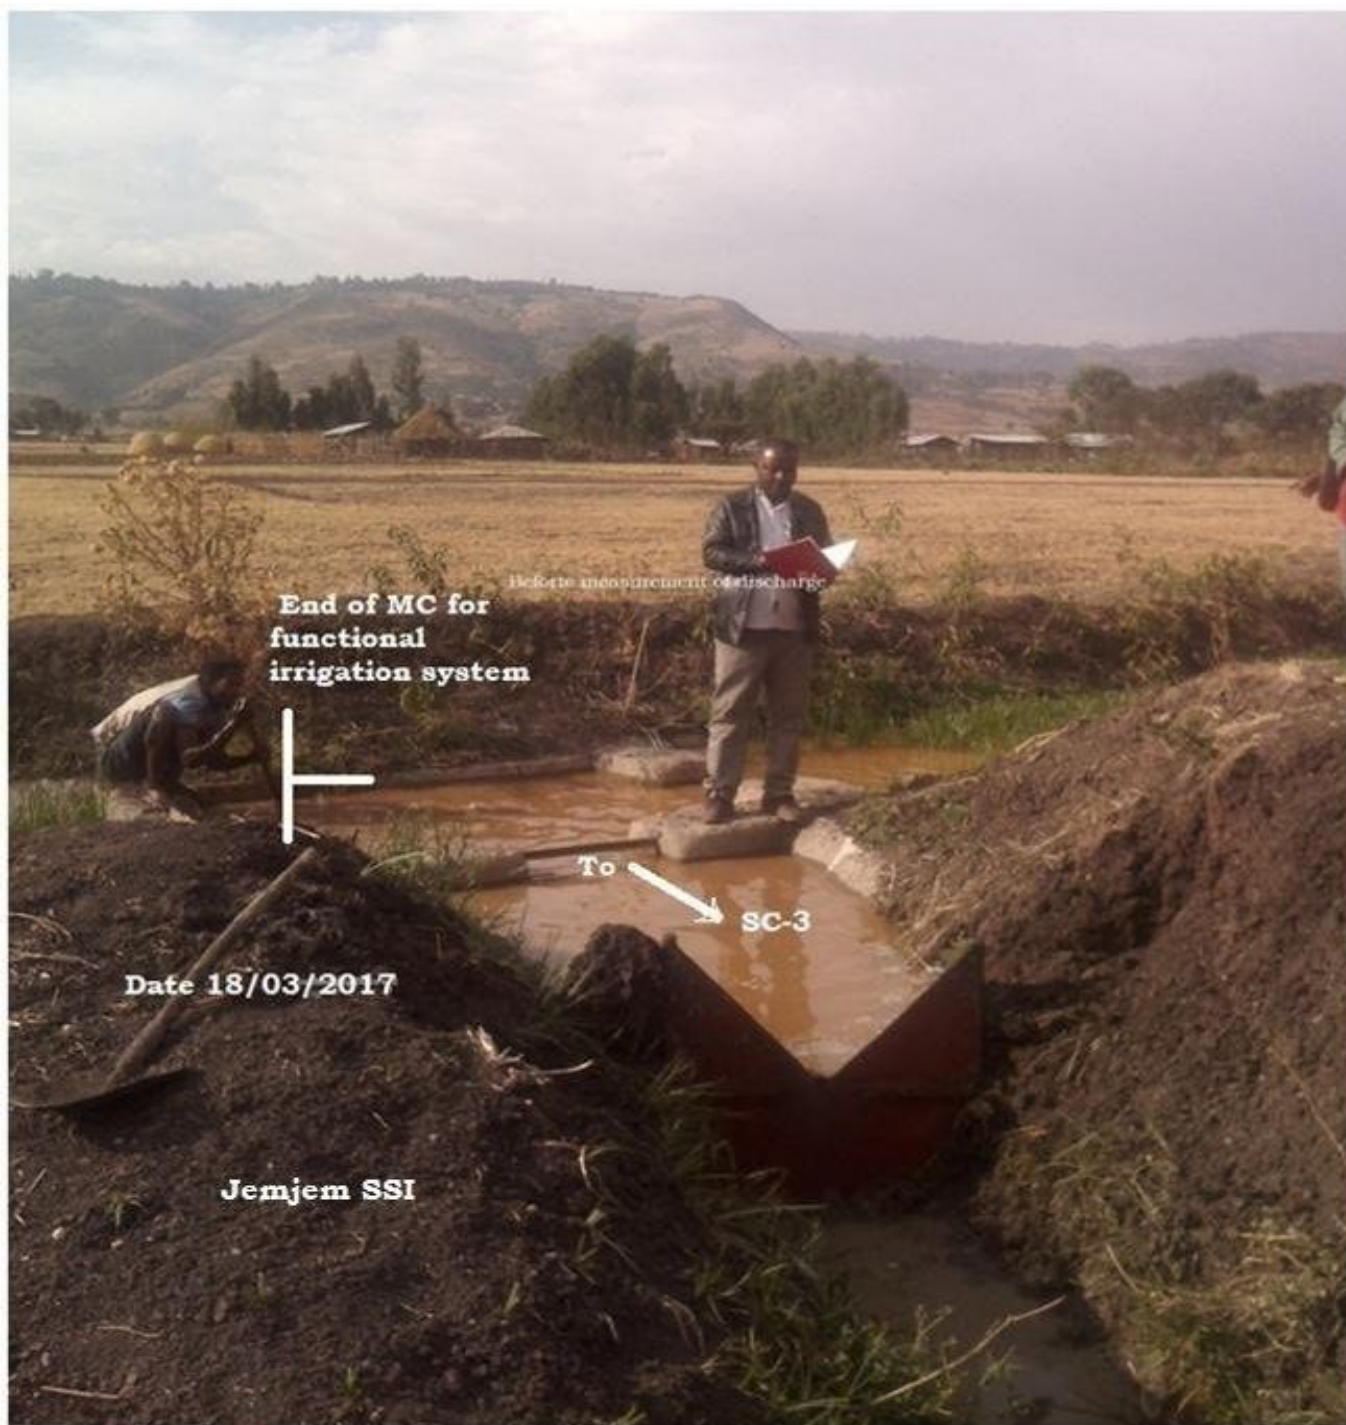
Figure B-6 canal flow before discharging over the weir during the measurement
