THE CONSERVATION STATUS AND CHALLENGES OF GENETEMARYAM ROCK HEWN CHURCH, NORTH WOLLO.

A Thesis Submitted to post Graduate Studies of Addis Ababa University.

June, 2022.

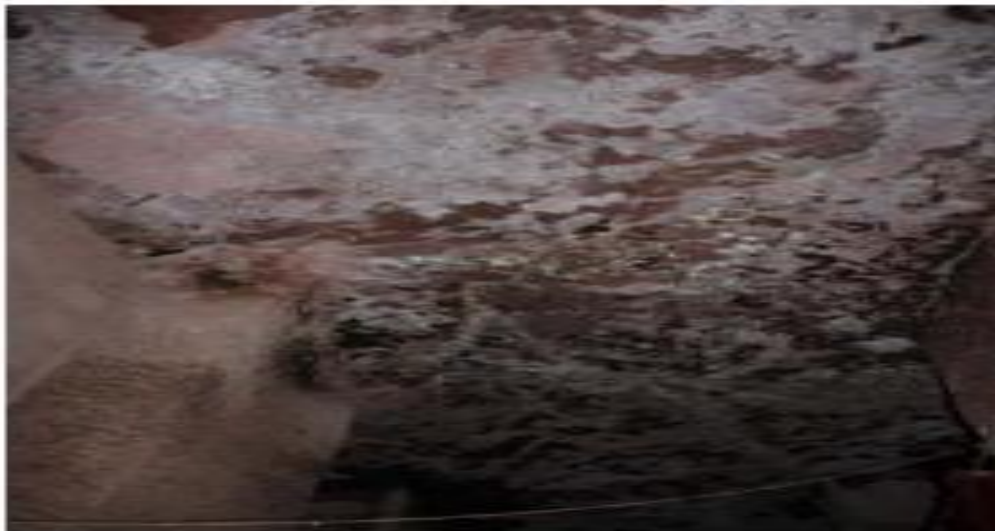
According to ICCROM (1978) it is opinion of authors that the cracking due to whatever cause is of secondary importance to the phenomena associated with water. The presence of basalt is integral in the deterioration, as it forms an impermeable membrane through which water cannot penetrate. A structure built on basalt will absorb the water lying directly on top of basalt. Alternate wetting and drying of the scoria will result in damage of the rock surface. In the case of salts, this resulted in changing the color of the rock in to white natures and finally leads to disintegration of the rock. This is mostly observed in Arbatu Ensesa churches.

Fig 2: The effect of salt in the church of Arbatu Ensesa at its roof. (Source Lasta woreda Culture and Tourism Office.)

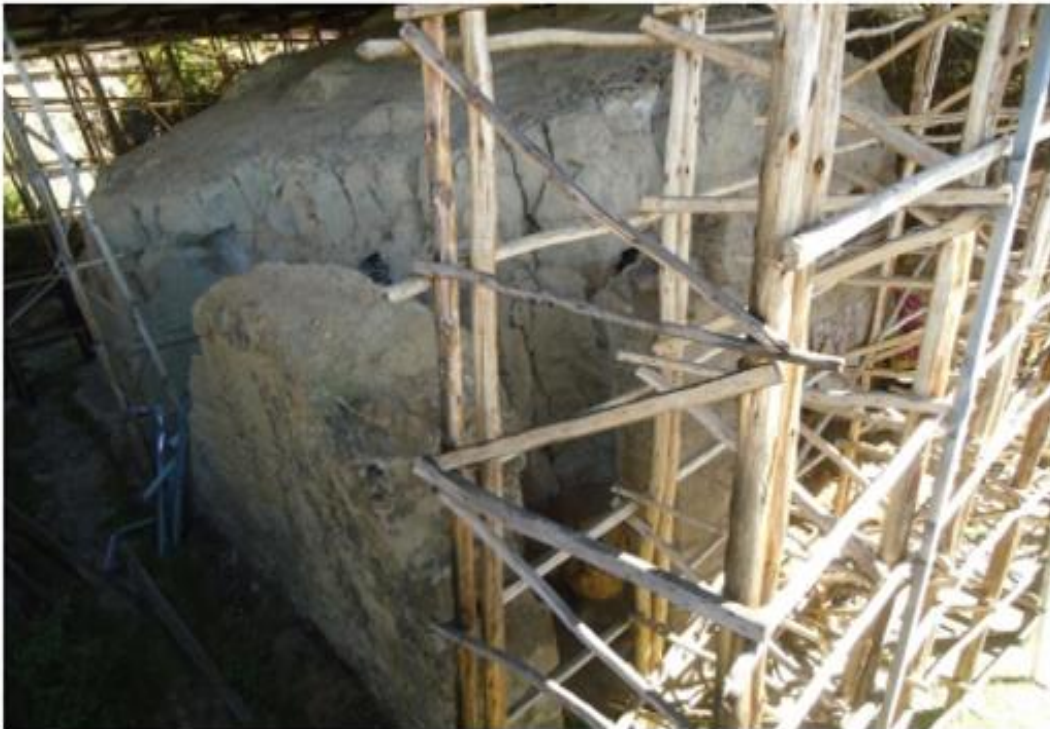
factors accelerating weathering processes. Weathering due to hydration and cyclic hot and cold air temperature leads to easy decomposition of feldspar mineral constituents. As a result wall and roofs elements of the churches have started to pill off since long period of time before present. Together with this biological colonization play a relevant role in churches like Kenkenit Michael and other churches too. According to our forefather, In Kenkenit Mikael church a big olive tree were grow on its roof of this church, they consider the tree as like parts of the church and leave the tree for long years which finally resulted in partial collapse of the church.

Fig.3. Partial collapse of the church of kenkenit Mikael due to big tree grow on its roof. (Source Lasta culture and tourism office)

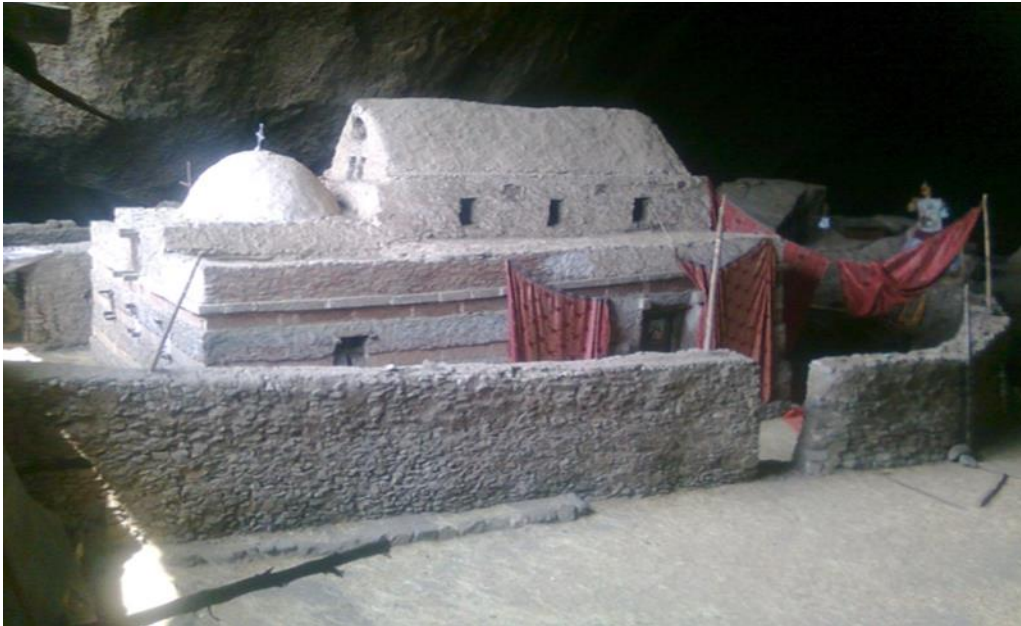
Figure.4: The in accessible Cave built up churches of Emekina Medhanialem (lasta culture and tourism office.)

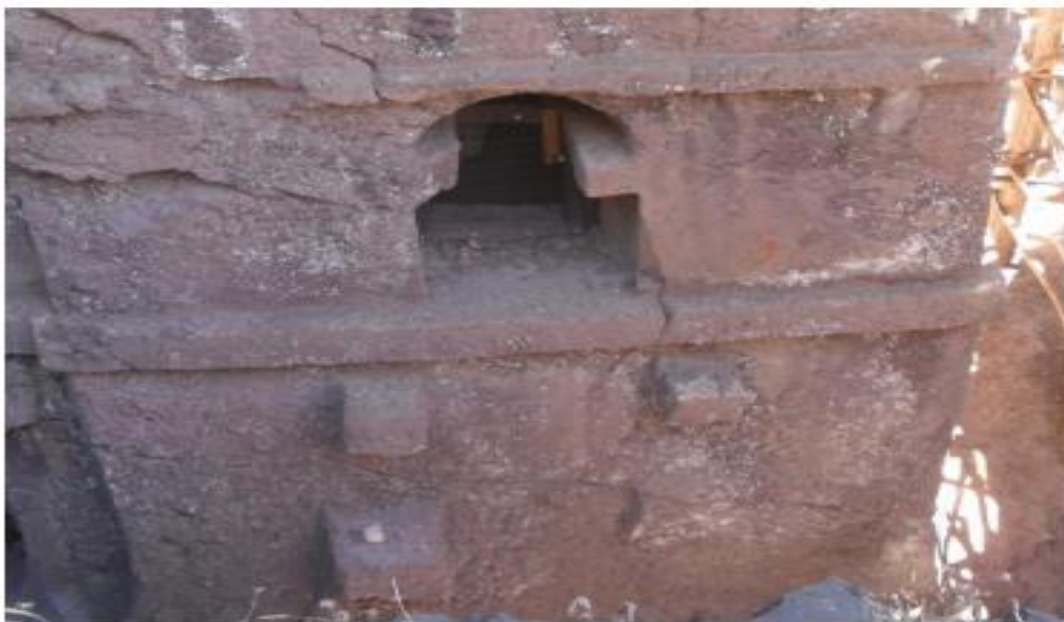
According to (Delmonco et al 2010) pedogenesis resulted from raindrops on roof of churches is dominant cause of degradation of roofs of churches like Arbatu Ensesa churches in lasta. The same process coupled with biological factors resulted deterioration of roof and other parts of the church. Soil formed through such process is evident on the roof of this church and it provided favorable condition for growth of plants. Scientific methods are not used to remove plants grown on churches.

Figure 5: Highly degraded churches of Arbatu Ensesa (Source Lasta culture and Tourism office)

Churches like Arbatu Ensesa and Sarzina Mikael are highly affected from flood and raindrops seeping through its roof and walls of the churches. In all rock churches of Lasta, water caused deterioration is critical. In this regard, Sarzna Mikael needs special care and treatment. As indicated above the church had gone through maintenances. But it remained under critical condition as seeping through the roof is causing destruction of pillars (inside and outside) of the church. The current look of eastern façade and part of the southern side of the church are result of the previous renewal. Degraded original pillar from the inside and outside of the church seems not able to support the thick roof above it much longer. Soils formed on the roof of the church are indicative of seriousness of deterioration process. Cracks on the walls of the church are also sever compared to other churches. In this church, Traces left by rain water on roof, ceiling and walls of the church indicate the porosity nature of the rock and high concentration of salt.

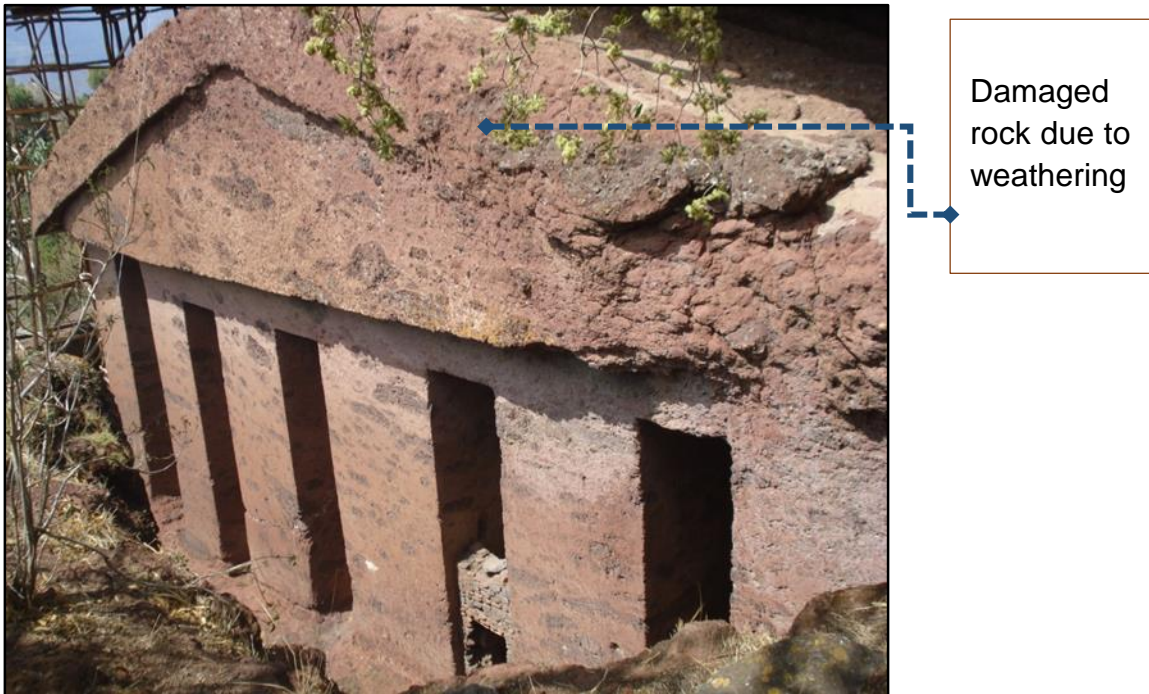
The main damage phenomenon for this was rainfall followed by wind erosion, biological growth mainly due to lichens and algae and salt decay connected with moisture are another factors. These deterioration mechanisms will led if not proper measure take to its final collapse. The effects of temperature changes on the surface of the rock is another mechanism for stone deterioration. When the surface of the rock is overheated by the sun, and then cooled down by a sudden shower, the rock undergoes become weak and weak. Which produces superficial scaling and exfoliation over time. They are all influenced by the mode of weathering of their environment. (Ruedrich et al., 2011; Sigismund and Snethlage, 2014).

Figure 6: Damage Rock Due To Weathering (source the author)

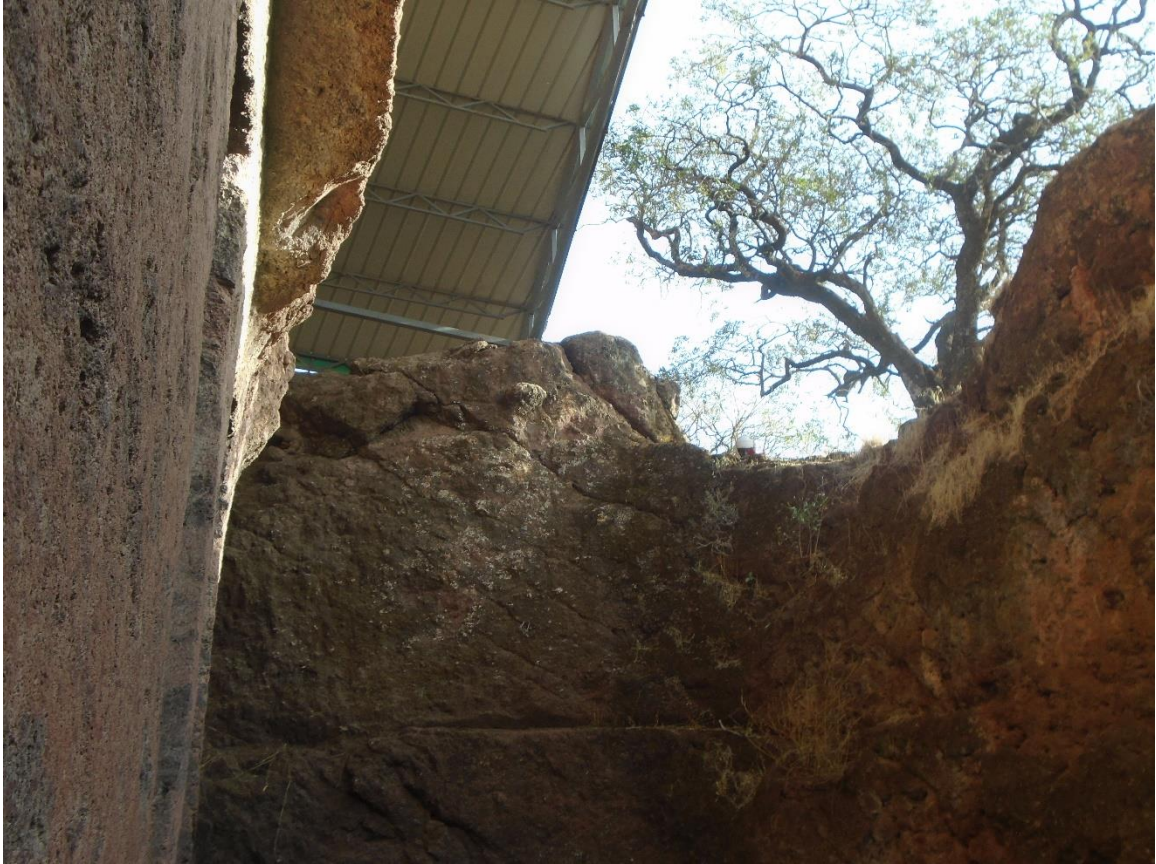
A massive growth of lichens, mosses, algae and tree has been observed in the church mostly at its courtyard and the church Betlehem. Mosses appear to do the most harm and need wet or damp areas in which to spread. The main cause for the runaway growth of mosses is the water that accumulates during the rainy season and through capillary action invades the porous rock, facilitating its structural deterioration from within and permitting mosses to cover the surface. Ethiopian authorities like the ARCCH, have been investigating the possibility of using herbicides to control the mosses, but will not use them until environmental impact studies have been carried out. The growth of roots and branches of the plants on and around the church can crackdown, break and loosen stones and large fragments of the rock due to natural factors. Once plant grow on the rock it will deepen its root inside the rock which finally resulted in its total or partial collapse. Beside to their direct impacts, the plants (the trees and shrubs) grown in and around the monuments allow infestation of animals such as rodents that cause mechanical damages while they dig the monumental grounds to make their habitats within the structures.

Figure 7, the growth of plants and trees in the court yard of the church, (source the author)

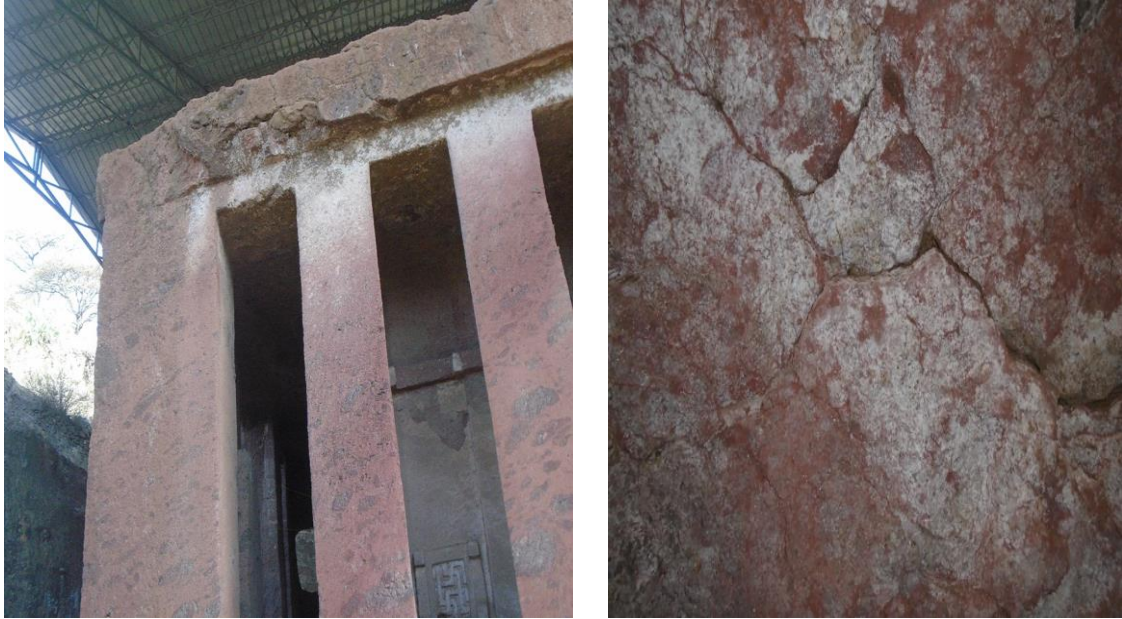
The salts, as discussed earlier, constitute probably the gravest threat to the integrity of the rock. The most damaged areas all show the presence of hygroscopic salts, which-in combination with humidity- are known to be one of the most destructive agents in weathering and breaking down of stone. The salt change the color of the rock in to white nature. Finally it will lead the rock to lose its original design and shape. The effect of salting can be easily shown in the southern parts of the roof of the church.

Figure 8: The Effect of Salt in Genetemaryam Church in its Betelhem and southern faced of the church. (Source the author)

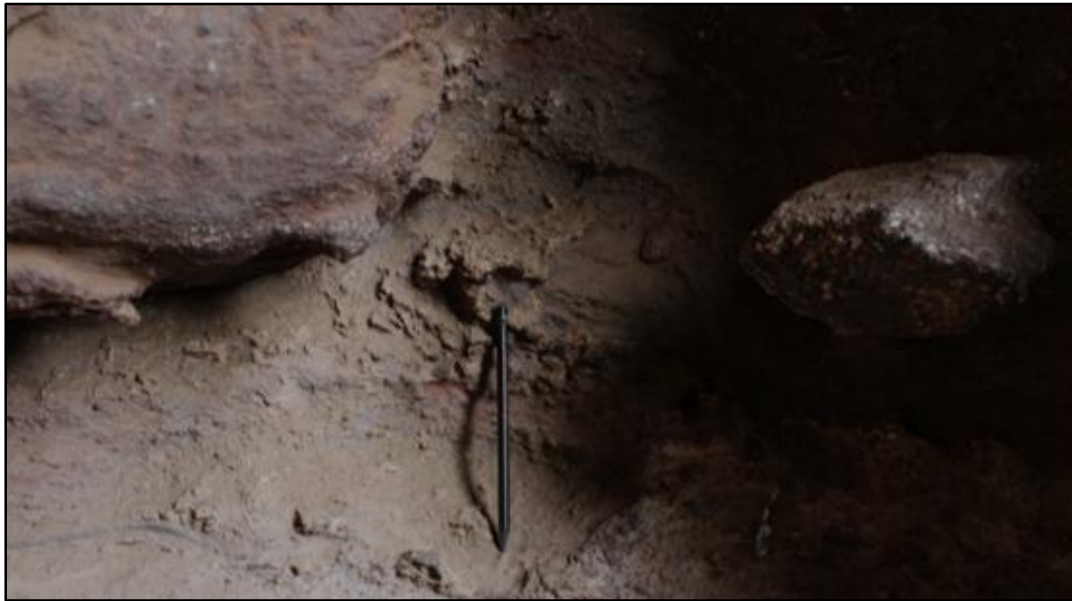
Figure 9: Eroded Part of the church due To the Weathering Process (source the author)

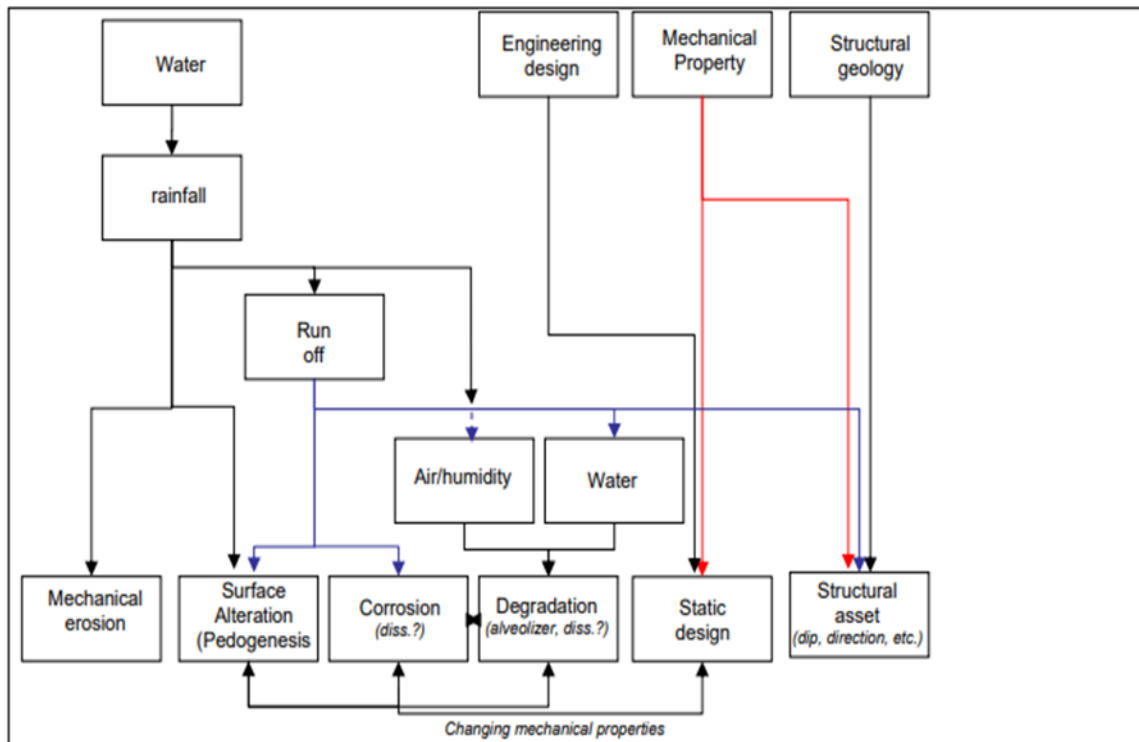
Several combined reasons that cause physical and chemical decay in the hewn rock, and their interrelations have been identified: characteristics of the basalt and tuff, evaporation of salts, decomposition of the rock, heavy weight of hewn roofs versus a lighter bearing capacity of the walls, dilatation of the large monolithic structures, mechanical erosion produced by rain drops, tuff stone alteration due to climatic factors, discontinuities in the rock geological formation with direction and dip capable to generate a sliding, etc.(Leisen 2008). Further studies should be undertaken to reveal the progress in understanding the precise causes of decay, but still need to be deepened and improved. Tests still need to be done systematically to fully analyze the decay related to the geological, geophysical and chemical properties of the hewn rock. In addition, the humidity rates inside the churches should be analyzed and monitored.

Figure 10: Chemical and Mechanical Degradation Phenomenon of Rock Churches and Possible Causes. (Source Claudio Margottini.)

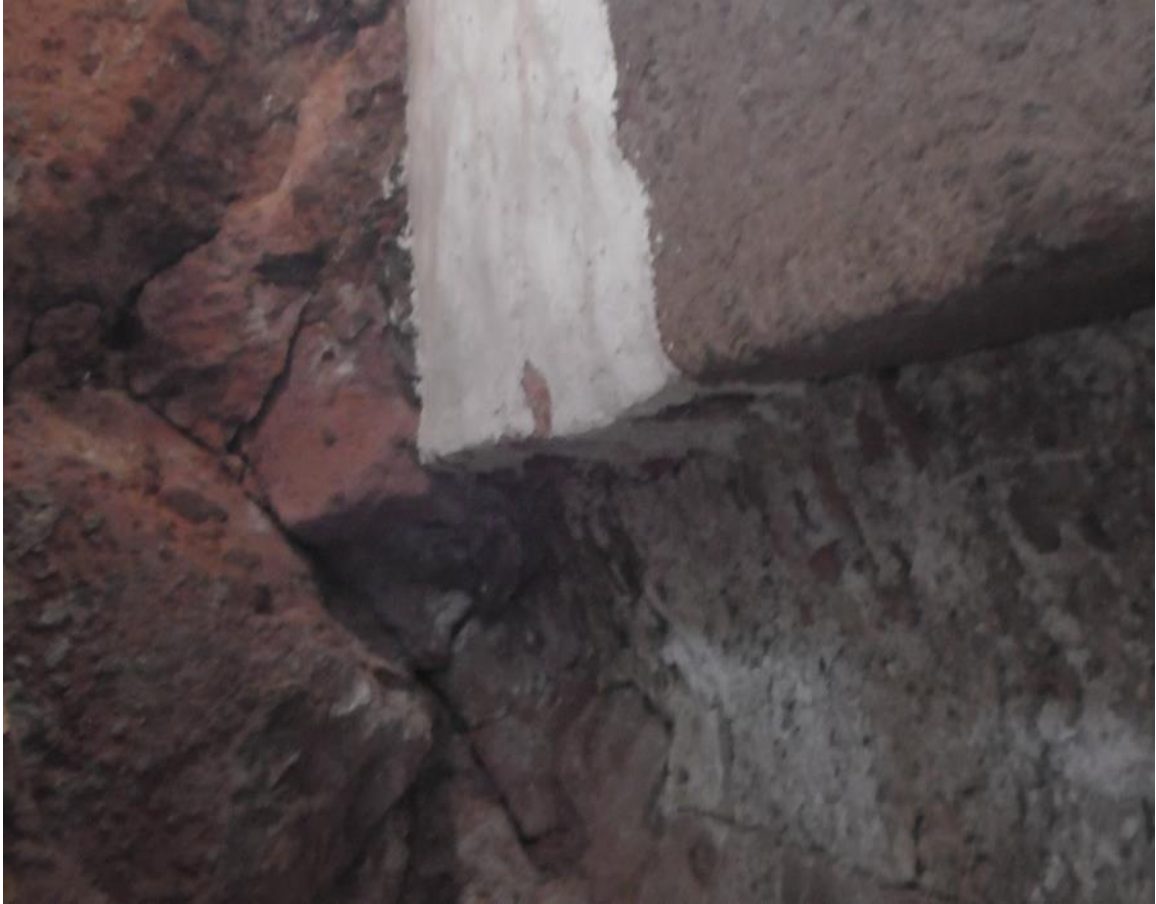
Based on my observation, the most critical structural problems have been identified in this church where an imminent risk of collapse is possible in the near future. Immediate studies and remedial measures need to be undertaken especially at its eastern part in the corner of the pillars and the roof of the church. The sliding problem seems too far, but necessitates further monitoring and, if needed, consolidation measures especially inside the pillar and of the church. In Genetemaryam, structural investigation is necessary to determine if the past structural failures have stabilized or are still active. To define the appropriate solutions, detailed studies of the structural behavior need to be undertaken and a monitoring system installed in the pillars and roof part, also systematic structural assessment should be done in the holy of holies.

Figure 11, Crack at its roof part of the church, (source the author)

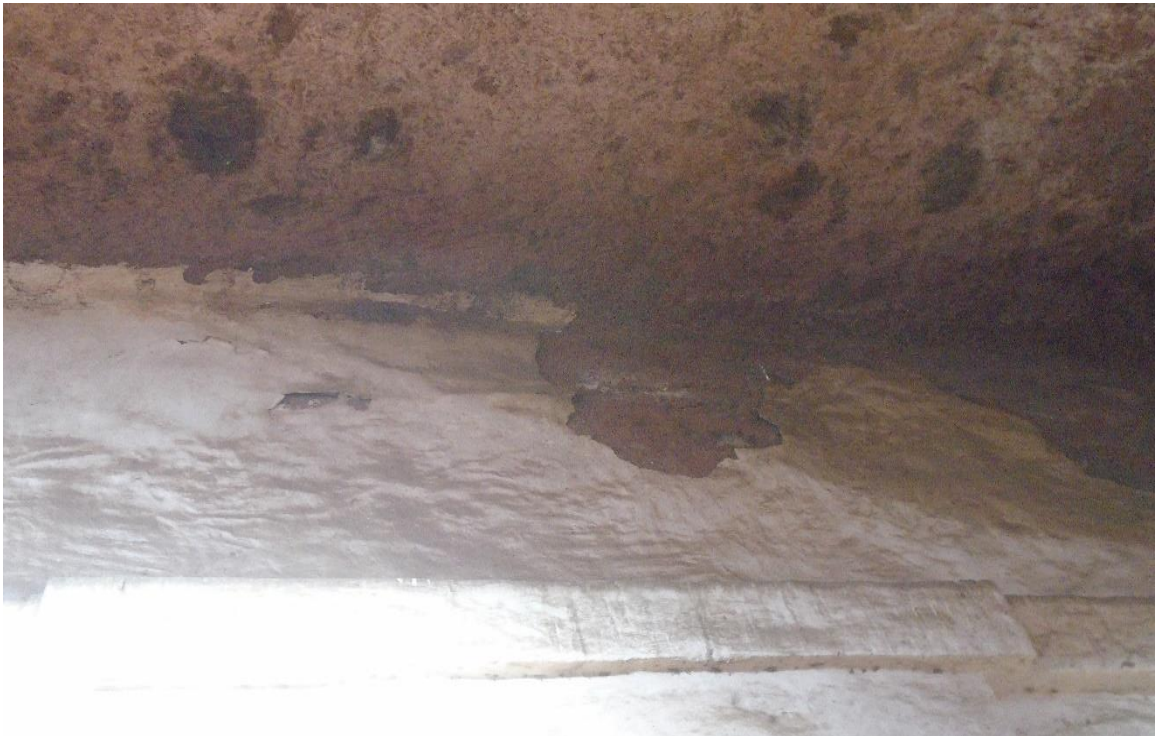
features are hardly recognizable. These elements should be surveyed and restored following historical research, a detailed survey and recording, and an analysis of their decay pattern in order to define a restoration action plan. Nevertheless, conservation studies and works will concern the protection of paintings and sculptures from already identified decay factors. Marya j. and BobF. (2015)

Figure, 12. The plaster are peeled off in many parts inside the church (Source the author)

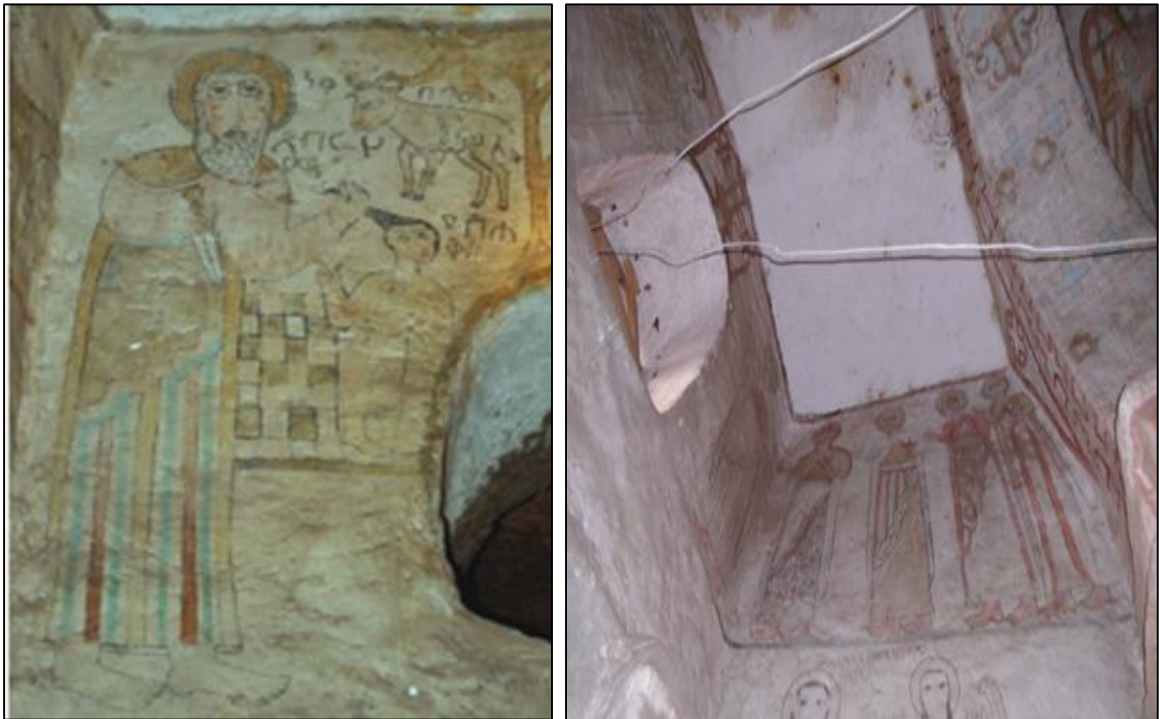
unconsciously destroy paintings. Paintings on columns and pilasters of churches mostly are deteriorated this way. Church materials like “drum and praying stick”, electric installation, chairs and other materials are placed near columns play the largest part of destruction as human cause of destruction in many churches. Such materials deteriorate paintings when they are moved from place to place. On the other hand, deteriorated plaster on a column in this rock hewn church are the water seeping through roof and walls of buildings take the largest part as natural cause of destruction especially before the construction of the shelter. Plaster layers are continuously flicking off from walls and ceiling of the churches as a result of water agency as a factor of deterioration. (Mariam. and Bob,F.(2015.)

Figure 13: Damage of Wall Painting in the Church (Source the author.)

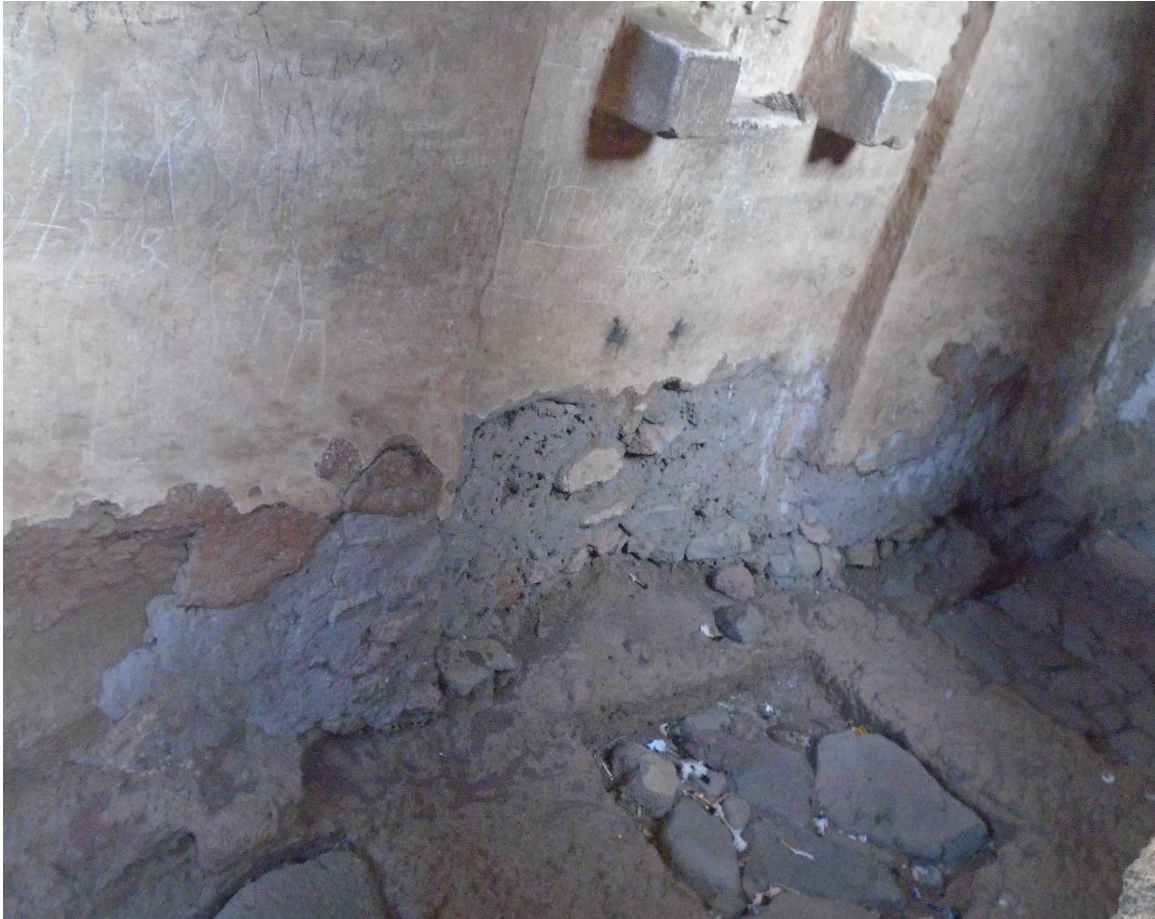
Conservation is a problem if we are failing to do it properly. In one way or another we can easily see this effect in most churches of the country. There is a shortage of well trained and experienced expertise in the field of conservation with in the country. It also needs great skills in the field with adequate experiences and if we are doing faults in conservation it is dangerous for the heritages; because heritages are irreplaceable human resources once we have lost them. There should not be trial and error on heritages during conservation work. If possible it should be well planned and executed with the principle of reversibility.

Figure14, Improper Conservation Work at the wall of the Church. (Source the author.)

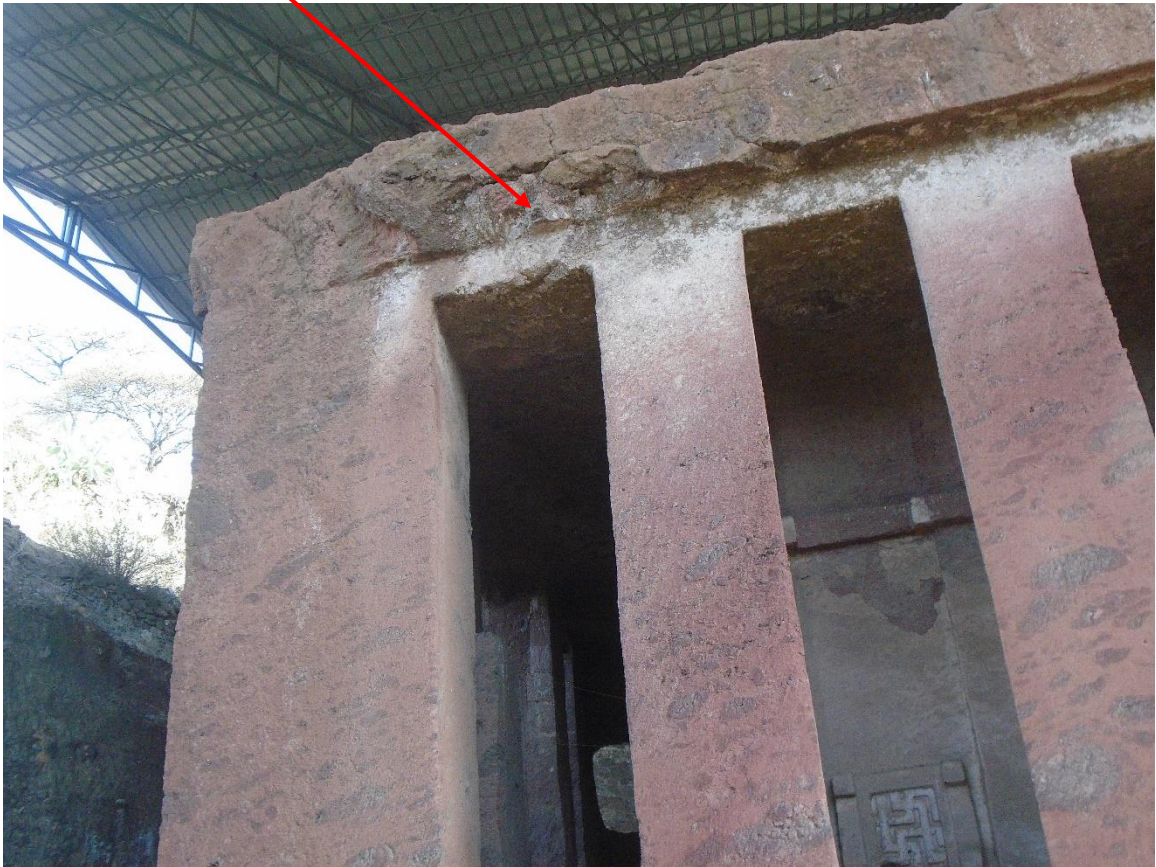
Figure16, Damaged part of the south faced of the church (source the author.)

Step one was to clean surfaces and cracks. Syringes and pipes were used to flush out cracks, removing accumulated dirt and organic matter.

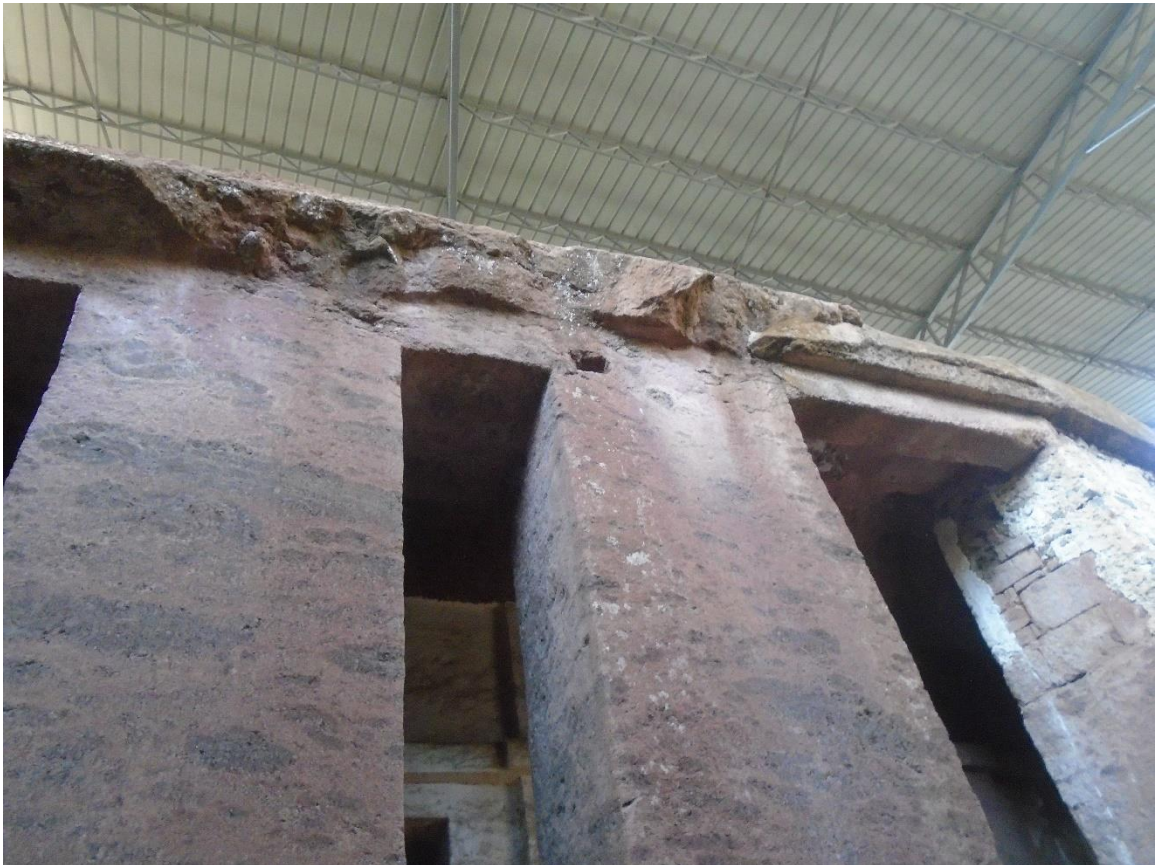
Figure 17, Damage of the rock at its northern faced of the church (source the author)

This include a series of interventions with the aim to re-building the damage part on the roof surface and due to the natural ageing of materials, absence of maintenance and mechanical stress. These interventions regard both historical valence of the monument and the restitution of the loss structural efficiency. The reproduction of missing parts is carried out with solutions which allow to discriminate the existing parts from the additions (for example, employment of compatible material but with different color or manufacturing (Studio croci 2014.)

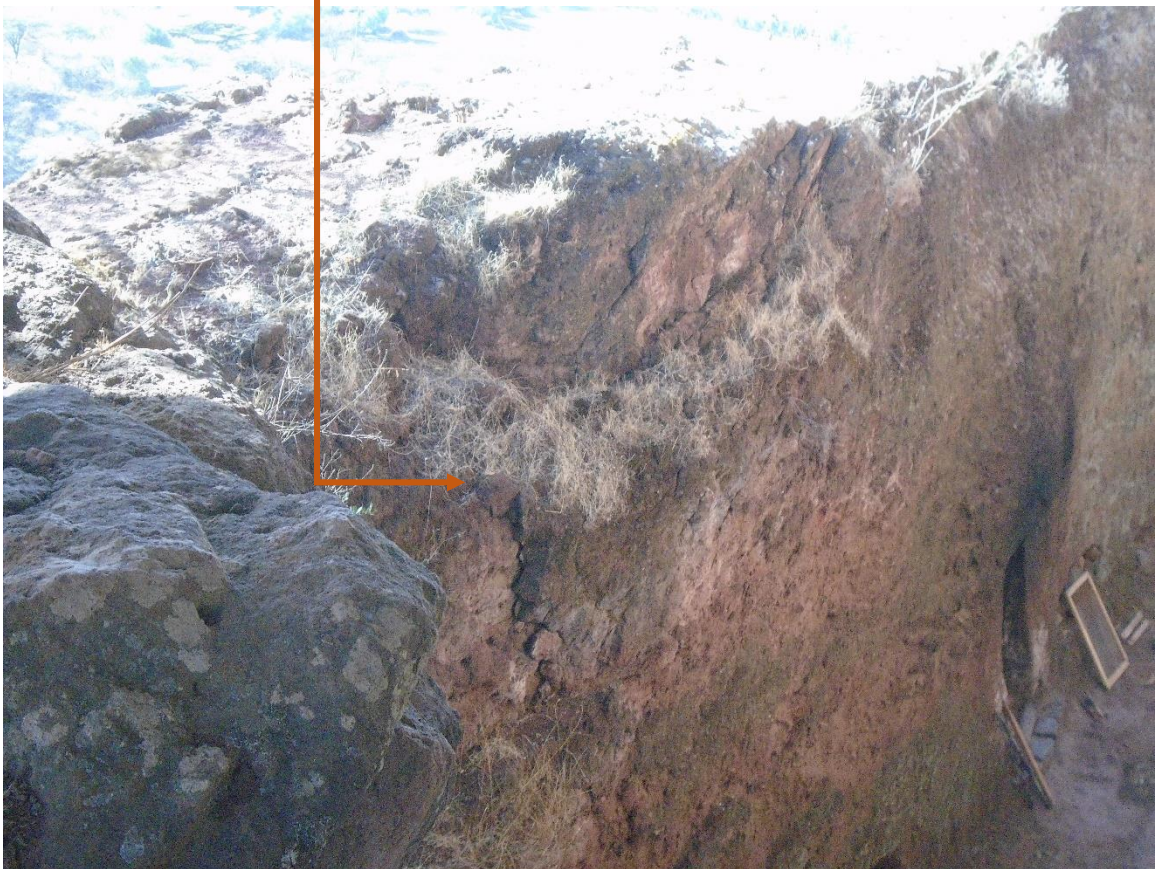
Damaged Roof of the church Betelhem small plants are grow on it and start to disintegrate due to the rain and it needs a shelter.

Figure18, The roof part of the church Betelhem (source the author.)

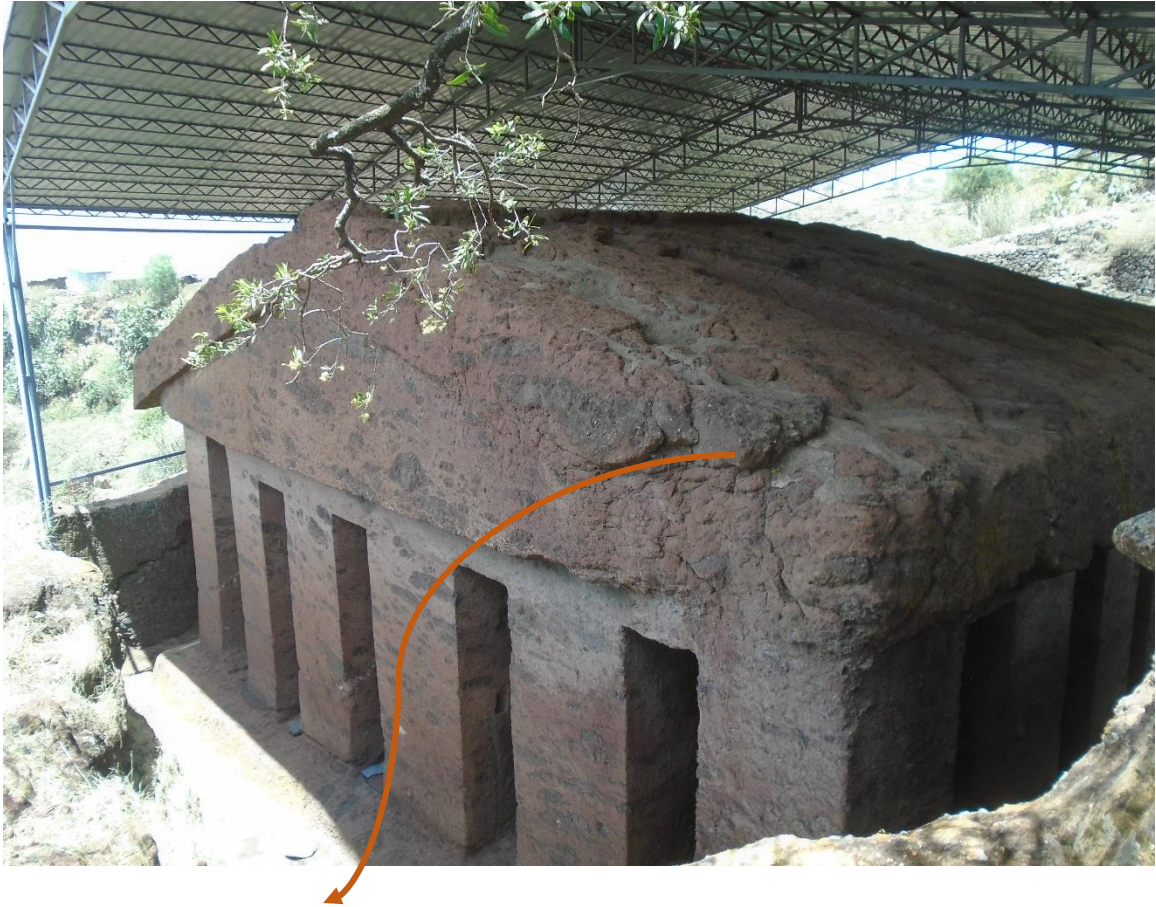
Damaged part of the roof surface of the church before the shelter which needs consolidation work.

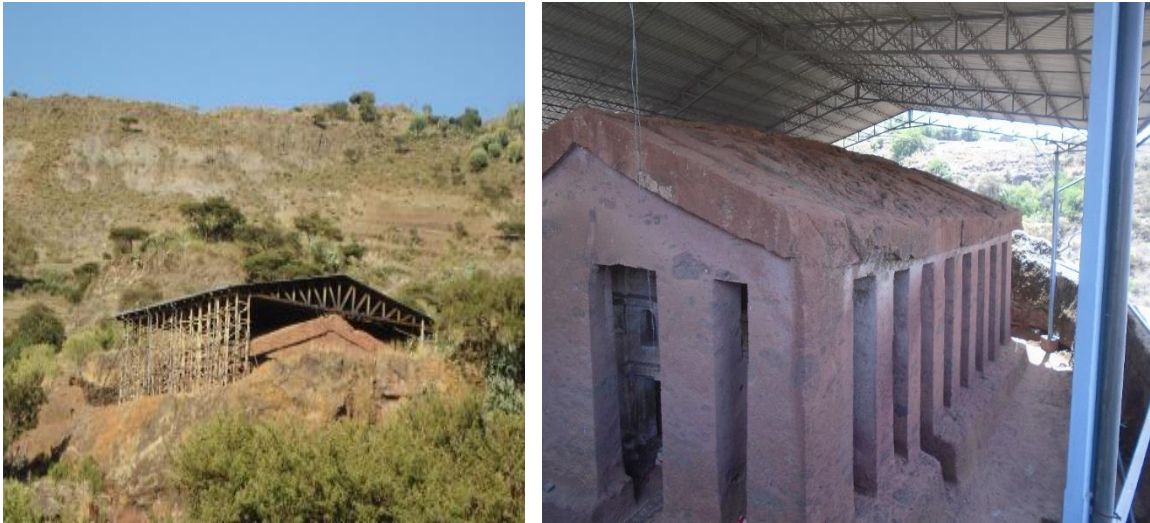
Since its carving, it has been exposed to multiple natural and manmade factors of deteriorations. As a result the mother rock (the monolithic) has degraded a lot in the course of the time. Conservation were a recent phenomenon in Ethiopia. According to the church father, an initial attempt in this church were made by Sandro Angelini before 60 years ago when he was restoring the rock hewn church of Lalibela. It was a partial solution in masonry with white cement applied on the roof and pillars of the church just to its western side. After that a wooden shelter have been constructed several times by the CRCCH (now ARCCH) in collaboration with the local culture and tourism office. Though similar temporary shelter have been constructed recently it could be said that the practice of conservation is still at its infancy.

Figure 20, previous restoration work in Genet Maryam church. (Source the Author)

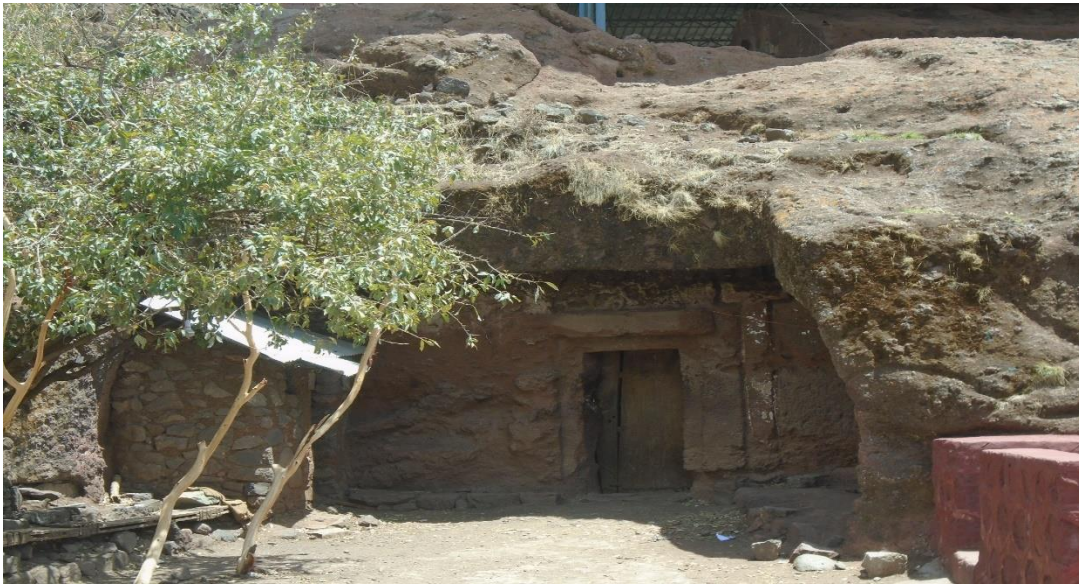
Genetemaryam is one of the few monolithic rock hewn churches in Ethiopia. The church has 24 outside and 4 internal pillars, 3 doors and 24 windows of different shapes. It is very similar with Bete Medhanialem church by its structure and with Betemaryam by its wall painting. Entry to the church courtyard is through a breach in the south wall of the trench, which has a gate house. (maria,J. and Bob,F).

Figure 22, underneath entrance to the church. (Source the author.)

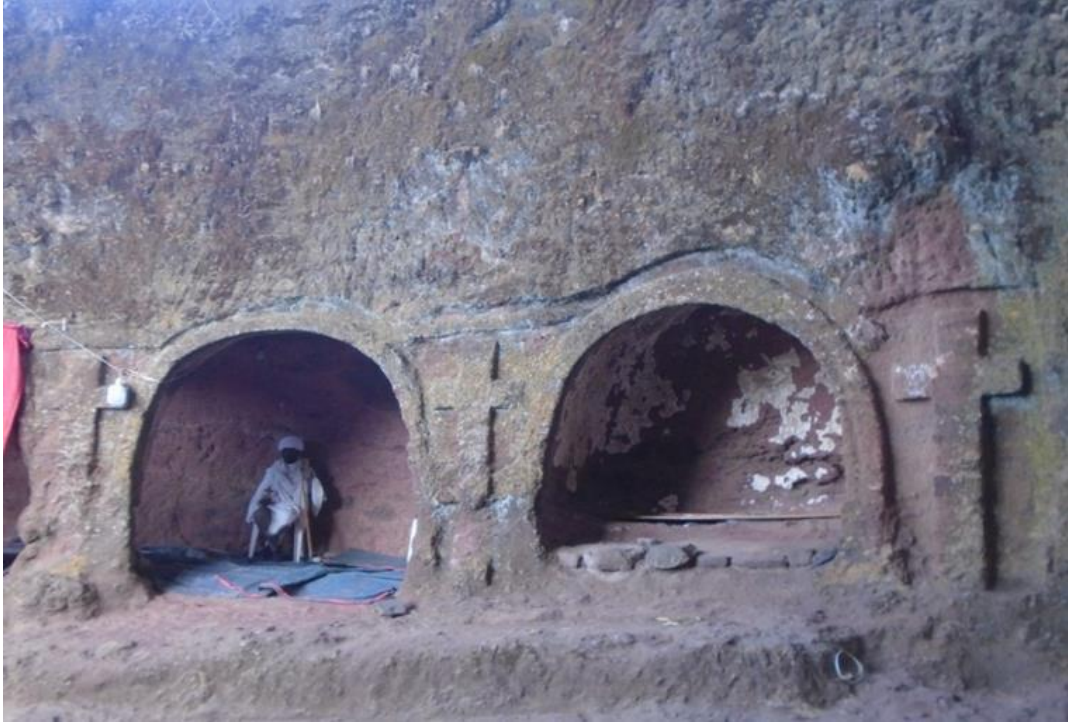
In the trench west wall, two open rooms have been excavated, the larger having a central rock hewn column. If you visit the church fairly early in the morning, you will be able to see and hear the priests beating their drums and shaking their sistra in these rooms.

Figure 23, Qinemahlet outside the church, (Source the author.)

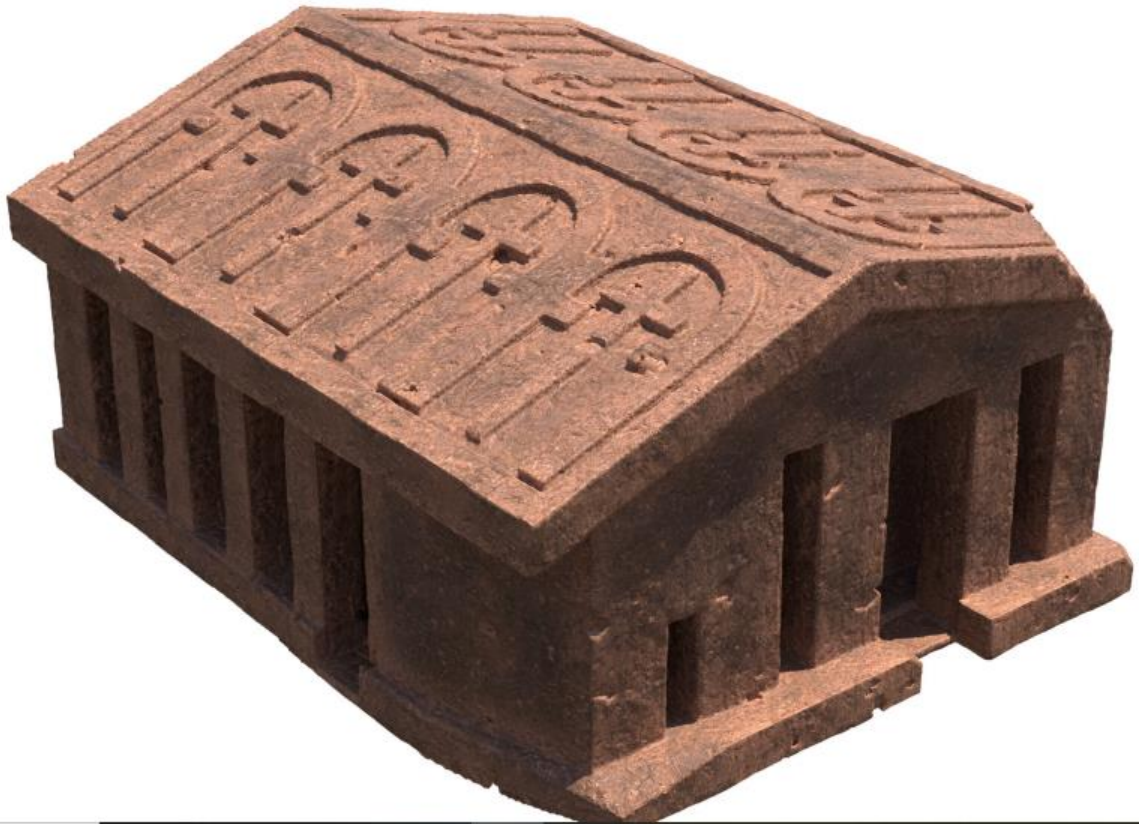
The exterior dimensions of the church are: 20 *meters* long by 16*metres* wide and 11 meters high. It has a slightly truncated saddle back roof and colonnade of rectangular, rock- hewn pillars, which run around all four walls, evocative of Greek temple. Each slope of the roof has been carved with four arches resting on corbelled capitals at the top of pillars; within each arch there are carved crosses. (Maria j. and BobF.2015).

Figure24, Isometric 3d render (source Betsegaw Ayenew.)

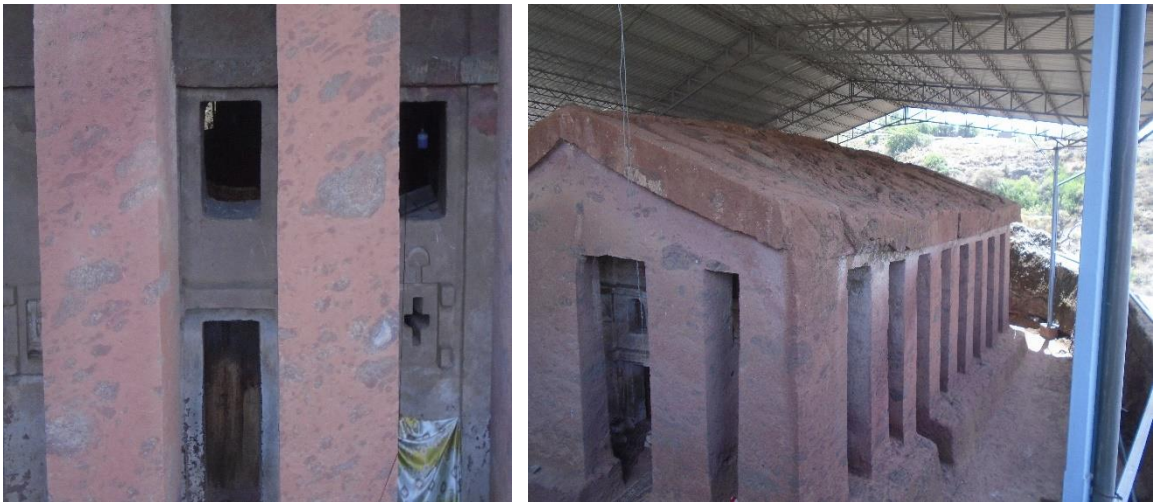
Figure.27. Windows, doors and pillars of the church, (Source the author.)

The interior is of the basilica type with a nave and two aisles separated by two rows of four rectangular columns. It is four bays deep and has a sanctuary at its eastern end.

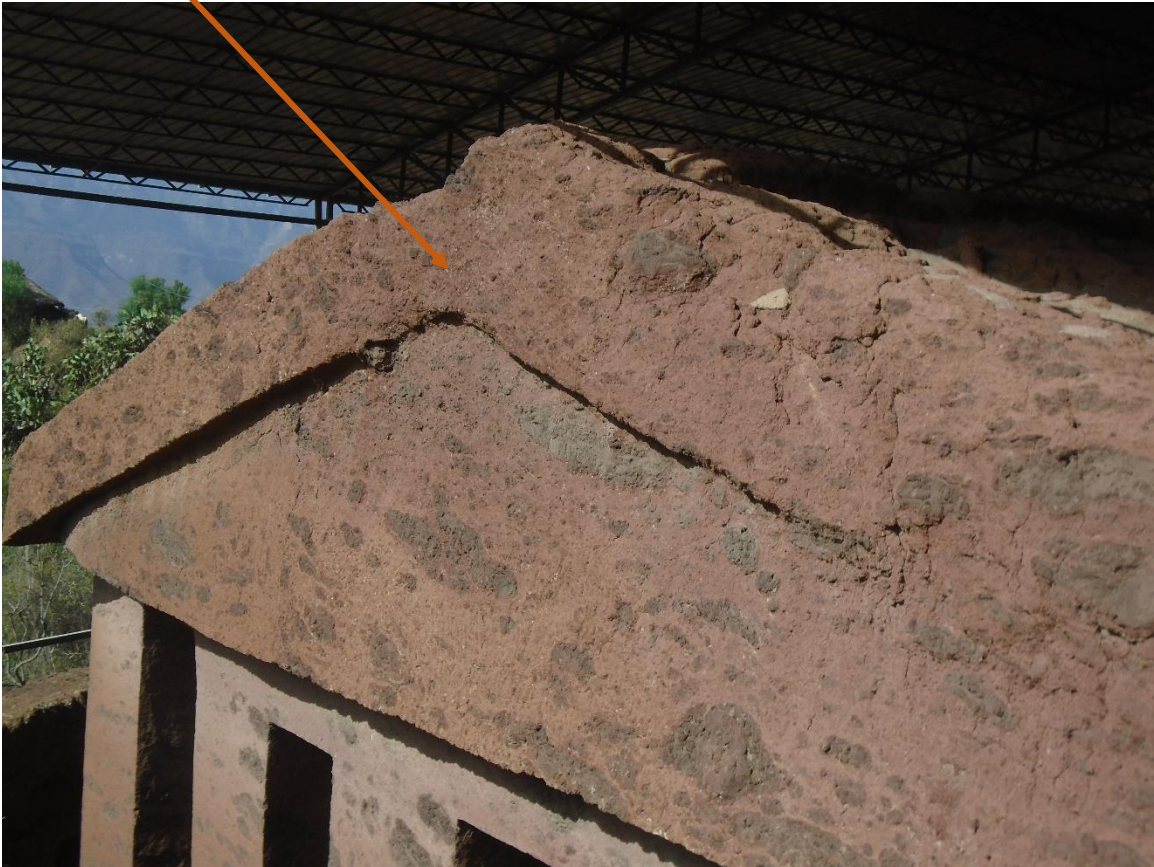
Heavy loads of roof of the church, it is difficult to sustain its load.

Figure36, Heavy roof of the church. (Source the author)
