THE CONSERVATION STATUS AND CHALLENGES OF GENETEMARYAM ROCK HEWN CHURCH, NORTH WOLLO.

A Thesis Submitted to post Graduate Studies of Addis Ababa University.

June, 2022.

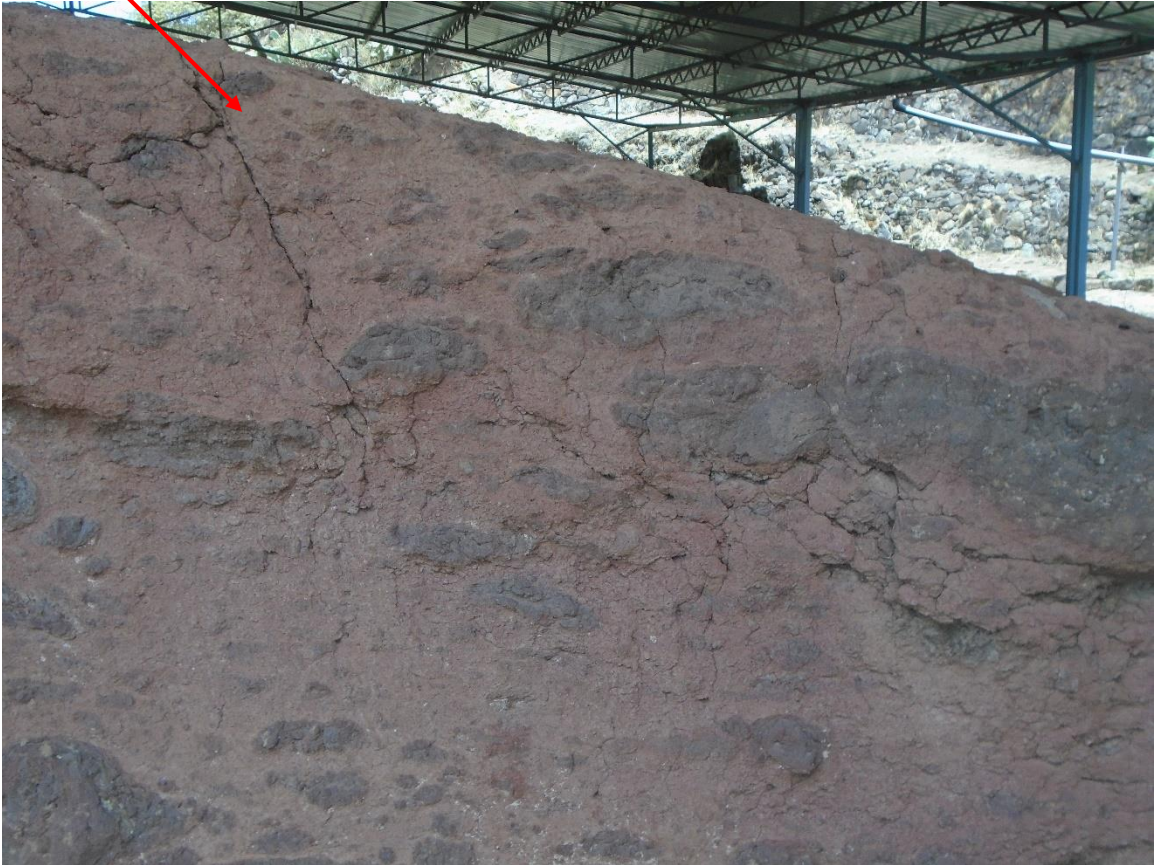
Large cracks on the roof parts of the church due to natural factors.

Figure 37. Large cracks on the roof parts of the church. (Source the Author)

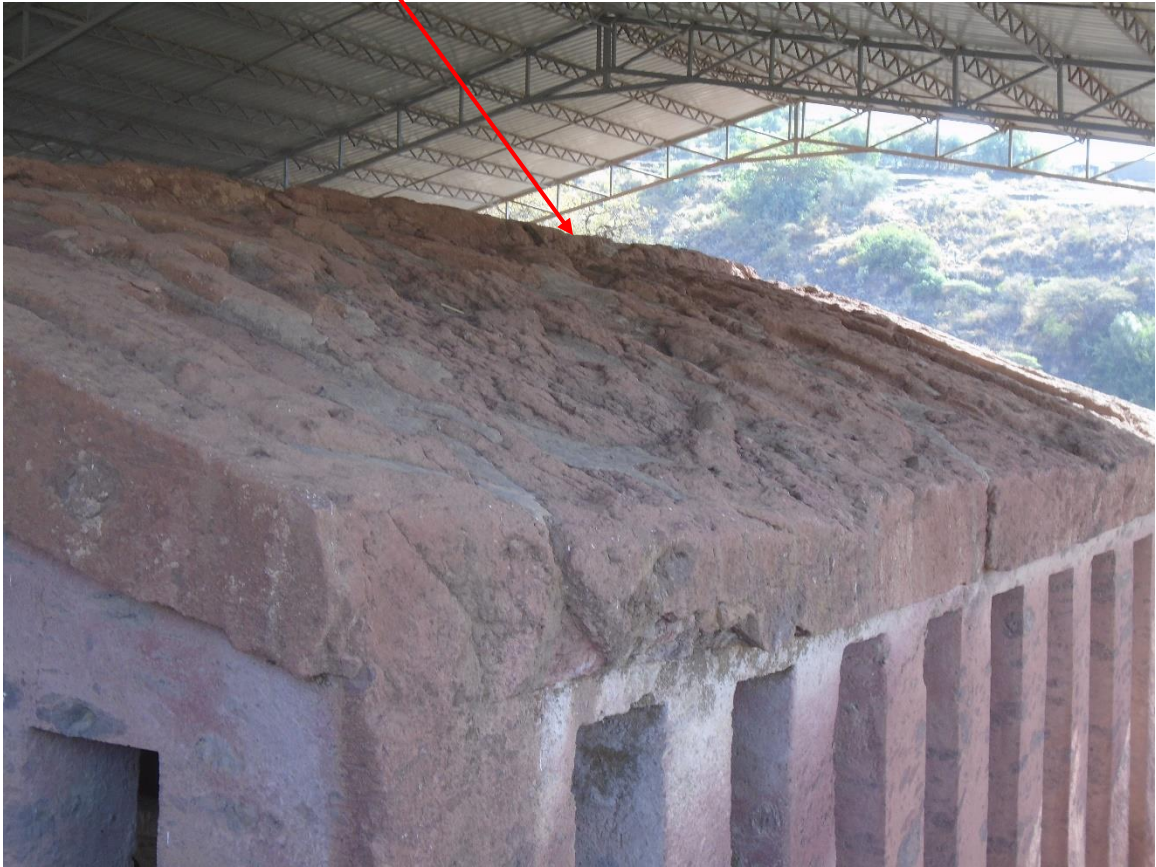
Eroded surface of the roof due to weathering effects

Figure 38: Eroded surface of the roof due to weathering effects. (Source the author)

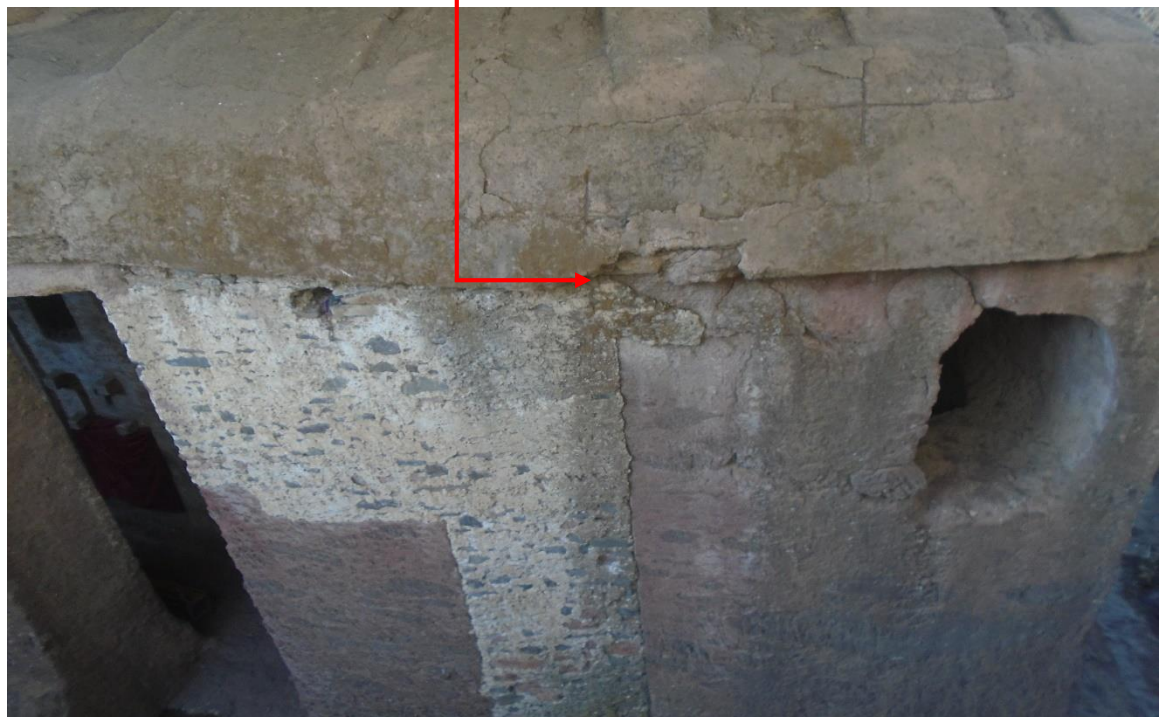
Figure 39, its previous restoration work start to breaking (Source the Author.)

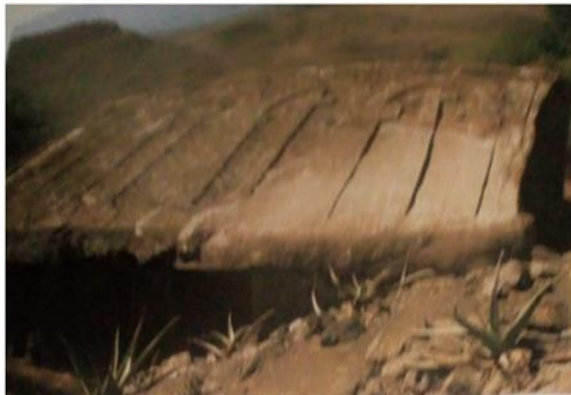
1

Damages due to water infiltration

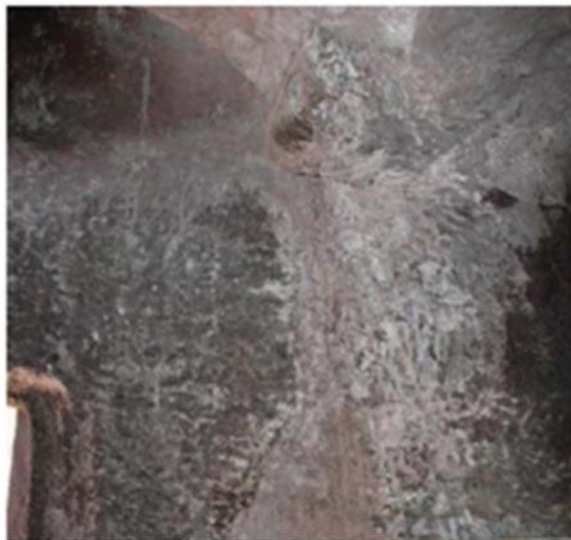
2

Damage of the rock due to bad restoration work.

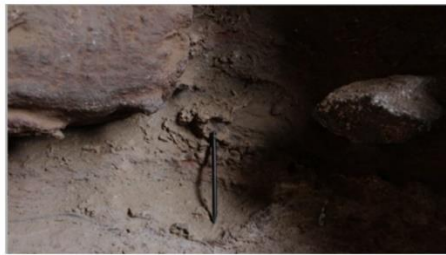
1 Weathered rock due Erosion

eroded parts of the rock due to large amount of rainwater and cycles of wetting and drying.

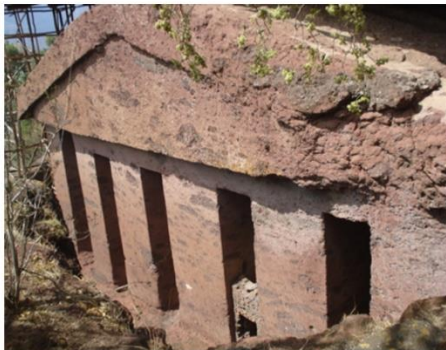
2 Weathered rock due to sun and rain

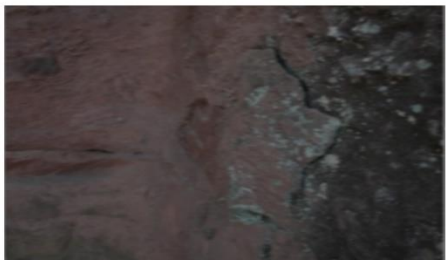
This is a phenomena of breaking down of rock elements through time due to natural factors. Ones the part of a rock crumbles and the crumbled element eroded by wind and rainfall

3 Crumbling of the rock

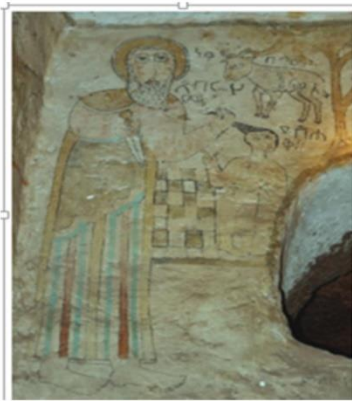
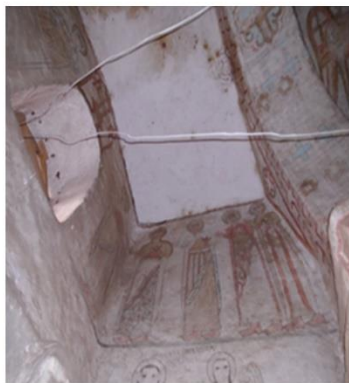
paintings inside the churches has occurred in the previous years due to natural and many other human factors. The paintings properties and decay factors should be thoroughly studied in order to define restoration solutions.

The paintings are now deteriorating and need restoration
