Impacts of pavement Condition and Geometric Characteristics on Traffic performance at Mid-Block Road Segment

(In the case of Addis Ababa city)

A Thesis Submitted to the School of Graduate Studies in

Road and Transport Engineering.

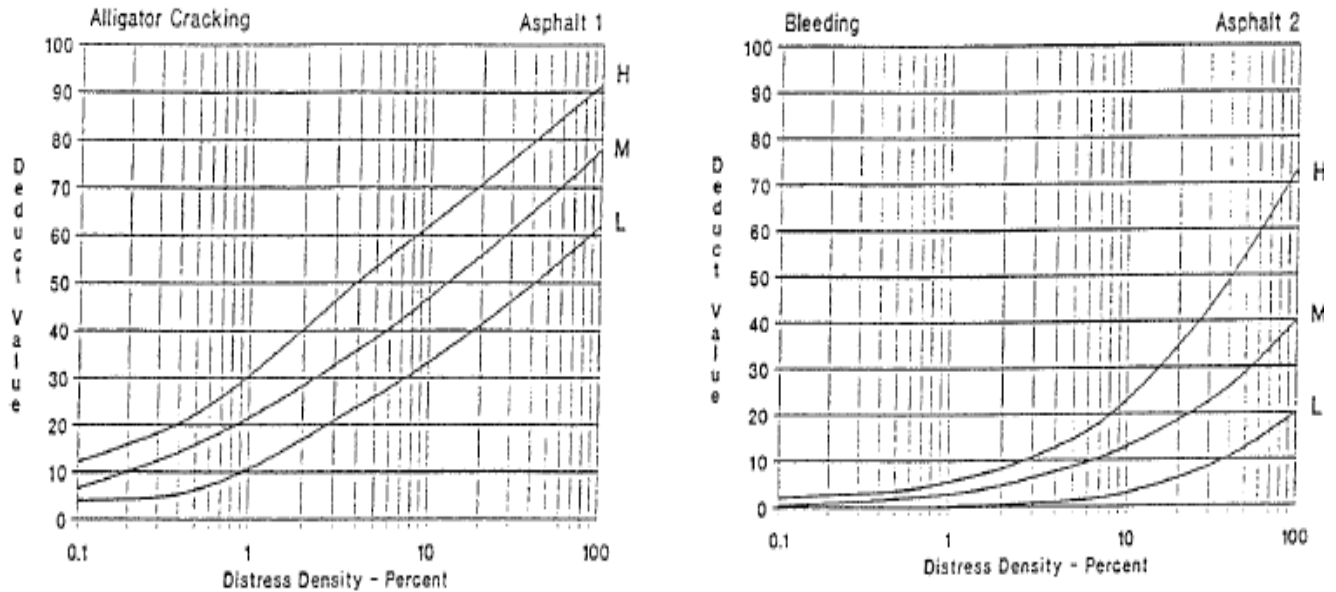
The deduction values for different types of asphalt distress, which indicate the extent to which pavement condition deteriorates with each distress, can be determined by referring to deduct value curves. These deduct value curves take into account the density and severity level of the distress. In accordance with ASTM D 6433, the deducted values for each type of asphalt distress are as follow

Figure 2-4 Alligator cracking deduct value curve and bleeding deduct value curve

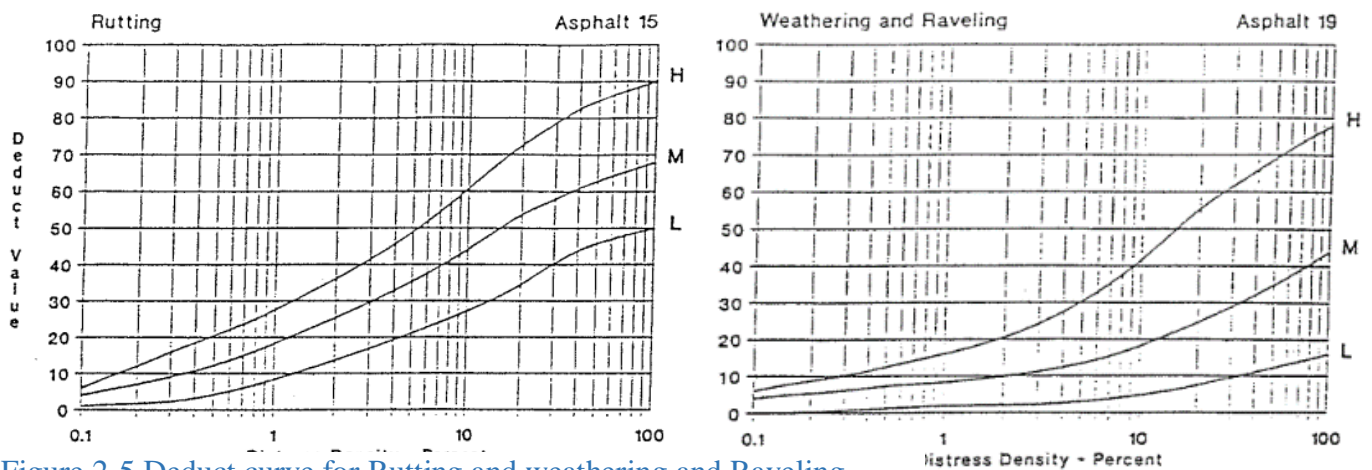
Figure 2-5 Deduct curve for Rutting and weathering and Raveling

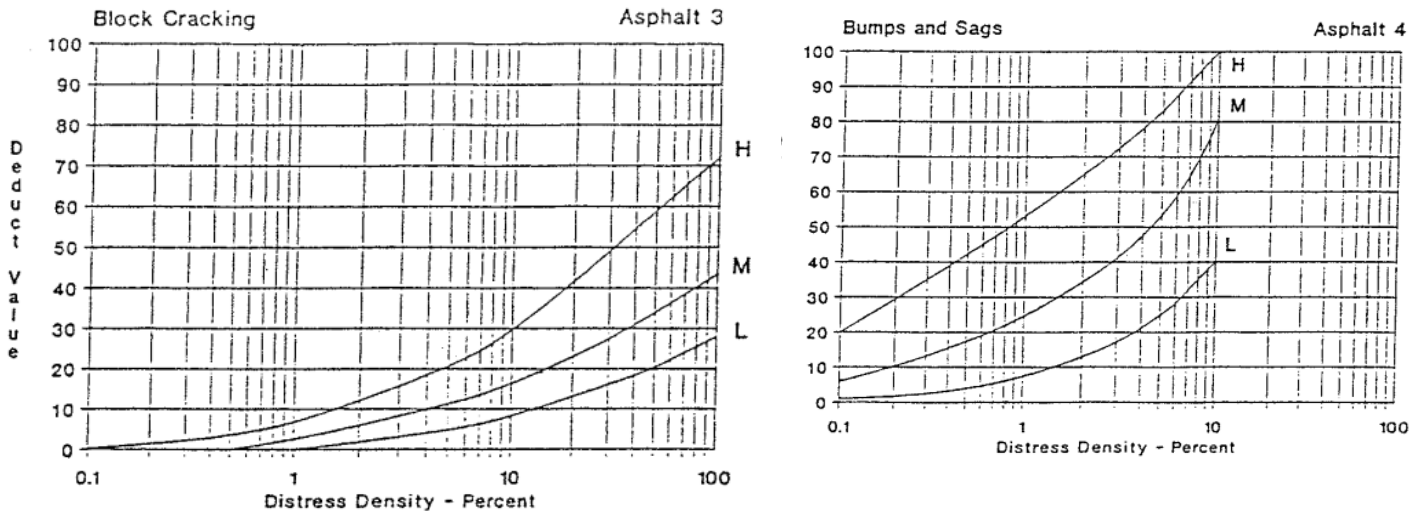
Figure 2-6 Block Cracking and Bumps and sags deduct value curve

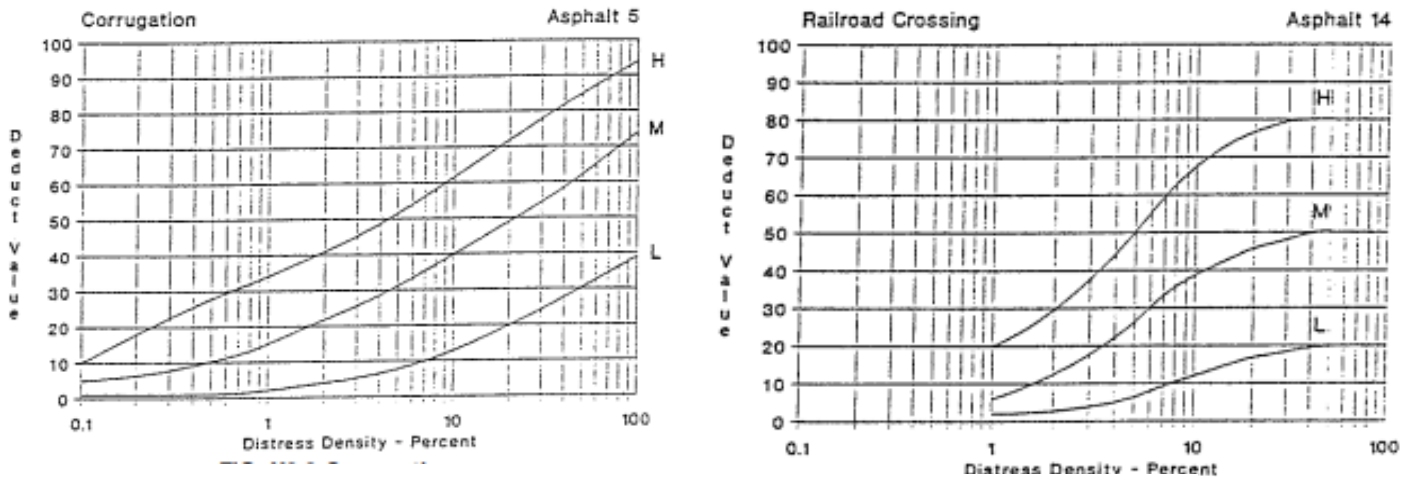
Figure 2-7 corrugation deduct value curve and Railroad deduct value curve

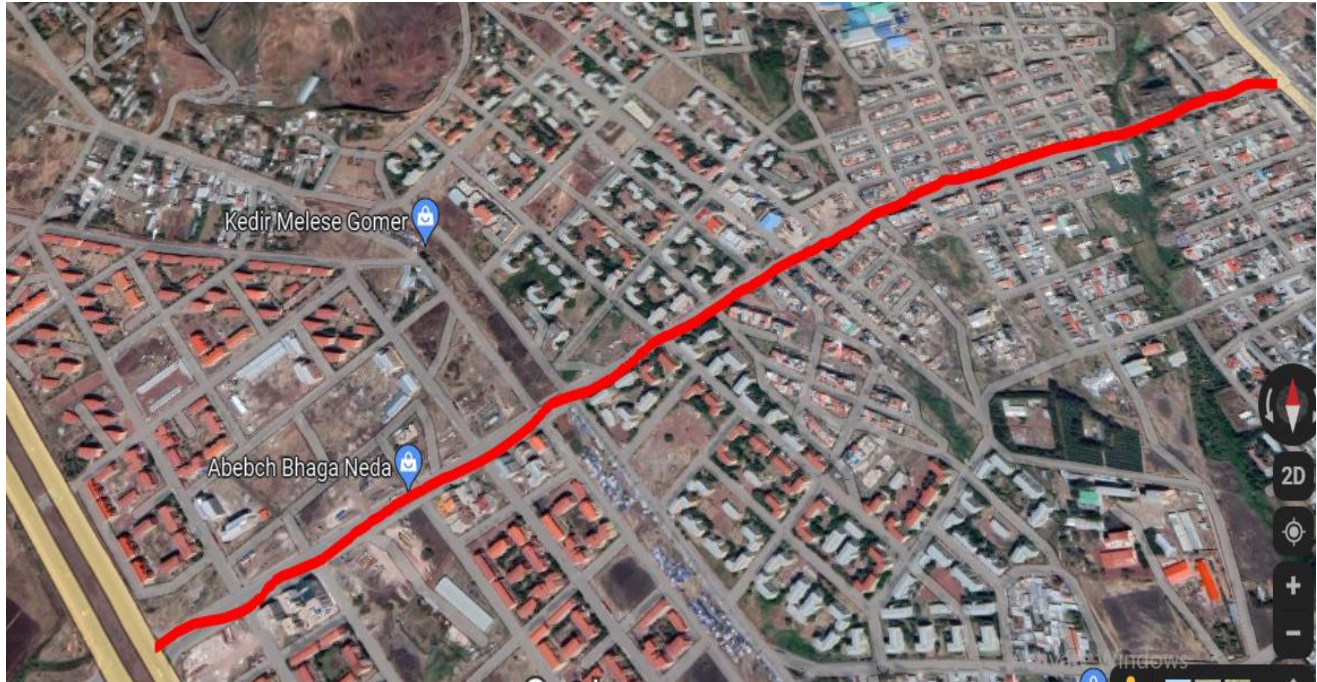
Figure 3-2 Deberezeit road to Glean Condominium

In 2015 E.C., only 0.74km of the total 2km length of this road segment was maintained. There is a distressed section of 0.9km that requires attention. However, the remaining 0.36km has a different function classification, so it was not included in this study.

To assess the impact of the pavement condition and geometric characteristics on traffic performance, necessary data was collected before and after the maintenance. plan view of the Mid-block is shown in **Figure 3-2**.

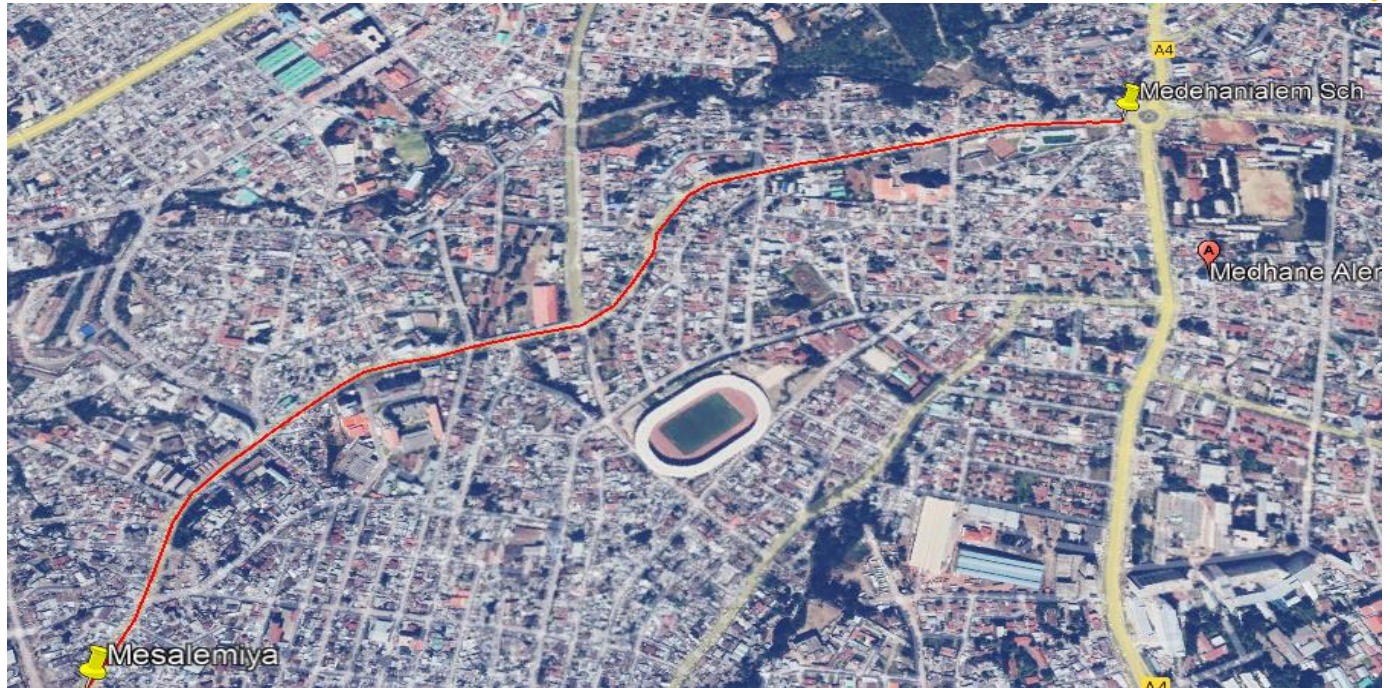
Figure 3-3 Mesalemiya –Medehanialem School

According to visual inspection, Mesalemia to Medehanialem Square is a deteriorated road pavement that measures 2.2km in length. From Ethio tebieb to Medehanialem Square. 1.06km Maintained on 2014 E.C and 1.14km is distressed section but the maintained section of the segment distresses pavement survey is taken. The pavement condition, average travel speed and Geometric characteristics were surveyed for both the maintained and distressed sections at the mid-block of the road. plain view of the Mid-block is shown in **Figure 3-3**.

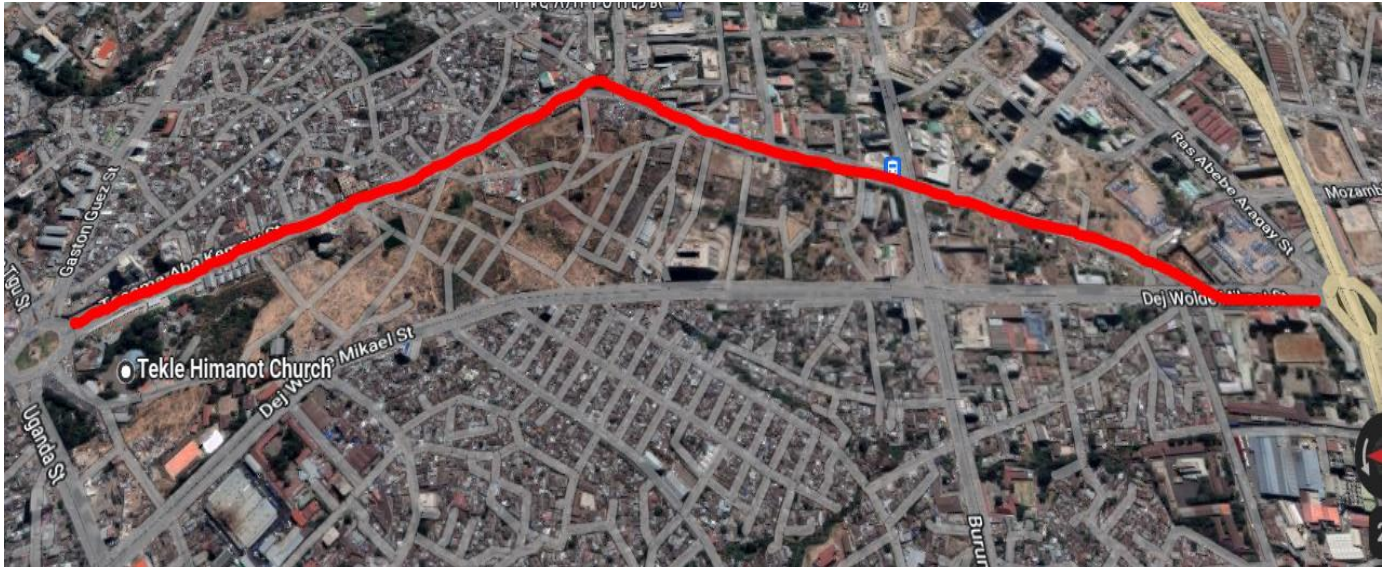
Figure 3-5 Tikelhaimanot –Tikor Anbesa -Mexico square

The mid-block segment from Tikelhaimanot church through Tibur Anbesa Hospital to Mexico Square consists of both distressed and non-distressed sections. It is worth noting that both sections have the same width, number of lanes and walkway after the maintenance activities.

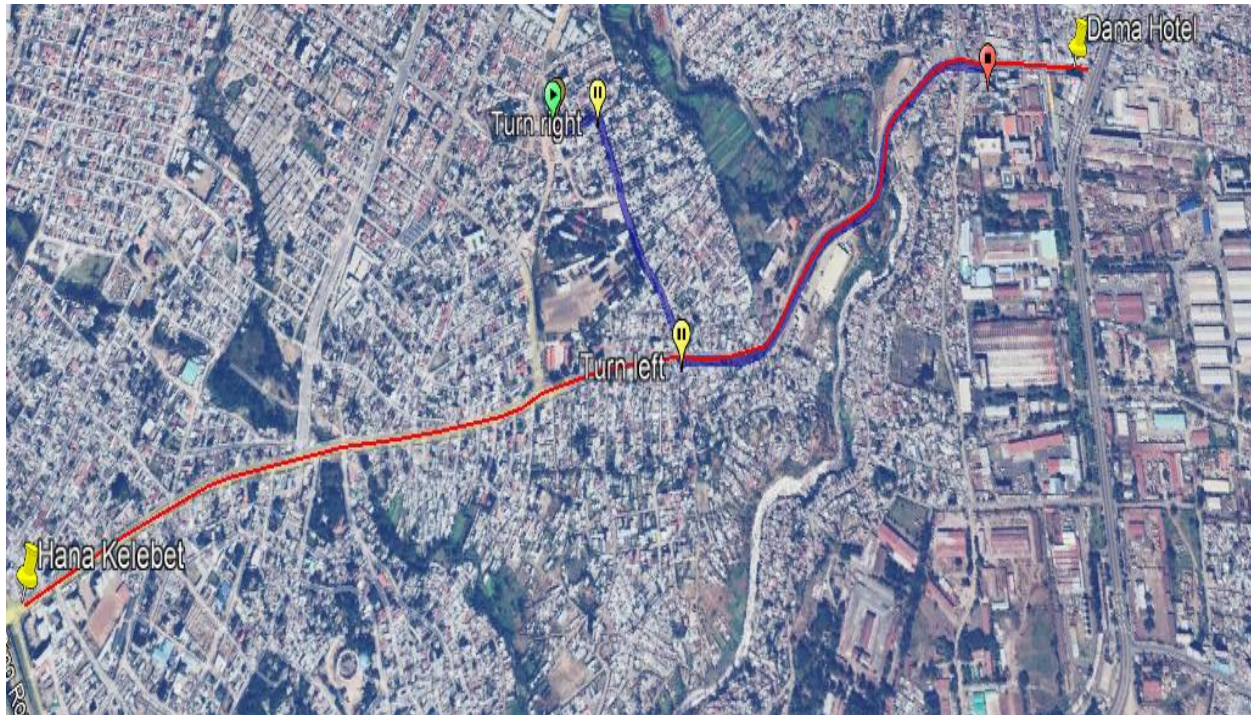
Figure 3-7 Hana kelebet to dama hotel

Hana kelebet to dama Hotel road segment is classified as Sub Arterial street but Only the mid-block segment section is taken for further investigation from Hana Mariam kelebet to Dama Hotel and constructed in 2009E.c. All data are taken for the distressed and Non-distressed sections (1.53km maintained from lafto 58 to dama hotel).

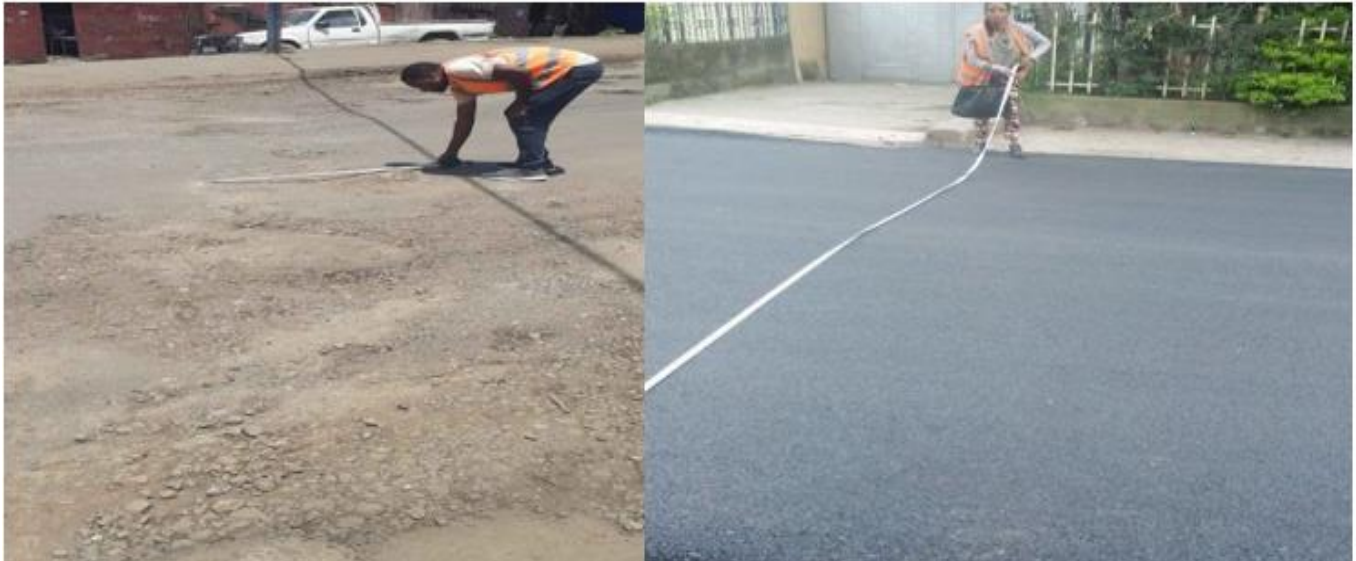
Figure 3-8 Distressed and non-distressed sections of study area

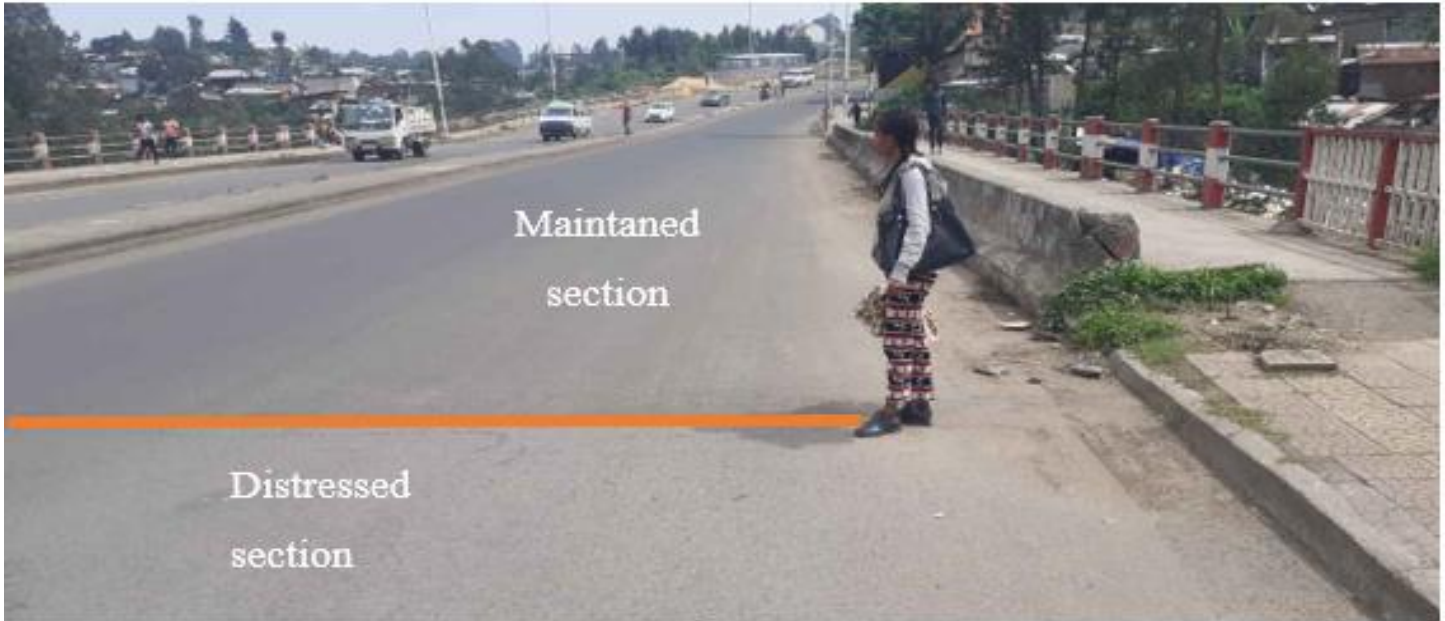
Figure 3-9 the boundary of maintained and distress section

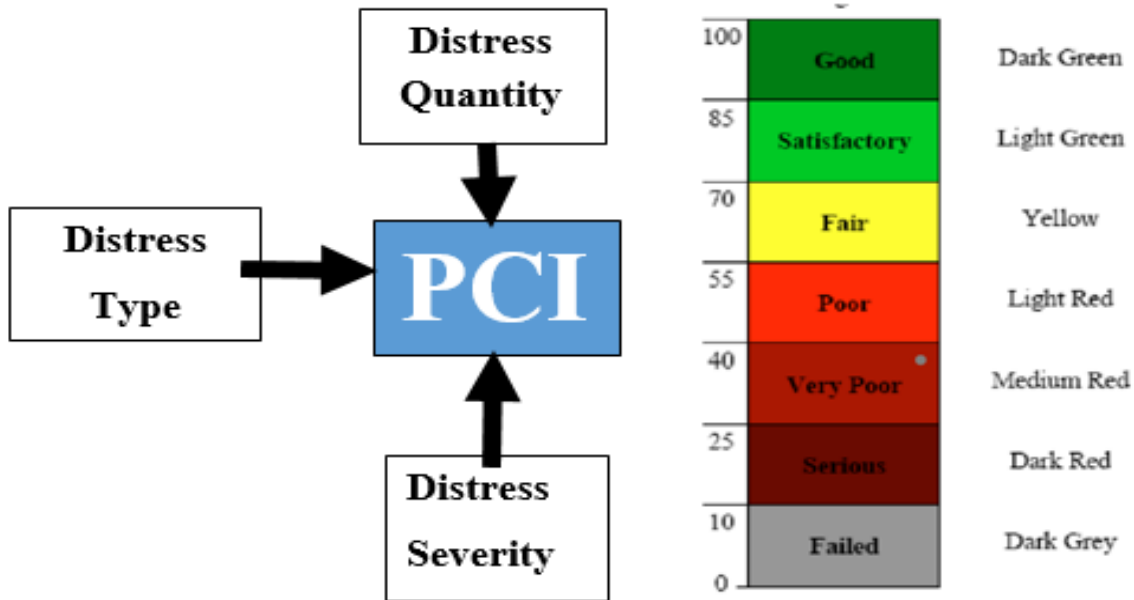
Figure 3-10 Pavement condition index Procedures (ASTMD6433)

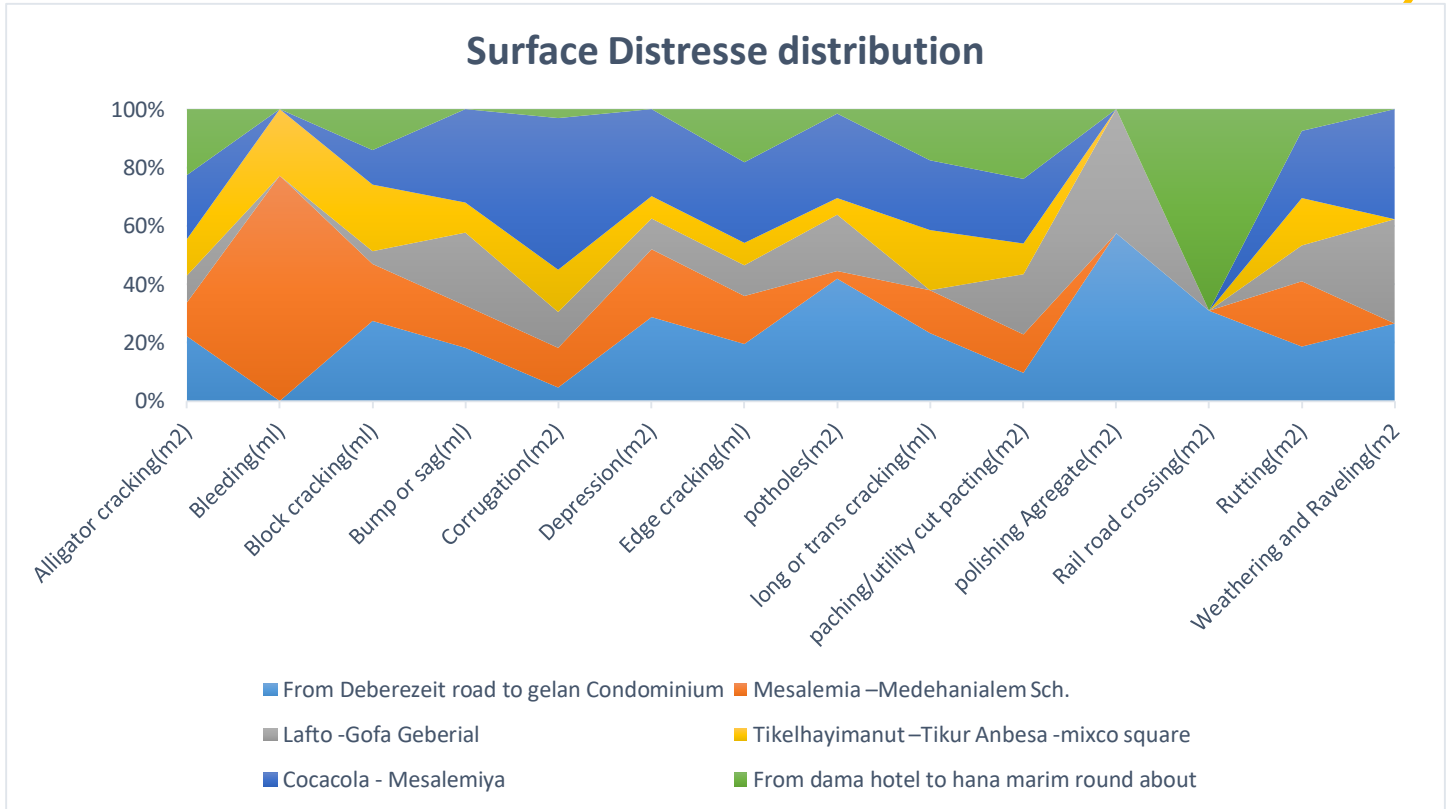
The pavement condition survey conducted on the Mesalemia-Medehanialem Sch. Mid-block revealed the presence of multiple surface distresses. The survey found that corrugation and alligator cracking were the most prevalent surface distresses, accounting for 16.7% and 14% of the total surface distress, respectively. In contrast, the bump or sag had the smallest surface defect relative to the other distresses, accounting for only 0.5% of the total surface distress.

Figure 4-1 Surface distress distribution in each section of the study area

After conducting a pavement condition survey on the lafto to Gofa Geberial mid-block, it was discovered that several surface distresses were present. The survey revealed that the most common surface distresses were potholes and corrugation, accounting for 54.4% and 8.2% of the total surface distress, respectively. Conversely, the depression was the smallest surface defect in comparison to the other distresses, accounting for only 0.5% of the total surface distress.

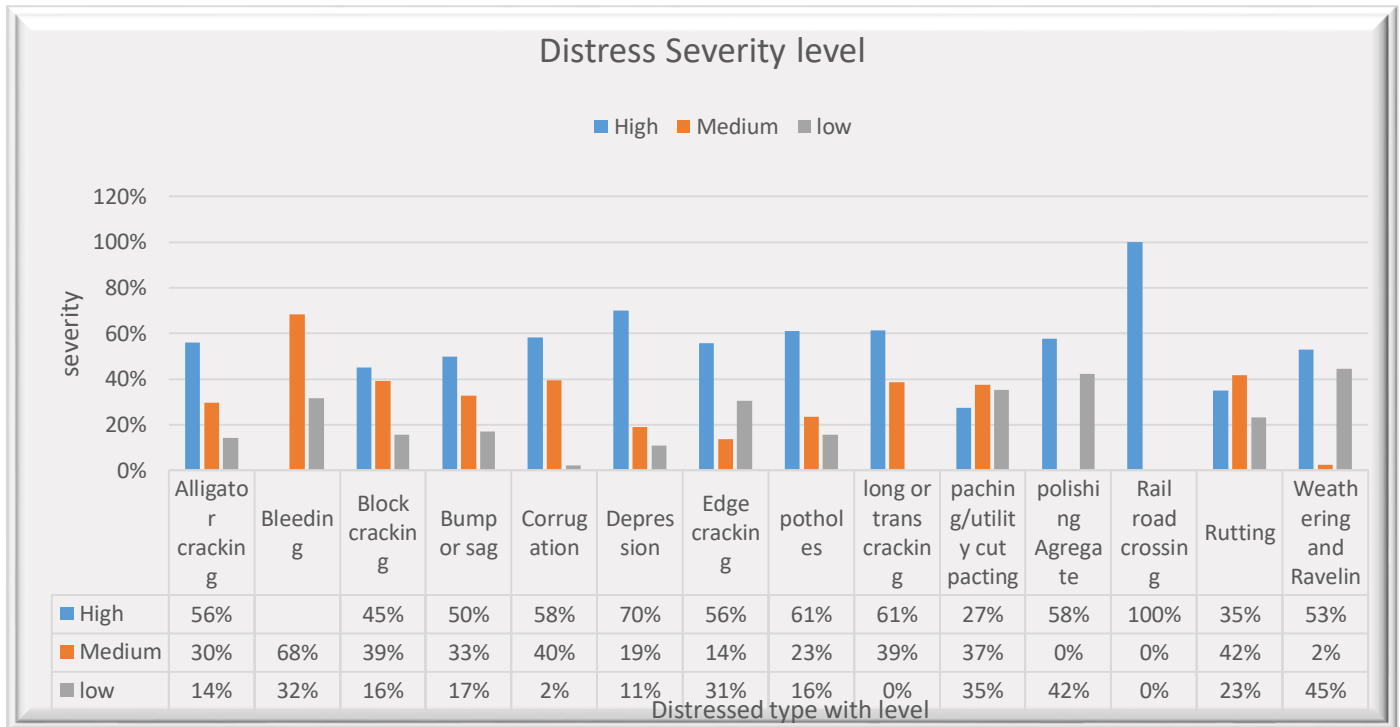
Figure 4-2 Severity Level

Figure 4-2 displays the percentage of different types of distress, including alligator cracking, railroad crossings, potholes, and depression, observed in the study area. The data reveals that 56% of the observed alligator cracking is classified as high severity, 30% as medium severity, and 14% as low severity; 100% of the observed railroad crossing is classified as high severity; 61% of the observed pothole is classified as high severity, 23% as medium severity, and 16% as low severity; and 70% of the observed depression is classified as high severity, 19% as medium severity, and 11% as low severity.

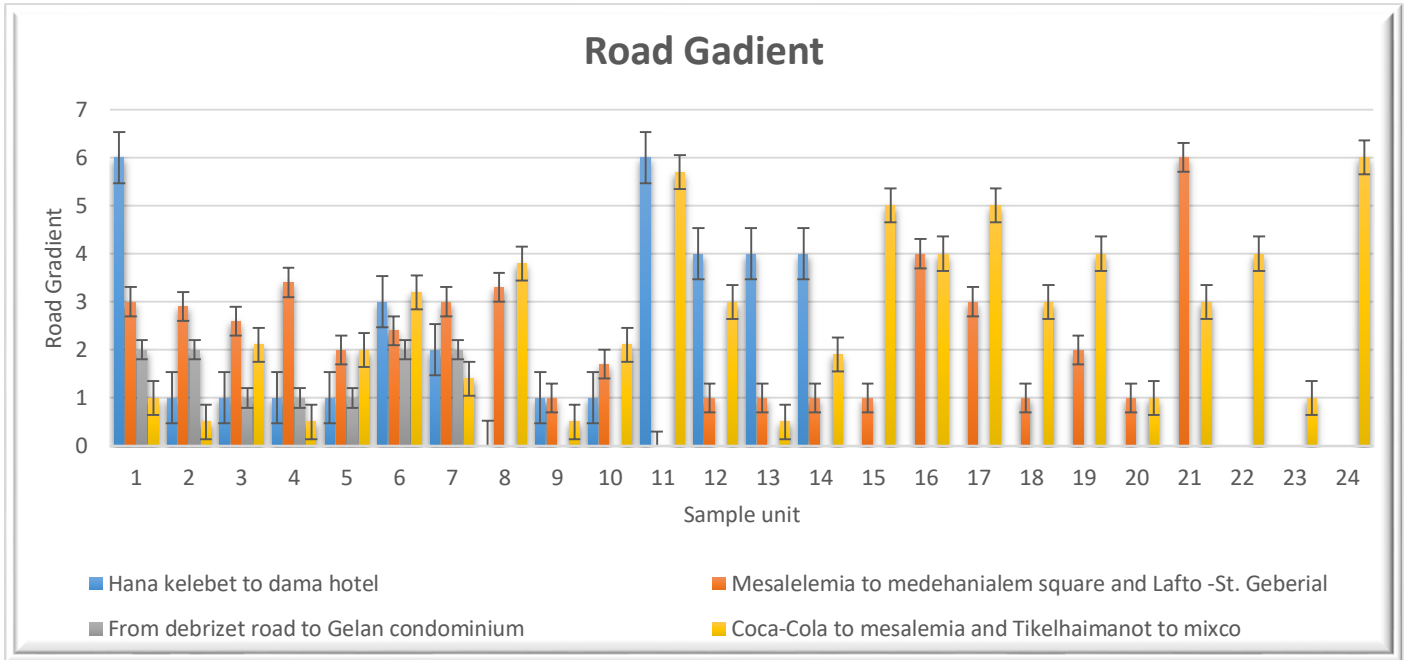
Tikelhaimanot to Mexico sections, the slope ranges from 0.5% to 7%, with a higher mean slope of 2.504%. This indicates a higher overall steepness in this section compared to others.

Figure 4-9 Road Gradient Data distribution for study area

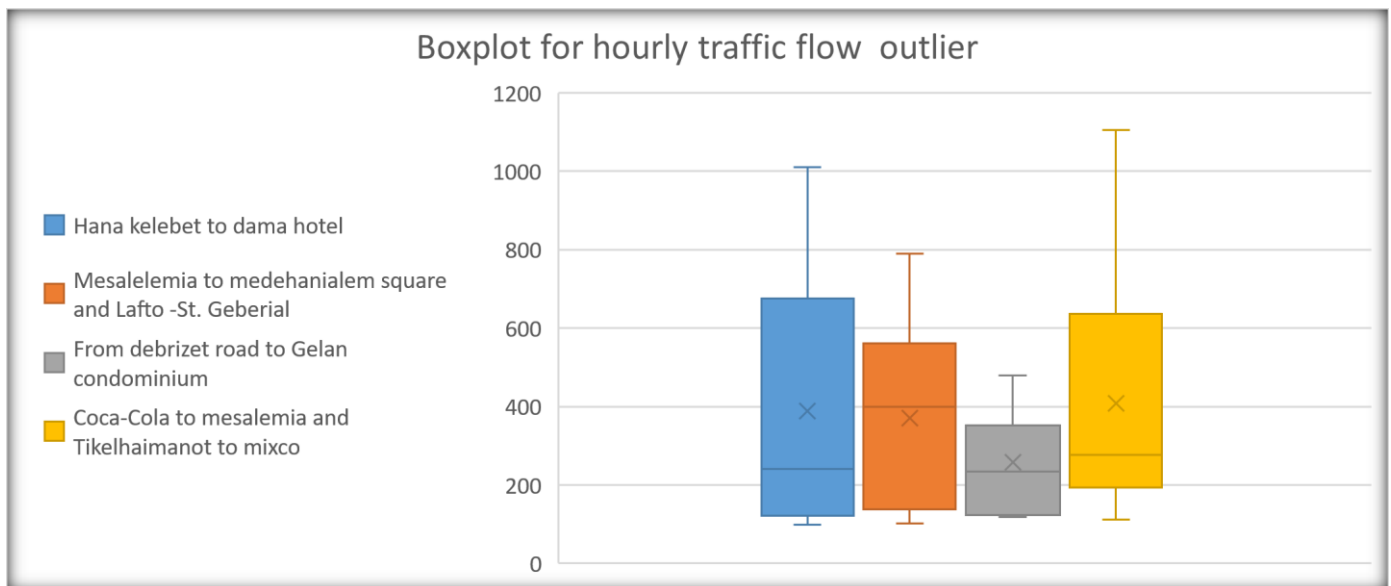
From conducted data Coca-Cola to mesalemia sample unit 16 and 17 hourly traffic flow data which is outlier (too much larger or smaller) is removed from a dataset.

Figure 4-8 Boxplot Traffic flow data for outlier data checking

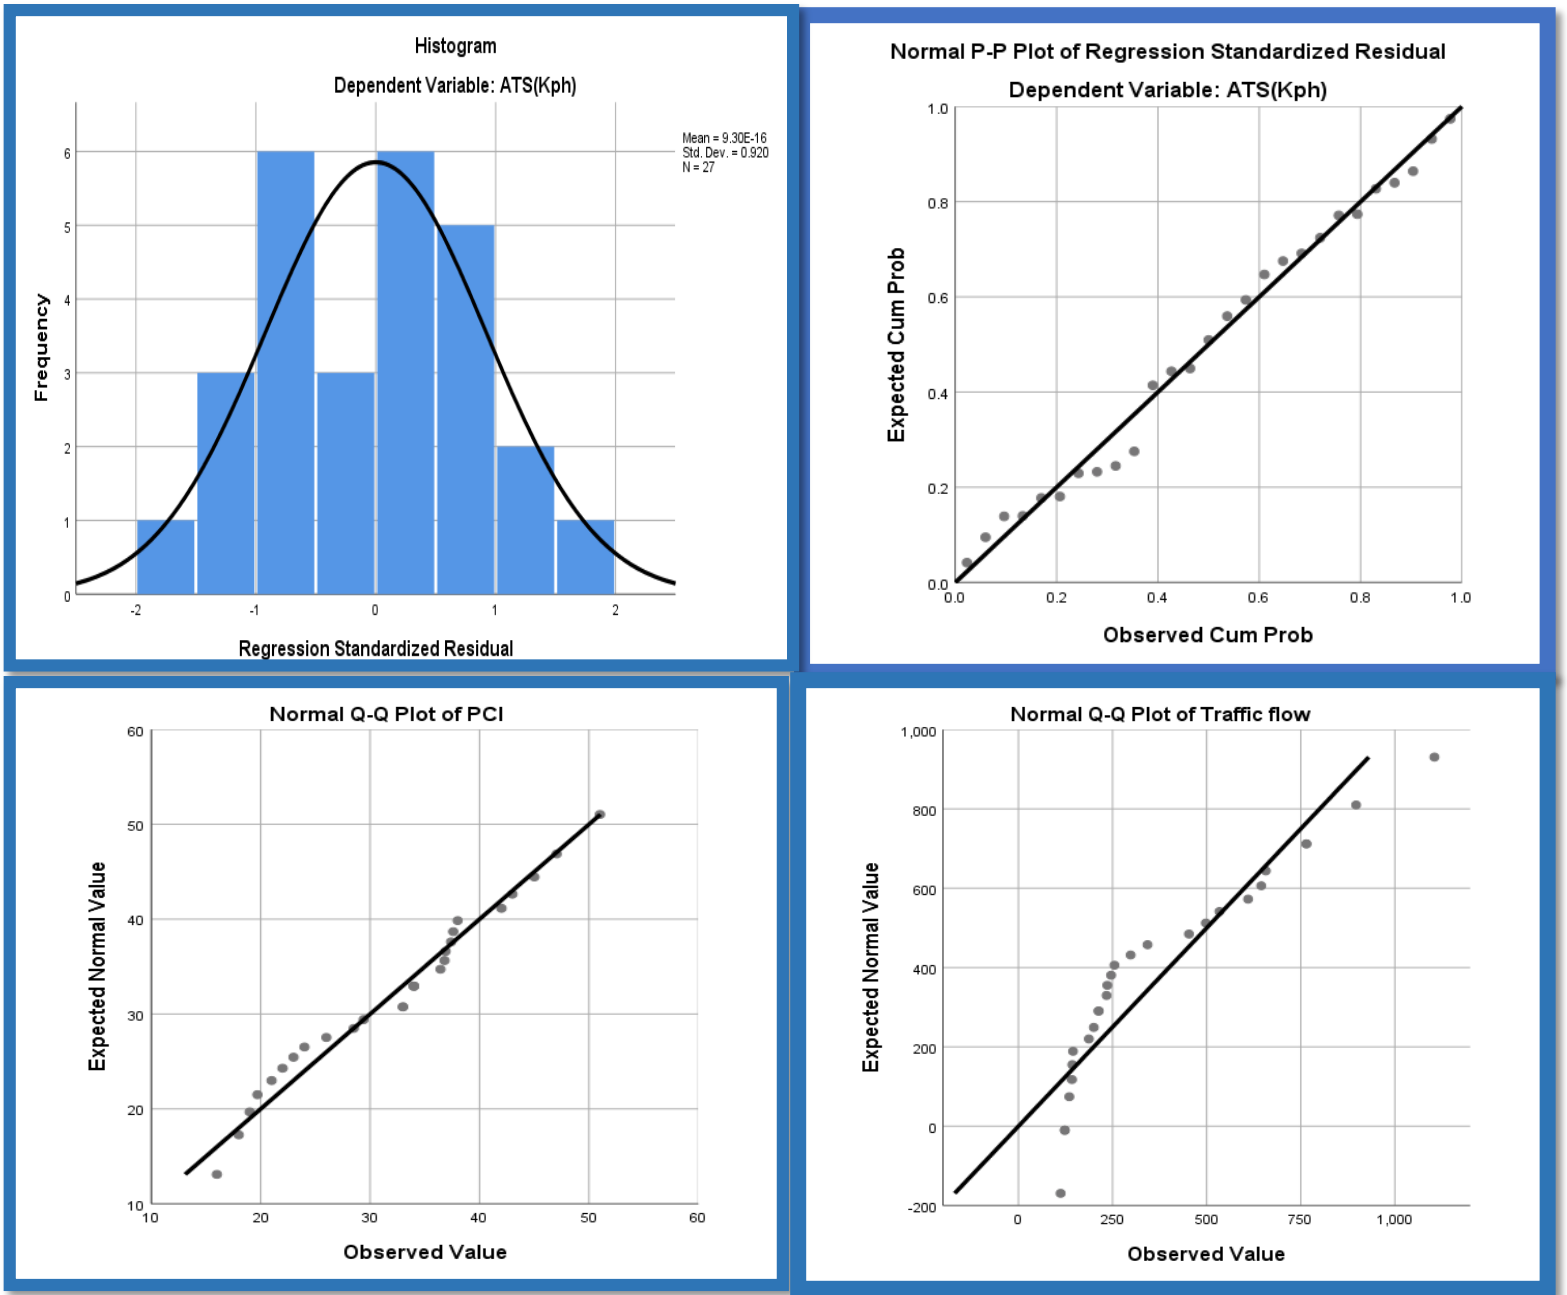
Based on the results obtained from the histograms, it observed that the data followed an approximately bell-shaped graph. This shape is often referred to as a normal distribution or Gaussian distribution

Figure 4-10 Coca-Cola to Mesalemia and Tikelhaimanot -Mexico road segment

The histogram of the mentioned road segment and the remaining study area indicates that the data is distributed in a manner that closely resembles a normal distribution.
