**Mechanistic Behavior of Historical Masonry
Assemblages of Fasil Ghenbe and Structural
Response Assessment of Mentwab Castle Under
Vertical Loading; A Case Study**

A Thesis in structural Engineering

By Kidist Dereje

July, 2018

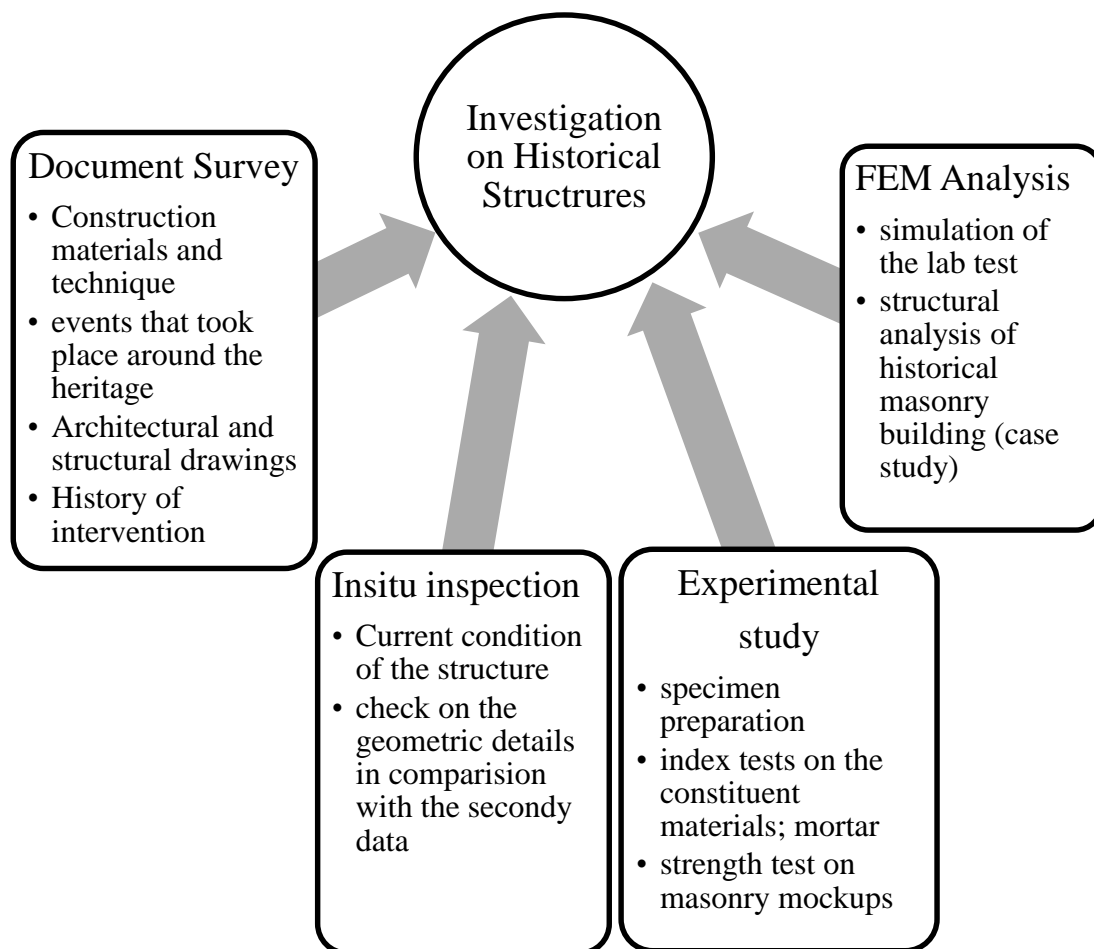
Figure1.1 Summary of the methodology

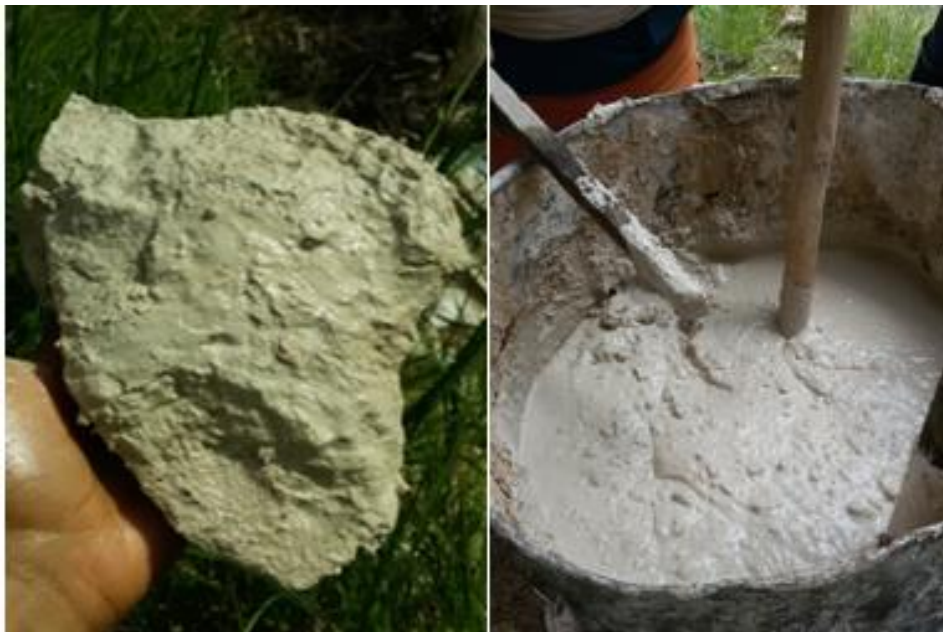
Figure 3.1 a) Hydrated lime unearthed from the slaking pit b) Hydrated lime agitated to form a lime putty

The first step in the preparation of the mortar was to unearth the slaked lime from the open pit and collect the required amount in a barrel then it was gently agitated for five days consecutively, without the addition of extra water. This was done in order to break down the mud like hydrated lime and to bring it into being a uniformly mixed lime putty, Figure 3.1.

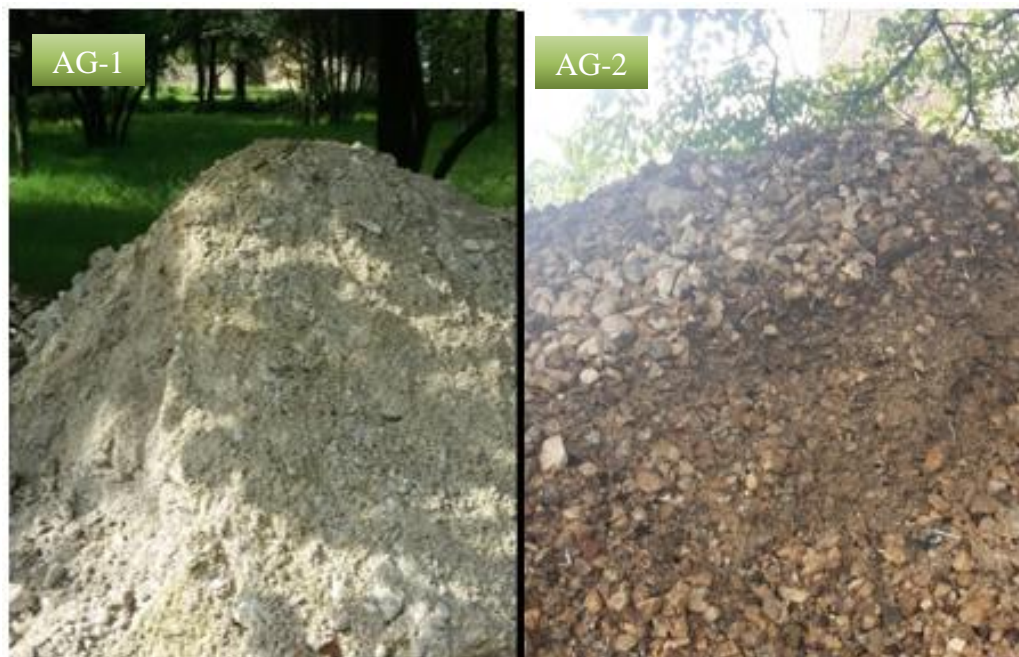
Figure 3.2 Aggregate AG-1 and AG-2

It should be noted that the production of the quicklime is not in a factory scale but simply by burning in a traditionally made kiln. As a result, in the production of quicklime, unburned limestone is also obtained with the ash, quicklime. The limestone, which is not fully changed into quicklime is the one that is being used as an aggregate, Figure 3.2.

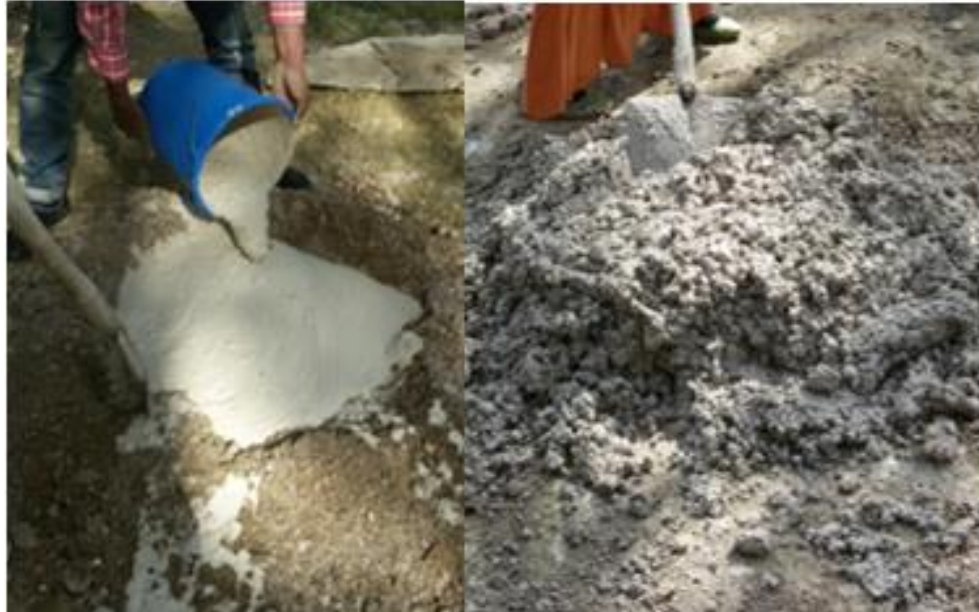
Figure 3.3 Mixing of aggregate with the lime putty and prepared mortar

As the mortar preparation is in accordance with the traditional method there is no clearly defined mix ratio of the ingredients. Nevertheless, the experienced masons can tell, the appropriateness of the mix proportion for the intended use. Accordingly, the lime putty was mixed with the aggregates and the lime mortar was prepared, see Figure 3.3.

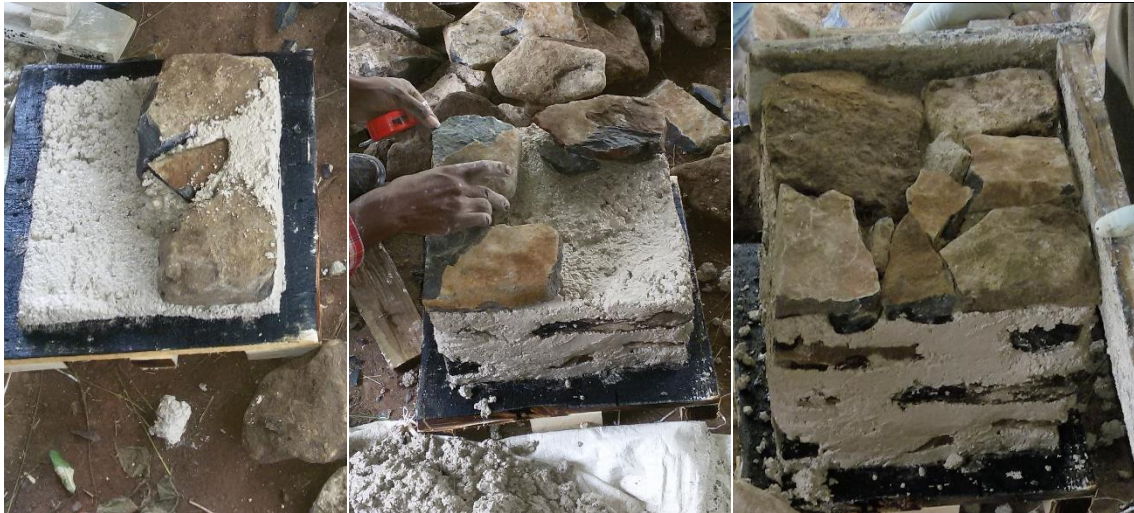
Figure 3.4 Masonry specimen construction

Similarly, specimens for triplet tests were also built with stone units with irregular shape and dimensions but special attention was paid in order to create three horizontal layers of mortar and stone assemblages (each 10 cm height) with two nearly horizontal bed joints Figure 3.4.

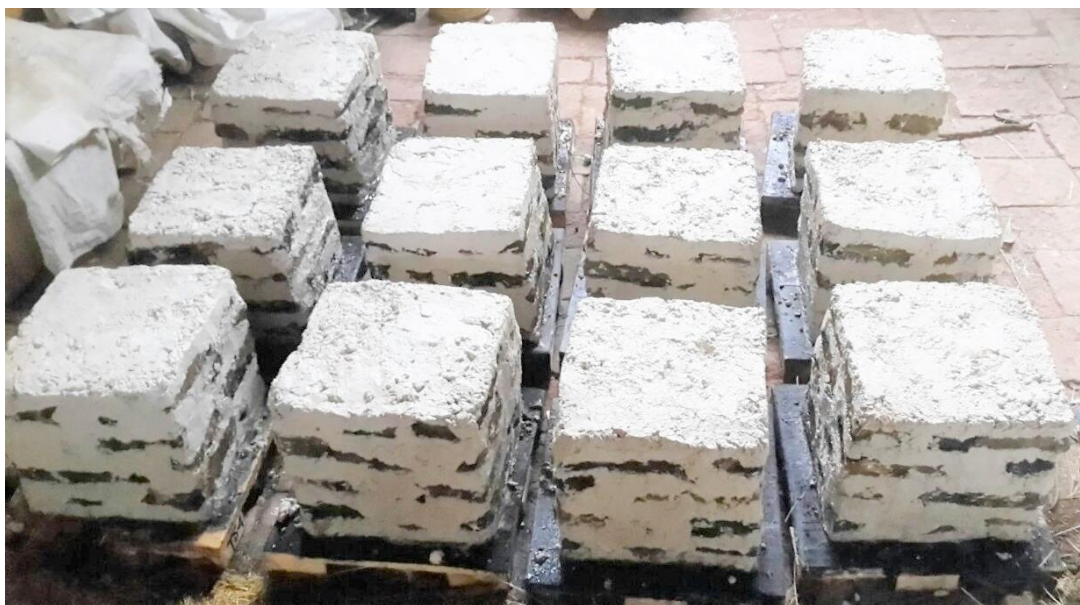
Figure 3.5 Masonry specimens during the curing period

For the first 27 days, starting from the day after their construction, the samples were being cured by sprinkling water twice a day and after the 27th day, they were left to harden inside a room where there was a good ventilation, Figure 3.5. This curing technique was adopted from the traditional practice.

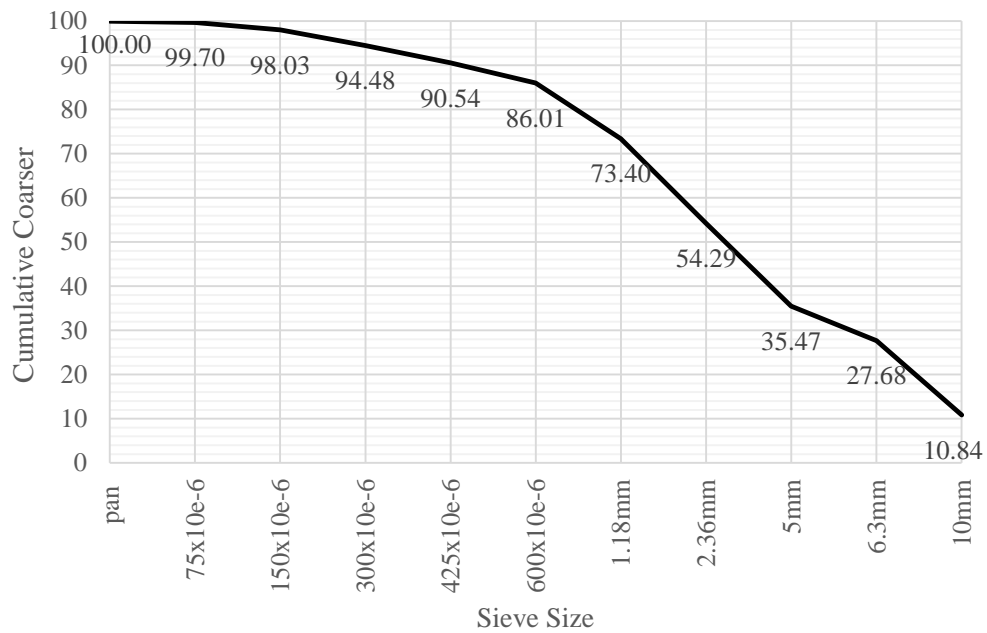
Figure 3.6. Gradation of the Fine Aggregate AG1

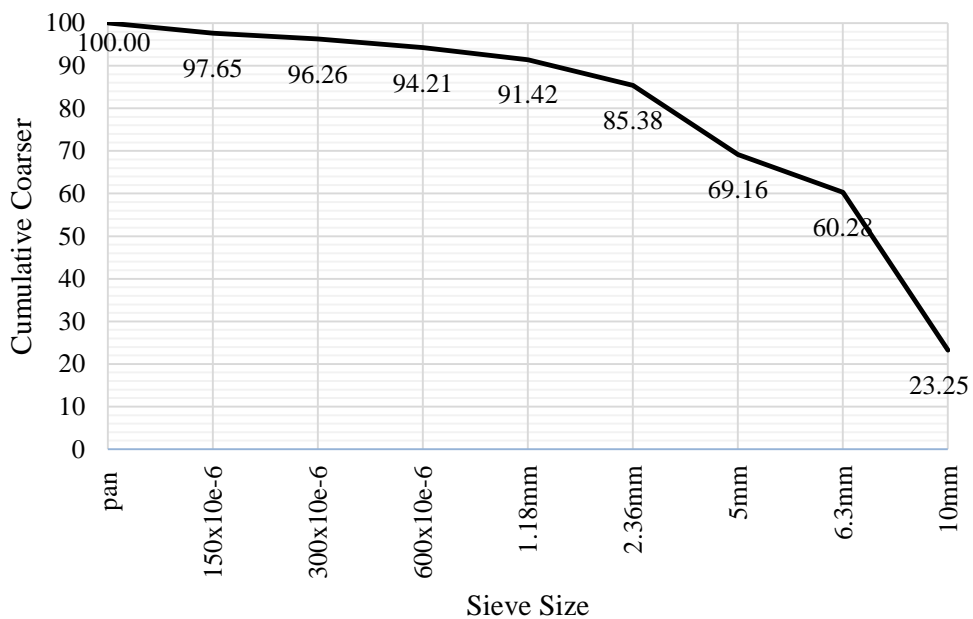
Figure 3.7 Gradation of the crushed Aggregate AG2

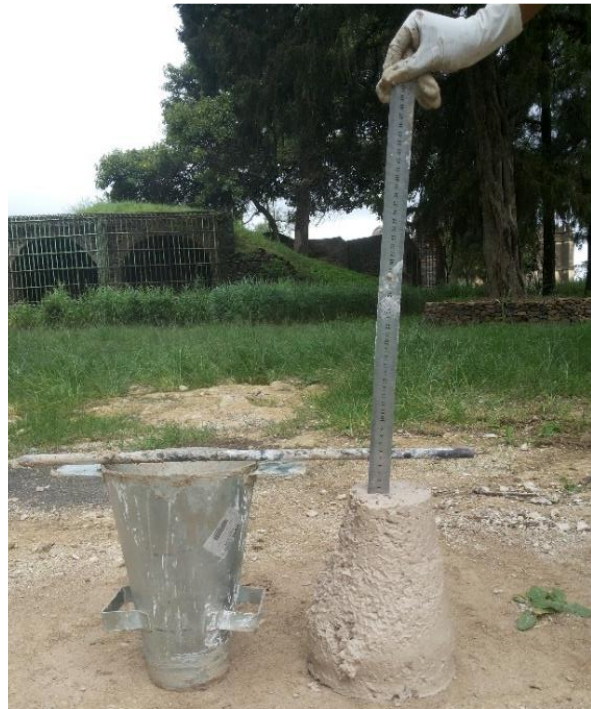
Figure 3.9. Slump Test

Thus, in the course of the fabrication of the masonry mockups, slump test was conducted on the lime mortar, Figure 3.9.

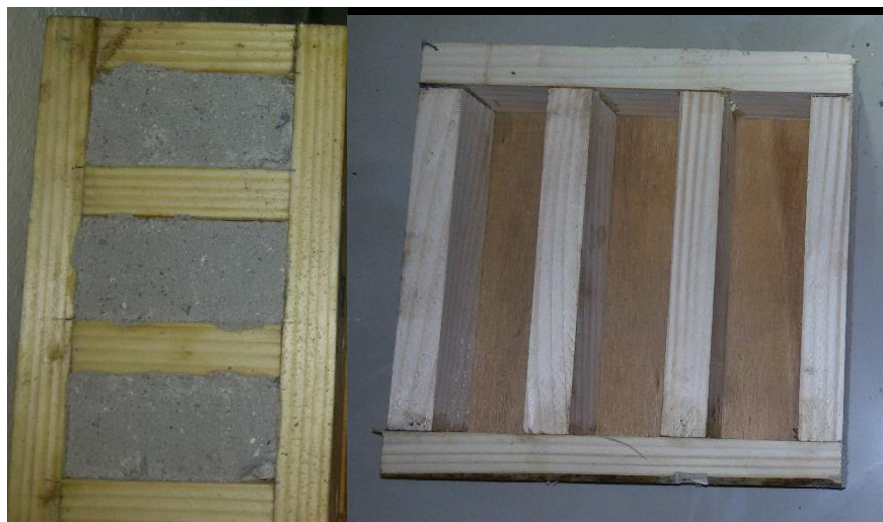
Figure 3.10 Compressive and flexural test specimens

To this goal, wooden molds having the above sizes were made and used to cast the mortars during the fieldwork, Figure 3.10. Then the samples were brought to AAiT material testing lab. Unfortunately, most of the mortar samples were broken in an attempt to remove them from the wooden molds. Thus, the proposed strength tests were not conducted on the mortar. However, the broken samples were used for another purpose, to investigate the carbonation of the mortar.

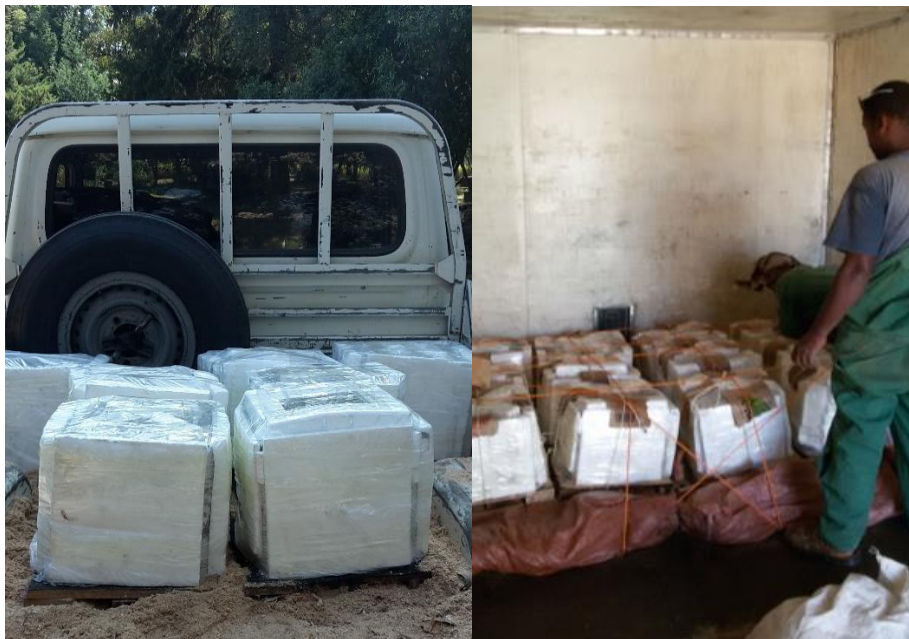
Figure 3.11. Masonry samples during Transportation

The other protection is the mechanism that was used to minimize the effect of shock, caused by the vibration of the car, as it goes on all the way long over the uneven roadways. For this purpose, the protection against the effect of vibration was achieved by using half full sacks of sand that are laid upon the bed of the car. Then the samples were placed over those sacks and tied to the base of the car, see Figure 3.11. This way the samples were transported safely and arrived at the material testing laboratory of AAiT.

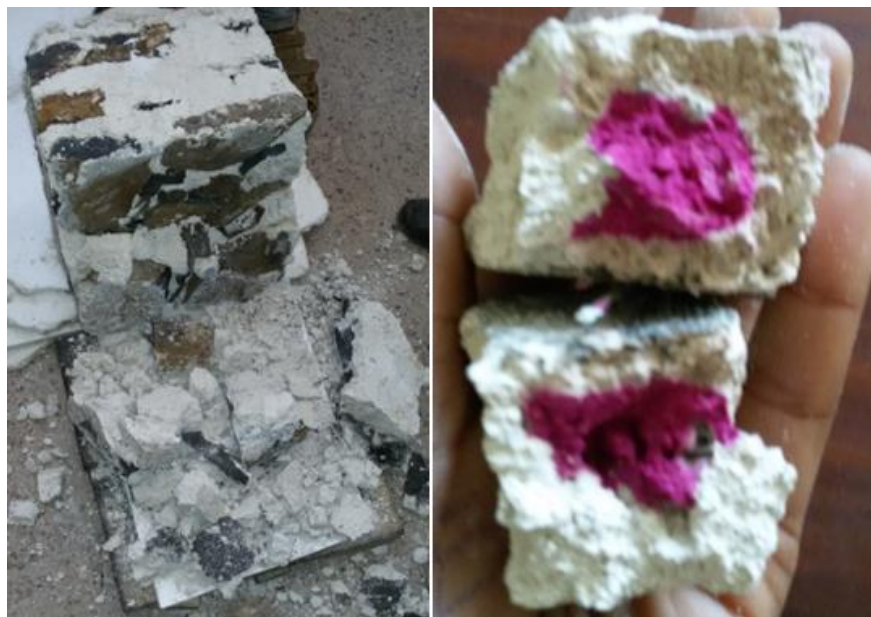
Figure 3.16 Broken specimen and phenolphthalein test on the mortar

Accordingly, the test conducted on the mortar of the broken specimen has shown that the mortar was not fully carbonated, see Figure 3.16. Then the next attempt was to enhance the strength of the mortar by accelerating the carbonation. In an attempt to accelerate the carbonation rate and strengthen the mortar, mini carbonation chamber has been devised in Chemical Laboratory, AAiT. In fact, carbonation is affected by factors such as carbon dioxide concentration, temperature, and relative humidity. Therefore, when it was planned to set up the carbonation chamber, the above environmental factors were considered. Basically, the effort was to create an environment that has a high CO₂ concentration and moderate humidity.

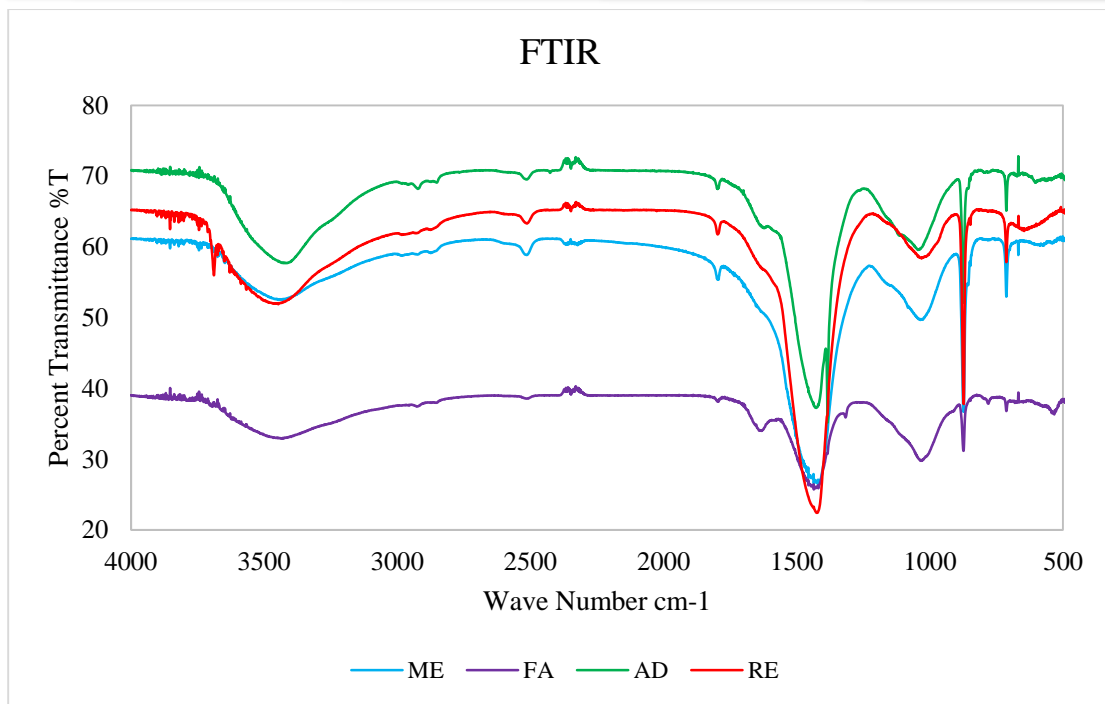
Figure 3.20 Infrared spectrum of the mortar samples

The subsequent task was to interpret the graph and look for the functional groups that are indicative for the presence or absence of amino acids which are the building blocks of protein. the graphs of Figure 3.20 were interpreted with the aid of IR correlation charts.

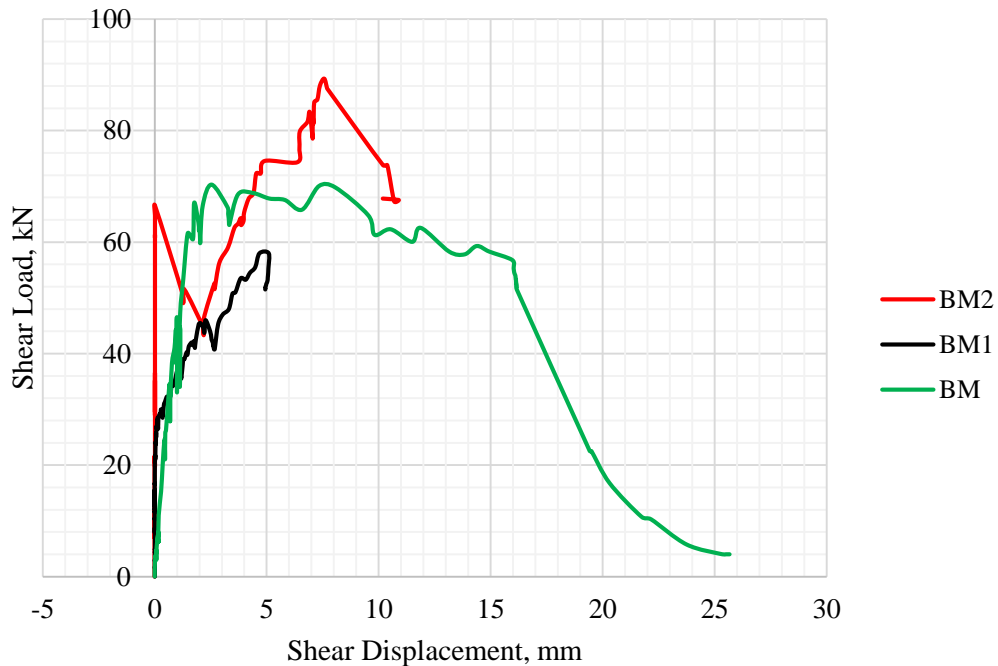
Figure 4.3 Shear load-shear displacement relation for brick masonry

The shear load-shear displacement graphs of the brick masonry samples, Figure 4.3, are characterized by a sharp initial vertical stretch. Then the peak loads are attained for a very small shear displacement. Although this is true as a general characteristic of the specimens (for BM1 and BM2), there are also some other clear differences among the results.

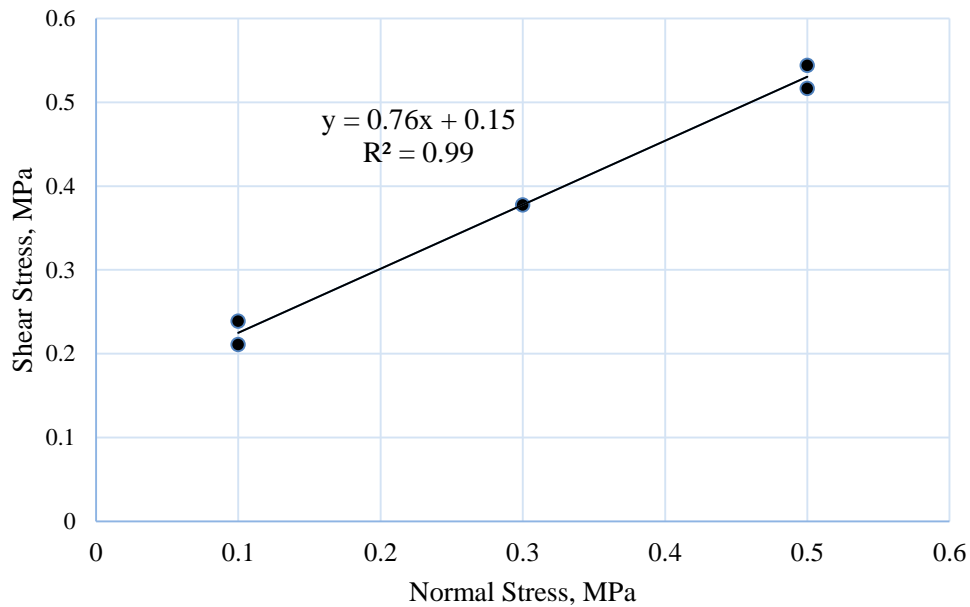
Figure 4.7 Normal Stress versus Shear Stress

It is important to note that the good correlation between the experimental results and the linear regression line, confirms the initial assumption of Coulomb's friction law for the shear strength of horizontal bed joints in the lime-based masonry samples. As a result of the linear regression the cohesion and coefficient of friction for the lime-based masonry samples, TSs, were found to be 0.15 and 0.76 (43.5°), respectively.

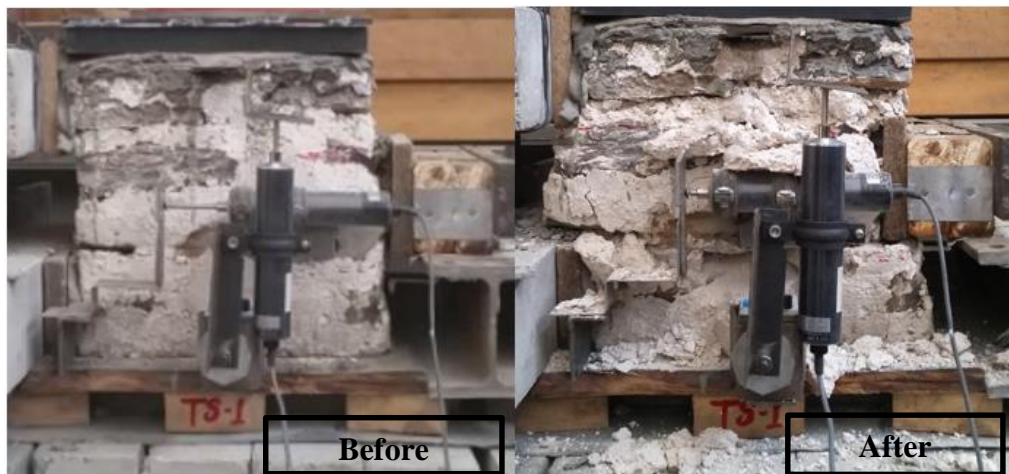
Figure 4.8 Failure mode of Specimen TS1

As stated in the previous chapter, the historical masonry specimens were built with three roughly defined layers and each layer comprising a combination of mortar and basaltic stones.

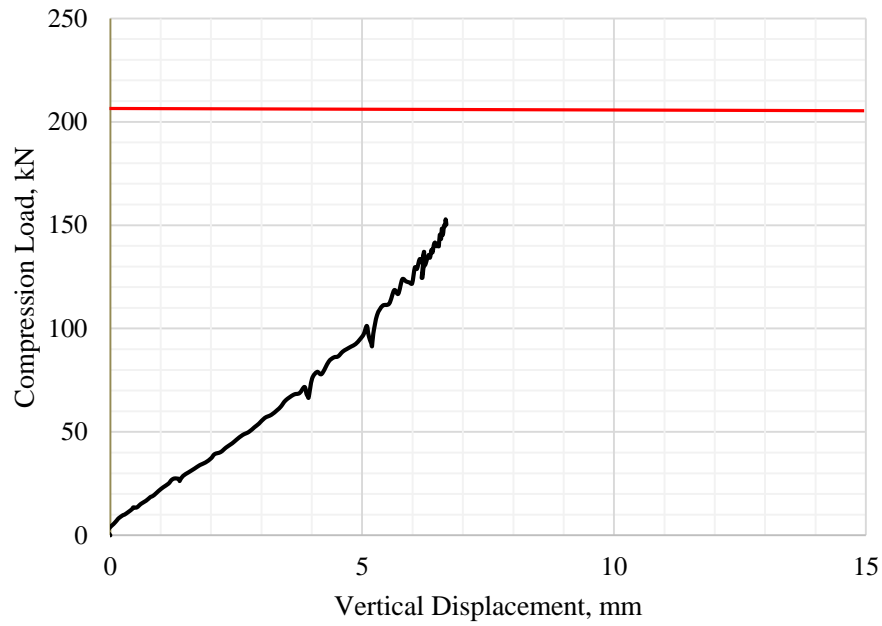
Figure 4.9 Compression test on specimen C1

Specimen	Maximum Load, kN	Compressive strength, MPa	Modulus of elasticity, MPa
C1	207	2.3	40.2
C2	217	2.4	34

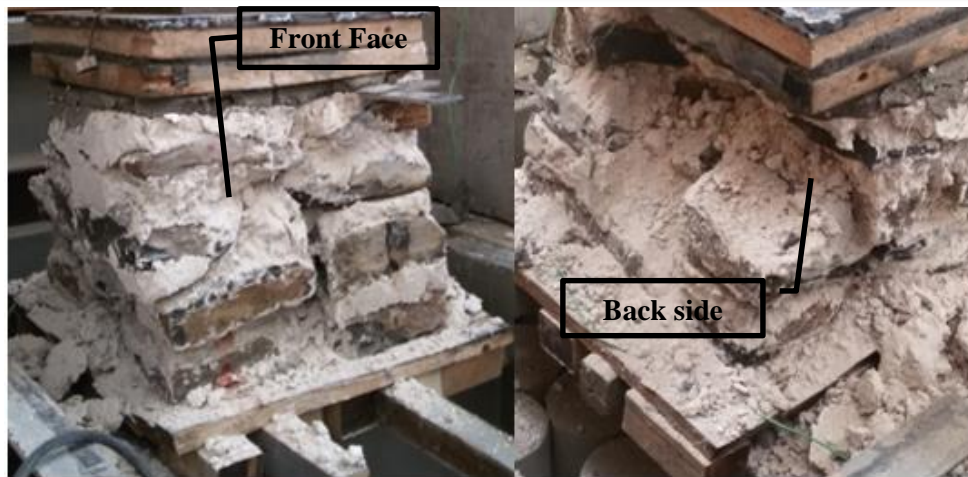
Figure 4.11 Specimen C1 after compression test (failure mode)

And for specimen C1, once the load reached 150kN, the specimen disintegrated explosively. This happened when some highly stressed stones burst out from the back side of the specimen, see Figure 4.11. As for specimen C2, the stones failed in a random manner.

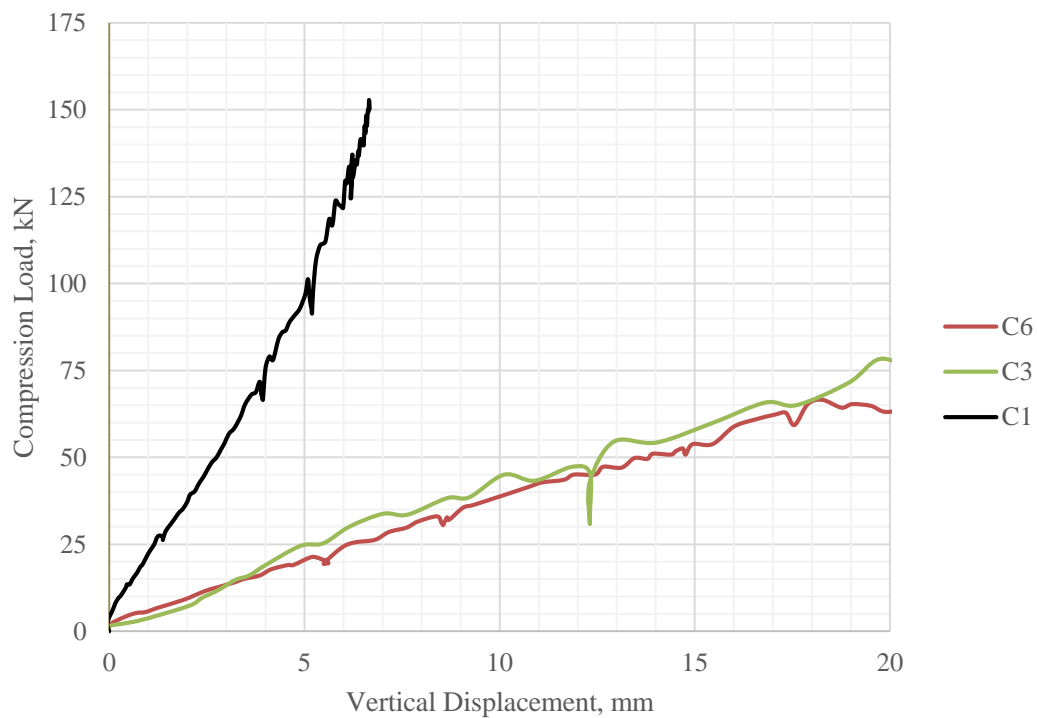
Figure 4.12 Effect of tensile stress in the compressive strength of masonry

As it is depicted in Figure 4.12 the stiffness as well as the strength of specimen C3 & C6, are much lower than that of the pure compressive tests conducted on other specimens.

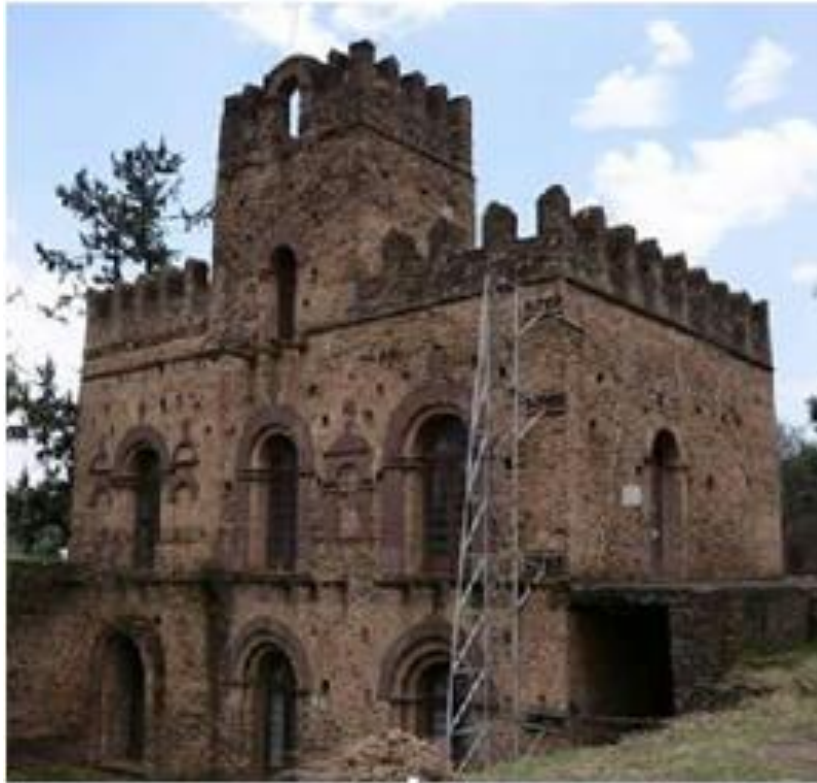
Figure 5.1 western side of Mentwab Castle

The western façade of the castle has three, triple-layered, arched entrance doors on the ground and first floor, in addition one on the second floor. Those on the two upper floors appear to open out to wooden balconies which no longer exist, Figure 5.1. The eastern façade has a tall triple-layered arched door on the northern side of the first floor that opens out to an impressive staircase that leads down to the ground level, Figure 5.6.

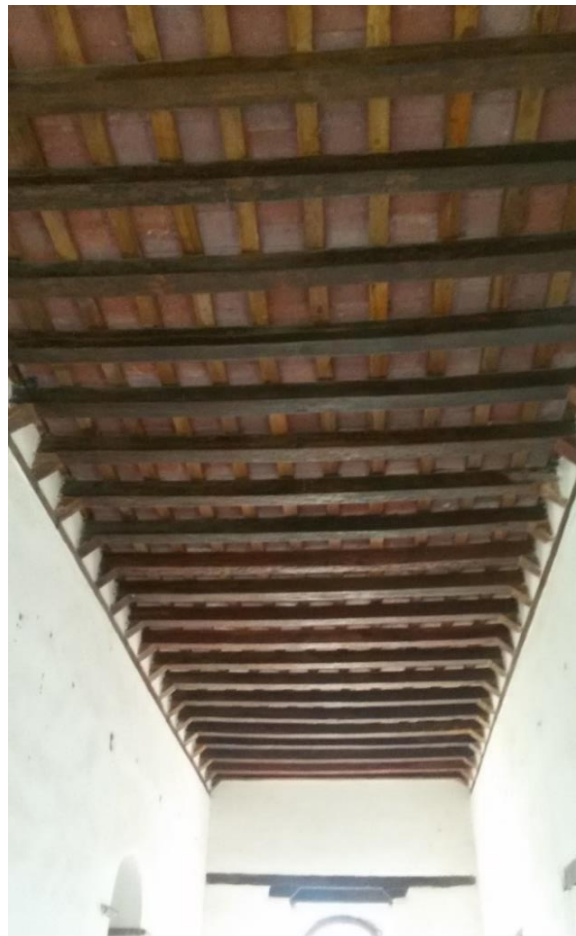
Figure 5.3 Interior of roof above banquet hall

room is made of vertically laminated timber beams with scarf and dovetailed joints. Concerning the middle room, it is estimated that its roof is made of concrete beams.

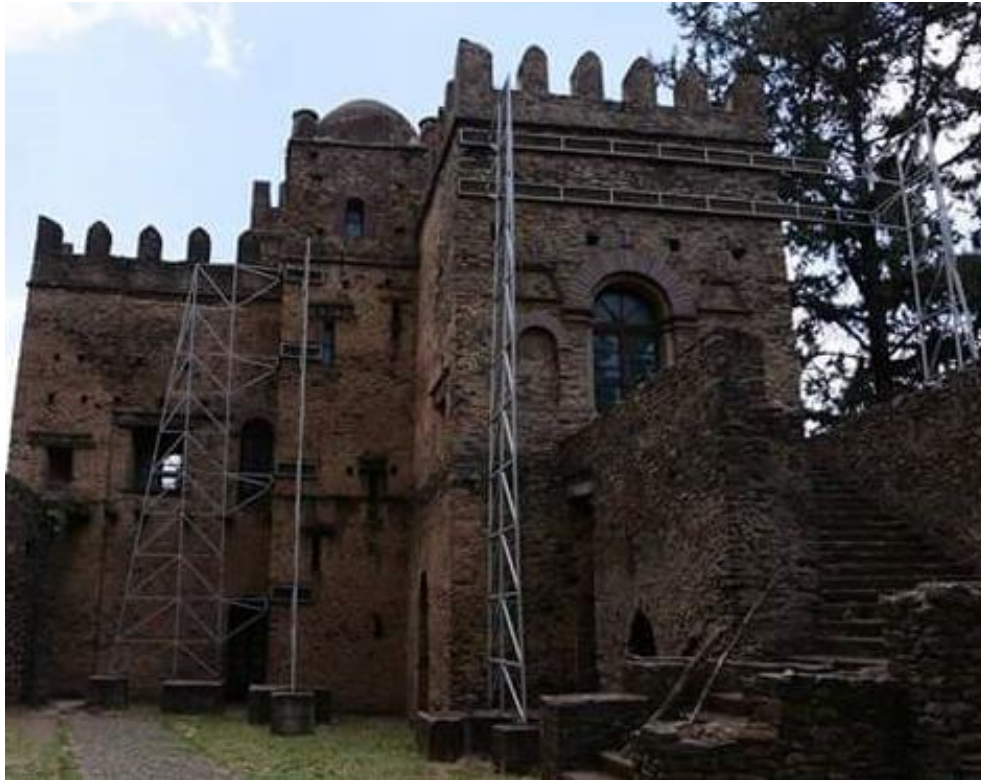
Figure 5.6 Shoring on the east and south of the castle

Although, the shoring system is placed to safeguard the building, its efficiency is reported as being highly doubtful.

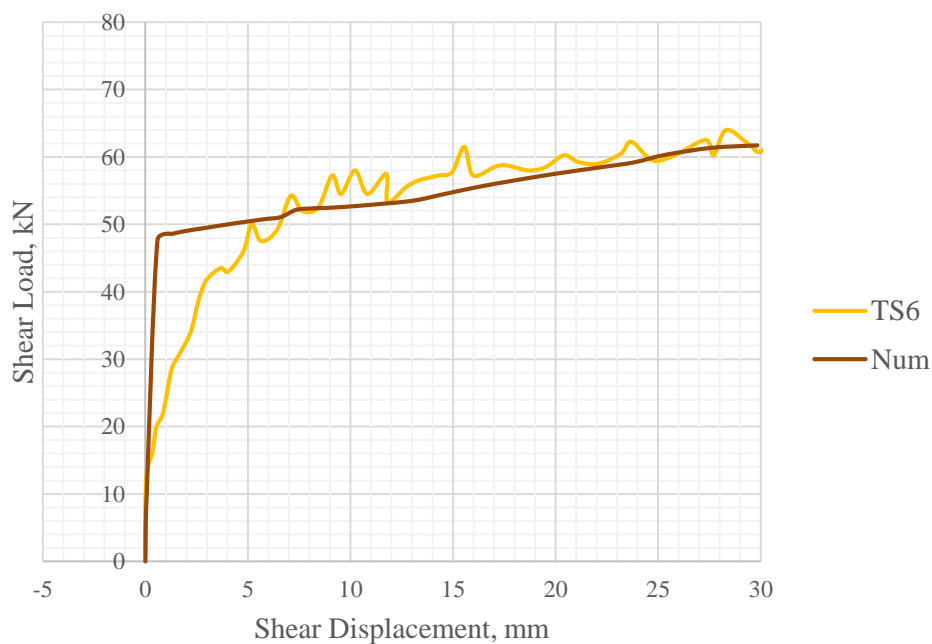
Figure 5.8 Comparison of FEM analysis and experimental result for shear

As a result of the analysis shear deformation shown on Figure 5.7 was obtained. When the result of the FEM analyses was compared with that of the experimental test results, it was observed that except the lowest confinement level, the model resulted in acceptable values for the peak loads.

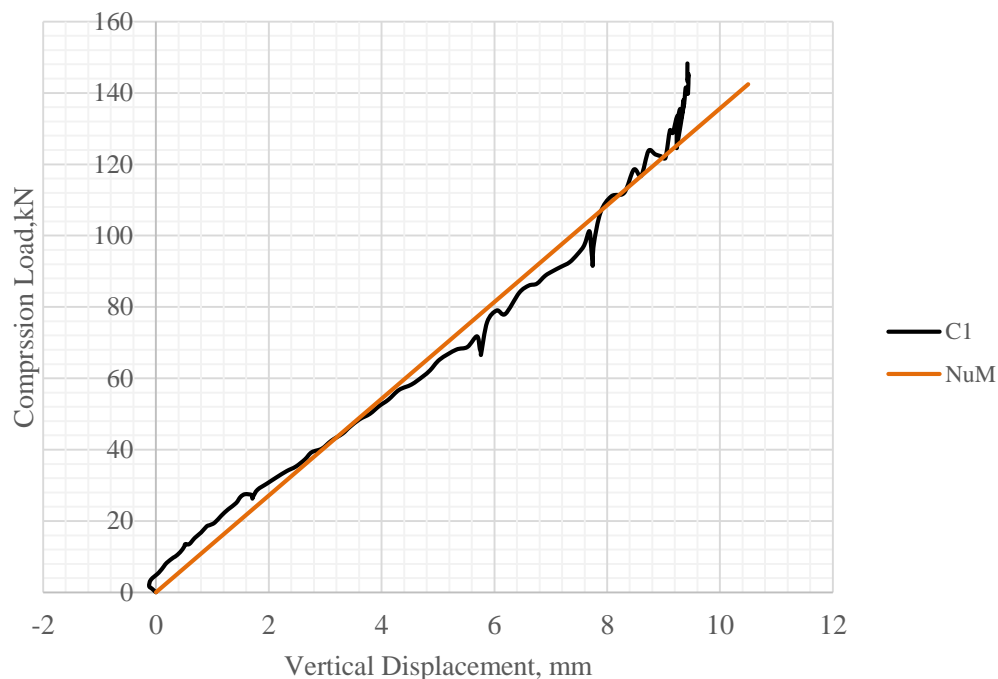
Figure 5.9 Comparison of FEM analysis and experimental result for compression

As a result of the analysis conducted on the finite element model, the vertical load versus vertical displacement graph depicted in Figure 5.9 was obtained.
