**Geological and Environmental Appraisal for the New Sanitary  
Landfill Site at Chebe Weregenu, North East of  
Addis Ababa, Ethiopia**

*In Partial Fulfillment of the requirements for the Degree of Masters in  
Environmental Geology*

**Netsanet Mengistie  
June, 2012**

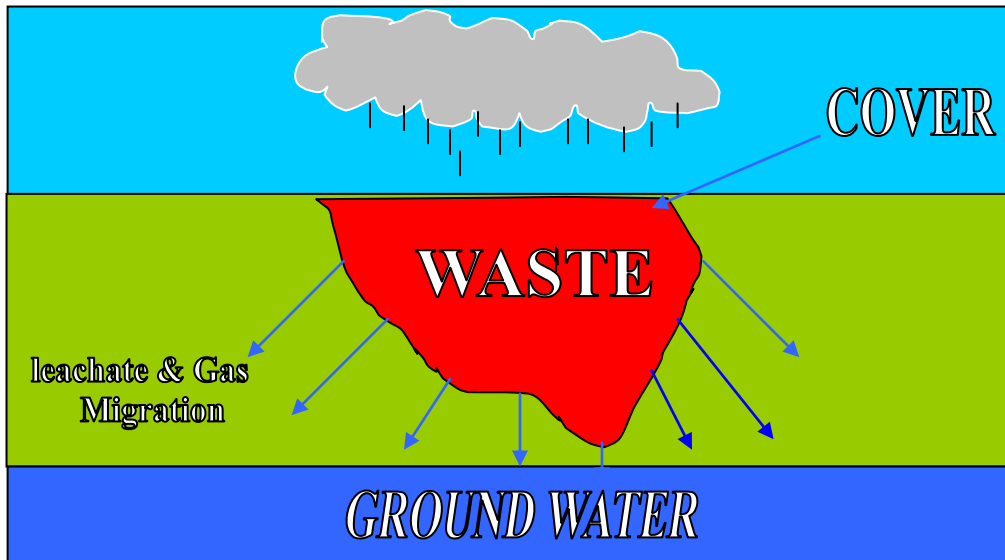
Fig. 1.1 Sketch showing how leachate and gas migrate in to the ground

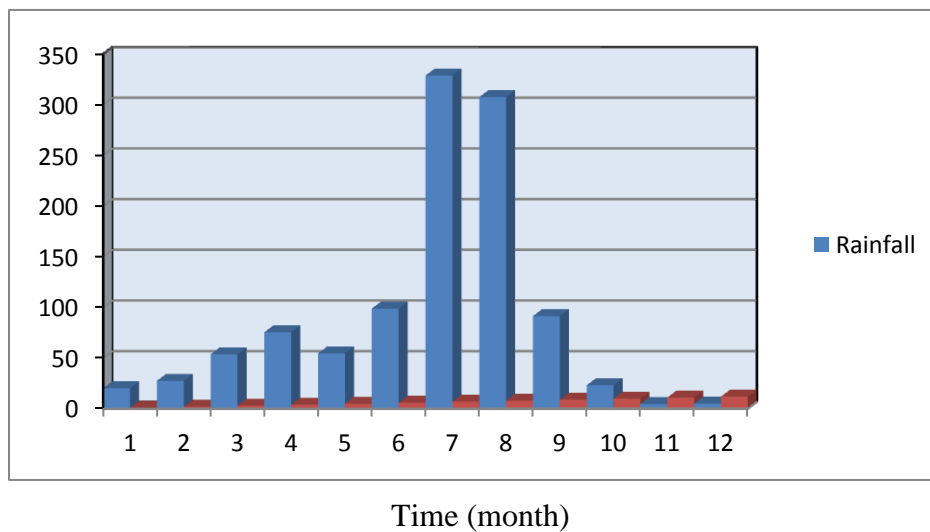
**Fig.2.3 Mean Annual Rainfall Chart of Sendafa Station (in mm)**

The charts (Fig. 2.3 and 2.4) clearly show that the area has maximum rainfall in July and August. And the minimum rainfall is recorded in November and December.

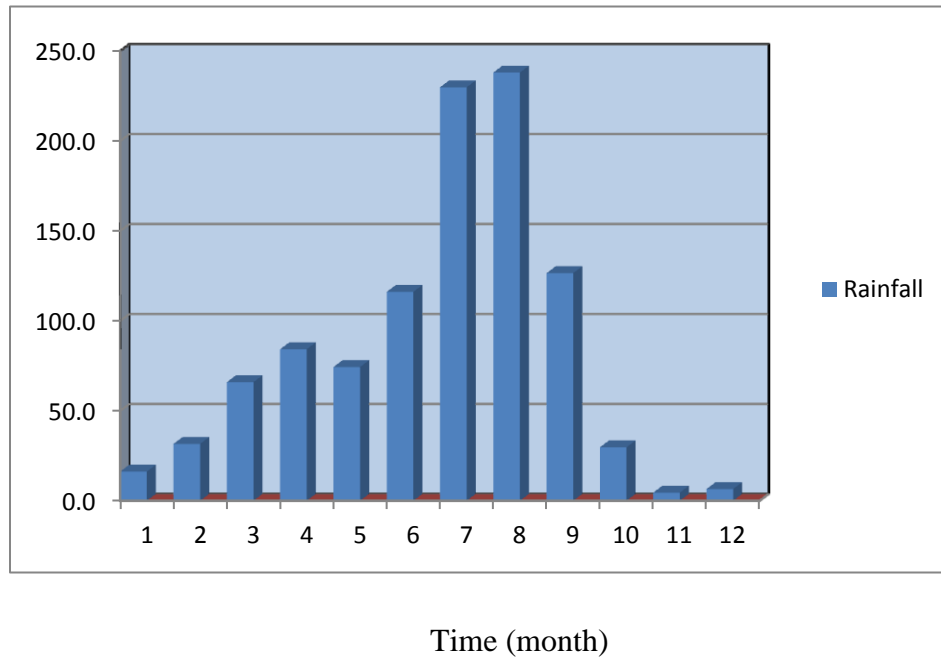
**Fig.2.4 Mean Annual Rainfall Chart of Addis Ababa Station**

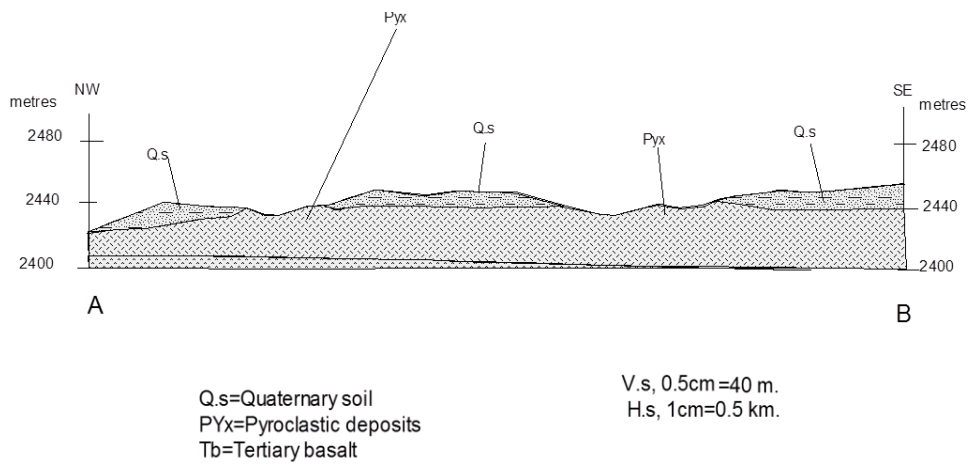
**Fig. 2.6 Geological cross section along line A-B.**

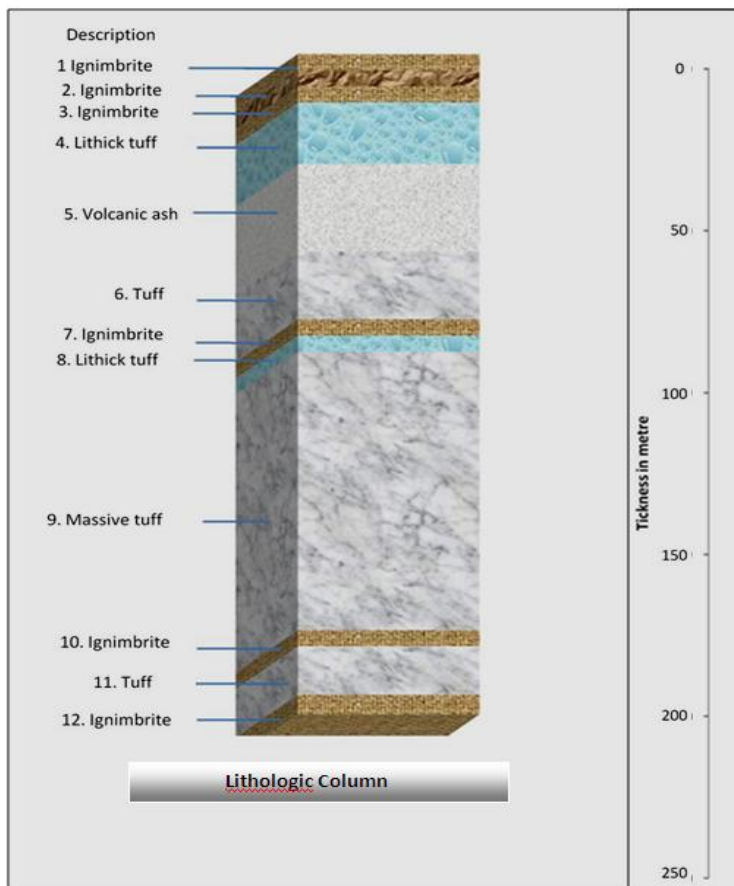
**Fig. 2.7 Lithostratigraphy of Chebe-Weregenu area (modified after GSE, 2010)**

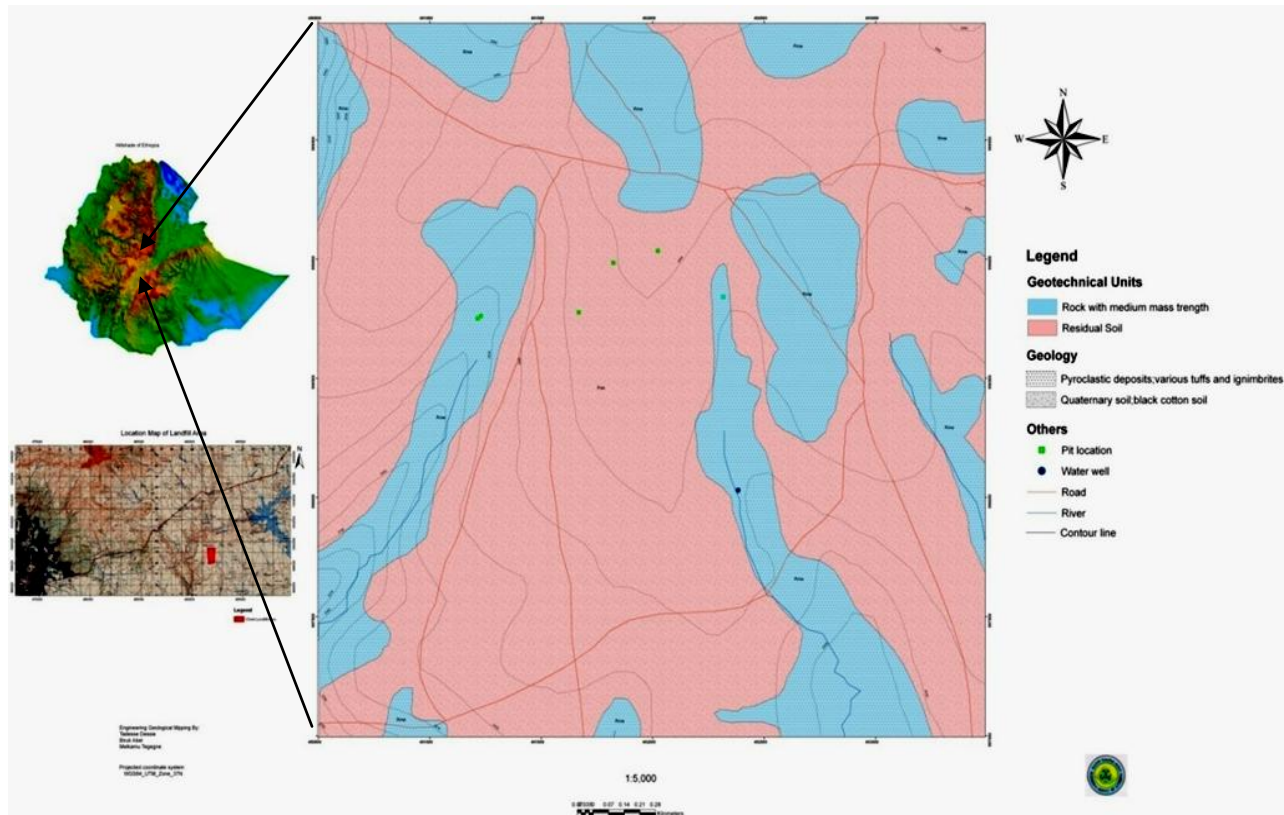
Fig.2.8 Engineering geological map of the Chebe-Weregenu landfill site (Source: GSE, 2010)

Residual soil is an in-situ developed soil from the underlying parent rock by mechanical and chemical decomposition (GSE, 2010). Fig.2.8 shows the engineering geological map of the study area at 1:5,000.

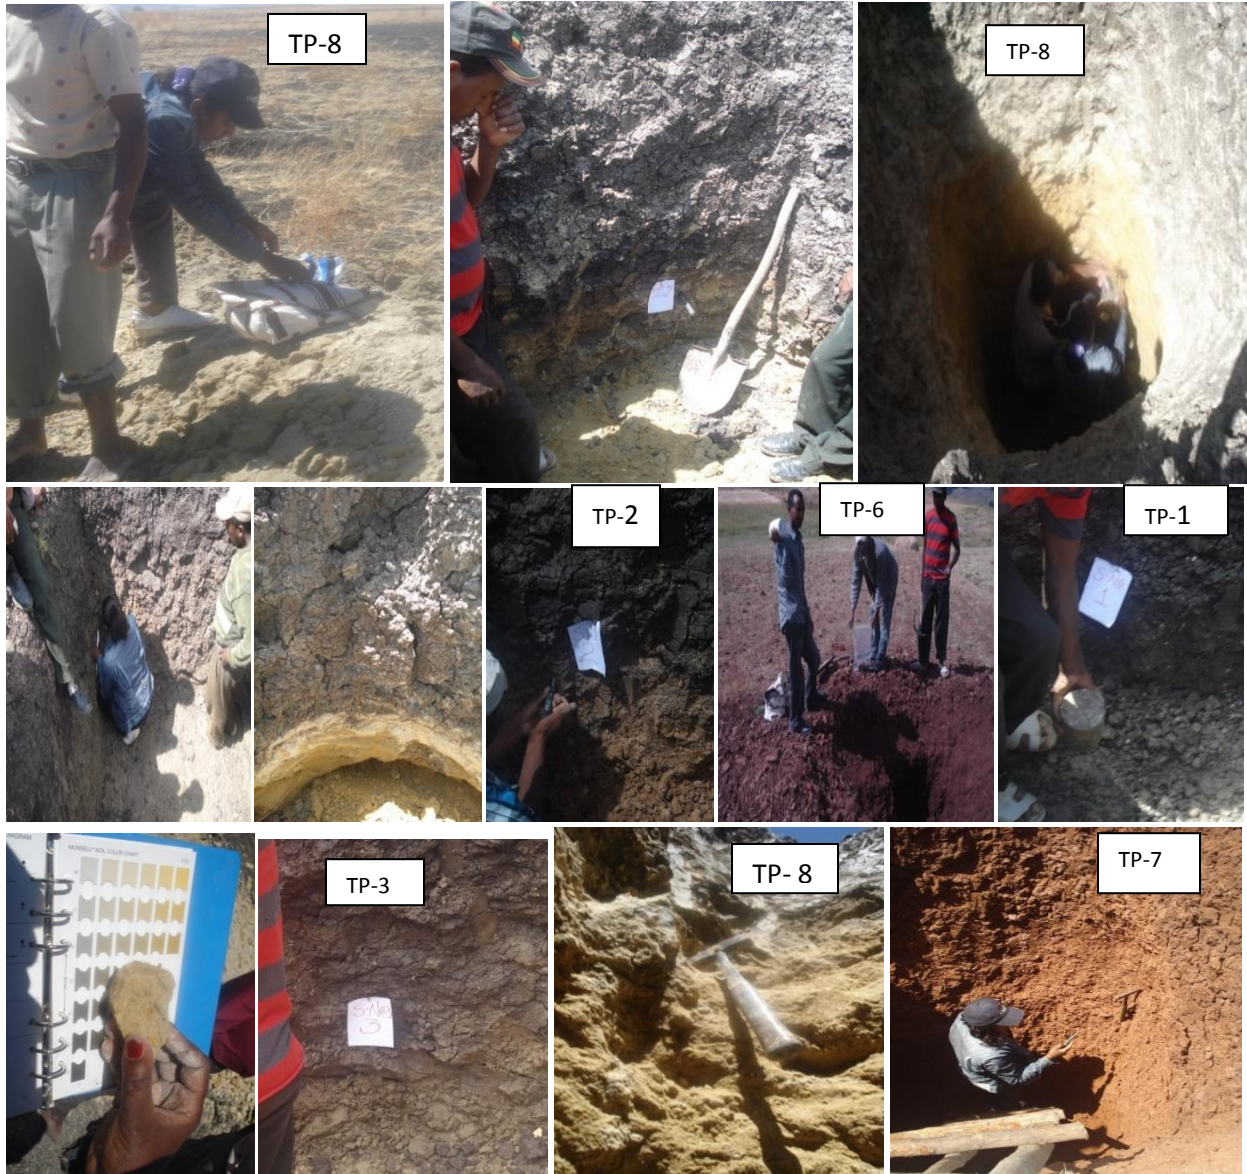
Plate 1- Different test pit excavations at Chebe landfill site

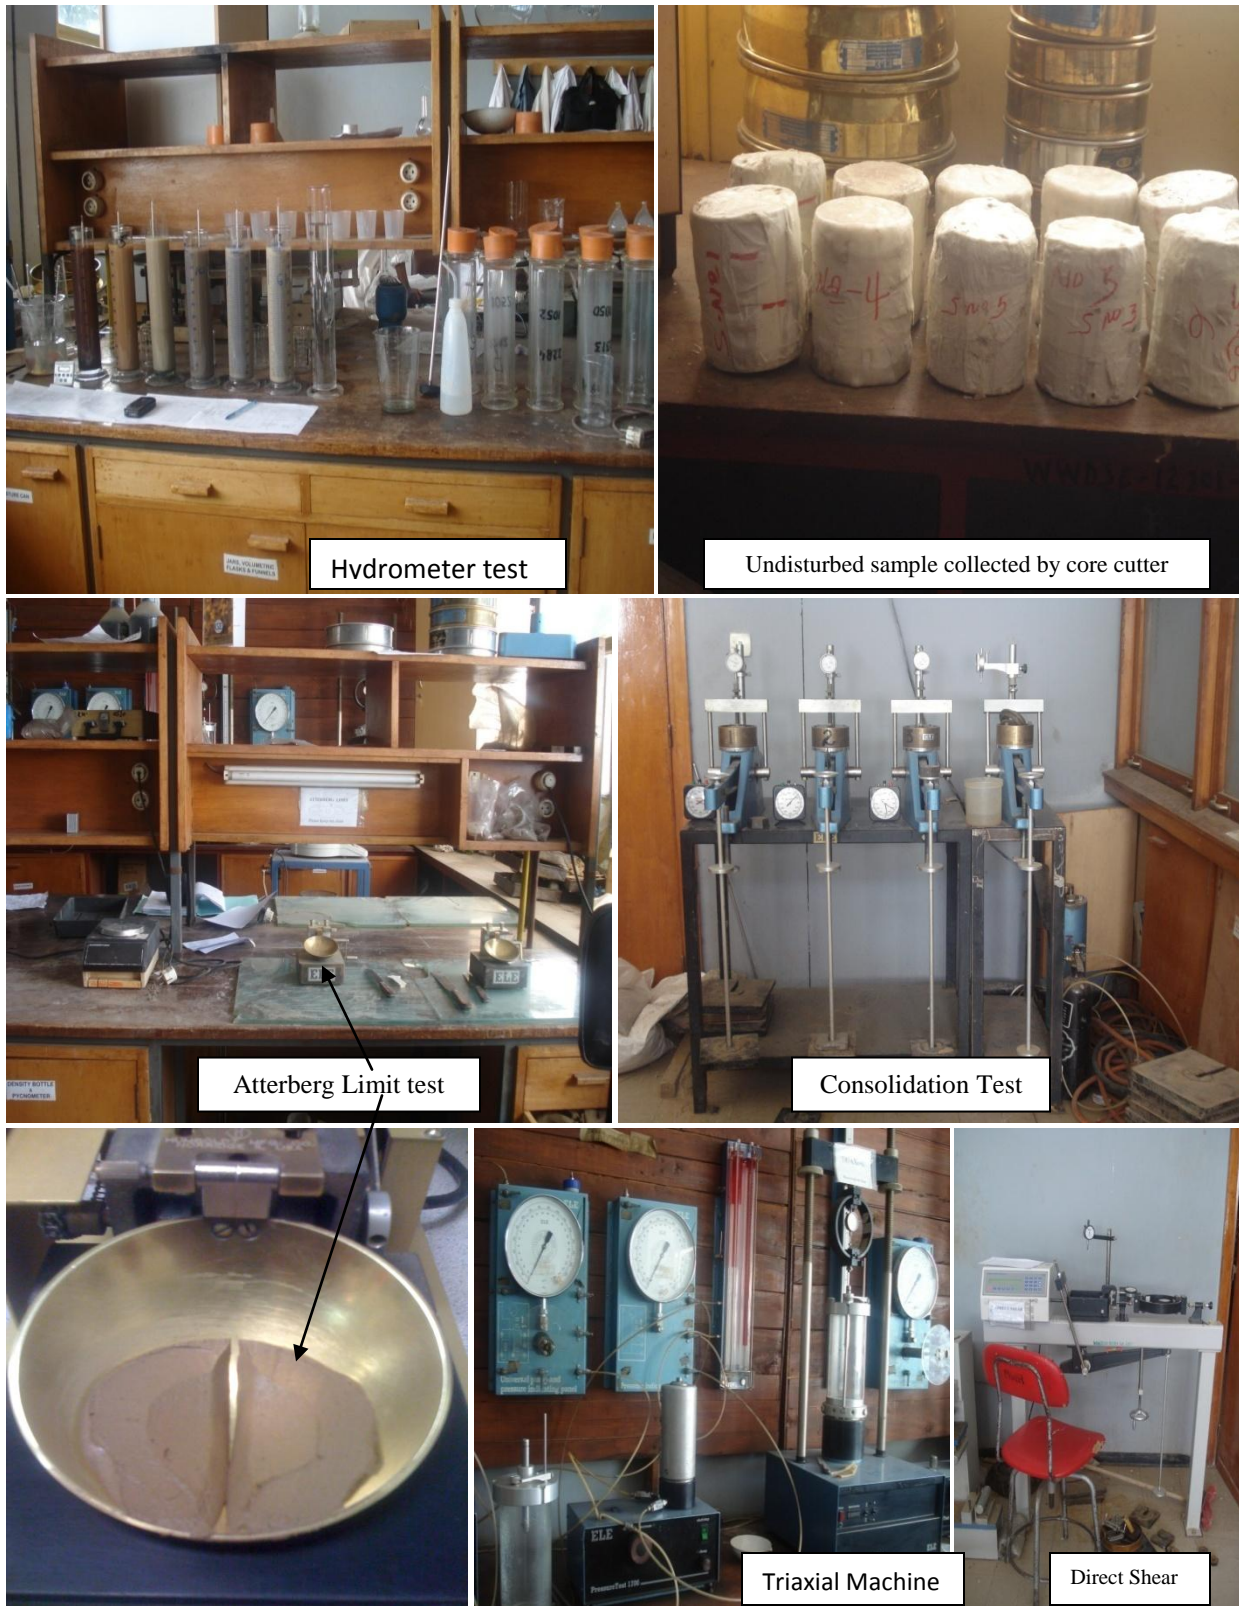
Plate 4: Some of laboratory test instruments used during the research study

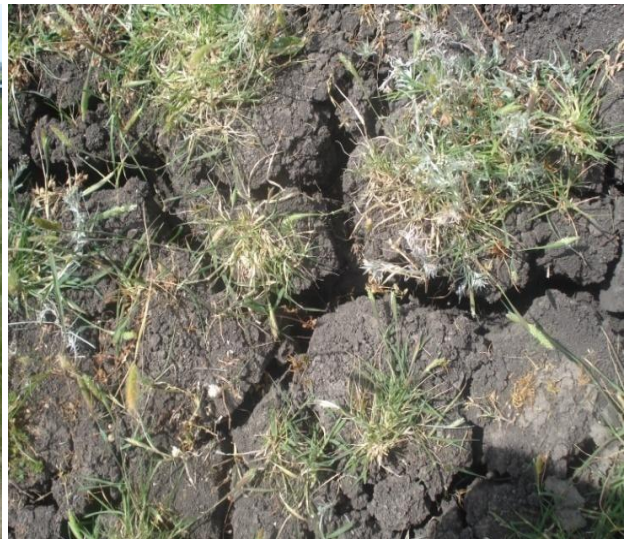
Surface cracks formed during drying of swelling clays, Feb, 2012

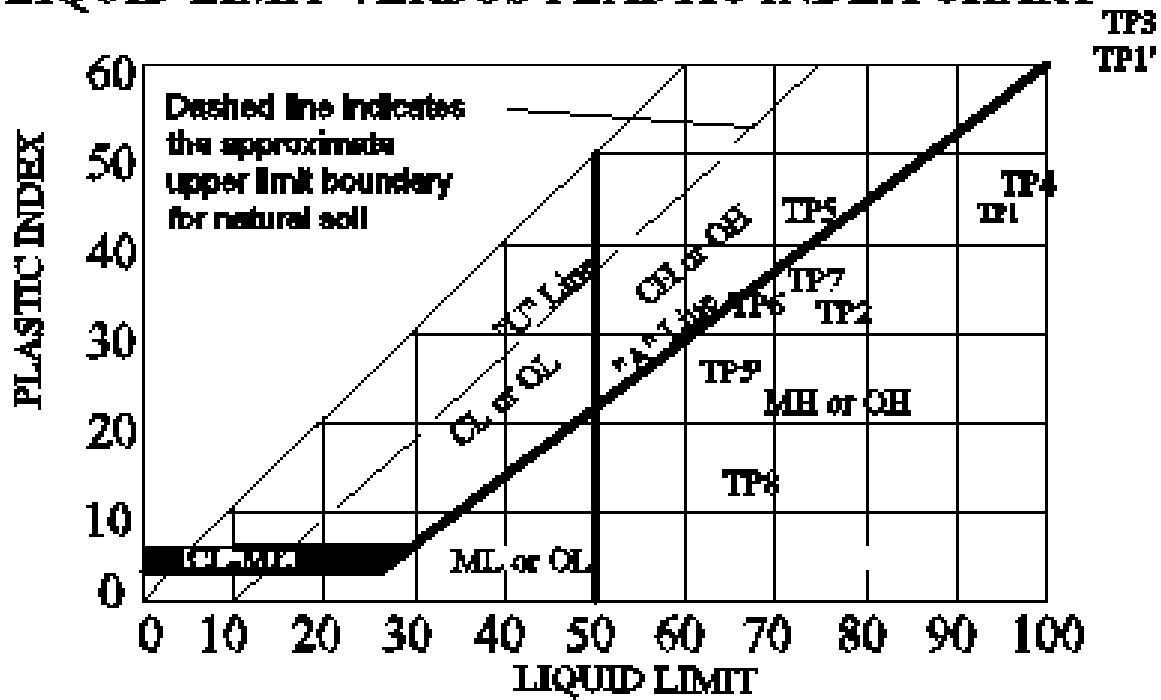
SOIL DATA						
SAMPLE NO	DEPTH (m)	NATURAL MOISTURE CONTENT (%)	LIQUID LIMIT (%)	PLASTIC LIMIT (%)	PLASTICITY INDEX (%)	USCS
TP1	0.0-1.3	-	91.70	45.55	46.15	OH
TP7	1.3-2.0	27.72	105.28	42.31	62.97	OH
TP2	1.2-2.0	51.93	78.30	44.50	33.80	OH
TP3	0.0-2.0	36.34	106.30	41.98	64.32	OH
TP4	0.0-2.0	43.99	95.32	45.71	49.61	OH
TP5	0.0-1.2	37.87	75.1	34.01	41.09	CH
TP9	1.2-2.0	54.84	62.63	39.21	23.42	OH
TP6	0.0-1.2	31.35	65.62	34.59	31.03	OH
TP7	3.5-4.0	40.31	76.63	38.70	37.93	OH
TP8	1.37-3.17	-	69.00	55.42	13.58	OH
TP9	3.17-4.5	63.30	-	-	-

Fig. 3.2 Plastic Index versus Liquid Limit Chart

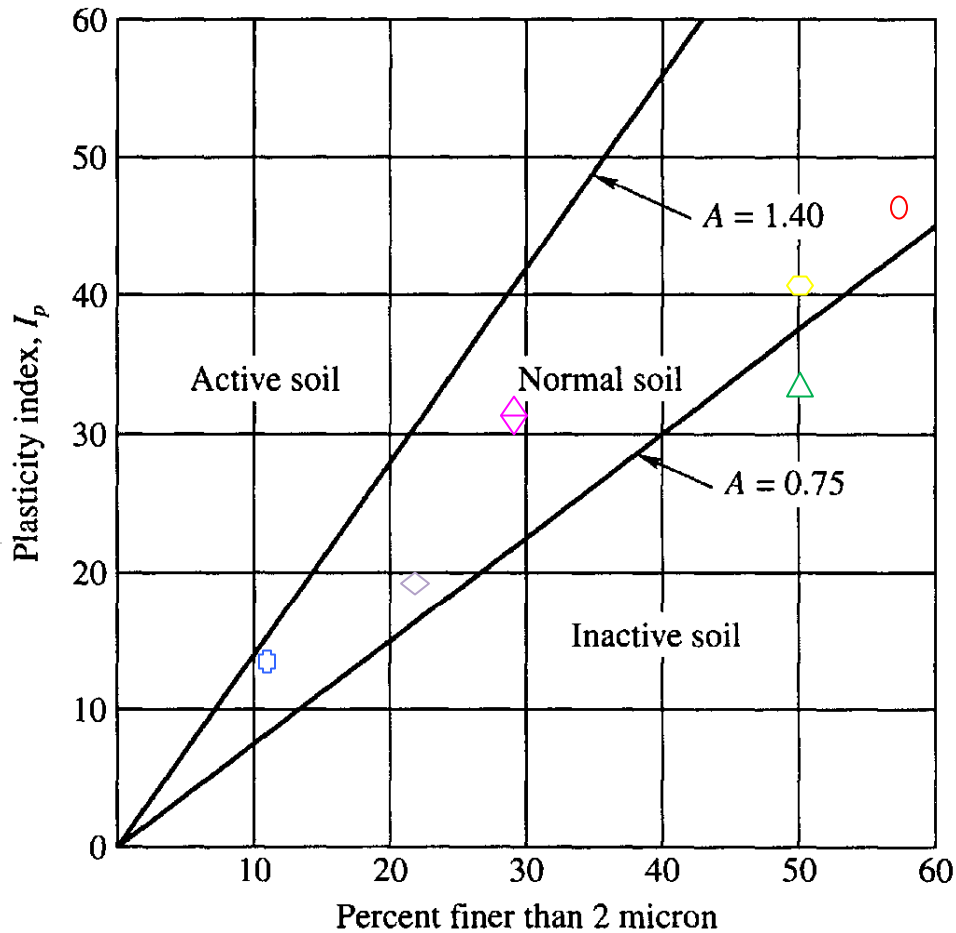
Fig.3.3 Soil classification chart (Skempton, 1953).

☞ Based on the soil classification chart (Skempton, 1953) indicated on figure 3.3 and activity classification table 3.23, all the soil test results fall in normal and inactive soil groups. This shows that the soil is not the type that swells.

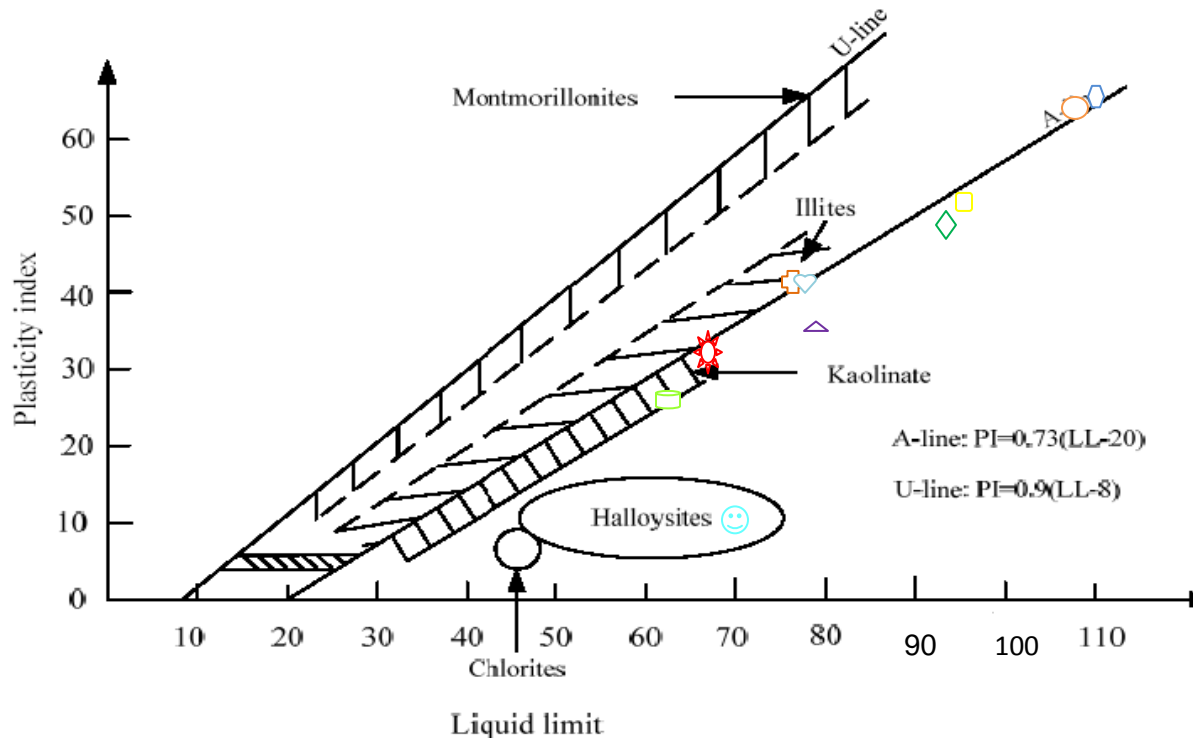
Fig.3.4 Plot of clay minerals on Casagrande's chart (Chleborad, 2005).

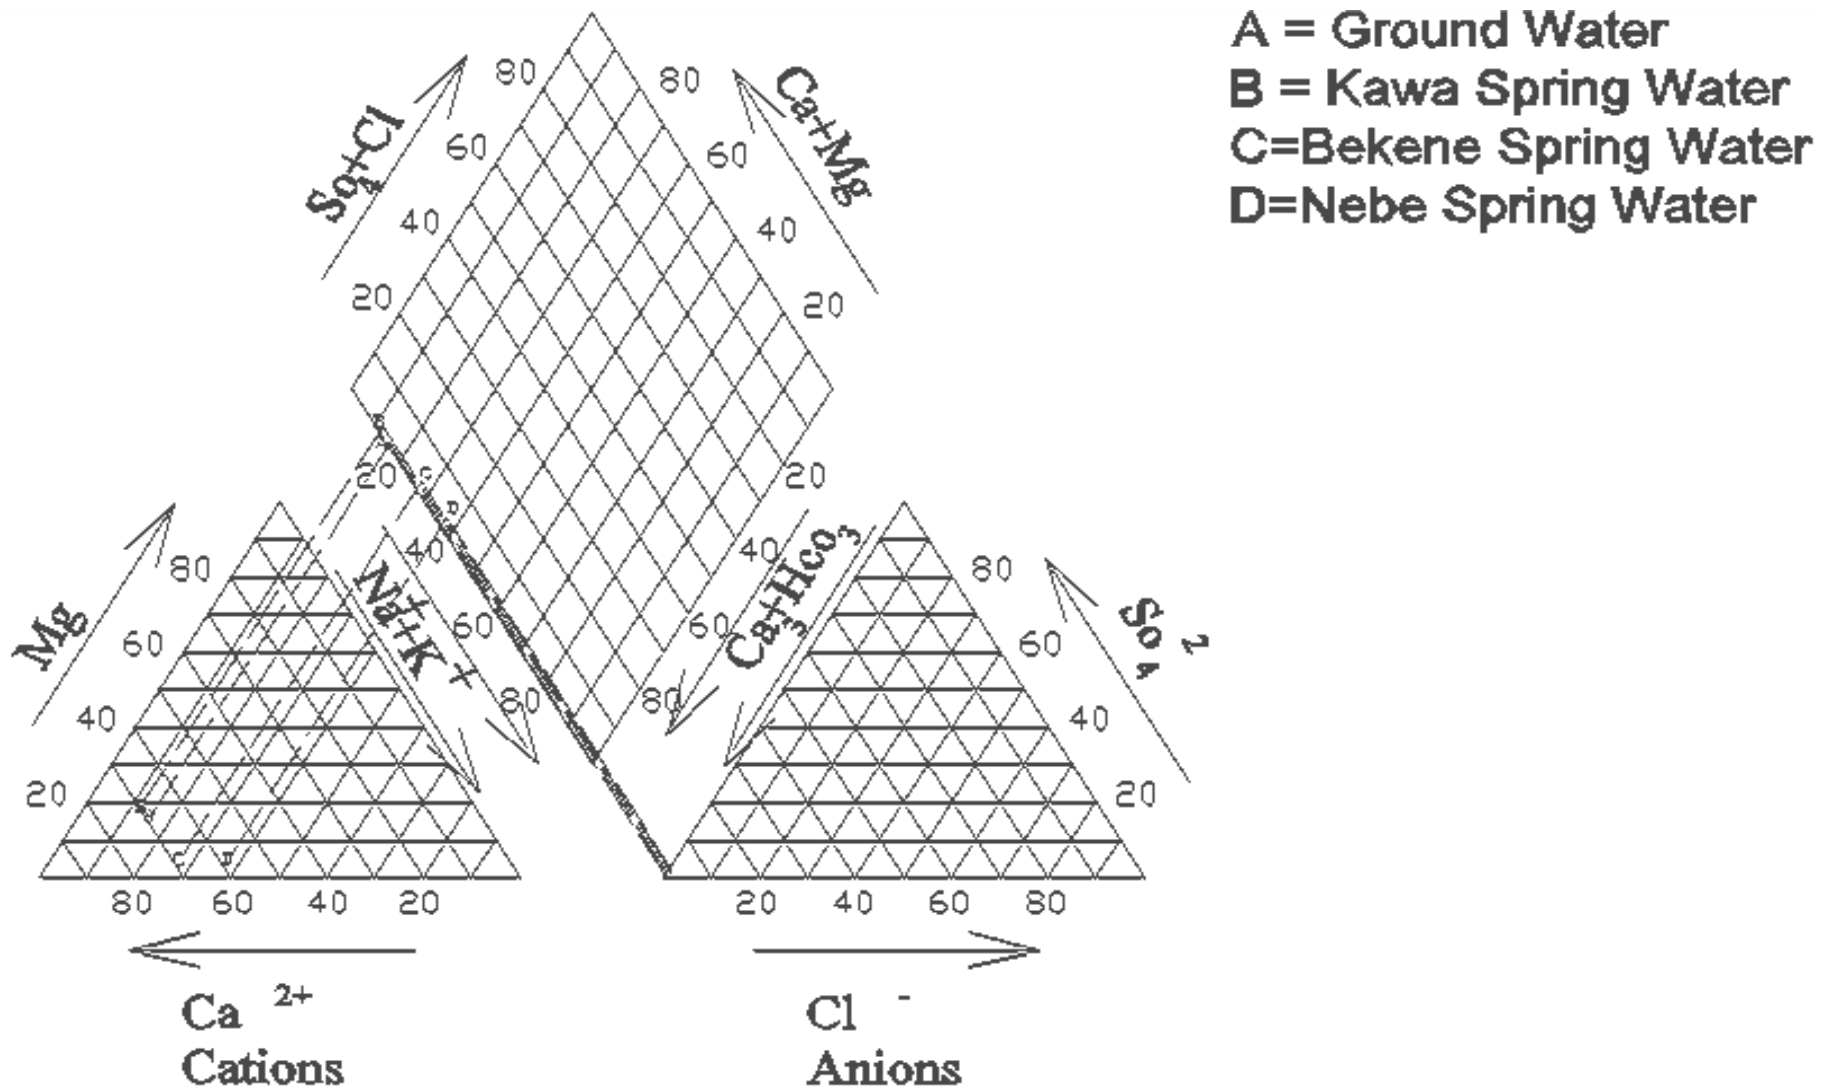
Figure 3.5: Water analysis of four samples plotted on a piper diagram

Groundwater sample, Nebe spring and Bekene spring water sample have shown Ca-Na/HCO<sub>3</sub> water type, where as Kawa spring show Ca-Mg/HCO<sub>3</sub> type (see figure 3.5).

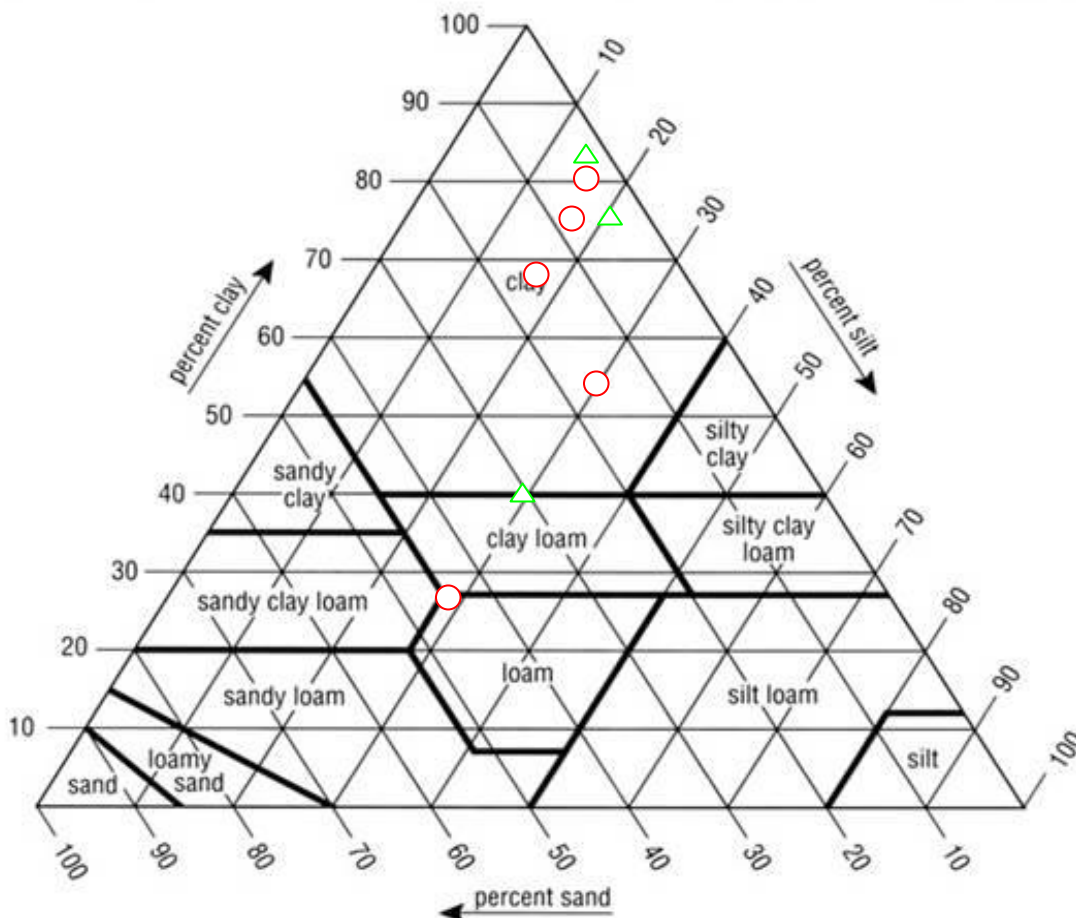
Figure 3.6 Soil Textural Triangle Classification Chart

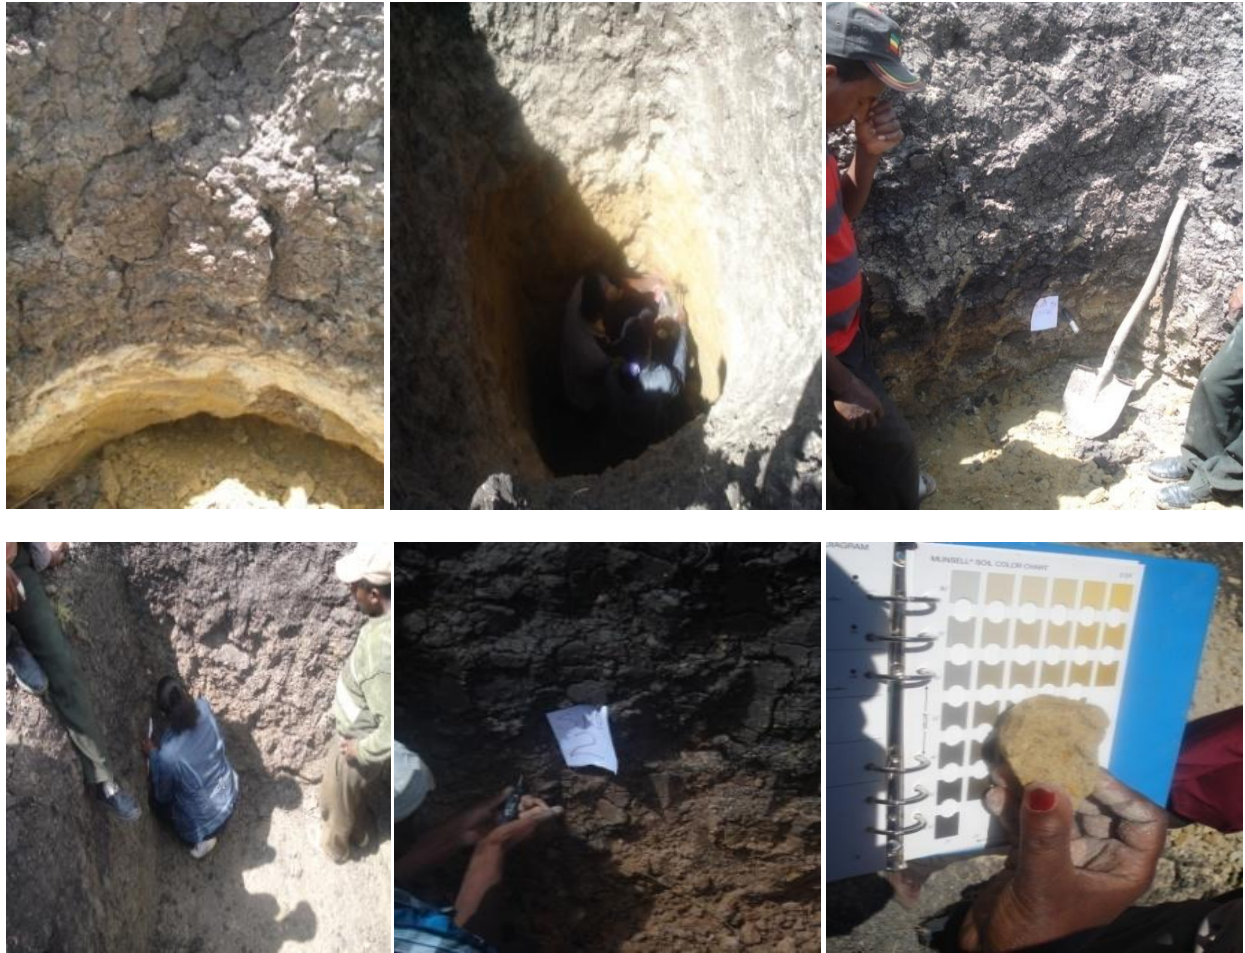
**Plate 6: Different test pits at site**
