Study of Construction Defects in Public Building Projects in Addis Ababa

(A Case study of Federal Government Office Building Projects)

By Bedru Merhaba

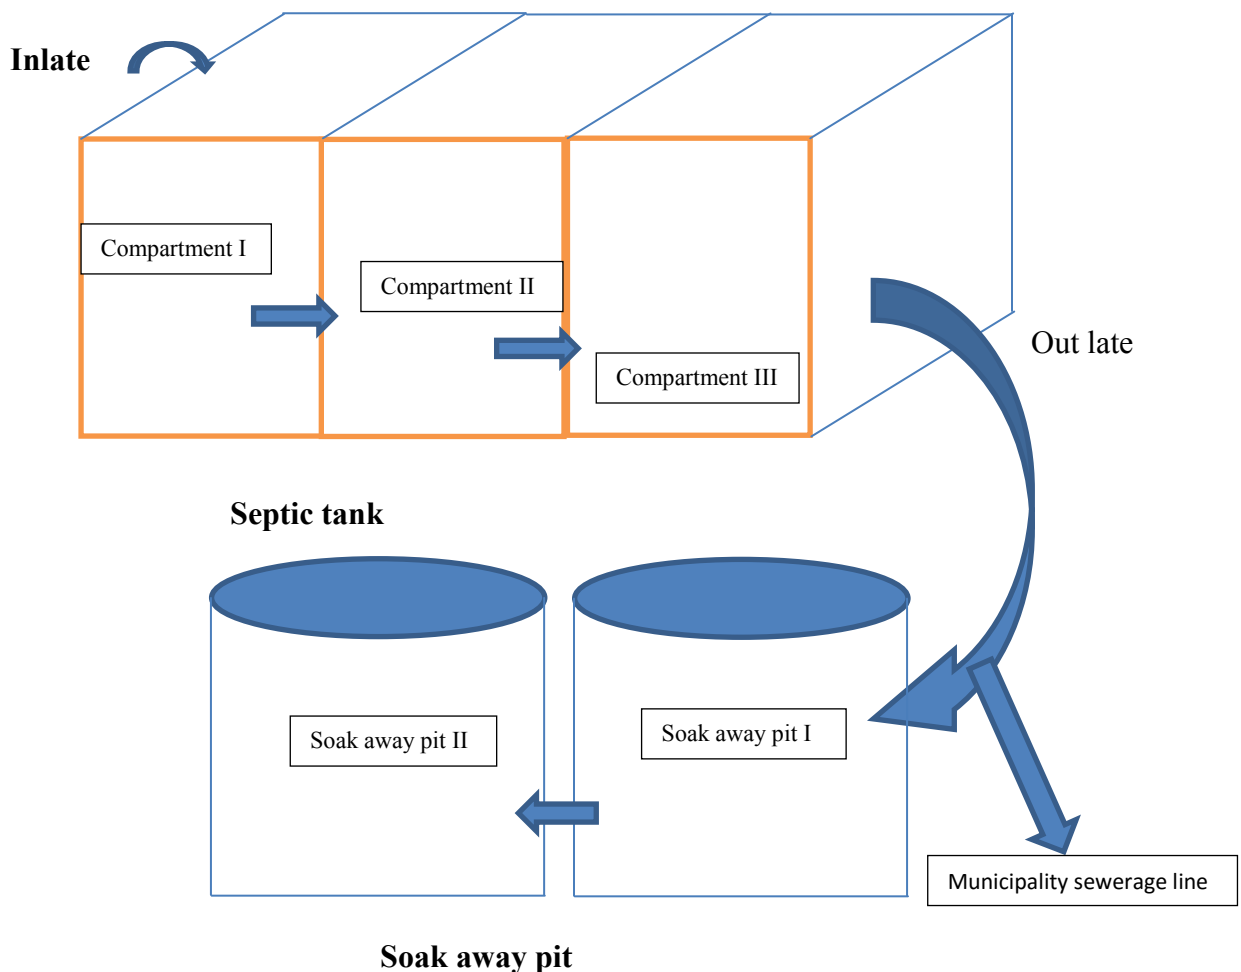
Fig 4.1: – Typical sewerage line

Typical sewer system of old buildings (Ministry of Health, Ministry of Agriculture and Custom and Revenue Authority) was as follow in the Fig 4.1 below. As shown on the figure after the sludge entered to the septic tank at the inlate allowed passing through compartments with aiming to trap solid waste & letting the water to the soak away pit and there through filtration it joins to ground water. In rainy season the ground water table is raised and it filled the soak away pit. When this happen the soak away pit is no more in function and flowing of water to soak away pit was blocked, then the compartments being full. Finally the sewer line stops functioning.

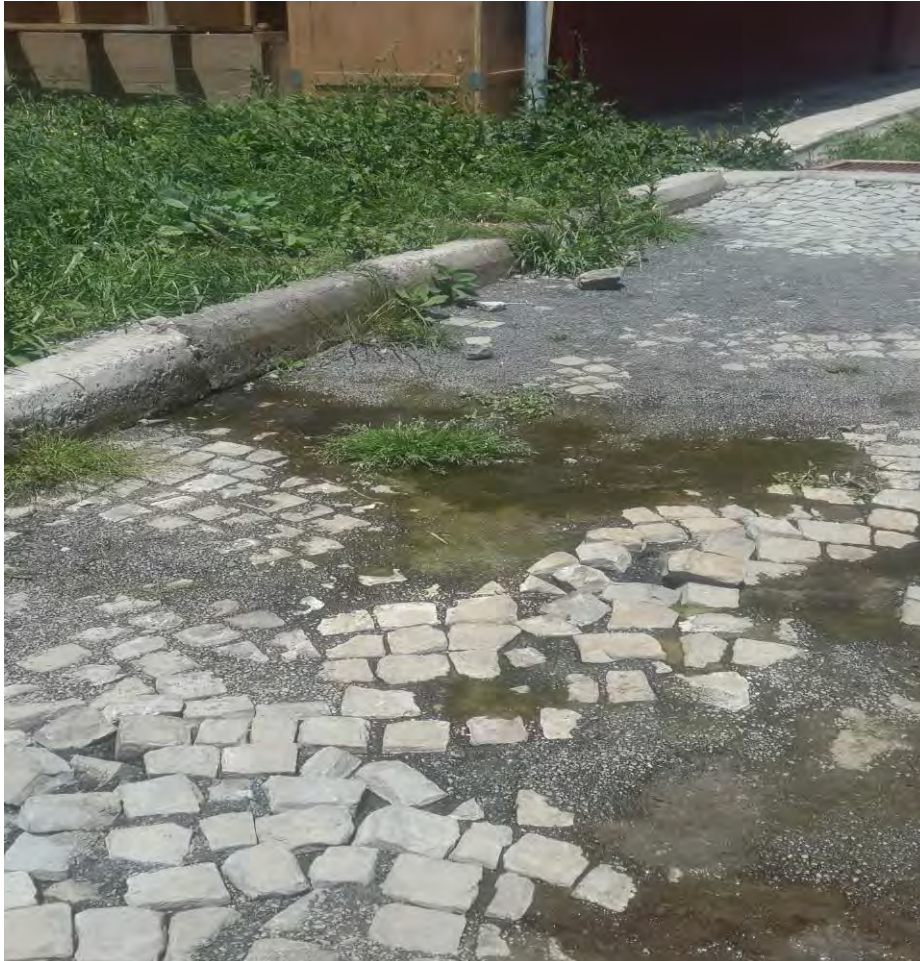
Fig 4.2: – Sludge drains to the surface

This type of defect was observed in all three buildings. At Custom and Revenue Authority the problem was not because of ground water table raising rather it was because the septic tank and soak away pits were constructed in hard rock. As shown in the fig 4.2 the water flowing to soak away pit cannot drain to the ground rather it drained to the surface

At Ministry of health the problem was solved by connecting building sewer line directly to municipality sewer line. At Ministry of Agriculture and Custom and Revenue Authority the problem was not solved and the proposed temporary solution was sucking the waste. Also the client proposed permanent solution which is connecting the sewer line to municipality sewer line at the locality. But this will work if and only if city administration constructs sewer line at that locality. For remaining project design modification was done, connecting building sewer line to municipality sewer line.

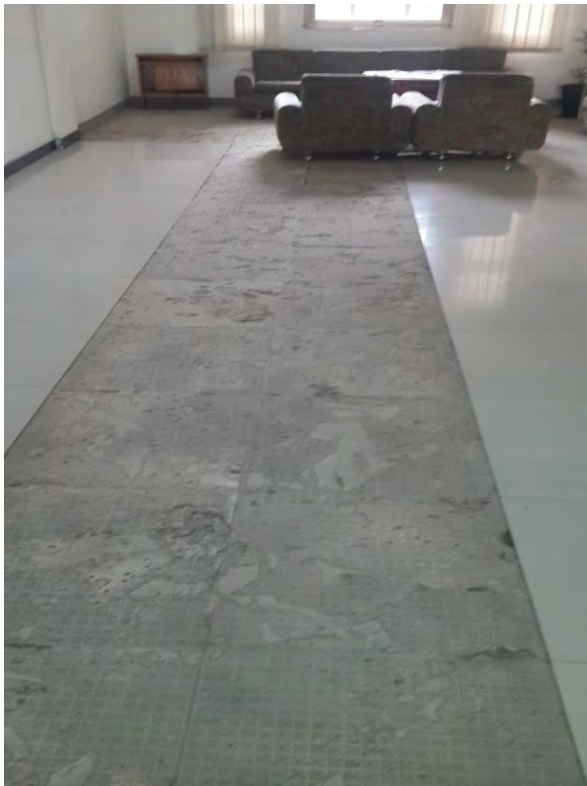
Fig 4.3: – Loosen floor tile

This type of defect was observed at many case study buildings, where floor finish is ceramic floor tile. The defect was break down of ceramic floor tile after getting loose. This problem was observed at area which experienced relatively larger traffic which means not this defect was attributed by large traffic rather this defect was attributed by poor lining of tiles as a result of defective method of construction. Similar problem was observed at toilet wall finish there the ceramic tiles become loose and then fallen down. Unfortunately the same defect was observed in recent projects too. For clarity bellows are pictures captured at these building

The method of construction adapted was after chiseling the floor pour 1:3 cement to sand ratio mortar then fix tile on it. According to senior site engineers, this method of construction requires highly experienced workmanship unless otherwise it is difficult to attain level surface beneath the tile which in turn after continuous trafficking cause tile break. According to senior engineers

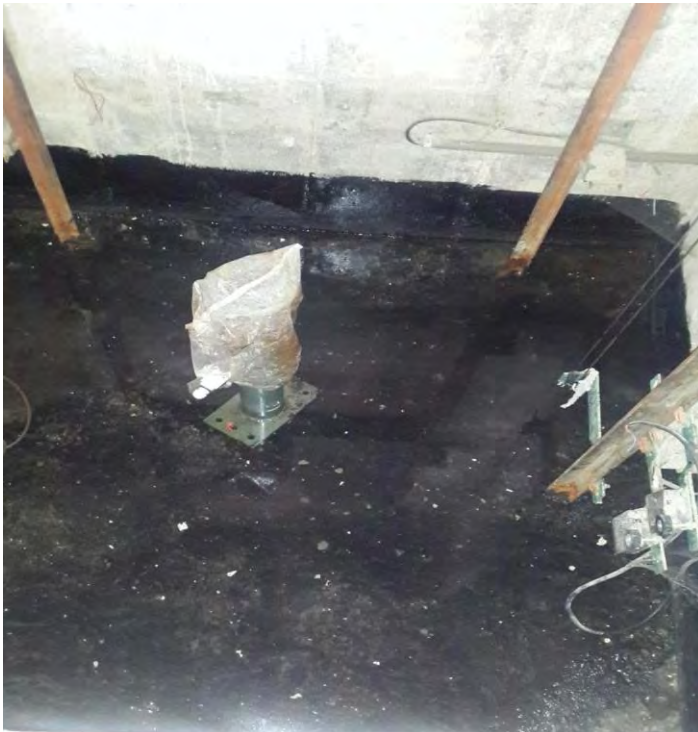
Fig 4.5: - Lift case filled with water

Water leakage to lift case was among one of common defects observed in case study building. This defect was observed in buildings constructed respectively in low areas and the defect was seasonal. In rainy season, when the ground water raised, the water leaks to the lift case. Then cause frequent lift stoppage and electric shock.

This defect was attributed by design error, poor soil investigation, which was manifested in low capacity water proofing material selection. Asphalt lining in the internal part of the lift case was applied as water proofing material but because the pressure is relatively high the water easily leaks to the lift case. Instead membrane lining or cementitious waterproofing materials have high water resisting capacity. Other possible cause to this problem was not providing drain pipe at the periphery masonry of the building. As shown in the figure below the lift case was filled with water. The solution proposed and expected to be implemented soon is lining water proofing materials in layers to the internal parts of the lift case.

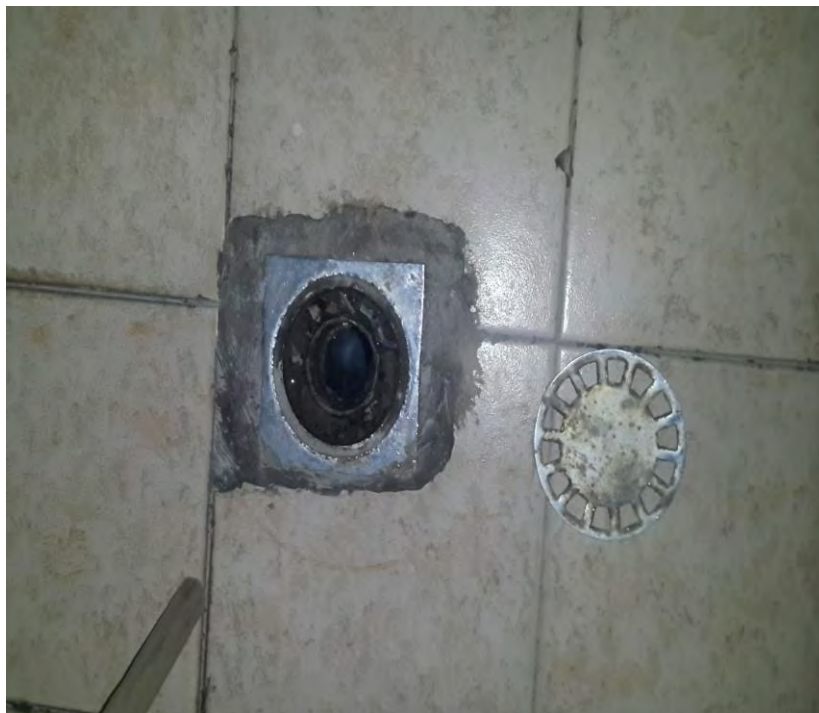
Fig 4.6: - Defective floor drain

Unpleasant odor coming out from floor drain was observed in old case study buildings; there the floor drain was not constructed by providing S-trap. This problem happened because of fermentation of sewage at septic tank. During fermentation (chemical reaction which forms gases) gases have been produced and then search opening to escape. During this journey the gases come to water closet and floor drains before reaching a tube, which was constructed for this purpose. At water closet the gases were entrapped by water at S-trap but it escaped from floor drain.

The possible cause of such a defect was design error, not providing S-trap at floor drains during design. Also the contractor should be responsible for this defect because the contractor shall notice such obvious design error. The possible solution to this problem was re-constructing floor drain by providing S-trap.

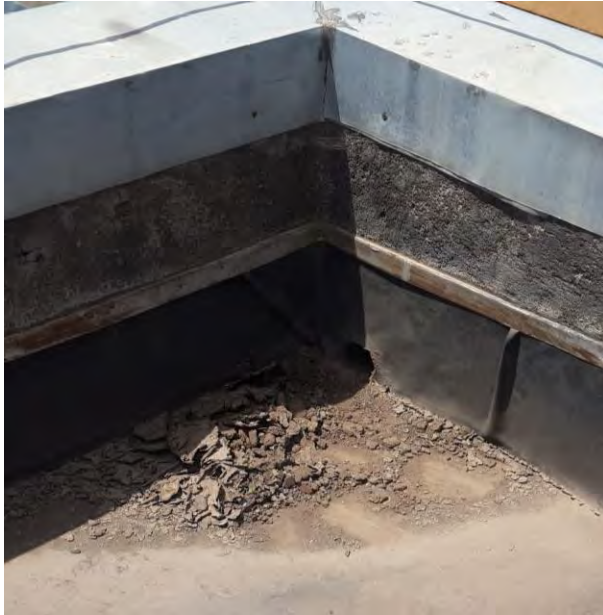
Fig 4.7: – dust accumulated at gutter opening

Observed defective prevention areas were at parapet wall, roof & external wall. There the copping, damp proofing & external wall finishing were defective. Literarily this defect was

attributed by poor workmanship. Small portion of this defect might be caused by improper usage of building service, like putting large mass on the top of the roof and accumulations of dusts at gutter openings. Below are figures taken from defective building. For ease of understanding the remaining defects were tabulated next to it.
