**GIS-Based Statistical Analysis for Evaluation of Landslide
Susceptibility Mapping: A Case Study in Blue Nile Gorge,
Gohatsion-Dejen Road Section, Central Ethiopia**

**Presented in Partial Fulfillment of the Requirements for the Degree of
Master of Science (Engineering Geology)**

ADDIS ABABA UNIVERSITY

September, 2021

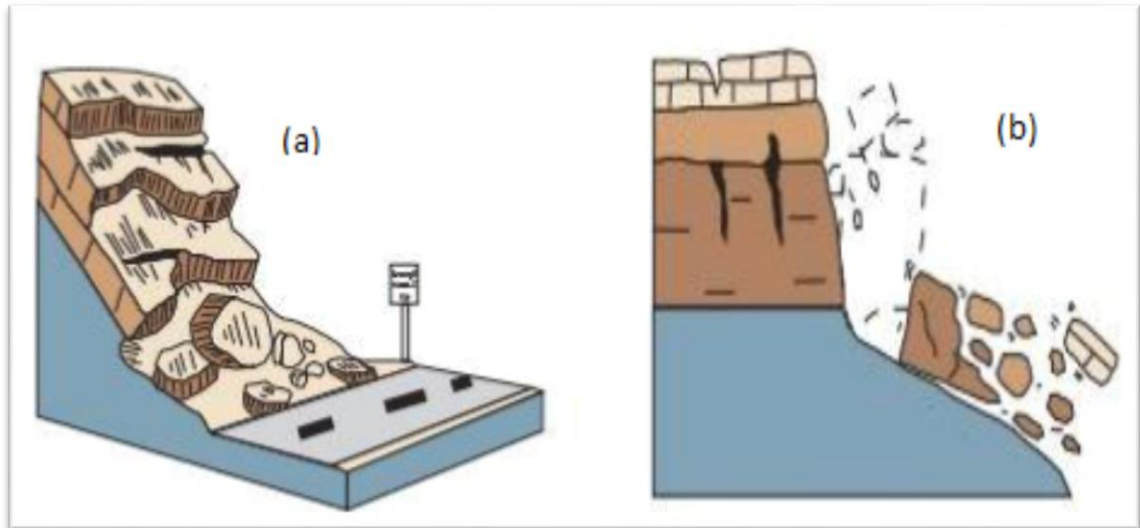
Figure 2.1 Schematic representations of a) Rock fall and b) Topple

This type of slope failure is usually downward movement of large pieces of rocks. It is forward rotation and movement of rock out of the slope. This type of slope failure occurs around an axis at or near the base of rock (Figure 2.1b). The cause for this type of slope failure may be gravity, ice or water occurring within discontinuities or weak zones like cracks or joints that weaken the rock mass. The rate of failure ranges from extremely fast to extremely slow movement (Highland and Bobrowsky, 2008).

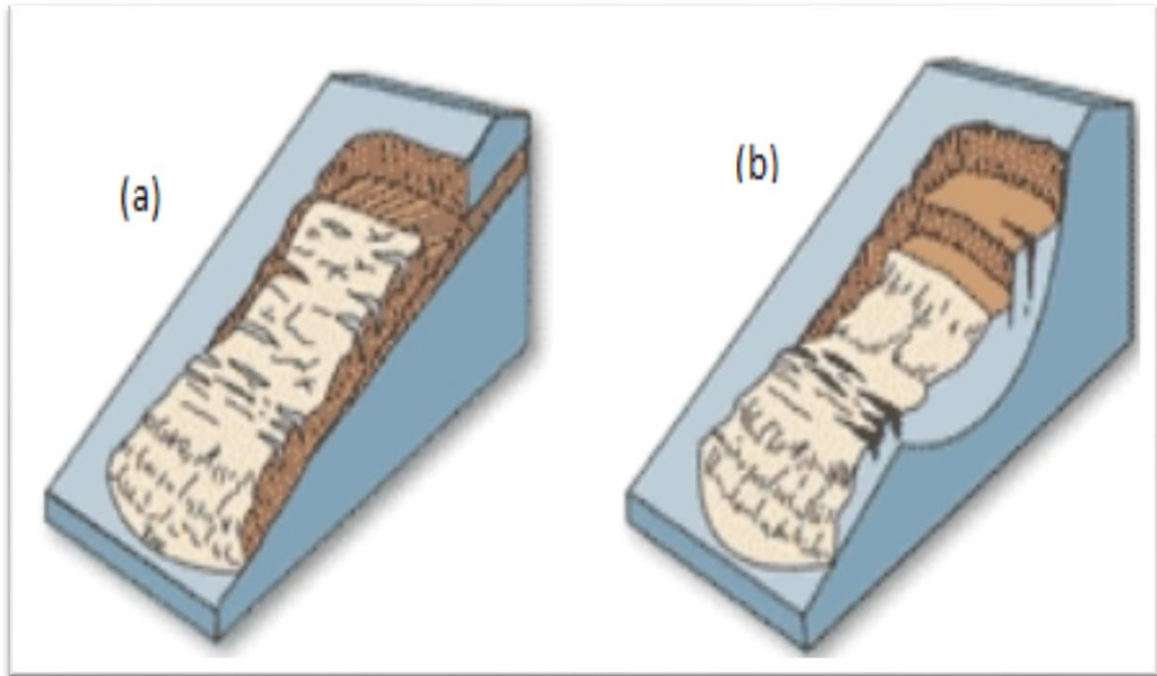
Figure 2.2 Schematic representations of a) translation and b) rotational slides

a) Transitional slide: slide may be a slide during which a mass moves along a roughly planar surface with little rotational or backward tilting (Figure 2.2a). This type of failure happens with little rotation or back ward tilting (USGS, 2004).

b) Rotational slide: rotational slide is one type of slide in which broken/rupture surface is curved concavely upward following the contour and thus the mass movement is roughly rotational about an axis that is parallel to rock bottom surface and transverse across the slide (Varnes, 1978) (Figure 2.2b). It occurs when the inside strength of slope material is overcome by its own weight (USGS, 2004). Rotational and translational slides are kinds of slides, they are common in unconsolidated soils and their rate of movement ranges from extremely slow to moderately fast and mostly they will damage structures but not life if their movement is slow (Highland and Bobrowsky, 2008).

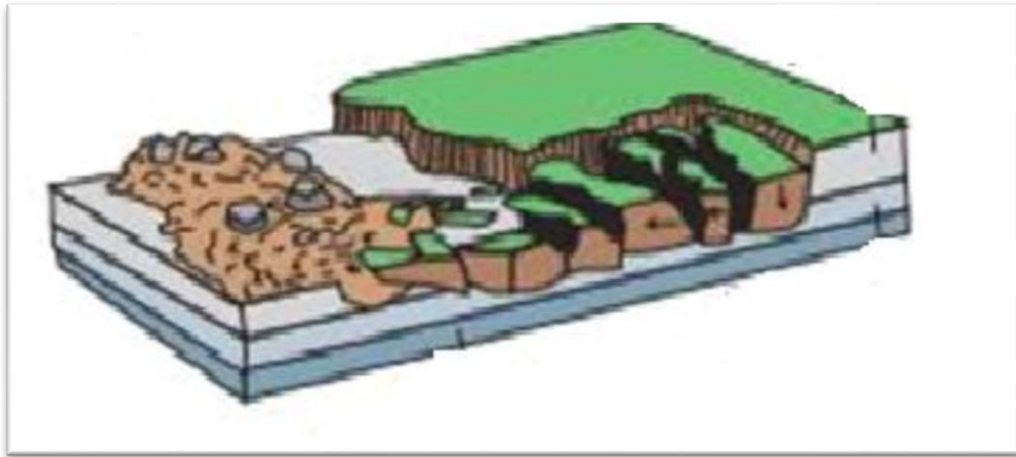
Figure 2.3 Schematic representation of lateral Spread

This type of movement is unusual because it occurs on a very gentle slope or a flat terrain. The mode of movement is lateral extension accompanied by shear/tensile fractures (Figure 2.3). The failure is caused by liquefaction. When loose and cohesion less sediments (sands and silts) will be saturated they will be liquefied or changed liquid state. Failure is usually triggered by rapid ground motion, which will be induced by natural and artificial ground motions. When coherent fine grained materials, either bedrock or soil, rests on materials that liquefy, the upper units may undergo fracturing, extension then subside, translate, rotate, liquefy and flow off. Lateral spreading is usually progressive in fine-grained materials on a shallow slope. Lateral spreads typically damage pipelines, utilities, bridges, roads and other structures having shallow foundations (Highland and Bobrowsky, 2008).

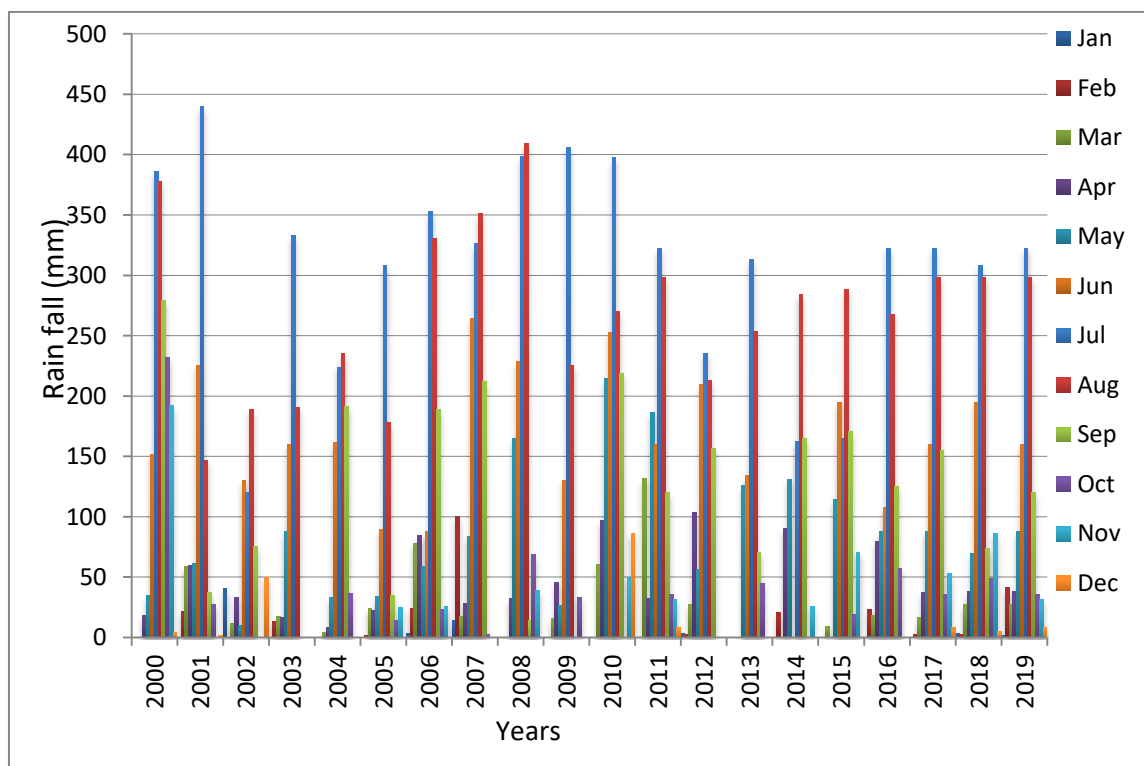
Figure 3.4a Monthly rainfall distributions on Filiklik station

In the present study area there are three metrological stations. These metrological stations are installed in Filiklik, Gohatsion and Dejen towns and the mean annual rainfall recorded at these stations were 1110.1mm/20yrs, 1219.3mm/19yrs and 1321.9mm/18yrs, respectively (Apendix-1a,1b & 1c). For the assessed various years data on Filiklik, Gohatsion and Dejen station the maximum monthly rainfall were 439.7mm in 2001, 464.3mm in 2017 and 645.4mm in 2001 respectively which were recorded in the month of July (Figure 3.4a, b & c). In the months July and August the rainfall reaches at peak.

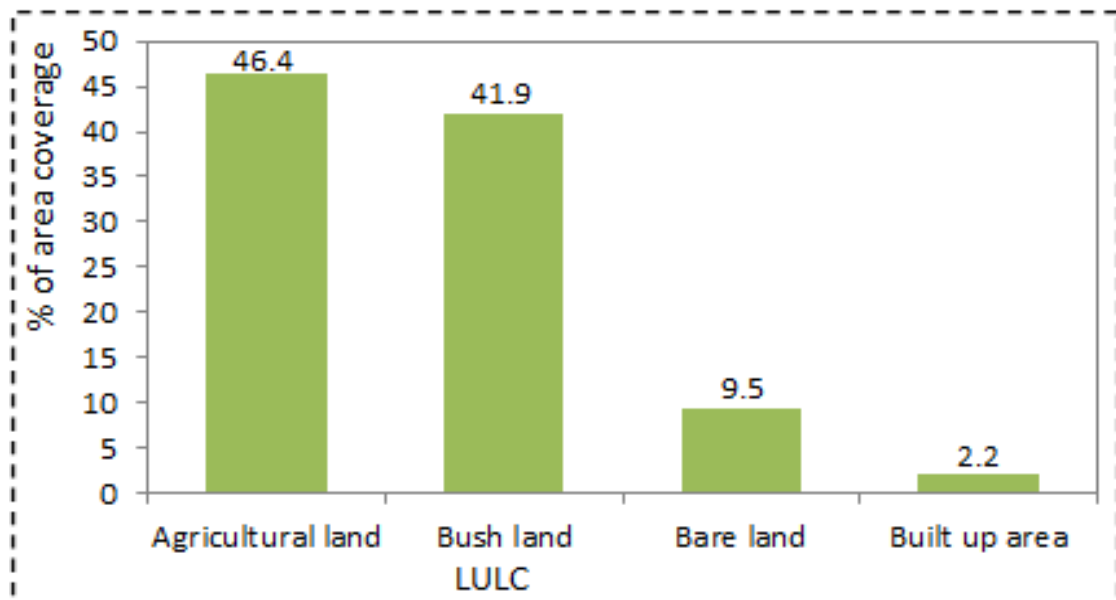
Figure 3.6 % of area coverage and LULC type

LULC	Area (km ²)	% of area coverage
Agricultural land	118	46.4
Bare land	24	9.4
Built up area	6	2.2
Bush land	107	41.7

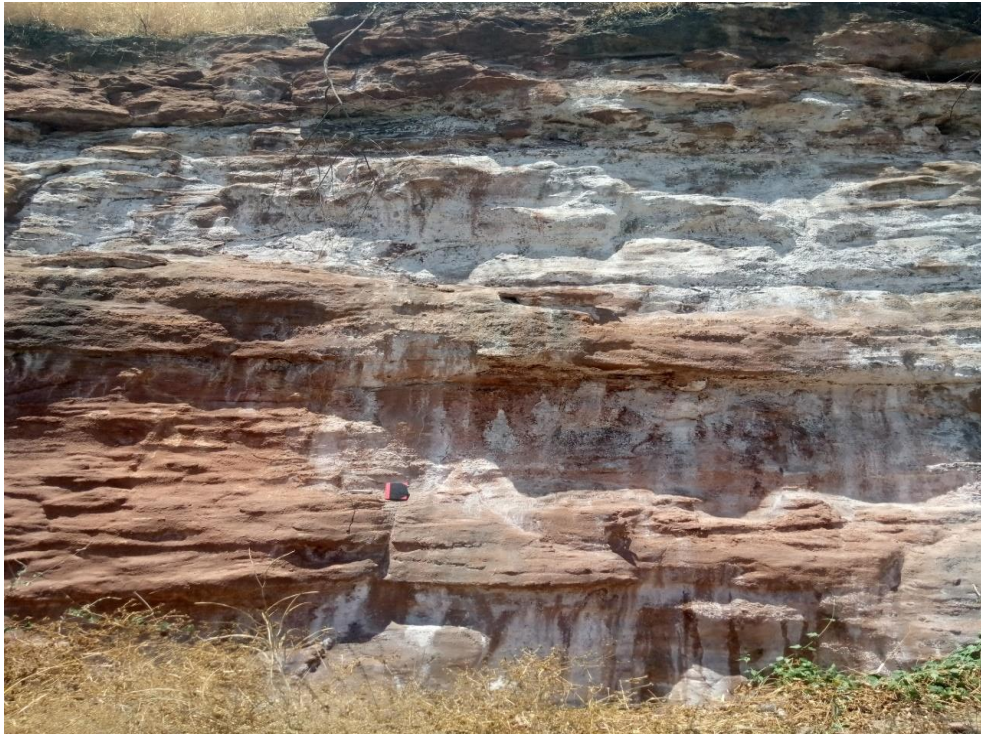
Plate 3.1 Sandstone exposure along Gohatsion-Dejen road section in the study area

Sandstone is the oldest unit within the study area and belongs to Adigrat formation which unconformably overlies on Paleozoic sediments. It is exposed on each side of the Abay River. This unit is intercalated with mudstone, siltstone and shale within the lower part, and conglomerate within the upper part. It is 270 meters thick (Almaz Gezahegn and Tadesse Dessie, 1994) well cemented fine to medium grained. The rock is brownish red in color, but because of weathering effect it is changed in to white grey and brownish dark (Plate 3.1). No fossils are reported within the unit. This unit is underlain by upper Paleozoic sediments and has gradational contact with the overlying mud rock. Most of this unit is horizontally bedded, but also locally show cross bedding. The upper part of the sandstone is thickly bedded whereas the lower part is thinly bedded. Structurally this unit has three well- developed joint sets, the bedding plane which is horizontal and other two sets trending NW and NE (JICA and GSE, 2012). It forms a vertical cliff, leading to rock falls due to the intersection of those three joint sets.

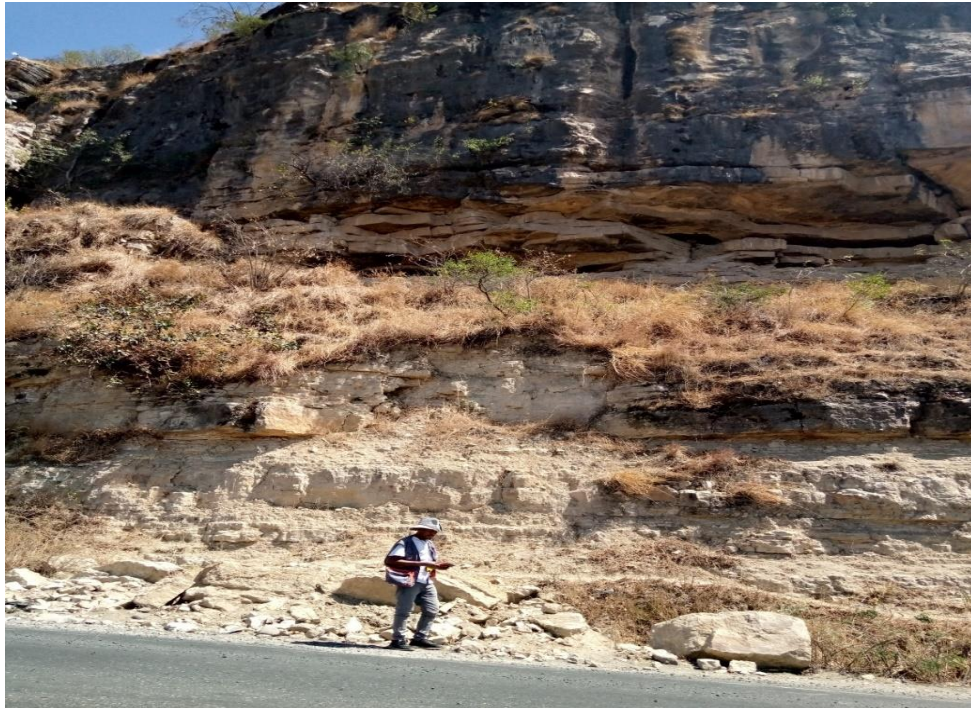
Plate 3.2 Limestone exposure along Gohatsion-Dejen road section in the study area

In general, this unit is horizontally bedded and has three well-developed joint sets; bedding plane which is almost horizontal and two other joint sets trending NW and NE (JICA and GSE, 2012). The joints of the limestone are crammed with calcite, marl or both fragments. The three joint sets with both closely and widely spaced fractures would lead to huge rock failure due to the intersection. The upper part of the limestone is thickly bedded whereas the lower part of it is thinly bedded.

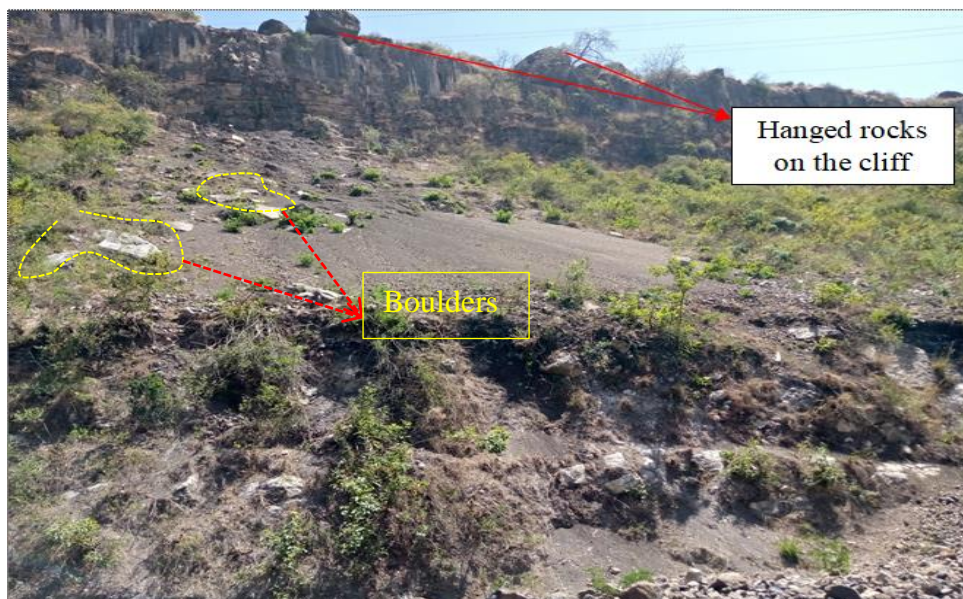
Plate 3.3 Thick colluvial deposit on the foot of limestone cliff along the main road in the study area

Colluvial soils are deposits displaced from their original location of formation or deposition by gravity force. Colluvium soil is found all along the valley with varying thickness but are mainly concentrated on the terraces of volcanic units, gypsum beds, Abay limestone and at the foot of the cliffs. The colluvial deposits are accumulation of thin soil layers, rock cobbles and boulders. They come from denudation terraces on the top of the cliff and fall off cliff suspended blocks. Their thickness is more than 20m especially on the Dejen side of the valley where numerous unstable landslides are concentrated (Almaz Gezahegn and Tadesse Dessie, 1994; JICA and GSE, 2012).

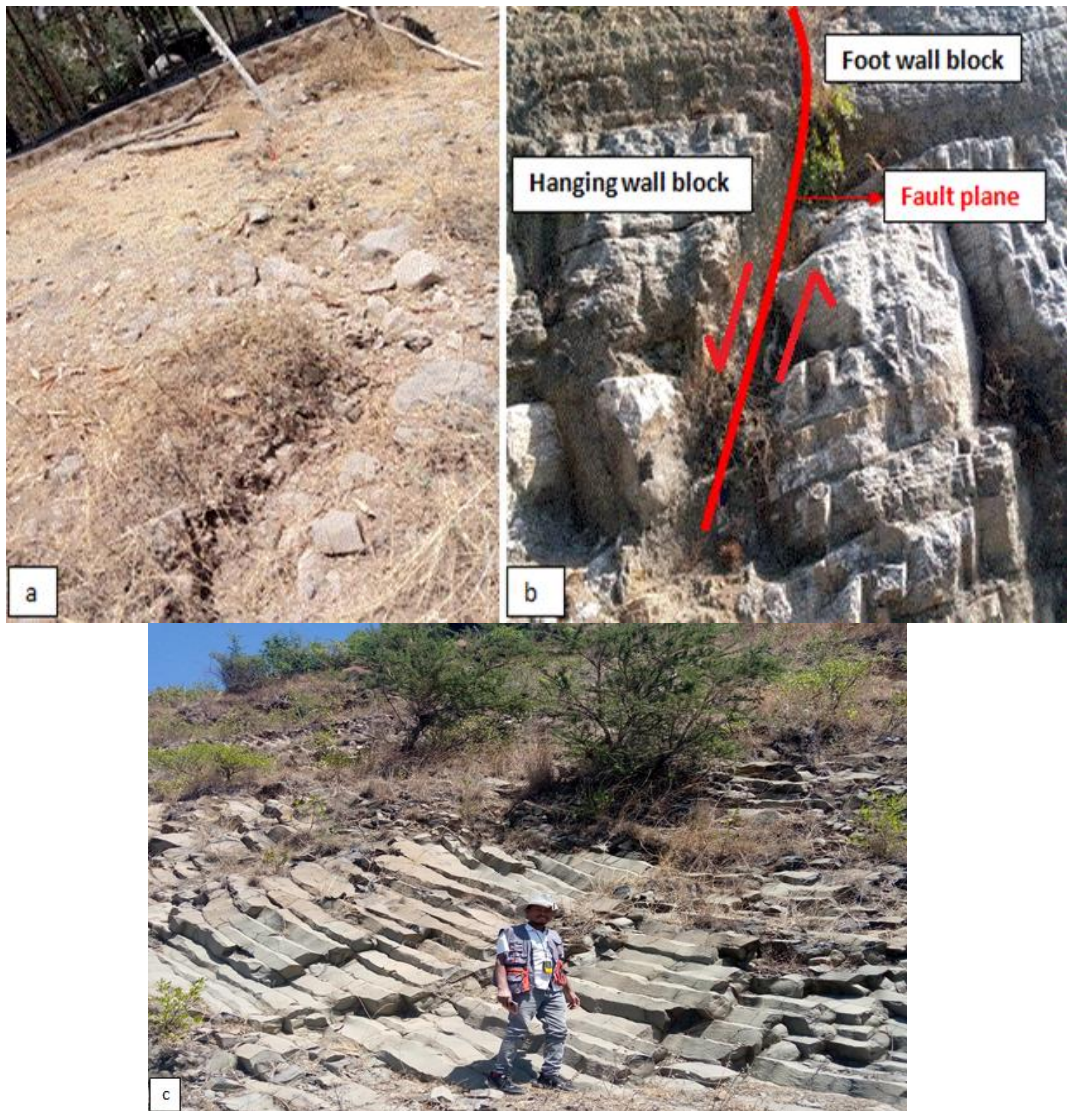
Plate 3.4 Geological structure in the study area

Many columnar joints in the study area are observed in basalt rock mass. Surface cracks are also observed in the study area on colluvial deposit around Filiklik and Kurar vilages.

a) Ground crack on the Church compound in Kurar village, b) Normal fault on gypsum bed & c) columnar jointed basalt

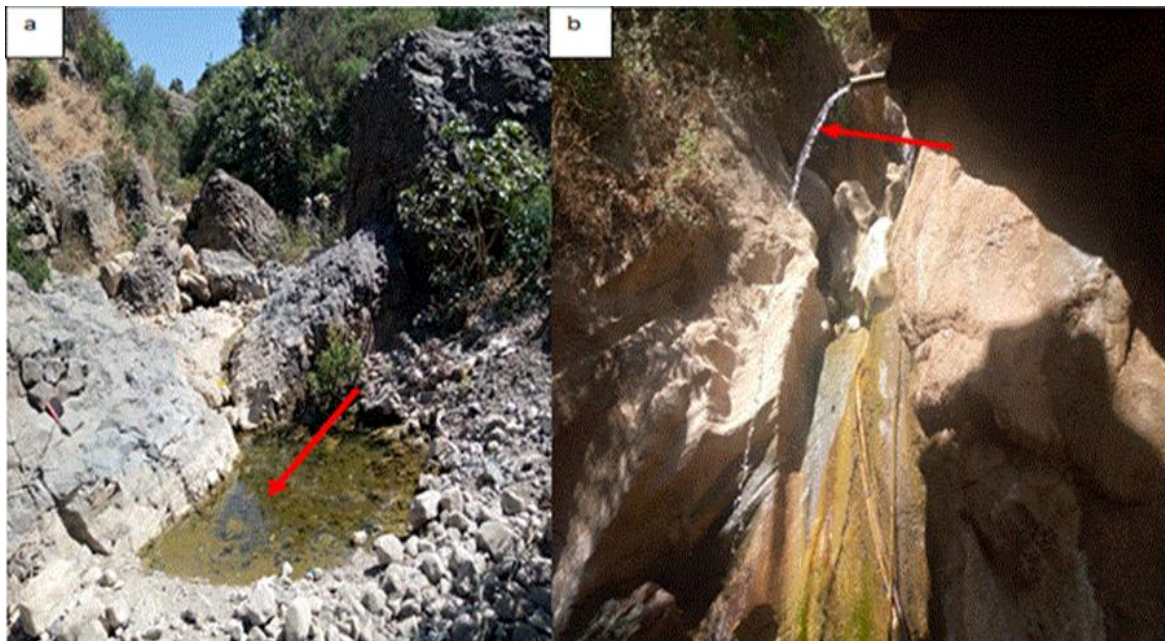
Plate 3.5 springs at various locations

Groundwater - ground water condition at the surface certainly can be observed from spring located and available precipitation records (Varnes, 1984). Therefore, ground water condition of the study area should be observed by the presence of springs, algal growth on shadow areas, gully development, slope toe erosion, stream bank erosion and other water marks on slopes face (Plate 3.5). The springs face towards the downslope. It is assumed that the intensive fracturing favors a higher amount of water to infiltrate downwards and emerges through the fractures of the impermeable horizontally bedded limestone with shale's and sandstones.

a) Spring at the left flank kola Jemo landslide b) Spring at Chifinchi locality

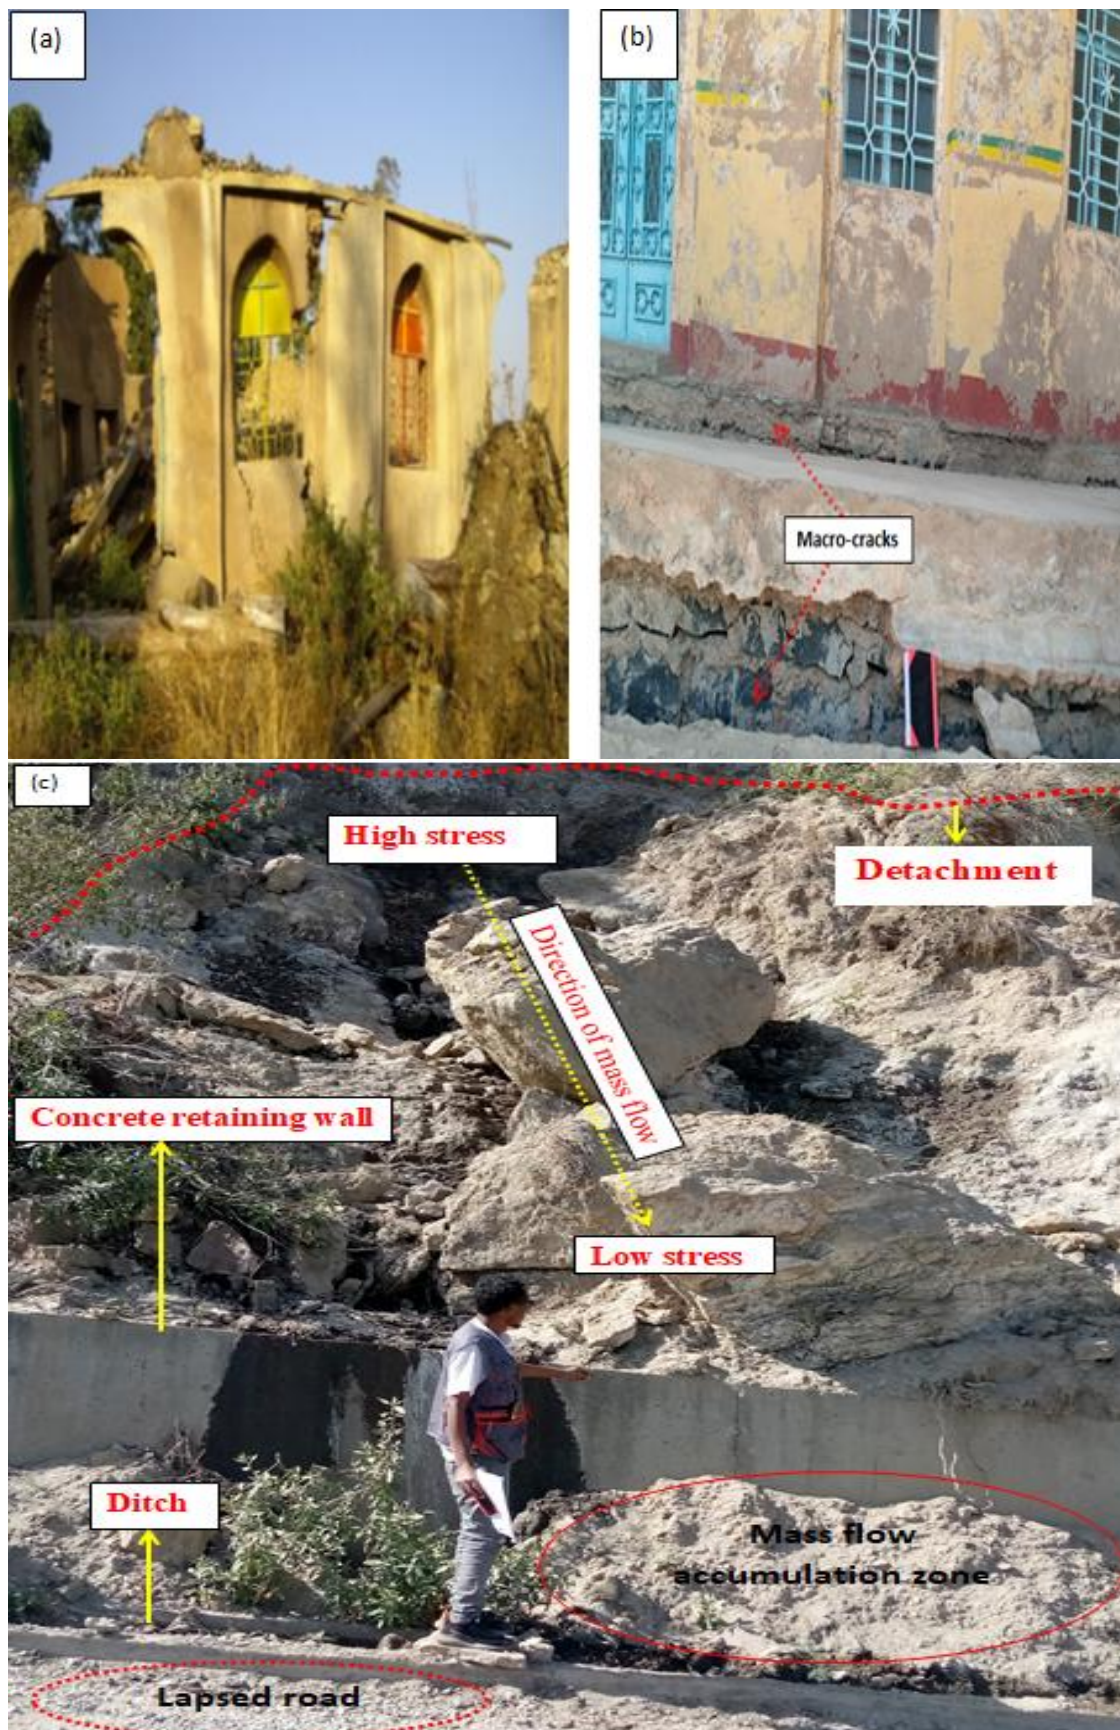
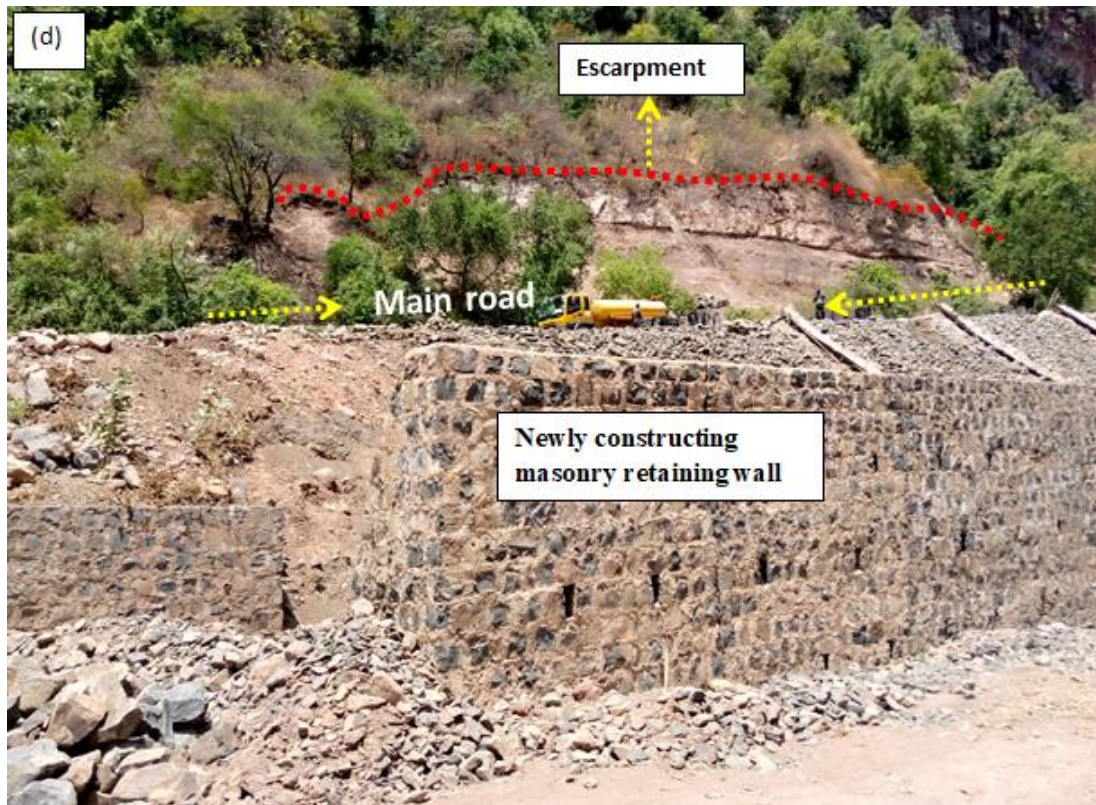
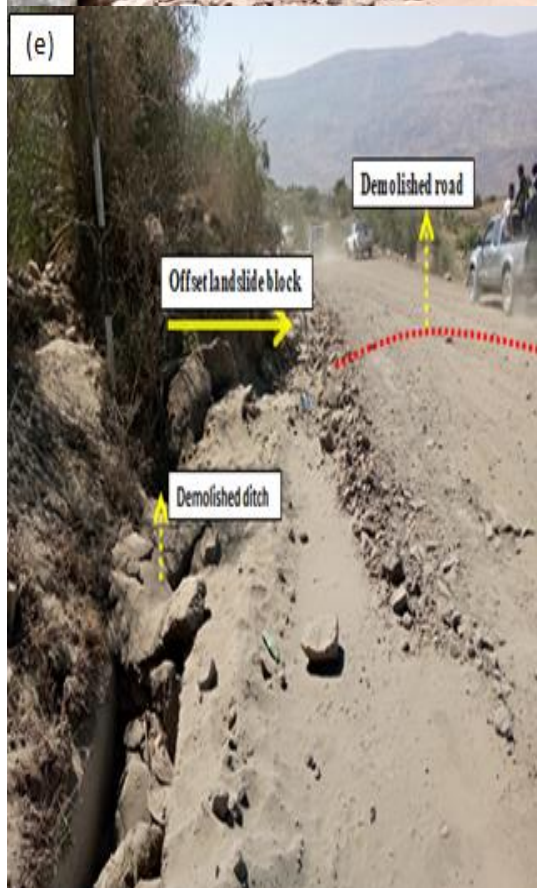
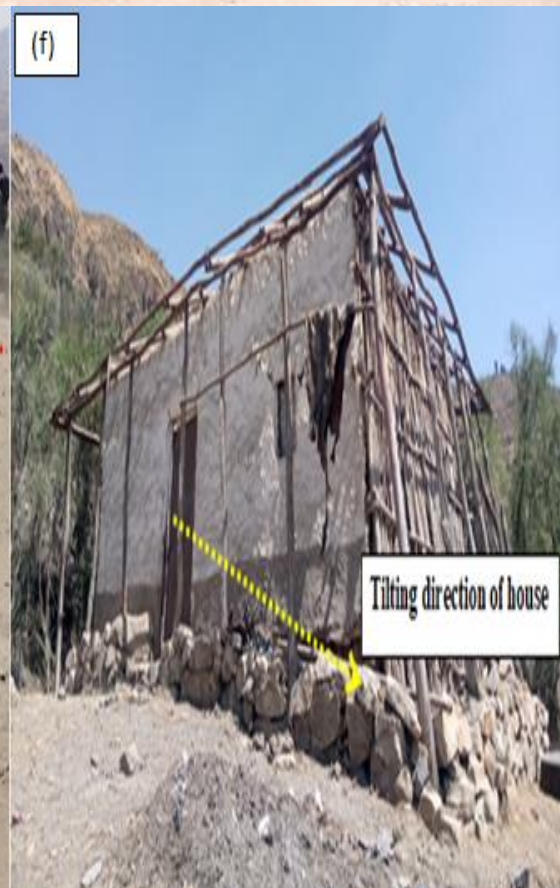
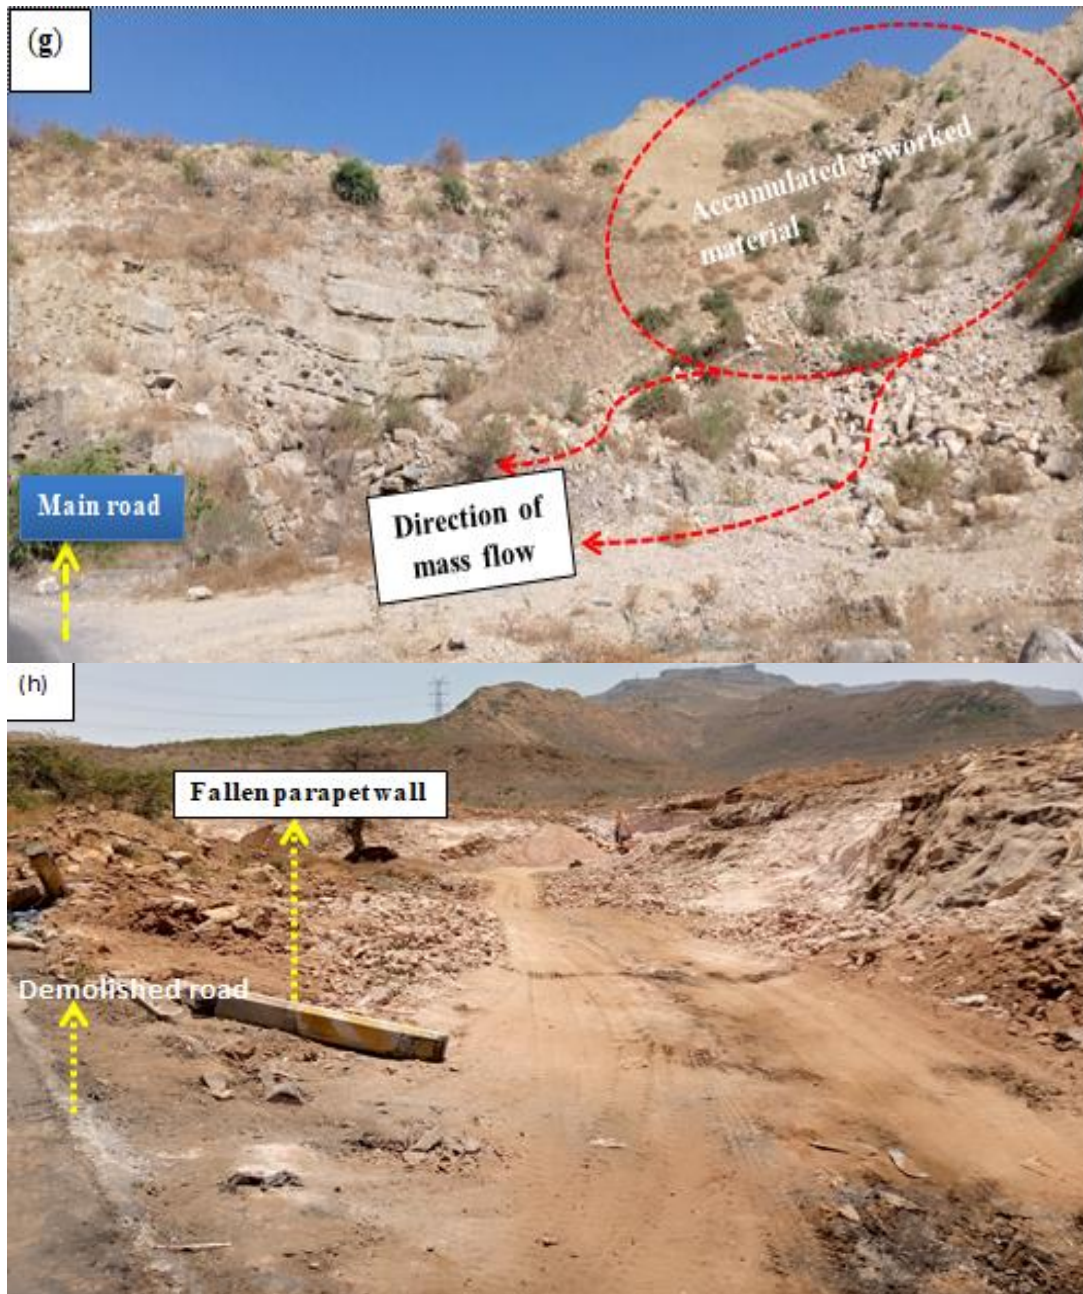
Plate 5.2 Landslide hazards in different locations of the study area

The plates listed from 5.2a up to plate 5.2h are good illustrations for the current situation of the present study area.

a) Already collapsed Church (source: JICA & GSE, 2012), b) Macro-cracked newly constructed Church in Kurar Gebriel locality, c) Landslide in Turet locality, d) Newly constructing masonry retaining wall below the main road at Chifinchif locality landslide, e) Offset landslide block and demolished road in Kola Jemo Gidara kebele, f) Sunked and tilted house in Dembeza Mariam locality, g) Accumulated excavation material & h) quarry site in the study area

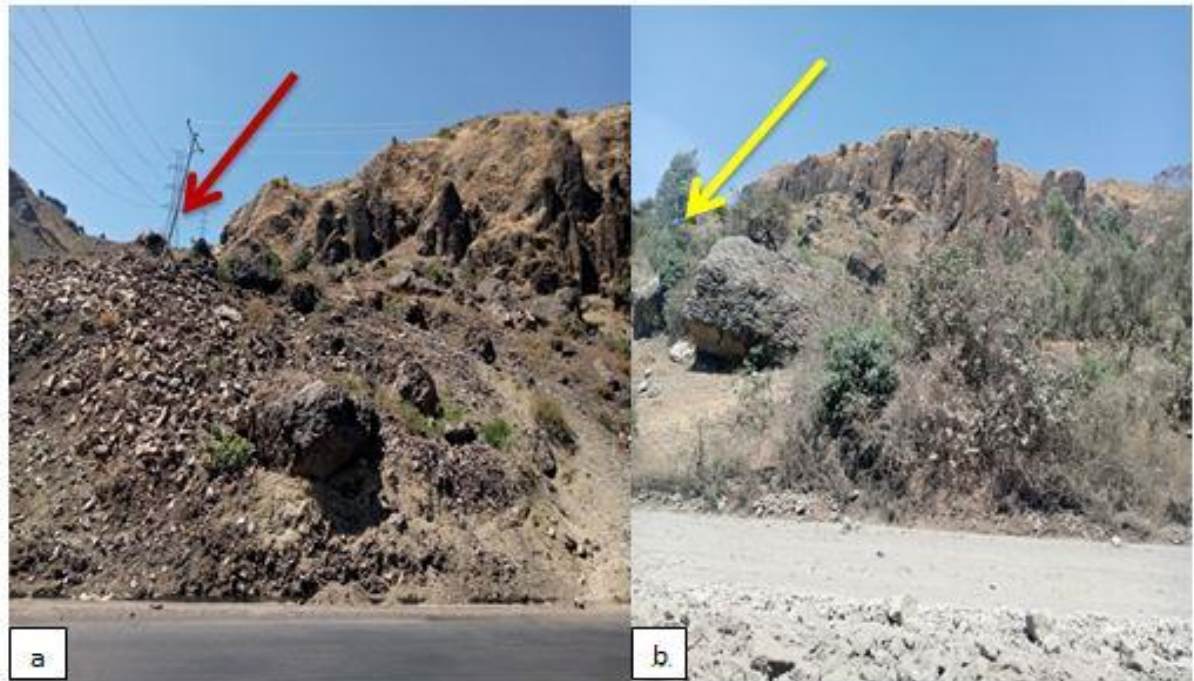
Plate 5.3 Manifestation of landslide in the area

During field survey various landslide manifestations were observed. Some of these are; tilting of trees and electric poles, hanging of rocks on high cliffs, presence of tension cracks, houses sank and failure of road. For instance Plate 5.3a & b with red and yellow arrow of tilted electric pole and tilted tree respectively are illustrations of landslides presence in the study area.

a) Tilted electric pole & b) Tilted tree

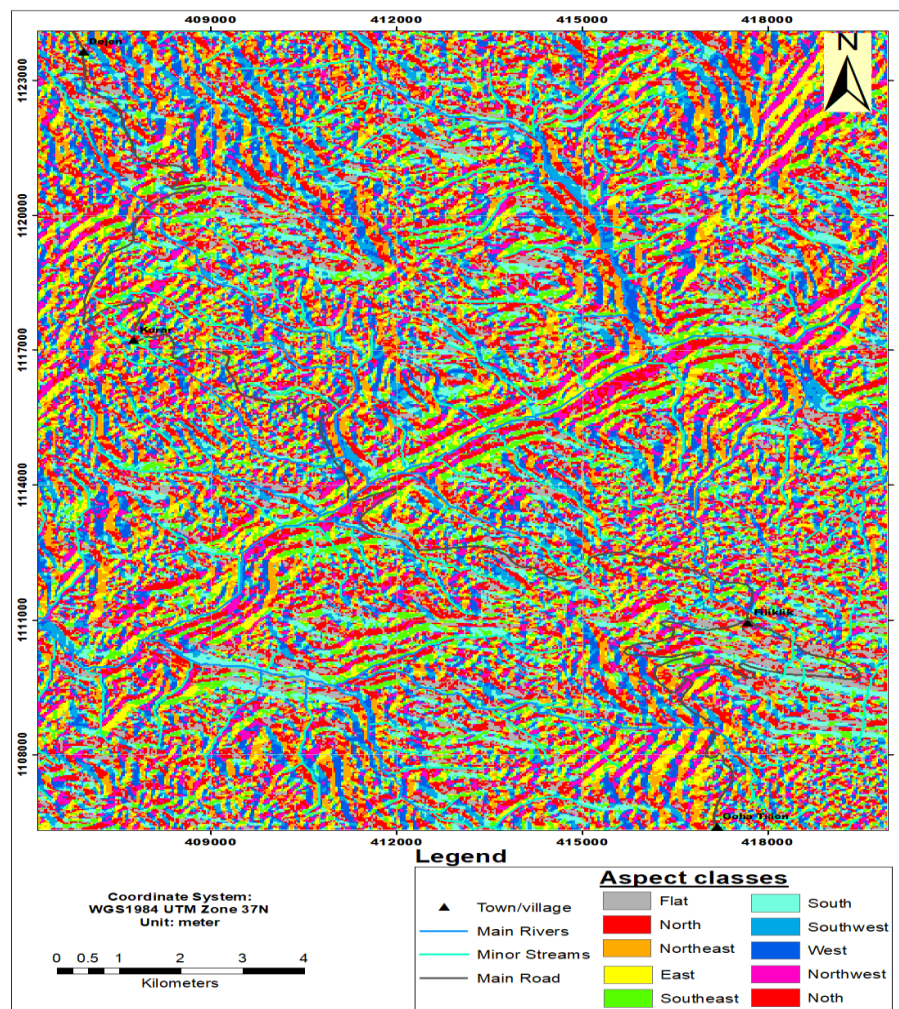
Figure 5.5 Aspect map of the area

The aspect map (Figure 5.5) of the study area was derived from at SRTM 30m*30m resolution DEM. The aspect of the study area is split into ten classes namely: Flat (-1 – 0), North ($0-22.5^{\circ}$), Northeast ($22.5-67.5^{\circ}$), East ($67.5-112.5^{\circ}$), Southeast ($112.5-157.5^{\circ}$), South ($157.5-202.5^{\circ}$), Southwest ($202.5-247.5^{\circ}$), West ($247.5-292.5^{\circ}$), Northwest ($292.5-337.5^{\circ}$) and North ($337.5-360^{\circ}$). Aspect classes represent the orientation of the slopes throughout the study area.

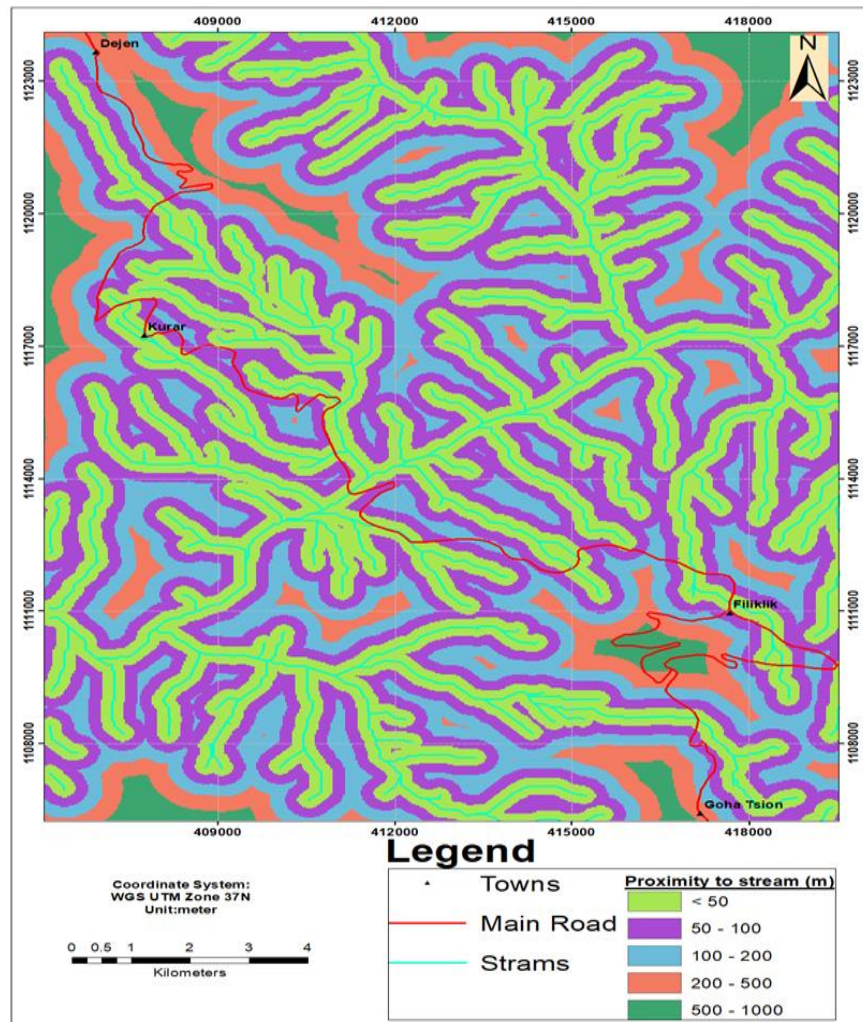
Figure 5.8 Proximity to stream map of the area

Distance from stream map (Figure 5.8) was developed using Euclidean distance in the spatial analysis tool of Arc GIS v 10.7. The map was classified into five subclasses: 0 – 50m, 50m – 100m, 100m – 200m, 200m – 500m and 500m – 1000m.

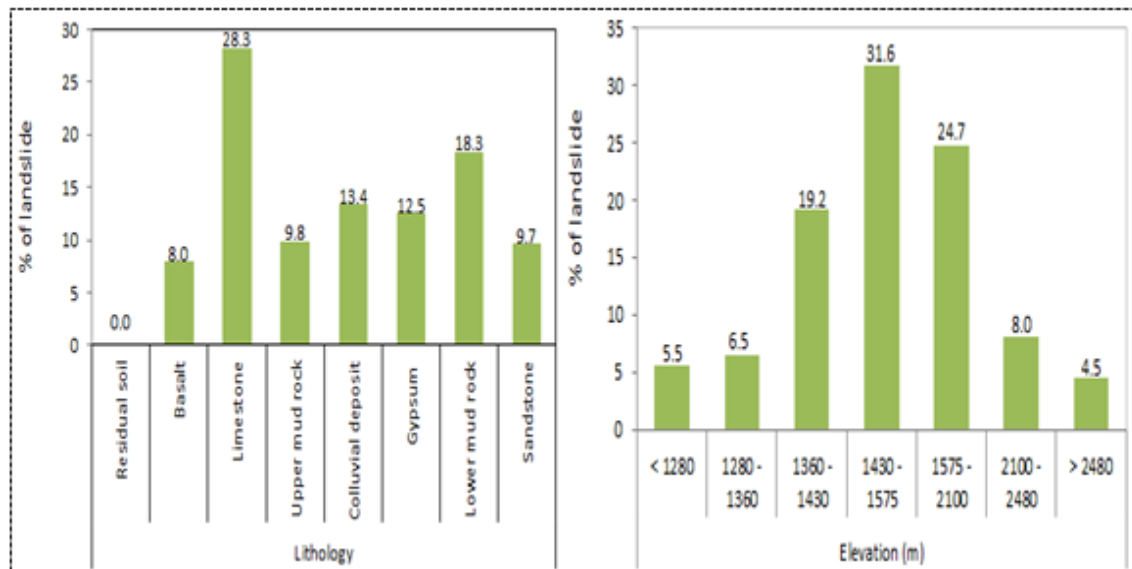
Figure 6.1 Relations between the percentage of landslide distribution with causative factor classes a) Lithology and b) Elevation

Generally, the number of landslides related to elevation is highest in 1430m to 1575m, 1575m to 2100m followed by 1360m to 1430m, while few are observed at other elevations.

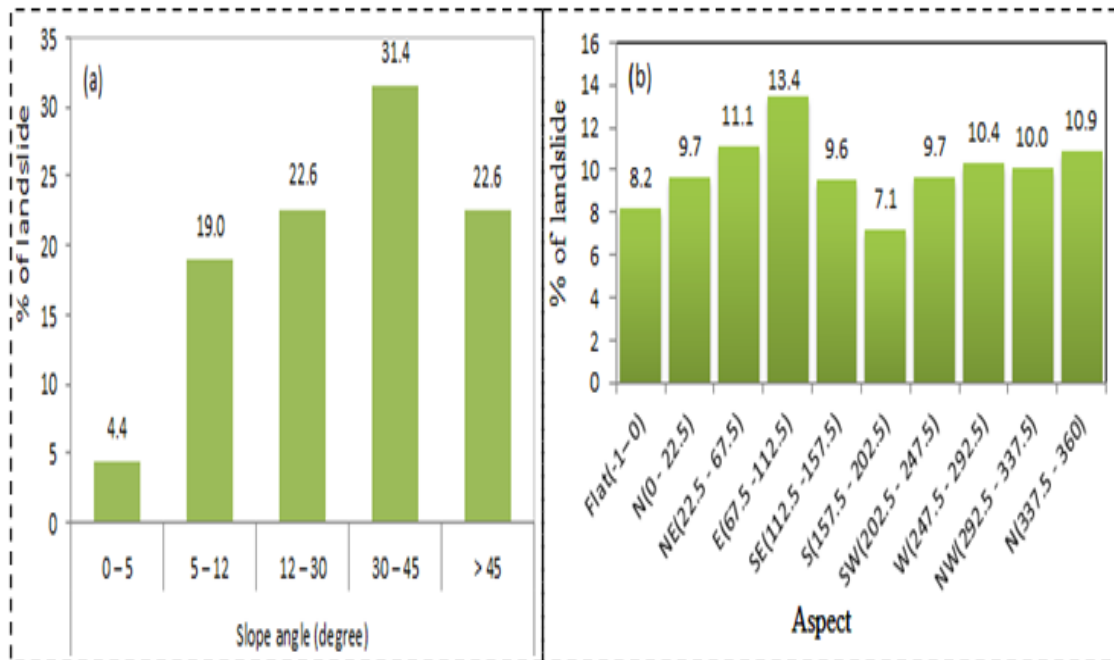
Figure 6.2 Relations between the percentage of landslide distribution with causative factor classes a) Slope and b) Aspect

Further, the overlay analysis showed that 13.4% landslides occurred in slopes that are oriented towards east, 11.1% occurred in slopes that are oriented towards northeast, 10.9% occurred in slopes that are oriented towards north northwest, 10.4% occurred in slopes that are oriented towards west, 10.0% occurred in slopes that are oriented towards southeast direction and the remaining 9.7%, 9.7%, 9.6%, 8.2% and 7.1% landslides occur in slopes oriented towards north, southwest, southeast, flat and south respectively (Table 6.1 and Figure 6.2b).

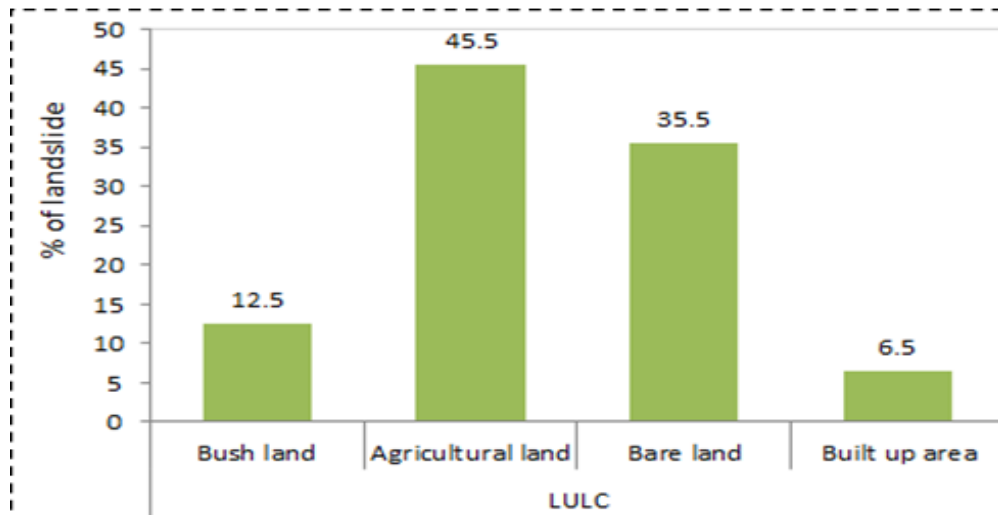
Figure 6.3 Relations between the percentages of landslide distribution with causative factor classes LULC

The statistical information value is negative in bush lands and agricultural lands (Table 6.1). Thus, bush lands and agricultural lands show lowest probability for a landslide occurrence. These four land-use land-cover classes and percentage of landslide occurrence is presented (Figure 6.3)

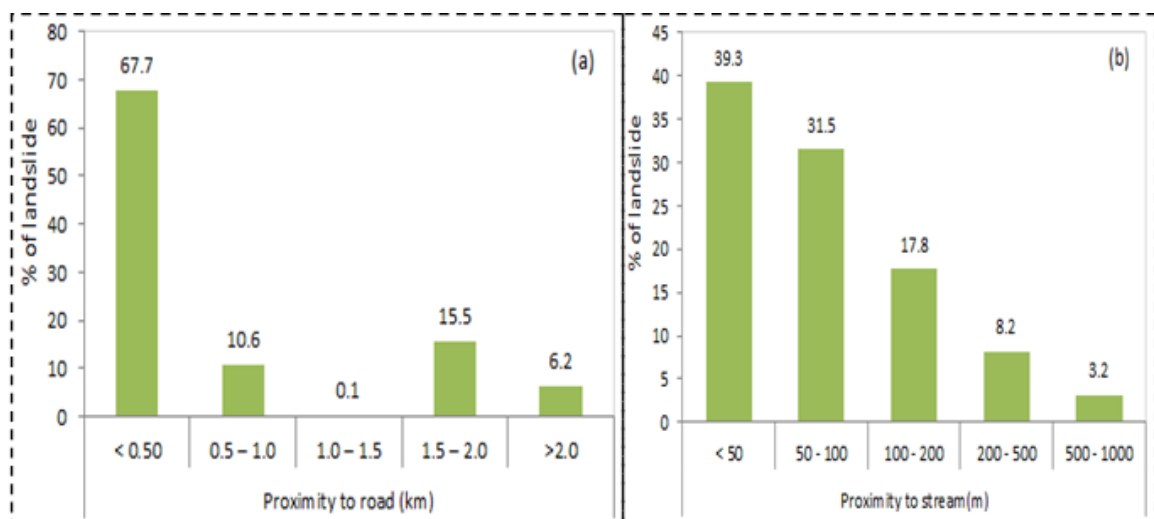
Figure 6.4 Relations between the percentage of landslide distribution with causative factor classes a) Proximity to road and b) Proximity to streams

Slope failure probability is higher around streams because streams will erode slopes. Proximity to stream was classified into five subclasses: 0 – 50m, 50m – 100m, 100m – 200m, 200m – 500m and 500m - 1000 meter. In case of proximity to streams, the classes 0 – 50 and 50 – 100m have higher probability for a landslide occurrence, while the class 100 – 200, 200 – 500 and 500 – 1000m have low probability of a landslide occurrence because of statistical information value results (Table 6.1). The higher landslide occurrence contribution is noted within the two class ranges 0 - 50m and 50 – 100m proximity to the river. The present study area is dissected by various perennial and seasonal streams like, Abay, Mekentuta, Muga Rivers and other unnamed streams. Close to these streams dense landslides are occurred, since foot of the slope is eroded by streams the slope is devoid of support and prone to failure. The percentage of landslides against proximity to stream class of causal factor is presented in Figure 6.4b.
