**ADDIS ABABA UNIVERSITY**

**Assessment of Road Safety Audits in Reducing Traffic Accidents: The Case of  
Addis Ababa City**

*This audit evaluates road safety conditions across three major urban corridors in Addis Ababa: Leghar to Ayat via Megenagna and CMC, Shiromeda to Bole via 6 Kilo, and Megenagna to Kara. The assessment used a checklist of 78 items to review key infrastructure components including traffic signage, road markings, street lighting, pedestrian facilities, guardrails, landscaping, and other roadside safety features. The findings reveal widespread deficiencies, particularly in the areas of traffic signing, road markings, and pedestrian safety. While certain elements—such as street lighting coverage and landscaping were found to be partially compliant, critical features like clear zones, protective barriers, and accessibility infrastructure remain largely inadequate. These shortcomings pose serious safety risks to both motorists and pedestrians. Of particular concern is the Megenagna to Kara corridor, which is outdated and has not been upgraded due to ongoing corridor development. This route demands urgent attention and safety intervention. In contrast, newer corr

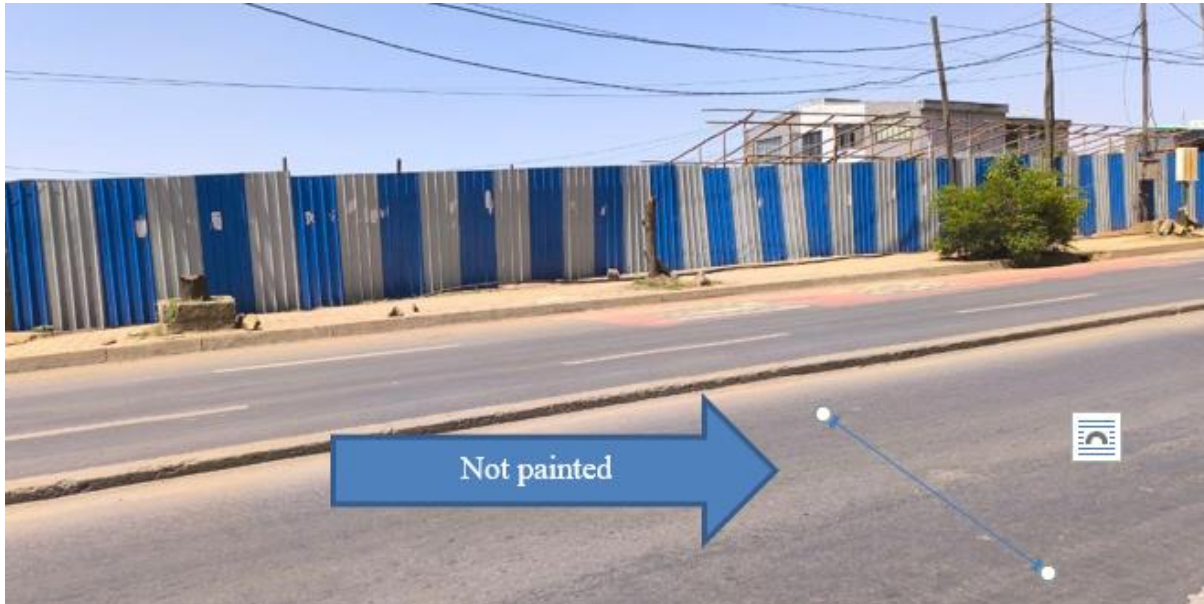
**Figure 5 Absence of Correct type of longitudinal line markings**

The image shows a significant road safety concern: the absence of lane markings on a section of the roadway. Unpainted lanes pose serious risks to drivers, cyclists, and pedestrians by reducing visibility and guidance, particularly during low-light or adverse weather conditions. Clear lane separations are essential for maintaining proper vehicle alignment, facilitating safe overtaking, and minimizing the risk of side-swipe or head-on collisions. The lack of markings may also contribute to driver confusion and erratic lane behavior, especially in urban areas with high traffic volumes or near construction zones like the one shown in the image. This issue should be prioritized in audit recommendations to enhance road safety and ensure compliance with road design standards.

To address the absence of lane markings and enhance road safety, it is recommended that proper lane demarcation be applied using high-visibility thermoplastic road paint, which is durable and resistant to wear. Reflective paint or embedded road studs (cat's eyes) should be incorporated to improve visibility at night or during adverse weather conditions. The lane painting should follow standard road width guidelines and be applied uniformly across the entire stretch of the road.

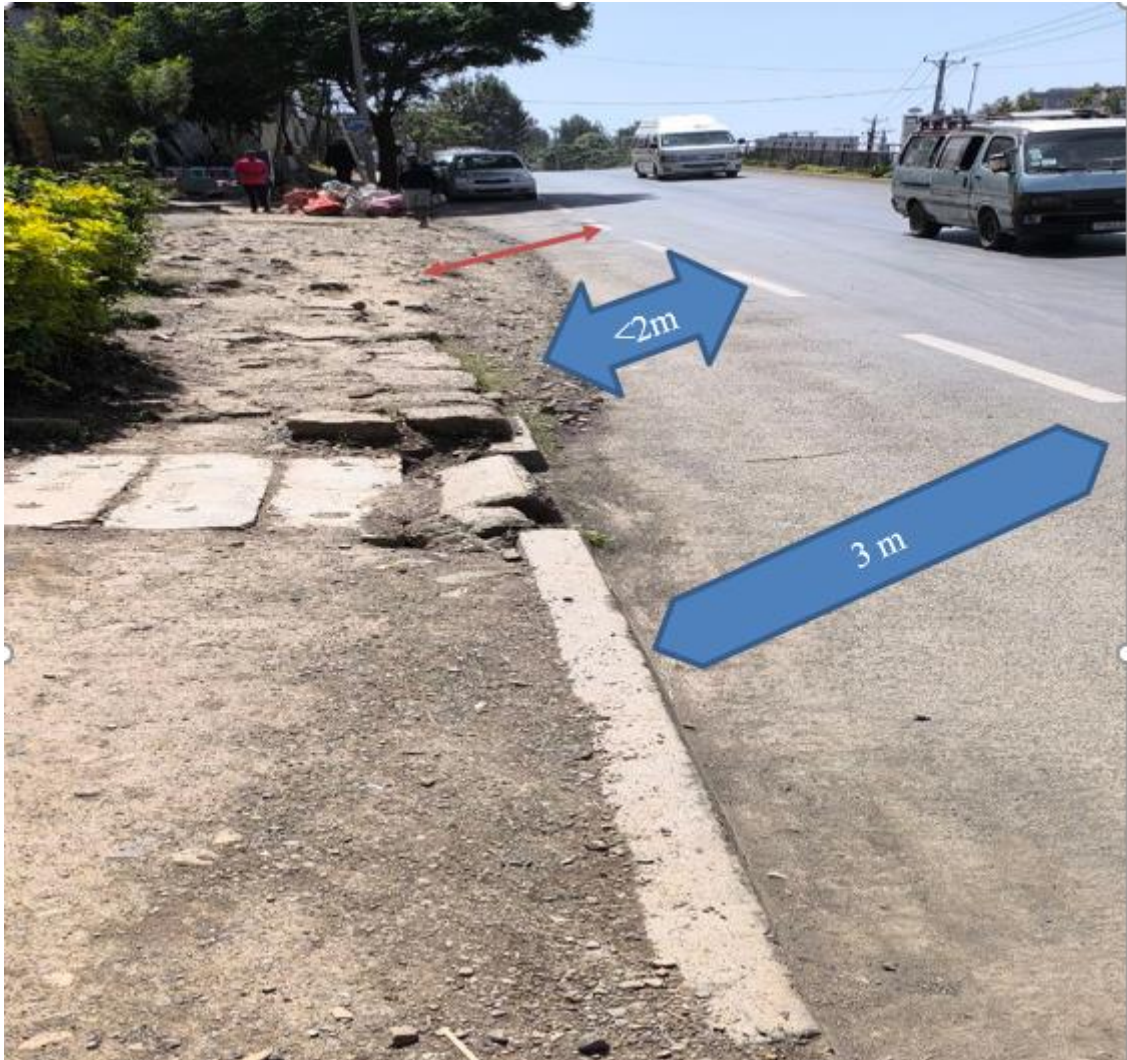
**Figure 6 Discontinuities in “through” lanes and unsafe “trap” lanes are identified**

The image illustrates critical issues related to discontinuities in “through” lanes and the potential for unsafe “trap” lanes. The shoulder, measuring less than 2 meters, is heavily eroded and encroached upon, disrupting the seamless flow of traffic and forcing vehicles to swerve into adjacent lanes to avoid obstacles or pedestrians. The sidewalk is in disrepair and lacks a continuous, safe path, leading pedestrians to walk dangerously close to moving vehicles. Although not visibly marked, the degraded shoulder can be misinterpreted as a drivable lane by drivers, creating a “trap” lane scenario where sudden re-entry into traffic may cause accidents or erratic maneuvers. To address these issues, it is proposed to reconstruct the sidewalk to a minimum standard width of 1.5–2 meters with durable pavement, clearly define and separate the shoulder from the vehicle lane using curbs or road markings, and install appropriate signage to warn drivers of any lane changes or shoulder

conditions. These measures will enhance pedestrian safety and ensure uninterrupted vehicle movement.

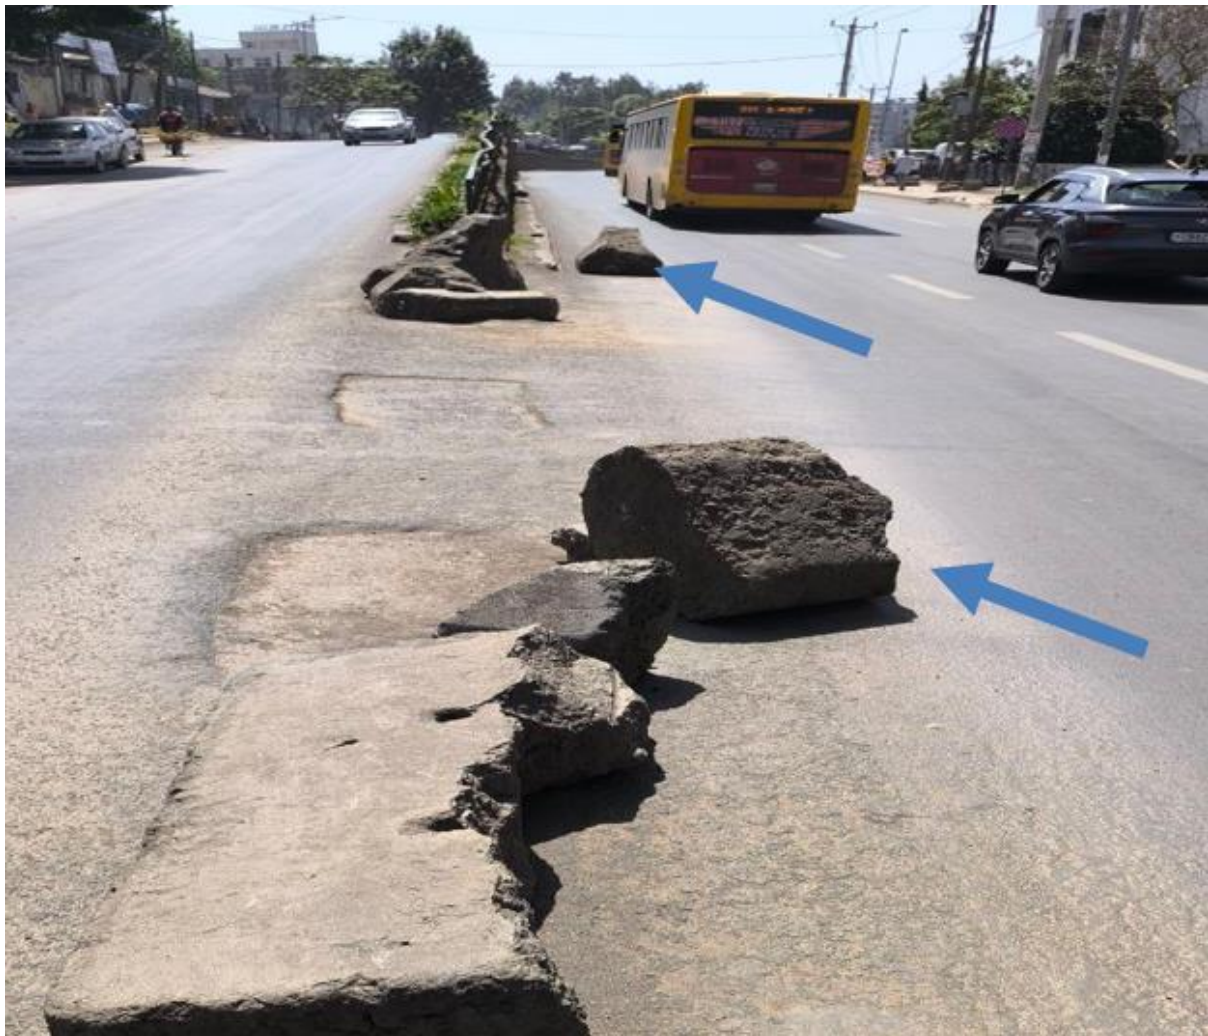
**Figure 7 Obstructing the vehicle path.**

As it shown above figure 7 above the median is not properly aligned with the longitudinal center of the lane, and a large stone is obstructing the vehicle path. This misalignment and obstruction significantly increase the risk of severe crashes, especially when a driver attempts to change lanes at high speed. The vehicle may strike the stone or improperly aligned median, causing damage particularly on the right side—and potentially leading to loss of control or secondary collisions.

To enhance road safety, a proper clear zone should be provided—free of fixed and non-frangible obstacles to allow errant vehicles a recovery area without causing severe damage. Additionally, all roadside furniture and structures within this zone should be made of frangible (breakaway) materials to minimize impact forces in the event of a crash. Realigning

the median correctly with the lane's longitudinal axis and removing or replacing fixed hazards like the stone with safer, energy-absorbing alternatives will significantly reduce the potential for vehicle damage and injury.

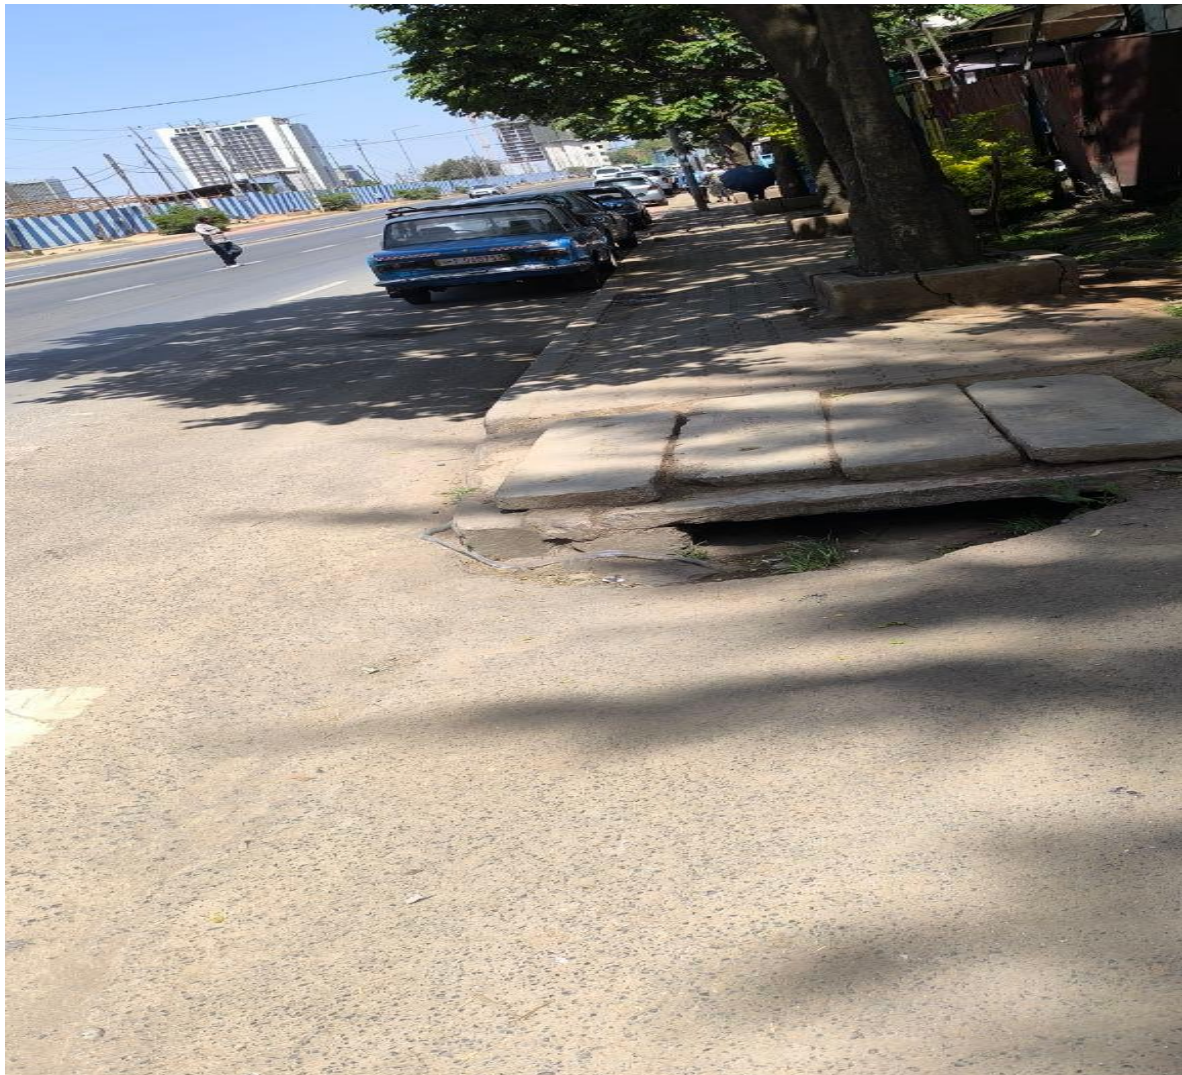
**Figure 8 Road side infrastructure**

As shown in the figure above, the roadside infrastructure presents several safety and functional issues due to poor planning and maintenance. There is no clearly designated vehicle lane or pedestrian walkway, which creates confusion and increases the risk of accidents for both drivers and pedestrians. Additionally, the drainage ditch is blocked, which could lead to water accumulation on the road, further deteriorating driving conditions and potentially damaging the road surface. Trees are growing haphazardly within the space that should be allocated for pedestrian and bicycle use, obstructing movement and forcing vulnerable road users into unsafe positions closer to vehicle paths. The lack of organized road elements and the intrusion of natural growth into human-use areas highlight a failure in urban

road design standards. To ensure safety and usability, the area needs to be restructured with clear demarcations for vehicle lanes, pedestrian paths, and bicycle tracks, proper landscaping control, and effective drainage solutions to support both mobility and environmental resilience. To address the safety and functional issues identified in the roadside infrastructure, a comprehensive redesign and rehabilitation plan should be implemented. First, clear and properly marked lanes for vehicles, pedestrians, and cyclists must be established using durable road markings and signage that meet urban planning and traffic safety standards. The blocked drainage ditch should be cleaned, repaired, and regularly maintained to ensure proper water flow and prevent flooding or road damage. Additionally, trees and vegetation encroaching on pedestrian and bicycle paths should be pruned or relocated as part of a structured landscaping plan that balances greenery with safety. Installing curbs or protective barriers can help separate different traffic types and enhance overall organization. Urban planners should also ensure ongoing maintenance, including monitoring vegetation growth, repainting road markings, and maintaining drainage infrastructure. By implementing these solutions, the road can become safer, more accessible, and more sustainable for all users(Jain et al., 2017).

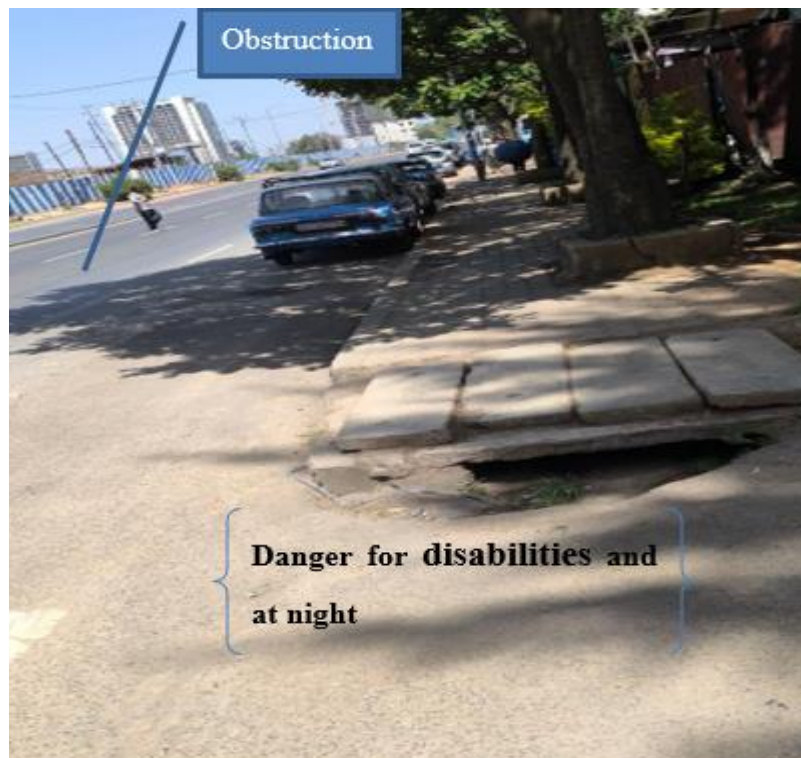
**Figure 9 Site obstruction**

The current line of route presents a significant visibility issue, particularly at the right turn, due to the presence of an overgrown or obstructive tree. Additionally, the roadside ditch is not properly constructed or maintained, creating a hazardous condition. These factors pose a heightened risk for elderly individuals, persons with disabilities, and pedestrians or drivers traveling at night, increasing the likelihood of accidents or injuries.(Jain et al., 2017; Miller et al., 1969; Morris, 1981)

The obstructive tree should be trimmed or, if necessary, removed to improve visibility at the right turn. This will enhance safety for all road users, particularly during low-light conditions.

Place clear signage ahead of the turn to warn of the visibility limitation and potential ditch hazard. Reflective road markings can also help guide traffic more safely.

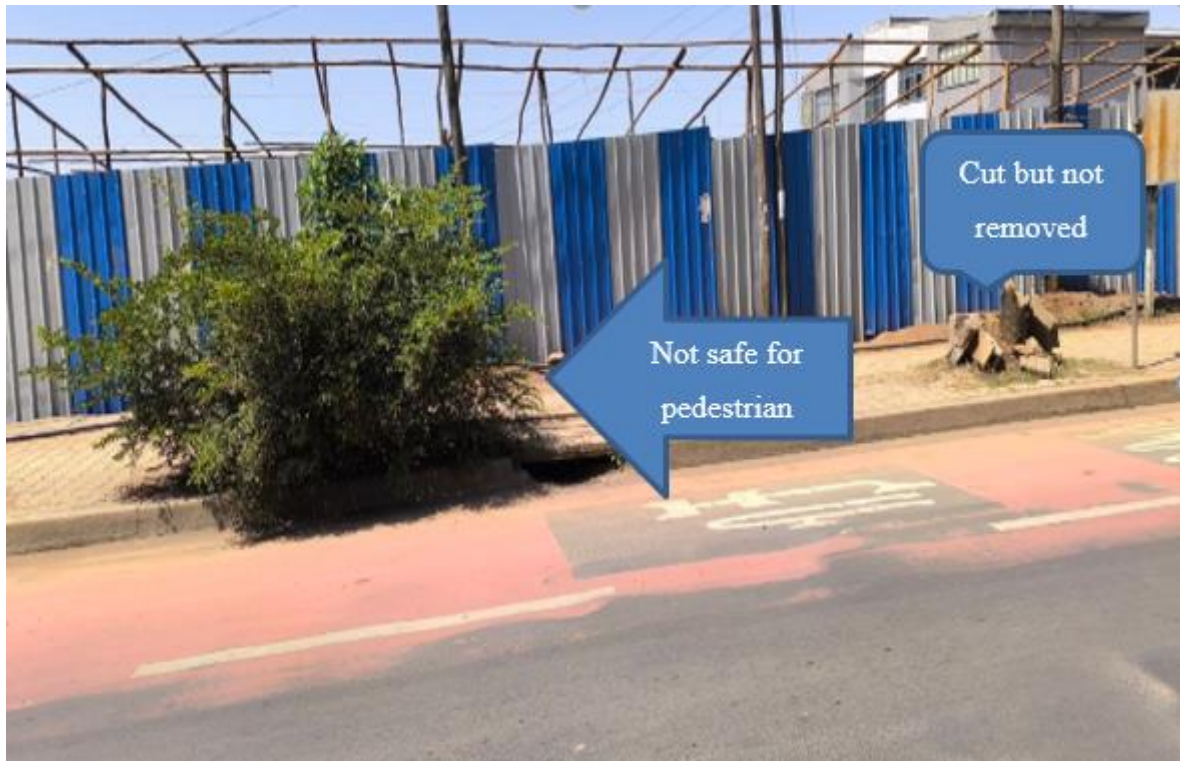
**Figure 10 Road side tree**

The species and size of the trees currently planted within the roadside clear zone present a major visibility obstruction for both drivers and pedestrians. These trees have grown horizontally into the line of sight, limiting visibility of oncoming traffic, road signs, and pedestrians walking along the roadside. This is especially dangerous at night or in poor weather conditions. As shown in the referenced image, the side branches of the trees have extended horizontally, instead of growing vertically. This improper growth pattern not only blocks visibility but may also force pedestrians closer to traffic, increasing the risk of accidents.

- Implement a regular tree maintenance schedule to monitor and cut any branches that may become obstructive over time.
- Periodic trimming will prevent future safety issues and maintain a clear line of sight.

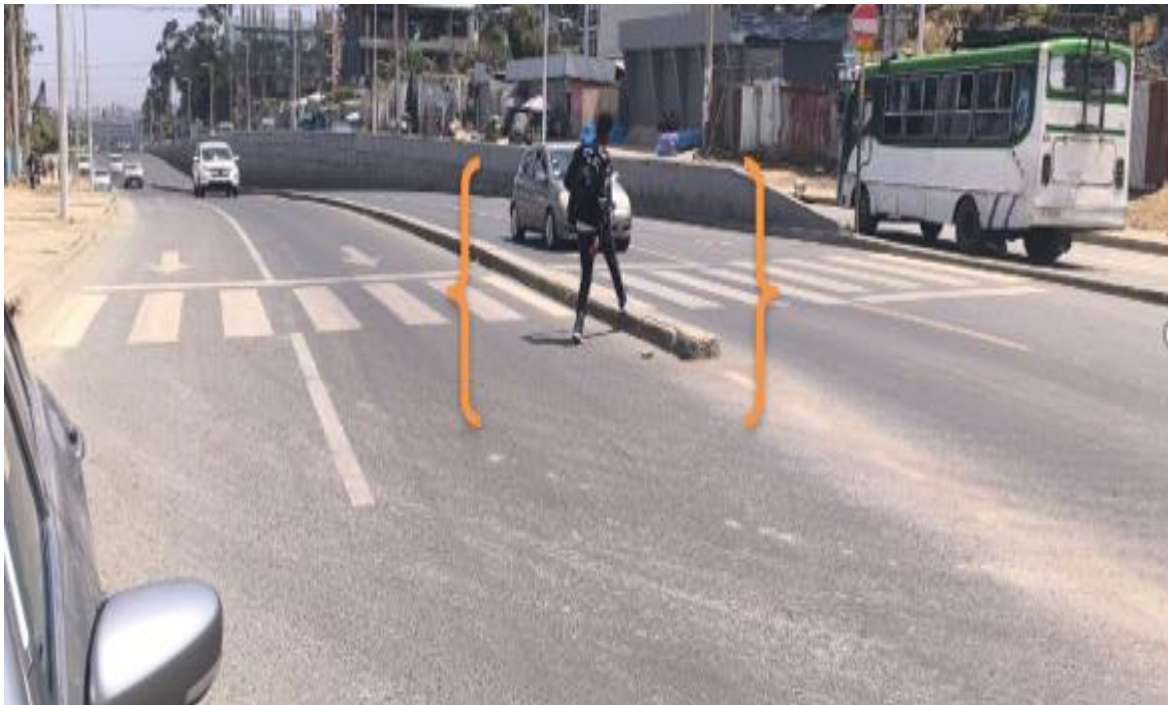
**Figure 11 Median size and length of pedestrian crossing**

As shown in the image above, the width of the median is not proportional to the total carriageway width. The road is a two-way, four-lane carriageway (two lanes in each direction), but the existing median is too narrow to accommodate pedestrians safely.

When pedestrians attempt to cross the road, they are required to cross two lanes in one direction before reaching the median. However, due to the narrow design of the median, there is no sufficient space for them to stand safely while waiting to cross the remaining two lanes. As a result, pedestrians are often forced to stand within or near the live traffic lanes, posing a serious safety hazard. This situation is particularly dangerous during peak traffic hours or at night when visibility is low.

- Engage local authorities, traffic engineers, and urban planners to redesign the median and crossings based on traffic and pedestrian flow data.
- Involve community members to identify the most commonly used crossing points and ensure new infrastructure meets their needs.

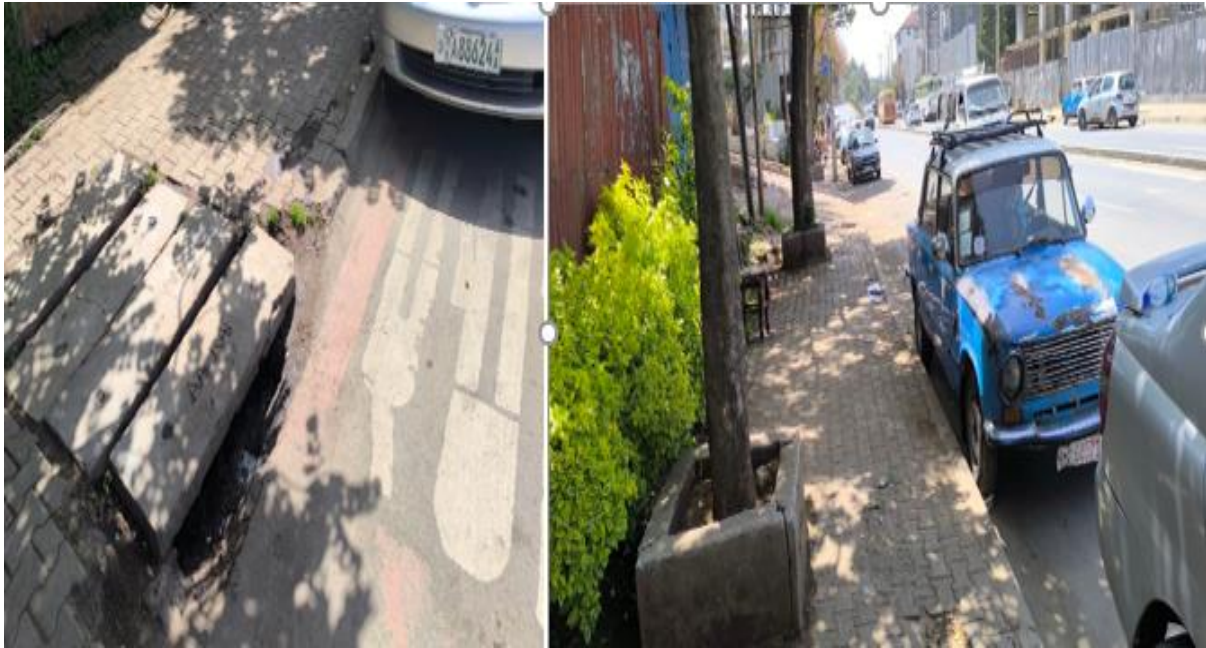
**Figure 12 Improper parking dedicated for buses**

In many areas, taxis are parking in lanes that are specifically dedicated for buses. This is a serious issue because it leads to traffic congestion. When taxis block these dedicated bus lanes, buses are forced to change lanes or slow down, causing delays not just for bus passengers but for all other road users as well. The situation becomes worse during peak hours when public transportation is most needed to reduce road traffic (Hoonsiri et al., 2021; Tsitsokas et al., 2021) (Russo et al., 2022).

In some areas, allow taxis to use certain lanes during non-peak hours but keep them strictly bus-only during rush hours.

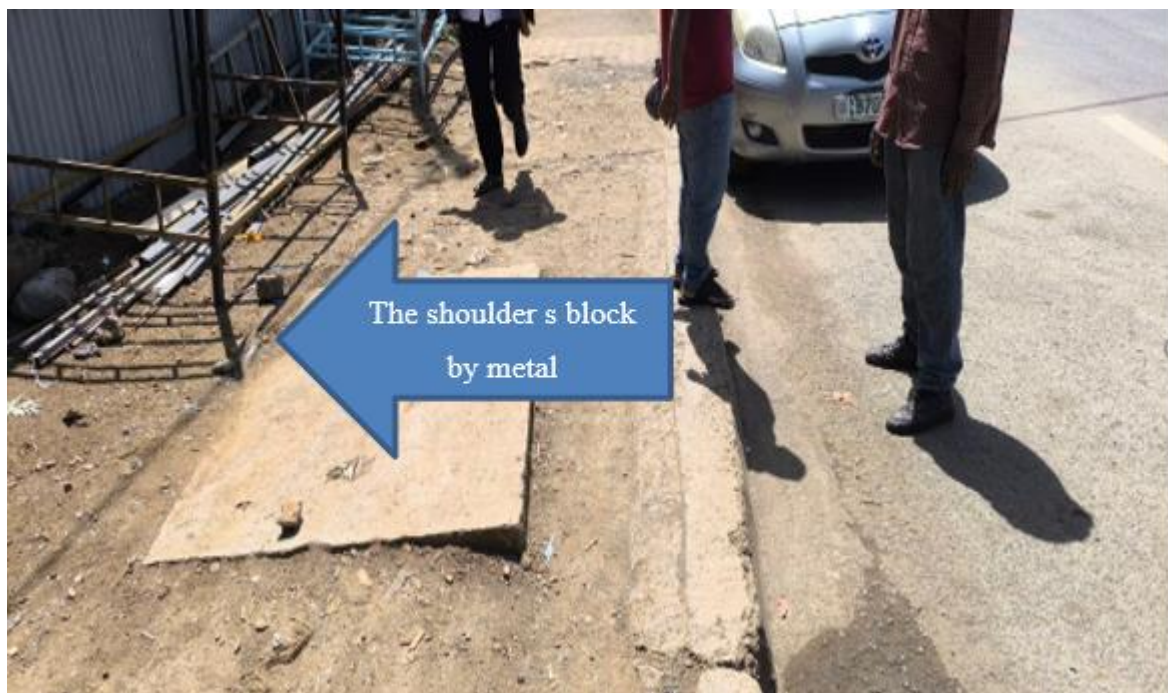
**Figure 13 Shoulder cleanness and barrier for road users**

As observed on-site, the shoulder area of the road is currently blocked due to the placement of metal works. Additionally, the ditch cover along the roadside has been poorly constructed or remains incomplete. This condition creates a physical barrier for pedestrians who attempt to use the roadside for walking. As a result, pedestrians are being forced to walk along the edge of the main traffic lane particularly on the right-side corner of the route where space is already limited. This encroachment onto the carriageway increases the risk of accidents and disrupts the smooth flow of vehicular traffic. Their impact are (Quezon & Kumala, 2018).

- **Pedestrian Safety Risk:** With the sidewalk blocked and ditch covers not in place, pedestrians are left with no safe walking space, exposing them to moving vehicles.
- **Traffic Congestion:** The displacement of pedestrians into the main lane causes partial blockage, leading to congestion especially during peak hours.
- **Increased Enforcement Burden:** The current setup increases the need for continuous traffic management and law enforcement to ensure safety.
- **Reduced Accessibility:** The obstruction particularly affects vulnerable groups such as children, the elderly, and people with disabilities.

1. **Immediate Clearance of Metal Works:** Remove or relocate any construction materials or metal works currently obstructing the shoulder.
2. **Proper Construction of Ditch Covers:** Ensure the ditch covers are well designed, safely constructed, and level with the road surface to allow safe pedestrian use.
3. **Provision of Temporary Pedestrian Pathways:** Until permanent work is completed, install temporary barriers or markings to guide and protect pedestrian movement.
4. **Install Signage and Warnings:** Erect appropriate signage to alert both pedestrians and drivers about the ongoing hazards.

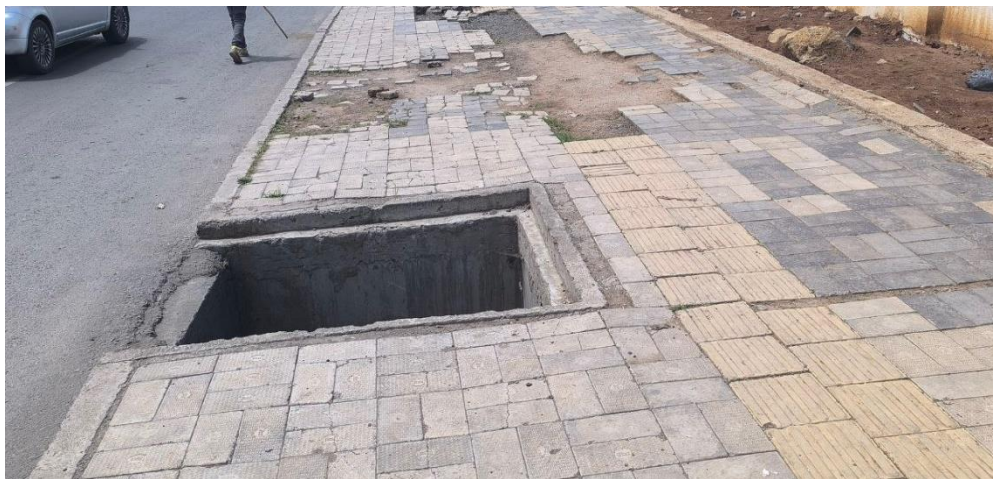
**Figure 14 Extremely dangerous man hole**

A dangerously exposed or damaged manhole has been identified along the pedestrian path. This condition presents a severe safety risk to all road users, especially:

The absence of a proper cover or warning around the manhole increases the likelihood of serious injuries or fatalities. It can cause pedestrians to trip, fall, or suffer impact-related harm. In nighttime conditions, when lighting is limited or absent, the danger becomes even more critical.

- **Injury or Fatality:** A fall into an open or unstable manhole could lead to severe injury or death, particularly for children, elders, and visually impaired individuals.
- **Legal and Liability Issues:** Failure to address the hazard could expose responsible agencies or contractors to legal consequences.
- **Public Distrust and Frustration:** Visible hazards that go unresolved diminish public trust in infrastructure management.

1. **Immediate Securing of the Manhole:** Cover the manhole securely with a durable, high-visibility lid or barrier.
2. **Temporary Protection Measures:** Until permanent repairs are made, cordon off the area with reflective tape, cones, or barricades to prevent access.
3. **Repair or Replace Damaged Infrastructure:** If the manhole cover is missing, cracked, or loose, it should be replaced immediately with a standard-compliant and tamper-resistant cover.
4. **Install Warning Signs and Lighting:** Install visible signage and, if possible, solar-powered warning lights around the area to alert pedestrians and drivers.

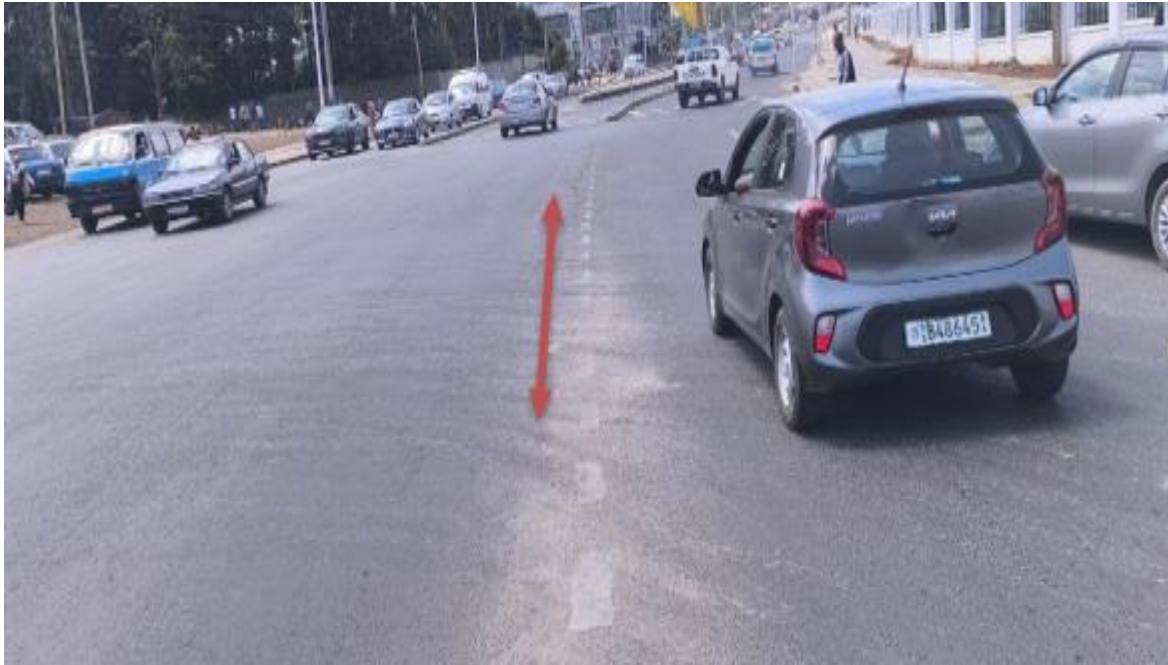
**Figure 15 Missing or faded median and lane division lines**

It has been observed that the median markings and lane division lines on this section of the road are either missing, faded, or not clearly visible to drivers. This lack of clear road markings creates confusion among motorists, particularly during night-time or poor weather conditions.

- **Increased Risk of Conflict and Collisions:** Without clear lane guidance, drivers may unintentionally drift into adjacent lanes or cross into oncoming traffic, increasing the likelihood of side-swipe crashes and head-on collisions.
- **Reduced Road Discipline:** The absence of clear lane divisions encourages unsafe overtaking, lane weaving, and unpredictable driving behavior.
- **Poor Night Visibility:** The lack of reflective or visible paint lines makes it especially dangerous at night or in low-visibility situations (rain, fog, etc.).
- **Challenges for New or Visiting Drivers:** Drivers unfamiliar with the road layout may become disoriented, leading to unsafe decisions.

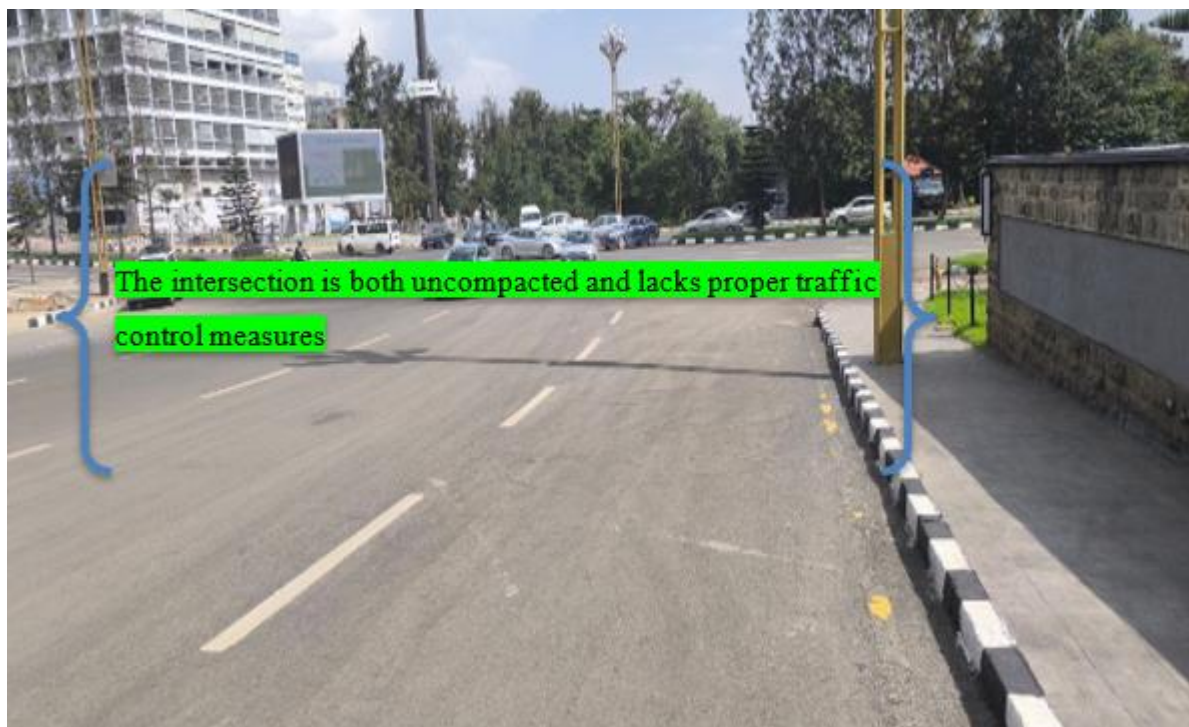
Figure 16 Uncompacted and lacks proper traffic control measures

The intersection in question presents multiple critical road safety and operational issues:

- An uncompacted intersection surface leads to poor traction, especially during adverse weather conditions, increasing the risk of vehicle skidding and accidents.

- Loose or uneven surfaces can cause vehicle damage, particularly for two-wheelers and non-motorized users.

- **Signage:** Install appropriate signs (e.g., STOP, YIELD, and intersection ahead warnings) at all approaches.

- **Traffic Signals or Roundabout:** Based on traffic volume analysis, install signals or construct a roundabout to manage vehicle movements.
- **Markings:** Add clear lane markings, stop lines, and directional arrows.

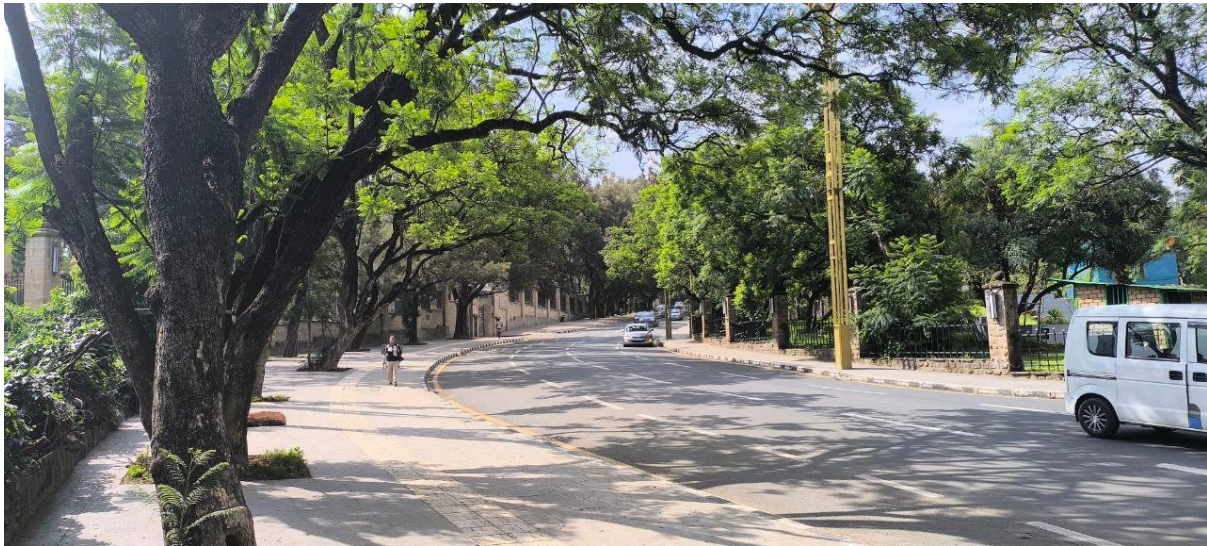
**Figure 18 Tree-lined urban street**

The image shows a tree-lined urban street with the following characteristics during observation in the filed survey.

- **Well-maintained sidewalk:** A wide pedestrian pathway is present on the left side, providing comfortable walking space and shaded by large overhanging trees.
- **Curved roadway:** The street gently curves to the left, which may reduce visibility for drivers and pedestrians alike.
- **No visible traffic control:** There are no visible traffic signs, signals, or speed-calming devices in the image.
- **Lighting concern:** The tree canopy is dense and may obstruct street lighting, especially at night, reducing visibility and potentially creating unsafe conditions.
- **Mixed-use road:** Vehicles, including a small van, use the street, and a pedestrian is also visible, indicating shared use but no distinct crossing or safety infrastructure (like pedestrian crossings or warning signs).

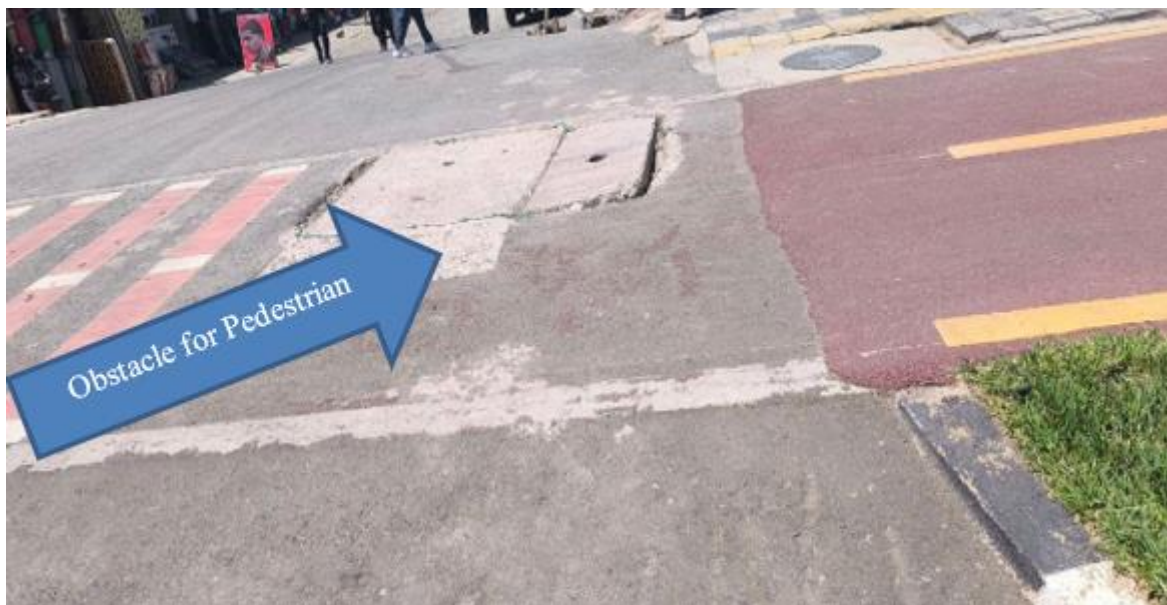
**Figure 20 Pedestrian safety and cycle lane discontinuity**

As shown in the figure above, the bicycle lane is discontinuous, and the drainage ditch (ditch line) is not properly installed or aligned. These design flaws pose significant safety hazards, particularly for cyclists and individuals with disabilities. The lack of a continuous and clearly marked bicycle lane forces cyclists to merge into the main traffic lane unexpectedly, increasing the risk of collisions with motor vehicles. Furthermore, improperly constructed or exposed ditch lines can cause cyclists to lose control or trip, leading to injuries or damage to bicycles. These issues are especially dangerous for people with mobility challenges, such as wheelchair users or those with visual impairments, who rely on smooth and predictable

pathways. To address these problems, the bicycle lane should be made continuous throughout the corridor, with clear and durable markings to guide riders safely. Additionally, the drainage ditches should be properly designed and covered or relocated to prevent hazards along the cycling and pedestrian paths. Using smooth, slip-resistant materials and ensuring level transitions between lanes and adjacent surfaces will further improve safety and accessibility for all users (Chen & Xie, 2009; Phillips et al., 2011; Vasic & Ruskin, 2013).
