**ASSESSMENT OF SLOPE STABILITY USING COMBINED
PROBABLISTIC AND DETERMINISTIC APPROACH FOR
SELECTED SECTIONS ALONG GOHATSION DEJEN ROUTE,
BLUE NILE GORGE, CENTRAL ETHIOPIA**

*In Partial Fullfillment of the requirements for the Degree of
Masters in Engineering Geology*

MULUGETA BEYENE

June 2013

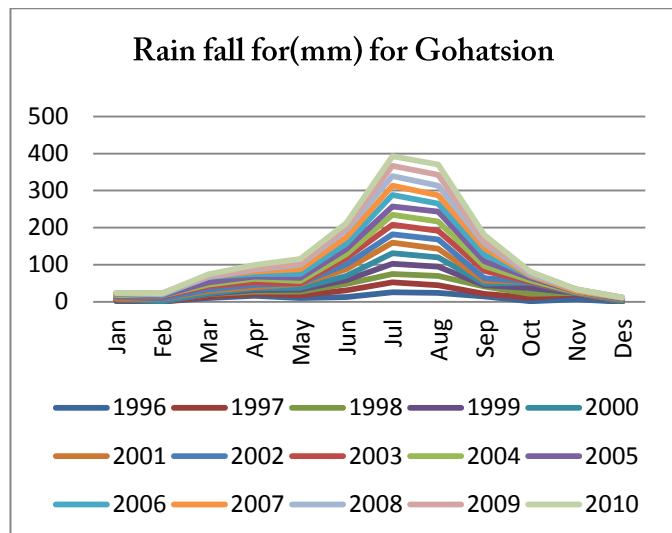
Fig. 1.2 Graph showing monthly rainfall of Gohatsion station.

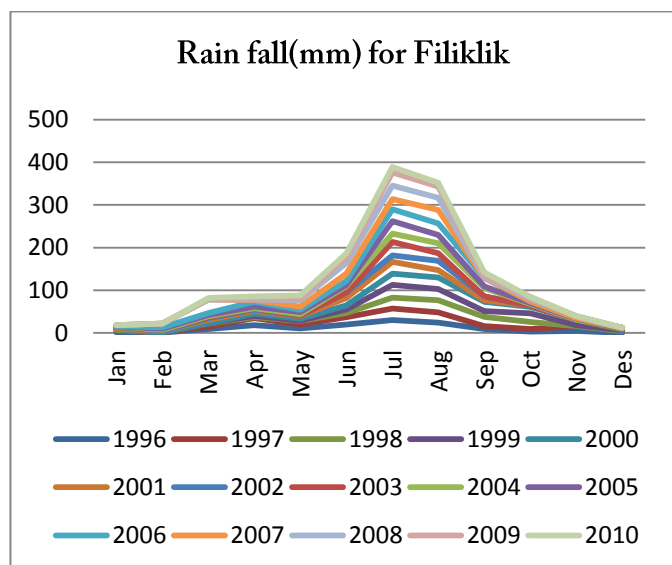
Fig 1.3 Graph showing monthly rainfall of Filiklik station.

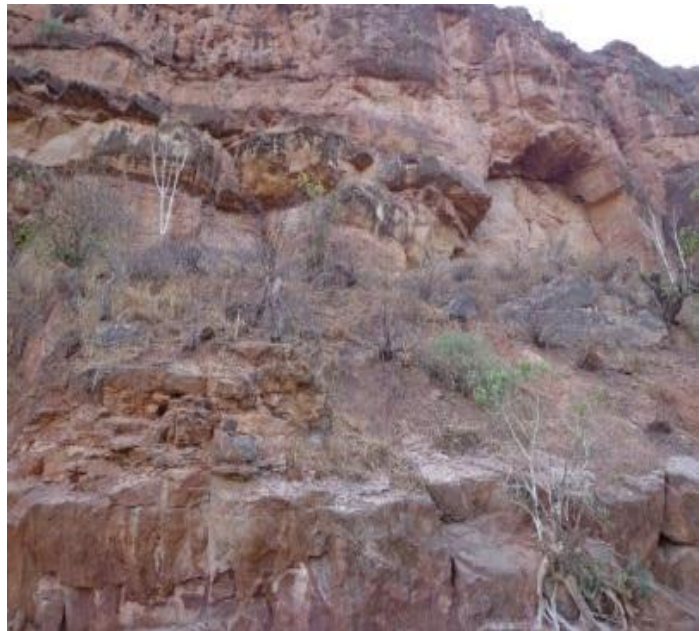
Structurally the unit has three well developed joint sets, the bedding plane which is horizontal and other two sets trending NW and NE. It forms a vertical cliff resulting rock fall due the intersection of the three joint sets (Almaz and Tadesse, 1994). On the middle part of this unit along the road cut the orientation of these joint sets were also resulting into plane failure that was one of the selected section for further analysis in the present study.

Fig 3.3 Lower sandstone unit

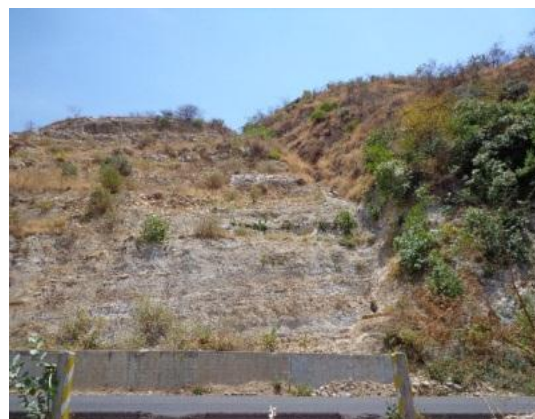
Fig 3.5 Alternating shale, dolomite and gypsum layer within gypsum unit

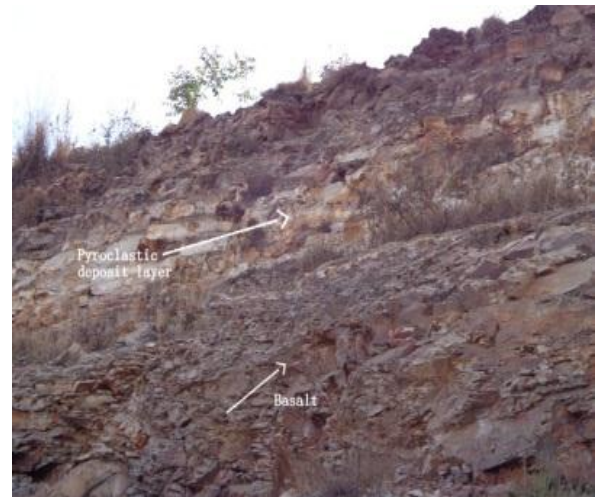
Fig 3.6 Pyroclastic deposit on basaltic unit (Gohatsion side)

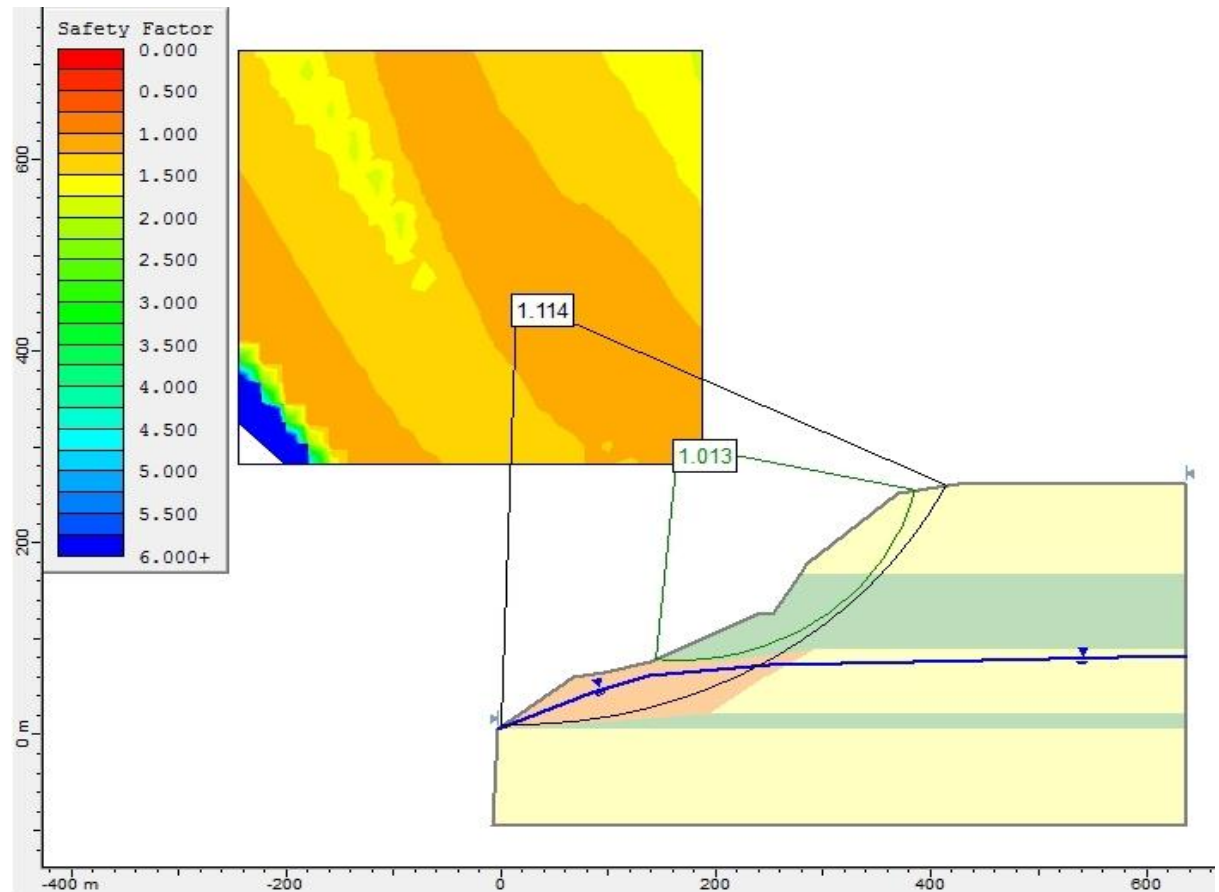
Fig 5.2 SLIDE factor of safety results of SL1 under static dry condition

A Perusal of results reveal that the deterministic factor of safety of the slope near road section without earthquake loading (static analysis) and in dry state (ground water table was assumed at its lowest level) comes out to be 1.013 (Stable condition) and for the entire section it is 1.114 (Stable condition) as shown in the Fig. 5.2. The safety factor results displayed in Fig. 5.2 were calculated from ‘Bishop Simplified’ method. Further, factor of safety results as calculated by Janbu Simplified, Janbu Corrected, GLE and Spenser are presented in Table 5.1. Moreover, the critical slip surface depth as determine from this grid search was 16 m below the road section for safety factor 1.013 and 64m for safety factor value of 1.114, respectively.

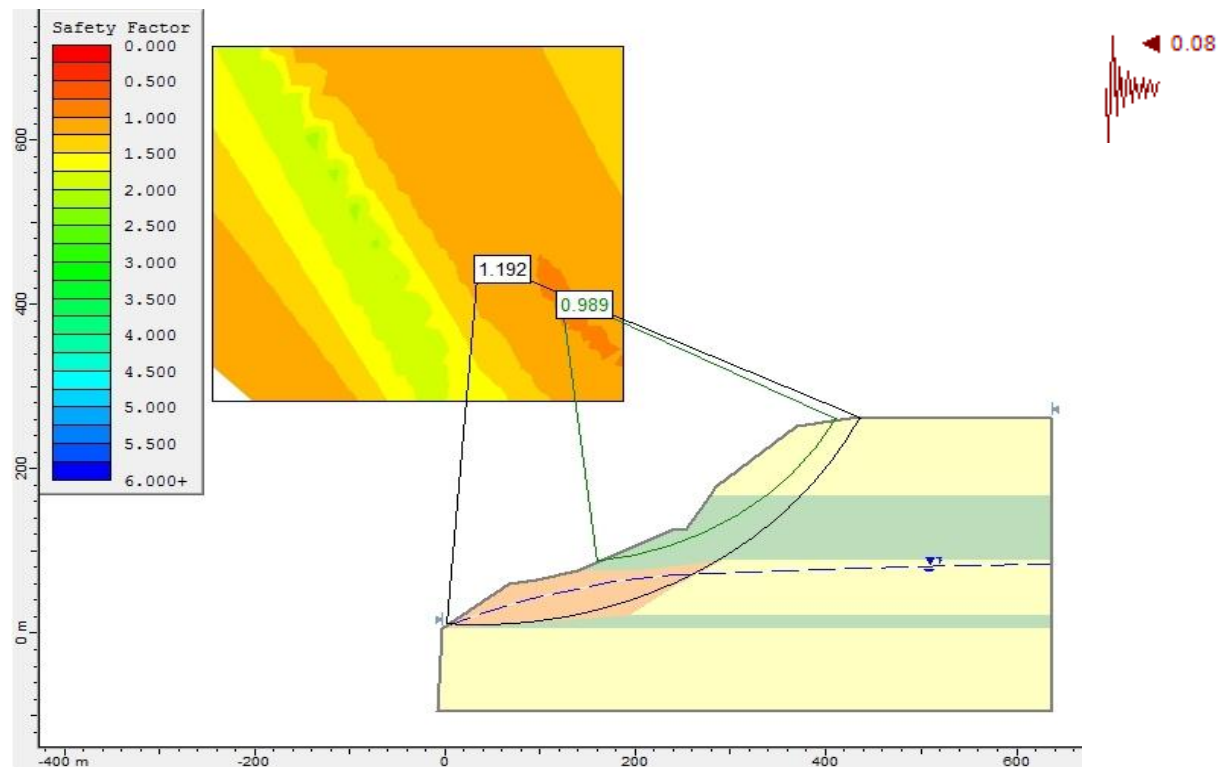
Fig. 5.4 SLIDE safety factor results of SL 1 Section under dynamic dry condition

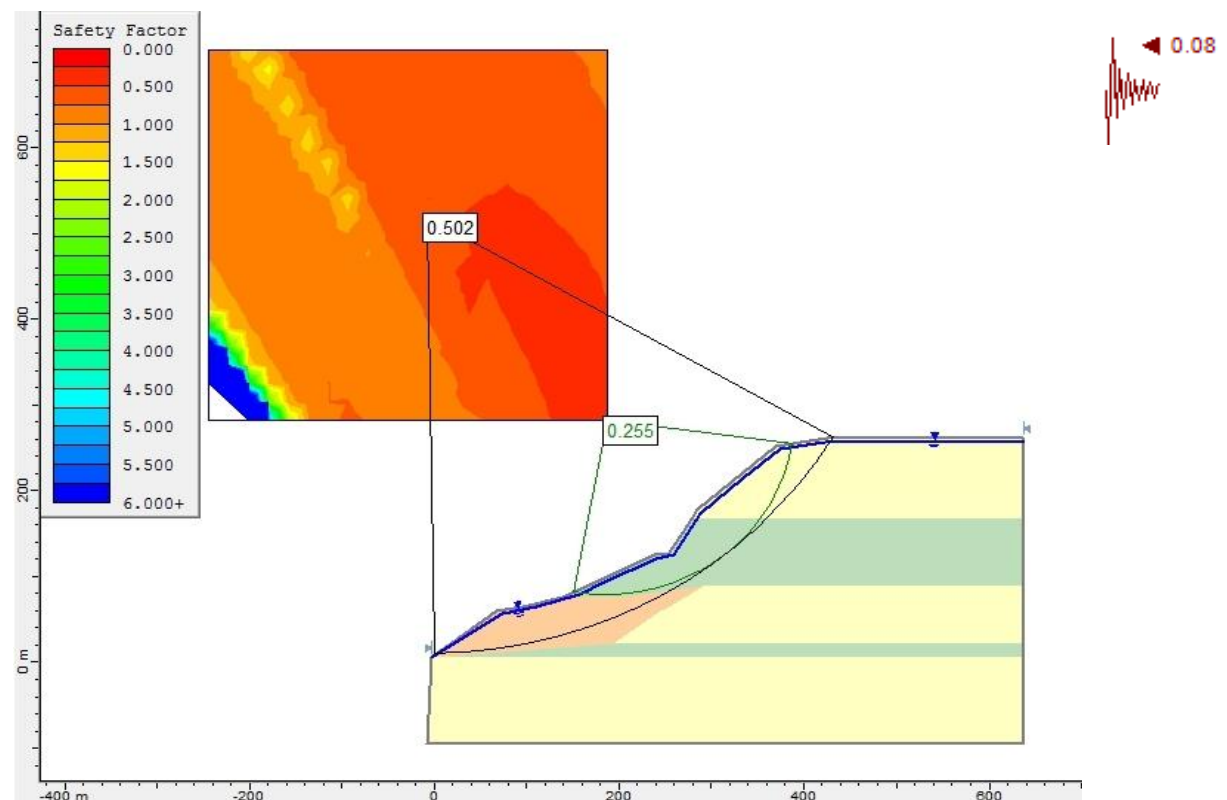
Fig 5.5 SLIDE safety factor results of SL 1 Section under dynamic saturated condition

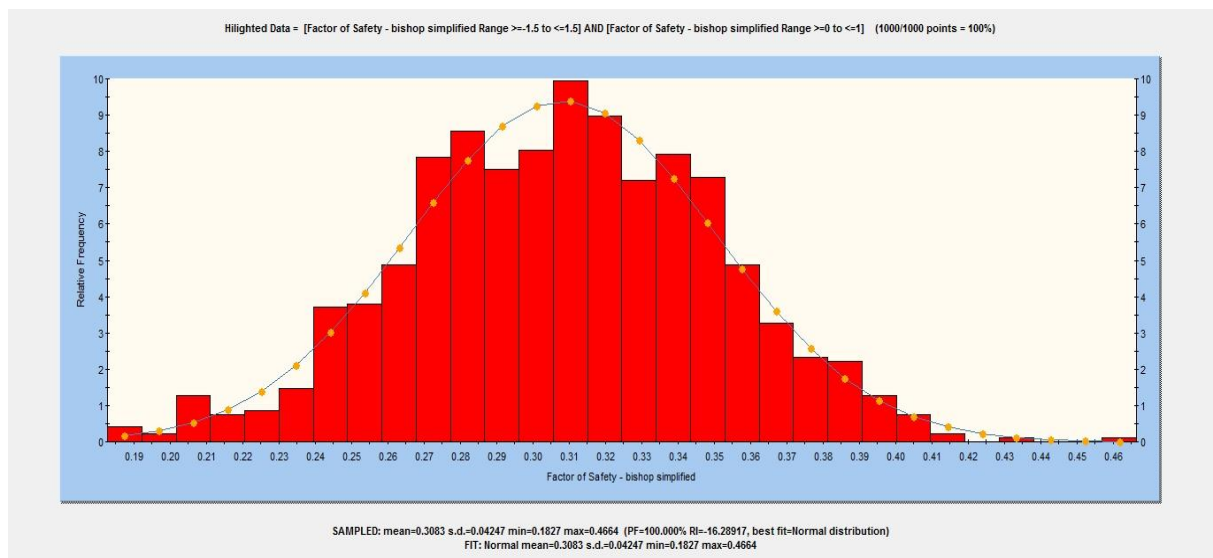
Fig 5.7 (b) probability distribution of safety factor results of SL 1 under static saturated condition

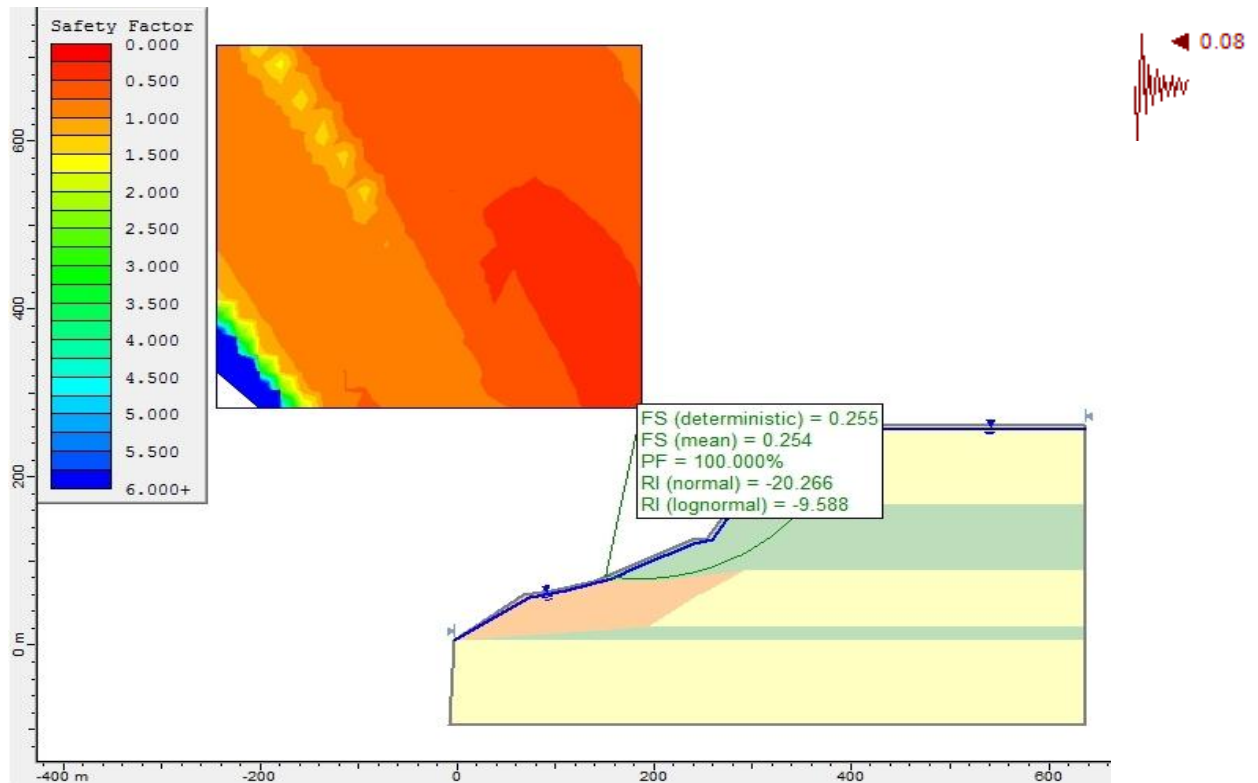
Fig 5.9 (a) SLIDE safety factor and probability of failure results of SL 1 under dynamic saturated condition

The most anticipated worst case for any slope is a condition when it is fully saturated and subjected to an earth quake. The same condition was considered for SL 1 section and Probabilistic stability analysis was performed.

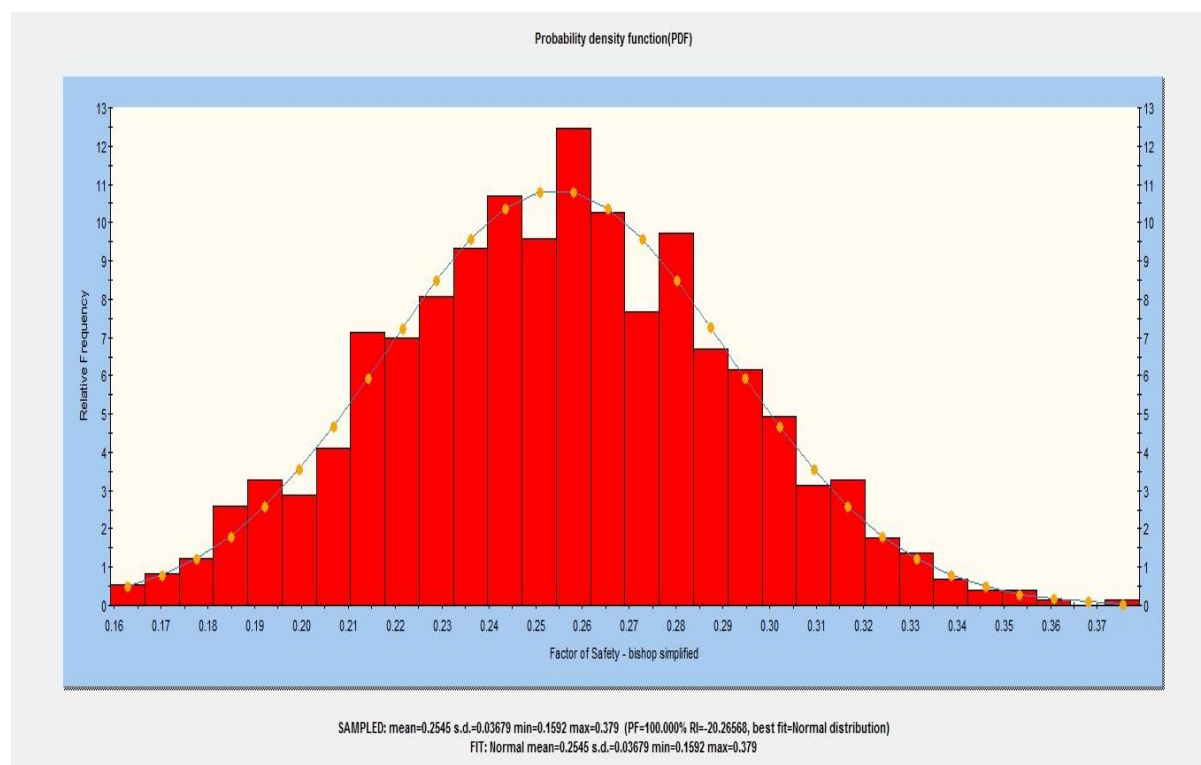
Fig 5.9 (b) Probability distribution of safety factor results of SL 1 under dynamic saturated condition

Further, the probability distribution of safety factors (Fig. 5.9 (b)) indicates that the slope is completely in a safety factor range of less than zero with a mean value of 0.254.

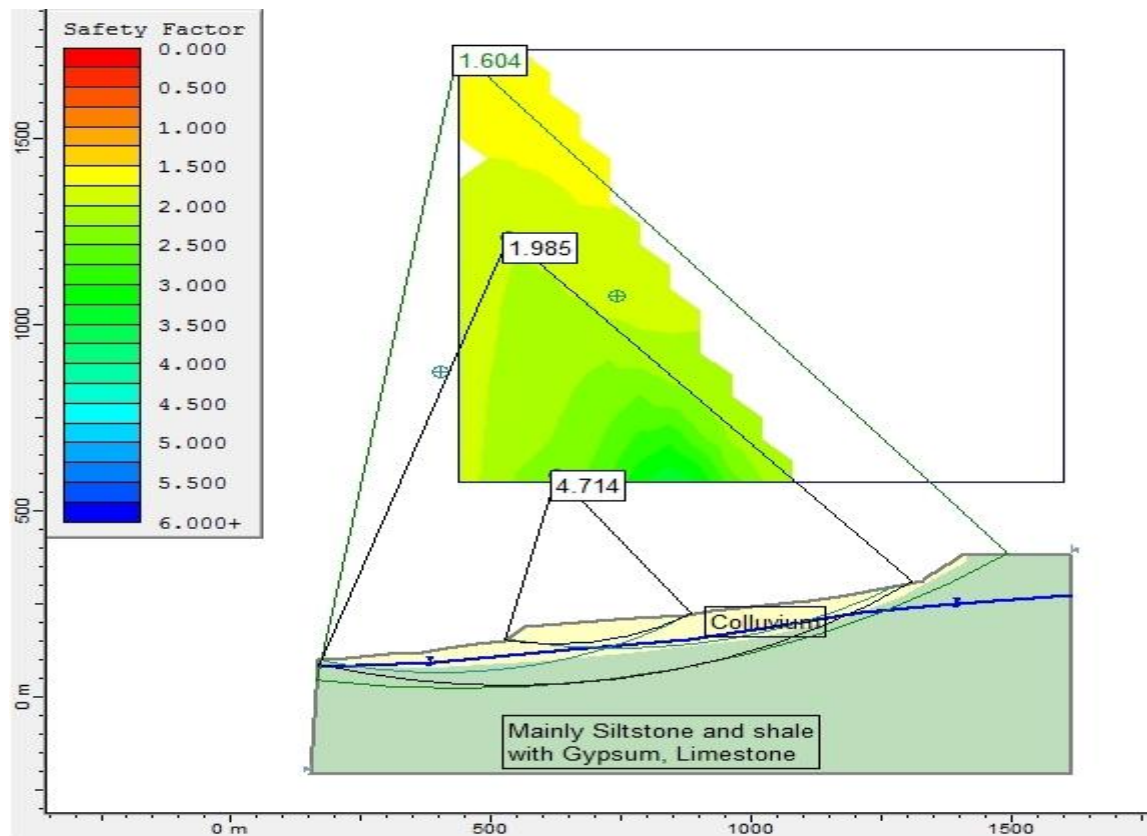
Fig 5.11 SLIDE Safety factor value under static dry by Bishop simplified and possible slips surfaces

For computation, in both approaches critical failure surface using Grid search method of SLIDE software was used in similar manner as discussed earlier in this chapter. However, as the main concern of this study was to assess the slope condition with respect to effect on the road, the window of search in software was placed on the road to determine the slip surface. Accordingly, slip surfaces were produced considering the road. Possible failure surfaces are also shown in Fig. 5.11.

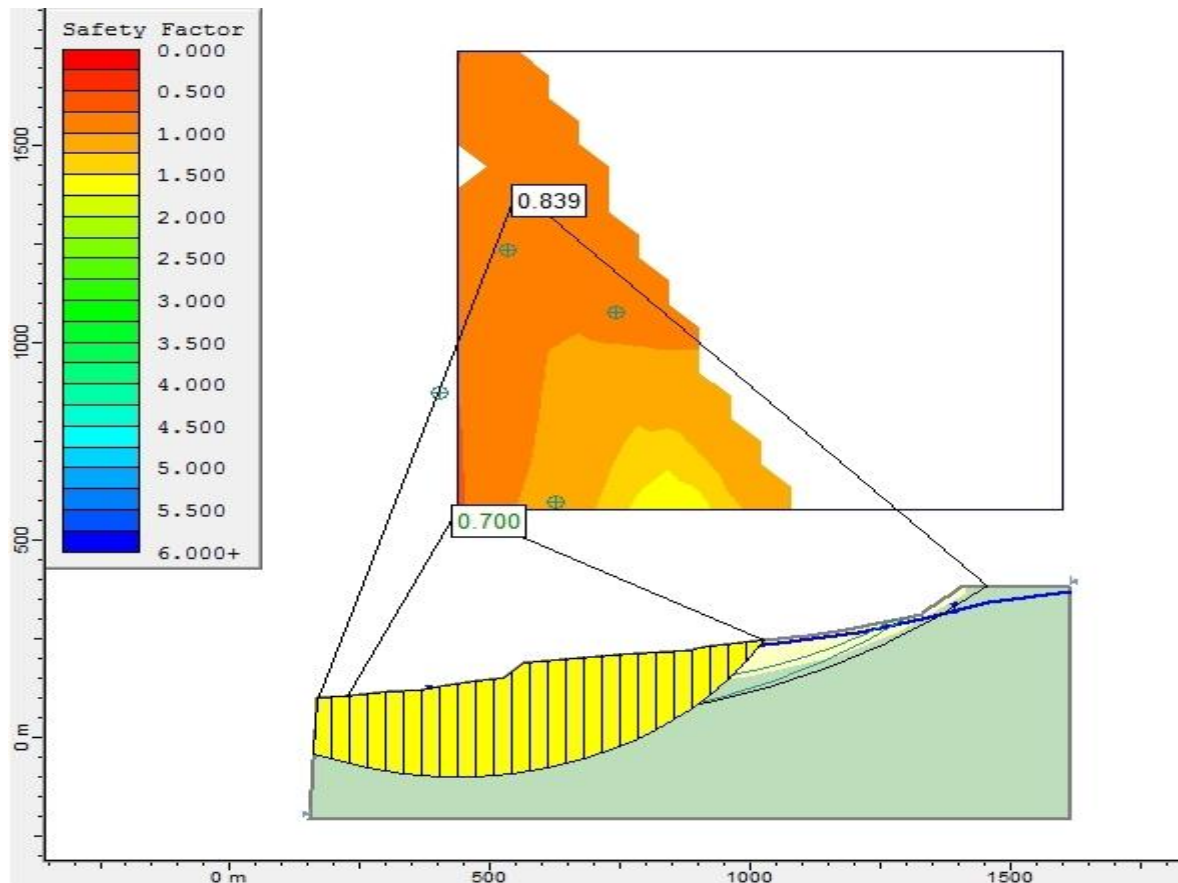
Fig 5.12 SLIDE Safety factor value for SL 4(1) Section under static saturated condition

The typical slope section for anticipated worst condition with possible slip surface and calculated safety factor is shown in Fig. 5.12.

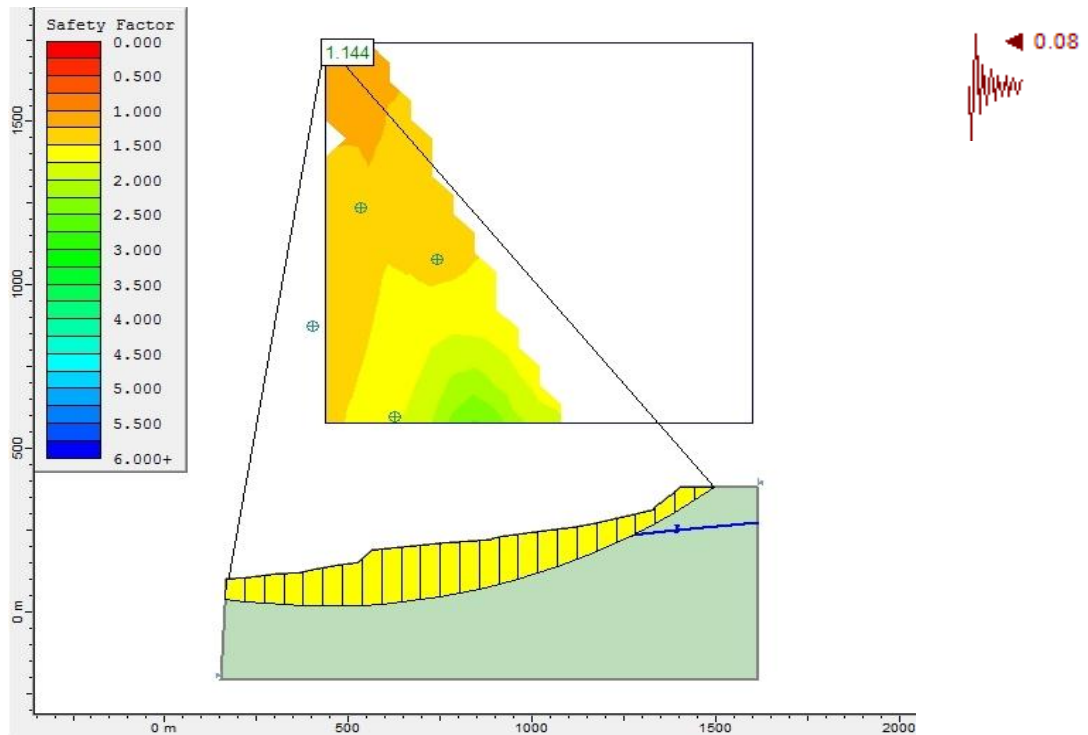
Fig 5.13 SLIDE deterministic safety factor calculation results for SL 4 (1) Slope Section under dynamic dry condition

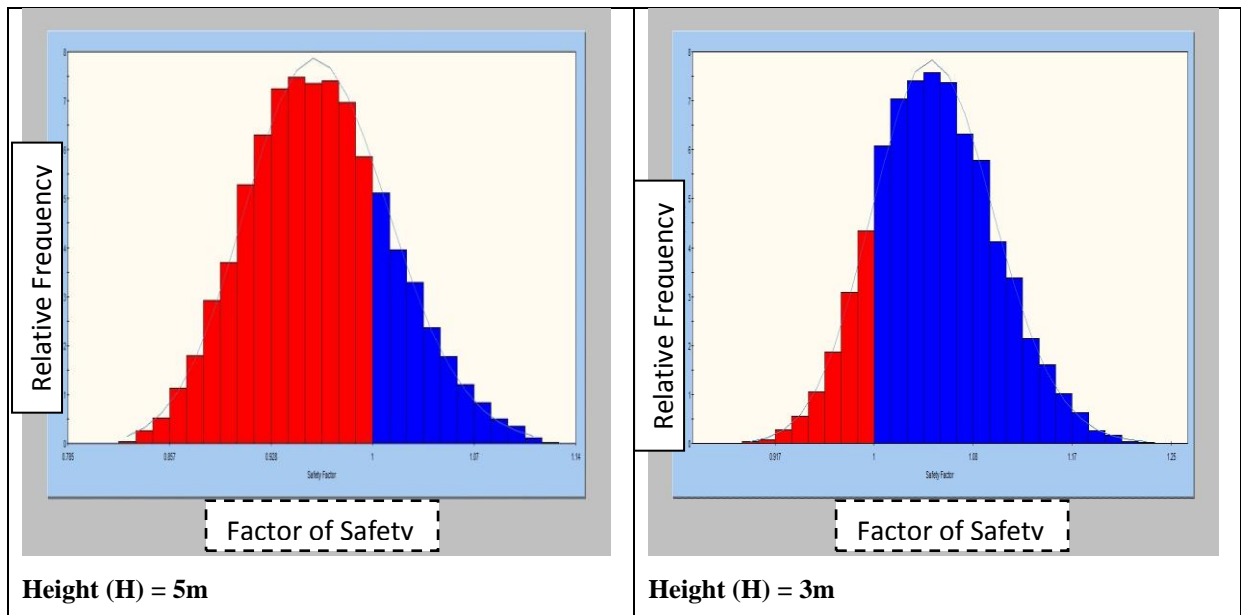
Fig 5.25 Probability distributions of safety factor for variable height (H) around their mean value for slide blocks in Slope Section SL 3
