**THE PALACE OF GUZARA AND ITS ENVIRONS:  
ITS HERITAGE MANAGEMENT AND CONSERVATION**

**November, 2018**

**A THESIS SUBMITTED TO  
THE DEPARTMENT OF ARCHAEOLOGY AND HERITAGE MANAGEEMENT IN  
PARTIAL FULFILLMENT OF THE REQUIREMENTS FOR THE DEGREE OF  
MASTERS OF ARTS IN ARCHAEOLOGY**

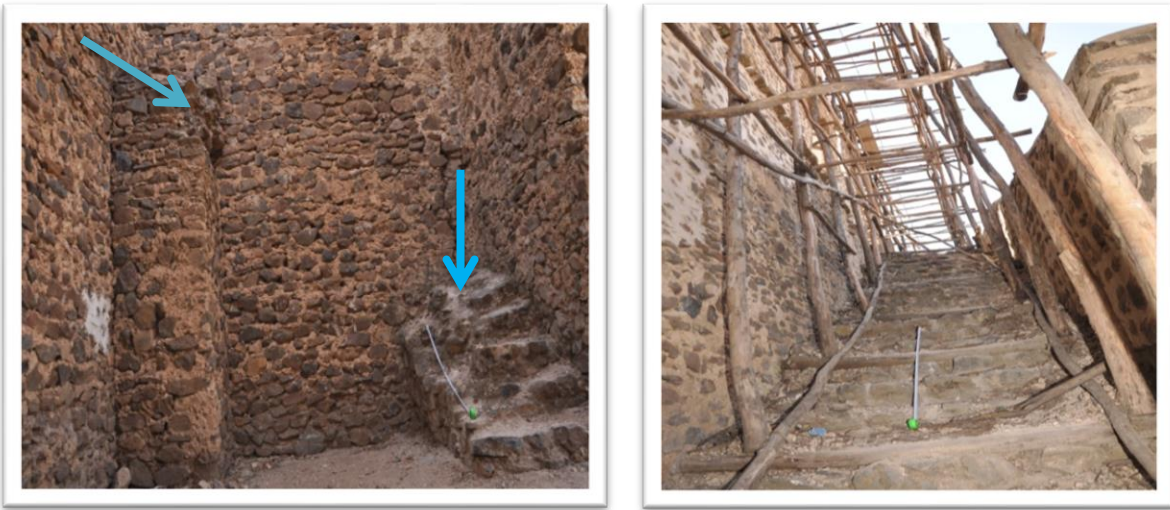
Figure 3.3. A destructed staircase inside the palace leading to the upper floor (the left figure); the outside stair case (the right figure) (Photo by Kedir 2018)

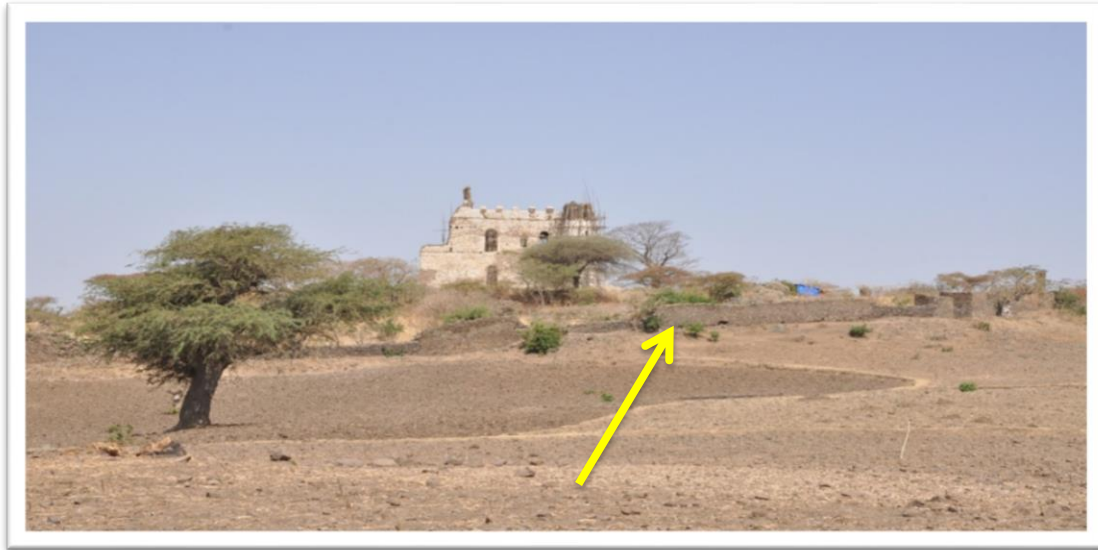
As noted above, Guzara palace is situated at a plateau where it catches the attention of eyes of everybody who sees it. It is walled by a large circular fence (Figure 3.7). Albeit much part of the fence is destructed due to natural and cultural causes, some parts are still preserved in situ showing how it was looked like originally. My informant (Samuel Mekonen, 2018), expressed that the overall wall of the palace measures 580 meter from which 280 meter is reconstructed by small stones without attaching it by lime mortar, but diminishes the original characteristics of the palace and its wall while 300 meter is still preserved keeping its authenticity. As to my measurement, the thickness of the old enclosure is about 80 centimeter whereas the thickness of the reconstructed wall ranges from 80 centimeter to 1 meter, and the length of the old compound wall measures 3.2 meter whereas the reconstructed one is 1.30 meter(See. figure 3.8).

Figure 3.7. Wall surrounded the Palace of Guzara (Photo by Kedir 2018)

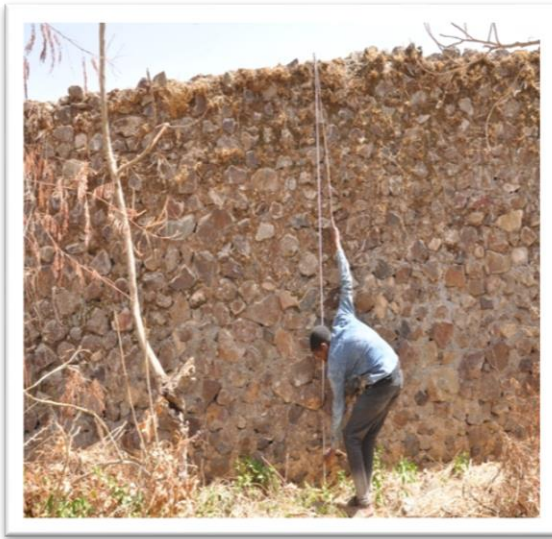
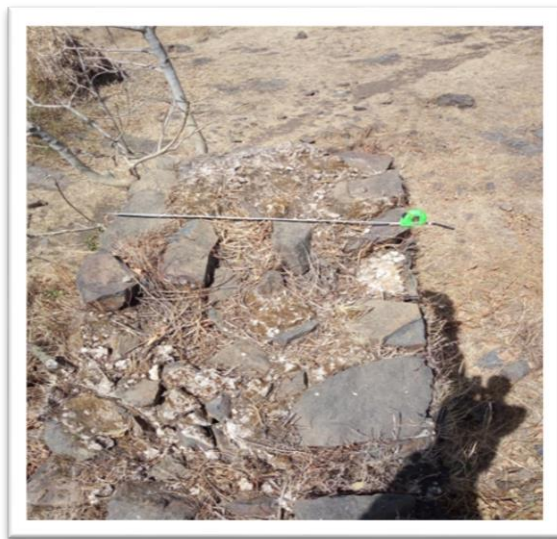
Figure 3.8. The length and thickness of the old compound wall of the Palace: the length (left figure), and its thickness (right figure) (Photo by Kedir 2018)

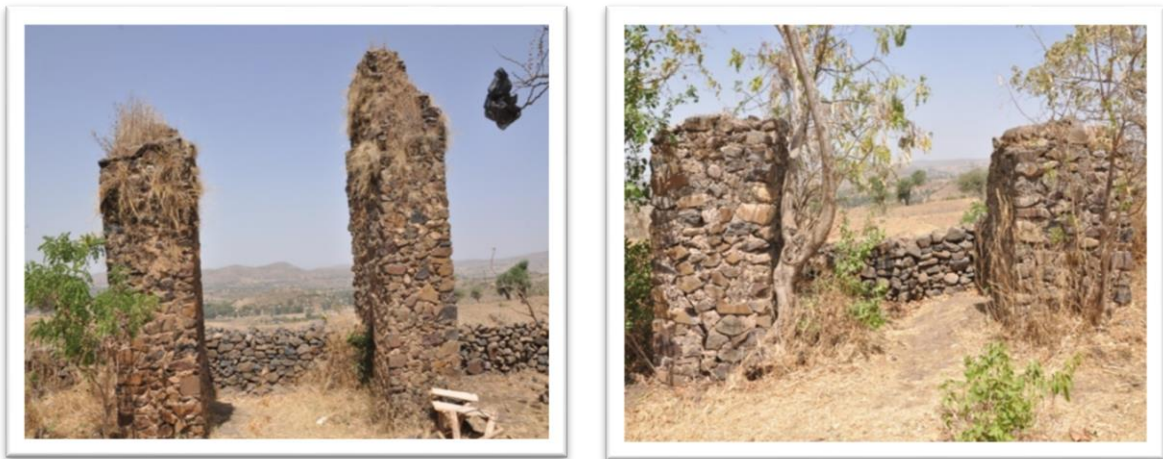
As to my field survey and my informant, Samuel, 2017, the palace of Guzara had four gates, two each in the eastern and western direction. Currently these gates are in a destructed state, thus one cannot easily identify for what purpose they were constructed as they are destructed and not giving service today. Currently, there is a new gate which leads to the compound of the palace in the western direction near to the two old gates (Figure 3.9, 3.10 and 3.11).

Figure 3.10. Western gates of the Palace (view from inside): better preserved but grasses are grown on it (left figure), and gate on destruction (right figure) (Photo by Kedir 2018)

The width of the larger western gate is about 2.35 meters while the smaller one measures about 2.10 meters. The two gates which are found in the eastern direction from south to north direction measures 2.75 meter and 2.80 meter respectively.

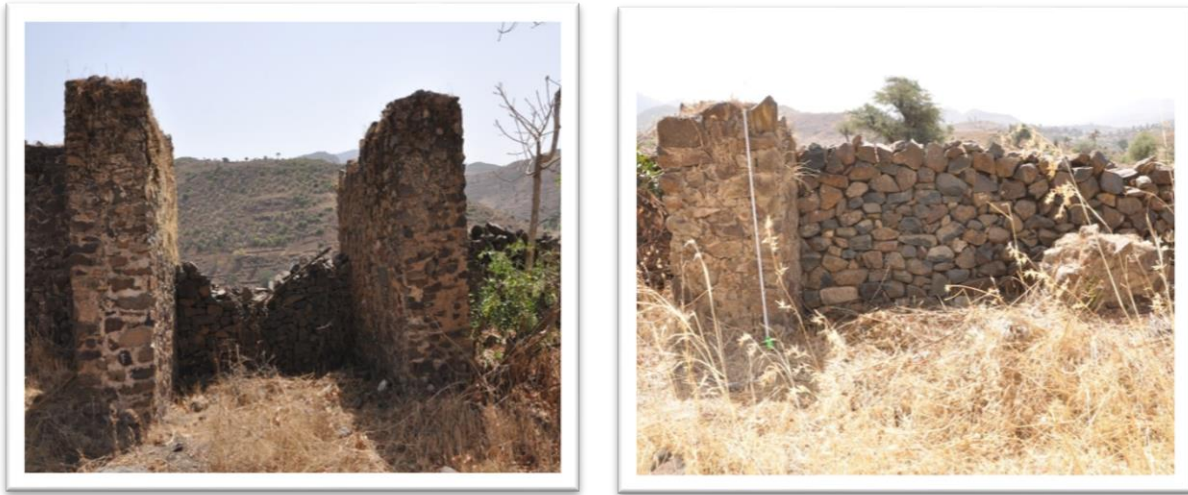
Figure 3.11. Gates of the Palace at its eastern direction from north to south direction: better preserved (left figure), and destroyed gate (right figure) (Photo by Kedir 2018)

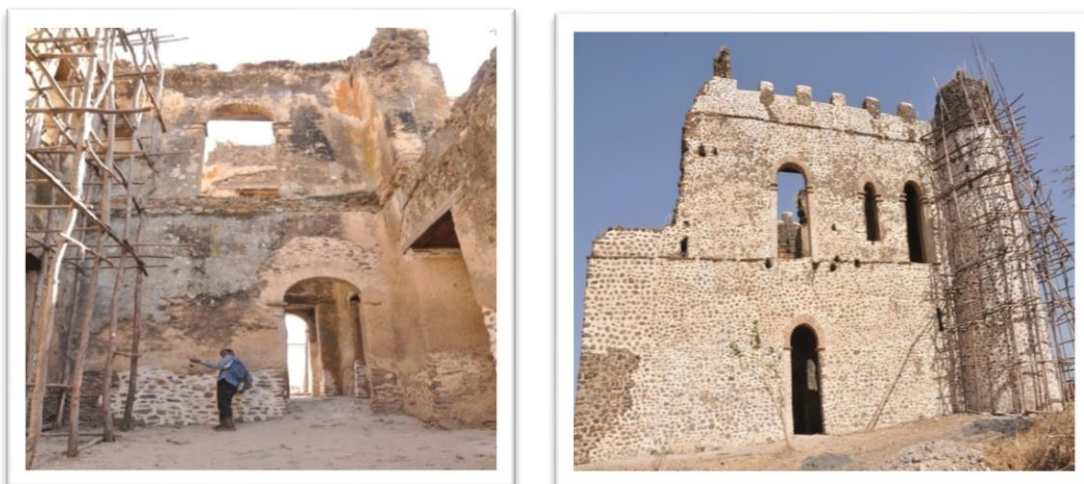
Figure 3.14. Palace of Guzara: in deplorable state, internal face (left figure), and in a good condition, its eastern facade (right figure) (Photo by Kedir 2018)

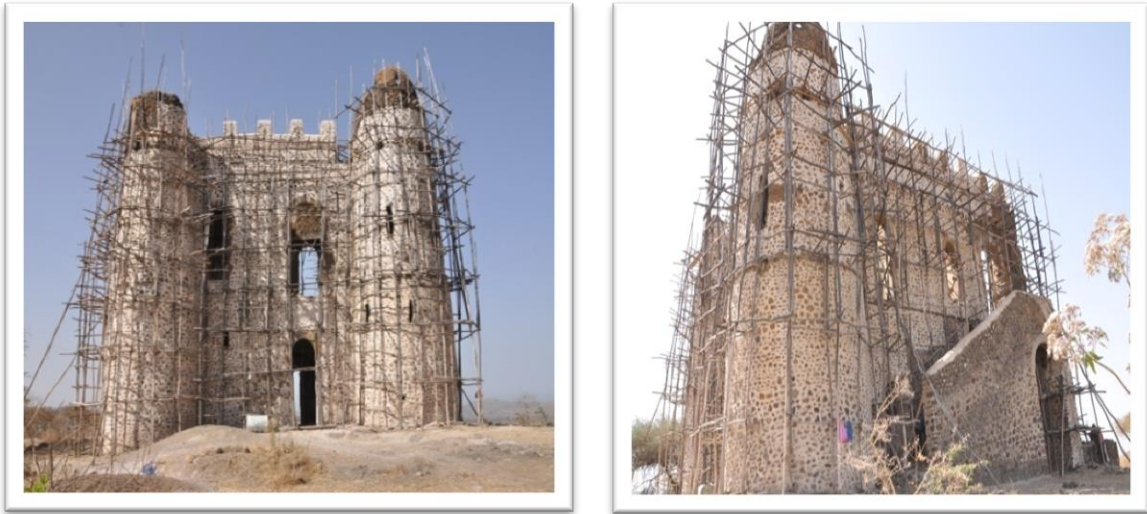
With the fund of 825,000 Ethiopian birr from Federal government of Ethiopia and additional 400,000 birr from the regions culture and tourism bureau, the conservation activity started in 2014/15 G.C. with the auspice of Culture and Tourism office of north Gondar administrative zone and ARCCH. However, due to ceasure of budget which was released each year the conservation was interrupted for one year. Again, in July 2017/18, it was restarted and still the conservation is going on to the present day (informants: Sahlemariam, 2018; Girmachew, 2018) (See figure 3.17).

Figure 3.17. Guzara Palace on Conservation: the northern face (left figure), and the western face (the right figure) (Photo by Kedir 2018)

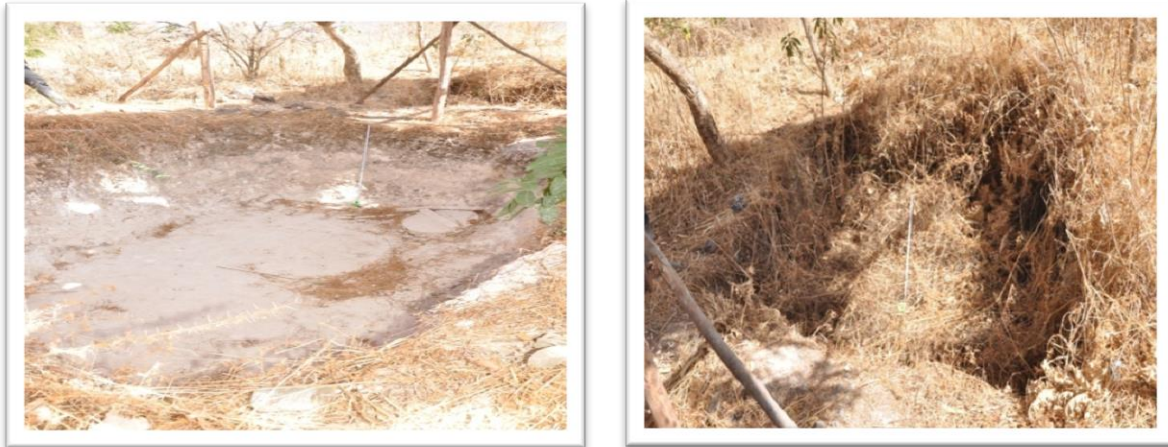
“First, we brought the lime stone/ or locally called Nora from Ambo, west Ethiopia. Then, it was sieved to separate the pure limestone from its sands and ingredients (coarser limestone). Then, the powder limestone was mixed by water very well, finally to be buried in the soil for either seven or eight years, but in the case of Guzara it was buried (See Figure 3.18), for four years and it was fetched by water. After that, the limestone is taken out from where it was buried and put inside container to be mixed with water and rolled by hand material for five or six days (Figure

Figure: 3.18. A place where lime stone was buried beneath the surface; lime stone taken out to be boiled with water in containers (left figure), lime powder still buried (right figure) (Photo by Kedir 2018)

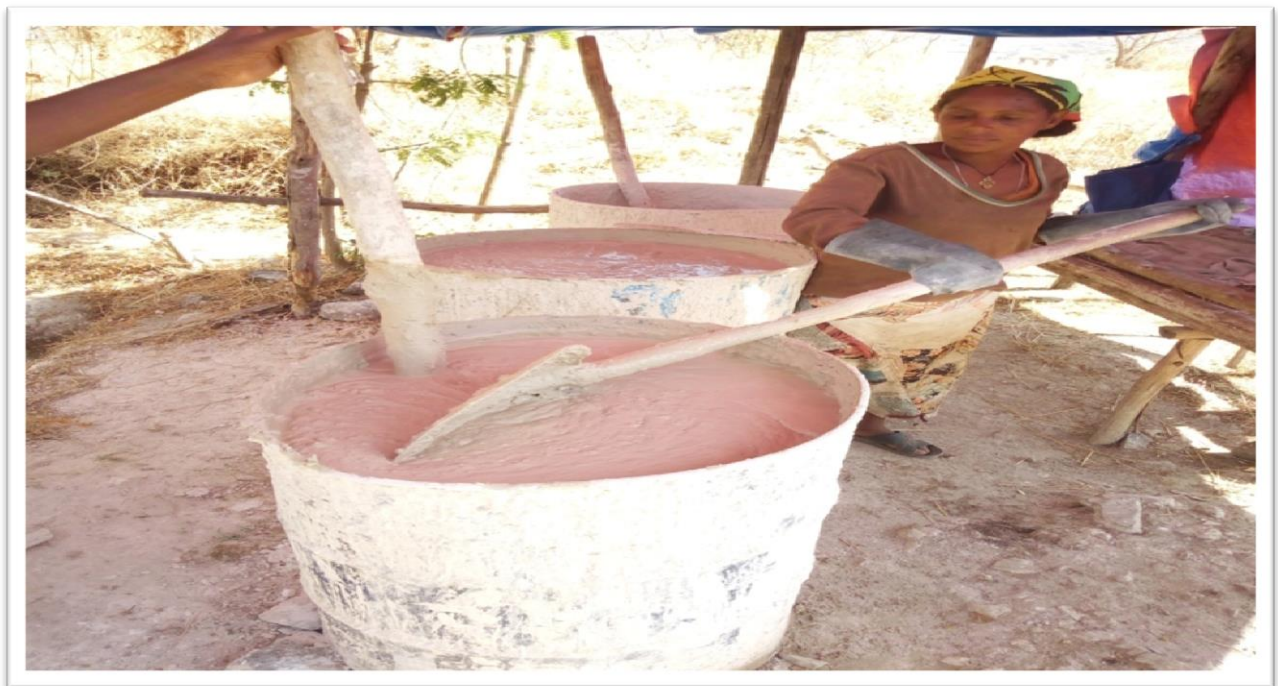
Figure 3.19. A woman boiling the lime powder, which was buried, with water (Photo by Kedir 2018)

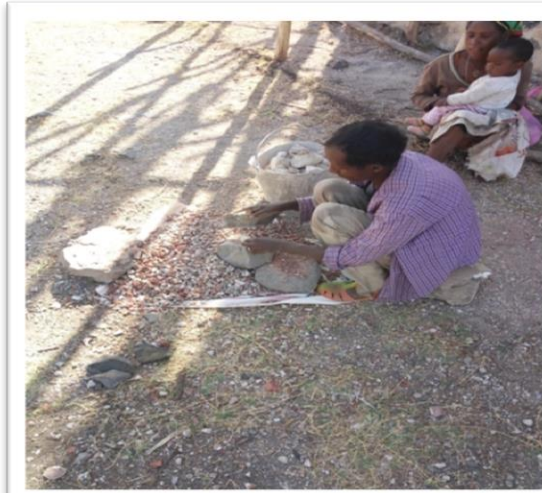
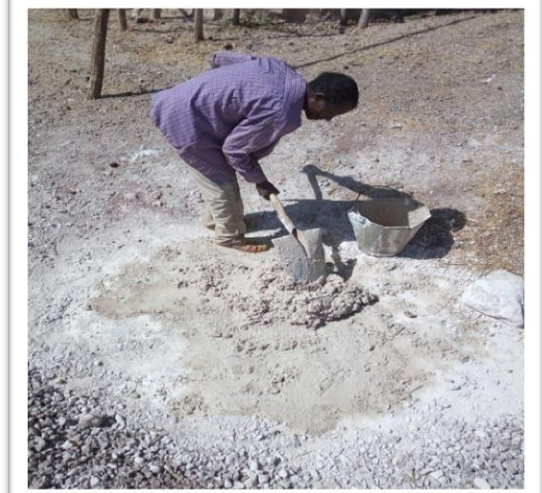
3.19). Finally, this limestone mixing with the coarse limestone which was left when sieving will be used for conservation activities as a mortar (See figure 3.20, and Figure 3.21)”

Figure 3.20. A man pounding coarse limestone debris (left figure), and a man mixes limestone powder with coarse limestone debris to make it ready for conservation (right figure) (Photo by Kedir 2018)

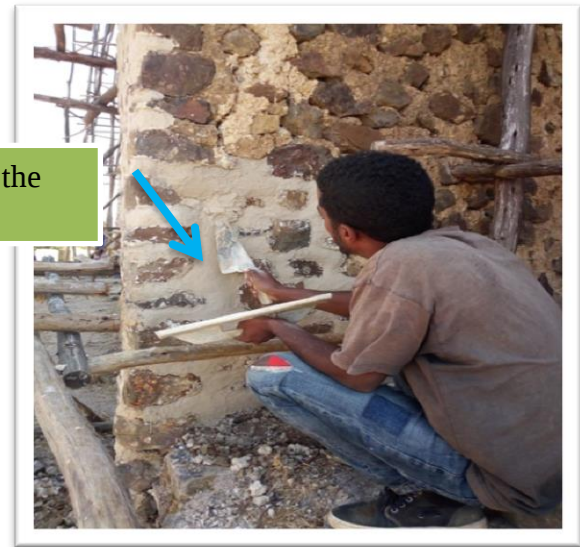
A man repairing the  
palace by mortar

Figure 3.21 Mortar used in repairing the Castle (Photo by Kedir 2018)

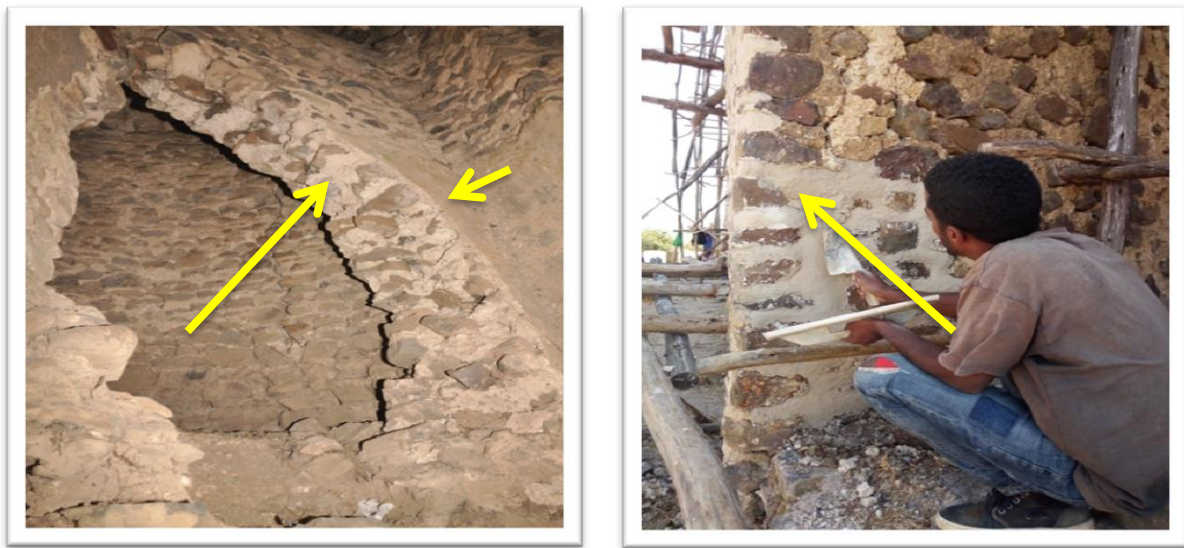
stated, unprofessional act of conservation is a challenge or threat to the heritages of Ethiopia. Similarly, I have forwarded the following reasons for the conservation being conducted is unprofessional. Firstly, the concerned authorities did not conduct a deep scientific preliminary study very well. Since the palace is hugely destructed long ago, it becomes very difficult to maintain the original character of the building (to keep its authenticity), and now it is shown as the conservation continues they are very challenged to conserve especially the first floor of the building, which is totally damaged. Secondly, because the conservation on the palace is not supported with concrete evidence, it is repaired against as to how the profession of conservation orders that conservation should be conducted. As I observed the process of conservation during field work, the masons simply paint the mortar on the building which is not exactly similar with original building as it is clearly visible from parts of the debris of the building and enclosure of the palace (Figure 3.22).

Figure 3.22 Conservation difference: old building, very compacted, well done where much amount of lime mortar used, (left figure), and wall conserved slightly by lime mortar (right figure) (Photo by Kedir 2018)

Thirdly, there is no professional supervisor who guides the conservation. As to informants, (Girmachew, 2018, and Samuel, 2018), the process of conservation is guided by culture and tourism office of north Gondar administrative zone. *Ato Sahlemaryam*, a surveyor, is the person who supervises the conservation. Though he has experience about conservation because he

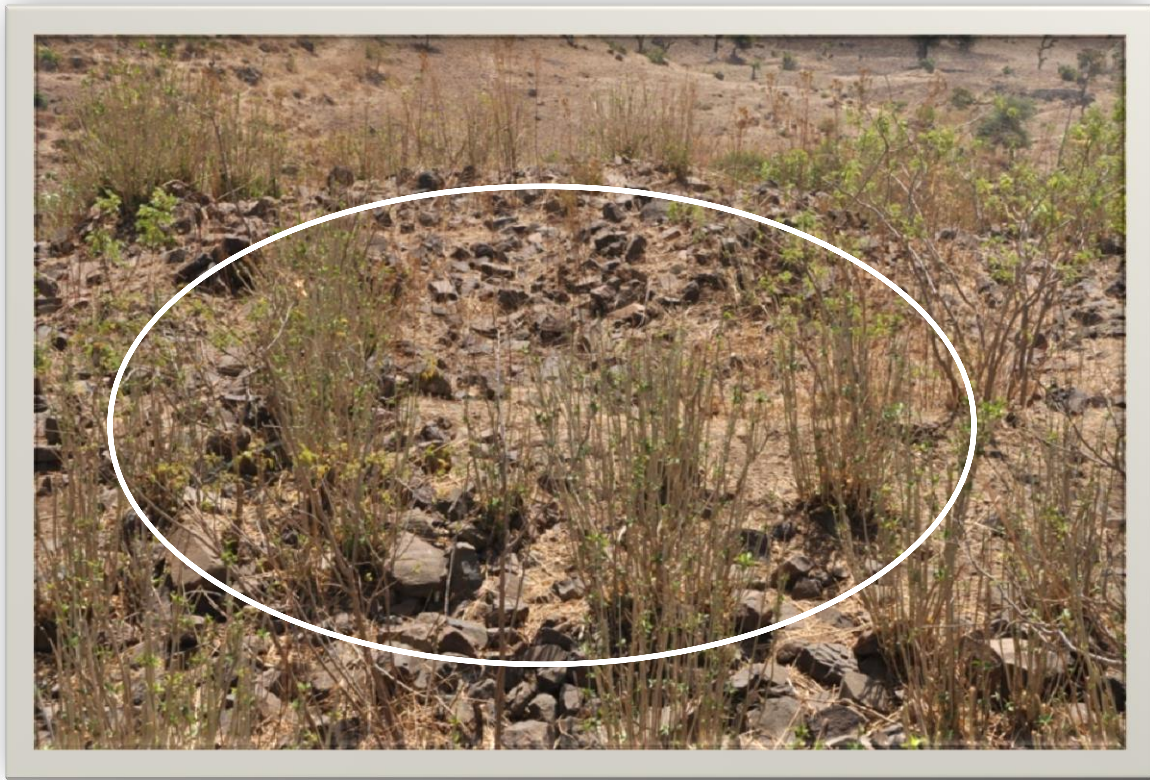
Inside the ruined enclosure, there is accumulation of stones making a circle which might be the ruins of the church. The church is totally damaged, except the collected stones. Besides, most parts of the enclosure of the church are destructed but few parts of it are intact preserved (See Figure 3.27, Figure 3.28, Figure 3.29, and Figure 3.30). According to my field survey, the techniques and material construction of the church is exactly the same as the Guzara palace, and it is evidenced on the enclosure of the church in which small stones are plastered with lime mortar, which is identical with the palace of Guzara. Therefore, it can be said that both them were constructed at the same time, might be the oral tradition attribution by King Sertse Dingle (r. 1563-1597).

Figure 3.27 Ruins of the Church, collections of stones in circle at the middle of the compound (Photo by Kedir 2018)

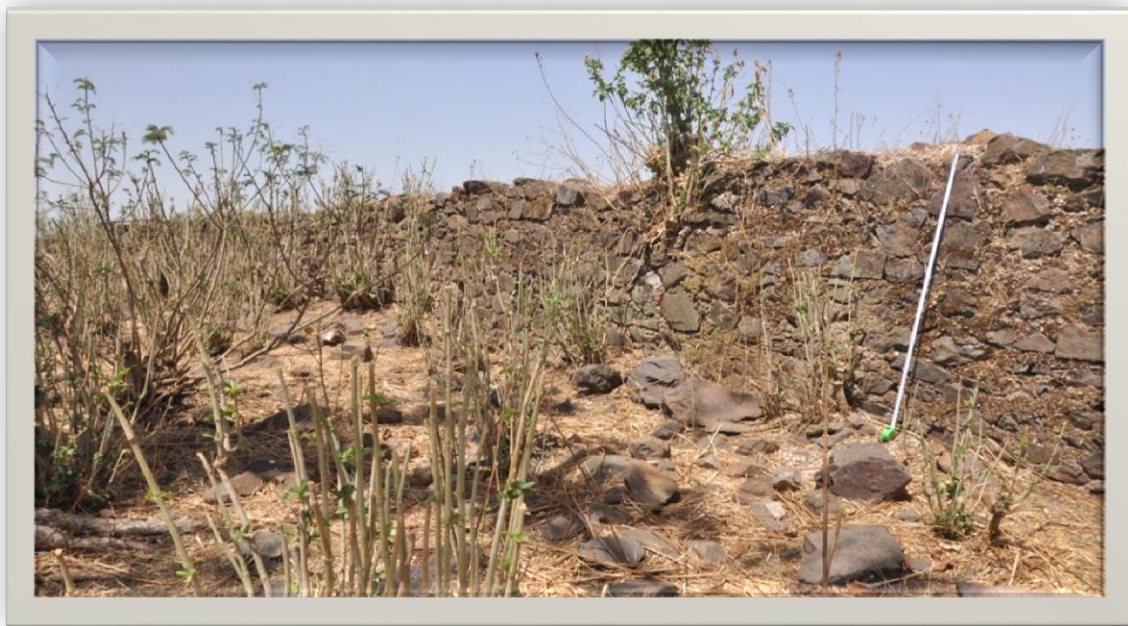
Figure 3.29 Well preserved Enclosure of the Church (Photo by Kedir 2018)

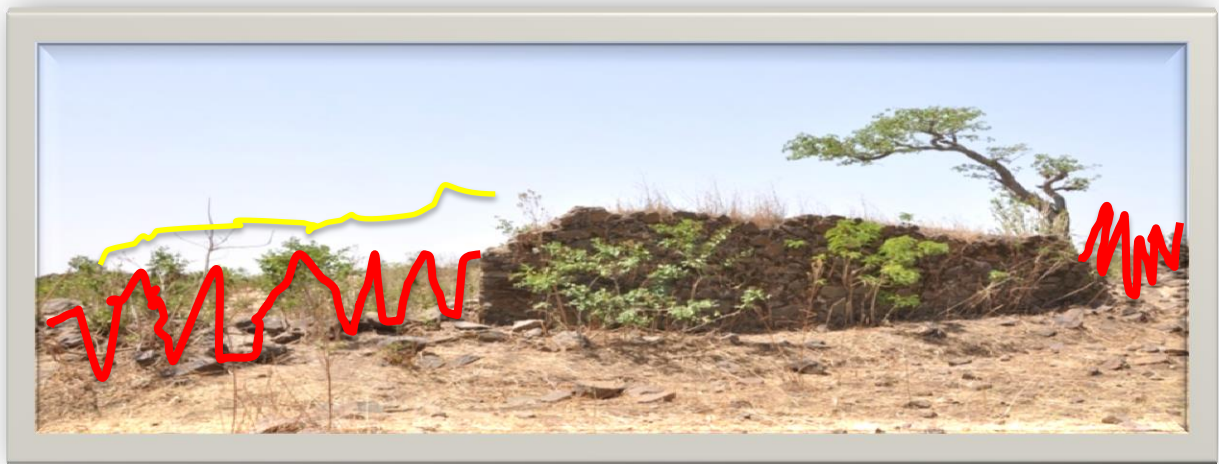
Figure 3.30 Destructed Enclosure of the Church (Photo by Kedir 2018)

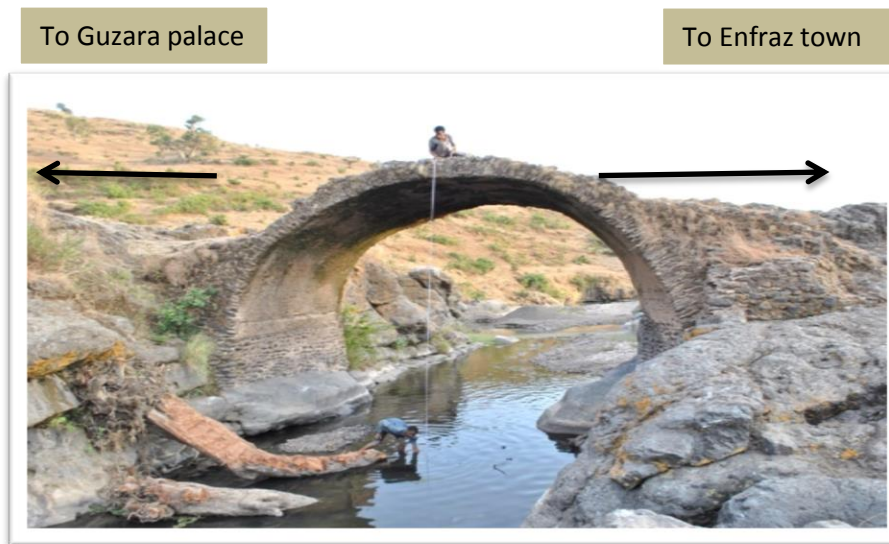
As to my field work, the bridge was constructed by combining small rough stone one with lime mortar on a natural foundation which is made up of granite stone that has maintained the bridge since its erection (See also Engdu eta'l, 2017: 3). The bridge's outer length is 12 meter whereas its height from the earth is 6.5 meter. At the base, the length of the bridge measures about 4.8 meter. The choice of the foundation at which the bridge was constructed tells us that how much the past society had been knowledgeable and their engineering capabilities would have been. However, as the same is true for other monuments of the study area such as Bahri Ghinb, Debsan Ghnib, and Guzara palace, Gobatit Dildiy has been and is being deteriorated by agents of destruction (Figure 3.31).

Figure 3.31 Gobatit Dildey (Photo by Kedir 2018)

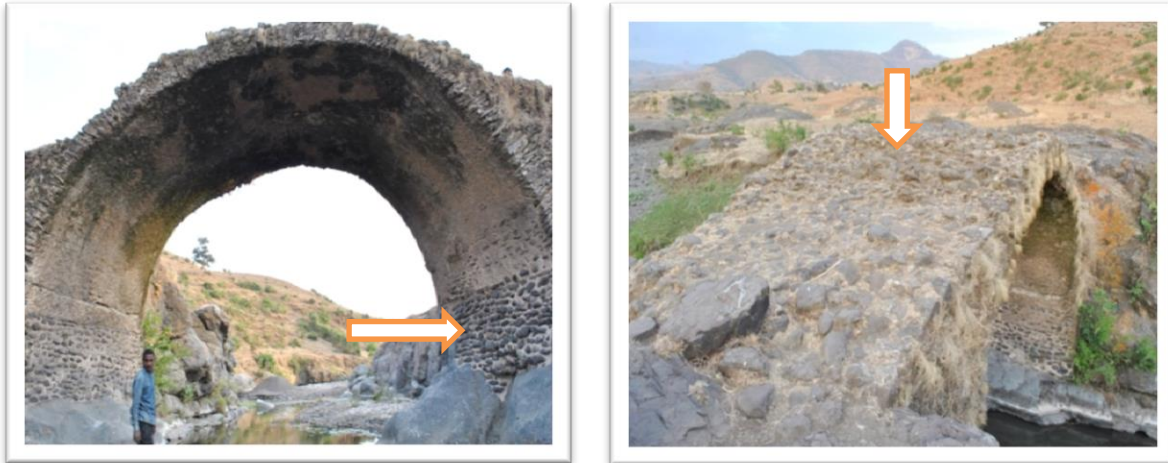
Notwithstanding the bridge is perhaps the first to be constructed in this part of the country (Pankurst, 1978:419; Engidu, et'al 2017:3), sadly speaking, it is being deteriorated because of long age, the river's winter flood, weathering, low awareness about the value of heritages among the communities, negligence and poor handling both by societies and government, lack of professionals, and poorness etc. If we carefully look at it, the surface of the bridge is eroded by animal and human movement, and the effect of weathering (rain, wind, dust and sun) while its part immediately above the base is eroded by flood of the rainy season. The nearby locally called *Warka* or sycamore tree has been failed by the flood. Therefore, unless measurement is taken now, this very spectacular ancient bridge will be the next to be broken and lost forever (Figure 3.32).

Figure 3.32. The base of the Bridge eroded by the rainy flood (left figure), and its deteriorated surface (right figure) (Photo by Kedir 2018)

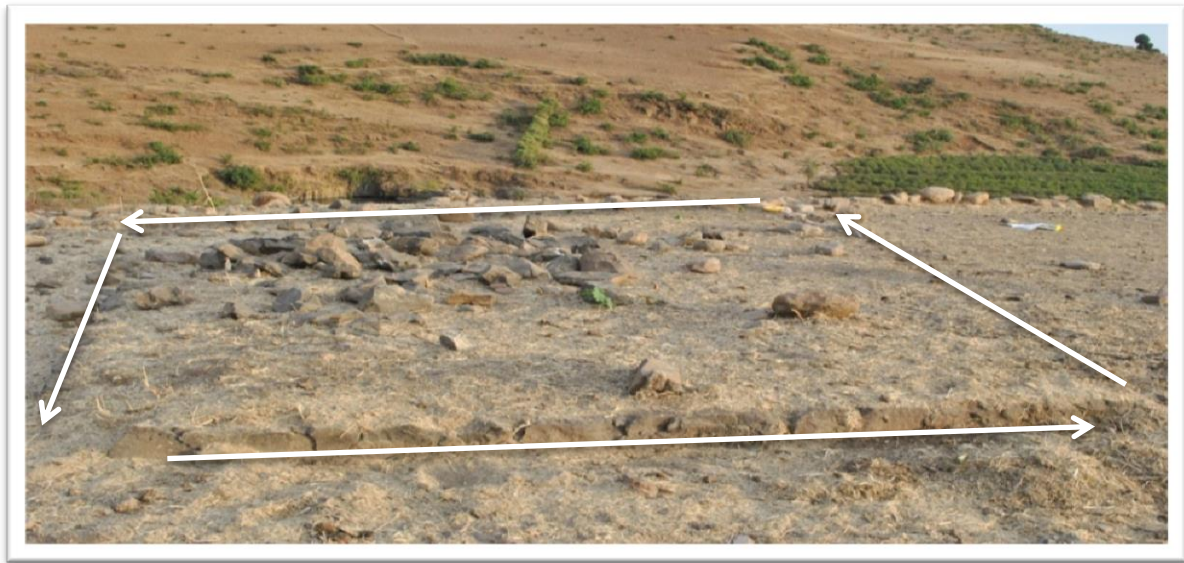
Very near to Gobatit Dildiy, some 50 meter away to the western direction, we found a foundation which is a rectangular in shape and does not give a clear hint what it was originally. But, according to the surrounding communities (informant: Engdaw Aragai, 2018), orally, it is believed that there was an underground house/ structure beneath the foundation. It is located in a raised area than its surrounding (Figure 3.33 and Figure 3.34). However, it needs further investigation to proof it.

Figure 3.34 Foundation of Ruined Building near Gobatit Dildey (Photo by Kedir 2018)

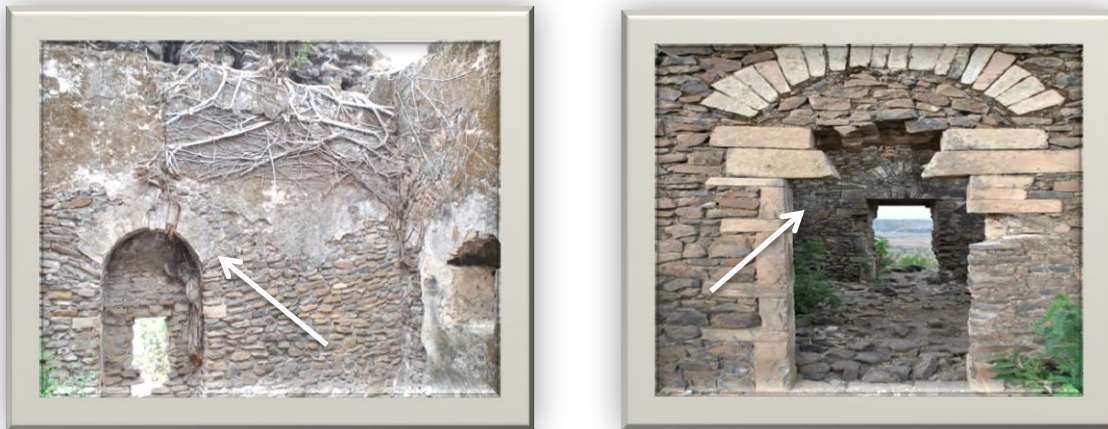
It has eight doors and eight windows, but currently all of them are lost forever and free for everything to get in. The doors and windows of the building of Debsan are arched just so what is seen in the palace of Guzara, in Bahri Gemb, and in Gondar palaces. The top of the doors and windows are made by well-dressed limestone and bricks indicating how were the technology during the period when it was erected. Of eight doors in general, four of its top which seemed like arch-shaped were made by well-dressed lime stone while the rest four were made by bricks (See. Figure 3.37 and Figure 3.38).

Figure 3.38 Arched Windows (left figure) and Doors (right figure) (Photo by Kedir 2018)

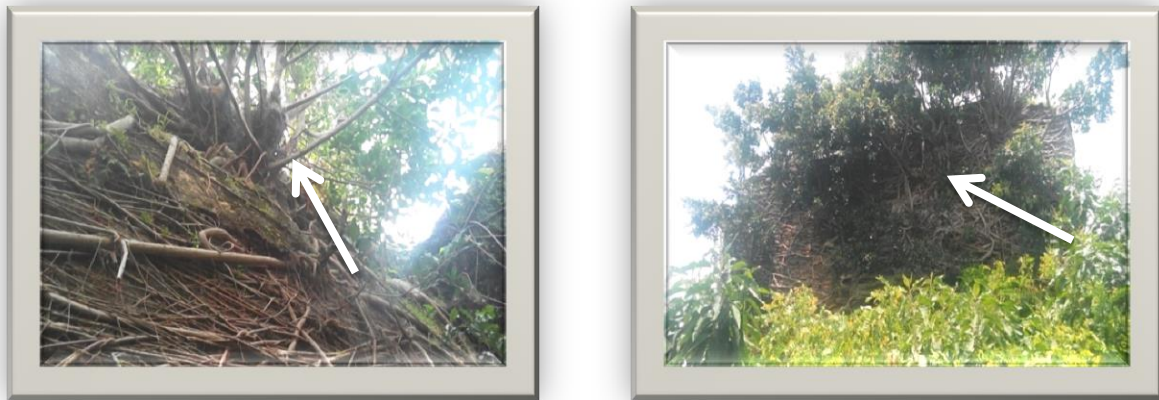
Figure 3.39 Trees grown on the building: at inside (left figure), and at outside, the eastern face (right figure) (Photo by Kedir 2017)

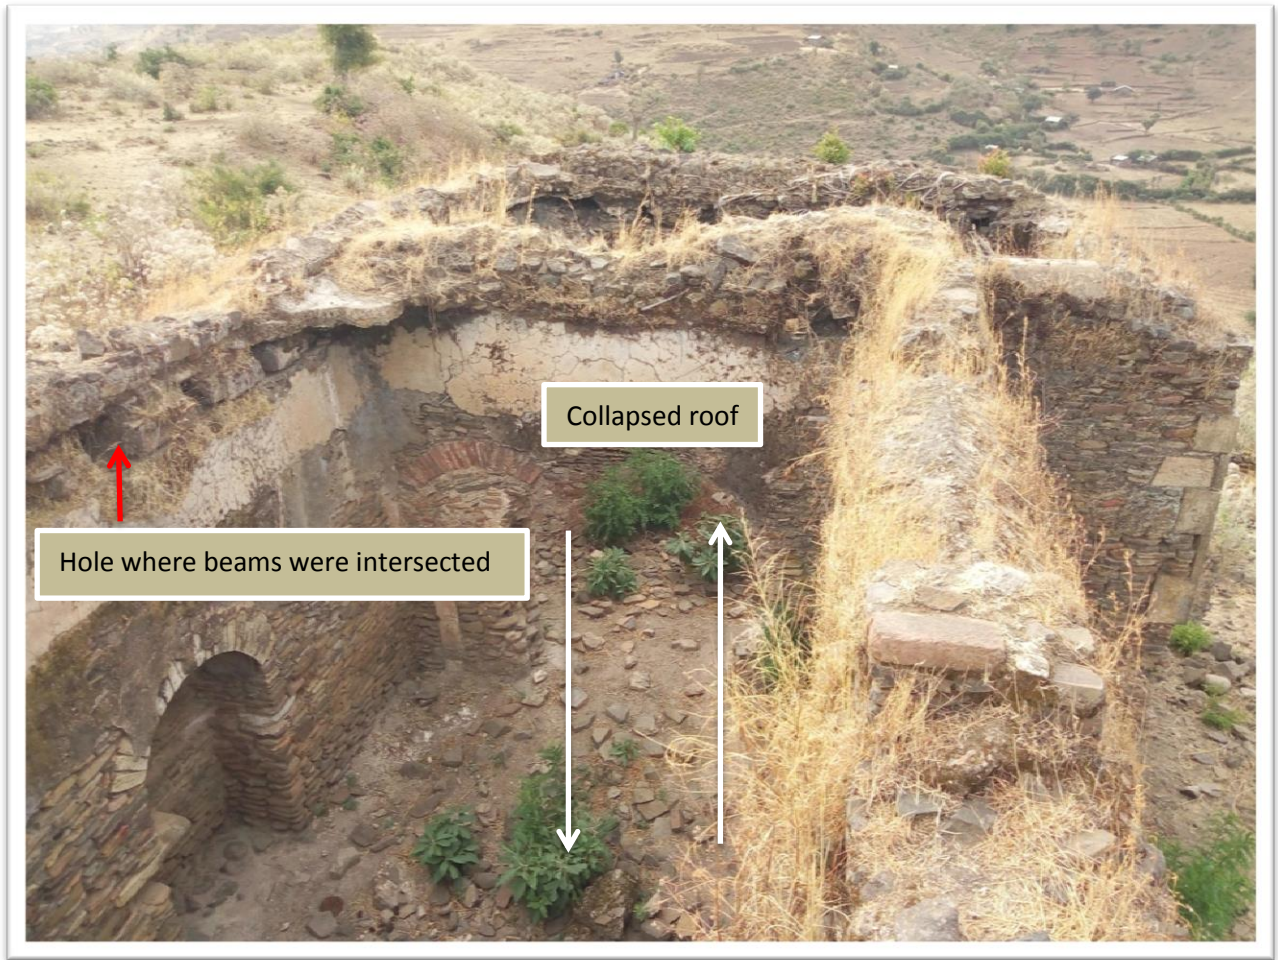
Figure 3.40 Aerial view of the Building, showing how much it is deteriorated (Photo by Kedir 2018)

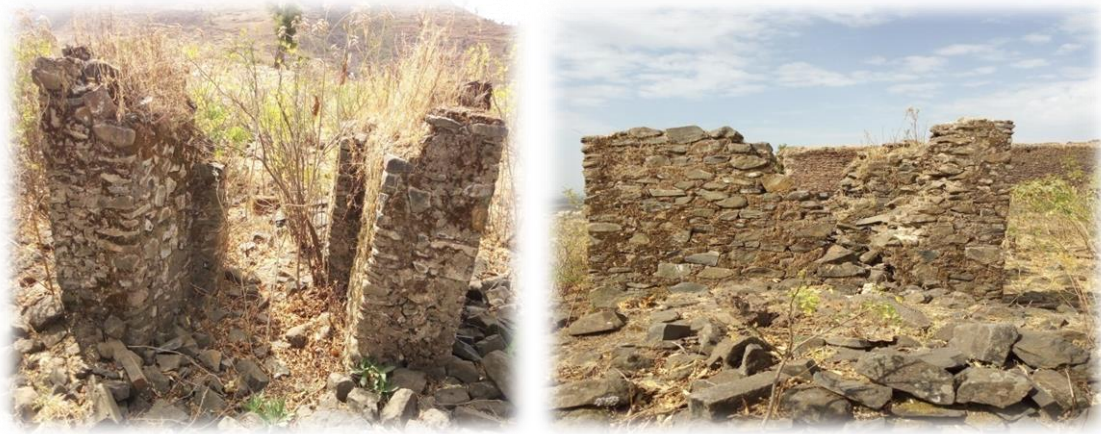
Figure 3.41 Destroyed Pillars, located to north of the Building, might have been served as gates (Photo by Kedir 2018)

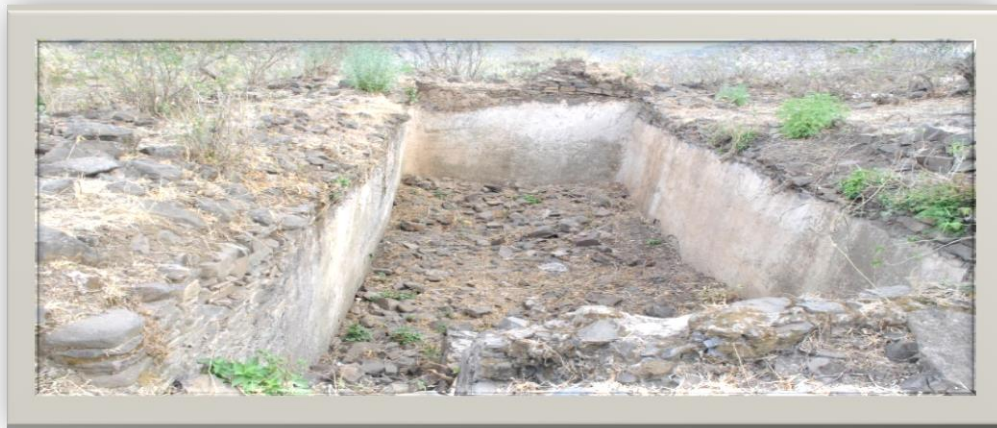
Near the building to the western direction, there is a rectangular structure which was used as a cistern which is 10.5x3.7 meter with a height of 2.5 meter long (Figure 3.42).

Figure 3.42 Cistern near to the Building, south of the Debsan Ginb (Photo by Kedir 2018)

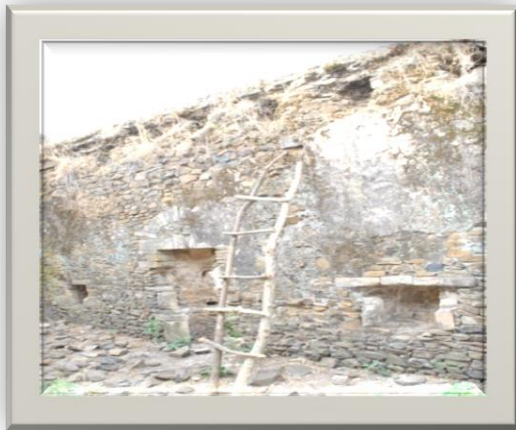
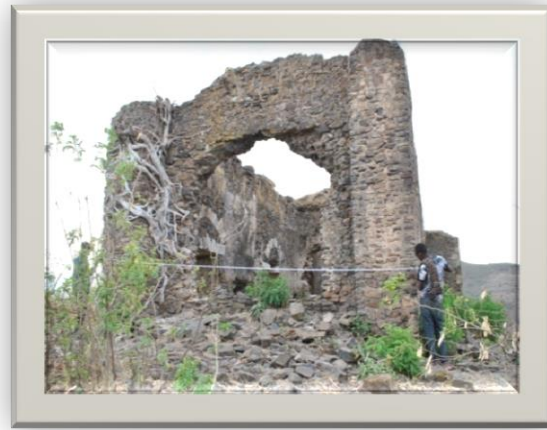
Figure 3.43 Ladder used to photograph and measure the building (left figure), and totally damaged western view of the Building (right figure) (Photo by Kedir 2018)

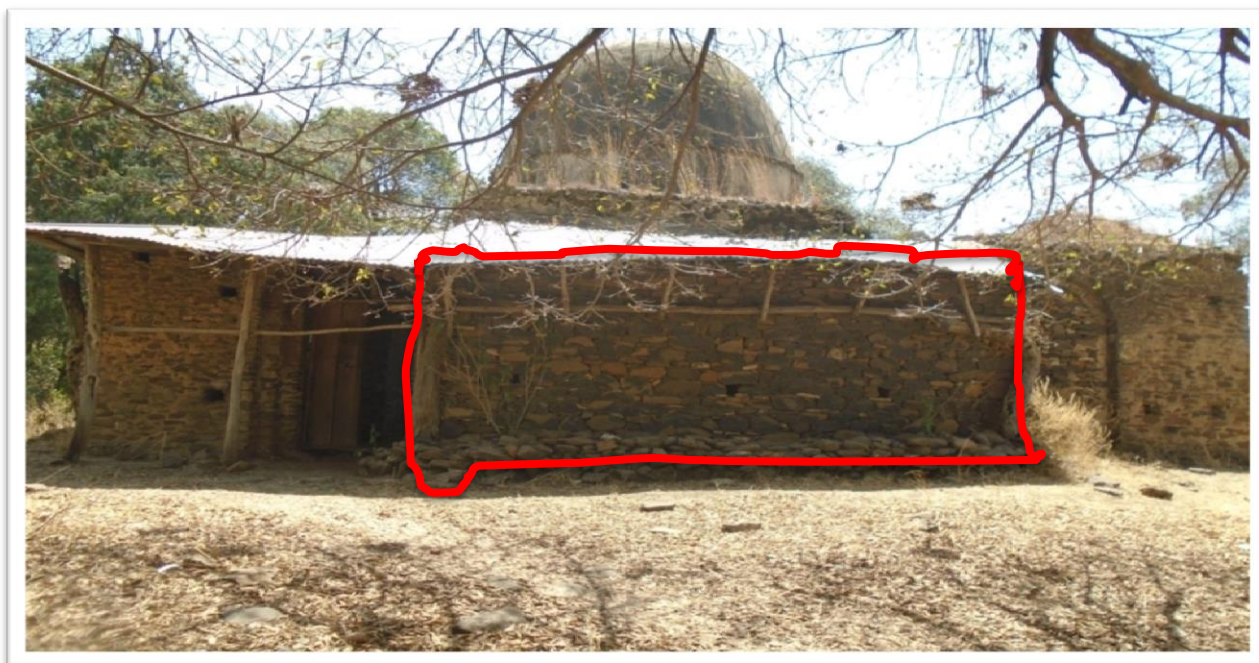
Although this building, like others, is very spectacular monument of the study area, it has been damaged by various threats. Most parts are missed except the inner part which is the so called Makdes. The outer part of the building in all its directions (particularly the northern face) have been deteriorated; only the pillars and parts of the wall and gates of the building, albeit deteriorated, are still erecting. Because of the absence of management by the concerned bodies, the church communities did unnecessary activities on the building whatever they want, for example, they built new room annexed to the western part of the building, filled windows as well as doors, and entrances by stones which were open originally, attempted to conserve the outer part of the building with local stones (especially the northern face), tried to cover the roof of the building with iron sheets, and replaced the doors with iron doors, especially the inner part of the room, all of which were against the profession of conservation and did not respect the authenticity of the original building (See Figure 3.50, Figure 3.51, Figure 3.52, Figure 3.53 and Figure 3.54).

Figure 3.50 Western views, new added room (Photo by Kedir 2018)

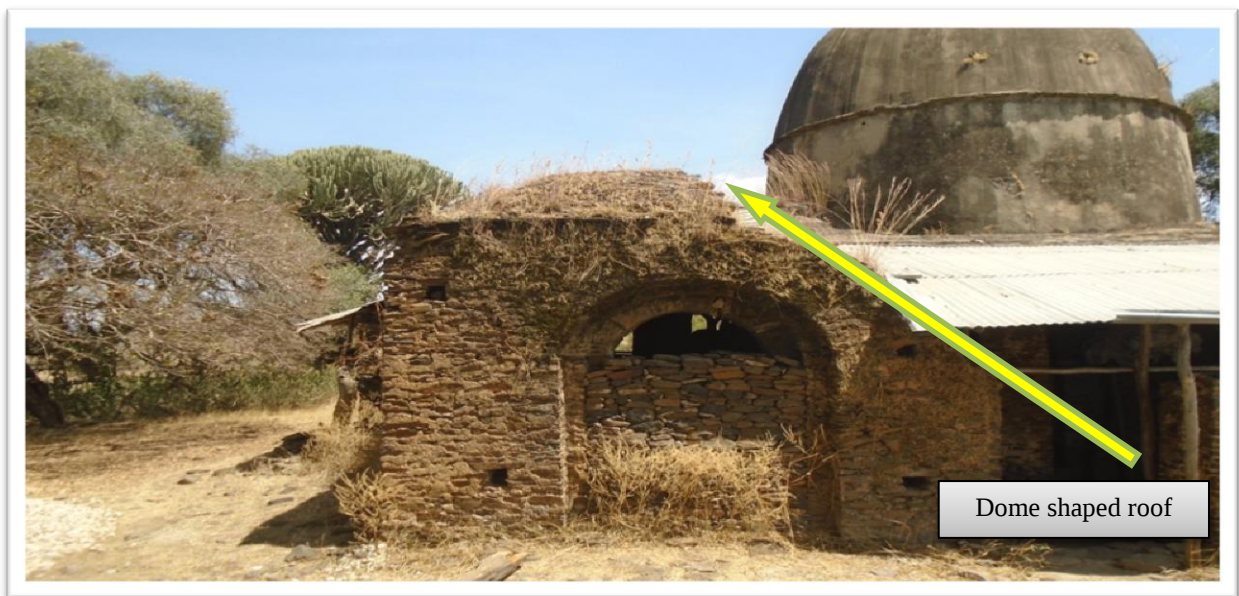
Figure 3.53 A part of the Bahri Ginb roof, providing a hint how the original roof of the building seemed like (Photo by Kedir 2018)

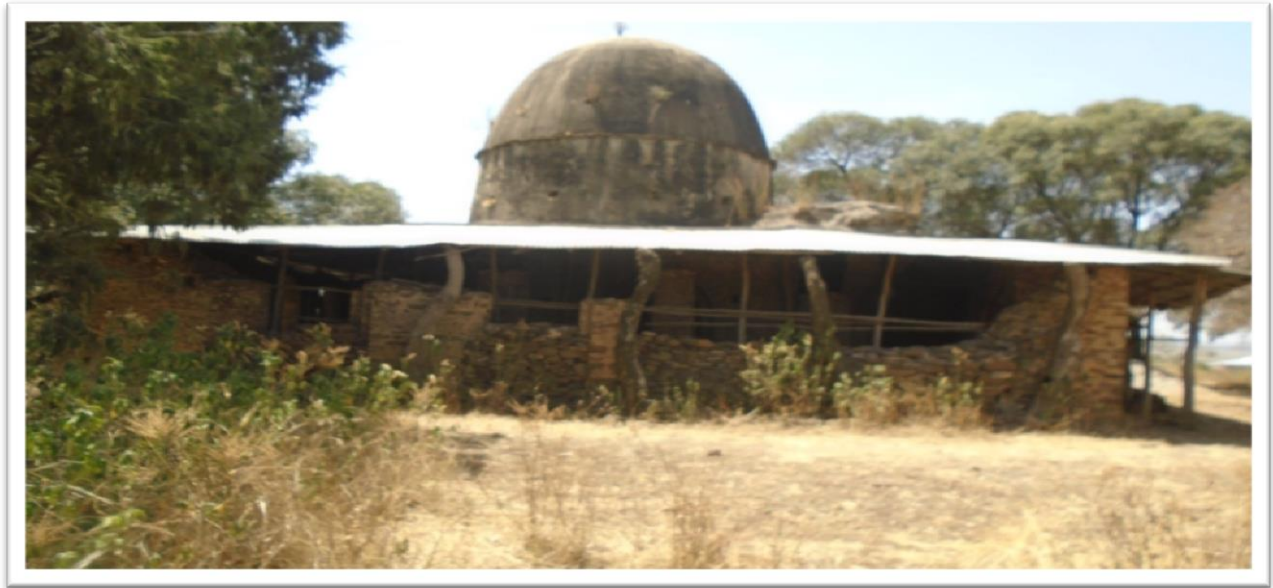
Figure 3.54 Northern face of Bahri Ginb, destroyed but repaired with stones without keeping the authenticity of the original Building (Photo by Kedir 2018)

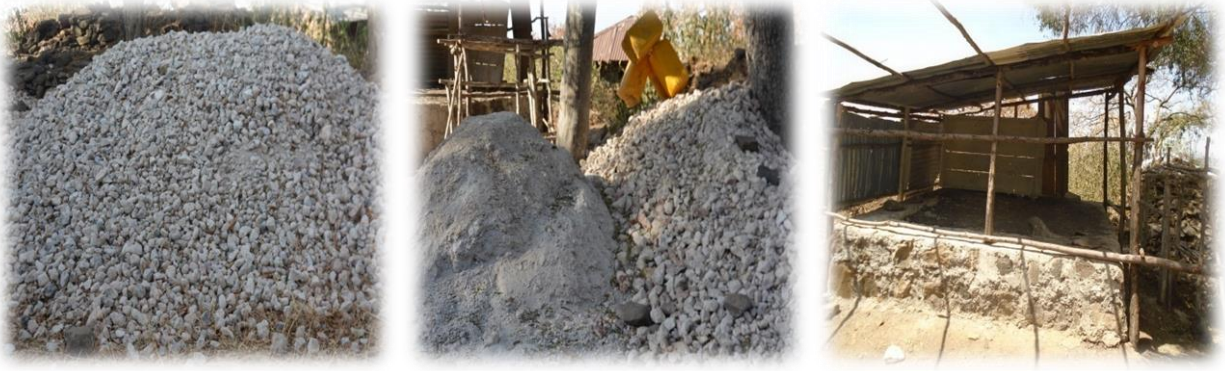
Currently Bahri Ginb does not give a church service as it is ready to be conserved in the near future. It is at the nearby former treasure house called Betelehem that religious activities are being conducted today. According to the information got from Culture and Tourism Bureau of Gondar Zuria *Wereda* (2018) the communities who were settled inside the church compound were replaced to another area for the sake of conserving the building. Therefore, now the necessary conservation materials are being prepared, for example, the lime stone was brought and buried inside the earth as you can see in the next figure (Figure 3.55). However, the problem is that this conservation activity will also be faced by conservation problems as similar with the problems occurred in the conservation of the palace of Guzara as there are no professionals responsible for the conservation work, no deep knowledge how to do conservation, lack of professional pre-conservation study prior to the actual conservation is started, lack of adequate fund for the project etc.

Figure 3.55 Conservation Process of Bahri Ginb, coarser lime stone (the left two figures) and the buried lime powder (right figure) (Photo by Kedir 2018)

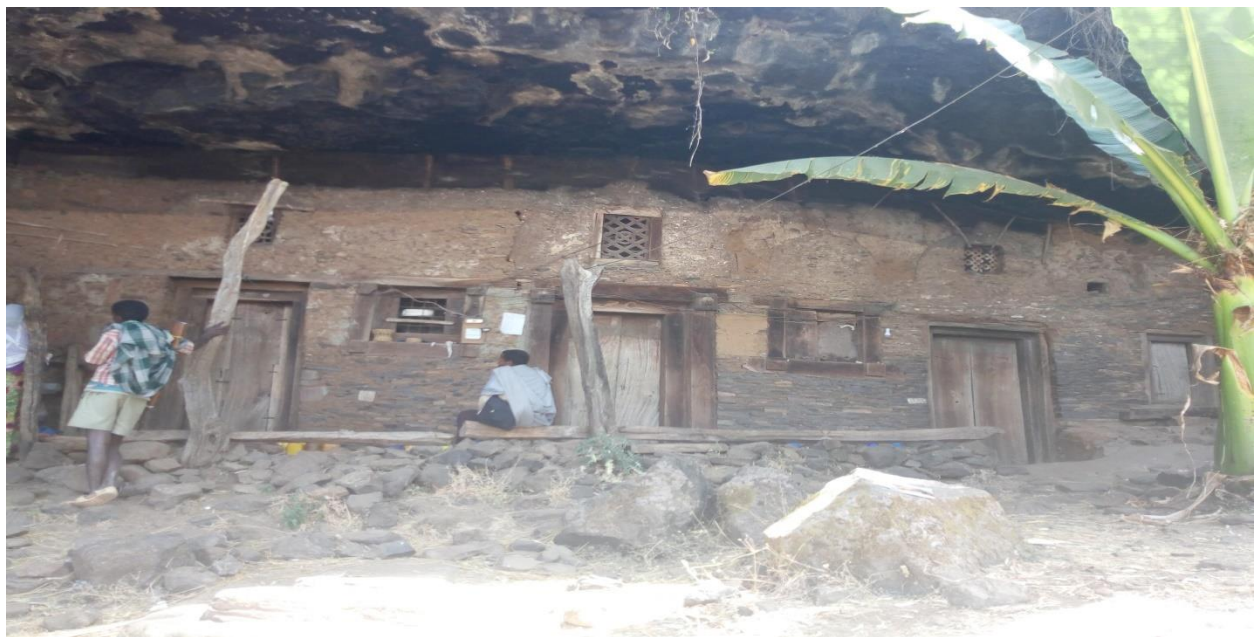
Twelve kilometers away from Addis Zemen in the western direction, in a wide and large plateau of *Tara Gedam* dense forest is an area where we can find an ancient cave church which is locally called as Washa Endrias. The cave's inside is 30 x 40, with 20 meter long from surface to top (LKWGCO, 2018; LKCTB, 2017). It is located along Bahir Dar –Gondar road after passing Addis Zemen town in a forested area called Tara Gedam found some 7 kilometer before we come across Guzara Palace (Figure 3.62).

Figure 3.62. Washa Endrias Cave Church, its front view (Photo by Kedir 2018)

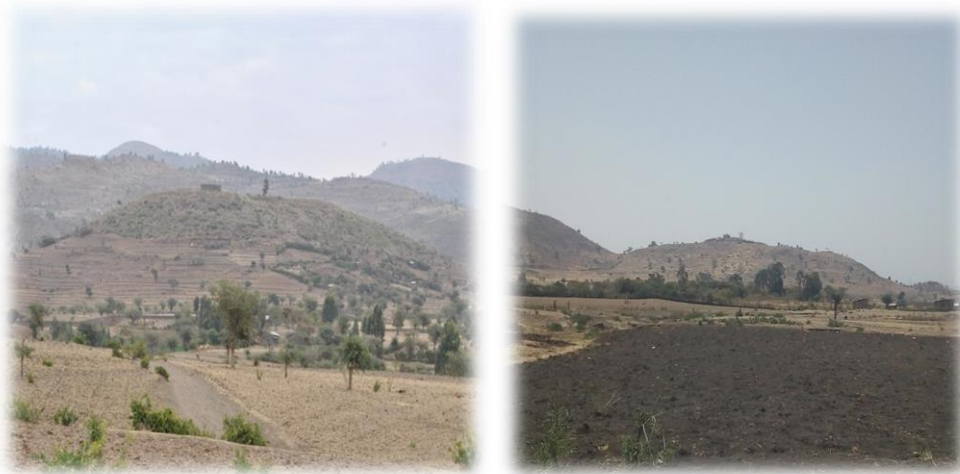
Figure 4.1 Distant view of Monumental site of DebsanGemb (left figure) and Palace of Guzara (right figure) (Photo by Kedir , 2012)

Besides, in addition to the Palace of Guzara, the rest sites of the study area, except for Gobatit Dildiy and Bahri Ginb, are situated at a higher plateau (Figure 4.1.) This once again tells us that those areas were strategic places to control the surrounding environment. Likewise, Dawit (2009) stated that pre-Gondarian monuments situated north of Lake Tana were built on a relatively higher ground, probably in addition to controlling the activities carried out in the surrounding area, they also aimed at incorporating their power in the minds of their subordinates.
