**THE PALACE OF GUZARA AND ITS ENVIRONS:  
ITS HERITAGE MANAGEMENT AND CONSERVATION**

**November, 2018**

**A THESIS SUBMITTED TO  
THE DEPARTMENT OF ARCHAEOLOGY AND HERITAGE MANAGEEMENT IN  
PARTIAL FULFILLMENT OF THE REQUIREMENTS FOR THE DEGREE OF  
MASTERS OF ARTS IN ARCHAEOLOGY**

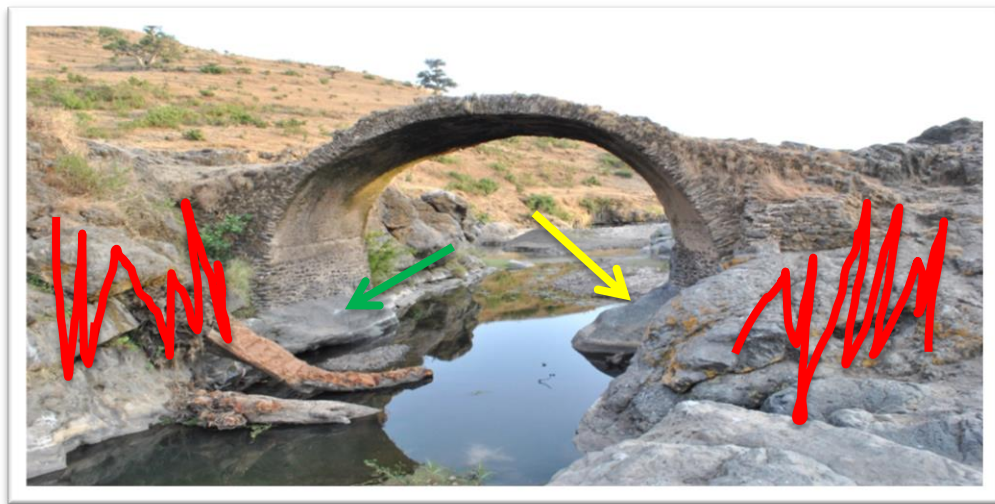
Figure 4.2. Shows the basement Granite rock over which Gobatit Dildiy was built (Photo by Kedir 2018)

Understanding the techniques and the way monuments of the past were built helps us to reconstruct the technology and mind consciousness of the past societies. If we carefully examine, for instance, the system and the choice of the geographical setting at which Gobatit Dildiyy was built, we can at least infer about the mind set and the technology of the society during that period, which was very intelligent. It was built on a hard black granite stone which secures the bridge not to be disintegrated easily against agents of deterioration (Figure 4.2). It is their great

mind consciousness and technology that helps the monument to be served for them for long period of time and transferred to the present society by withstanding the windy, rainy, sunny (in general the effects of weathering condition) for more than 400 years since its erection. They knew that the rock, the granite boulder over which the bridge is erected, is harder than the surrounding geology of the earth. This shows that they were aware of the geology of their surrounding which in turn indicates their great mind consciousness and technology. To build the bridge they used small local stones (natural gift undecorated ones) plastered by lime mortar. The art of using lime mortar which attached the stones of the bridge together without disintegration for long period of time indicates how good the technology was during that time. Thus, it keeps the bridge to continue to the present as it was since its erection. Therefore, from this monument we could infer how good the technology and mind consciousness of the past societies were.

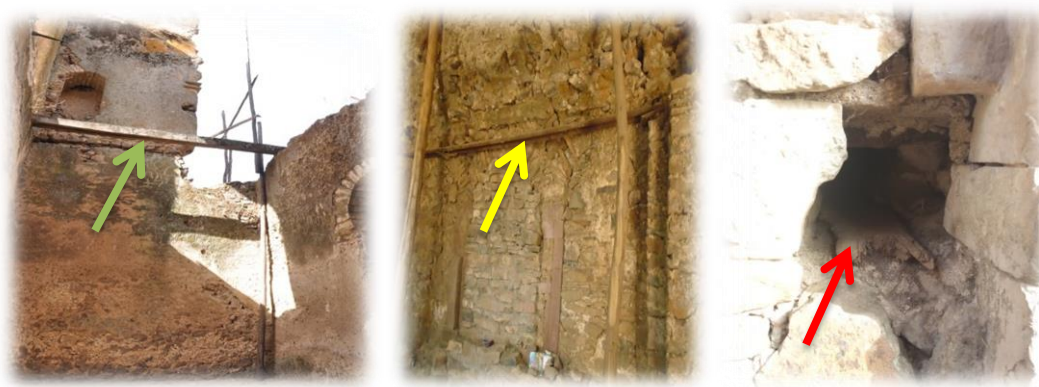
Figure 4.3. Materials used to construct a) Wood beams at Guzara Castle (the left figure), b) Metals at Bahri Gemb (the middle figure), and c) Wood beams at Debsan Ginb (the right figure) (of the Monuments) (Photo by Kedir 2018)

As to my observation, some wood beams are visible today on the damaged floors of the upper rooms of the building (See. Figure 4.3). In the case of Debsan Gemb, in addition to fragments of wood beams, bricks were also used as a source of raw material for its construction, where it was used to make the windows and doors of the building. The same is true for the church of Betelehem, which was made by a local person called Hailesellasia during the Haileselassie I regime, which is found in the compound of Bahri Ginb (Informants: Baye Birhan and Aymiro

Seyoum, 2018). Fragments of bricks are scattered today on the surface of the earth around the compound of Bahri Ginb St. Michael Church. However, what is strange is that, unlike in the others, steel was used as a construction material for the Bahri Ginb St Michael Church (Figure 3.3). On the eastern face of the building above the two purposely closed windows, long steel connecting the walls of the building is visible. But, it must be assured that it is not used during reconstruction of the building. So, further investigation should be conducted.

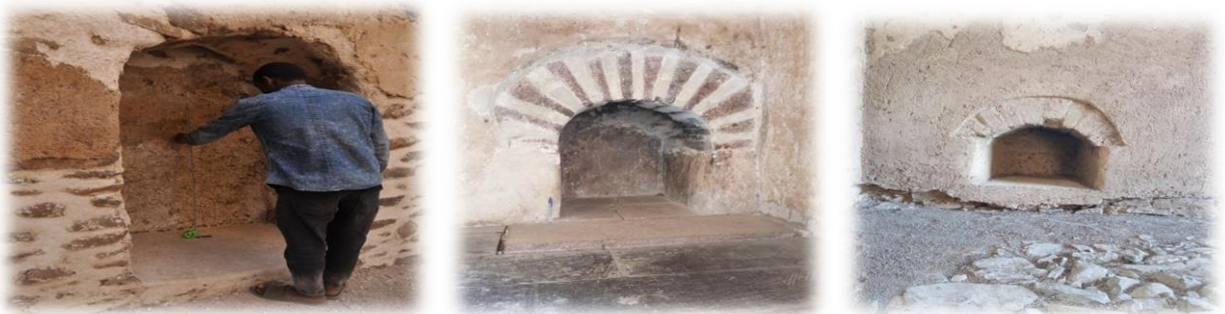
Figure 4.6. Chimneys at the Palace of Guzara (left figure), Fasiladas Castle (middle figure), and Iyas's Castle (right figure) (Photo by Kedir 2018)

Take a look at the following pictures showing architectural similarities between the Palace of Guzara and the Castles of Gondar (Figure 4.5, 4.6, 4.7).

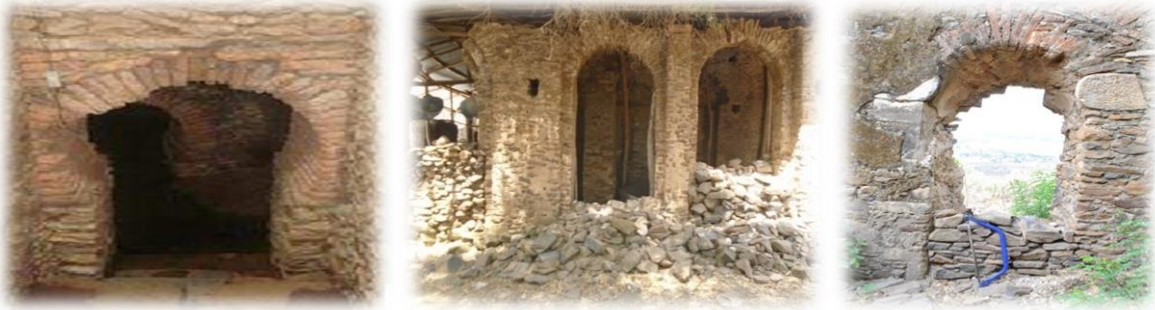
Figure 4.8. Lime mortared Brick of Arches found in Aksum (left figure) (after Werku 2015) and a similar architecture in Bahri Gemb (middle figure), and in Debsan Gemb (right figure) (Photo by Kedir 2018)

Furthermore, in my study area some of the monuments that are in Pre-Gondarian which were built long before the coming of the Jesuits showed the use of lime mortar. For instance, the Palace of Guzara, Gobatit Dildiy, and Bahri Gemb were constructed by small local stones

mortared by lime mortar, where some architectural characteristics such as the arches in Bahri Gemb and Debsan Gemb are similar with the Brick of Arches of the Aksumite (Figure 4.8).

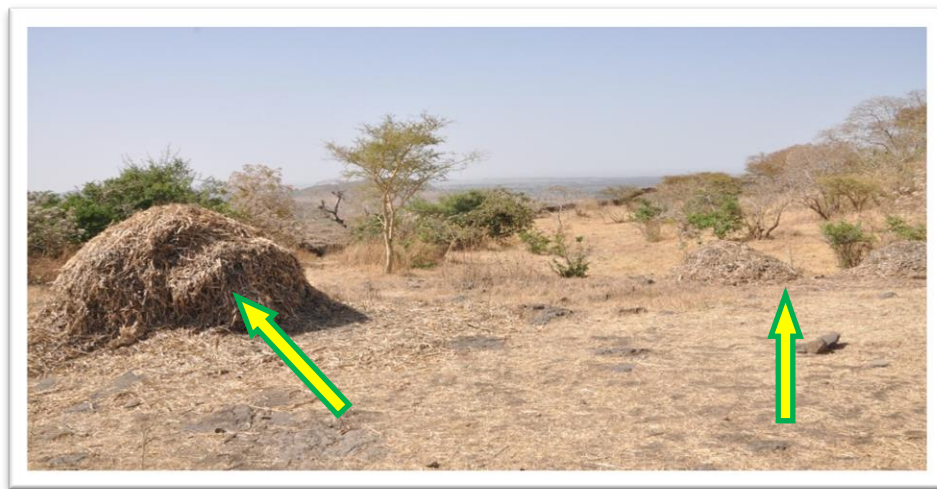
Figure 4.9. Chaff heap of cows inside the compound of the Guzara Palace (Photo by Kedir 2018)

generations (See also UNESCO, 1970; UNESCO, 1972; Ethiopian Proclamation no. 209/2000). In our case, it is clearly seen that the heritages of the study area in particular and the country at large have not received the necessary conservation activity; hence, without overstating the issue, all of them are in a state of destruction. If we take the Palace of Guzara, though it is being on conservation today, most parts of the building including its compound wall are severely destroyed. All of the doors and windows of the building were lost forever. The rooms of the second and third floor of the building were damaged and lost forever. The beams over which the second floor of the building was standing were lost forever. The wall of the building is affected by both natural and cultural calamities. Algae, lichens, smaller trees etc. are grown on the wall of the building. Much part of the original compound pale of the palace is destroyed, though today it is restored by simple wall with small stones which does not keep the authenticity of the original fence. These all indicates that the Guzara Palace did receive little management from the concerned bodies. It is a shame that part of the world heritage site of Gondar is negatively affected by both cultural and natural calamities. Look at the following picture showing the compound of the Palace of Guzara serving as storage of chaff heap for the cows of the surrounding farmers (Figure 4.9).

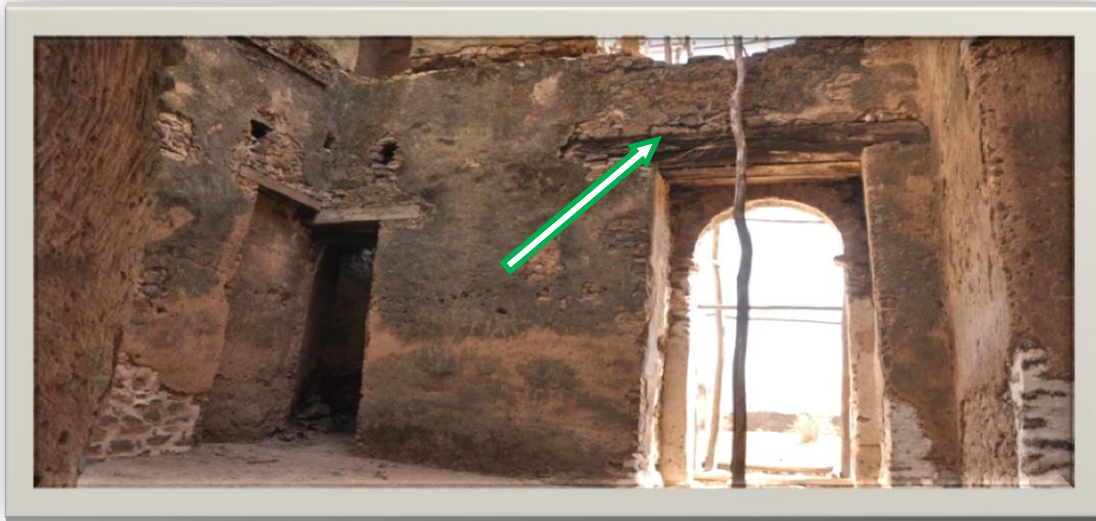
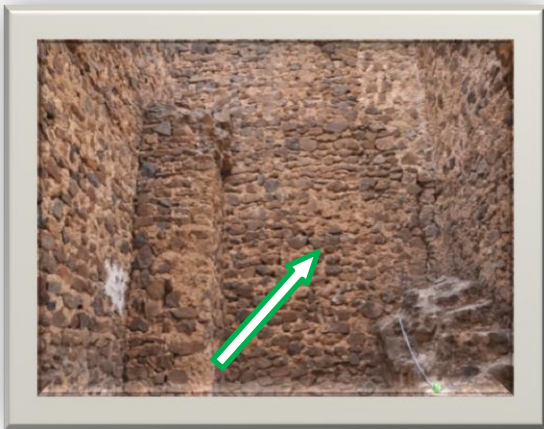
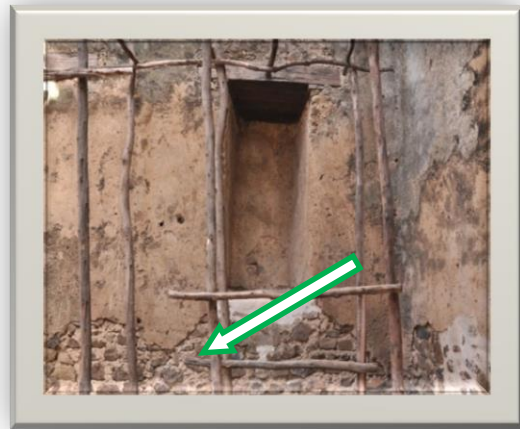
Figure 4.14: Deterioration of the Mortar and decay of the Palace of Guzara (Photo by Kedir 2018)

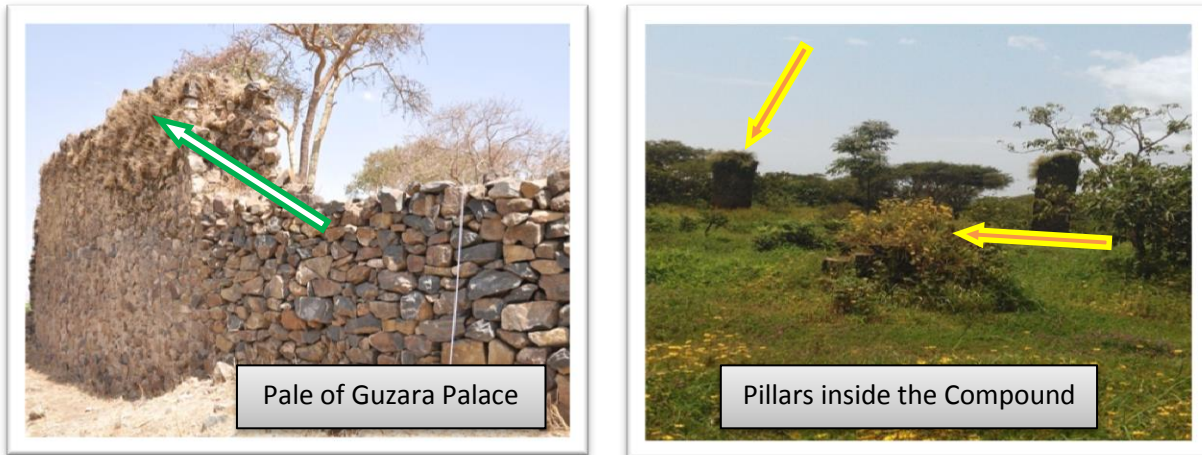
Figure 4.16. Mortar Deterioration, decay and damage of the Guzara Palace due to Biological Causes (Photo by Kedir 2017/2018)

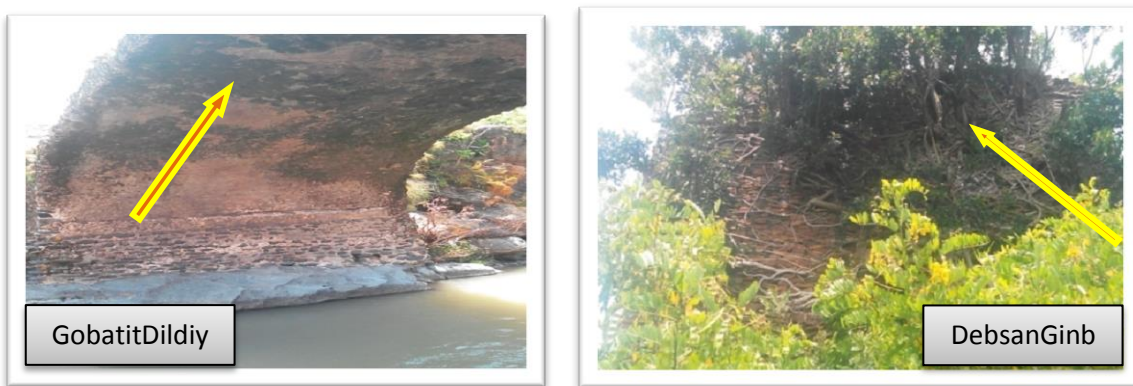
Figure 4.17 Gobatit Dildiy and Debsan Ginb (from left to right) affected by Biological Causes (Photo by Kedir 2017)

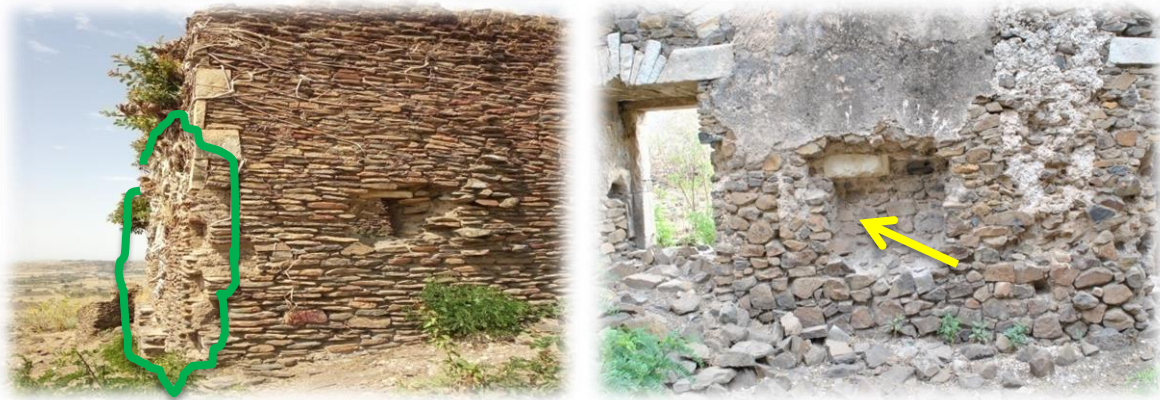
Figure 4.19. Destruction of Debsan Gemb by Humans in search of Lime Stone (Photo by Kedir 2018)
