**Drinking Water Quality and Management Practices from
Source to Household: The Case of Kombolcha Town,
Ethiopia**

**A Thesis Submitted to the School of Graduate Studies of Addis Ababa
University in Partial Fulfillment of the Degree of Master of Science in
Water Supply and Sanitation**

Bezawit Tesfaye Ejigu

June, 2020

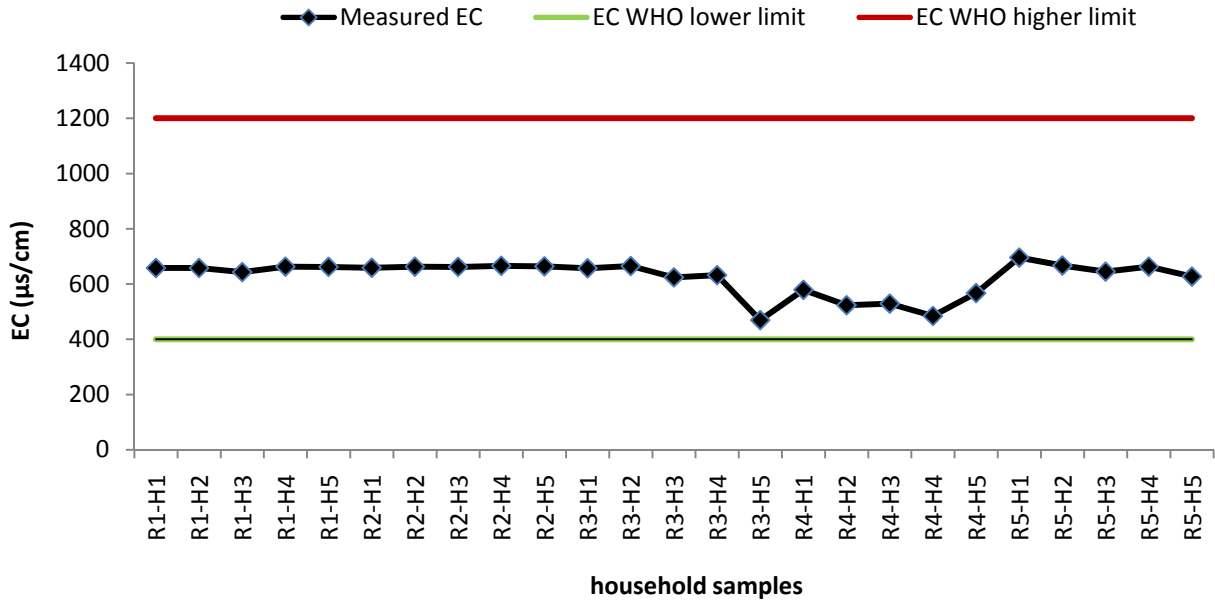
The EC values recorded during this study were between 447 μ S/cm and 737 μ S/cm. The result shows that all the water samples fall within the WHO permissible limit for drinking water. The maximum limit of EC for drinking is 1200 μ S/cm. Even though all water samples are within the limit the ionic concentrations of boreholes have distinctly high EC value. This is because of the fact that groundwater has higher ionic concentration than surface waters due to rock-water interactions.

Figure 4-5: Electric conductivity values of boreholes, reservoirs and main distribution lines

Figure 4-6: Electric conductivity values of household samples

The EC results of other sampling points of reservoir, main distribution line and households show relatively higher EC. Similar taste were reported in the study conducted in Agaro town ground water source was the highest in EC (Tadesse et al., 2017).

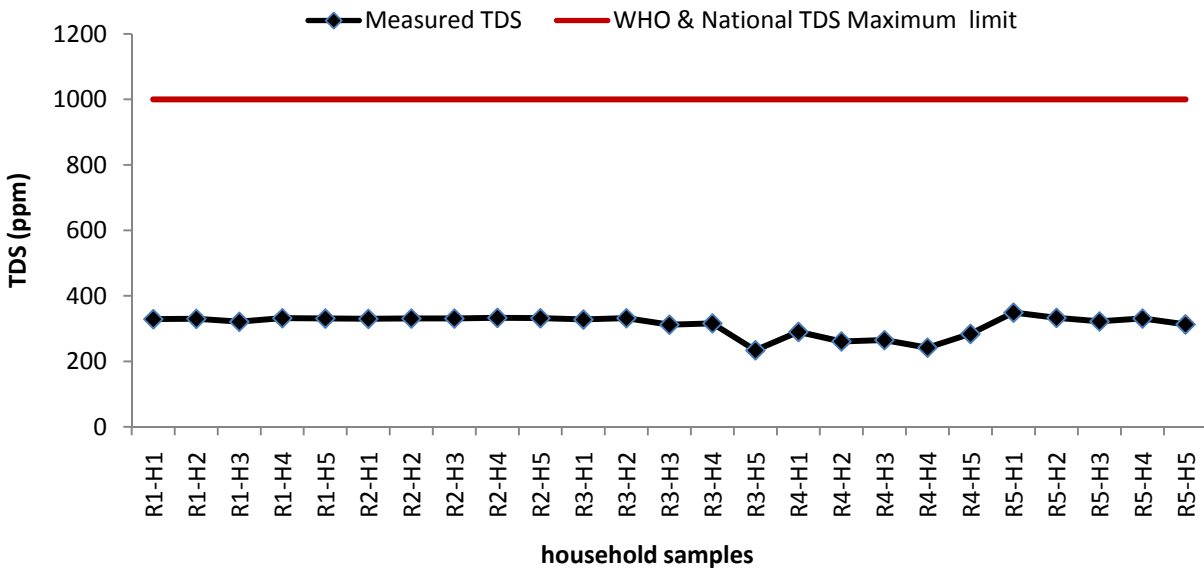
The TDS values found in this study ranges from 223 -369 ppm. Depending on these values it is clear that the health risks are not significant as the values of TDS are much less than 1000 ppm, which is the WHO and National standard maximum permissible limit. In similar study, the findings of the research work which was done in WondoGenet showed that the TDS levels of all source water samples were compliant with both WHO and National Guide line (Israel & Awdenegest, 2012).

Figure 4-7: TDS values of boreholes, reservoirs and main distribution lines

Figure 4-8: TDS values of samples taken from households

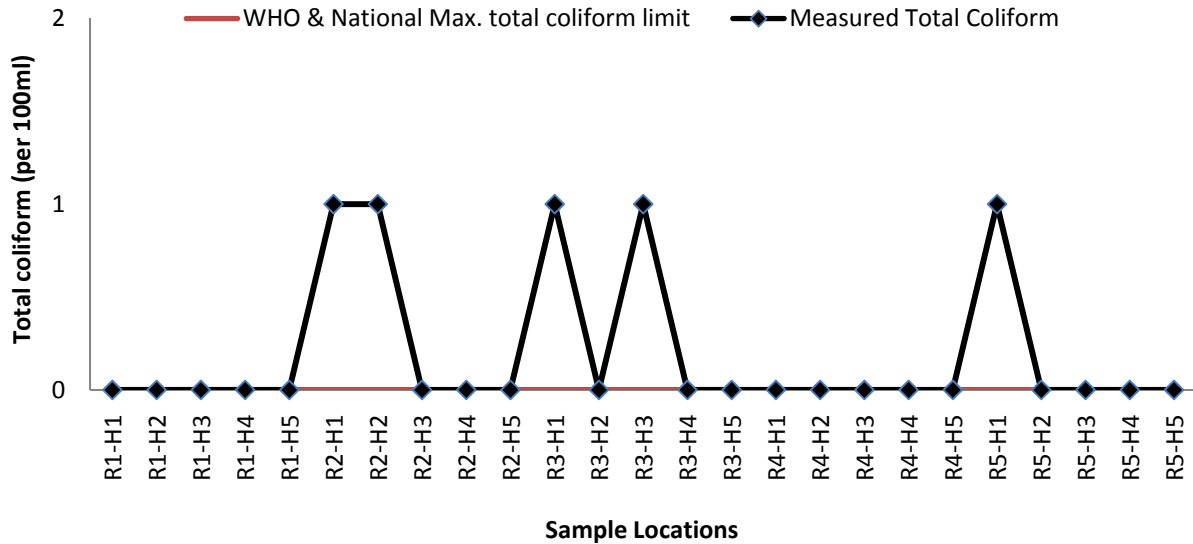
The test result for household samples indicated that five households contained 1CFU/100ml of total coliform. The reason for this has been the leakage from old pipelines which pave the way for intrusion of contaminants and also there was no or very low residual chlorine at household

Figure 4-20: Total coliform values for samples taken from households

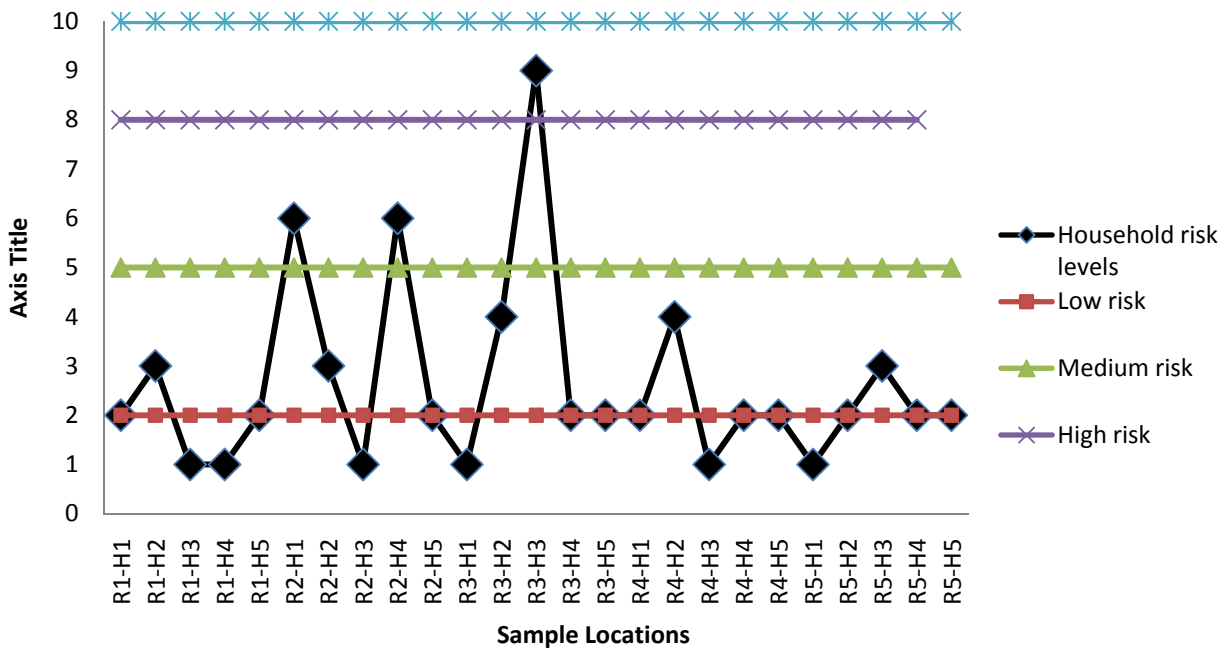
The sanitary conditions of household taps were evaluated. Observation check-list was prepared in order to check the selected household taps during sanitary assessment. WHO prepared a standard evaluation checklist for piped tap which has a score of the risk out of ten (9-10=very high risk, 6-8=high risk, 3-5= intermediate risk, and 0-2=low risk). Out of the total twenty five households 17 households have low risk level. This finding showed that five households scored medium risk level as the results of leakage in the pipe, eroded tap and service discontinuity. However R2HH1 and R2HH4 has high risk level. Moreover, R3HH3 was identified as very high risk level. Sample points with medium and high risk level were due to the leakage at tap stands, collection of surface water around taps, presence of erosion at tap stand, discontinuity of water service and pipe breaks. The association between the water quality and sanitary inspection results at households suggested that there is interconnection between pipe leakage, loss of free residual chlorine and total coliform contamination at households.

Figure 4-22: Risk assessment score classes at households

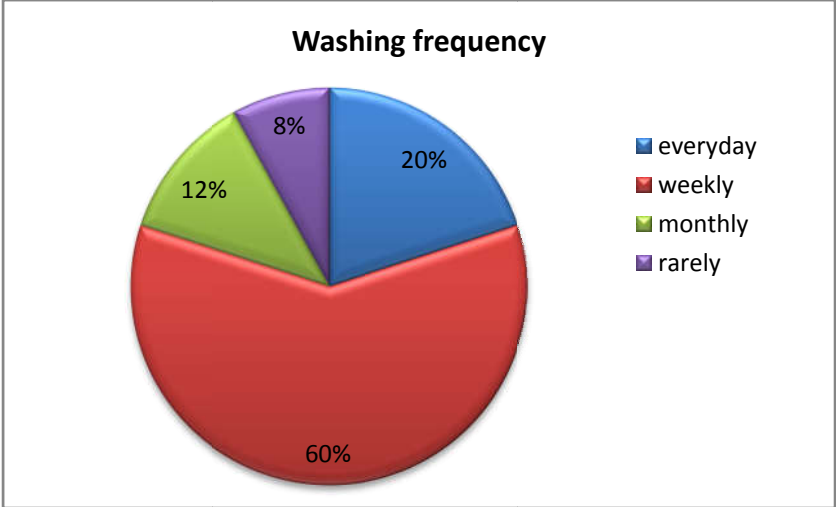
The storage container washing frequency among the households has been assessed and it was found that only 5 (20%) households wash containers every day before refilling while others used to wash every week, every month and rarely are 15(60%) , 3 (12%) and 2 (8%) respectively. It clearly indicates that the containers were not washed frequently which might lead to contamination of drinking water.

Figure 4-23: Washing frequency of containers at households
