**CORROSION OF STEEL REINFORCEMENT IN REINFORCED  
CONCRETE STRUCTURES – EFFECT AND METHODS OF REPAIR**

Presented in Partial Fulfillment of the Requirements for the Degree of Master of  
Science in Civil Engineering (Structural Engineering)

Addis Ababa University

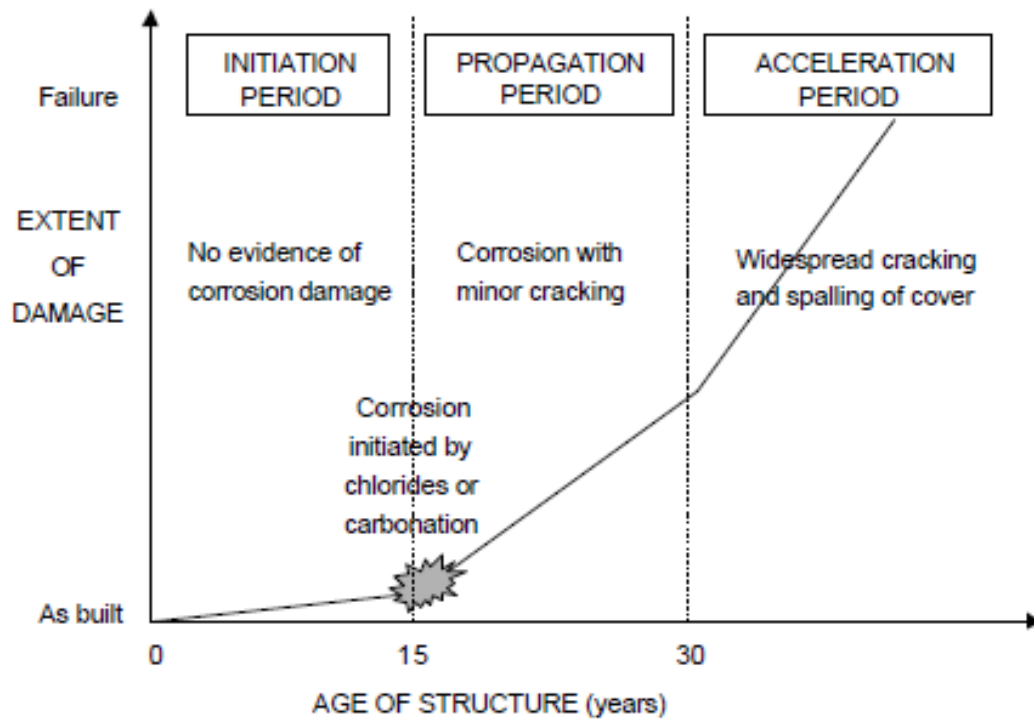
The loss of serviceability of corroded reinforced concrete structures may be described by a three phase damage model shown in Figure 2.3.

**Figure 2.5** Three phase corrosion damage model

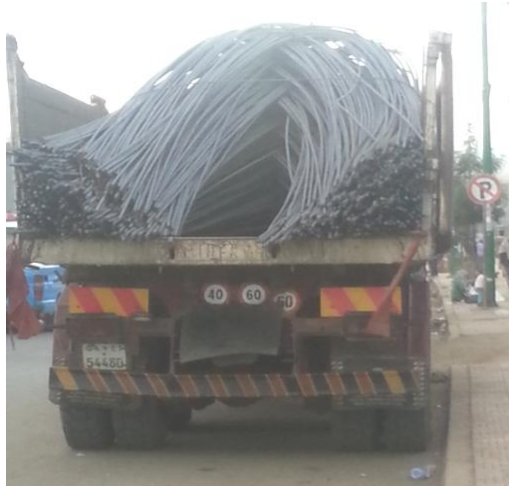
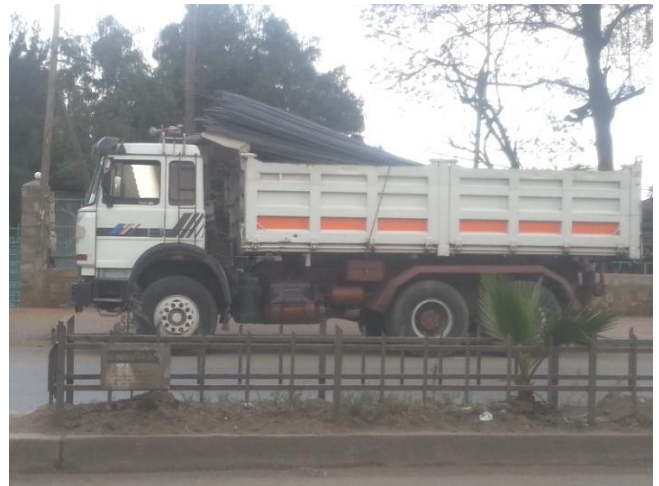
**Figure 3.1** Photograph showing trucks carrying reinforcement bars

Due to the rapid economic growth of our country, many structures are under construction. Their locations are different and are throughout the country. Due to this, some sites may be far from the factories many kilometers away. To transport these materials, it may take two or three days. As it is known, the trucks carrying the reinforcements do not have covers. As a custom and due to their length, reinforcements are not covered and even it is considered as if it should be transported in that way. Due to this, temperature variation may cause to initiate the reinforcement corrosion. Since carbon dioxide and water are the main causes of corrosion, the process may start during transportation. Sample transportation truck to transport steel is shown in figure 3.1 below.

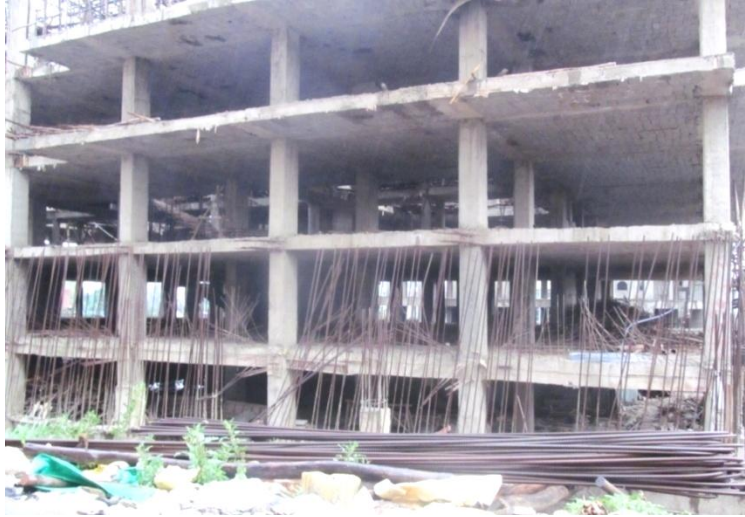
However, reinforcements are not stored as with great care as the cements. They are usually stored in an open area. In our country, it is true that the construction progress of most construction sites is too slow and the reinforcements may be delivered in bulk quantities. As a result, seasons may change in those reinforcements being stored at one place. In fact, in some construction sites some supervisors force the contractors to clean the dirt and also the corrosion materials from the reinforcement surfaces. But this is not done effectively because it is time taking and needs the supervisors' careful attention. Figures 3.2 to 3.13 represents storage conditions as practiced in most of the sites in our country.

**Figure 3.2** Photograph showing storage of reinforcement bar for construction of mixed use building  
Bambis area, Addis Ababa -1

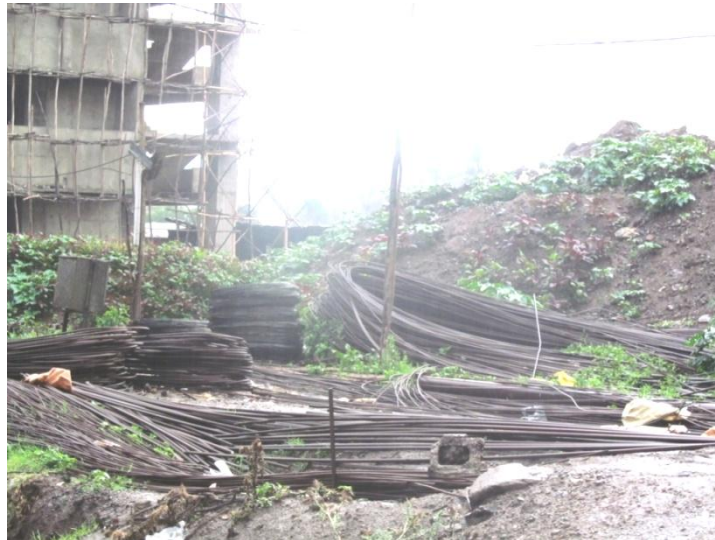
**Figure 3.3** Photograph that shows accumulated reinforcement bars for construction of mixed use building  
Bambis area, Addis Ababa-2

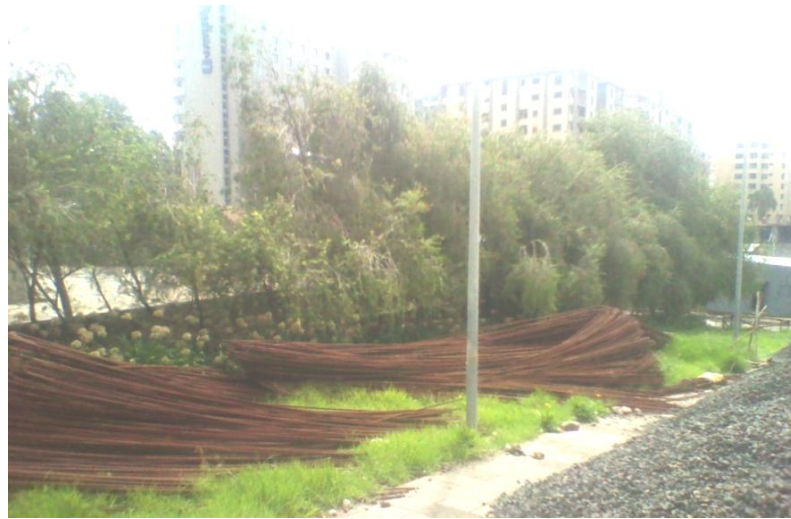
**Figure 3.6** Photograph showing storage of reinforcement bar for construction of G+3 parking Kazanchis area, Addis Ababa - 1

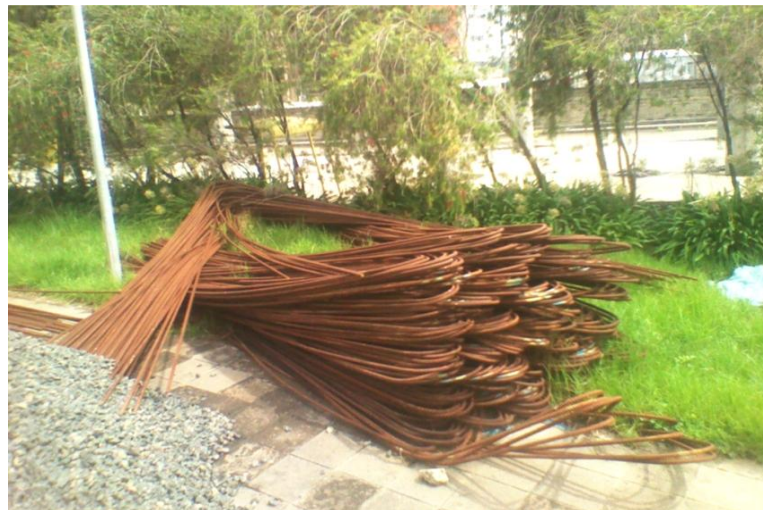
**Figure 3.7** Photograph that shows storage of reinforcement bar for construction of G+3 parking Kazanchis area, Addis Ababa - 2

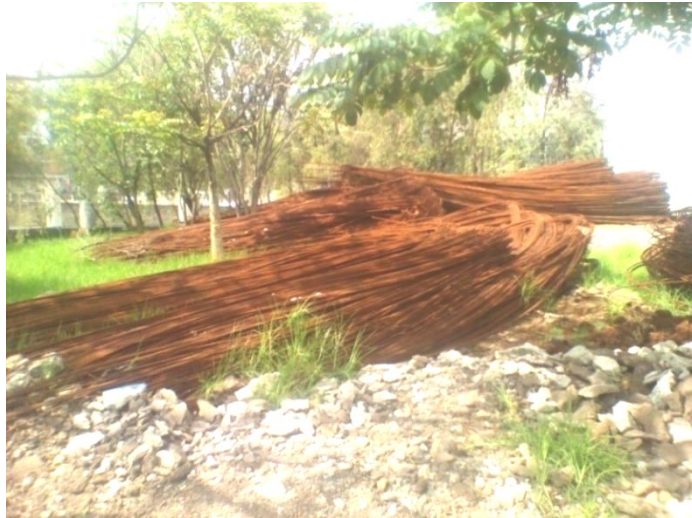
**Figure 3.8** Photograph illustrating storage of reinforcement bar for construction of G+3 parking Kazanchis area, Addis Ababa - 3

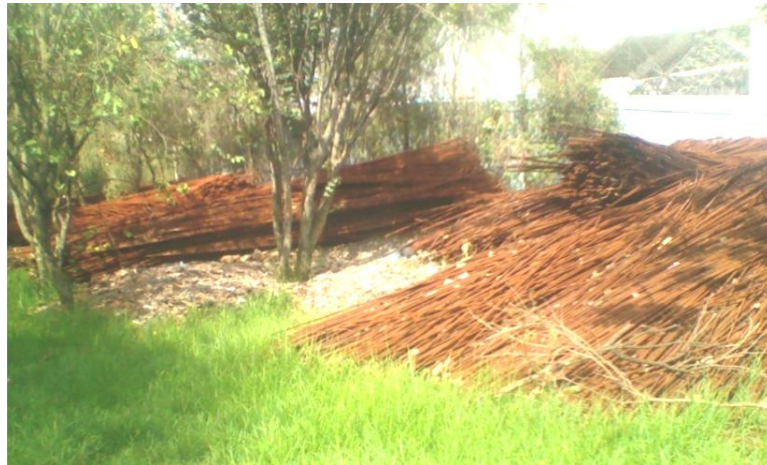
**Figure 3.9** Photograph that illustrates storage of reinforcement bar for construction of G+3 parking around Kazanchis, Addis Ababa – 4

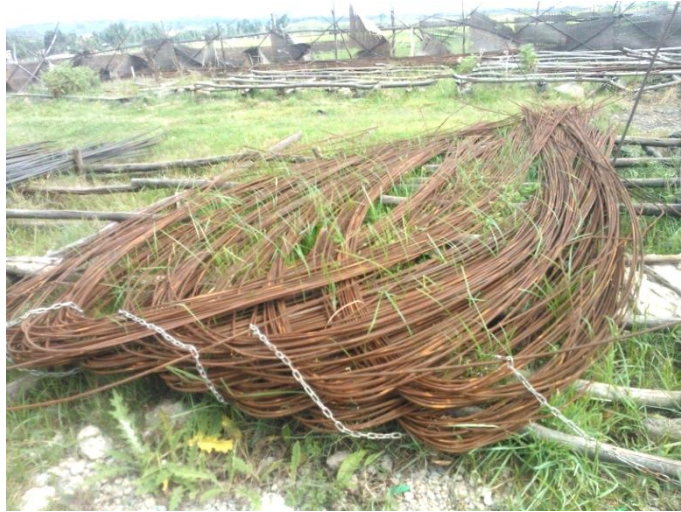
**Figure 3.10** Photograph showing storage of reinforcement bar for construction of G+6 office building around Yerer, Addis Ababa - 1

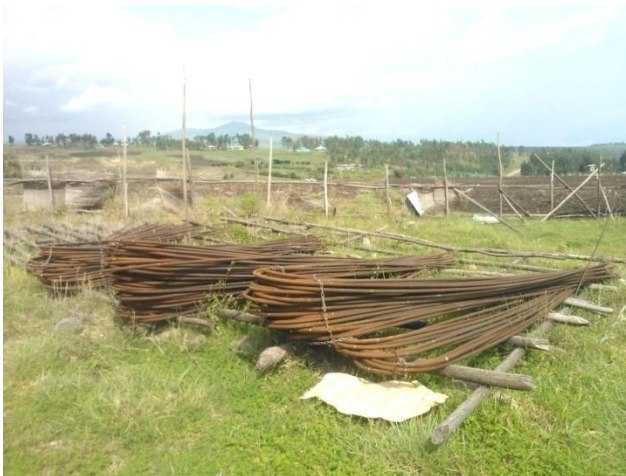
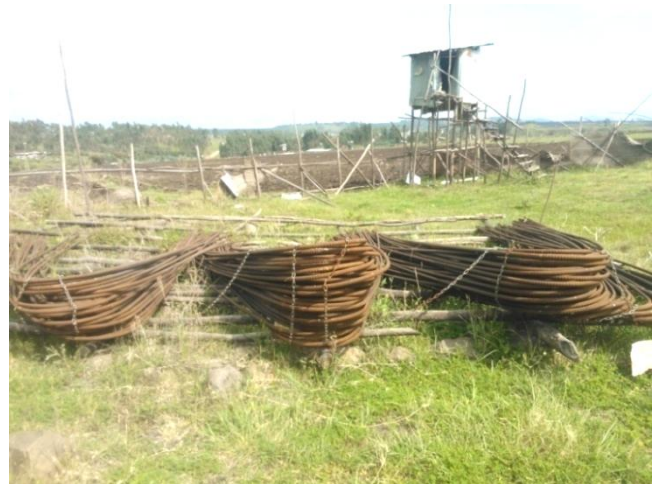
**Figure 3.11** Photograph that shows storage of reinforcement bar for construction of G+6 office building around Yerer, Addis Ababa – 2

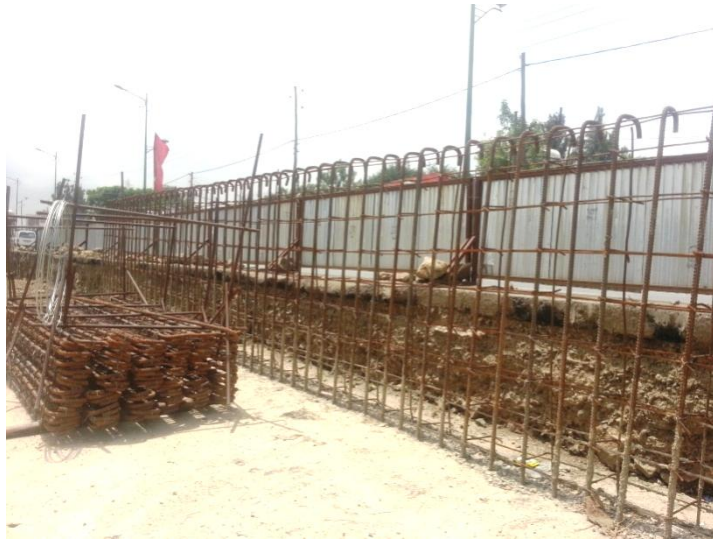
**Figure 3.12** Photograph demonstrating storage of reinforcement bar for railway project around St. Joseph Church, Addis Ababa

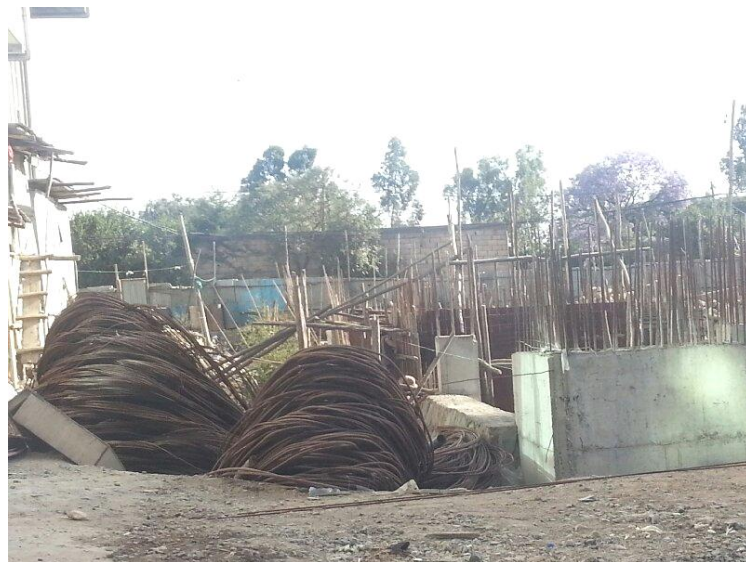
**Figure 3.13** Photograph indicating storage of reinforcement bar for a mixed use building around WuhaLimat , Addis Ababa

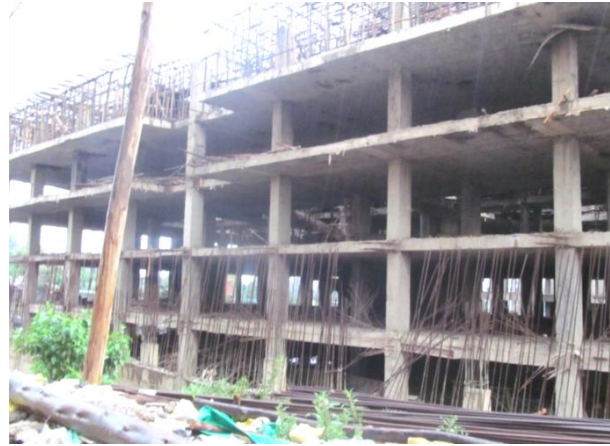
Reinforcements placed and exposed to rusting on structures under construction may last months and sometimes years are shown in Figure 3.14 – 3.20.

**Figure 3.14** Photograph illustrating reinforcements prepared prior to casting of concrete and exposed to various environments mixed use building around Bambis area, Addis Ababa -1

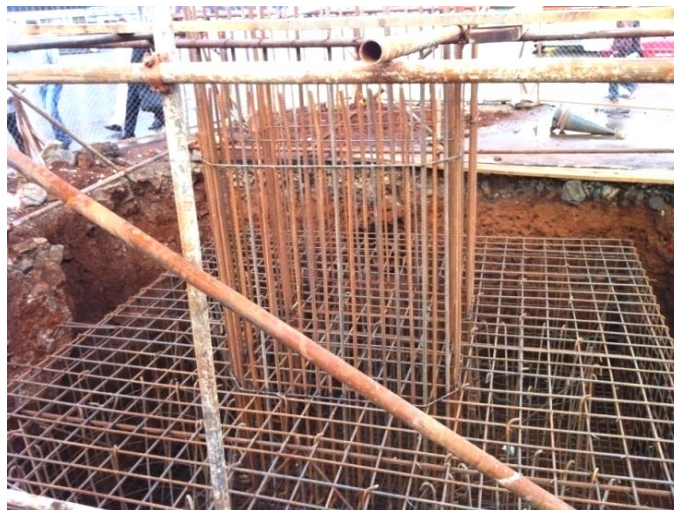
**Figure 3.15** Photograph that illustrates reinforcements prepared for footing for Railway project around Meskel square, Addis Ababa- 2

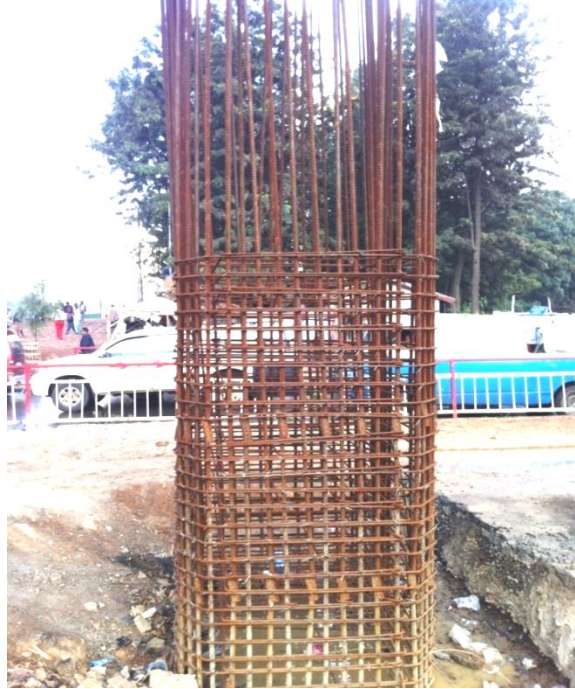
**Figure 3.16** Photograph showing reinforcements prepared for footing for Railway project around Meskel square, Addis Ababa- 3

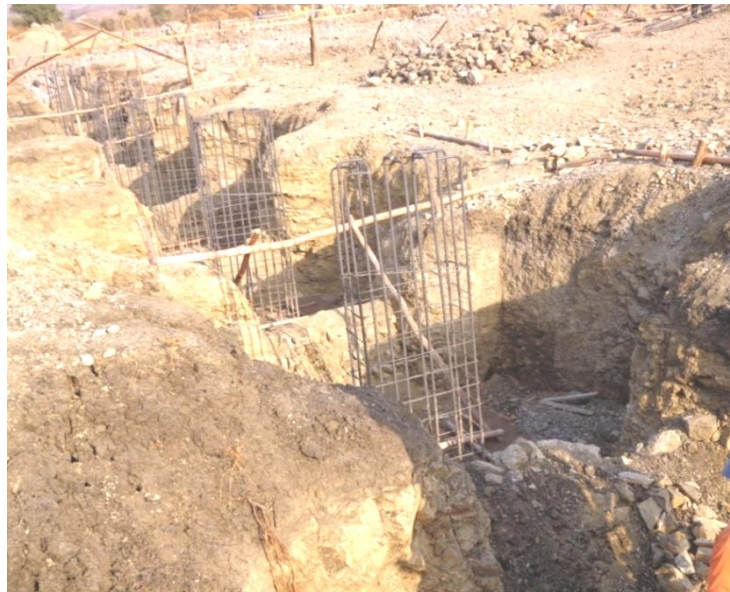
**Figure 3.17** Photograph that illustrates prepared reinforcement bars prior to casting of concrete at TanaBeles sugar factory, BahirDar

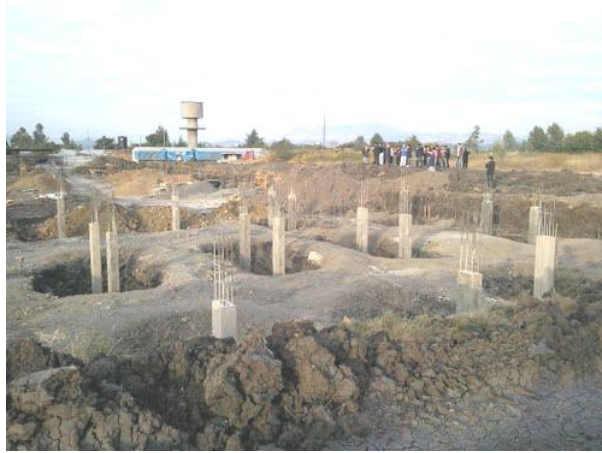
**Figure 3.18** Photograph that shows prepared reinforcement bars prior to casting of concrete around Gerji area, Addis Ababa

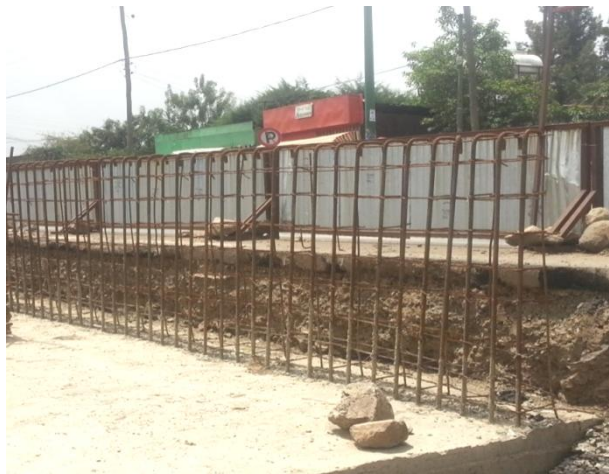
**Figure 3.19** Photograph that illustrates prepared reinforcement bars prior to casting of concrete at for the new rail way project around St. Joseph Church

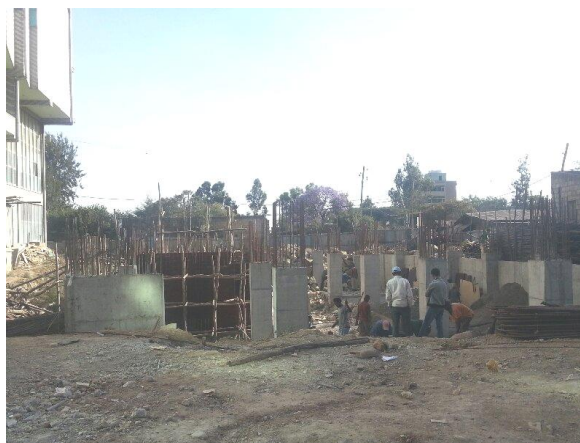
**Figure 3.20** Photograph that illustrates prepared reinforcement bars prior to casting of concrete around 22 Mazonia, Addis Ababa

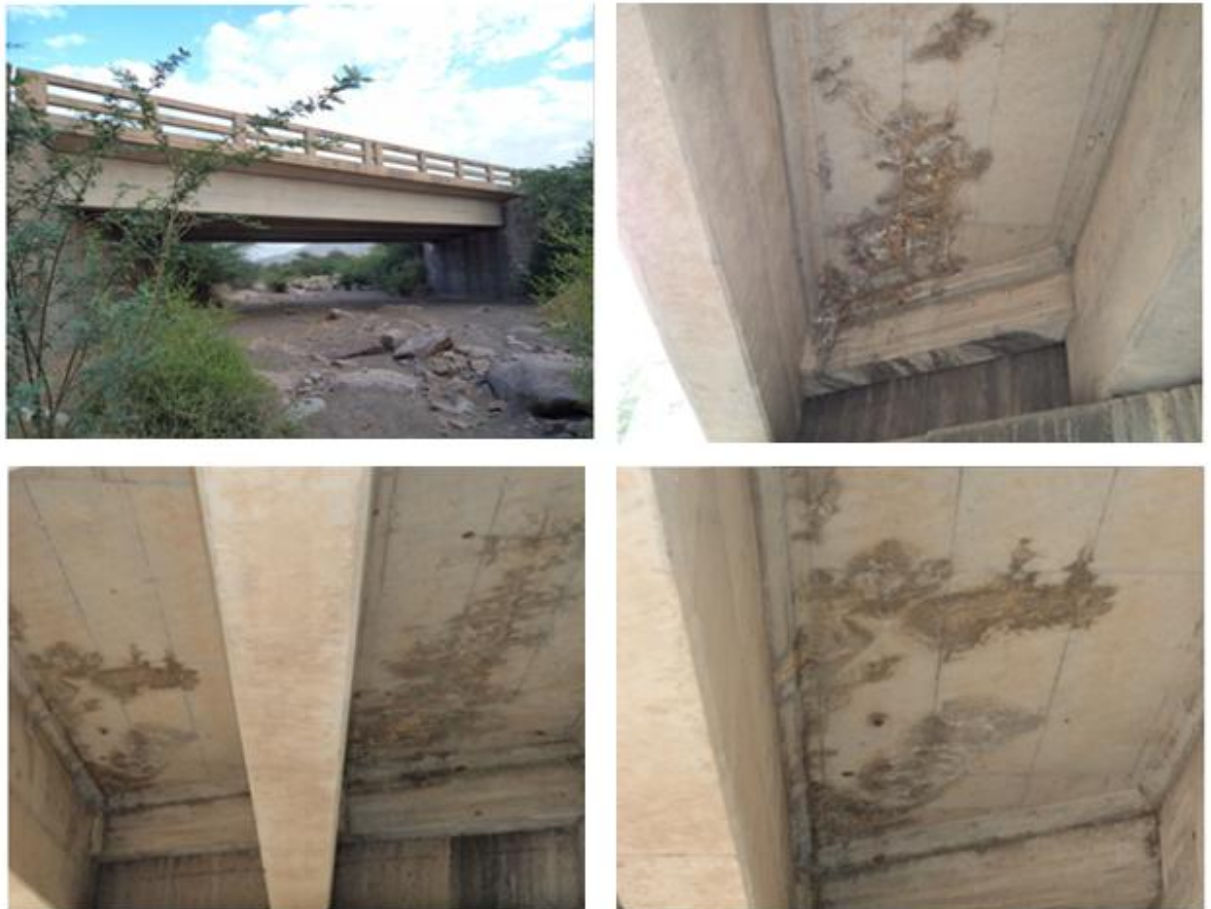
**Current condition** - Crack and water leakage on deck slab

**Figure 3.23** Crack and water leakage on deck slab

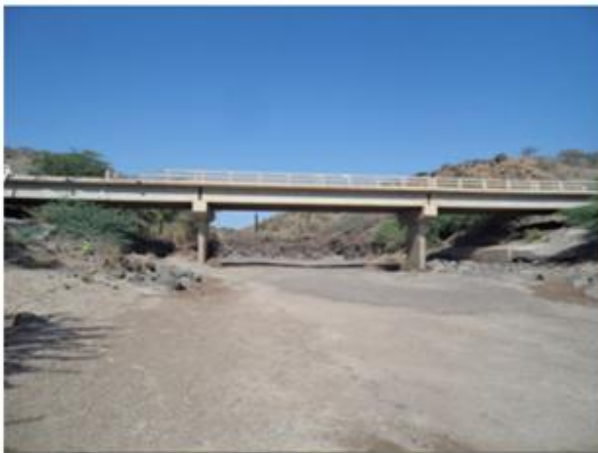
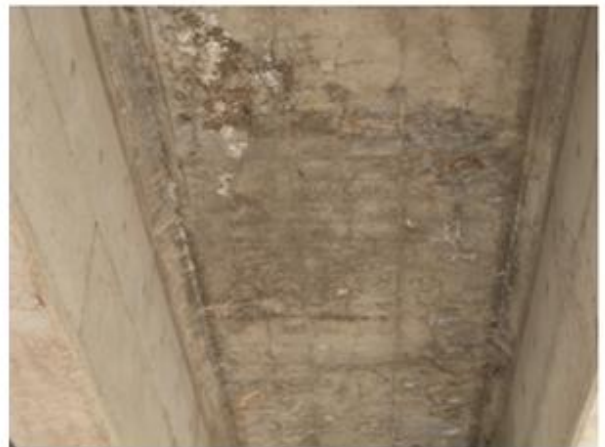
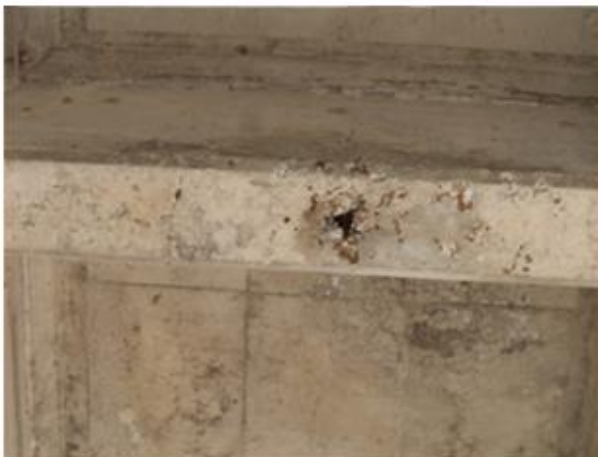
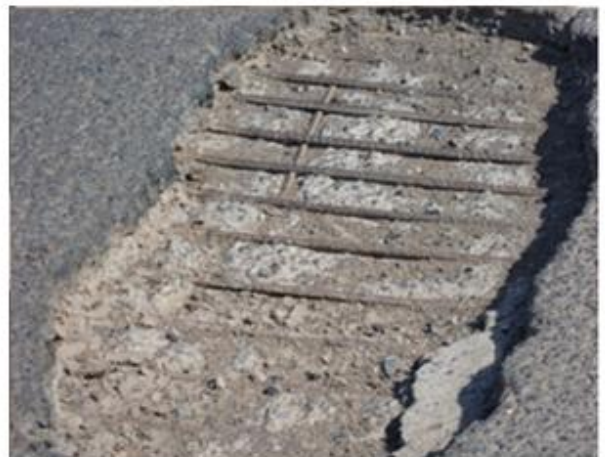
**Current condition** - The bridge deck slab and girders are cracked. There is void on the deck slab and rebar exposure on the top of the deck slab.

**Figure 3.24**Crack and rebar exposure

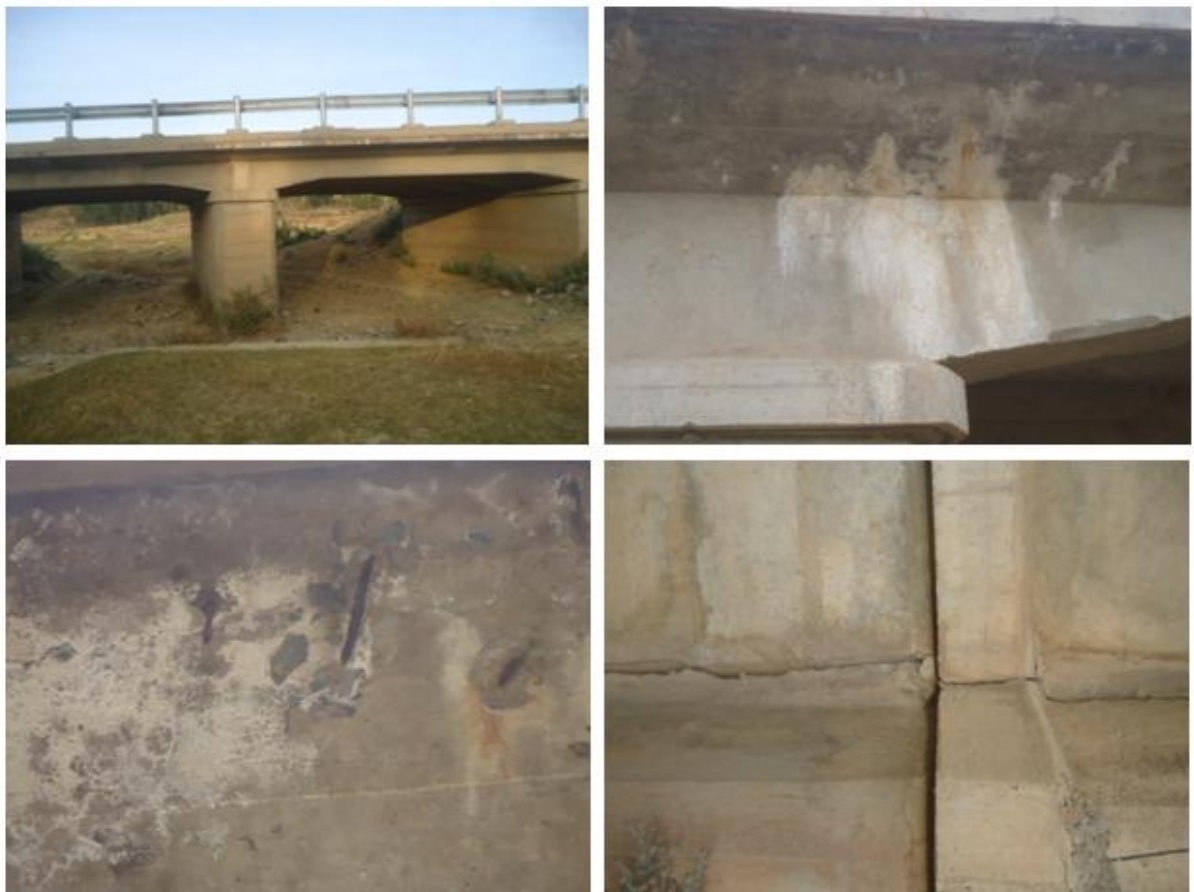
**Current condition** - Severe cracking on the slab and girder ; water leakage on the slab and abutment walls.

**Figure 3.25**Crack and water leakage

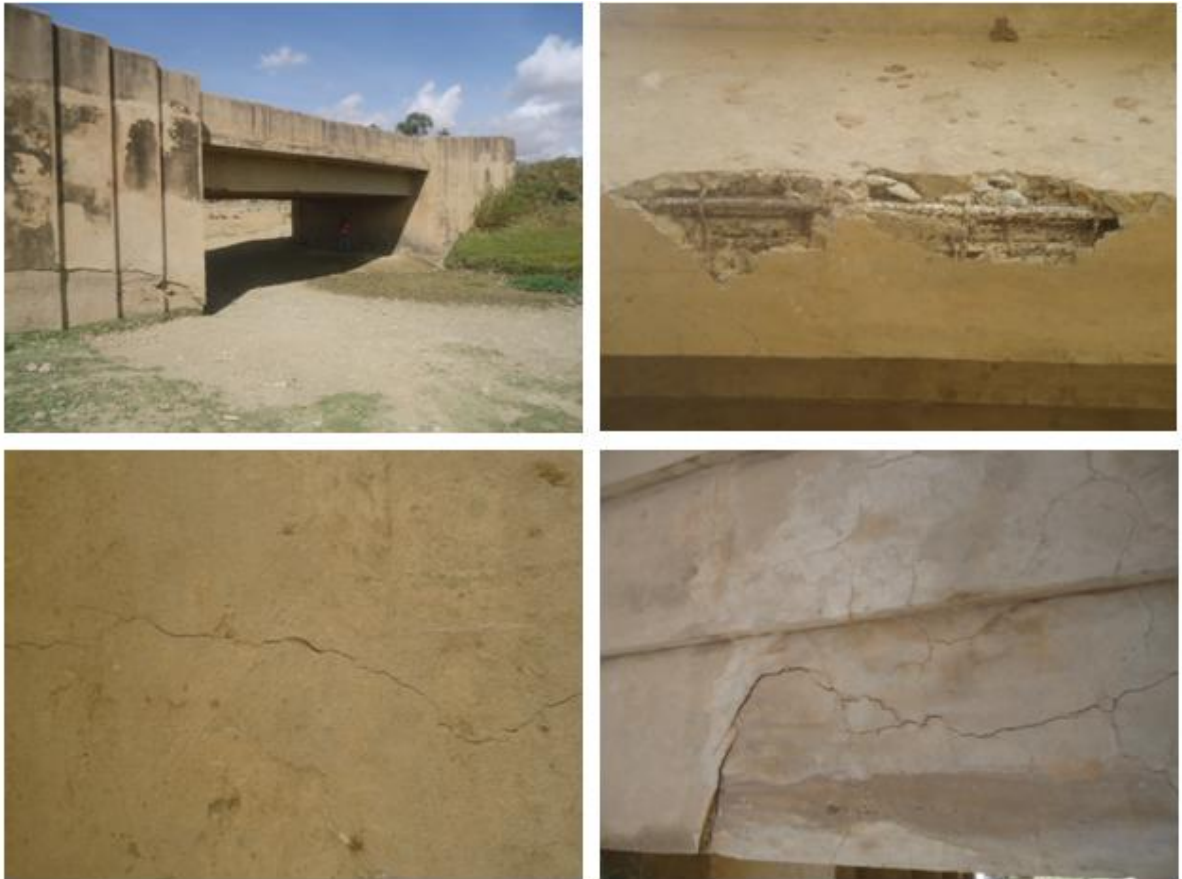
**Current condition** - Cover concrete peel off & water leakage and rebar exposure

**Figure 3.26** Water leakage, rebar exposure and spalling of cover concrete

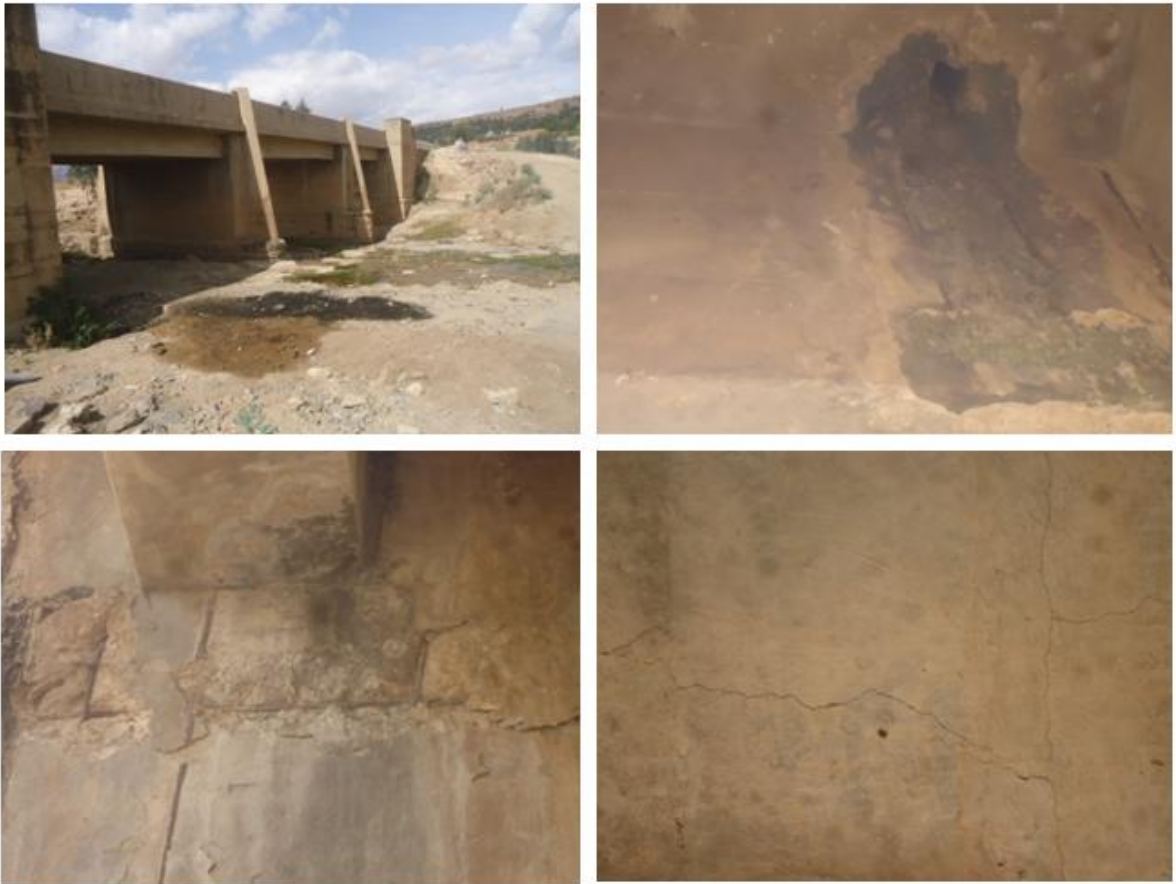
**Current condition** - Crack on the abutment, pier and girder, rebar exposure, cover concrete peel off and water leakage on the deck and pier

**Figure 3.27** Crack, Water leakage, rebar exposure and spalling of cover concrete

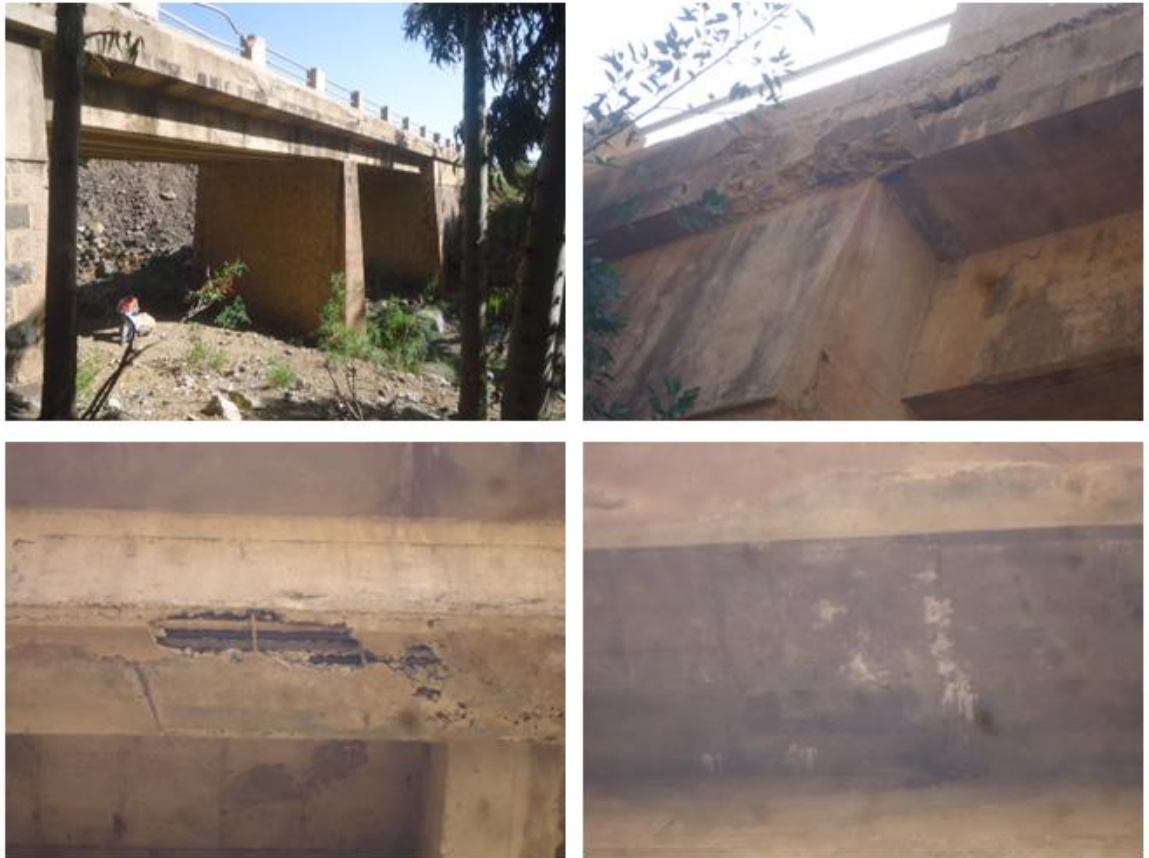
**Current condition** - Crack on the deck slab, rebar exposure & peel of concrete cover on the girder

**Figure 3.28** Crack, Water leakage, rebar exposure and spalling of cover concrete

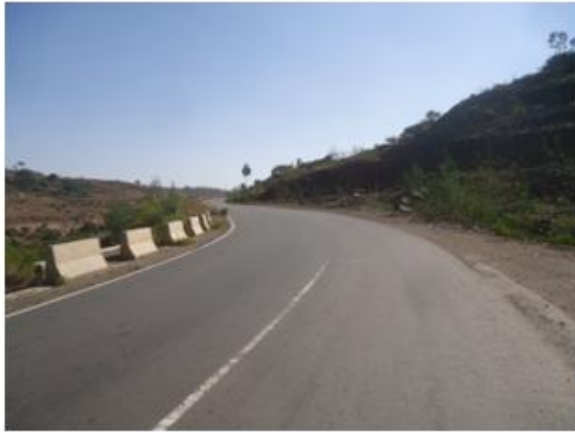
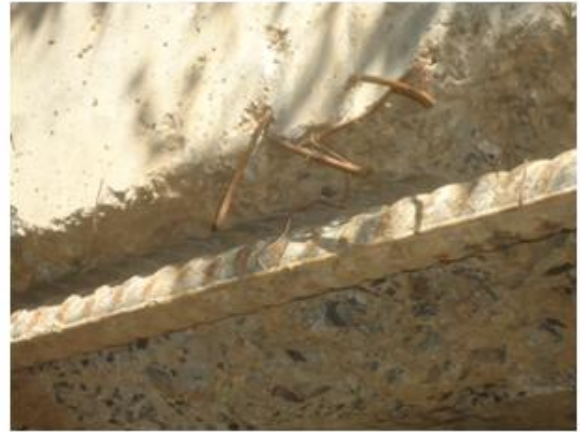
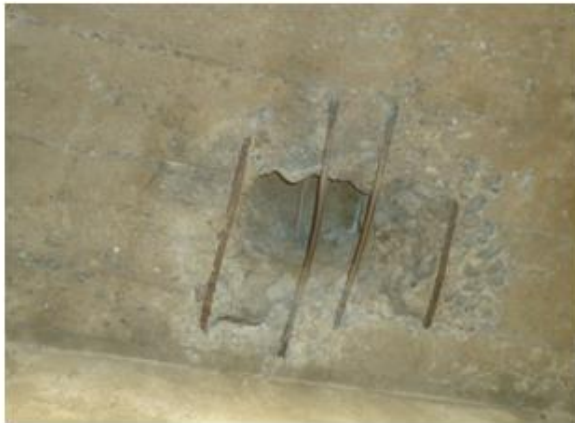
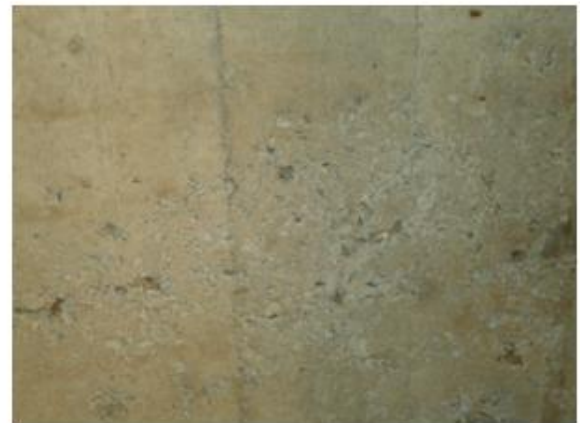
**Current condition** - Honey comb on the deck slab, rebar exposure & cover concrete peel off on the girder

**Figure 3.29**Honey comb on the deck slab, rebar exposure & cover concrete peel off on the girder

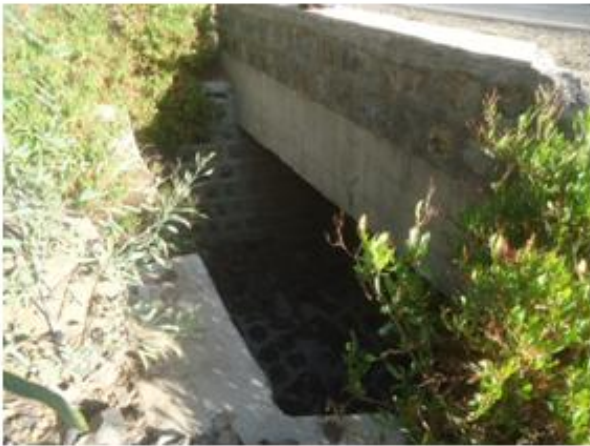
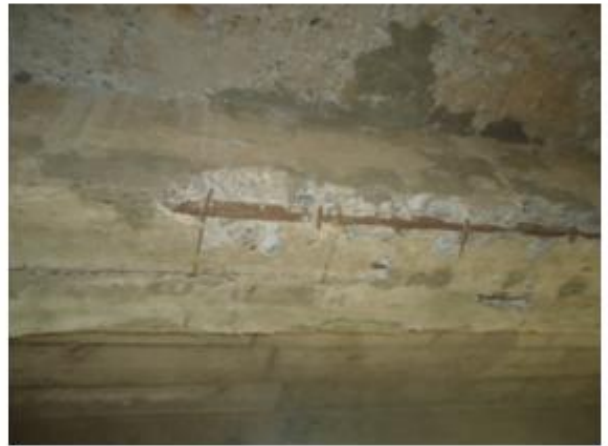
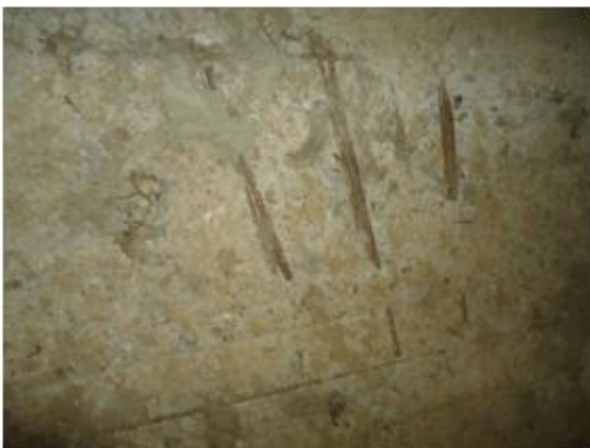
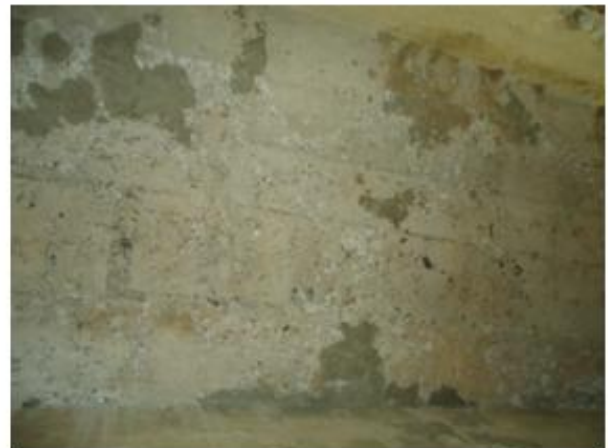
**Current condition** - Cover concrete peel off and rebar exposure on deck slab

**Figure 3.30** Cover concrete peel off and rebar exposure on deck slab

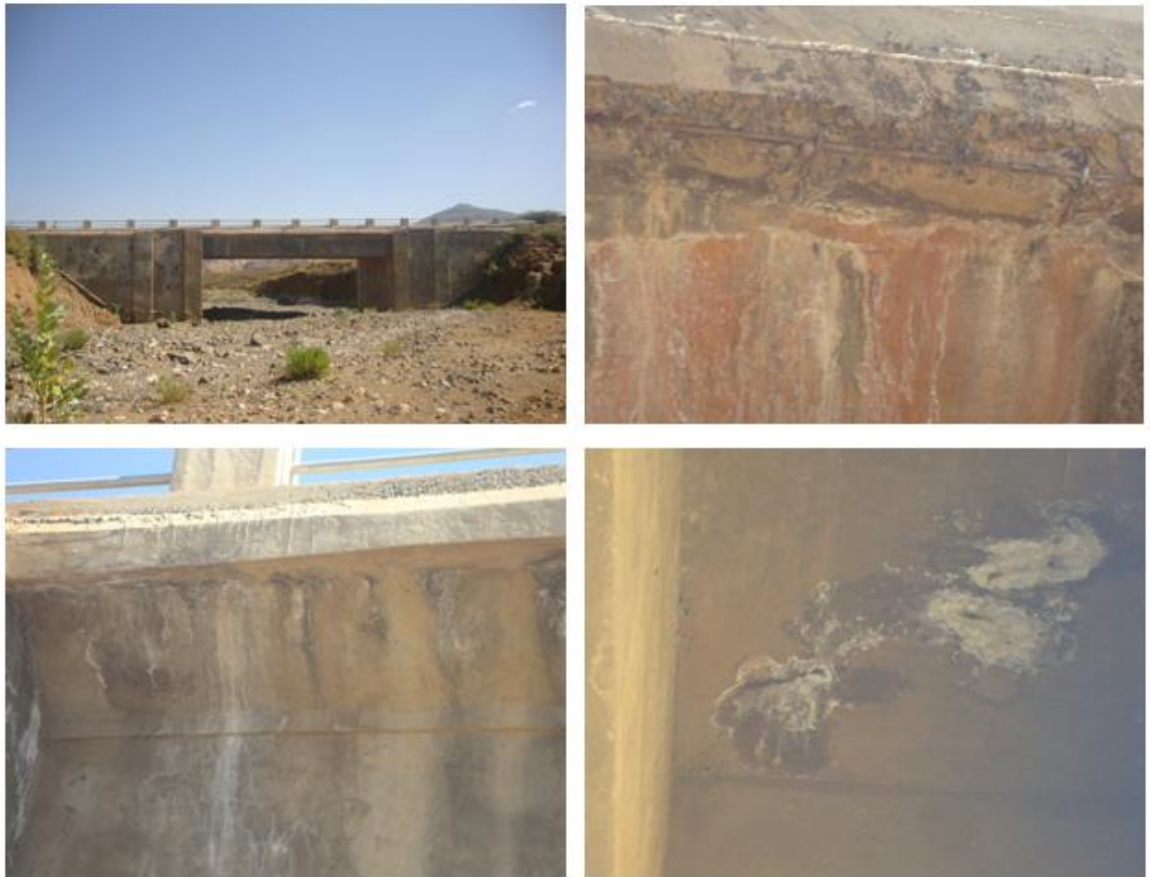
**Current condition** - Cover concrete peel off on deck ; rebar exposed and water leakage

**Figure 3.31** Cover concrete peel off and rebar exposure on deck slab

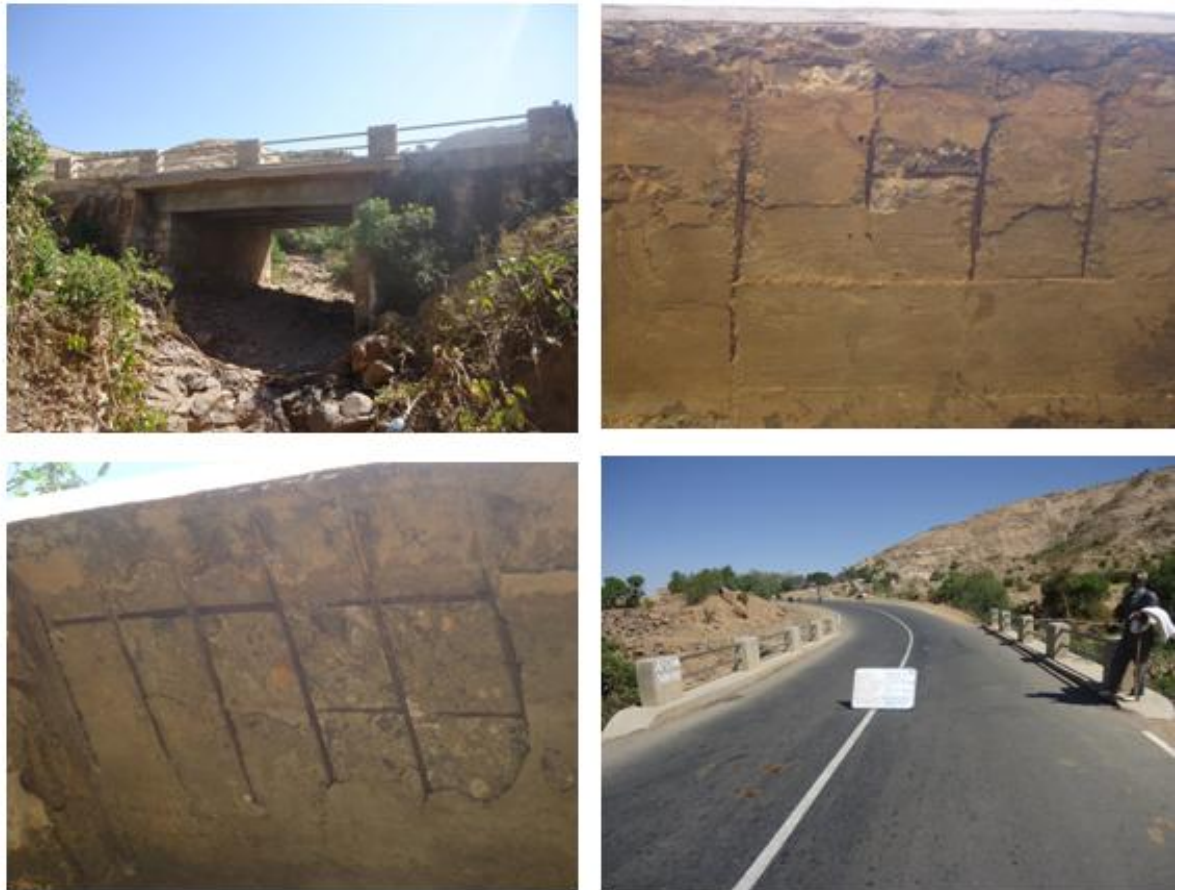
**Current condition** - Water leakage and rebar exposure

**Figure 3.32** Water leakages and rebar exposure

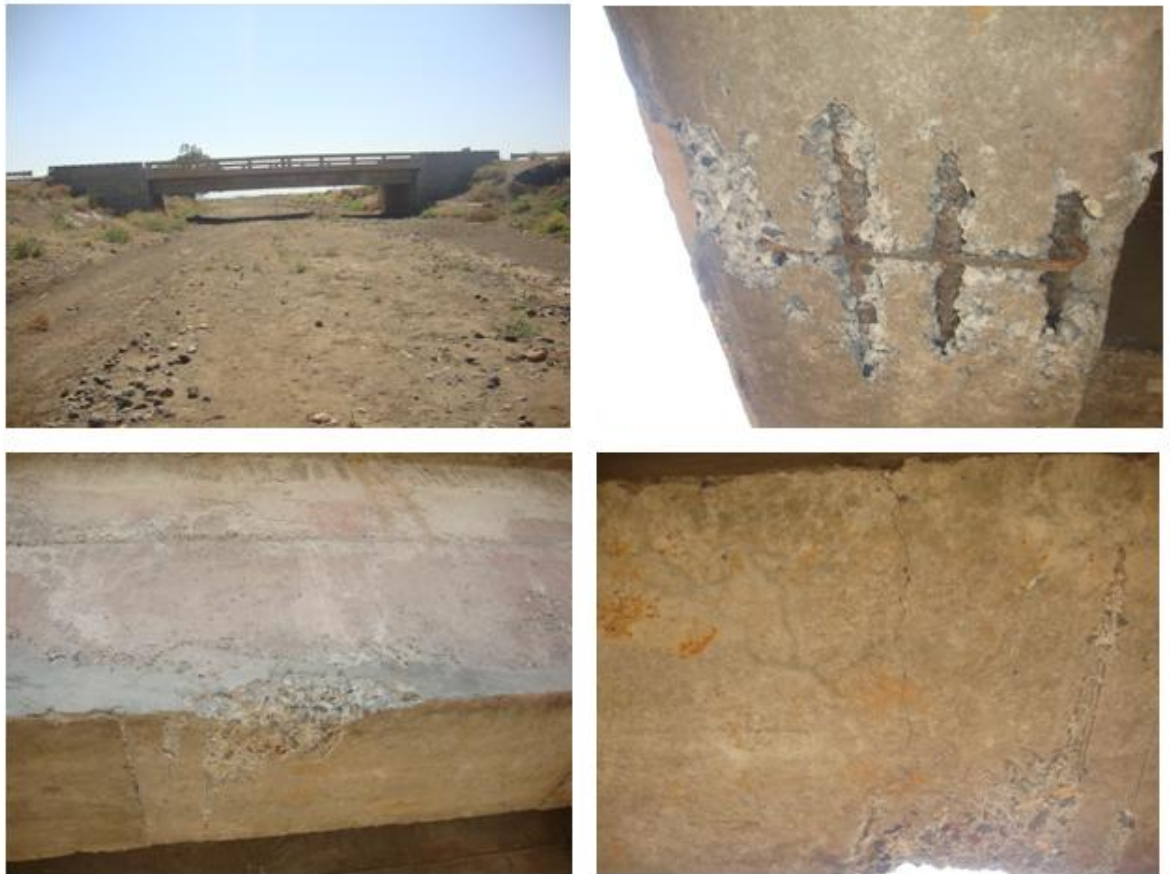
**Current condition** - Cracking and Peel of deck slab;honey comb and rebar exposure

**Figure 3.33** Cracking and Peel of deck slab, honey comb and rebar exposure

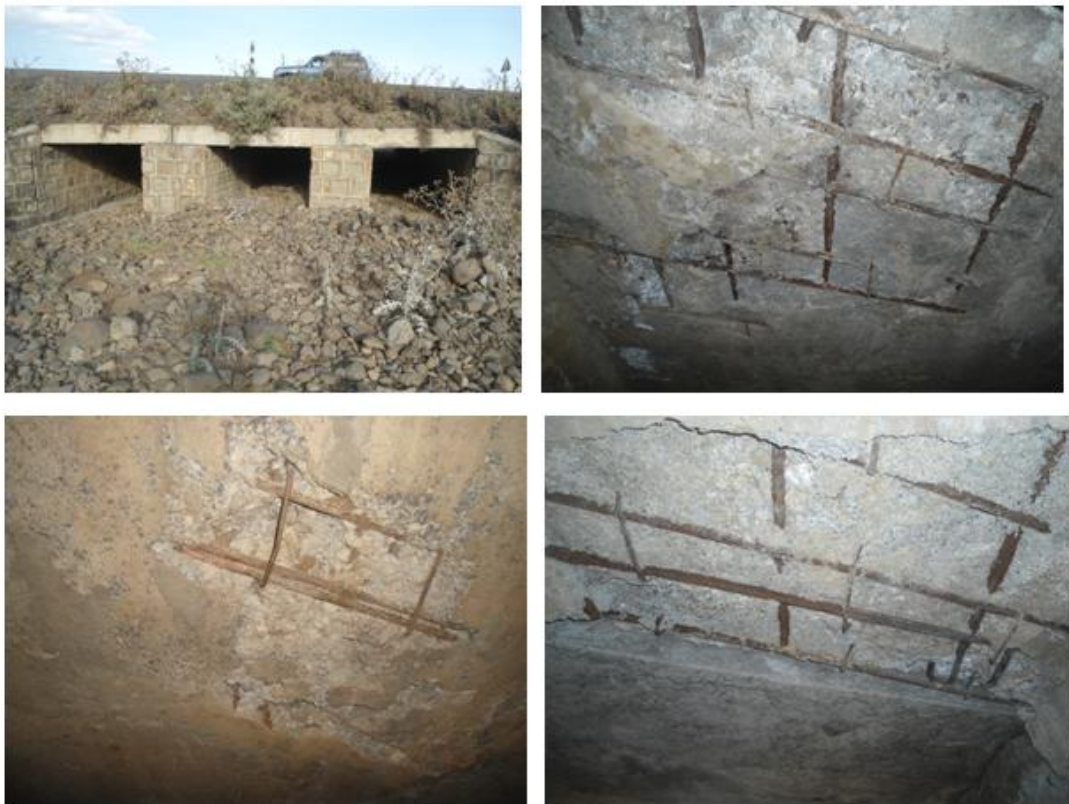
**Current condition** - Severe peel off, rebar exposure and voids on the deck slab; honey comb on the deck slab

**Figure 3.34** Severe peel off, rebar exposure and voids on the deck slab, honey comb on the deck slab

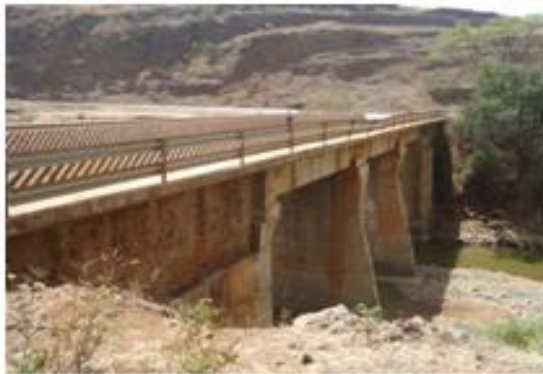
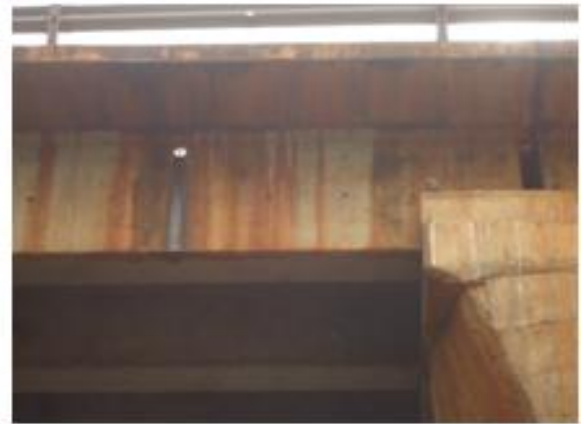
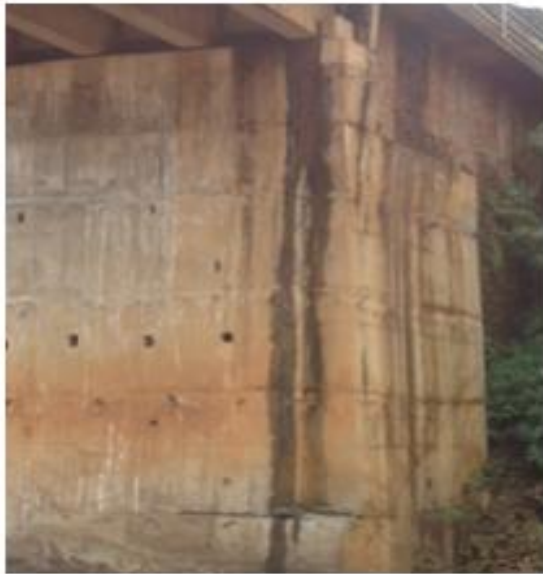
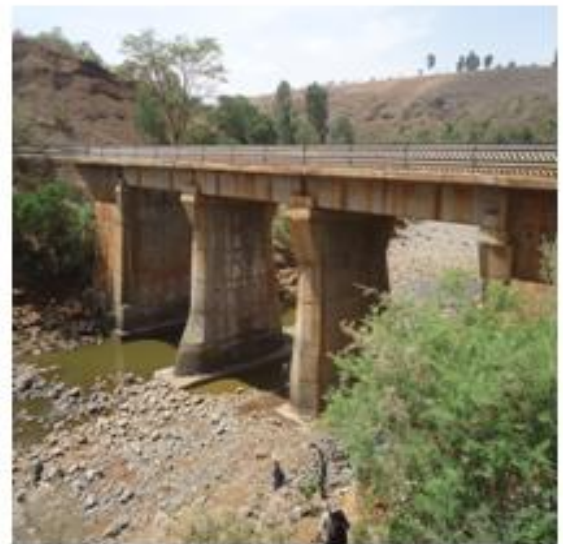
**Current condition** - Water leakage on girder and abutment

**Figure 3.35** Water leakage on girder and abutment
