**CORROSION OF STEEL REINFORCEMENT IN REINFORCED  
CONCRETE STRUCTURES – EFFECT AND METHODS OF REPAIR**

Presented in Partial Fulfillment of the Requirements for the Degree of Master of  
Science in Civil Engineering (Structural Engineering)

Addis Ababa University

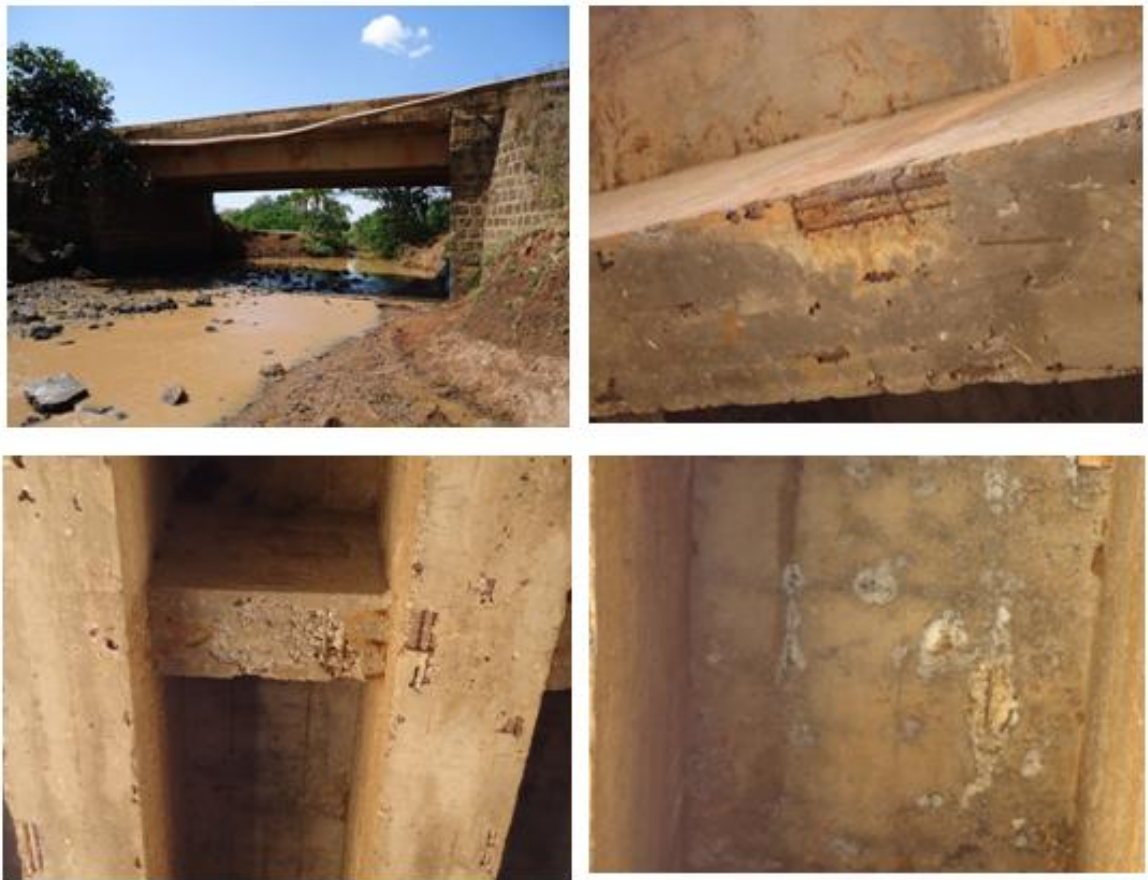
**Current condition** - Honey comb on girder & deck slab; Cover concrete peel off ; rebar exposure and water leakage on the deck slab

**Figure 3.36** Honey comb on girder & deck slab; Cover concrete peel off; rebar exposure and water leakage on the deck slab

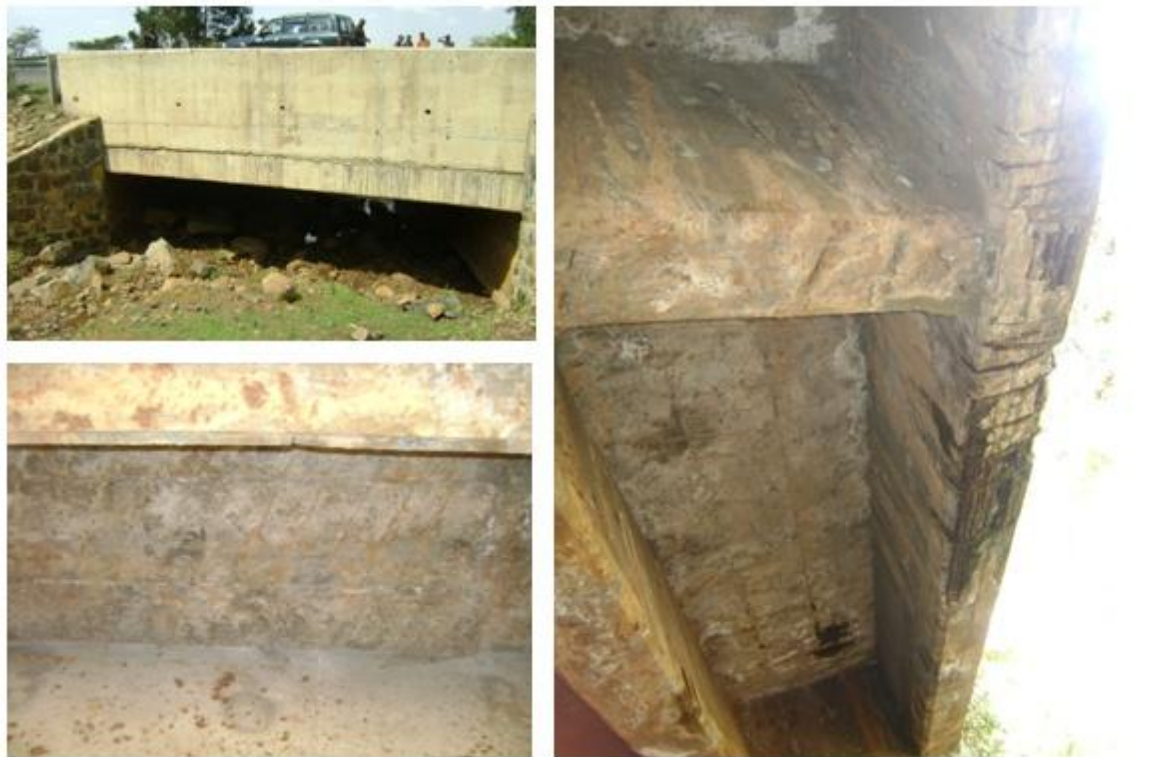
**Current condition** - Severe rebar exposure & honey comb

**Figure 3.37 Severe bars exposure & honey comb**

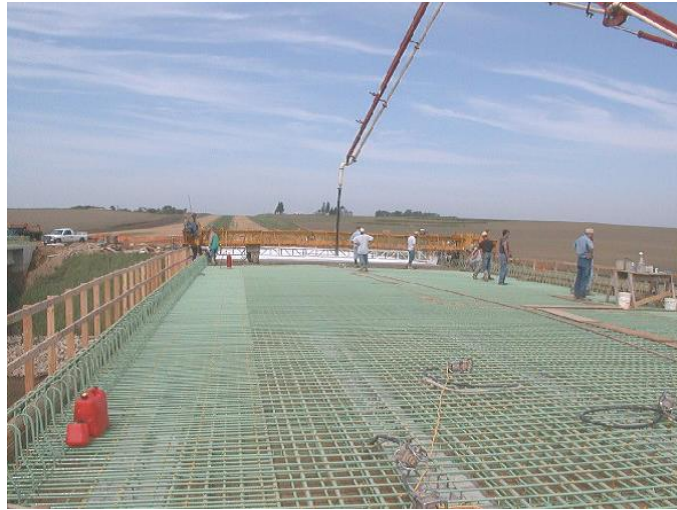
**Figure 5.1** Bridge deck concrete placements (epoxy coated reinforcement bars)
