**ASSESSMENT OF DAMAGES CAUSED BY EXPANSIVE SOIL ON ROADS  
CONSTRUCTED IN ADDIS ABABA**

**MASTER OF ENGINEERING PAPER WORK**

**Submitted in partial fulfillment of the requirement for the Degree of Master of  
Engineering in Civil Engineering (Geotechnical Stream)**

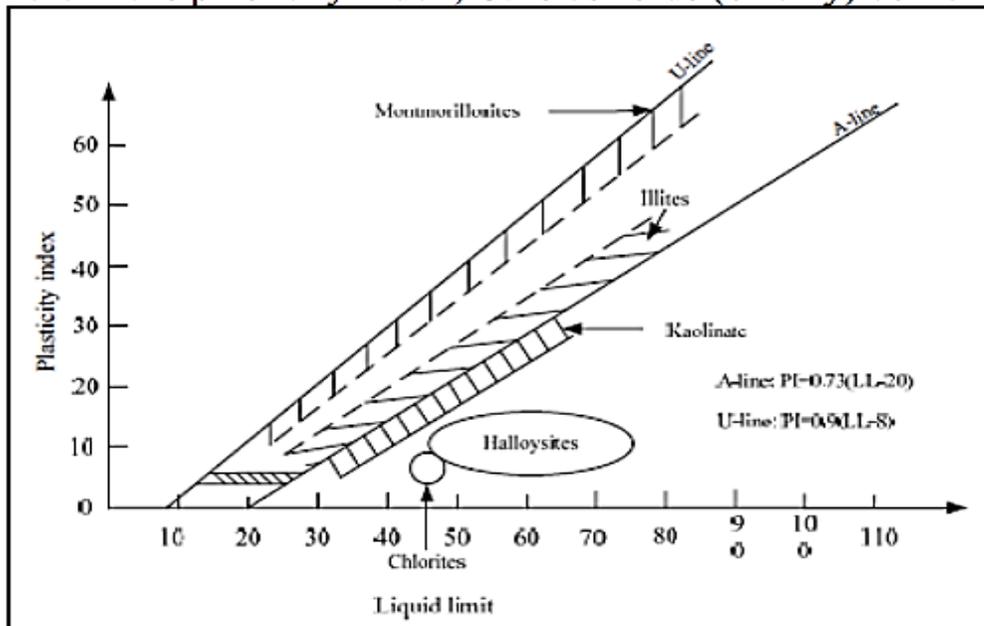
Figure 2.3. The plot of clay minerals on Casagrande's chart,

The proposed classification chart is shown in Figure 2.3. The activity term in the Figure is defined as follows:

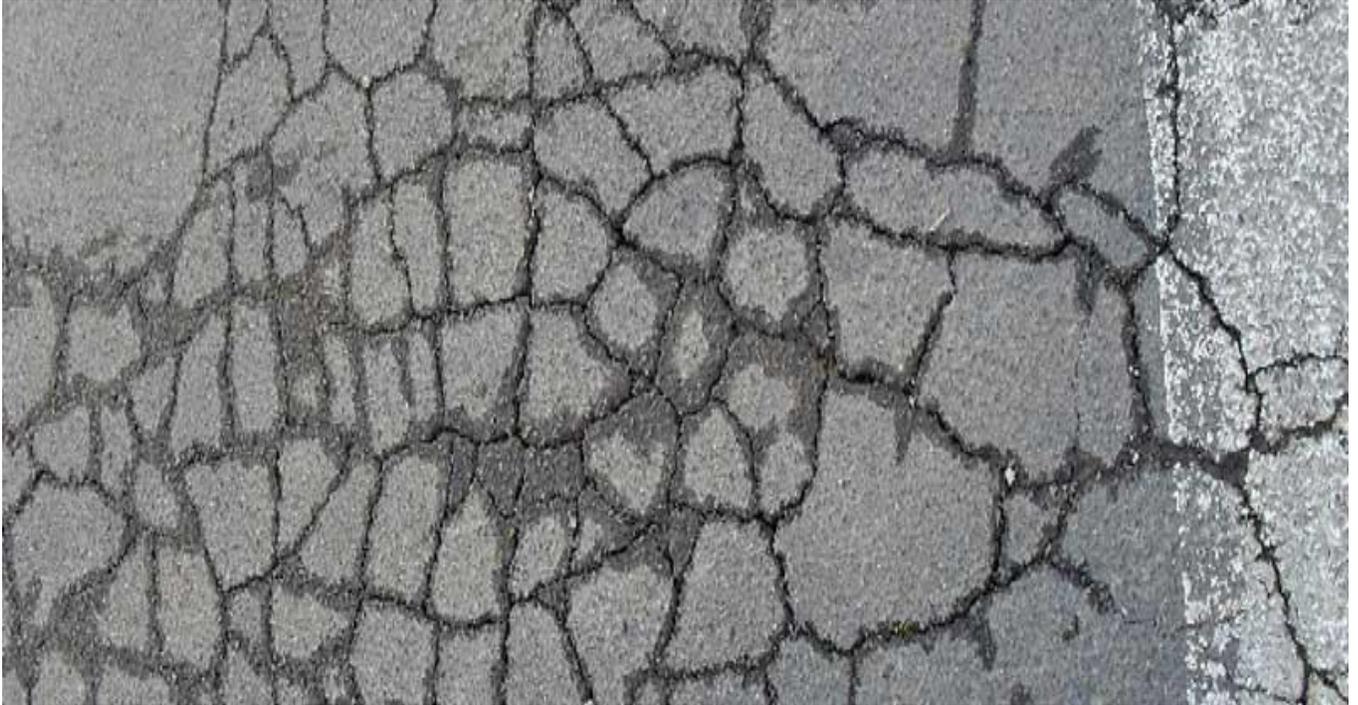
Figure 2.4 Alligator crack

Simply put, alligator cracking occurs when the pavement supports loads that the supporting structure cannot support. As with any surface, put enough pressure on the asphalt and it will crack. Asphalt road finish levels required a desirable foundation to withstand traffic smoothly. If small cracks of pavement damage are not treated, they allowed moisture to spread the base and subfloor. The top face of the pavement can no longer bear the weight of vehicles, so the widespread cracking form of alligator asphalt happens.

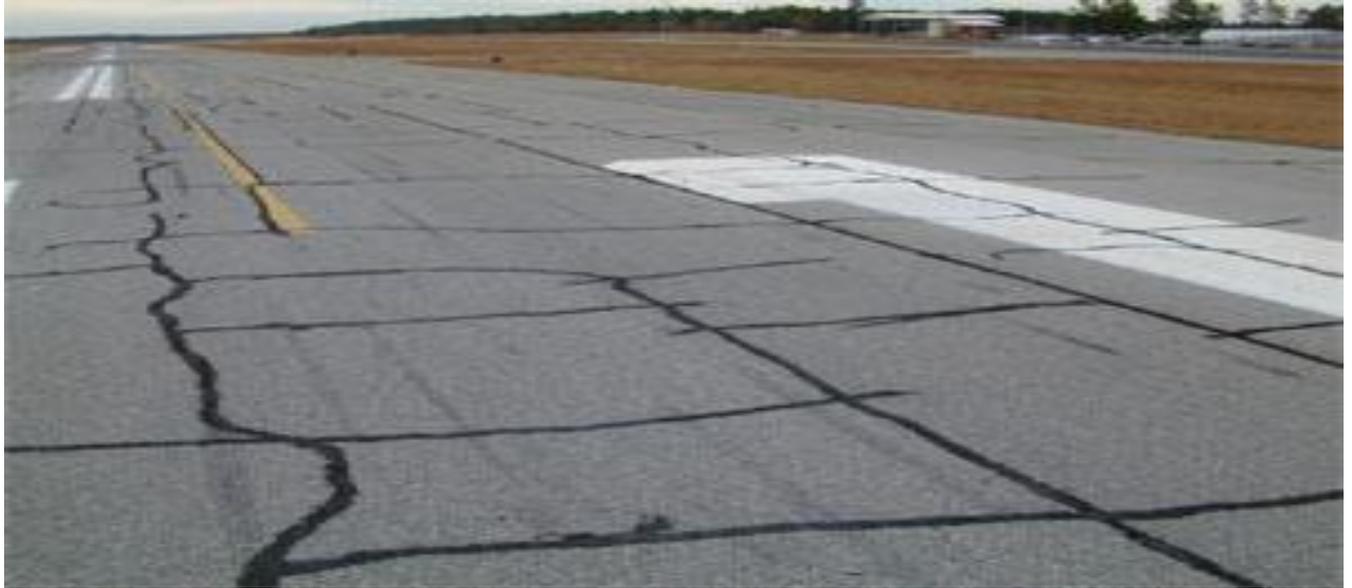
Figure 2.5 Block cracking

Block Cracking is **a series of interconnecting cracks that form in a roughly rectangular pattern**. It can occur in both concrete and flexible road pavements.

Block cracking is mainly caused by shrinkage of the asphalt concrete and daily temperature cycling, and it is not load associated. The appearance of cracks in the blocks usually indicates that the asphalt has hardened significantly. Block cracking normally happens over a large portion of the pavement surface.

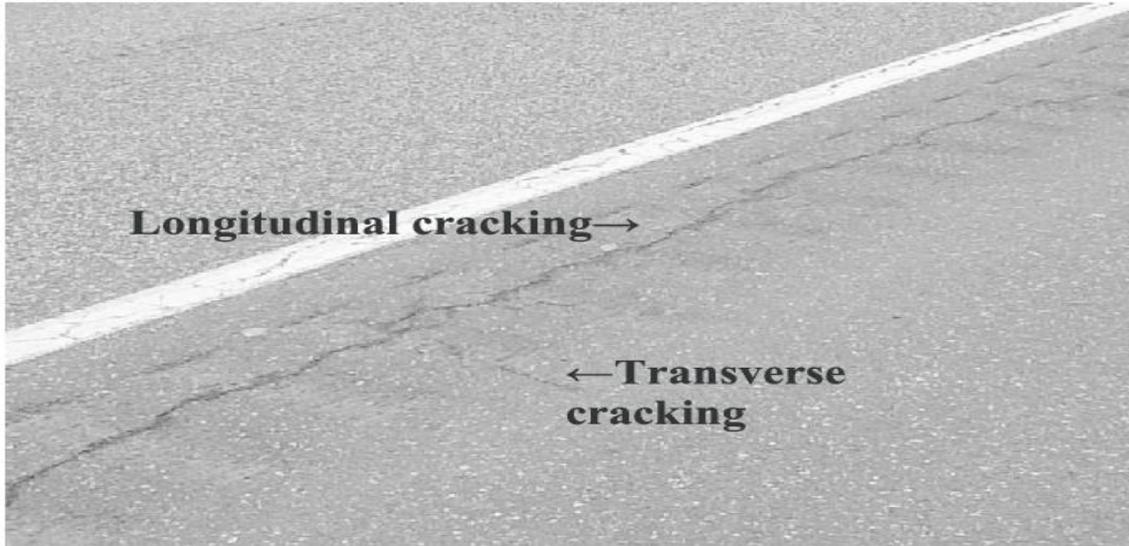
Figure 2.6 Longitudinal and Transverse cracking

Longitudinal cracks are parallel to the pavement's centerline or along the roadway direction. Whereas, transverse cracks extend across the pavement at roughly right angles to the centerline of the pavement or direction of the roadway line.

Longitudinal cracks are caused by poorly constructed paving lane joint, temperature cycling, reflective cracking in a base layer, or volume changes in the subgrade.

Longitudinal cracks caused by sub-grade movement will generally be quite long and can meander across the carriageway. These can occur because of poor construction practices, swelling in the plastic subgrade, or embankment materials, and the settlement or collapse of embankments.

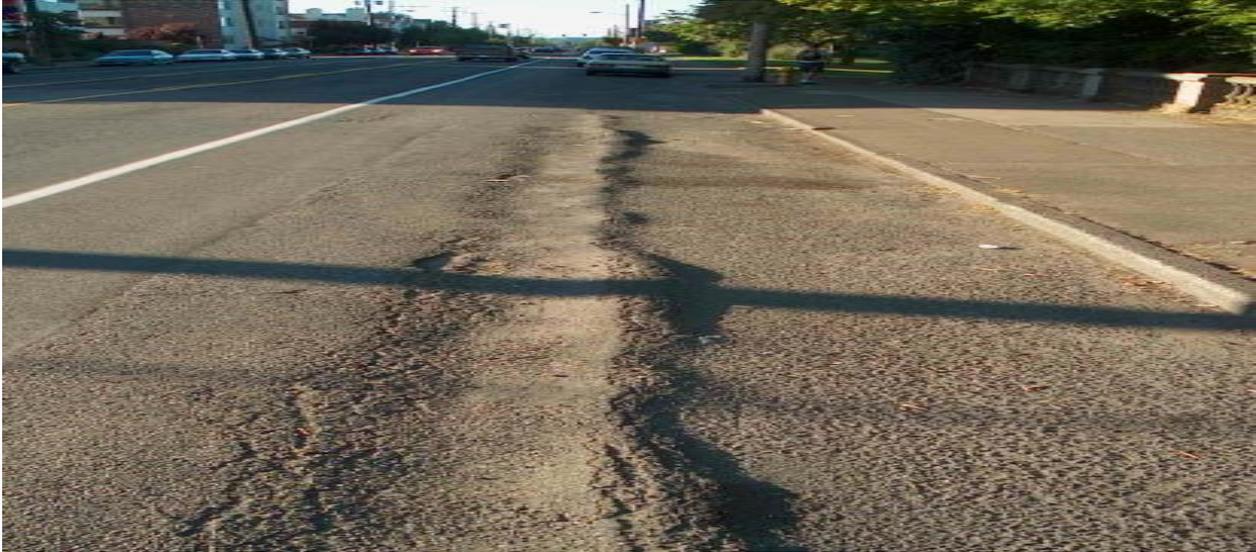
**Figure 2.7 Rutting crack type**

When a permanent deformation or consolidation builds up in asphalt is called a Rutting. This is usually seen from the wheel path dug into the road. The rut can be triggered by a lack of adequate densification, inadequate pavement thickness, and poor asphalt mixes. Some of the typical causes of the rutting can be lack of proper mix design or manufacture (e.g., when a large amount of asphalt content, traffic load too high, an insufficient amount of corner aggregate particles) Subgrade rutting Subgrade changes under load.

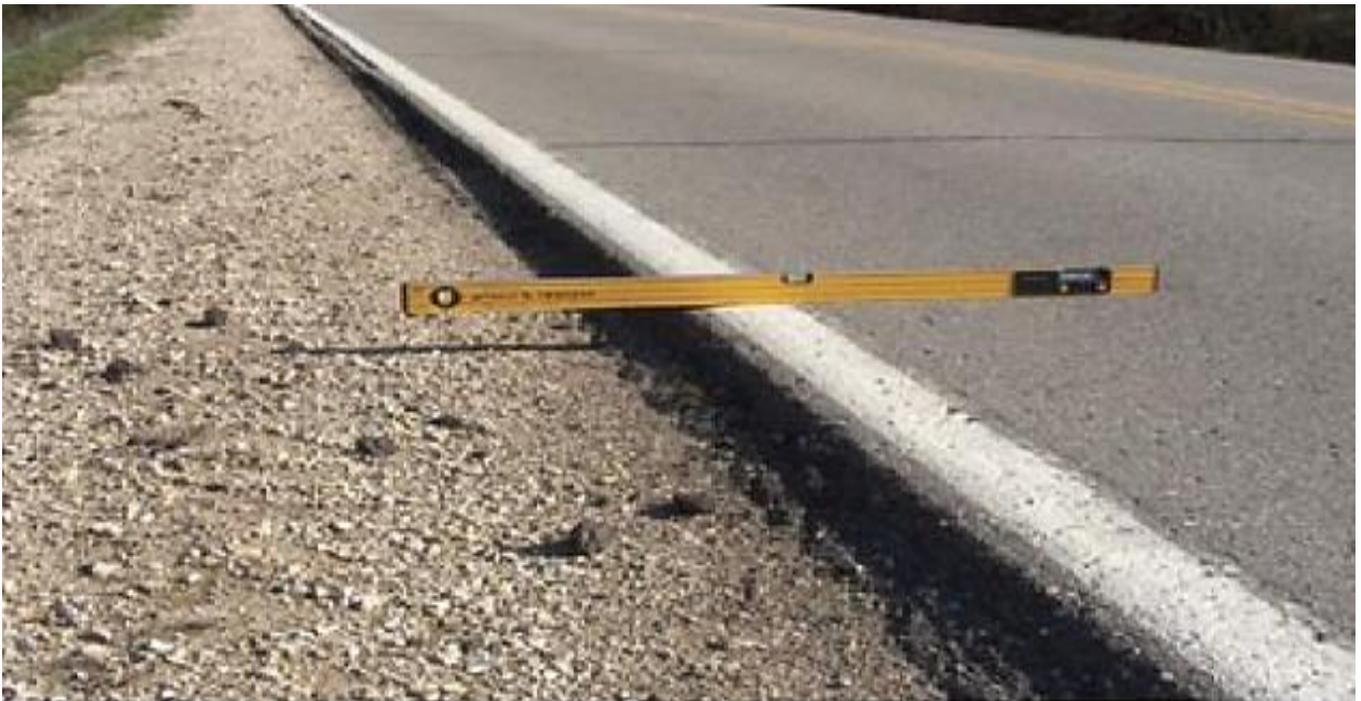
Figure 2.8 Drop – significant grade due to erosion

A shoulder or pavement edge drop-off refers to a defect of road geometry where the elevation change (vertical distance) between the travel lane and its adjacent shoulder, or between two travel lanes, exceeds acceptable limits. Because of the drop-off, the driver may move out of the travel lane.

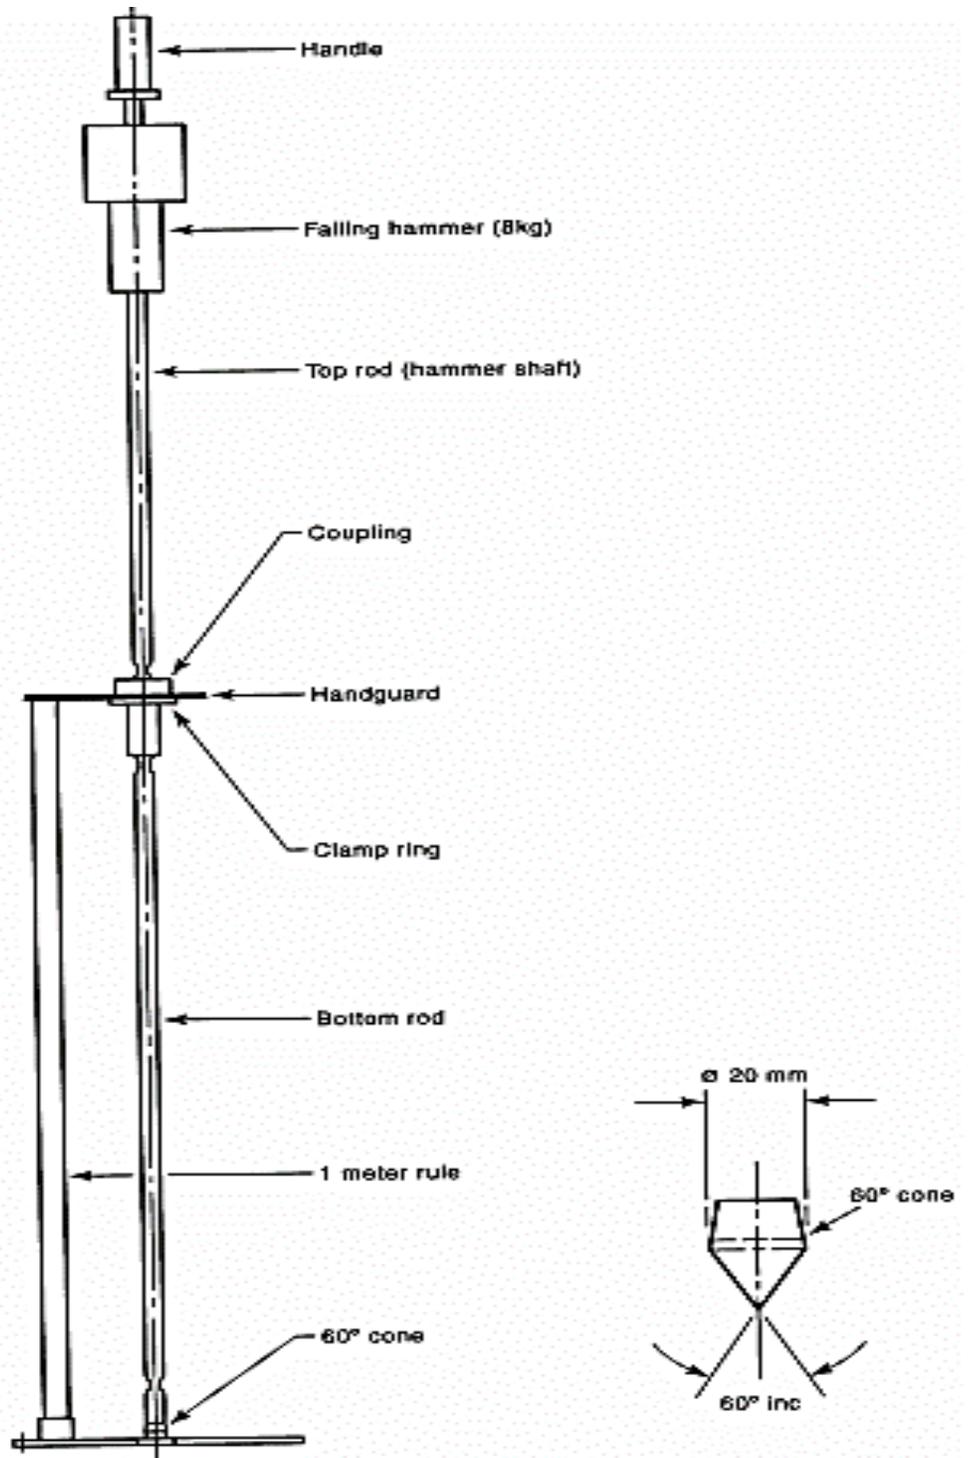
Figure 2.9 Dynamic cone penetrometer

- To control the quality of construction
- To determine in situ CBR value
- To evaluate the quality of flexible pavement

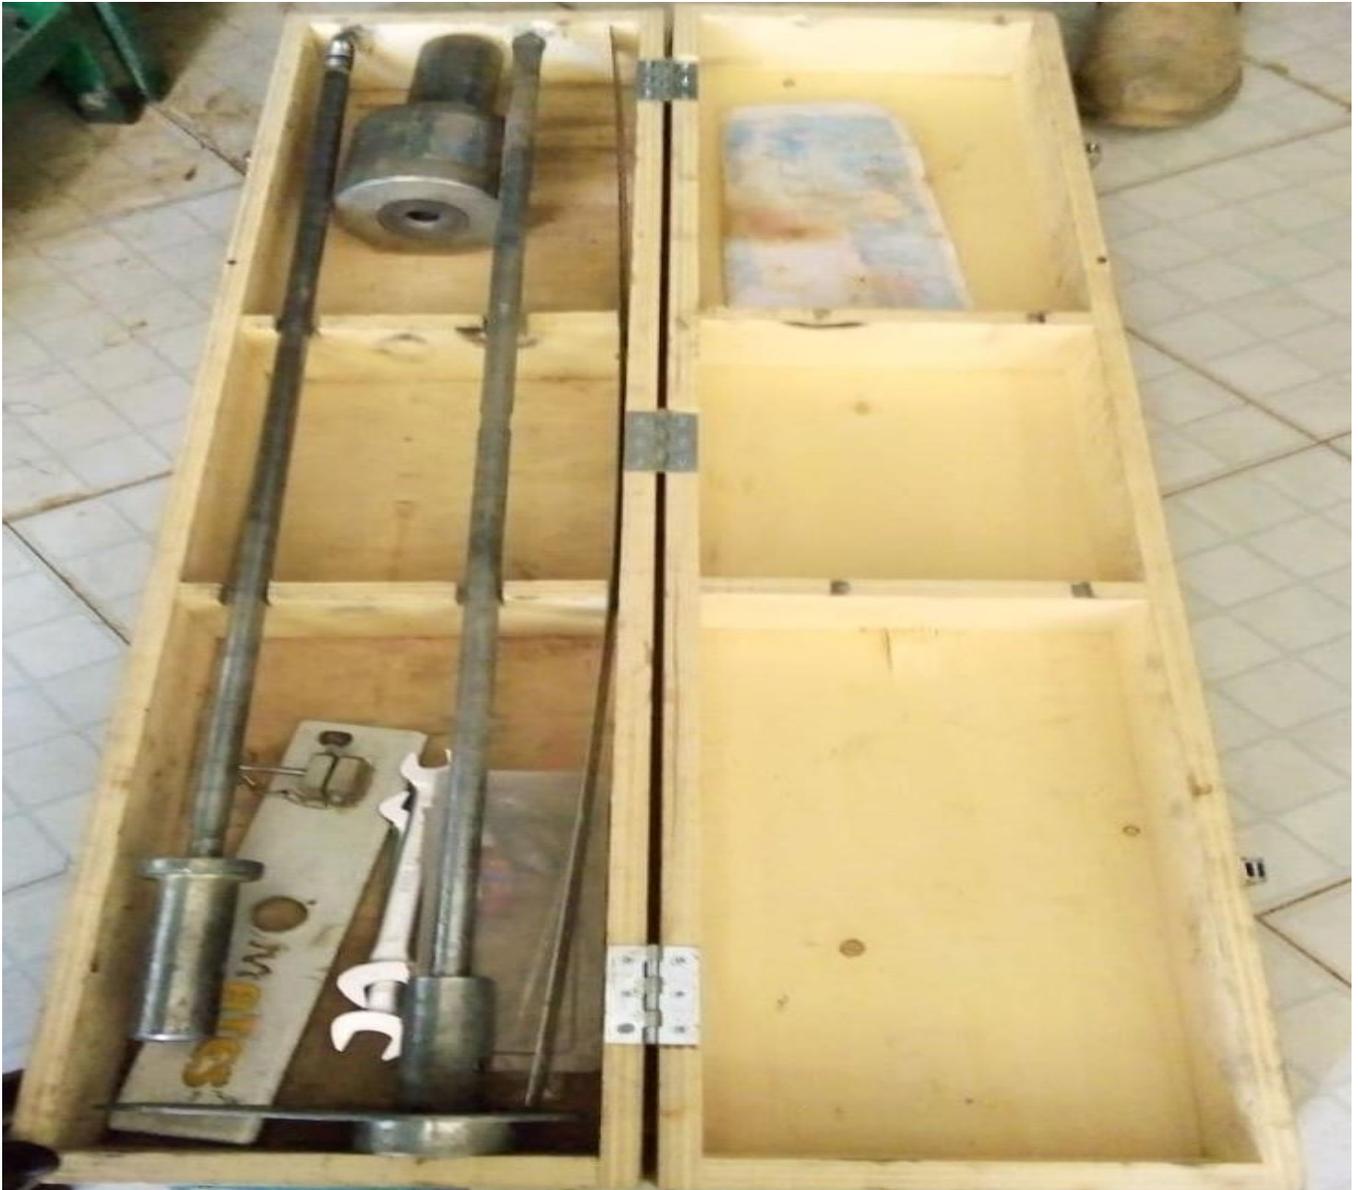
The available Dynamic Cone Penetrometer test machine with its bag in AACRA

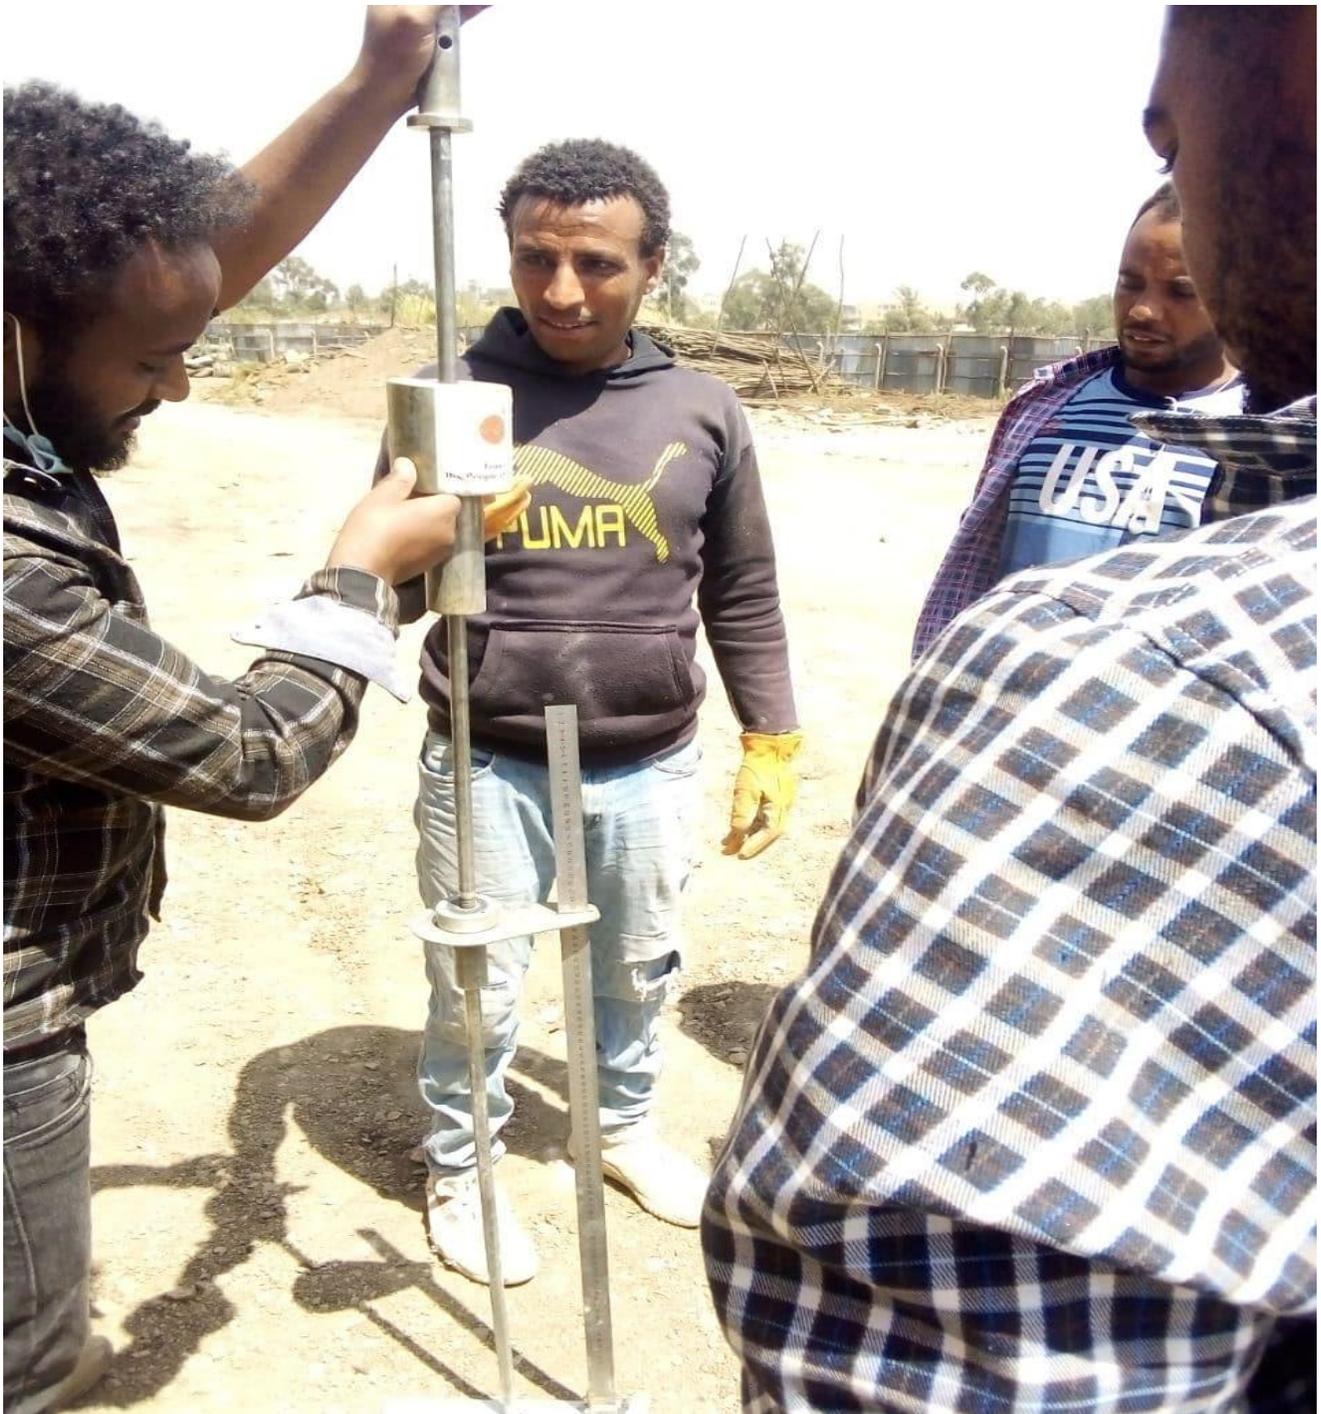
DCP Test on site

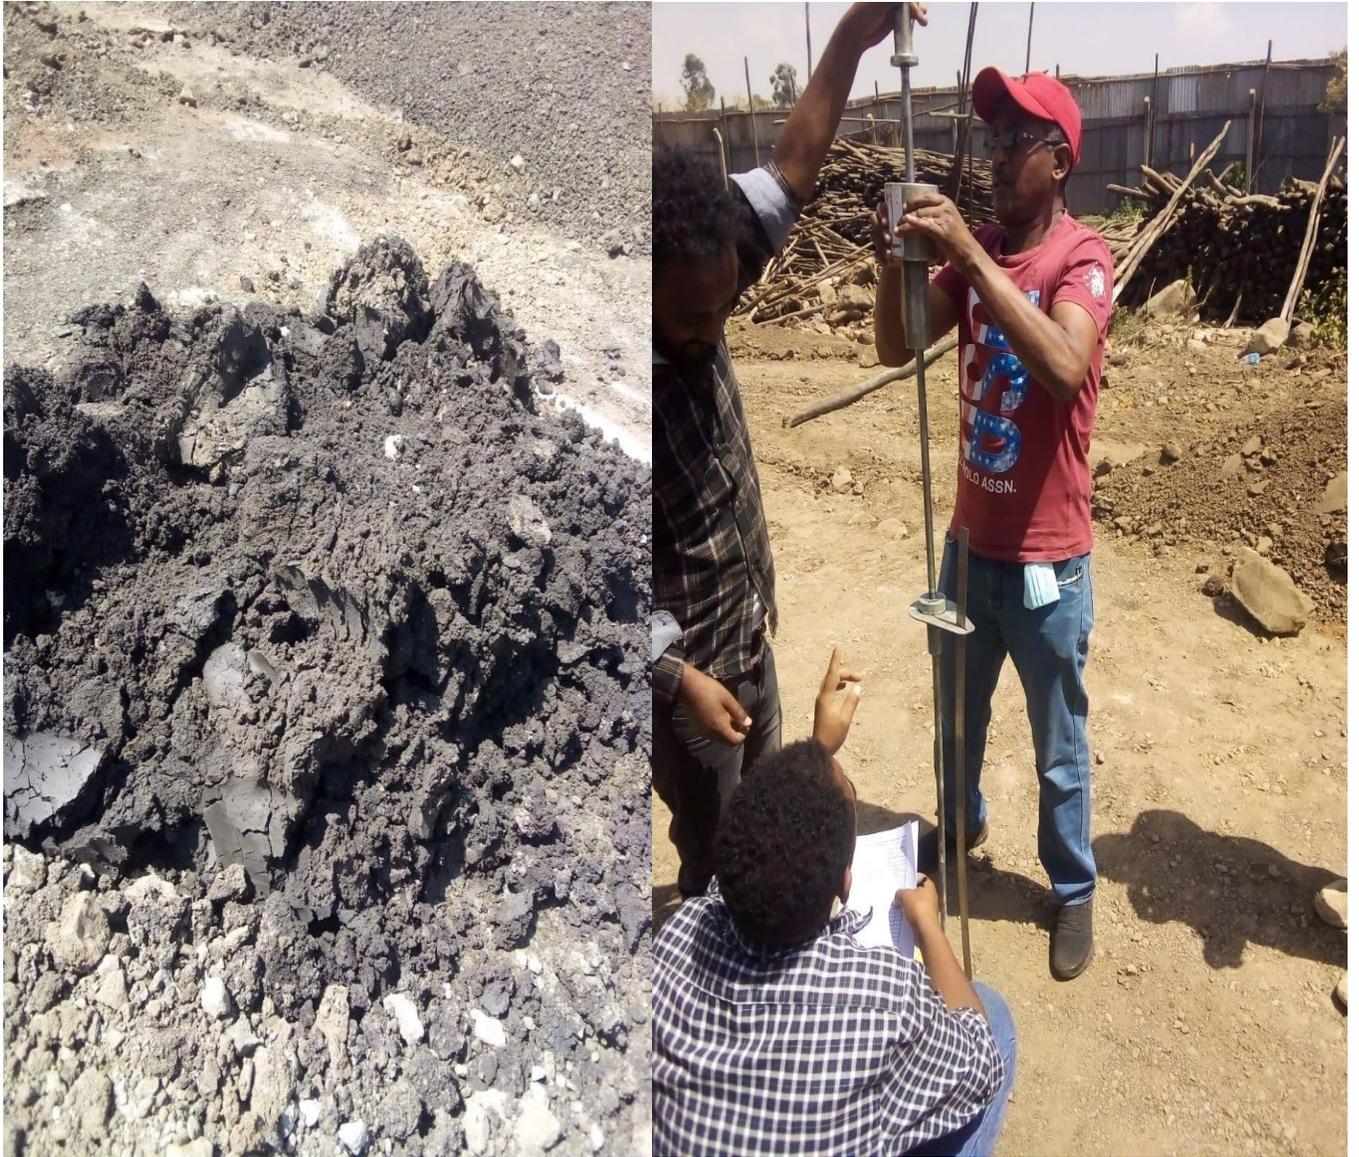
Photos of Mekanissa tested soil and DCP test

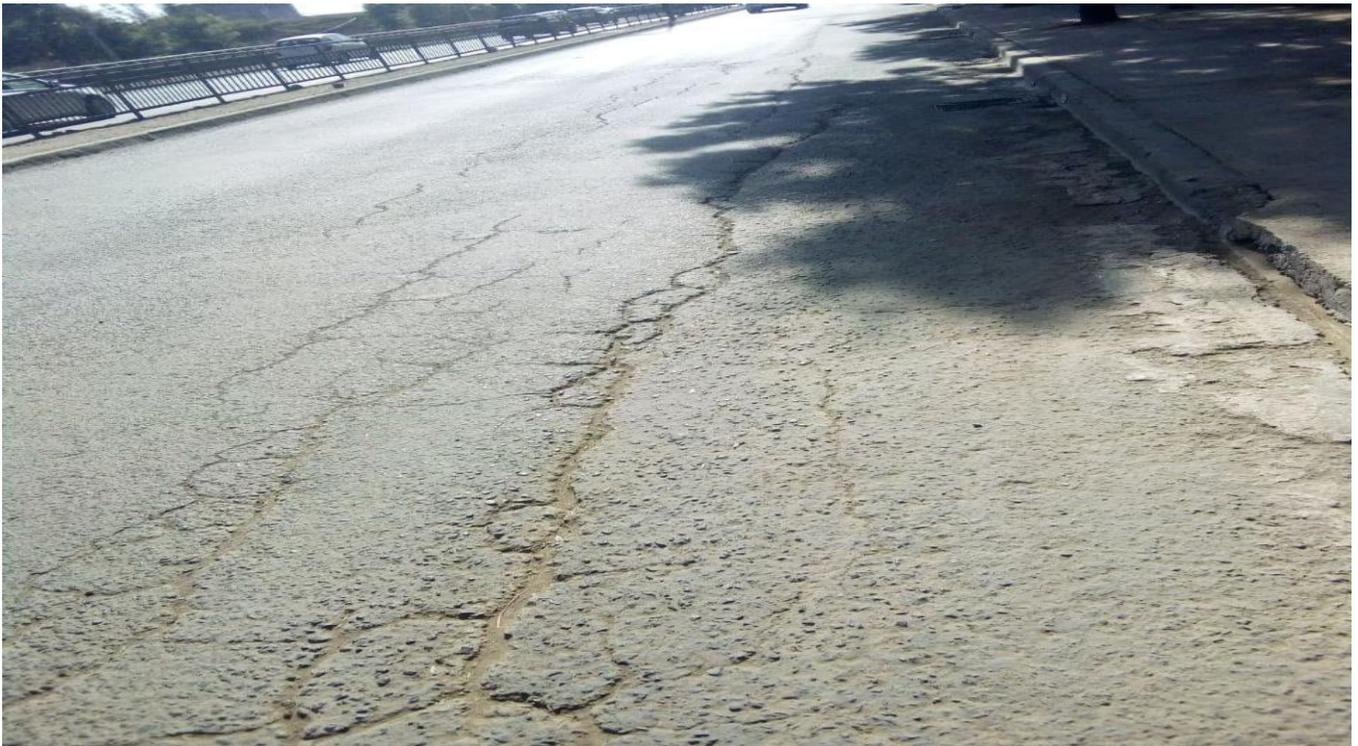
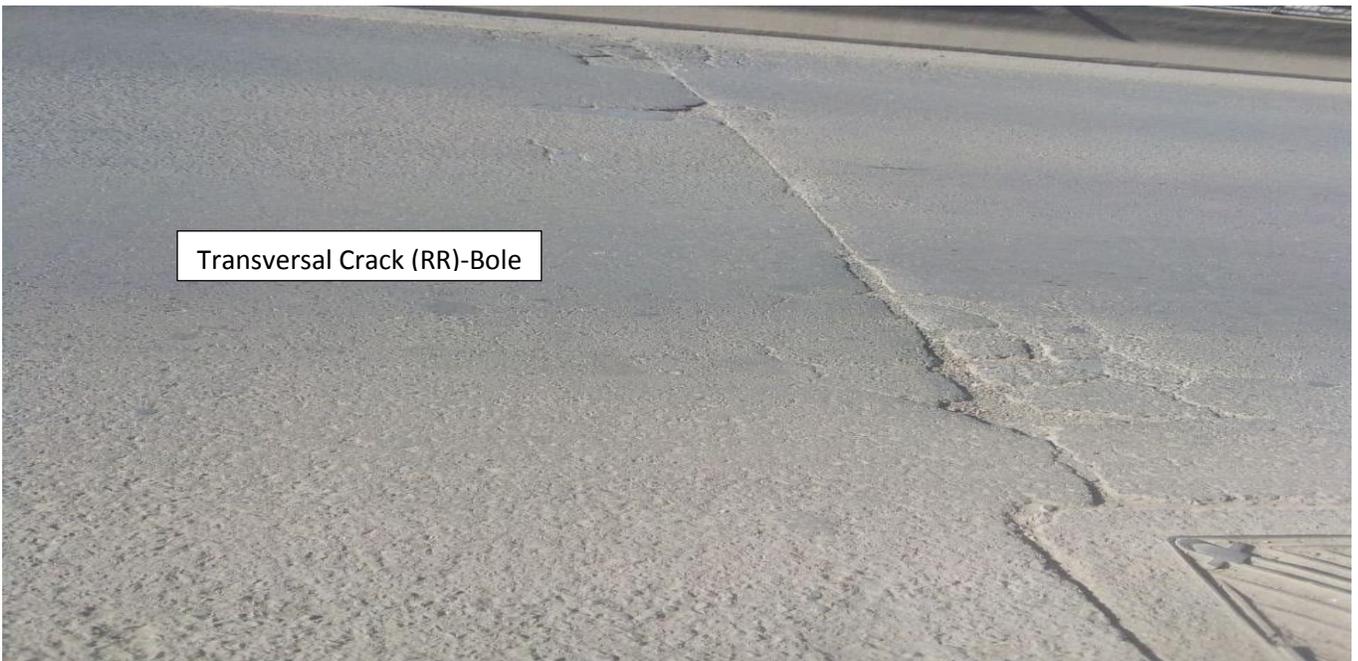
Different types of failure observed around Bole airport road

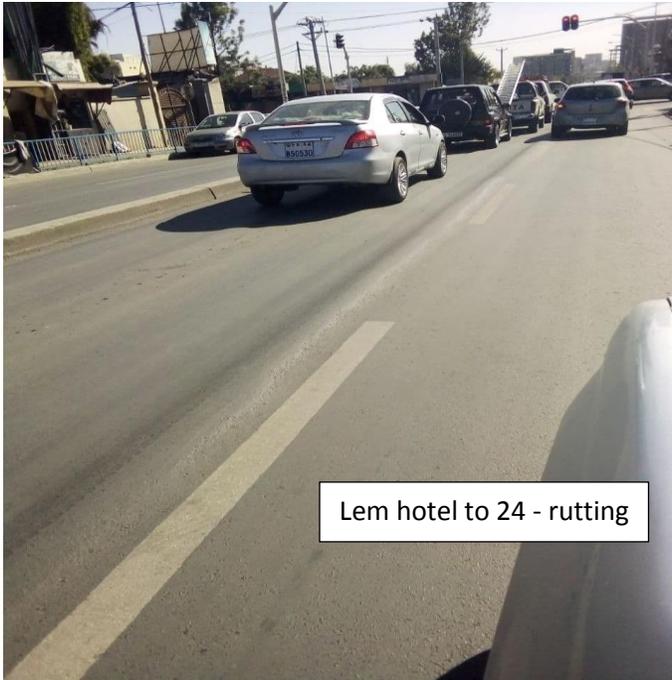
Lem hotel to 24 - rutting

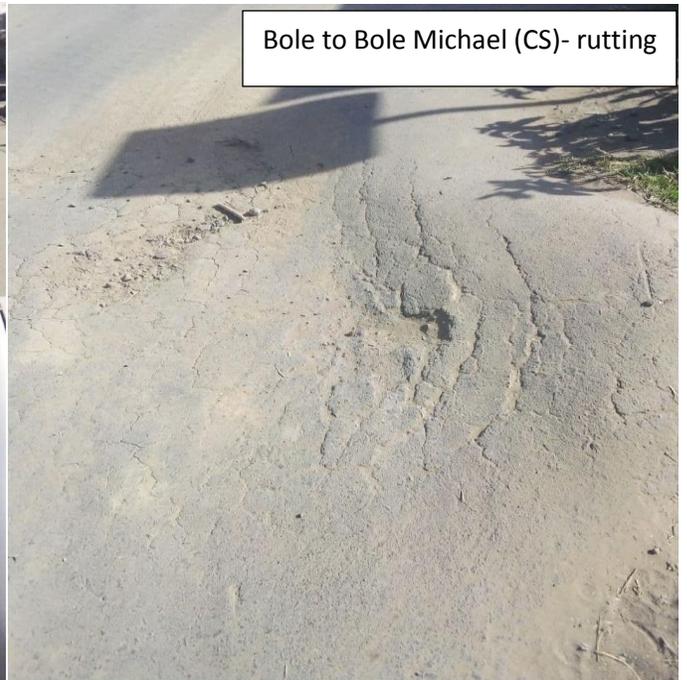
Bole to Bole Michael (CS)- rutting

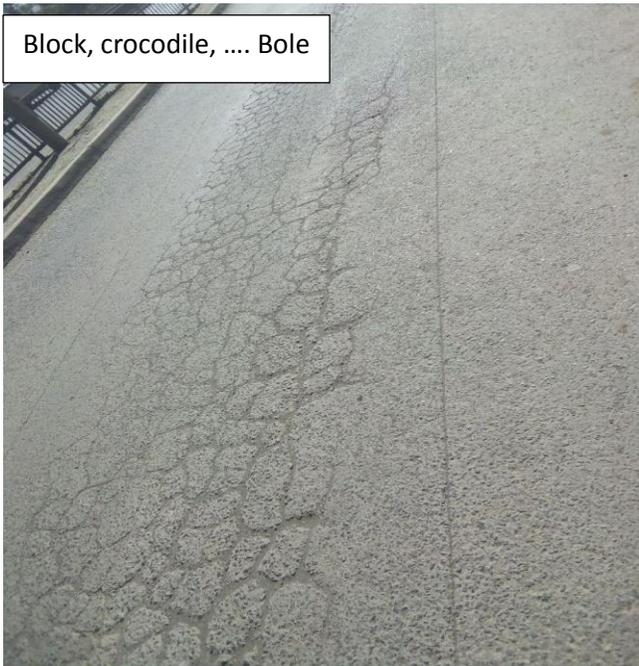
Block, crocodile, .... Bole

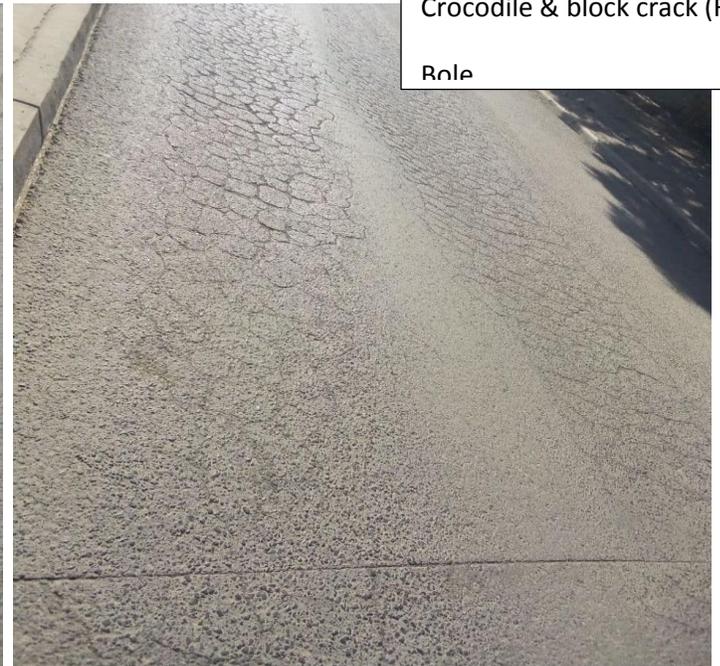
Crocodile & block crack (RR)  
Bole

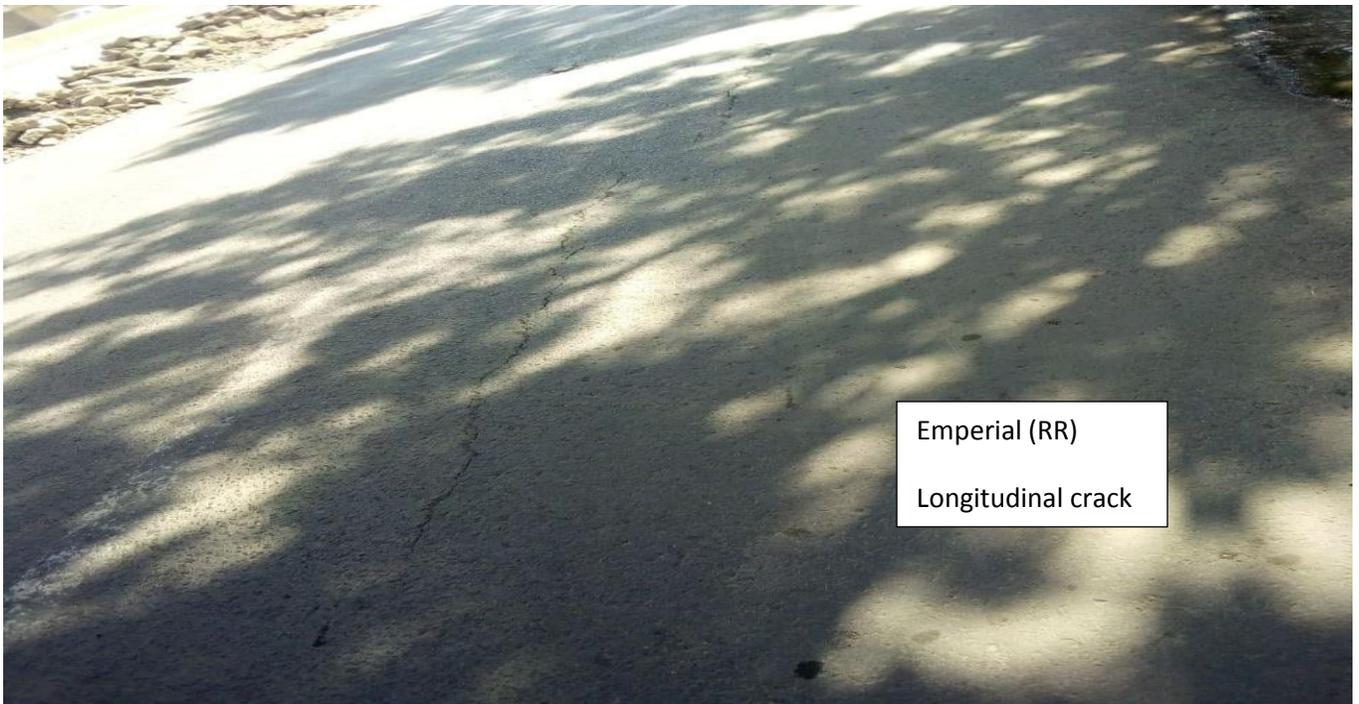
Emperial (RR)  
Longitudinal crack

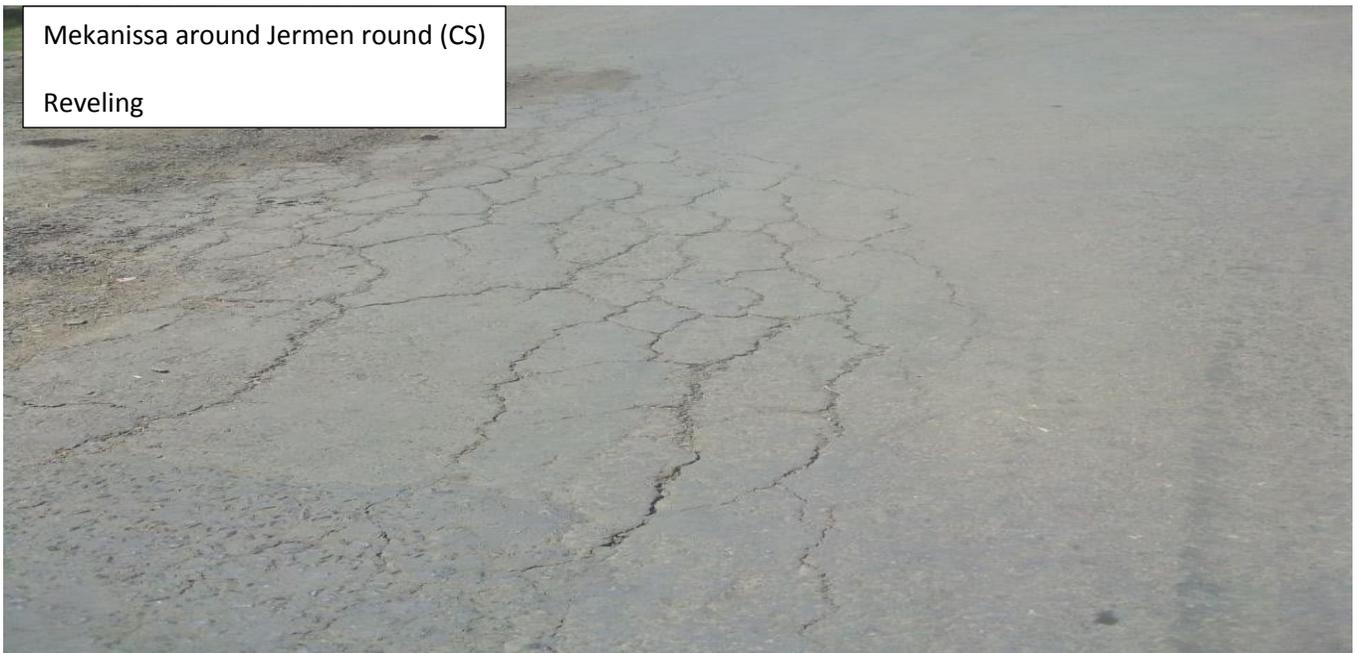
Mekanissa around Jerman round (CS)  
Reveling

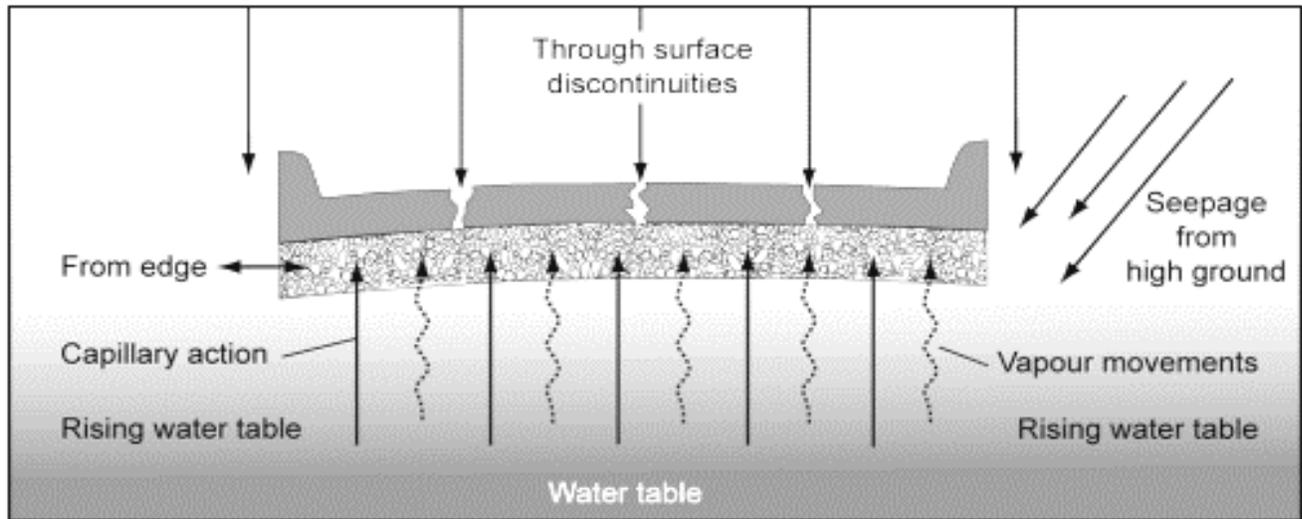
Figure 4.1: Sources of moisture in pavements. Modified from US DOT FHWA (2006)

In the road construction process moisture is the single most important factor affecting pavement performance and long-term maintenance costs. Therefore, one of the major challenges faced by the designer is to provide a flooring structure in which the adverse effects of moisture are contained to acceptable limits in relation to the traffic loading, nature of the materials being used, construction/maintenance provisions, and degree of acceptable risk. Excess moisture is known to have a detrimental effect on pavement structures. This also applies to expansive and, to a lesser extent, dispersive soils. Humidity, in combination with other factors, can have a profound negative effect on both the material properties of the subgrade and the overall performance of the pavement. As shown in Figure 4-1, moisture can enter the pavement from a variety of sources. It may seep downward from higher ground, may infiltrate through the surface, or could flow laterally from the pavement edges and shoulder ditches. Capillary action and moisture-vapor movement are also important. Capillary properties are the effect of surface tension and the attraction between water and soil. The movement of vapor is associated with fluctuating temperatures and other climatic conditions.
