**HYDRAULIC FAILURE OF MICRO
EMBANKMENT DAMS AND REMEDIAL
MEASURES
(CASE STUDY: ZANA MED, AMHARA REGION)**

**By
TIGIST ANTENEH MEKONNEN**

A THESIS SUBMITTED TO THE SCHOOL OF GRADUATE STUDIES OF ADDIS
ABABA UNIVERSITY IN PARTIAL FULFILLMENT OF THE REQUIREMENTS
FOR THE DEGREE OF MASTERS OF SCIENCE IN HYDRALIC ENGINEERING

June, 2008

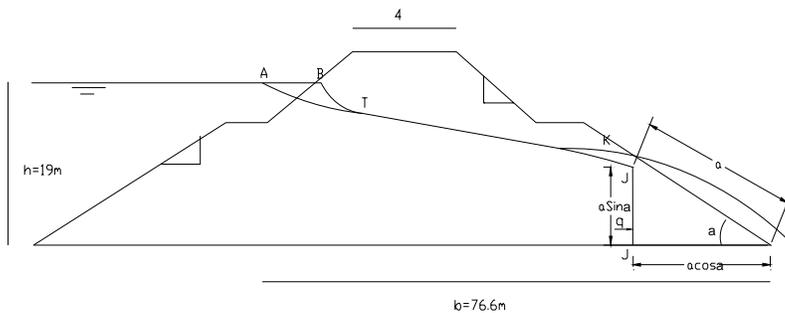
Fig 4.3: Phreatic Line at the Homogeneous Dam

Table 4.1: Coordinates Points of phreatic Lines

X(m)	21.5	26.5	31.5	36.5	41.5	46.5	51.5	56.5	61.5	66.5	71.5	76.5
Y(m)	10.2	11.3	11.5	13.2	14.0	14.8	15.6	16.3	17.0	17.7	18.3	18.9
	5	3	5	2	7	7	3	5	5	2	6	8

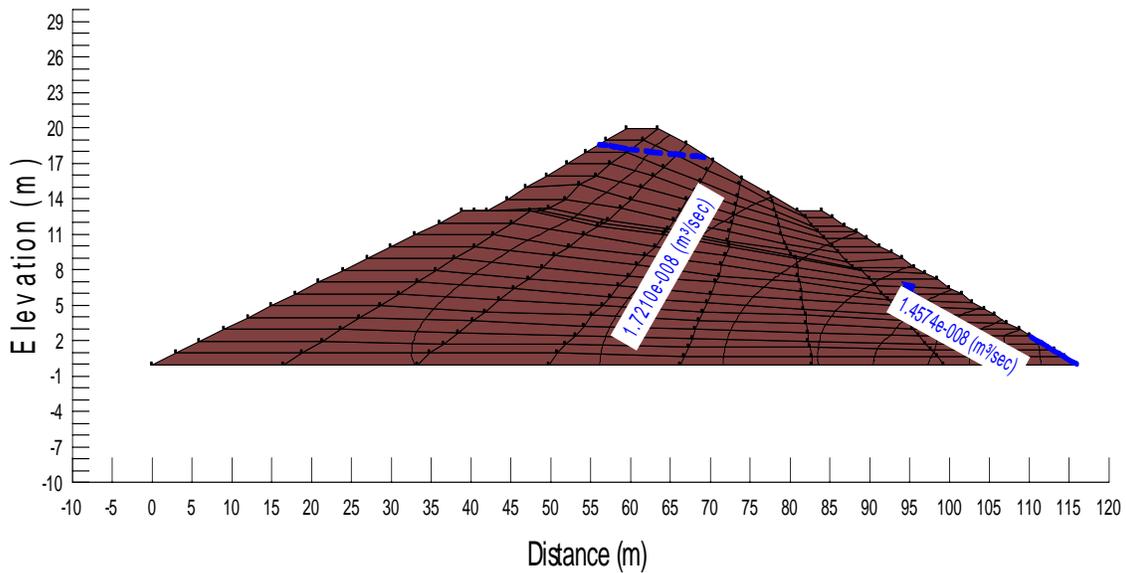
Fig 4.5: Seepage Analysis through Homogeneous Dam

The result of the analysis using SEEP/W software model for the case of homogeneous dam is presented below. The analysis considered the dam without filter drainage system and neglected the impact of foundation seepage. The adopted parameters of the dam are 116.5m of bottom width, 4m top width and dam height of 20m .Its permeability coefficient has a value of 2.34×10^{-6} cm/sec. As shown from the figure the estimated

quantity of seepage at the center the dam and near the toe of the dam are $1.72 \cdot 10^{-8} \text{ m}^3/\text{sec}/\text{m}$ and $1.457 \cdot 10^{-8} \text{ m}^3/\text{sec}/\text{m}$ respectively.

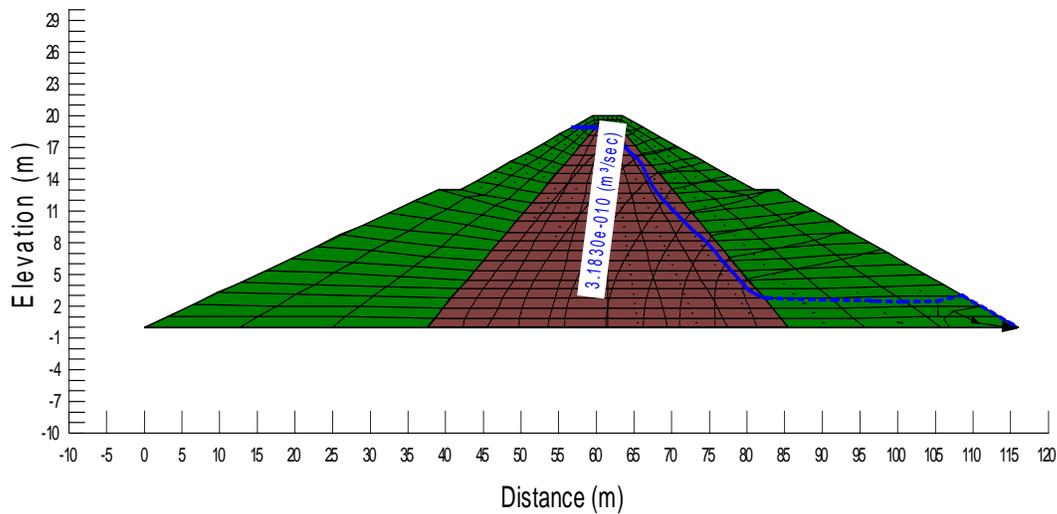
Fig 4.6: Seepage Analysis through Zoned dam

The analysis of zoned dam using SEEP/W soft ware model is differ with the other two method used above. In this case the dam is analyzed without filter drainage system and foundation seepage .However, the analysis is considered the impact of shell material with the core. The adopted parameters of the dam are 116.5m of bottom width, 4m top width and a dam height of 20m. The permeability coefficient of shell and core material has

2.34×10^{-6} & 11.2×10^{-9} cm/sec respectively. As shown from the figure the estimated quantity of seepage at center of the dam is $3.183 \times 10^{-10} \text{ m}^3/\text{sec}/\text{m}$.

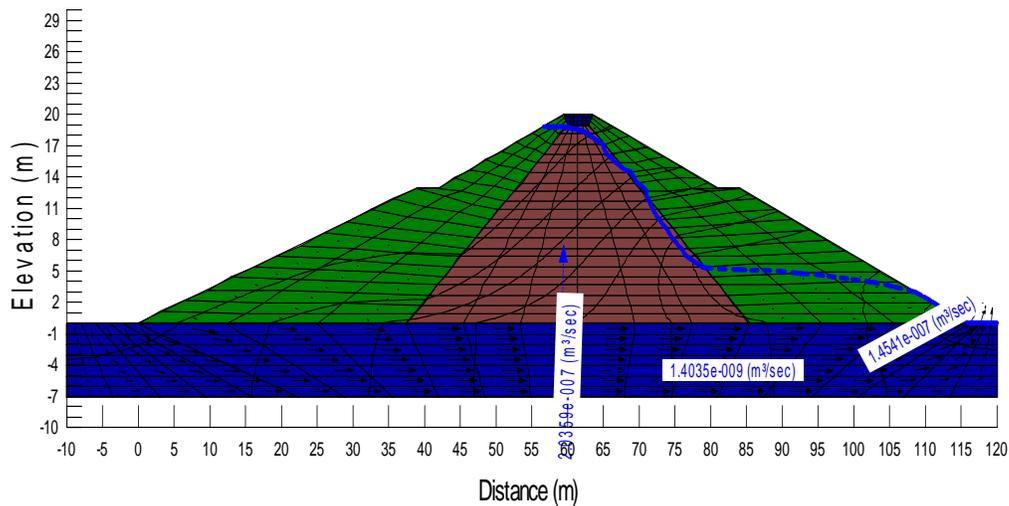
Fig 4.7: Seepage analysis through Zoned dam with foundation

For the case of zoned dam with consideration of foundation seepage using this model is shown below. The analysis considered the dam without filter drainage system. The required data are adopted from the dam design and geology report. The parameters of the dam are 116.5m of bottom width, 4m top width and dam height of 20m. In addition to this

the permeability coefficient of shell and core material are 2.34×10^{-6} & 11.2×10^{-9} cm/sec respectively. From the geology report the base rock is found at a depth of 7m and considers total longitudinal length of 130m. The coefficient of Permeability at the foundation is assumed saturated permeability. The estimated quantities of seepage at center of foundation and at the toe of the dam are $2.03 \times 10^{-8} \text{ m}^3/\text{sec}/\text{m}$ and $1.457 \times 10^{-8} \text{ m}^3/\text{sec}/\text{m}$ respectively.
