IMAGE BASED PAVEMENT CONDITION ASSESSMENT

A Thesis in Road and Transport Engineering

By Jibril Akmel Mohammed

August, 2022

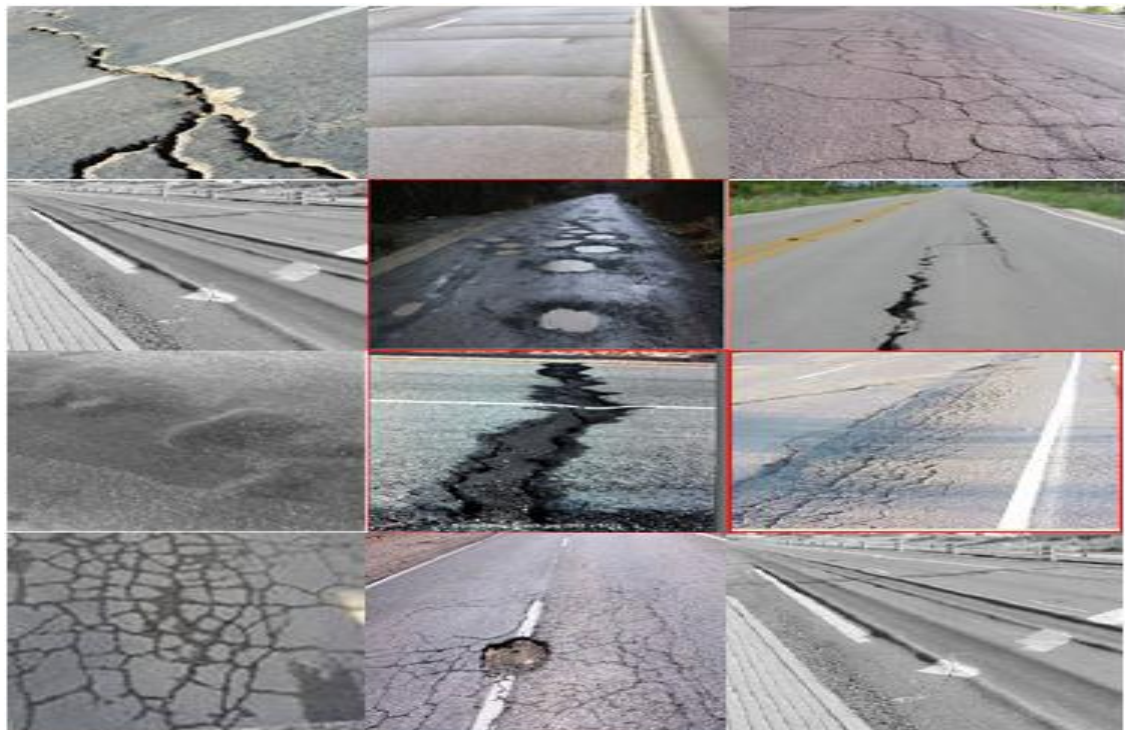
Figure 11: Flexible Pavement distresses

Here be present below, the different pavement distresses, that will be imported in to the software after calibration for analysis.

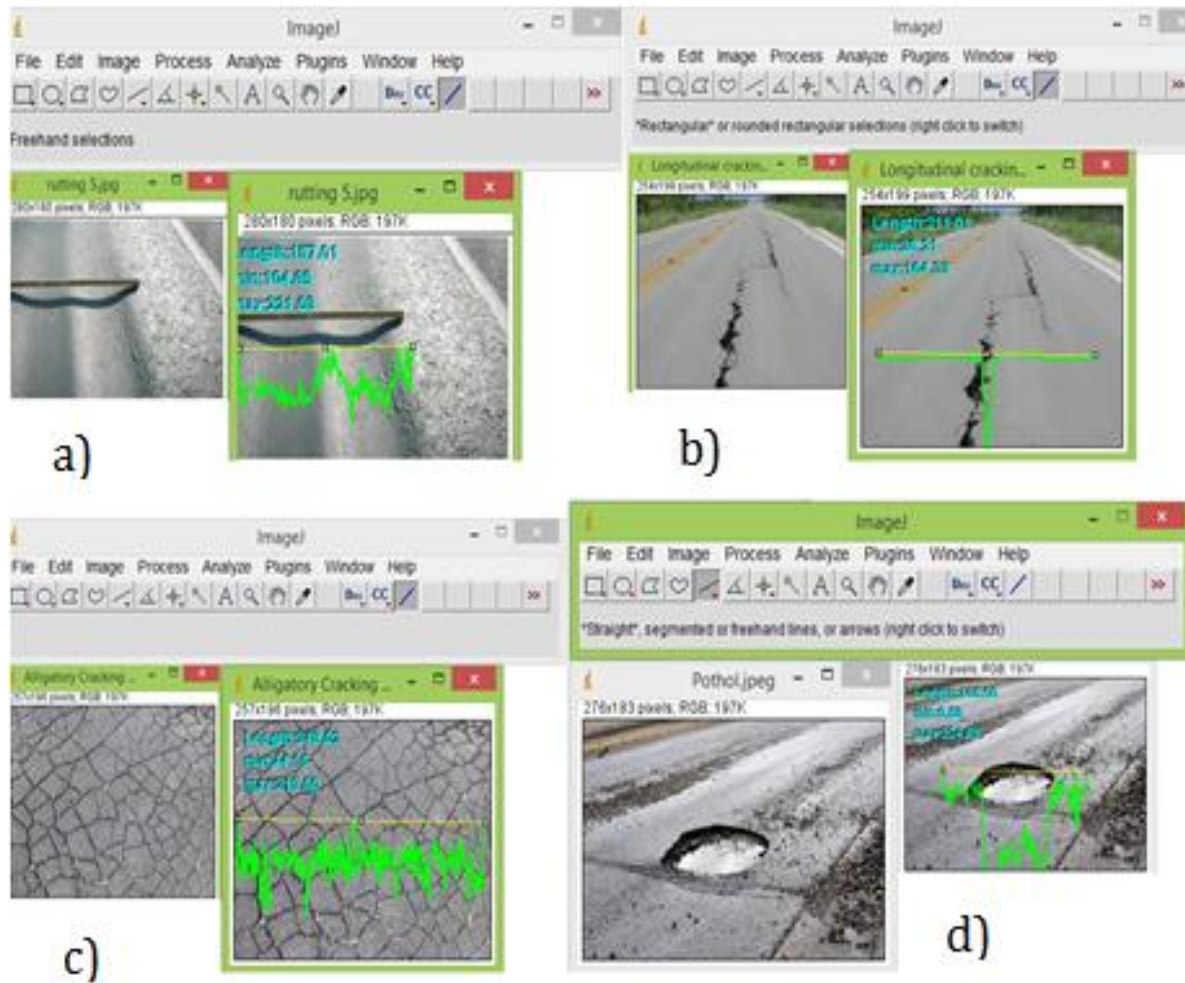
Figure 14: Distresses profile drawing tool Results: a) Rutting b) Longitudinal Cracking

Following software customization for our case in point, it is demonstrated on the aforementioned photographs that the software is able to construct corresponding profiles of the distress image for each type of pavement distress, which aids in determining the severity level and further analysis.

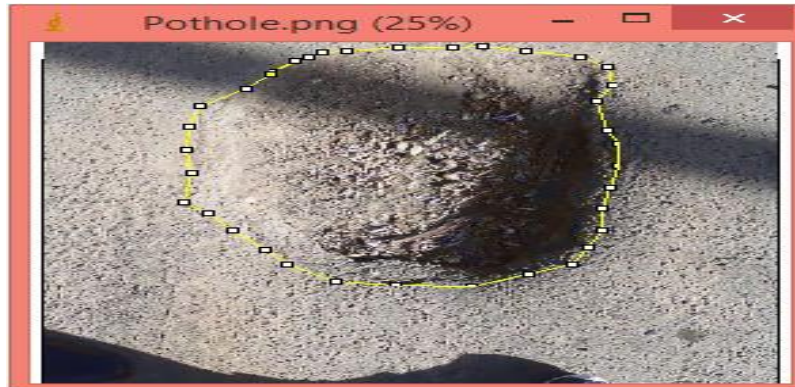
Figure 18: fitting a set of polygon border points

This section outlines the procedures needed to determine the area of a pothole. It can act like an alligator cracking if you enter the curve fit software in specific areas on a pothole's edge. In Figure 18, a spline curve is fitted using a set of points that are situated along a polygon's edge.

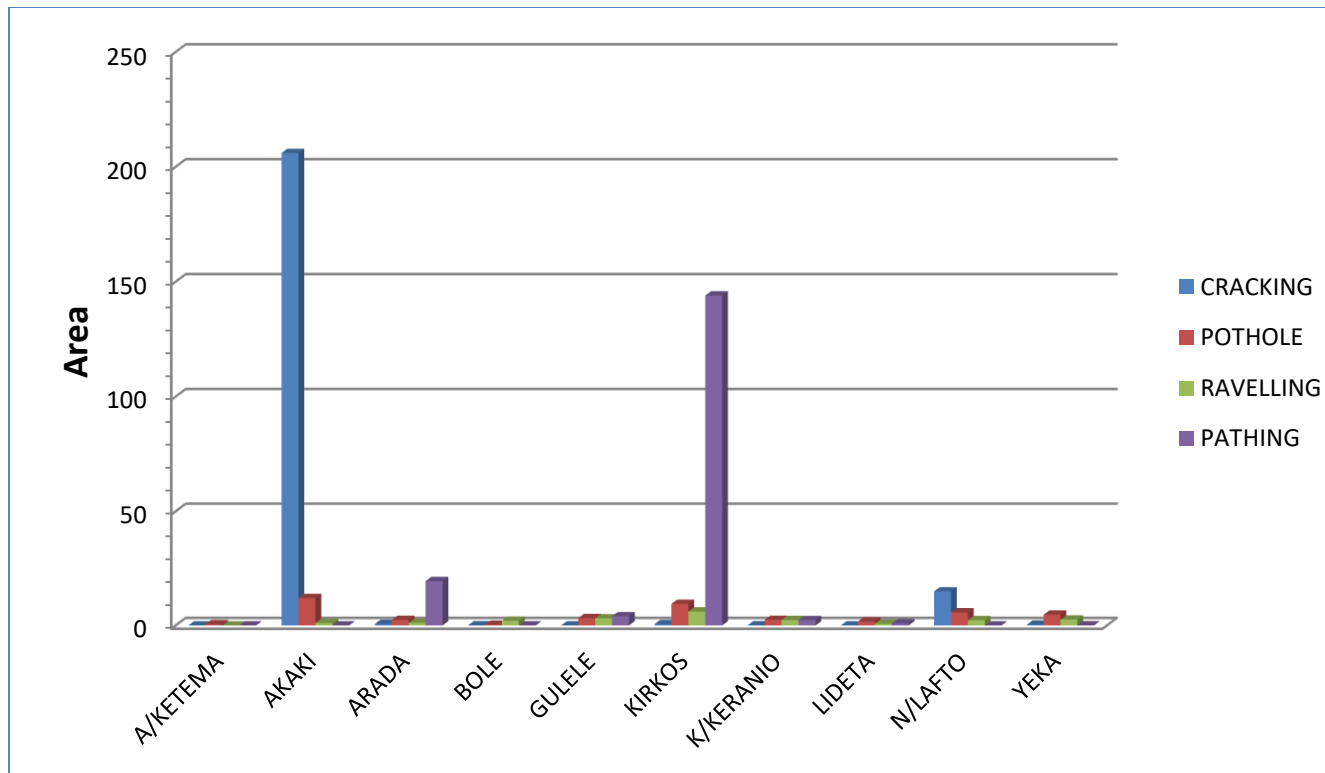
Figure 28: Distress Area Distribution on Selected Road Section

The figure below shows how the study road sections' distress areas are distributed. The areas with the most distresses were in Akaki Sub city under Derartu Tulu High School to the quality total road section, while the areas with the least distresses were in Addis Ketema Sub City with in Chew Brenda to Gulit Sefer pavement section, which was recently built when the data was collected.

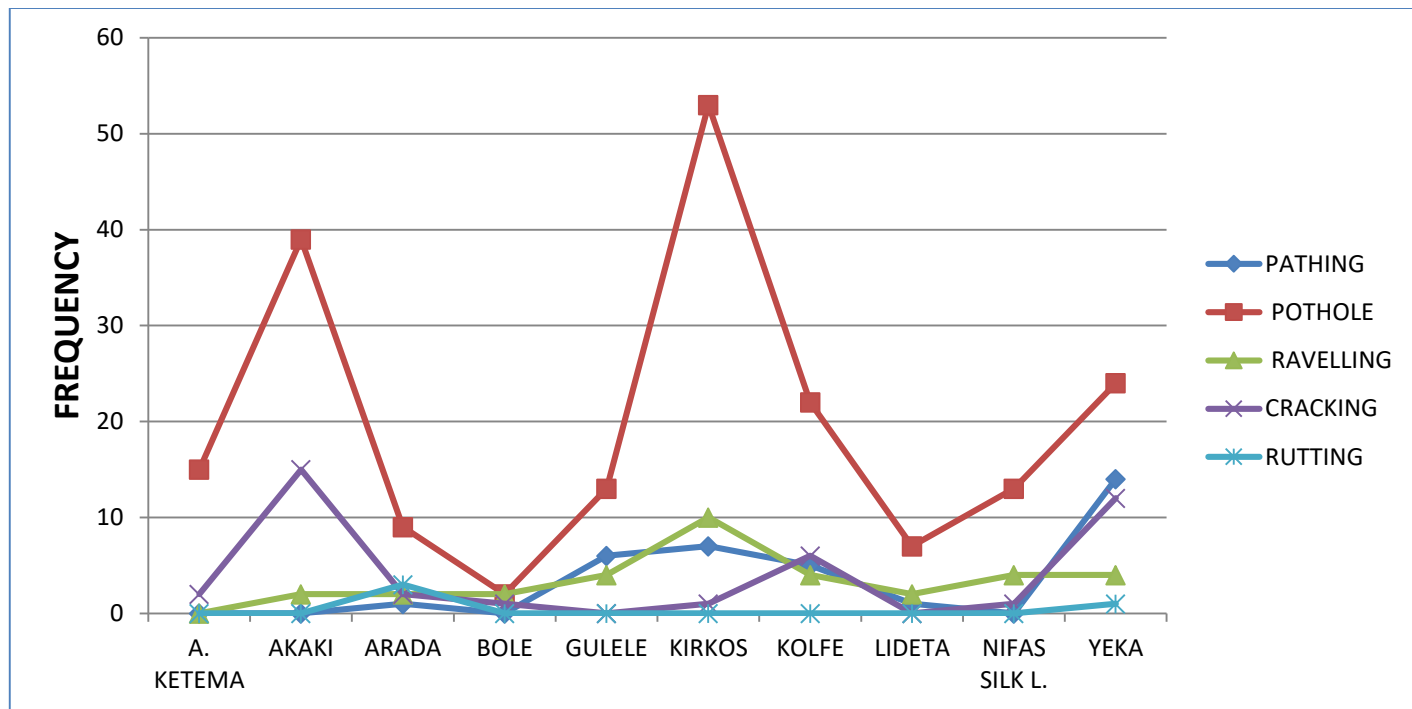
Figure 29: Distresses Frequency per Each Section

Figure 29's line graph shows how frequently pavement distresses occur throughout the study area. The red color denotes potholes with a maximum frequency, whereas the pale blue tint refers to minimum frequency distresses that indicate rutting. Which suggests that potholes caused a significant portion of the distress in the research area, possibly as a result of heavy traffic.

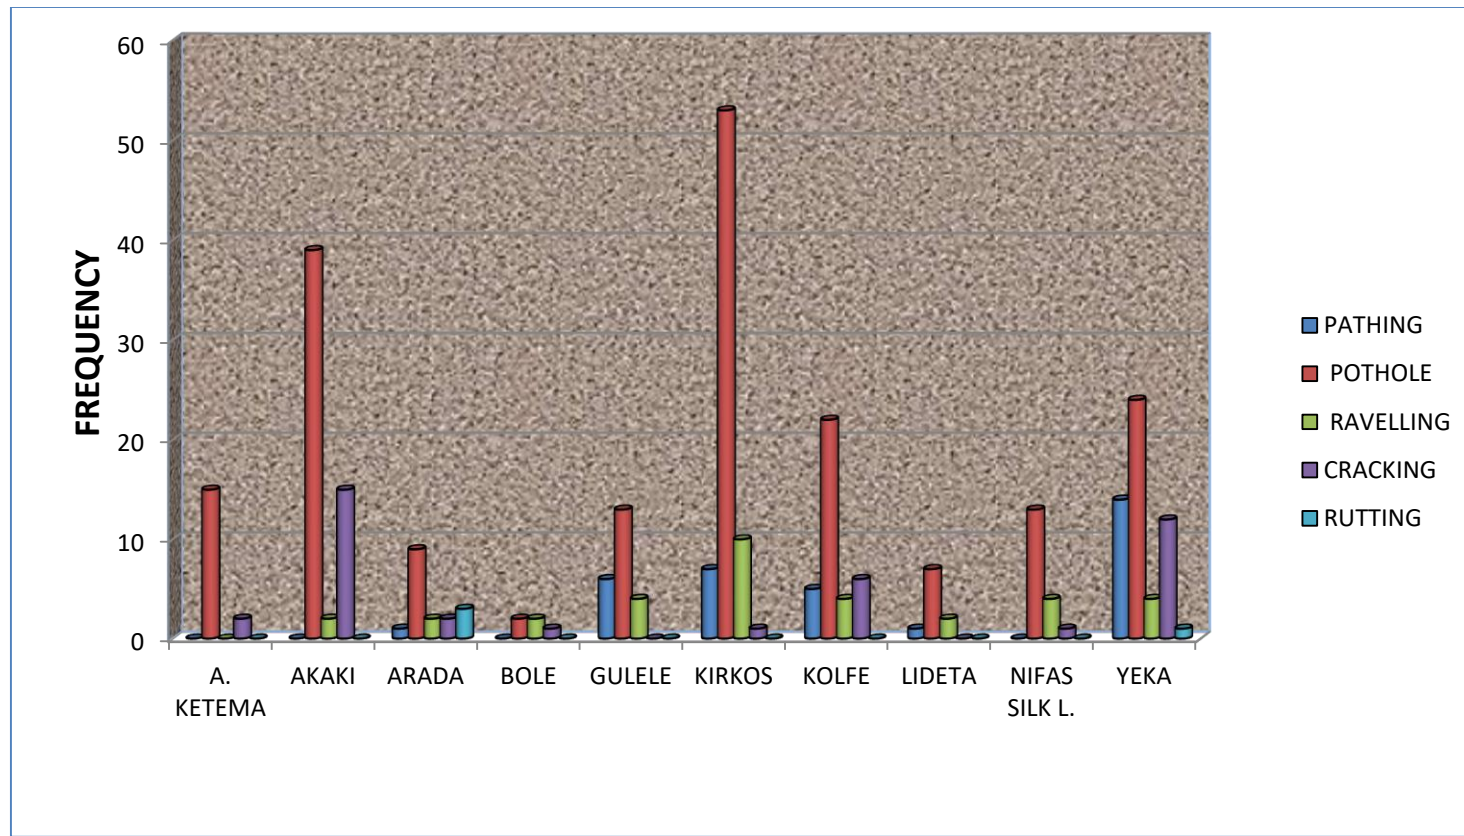
Figure 30: Pavement Distresses Distribution

The aforementioned graphic illustrates how frequently the pavement segments under consideration experience distress. The Posta Bet to Wudasse pavement segment of the Kirkos sub-city saw the highest distress on average, according to this graphic and the output described above. The lowest frequency was found in the Dinberuwa to 22 Mazoria pavement stretch of the Bole sub-city.

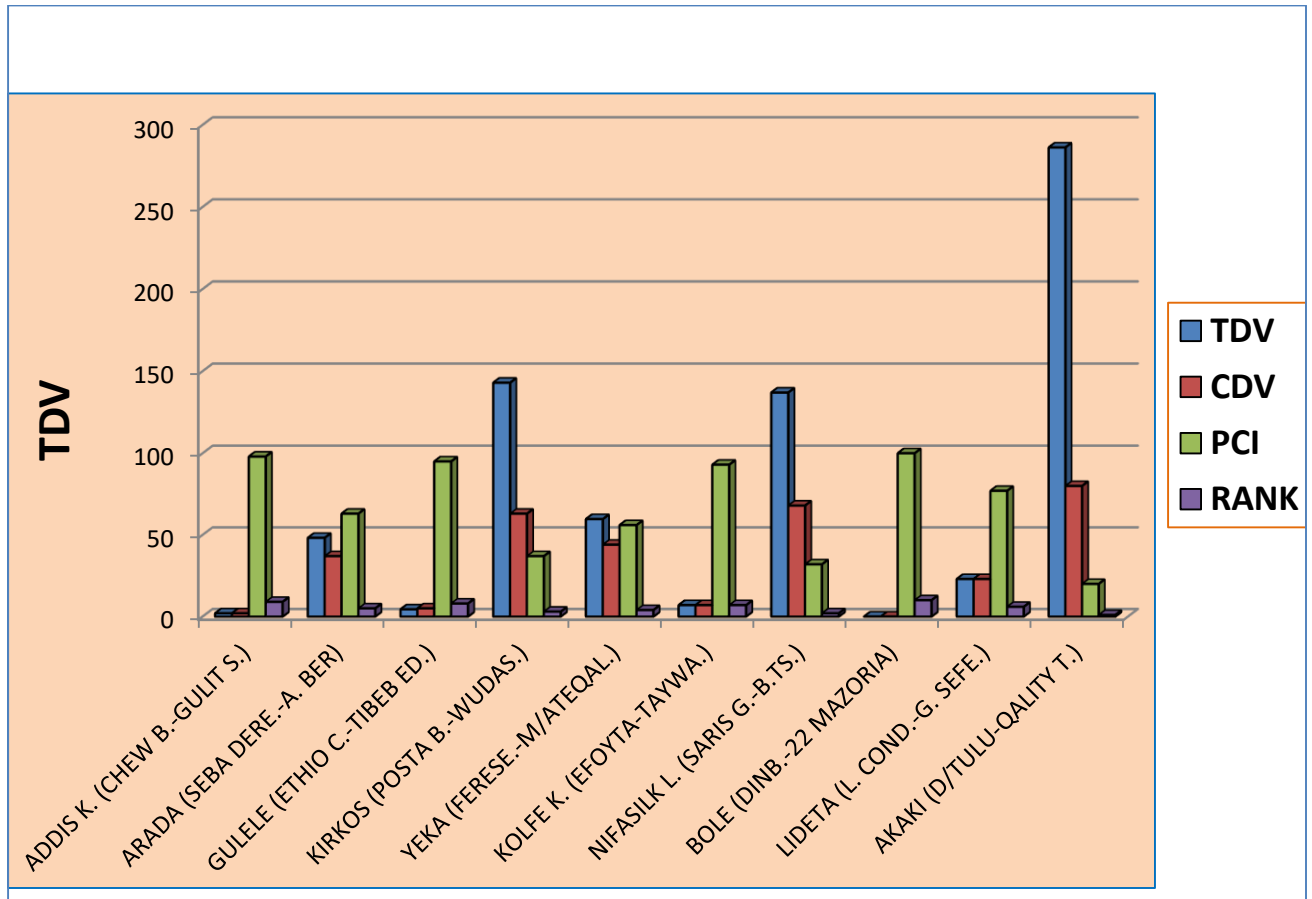
Figure 32: Summery of Pavement Results

According to the above summary of pavement distress sections, the pavement conditions in Chew Berenda, Ethiopian Clinic, Efoyta, and Dinberuwa are in a Good condition. Posta Bet and Saris Gebeya portions are in very poor condition, whereas Seba Dereja and Feresegna Sefer sections are in fair condition. Lideta Condominium section is rated satisfactorily. The school area of Derartu Tulu is now in a serious severity level. Conferring to the results of the PCI calculation, the road section that needs to be maintained first is the road from Akaki Sub City to

Tulu Dimtu Kaliti Total, and the last level is the pavement section from Dinberuwa to the 22 Mazoria in Bole Sub City.

The aforementioned bar graph shows the overall study pavement sections' calculated value, corrected computed value, pavement condition index value, and priority order of the distressed parts. Therefore, based on the results, the Derartu tulu pavement portion will receive first priority maintenance, whereas the Dinberuwa pavement section will receive last priority maintenance due to its severe pavemen condition.

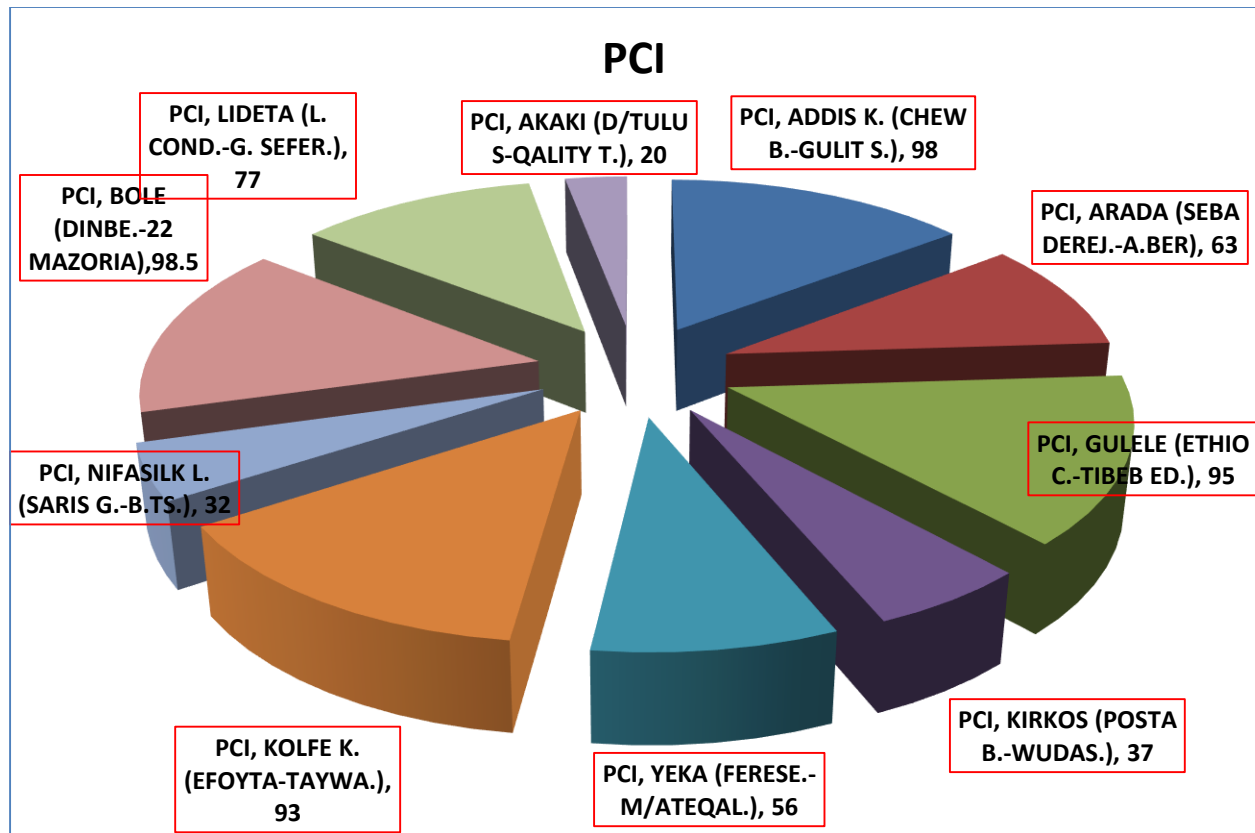
Figure 33: Pavement Condition Index Value

The final pavement condition index result for the study area is depicted in the pie chart above. The PCI value varies from 98.5 to 20, which denotes good and collapsed pavement conditions respectively.

The Pavement Condition Index Values vary from zero (pavement in degraded condition) to 100 based on the analysis's findings (perfect condition pavement). Sections with lower PCI Values had higher maintenance priorities. This PCI Value was later transformed into a priority rating scale. Each section was given a priority ranking based on the priority rating value, as shown in the table below. Akaki section Road is discovered to have the highest priority rank with the lowest priority rating value in this study, while Bole section Road has the lowest priority rank with the highest priority rating value.

The Derartu Tulu pavement part will receive first priority for maintenance due to a serious severity rating, and the Dinberuwa pavement section will receive last priority because of the pavement's good state of condition.

4. The existence of the pavement condition in question in a Critical PCI Range, such as the Feresegna Sefer Pavement Section, justifies prompt rehabilitation. If not, reconstruction is required, which will cost a lot of money.
