# **ASSESSMENT OF ROAD PAVEMENT FAILURE ALONG ADDIS ABABA-MODJO TRUNK ROAD**

**A thesis submitted to School of Civil and Environmental Engineering  
In  
Partial fulfilment of the requirements for the degree of Master of Science in  
Civil Engineering  
(Geotechnical Engineering)**

**By: Asnake Abate**

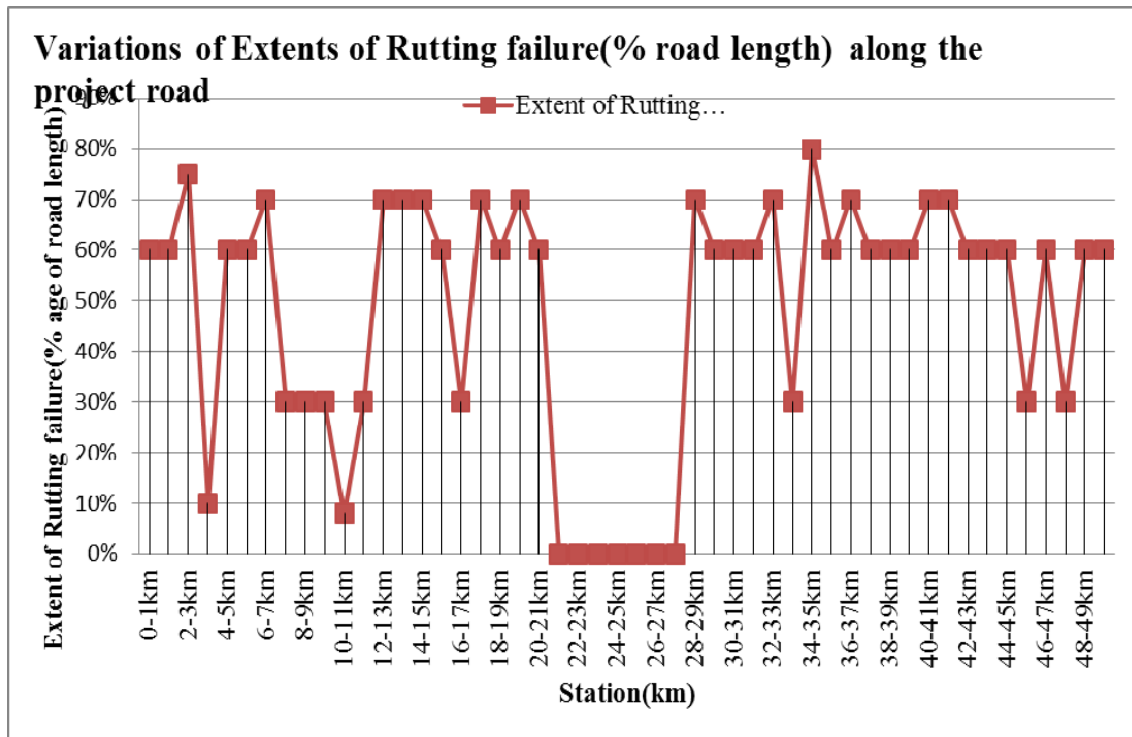
Figure 4-3. Variations of extents of rutting failure(% road length) along the project Road.

The extent of rutting failure varies along the stations of the project road as shown in Figure 4.3 below. From station 21km to station 28km, rutting were not observed. In most of the stations from 29km to the end of the project road, the severity of rutting is more than 60%. The severity of the rutting at 32-33km, 45-46km and 47-48km is observed about 30%. The stations from 0-21km experience mostly a rutting severity of above 60%. In some stations of this section, severity varies from 10%-30% as shown in Figure 4.3 below.

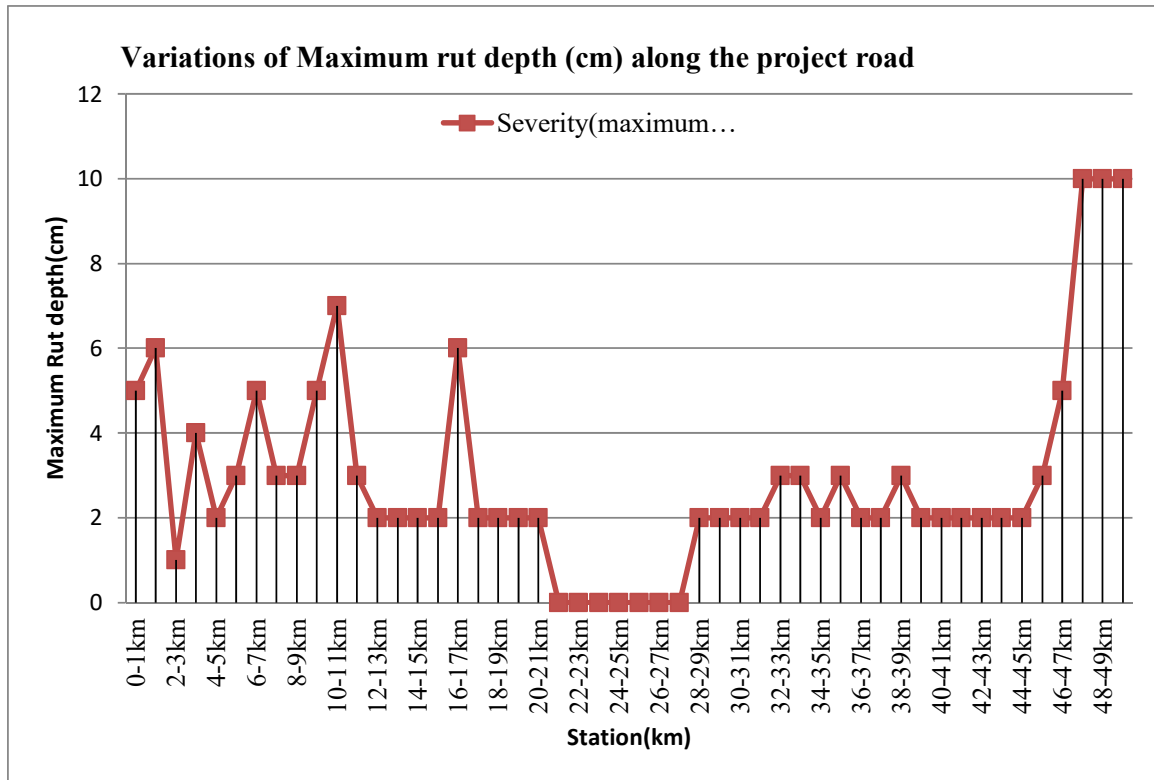
Figure 4-4: Variations of maximum Rut depth (cm) along the project road

Similarly the maximum rut depth was observed ranging from 2-6cm in most of the project road. The maximum rut depths from station 48-50km were observed about 10cm as shown in Figure 4-4 below.

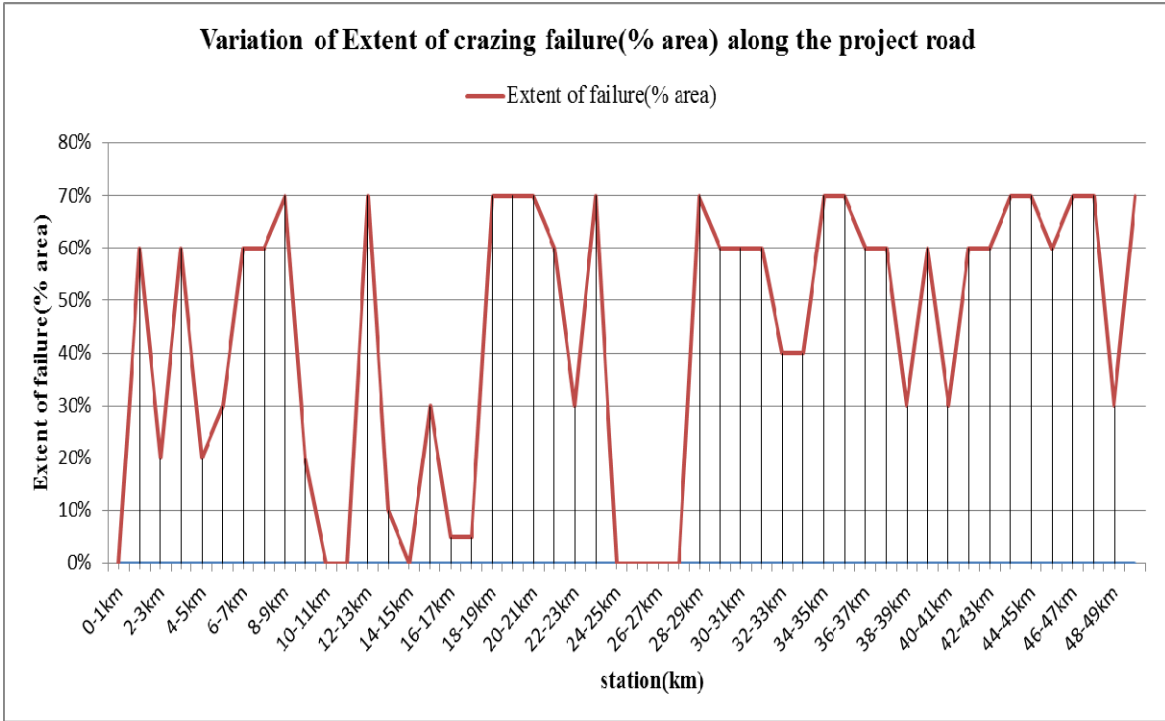
Figure 4-5: Variations of extent of crazing failure (% area) along the project road.

Extent of crazing failure varies along the project road as shown Figure 4-5 below. In most of the stations from 29km to the end of the project, the extents of crazing failure were observed more than 60%. In the rest of the project section, the extent varies from 0-70% as shown in Figure 4-5.

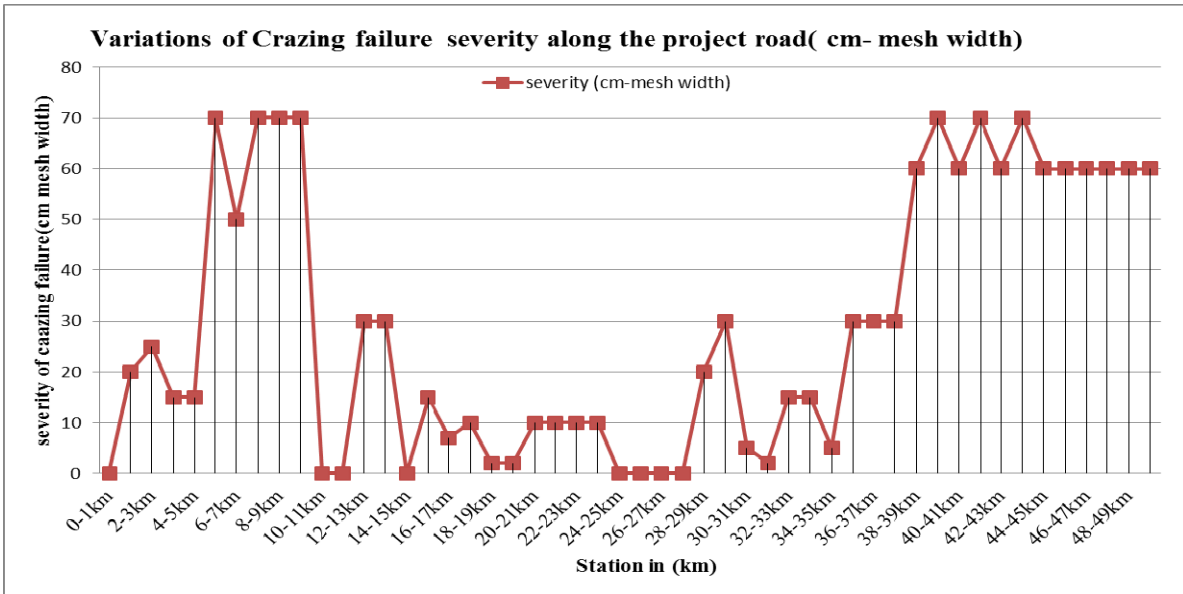
Figure 4-6: Variations of crazing failure severity along the project road (cm-mesh width)

Similarly, the severity of crazing failure ranges from 0 to 70 cm cracking mesh width as presented in figure 4-6 below. In sections from 4-10km, the severity of crazing failure is higher mostly about 70cm. In addition most of the sections 38 to the end of the road project experiences a severity of more 60cm. The sections from 10-38km have faced relatively lower severity level ranging from 0-30%.

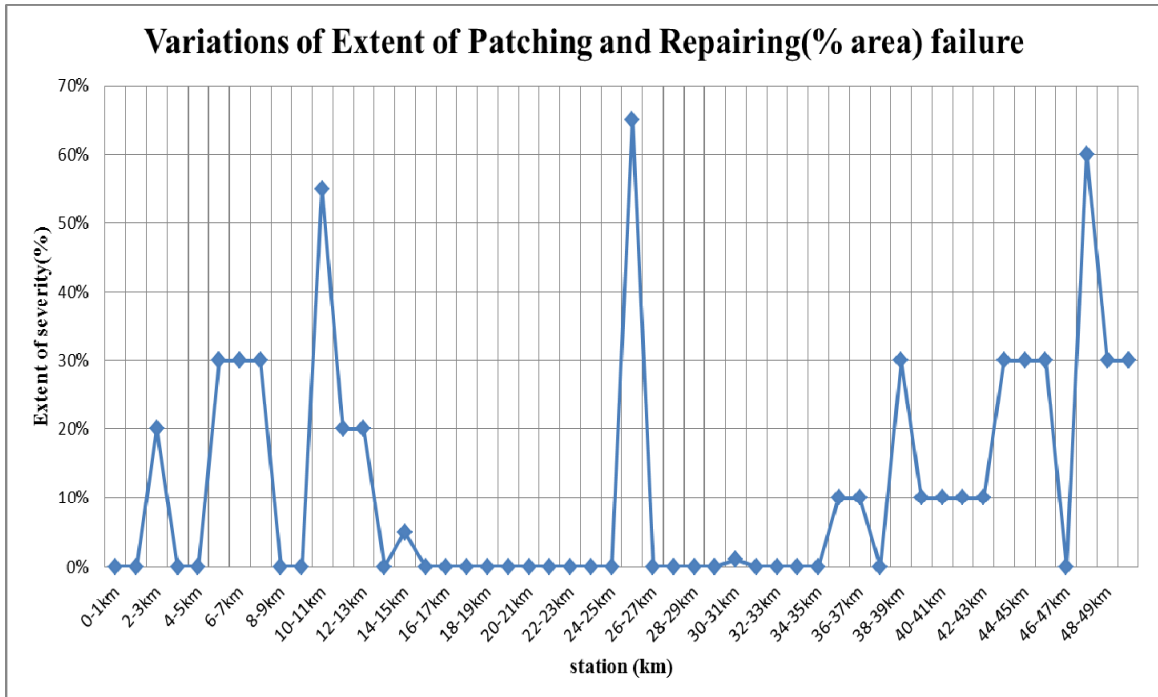
Figure 4-8: Variations of extent of patching and repairing (% area) failure along the project road.

Patching and repair were observed in the project road. Variation of extent of patching and repairing (% age area covered) were summarized as shown in Figure 4-7 below. The extent of patching and repairing failure were ranging from 0 to 30% in most of the stations of the project road. In stations from 15-35km the extent of patching and repairing failure is 0% except at 25-26km which is more than 60%.

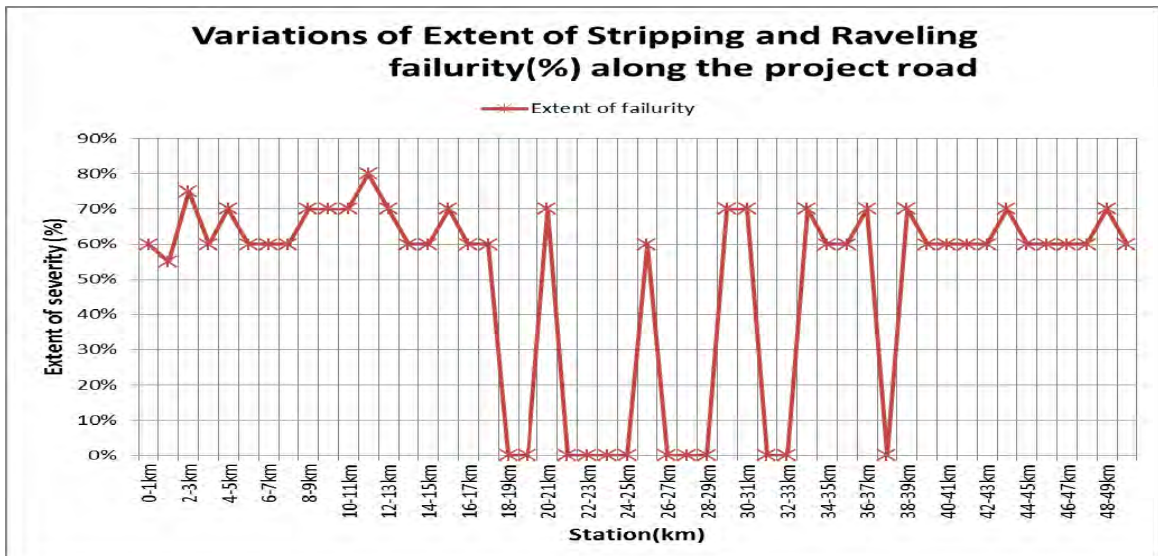
Figure 4-9: Variations of extent of stripping and raveling along the Project Road

Stripping and raveling were observed along the project road and the variations of failure along the project road were presented as shown in Figure 4-9 below. In most of the project road the extent of stripping and raveling was more than 60%. The station from 18-33km have faced relatively lower stripping and raveling failure as shown in Figure 4-9.

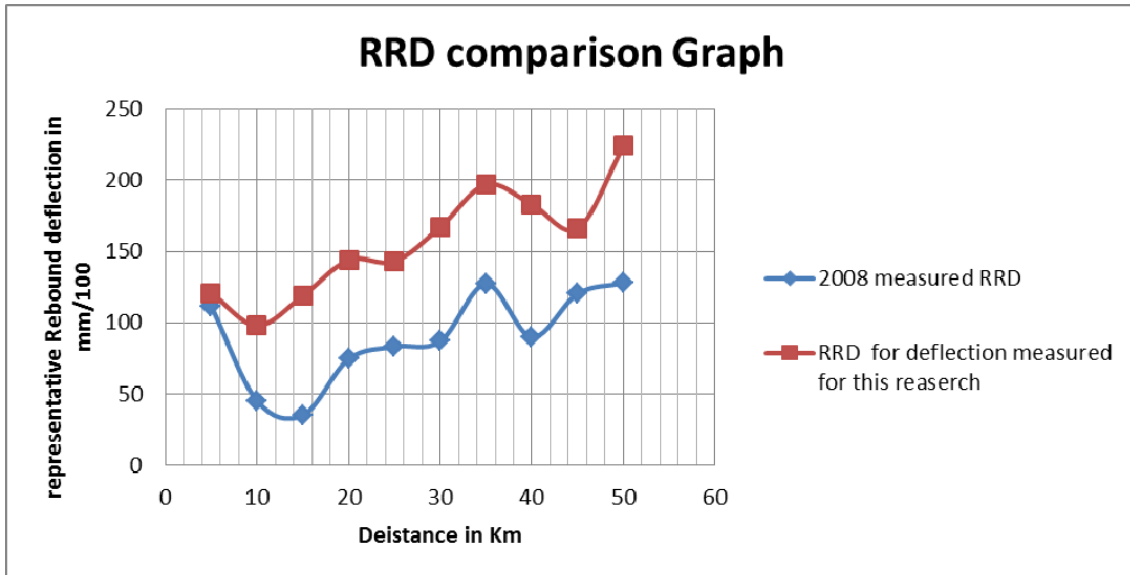
Fig. 4.11 Rebound deflection (RRD) graph

The RRD measured in September 2012 exceeds the previous existing data collected by Metaferial/Omega Consulting Engineers in 2008 as shown in Figure 4.11. This shows that the pavement structure has deteriorated more than anticipated with in the project life (i.e terminating deflection **20mm**).

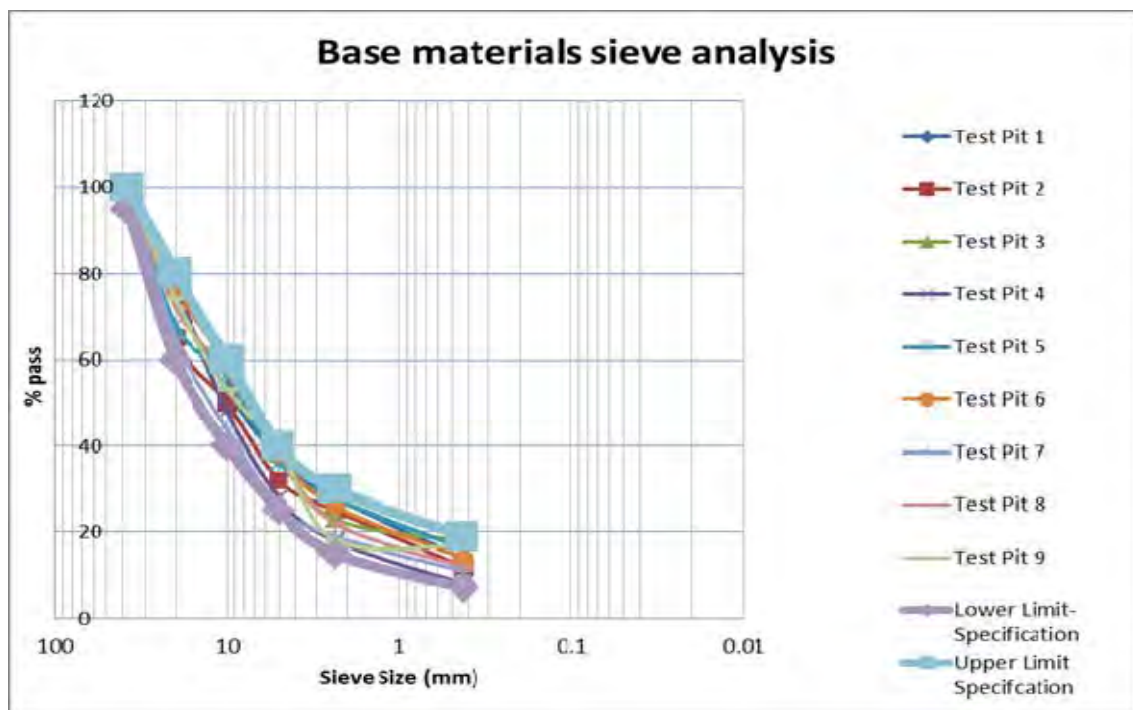
**Figure 4.13. Base course material gradation analysis**

The gradation of base course material lays with in a specification for all of the test pits as shown in Figure 4.13 and Table 4.14.

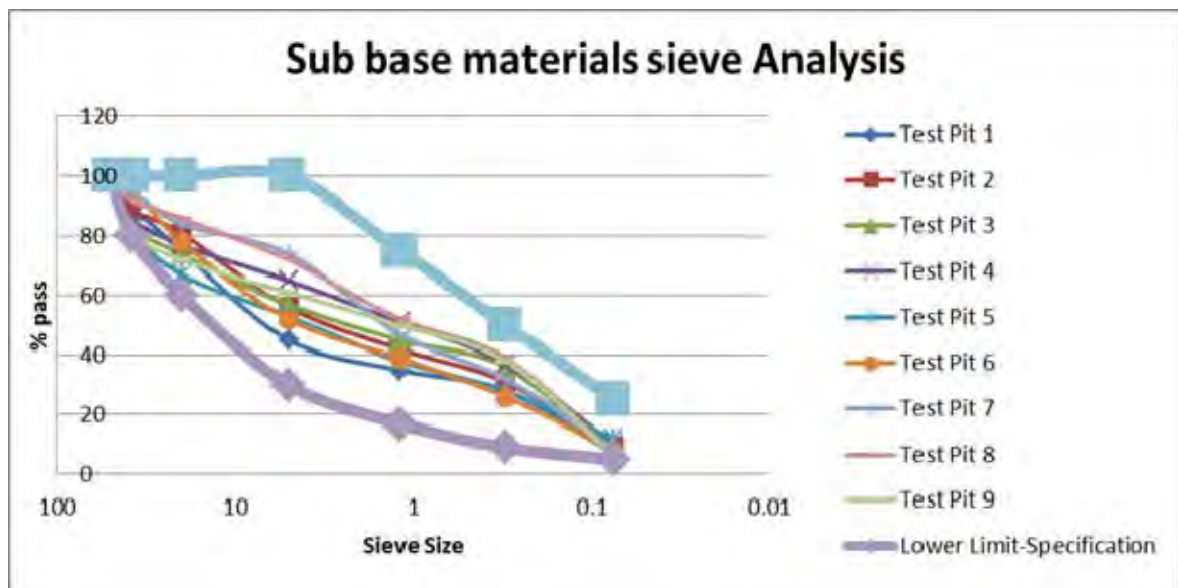
Figure 4.14. Gradation of subbase materials

The gradation of sub base materials for all test pits lays with in the specification in all sieve size as shown in Figure 4.14 and Table 4.16.

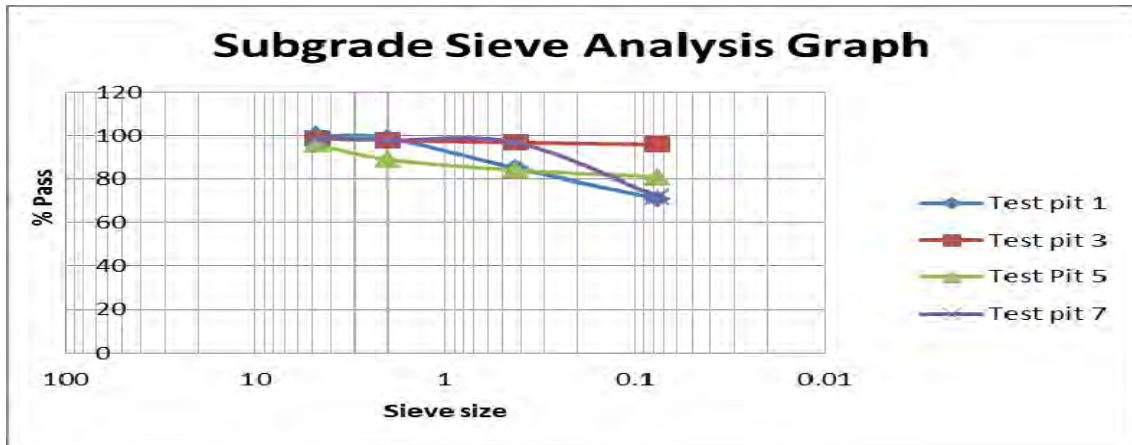
Figure 4.15 Subgrade Sieve analyses

Therefore, the rutting failures may be due to infiltration of water into the subgrade layer. Most subgrade CBR values at 95% MDD lays below 3%. This value shows that the samples are not suitable as subgrade because their CBR is less than 3%; High quality subgrade material at station 0+000 with CBR value of 42% is observed.

The gradation of subgrade materials for test pits is summarized as shown in Figure 4.15 and Table 4.18.

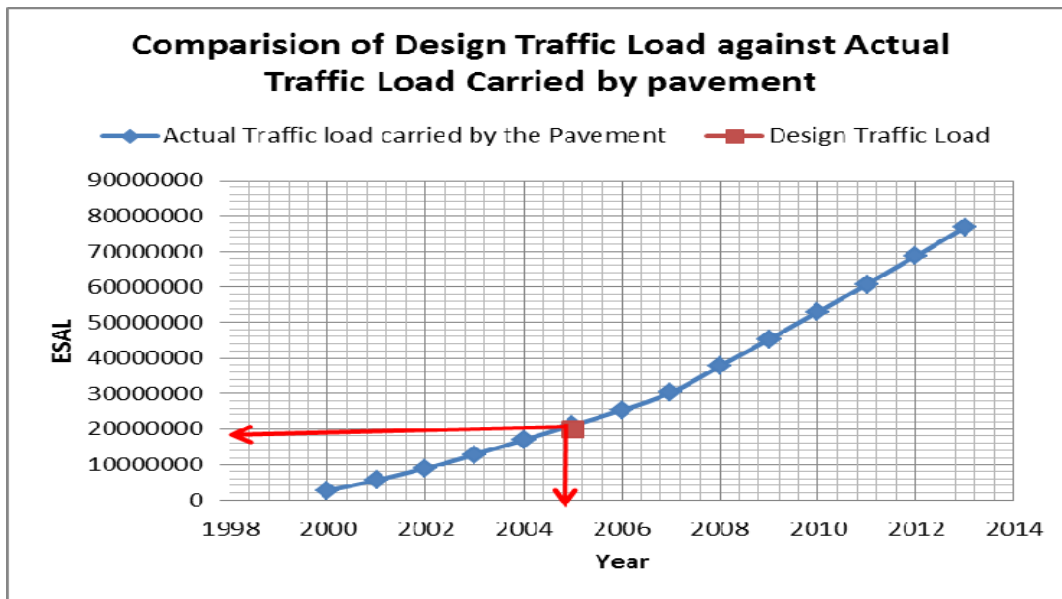
Fig 5.0 Cumulative Equivalent Standard Axle Load carried by the pavement Vs. Design Load (Debreziet-Mojo section)

In order to accommodate the traffic load from the opening date (2000 to 2013), the pavement thickness should have been designed to accommodate the correct traffic loading for safely distributing stress to the subgrade. The thickness of the existing road consists of Asphalt Concrete 100mm, Crushed stone base of 200mm and Subbase about 200mm thick milled or Cinder.

This deficit in thickness has caused the insitu subgrade to carry repeated loads, which is subsequently resulting fatigue cracking and rutting.
