LANDSLIDE ASSESSMENT AND HAZARD ZONATION IN MERSA & WURGESSA, NORTH WOLLO, ETHIOPIA

A Thesis Submitted to
The School of Graduate Studies of Addis Ababa University
In Partial Fulfillment of the Requirements for the
Degree of Master of Science in
Engineering Geology

By
Jemal Ibrahim

June 2011

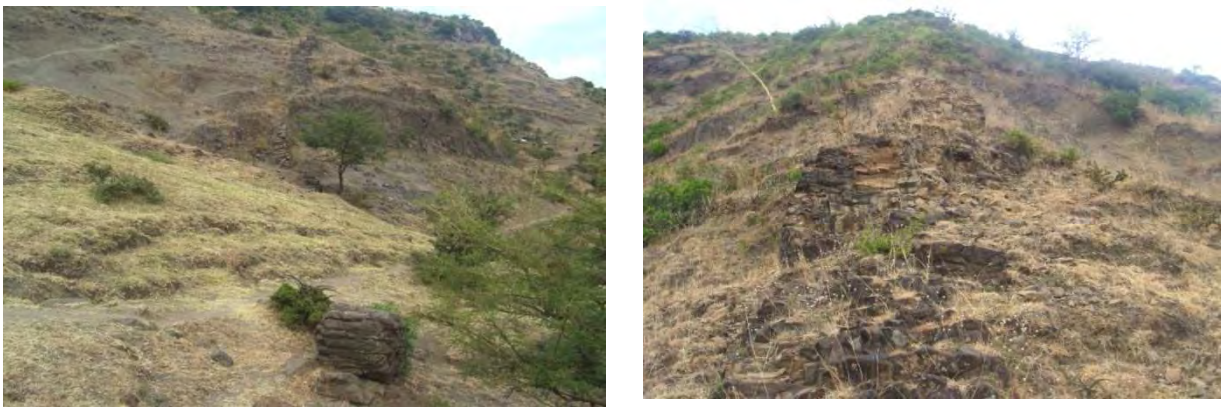
Plate 4.4 Dikes near Seblo ridge in Mersa area.

Basaltic dikes with strike orientation of NW-SE exposed near seblo ridge (Fig 4.4) and at the crossing of Birbissa stream of Mersa area and near to Gatira Giorgis of Wurgessa area. These dikes are aphanetic basalt with width 1 to 2 meter. These are weak zones which favors passage of basaltic lavas through easily.

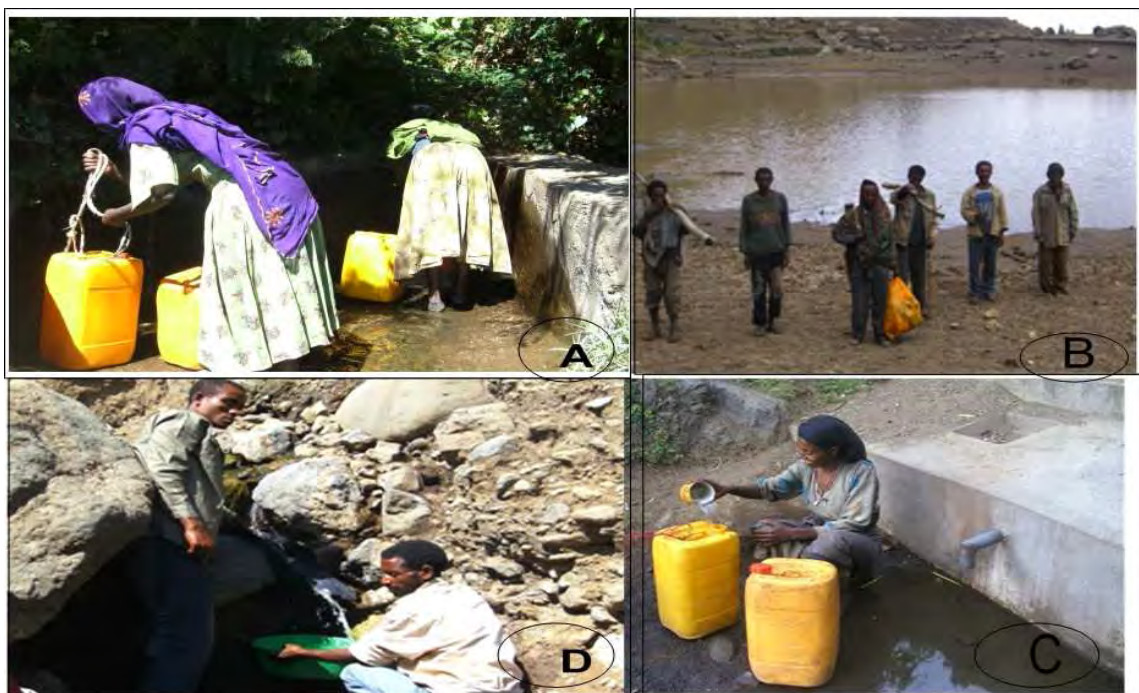
Plate 4.6 Ground water & Surface water potential Indication of the study area.

In the south – western part of Wurgessa study area there is a pond (lake) at the foot of the escarpment (Plate 4.6.B). This pond has a perimeter of 440 meter, and it has area coverage of 14,820 km², which is equivalent to a foot ball field. Depth estimation of the lake using conventional method was not possible. Due to its topography and geological setting of the area it seems that there is a relationship between this lake and the perennial streams down, however it needs some additional investigation.

The wurgessa town water supply is from the spring near Gatira Giworgis. In this area the spring called Chefa Wuha (Plate 4.6 A) has estimated discharge of 0.5 l/s at the time of spring development; however discharge measurement at this time is very difficult due to the flow of water in many directions. The spring which is called Kok Wuha, (Plate 4.6. D) and Enquirt Wuha, in Wurgessa area have estimated discharge of more than 0.5 and 0.6 l/s at the dry season respectively. These springs have very high discharge (like River) at the time of rainy season. In August 2010 kok Wuha spring has caused a translation sliding, (chapter 5, Plate 5.5) and Enquirt Wuha has caused very huge amount of debris flow (chapter 5, Plate 5.6).

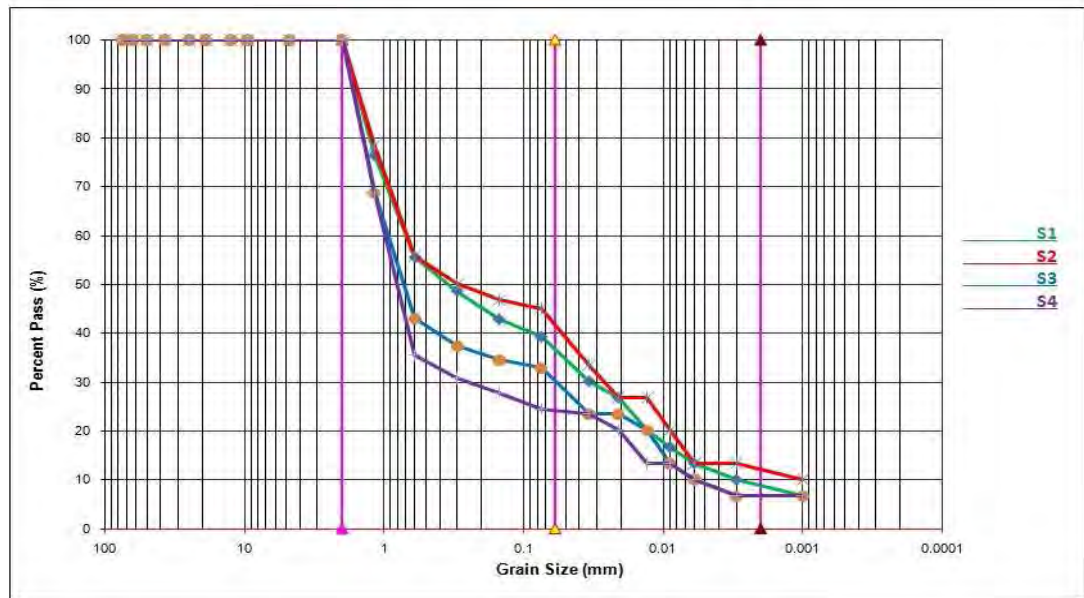
Fig 5.1 Gradation curve of the samples of the study area

The gradation test was performed on all four samples and the particle size distribution thus obtained is presented in Fig. 5.1 and Table 5.2.

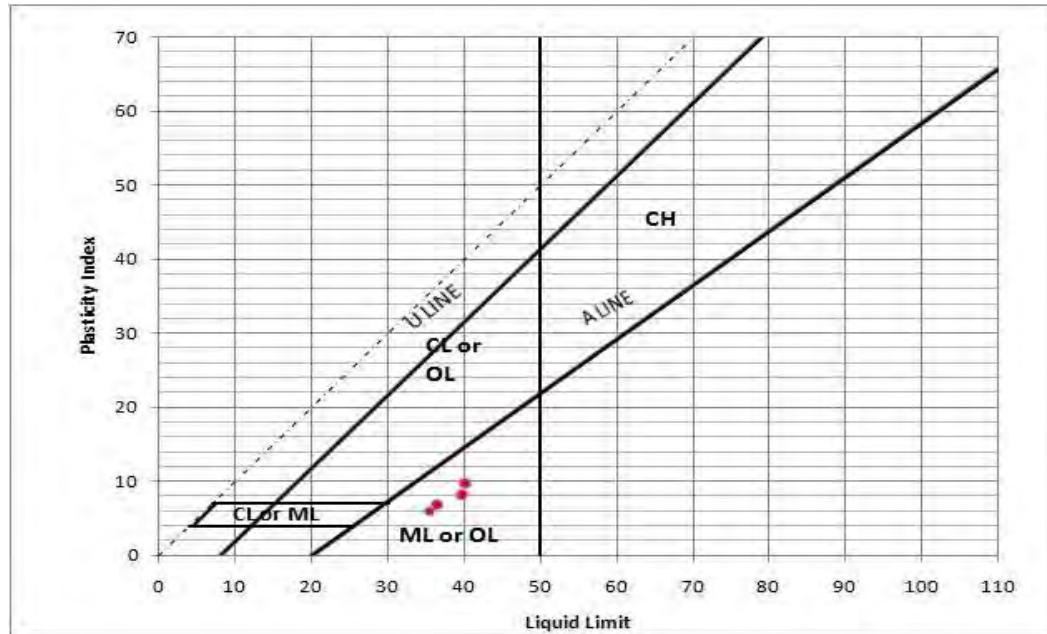
From the Atterberg limit analysis (Fig. 5.2) liquid limit vs. plasticity index has been plotted and all four samples fall below A line. Therefore, it is classified as silty sand, sand-silt mixture or (SM). These kinds of soils have high water permeability capacity. Therefore, the water which percolates through the weathered profile, when it reaches to the low permeable media, the seepage forces develops and ultimately leads to potential instability of the slope.

The plasticity index of the soils of Wurgessa area (S-No 2) is 9.74 and Mersa (S-No 3 and 4) are 6.85 and 5.94, respectively (Table 5.4). Therefore, according to the plasticity index classification system (Atkins, 2003) (Table 5.5), the soils of Wurgessa area are grouped as Moderate plastic and the soils of Mersa area as slightly plastic soils.

Fig 5.2 Plasticity chart of the samples analysed.

Therefore, it can be concluded from the above analysis that the residual soils of the area have some clay content. However, it is in small amount thus soils in general possess low cohesion, same has been deduced from the laboratory results also. From field observation at the time of the landslide in Mersa area, and from the interview of the community, the sticky clayey nature of the soil has been observed while it is moist. Moreover, the good permeability nature of the sand size soil particles, allow infiltration of water which will saturate the slope material and thus, thereby induce slope instability.

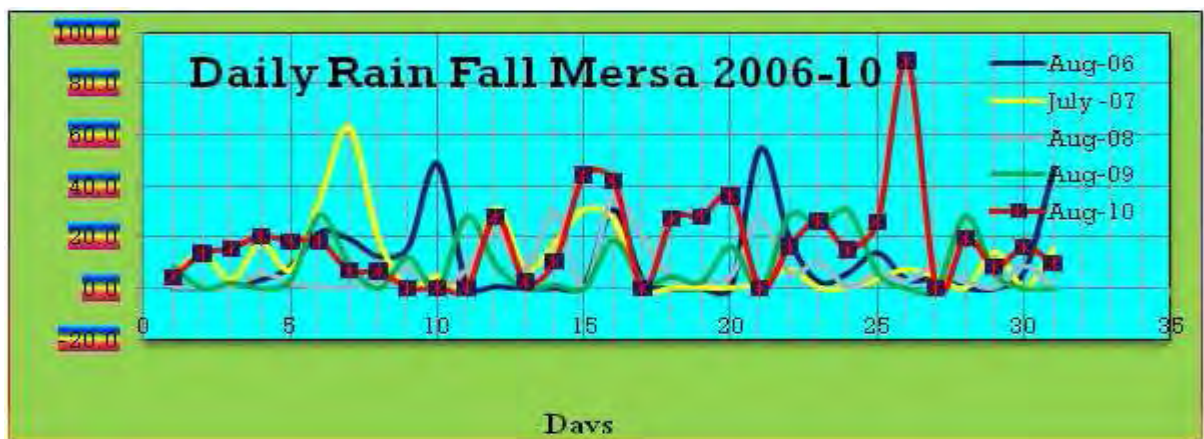
Rainfall is the main triggering factor which has initiated the landslides in the present study area. The amount of rainfall recorded in Mersa area was 871.5 mm, which is from the month of July (2010) to the end of August (2010) for total of 50 days. In proportion it is about 90% of the mean annual precipitation. The total rainfall recorded in Wurgessa area was 1038.7mm, which is from the month of July (2010) to the end of August (2010) for total 50 days. In proportion it is about 87% of mean annual precipitation.

Fig 5.4 Daily rainfall for highest month from 2006 –2010 for Mersa town

A perusal of Annexure F clearly indicates that from May 15, 2010 upto July 10, 2010, it was totally a dry period. Later from July 10, 2010 up to August 30, 2010 a total rain fall of 1038.7mm and 871.5mm was recorded in Wurgessa and Mersa area, respectively.

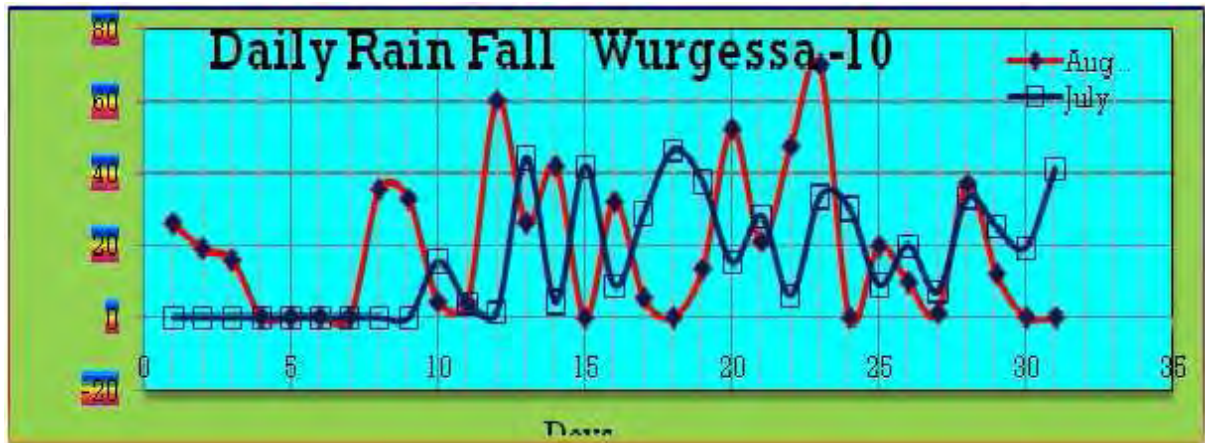
Fig 5.5 Daily rainfall for the month of July and August 2010 of Wurgessa

As it is previously discussed, the rainfall amount recorded in the month of August, 2010 was 587.2 mm and 546.9mm for Wurgessa and Mersa area, respectively. From this, it can be concluded that the monthly rainfall of August, 2010, was the maximum recorded precipitation for the last 44 years. This clearly shows that, the high amount of rainfall which has fallen was the major triggering factor for slope failures/ instability in the study area.

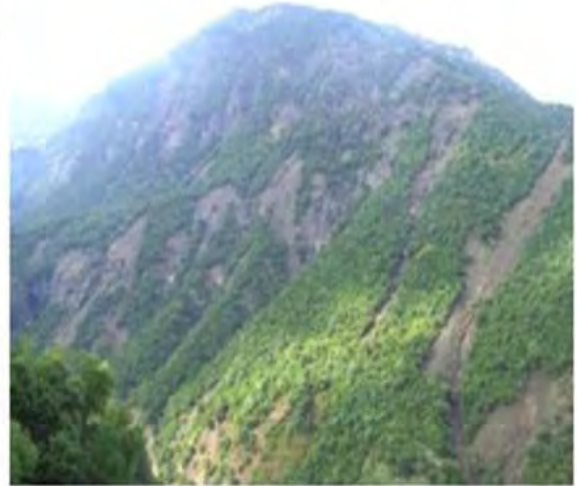
The slope instability in association with alluvial deposit of the study area concentrated where there are streams. In the study area stream toe and bank erosion was observed (Plate 5.2 D and Plate 5.10) where streams has steeply cut the slope and made it susceptible to failure.

Plate 5.11 stream bank erosion (Wurgessa)

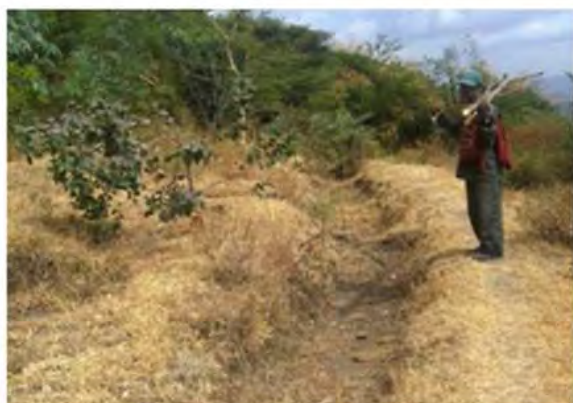
More than 50% of the present mountainous parts of the study area are covered with drainage ditches (Plate 5.12) which has average dimension of 0.5 – 1 m depth, 1 to 3 meter length and 1 m width. These ditches were constructed intentionally by spending many resources in collaboration with government, nongovernmental organizations and the community for the purpose of flood control and soil harvesting.

Plate 5.12 Drainage Ditches in the upper slope of the Main Landslide

Further, 38% of Mersa and 10% of Wurgessa area is covered with drainage ditches. These drainage ditches (Plate 5.12) were dug by the local community in collaboration with governmental and non-governmental organizations for flood protection and soil harvesting. These drainage ditches are used as temporary storage of water for continuous supply through structural discontinuities. Therefore, the contribution of these drainage ditches has been considered as one of the important factor in causing instability through ground water recharging.

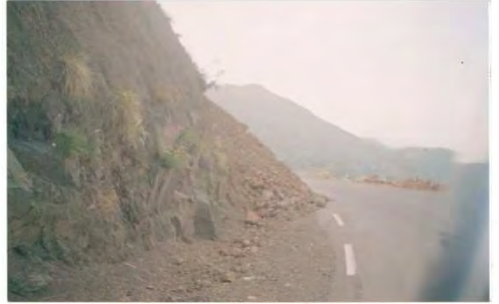
<p>Rock falls / Soil falls</p> <p>Rock falls/ Soil falls is not dominant types of landslide in the study area. However this type of slide observed at very steeply cut natural and artificial slopes of the study area, at a place called Nini-Ber near the study area</p>

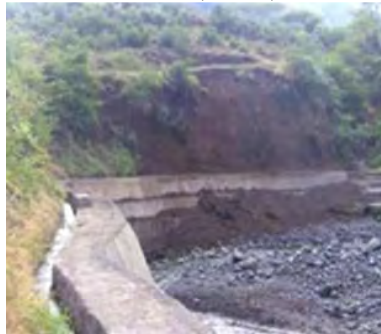
(d) Irrigation canal affected by the landslide (Mersa).

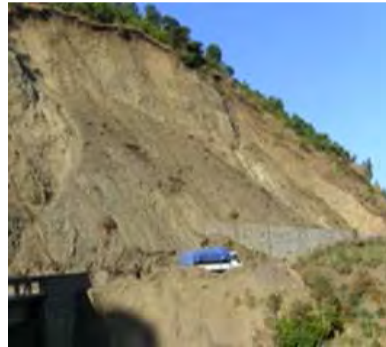
(e) Retaining wall affected by the landslide at the main bridge of Golo River (Wurgessa).

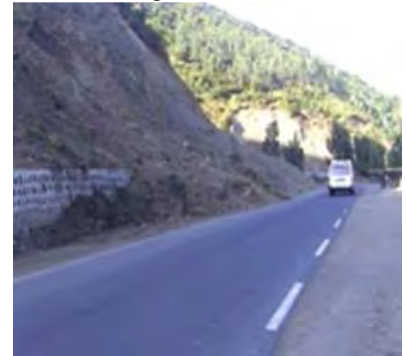
(f) Retaining wall affected by the landslide (Wurgessa).

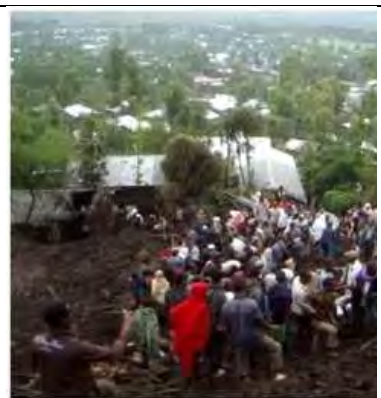
(g) Local residents are searching for bodies buried in Mersa.

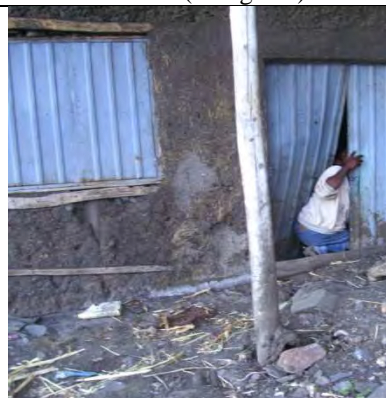
(h) Partially buried house by Debris flow in Wurgessa.

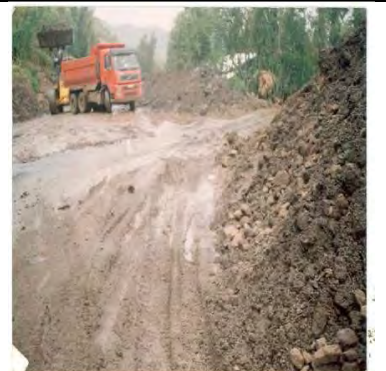
(k) The road affected by debris flow

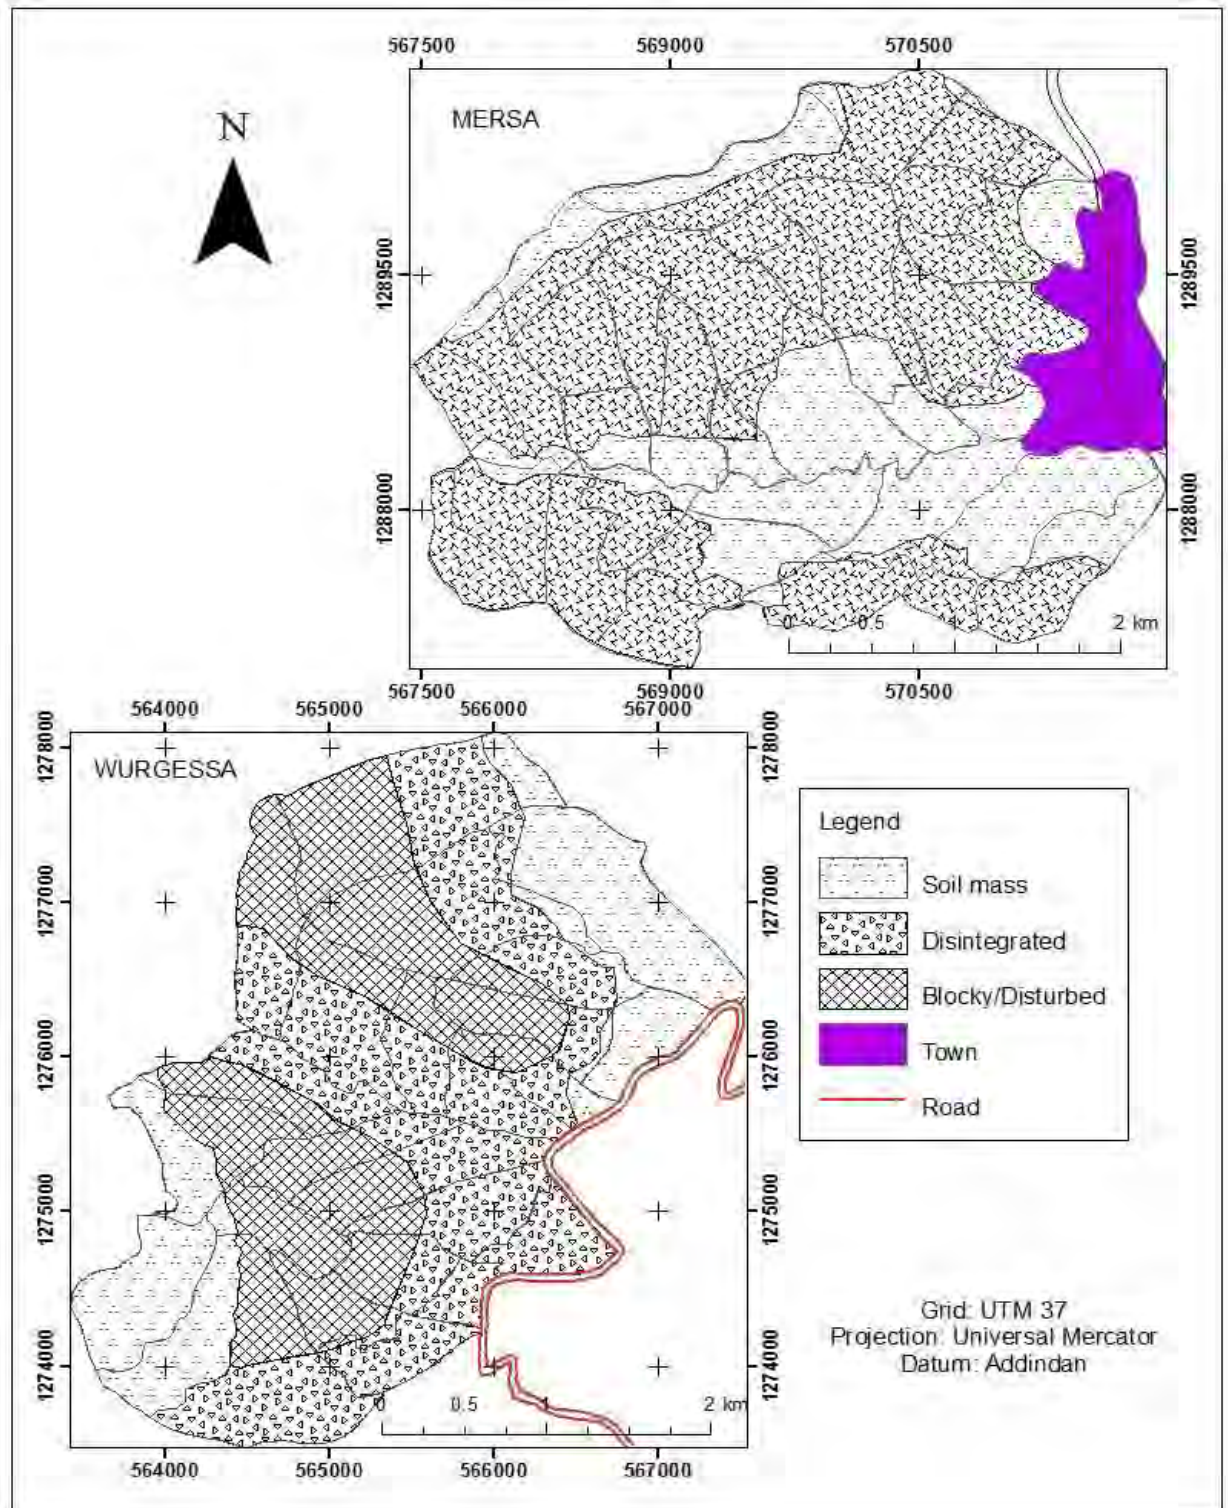
Fig 6.12 Slope material as rainfall parameter

A perusal of Fig.6.12 shows that in Mersa area 64% of the slope material is disintegrated rock mass whereas about 36% of the area is soil mass. In Wugesssa area 43% of the slope material is disintegrated rock mass, 31% is soil mass, and 26% is blocky /disturbed rock mass.

In general in the study area, rocks are highly weathered, disintegrated, closely fractured and faulted. As a result much of the rain water may infiltrate into the slope mass and may induce significant instability to the slope mass.

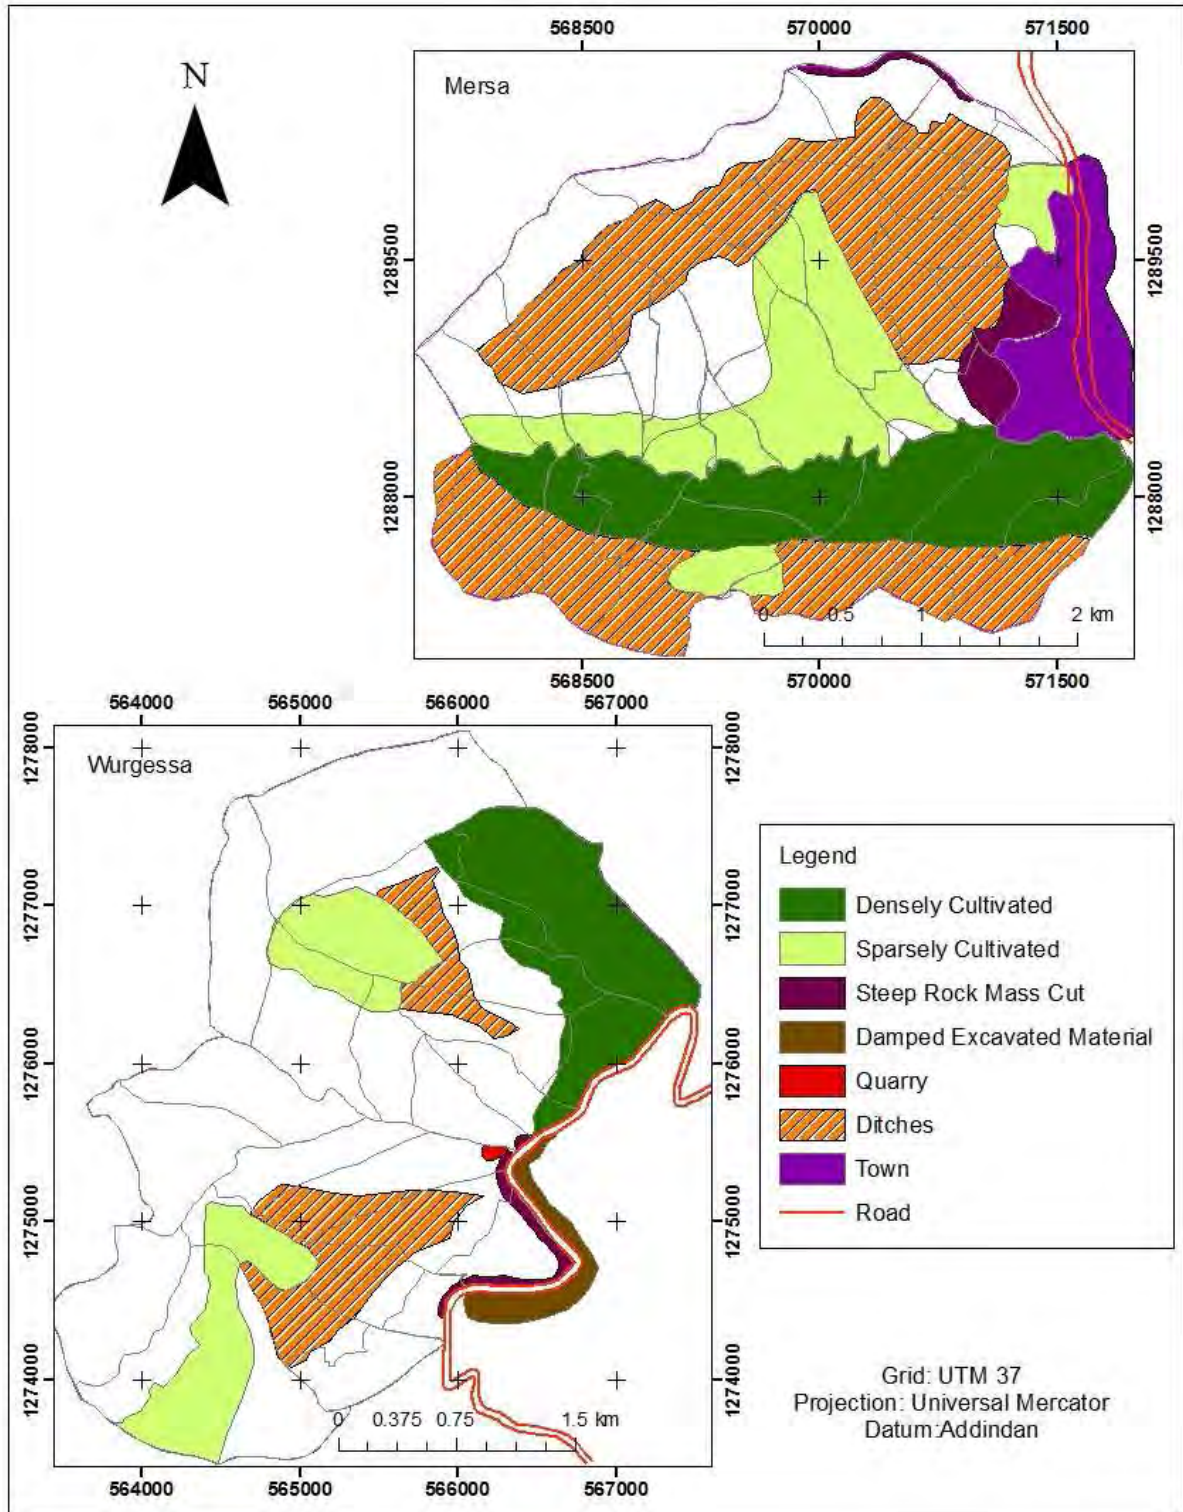
Fig 6.13 Manmade activities of the study area

The developmental activities has resulted into steep slope cuttings which has made many slopes to overhang and thus, more prone for landslide activities. The cultivation practices over the slopes have also an impact on slope instability. Unplanned irrigation practices over the slopes makes slope mass recharge and which may result into reduction of shear strength of the soil mass, besides pore water pressures may also develop within the soil mass. Thus, ultimately leading the soil mass to fail provided other causative factors also favor the sliding.

The manmade activities being practiced in the study area is shown through (Fig. 6.13). A perusal of this map shows that in Mersa area 19% of the area is covered by dense cultivation, 18 % by sparse cultivation, 39% by ditches and 0.8% by steep rock mass cut for construction activities. Similarly, in Wurgessa area 13% of the area is covered by dense cultivation, 23% by moderate cultivation 12% by sparse cultivation, 12% by ditches, 0.9% by steep rock mass cut for construction activities, 2% by dumped excavated material and quarry. Thus, accordingly ratings were assigned to each of the slope facets from the standard Table 3.2. While assigning ratings for developmental activities adjustment factors such as; slope toe support by retaining structures, provision of proper drainage system, slope face dressing in to terrace design and dumping of the excavated material down the slope were also considered (Fig. 6.13; Annexure A).

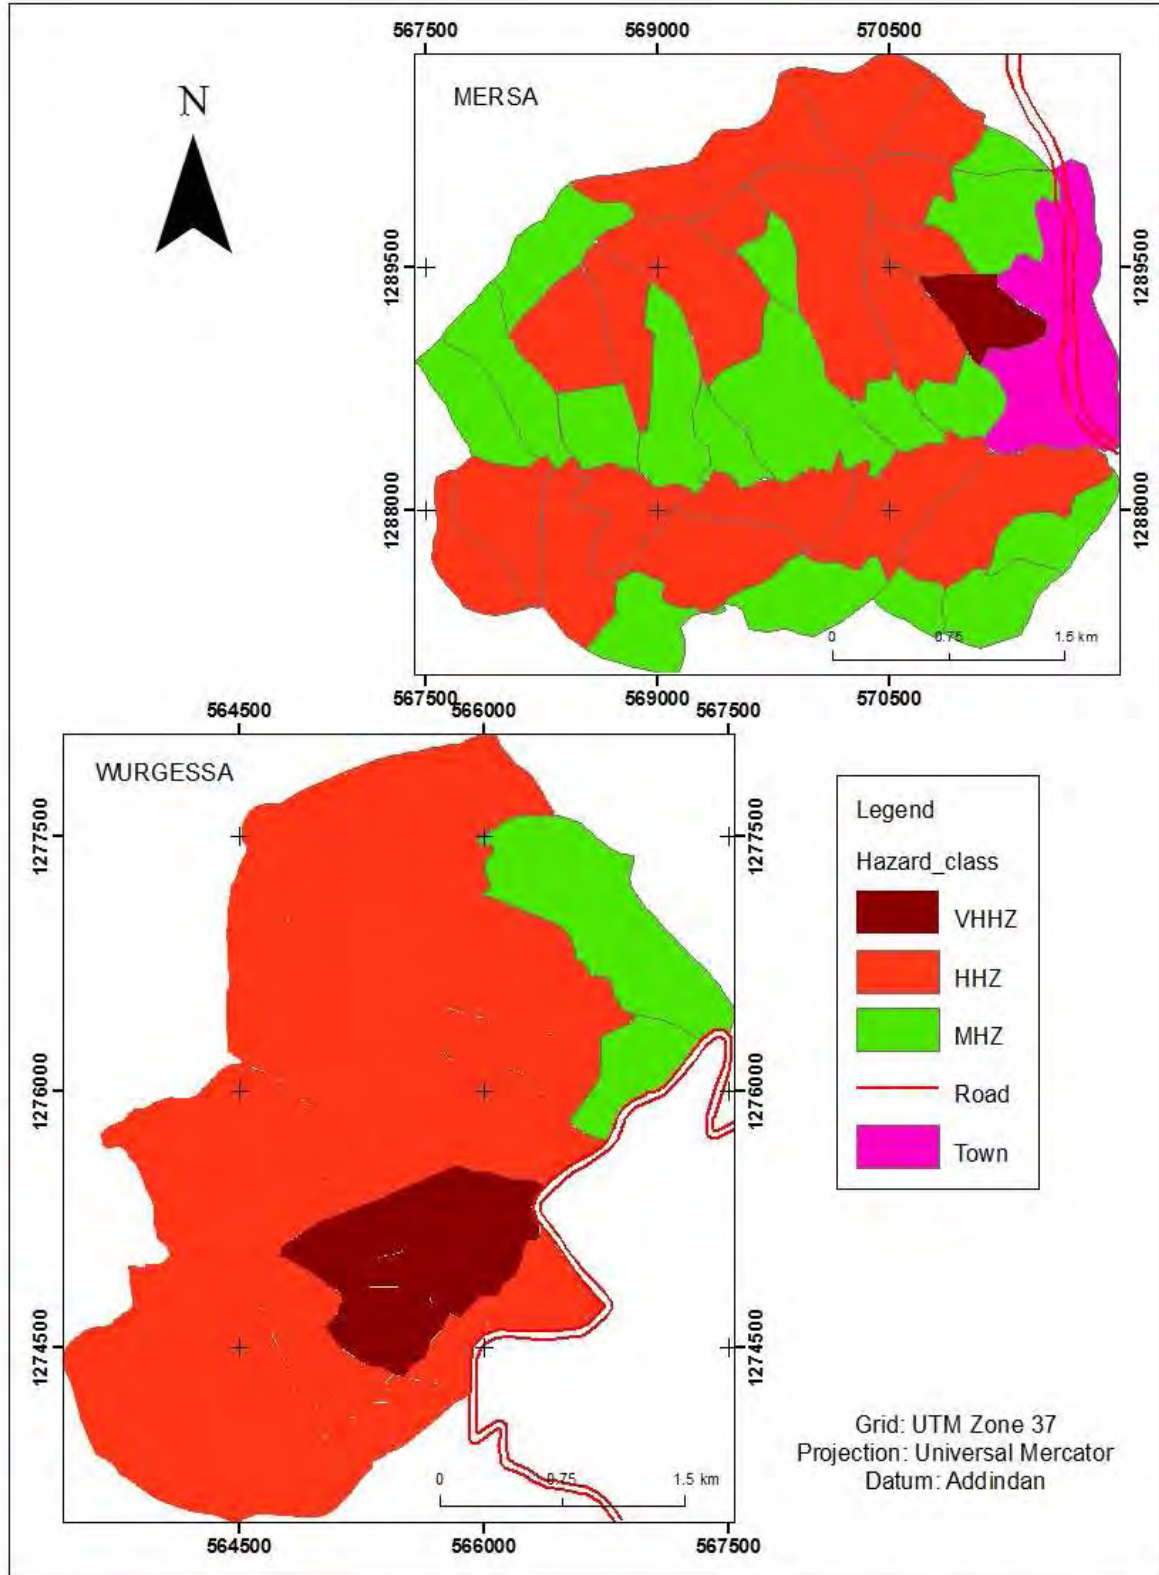
Fig 6.15 Landslide hazard zonation map of the study area

Landslide hazard zonation map of the study area has been prepared from the distribution of the total value of the slope stability susceptibility evaluation parameters facet wise. For these facet wise ratings, all intrinsic and triggering parameters were summed up and accordingly various landslide hazard zones in the study area were delineated (Annexure A). Accordingly, the study area has been classified into three major classes; Very High hazard zone, High hazard zone and moderately hazard zone (Fig. 6.15; Table 6.1). A perusal of Fig. 6.15 clearly shows that very low hazard and low hazard zones are not present in the study area.

Out of the total evaluated facets four facets fall in very high hazard zone. Among these, three facets fall in Wurgessa and one in Mersa area. In Mersa area only 2% (with area coverage of 253,319 m²) of the total area is covered by very high hazard zone whereas, in Wurgessa area

it covers 10% (with total coverage area of 1,116,322 m²) of the total area. In Mersa area very high and high hazard zone is located close to the Mersa town and left bank of Birbisa stream whereas, in Wurgessa it is located in the central portion, just adjacent to Dessie - Woldiya main asphalt road.

Majority of the study area falls into high hazard zone. In Mersa area 51% (with total coverage area of 6,847,750 m²) of the total area, is covered by high hazard zone whereas, in Wurgessa area it covers 81% (with total coverage area of 8,821,012.6 m²) of the total area. The high hazard zones in the study area generally are characterized by steep slopes and significant groundwater surface traces.

In Mersa area 39% (with total coverage area of 4,557,916 m²) of the total area is covered by moderate hazard zone whereas, in Wurgessa area it covers 11% (with total coverage area of 1,162,277m²) of the total area. The moderate hazard zones in the study area are generally characterized by relatively gentler slopes with dry to low groundwater surface traces.

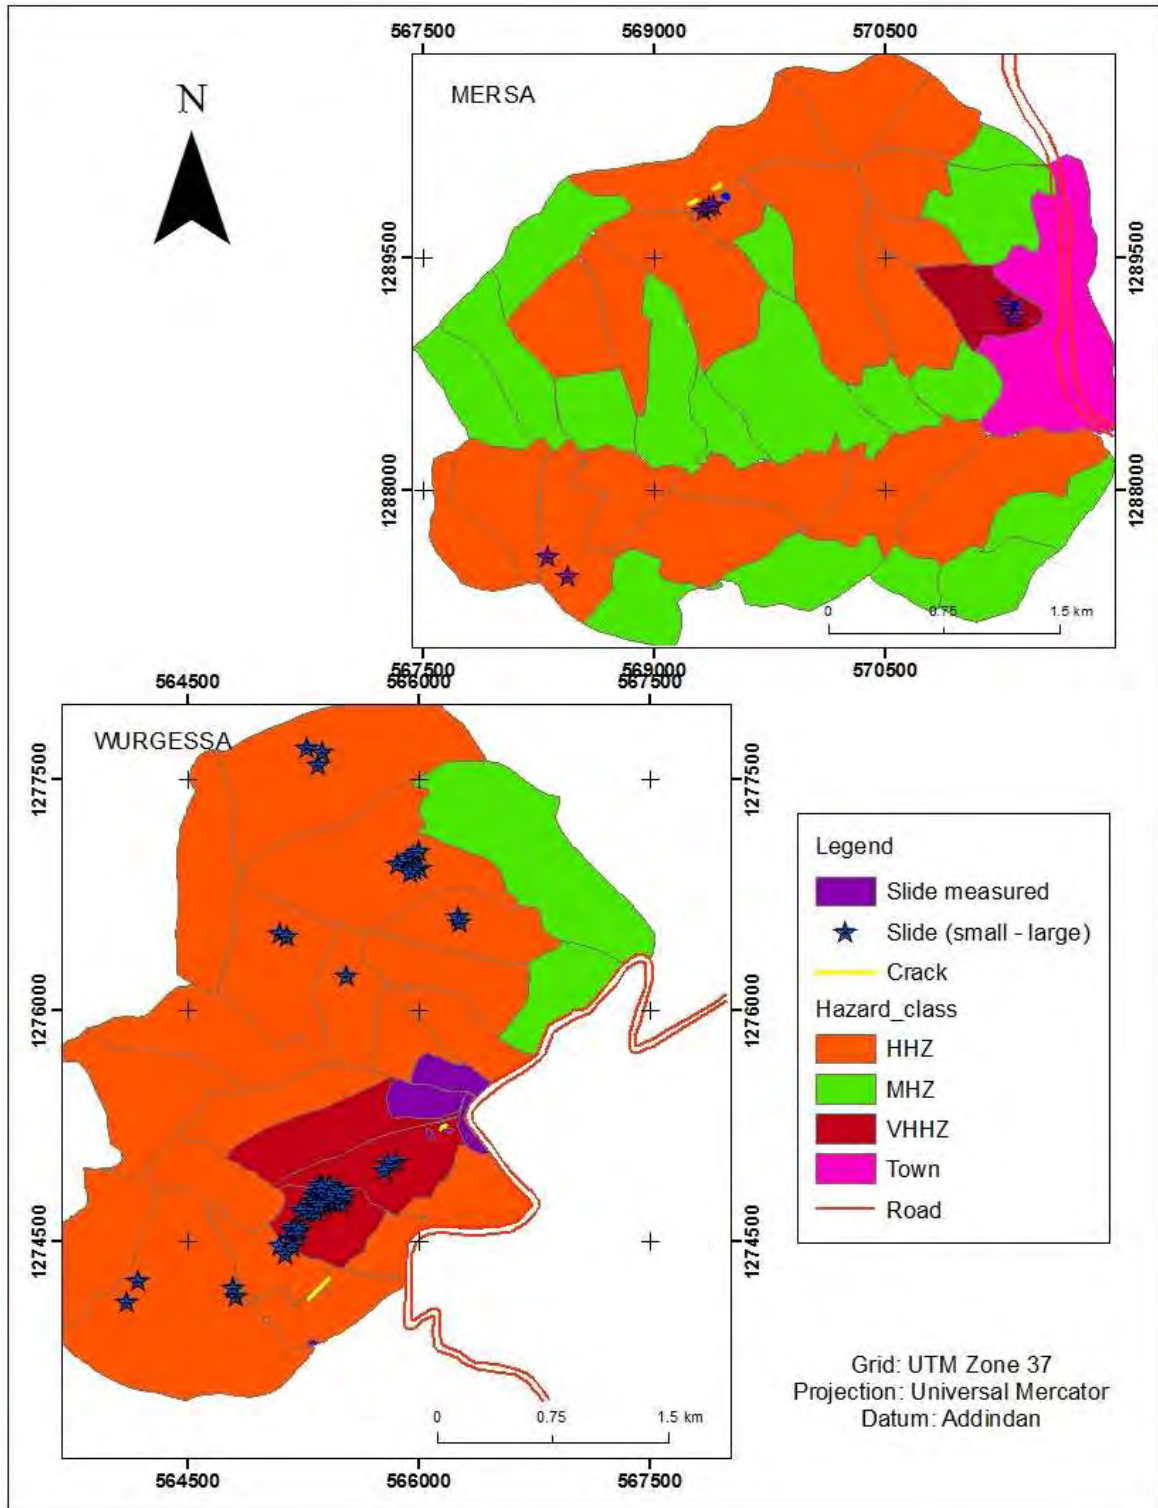
Fig 6.16 Landslide Inventories of the study area

Field observation and GPS data collection were made for the preparation of Landslide inventory map of the study area. As it can be seen from the inventory map of the study area (Fig 6.16), most of the landslides are concentrated in Wurgessa area however there are some landslide occurrences in Mersa area also. This is due to the abundance of causative and triggering factors in Wurgessa than in the Mersa area.

These landslide activities were mainly concentrated along the road section. A perusal of Fig 6.16 clearly shows that most of these landslide activities fall within very high hazard zone and high hazard zone as delineated during the present study. Out of these 68 landslide activities 40 (59%) are falling within Very High Hazard zone and 28 (41 %) of it falls within

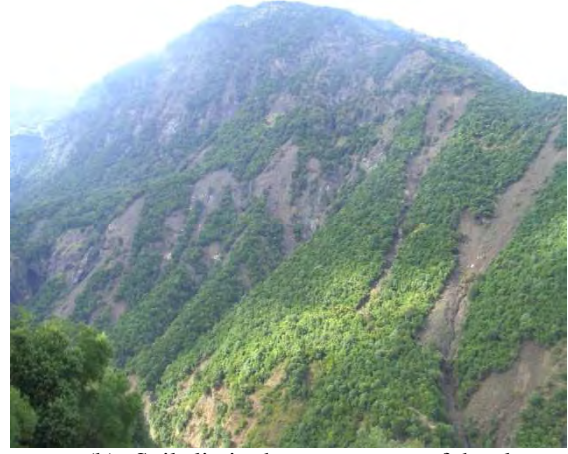
(b) Soil slip in the steeper part of the slope.

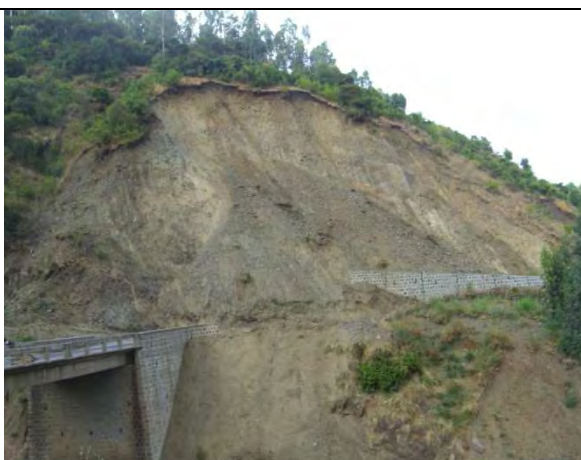
(e) Landslide which has affected retaining wall near Golo stream bridge (Wurgessa).

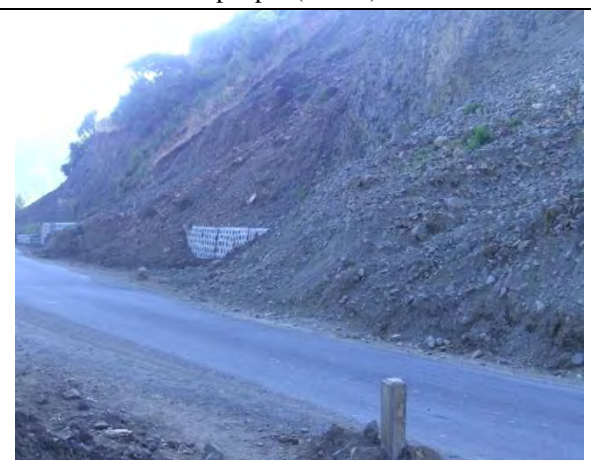
(f) Retaining wall affected by colluvial slide (Wurgessa near Golo stream).
