**Power Distribution System Failure and Vulnerability  
Analysis in Ethiopia  
Case Study : Kotebe Distribution System**

**A Thesis Submitted to the School of Graduate Studies of  
Addis Ababa University in Partial Fulfilment of the  
Requirements for the Degree of Masters of Science in Power  
Engineering**

November 2021

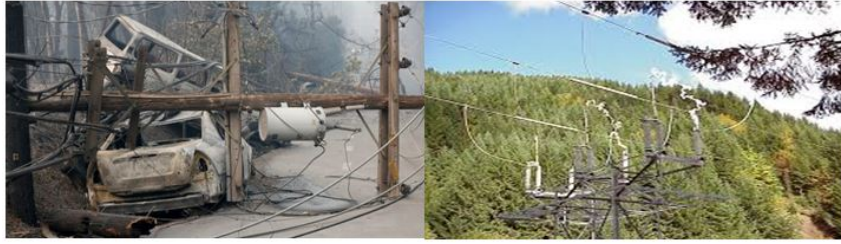
Figure 1.2: Distribution system failure due to different causes (Source: google images)

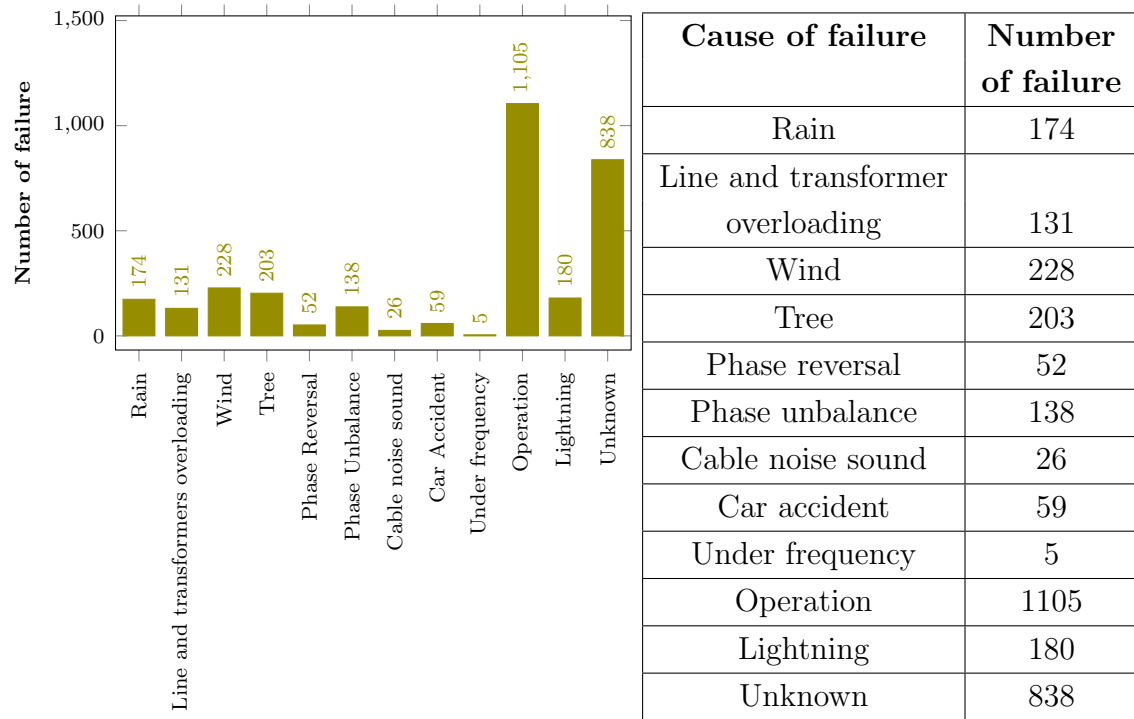
The causes identified used for the study are the data from the maintenance reports. The causes of distribution system failure in the region are summarized as shown in figure 3.6. From the data, it can be shown that many of the interruptions are due to operation and maintenance, weather influence, and accidents.

The weather influences are rain, wind, and lightning. They are among the most common identified causes of interruption. Above 48.6% of the known failures causes excluding interruption due to operation, and 25.3% of the known failures including interruptions due to operation, are caused by weather influences. Usually, while there is rain or wind in the

Figure 3.6: Causes of Kotebe distribution system failure

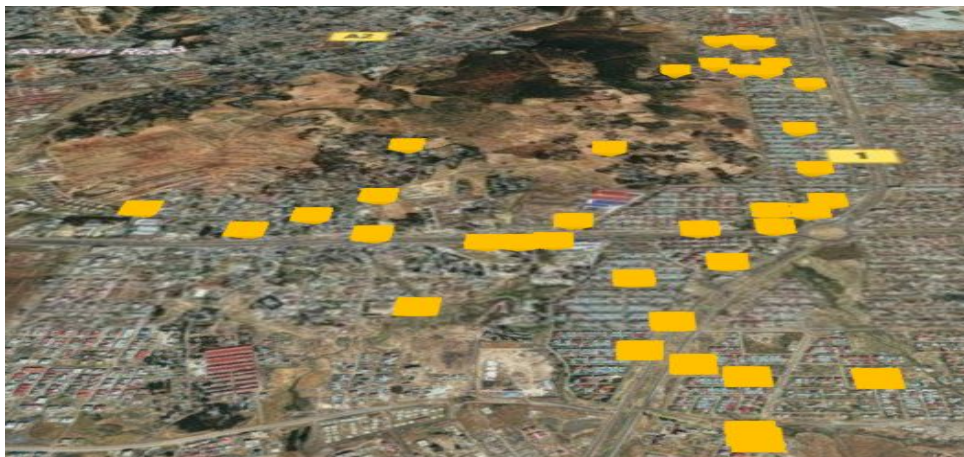
Locating the transformers which are working overloaded helps the utility to take appropriate measures easily before failure happens. The exact locations of overloaded transformers are indicated using the 3D map shown below. The location of those transformers looks

Figure 3.10: Location of overloaded transformers using 3D Google view

clustered on 3D map view. But it is a sound indicator to visualize the location of those transformers and take immediate action. The area is around CMC square and the Ayat zone.

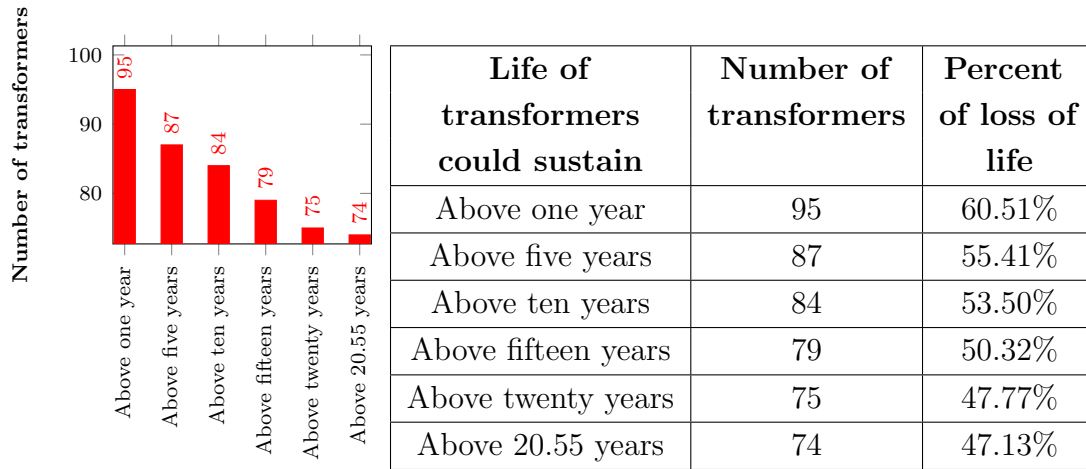
Figure 3.11: Expected number of transformers that could sustain certain years

The above analysis indicates the number of transformers that could sustain the required life. For instance, only 74 of 157 transformers could sustain the standard 20.55 years (i.e., 47.13% of the total number of transformers). The remaining 83 transformers sustain below 20.55 years. The others also follow the same principle.

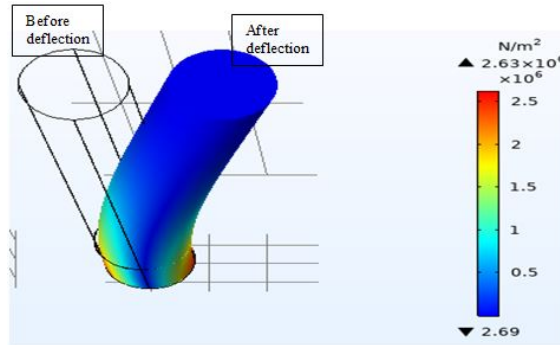
Figure 4.2: Deflection of wooden pole due to weather influence ( $\theta = 0^\circ$ )

The maximum deflection occurs at the top of a pole and the minimum deflection at its bottom. The stress distribution along the poles and displacement from the original position is simulated. Tilted poles and their effects are also considered.

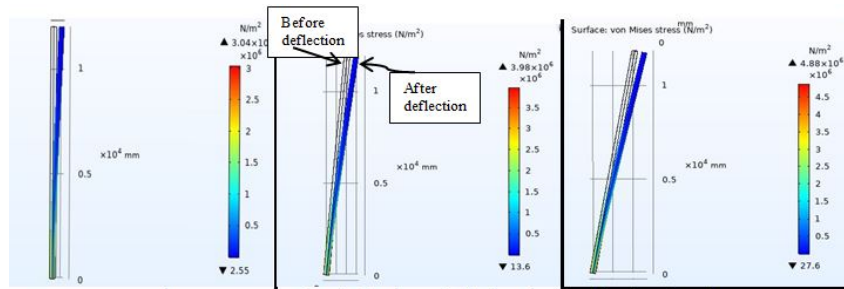
Figure 4.3: Angular deflection of tilted poles by  $0^\circ$ ,  $5^\circ$  and  $10^\circ$  respectively

above when it is enlarged. Many conditions were considered and simulated, but only few of the results are included here. The results of the other tilted poles deflection (i.e.,  $15^\circ$ ,  $20^\circ$  and  $25^\circ$ ) have similar characteristics with those shown figure 4.3 above.

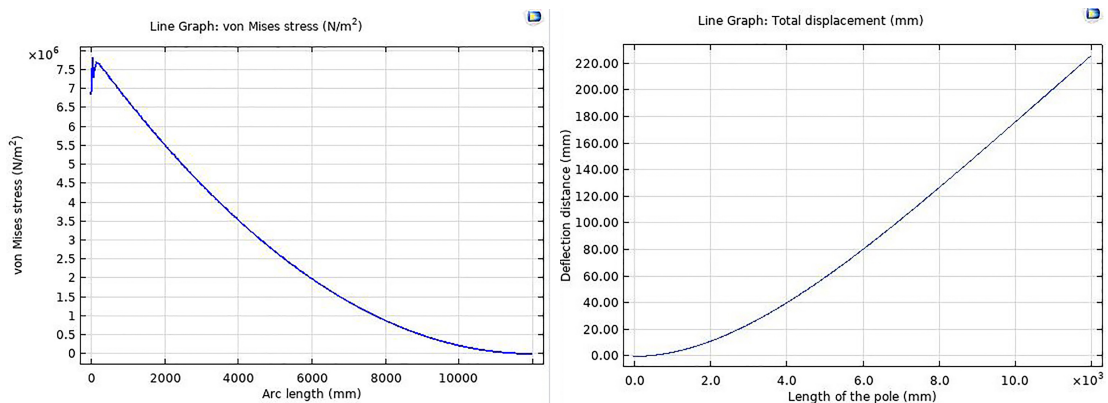
Figure 4.4: Graph of stress and displacement along surface of  $0^\circ$  tilted pole

The results from the simulation indicate that deflection angle due to weather influence ranges from  $0^0$  to  $1.288^0$  at the bottom and top of the poles, respectively. Stress developed at different heights of the poles is also indicated.

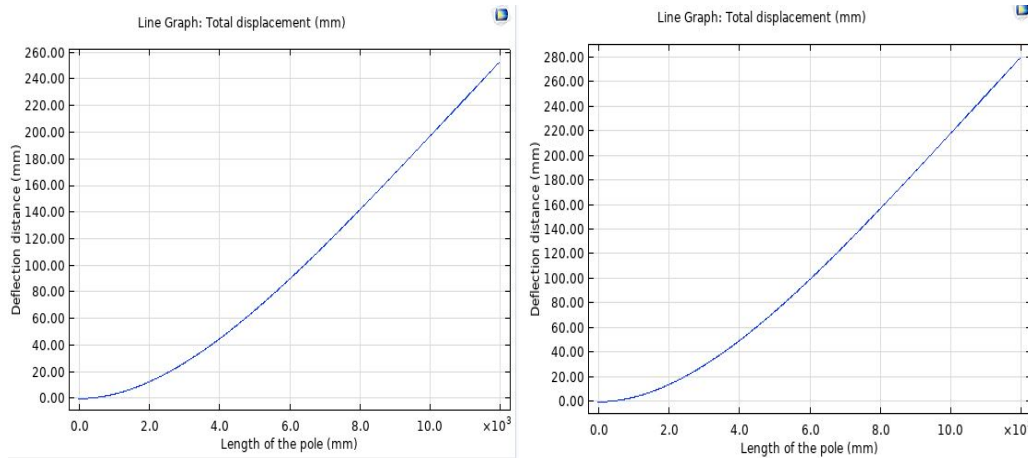
Figure 4.5: Displacement of poles for tilt angle of  $5^0$  (left) and  $10^0$  (right side)

As the tilt angle increase, the effect of weather and gravitational force becomes higher, and the deflection angle would increase. The deflection displacement at the top of the pole is 262.16mm ( $1.444^0$ ) and 282.53mm ( $1.596^0$ ) for poles tilted by  $5^0$  and  $10^0$  respectively. The deflection angles for  $15^0$ ,  $20^0$  and  $25^0$  are  $1.7434^0$ ,  $1.884^0$  and  $2.018^0$ , respectively. The results for more tilted poles have similar characteristics.

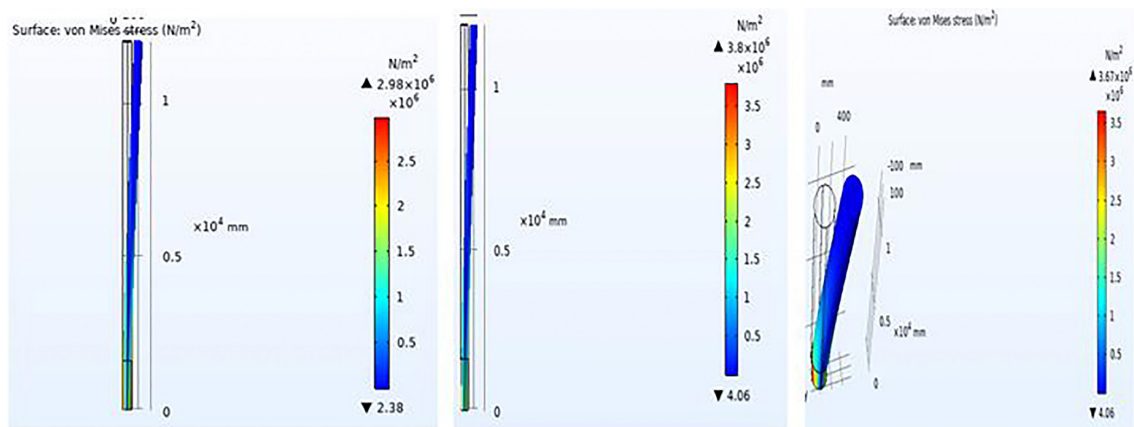
Figure 4.8: Weather influence on decayed wooden distribution poles of 5, 10 and 15 years age ( $\theta = 0^\circ$ )

As its age increase, the decay depth, deflection due to weather and other influences increases. The simulation is performed for a certain time effect of weather influence. The deflection is continuous as the weather effect is available. Thus, the effect will become high, and the distribution system will be vulnerable to failure.

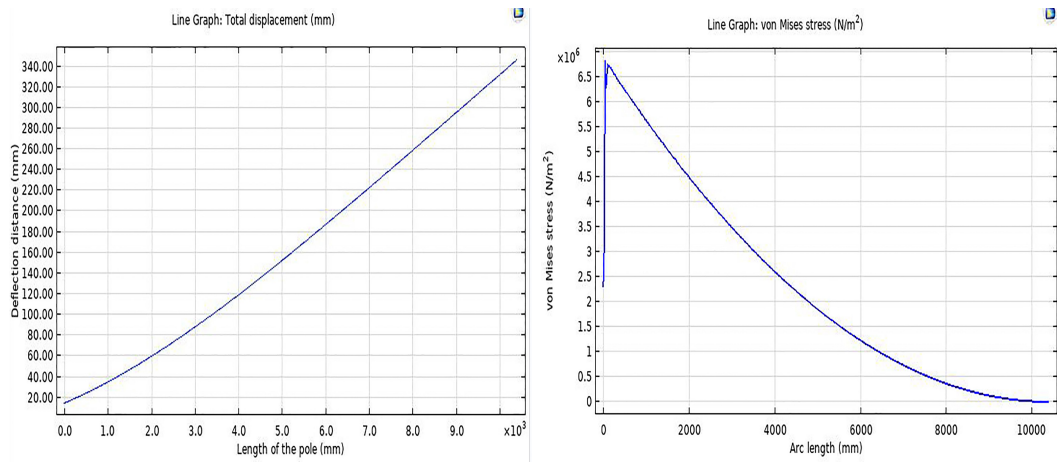
Figure 4.9: Deflection (left side) and stress (right side) of 15 years aged decayed poles ( $\theta = 0^\circ$ )

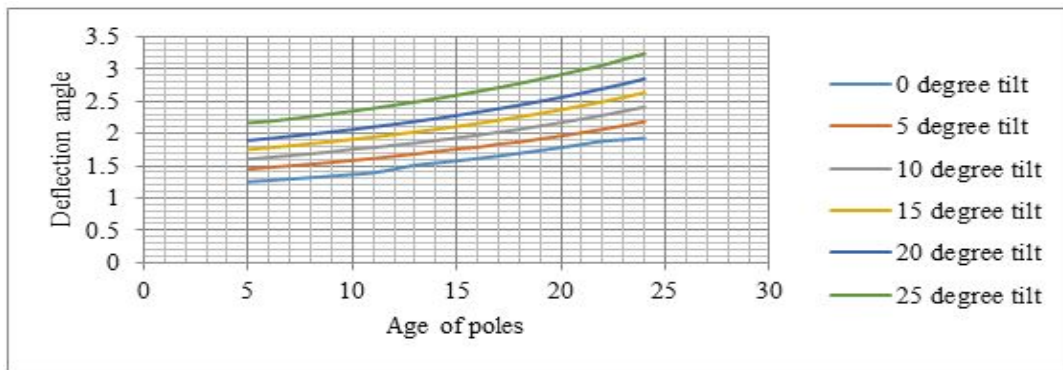
From the result, the deflection of poles increases with their aging. More tilted poles will

deflect more with a single disturbance. It could enter the worst resilience condition with continuous disturbances. Thus, appropriate maintenance is needed.

Figure 4.10: Deflection of poles with increased ageing

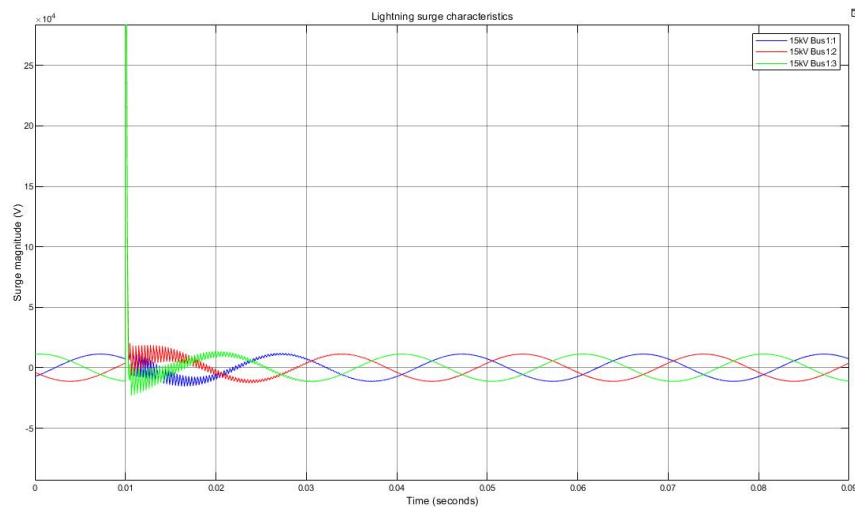
Figure 4.15: Surge voltage at bus 1 when lightning occur at bus 1 of the transformer

As shown from the result, when lightning happens at bus one of the distribution transformers having no surge arrester, the voltage magnitude at all buses exceeds the BIL. The surge magnitude range from 98.18kV to 350.2kV at the sending and receiving end buses of the line, respectively. Also, the surge at the other terminal of bus 2, bus 3, and bus 4 is 202.2kV, 262.7kV, and 305.2kV, respectively. The result at the different buses of the transformers without surge arrester is as shown in figure 4.16.

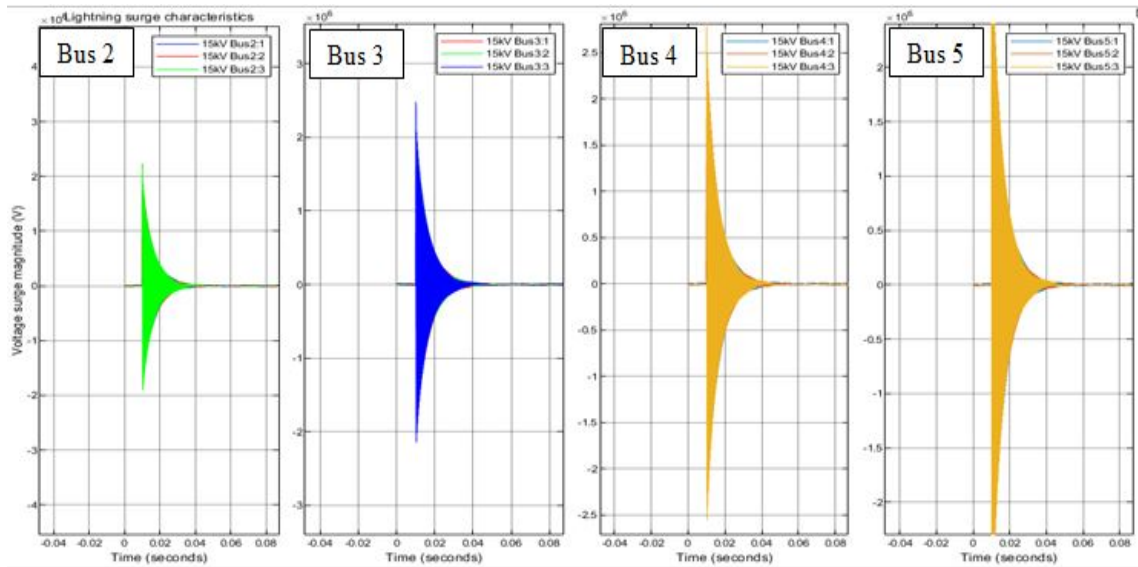
Figure 4.16: Surge voltage at bus 2 to 5 of the transformers when lightning occur at bus 1 of the transformer

to the lightning surge characteristics at the entrance. Since all transformers are considered to have no surge arrester, the surge magnitude increases as the length of the line increase. The surge voltage decays faster with time. But its magnitude is high and the energy that will dissipate is too high that could result in damage to transformers.

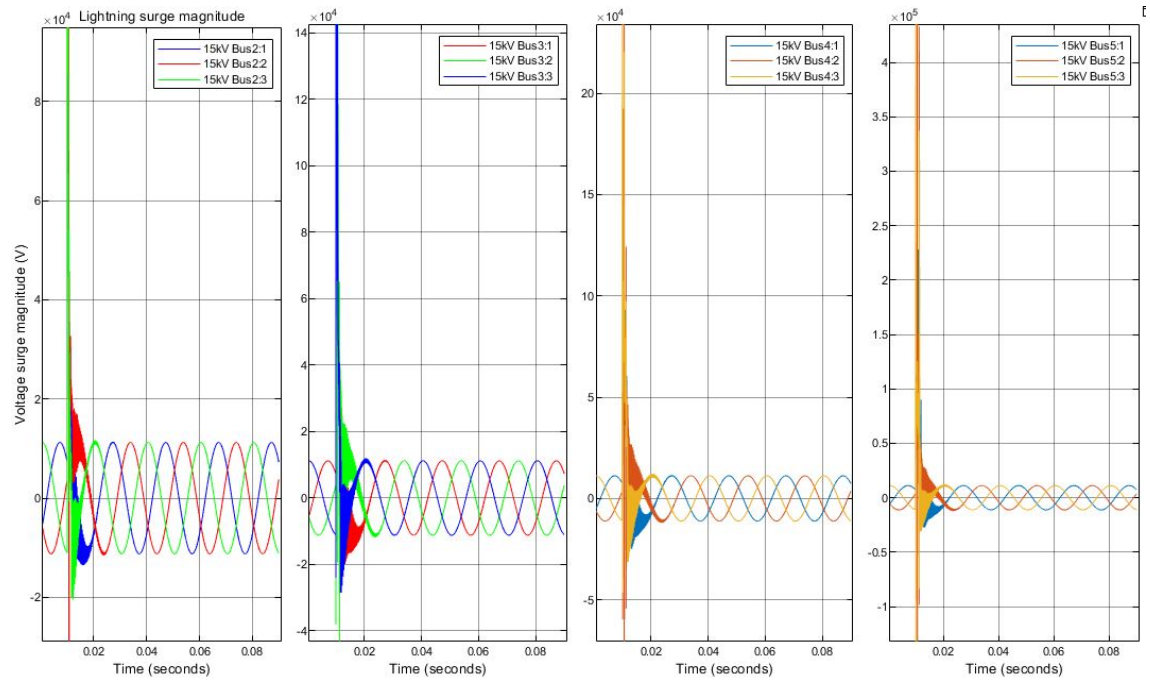
The surge at the point of strike (bus 1) has a higher magnitude and similar characteristics to the lightning surge of the entrance. The surges at the other buses have similar wave characteristics except their magnitude. The surge voltage magnitude at bus 1, bus 2, bus 3, bus 4, and bus 5 is 34.52kV, 26.39kV, 19.45kV, 18.72kV, and 18.09kV, respectively. The surge magnitude at the different length of the line is indicated by the figure 4.18

Figure 4.18: Surge voltage at different bus of transformers with  $25\Omega$  grounding resistance

From the result, it can be shown that grounding with the required standard helps to reduce the surge magnitude. Since all transformers are considered as having surge arresters, voltage magnitude decrease as the length of the line increases. Thus, the effect at the farthest distance will be lower.

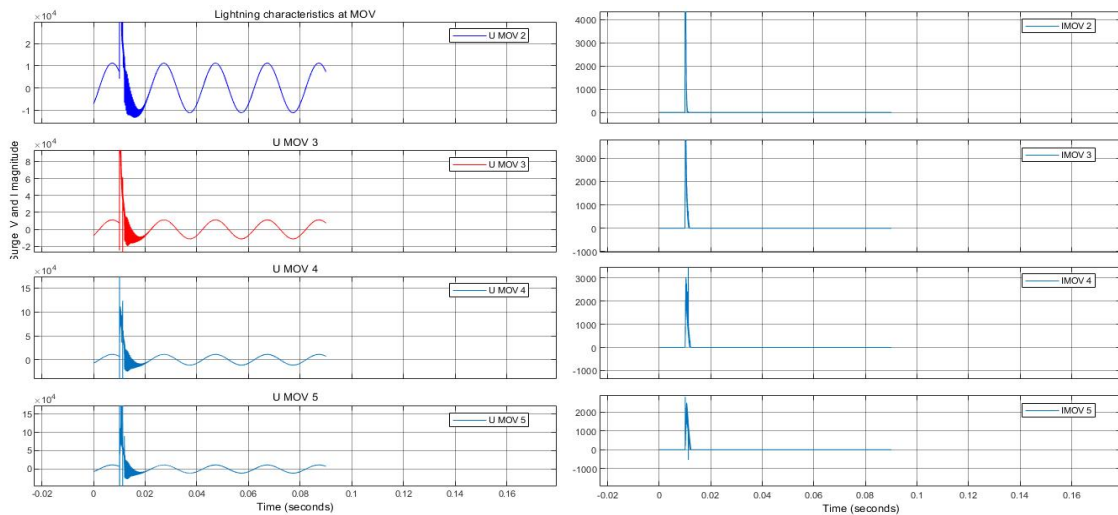
Figure 4.19: MOV surge arrester current and voltage waveform at different buses

The surge arresters conduct while the surge voltage is above the rated basic insulation level (BIL). Otherwise, it does not conduct, and the current will be zero since the arresters become a high resistance insulator at rated voltage. The surge magnitude will be lower as the distance from the lightning strike is farther. As shown, its magnitude at the receiving end is lower. The voltage and the current through the MOV surge arrester when lightning happens is as shown figure 4.19.

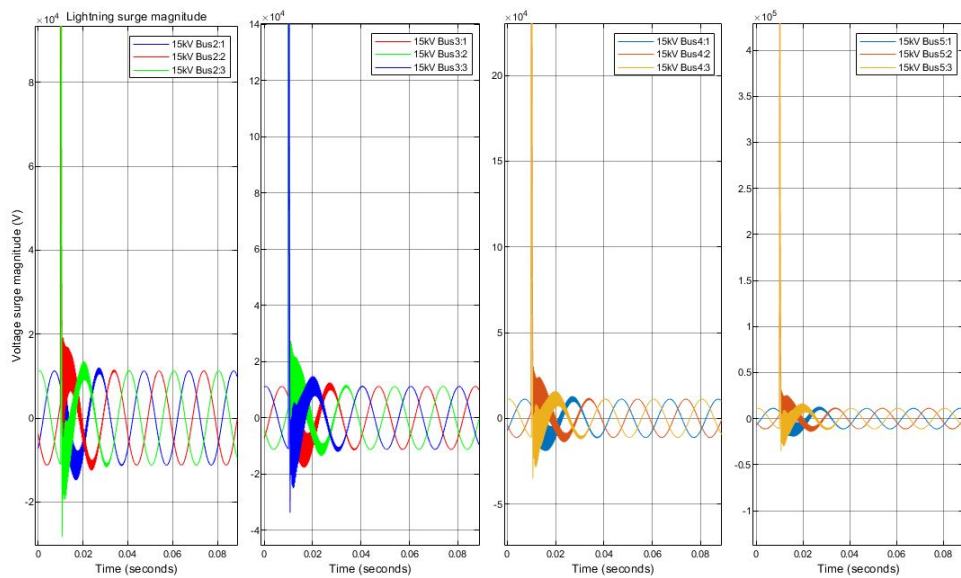
Figure 4.20: Surge voltage at different terminal of transformers for  $274\Omega$

The surge voltage at  $274\Omega$  is higher than  $25\Omega$  resistance. The surge magnitude at bus 1, bus 2, bus 3, bus 4, and bus 5 is 72.43kV, 52.74kV, 41.09kV, 34.96kV, and 28.41kV, respectively. This indicates that the surge magnitude is higher for higher soil resistivity. This can result in damage to both surge arresters and transformers. Once a surge arrester fails, any surge can easily damage transformers.

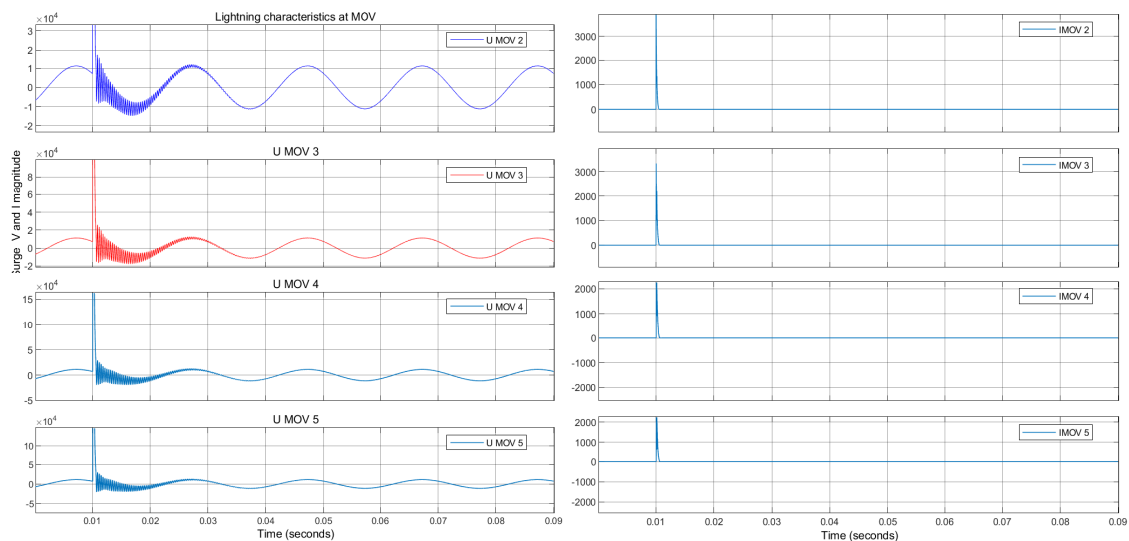
Figure 4.21: MOV surge arrester current and voltage waveform from bus 2 to 5

The surge current at MOV arresters is lower relative to the above  $25\Omega$  resistance. The resistivity of the soil and the rod size limits the capability of surge arresters to surge the current to the ground. The MOV current and voltage at the other buses hold similar characteristics to the indicated buses.

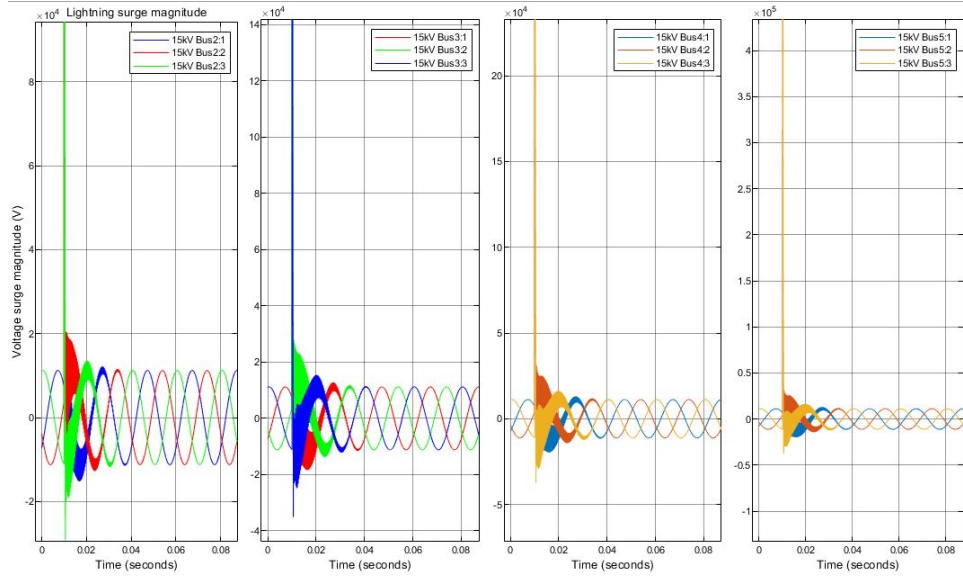
Figure 4.22: Surge voltage at different buses of transformers for  $382\Omega$  grounding resistance

Surge voltage magnitude for grounding resistance of  $382\Omega$  at bus 1, 2, 3, 4, and 5 is 74.42kV, 58.32kV, 49.78kV, 41.08kV, and 35.05kV, respectively. Its magnitude is higher than  $25\Omega$  and  $274\Omega$ . The surge magnitude is higher than the BIL value except at the receiving end of the line. The MOV arrester voltage and current during the surge are shown in figure 4.23.

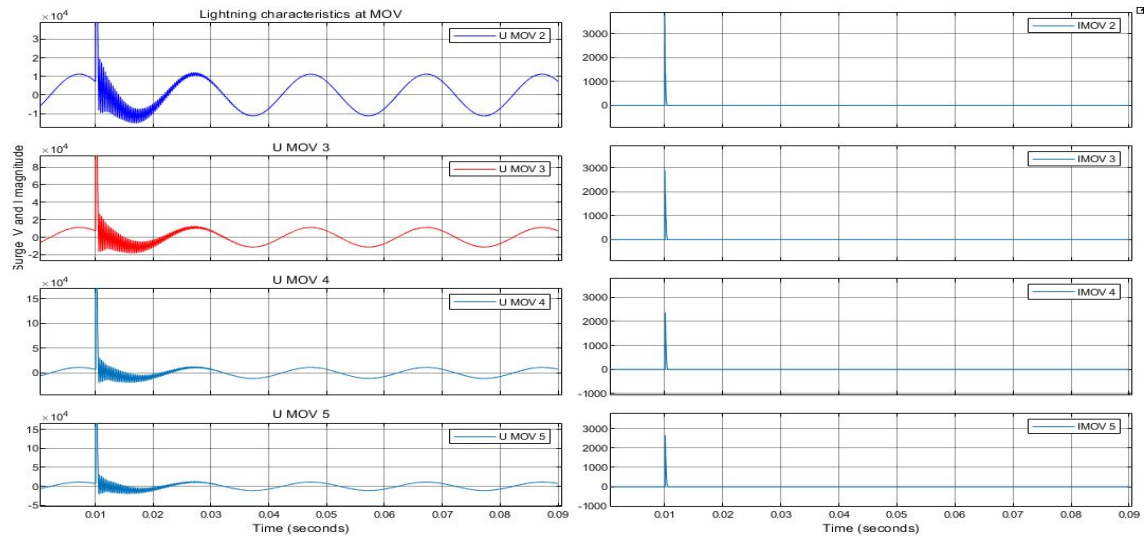
Figure 4.23: MOV surge arrester current and voltage waveform for  $382\Omega$  grounding resistance

The current through the MOV is very low as the soil resistivity is high. The surge properties discussed above for  $274\Omega$  hold for this also.

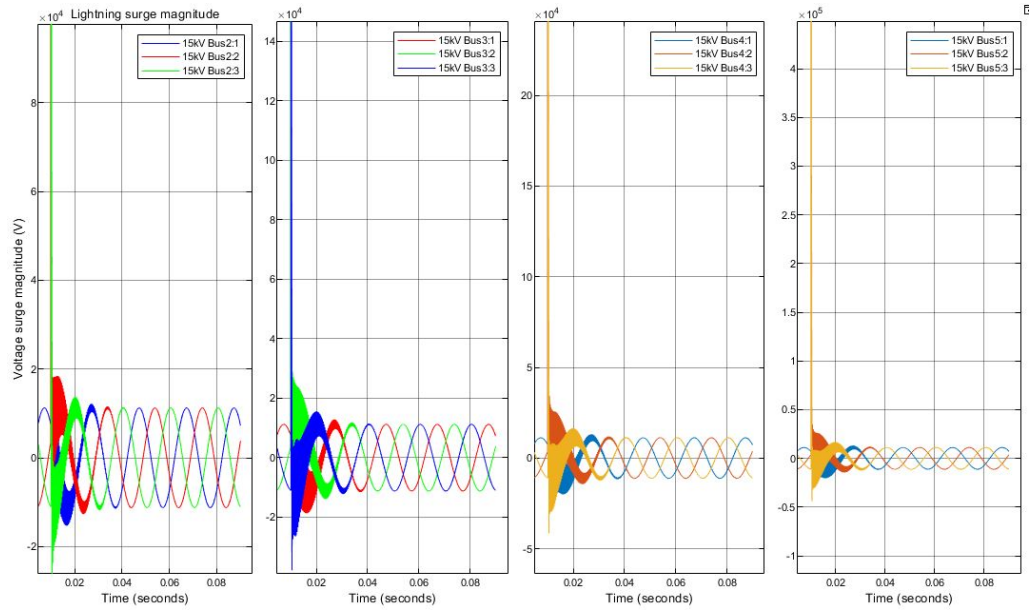
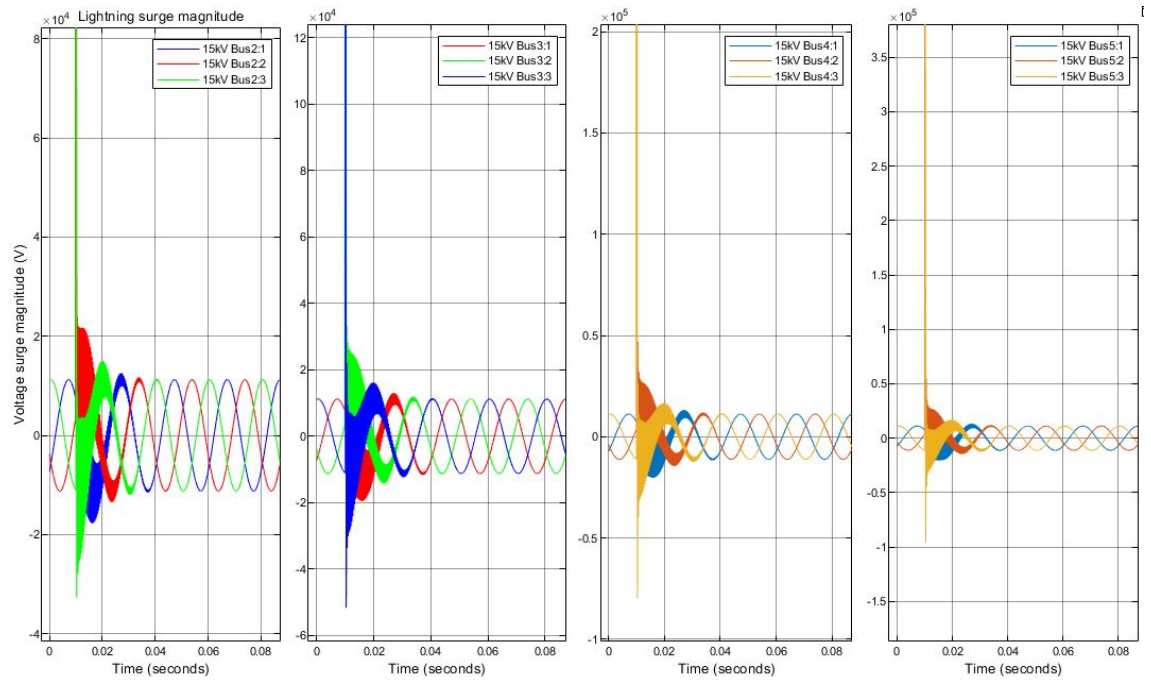
Figure 4.24: Surge voltage at bus 2, 3, 4 and 5 terminals of  $523\Omega$  grounding resistance

The lightning surge considering  $523\Omega$  and  $657\Omega$  grounding resistance shows similar characteristics with different values of the previous grounding resistance except its magnitude. The surge magnitude for  $523\Omega$  is higher than the indicated lower grounding resistances, which holds for  $657\Omega$  grounding resistance.

Figure 4.25: Surge voltage from bus 2 to 5 terminals of  $657\Omega$  grounding resistance

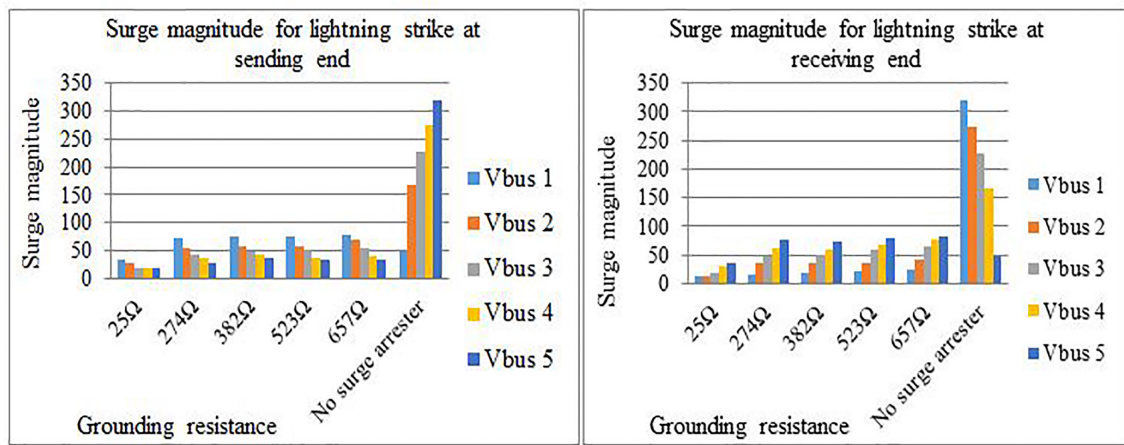
In general, the surge magnitude for transformers having surge arresters is higher around the strike point and decreases to lower values for the distant buses. The surge magnitude at different buses of the line is shown graphically in figure 4.26.

Figure 4.26: Surge magnitude at different buses for a lightning strike at sending and receiving end
