**GEOTECHNICAL INVESTIGATION OF
SOME FAILED SECTIONS ALONG OMO
RIVER-TERCHA ROAD PROJECT**

A Thesis in Geotechnical Engineering

By
Biniam Yihun
April, 2024
Addis Ababa

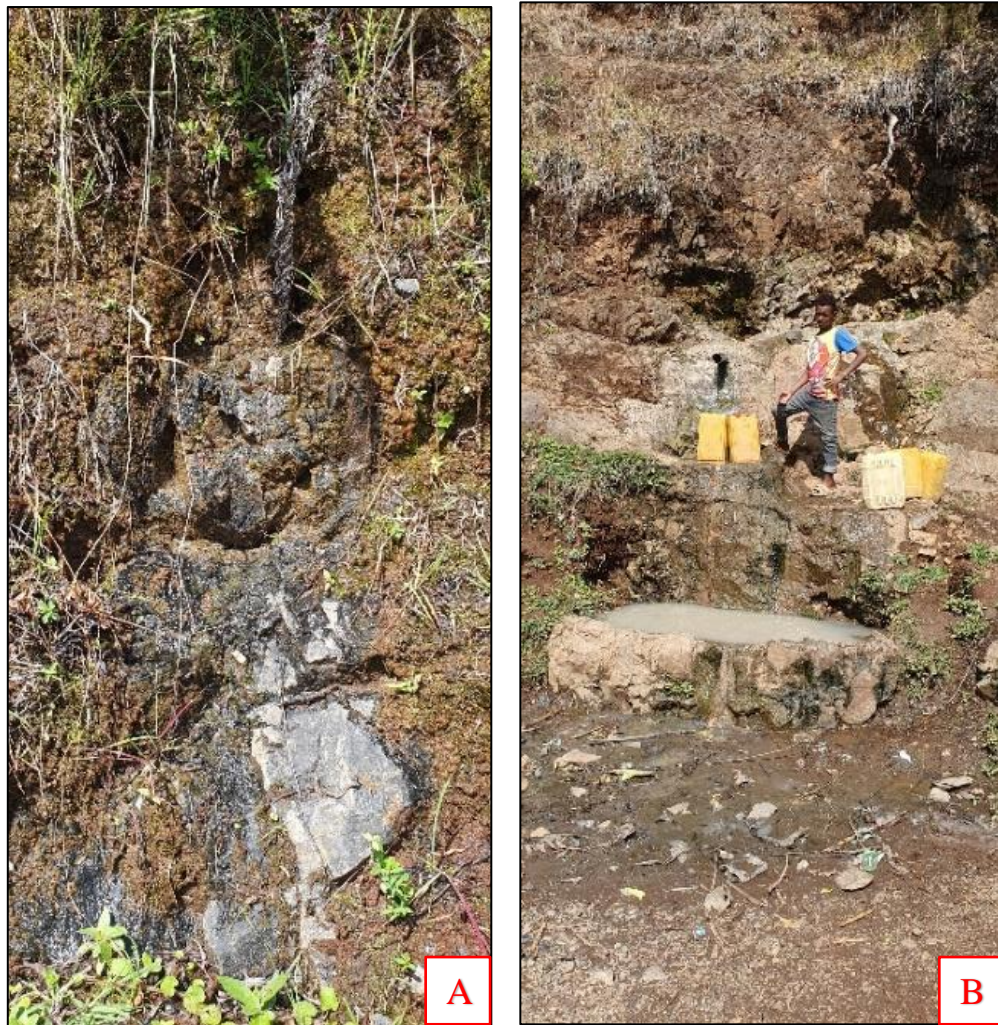
- This is the condition where the groundwater infiltrates and saturated the soil beneath the pavement which is progressively leading to instability and damage the road structure.
- This seepage is occurred when the slope above the road is saturated and progressively causing the water to flow downward and infiltrate to the soil beneath the road surface as the presence of moisture is shown in Figure 3-5.

Figure 3-5: A) Wet patches at the surface of back slope B) Visible outflows from high ground to the pavement @ Km 105+000 RHS

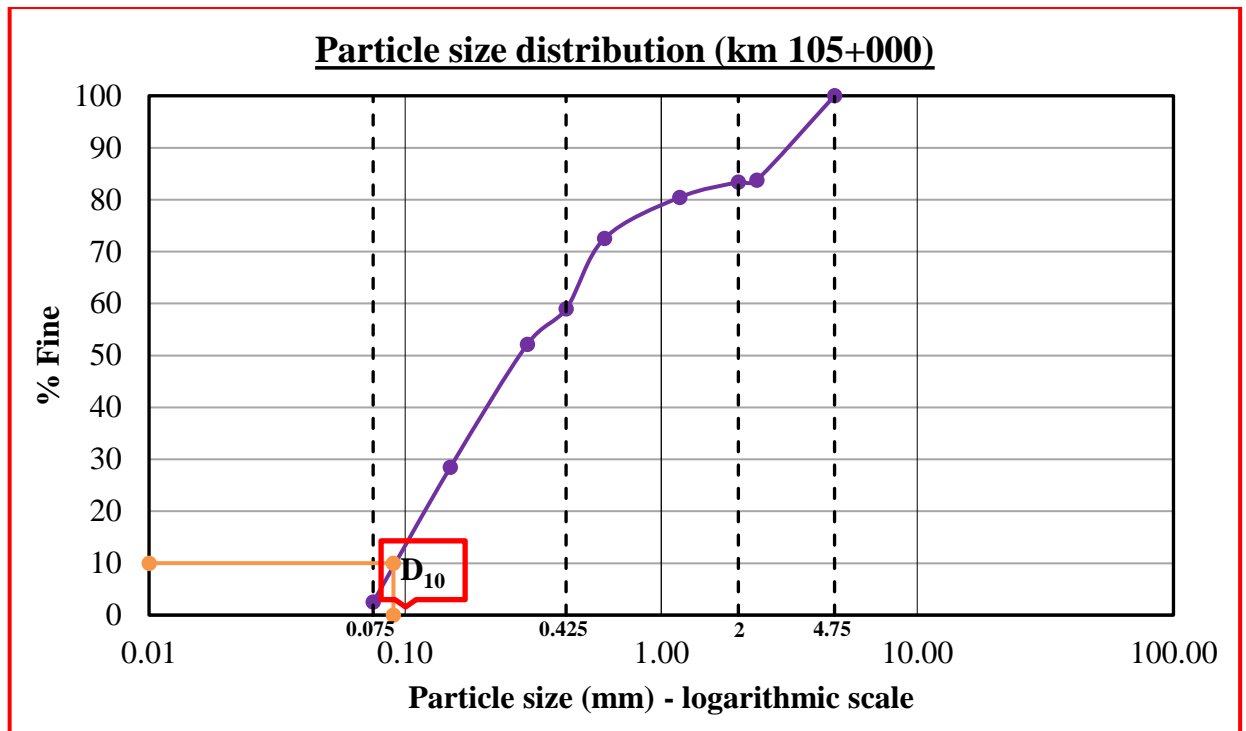
Figure 4-6: Particle size distribution (km 105+000)

- Coarse gravel (75 mm-19 mm): 0%
- Fine gravel (19 mm-4.75 mm): 0%
- Coarse sand (4.75 mm-2.0 mm): 16.23%
- Medium sand (2.0 mm-0.425 mm): 24.41%
- Fine sand (0.425 mm-0.075 mm): 56.45%
- Silt and clay (< 0.075 mm): 2.50%

Considering these findings, the soil appears to have a mixture primarily composed of fine to medium sand particles, with a smaller presence of coarse sand and minimal silt/clay content. This composition suggests a moderately permeable soil, with good potential for water movement due to the dominance of sand particles, particularly in the fine sand range. The value of the coefficient of permeability of a soil can be estimated by using indirect method, one of the method is by using Allen Hazen’s formula,

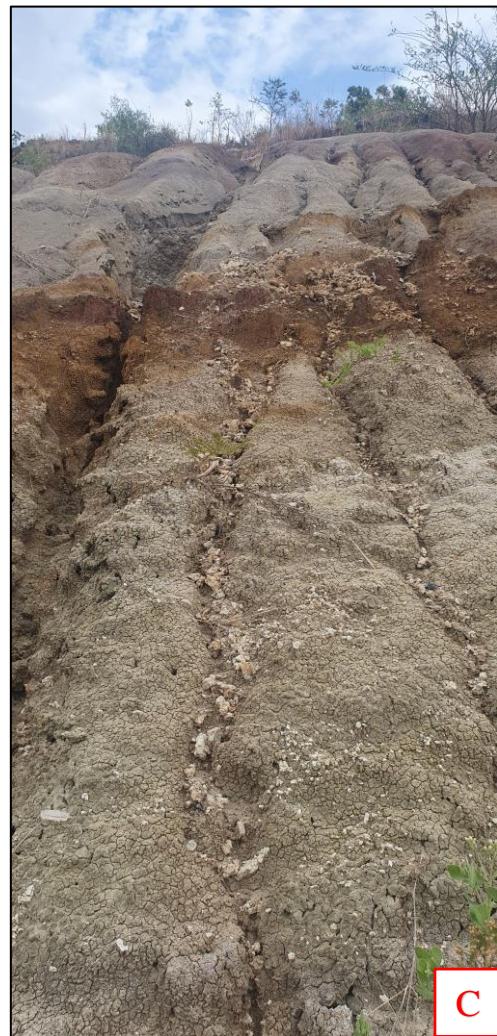
At the designated station along the roadway, the presence of rills and gullies on the slope surface has been observed. These formations range from small channels (rills) to larger, deeper channels (gullies) as shown in Figure 4-8 A & B. The existence of these channels indicates the concentrated flow of water, which is progressively causing erosion and soil removal Figure 4-8 C.

Figure 4-8: A & B) Formations of rills and gullies on the surface of slope C) Crack and fissures on the surface of slope soil

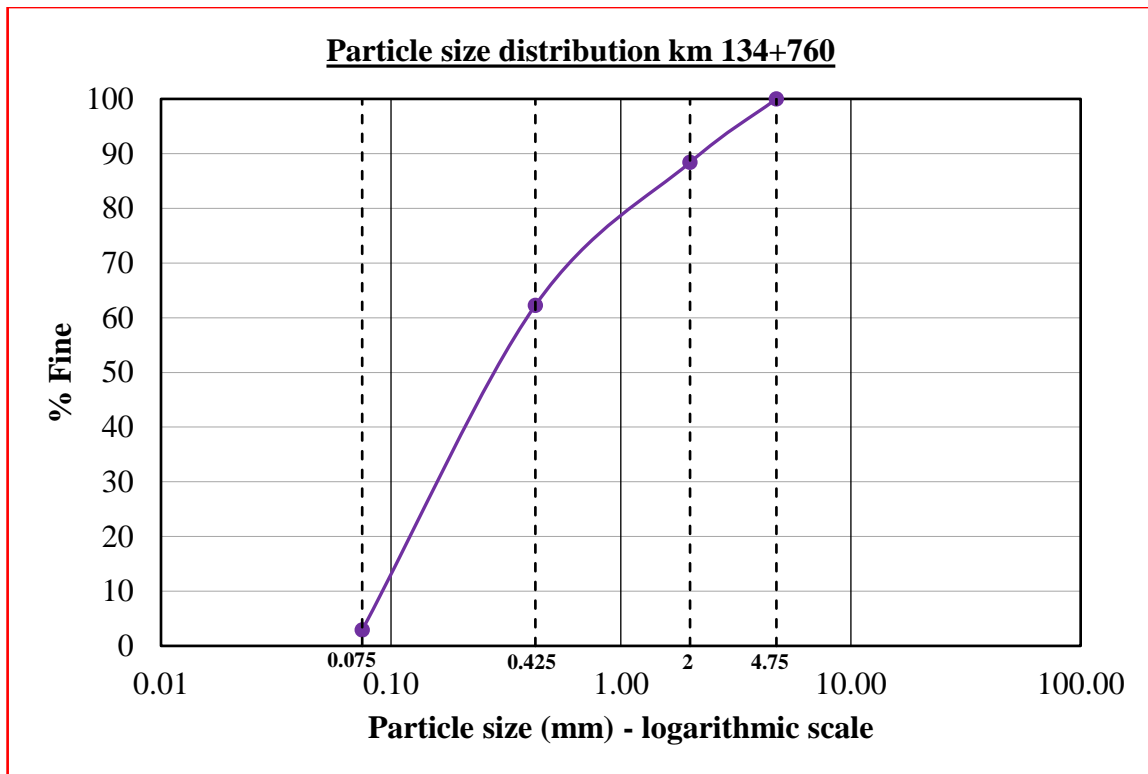
Figure 4-12: Particle size distribution km 134+760

Given that the soil on the slope is of a coarse-grained nature, referencing these erosion charts is particularly useful. As per these erosion charts, the roadway cut slope soil at 134+760, categorized as SP (poorly graded sand) under the USCS, falls into the high to very high erodibility category as shown in Figure 4-13. This conclusion is supported by the information provided in the Figure 4-14 below:

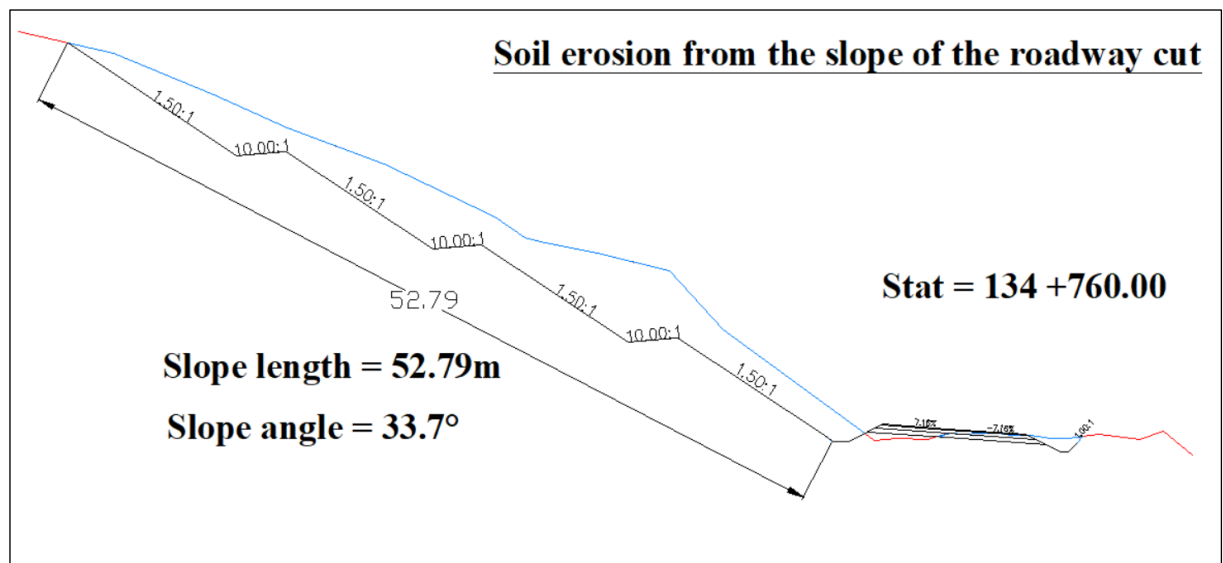
Figure 4-15: Cross-section of the road at km 134+760

Topographical features: as observed in the preceding cross-section as shown in Figure 4-15 of the road at station 134+760 RHS, the finished level exhibits a series of sequential slopes (comprising four in total) with an approximate incline of 1.5H:1V, equivalent to 33.7° from the horizontal plane. Between these consecutive slopes, there are three intervening benches, each measuring 3 meters in length, characterized by an incline of approximately 10H:1V or 5.7° . The collective length of the entire roadside cut spans 52.79 meters, maintaining an approximate 33.7° . This configuration signifies the presence of conditions conducive to soil erosion induced by rainfall. Notably, the extended length of the slope and its elevated slope angle serve as significant factors contributing to the ongoing erosion of the soil on the roadway cut slope.

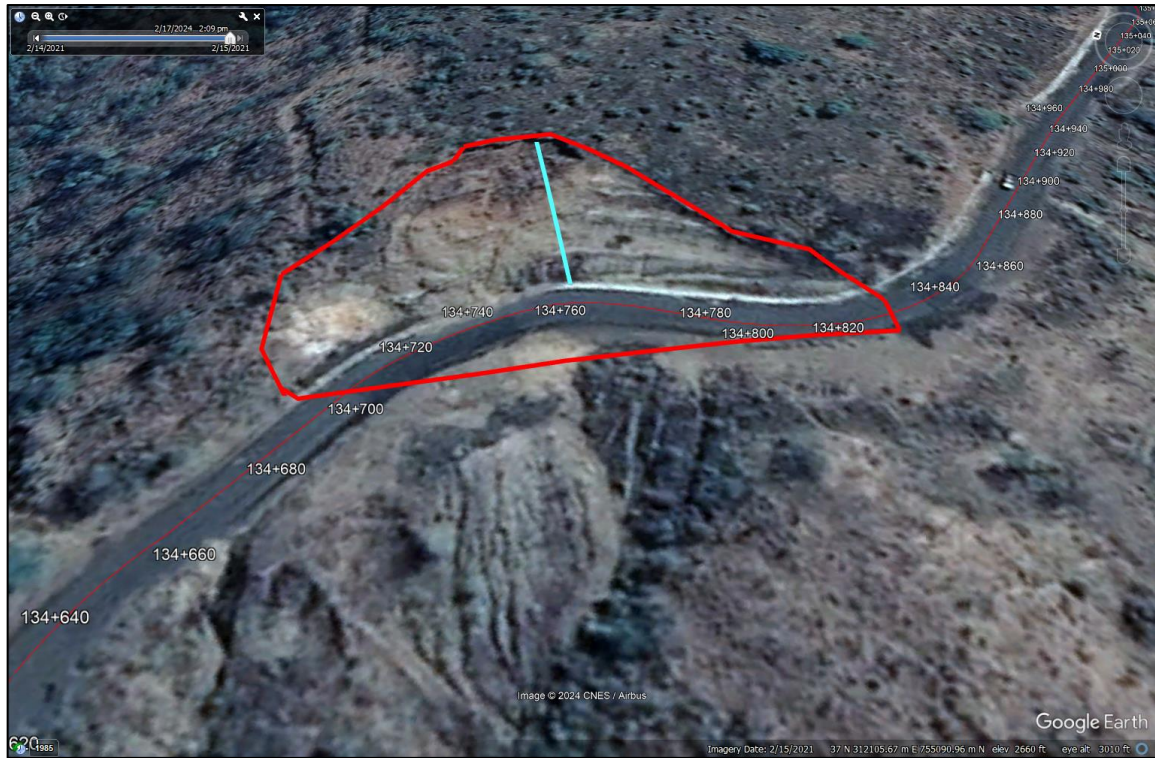
The historical evolution of the topography and vegetation cover in this susceptible area along the roadway has been examined using Google Earth's historical imagery tool. The analysis revealed that the construction of the road has led to the removal of existing vegetation cover, leaving the erodible soil exposed to rainfall without any remedial measures in place. The accompanying figures Figure 4-16 and Figure 4-17 in this section depict the changes in topography over time at kilometer 134+760.

The erosion spans from station 137+700 to 134+835, covering approximately 135 meters. The length of the sloping ground with erodible soil measures approximately 57.2 meters, as measured from the affected area on Google Earth.

Figure 4-16: Google earth historical imagery dated February, 2021 @ km 134+760 RHS

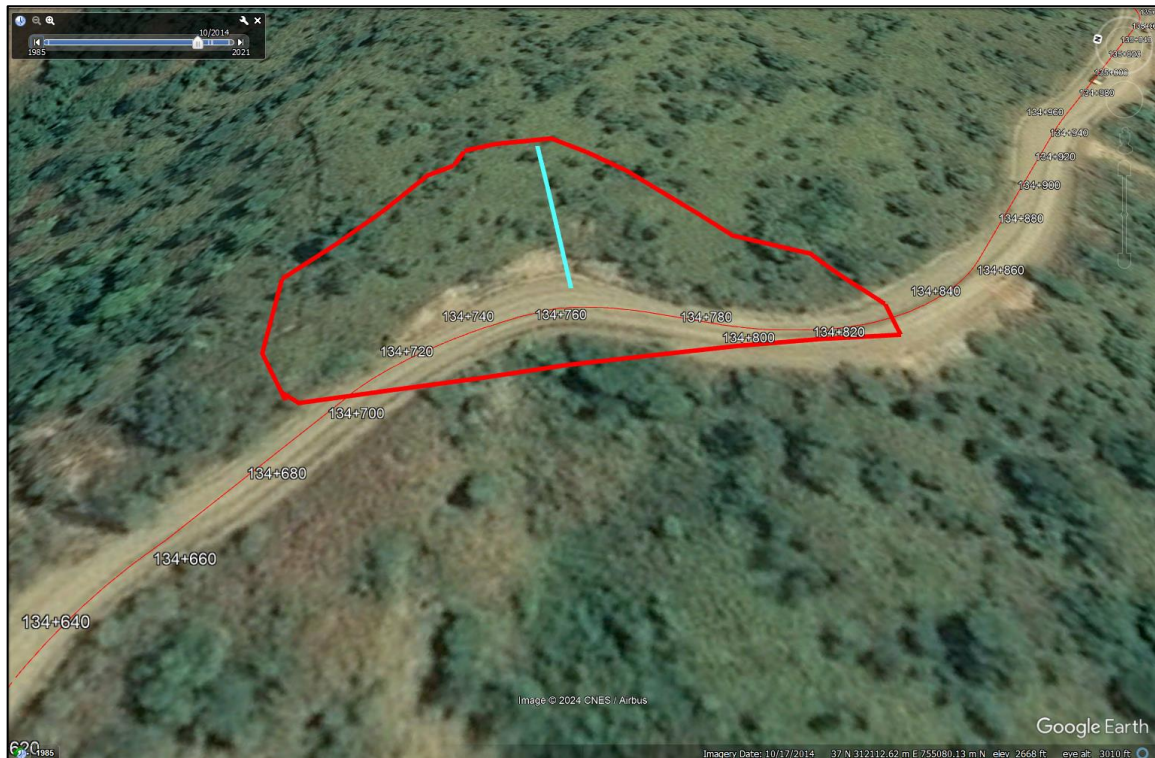
Figure 4-17: Google earth historical imagery dated October, 2014 @ km134+760 RHS

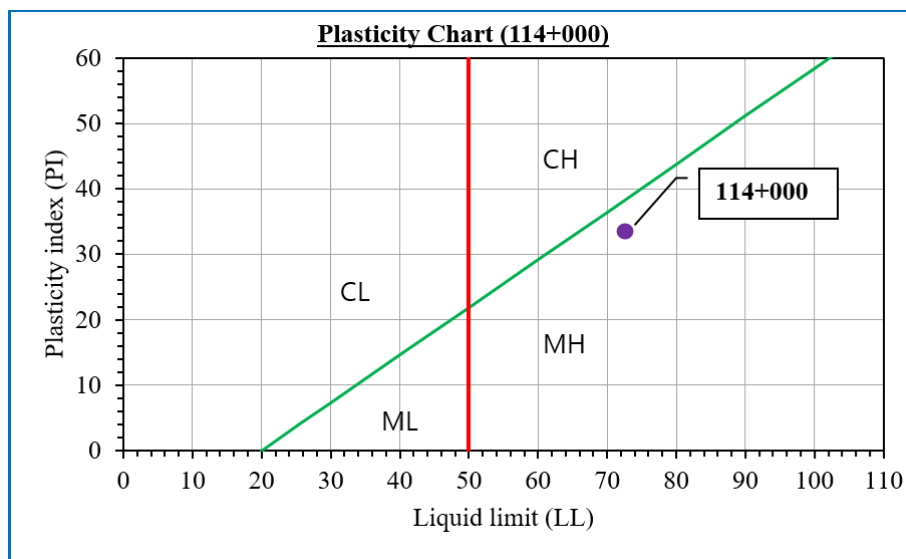
Figure 4-20: Plasticity chart (114+000)

- Soil classification as per AASHTO (114+000): the soil is classified as **A-7-5(17)**
- Soil classification as per USCS (114+000): Soil group symbol is **MH (Elastic silt)**

The soil is designated as A-7-5(17) according to AASHTO highway subgrade soil classification system. This classification implies that the subgrade's suitability as a pavement foundation is deemed "POOR," necessitating special treatment.

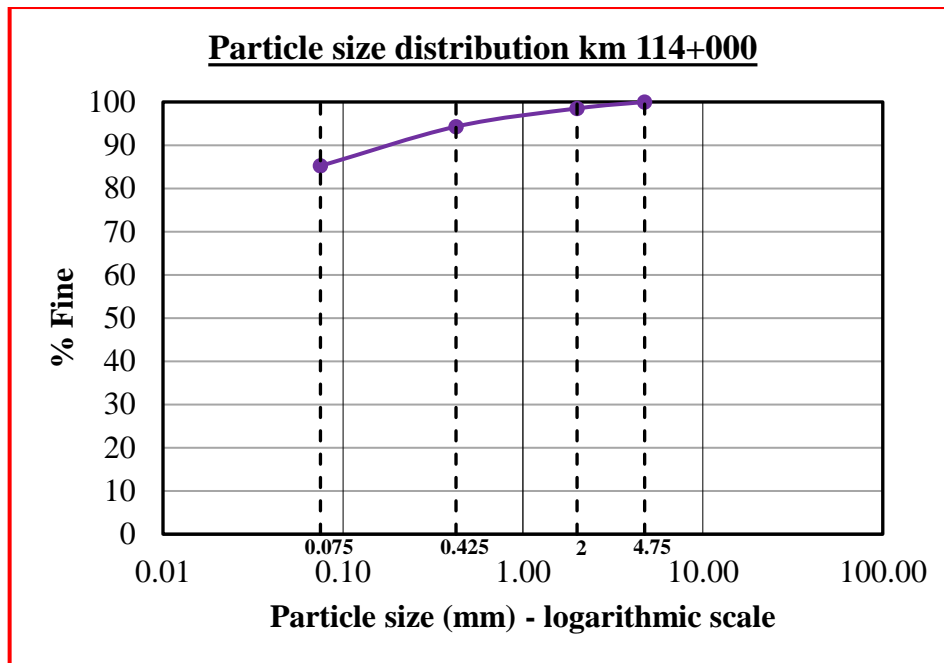
Figure 4-21: Particle size distribution km114+000

- Percent of coarse gravel (75mm-19mm): 0%
- Percent of fine gravel (19mm-4.75mm): 0%
- Percent of coarse sand (4.75mm-2.0mm): 1.50%
- Percent of medium sand (2.0mm-0.425mm): 4.20%
- Percent of fine sand (0.425mm-0.075mm): 9.10%
- Percent of fine-grained soil (<0.075mm): 85.20%

The particle size distribution results paint a pretty clear picture. The high percentage of silt and clay, which are fine-grained soils, indicates poor drainage and susceptibility to swelling when in contact with water. These soils tend to absorb water and expand, leading to swelling and shrinking behavior. This swelling can exert pressure on the flexible asphalt road, causing it to fail prematurely.

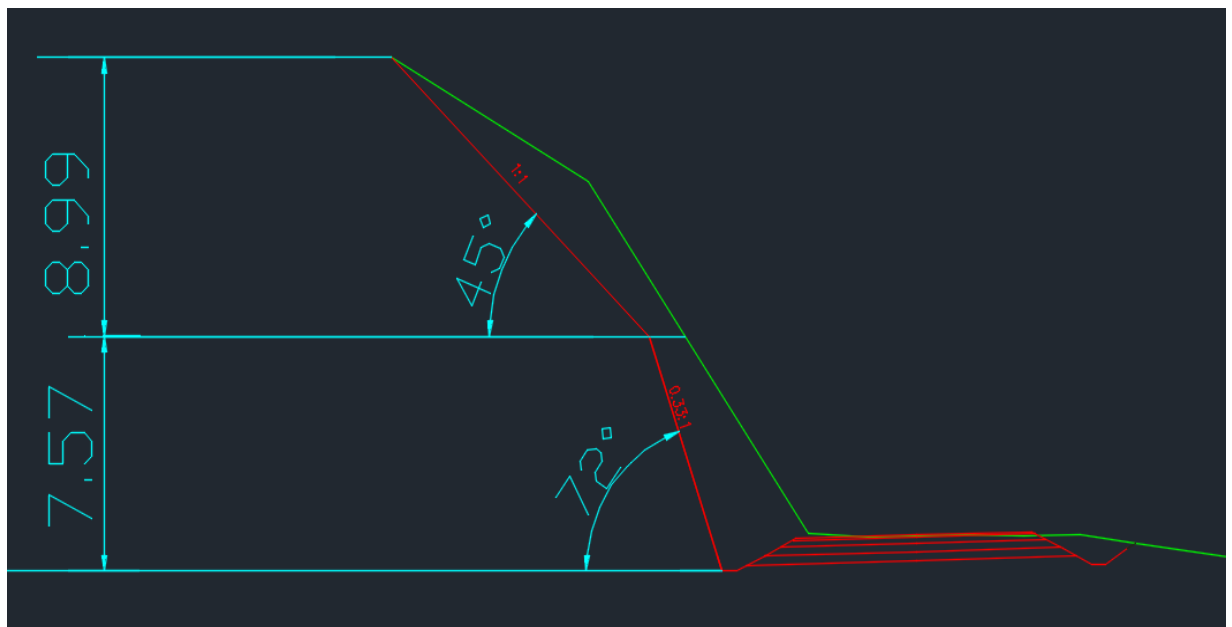
Figure 4-25: Cross-section of the road at station km 100+300 (Source: Project Consultant)

Examining the road’s cross-section, the original ground level is represented by the green line, while the finished level of the cut slope is denoted by the red line as shown in Figure 4-25. During the site investigation, two distinct soil formations were identified: the upper

layer (0.0 m - 8.99 m) and the lower layer (8.99 m – 16.56 m). Based on these formations, the roadway cutting implemented two slope angles, 72° angle (0.33H:1V) for the lower layer and a 45° angle (1H:1V) for the upper part as shown in Figure 4-26. Unfortunately, the slope of the roadway cut has experienced failure, leading to debris covering the adjacent surface side drainage and nearly half of the driving lane.

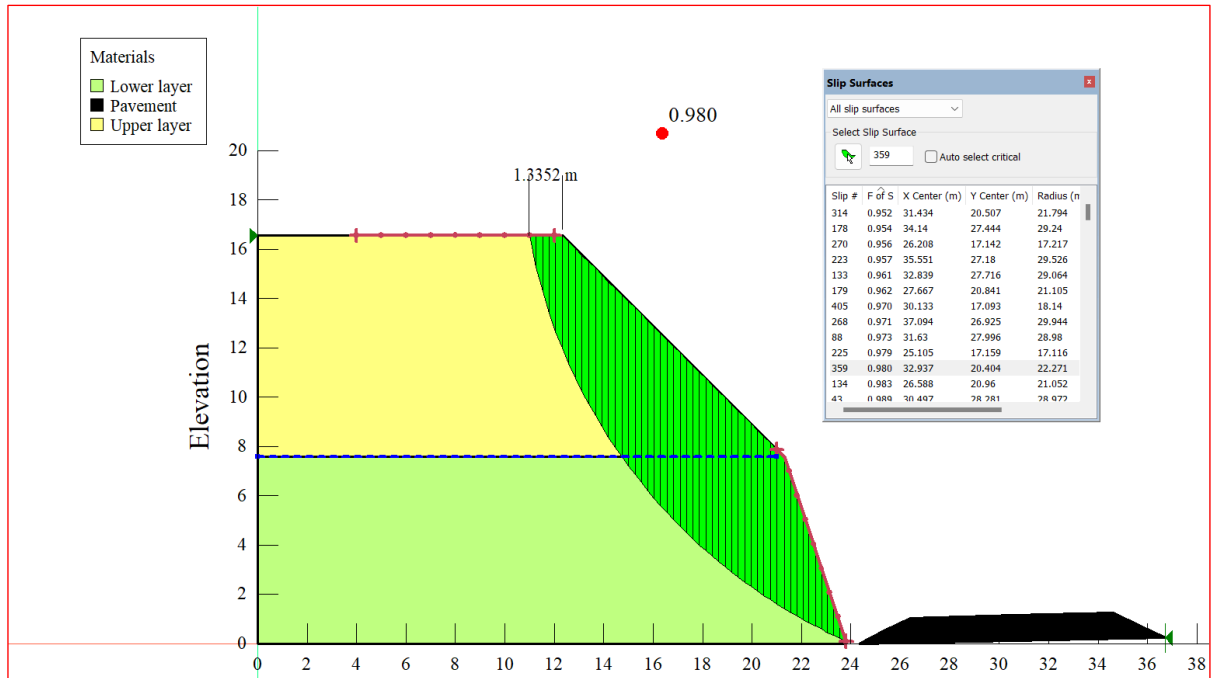
Figure 4-27: Slope stability analysis result (Bishop)

The factor of safety being less than 1 indicates that the driving forces causing the failure were greater than the resisting forces holding the slope in place.

This factor of safety which is less than 1 suggests that the slope was unable to withstand the applied loads or environmental conditions, resulting in a failure. This failure has occurred due to mainly steep slope angle.

The subsequent phase involves determining potential geometries for the failed roadside cut slope, aiming to achieve a minimum factor of safety of 1.5. Numerous iterations of slope geometries are being explored to ascertain an economically viable cut slope configuration as shown Figure 4-28.

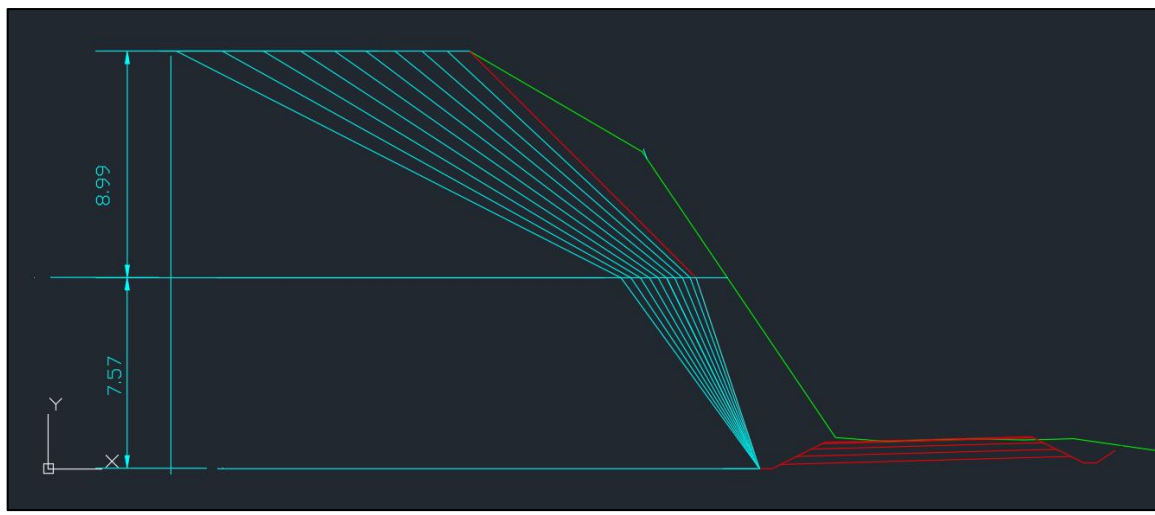
Figure 4-28: Trial slope geometries

The initial cut slopes for both the upper and lower layers were initially steeper than desired. The initial cut slope angle for the lower layer was 72° and over ten consecutive cut slopes, it was reduced by 2° each to achieve a flatter initial geometry. Similarly, for the upper layer, the initial slope was 45° and it was also reduced by 2° for ten consecutive cut slopes.

However, the overall cut slope, when subjected to slope stability analysis, proved economically impractical due to achieving a factor of safety of 1.5. Consequently, alternative geometries, including the introduction of a bench for the slope, were explored for further cut slope stability analysis.

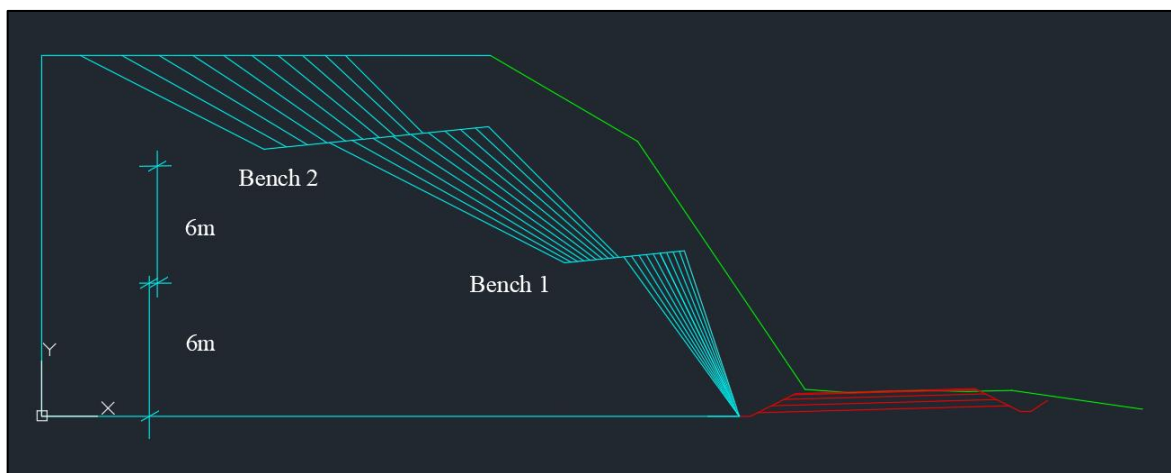
Figure 4-29: Trail cut slope geometry with two benches

According to the authoritative design manual on geotechnical issues ((ERA), Geotechnical Investigation Manual , 2013), it is recommended that cut slopes exceeding a height of 6 meters should incorporate a bench of at least 3 meters with an inward slope of not less than 10%. In light of this significant guideline for cut slopes, an attempt has been made to incorporate a bench in this particular slope and analyze its stability.

As a result, two consecutive benches were incorporated for every 6-meter increment in the cut slope height as shown in Figure 4-29. Subsequent slope stability analyses were conducted using the resultant cut slope geometry. Through multiple iterations, an economical cut slope geometry was determined, achieving a factor of 1.5, as depicted in the Figure 4-30 and Figure 4-31.

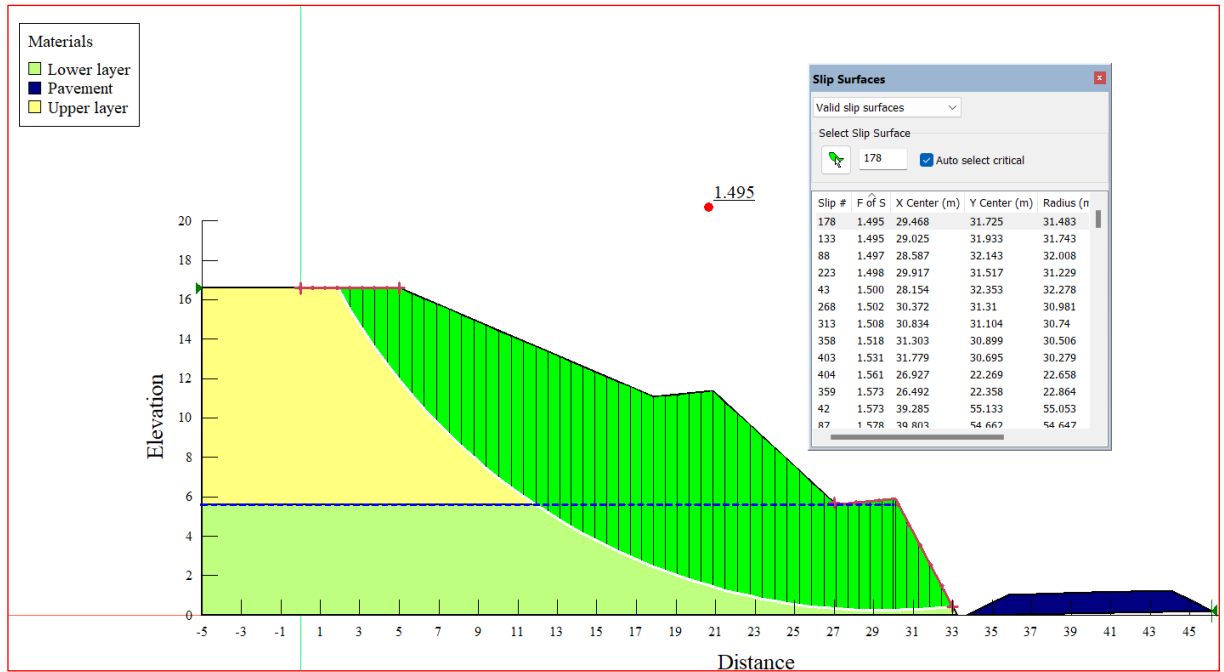
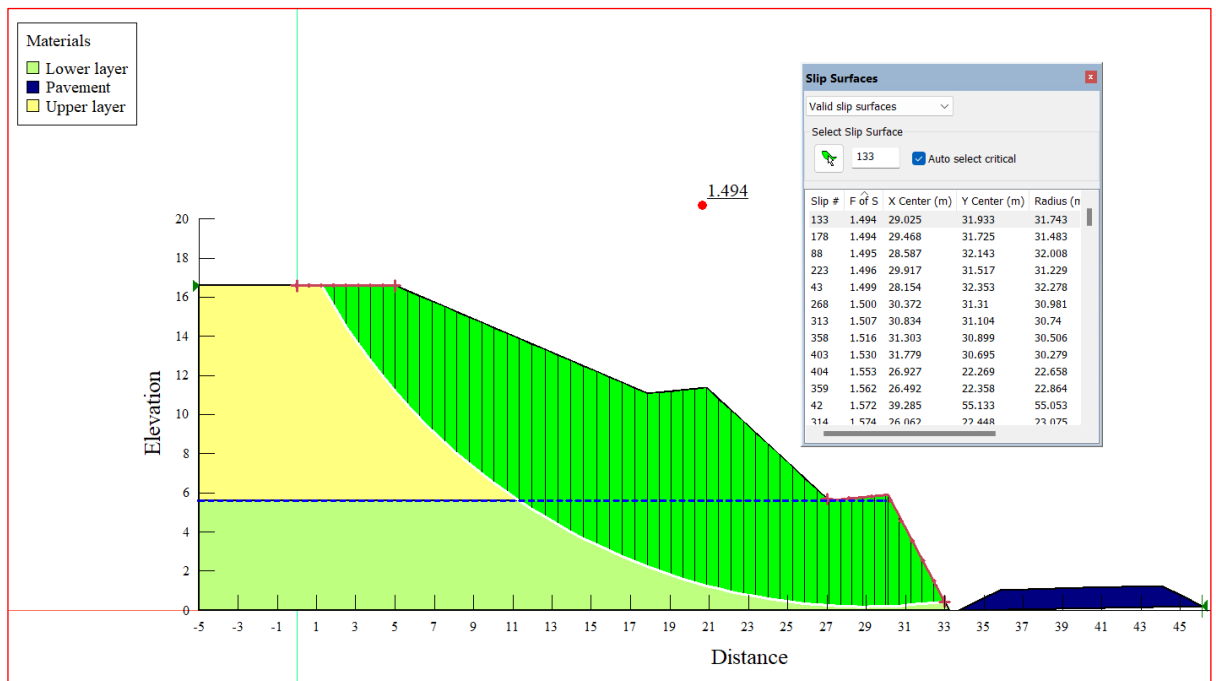
In conclusion, the primary factor contributing to the failure of the roadway cut was identified as the steep geometry during construction. Numerous iterations of new cut slope geometries were then analyzed for slope stability. The objective was to implement a flatter slope, reducing shear stress. Following the recommendations from manuals, a slope geometry with two benches, as depicted in the image above, was determined to be a safe

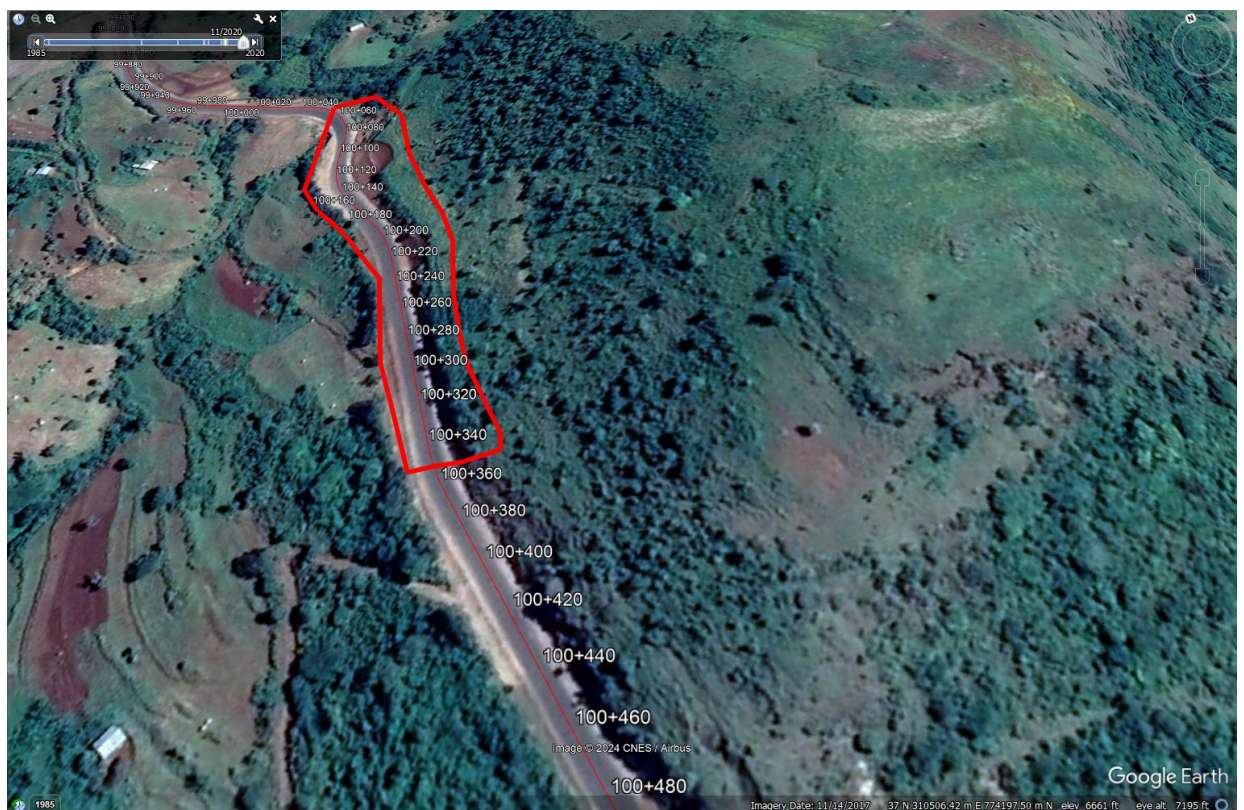
Figure 4-32: Google earth historical imagery dated November 2020 at km 100+300 (RHS)

The topography of the compromised roadway cut slope was examined using images from Google Earth’s historical imagery. As depicted in Figure 4-32, the failure of this road side cut slope spans from station km 100+060 to 100+360, covering approximately 300 meters. Contrarily, Figure 4-33 shows that the road side slope appears stable but with a reduced road width.

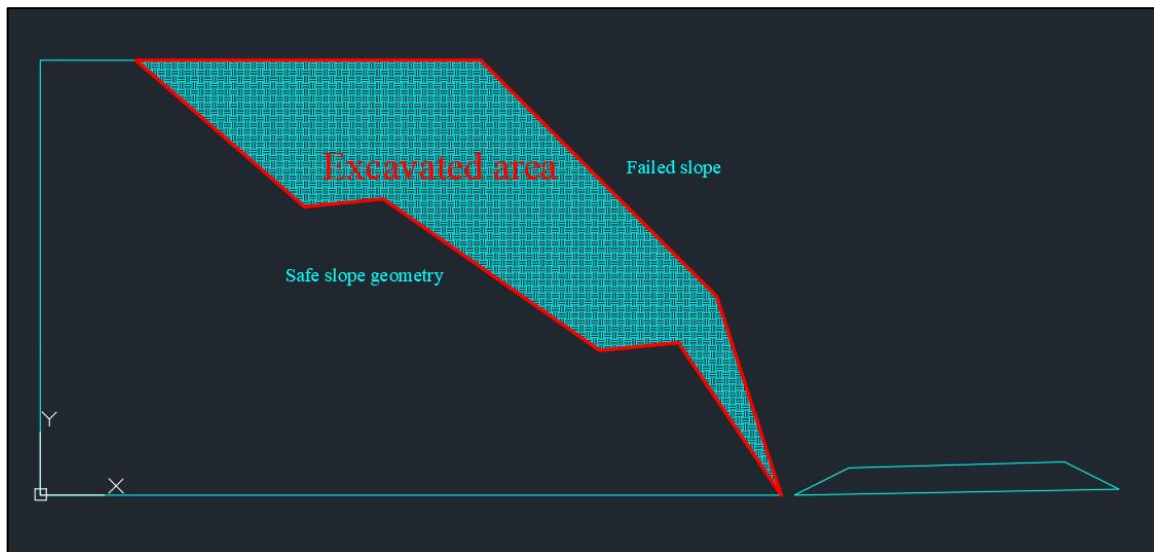
Figure 4-35: Slope flatterting

In summary, the geotechnical investigation conducted on the compromised section yielded crucial insights into the factors leading to the failure of the roadway cut slope. The analysis pinpointed the heightened driving shear stress resulting from the steep geometry as a predominant factor in the failure. Employing comprehensive geotechnical techniques, including extensive sampling, shear strength parameter determination and Geostudio modeling, a revised slope geometry has been proposed to alleviate the risks associated with the initial failure. This involves mitigating the impact of the sheared soils that have influenced into the side ditch and portions of the driving lane, extending up to the revised, flatter slope to reduce the steepness of the existing roadside cut slope.

Among several remedial measures considered within the project's context, the most effective and economical solution for addressing the ongoing slope failure involves implementing a geometrical method. This approach is not only straightforward and cost-efficient but also facilitates an easy enhancement of slope safety by transforming steeper slopes into gentler ones. The application of this method entails trimming the slope to a geometry where the factor of safety equals 1.5, inventory as shown in Figure 4-35.

The recommended remedial strategy encompasses the implementation of slope flattening, strategically adjusting the slope angle to align with the newly derived geometry. This adjustment ensures enhanced stability, minimizing the potential for future failures and mitigating the driving shear forces at play. To further fortify slope stability, it is advisable to introduce additional measures, such as grassing. Incorporating vegetation, particularly grass cover, not only enhances the visual appeal but also facilitates root reinforcement, contributing significantly to overall slope stability.

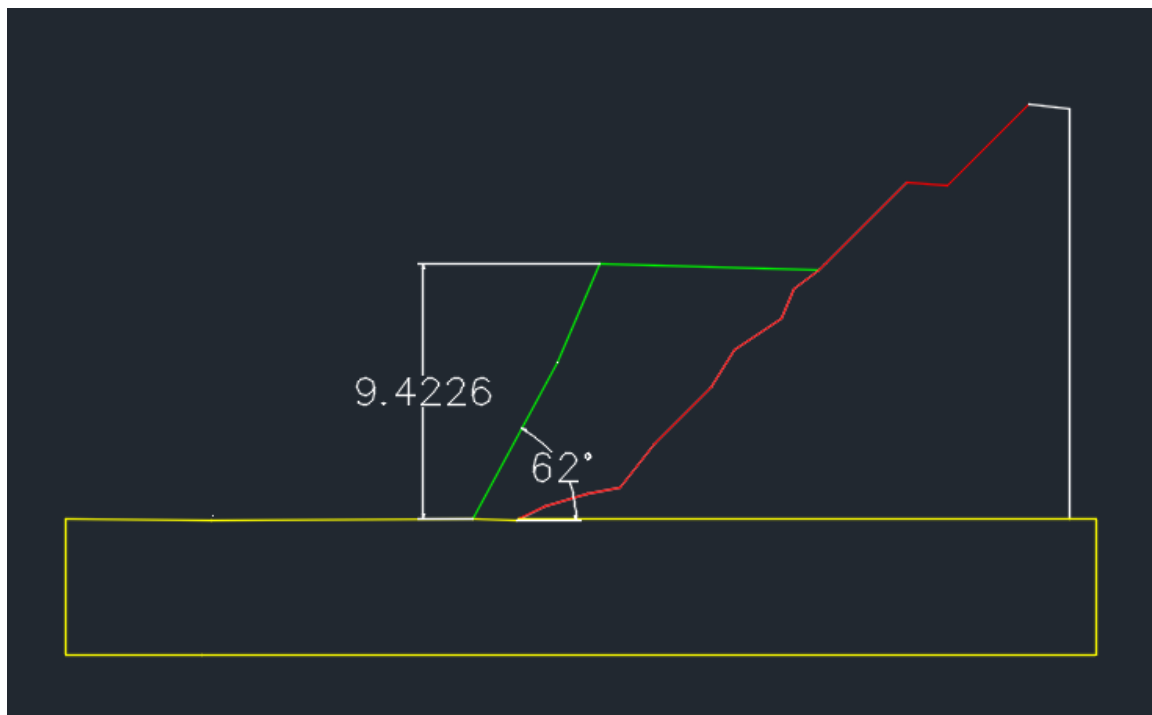
Figure 4-40: Geometry of roadside fill slope (km 126+000 LHS)

As depicted in Figure 4-40, the constructed side fill embankment at the specified station has a height of 9.43m above the original ground level, featuring a steep fill slope of 62° from the horizontal. Upon obtaining the shear strength parameters for the fill material, this

fill slope geometry was simulated for slope stability analysis. (The green line indicates the fill material finished level and the red line indicates that the original profile of the ground). Based on the topographic characteristics of the roadside fill slope mentioned above, a stability analysis was conducted using the material properties of each section. A slip surface resembling the actual failed roadside fill slope was chosen, guided by the measured length of failed fill material. Detailed site investigations revealed that the carriageway had become narrower due to the fill material's failure, with around 2 meters of the original fill slope collapsing. Utilizing data from multiple slip surfaces, the one with a failed length of 1.81 meters at the top was selected for analysis.

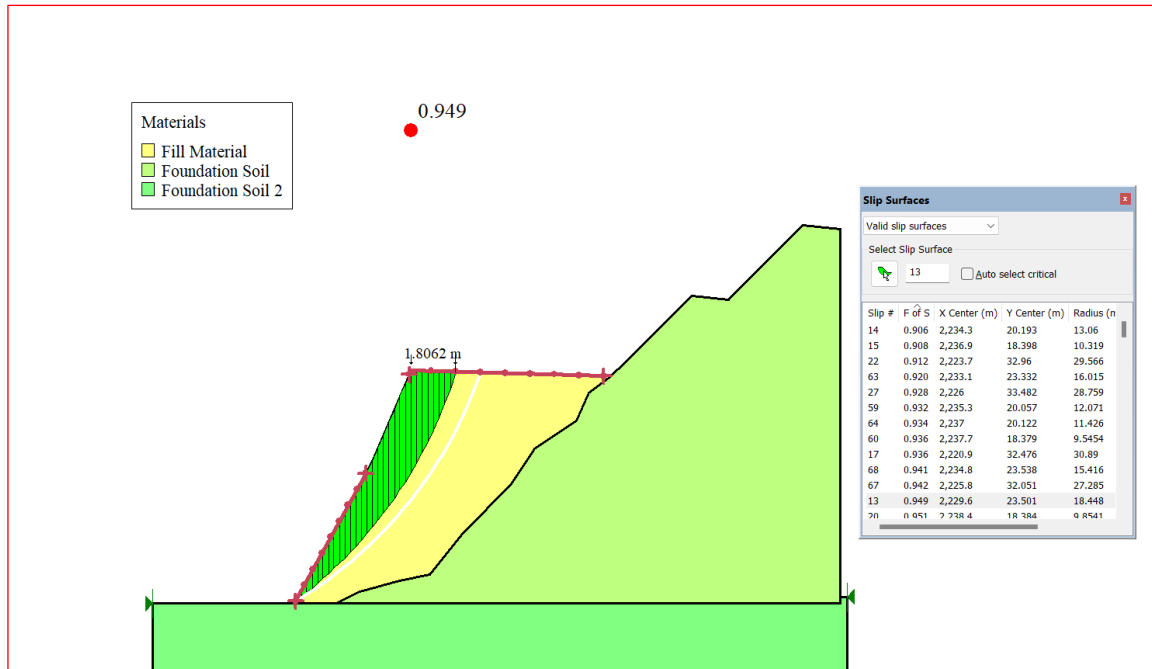
Figure 4-41: Fill slope stability analysis (Bishop)

The analysis revealed a factor of safety below the critical minimum value of 1.0. A factor of safety of 0.949 by Bishop limit equilibrium analysis as shown in Figure 4-41.

In both cases, the factors of safety are less than 1.0, signaling that the current slope conditions do not provide an adequate margin of safety against failure. It's crucial to reevaluate the slope design, consider potential contributing factors and implement appropriate remedial measures to ensure the stability of the fill slope.

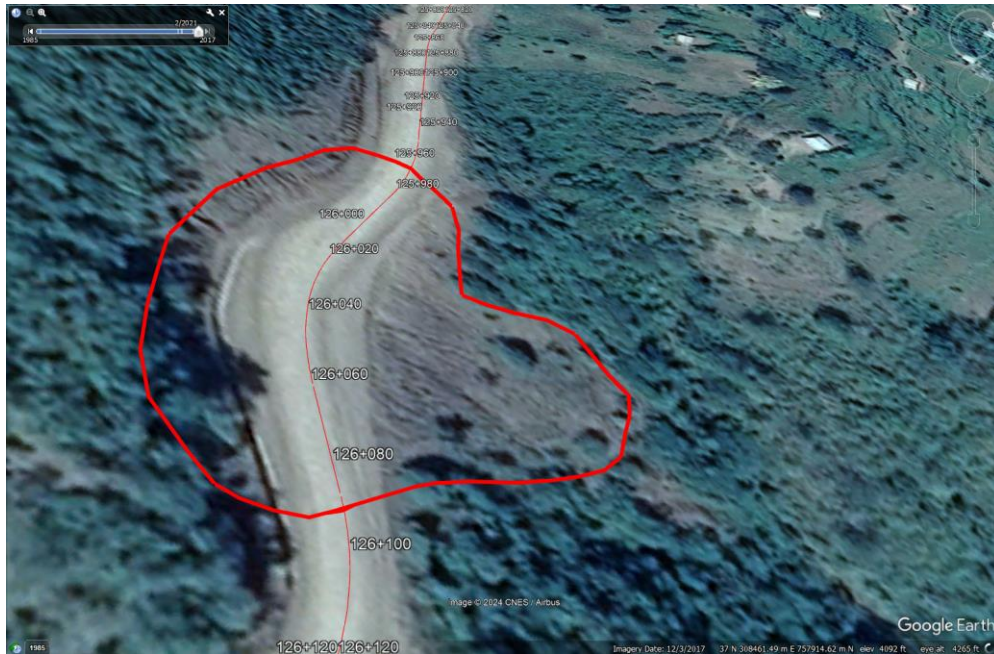
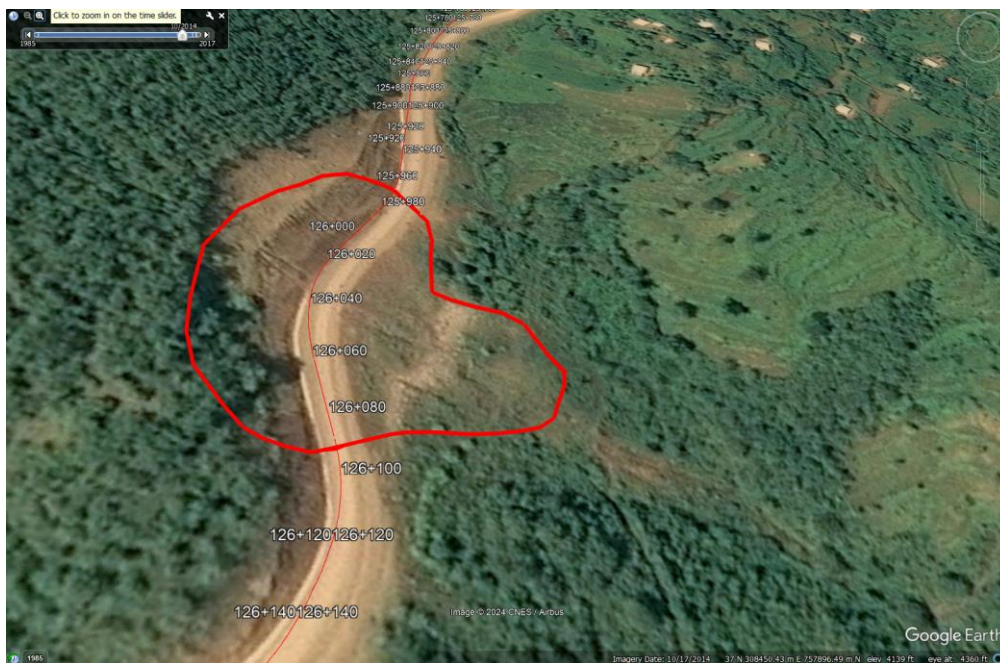
The analysis of the history of the failed roadside fill slope aimed to understand the previous topographical characteristics of the road at this particular station. Figure 4-42, depicts a seemingly stable road side fill slope, while Figure 4-43, illustrates the failure of the road side fill attributed to the steep angle of the fill slope. The extent of this fill slope failure spans from station km 126+090 to 125+980, covering approximately 110 meters.

Currently, no remedial measures have been implemented, rendering it impossible for two vehicles to use the road simultaneously. The narrowed road width, resulting from the failure of the side fill, necessitates one vehicle to wait for the other to pass.

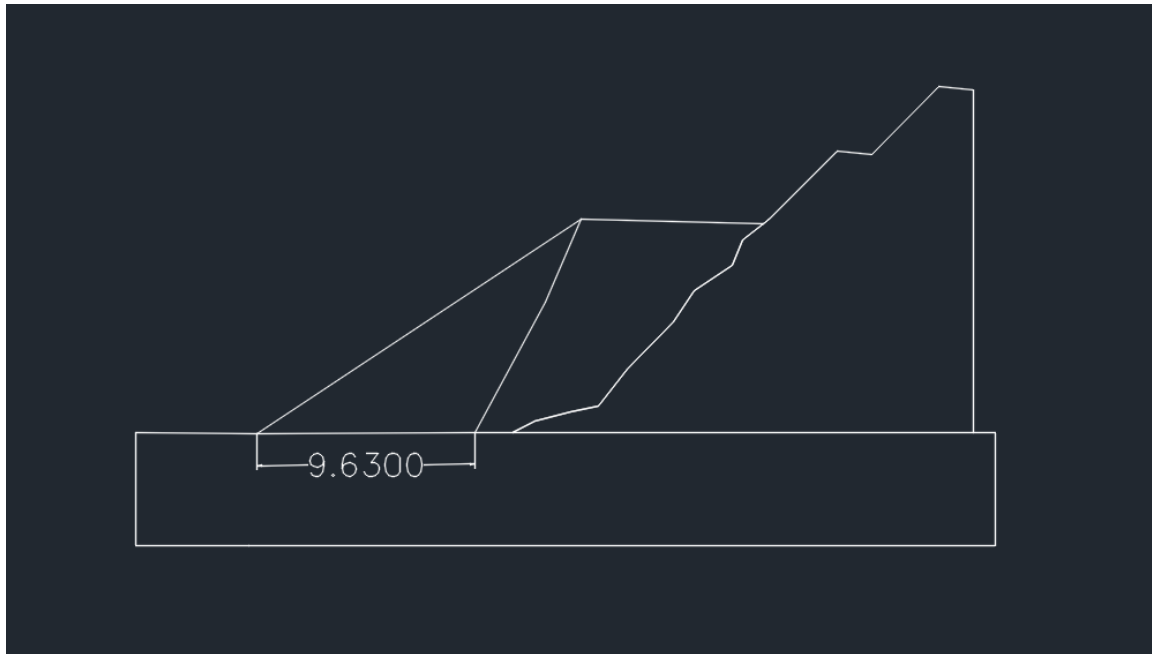
Figure 4-46: Safe fill slope geometry with additional space

Examining the cross section of the roadway fill slope above, the initial angle of 62° proved unsafe, resulting in failure. The slope stability analysis identified 33° as the safest angle for the fill slope. However, adopting this gentler slope requires additional space, approximately 9.63 m as shown in Figure 4-46. Considering the right-of-way limitations, stakeholders assert that the initially provided slope angle was the maximum feasible within the restricted area. Hence, an alternative approach is necessary to ensure the safety of the fill slope.

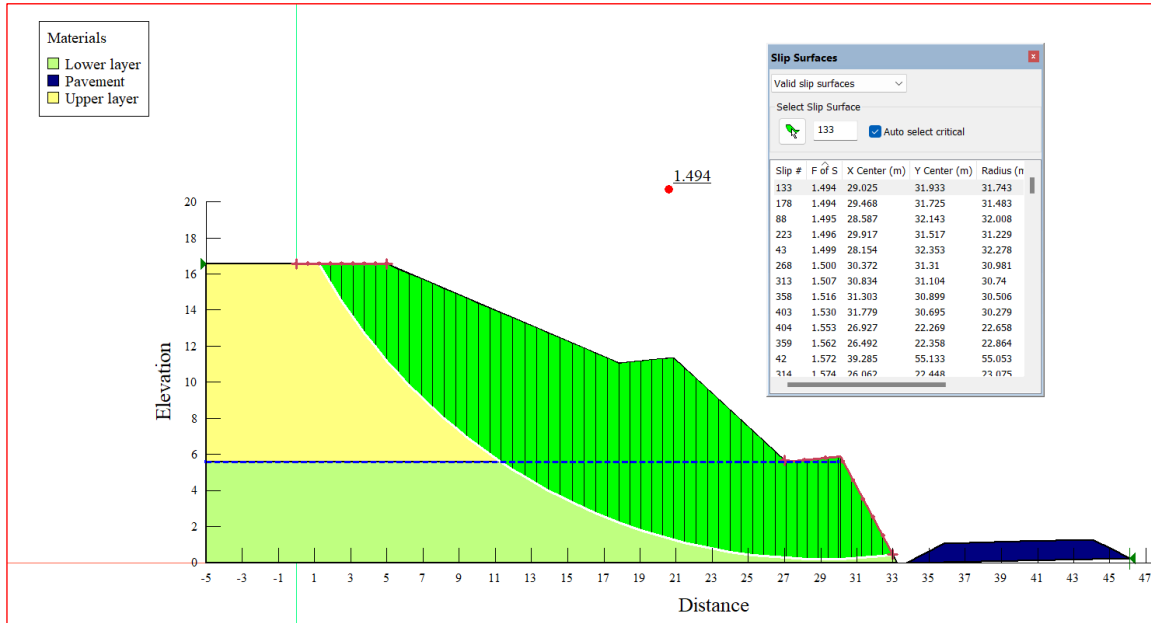
4	100+300 (RHS)	<p>Identified geotechnical problem:</p> <ul style="list-style-type: none"> • Roadway cut slope failure. <p>Observed failure signs:</p> <ul style="list-style-type: none"> • Slumping • Land slide • Debris fall <p>Failure causes:</p> <ul style="list-style-type: none"> • Steeper geometry of cut slope during construction.

Limit equilibrium slope stability analysis cut slope (100+300 RHS), **F.S = 1.494**

<p>Proposed remedial measure:</p> <ul style="list-style-type: none"> • Slope flattering with introduction of benches and grassing.
5	126+000 (RHS)	<p>Identified geotechnical problem:</p> <ul style="list-style-type: none"> • Roadway side fill slope failure. <p>Observed failure signs:</p> <ul style="list-style-type: none"> • Visible significant cracks on the fill slope surface. • Roadside fill slope exhibits noticeable bulging and deformation on its surface. • The surface of the road pavement shows notable signs of extensive cracking and settlement. • Vegetation disturbance and slope debris accumulations. <p>Failure causes:</p> <ul style="list-style-type: none"> • Insufficient compaction of the fill material, its density does not meet the specified minimum compaction standards. • Steeper fill slope construction due to limited space of ROW. <p>Proposed remedial measure:</p> <ul style="list-style-type: none"> • Geo-grid reinforced fill slope.

- Apply slope flattening: For steeper roadway cut slope, in order to decrease the driving mass and to make it stable slope it is recommend to flatter the slope by removing the soil up to a geometry with acceptable factor of safety against stability.

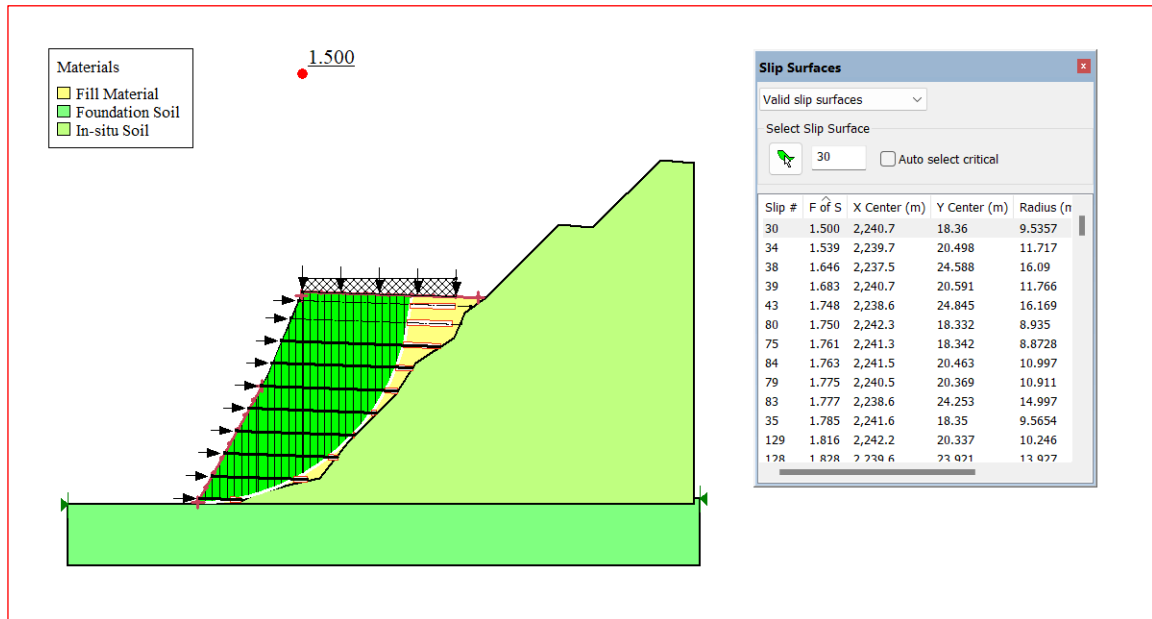
Limit equilibrium slope stability analysis reinforced fill slope (126+000), **F.S = 1.500**
