## **INVESTIGATION ON CAUSES OF LAND SLIDE IN THE BLUE NILE BASIN (GOHATSION-DEJEN ROAD AS A CASE STUDY)**

A Thesis Submitted to the School of Graduate Studies of Addis Ababa University  
in Partial Fulfillment of the Requirement for the Degree of Master of Science in  
Civil Engineering

**July 2013**

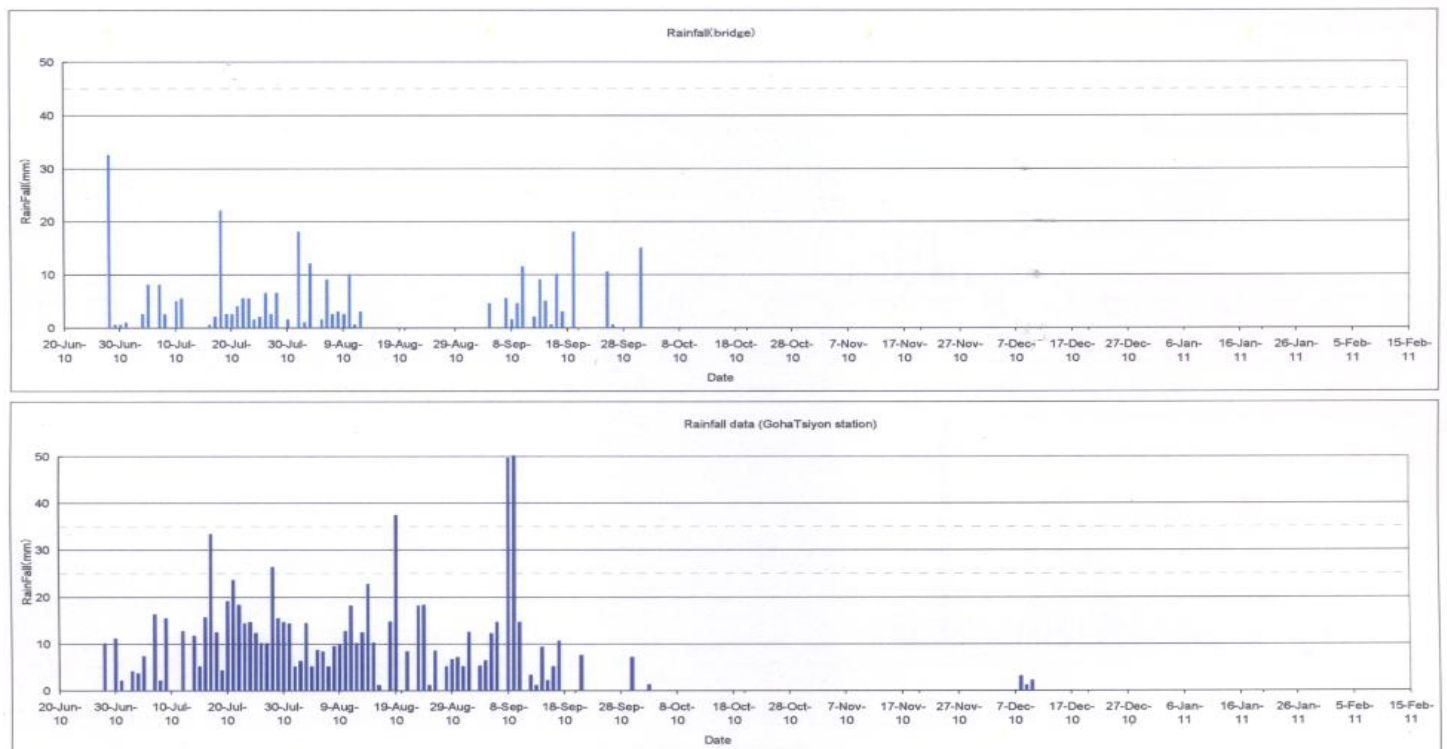
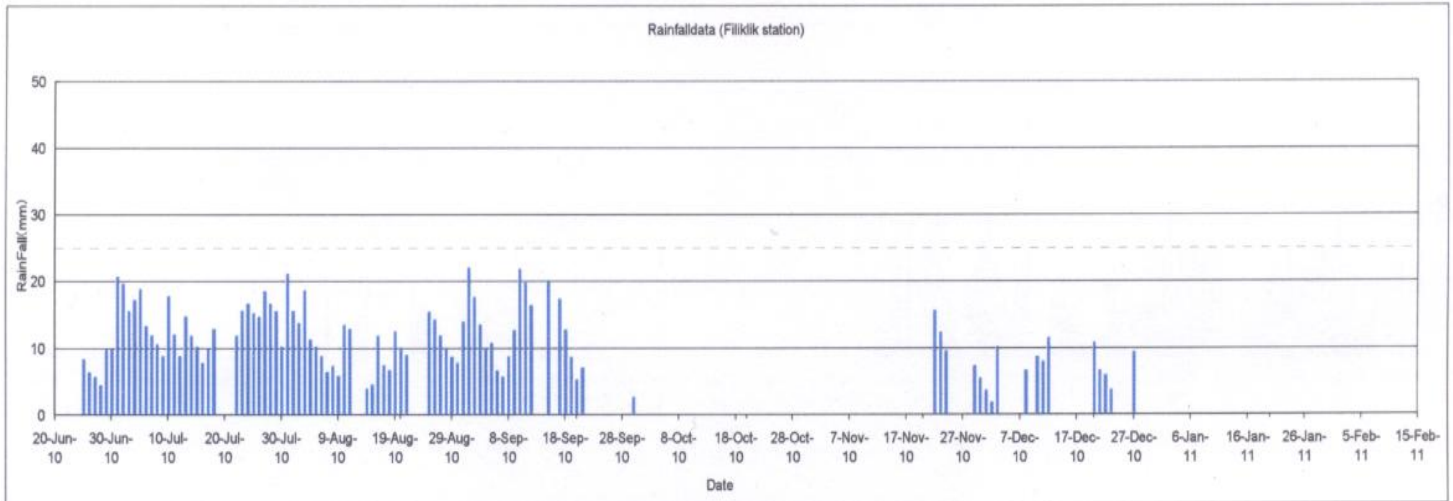
Figure 3-3 Rain fall Reading at Bridge station, Gohatsion station and Fliklik station (3)

From the Extensometer reading it has been observed that there is expansion in displacement around 15mm this also corresponds to the rainy season June to October as i have seen from rain fall data. At the middle of October it is observed that magnificent increment of displacement is recorded this is due to external disturbance of the Invar Line (wire) of the extensometer because there is no visible change in the cracks.

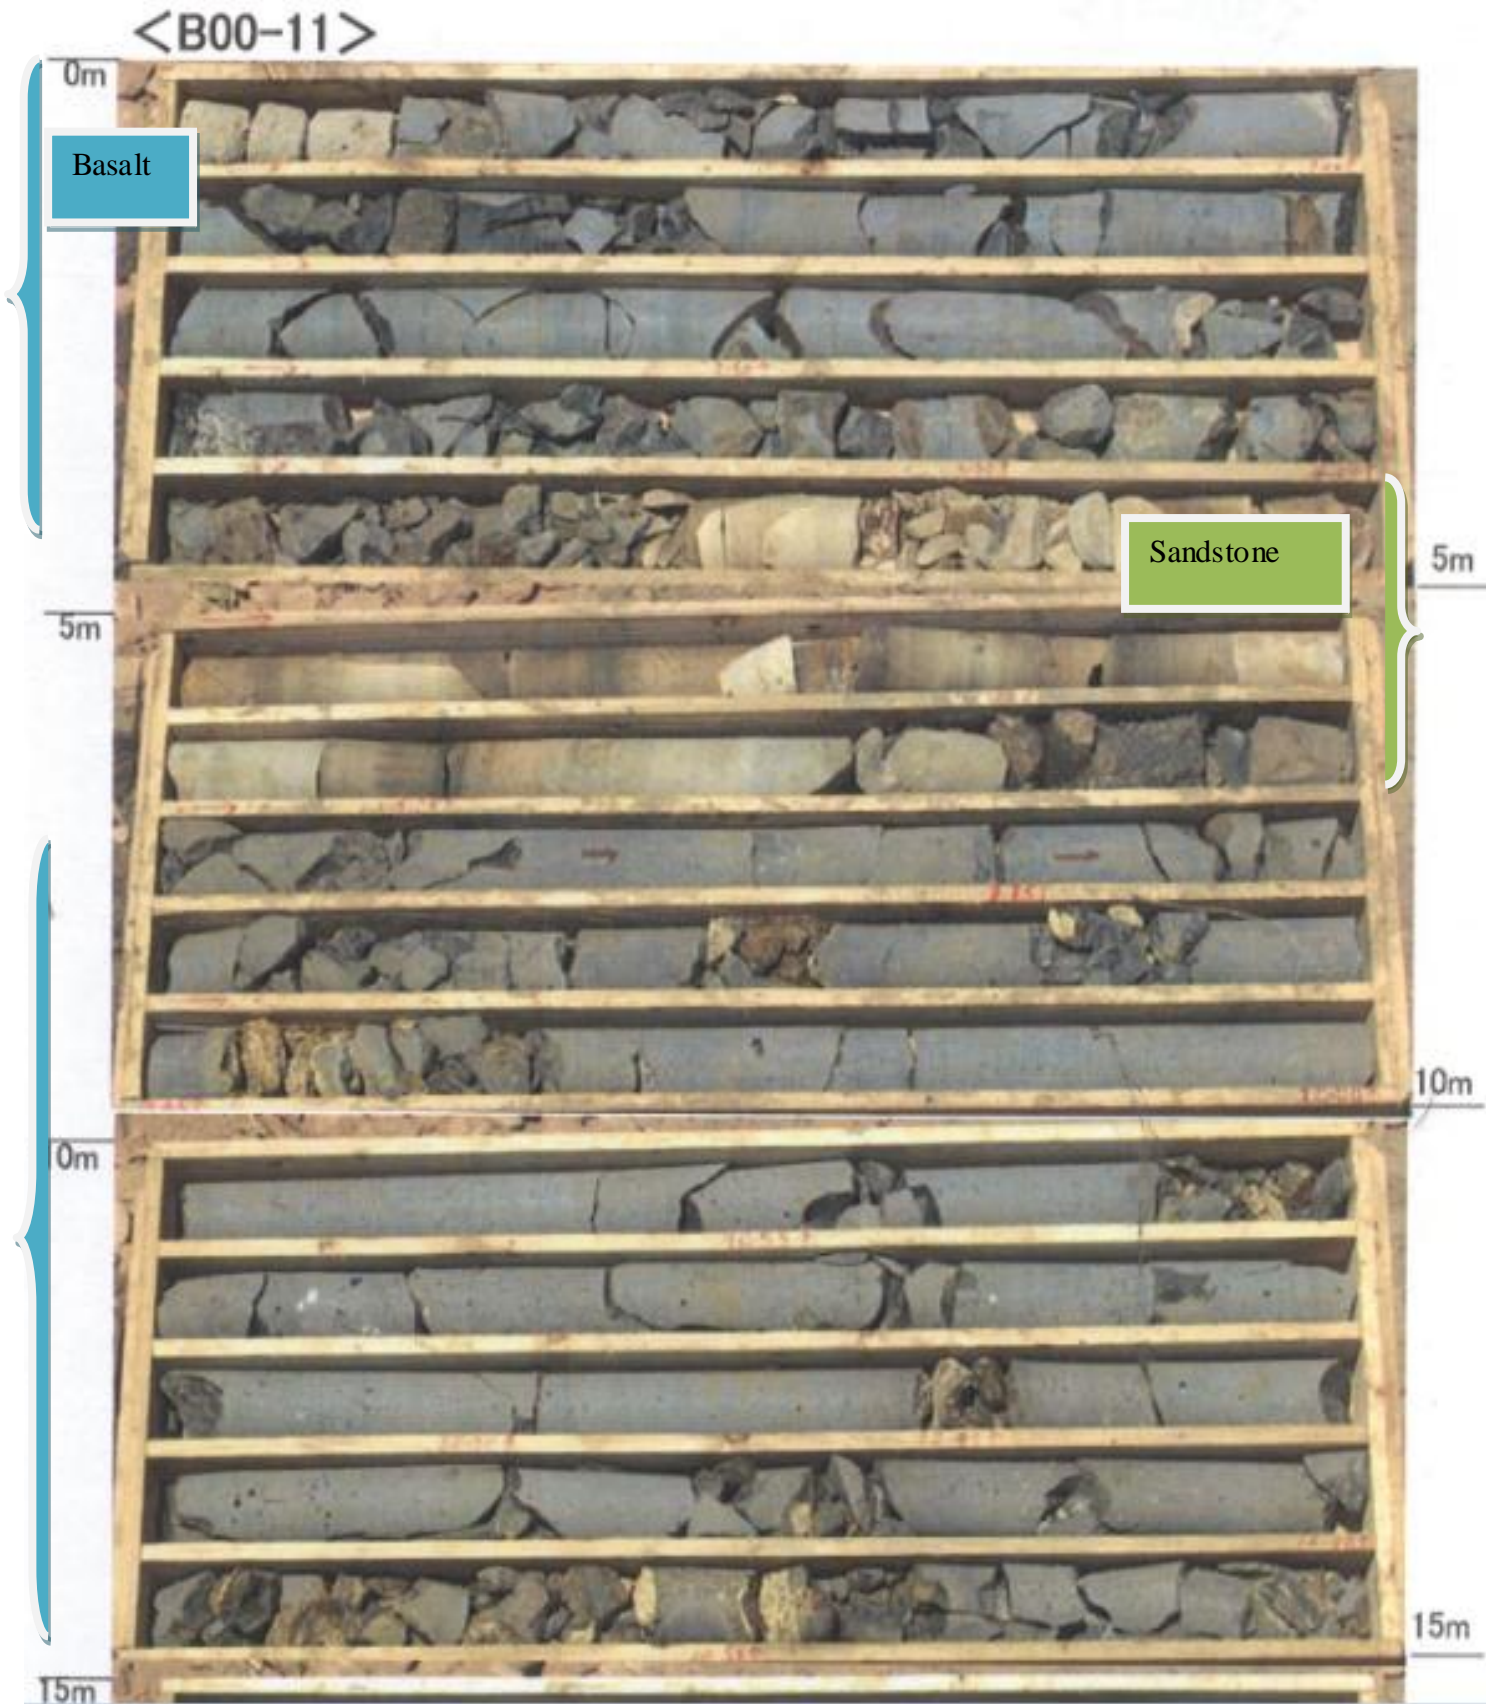
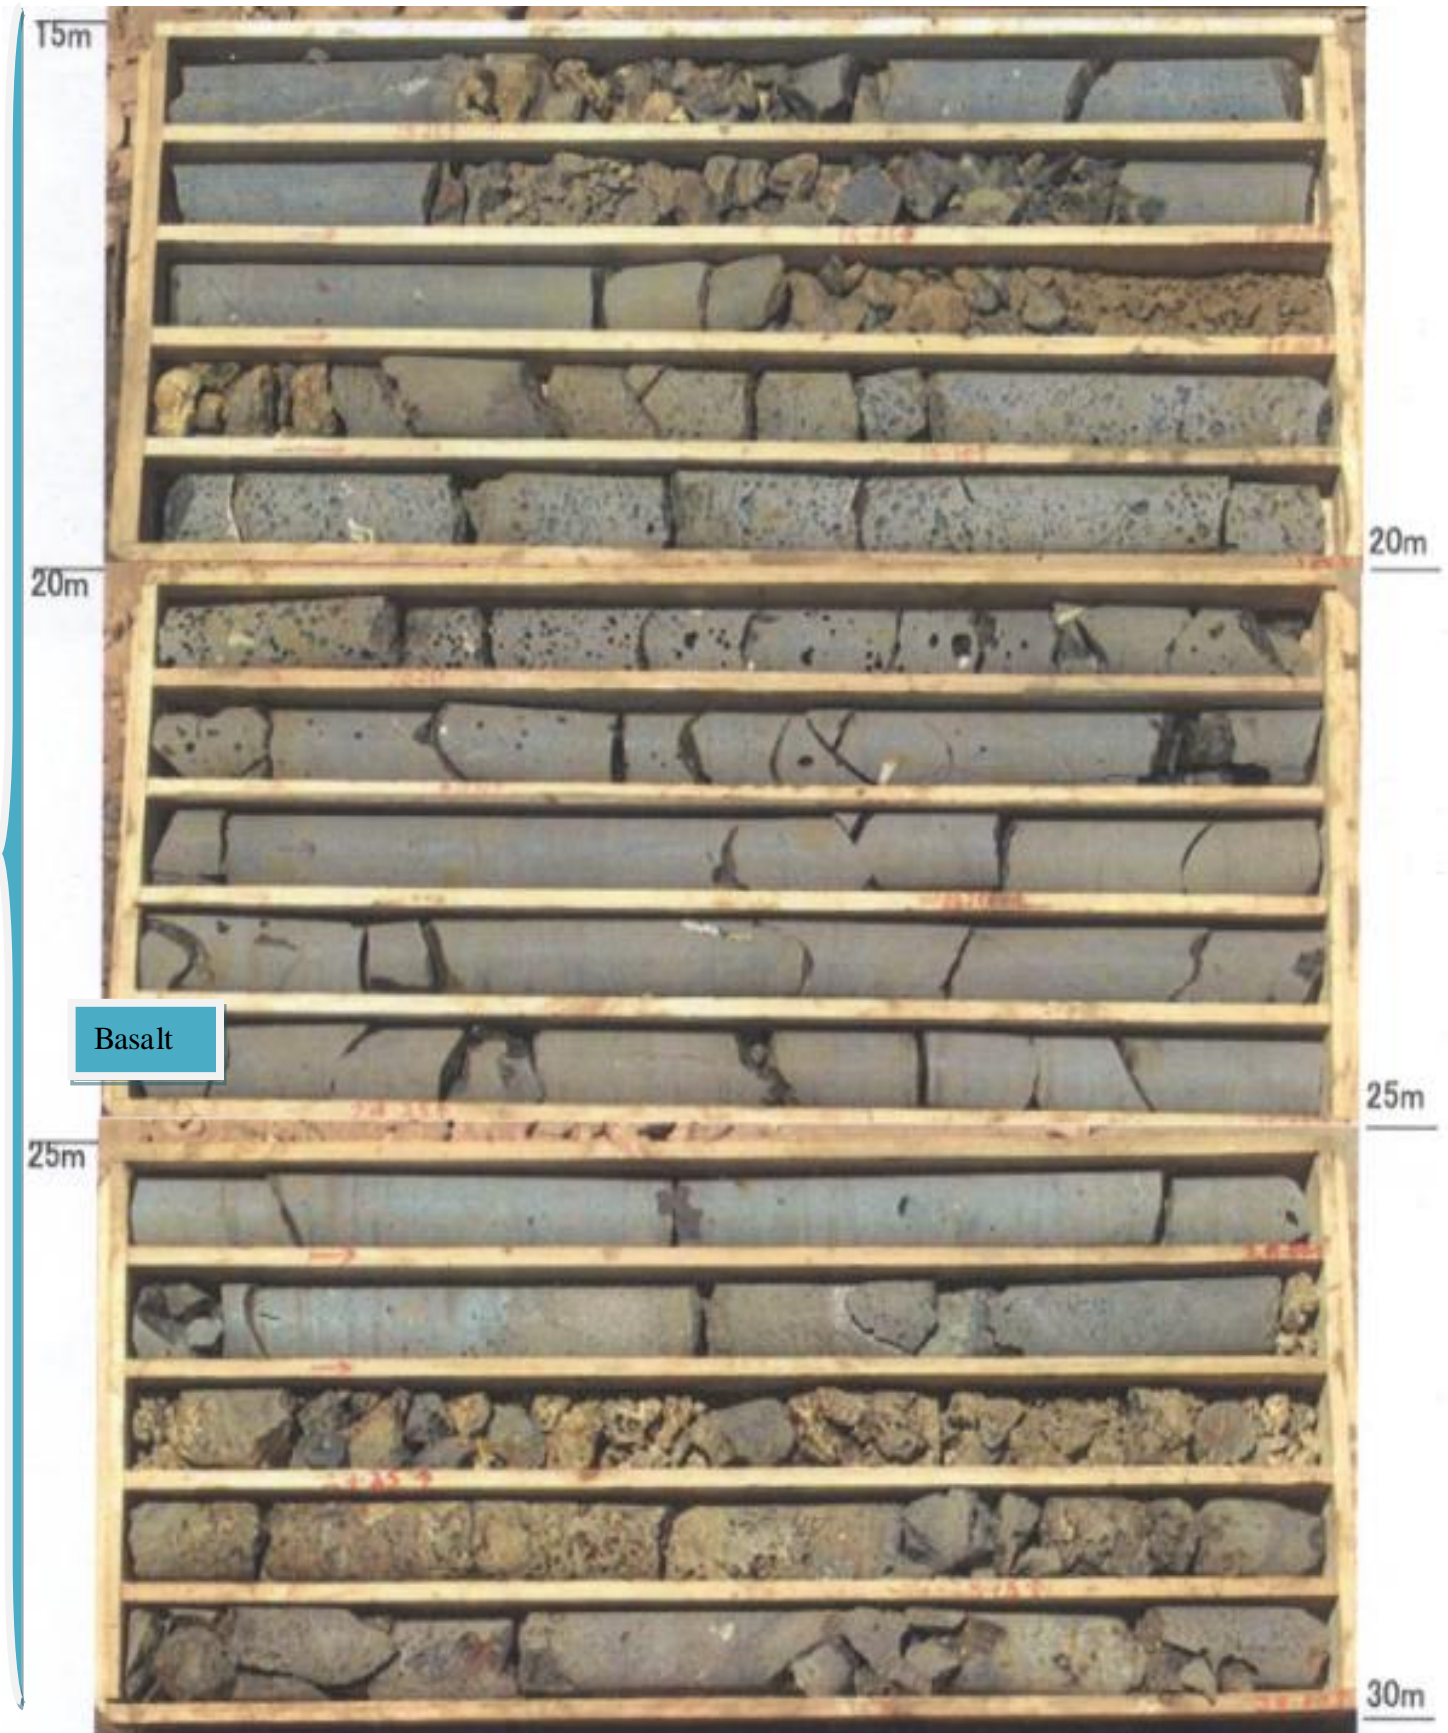
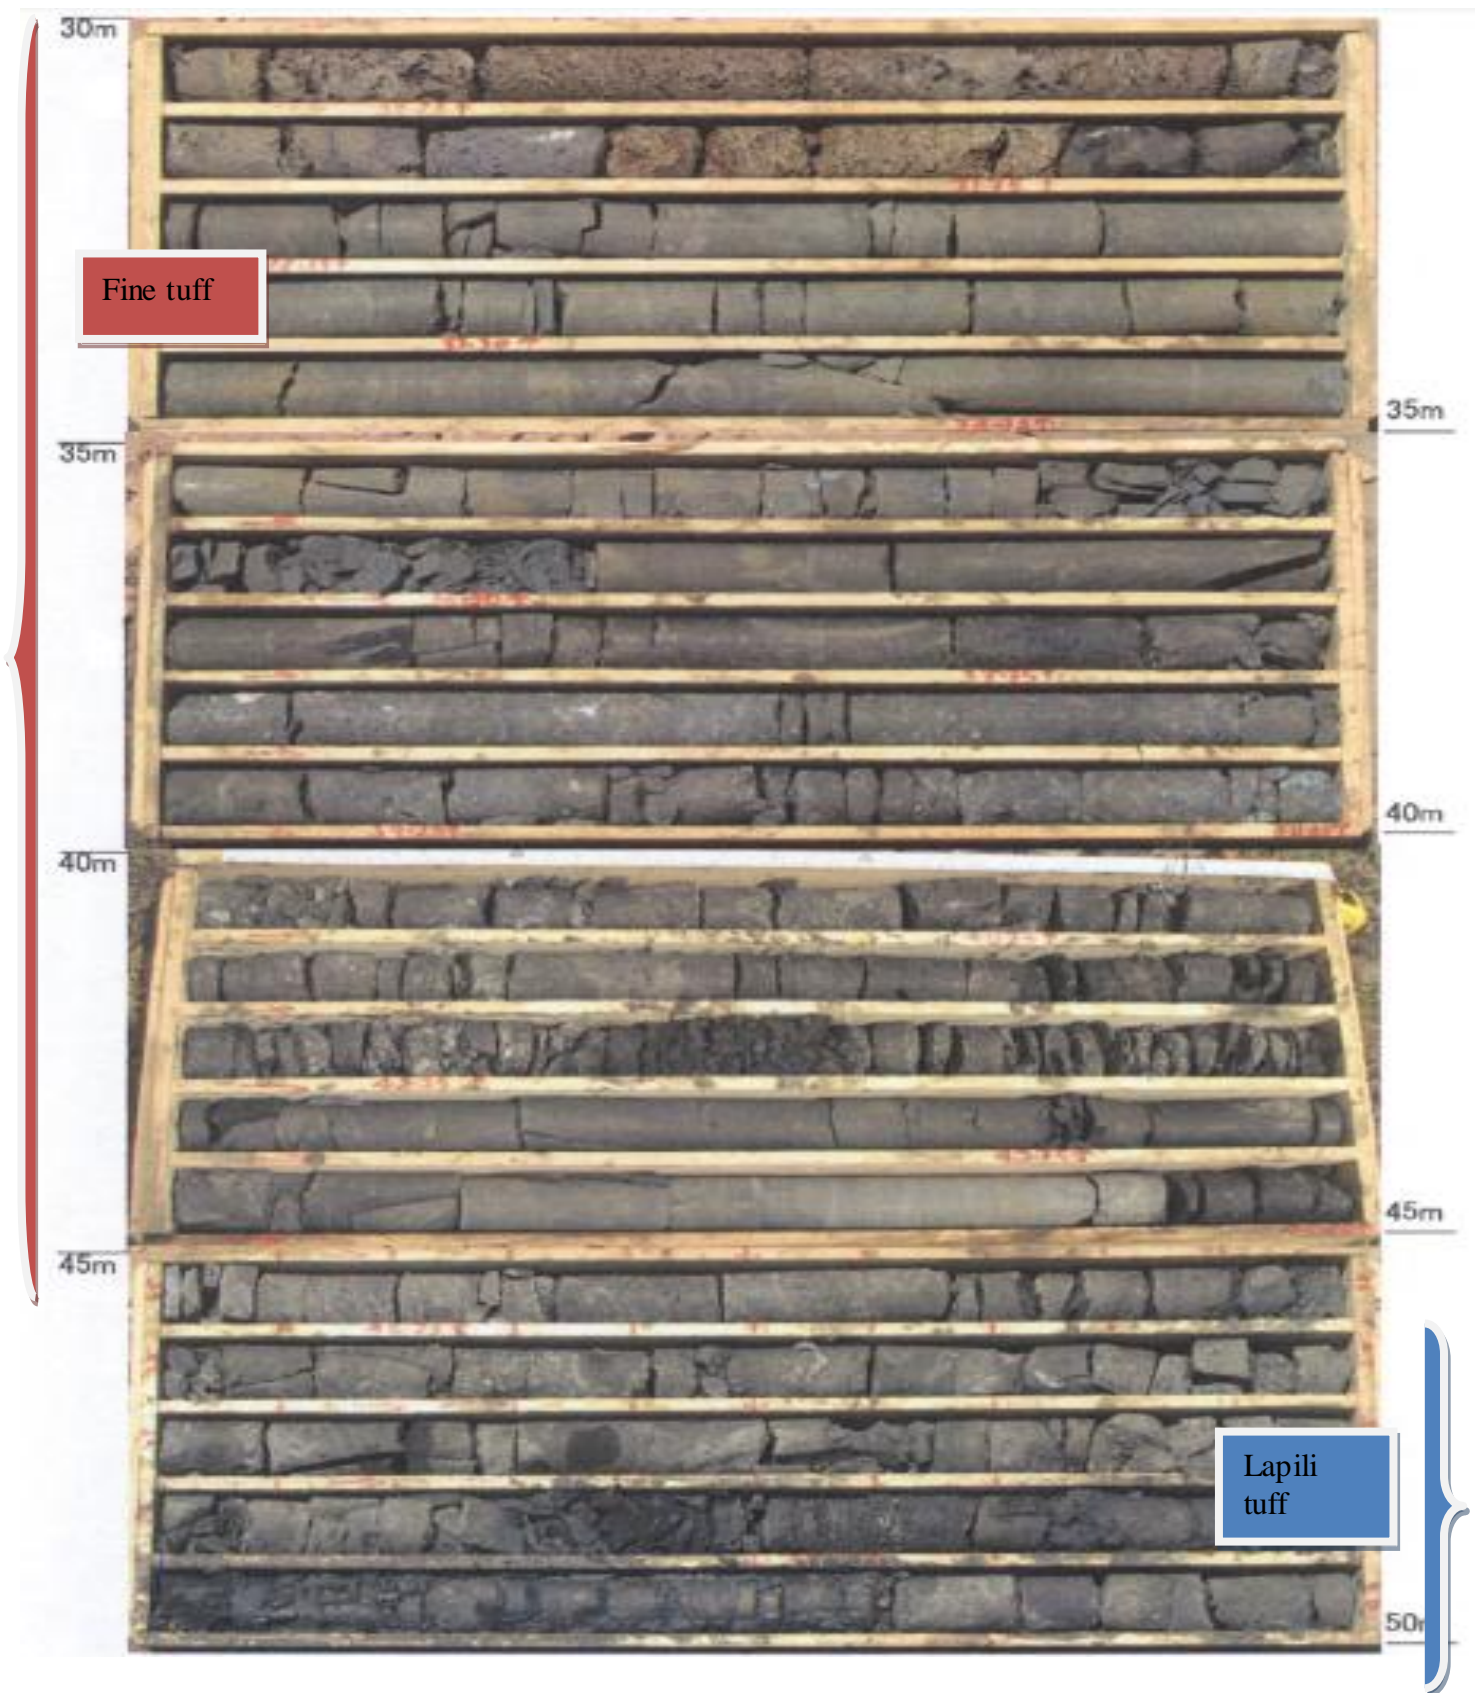
Figure 3-10 Core photographs for Bore Hole 11 at L/S00

11.0						bluish grey	relatively high	very hard	relatively fresh	2-35cm			90	30	55				
12.0													100	33	63				
13.0											Fractured cores around cracks or calcite veins with red-brown in color by weathering are found at 8.5m, 8.8m, 9.1m, 10.9m and 12.7m depth, which indicates groundwater path. Cracks at 14.0-14.6m, 15.25-15.6m, 16.25-16.85m depth are dominantly weathered with clay, sand and gravel.		100	28	69

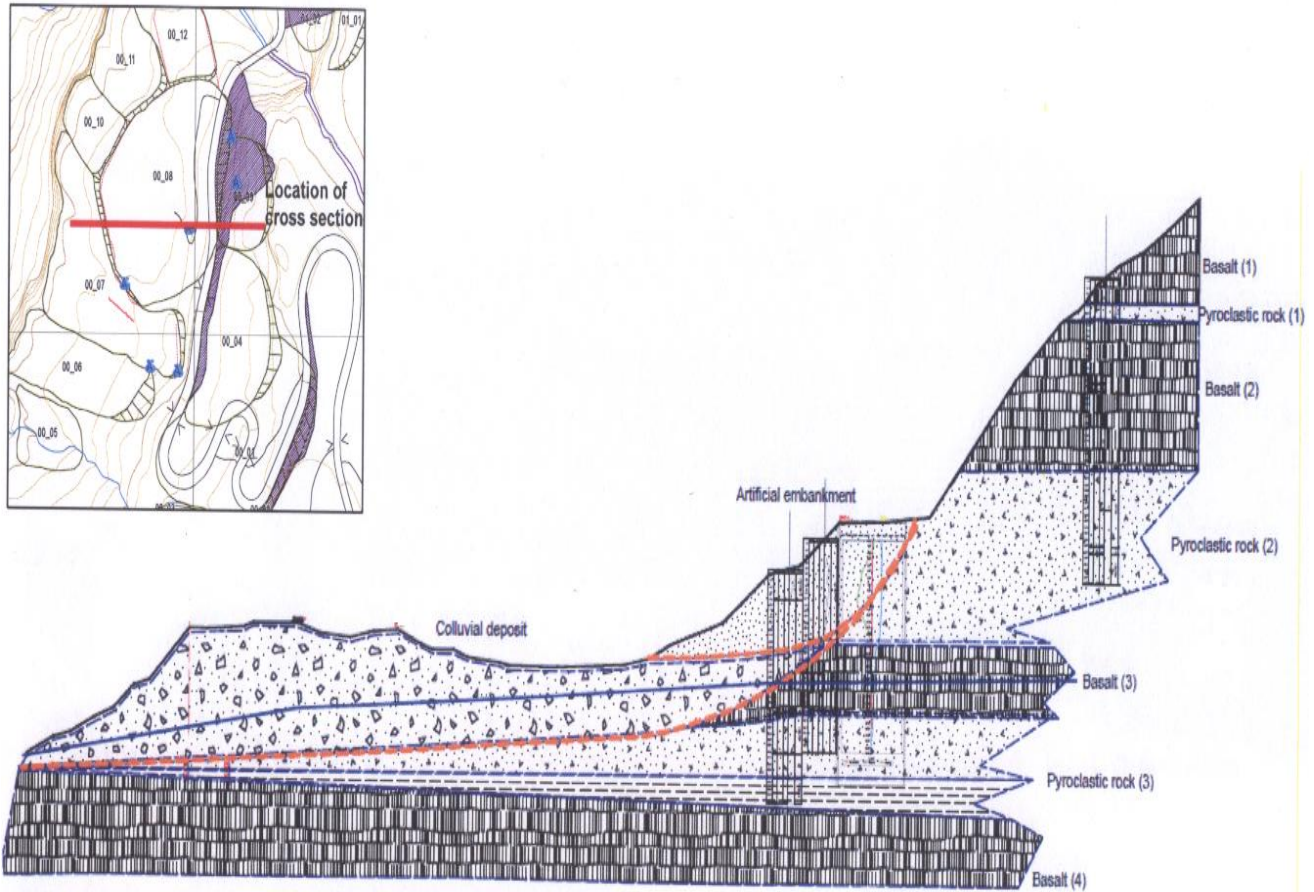
Figure 4-1 Geological cross section in L/S00 (3)

The basalt is widely exposed as steep escarpments over 100 m thick below the area. The unit is mainly black to dark grey and has clearly developed columnar joints which are mainly horizontal direction (around 20-100 cm). The top surface of the unit forms flat plane under this area, and it is exposed on the river surface next to the landslide site. Water permeability of the layer is controlled by the columnar joints and it is considered to be high.

Representative geological cross section is prepared on the basis of the geological features of landslide block in the previous description.

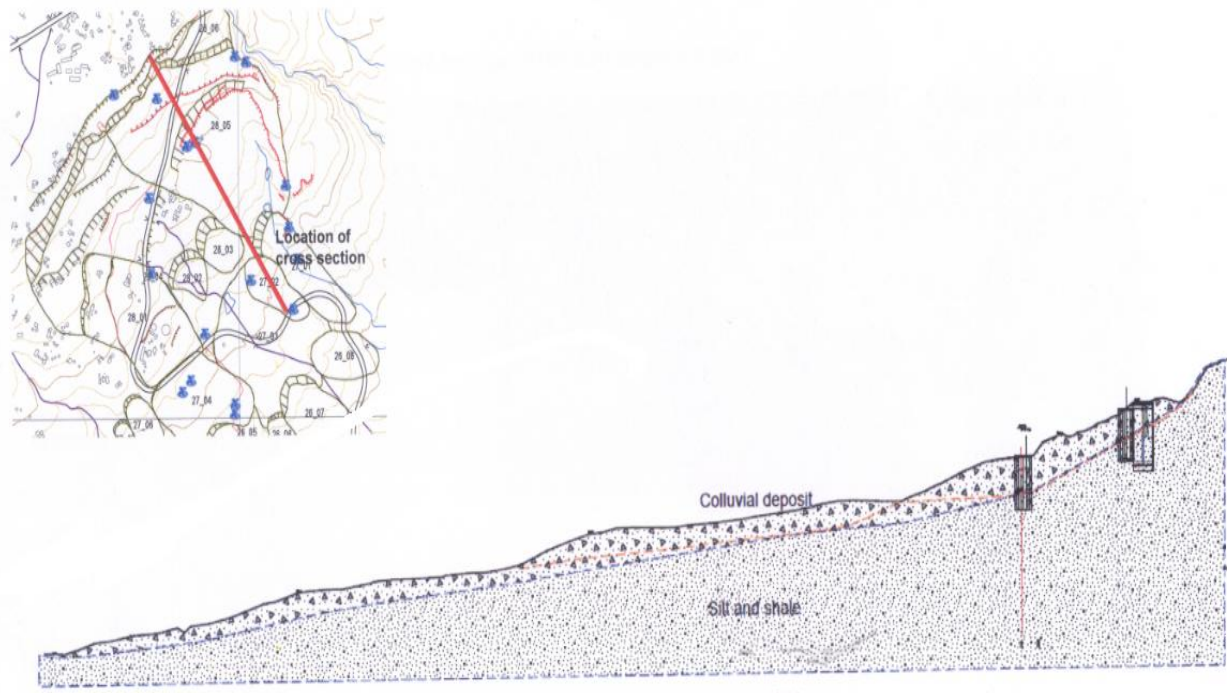
Figure 4-2 Geological cross section in L/S28 (3)

These units are mainly composed of siltstone and shale with minor limestone. These are mixed up with sliding soil mass in the area where landsides frequently happens, especially in the rainy season, therefore it is difficult to classify the sliding soil. The siltstone unit is composed of silt/clay particles cemented together. It is found intercalated with shale, mudstone and sandstone with calcite and/or gypsum veins in places. The color is white brown to reddish brown which have been weathered and yellowish green to brownish grey which are relatively fresh. The shale unit is argillaceous clastic sedimentary rock which contains a lot of clay minerals. A part of the shale is totally changed to clay by weathering, which is relatively soft and weak due to weathering.

The layers are susceptible to weathering and erosion, therefore the area shows an almost flat plane and/or gentle slope in the village area. In this area a gentle slope is formed by removed soil and has lots of landslide forms. Representative geological cross section is prepared on the basis of the geological features of landslide block in the previous description.

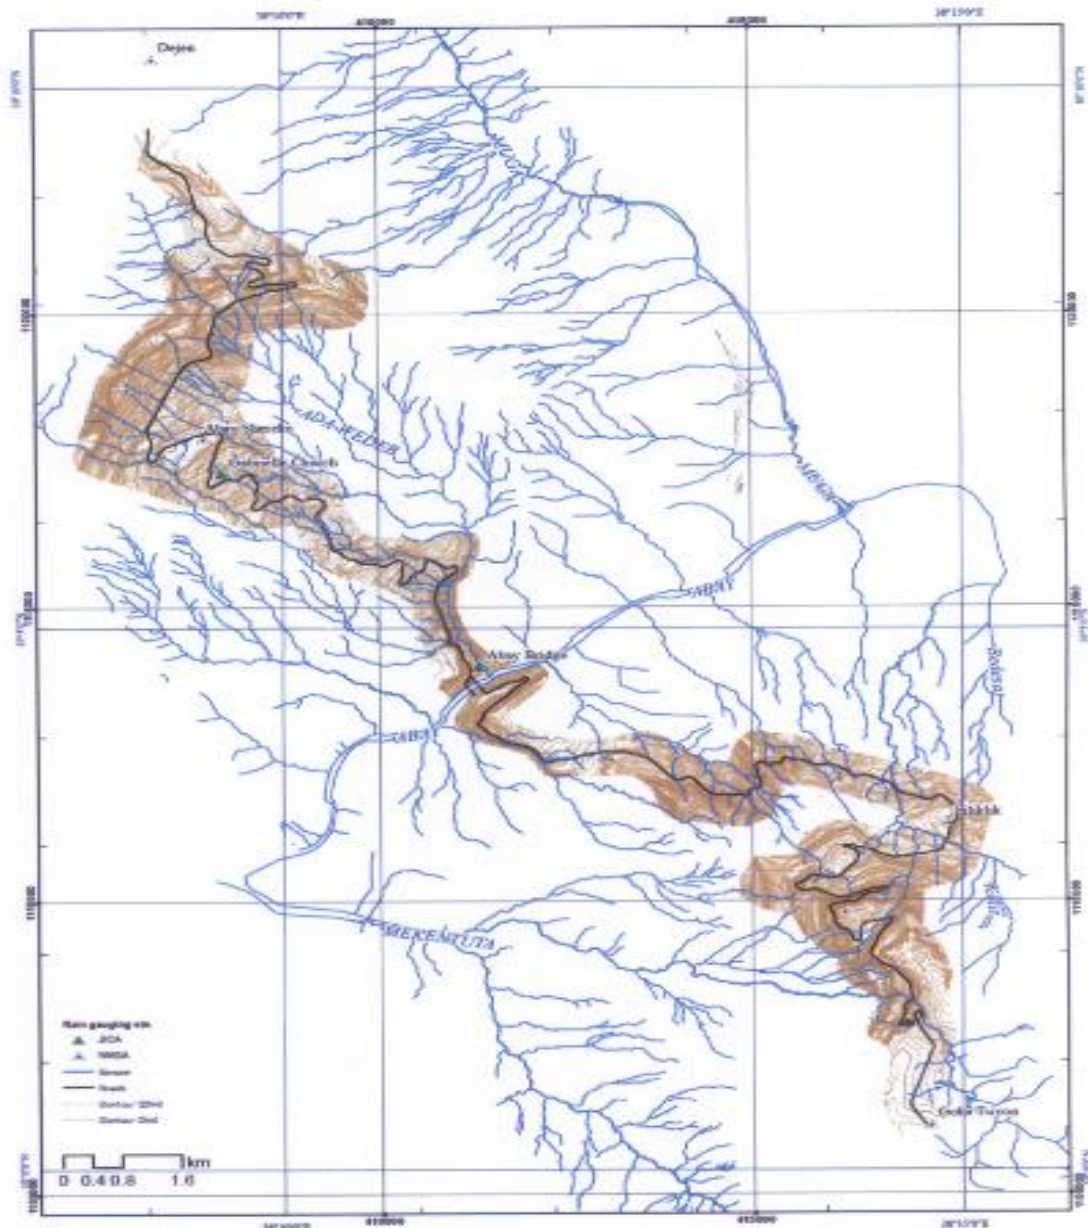
Figure 4-3 Drainage network (3)

The presence of streams and spring waters greatly influences the stability by toe erosion or by saturating the slope material or both. It is clear that the water which flowed into the osmosis and the mountain streams of surface water by rain turned into groundwater, and has contributed to the rise of the groundwater level. In the area high drainage density is observed. The Drainage network prepared by the JICA project shows the river network of the section between Dejen and Gohatsion.

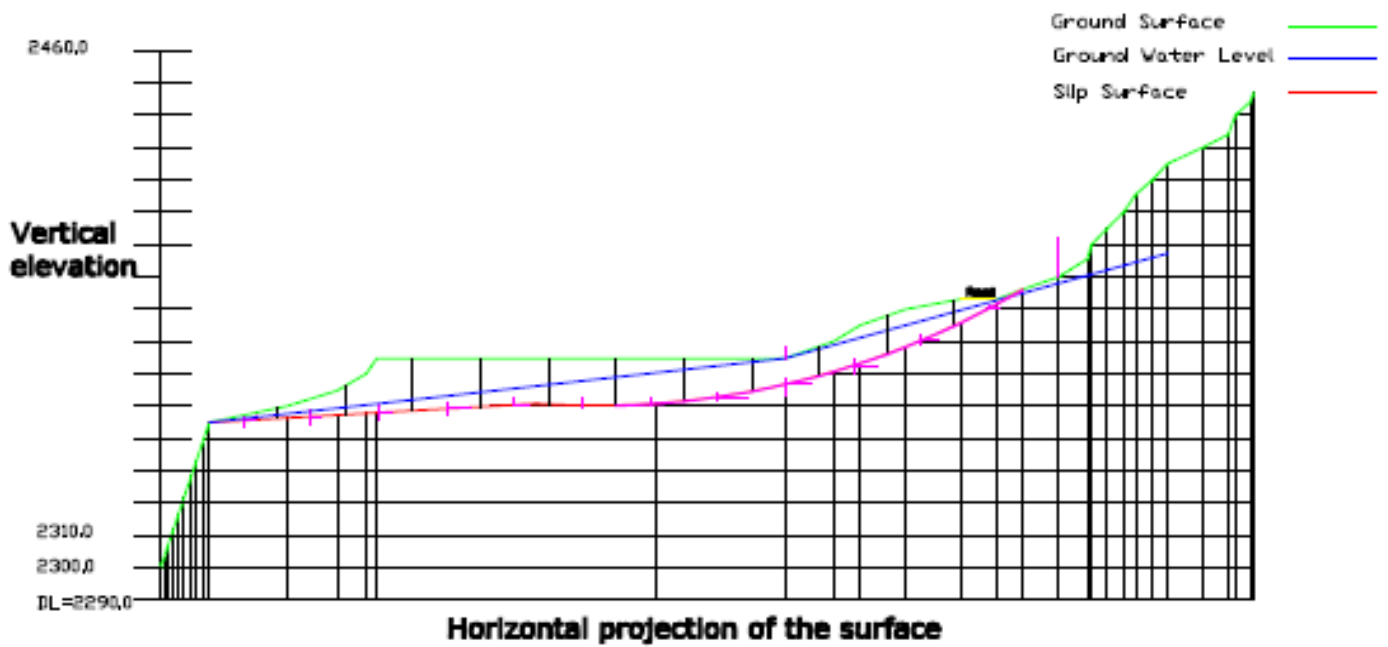
Figure 4-7 Shows Land slide block with Slice at L/S00

For the Back Analysis of L/S00 in the CAD drawing below any necessary data for analysis is taken from the drawing such as slice length  $l_i(m)$  , average height of slice  $h_{av}(m)$  , inclination angle of slip surface  $\alpha_i(o)$  , starting slice height  $h_i(m)$  , ending slice height  $h_{i+1}(m)$  then using the formula (1)  $F_o$  is calculated by using the following spread sheet and assuming different value of  $\phi'$  till calculated  $F_o$  is equal to  $F_o=0.98$  (Case in moving continuously for corresponding to rainfall).

In the above analysis the Colluvial deposit and Artificial backfill embankment is mainly composed of similar materials therefore the two units are assumed to be having similar unit weight and angle of internal friction.

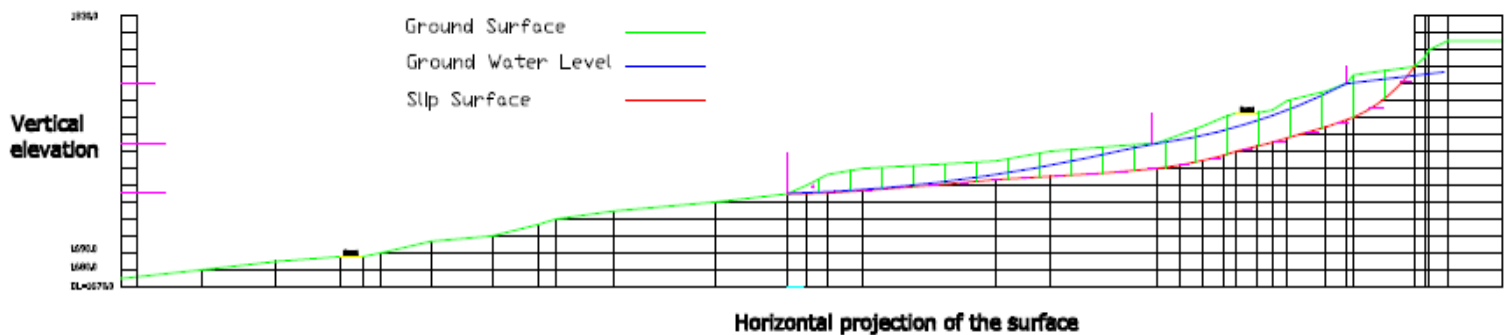
Figure 4-8 Shows Land slide block with Slice at L/S28

For the Back Analysis of L/S28 in the CAD drawing below any necessary data for analysis is taken from the drawing such as slice length  $l_i(m)$ , average height of slice  $h_{av}(m)$ , inclination angle of slip surface  $\alpha_i(o)$ , starting slice height  $h_i(m)$ , ending slice height  $h_{i+1}(m)$  then using the formula (1)  $F_o$  is calculated by using the following spread sheet and assuming different value of  $\phi'$  till calculated  $F_o$  is equal to  $F_o=0.98$  (Case in moving continuously for corresponding to rainfall).
