**ADDIS ABABA UNIVERSITY  
INSTITUTE OF TECHNOLOGY  
SCHOOL OF CIVIL AND ENVIRONMENTAL ENGINEERING**

**GEFERSA II EMBANKMENT DAM HYDRAULIC FAILURE AND  
REMEDIAL MEASURE**

**BY: KENBON HORDOFA**

**A PROJECT SUBMITTED TO THE SCHOOL OF GRADUATE STUDIES OF ADDIS  
ABABA UNIVERSITY IN PARTIAL FULFILLMENT OF THE REQUIREMENTS  
FOR THE DEGREE OF MASTERS OF SCIENCE IN HYDRAULIC ENGINEERING**

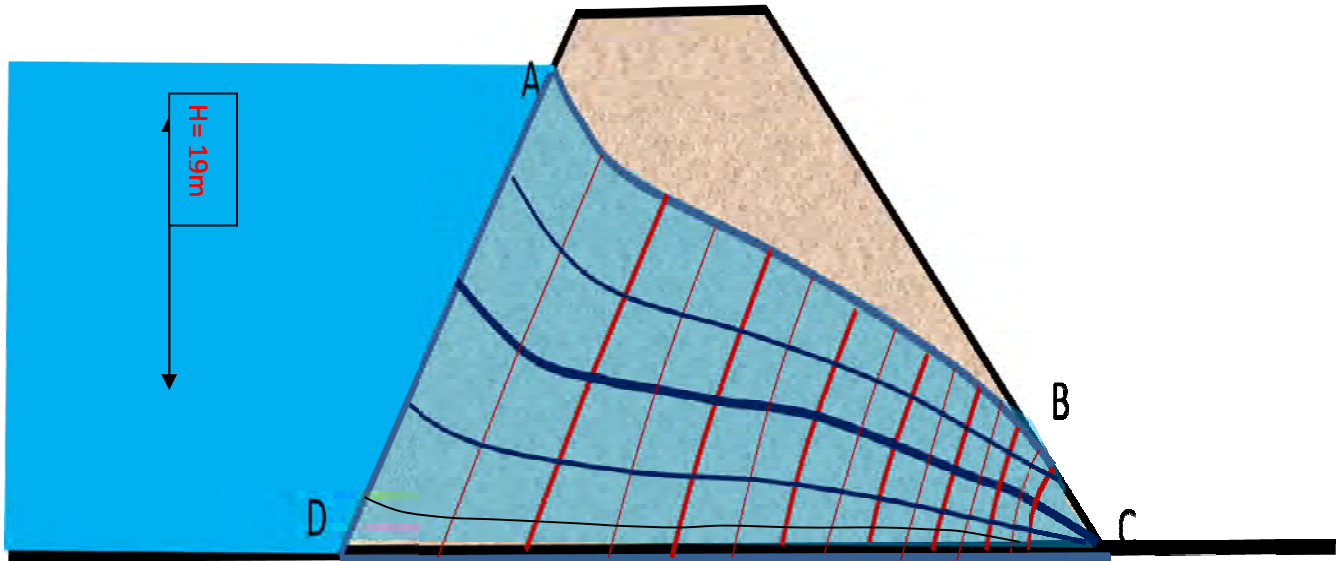
Fig 1.7 Flow net diagram for homogeneous dam

The total seepage over the full length of 48m is estimated to be  $6.24 * 10^{-5} \text{ cm}^3/\text{sec}$ .
