**Dam Heightening**

**(Case study: Gefersa I/II dam)**

**A Thesis Submitted to the School of Graduate Study of Addis Ababa University in Partial Fulfillment of  
the Degree of Master of Science (M.Sc.) in Civil and Environmental Engineering  
(Major In Hydraulic Engineering)**

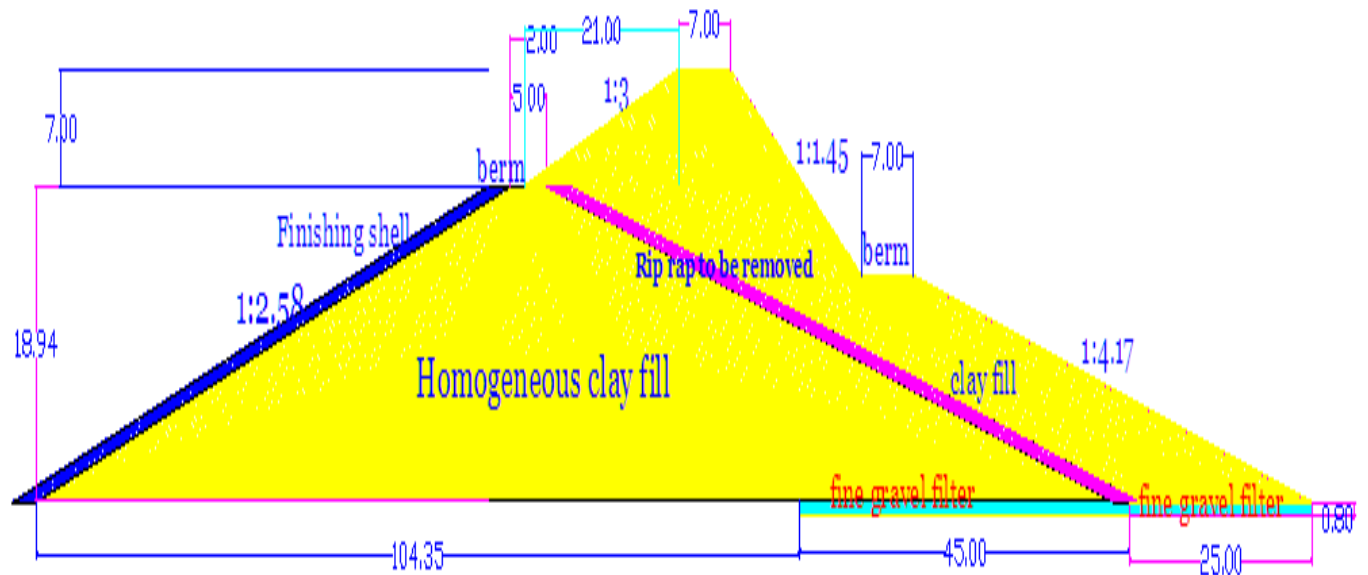
Figure 5: geometry of the heightened Gefersa I/II dam

downstream fill starts at 2m away from the upstream edge of the existing dam crest. As a result a 2m width of berm will be created in the upstream side.

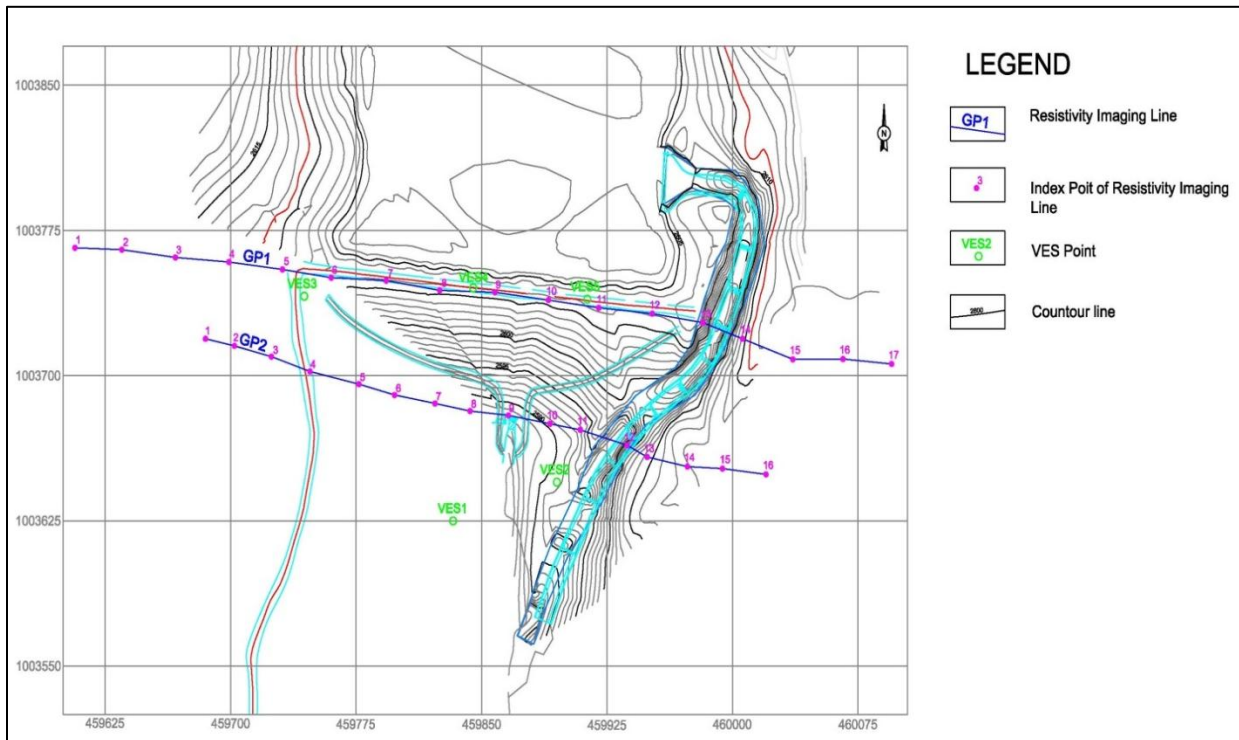
Figure 4.1: Geophysical investigation survey lines

A total of 2 resistivity imaging survey lines with a total length of 865 m were conducted. The location, length of survey line and depth of investigation are summarized in Table-1 below for corresponding electrical imaging survey lines.

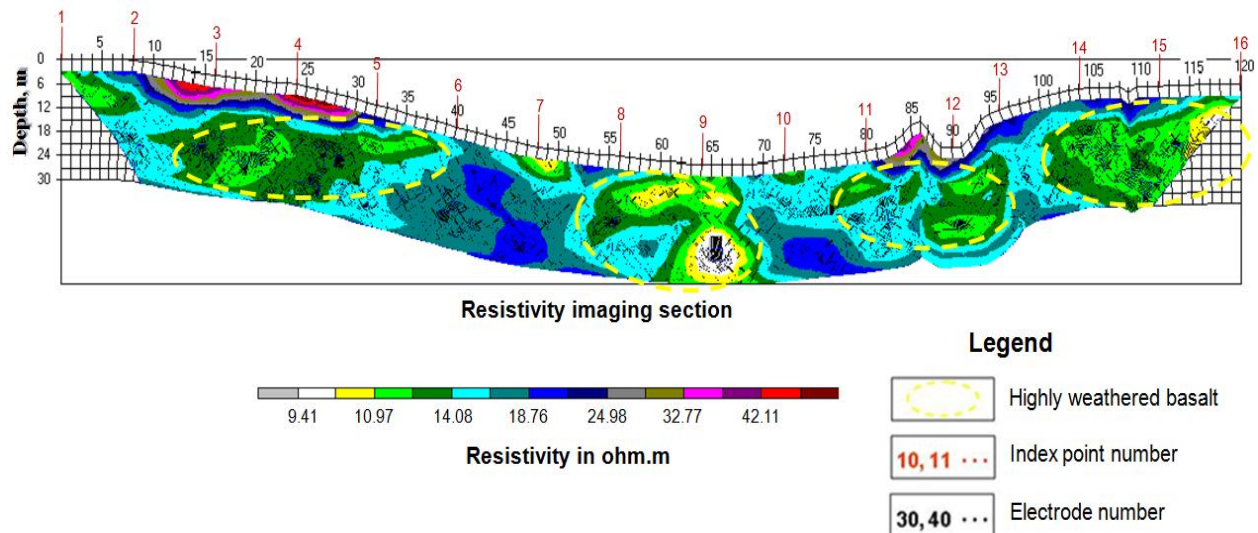
Figure 4.3: Resistivity imaging section along survey line GP2

- On the resistivity imaging section found at downstream of the Dam axis, the relatively low resistivity values less than  $14\Omega\cdot\text{m}$  reflected at the sub parts marked with elliptical block around electrode number 23, 65, 90 and 110 may be due to the highly weathered basalt.
- On the resistivity imaging on the downstream side of the dam axis, the resistivity values except the sub part marked with elliptical block are higher than  $15\Omega\cdot\text{m}$ , and it is expected to be the response of top bed (between electrode numbers 8 and 31) and highly/moderately fractured basalt (between electrode numbers 36 and 52 as well as between electrode numbers 69 and 78).

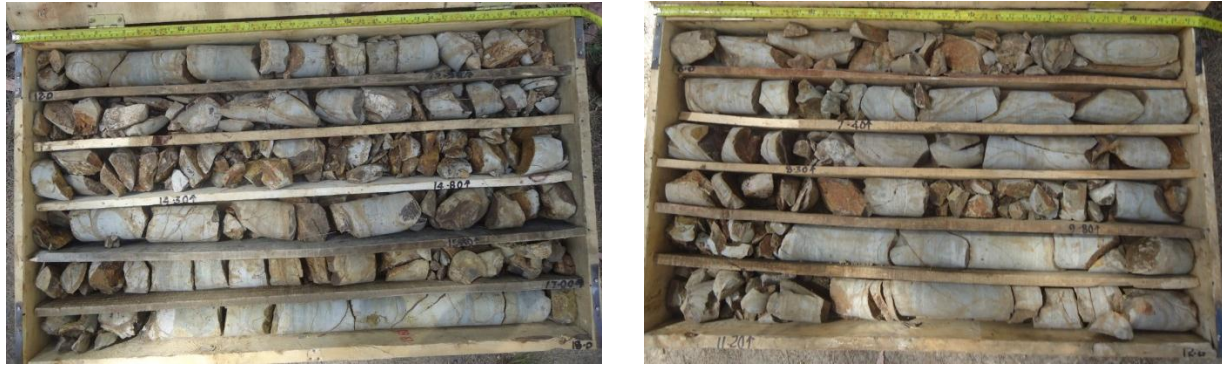
Plate 5.1: Photo showing the intensively fractured rock mass at the intake foundation

Intact rock properties are derived and characterized based on laboratory studies of samples collected from field work. The rock mass is characterized using the Geomechanics rock mass rating parameters which considers the intact rock property and effect of discontinuities, degree of weathering and the groundwater condition. Such properties of the rock mass were obtained from measurement and examination of drilling recovered core samples.

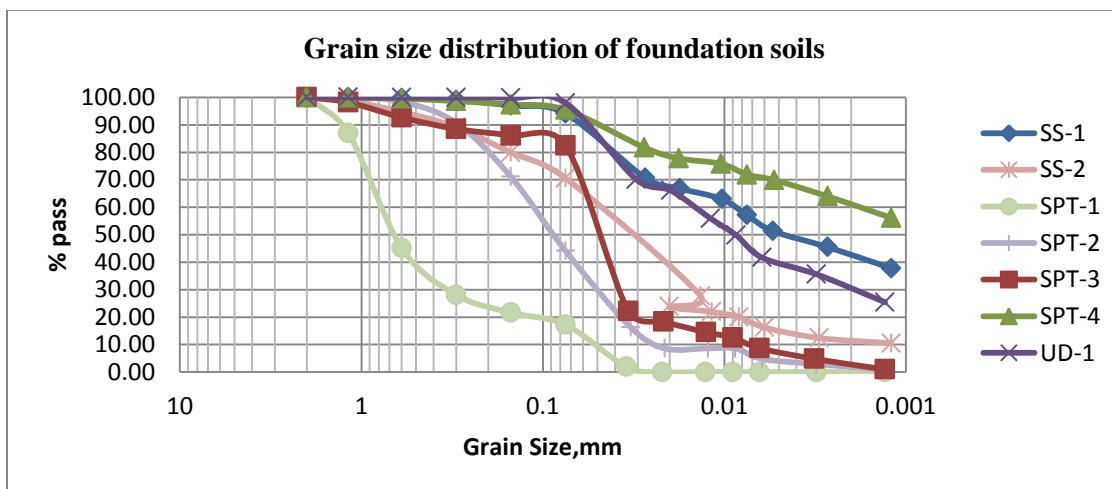
Figure 5.3: Grain size distribution curve of foundation soil samples

All the soil samples collected from boreholes and test pits are classified as MH/OH which is inorganic silts of high plasticity/ organic silts of high plasticity.

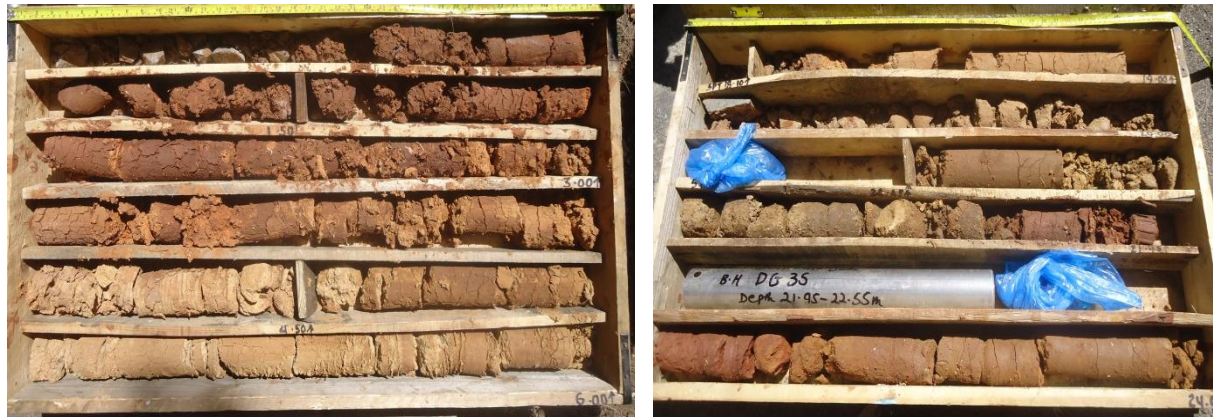
Plate 5.2: Photo showing residual soil at dam site

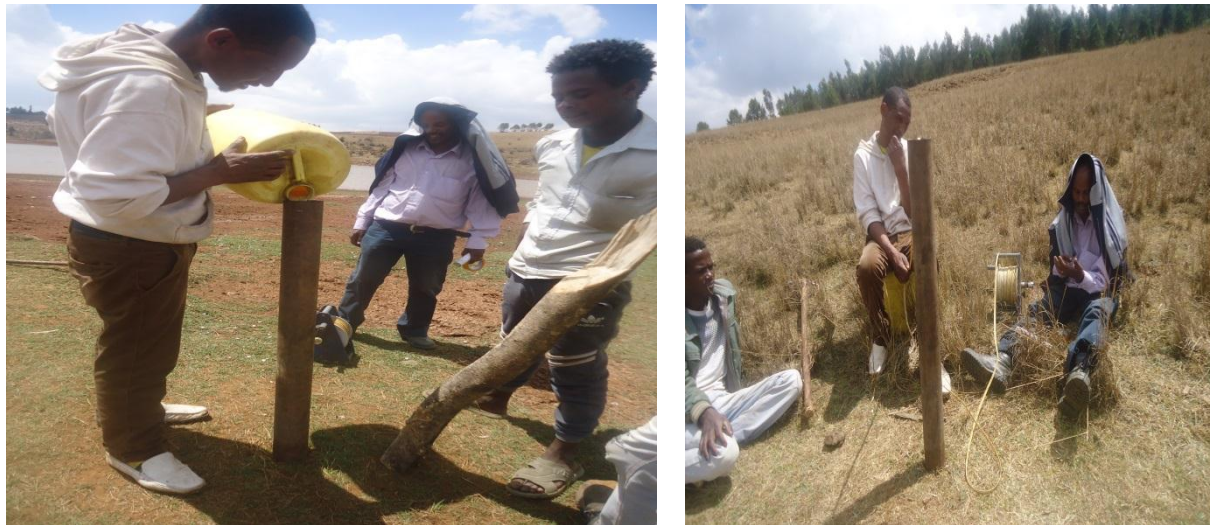
Plate 5.3: In situ infiltration tests in the reservoir area of the project area

The in situ falling head tests show that the silty clay soil has average infiltration rate ranging from  $1.34 \times 10^{-4}$  to  $7.45 \times 10^{-5}$  cm/s. Thus it is concluded from the field investigation and laboratory test results that the reservoir area of Gefersa Dam III is covered by sandy clayey silt/ sandy silty clay soil blanket of low permeability.

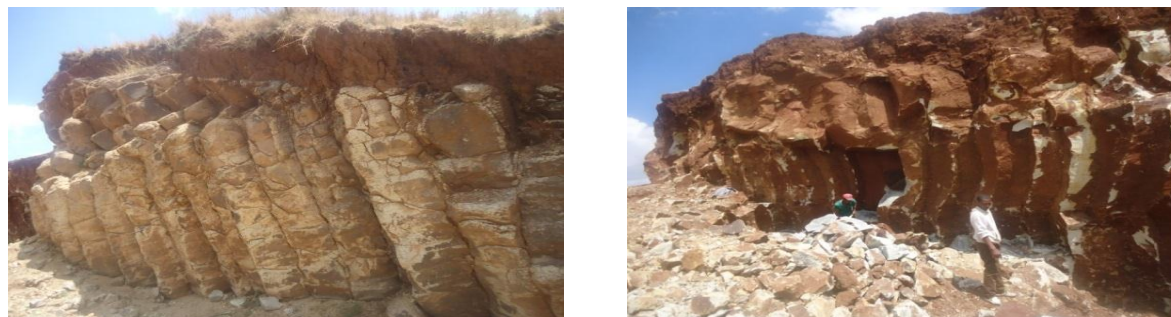
Plate 5.5: Proposed ignimbrite rock quarry for rip rap and masonry structures

Ignimbrite rock is abundant in the project area. The widely jointed, moderately to slightly weathered ignimbrite rock is the only material used for rock production for rip rap. Sites selected for rock quarry for the production crushed coarse aggregates are used for the production of rip rap for the proposed dams.

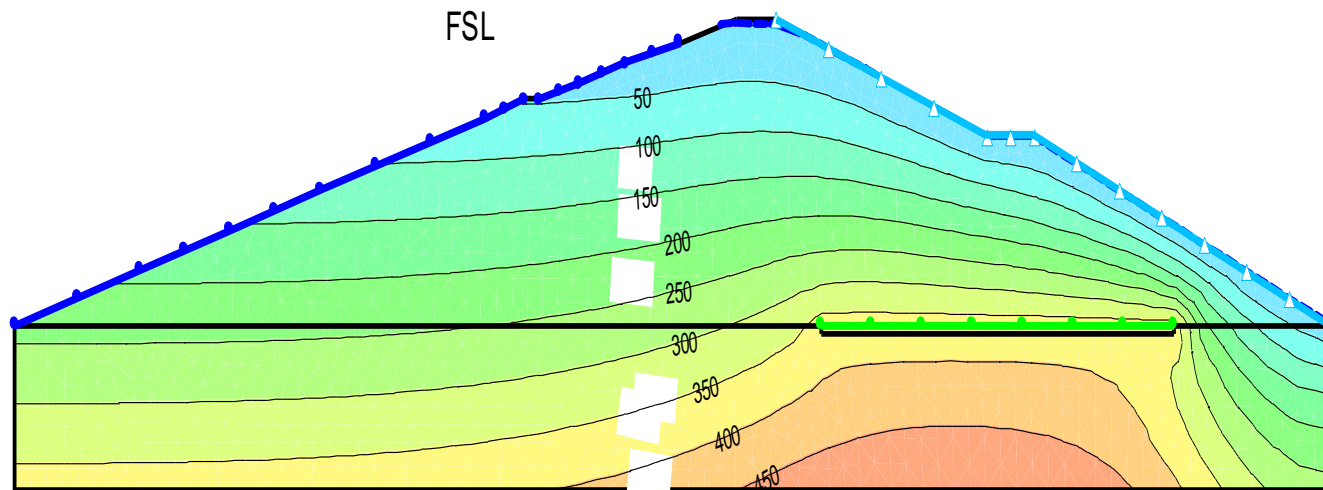
Figure 7: pore water distribution under steady state seepage

Pore-water distribution is also minimum at the top and maximum at the bottom along with the depth of water increment. The graphical representation of vertical and horizontal velocity and hydraulic gradient are presented below. As the graph show their value displayed centrally as expected.

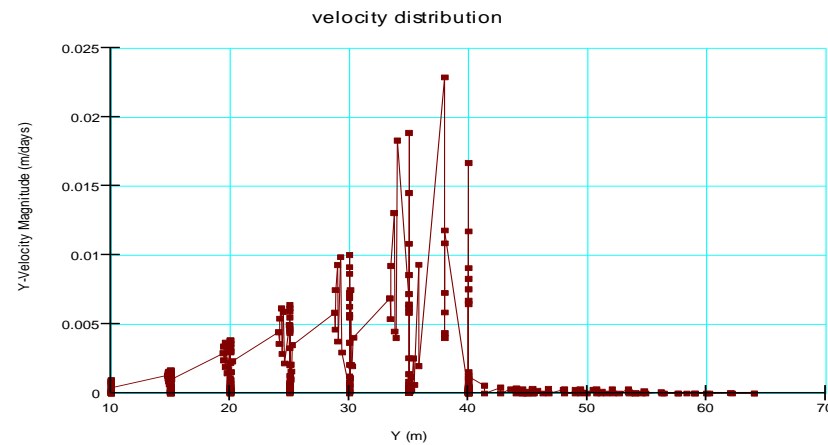
Figure 9:- y-velocity distribution vs y-coordinate through the body and foundation

The y-velocity distribution determines how fast the seep water to the foundation of the dam rather than to the body of the dam. As the above figures shows that the maximum velocity in the direction of x and y-axis are 0.023m/sec and 0.024m/sec respectively.

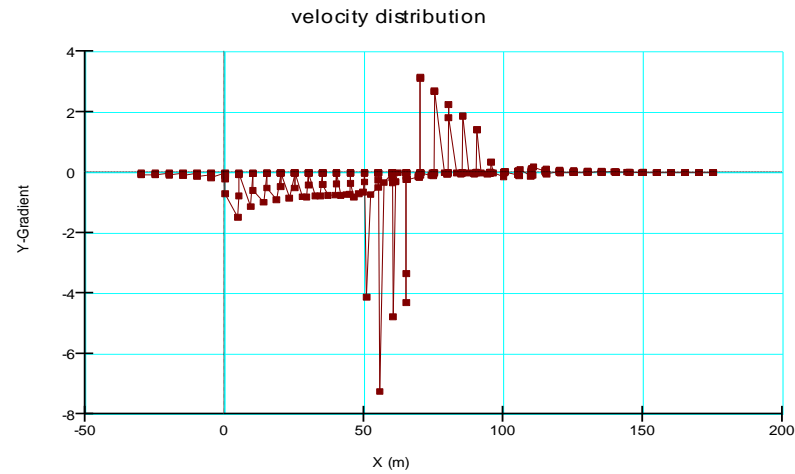
Figure 10:- y-gradient vs x-coordinate through the body and foundation

The y gradient of seep water to the body of the dam have steep slope (7.7) near the center of the dam at which the seep water dropped to the foundation with high gradient rather than crossing the body of the dam.

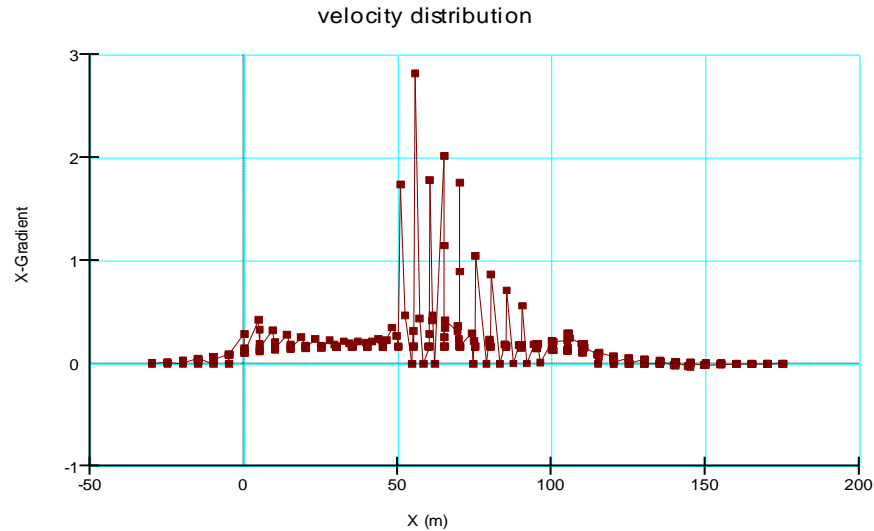
Figure 11:- x-gradient vs x-coordinate through the body and foundation

The x-gradient of seep water to the body of the dam have steep slope (2.8) near the center of the dam at which the seep water dropped to the foundation with high gradient rather than crossing the body of the dam.

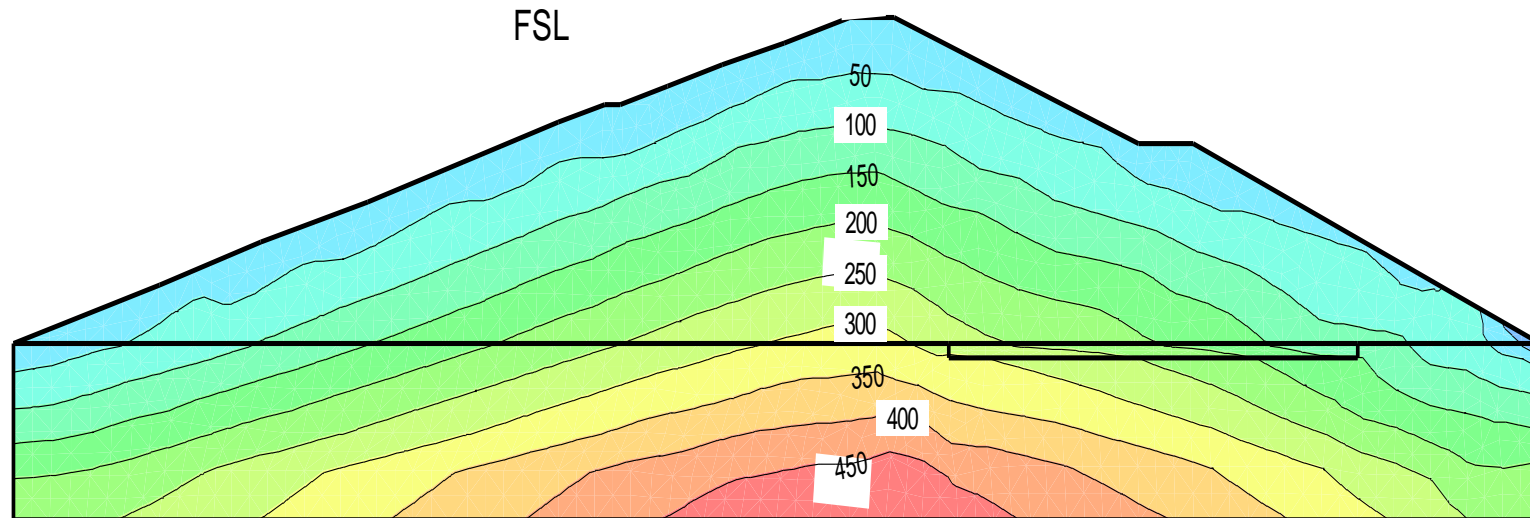
The stress and pore-water distribution are also presented below. The maximum value is 450kpa/m at the bottom and minimum value of 50kpa/m at the top as it expected.

Figure 11:- stress distribution over the dam
