**Engineering Geological Appraisal of Dam Foundation
For Gumara Dam, Amhara Region, North Western Ethiopia**

***In Partial Fulfillment of the requirements for the Degree of
Masters in Engineering Geology***

Agerie Genetu

July 2007

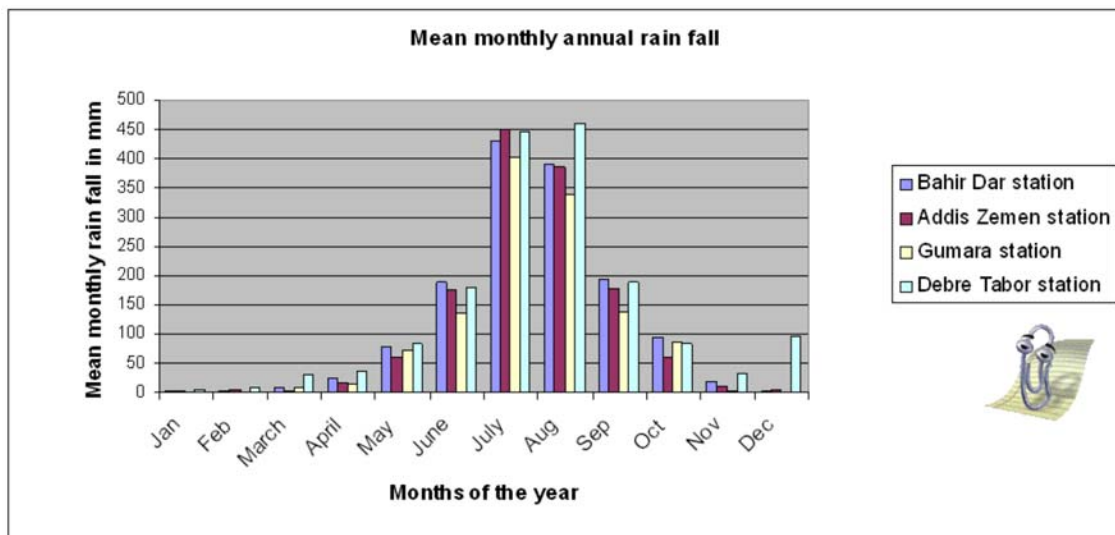
Fig. 2.3 Mean monthly annual rainfall as recorded at different meteorological stations around study area

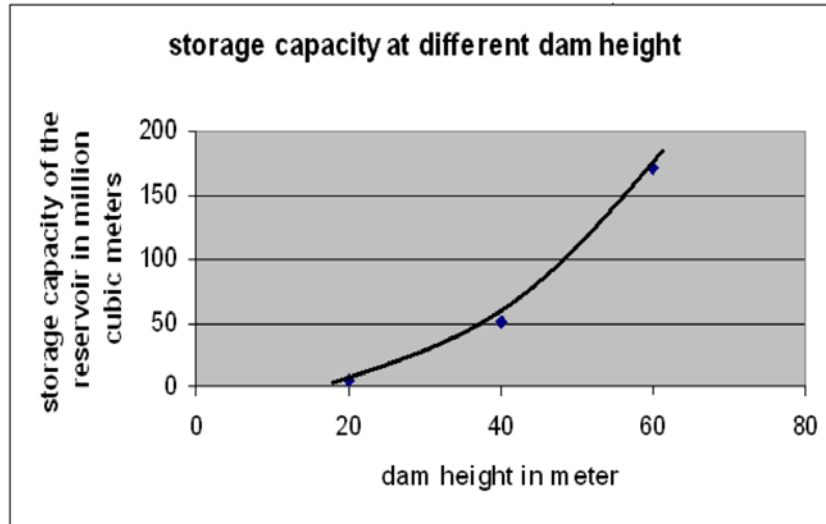
Fig.2.5 Computed storage capacity at different dam heights

Thus by using planimeter area for successive contours total reservoir volume at different levels were calculated. On the proposed dam axis of Gumara three contours at equal interval of 20 meters above the datum has been worked out. Table 2.9 and Fig.2.5 show the computed storage capacity at different dam heights. Thus the maximum storage capacity at maximum reservoir level comes out to be 171.6 M m³.

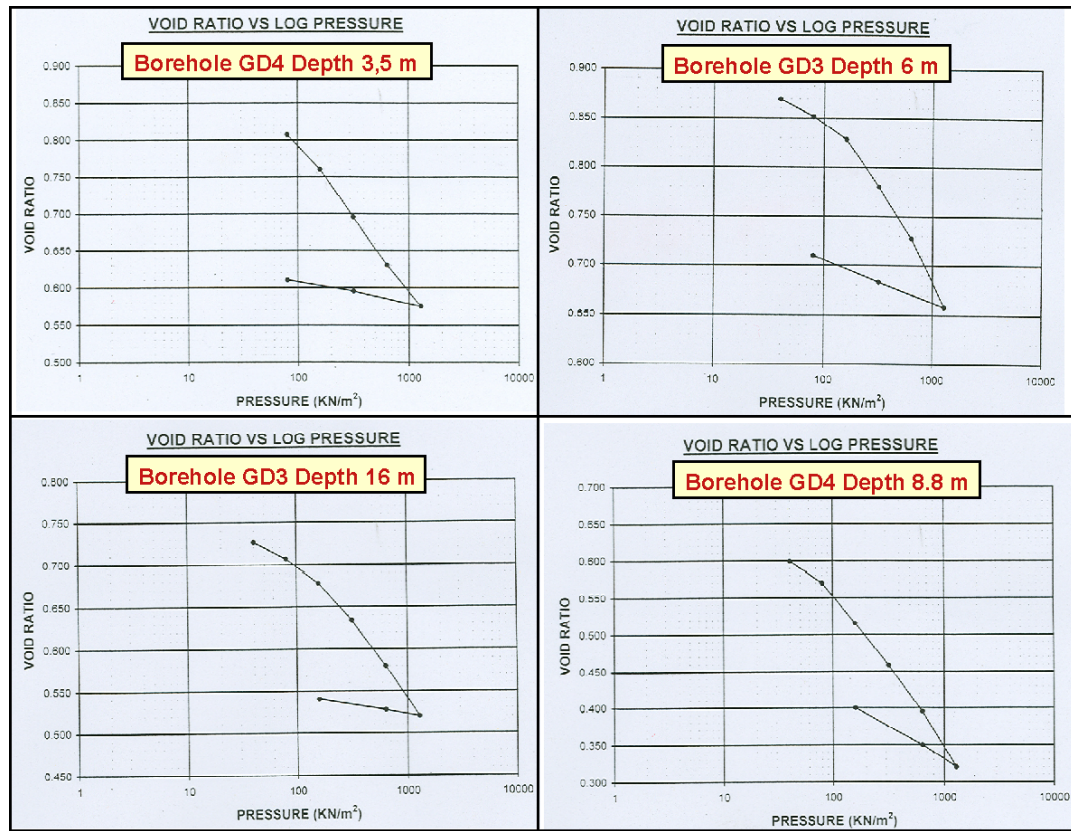
Fig. 4.8 Void ratio Vs Log Pressure curves for soil samples from foundation area
